# MoDOT Pavement Preservation Research Program

## Volume V. Site-Specific Pavement Condition Assessment

Final Report Prepared for Missouri Department of Transportation  
November 2015

Report cmr16-004

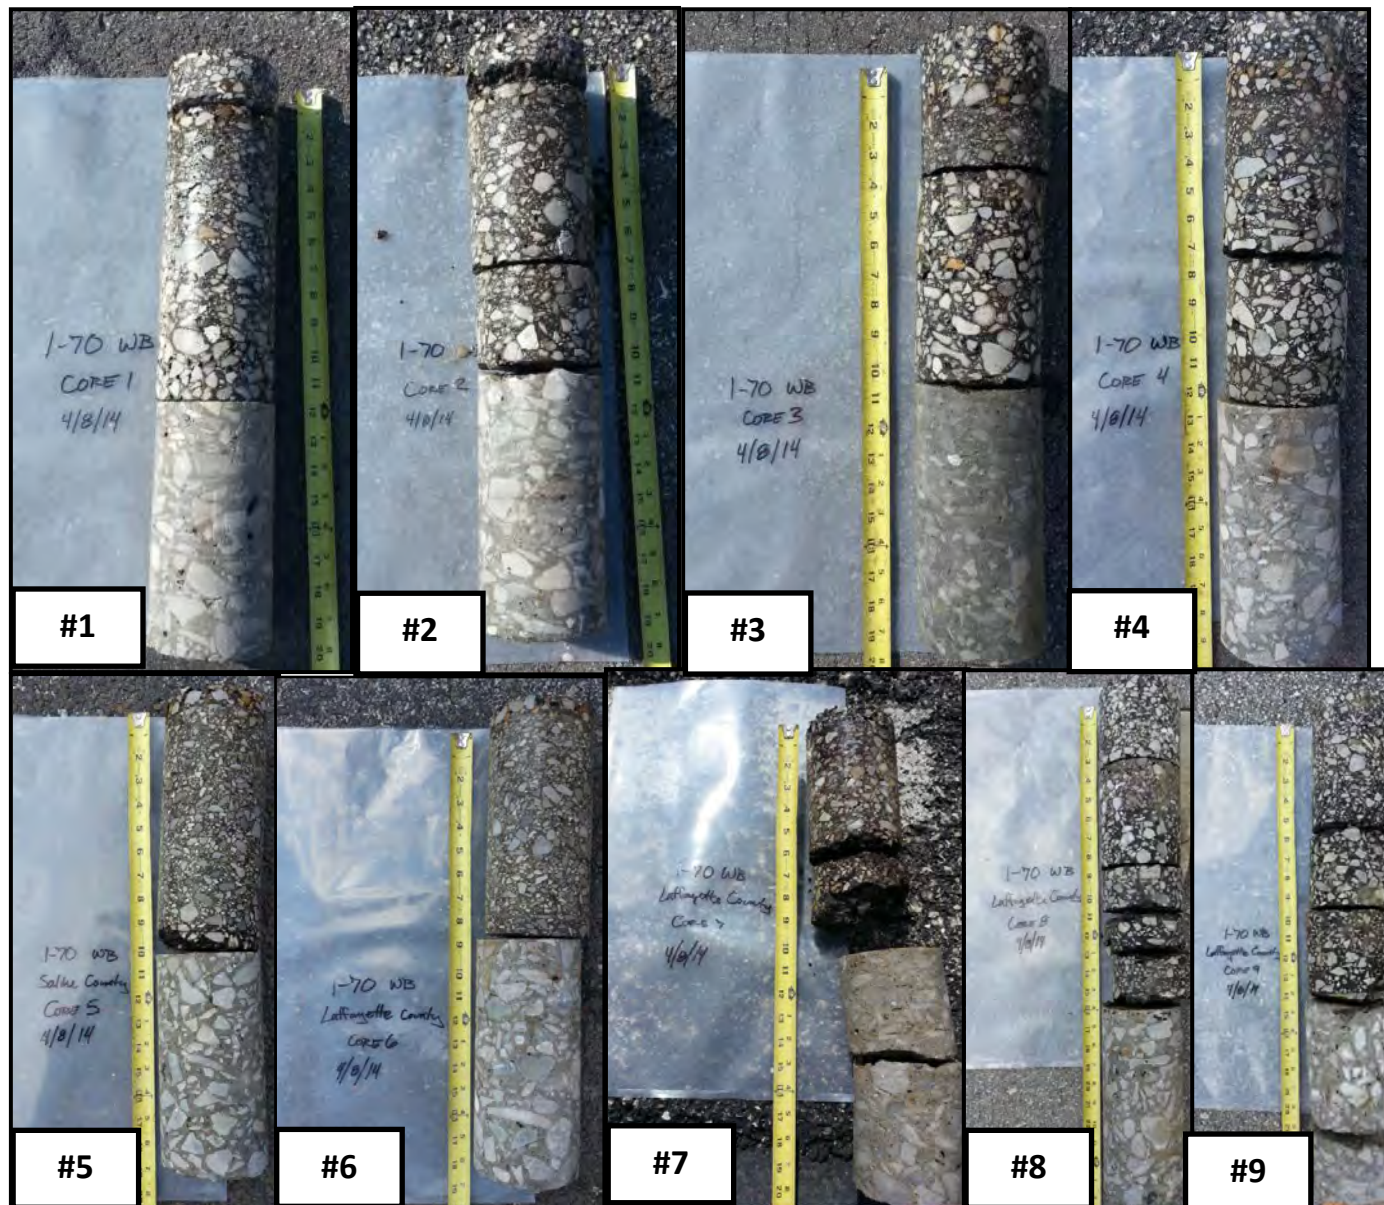
Fig. 2.39—Photographs of cores extracted at I-70 (network-level Site 9).

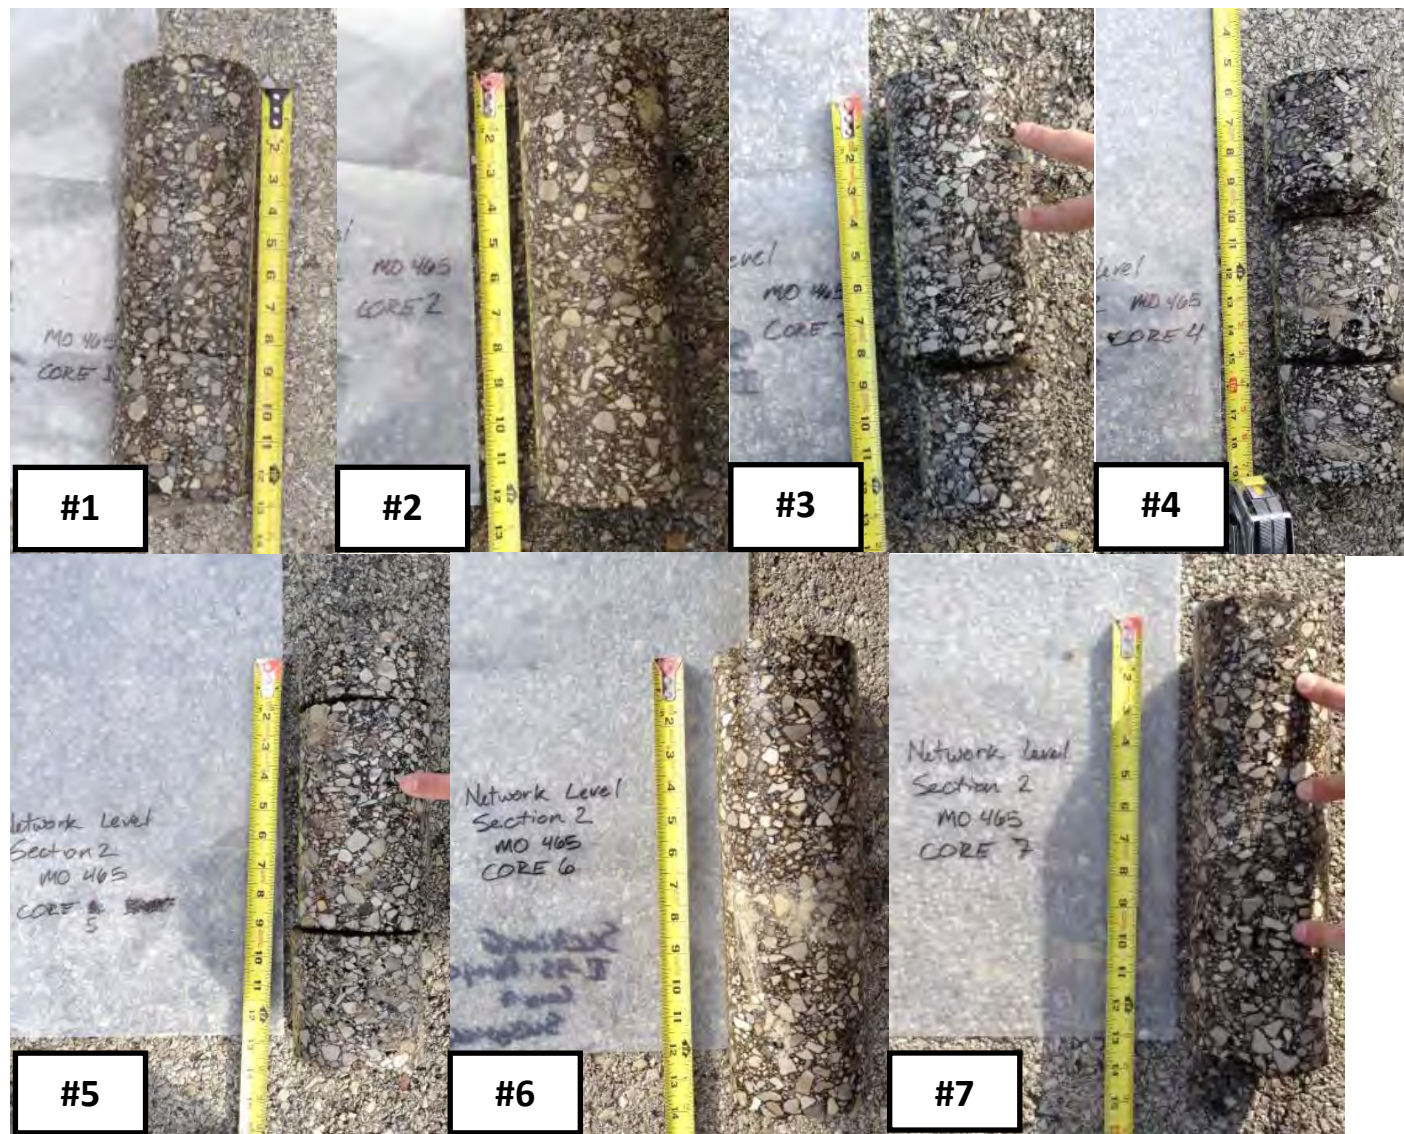
Fig. 2.40—Photographs of cores extracted at MO 465 (network-level Site 10).

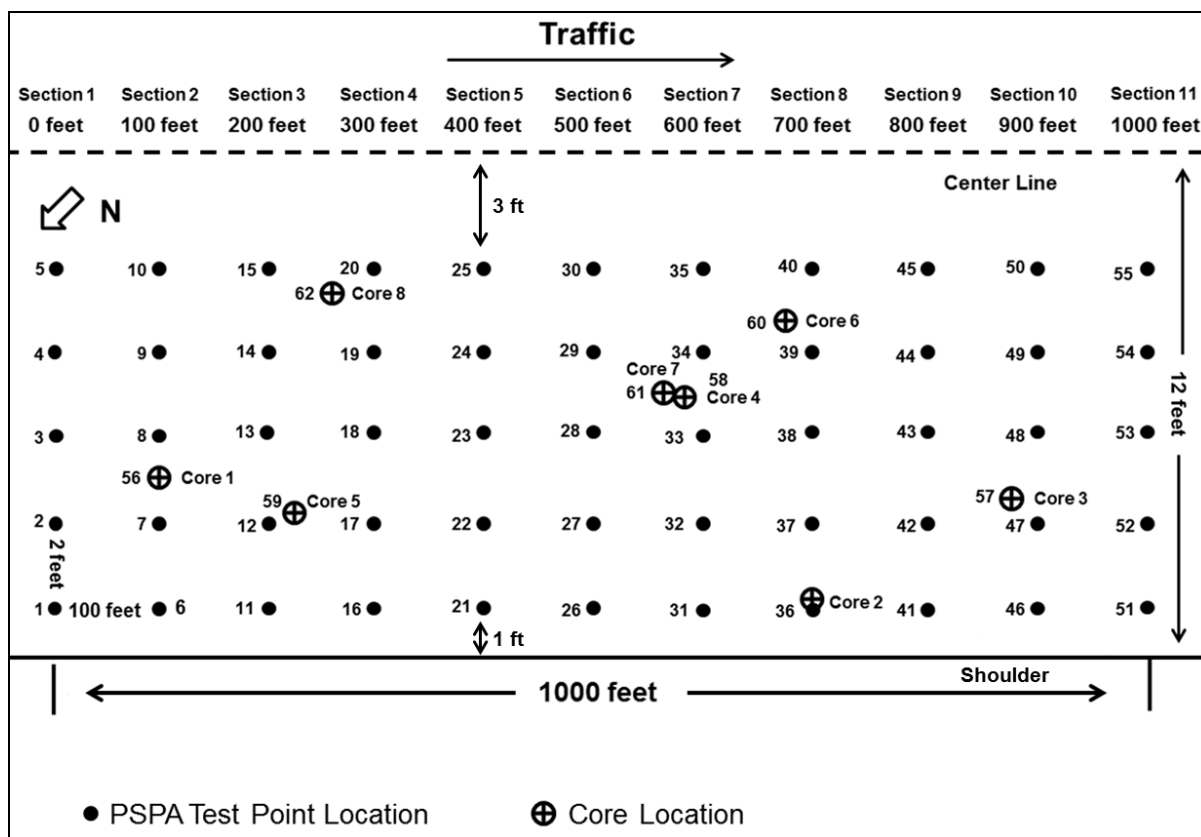
Fig. 3.2–Not-to-scale sketch showing PSPA test grid (2 ft x 100 ft) employed for each project-level Sites 1-6 and 8 (a 1.5 ft x 100 ft grid was employed at Site 7). As shown, five PSPA data sets (e.g. 1-5, 6-10, etc.) were acquired every 100 ft along each project-level pavement section. In total, 55 PSPA data sets were acquired for each project-level investigation except Sites 7 and 8 (where 66 PSPA data sets were acquired). All PSPA data sets were acquired along a GPR traverse (see Section 4 of this report). The spacing (1 ft in figure) between the outermost PSPA test locations and the edge of pavement varied from site to site. Core locations also varied from site to site.

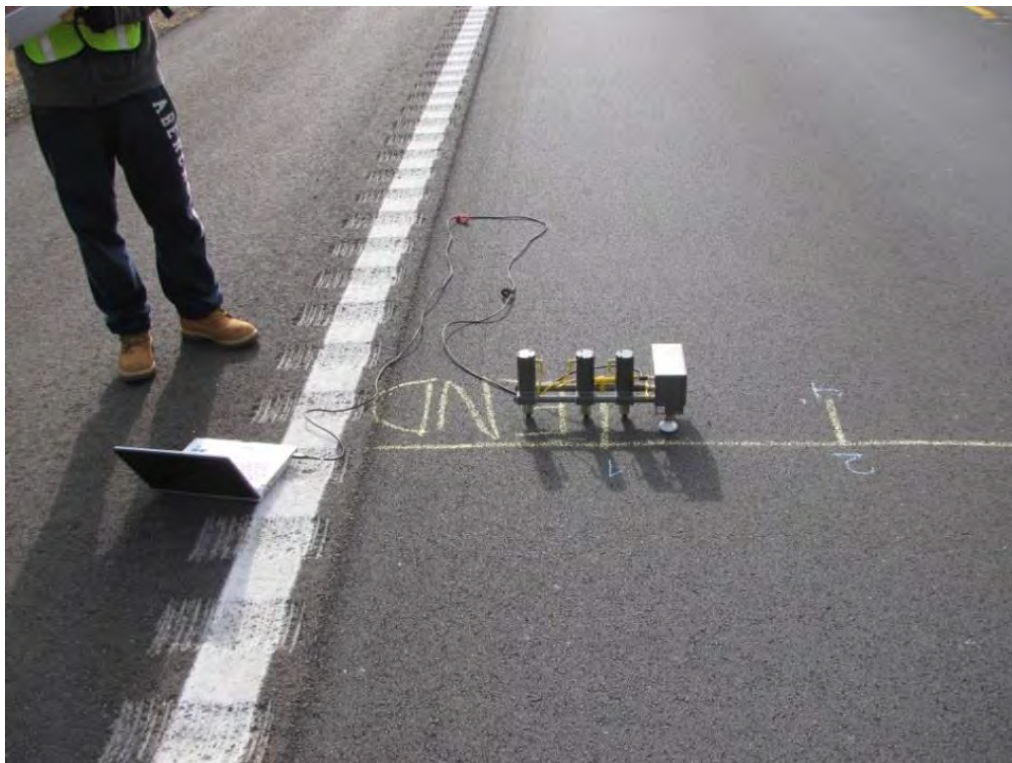
*Fig. 3.6—Photograph of PSPA tool placed on pavement at project-level Site 1 (US 63 N). Core 04 and the corresponding PSPA elastic modulus plot are shown in Fig. 3.9. The BM/PCC interface was debonded. However, there was no evidence of physical or chemical degradation of the underlying PCC.*

The average elastic modulus of the BM in core 04 is 3195 ksi indicating the BM is fair quality (Table 3.2). However, the elastic modulus of the BM is slightly less than 3100 ksi near the debonded BM/PCC interface. The apparent average modulus of underlying concrete layer is 3386 ksi. The average modulus of entire 5 in. tested section of BM and PCC is 3313 ksi.

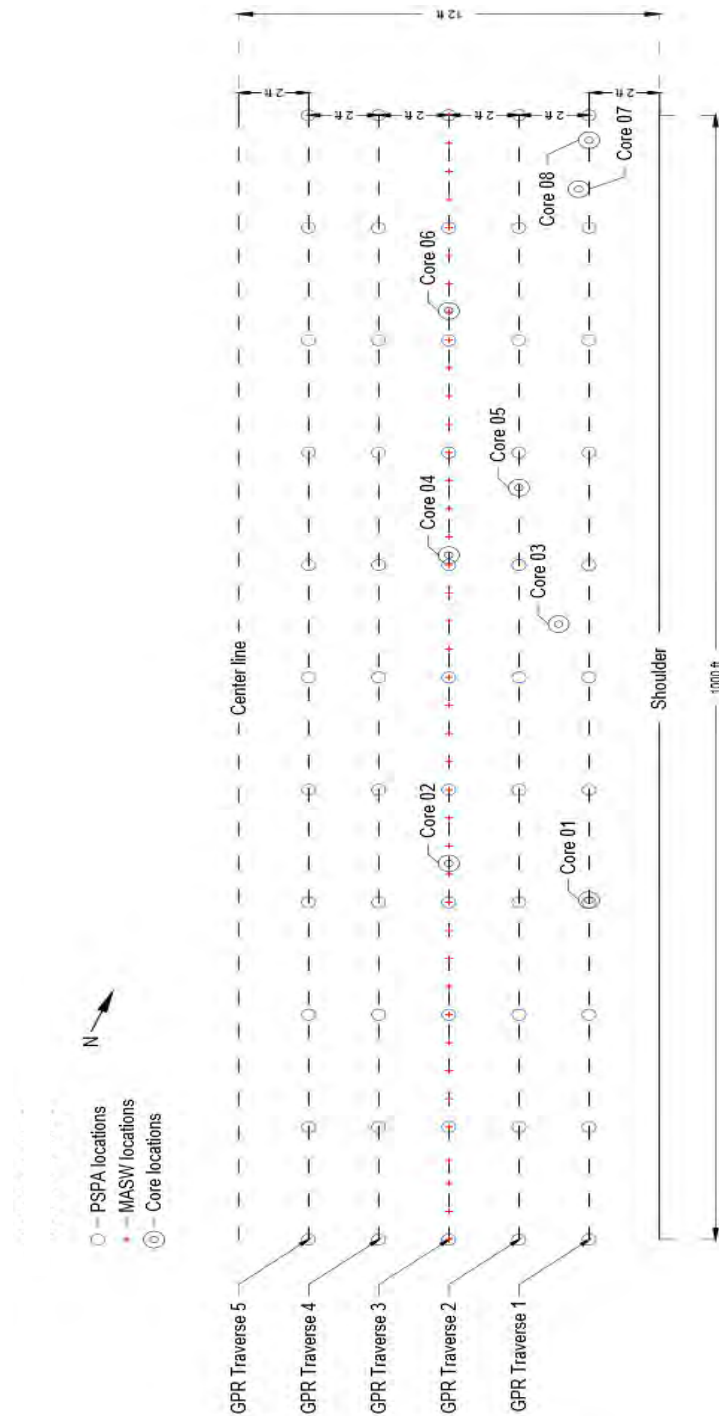
Fig. 3.7—Base map for project-level Site 1 showing PSPA test locations and core locations. PSPA data were acquired at 100 ft intervals along each GPR traverse. GPR traverse 1 was located 2 ft from the outer edge of the driving lane (shoulder). Only cores 1 and 4 were located within 10 ft of a PSPA location.

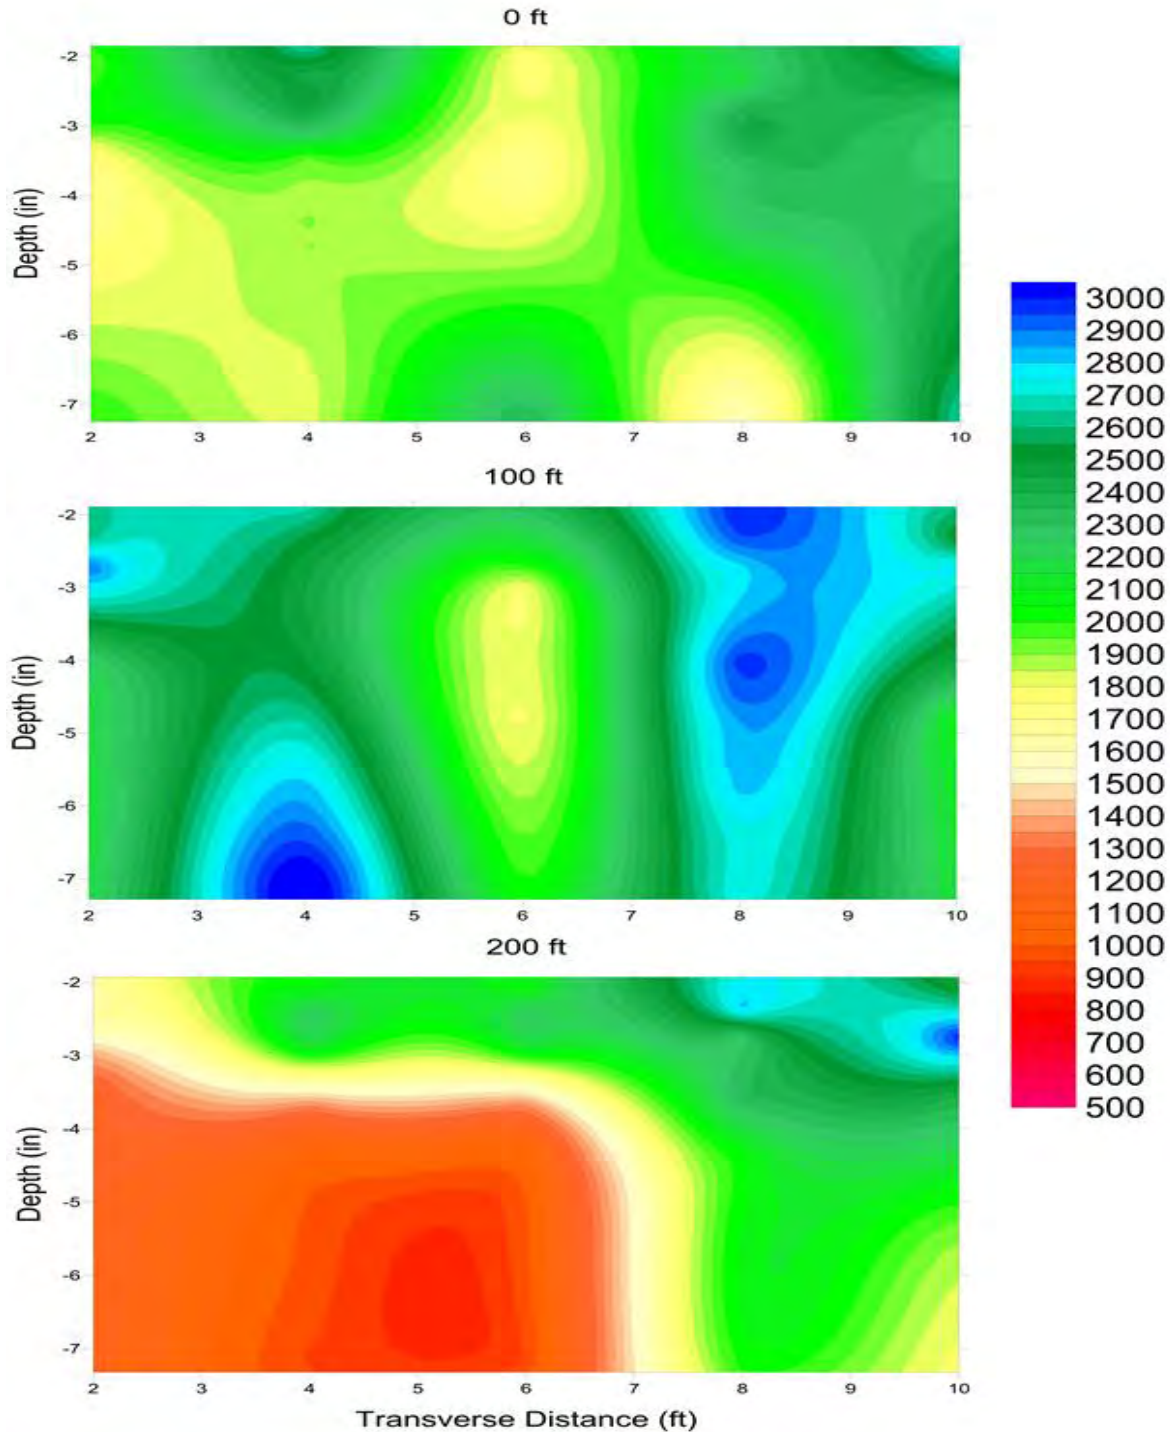
Fig. 3.25—Cross-sections depicting variations in the PSPA USW elastic modulus (ksi) of the BM at the 0 ft, 100 ft, and 200 ft intervals along the GPR traverses. The five PSPA USW data sets in each cross-section were acquired at 2 ft intervals starting 2 ft from the edge of pavement (Fig. 3.20). Depth of investigation extends from 2 in. to approx. 7.2 in.

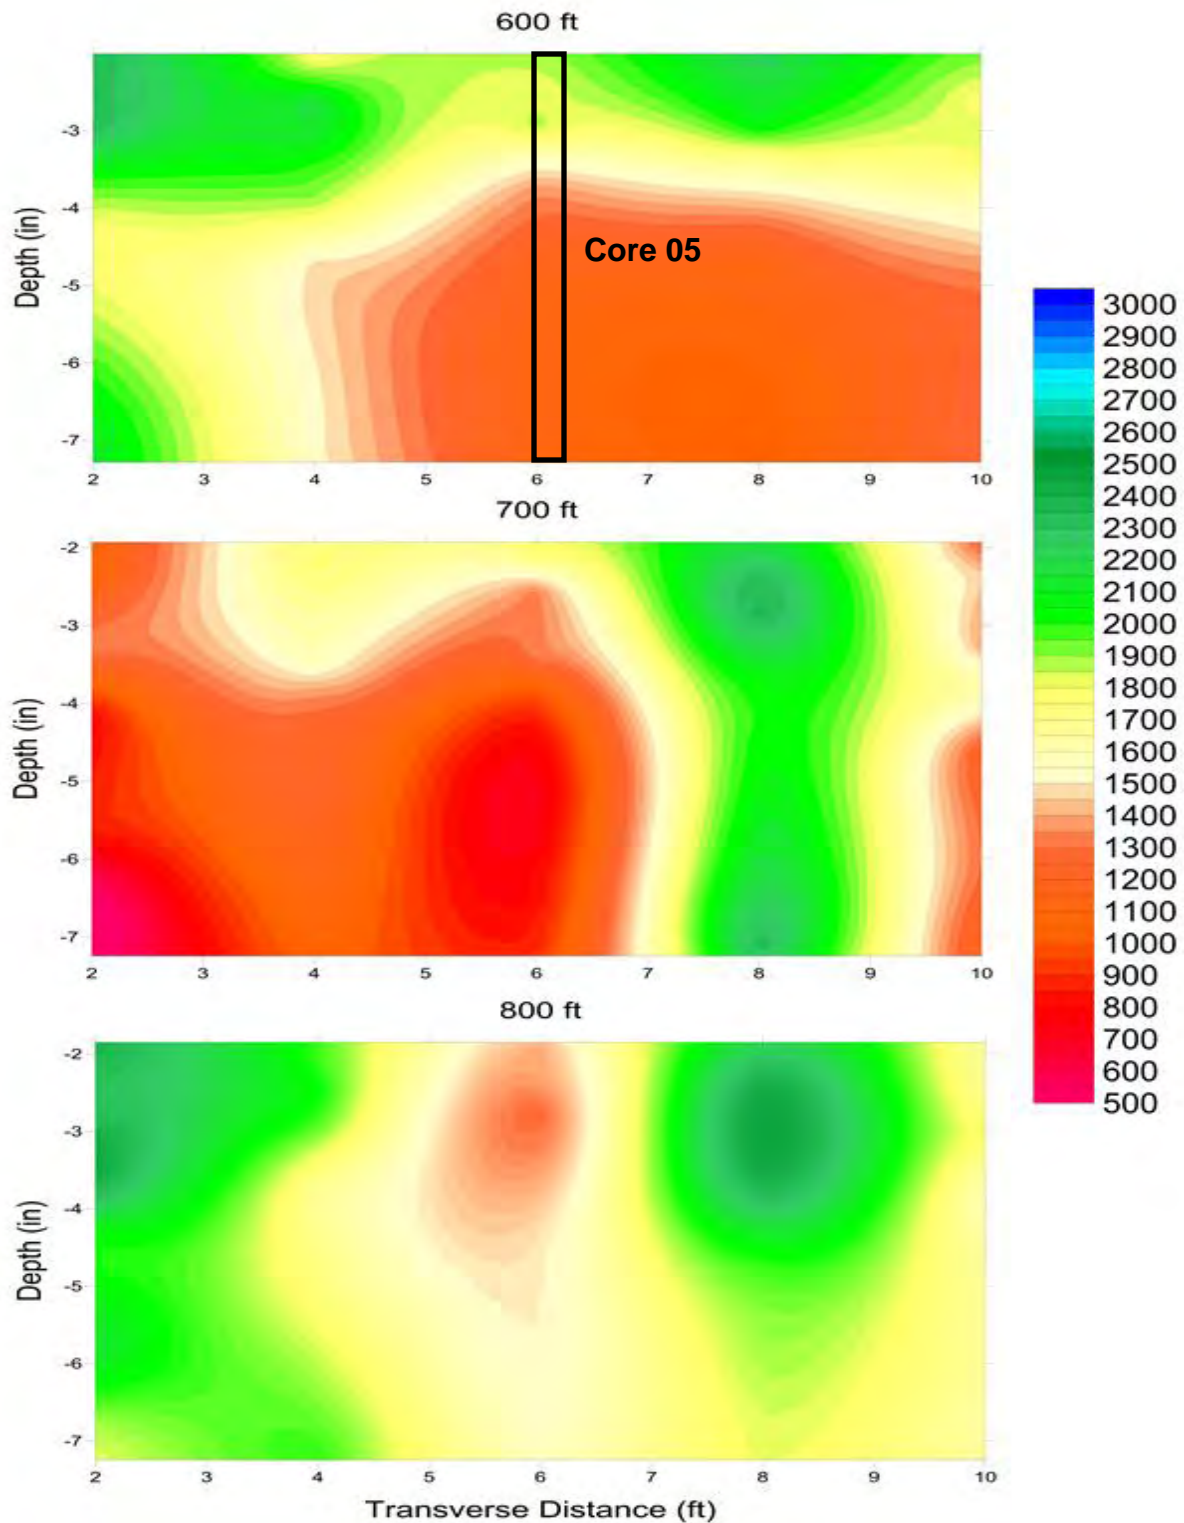
Fig. 3.27—Cross-sections depicting variations in the PSPA USW elastic modulus (ksi) of the BM at the 600 ft, 700 ft, and 800 ft intervals along the GPR traverses.

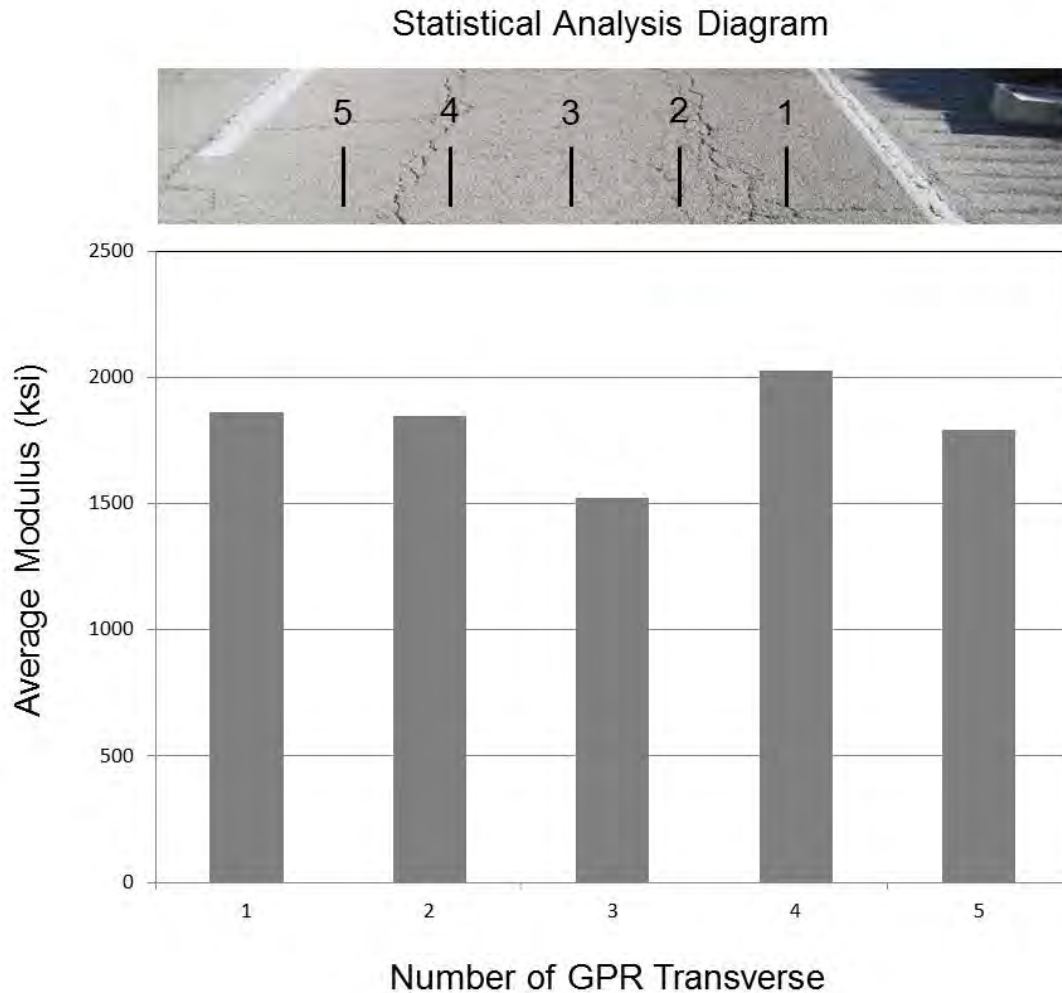
*Fig. 3.29—Plot of the average elastic modulus (over depth range of 2 to 7.2 in.) along each GPR transverse. The GPR traverses are spaced at 2 ft intervals. GPR traverse 1 is 2 ft from the outer edge of the pavement.*

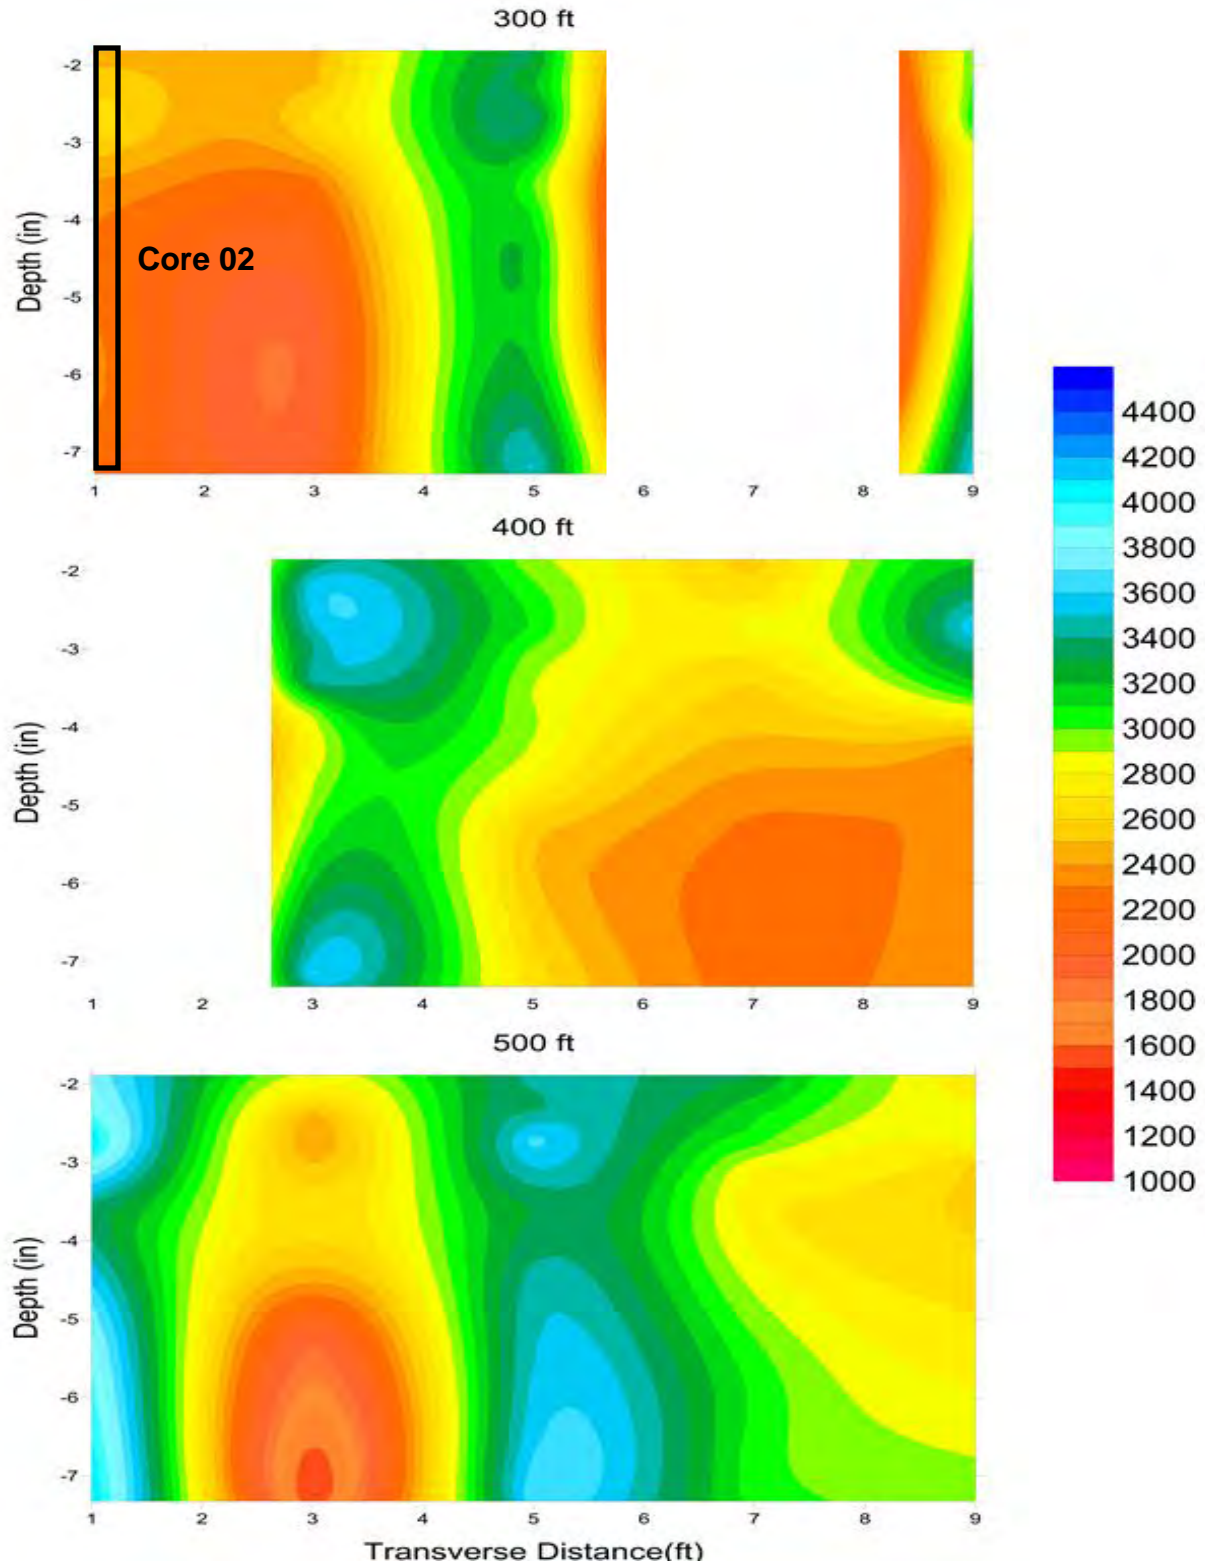
Fig. 3.38—Cross-sections depicting variations in the PSPA USW elastic modulus (ksi) of the BM at the 300 ft, 400 ft, and 500 ft intervals along the GPR traverses. PSPA data could not be acquired at several test locations because of the deteriorated nature of the paved surface.

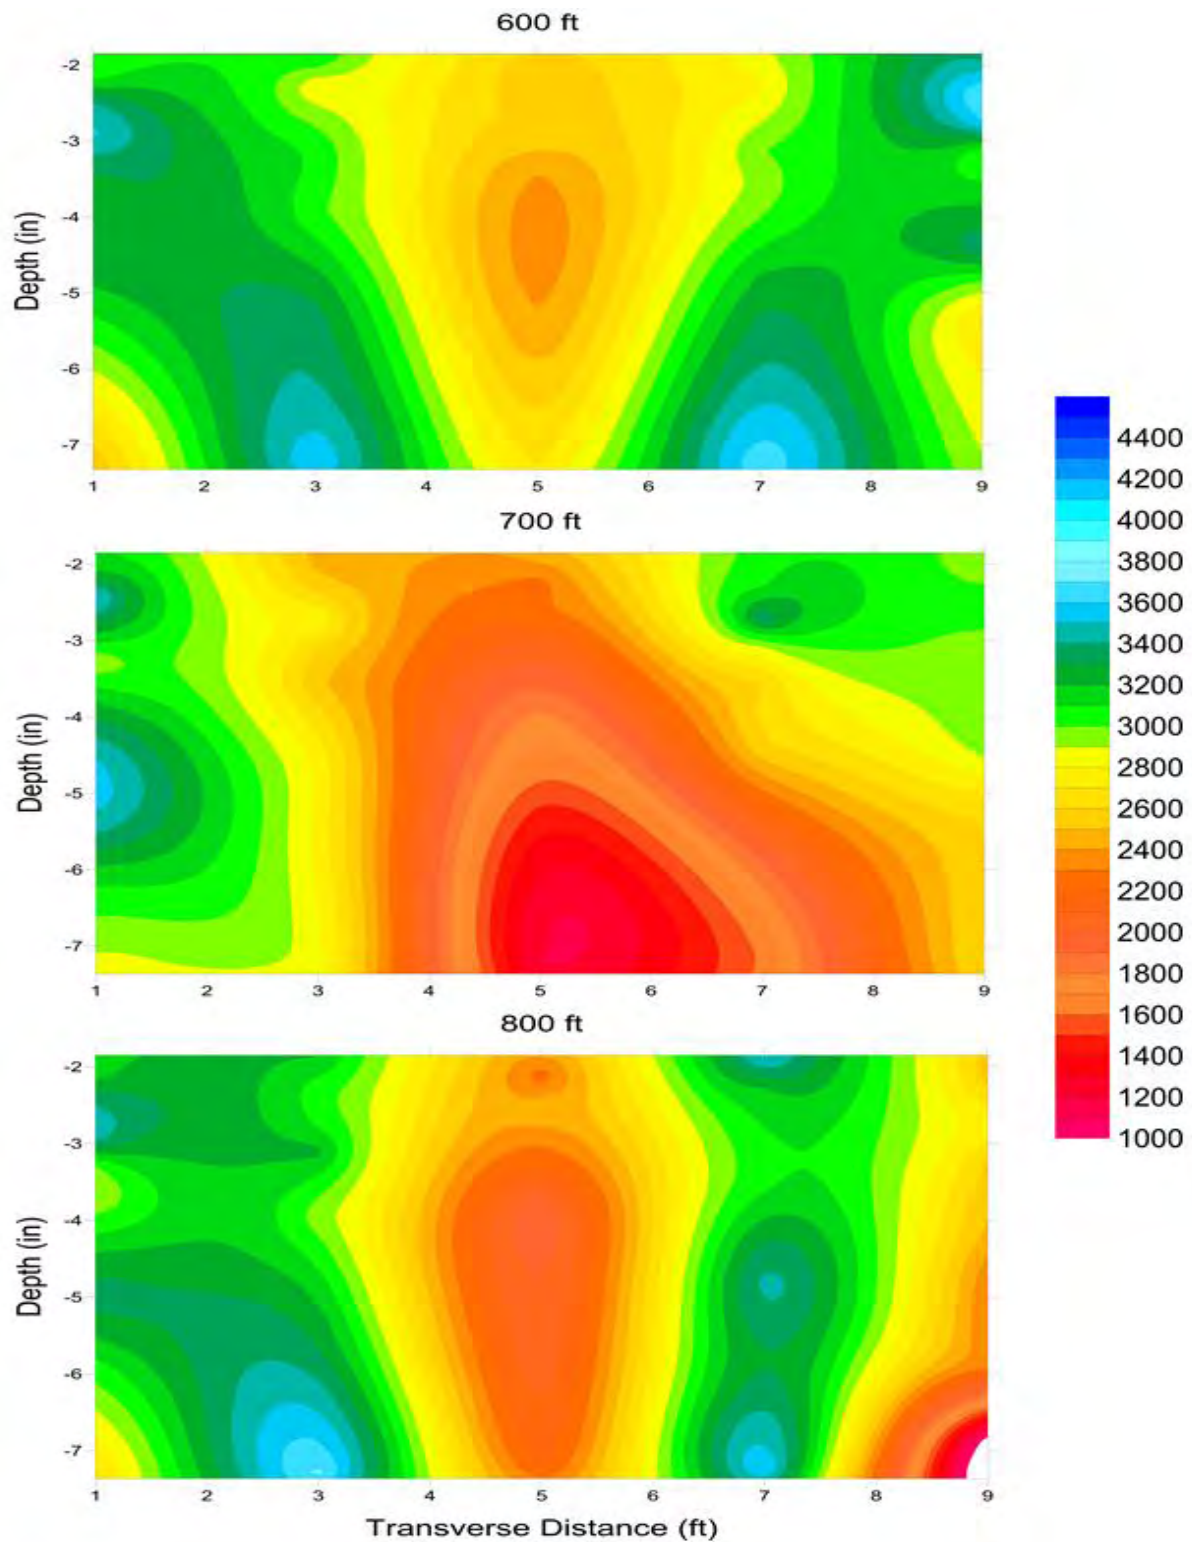
Fig. 3.39—Cross-sections depicting variations in the PSPA USW elastic modulus (ksi) of the BM at the 600 ft, 700 ft, and 800 ft intervals along the GPR traverses.

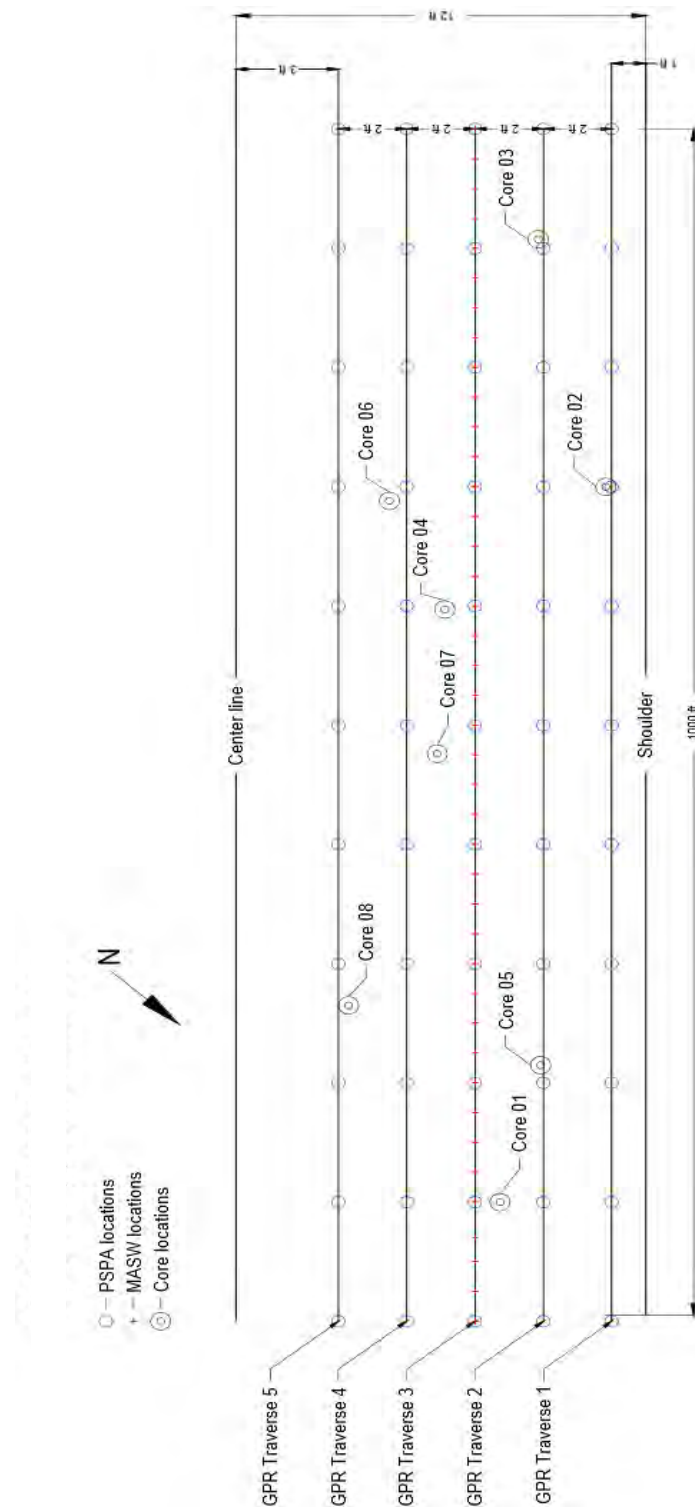
Fig. 3.56—Base map for project-level Site 5 showing PSPA test locations and core locations. PSPA data were acquired at 100 ft intervals along each GPR traverse. GPR traverse 1 was located 1 foot from the outer edge of the paved driving lane (shoulder). Only cores 01, 02, 03 and 04 are located within 5 ft of a PSPA location.

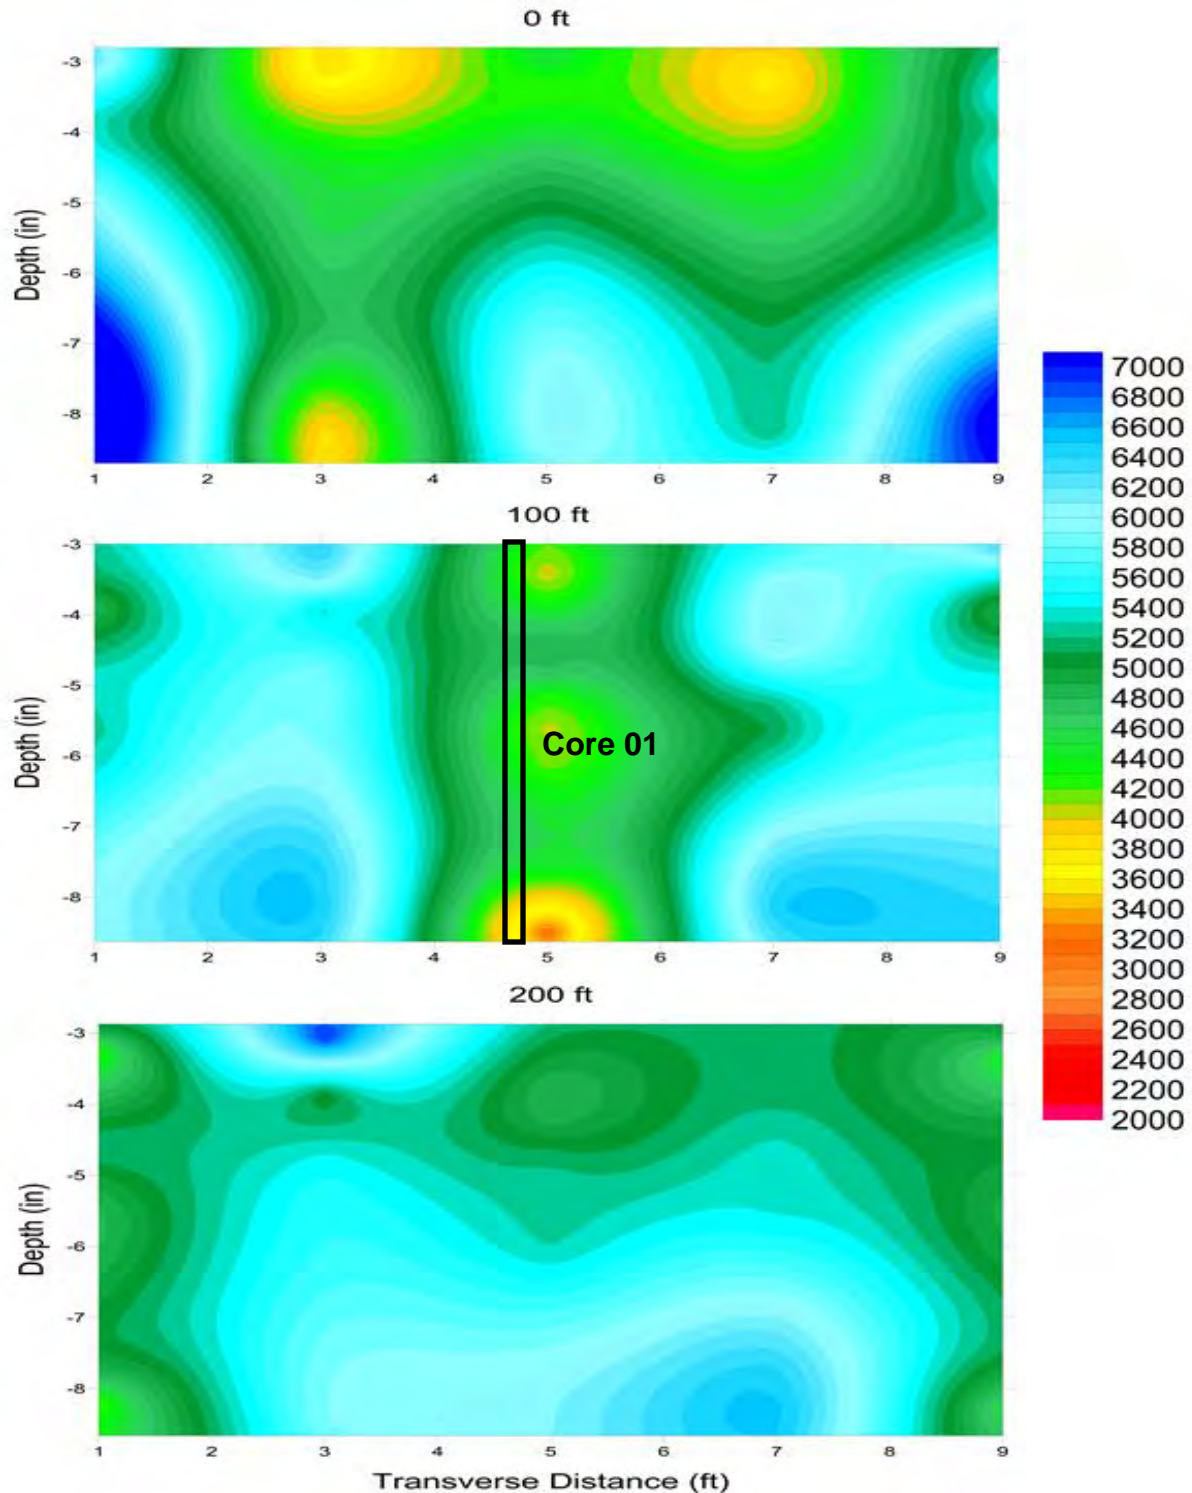
Fig. 3.61—Cross-sections depicting variations in the elastic modulus (ksi) for PCC for PSPA USW data acquired at the 0 ft, 100 ft, and 200 ft intervals along the GPR traverses. The five PSPA USW data sets in each cross-section were acquired at 2 ft intervals starting 1 ft from the edge of pavement (Fig. 3.56). Depth of investigation extends from 2 in. to 8.5 in.

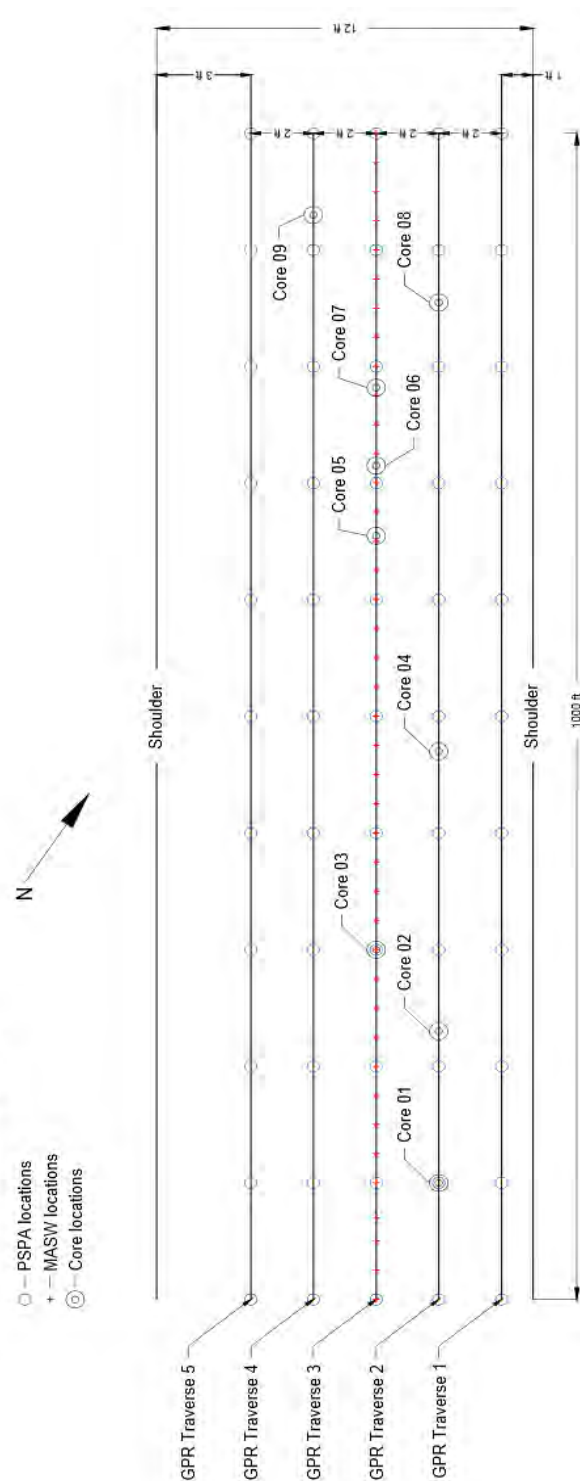
Fig. 3.71—Base map for project-level Site 6 showing PSPA test locations and core locations. PSPA data were acquired at 100 ft intervals along each GPR traverse. GPR traverse 1 was located 1 ft from the outer edge of the paved driving lane (shoulder). Only cores 01 and 03 are located within 5 ft of a PSPA location.

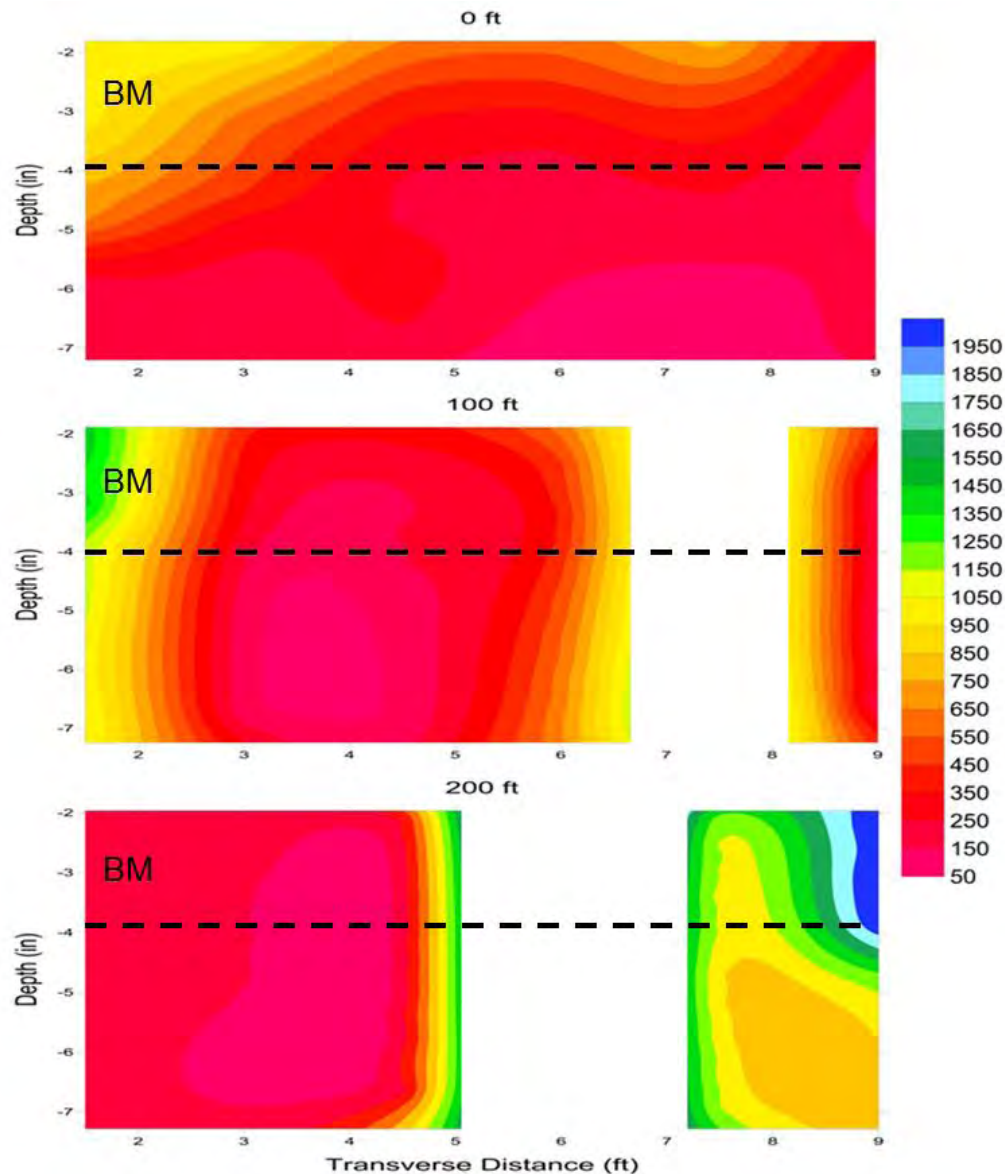
Fig. 3.84—Cross-sections depicting variations in the elastic modulus (ksi) for BM and for PSPA USW data acquired at the 0 ft, 100 ft, and 200 ft intervals along the GPR traverses. The six PSPA USW data sets in each cross-section were acquired at 2 ft intervals starting 1 ft from the edge of pavement (Fig. 3.81). Reliable PSPA data could not be acquired at several locations because of severe surface cracking. Where necessary and possible, the PSPA locations were shifted by up to 1 ft, so that data could be acquired as close as possible to the planned test locations.

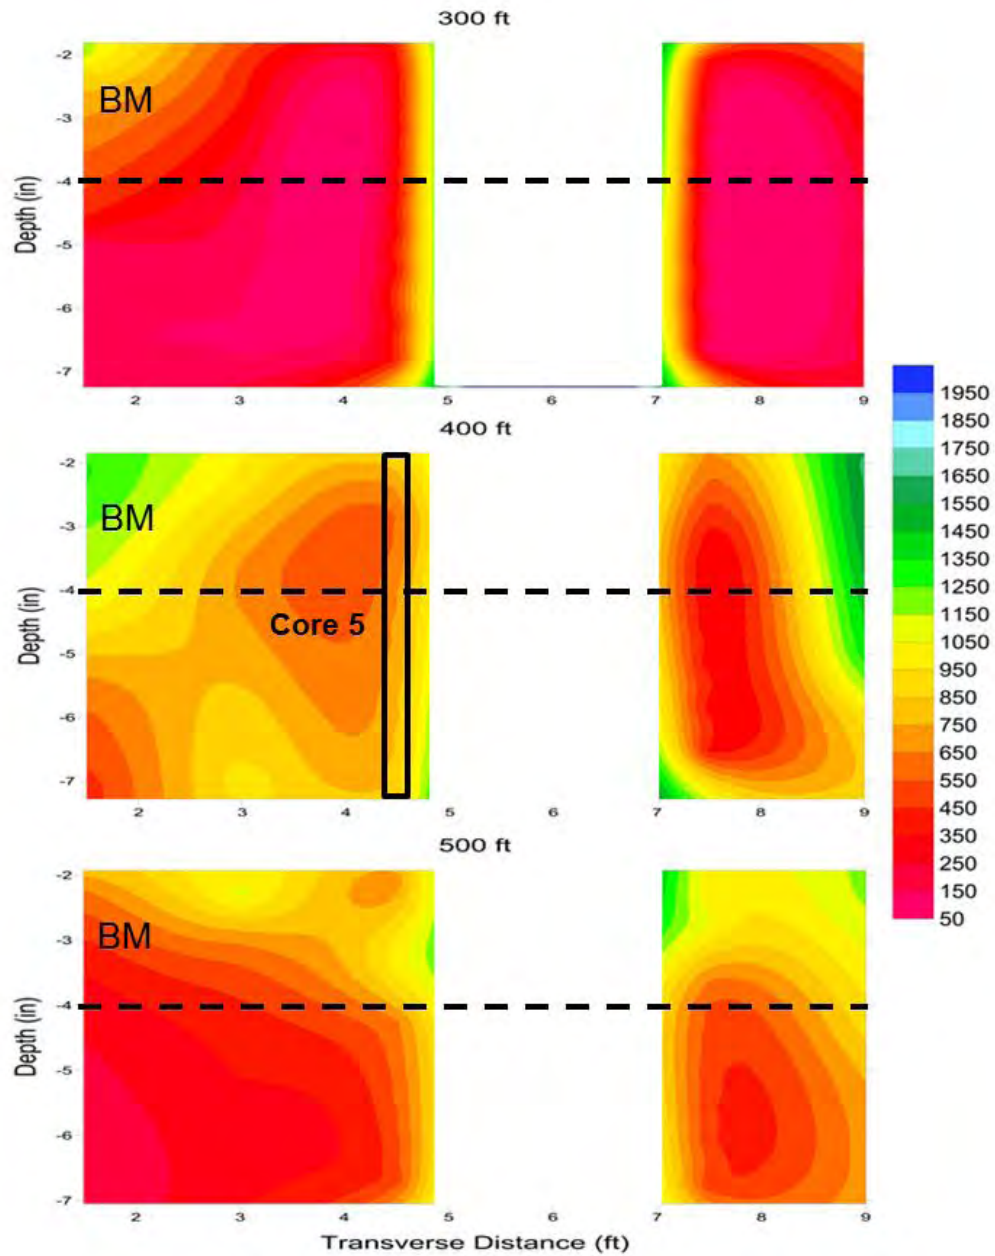
Fig. 3.85—Cross-sections depicting variations in the elastic modulus (ksi) for asphalt (BM) for PSPA USW data acquired at the 300 ft, 400 ft, and 500 ft intervals along the GPR traverses.

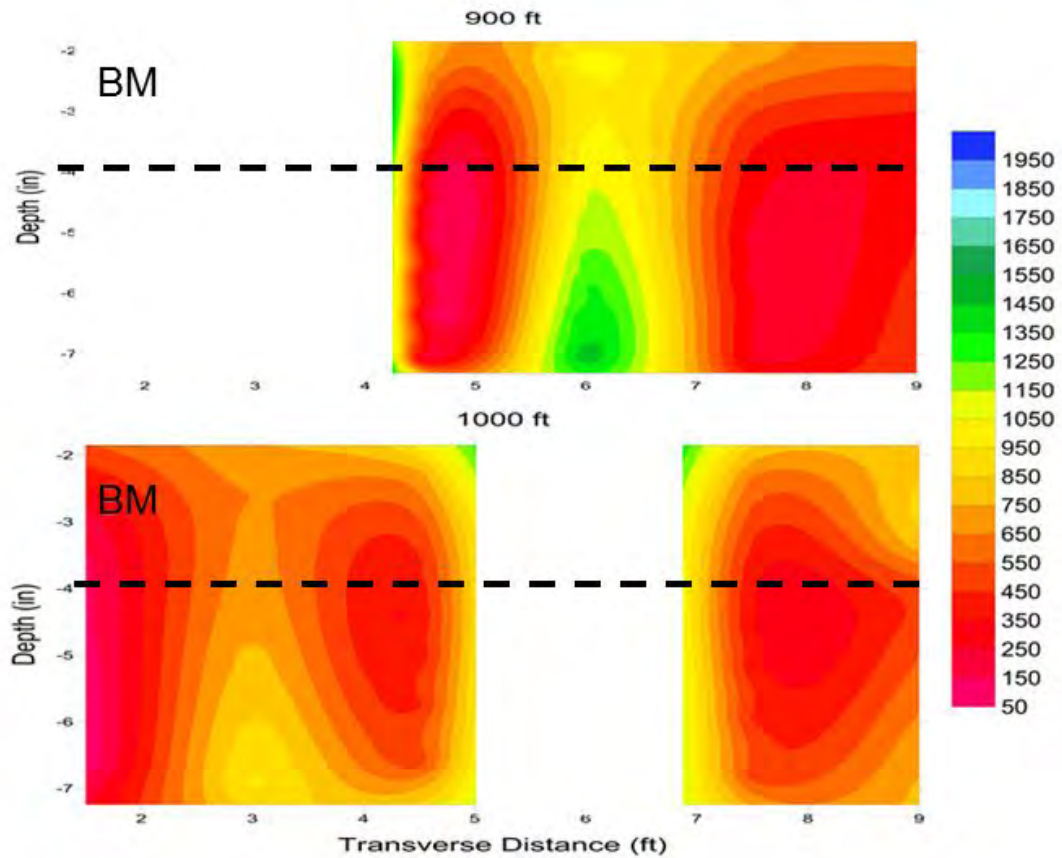
Fig. 3.87—Cross-sections depicting variations in the elastic modulus (ksi) for asphalt (BM) for PSPA USW data acquired at the 900 ft and 1000 ft intervals along the GPR traverses. PSPA data could not be acquired at several test locations because of the deteriorated nature of the paved surface.
