# MoDOT Pavement Preservation Research Program

## Volume V. Site-Specific Pavement Condition Assessment

Final Report Prepared for Missouri Department of Transportation  
November 2015

Report cmr16-004

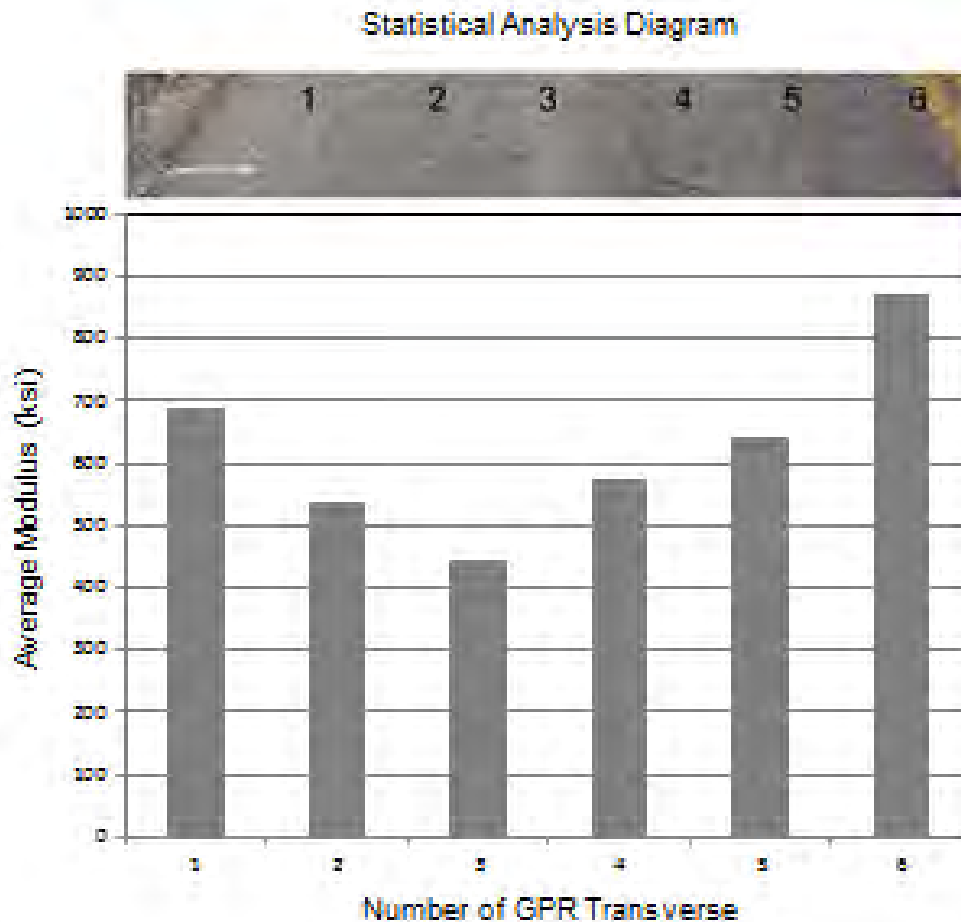
Fig. 3.88—Plot of the average elastic modulus (over depth range of 2 in. to 7.2 in.) along each GPR transverse. The GPR traverses are spaced at 1.5 ft intervals. GPR traverse 1 is 1.5 ft from the outer edge of the pavement.

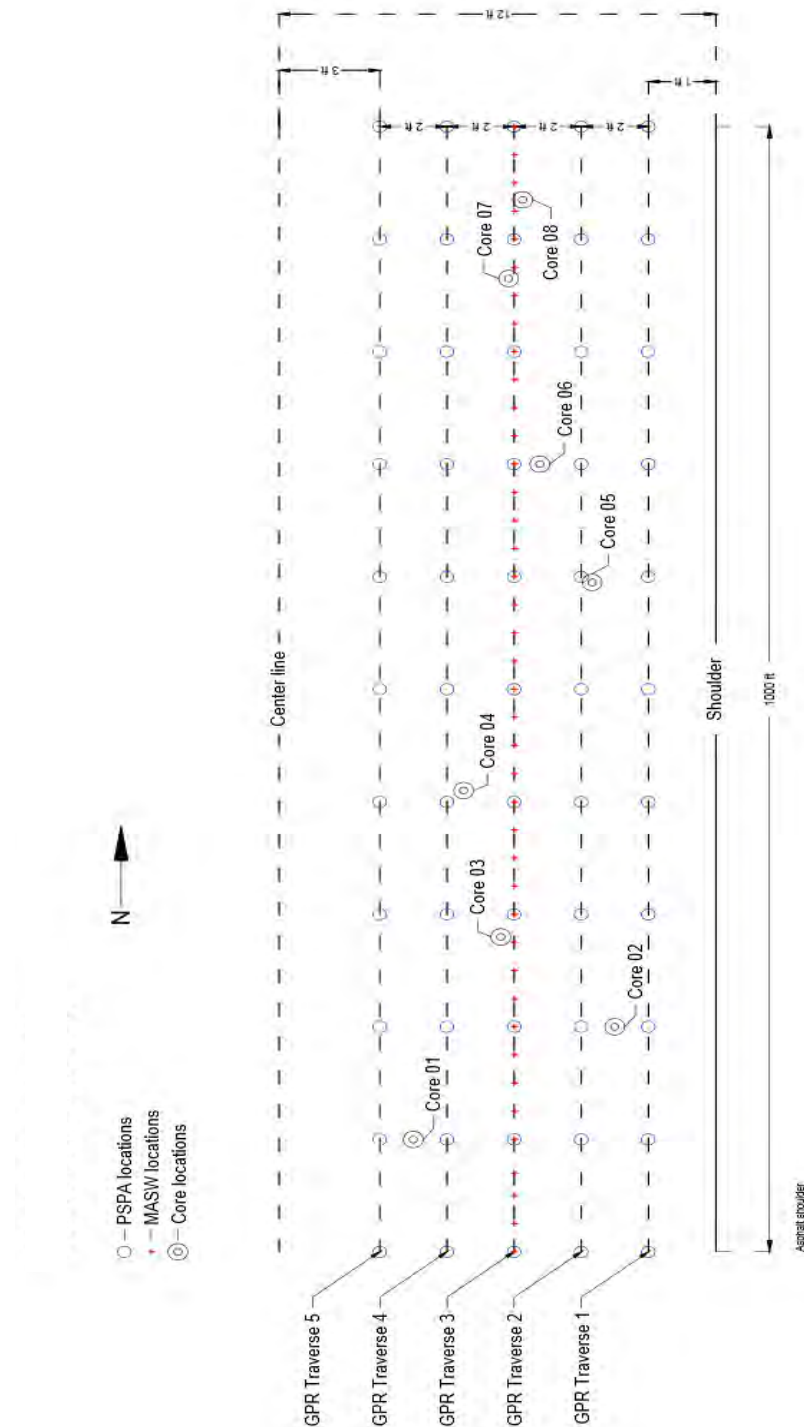
Fig. 3.91–Base map for project-level Site 8 showing PSPA test locations and core locations. PSPA data were acquired at 100 ft intervals along each GPR traverse. GPR traverse 1 was located 1 ft from the outer edge of the paved driving lane (shoulder). Only cores 01,02,05 and 06 are located within 5 ft of a PSPA location.

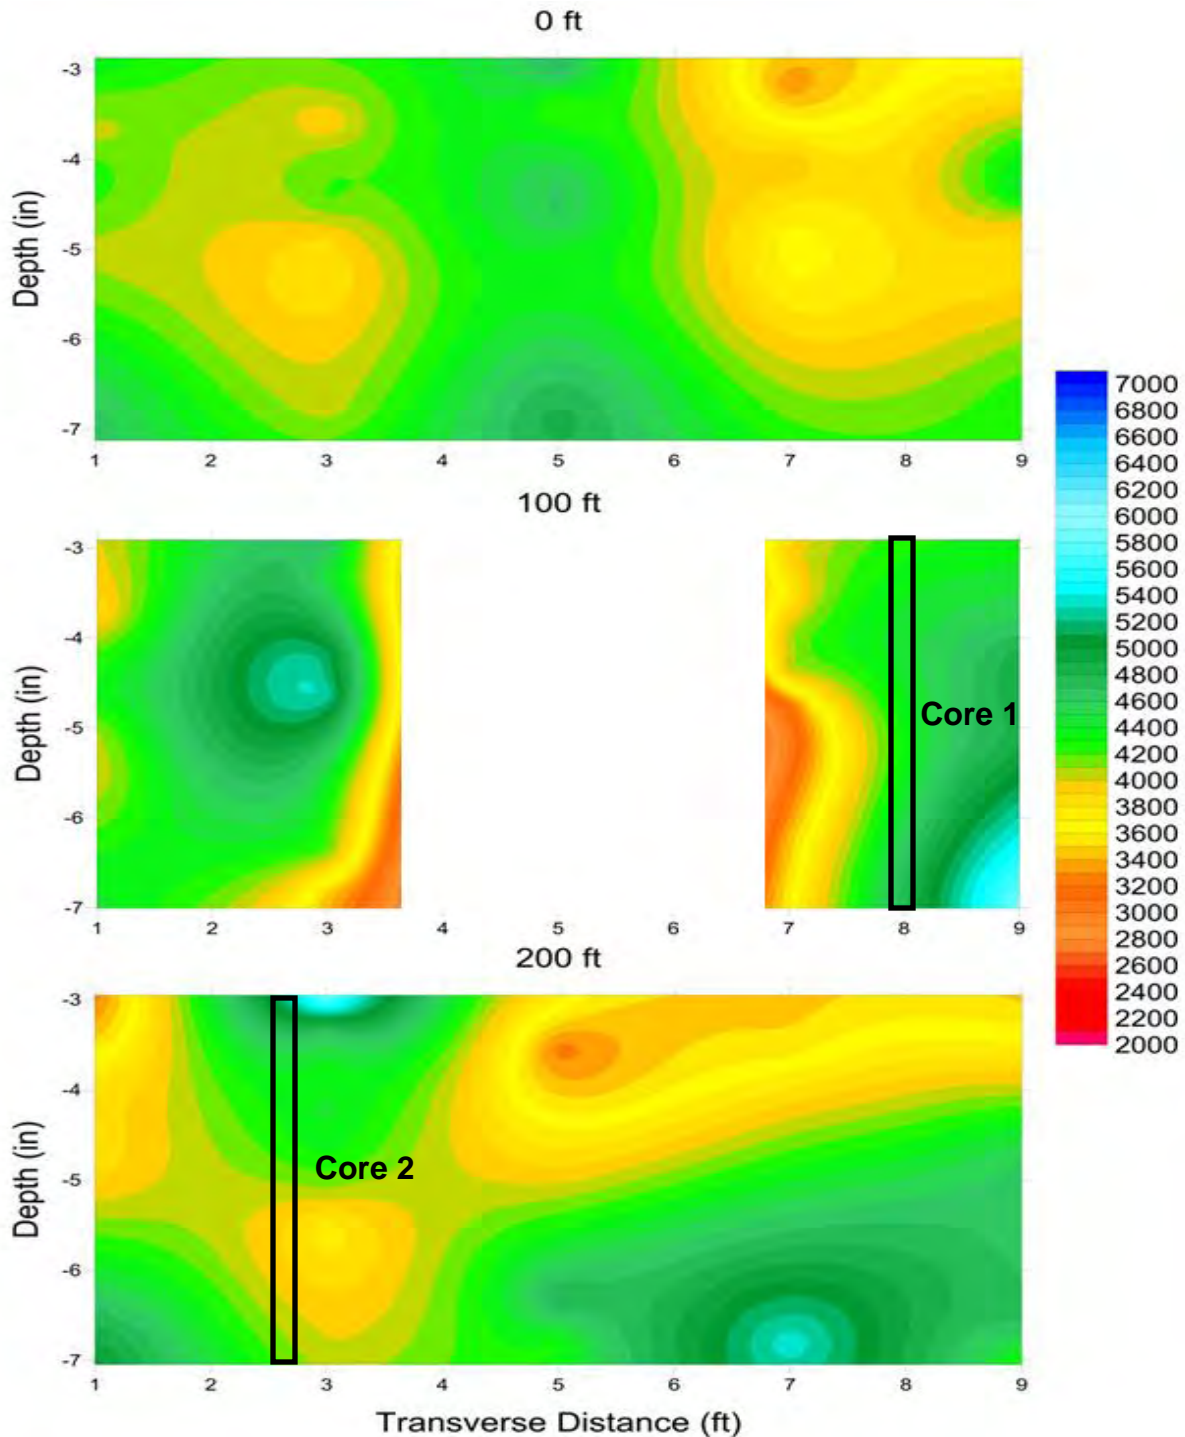
Fig. 3.94– Cross-sections depicting variations in the elastic modulus (ksi) for upper layer of PCC for PSPA USW data acquired at the 0 ft, 100 ft, and 200 ft intervals along the GPR traverses. The five PSPA USW data sets in each cross-section were acquired at 2 ft intervals starting 1 ft from the edge of pavement (Fig. 3.91). Depth of investigation extends from 3 in. to 7 in. PSPA data could not be acquired at several test locations because of the deteriorated nature of the paved surface.

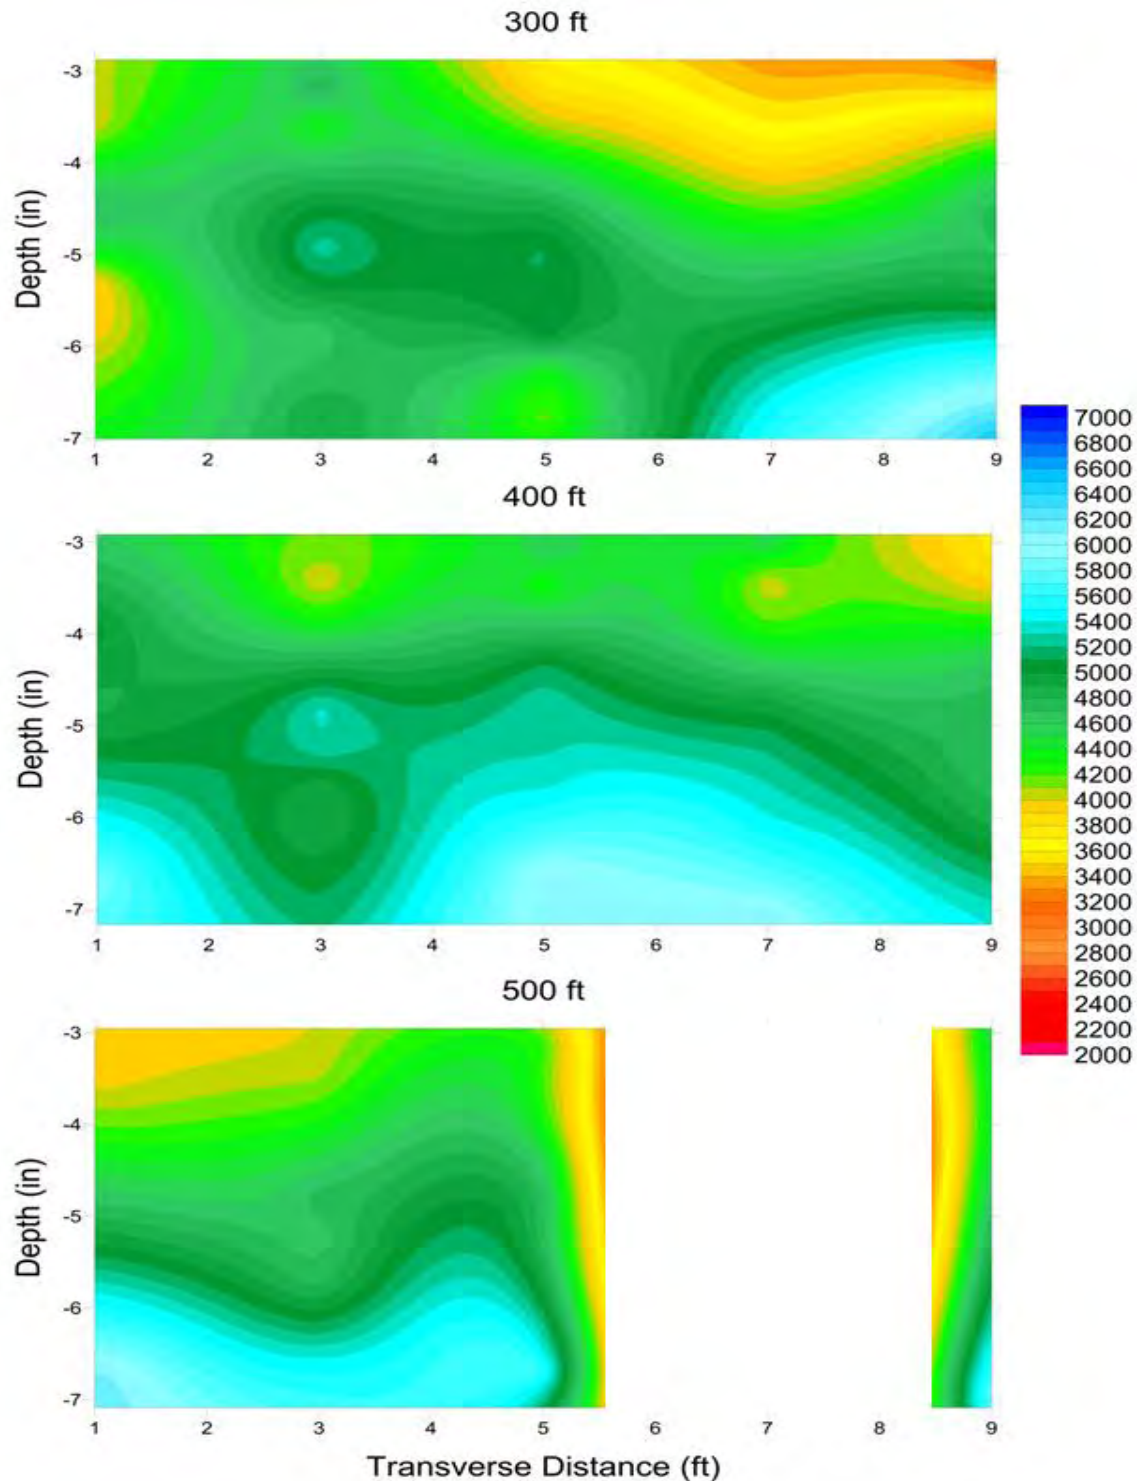
Fig. 3.95—Cross-sections depicting variations in the elastic modulus (ksi) for concrete for PSPA USW data acquired at the 300 ft, 400 ft, and 500 ft intervals along the GPR traverses. PSPA data could not be acquired at several test locations because of the deteriorated nature of the paved surface.

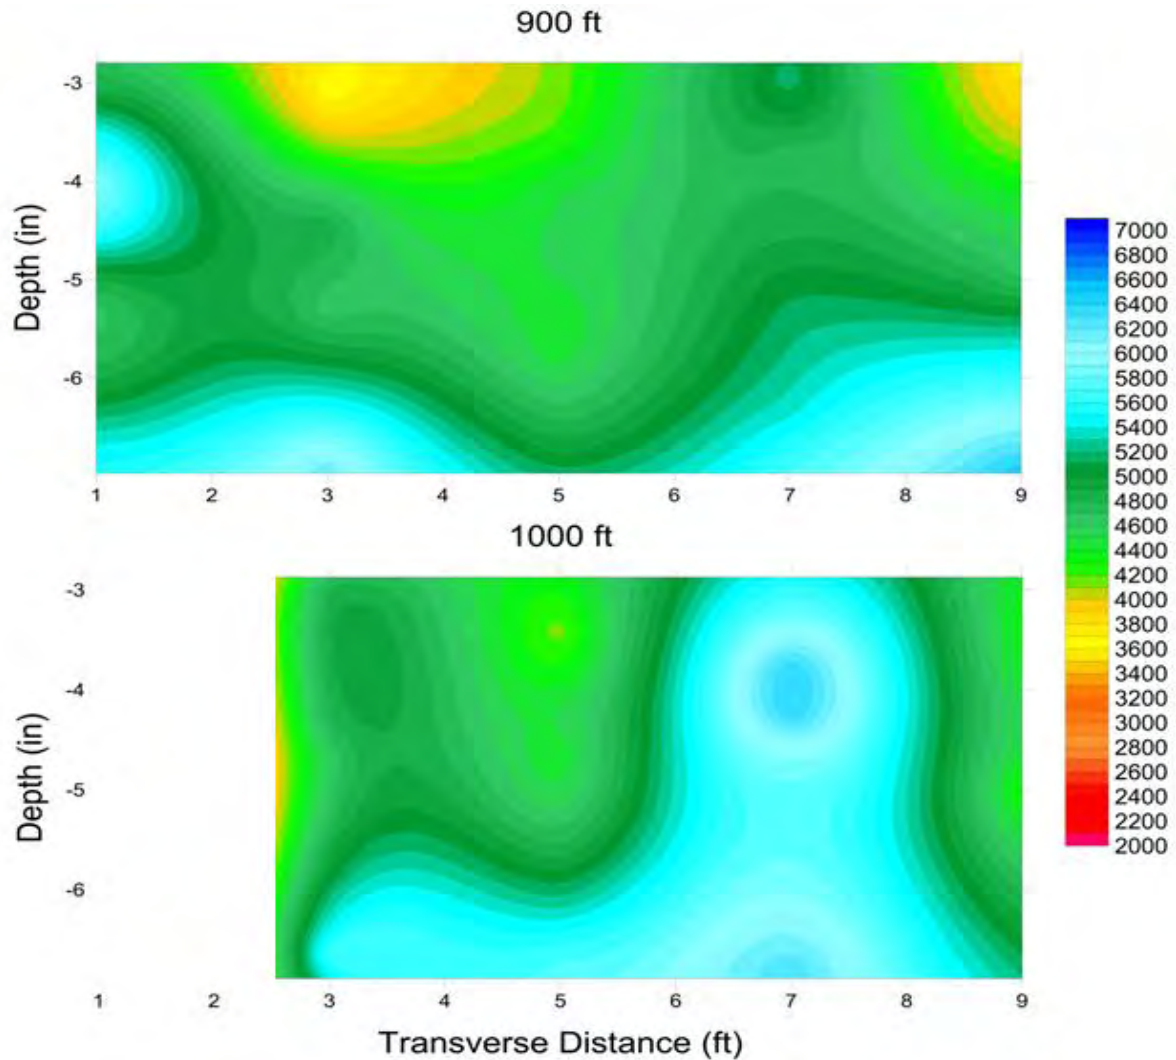
*Fig. 3.97—Cross-sections depicting variations in the elastic modulus (ksi) for concrete for PSPA USW data acquired at the 900 ft and 1000 ft intervals along the GPR traverses. PSPA data could not be acquired at several test locations because of the deteriorated nature of the paved surface.*

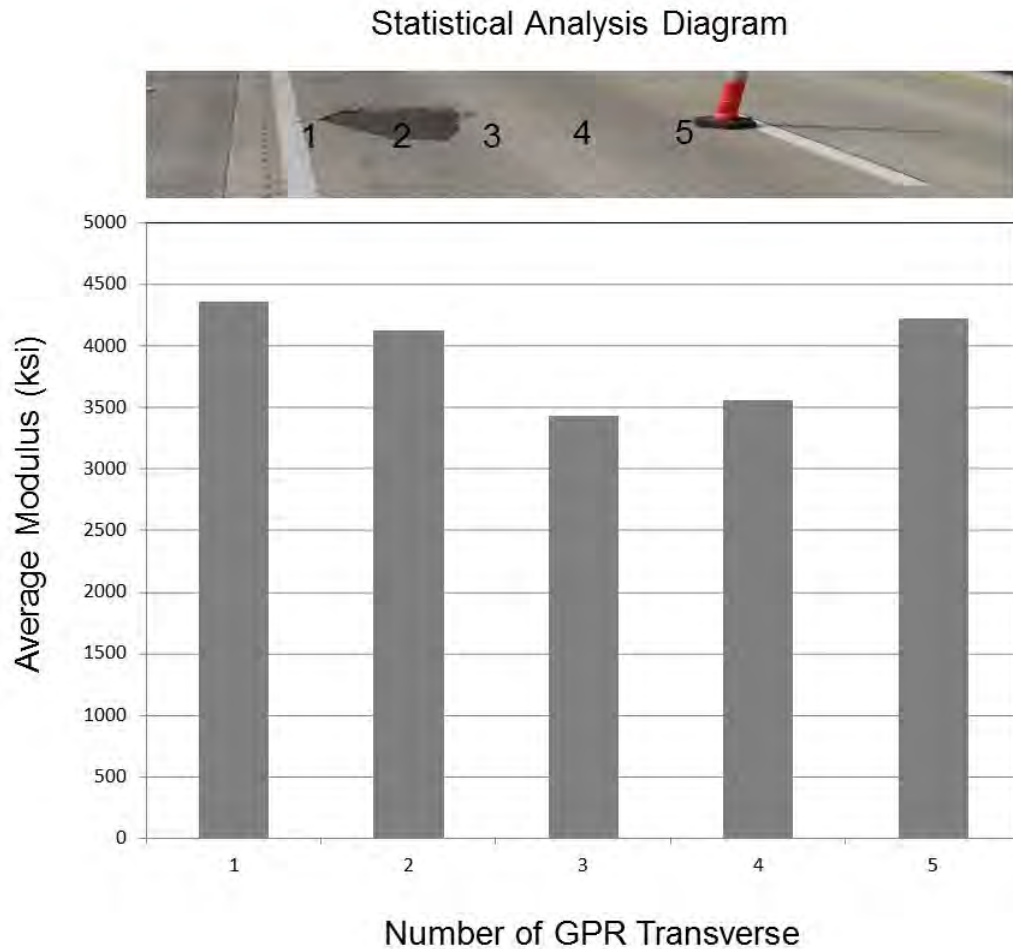
*Fig. 3.98—Plot of the average elastic modulus (over depth range of 3 in. to 11 in.) along each GPR transverse. The GPR traverses are spaced at 2 ft intervals. GPR traverse 1 is 1 ft from the outer edge of the pavement.*

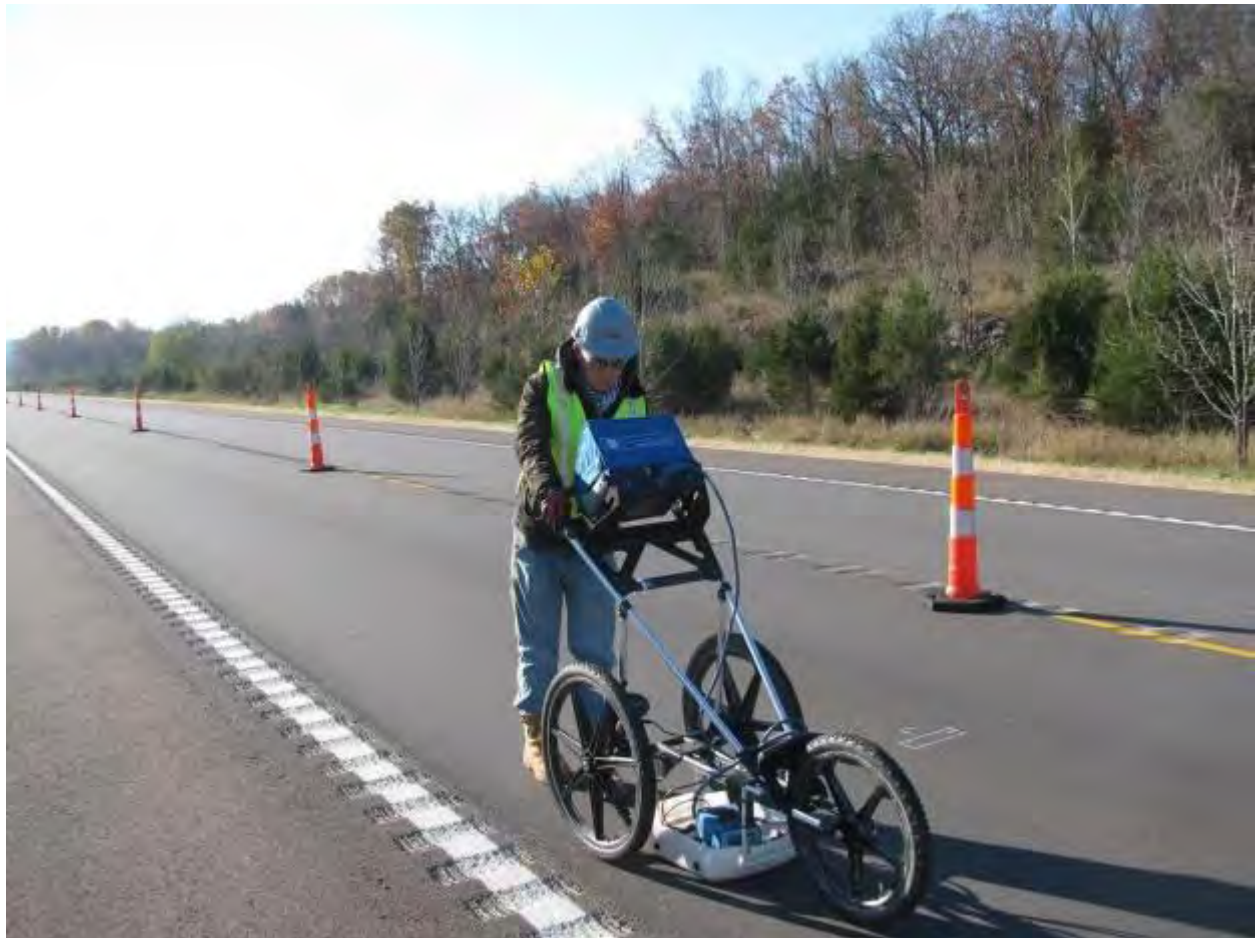
*Fig. 4.1—Photograph taken at Site 1 (US 63) showing operator, push-cart, high-frequency 1.5 GHz GPR antenna (in white plastic shell on pavement surface) and GSSI SIR-3000 control unit (top of cart). The 400 MHz data (discussed in Section 5) were acquired using the same set-up (lower-frequency 400 MHz antenna was placed in the white plastic shell). The acquired GPR data are displayed in real time on the control unit screen. At some project-level test sites, core locations were selected, in part, on the basis of the real-time interpretation of the acquired high-frequency GPR data.*

High-frequency ground-coupled ground penetrating radar (GPR) data are most commonly acquired using an antenna in monostatic-mode (transmitter/receiver housed in single case). However, in some situations (for example where velocity control is desired and/or to enhance the amplitude of specific reflections) high-frequency ground-coupled GPR data are acquired using two antennae in bistatic-mode (transmitter/receiver housed in separate cases). For Task 4 investigation purposes, pavement GPR data were acquired using single cart-mounted high-frequency (1.5 GHz) antenna operated in monostatic-mode (Fig. 4.1).

In this investigation, ground-coupled pavement GPR data were acquired at low speeds (walking speed; typically three to five miles per hour) using both a relatively high-frequency antenna (1.5 GHz; 1500 MHz) and a relatively low-frequency (400 MHz) antenna. A single cart-mounted antenna was employed (Fig. 4.1). The high-frequency GPR data are presented and discussed in Section 4.3 of this report; the low-frequency antenna data are presented and discussed in Section 5.3.

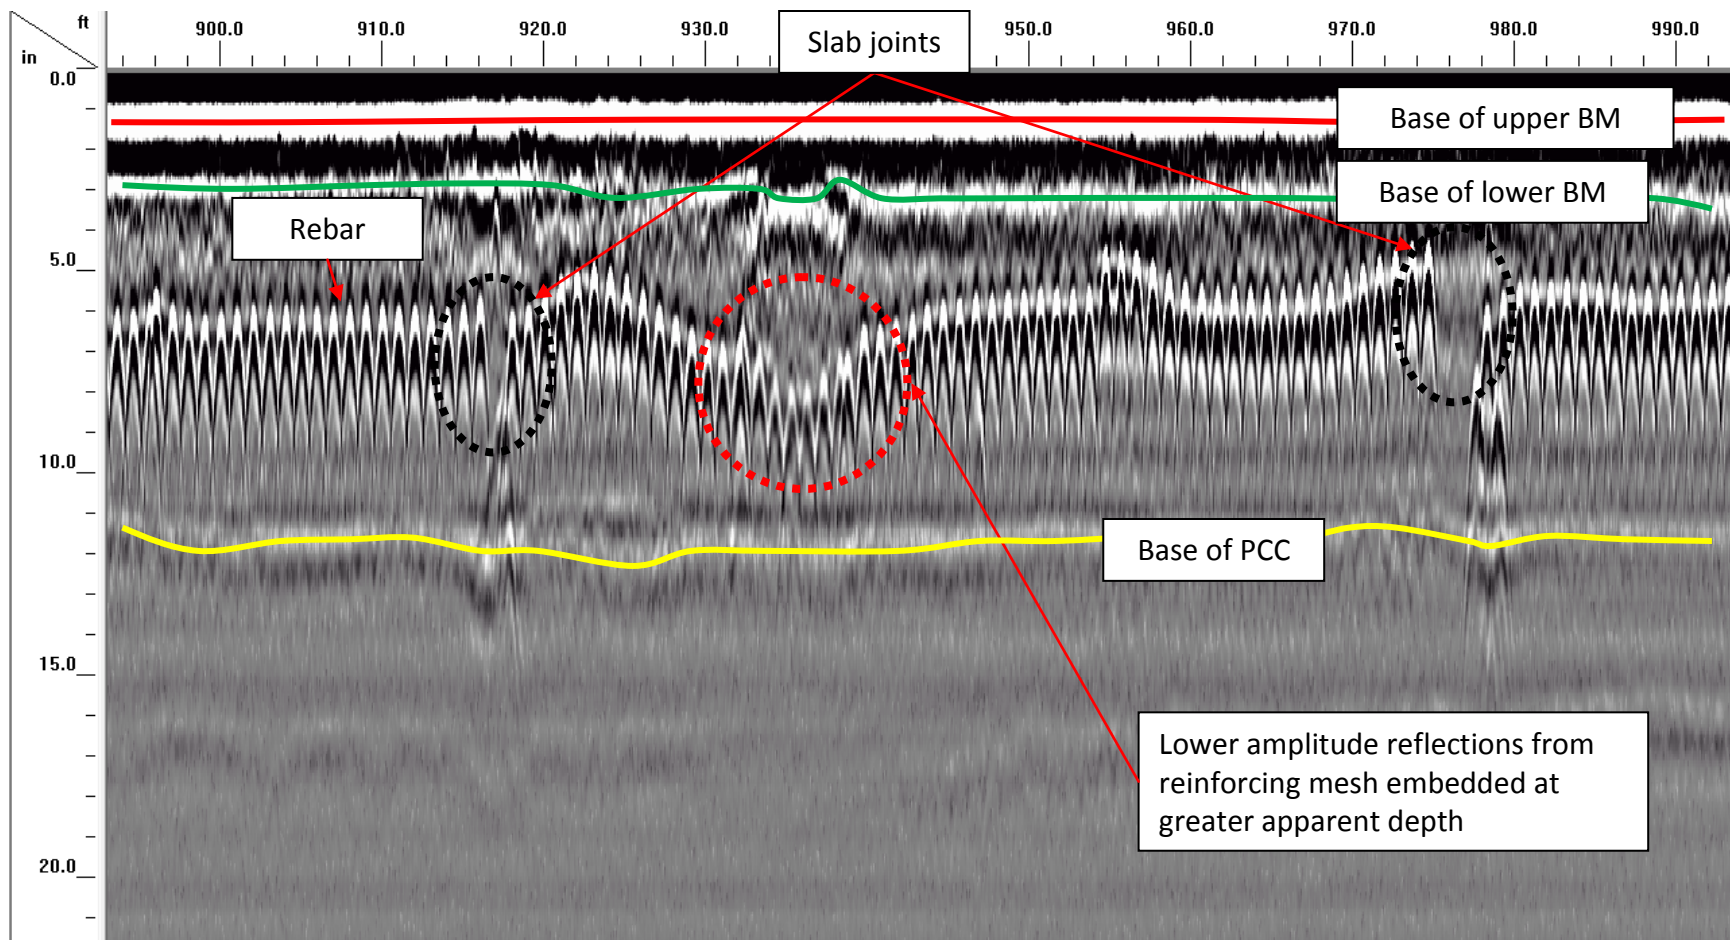
Fig. 4.4—Cross-sectional example of high-frequency (1.5 GHz) GPR data (Site 1; US 63). A constant GPR-pulse velocity (selected for each site based on the correlation between a “typical” core and the corresponding GPR data) was used to transform reflection travel times to reflector depths. The depths to each reflector, particularly on GPR data acquired at sites where pavement condition varied or where different pavement materials were used, are therefore “apparent” rather than “absolute”. The interpreted bases of upper and lower bituminous mix (BM) layers are marked in red and the green, respectively; the interpreted base of the portland cement concrete (PCC) layer is marked in yellow. The horizontal axis is in units of feet; the vertical axis is in units of inches.

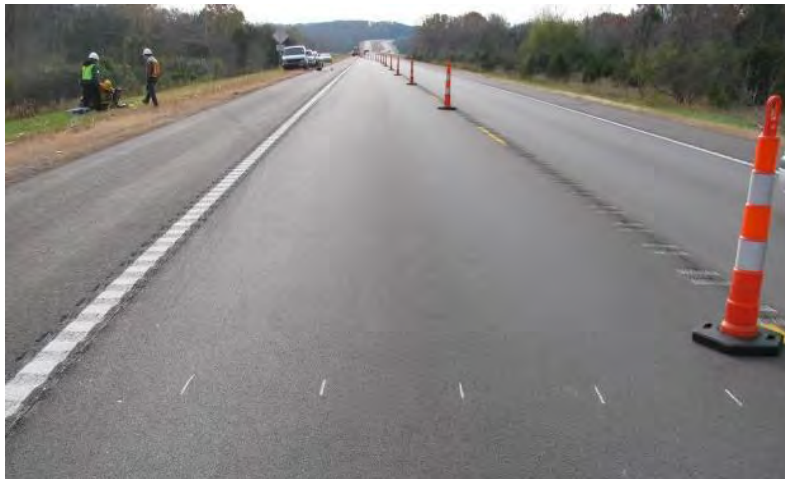
Fig. 4.5—Photograph of US 63 (Site 1). GPR traverses 1-5 (left to right) are marked (Fig. 4.7)

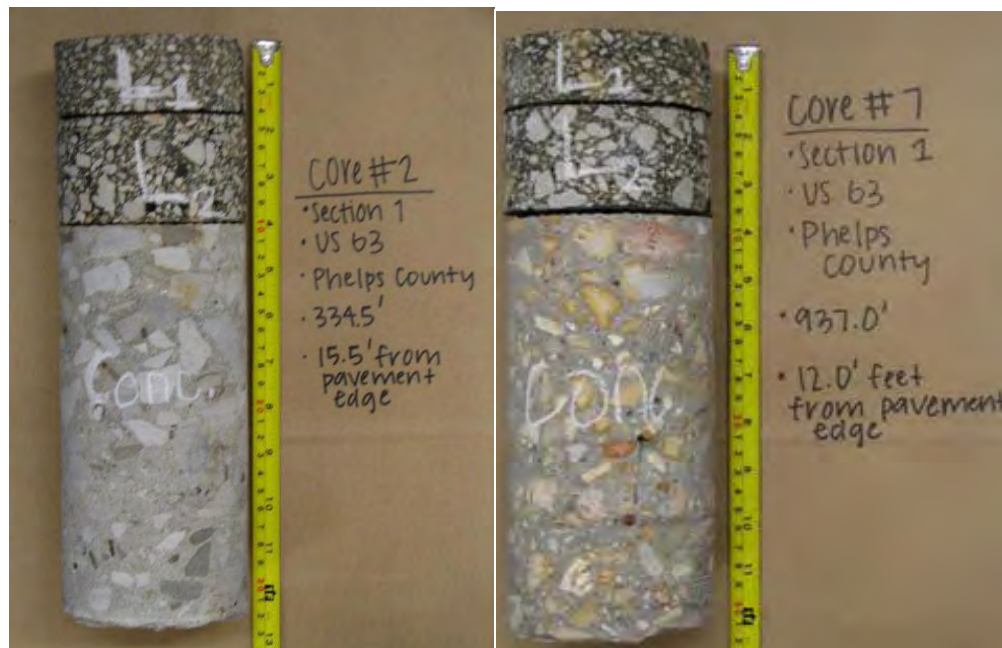
Fig. 4.6—Typical Site 1 cores consisted of three layers: approx. 1.5 in. of upper BM; approx. 2 in. of underlying BM; and approx. 8.5 in. of basal PCC. At core locations 1, 2, 4, and 7 the BM/PCC contact was debonded; at the other five core locations (3, 5, 6 and 8) the BM/PCC contact was not debonded. Debonded core 7 (above right) is the only core that showed visual evidence of chemical degradation (note staining of PCC). Core locations were selected on the basis of the preliminary on-site visual interpretation of the acquired GPR data. Edge of pavement (hand written notes in core photographs) refers to the edge of the driving lane. The edge of the driving lane was 10 ft from the edge of the paved shoulder (Fig. 4.5 and Fig. 4.7).

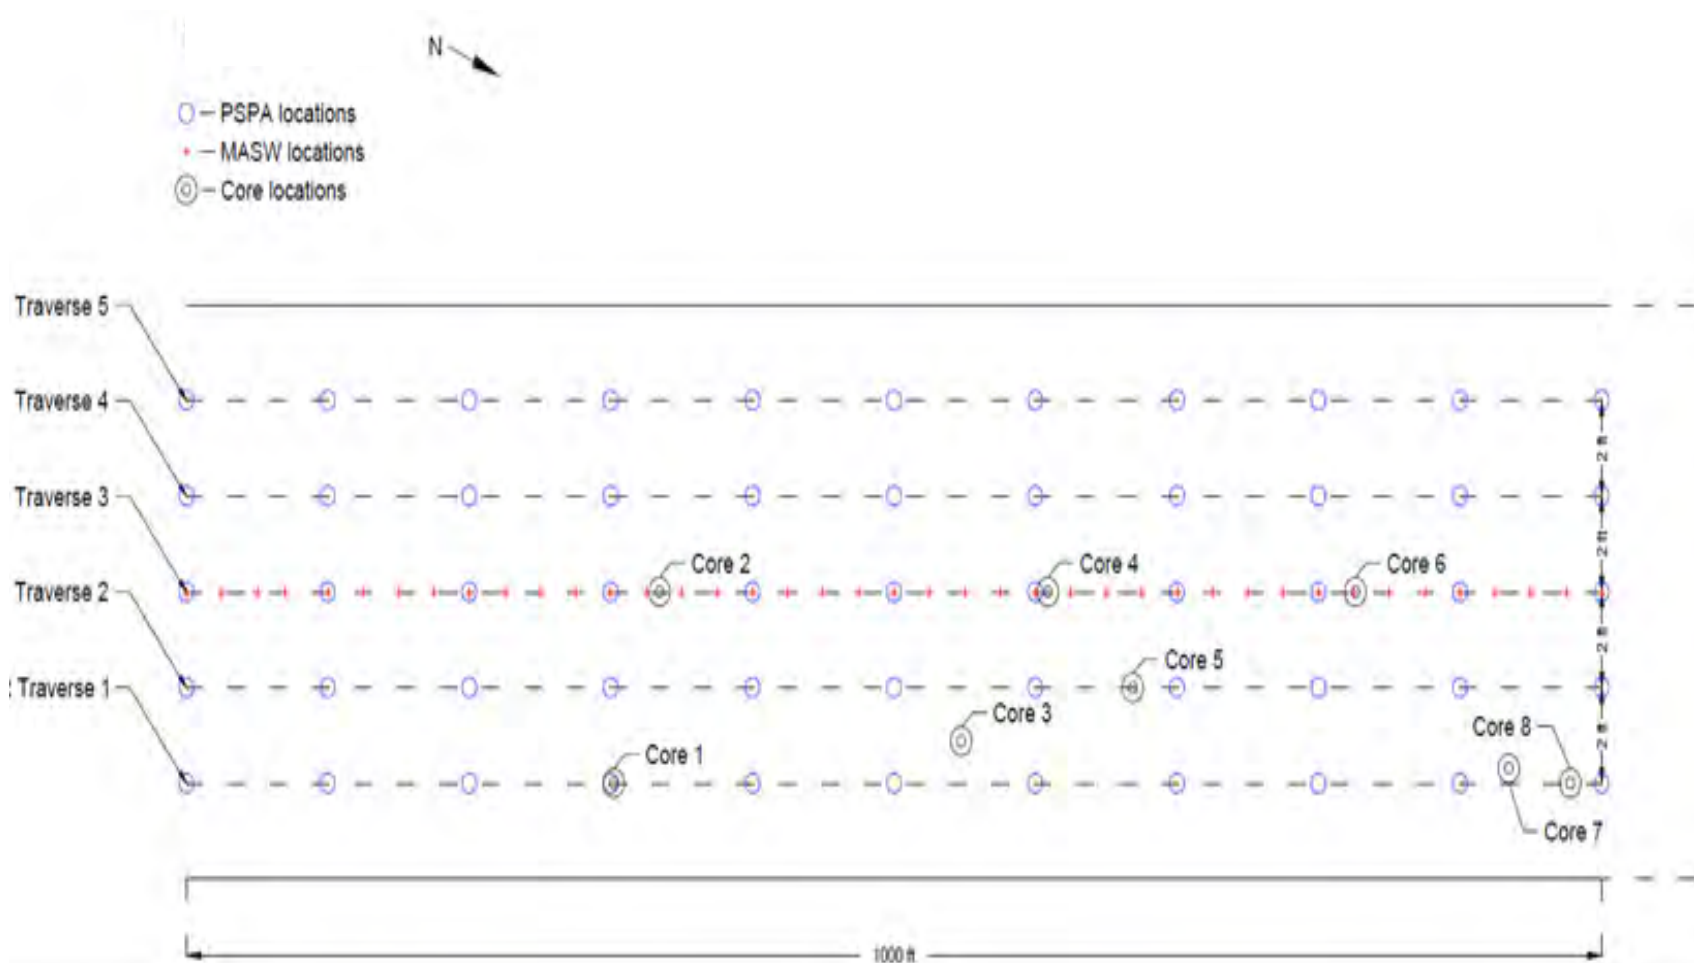
Fig. 4.7—Plan view map of US 63 (Site 1) showing locations of GPR traverses 1-5. High-frequency (1.5 GHz antenna) GPR data were acquired along all five traverses; low-frequency (400 MHz antenna) data GPR data were acquired along traverse 3 only. Solid black lines represent the driving lane boundaries. Lane width was 12 ft. Core locations are marked as black circles. PSPA locations are marked as blue circles. MASW locations are marked as red crosses. Traverse 1 was 2 ft from the edge of driving lane boundary (12 feet from edge of the paved shoulder; Fig. 4.5).

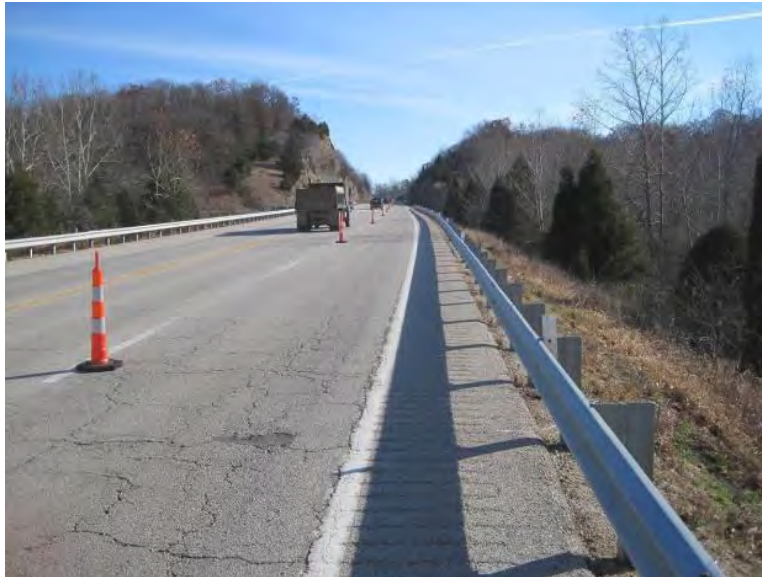
*Fig. 4.10—Photograph of site the project-level segment US54 (Site 2).*

The objectives of the high-frequency GPR investigation at Site 2 were to detect stripping and debonding within the BM and to estimate the thickness of the BM. Stripping in all ten cores was described as low to moderate. Debonding was observed at all ten core locations.

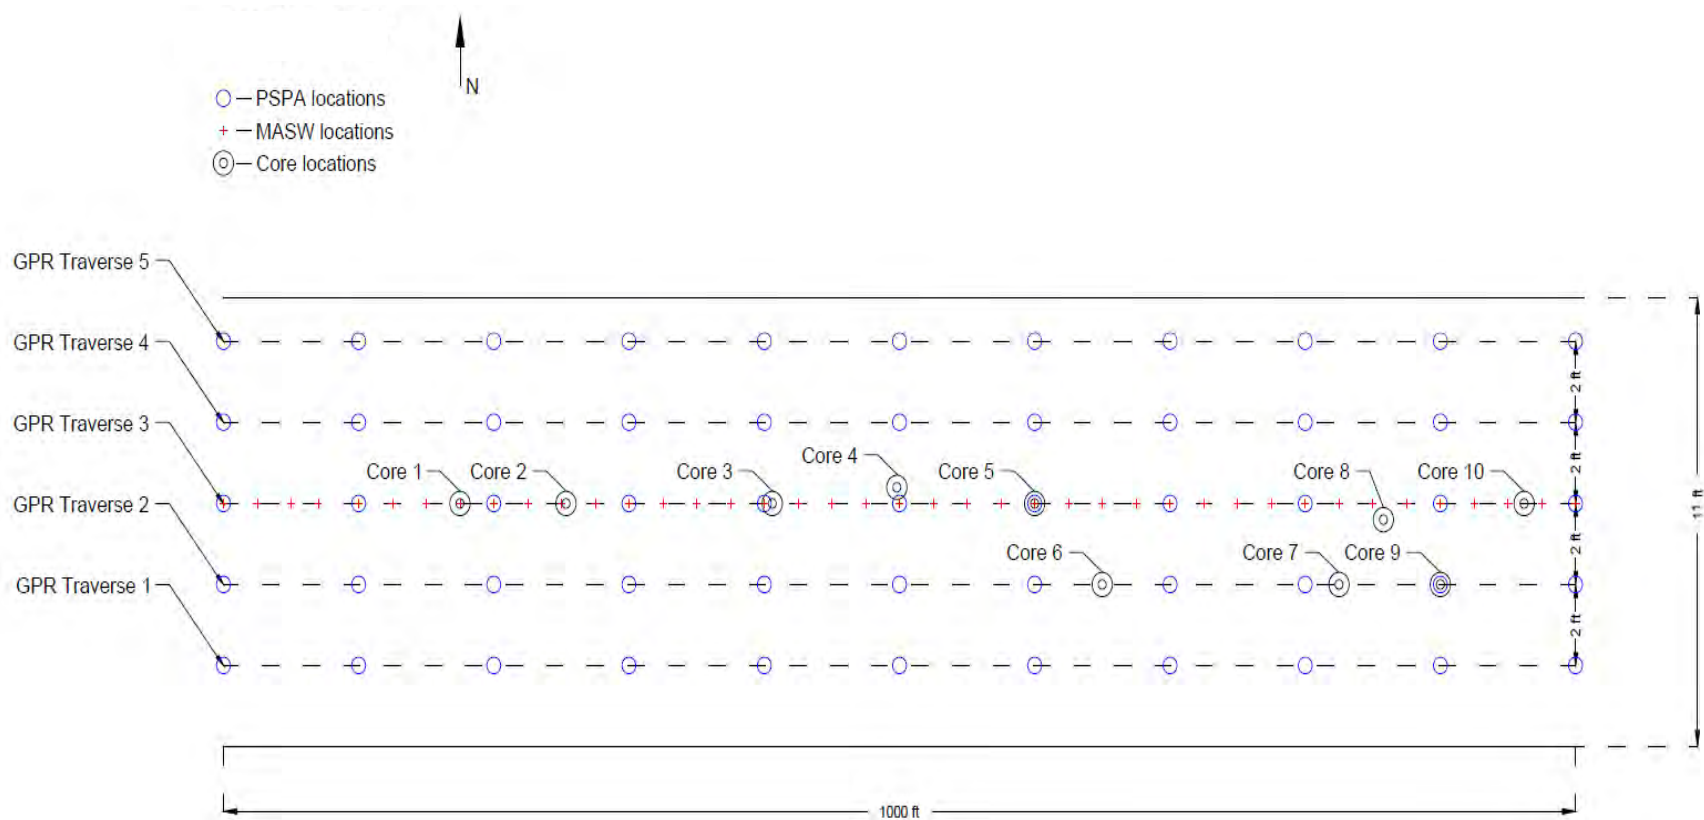
Fig. 4.11—Plan view map of US 54 (Site 2) showing locations of GPR traverses 1-5. High-frequency (1.5 GHz antenna) GPR data were acquired along all five traverses; low-frequency (400 MHz antenna) data GPR data were acquired along traverse 3 only. Solid black lines represent the driving lane boundaries. Lane width was 11 ft. Core locations (10) are marked as black circles. PSPA locations are marked as blue circles. MASW locations are marked as red crosses. Traverse 1 was 2 ft from the edge of driving lane boundary. Core locations are marked as black circles. PSPA locations are marked as blue circles. MASW locations are marked as red crosses.

High-frequency (1.5 GHz) GPR data were acquired in the east-bound lane of US 54 along five parallel traverses spaced at 2 ft intervals (Fig. 4.11 and Fig. 4.12). The acquisition parameters employed were 512 samples/scan and 48 scans/ft. A dielectric permittivity 8.0 was used to convert reflection times to reflector depths. All the Site 3 GPR data (low-frequency and high-frequency) were acquired in less than four hours.

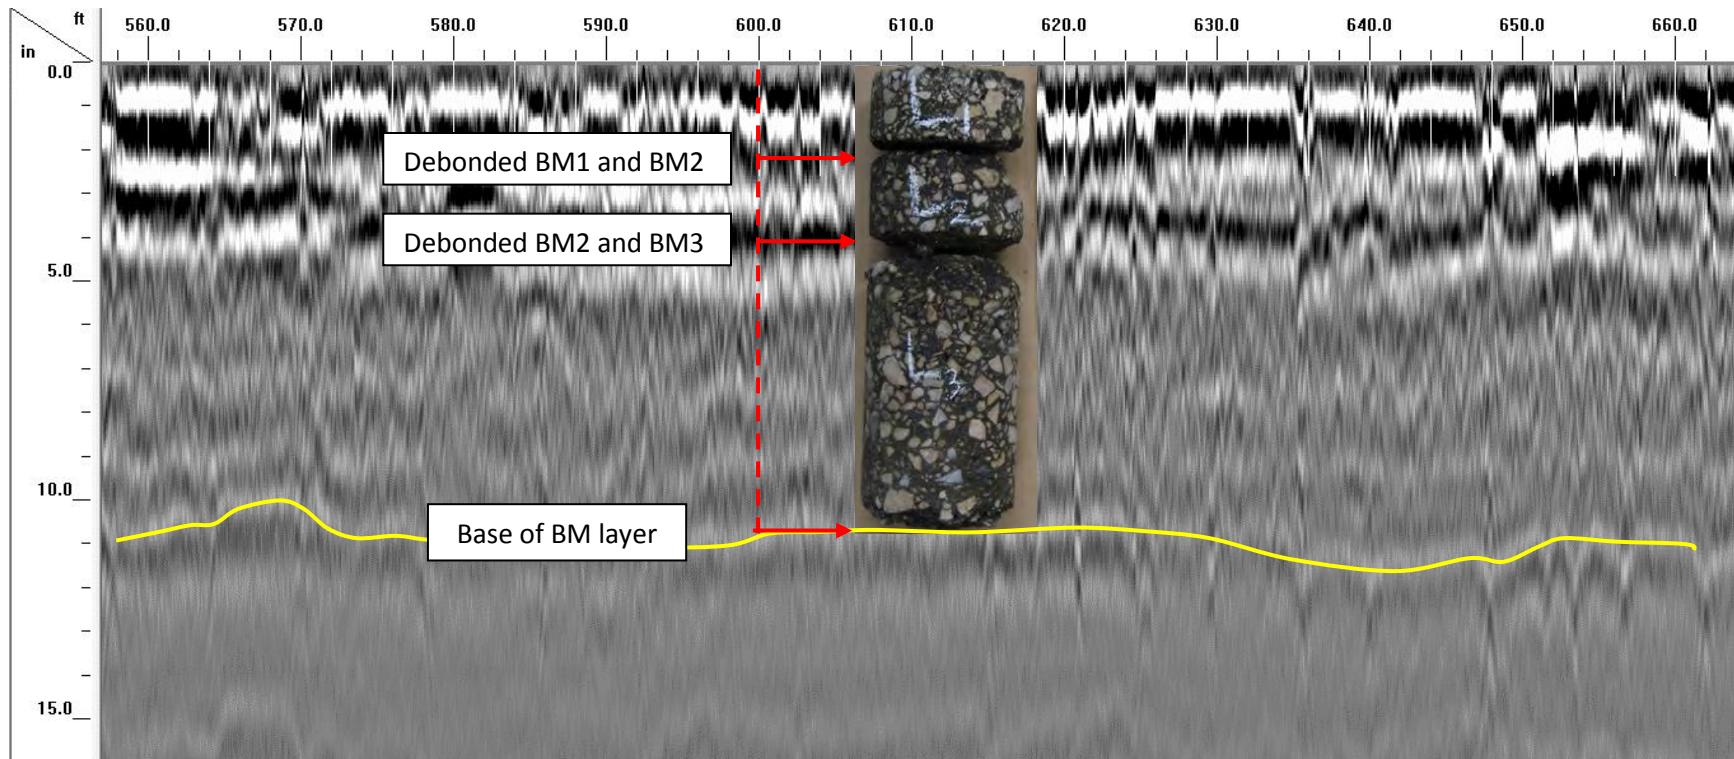
Fig. 4.12—Representative example of Site 2 high-frequency (1.5 GHz) GPR profile (GPR profile 3, stations 560-660) showing tie with core 5 (at station 600; Fig. 4.11). Reflections from the multiple stripped interfaces and the base of the BM can be identified. Variations in the apparent depth to the base of the BM are attributed to both lateral changes in the actual thickness of the BM and to lateral changes in the physical and chemical condition of the BM. The horizontal axis is in units of feet; the vertical axis is in units of inches.

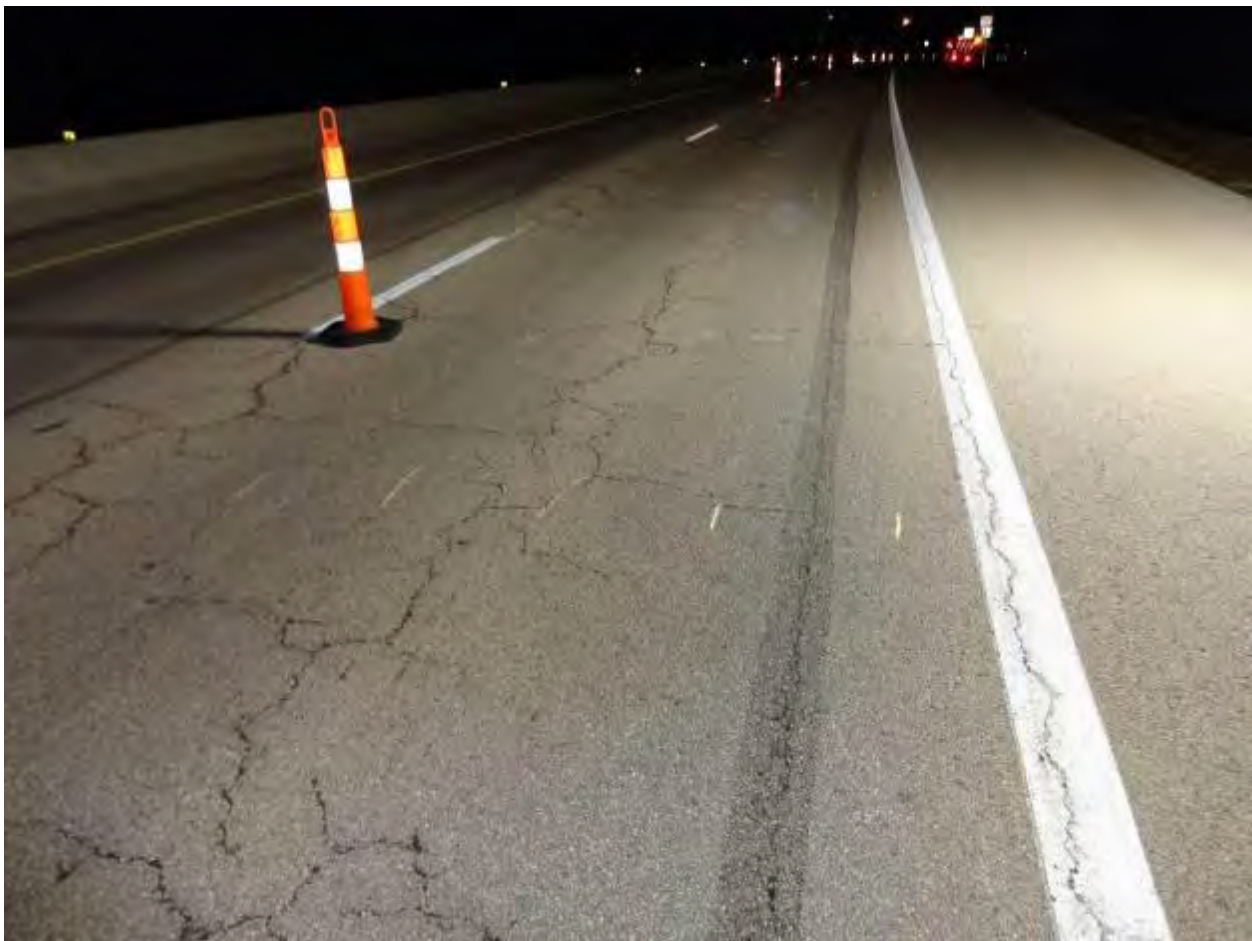
*Fig. 4.15—Photograph of site the project-level segment Rte 179 (Site 3).*

The project-level pavement Site 3 (MO 179) is located approximately 4 miles west of Jefferson City, Missouri. The pavement at Site 3 consists of approximately 12.5 in. thick full depth bituminous mix (BM) (Fig. 4.15).

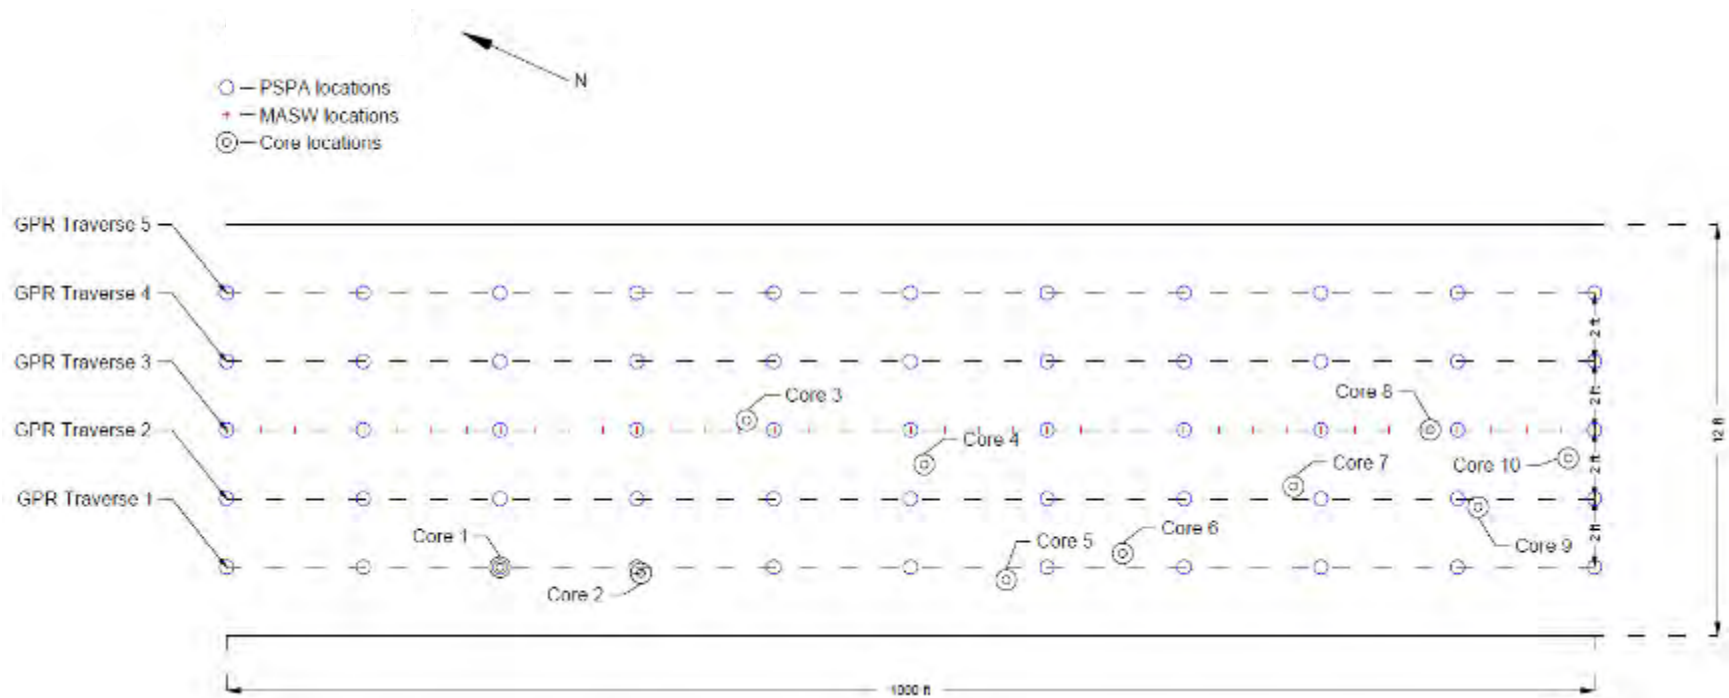
Fig. 4.16—Plan view map of MO 179 (Site 3) showing locations of GPR traverses 1-5. High-frequency (1.5 GHz antenna) GPR data were acquired along all five traverses; low-frequency (400 MHz antenna) data GPR data were acquired along traverse 3 only. Solid black lines represent the driving lane boundaries. Lane width was 12 ft. Core locations (10) are marked as black circles. PSPA locations are marked as blue circles. MASW locations are marked as red crosses. Traverse 1 was 2 feet from the edge of the driving lane. Core locations are marked as black circles. PSPA locations are marked as blue circles. MASW locations are marked as red crosses. All 10 cores were described as moderately to highly stripped. Cores 5-10 were described as debonded.

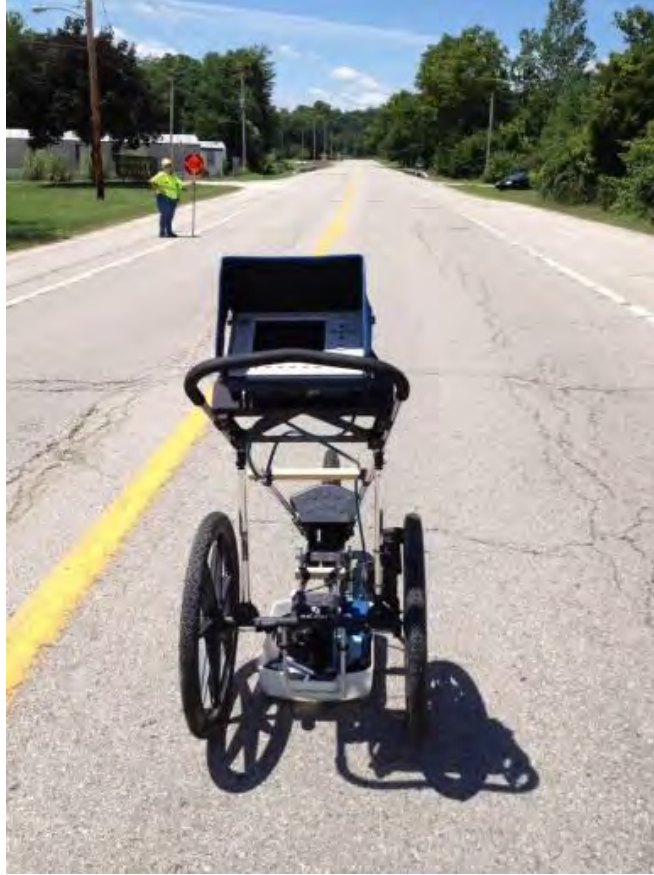
*Fig. 4.20—Photograph of site the project-level segment HWY AT (Section 4). Photograph was taken looking west.*

Project-level pavement Site 4 (HWY AT) is located approximately 7 miles east of Union, Missouri (Fig. 4.20). The pavement was variable depth BM over PCC. (Fig. 4.6).
