# MoDOT Pavement Preservation Research Program

## Volume V. Site-Specific Pavement Condition Assessment

Final Report Prepared for Missouri Department of Transportation  
November 2015

Report cmr16-004

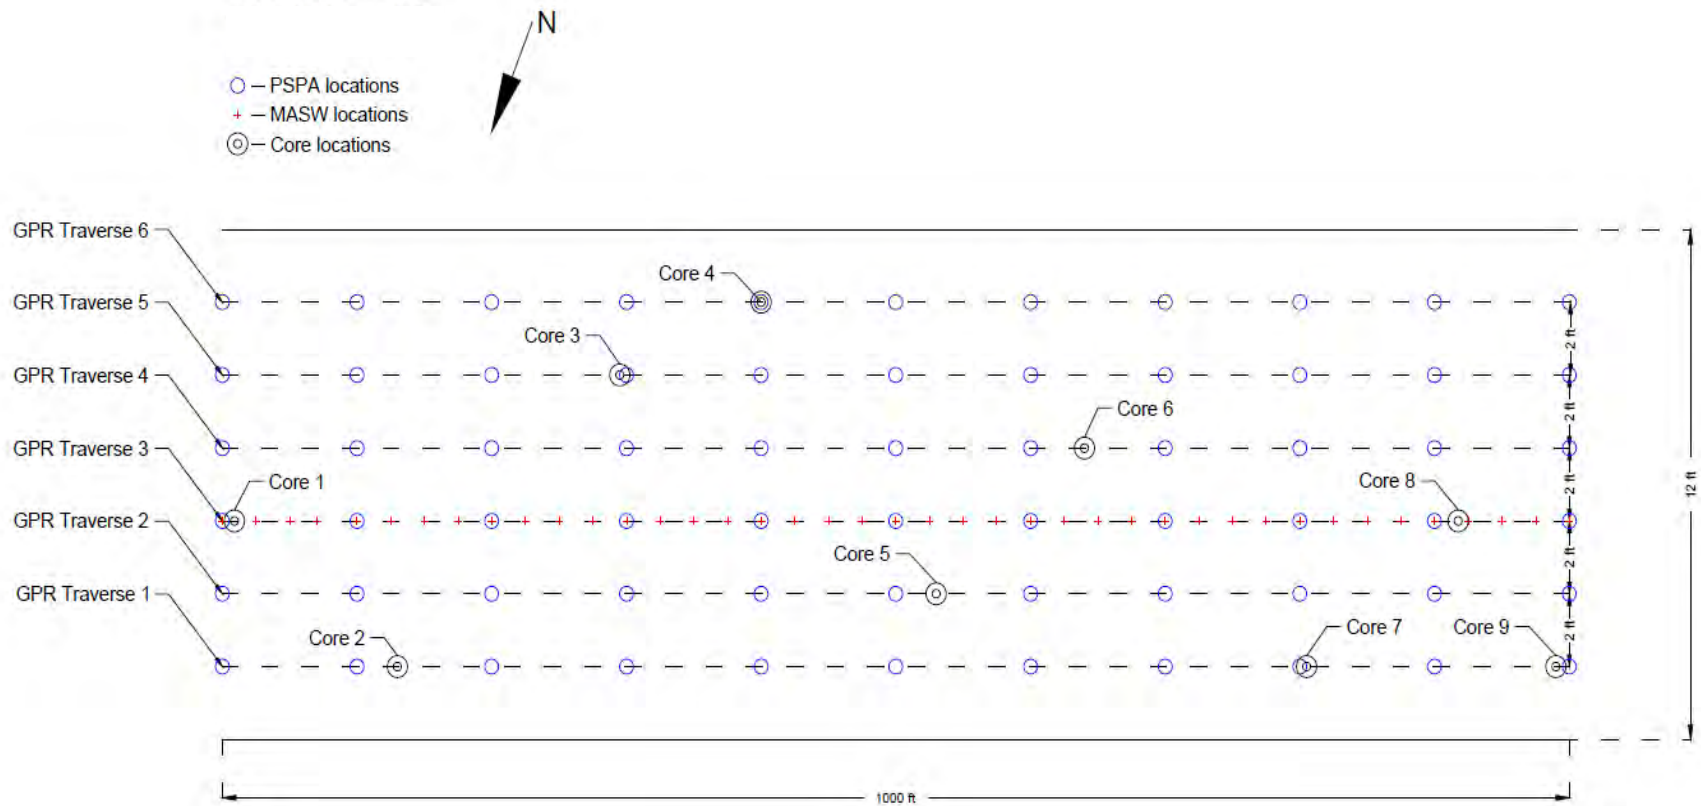
Fig. 4.21—Plan view map of HWY AT (Site 4) showing locations of GPR traverses 1-5. High-frequency (1.5 GHz antenna) GPR data were acquired along all five traverses; low-frequency (400 MHz antenna) data GPR data were acquired along traverse 3 only. Solid black lines represent the driving lane boundaries. Lane width was 12 ft. Core locations (10) are marked as black circles. PSPA locations are marked as blue circles. MASW locations are marked as red crosses. Traverse 1 was 2 ft from the edge of the driving lane. Core locations are marked as black circles. PSPA locations are marked as blue circles. MASW locations are marked as red crosses. The BM in all nine cores is described as stripped (low to moderate) and debonded at one or more levels.

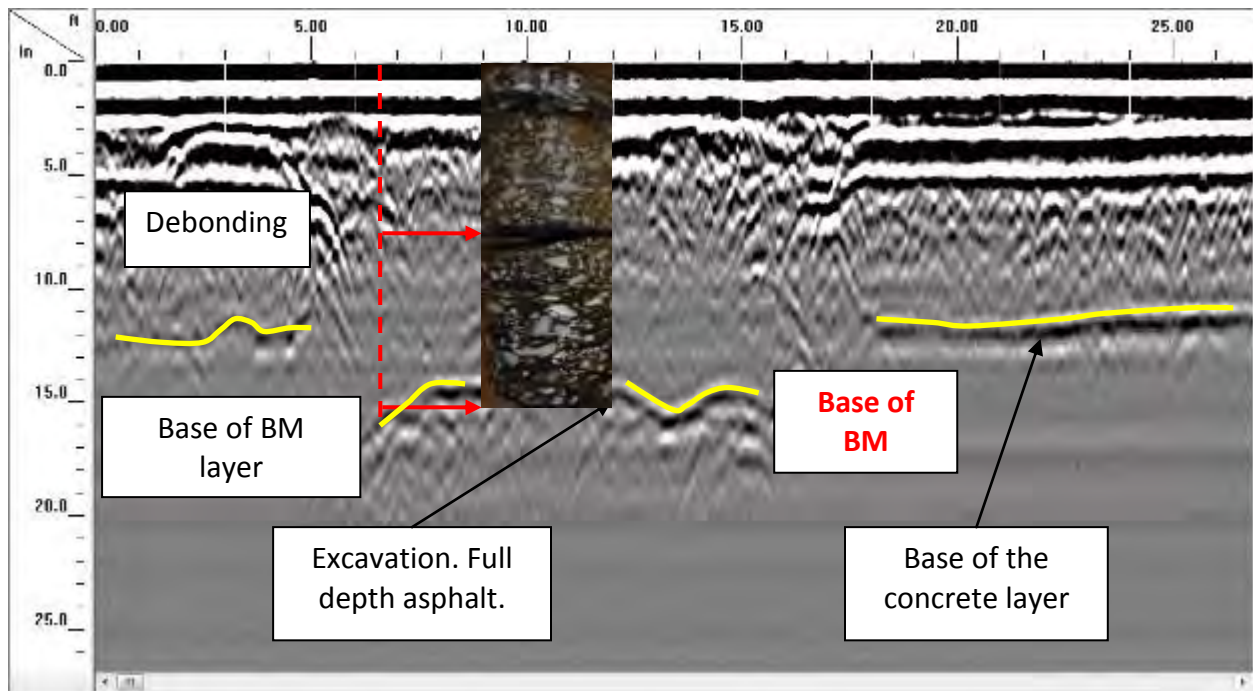
*Fig. 4.22—Representative example of Site 4 GPR profile (GPR profile 1, stations 0-25). Core 1 encountered 15.25 in. of BM; the other cores encountered variable thicknesses of BM over PCC. The horizontal axis is in units of feet; the vertical axis is in units of inches.*

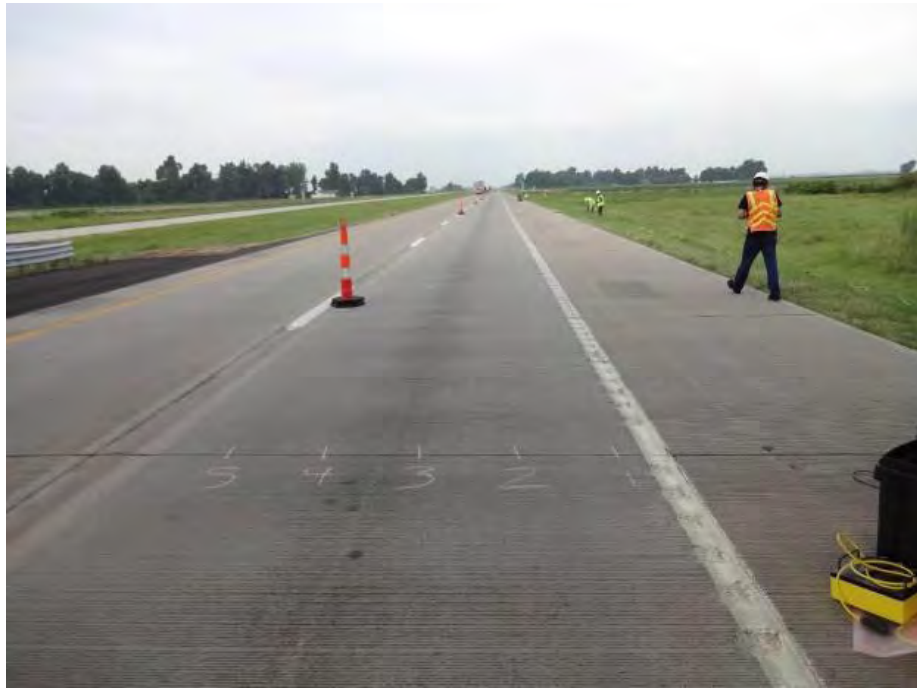
*Fig. 4.25—Photograph of site the project-level segment I-55 Pemiscot County (Site 5). Photograph was taken looking south.*

Project-level pavement Site 5 (I-55 Pemiscot Co.) is located approximately 13 miles south from Hayti, Missouri. (Fig. 4.25). GPR data were acquired in the south-bound lane along parallel traverses spaced at 2 ft intervals (Fig. 4.26). All of the GPR data, including low-frequency data, were acquired in four hours.

Project-level pavement Site 5 (I-55 Pemiscot Co.) is located approximately 13 miles south from Hayti, Missouri. The pavement at Site 5 consists of an upper layer of PCC (approximately 12 in.), an intervening layer of BM (approximately 2.2 in.) and a basal layer of PCC (approximately 10 in.) (Fig. 4.25).

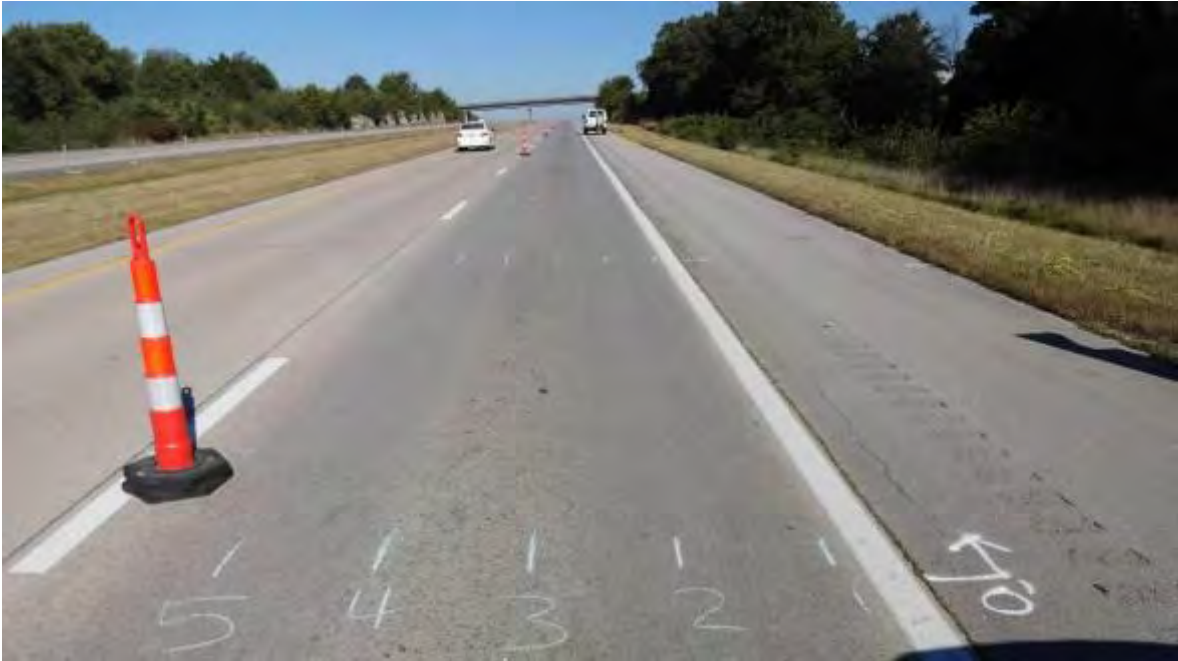
*Fig. 4.30—Photograph of site the project-level segment I-55 Perry County (Section 6). Photograph was taken looking north.*

The project-level Site 6 (I-55 Perry County; Fig. 4.30) is located approximately 8 miles north of Perryville, Missouri. The pavement at this site is comprised of approximately 9-11 in. of full-depth PCC. The objective of the GPR investigation at this site was to evaluate the condition of PCC pavement with problems at the joints.

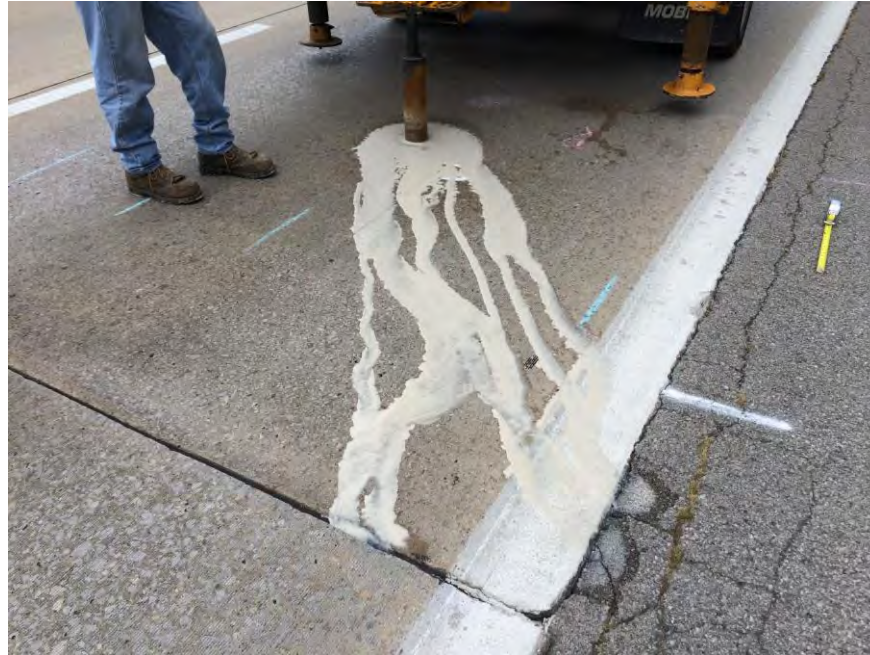
*Fig. 4.35—Core 5 location at Site 6. During coring it was noted that the water seeping through the slab transverse and edge joints, which probably caused fine material pumping out, and as a result, forming voids beneath the PCC layer.*

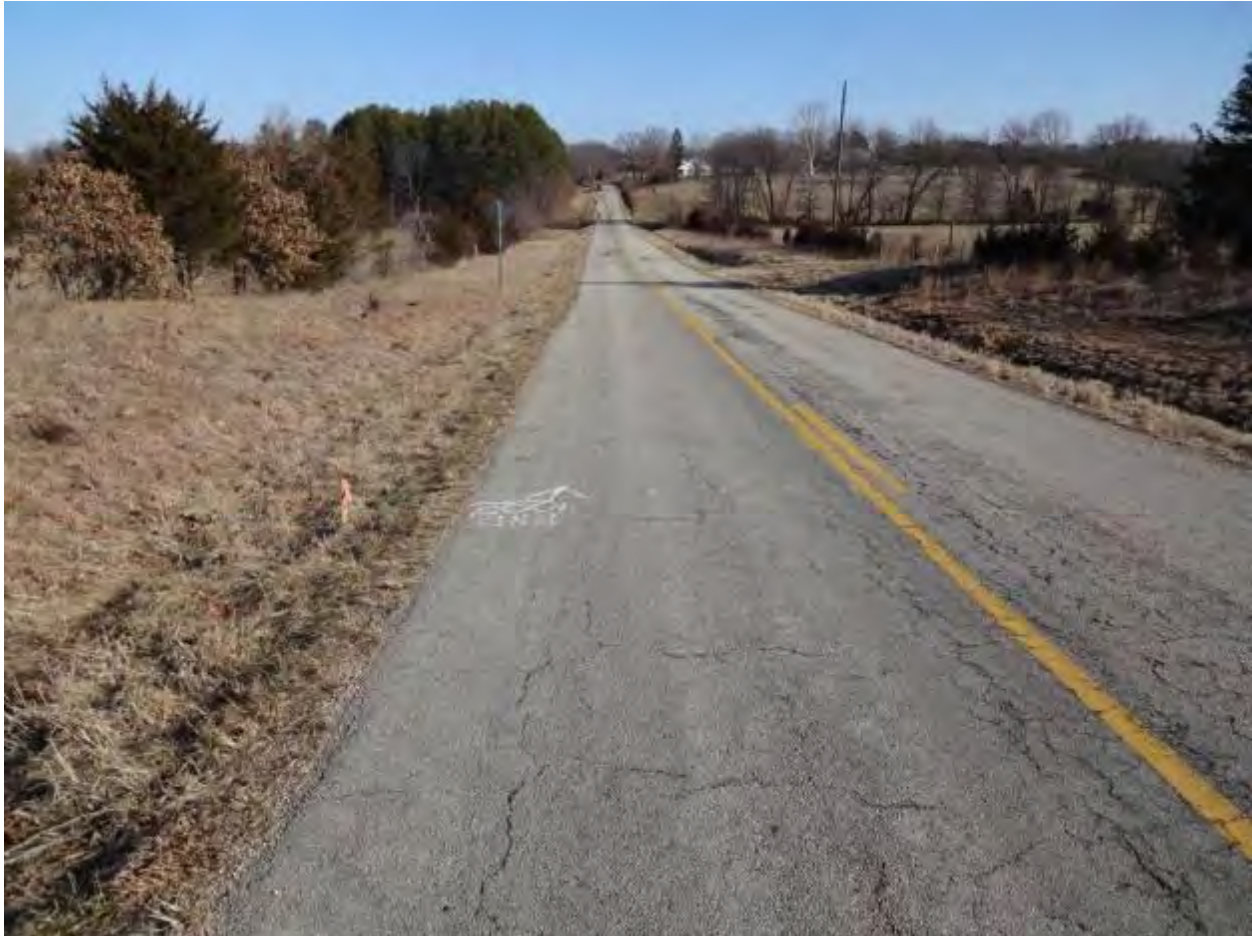
*Fig. 4.36—Photograph of site the project-level segment HWY U (Section 7). Photograph was taken looking north.*

Project-level pavement Site 7 HWY U (Fig. 4.36) is located approximately 6 miles north of Salem, Missouri. The goal of the GPR investigation at Site 7 was to evaluate a poor quality BM road. Type of the pavement was full depth BM. The GPR data were acquired on the top surface of the south-bound lane along six parallel traverses spaced at 1.5 ft intervals. General view of the pavement section HWY U is shown in Fig. 4.36.

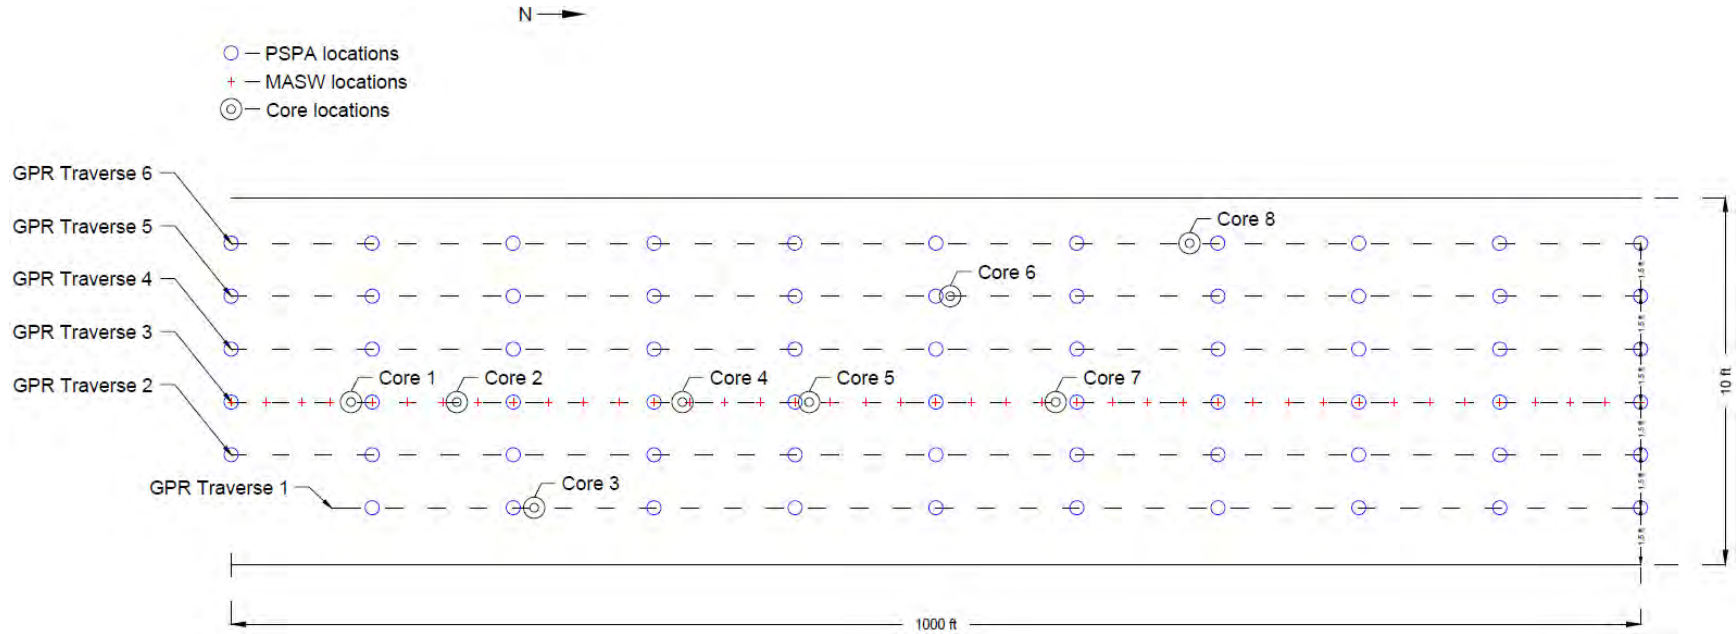
Fig. 4.37—Plan view map showing locations of the GPR traverses and the cores at the project-level Site 7 (HWY U). A total six GPR profiles (each 1000 ft long) were acquired along parallel traverses spaced at 1.5-ft intervals. High-frequency (1.5GHz antenna) data GPR data were acquired along all six traverses (spaced at 1.5 ft intervals), low-frequency (400 MHz antenna) data GPR data were acquired along Traverse 3 only. Solid black lines represent the lane boundaries. The total lane width was 10 ft. Core locations are marked as black circles. PSPA locations are marked as blue circles. MASW locations are marked as red crosses. Only partial cores were recovered at most core locations.

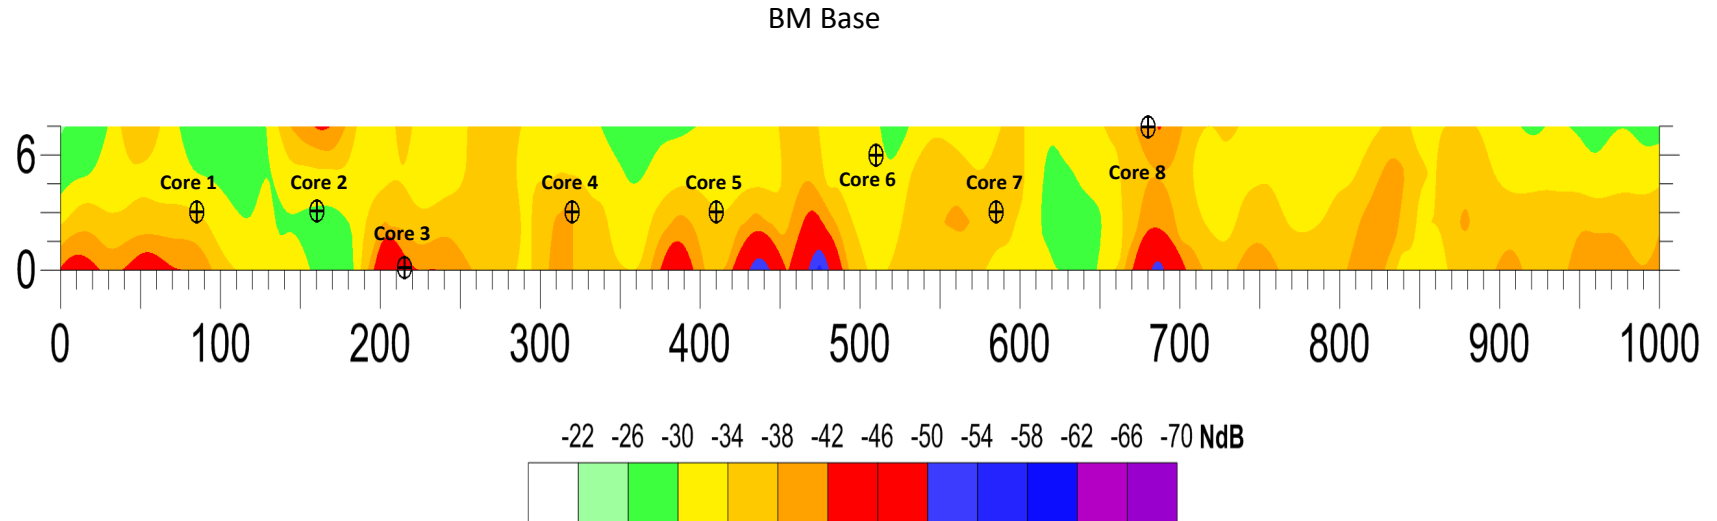
*Fig. 4.40—A base map with superposed GPR amplitude values from the bottom asphalt layer base. Areas highlighted in orange, red, and blue (<-34 NdB) indicate overall poor pavement condition. All cores (1 to 8) confirmed presence of deteriorated asphalt and debonding where two layers of asphalt recovered from the core. Traverse 1 was located 1.5 ft away from the pavement edge.*

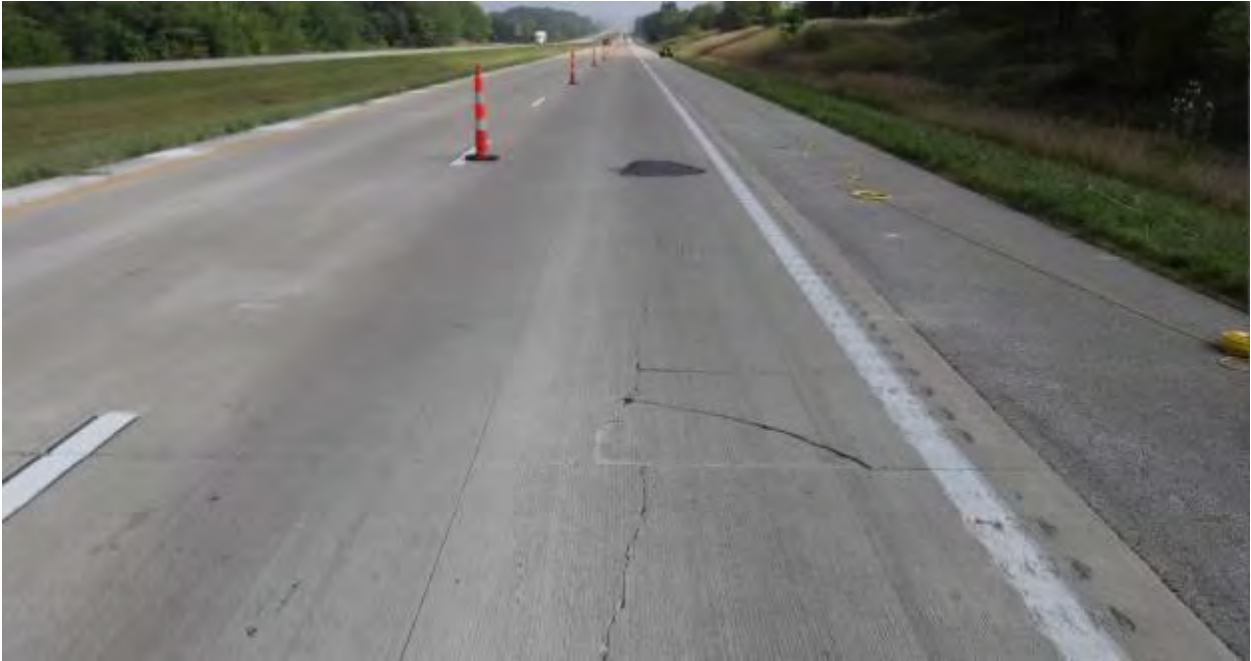
*Fig. 4.41—Photograph of site the project-level segment I-35 (Section 8). Photograph was taken looking north.*

The pavement at Site 8 consists of an upper layer of PCC (approximately 7 in), an intervening layer of BM (approximately 1 in.) and a basal layer of PCC (approximately 9 in.). The objective of the GPR investigation was to evaluate an unbonded PCC overlay with apparent problems.

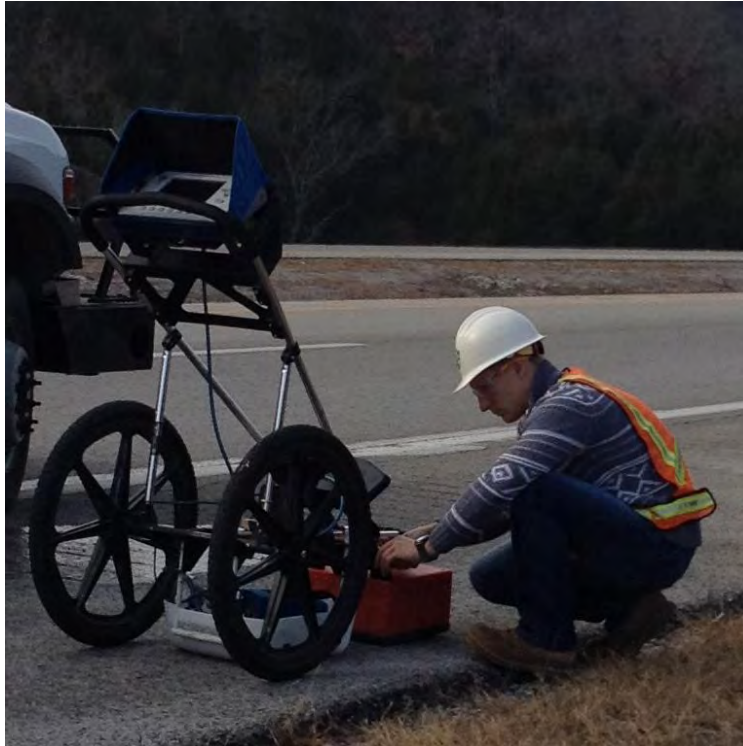
*Fig. 5.1—Photograph showing the push-cart and low-frequency 400 MHz GPR antenna (red box on pavement surface) and GSSI SIR-3000 control unit (top of cart).*

Low-frequency (400 MHz; Fig. 5.1) GPR data were acquired using sampling rates of 512 samples/scan and 24 scans/ft, but processed using 12 scans per ft. The GPR data were processed using GSSI RADAN 6 and RADAN 7 processing software. Initial processing steps included:

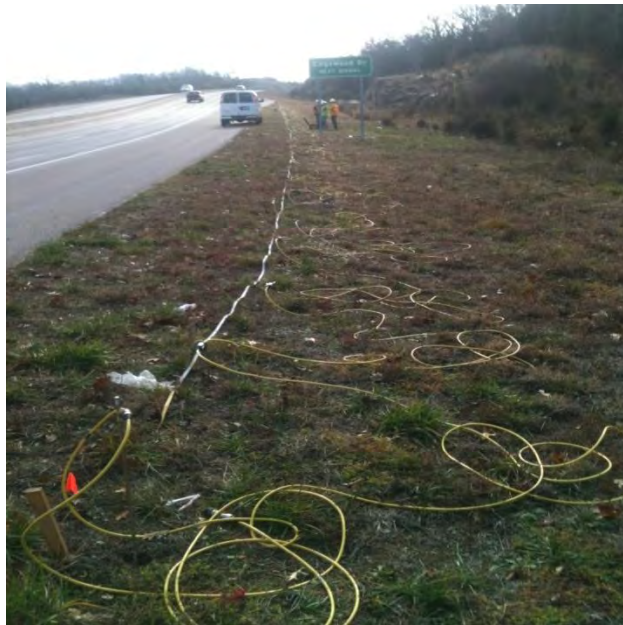
*Fig. 6.6—ERT data were acquired at each project-level site using an AGI SuperSting R8/IP resistivity system and a dipole-dipole array. Electrodes were spaced at 5 ft intervals. The intent was to image the subsurface to depths on the order of 40 ft.*

An array of interconnected electrodes (68 for this investigation) is coupled to the ground surface at uniform predetermined intervals (5 ft for this investigation) along a designated traverse and to the control unit (Fig. 6.6). At any instant in time, one pair of electrodes is used to induce current ( $I$ ) into the ground while a second pair of electrodes is used to measure potential differences ( $\Delta V$ ). The control unit automatically acquires apparent resistivity data ( $\rho_a$ ) by using all possible combinations of electrode pairs (depending upon type of array employed) as both current electrodes and voltmeter electrodes. Each recorded potential difference is used to calculate a value of resistance ( $R$ ;  $R = \Delta V/I$ ) and then a value of apparent resistivity ( $\rho_a$ ;

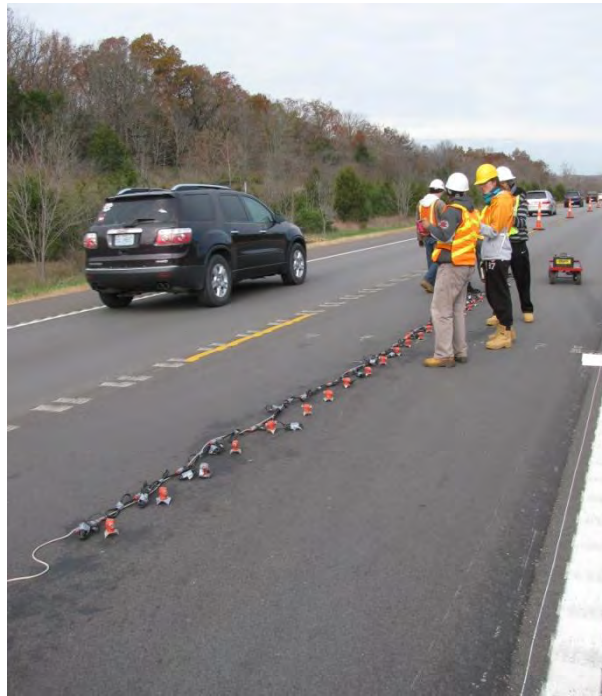
*Fig. 6.7—Active MASW data were acquired at each project-level site using a 24-channel engineering seismograph and 24 low-frequency (4.5 Hz) geophones spaced at 1.5 ft intervals. The intent was to image the subsurface to depths on the order of 40 ft.*

A linear array of geophones (24 geophones spaced at 1.5 ft intervals; Fig. 6.7) and an engineering seismograph were used to record active Rayleigh (surface) wave data. The array of geophones was centered at predetermined station locations (every 25 ft) along each project-level roadway. Active Rayleigh wave data sets were generated using a sledge hammer and striking plate (source discharged off the end of the geophone array). When the active source is discharged, the seismograph is triggered and field data are recorded (typically for one second or less). Stacking will improve the signal-to-noise ratio.

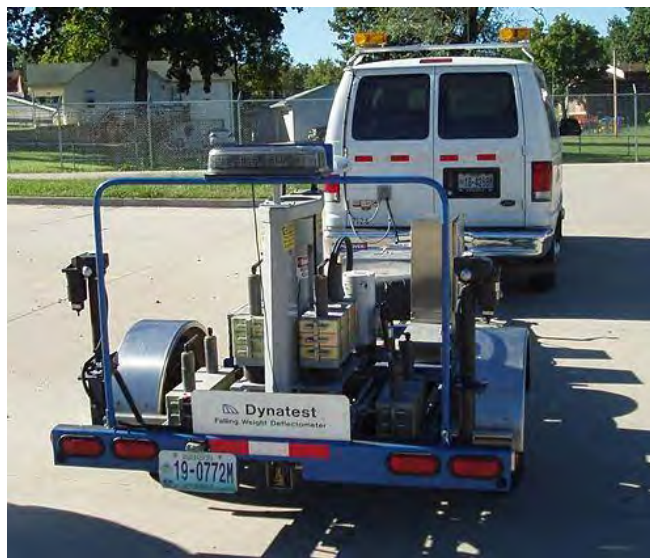
*Fig. 7.1– Photograph of the Falling Weight Deflectometer (FWD) manufactured by Dynatest and operated by the Missouri Department of Transportation (MoDOT).*

In current practice, deflection-based measurements are most commonly applied using the Falling Weight Deflectometer (FWD) device (Fig. 7.1). The FWD is a reliable and repeatable point-by-point deflection method that is employed to some degree by nearly all DOTs in assessing pavement properties and performance. The FWD applies an impact force to a loading plate on the pavement surface using a guided drop-weight. An array of geophones record the deflections of the pavement surface caused by the weight drop. Several different drop heights and/or impact weights can be used to measure the response under a wide range of applied pavement stresses. The FWD has been successfully used to evaluate individual components of the pavement system (e.g. Donovan and Tutumluer, 2009), characterize subgrade properties (e.g. Rahim et al., 2003), and support the decision making process for pavement management

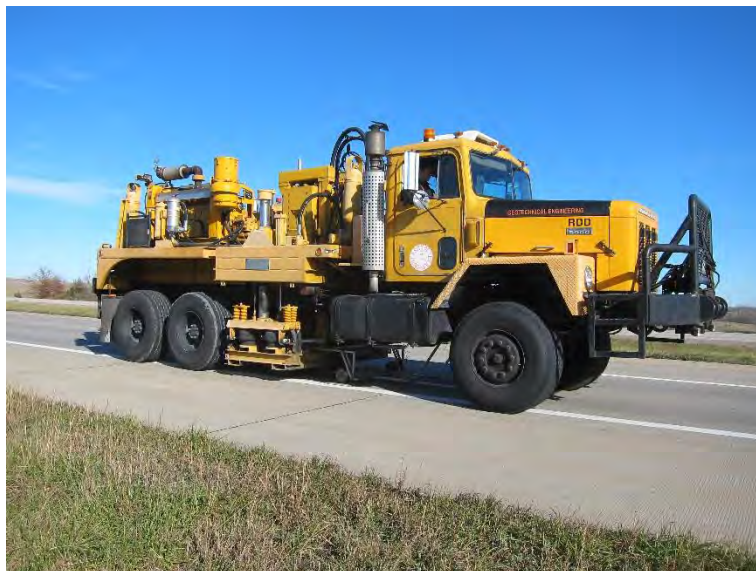
*Fig. 7.2—Photograph of the first generation Rolling Dynamic Deflectometer (RDD) used in this project.*

In recent years there has been progress in developing continuous deflection measurement devices to overcome some of the limitations of the FWD, namely the point-by-point implementation of the measurement. For this project the Rolling Dynamic Deflectometer (RDD) was studied as a tool for pavement assessment and management applications. The RDD was developed by the University of Texas and the Center for Transportation Research in Austin, Texas in the late 1990's as a proto-type device for measuring continuous profiles of pavement deflection (Bay, 1999). The RDD consists of a 50,000 lb (222.4 kN) Mertz Vibroseis truck (Fig. 7.2) which has been modified to allow for continuous dynamic loading and measurement of pavement deflections "on the fly". The dynamic load is generated using a hydraulic loading system and is applied to the pavement through a pair of rolling wheels located under the truck (Fig. 7.3a). Ground motions are measured using several rolling geophones mounted to an aluminum frame that extends from the dynamically loaded roller underneath the truck (Fig. 7.3b).

As the RDD profiles the surface at 1 to 2 mph (1.6 to 3.2 kph) the geophones record the deflection basin of the loaded pavement surface. The dynamic source typically tests pavement sections with a dynamic force of 10,000 lbs (44.5 kN) operating at a frequency of 30 Hz. One rolling geophone between the loading rollers aided by two or three additional rolling geophones attached to the aluminum frame capture the shape of the deflection basin in the

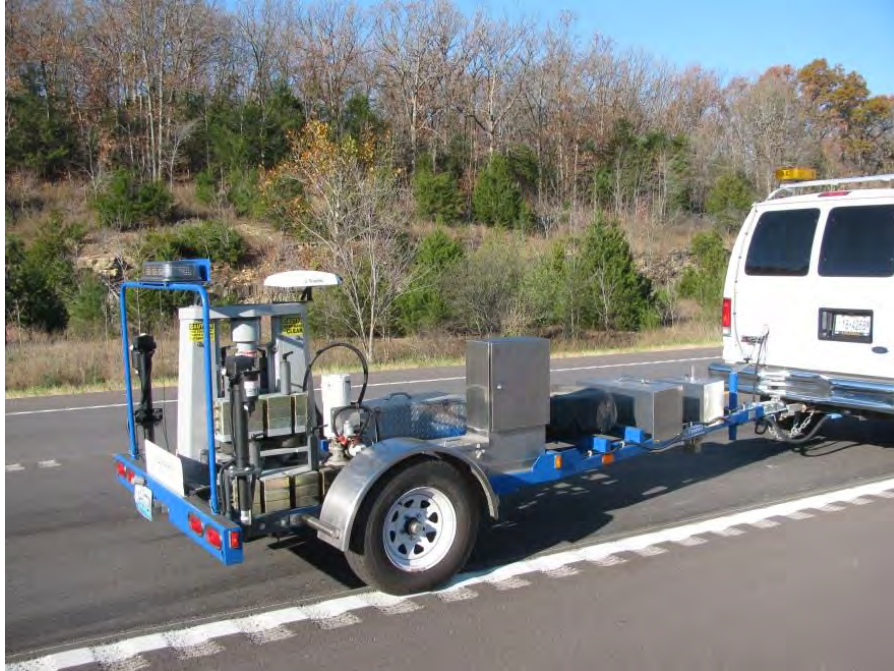
Fig. 7.4—Photo of falling weight deflectometer (FWD) equipment in operation at Site 1 (US 63).

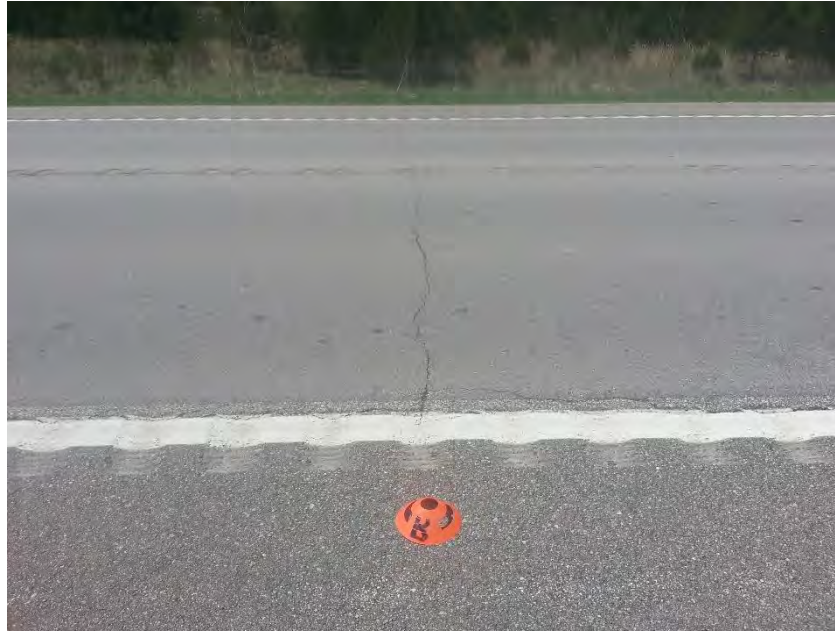
Fig. 7.11—Example of reflection crack observed at Site 1 (US 63) during RDD testing.

The locations of joints and cracks in the pavement are also apparent in the W1 profiles as spikes in the deflection plots, as shown in Fig. 7.12 and Fig. 7.13. The spikes in the profile indicate the increased deflection as the RDD approaches and passes over each joint and crack in the pavement. The magnitude of the joint deflections in the 1000-ft section recorded from the RDD and FWD are plotted and compared in Fig. 7.16. In this case the RDD showed lower joint deflections than the FWD over most of the profile, but slightly higher values for a few joints near the end of the section. Another way to isolate the performance of the joint using the RDD data is to subtract the W3 deflection from the W1 deflection (Chen, 2007), as shown in Fig. 7.17. Past studies by Chen, 2007 suggest threshold W1-W3 deflection value for reflection cracking of 4.4 mils. In this case, all of the W1-W3 values were less than 2 mils, although reflection cracking was apparent at nearly every joint location.

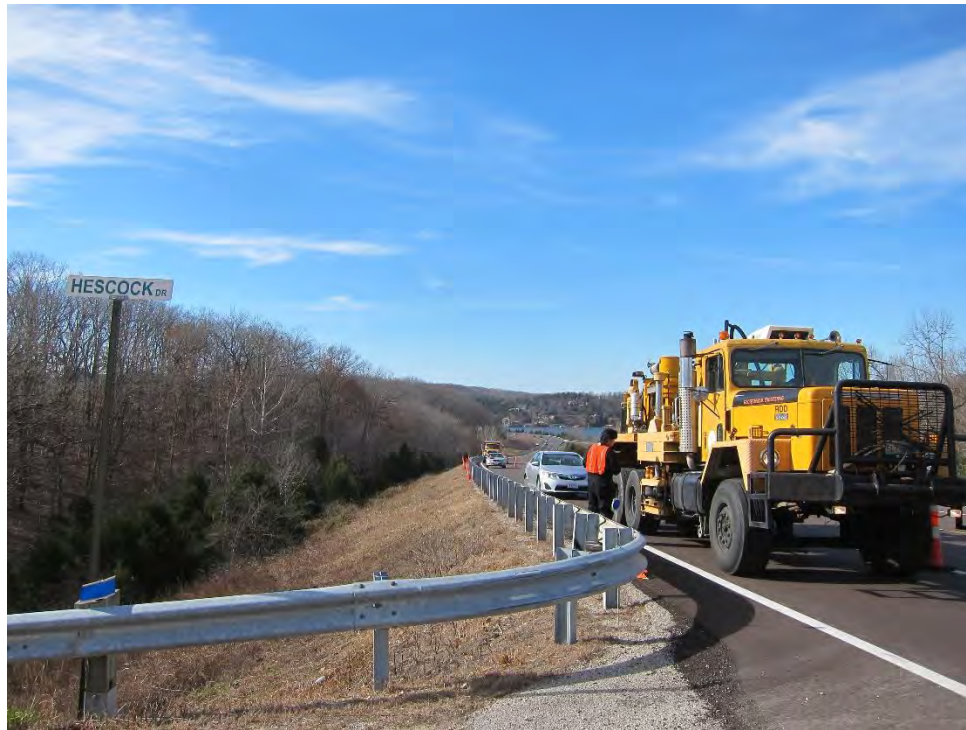
*Fig. 7.19—Photograph of the RDD in operation at US 54.*

Project level Site 2 is located on US 54 near Camden County, Missouri. The pavement profile when originally tested by the MS&T group (and MoDOT FWD) in November, 2013 consisted of approximately 11 in. of asphalt. At the time of the RDD testing there was no evidence of any surface distress or cracking in the newly overlaid section. Due to the different pavement conditions during the FWD and RDD testing it is difficult to make comparisons between the measurements. Fig. 7.19 shows a photograph of the RDD in operation at the newly overlaid US 54 site.

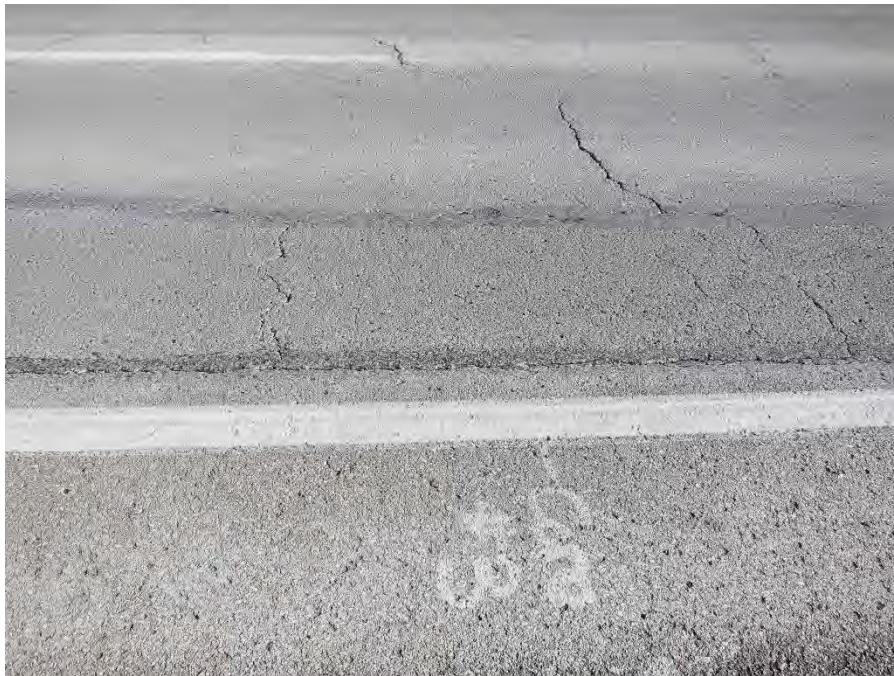
*Fig. 7.28—Photograph of pavement surface at Site 3 during RDD testing showing extensive longitudinal and transverse cracking in the asphalt layer.*

Project level Site 3 is located on HWY 179 in Jefferson City, Missouri. The pavement surface layer consists of approximately 12 in. of asphalt. This site was originally tested by the MS&T group and MoDOT FWD in December, 2013. The RDD testing was performed one year later in December, 2014. The pavement profile was unchanged between the time of the original testing and the RDD measurements, and extensive transverse and longitudinal cracking was evident in the pavement at both times (Fig. 7.28).

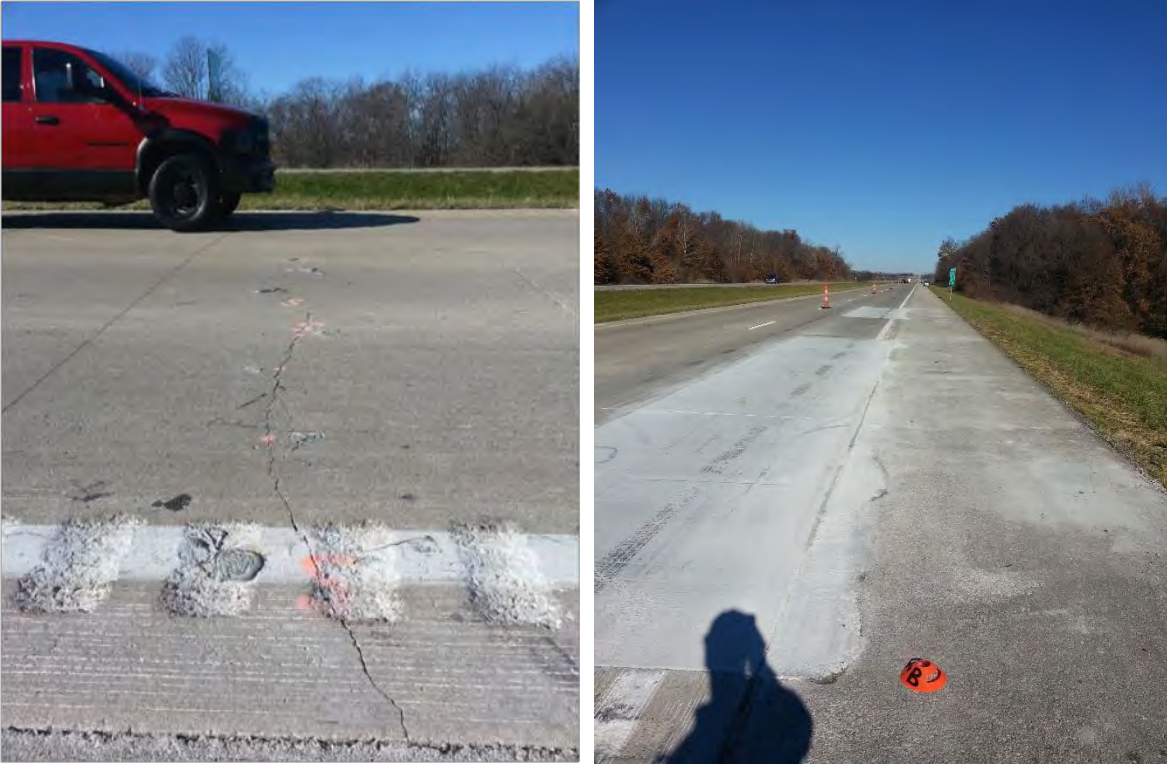
Fig. 7.48—Photographs of 1000 ft test section on I-35NB showing (a) repair of cracked slabs (b) replacement of slabs.

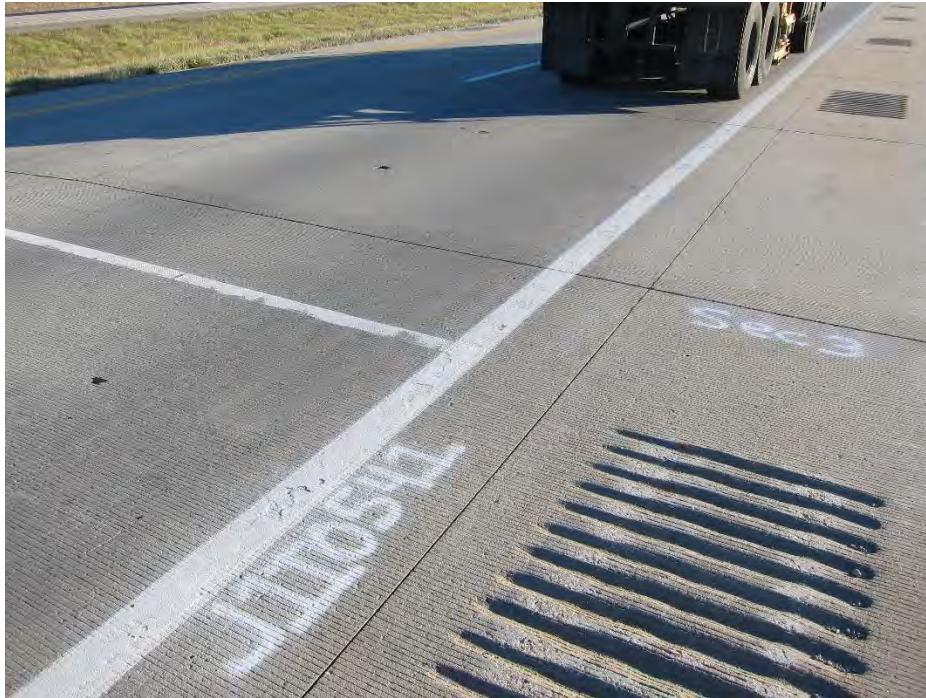
*Fig. 7.54—Photograph of section on I-35SB showing the good quality of pavement.*

An extra site was tested on I-35 north of Site 8. This site was chosen because it is an example of a good-performing unreinforced PCC pavement. The pavement consists of a 14 in. thick PCC with 15 ft joint spacing. The pavement has been in service since 1996 and shows minimal surface distress. A photograph of the pavement is shown in Fig. 7.54.

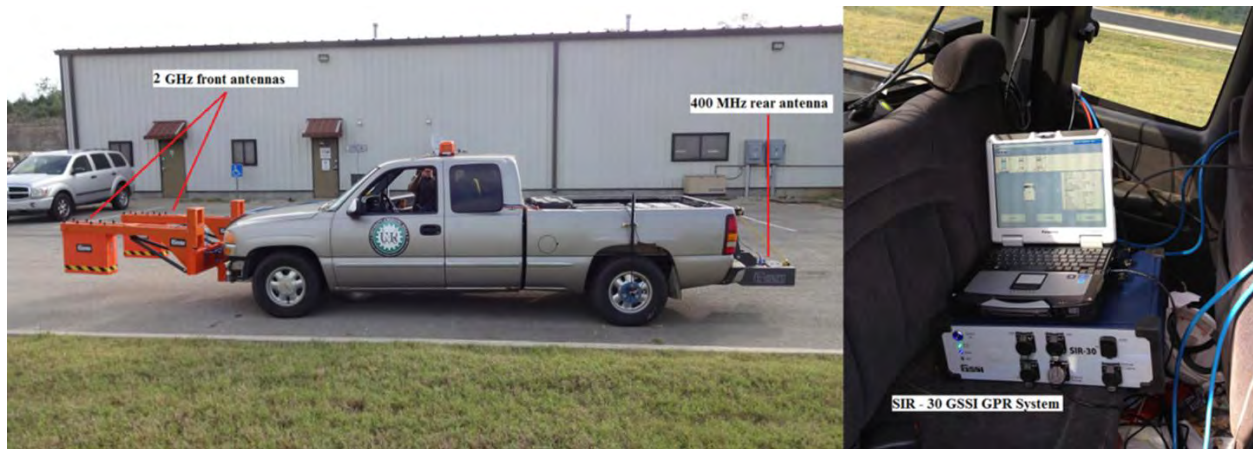
*Fig. 8.3– Two higher-frequency (2.0 GHz) GPR antennae were mounted to the front of the truck.*

Two higher-frequency 2.0 GHz horn antennae and one lower-frequency GSSI 400 MHz antenna were used to acquire example network-level GPR control. All three antennae were coupled to a vehicle (truck) with GPS capabilities. The 2.0 GHz horn antennae were mounted on the front of the truck; the 400 MHz antenna was mounted to the rear of the truck (Fig. 8.3). Acquisition parameters (4 scans/ft for 2.0 GHz antennae; 4 scans/ft for 400 MHz antenna; 325 scans/sec; 256 samples/scan for Site 9 and 6 scans/ft for 2.0 GHz antennae; 6 scans/ft for 400 MHz antenna; 325 scans/sec; 256 samples/scan for Site 10) were selected to enable quality GPR data collection at near-highway speeds (up to 50 miles per hour).

GPR data were in the west-bound driving lane using a GSSI SIR-30 system equipped with two higher-frequency 2.0 GHz GSSI 42000S horn antennas (mounted on the front of the truck; Fig. 8.3) and one lower-frequency 400 MHz GSSI 5103 shielded antenna (mounted on the rear of the truck; Fig. 8.4). As depicted in Fig. 8.4 and Fig. 8.6, the two 2.0 GHz horn antennas were mounted with 4 ft center-to-center spacing. Antenna 1 (channel 1) was mounted on driver side; antenna 2 (channel 2) was mounted on the passenger side. The 400 MHz antenna was coupled to the trailer hitch of the truck and set up as channel 3. A mechanical distance measuring instrument (DMI) was mounted on the survey truck wheel to measure distances along the profile based on number of revolutions per unit of distance and to trigger the GPR

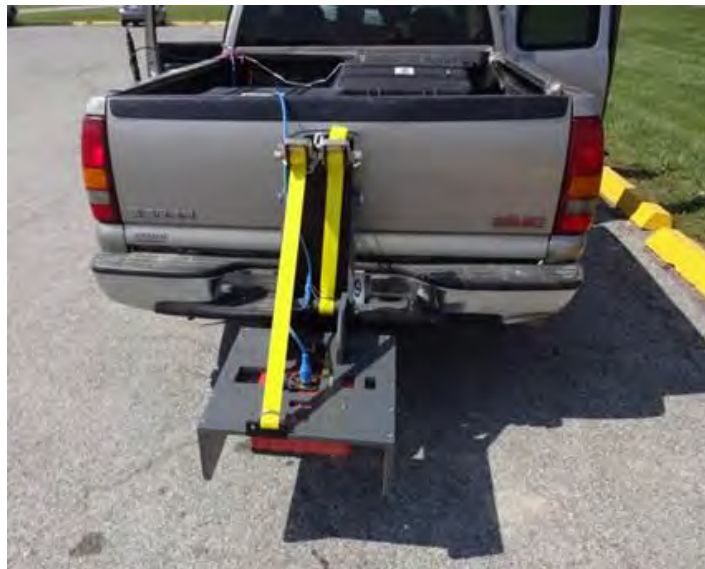
*Fig. 8.4– The lower-frequency (400 MHz) GPR antenna was mounted to the back of the truck.*

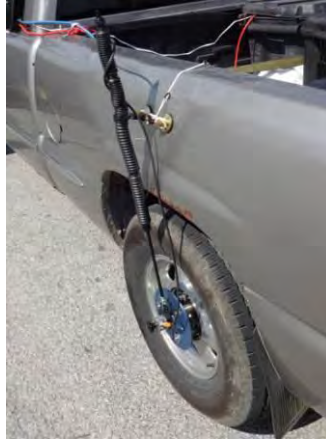
*Fig. 8.5– Distance measuring instrument (DMI) mounted on the truck wheel.*

instruments (Fig. 8.5). For GPS coordinates control, a GPS antenna was mounted on the top of the survey truck as shown in Fig. 8.6.

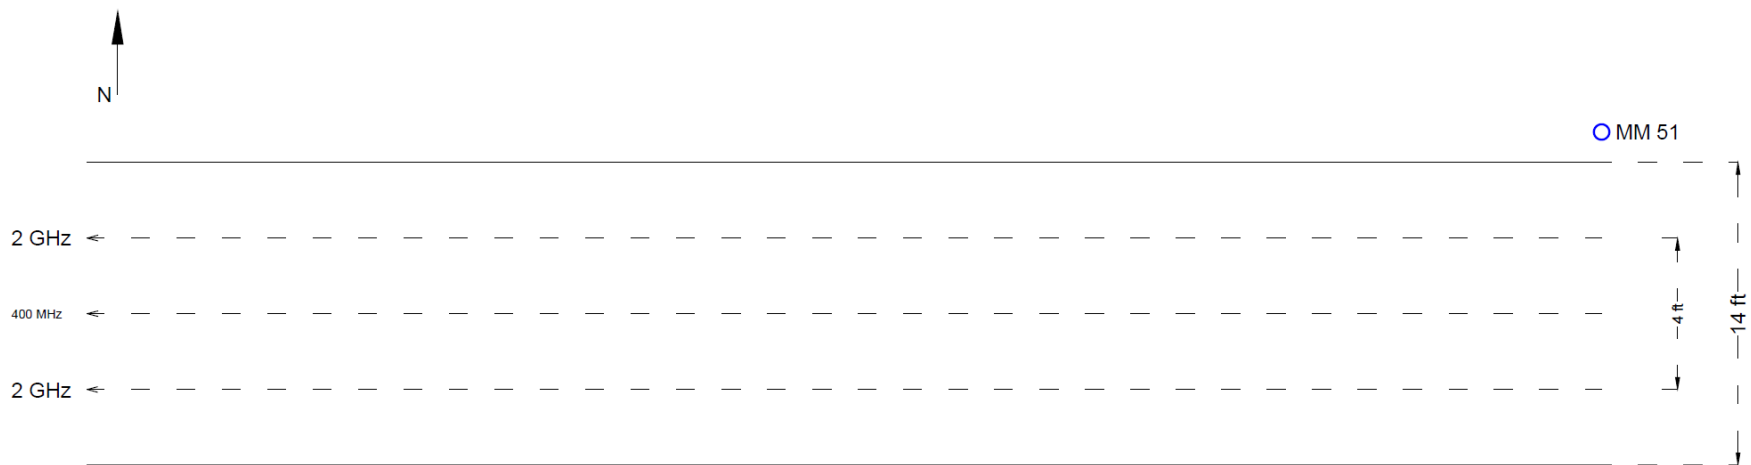
*Fig. 8.7— Schematic showing relative locations of the network-level Site 9 (segment of I-70) GPR traverses. Solid black lines represent the boundaries of west-bound driving lane. Mile marker 51 (MM 51) is shown for illustration purposes. The test segment of I-70 extended from mile marker 84.2 to mile marker 20.8 and extended across three counties (Jackson, Saline and Lafayette); GPR data were acquired in the west-bound driving lane only.*
