MDOT RC-1618A

**Research on Evaluation and
Standardization of Accelerated Bridge
Construction Techniques**

Appendices (Report 2013-2015)

**SLIDE PROJECTS' FIELD VISITS
DOCUMENTATION**

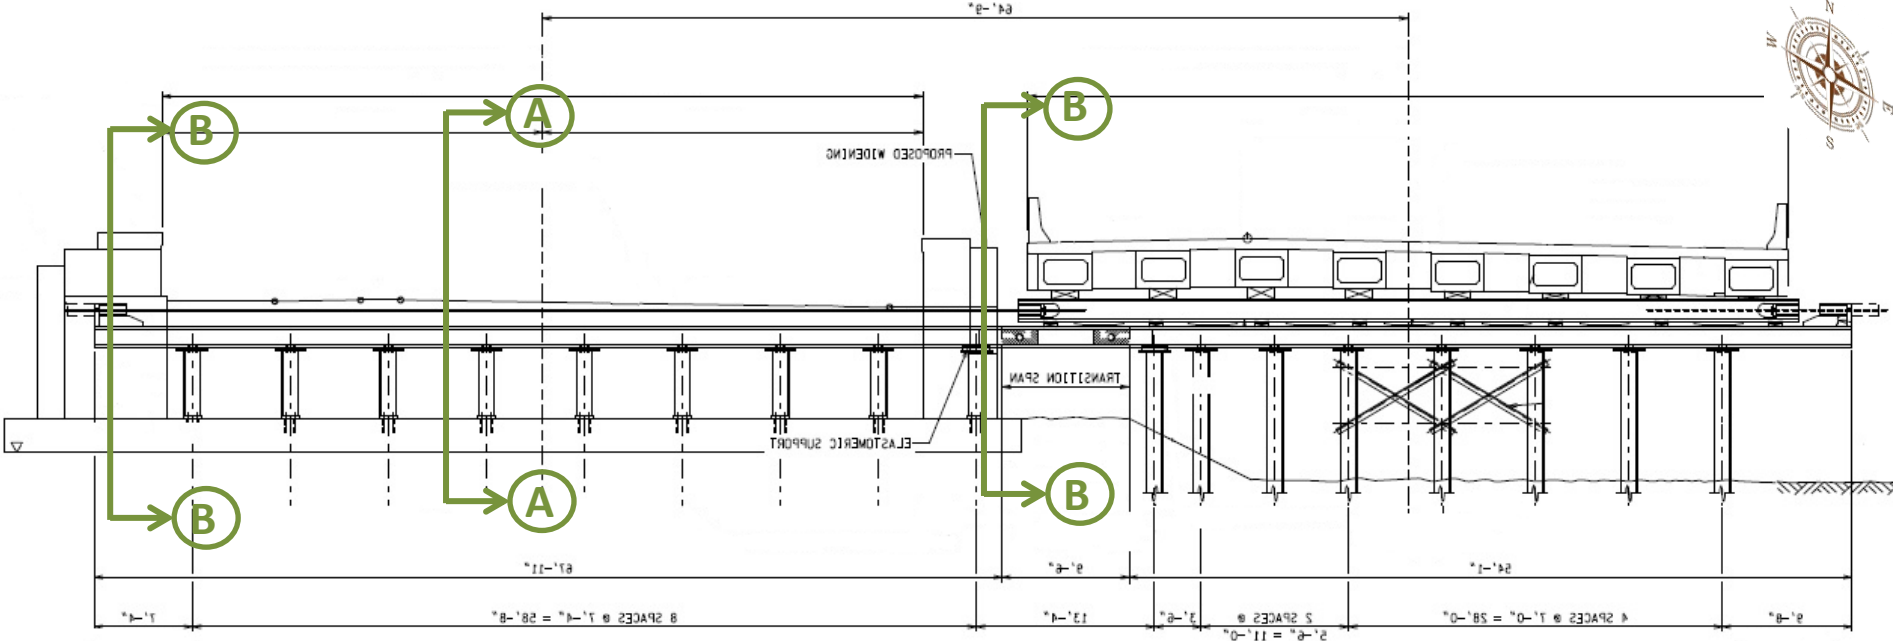
EXISTING ABUTMENT WITH PROPOSED WIDENING

TEMPORARY ABUTMENT

SECTION A-A

SECTION THRU EXIST ABUTMENT B

SECTION B-B

SECTION THRU ABUTMENT B WIDENING

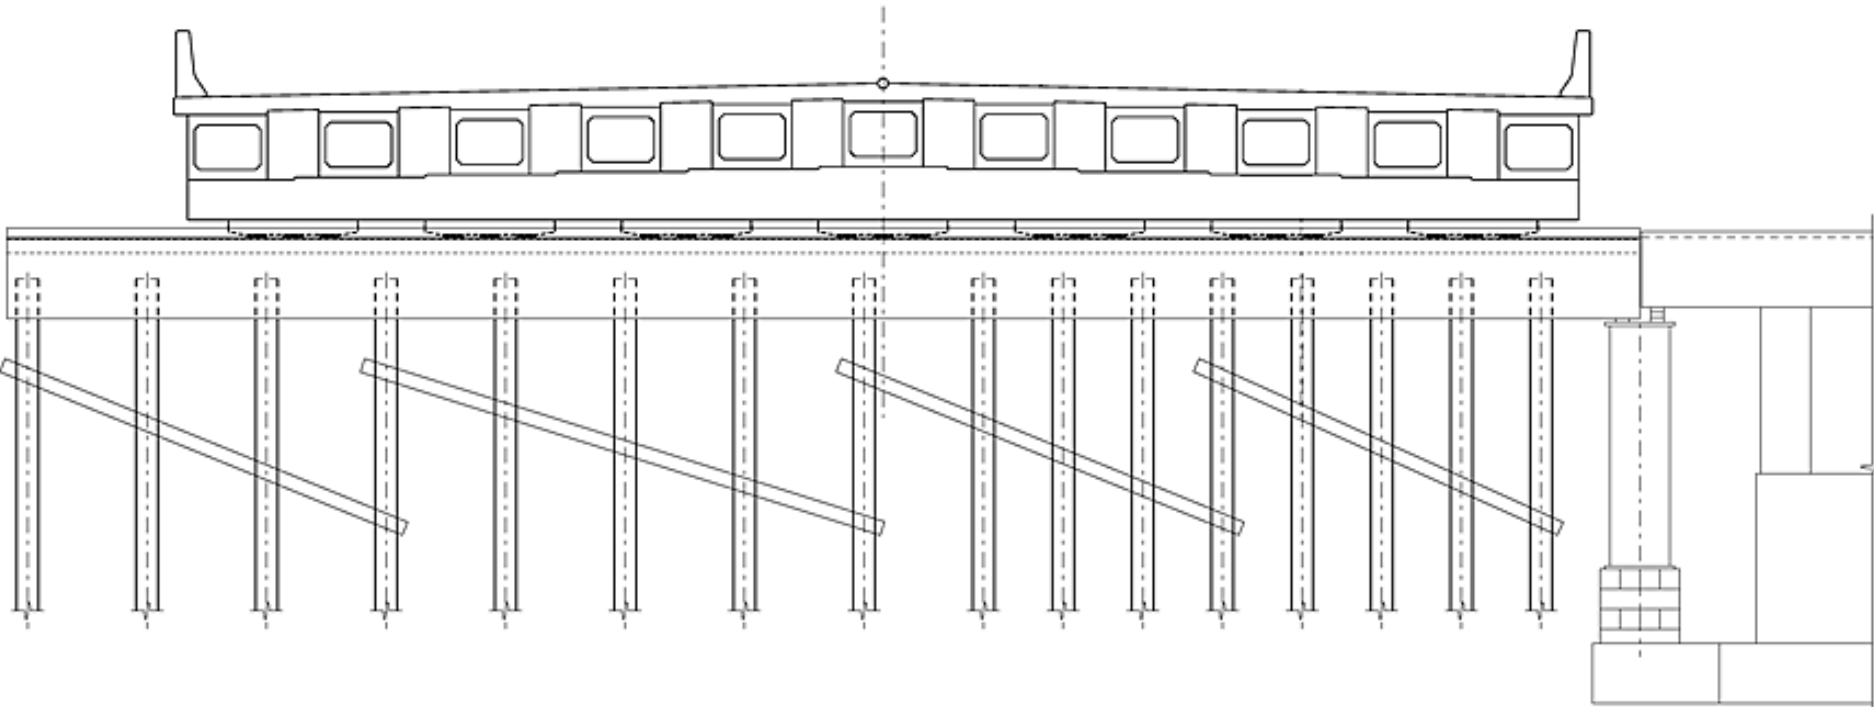
M-50 BRIDGE PIER (NEW) ELEVATION

Weight (kips)
Length	198 ft
Width	71.25 ft
Spans	2
Girders per span	11
Sliding shoes	7

Weight (kips)
Deck	1587
Girders	1775
Barriers	188
Pier diaphragm	167
Backwalls	264
Total weight	≈4000 kips

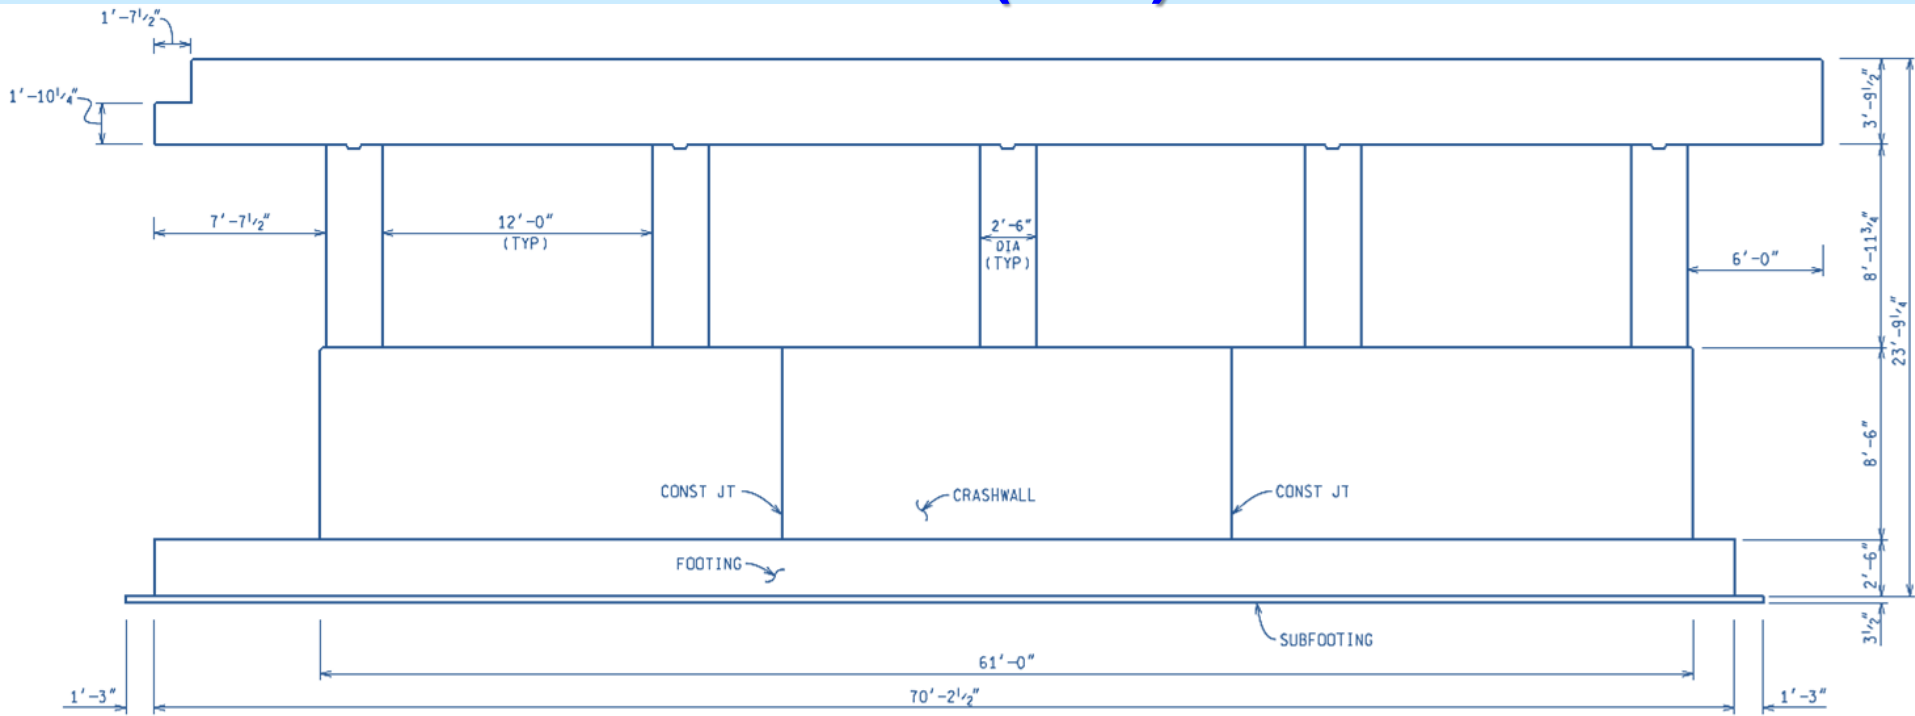
M-50 BRIDGE PIER (NEW)

Weight (kips)
Footing	513
Crashwall	233
Bent (bent cap & 5 pier columns)	157
Total weight	≈904

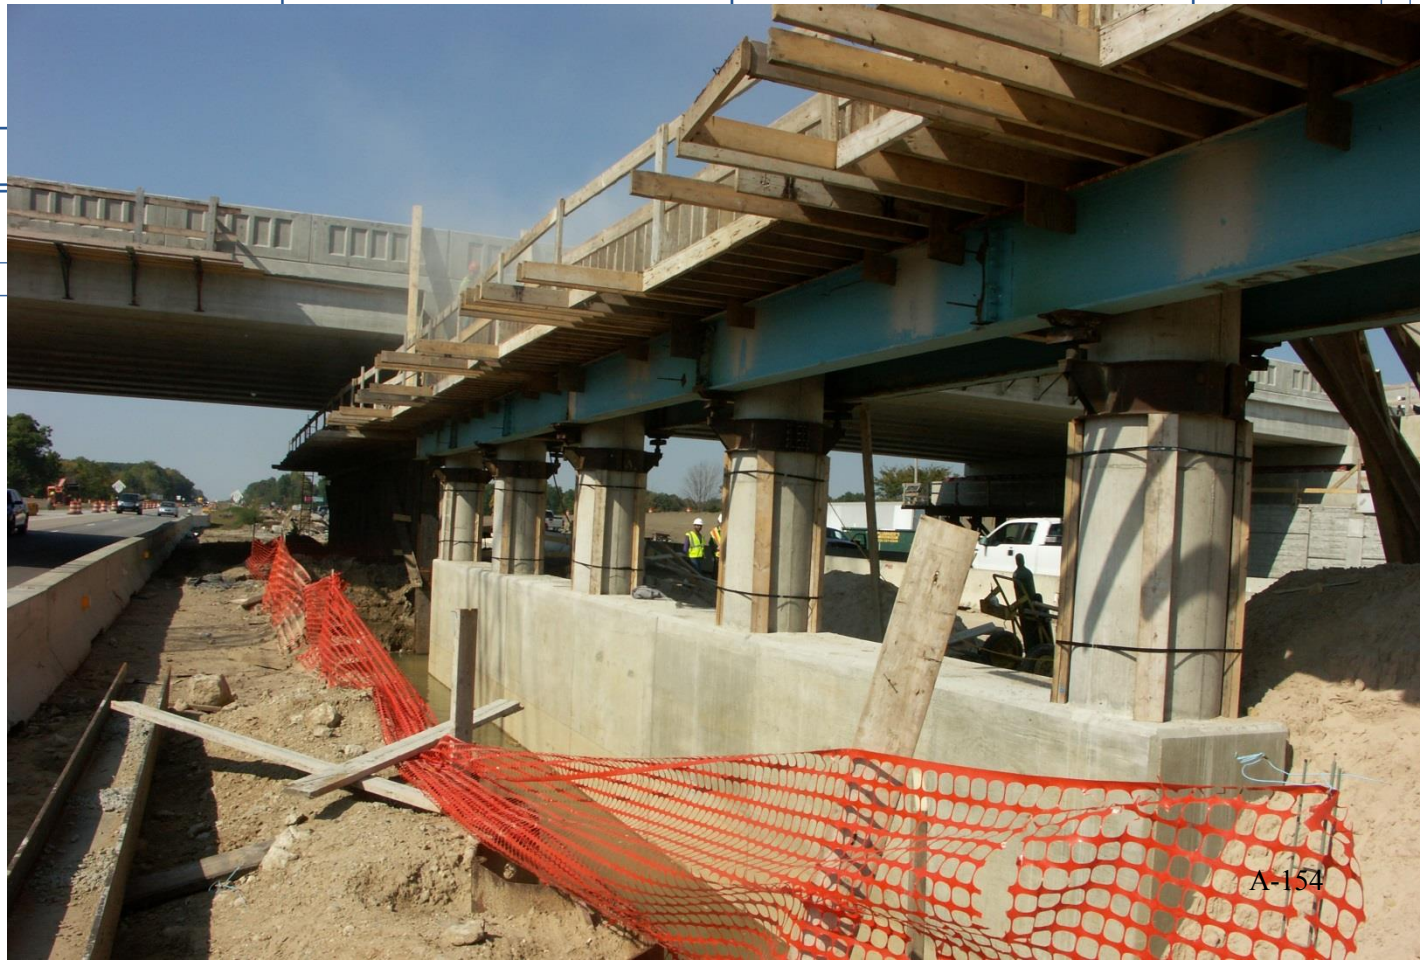
M-50 BRIDGE PIER MONITORING DURING SLIDE

WMU team reviewed the site accessibility and decided to install metal plates on the 5 pier columns (diameter = 2'6") for mounting the laser-tracker sensors. One sensor is also planned to be mounted on temporary steel column at the transition. A total of 6 sensors are planned to be used for monitoring the vertical settlement of the pier during the sliding operation. Laser-tracker is planned to be placed within the right-of-way of EB I-96 on the South side.

Metal plates with a curvature of radius of 1'4" are planned to be fabricated. The size of the metal plates is decided as 10" × 8"

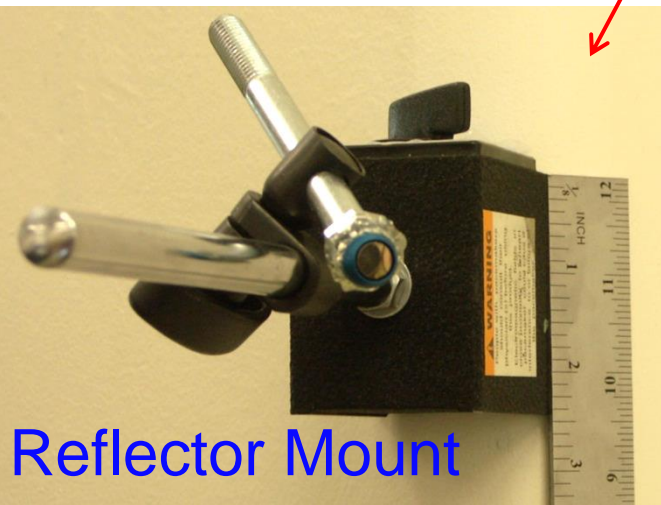
M-50 BRIDGE PIER MONITORING DURING SLIDE

PIER ELEVATION

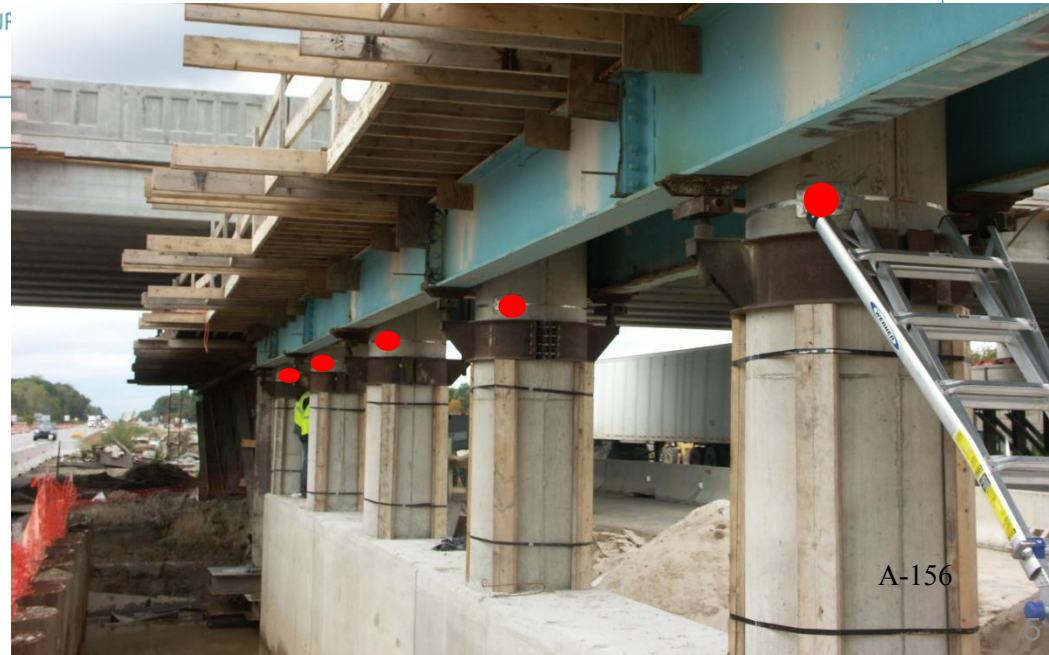
M-50 BRIDGE PIER MONITORING DATA ANALYSIS

- Axes for the pier

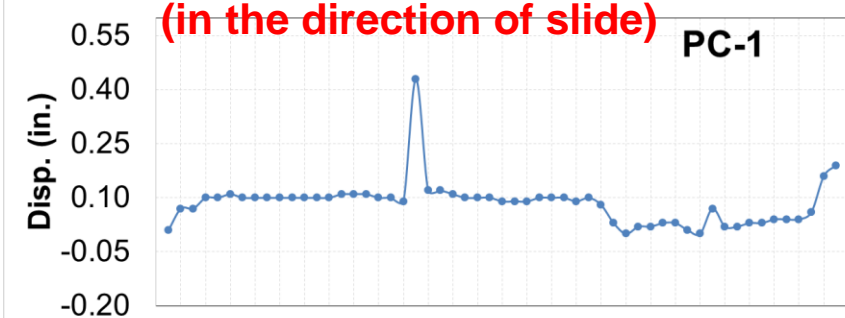
FIELD MEASURED DISPLACEMENTS OF M-50 BRIDGE PIER

X – Displacement

(in the direction of slide)

Y – Displacement (lateral drift)

(normal to slide direction)

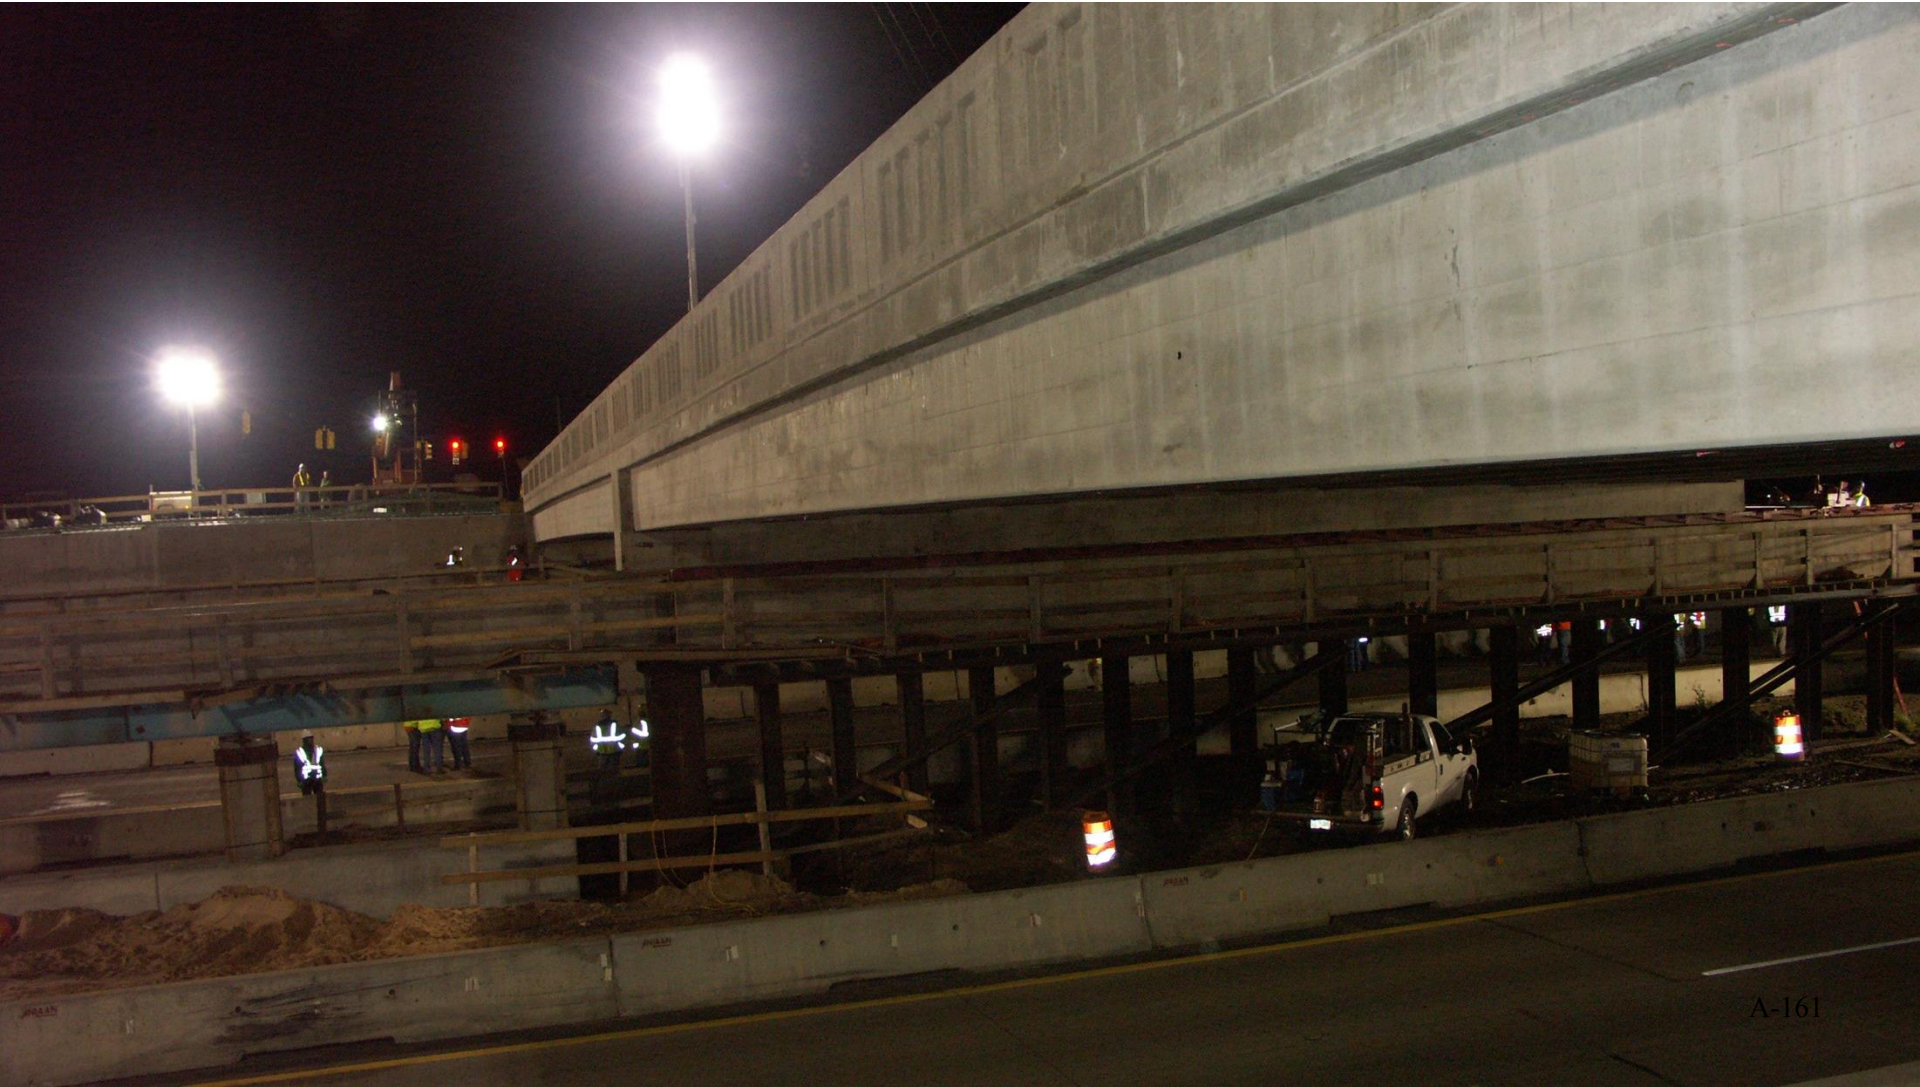
FIELD MEASURED DISPLACEMENTS OF M-50 BRIDGE PIER

- Data acquisition starts at 11:59 PM with slide (Oct 17, 2014)

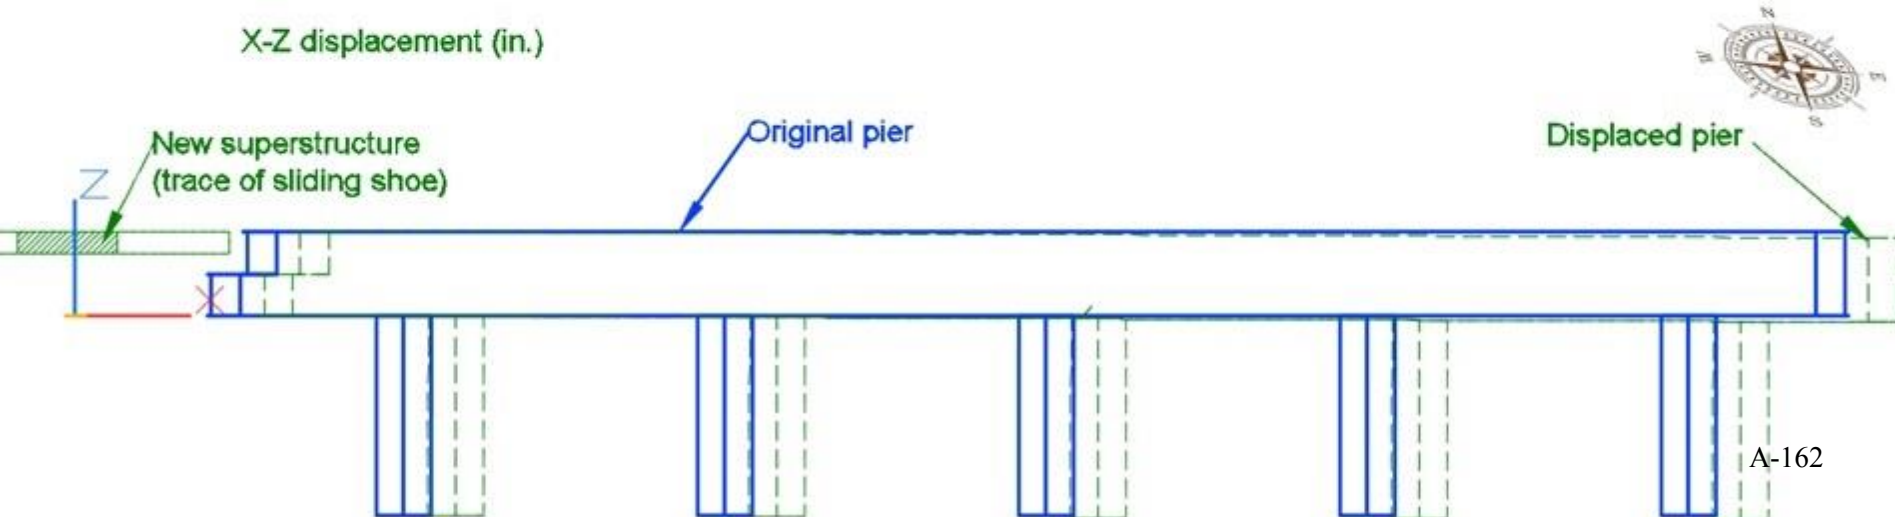
- Observation-1 at 11:59 PM (Oct 17, 2014)

Obs. no.	Time	Deflection of the pier centroid [in.]		
		X	Y	Z
1	11:59 PM	0.14	0.11	-0.01

X-Z displacement (in.)

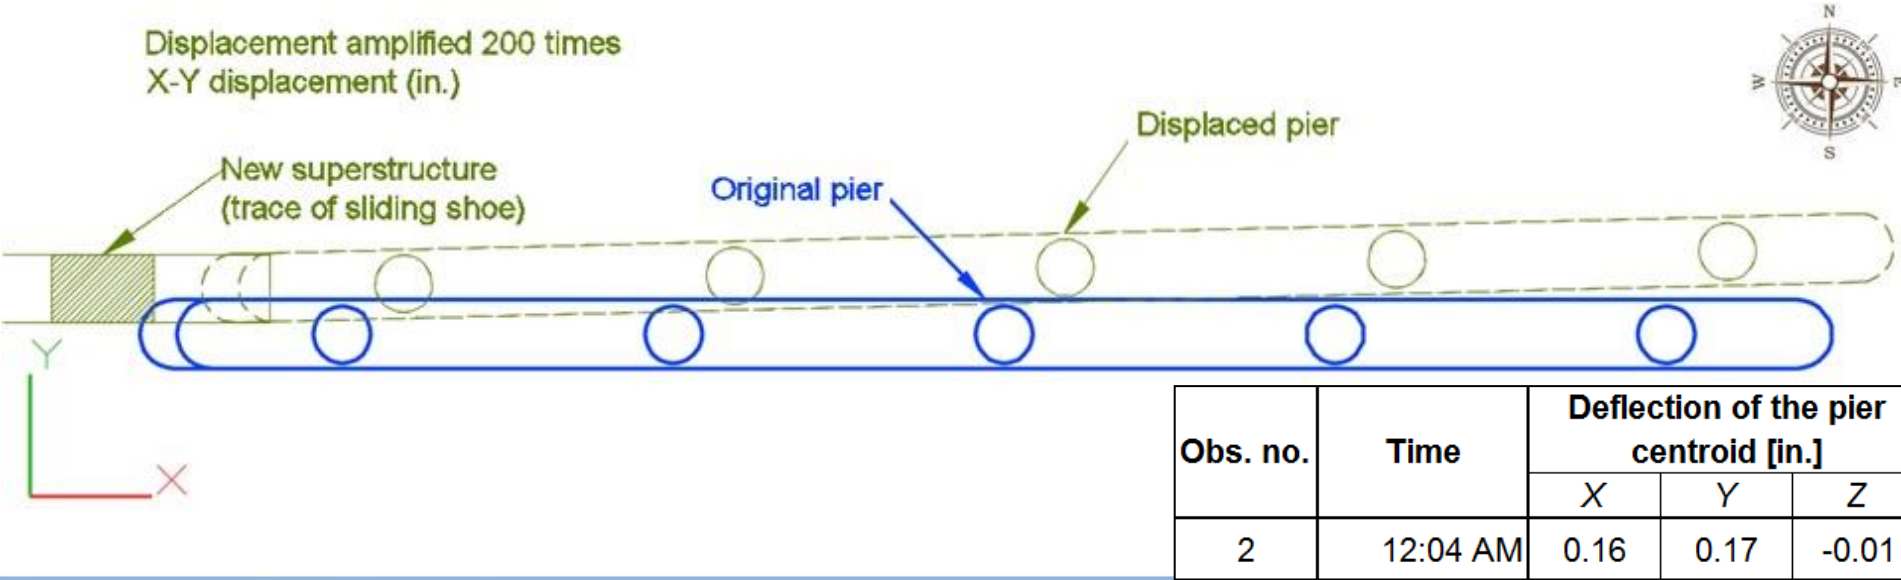
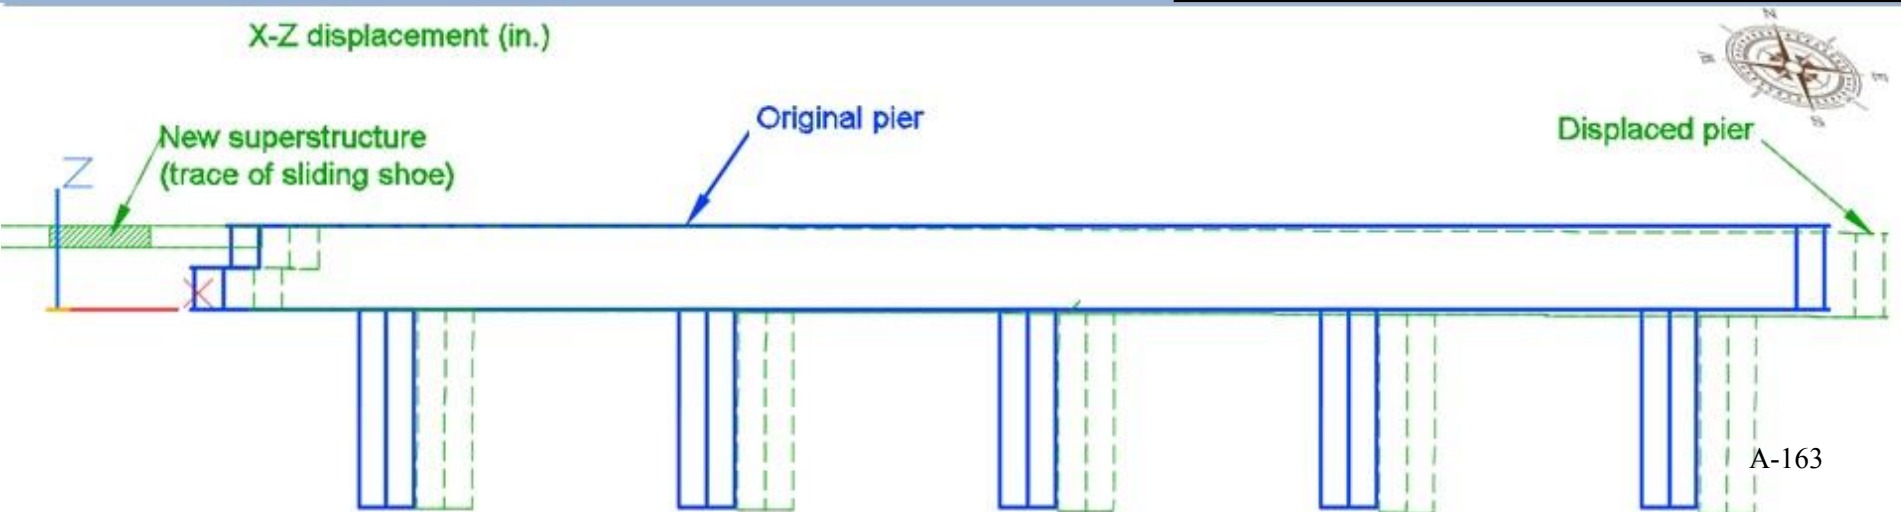
- Observation-2 at 12:04 AM (Oct 18, 2014)
 - First sliding shoe approaching temporary steel-column at the transition

Displacement amplified 200 times
X-Y displacement (in.)

X-Z displacement (in.)

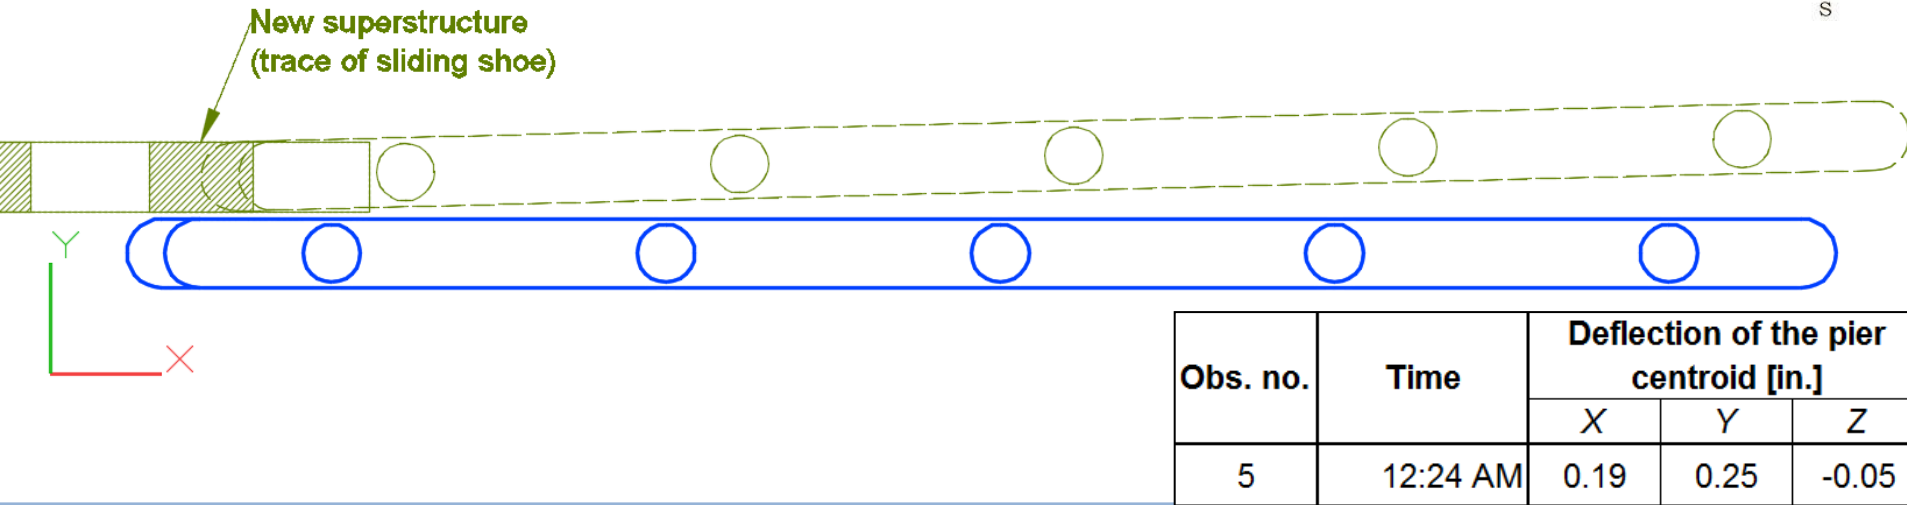
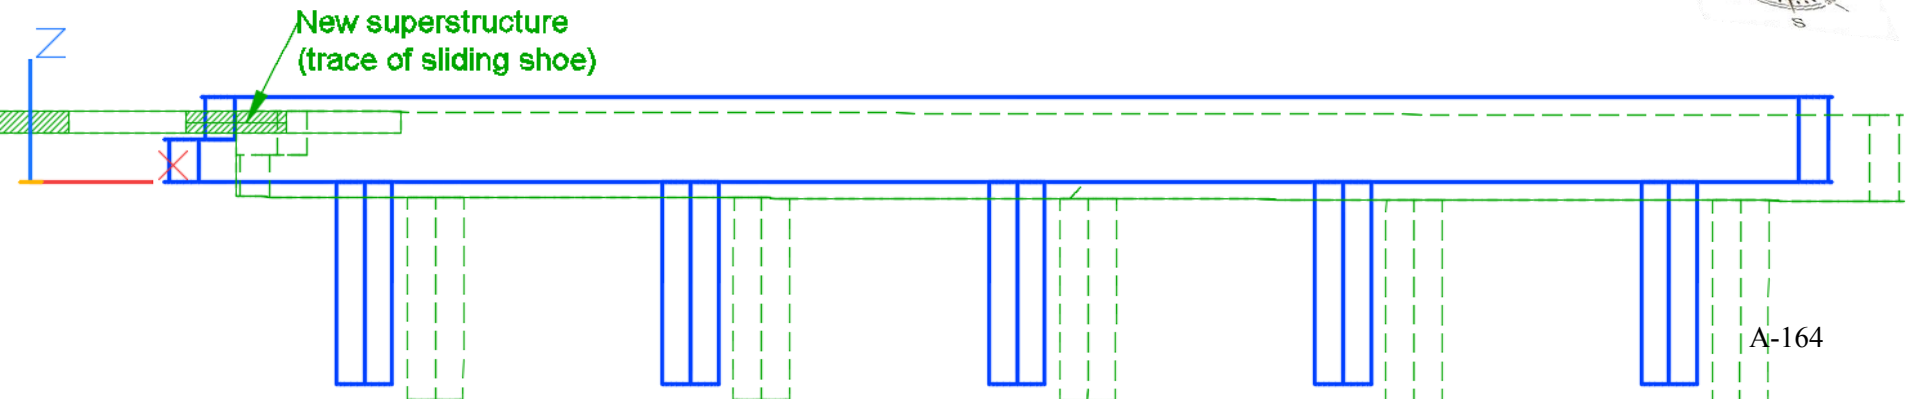
■ Observation-5 at 12:24 AM

- First sliding shoe at temporary steel-column at the transition

X-Y displacement (in.)

X-Z displacement (in.)

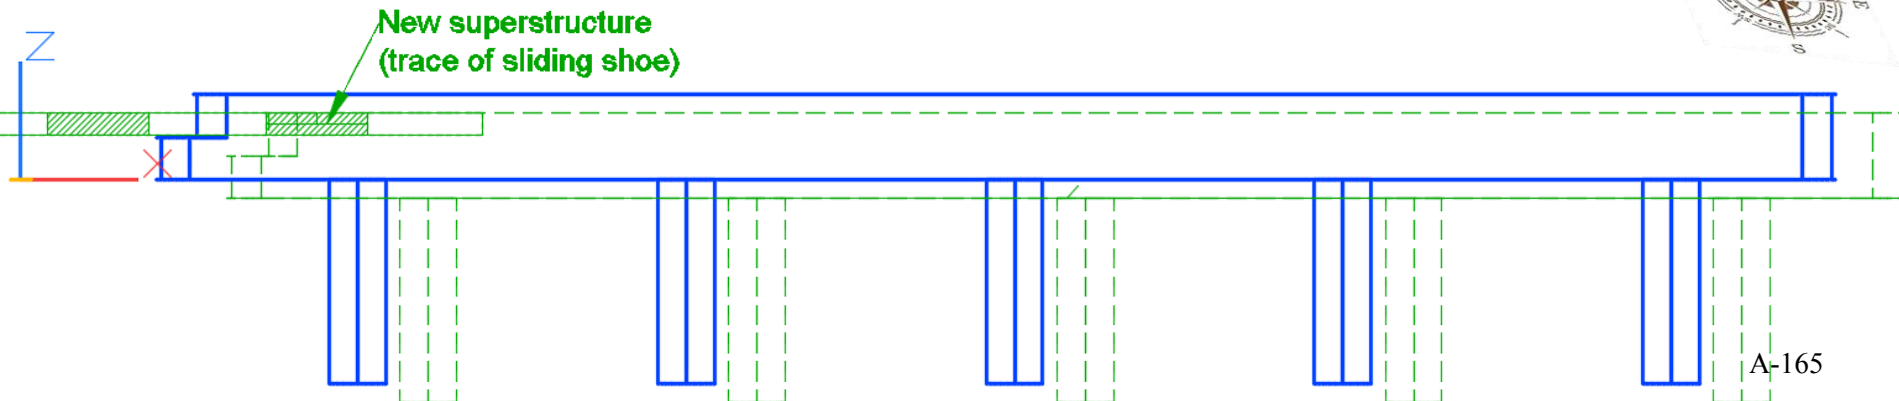
- Observation-8 at 12:41 AM
 - First sliding shoe completely on new pier before col.-1 (first column)

Obs. no.	Time	Deflection of the pier centroid [in.]		
		X	Y	Z
8	12:41 AM	0.20	0.24	-0.05

X-Z displacement (in.)

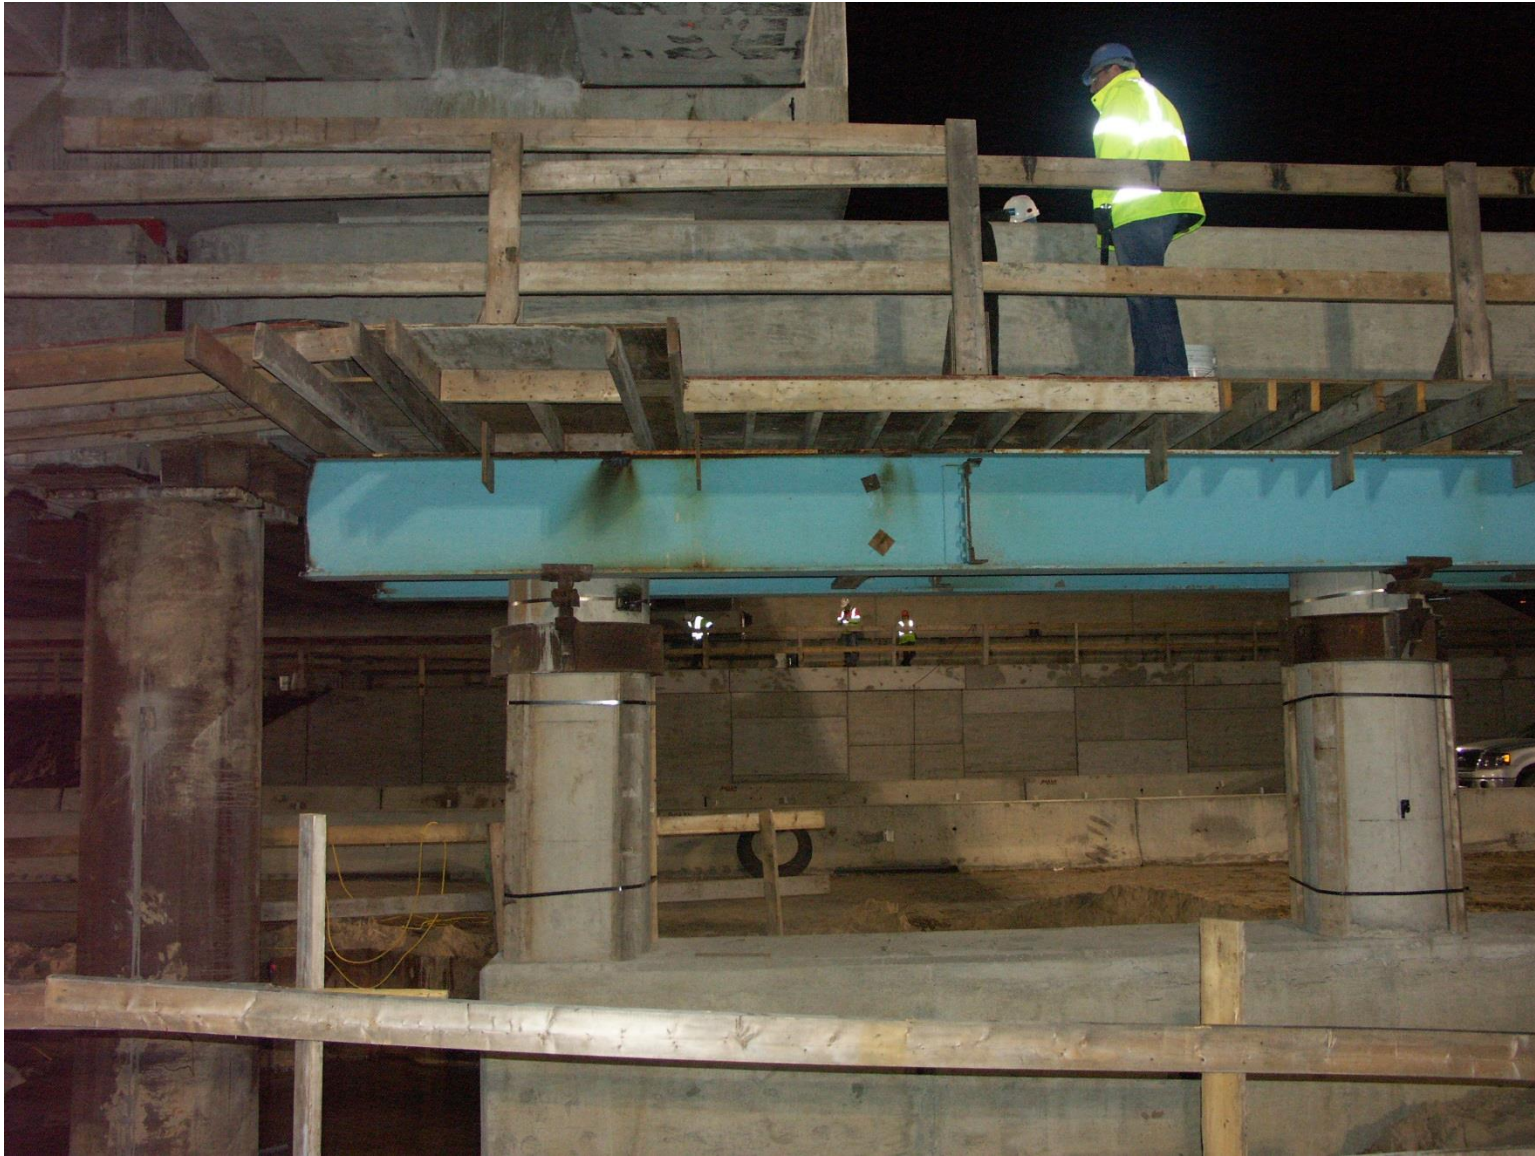
FIELD MEASURED DISPLACEMENTS OF M-50 BRIDGE PIER

- Observation-16 at 01:07 AM
 - First sliding shoe over col.-1 of new pier

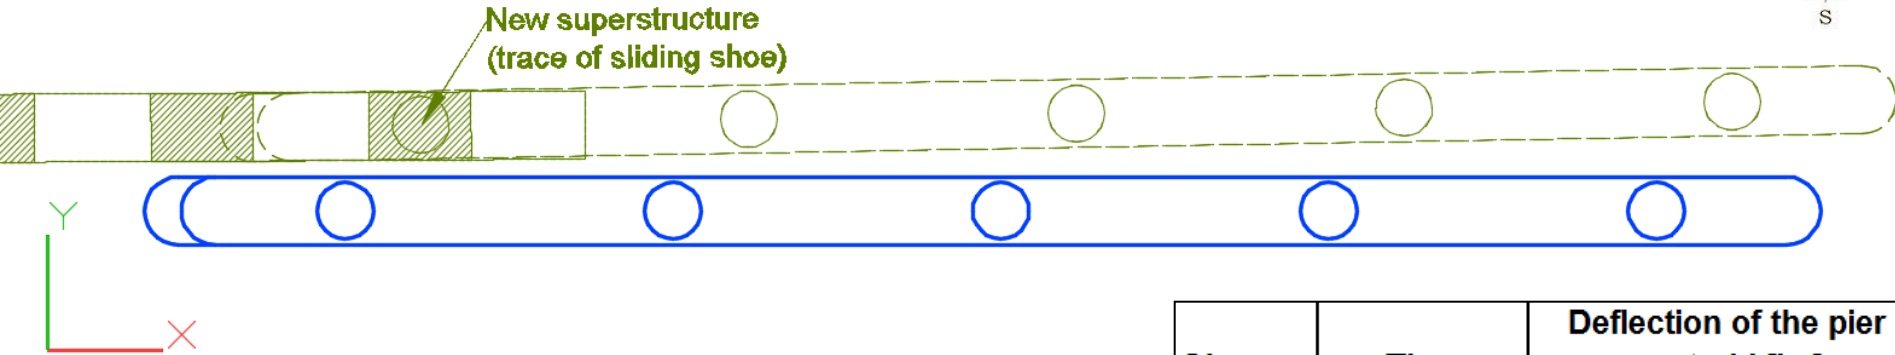
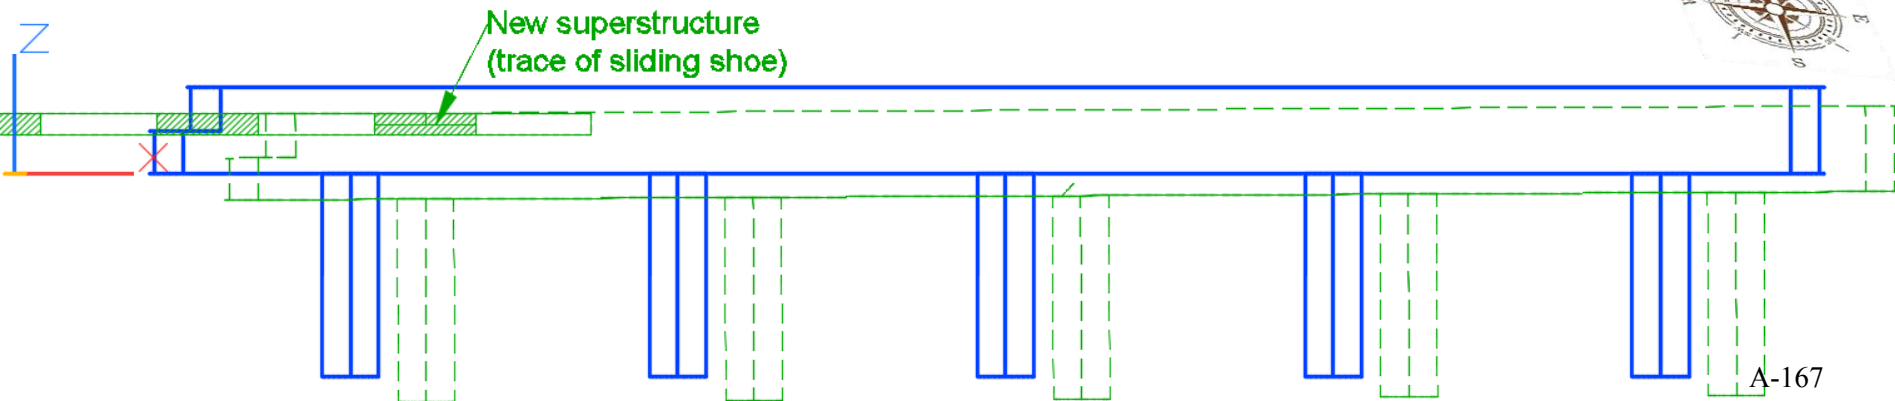
- Observation-16 at 01:07 AM
 - First sliding shoe at col.-1 of new pier

X-Y displacement (in.)

Obs. no.	Time	Deflection of the pier centroid [in.]		
		X	Y	Z
16	1:07 AM	0.20	0.26	-0.06

X-Z displacement (in.)

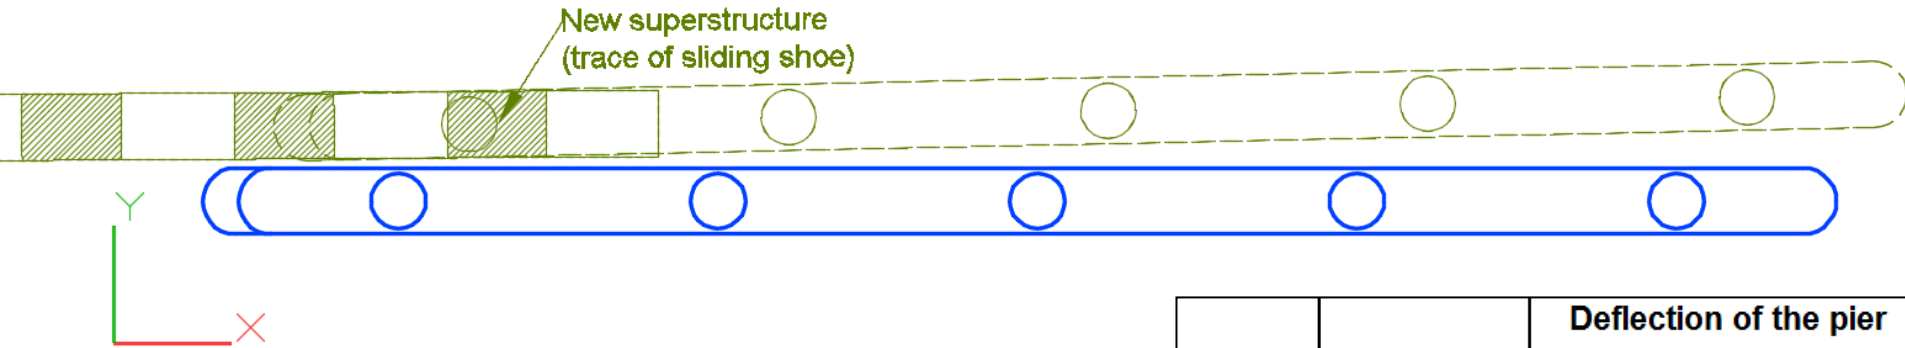
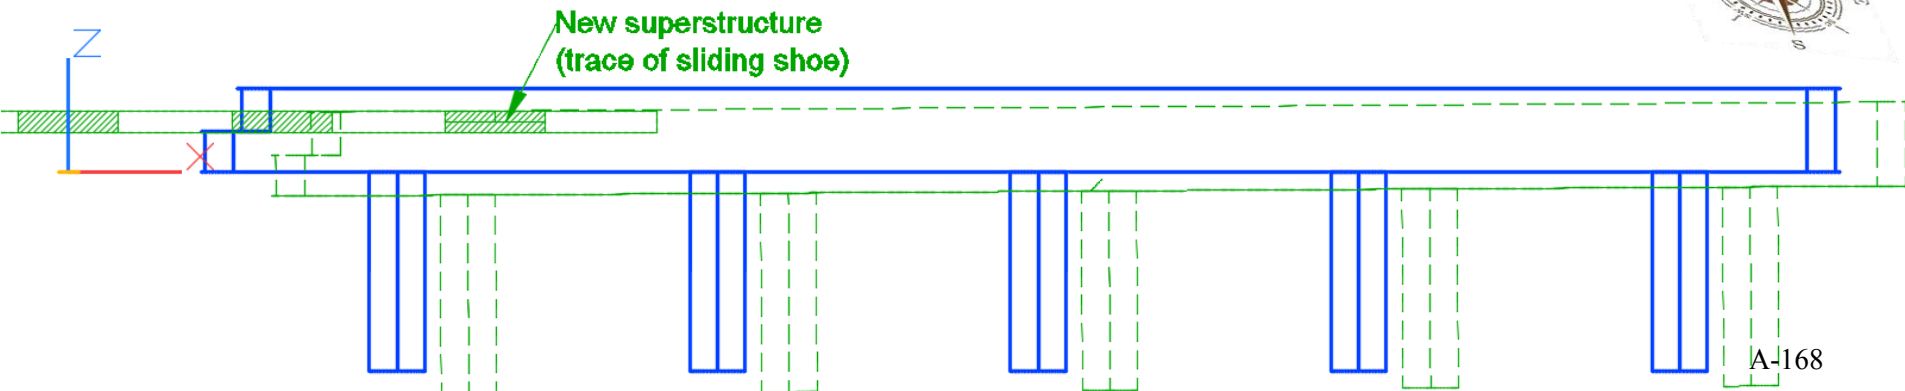
- Observation-18 at 01:18 AM
 - Second sliding shoe at the temporary steel-column at transition

X-Y displacement (in.)

Obs. no.	Time	Deflection of the pier centroid [in.]		
		X	Y	Z
18	1:18 AM	0.19	0.24	-0.05

X-Z displacement (in.)

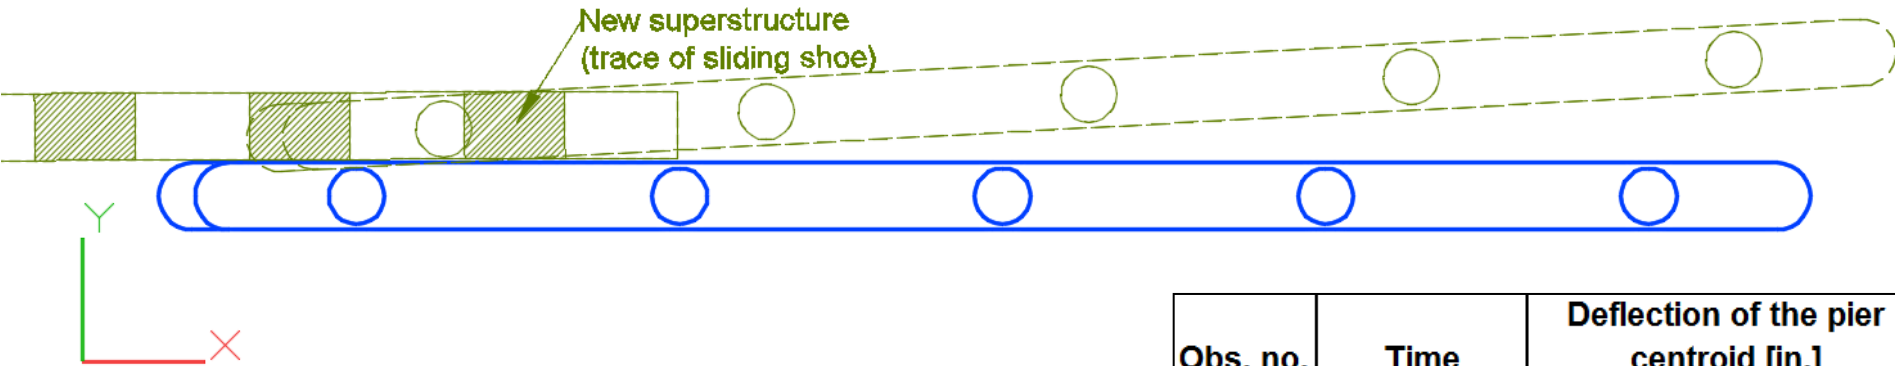
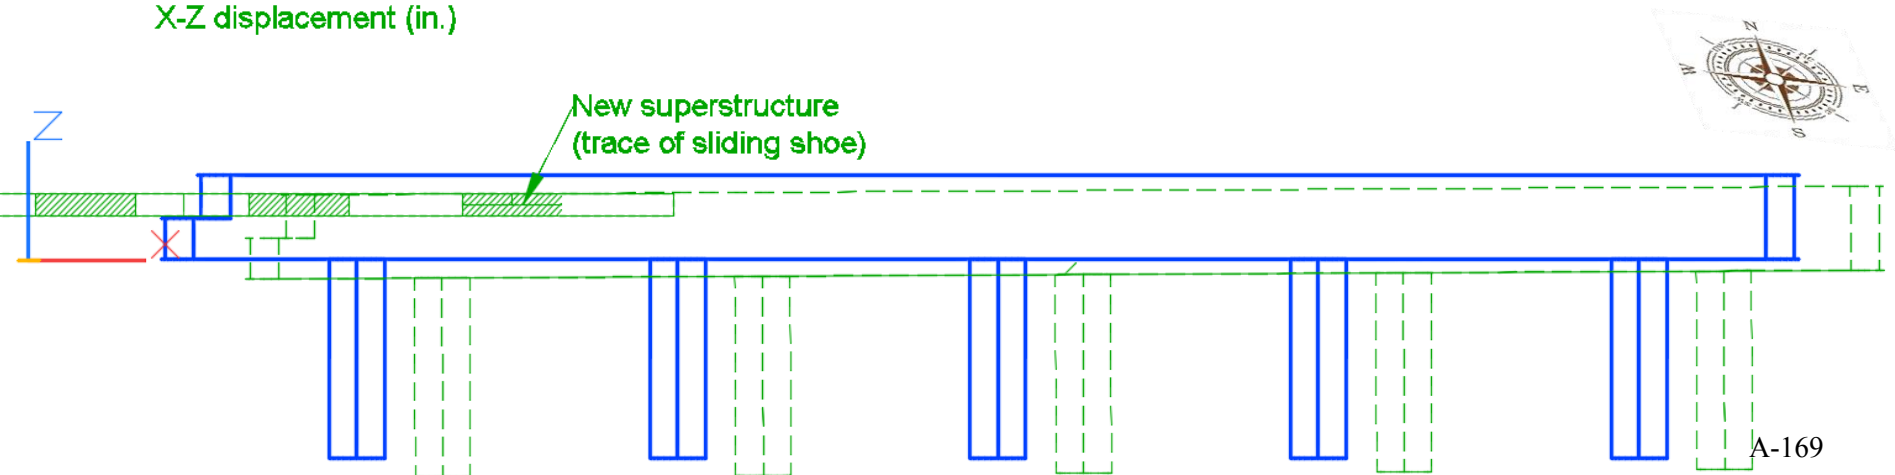
- Observation-20 at 01:24 AM
 - Second sliding shoe moving over the temporary steel-column
 - First sliding shoe just after col.-1

X-Y displacement (in.)

Obs. no.	Time	Deflection of the pier centroid [in.]		
		X	Y	Z
20	1:24 AM	0.23	0.27	-0.04

X-Z displacement (in.)

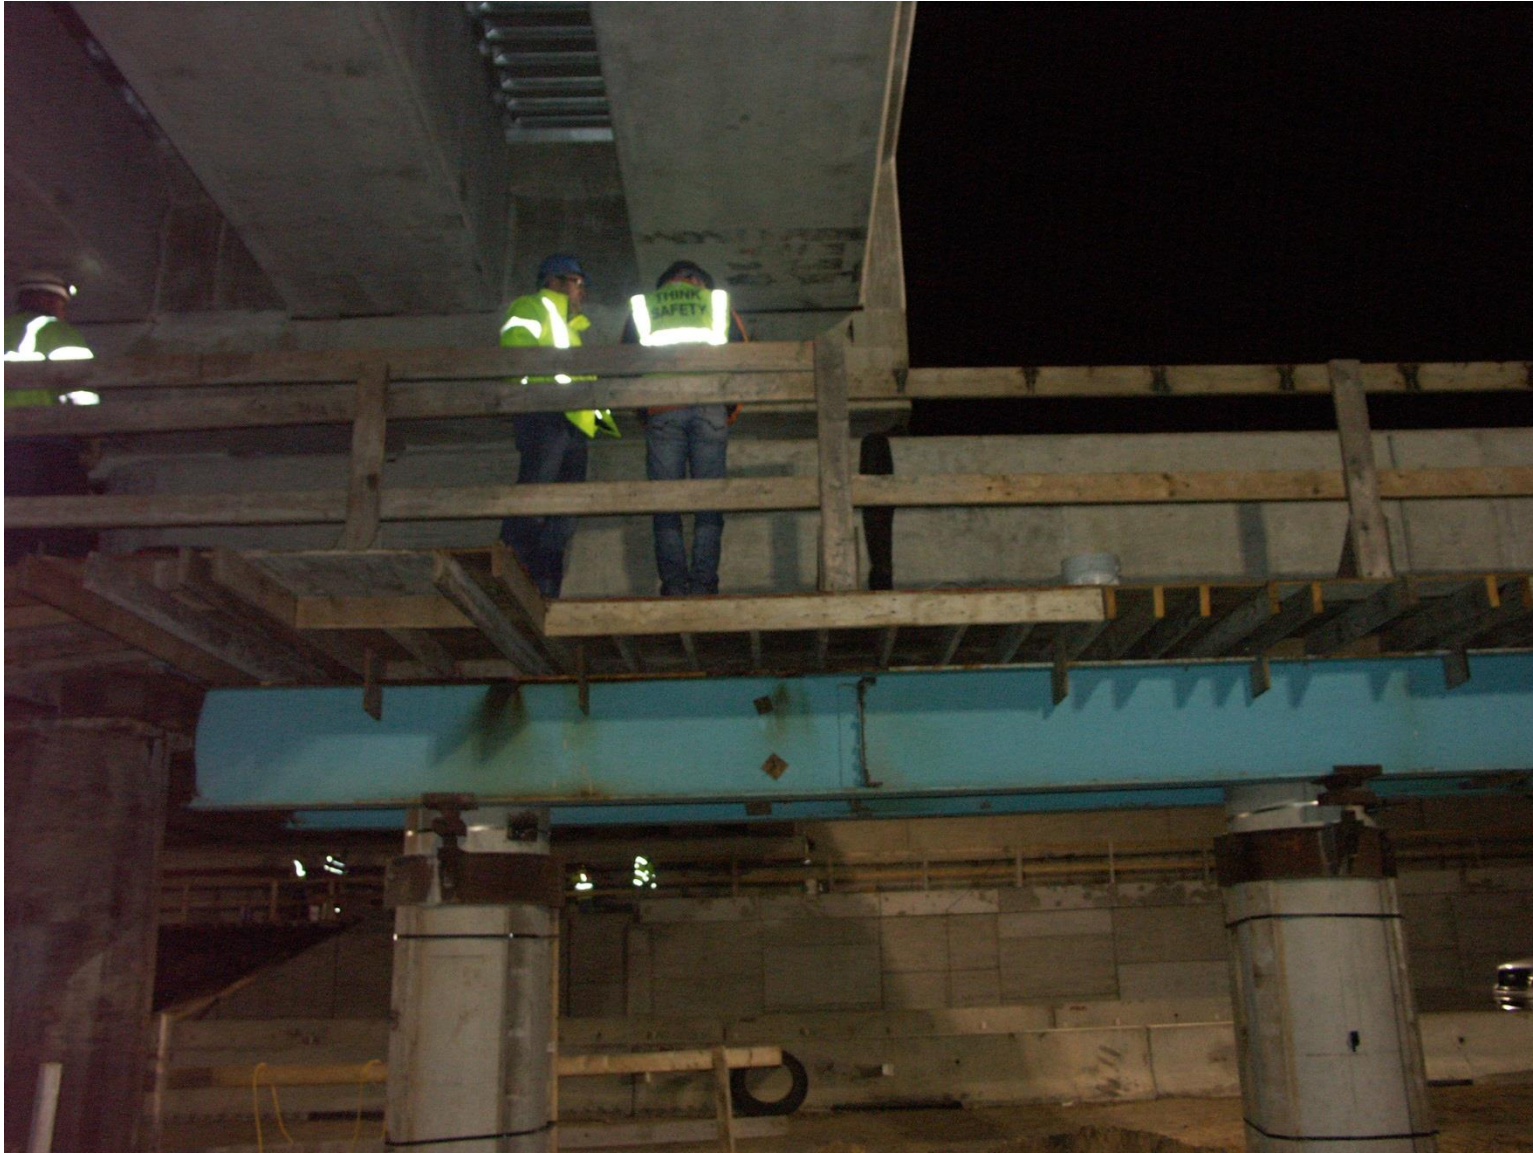
FIELD MEASURED DISPLACEMENTS OF M-50 BRIDGE PIER

- Observation-20 at 01:24 AM
 - First sliding shoe beyond col.-1
