MDOT RC-1618A

**Research on Evaluation and
Standardization of Accelerated Bridge
Construction Techniques**

Appendices (Report 2013-2015)

**SLIDE PROJECTS' FIELD VISITS
DOCUMENTATION**

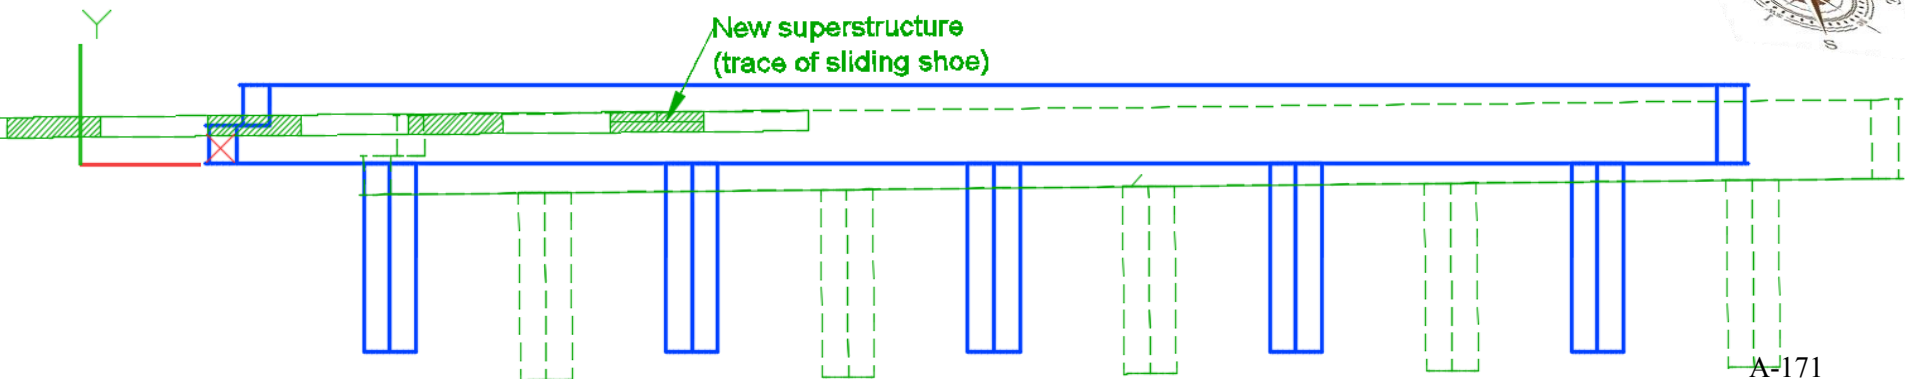
- Observation-21 at 01:32 AM
 - Second sliding shoe completely on new pier

Obs. no.	Time	Deflection of the pier centroid [in.]		
		X	Y	Z
21	1:32 AM	0.43	0.60	-0.06

X-Z displacement (in.)

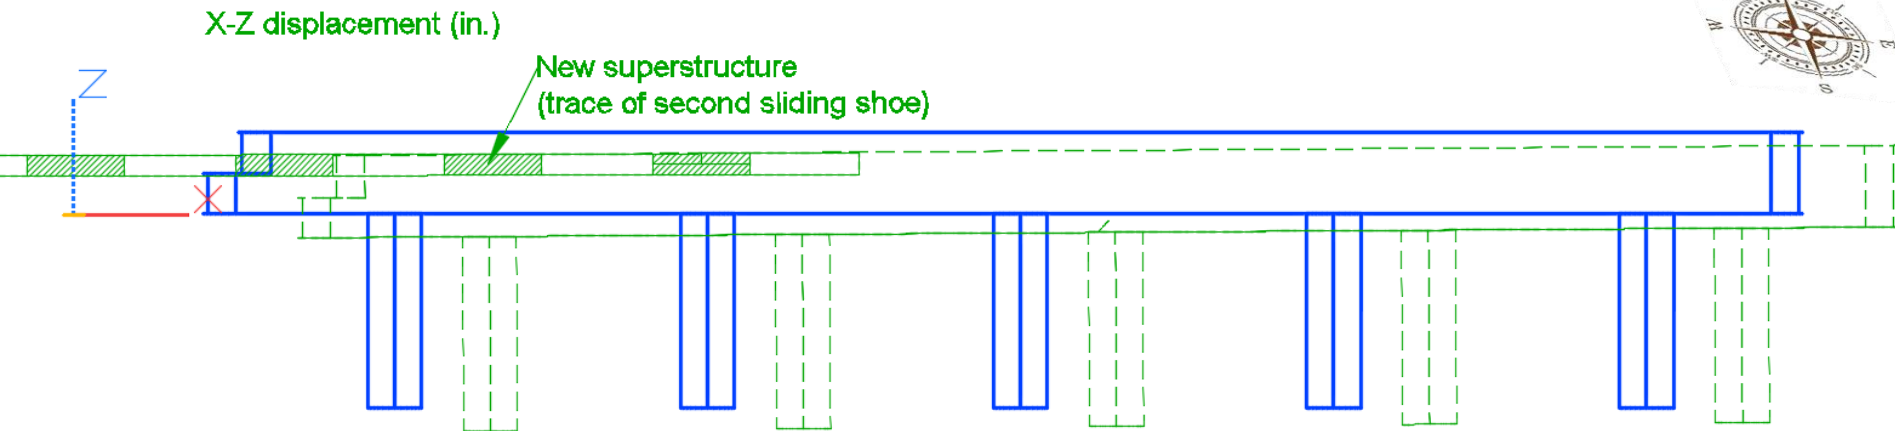
- Observation-22 at 01:38 AM
 - Second sliding shoe at col.-1

Obs. no.	Time	Deflection of the pier centroid [in.]		
		X	Y	Z
22	1:38 AM	0.27	0.30	-0.05

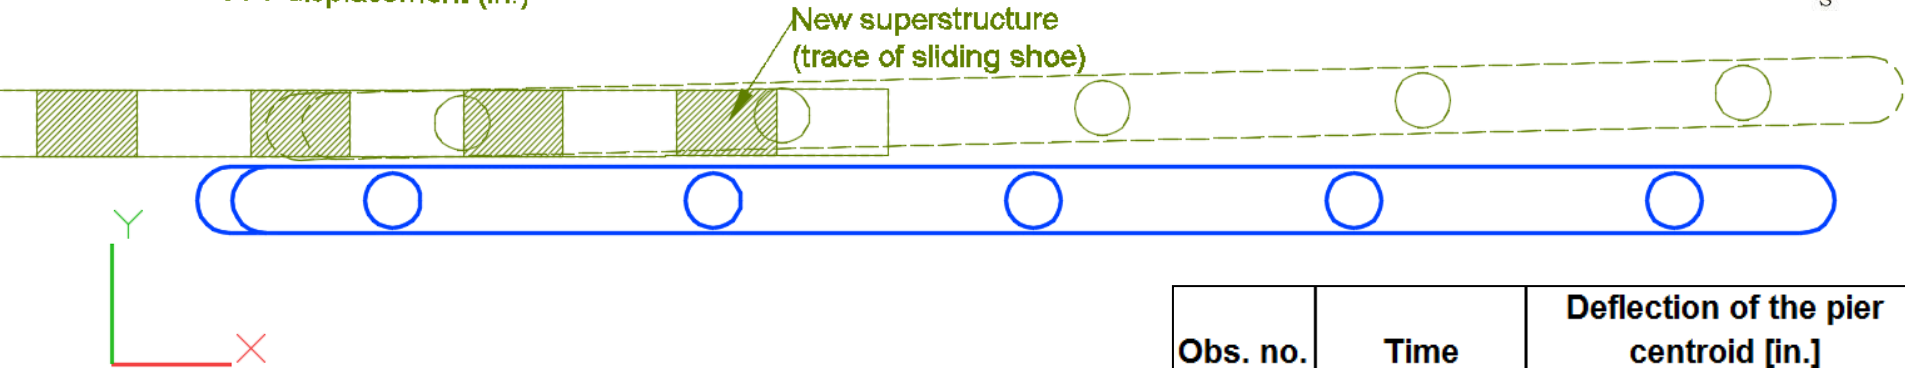
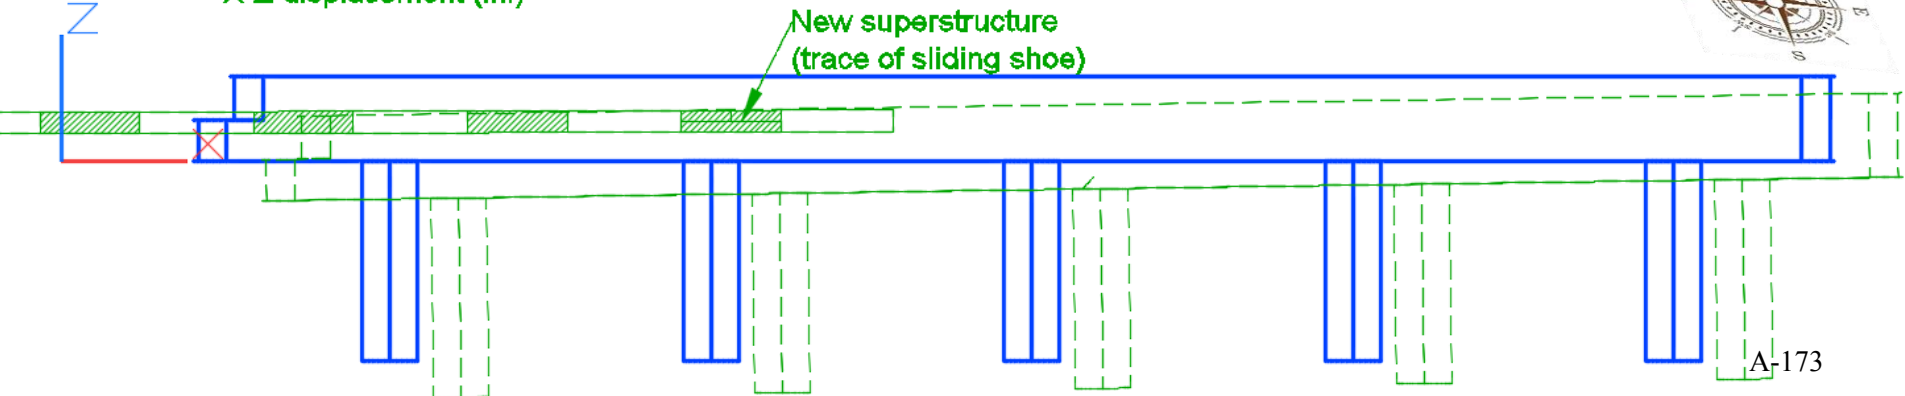
- Observation-25 at 01:48 AM
 - Third sliding shoe on temporary steel-column at the transition

X-Y displacement (in.)

Obs. no.	Time	Deflection of the pier centroid [in.]		
		X	Y	Z
25	1:48 AM	0.19	0.25	-0.08

X-Z displacement (in.)

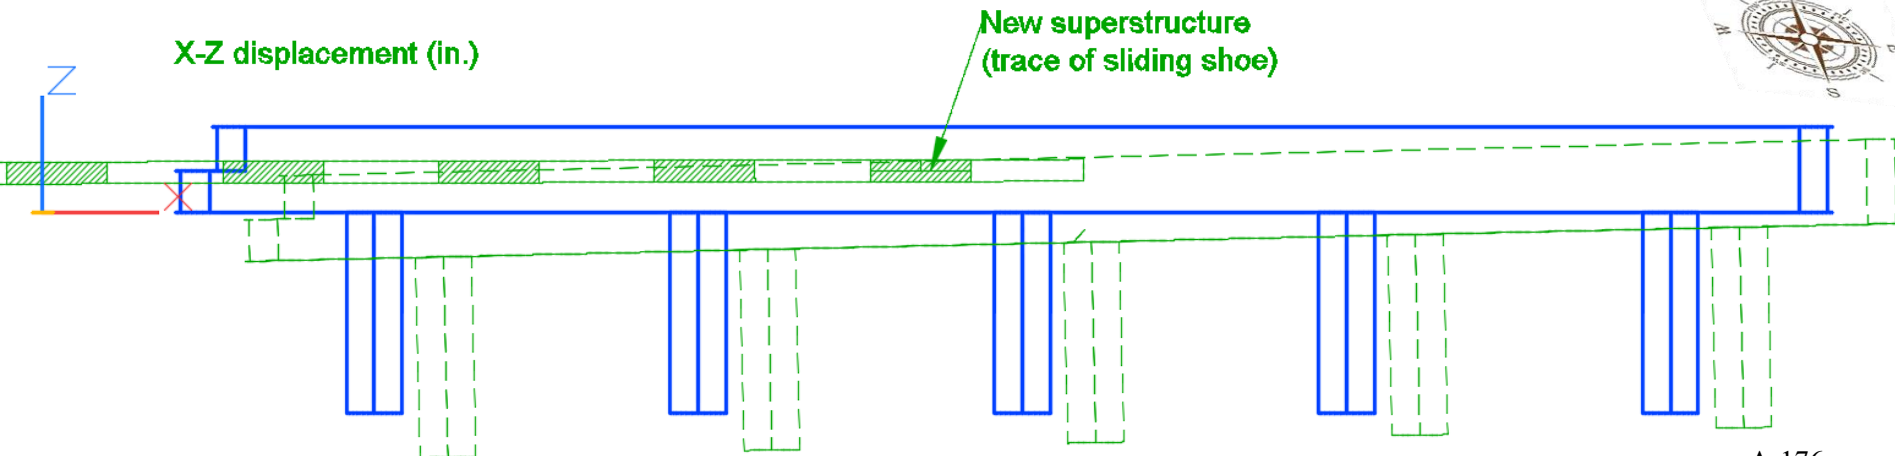
- Observation-32 at 02:32 AM
 - Fourth sliding shoe on temporary steel-column at the transition

Obs. no.	Time	Deflection of the pier centroid [in.]		
		X	Y	Z
32	2:32 AM	0.19	0.26	-0.08

X-Z displacement (in.)

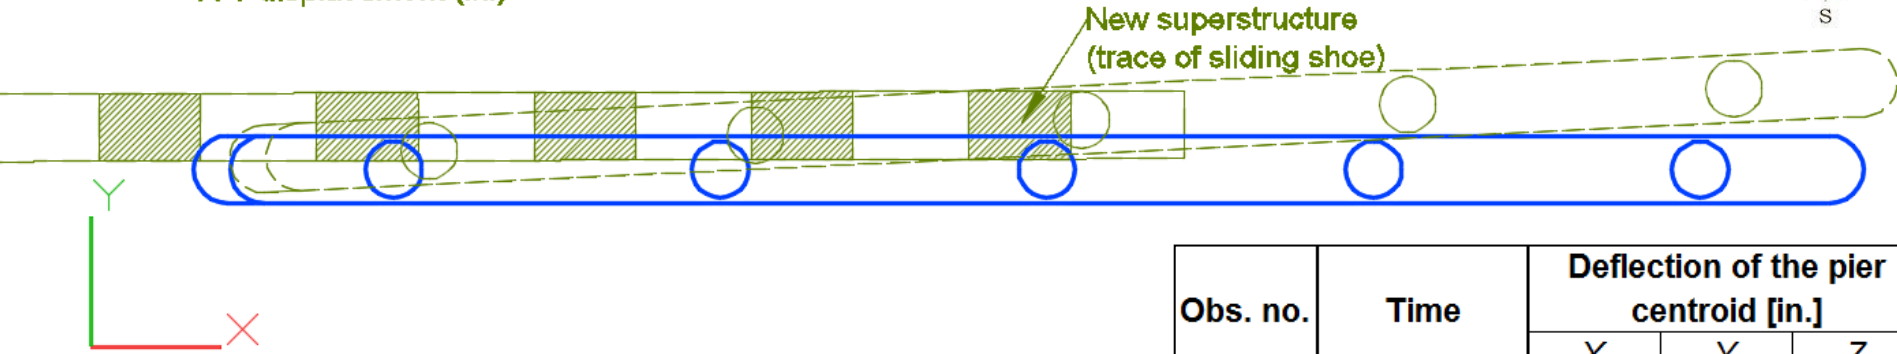
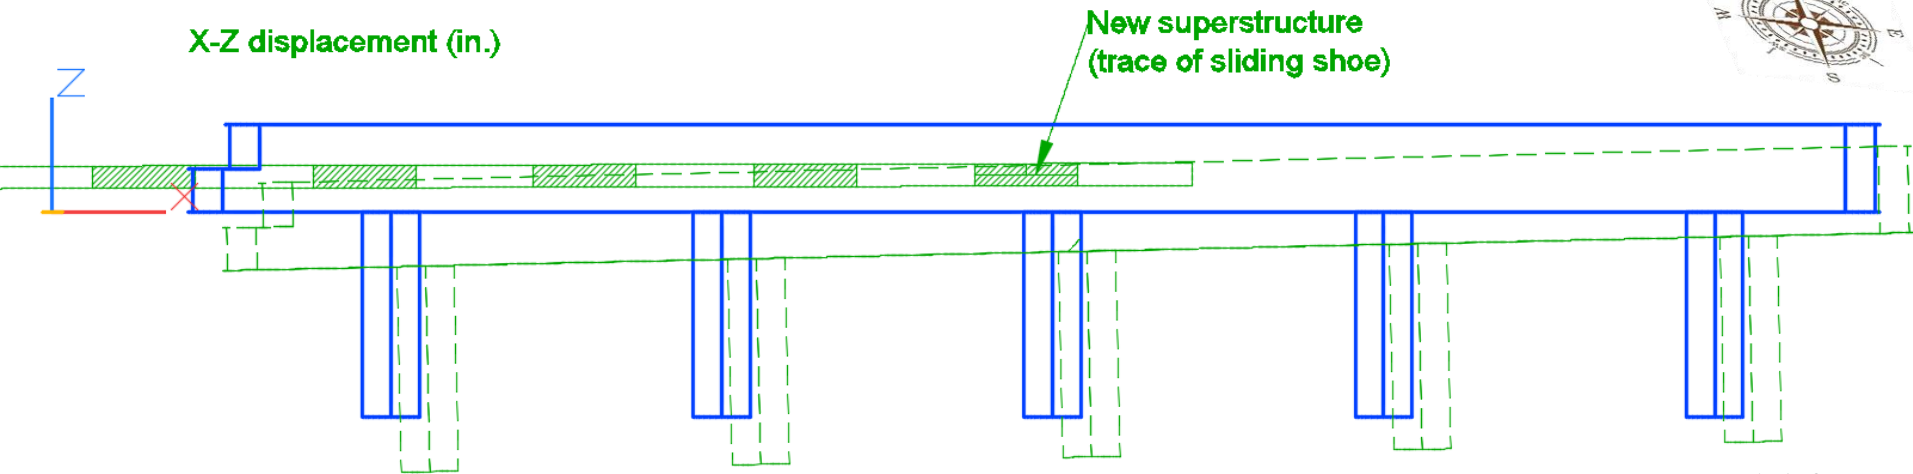
- Observation-38 at 02:52 AM
 - First sliding shoe partly on col.-3

X-Y displacement (in.)

Obs. no.	Time	Deflection of the pier centroid [in.]		
		X	Y	Z
38	2:52 AM	0.09	0.13	-0.10

X-Z displacement (in.)

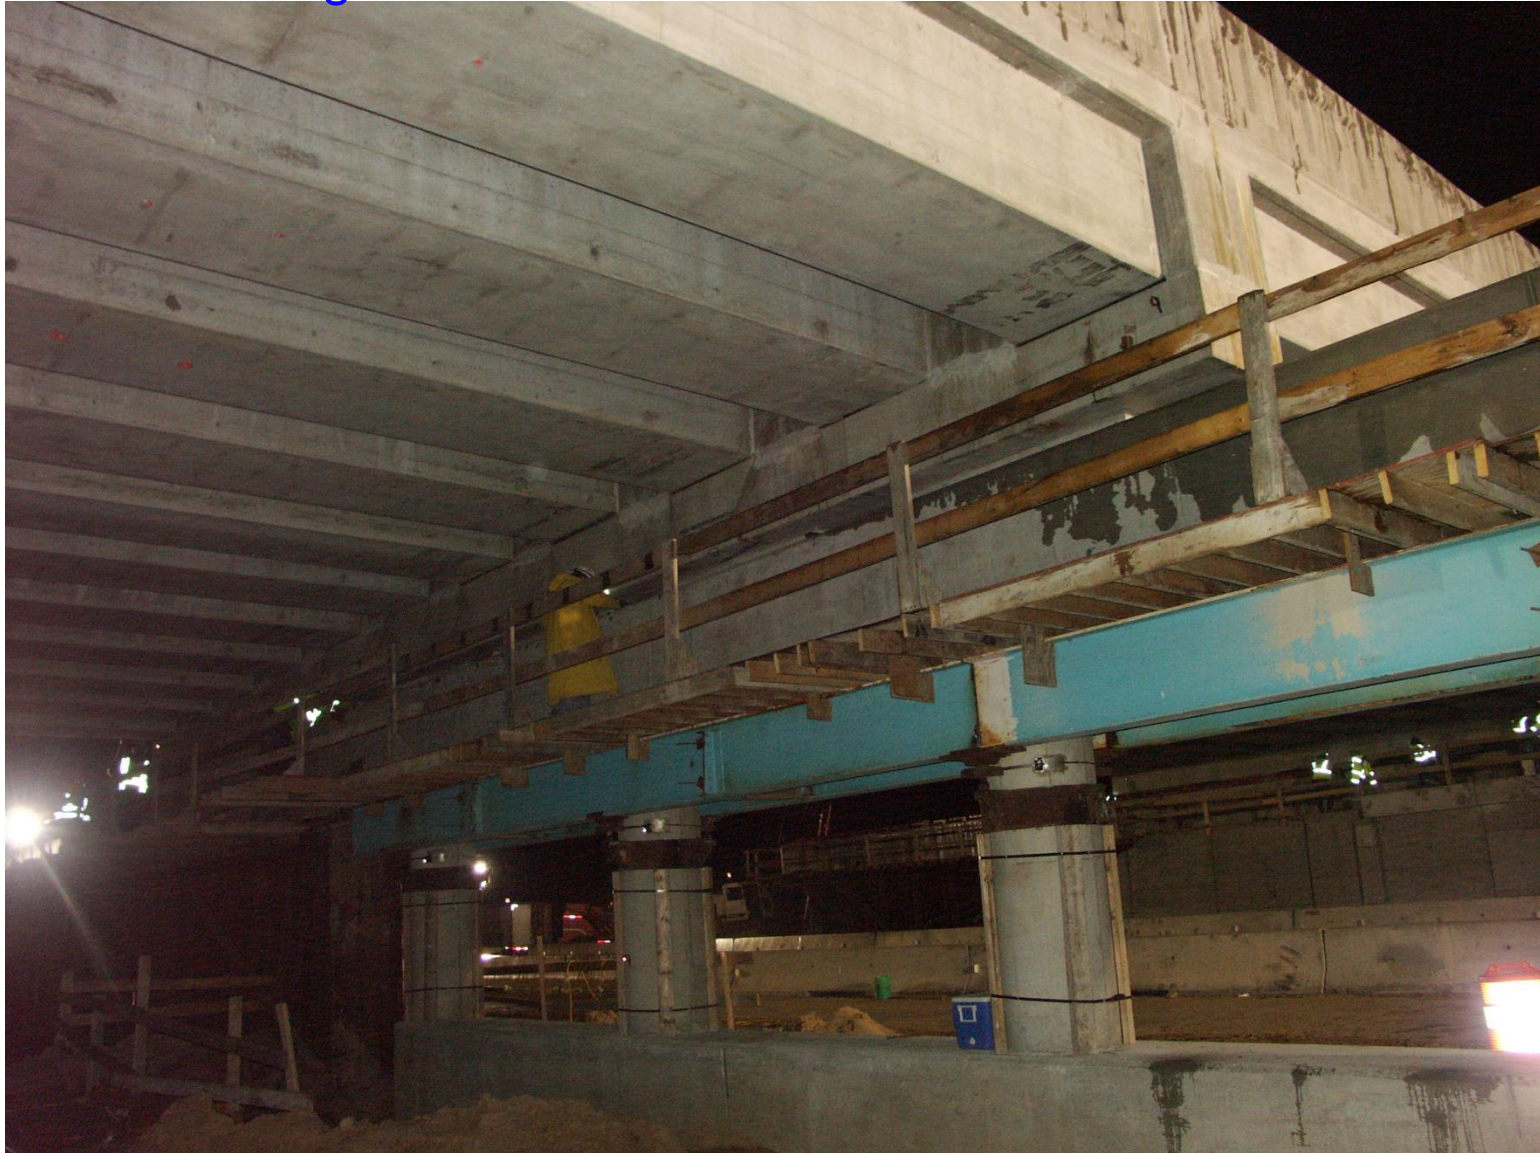
FIELD MEASURED DISPLACEMENTS OF M-50 BRIDGE PIER

- Observation-44 at 03:17 AM
 - Fifth sliding shoe over the transition column

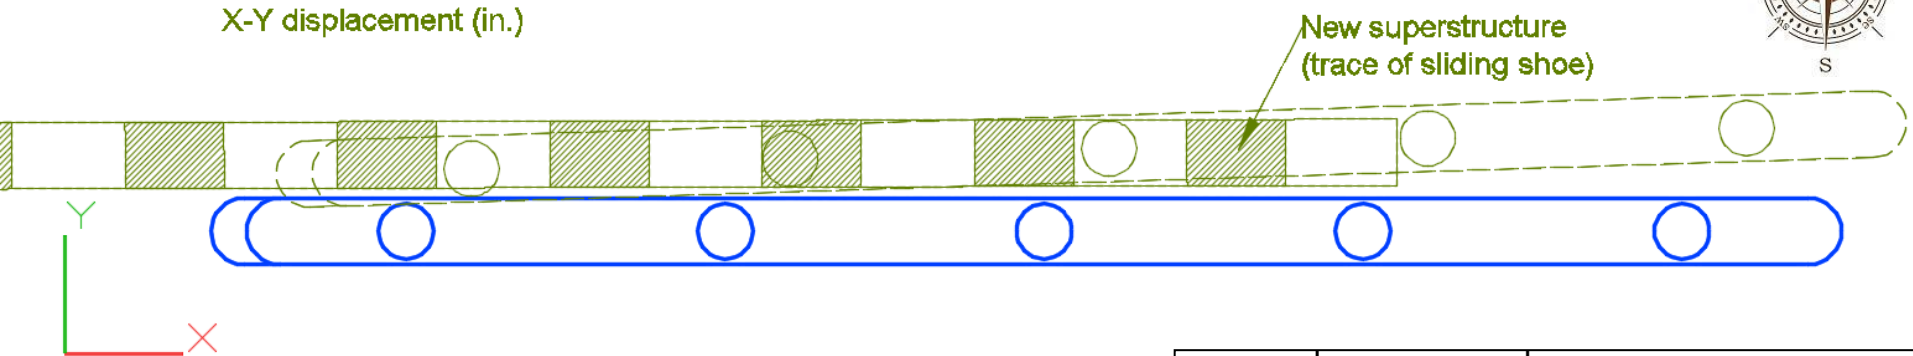
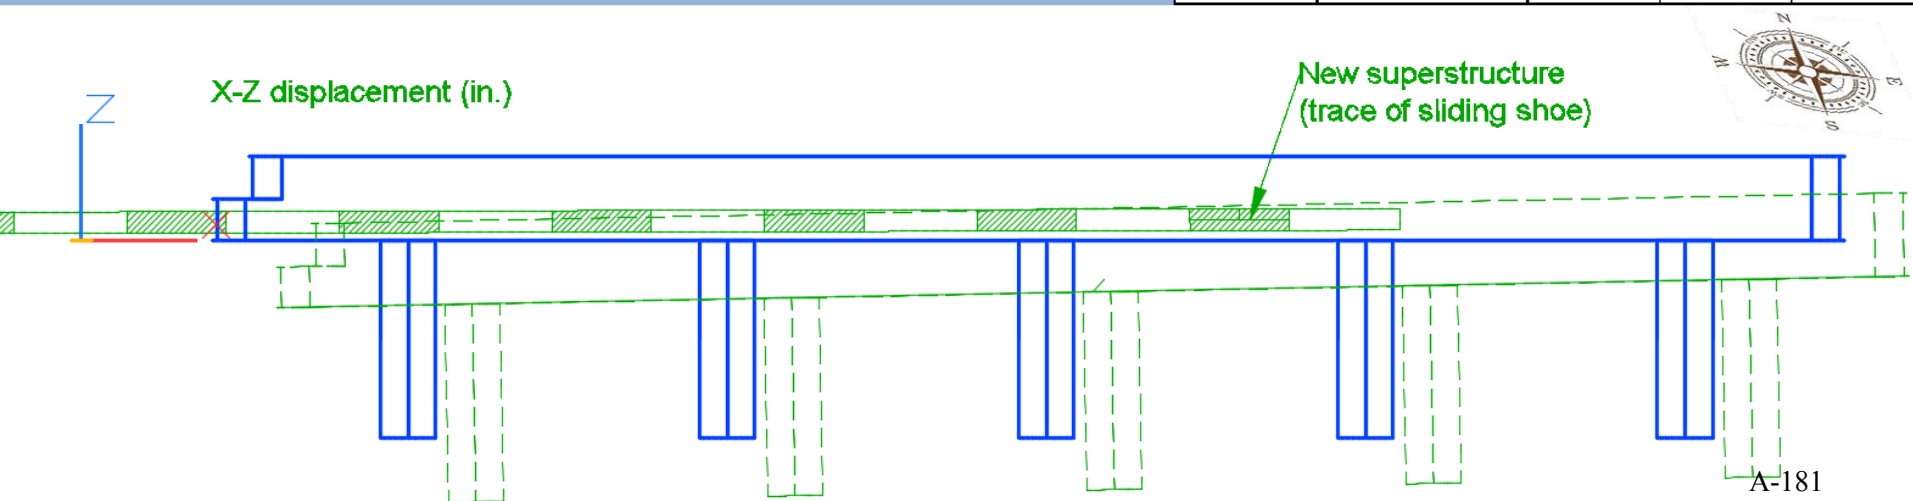
- Observation-45 at 03:21 AM
 - Fifth sliding shoe completely on pier

X-Y displacement (in.)

Obs. no.	Time	Deflection of the pier centroid [in.]		
		X	Y	Z
45	3:21 AM	0.18	0.22	-0.15

X-Z displacement (in.)

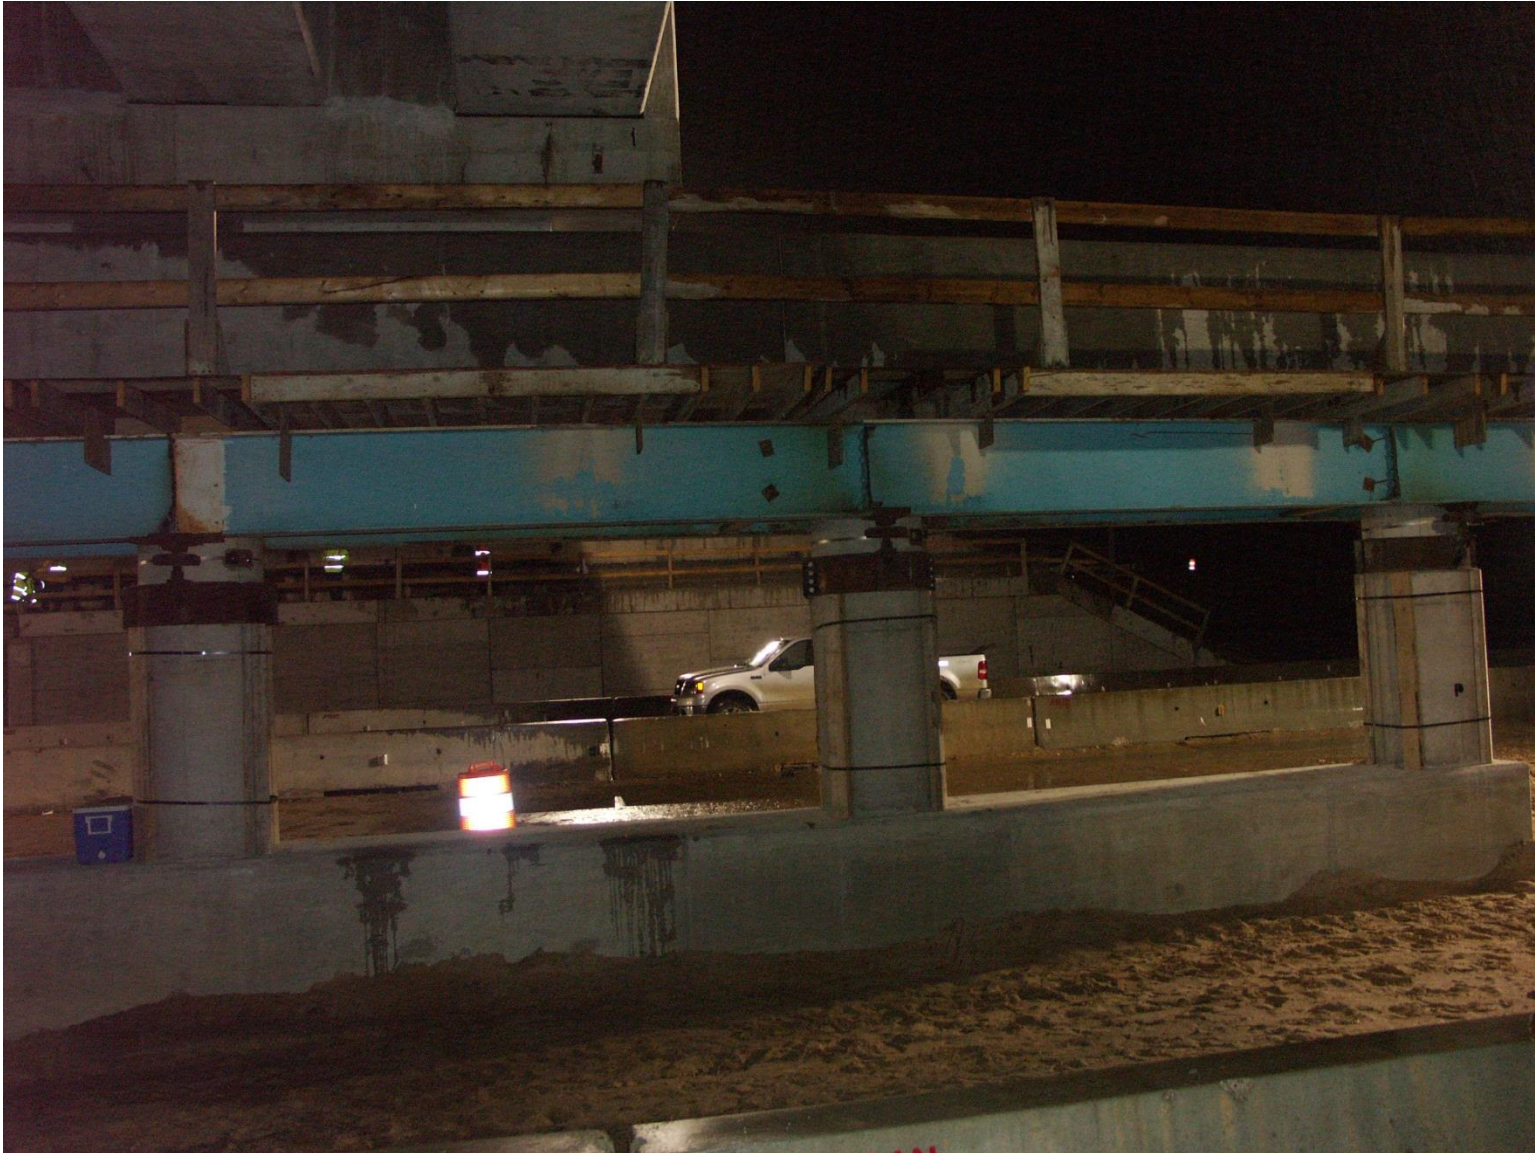
FIELD MEASURED DISPLACEMENTS OF M-50 BRIDGE PIER

- Observation-45 at 03:21 AM
 - First sliding shoe between col.-3 and col.-4

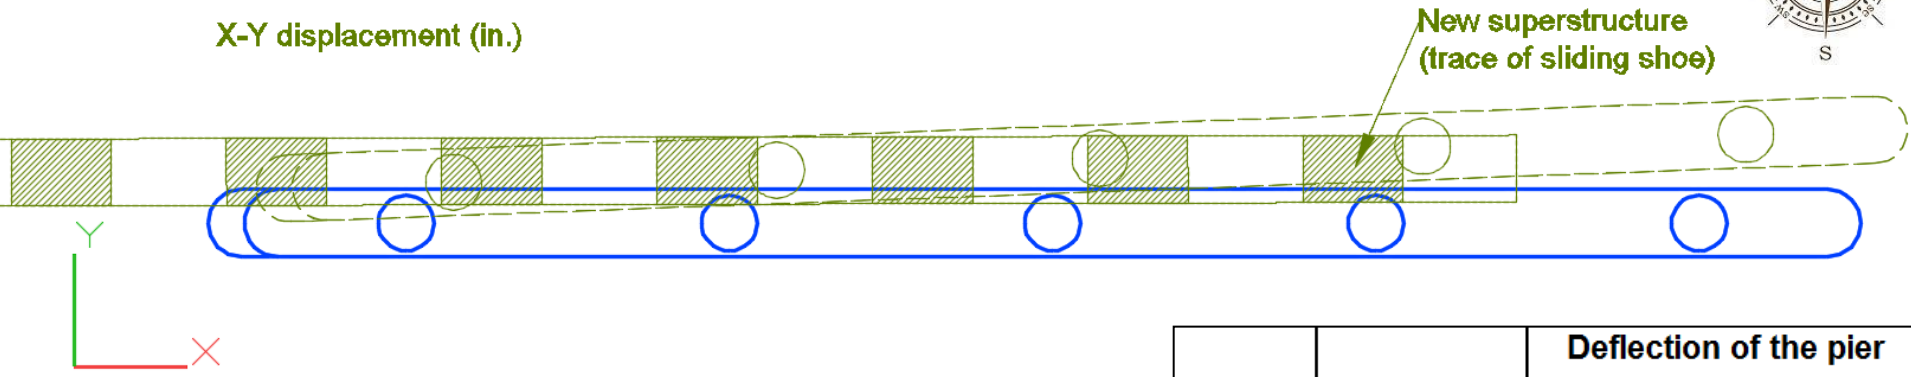
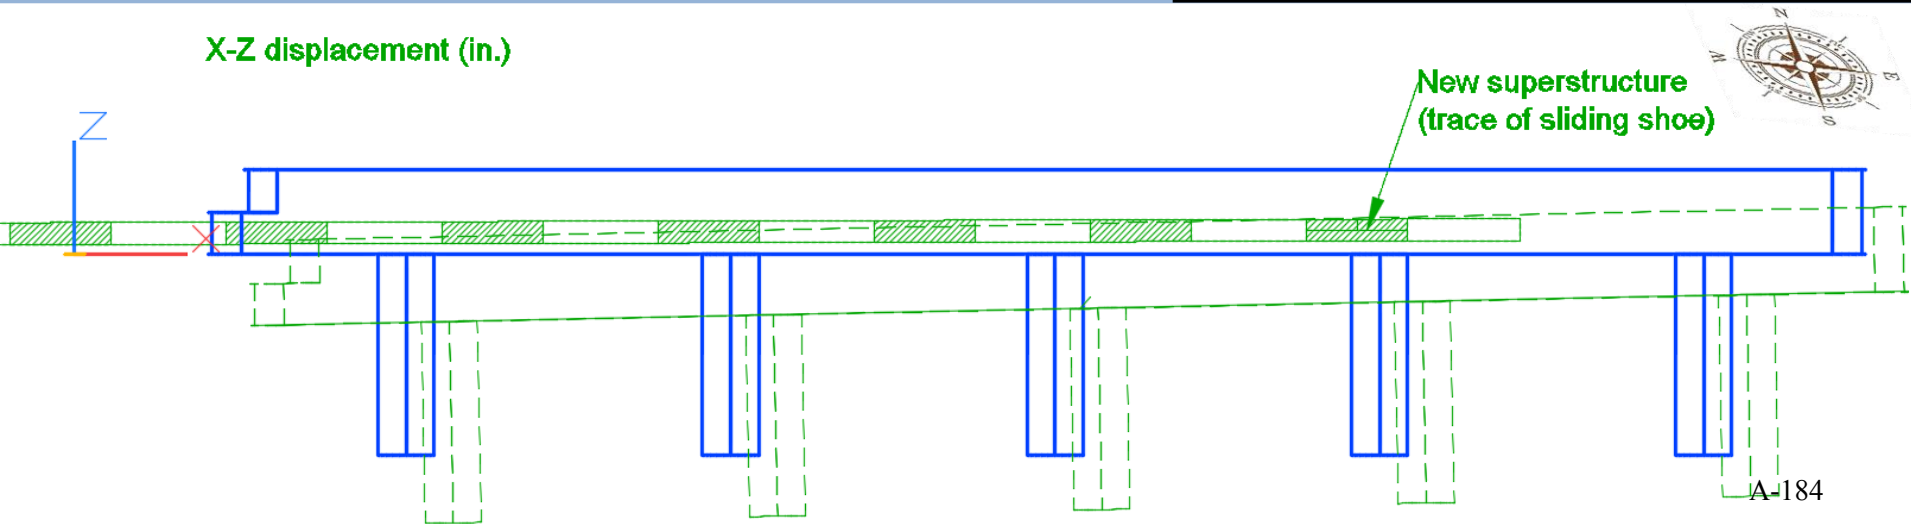
- Observation-52 at 03:46 AM
 - Sixth sliding shoe on temporary steel-column at the transition

X-Y displacement (in.)

Obs. no.	Time	Deflection of the pier centroid [in.]		
		X	Y	Z
52	3:46 AM	0.13	0.17	-0.15

X-Z displacement (in.)

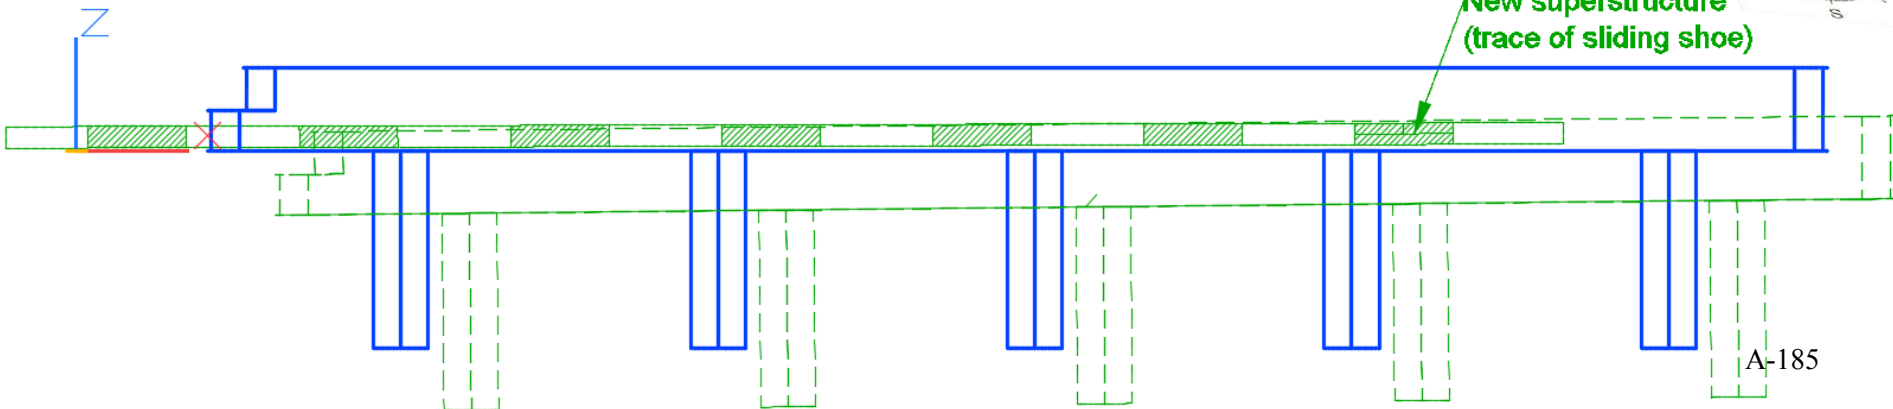
- Observation-55 at 03:57 AM (last observation)
 - First sliding shoe at col.-4

X-Z displacement (in.)

New superstructure
(trace of sliding shoe)

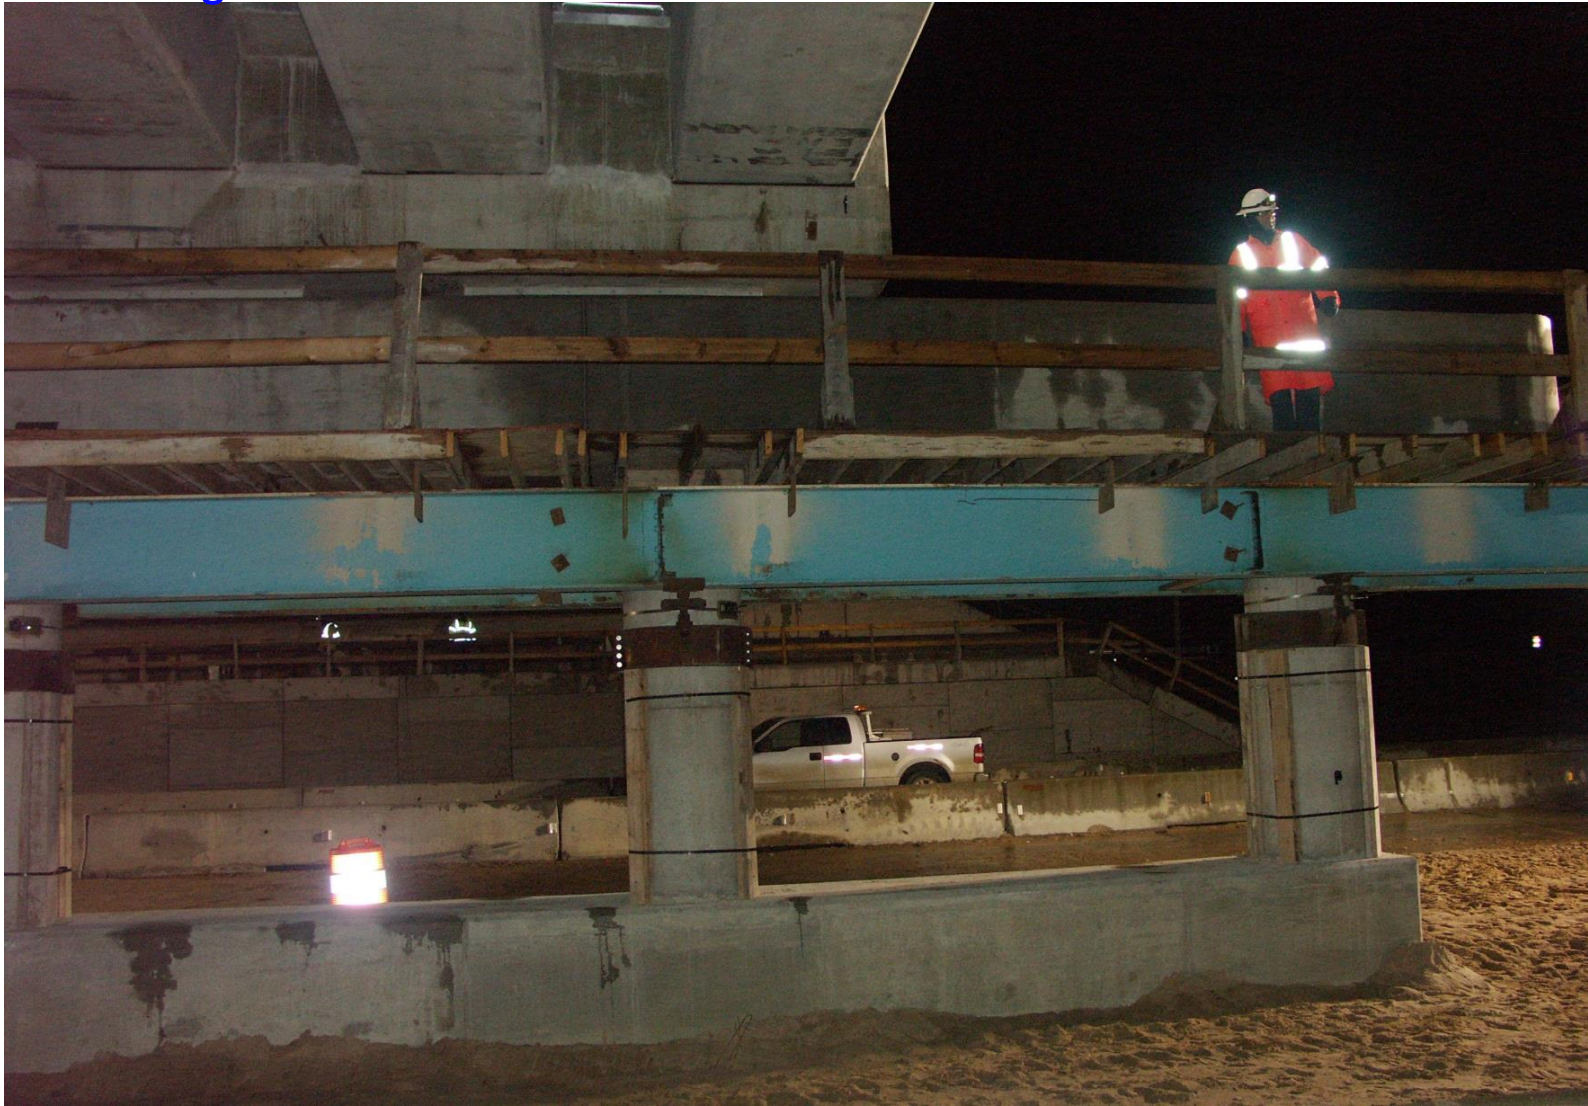
FIELD MEASURED DISPLACEMENTS OF M-50 BRIDGE PIER

- Observation-55 at 03:57 AM (last observation)
 - First sliding shoe at col.-4
 - Sliding was halted for more than an hour after this time.
