EVALUATING ALL-WEATHER PAVEMENT MARKINGS IN ILLINOIS: VOLUME 1

Research Report No. FHWA-ICT-15-018

**Evaluating All-Weather Pavement Markings
and Lab Methods to Simulate Field Exposure**

December 2015

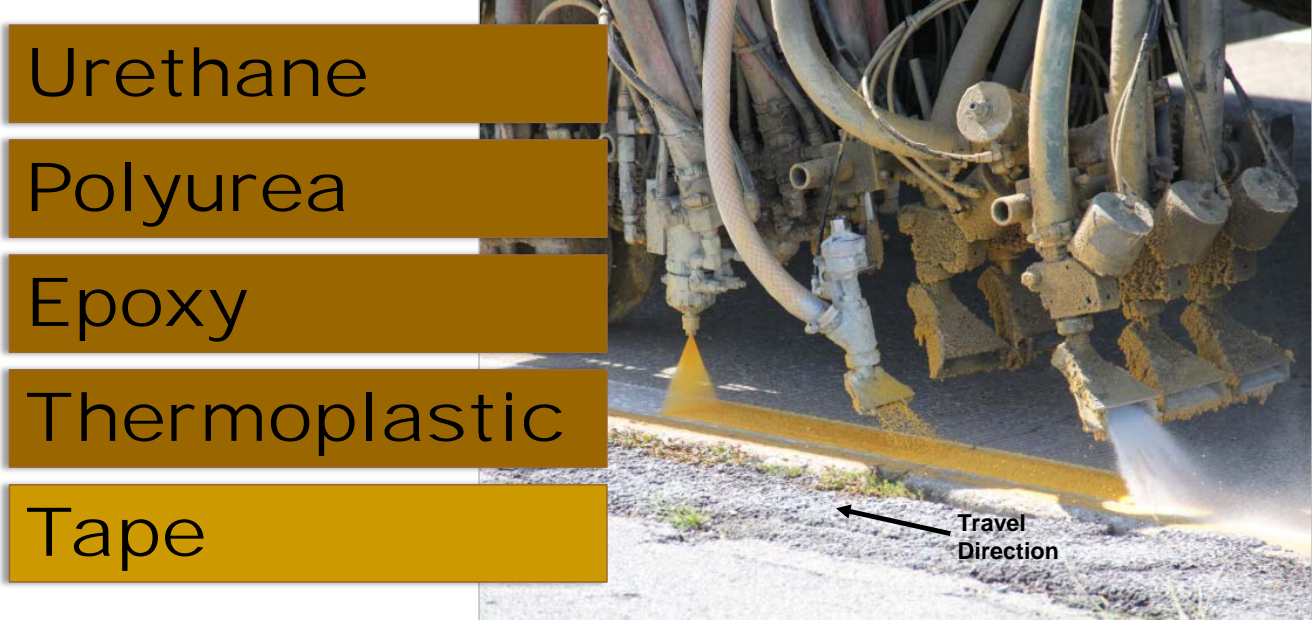
Figure 2.2 Marking materials and bead gun arrangement.

The wet reflective media were delivered to the line prior to the standard IDOT beads, as shown in the photo above. All liquid marking products were placed within a 60 mil groove with the exception of thermoplastic which was installed within a 125 mil groove. The liquid pavement marking products were placed on several types of roadway surfaces (PCC and ACC).

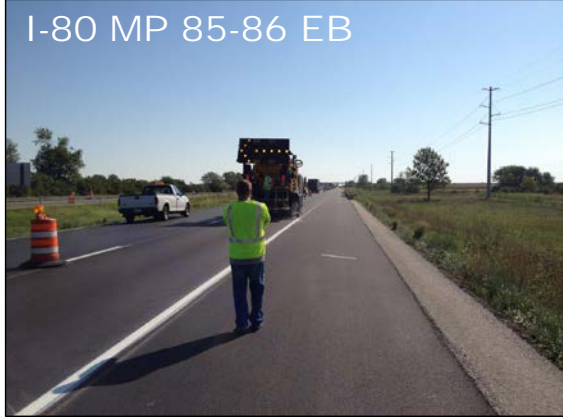
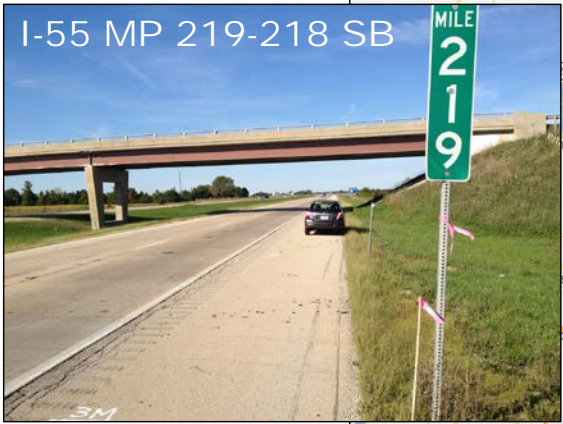
Figure 2.5 Test deck installation photo and locations for I-80 and I-55.

The I-80 test deck was part of a major resurfacing effort and included three different wet reflective tape products on the white skip line and three different all-weather products on the white edge line. The yellow edge line was not included because of issues with contractor staging. The segment lengths per product varied because this project had to be completed under construction staging conditions.

The I-55 test deck was installed on the existing Portland cement concrete (PCC) surface and included all-weather markings for the yellow edge, white skip, and white edge lines with equal one-third-mile segments for each product.

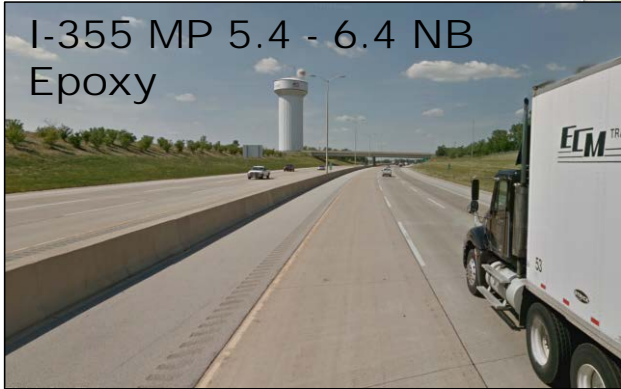
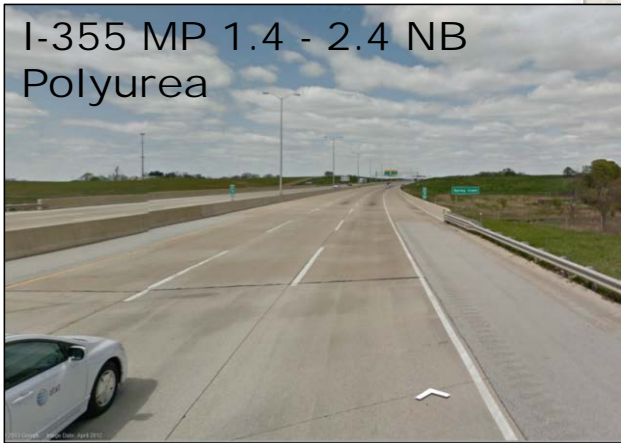
Figure 2.7 Test deck installation photo and locations for the I-355 tollway.

Figure 2.7 provides a map and photos showing the test sections and direction of travel for both sections receiving the all-weather markings along the I-355 tollway. Figure 2.8 provides the details specific to the location where each test product was placed, by line type and test deck segment.

The I-355 test deck markings were placed over an existing PCC roadway; however, the grooving operation was already completed for this project. The polyurea and epoxy decks were laid out in the same manner, by product and line type. This included test materials for the white edge line, the adjacent white skip line, and the yellow edge line. To minimize installation time, and given that there are two white skip lines on this four-lane road, the white skip line adjacent to the yellow edge line was not striped as a part of this study. Because of traffic demands, the materials were installed at night.

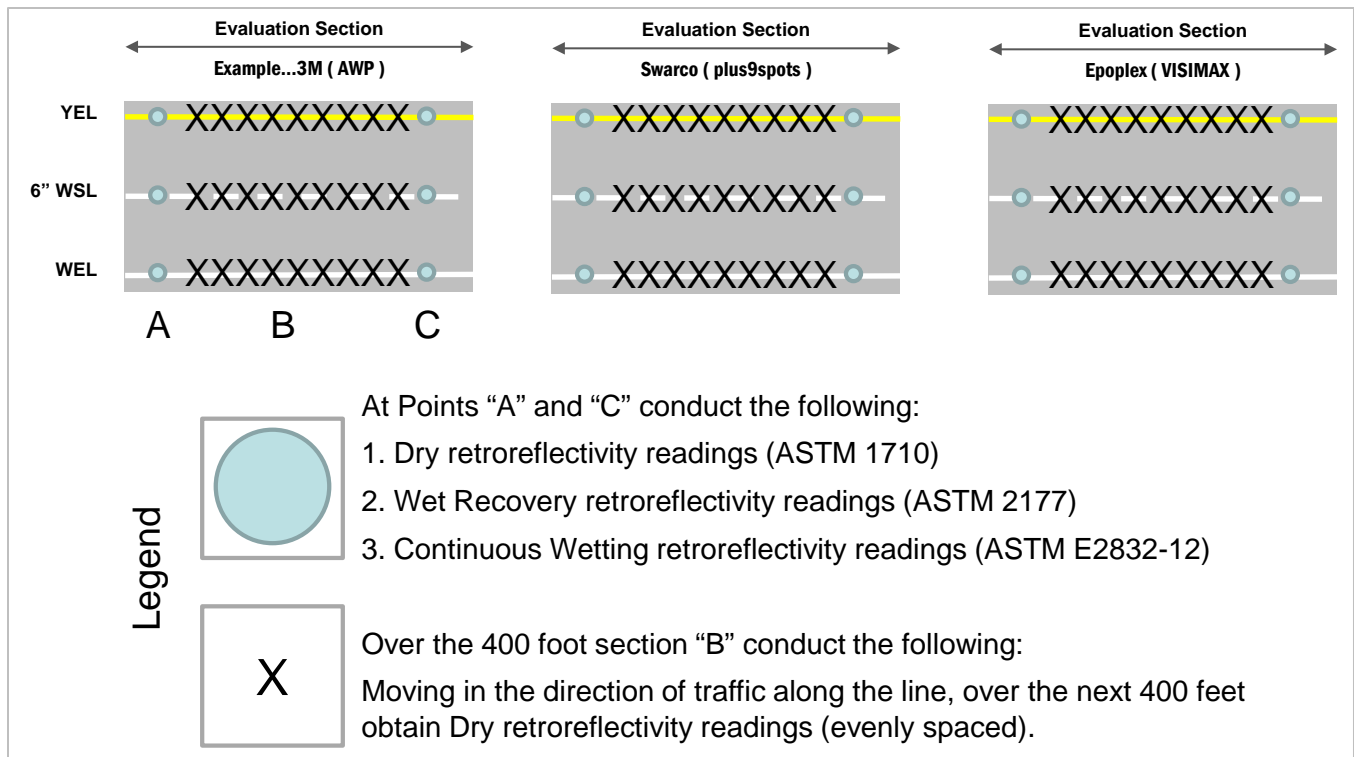
Figure 2.11 Field measurement methodology

- Point A. Identify the beginning location of the test segment and for each line type conduct the following tests:
 1. Dry retroreflectivity readings (ASTM 1710)
 2. Wet recovery retroreflectivity readings (ASTM 2177)
 3. Continuous wetting retroreflectivity readings (ASTM E2832-12)
- Section B. Moving in the direction of traffic along the line, over the next 400 feet obtain 20 dry retroreflectivity readings (evenly spaced).
- Point C. Roughly, 400 feet downstream from Point A, repeat measurements 1 through 3 exactly as at Point A.

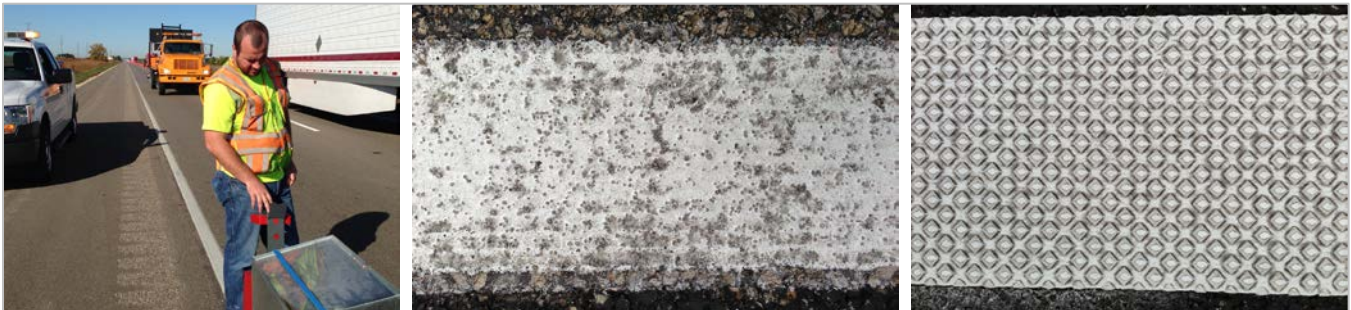
Figure 3.1 Taking a retroreflectivity (continuous wetting, left) reading on I-80 along with marking presence images for the white edge line (center) and centerline skip (right).

District 3 staff provided traffic control while the white edge and white skip lines were being measured. Initial measurements were completed in November 2012. Additional measurements were made in October 2013 (1 year) and June 2014 (2-year reading, or after two winters). Scheduling for all readings was a major effort and subject to district staff availability and traffic conditions. Figure 3.1 includes a few images from one of the measurement activities.

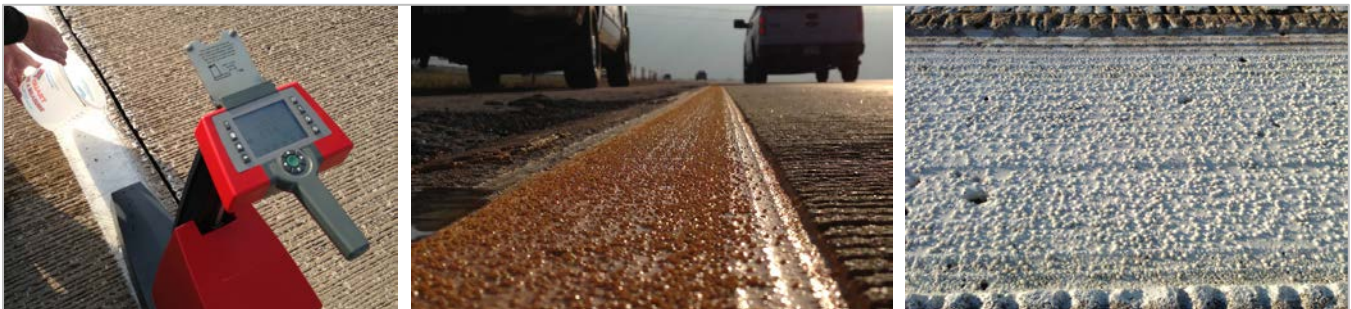
Figure 3.2 Taking a retroreflectivity (recovery, left) reading on I-55 along with marking presence images for the yellow edge line (center) and white edge line (right).

District 3 staff also provided traffic control for measuring the white edge, white skip, and yellow edge lines. This roadway was measured at the same times as I-80. Figure 3.2 includes a few images from one of those measurement activities.

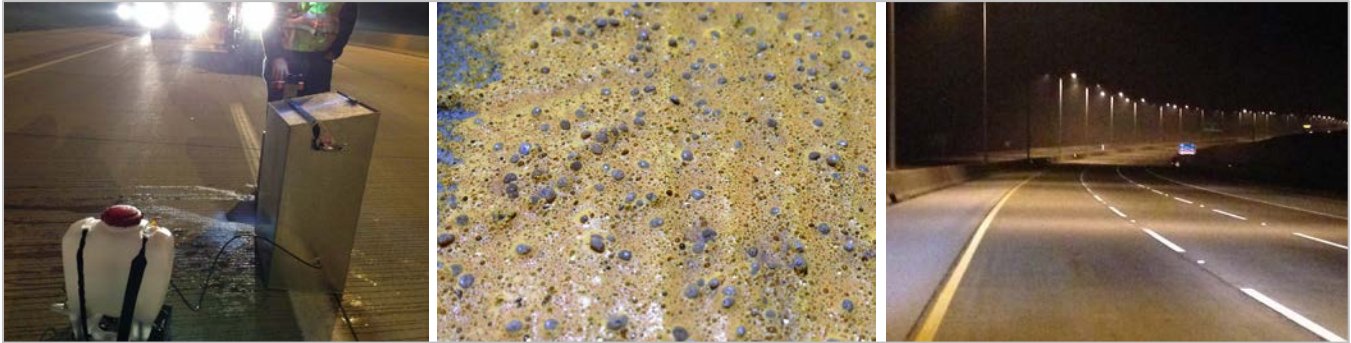
Figure 3.3 Taking a retroreflectivity (continuous wetting, left) reading on I-355 along with marking presence images for the yellow edge line (center) and general photo of all lines (right).

The Tollway's contractor provided traffic control while the two test decks on I-355 (all at night) were being measured. The white edge, white skip, and yellow edge lines were each measured. Initial measurements were completed in October 2013 followed by September 2014 (1 year). No additional measurements were taken beyond the 1-year time period because of the costs associated with obtaining the measurements and the wet retroreflective performance observed. Figure 3.3 includes a few images from one of the measurements.

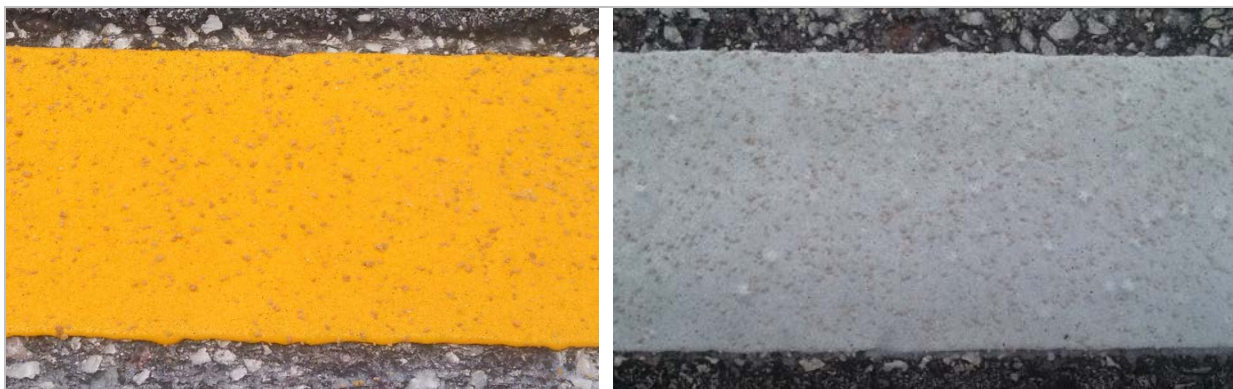
Figure 3.4 Initial installation images on I-57 for yellow edge line (left) and white edge line (right).

District 8 staff provided traffic control while the white and yellow edge lines were measured. Initial measurements were completed in November 2013 followed by readings in June 2014 (1 year) and June 2015 (2 year). Scheduling for all readings was a major effort and subject to district staff availability and traffic conditions. Figure 3.4 includes a few images from the initial installation of these markings.

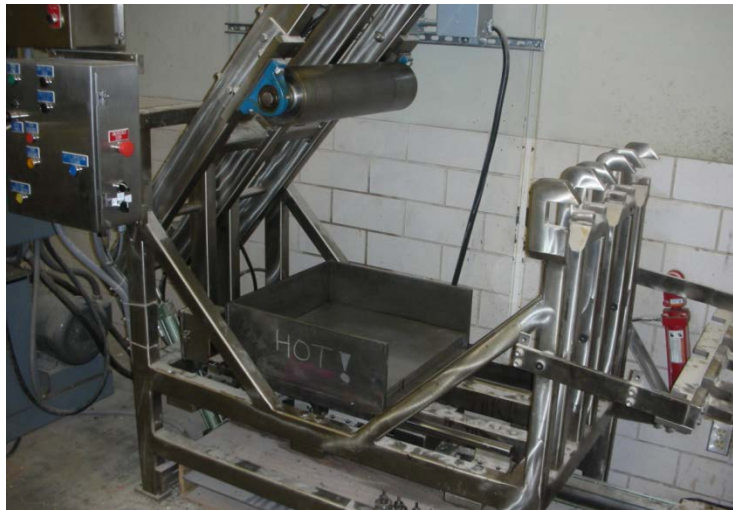
To conduct the initial lab testing, the researchers first needed to produce pavement marking samples. The researchers produced pavement marking sample substrates out of typical roadway materials. These materials were cast concrete and asphalt made with a kneading compactor (Figure 4.1).

Figure 4.1 Linear kneading compactor for preparing asphalt slabs.

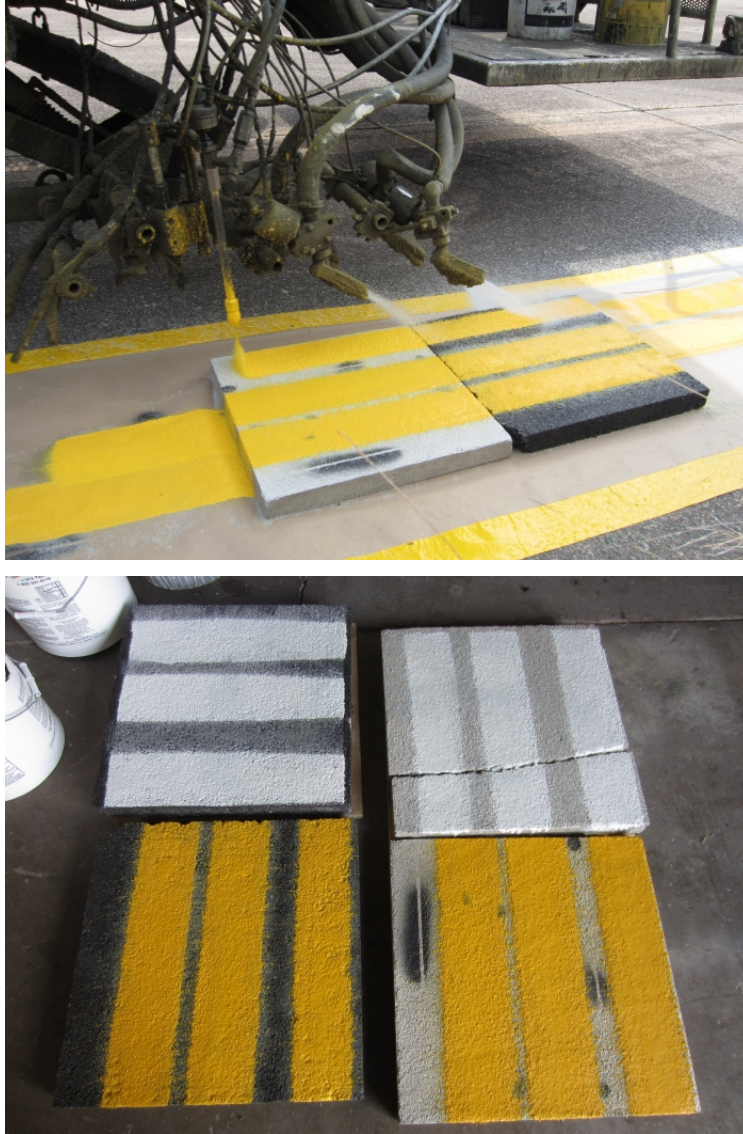
Figure 4.2 Pavement marking samples.

The researchers striped over the substrate slabs with a material similar to what was installed on the field test decks. The markings were white and yellow Epoplex LS50 epoxy with a double drop of AASHTO M-247 Type I and Type IV beads. Three stripes were put on each slab to allow for more flexibility in conducting the initial accelerated wear testing. Figure 4.2 provides an image of the slabs being striped and of the four striped slabs.

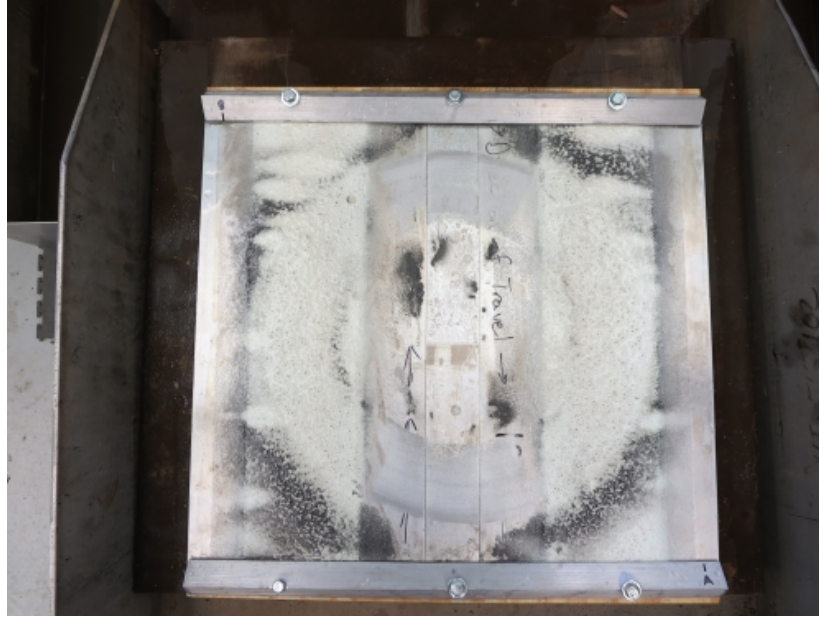
The pavement marking samples were cut using a band saw so that they would fit into the testing jig that was placed in the circular track polishing machine. Two samples were placed into the jig at the same time. The samples were marked with arrows to indicate the installation direction of the markings in the field. The markings were placed into the jig so that the wearing would occur in the direction that the markings were striped, which would be the same way they would be worn in the field by traffic. Not all of the markings were applied to the center of the substrate material. To account for the different positions, additional aluminum spacer strips were placed between the two samples in the jig. These spacers were used so that the markings were always in the same position under the accelerated wear device. This resulted in the marking samples all receiving wear centered along the marking sample. Figure 4.5 shows two marking samples on the test jig after testing. The wear path of the wheels is well defined on the sample.

Figure 4.5 Aluminum sample plates during testing.

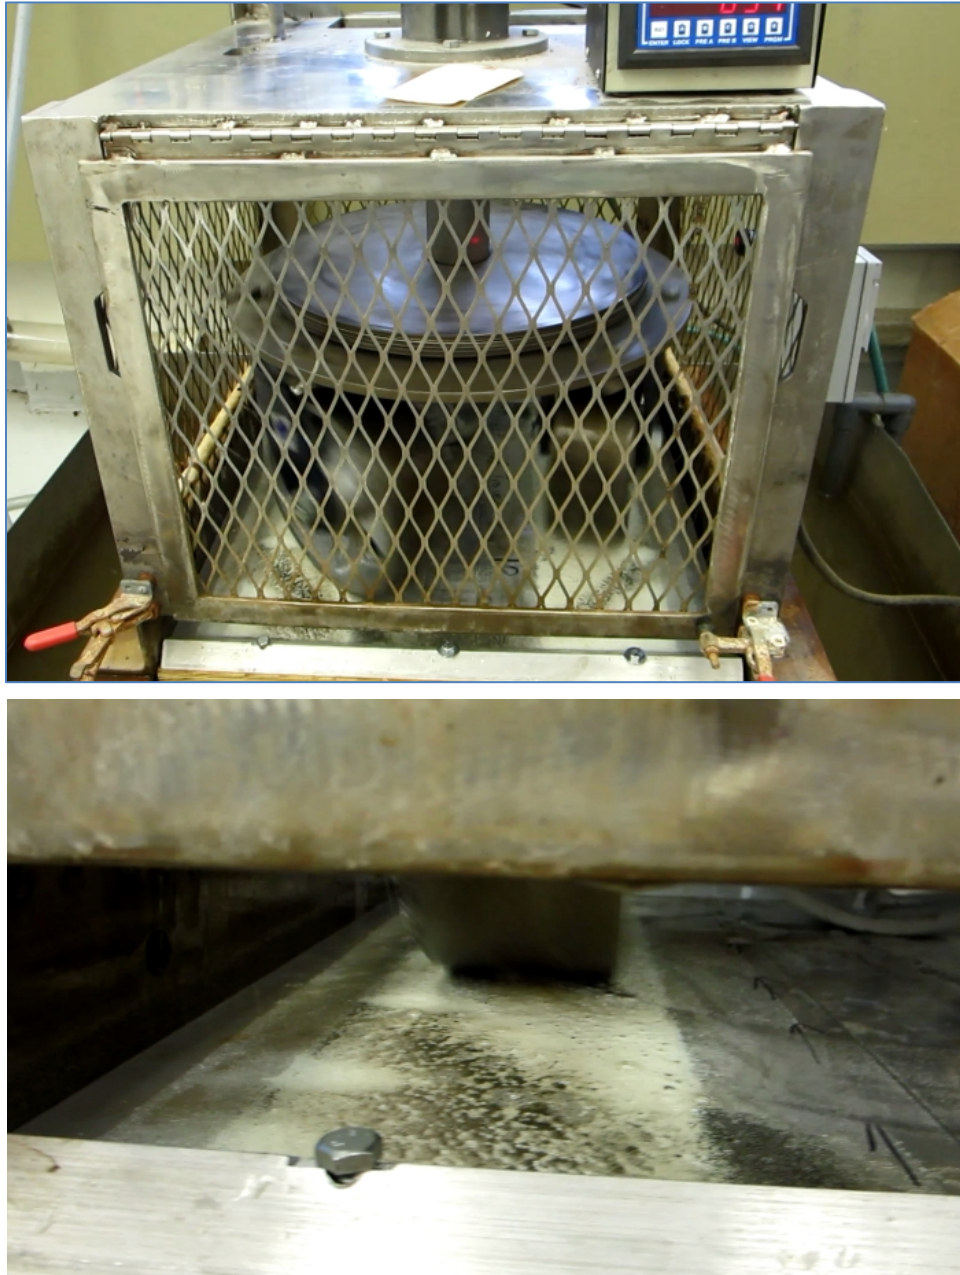
portion of the field samples for the markings that had not yet received the accelerated wearing. The performance of the samples was evaluated after 0, 250, and 500 cycles.

Figure 4.6 Accelerated wearing of samples from test deck.

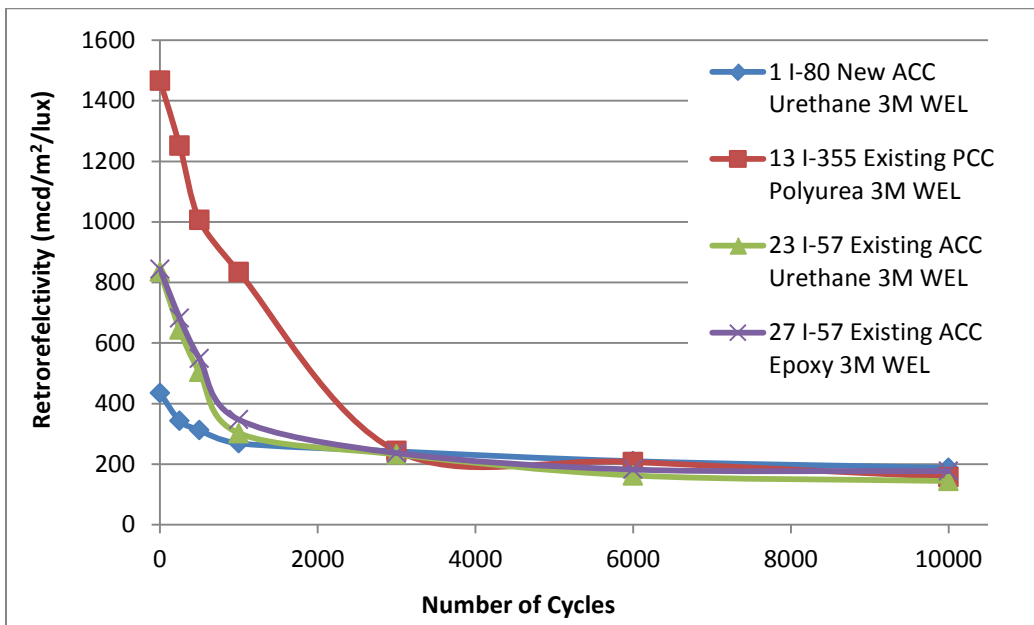
Figure 5.3 shows the dry retroreflectivity degradation curves of the four markings that received the additional accelerated wear. Figure 5.4 shows the recovery retroreflectivity degradation curves of the four markings that received the additional accelerated wear. Figure 5.5 shows the continuous wetting retroreflectivity degradation curves of the four markings that received the additional accelerated wear. The data plotted in the three figures are summarized in Table 5.11. The data clearly show a rapid decrease in retroreflectivity as the markings are worn. The markings' retroreflectivity degradation slows after the 1000- or 3000-cycle measurement interval.

Figure 5.3 Average dry retroreflectivity of samples after additional wear.

The data clearly showed a decreasing trend in performance for all conditions as the number of wear cycles increase. The dry performance was far superior to either of the wet conditions. The recovery retroreflectivity levels were higher than the continuous wetting retroreflectivity levels. Many markings did not make it to the 6000-cycle or full 10000-cycle levels because of a loss of wet-reflective performance or damage. There was a drastic reduction in continuous wetting retroreflectivity from the initial to the 1000-cycle level. The markings' retroreflectivity degradation slowed after the 1000- or 3000-cycle measurement interval.

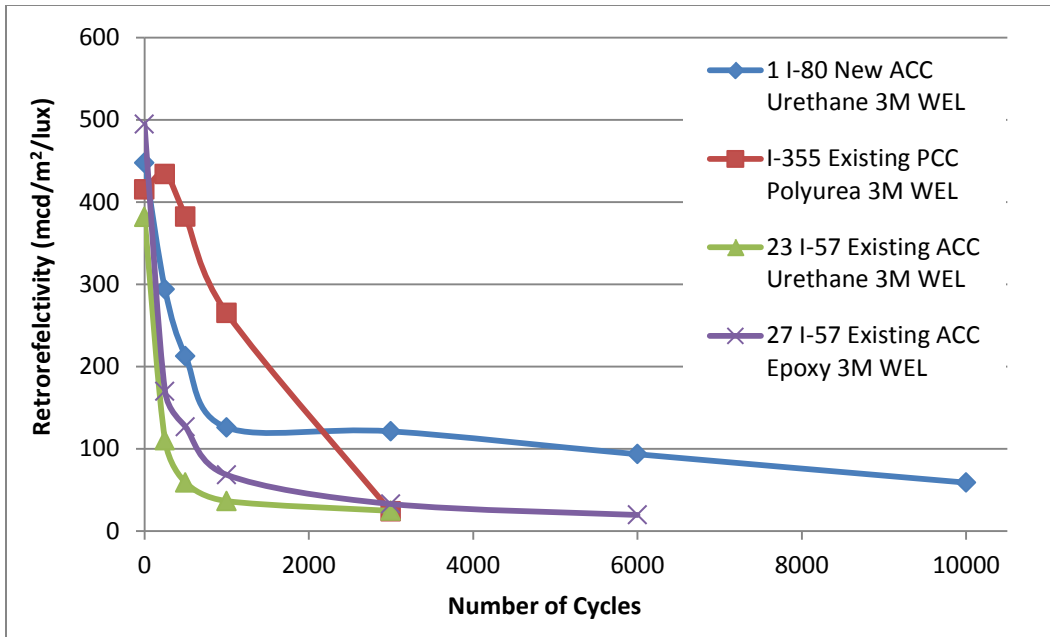
Figure 5.4 Average recovery retroreflectivity of samples after additional wear.

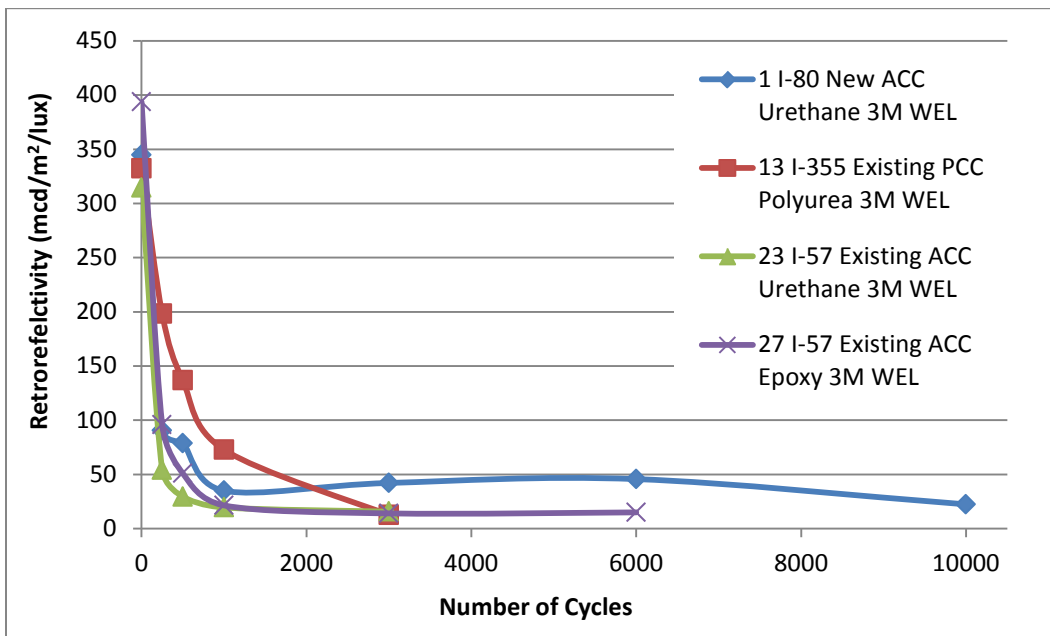
Figure 5.5 Average continuous wetting retroreflectivity of samples after additional wear.

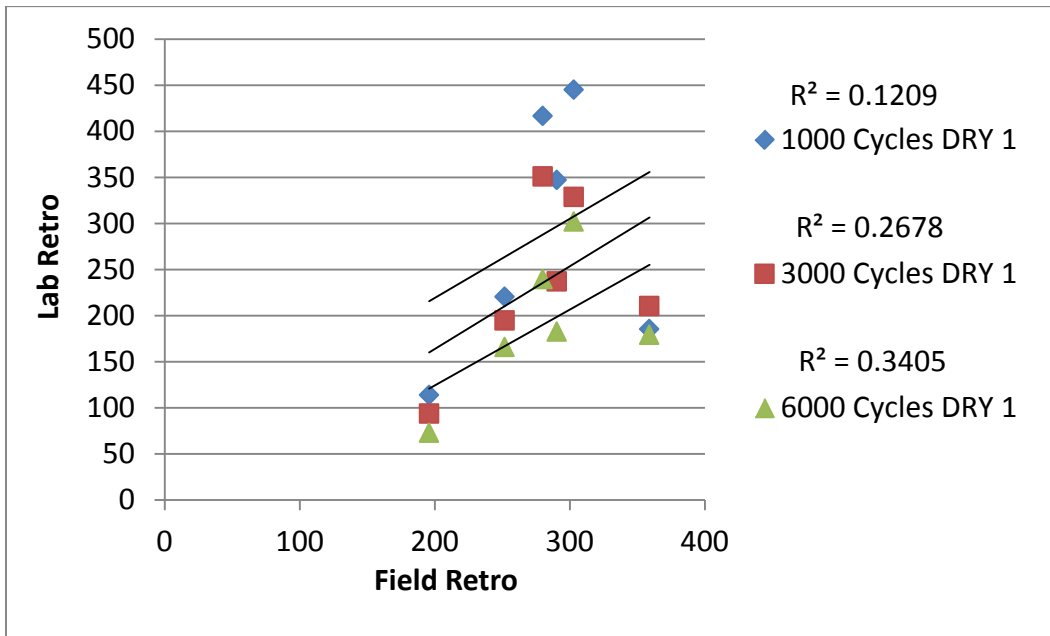
Figure 5.6 Comparison of lab and field retroreflectivity (dry, year 1) for epoxy markings.

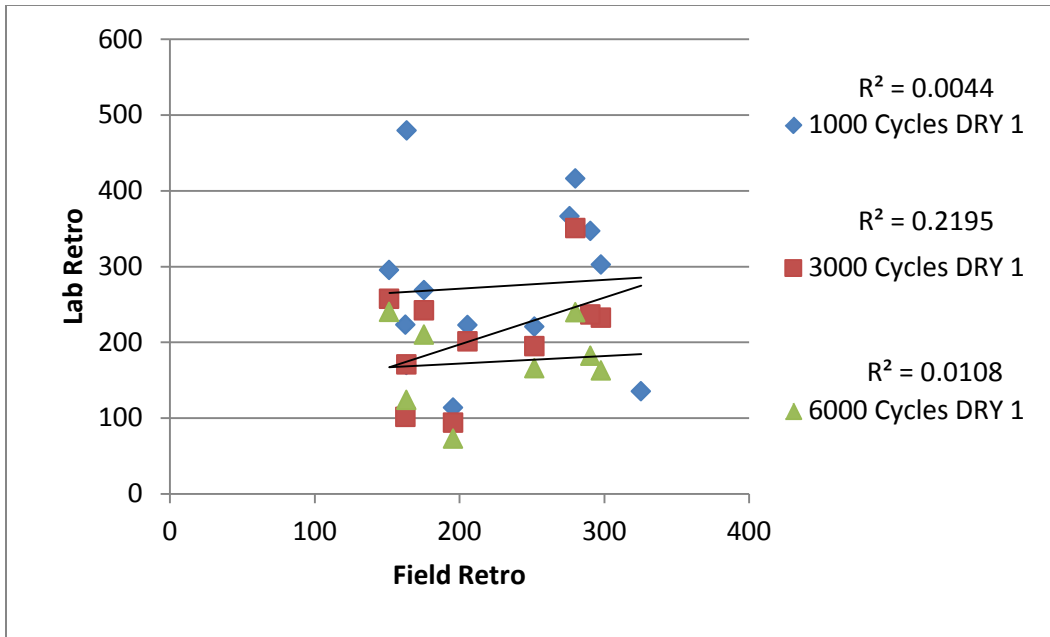
Figure 5.7 Comparison of lab and field retroreflectivity (dry, year 1) for markings on ACC surfaces.

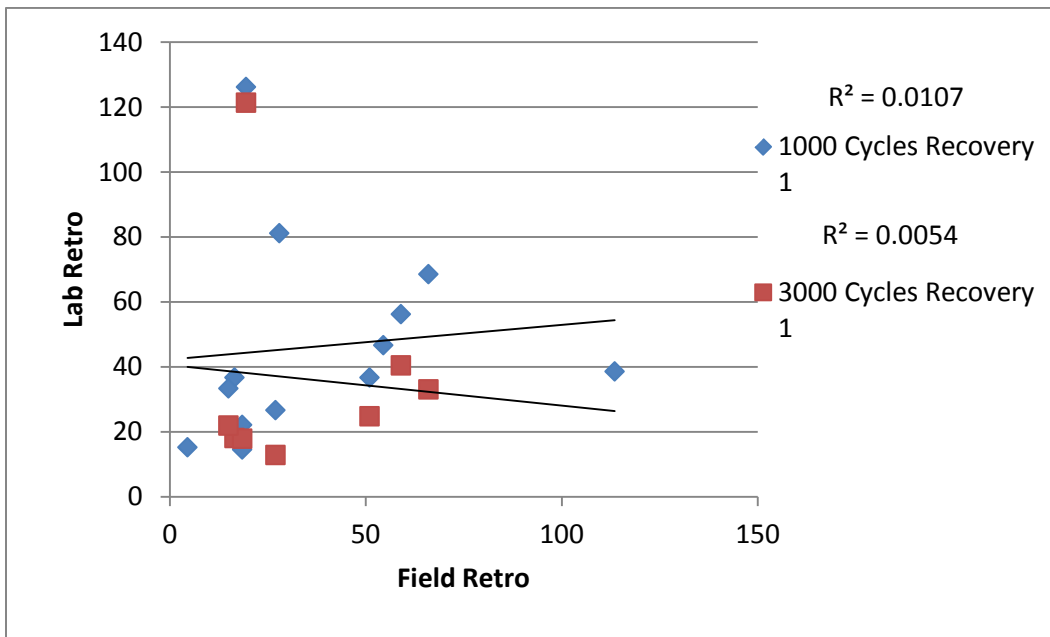
Figure 5.8 Comparison of lab and field retroreflectivity (recovery, year 1) for markings on ACC surfaces.
