# **EVALUATING PRESTRESSING STRANDS AND POST-TENSIONING CABLES IN CONCRETE STRUCTURES USING NONDESTRUCTIVE METHODS**

**Department of Civil and Architectural Engineering  
Lawrence Technological University  
Southfield, MI 48075-0134**

**November 2015**

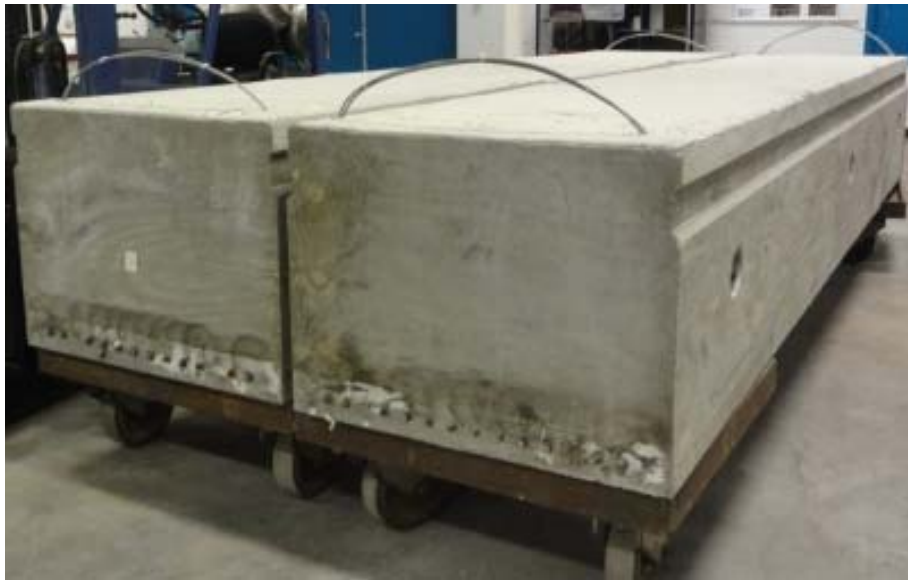
*Figure 3.1: Specimen 1 Box Beams, S1-1 and S1-2.*

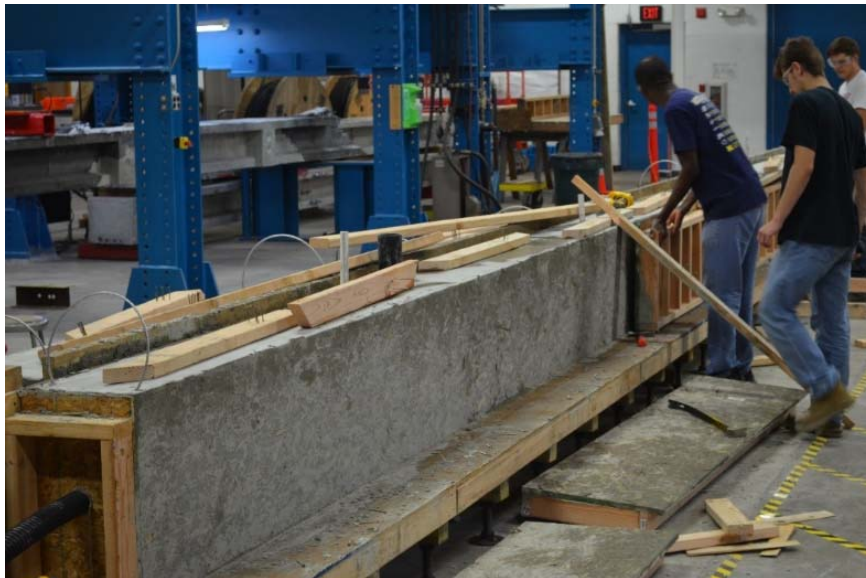
*Figure 3.3: Specimen Beams, S3-1, S3-2, S3-3 and S3-4*

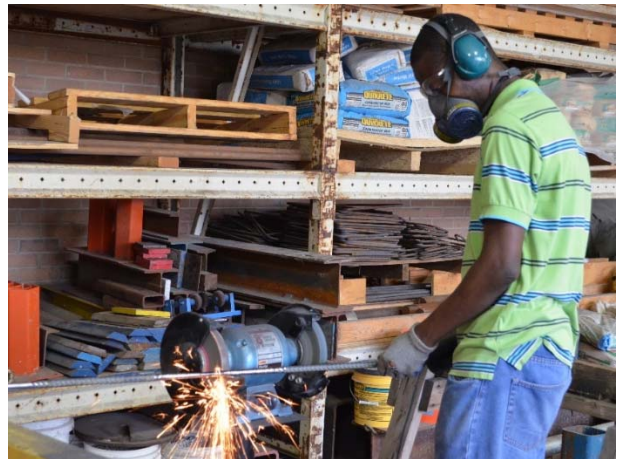
*Fig. 3.32: Cross-sectional area loss on reinforcement*

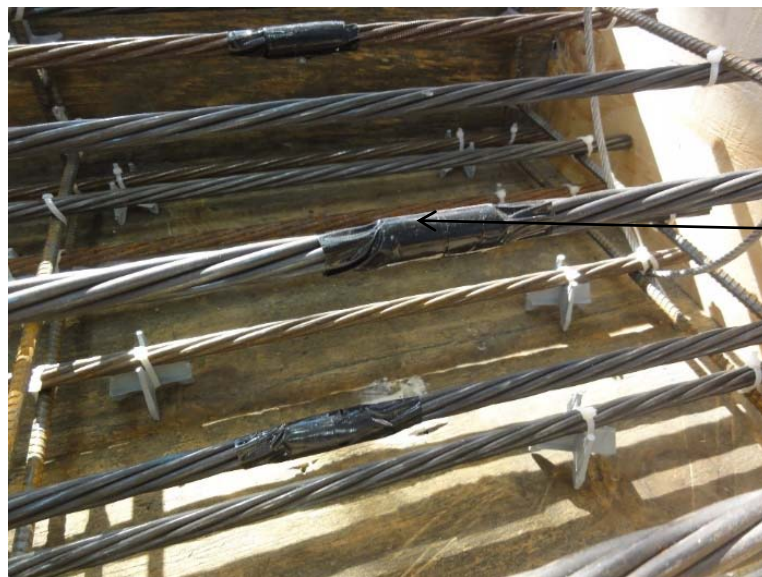
*Figure 3.39: Strands showing loss of wires covered with  
Dual wall polyolefin tube and duct tape*

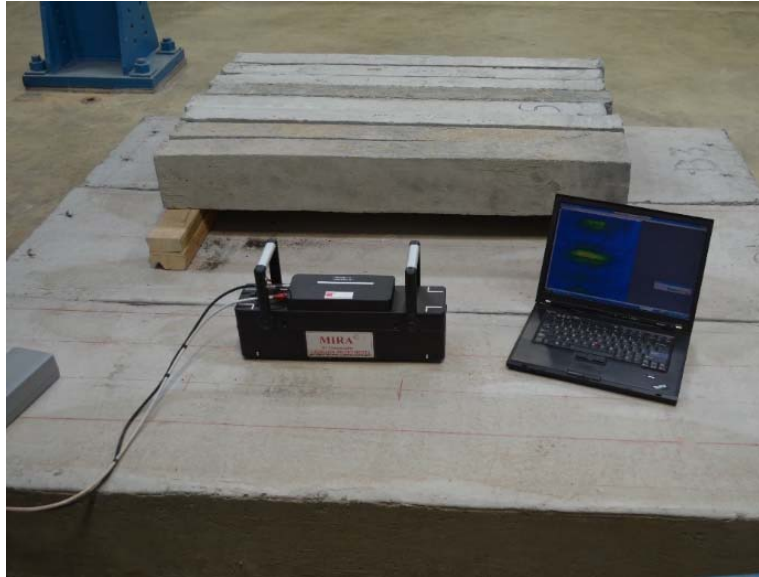
Figure 3.53: Ultrasonic assessment set-up for S2-1.
