Report No. FHWA-RD-77-24

VEHICLE-SAFE GRATE INLETS STUDY

Vol. 1. Hydraulic and Safety Characteristics of Selected Grate Inlets on Continuous Grades

June 1977
Final Report

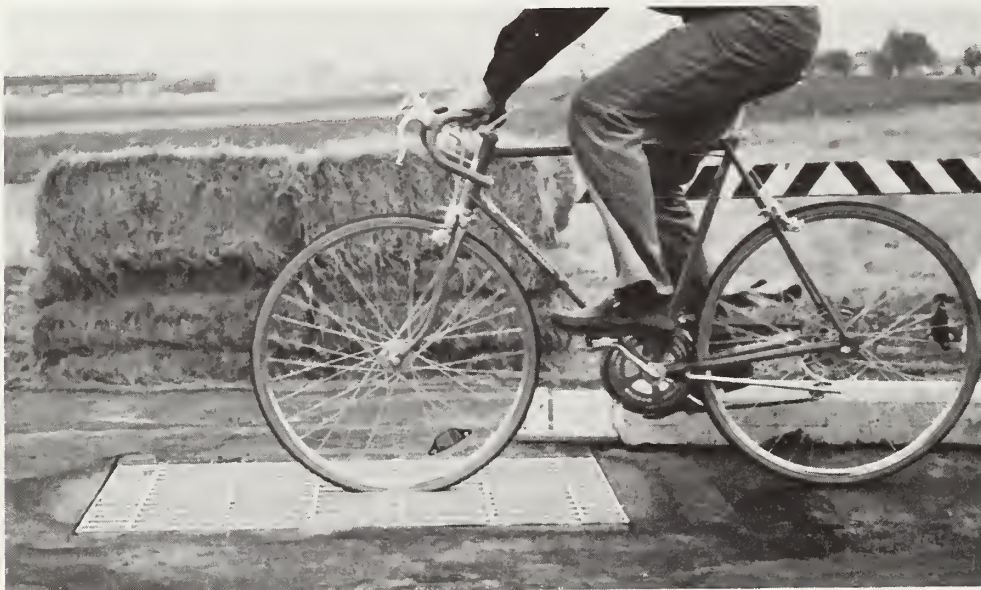
Figure 3-4. - Severe tire deformation on a grate with 8 in (203 mm) transverse bar spacing. Photo H-1765-59

- No direct evidence of tire or rim damage attributable to a specific grate was evidenced. Although several flat tires were incurred during the test program, these were attributable to thistle punctures. Photographic evidence does show significant tire deformation (figure 3-4 illustrates a case of severe tire deformation) on grates with the larger transverse spacings.
