DOT HS 807 000  
Final Report

June 1986

# Component Head Test Accident Reconstruction Feasibility Analysis

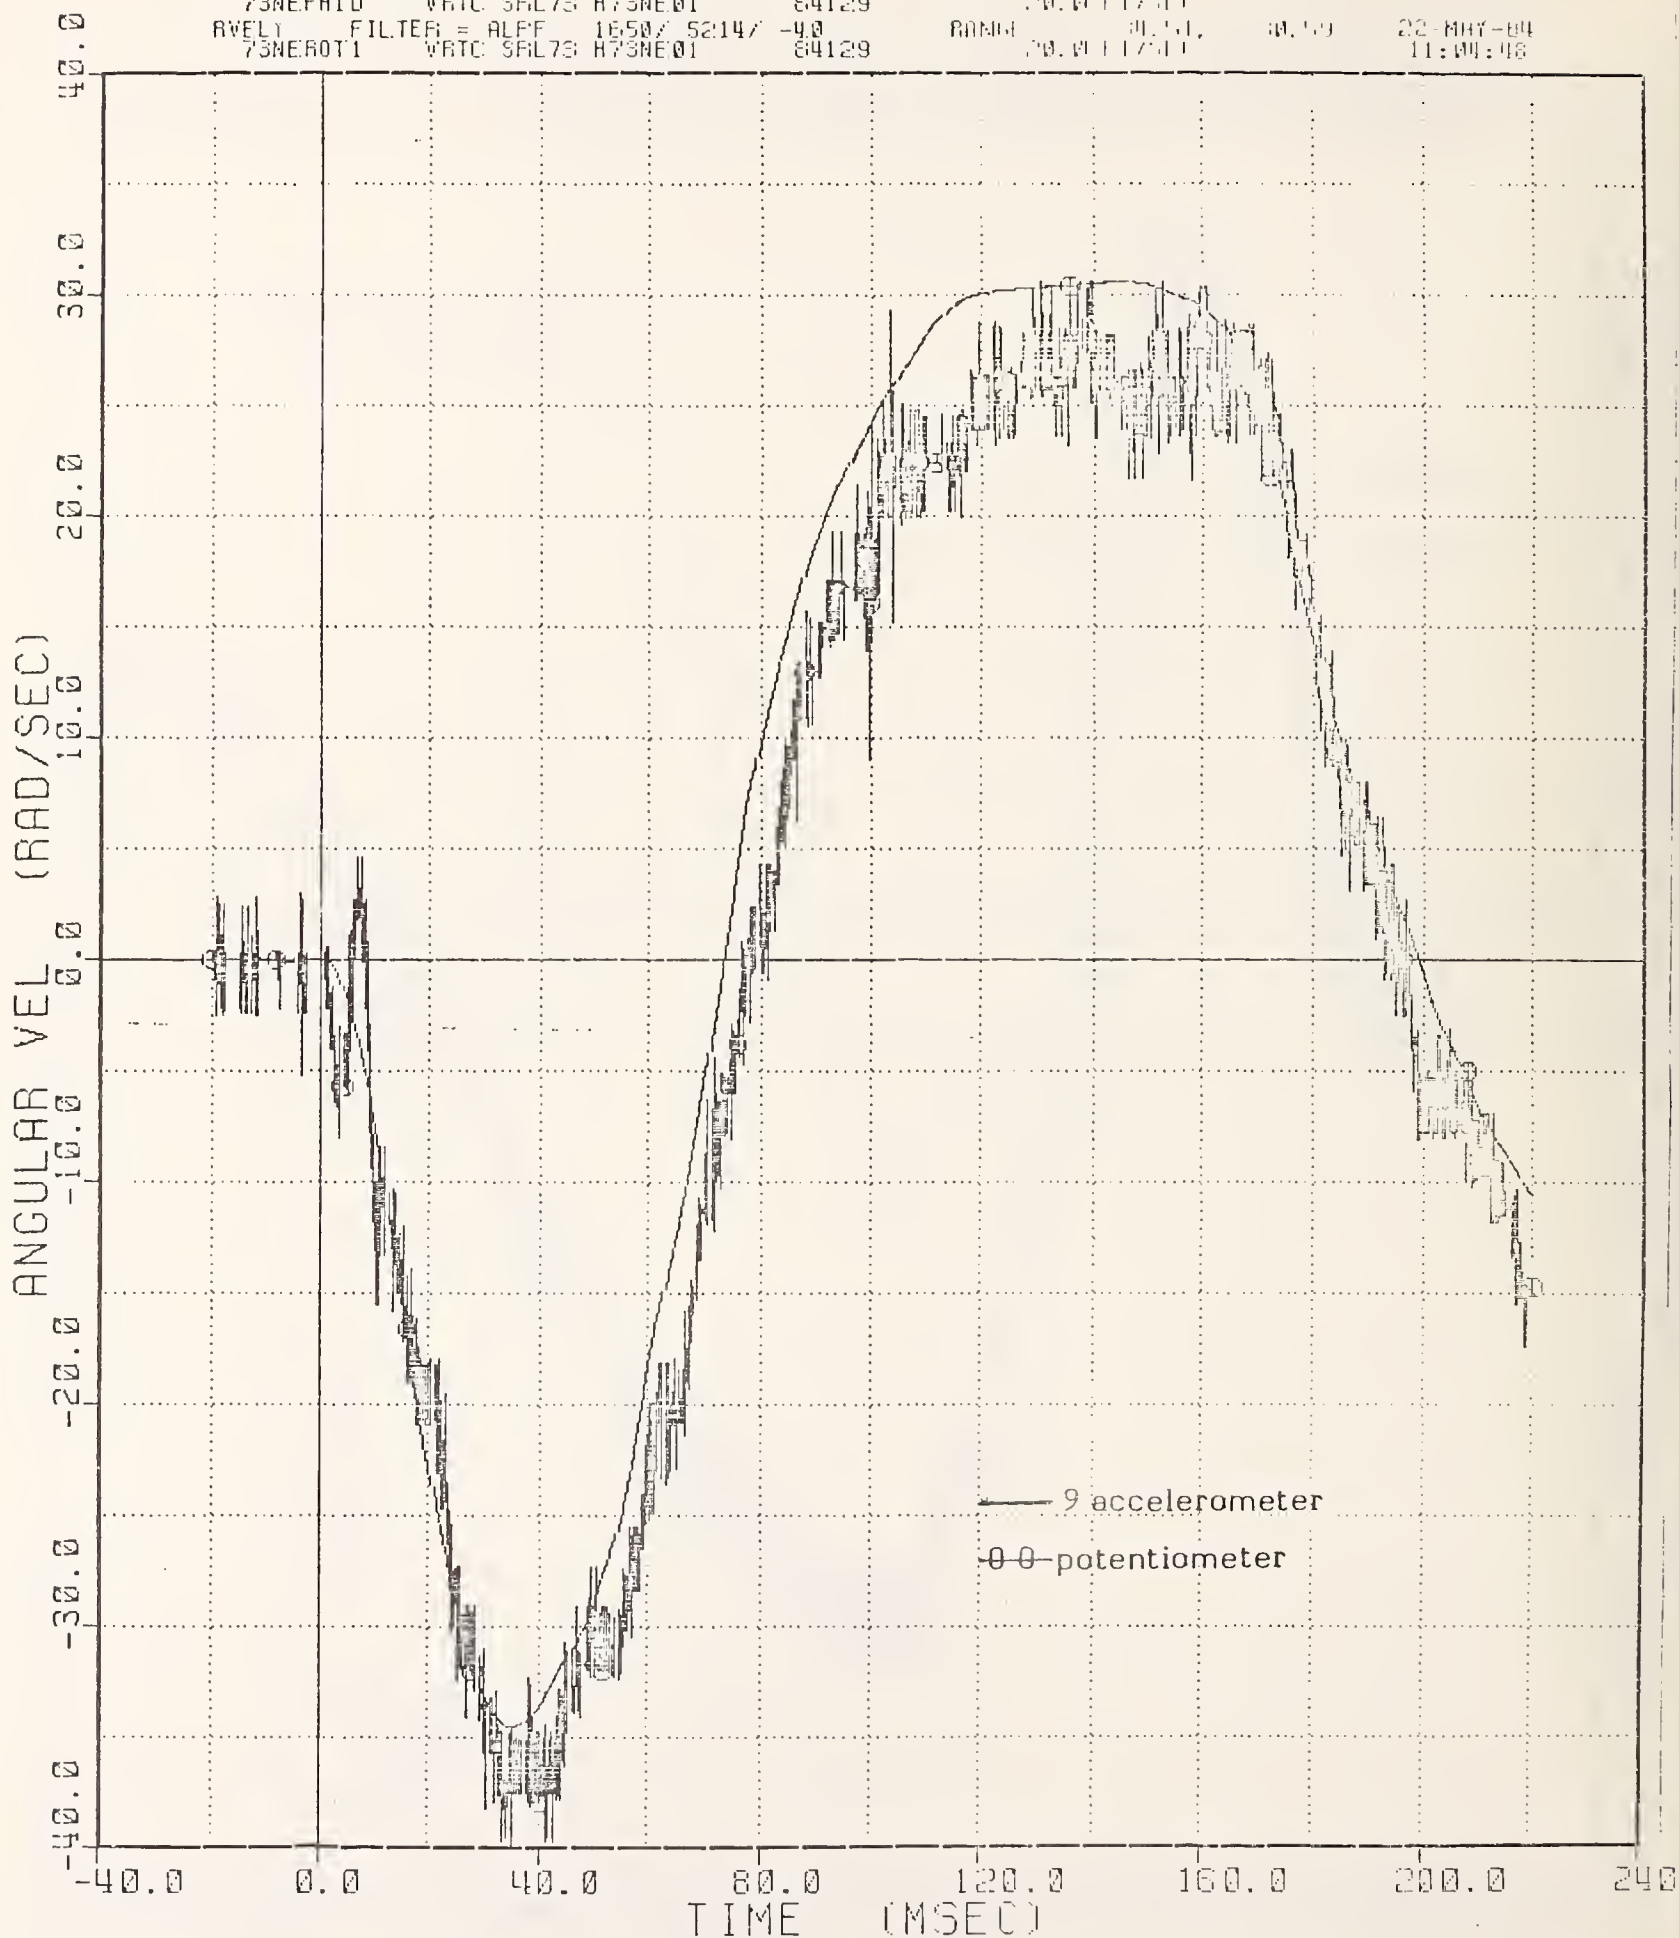
FIGURE 3.7 -- Comparison of Angular Velocity Versus Time From  
 9-Accelerometer and Potentiometer Data  
 For Neck Extension Pendulum Test.

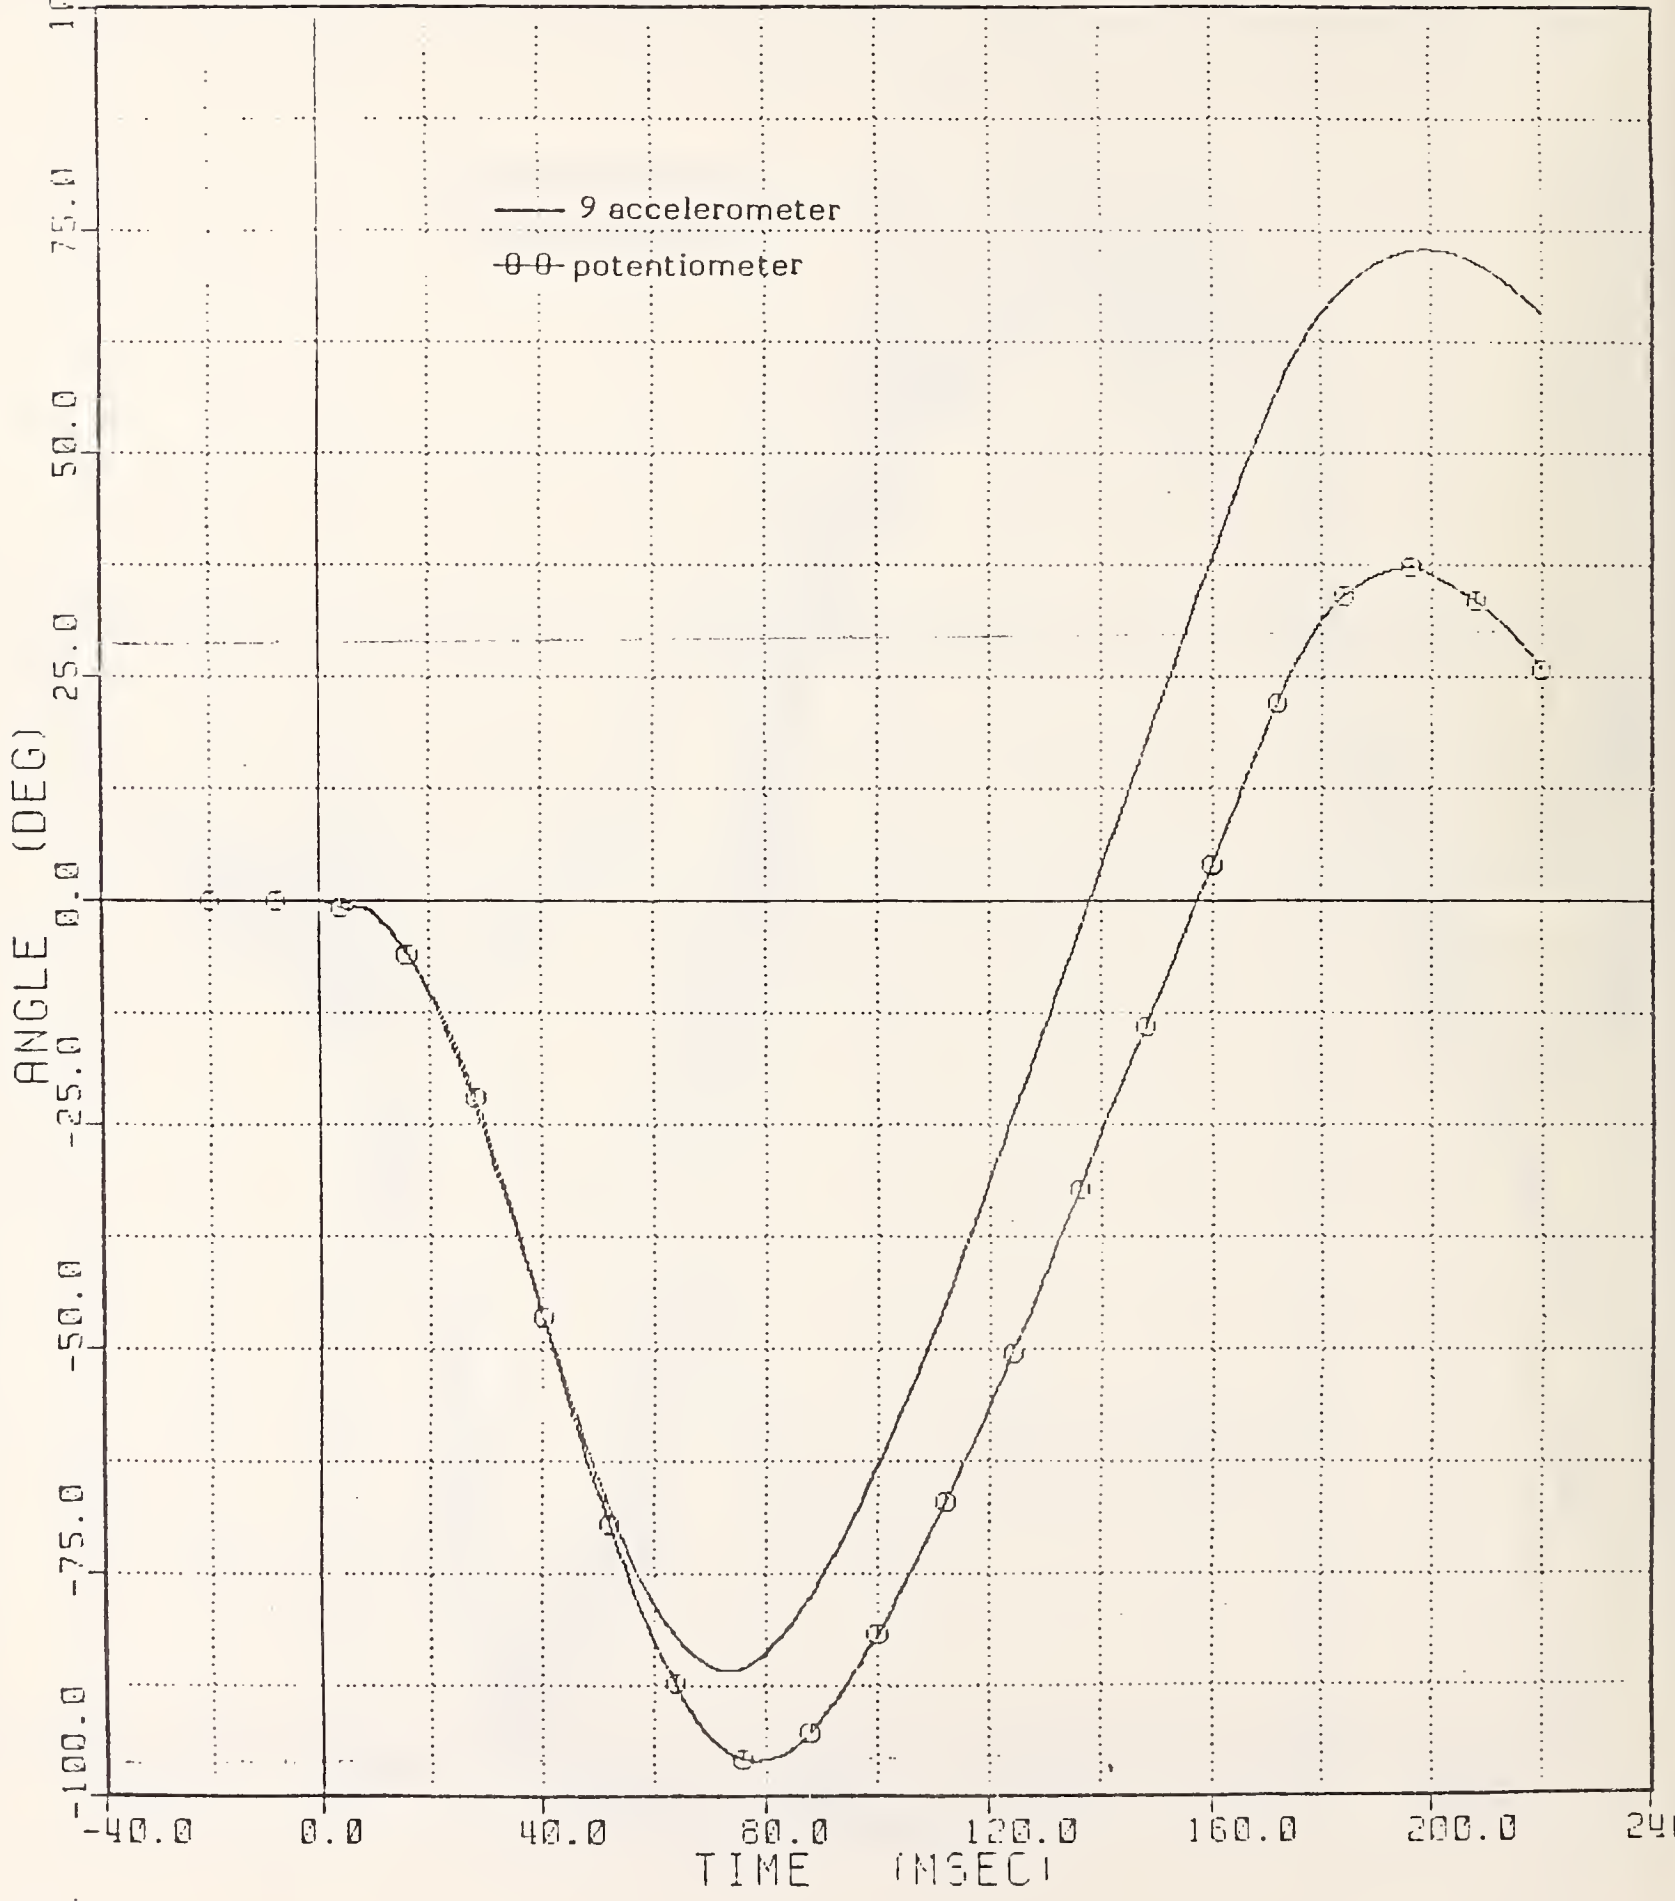
FIGURE 3.9 -- Comparison of Angle Versus Time From  
 9-Accelerometer and Potentiometer Data  
 For Neck Extension Pendulum Test.

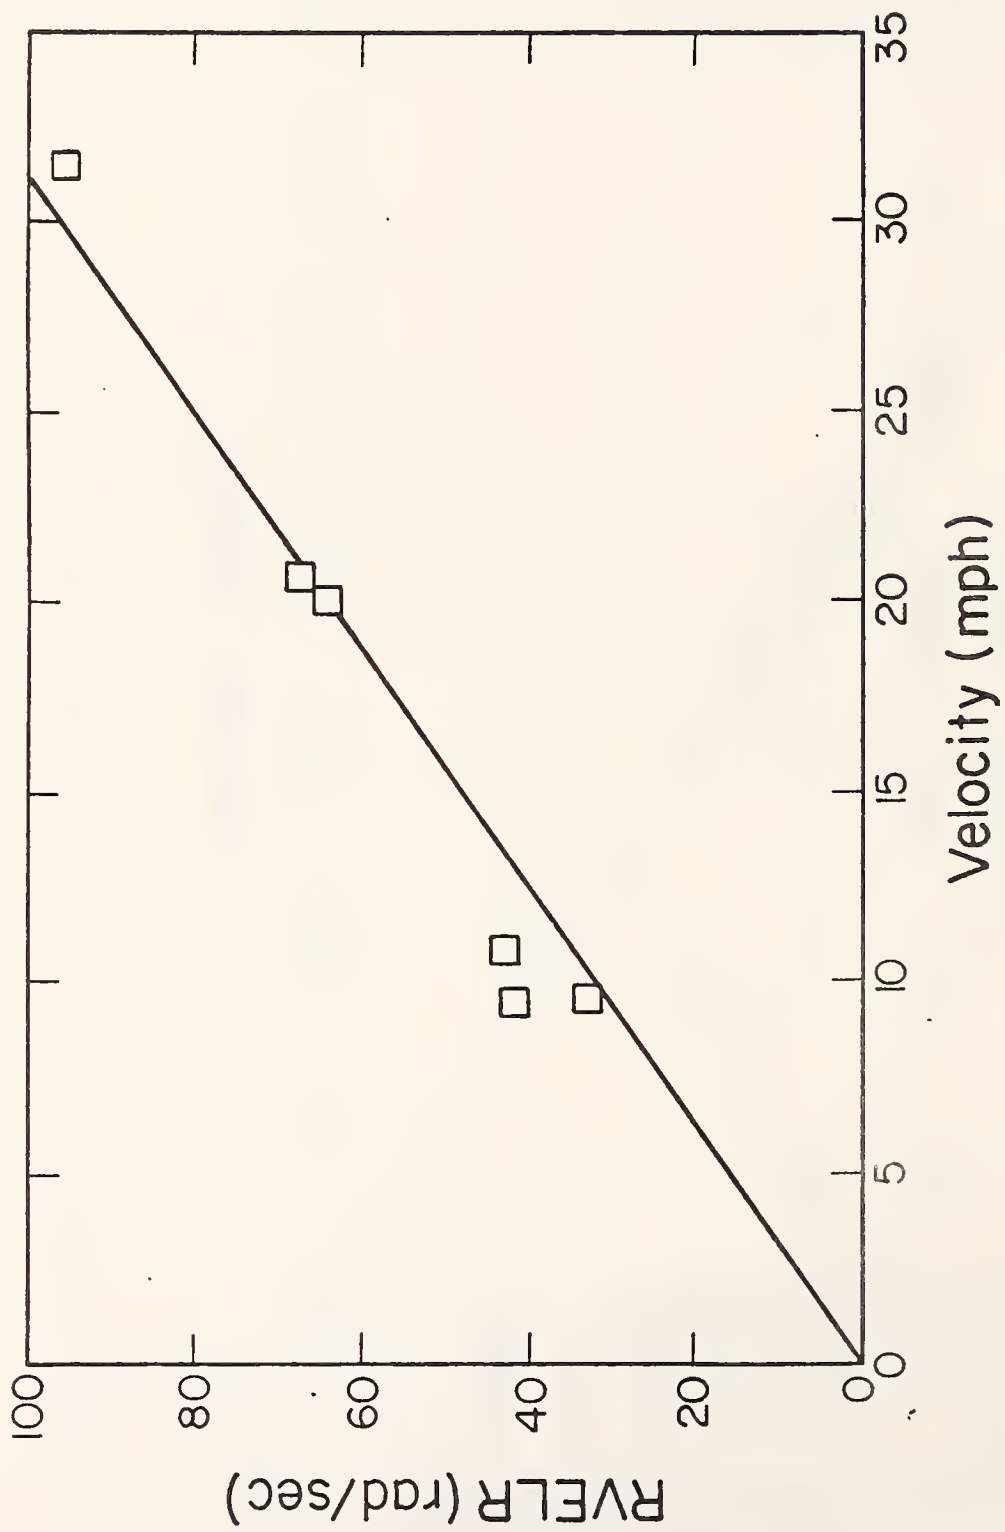
FIGURE 4.4 -- FMHF Peak Resultant Rotational Velocity Sensitivity to Impact Velocity.

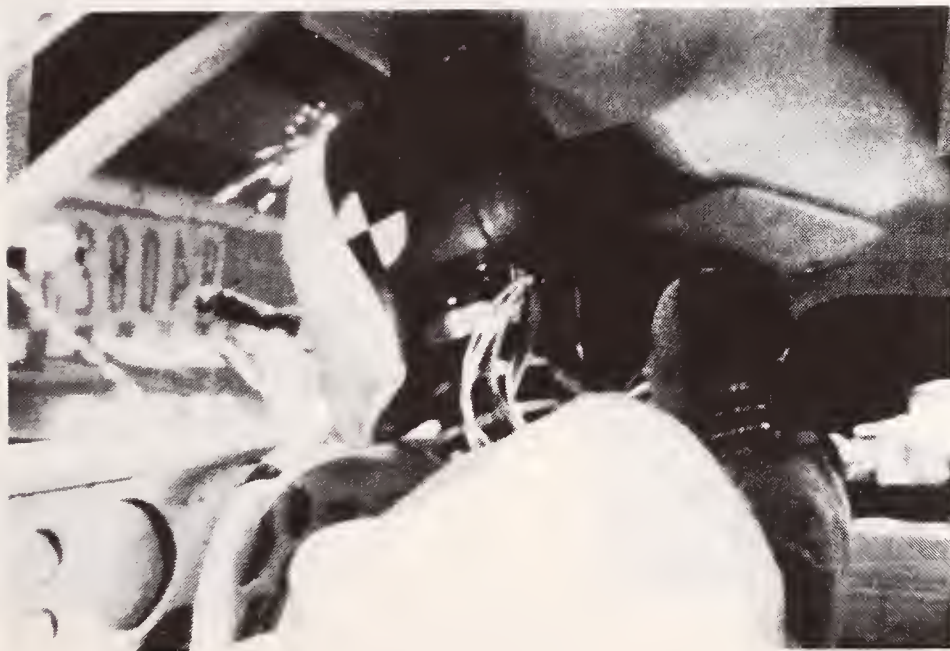
FIGURE 4.13a -- FMHF and Barrier Test-Position Comparison,  
0 msec.

FIGURE 4.13d -- FMHF and Barrier Test-Position Comparison,  
30 msec.

A qualitative kinematic response comparison between the FMHF and the passenger head is illustrated in Figures 4.13a -- d. (Note that the driver head response is not a valid comparison since it contacted the steering wheel first.) As with the accelerometer data, the positions of the passenger head and the FMHF vary only slightly for the two tests. For each test, time equal to zero was taken to be the frame before initial crack propagation was observed. The passenger head was initially tipped forward slightly more than the FMHF. At 10 msec neither headform had undergone much rotation, however, the FMHF had slid down the windshield several inches. At 20 msec, the rotation of the full dummy headform as well as its motion down the windshield was noticeable but not as much as the FMHF. These comparisons continued to diverge at 30 msec, at which time the FMHF has moved approximately 3-4 inches further down the windshield and rotated roughly 30 more degrees than the full dummy headform.

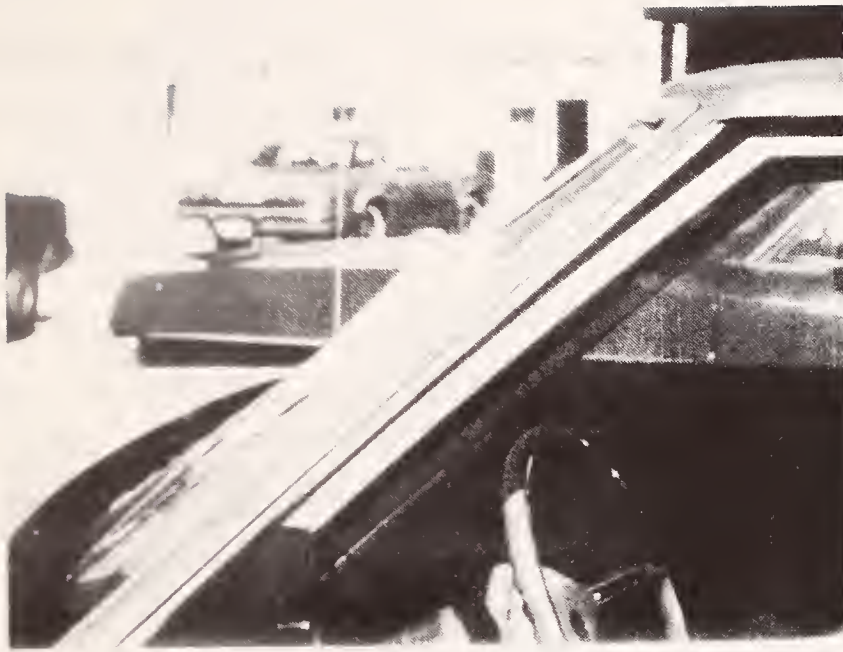
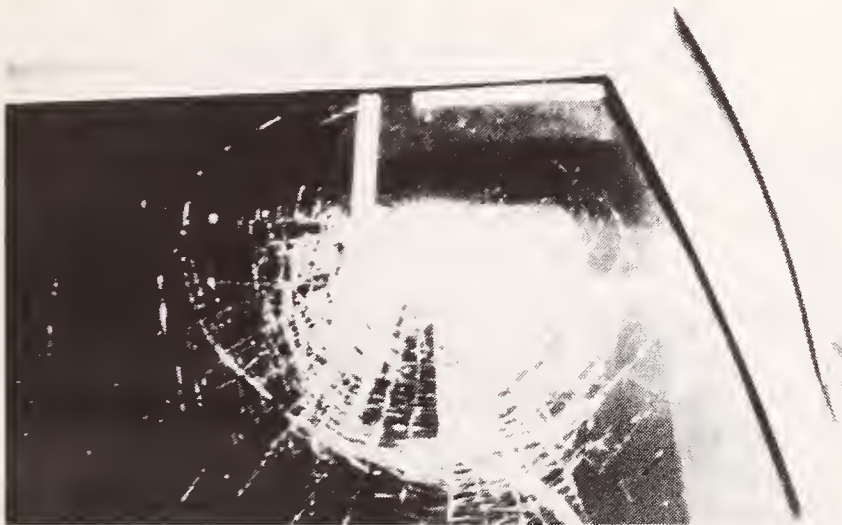
FIGURE 5.1 -- Aries Accident Damage Pattern.

The case vehicle, approaching the main gate of a facility, drifted out of its lane. The left wheels climbed a curb and the vehicle collided head-on with a concrete post protecting the gate's guard station. The subject, driver of the Aries, was probably in a normal seated position precrash. At impact, he was thrown forward, to the left and slightly upward. His forehead and chin contacted the windshield causing the lacerations and concussion (Figure 5.1). The right side of his abdomen contacted the steering wheel, collapsing the column one half inch and causing his rib fractures and abdominal injuries.

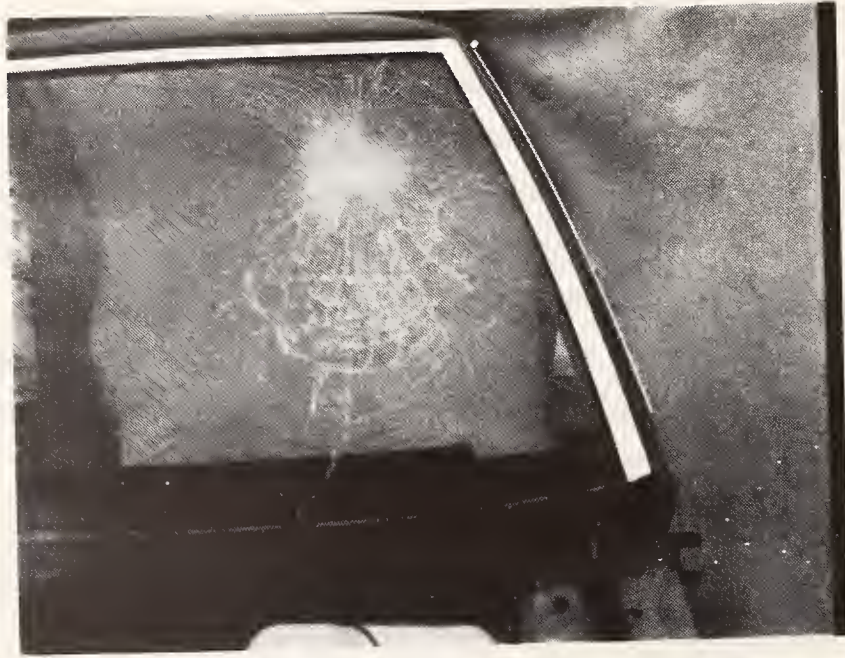
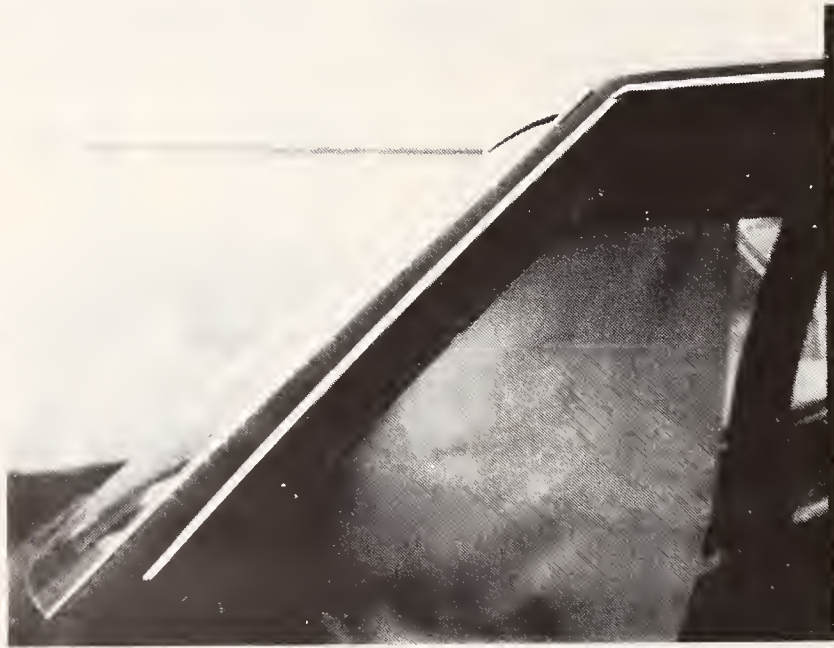
FIGURE 5.2 -- Aries Reconstruction Damage Pattern.

In reconstructing this accident, the impact velocity was the only parameter treated as an unknown. The impact orientation was horizontal and directed from the position of a normally seated occupant to the impact point on the windshield. It should be noted that the initial impact point represented by the center of the crack pattern in Figure 5.1a, is at the top of the bulge shown in Figure 5.1b. A summary of the reconstruction attempts is given in Table 5.2. The first test was at 14.8 mph, approximately the delta-v of the crash, and produced no damage. After performing a series of tests, the damage pattern was judged

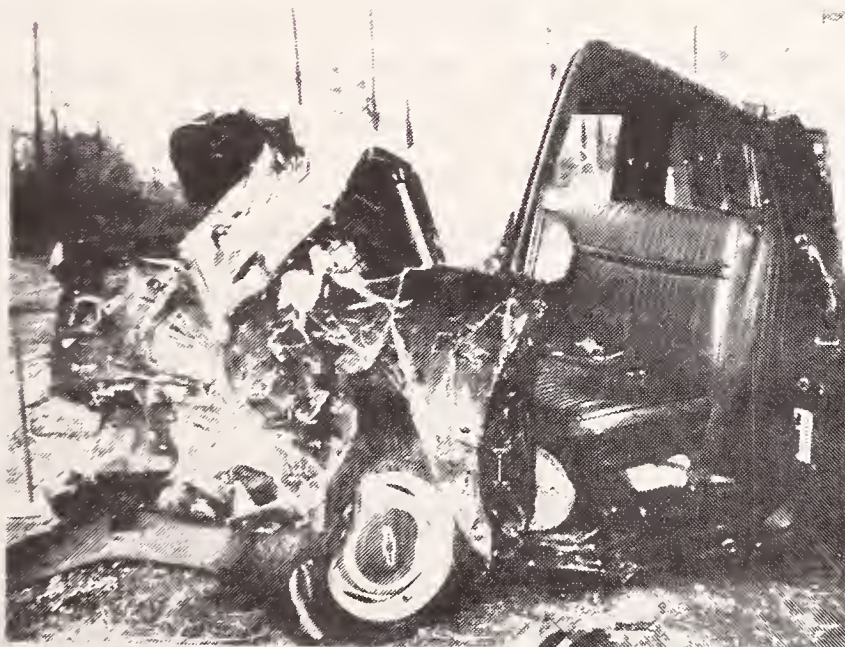
FIGURE 5.3 -- S-10 Accident Damage.

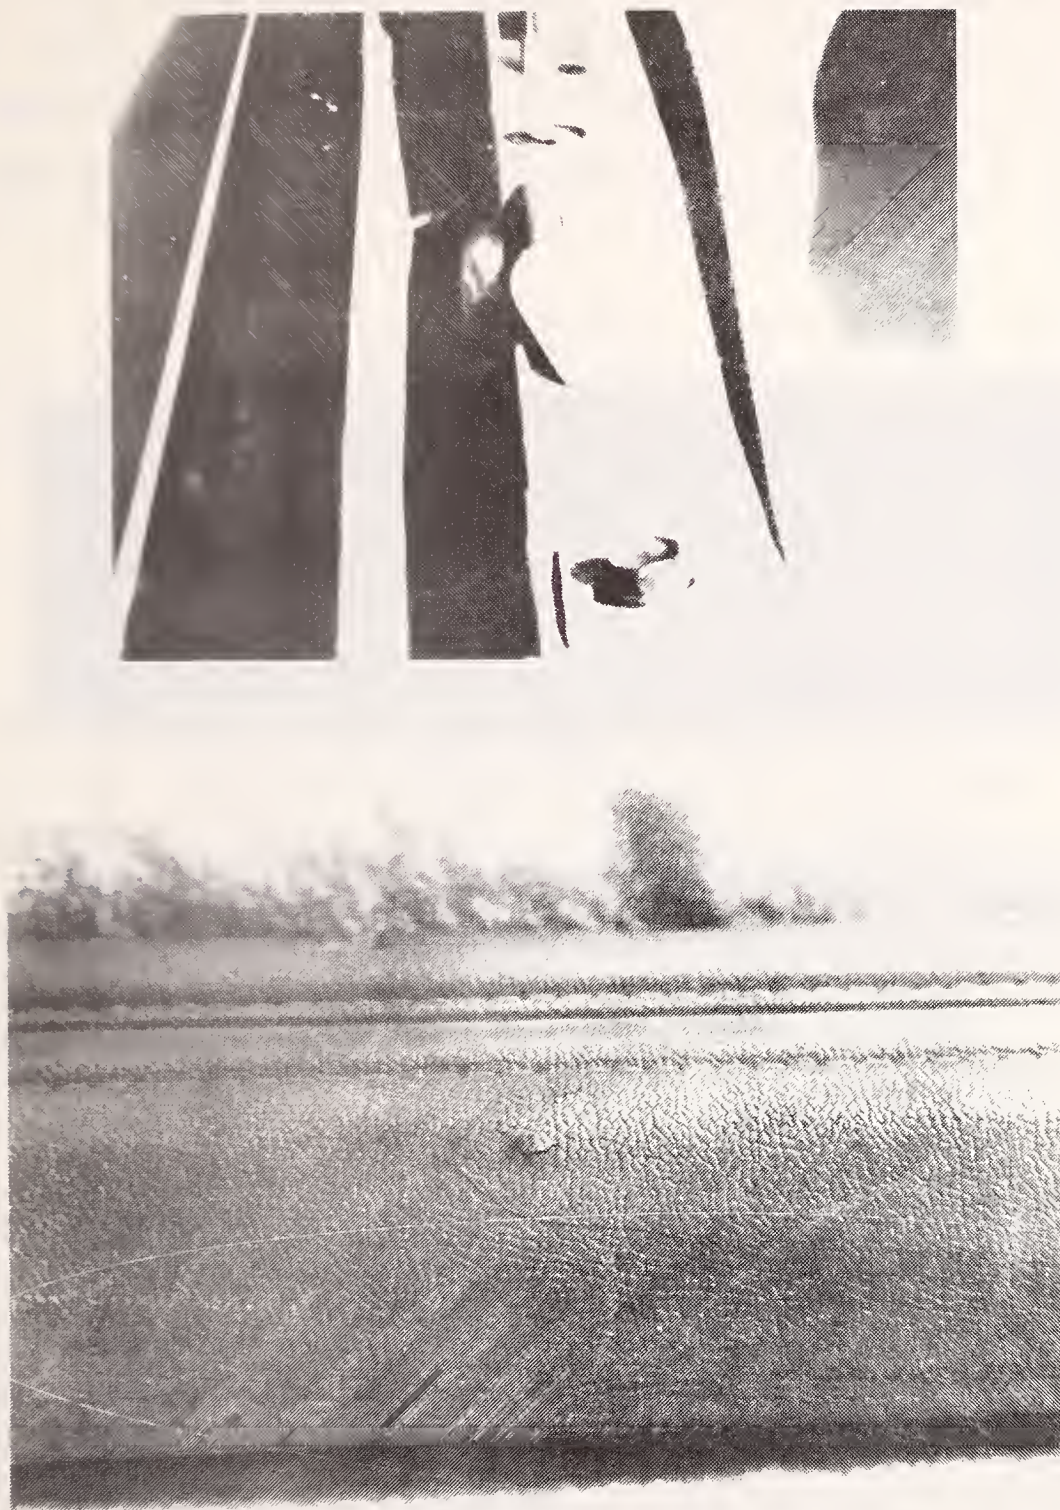
FIGURE 5.9 -- Window Sill Plastic Covering and Support Tab Accident Damage.

The observed damage pattern on the door due to the head impact consisted of: 1.) a slight crack on the plastic cover (Figure 5.8); 2.) a backward bend of a metal tab intended to support the plastic (Figures 5.8 and 5.9); and 3.) a slight dent in the metal window sill (Figure 5.10). The window sill dent illustrated in Figure 5.10 was the horizontal dent. There was also a vertical dent of approximately the same magnitude. The
