t No. FHWA-RD-78-133

# ENDING THE SERVICE LIFE OF EXISTING BRIDGES BY INCREASING THEIR LOAD CARRYING CAPACITY

Final Report

Prepared for  
FEDERAL HIGHWAY ADMINISTRATION  
Offices of Research & Development  
Washington, D. C. 20590

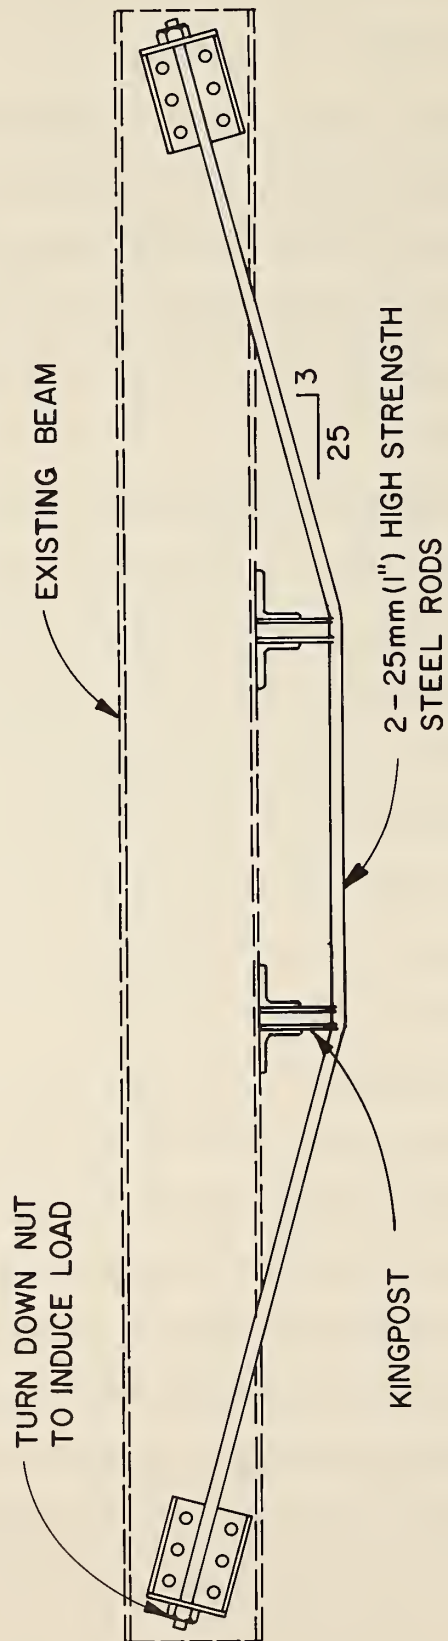
FIGURE 1

KINGPOST TRUSS BEAM REINFORCEMENT

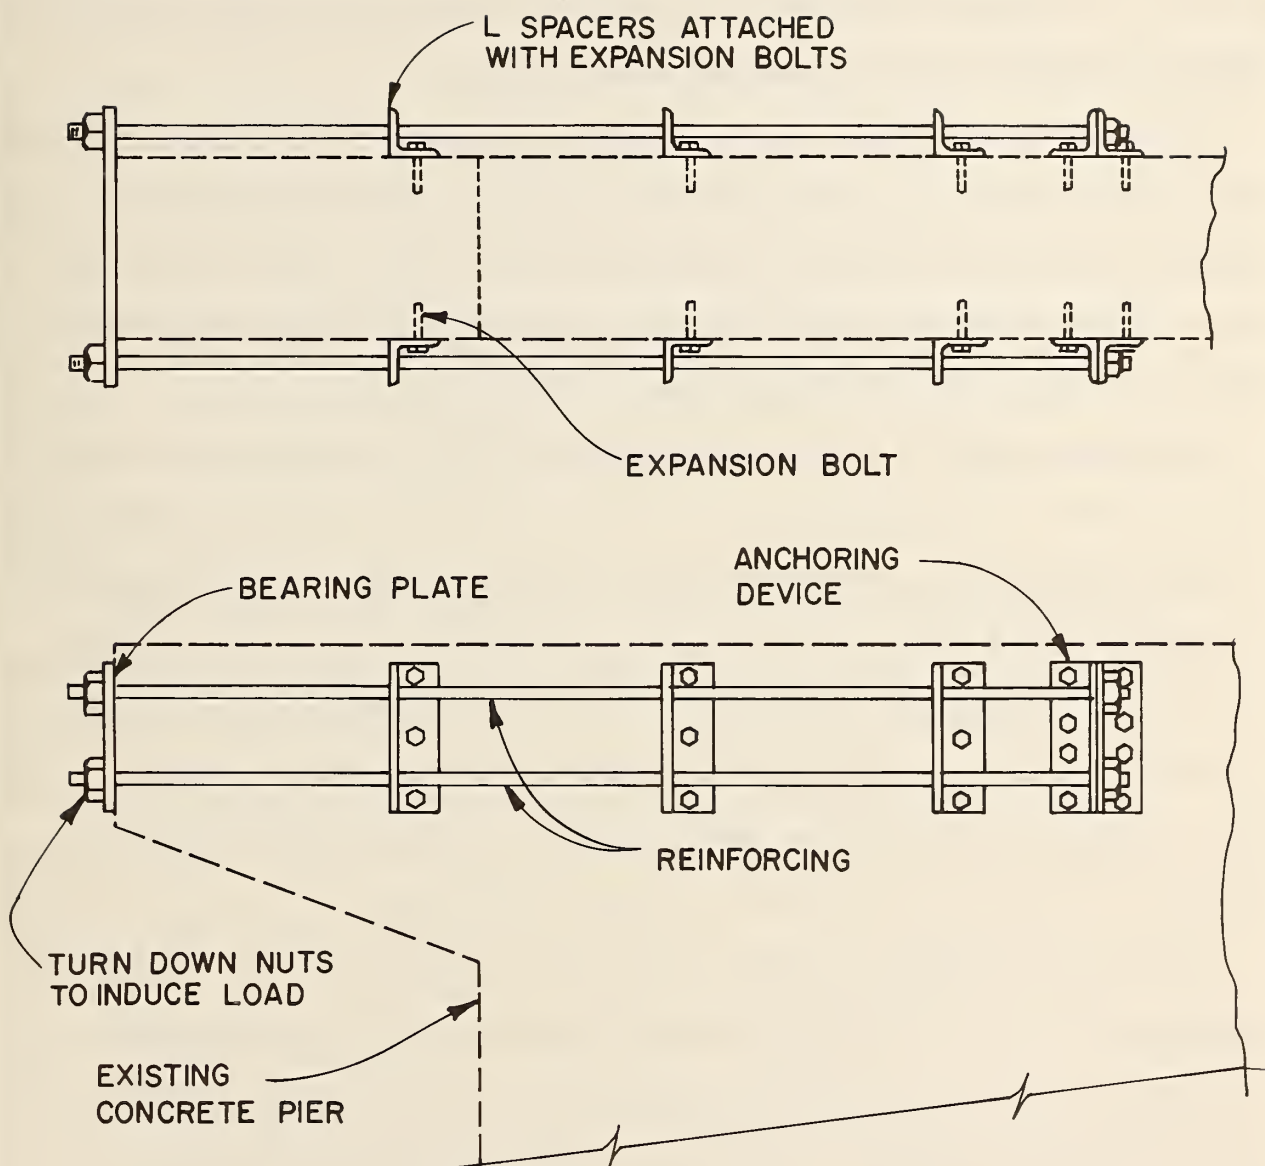
FIGURE 2

Concrete beam and girder bridges can be strengthened by adding steel beams or precast concrete beams between or adjacent to the existing concrete sections. Timber bridges likewise can be strengthened by adding additional primary steel members.

## EXTERNAL CONCRETE REINFORCING

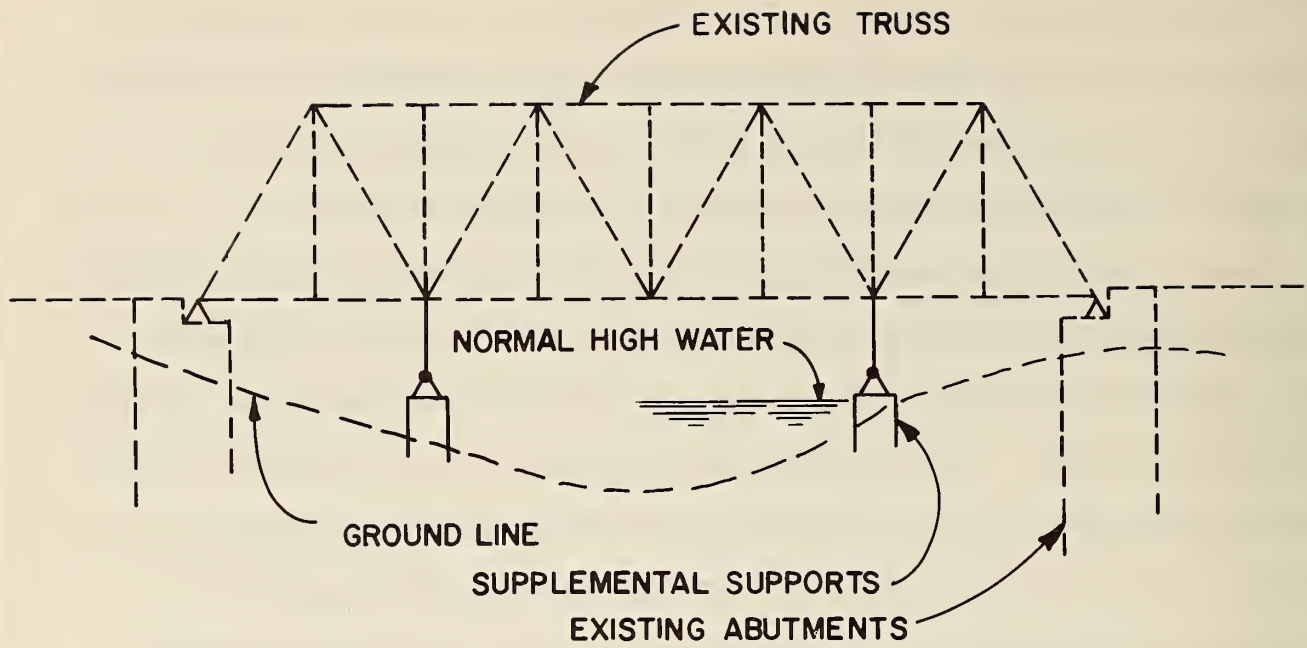
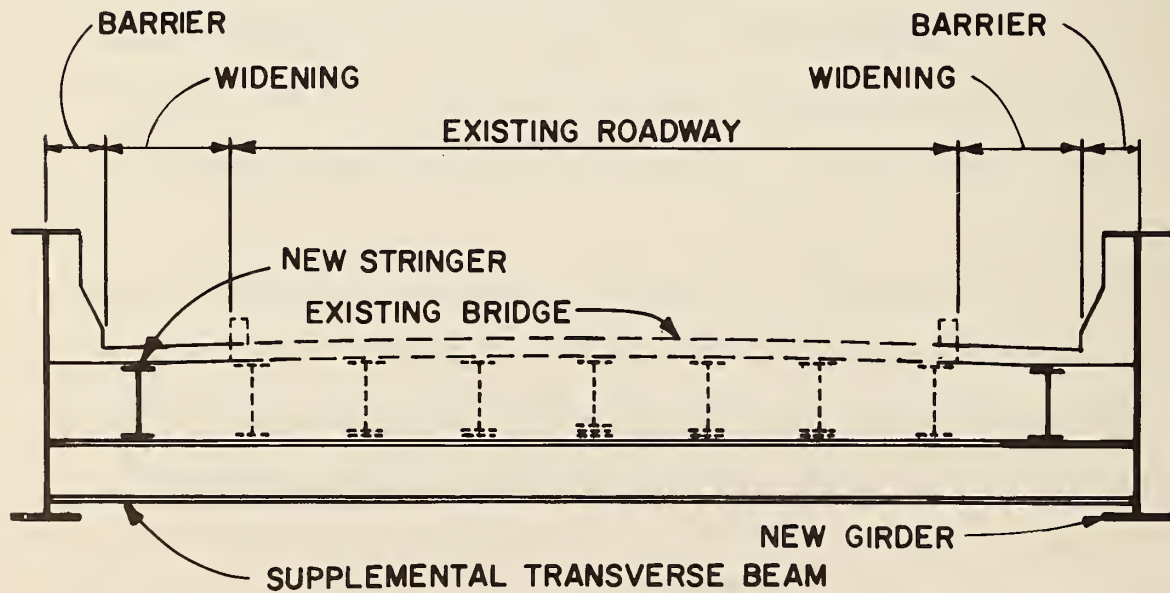
FIGURE 3

### SUPPLEMENTAL TRUSS SUPPORTS

### SUPPLEMENTAL TRANSVERSE SUPPORTS

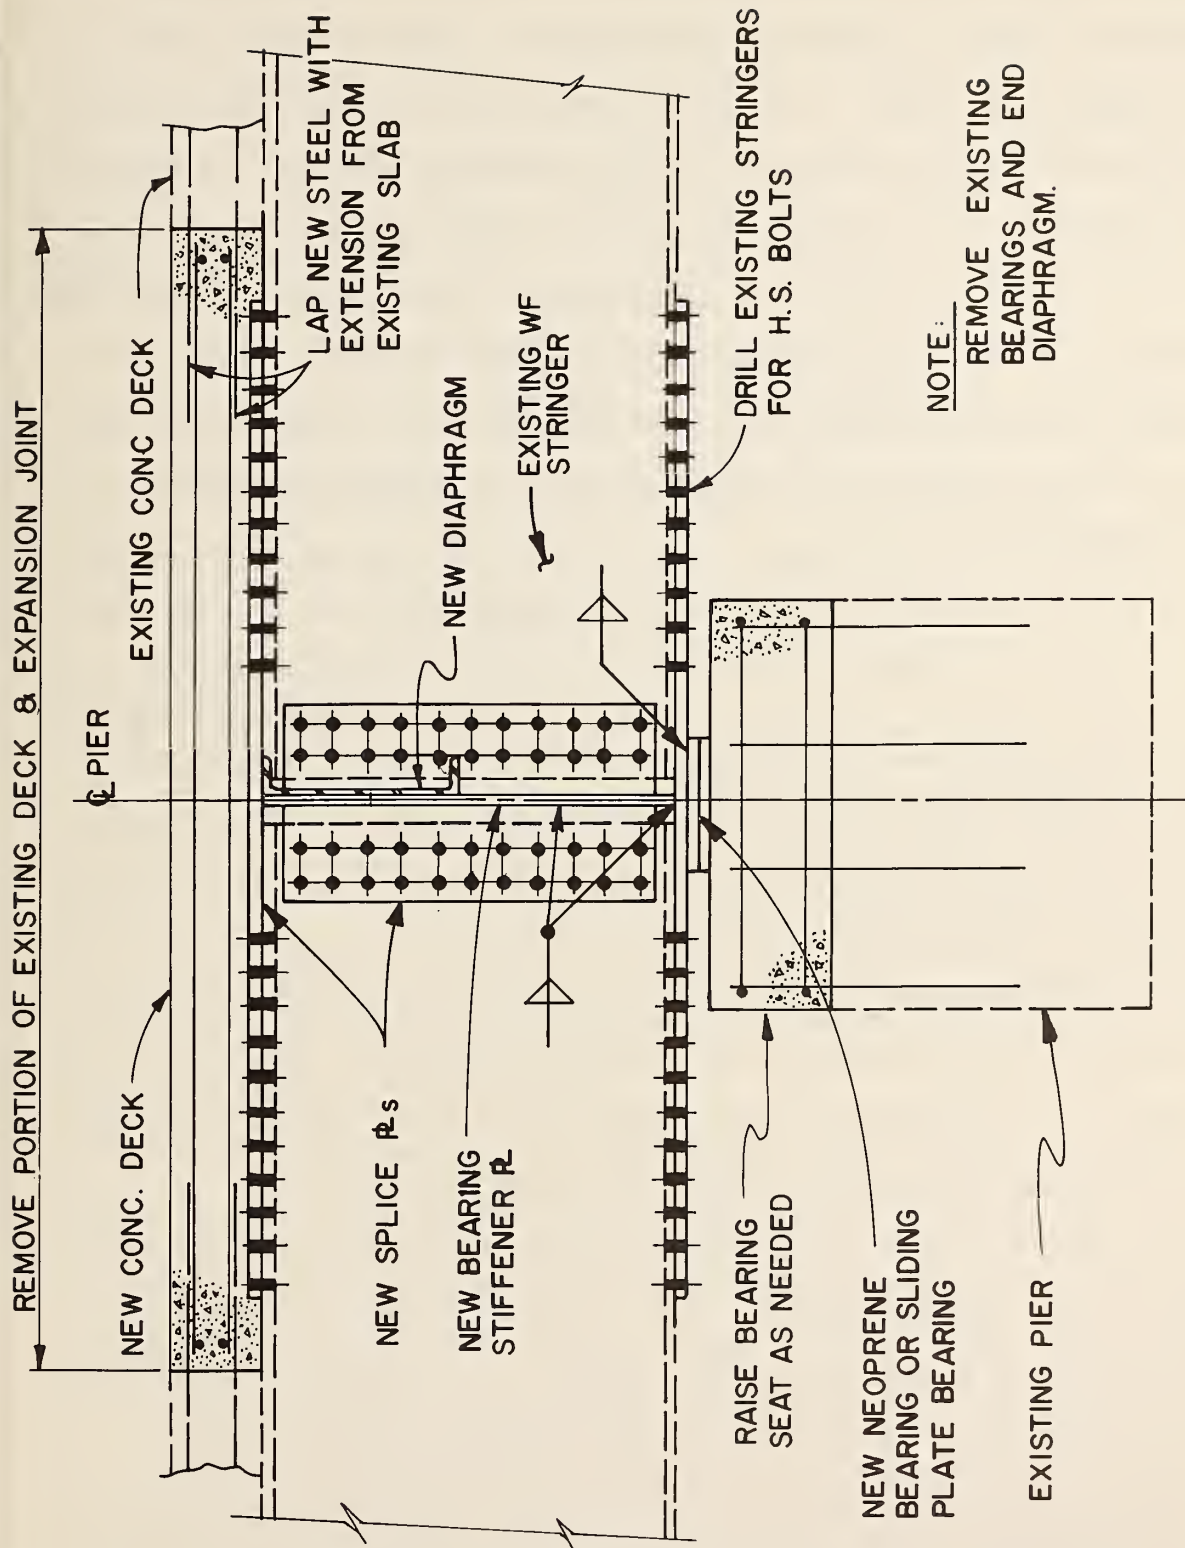
FIGURE 4

CONCEPTUAL DETAILS  
SIMPLE SPAN STEEL BEAM TO CONTINUOUS

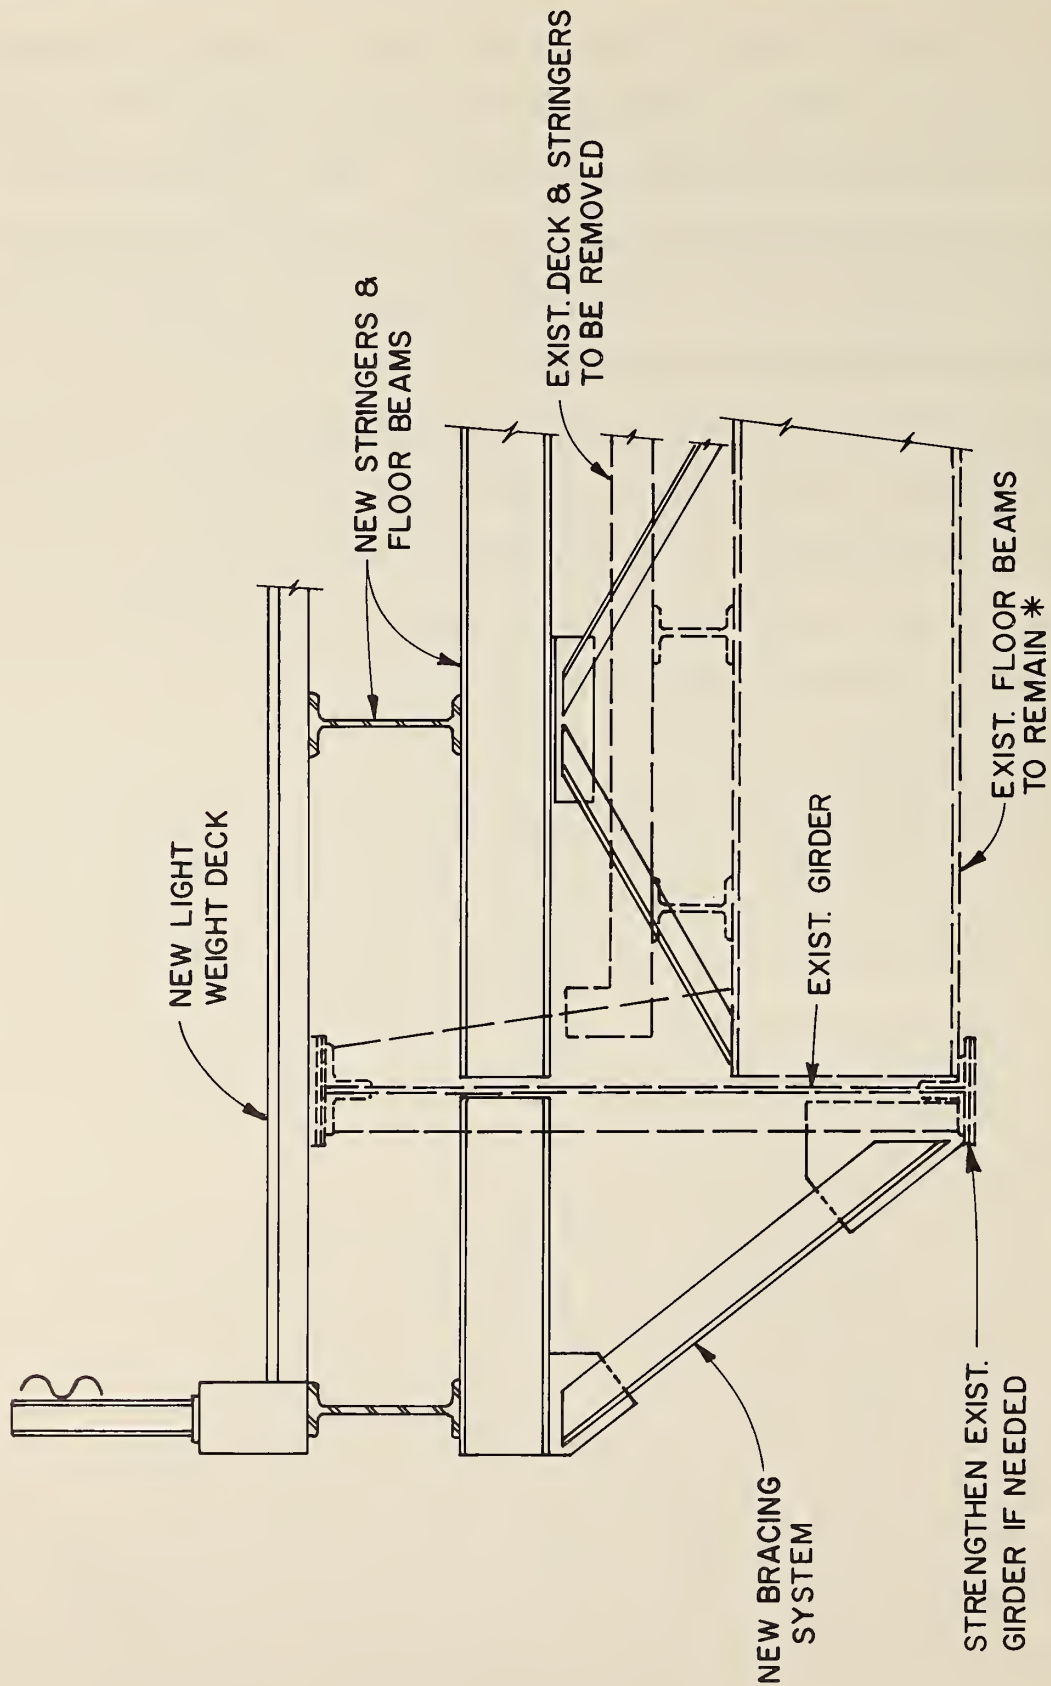
FIGURE 5

Through girder bridges and through truss bridges are more difficult to widen. Short of removing the entire superstructure and replacing with a new one, it is impracticable to consider widening a through truss bridge and in most instances, a pony truss bridge. Providing site conditions will permit adjustments in grade of several feet, it can be practical to widen a through girder bridge by moving the floor system to the top flange of the girder and constructing a wider deck. The main girders may require strengthening. However, this can be minimized by utilizing a lightweight deck in conjunction with the rehabilitation. A conceptual cross section of this is shown in Figure 5.

CONCEPTUAL DETAILS  
THRU GIRDER DECK WIDENING

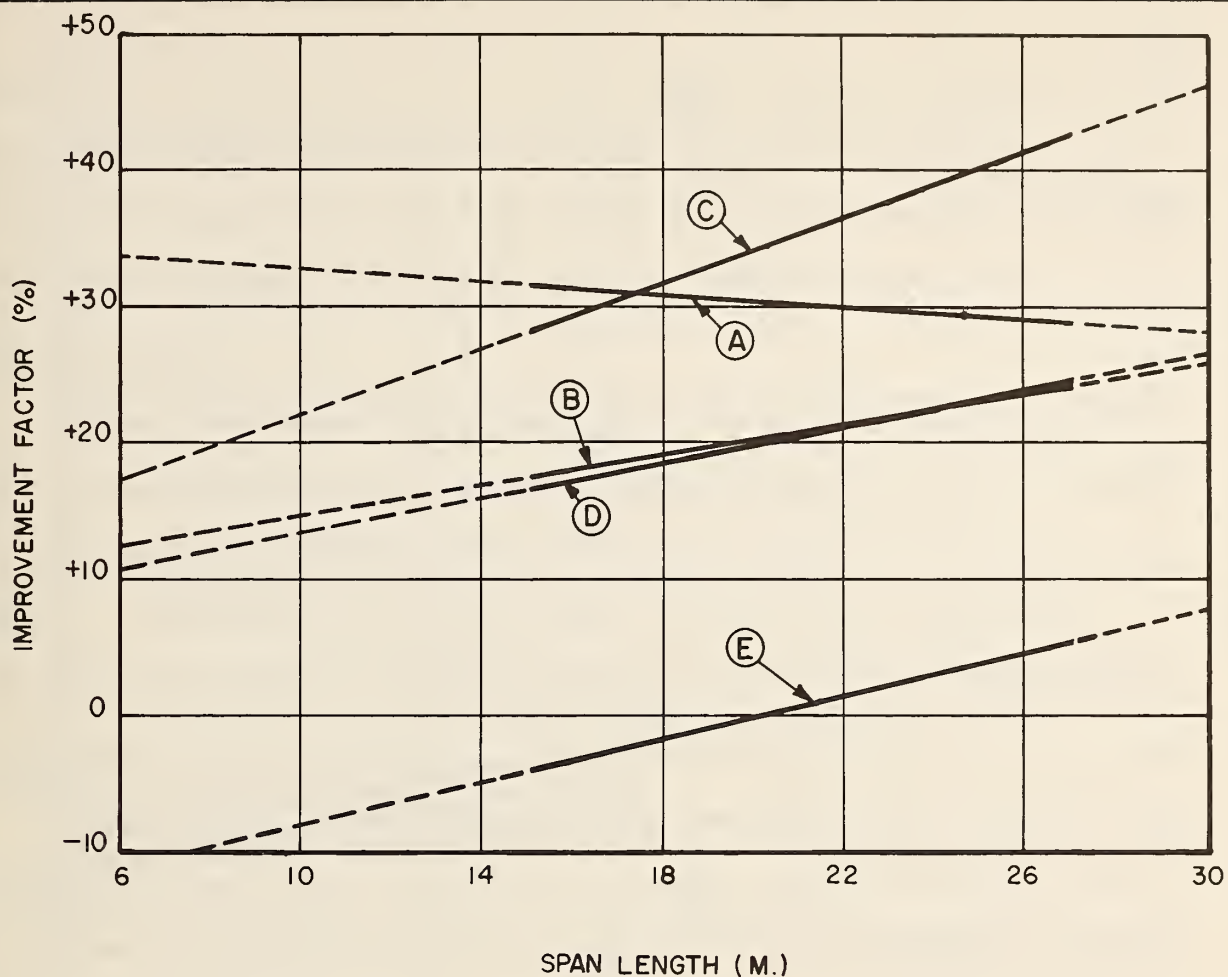
FIGURE 6

COST PER SQ. M.	
A	\$ 410
B	\$ 270
C	\$ 290
D	\$ 310
E	\$ 310

- A. STEEL PLATE W/ASPHALT WEARING SURFACE SUPPLEMENTAL DECK SUPPORT SYSTEM.
- B. CORRUGATED METAL W/ASPHALT WEARING SURFACE SUPPLEMENTAL DECK SUPPORT SYSTEM.
- C. OPEN STEEL GRID.
- D. CONCRETE FILLED STEEL GRID.
- E. LAMINATED TIMBER

## DEAD LOAD REDUCTION SYSTEMS

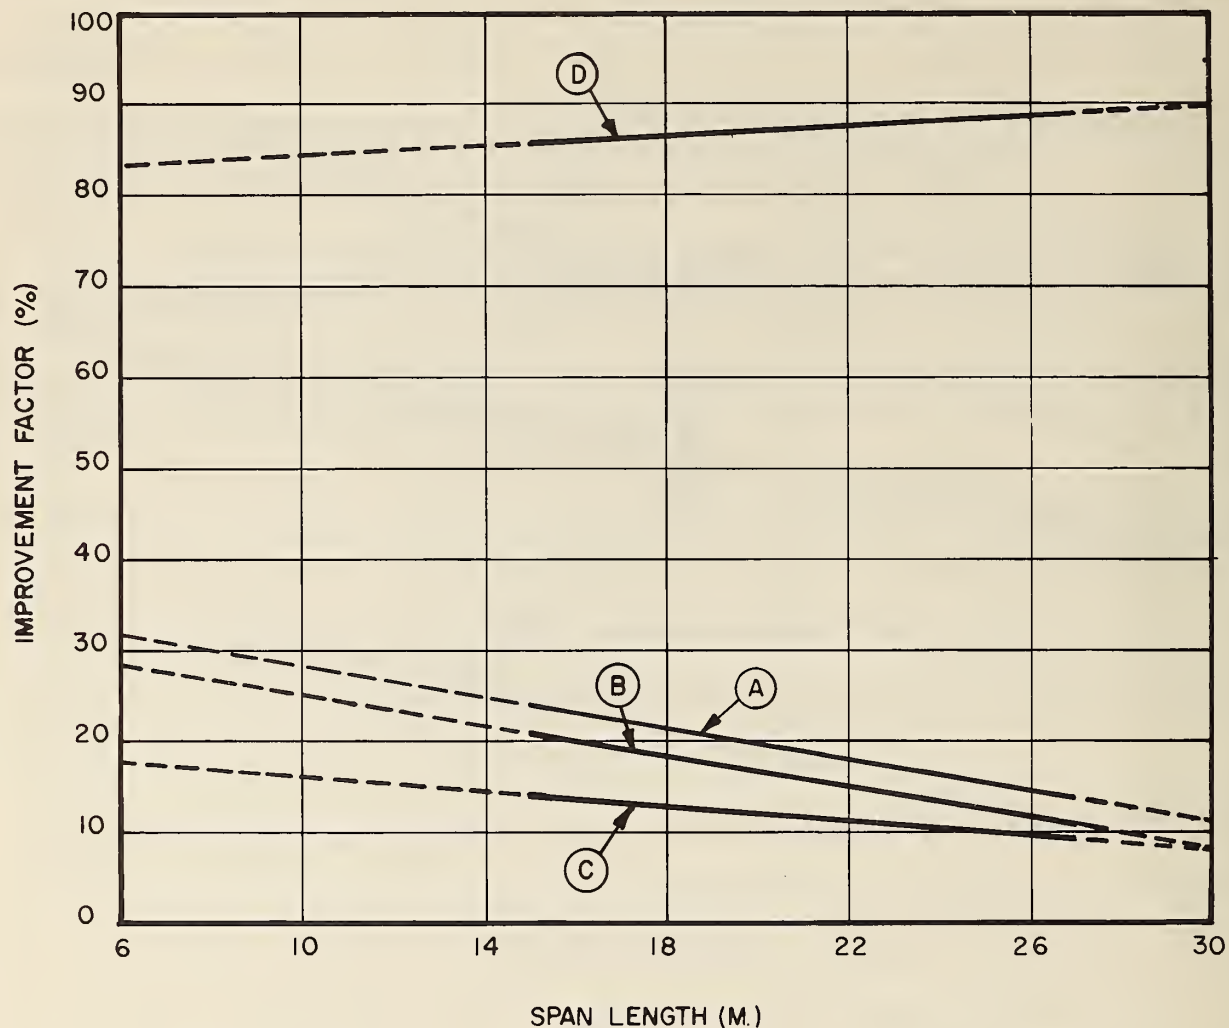
COST PER SQ. M.	
A	\$ 50
B	\$ 195
C	\$ 175
D	\$ 420

- A. KINGPOST TRUSS MODIFICATION.
- B. COMPOSITE ACTION-STEEL BEAM/CONCRETE DECK.
- C. CONTINUOUS MULTIPLE STEEL BEAM OR GIRDER.
- D. SUPPLEMENTAL FULL DEPTH STRINGERS W/LIGHT WEIGHT DECK.

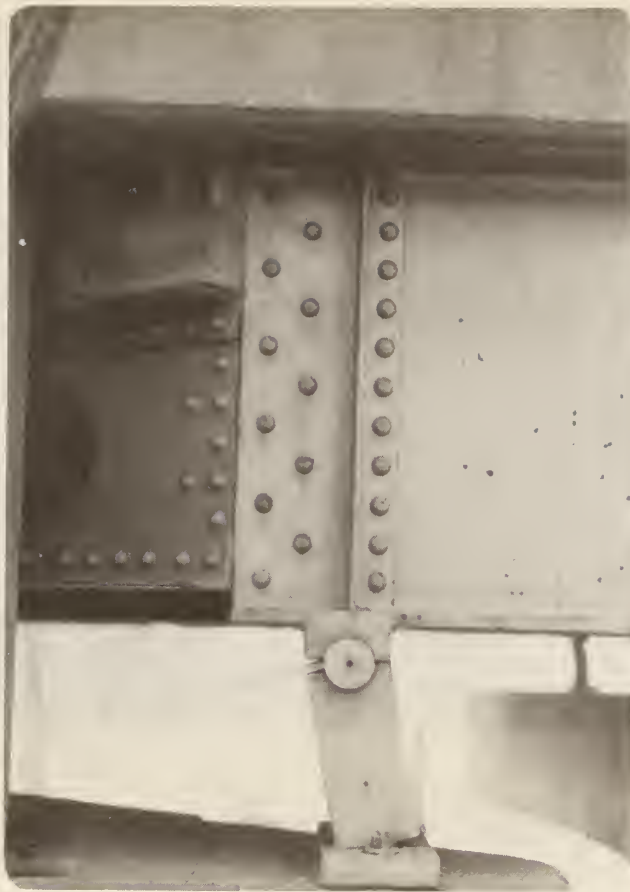
Steel Girder Bearing  
Severe Rocker Lean

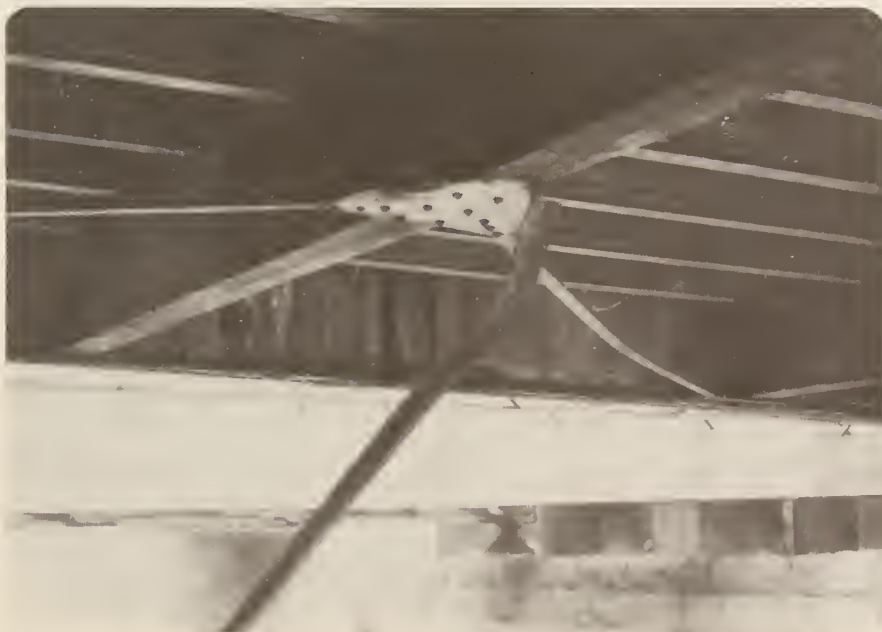
Steel Lateral Bracing  
Severed Member

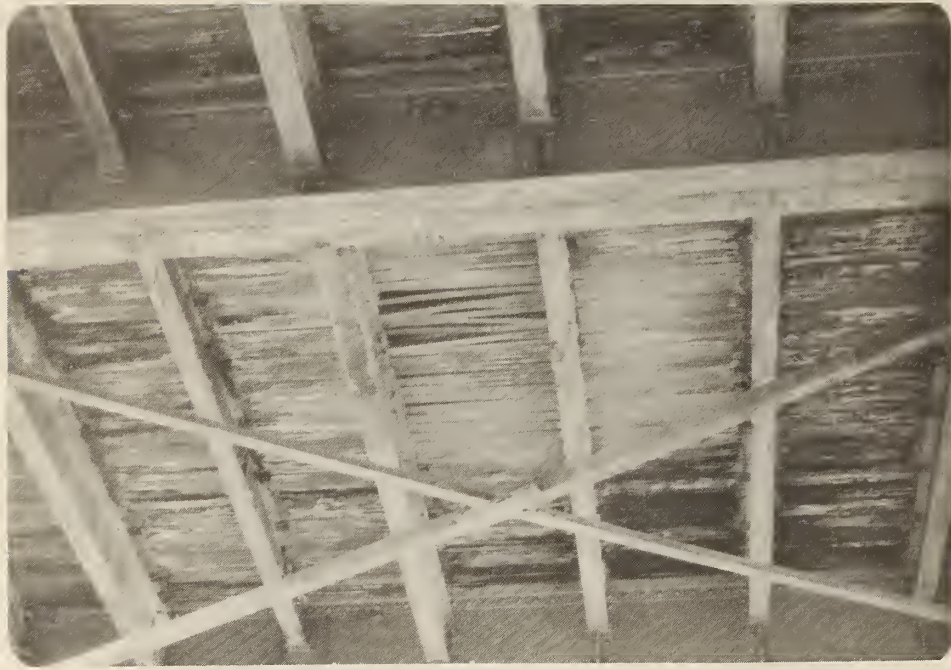
Timber Deck  
Timber Deterioration

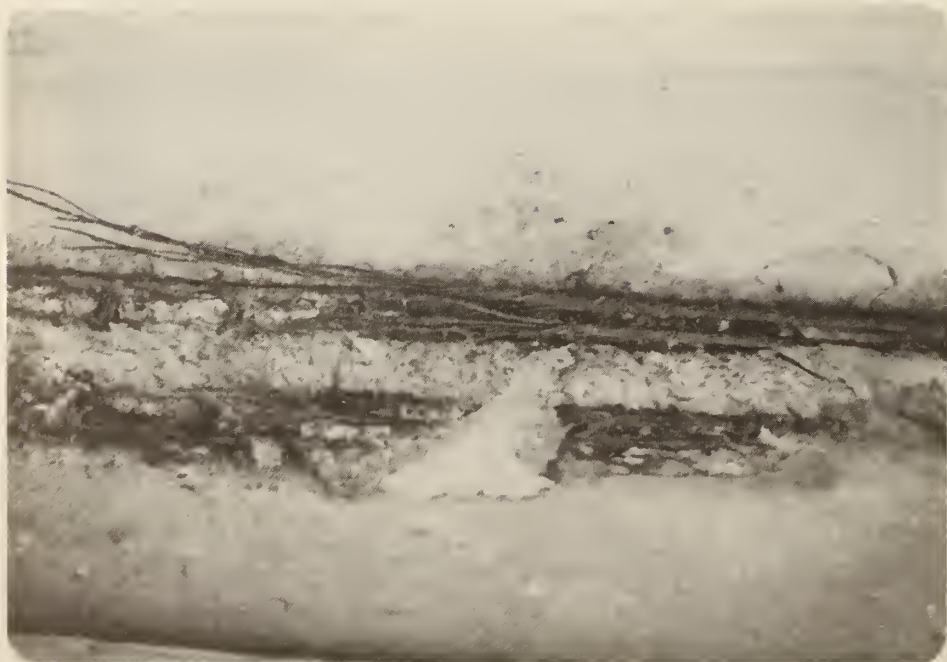
Prestressed Concrete Beam  
Concrete Spall-Broken Strands

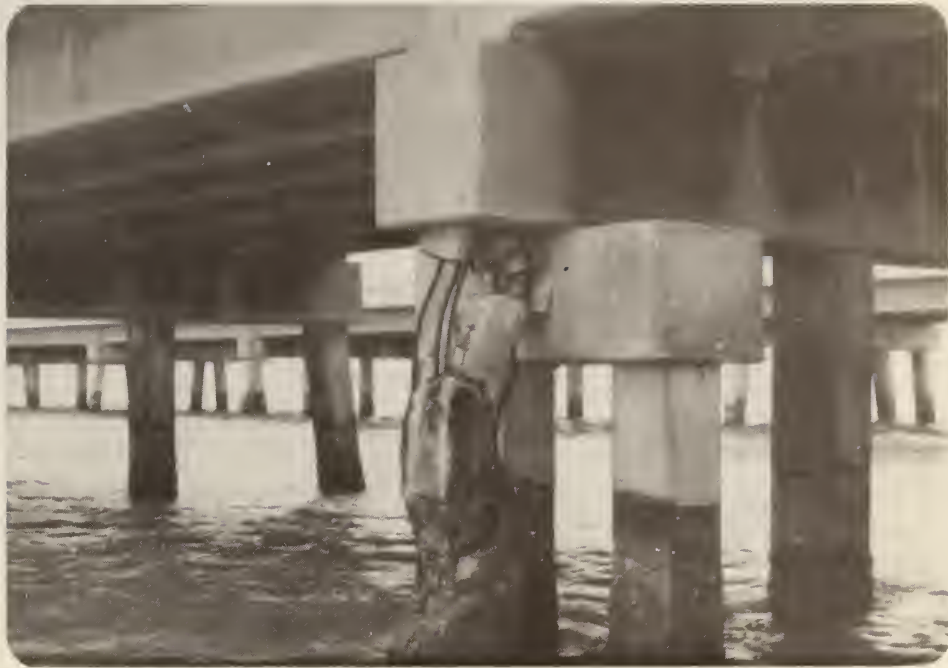
Concrete Pile Deterioration  
(Note "Crutch Bent" installed to replace pile)

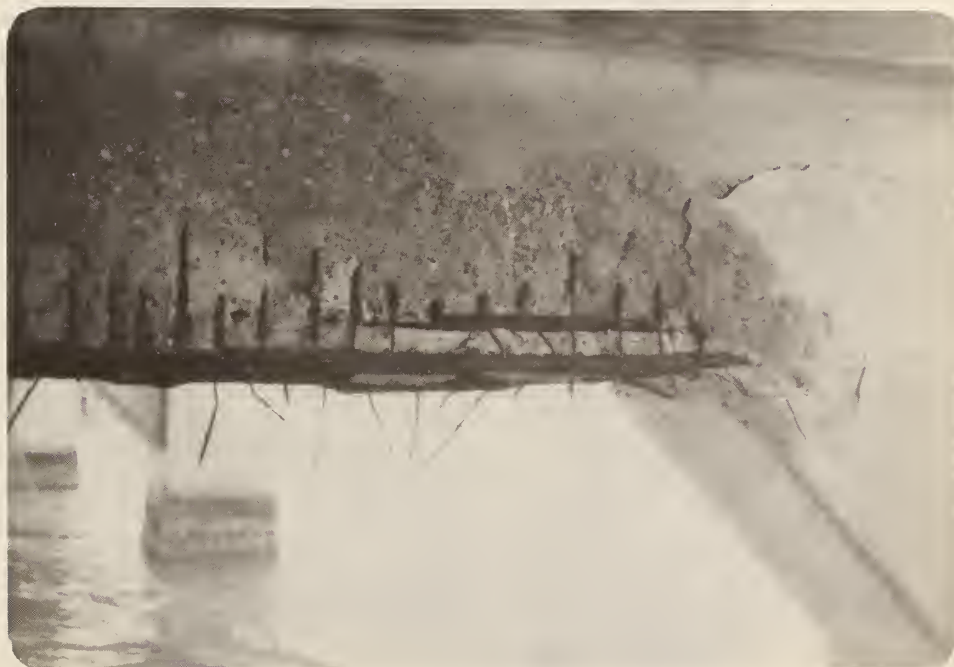
Concrete Pier Cap  
Exposed Re-bars and deteriorated concrete

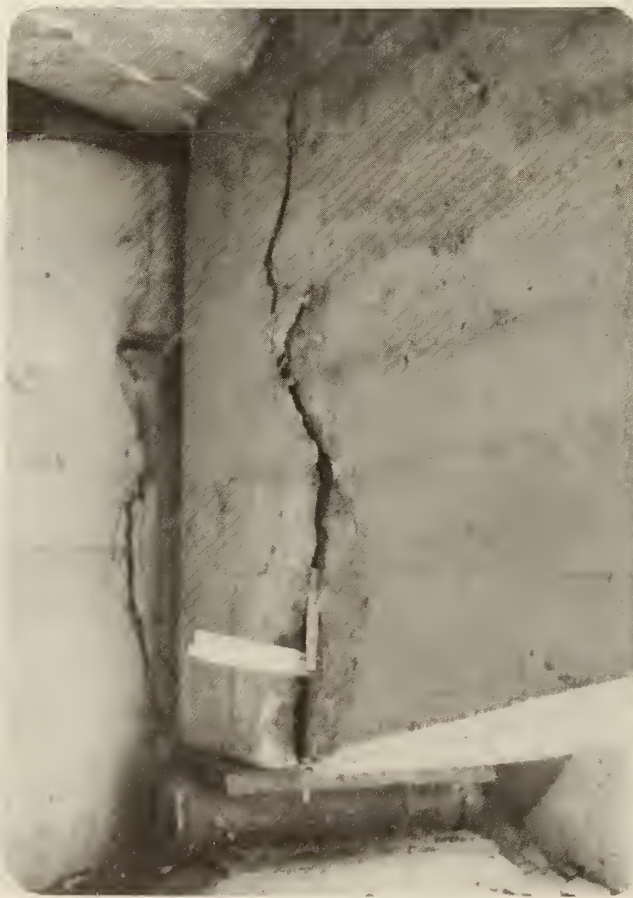
Concrete Beam  
Cracked Web at Bearing

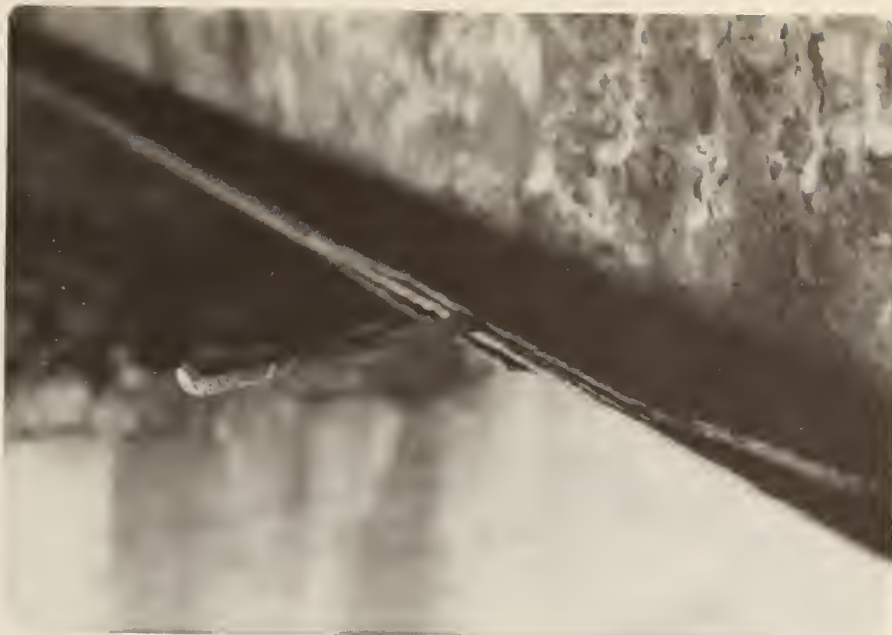
Steel Multiple Beam Bridge  
Flange and Web Corrosion

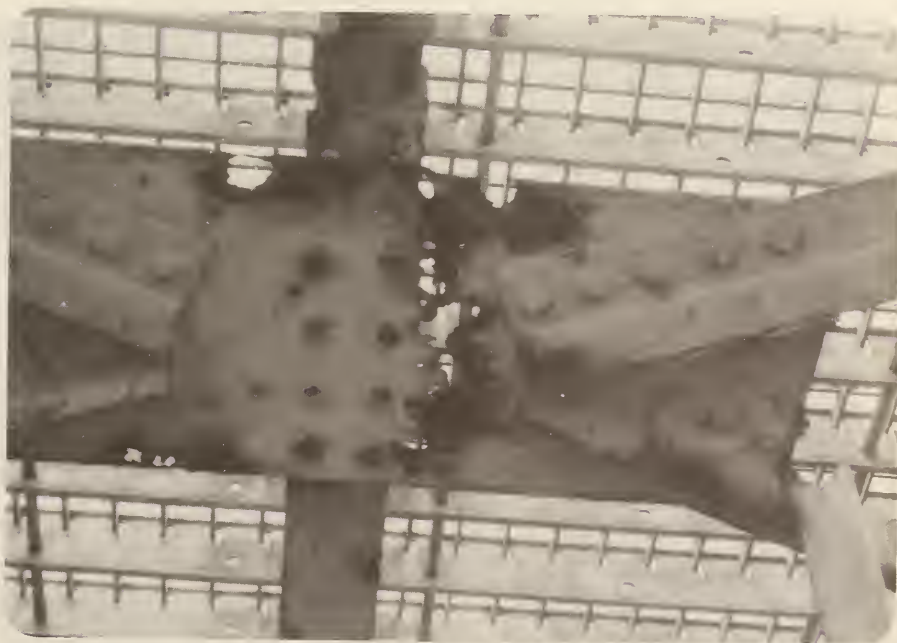
Steel Bracing  
Gusset Plate Corrosion

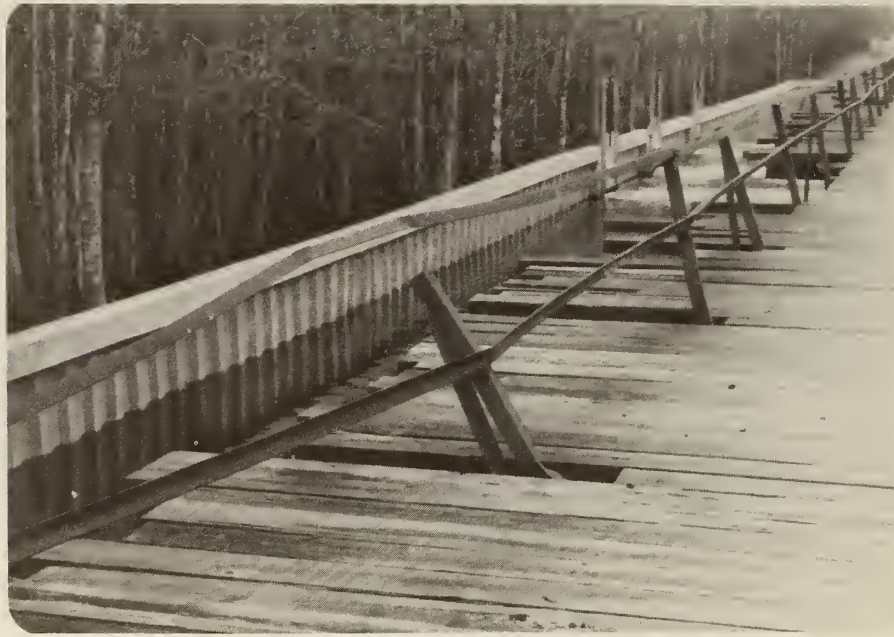
Steel Guardrail  
Inadequate

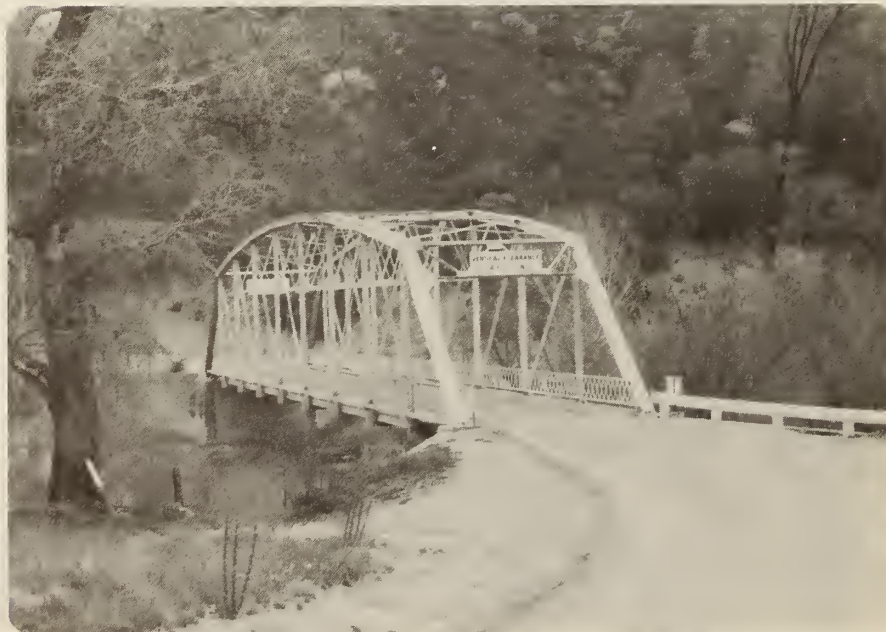
Inadequate Roadway Width  
2-lane Approaches, 1-lane Bridge

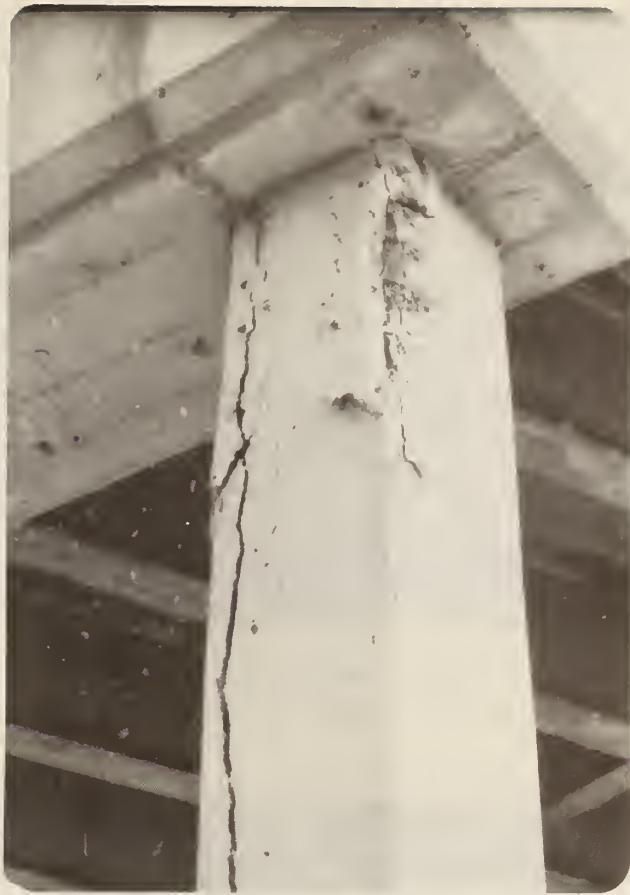
Concrete Pile  
Longitudinal Cracks

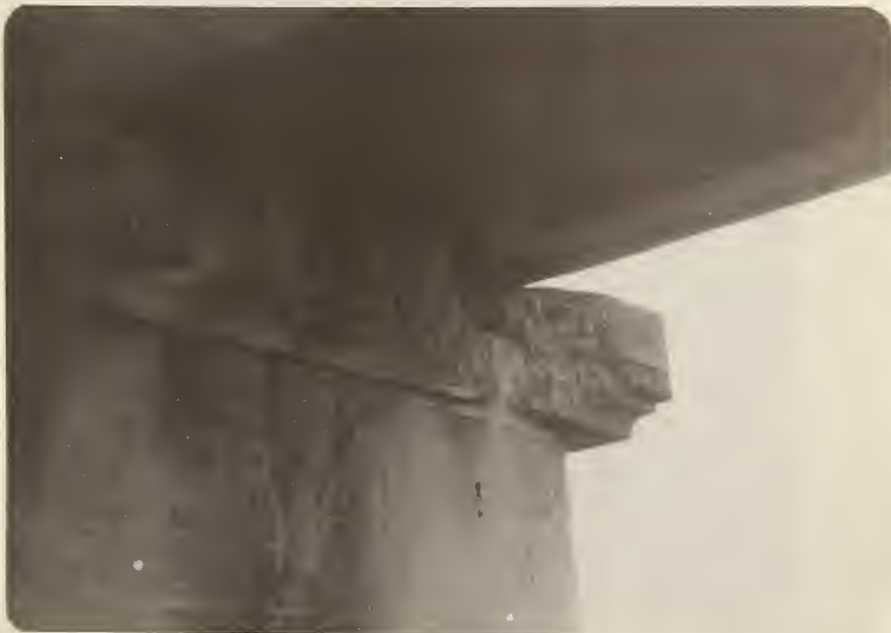
Solid Wall Concrete Pier  
Bearing Seat Deterioration

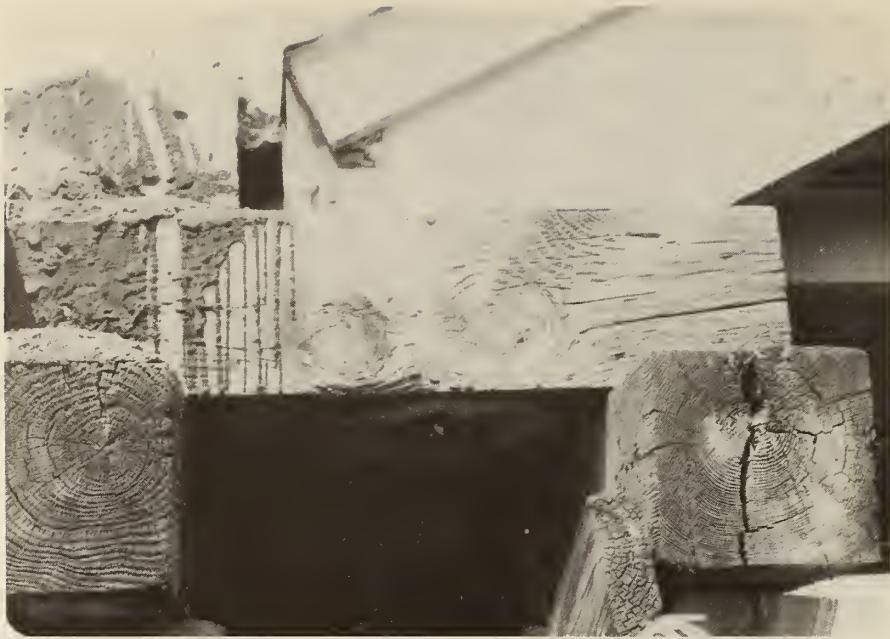
Timber Pile Cap  
Cap Weathering-Splits, Cracks

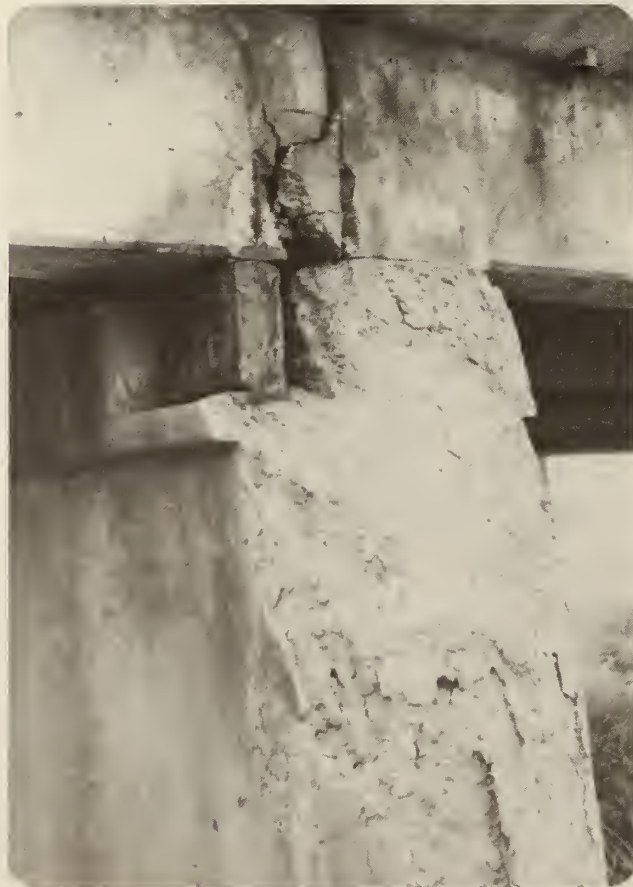
Solid Wall Concrete Pier  
Pier Nose Deterioration

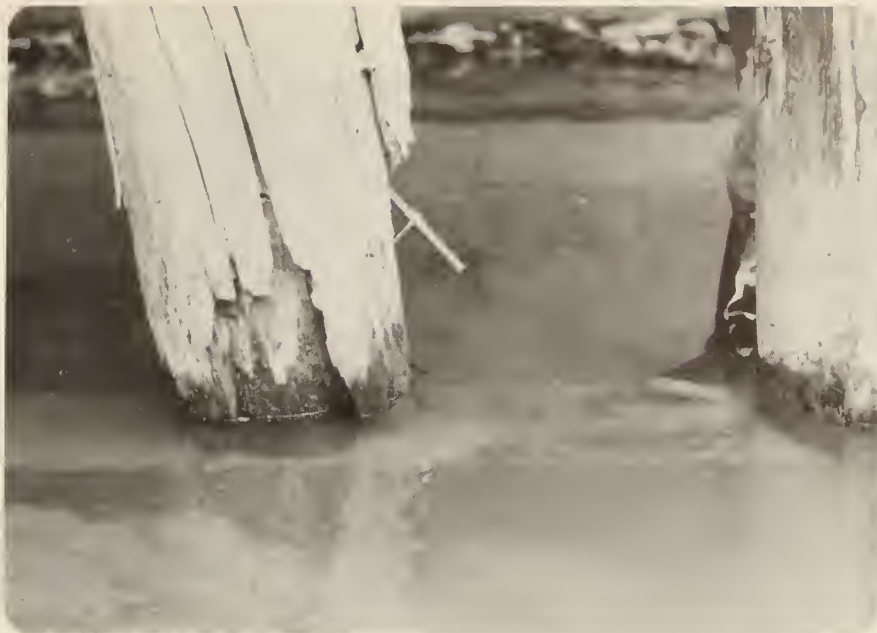
Timber Pile  
Decay - Rot

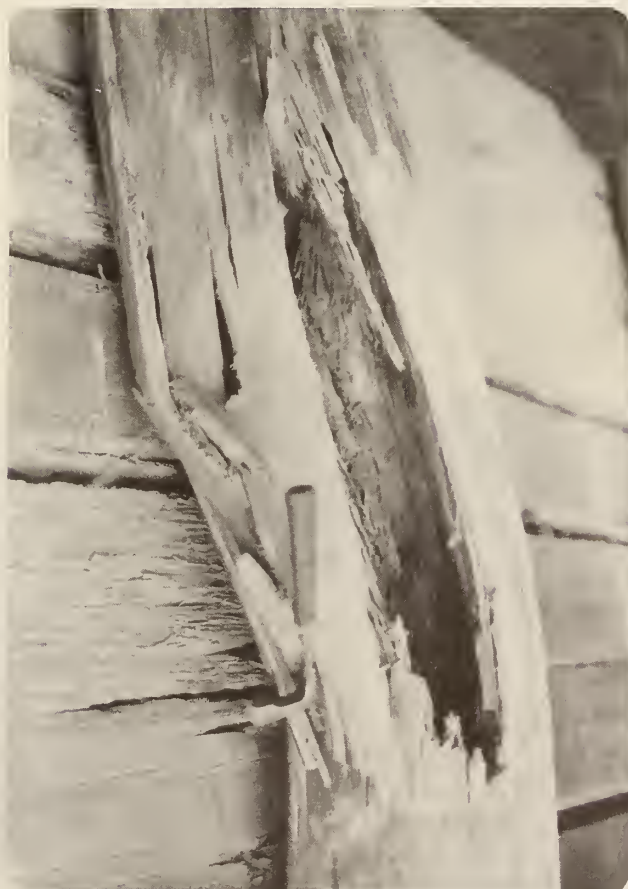
Timber Abutment Bulkhead  
Decay - Rot

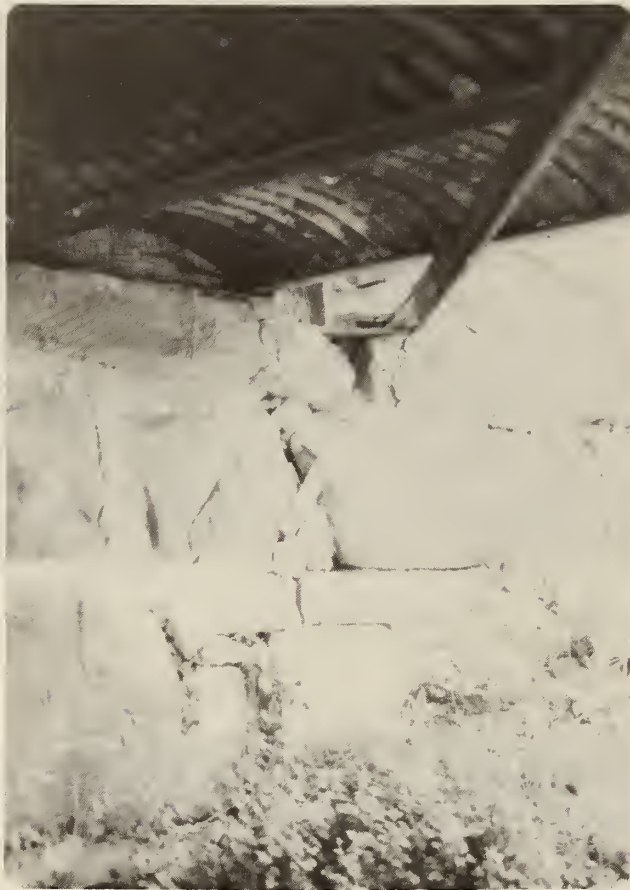
Masonry Abutment  
Mortar Deterioration

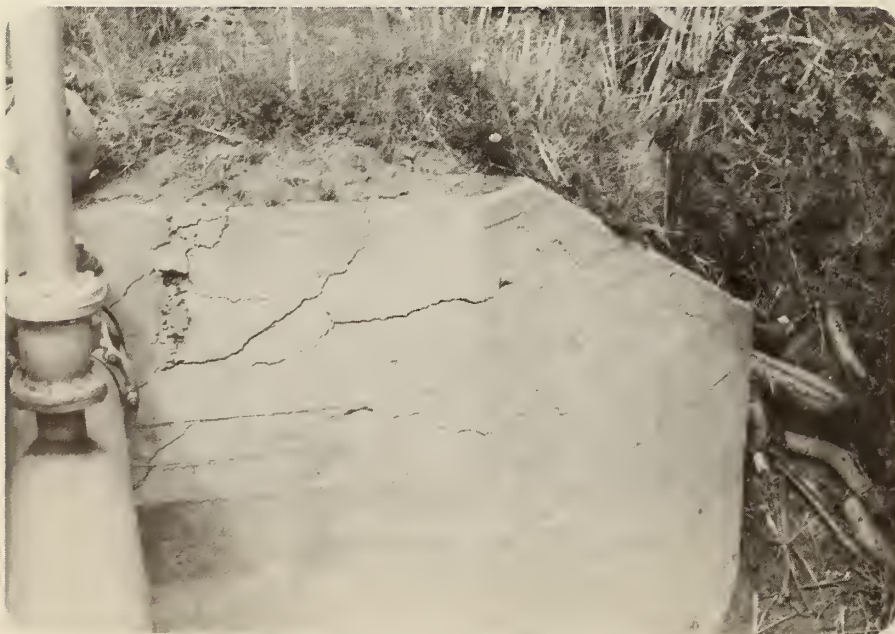
Full Height Concrete Abutment  
Cracking and Surface Spall

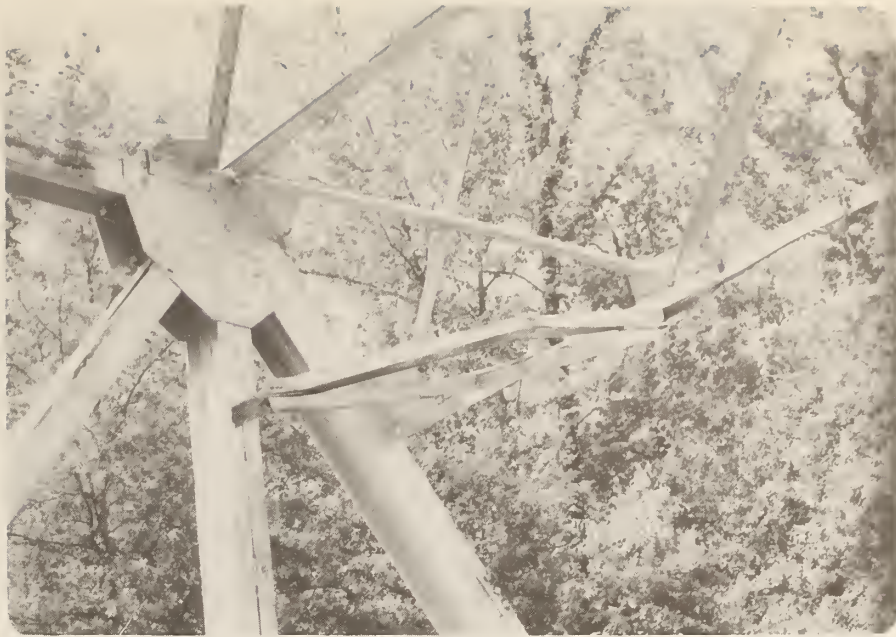
Steel Thru Truss  
Collision Damage - Portal

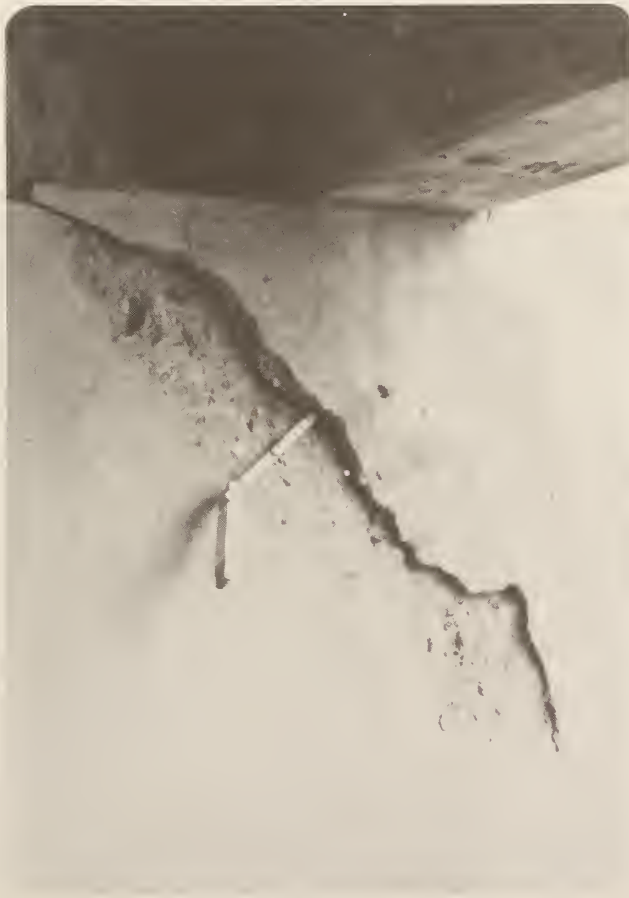
Concrete Stub Abutment  
Cracking and Surface Spall

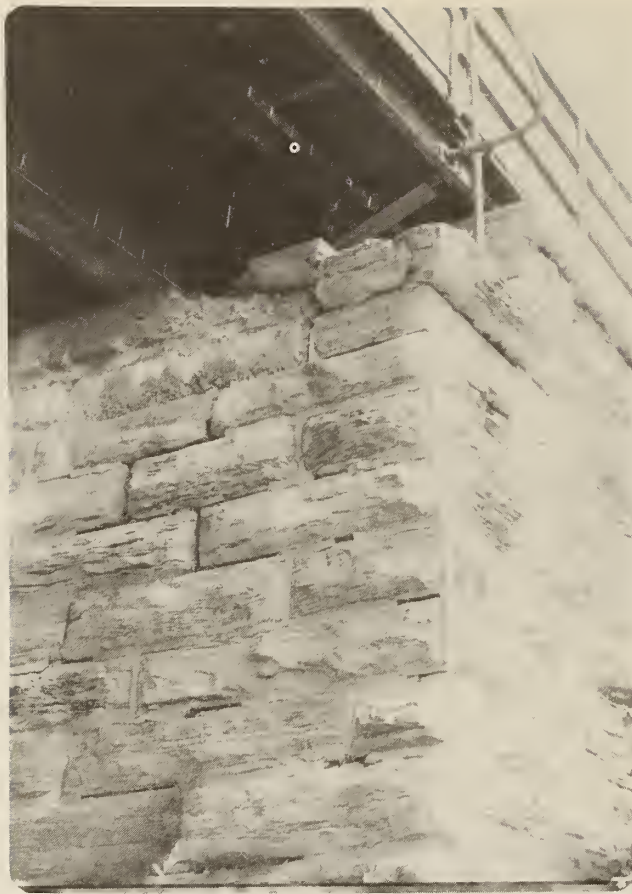
Masonry Abutment  
Bearing Seat Deterioration
