t No. FHWA-RD-78-133

# ENDING THE SERVICE LIFE OF EXISTING BRIDGES BY INCREASING THEIR LOAD CARRYING CAPACITY

Final Report

Prepared for  
FEDERAL HIGHWAY ADMINISTRATION  
Offices of Research & Development  
Washington, D. C. 20590

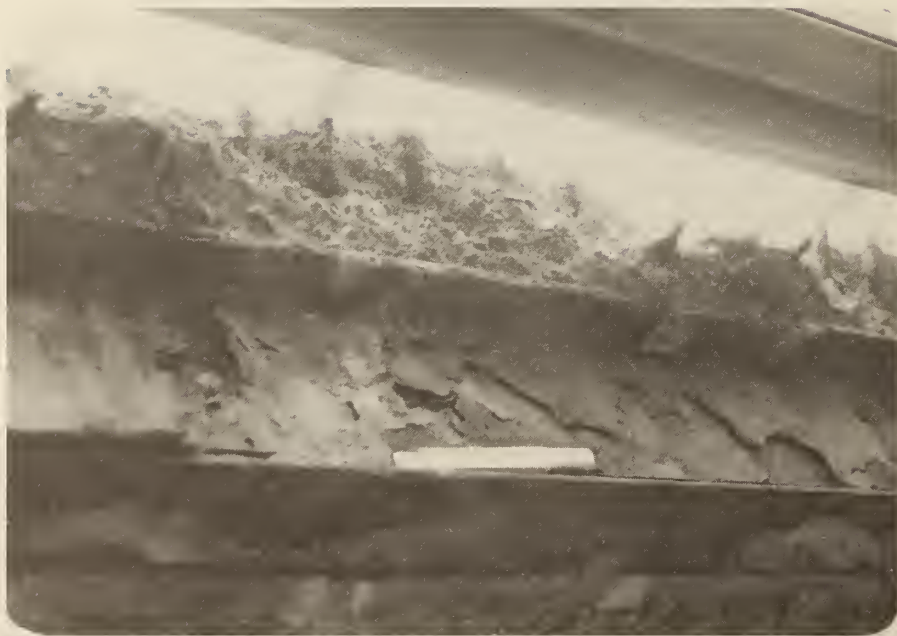
Steel Truss  
Fascia Stringer Corrosion - Flange and Web

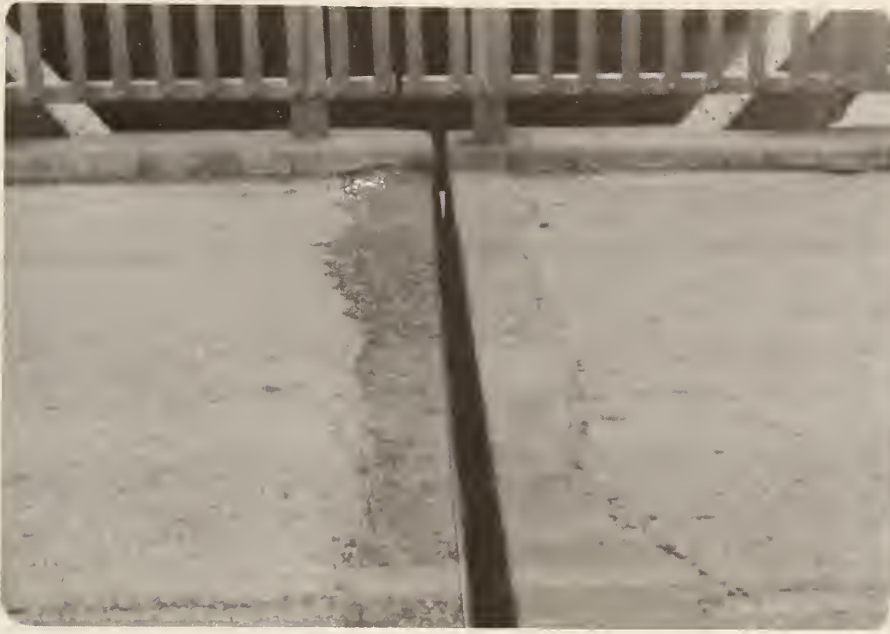
Deck Joint - Open  
Steel Floor System Exposed to Surface Runoff

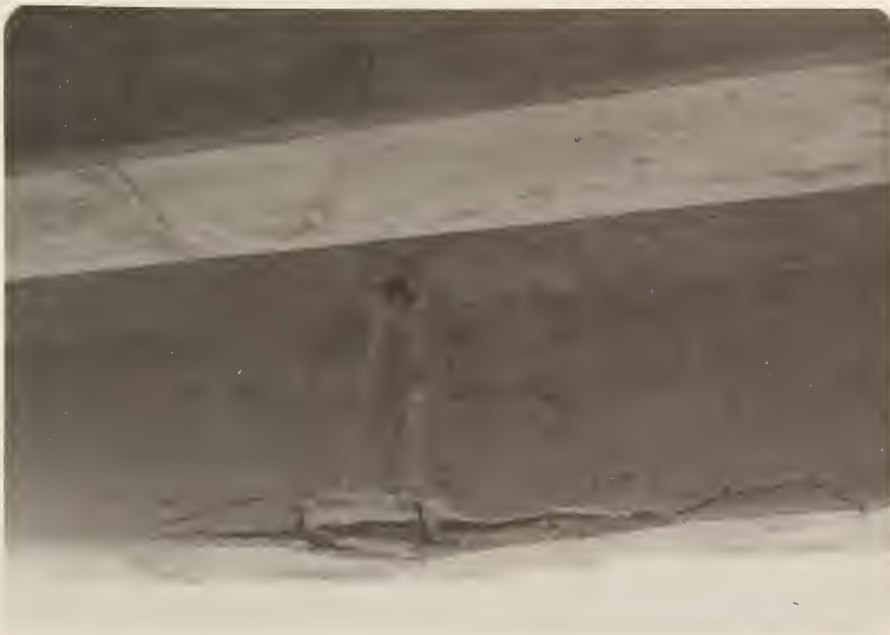
Scupper  
Drainage Discharge on Primary Members

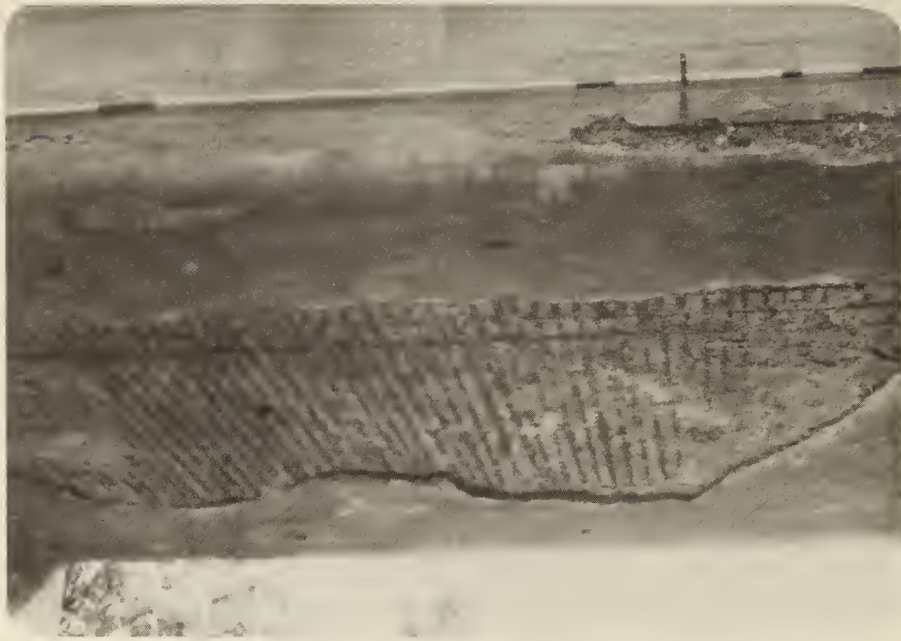
Concrete Slab Bridge  
Surface Spall-Rebar Exposure and Corrosion

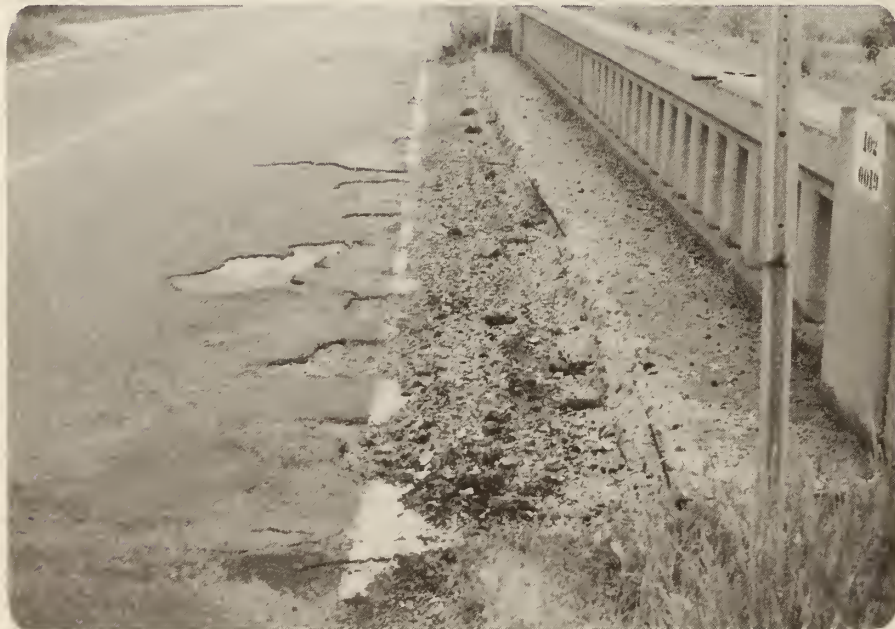
Reinforced Concrete Deck  
Wearing Surface Breakdown

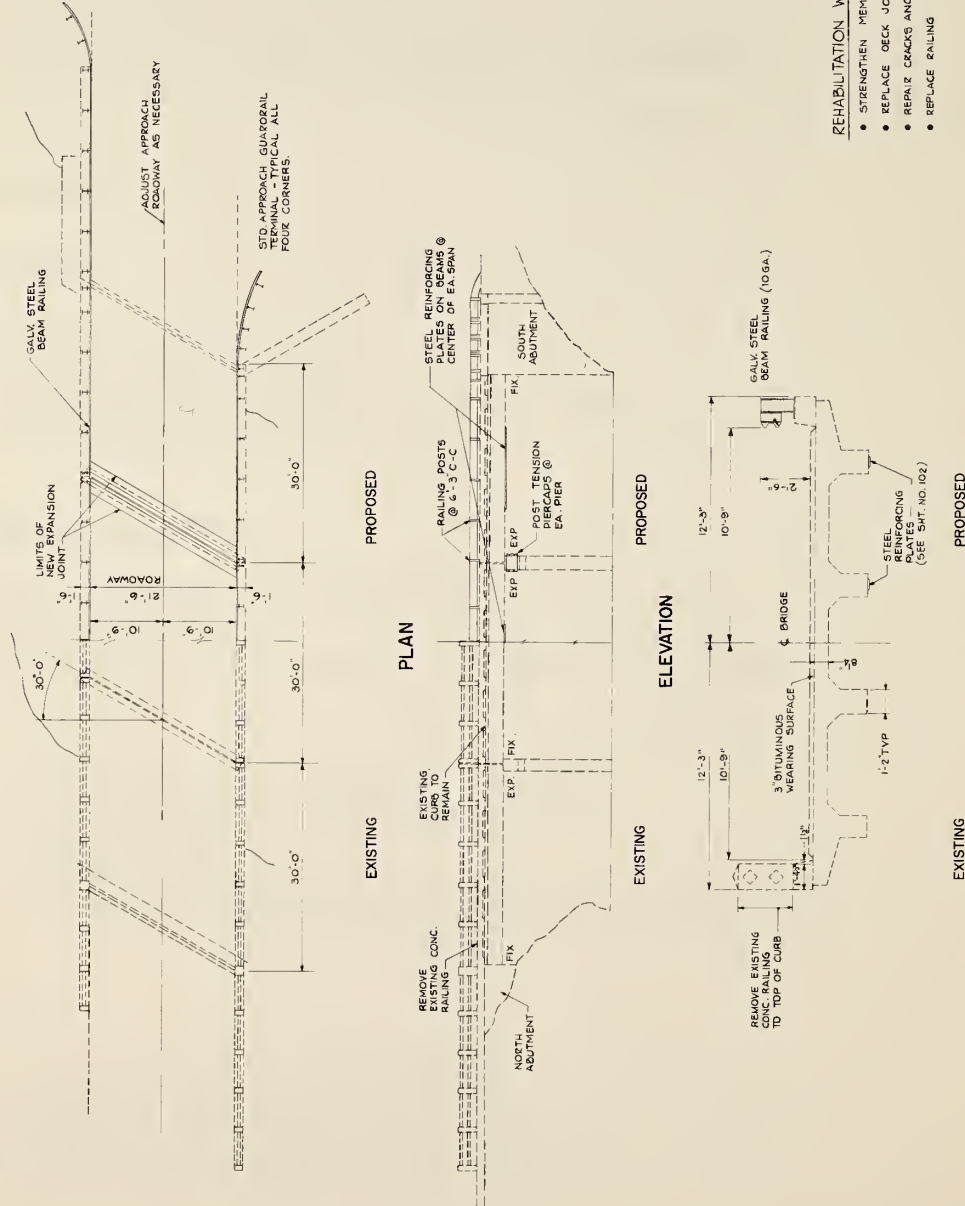
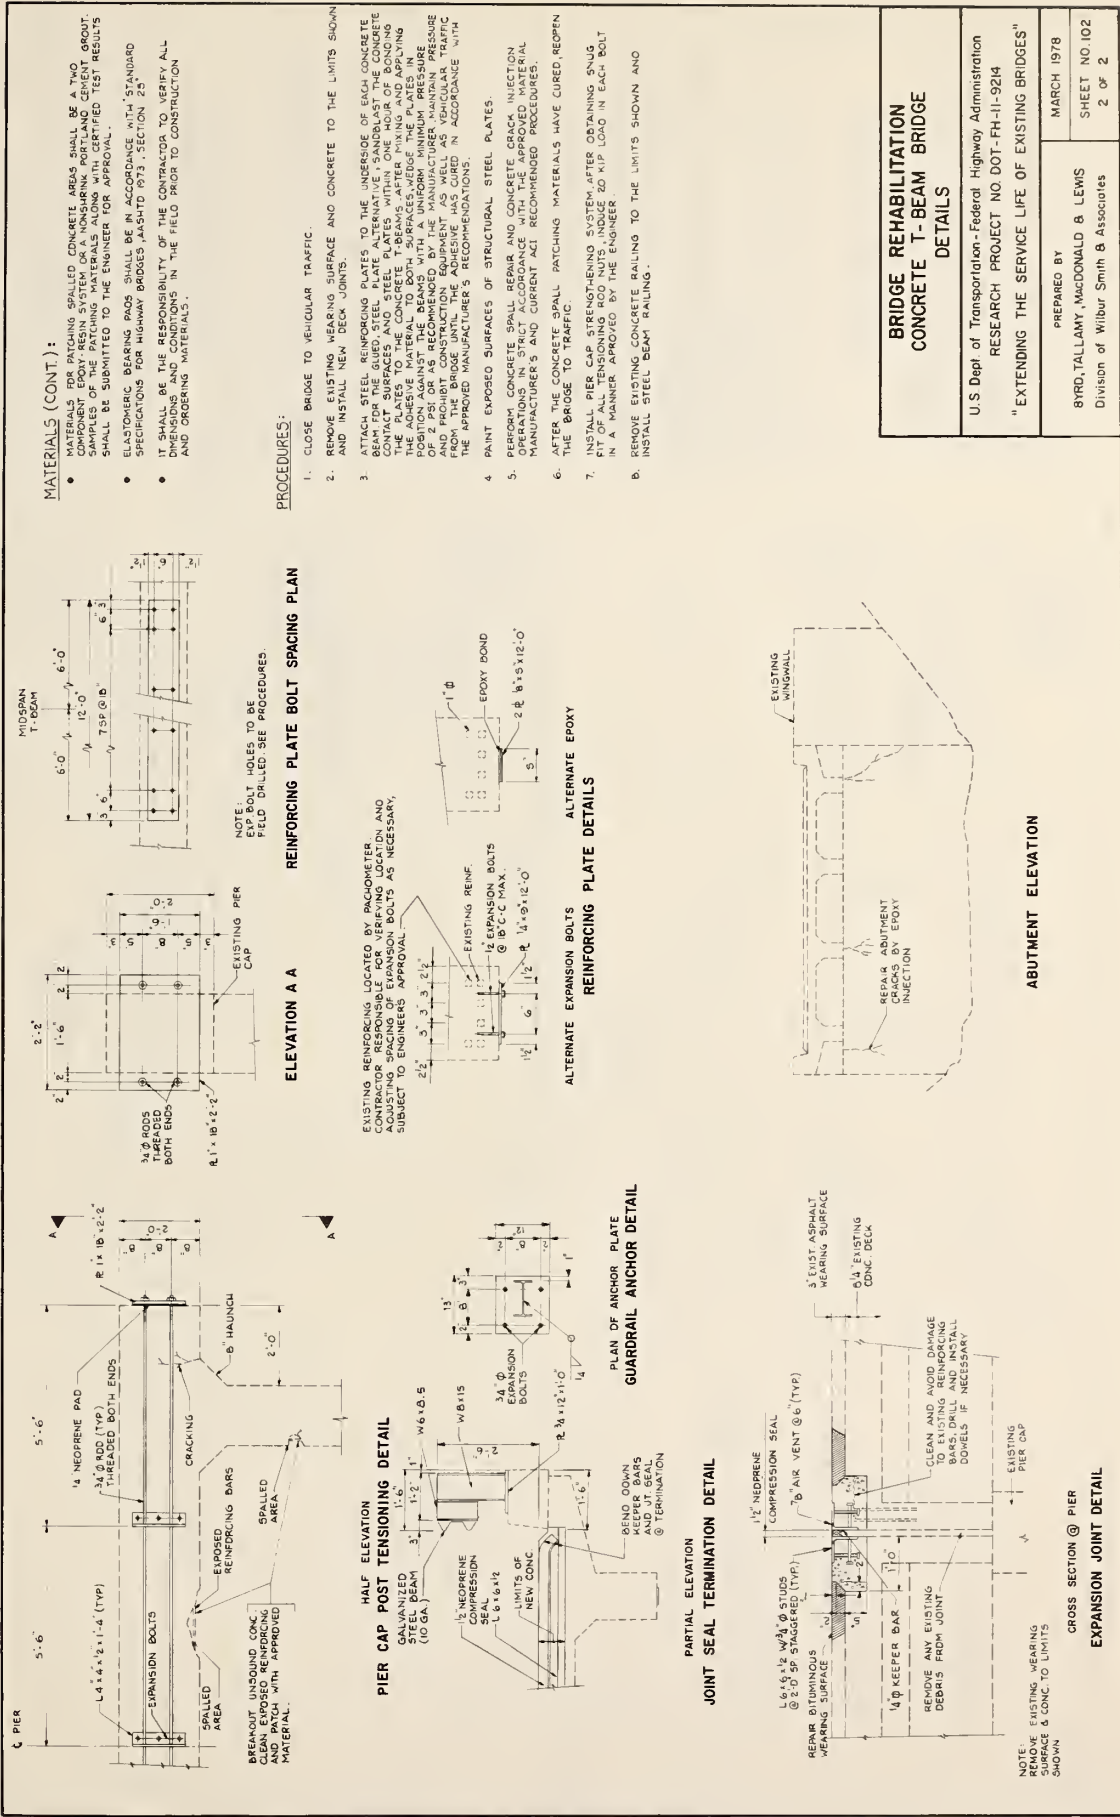
MARCH 1978  
SHEET NO. 201  
1 OF 3

REHABILITATION WORK:

- STRENGTHEN MEMBERS
- REPLACE CRACK JOINTS
- REPAIR CRACKS AND SPALLS
- REPLACE RAILING

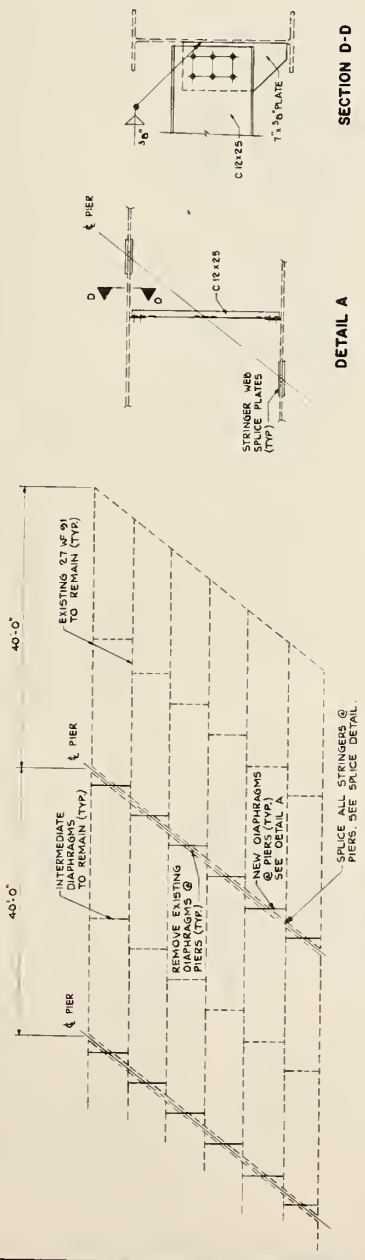
PARTIAL FRAMING PLAN

SECTION D-D

DETAIL A

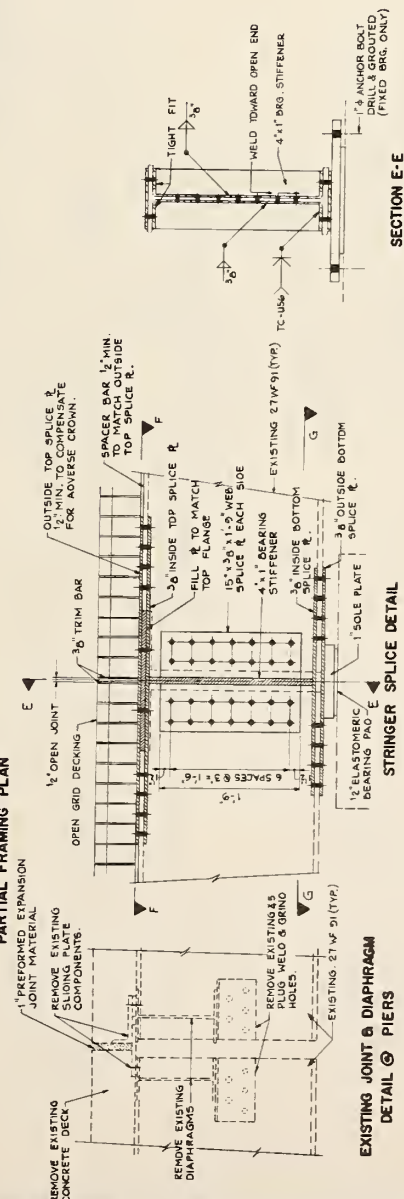
SECTION E-E

STRINGER SPlice DETAIL

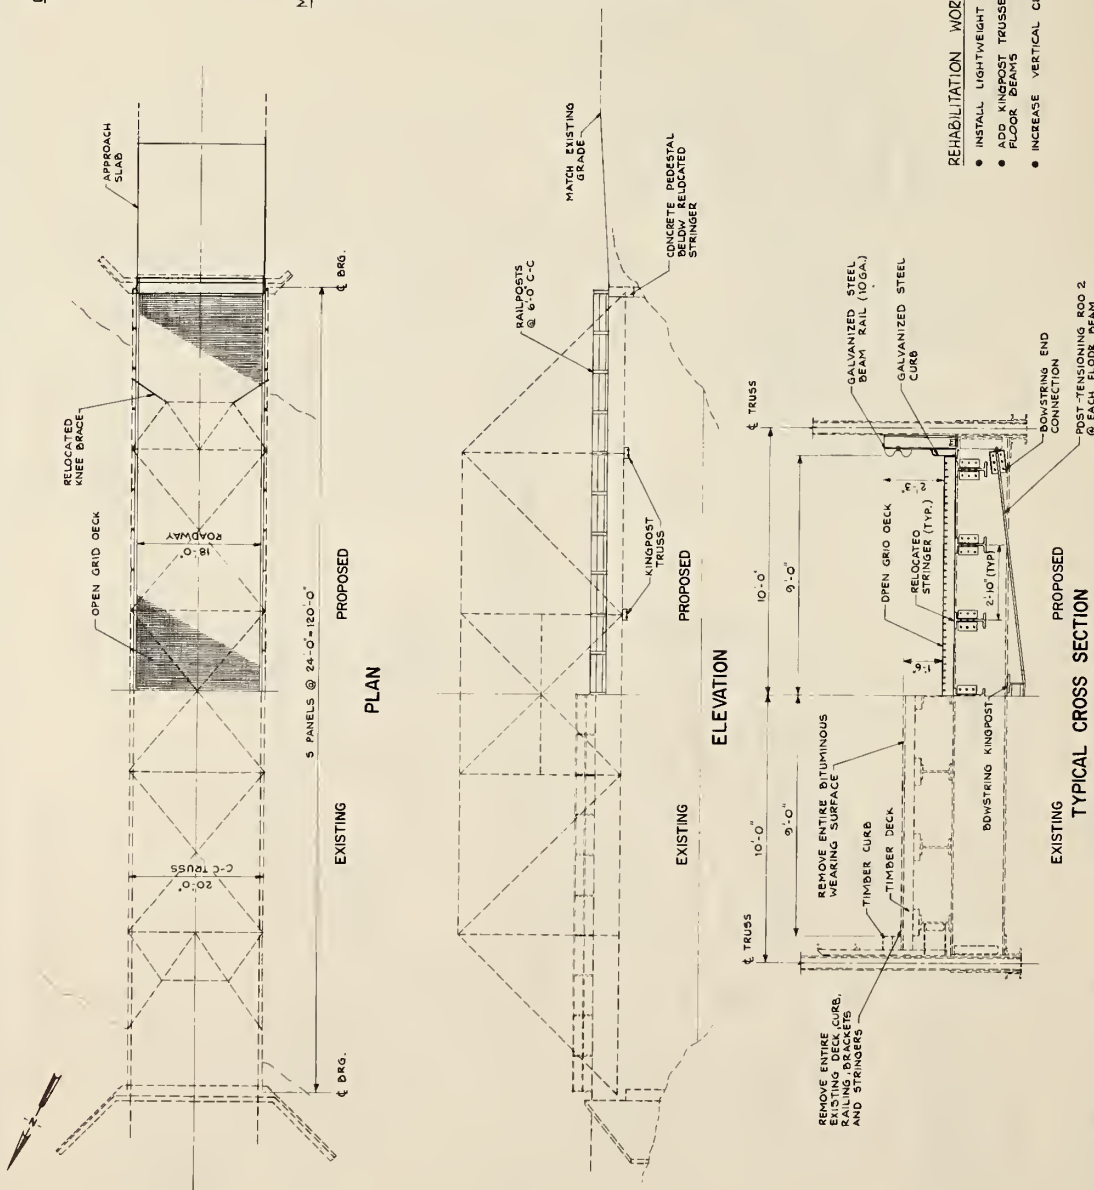
## REHABILITATION WORK :

- INSTALL LIGHTWEIGHT DECK
- ADD KINGPOST TRUSSES TO FLOOR BEAMS
- INCREASE VERTICAL CLEARANCE

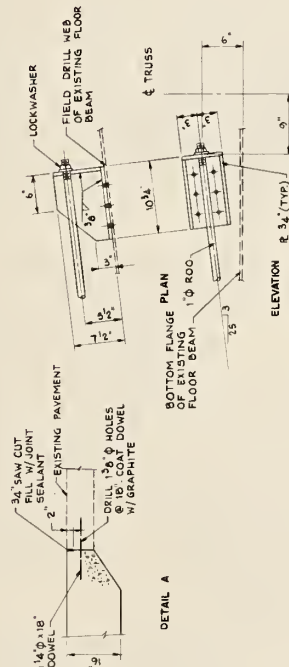
DETAIL A

BOWSTRING END CONNECTION DETAILS

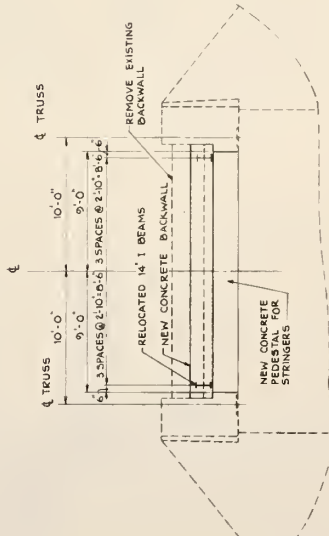
TYPICAL ABUTMENT ELEVATION

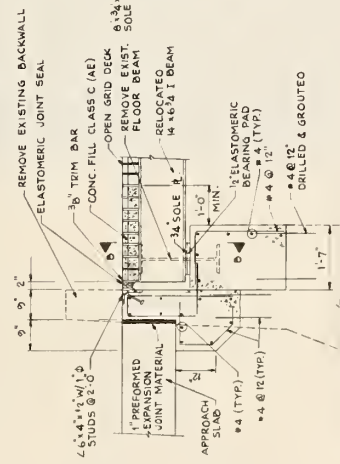
ABUTMENT JOINT & BACKWALL DETAIL

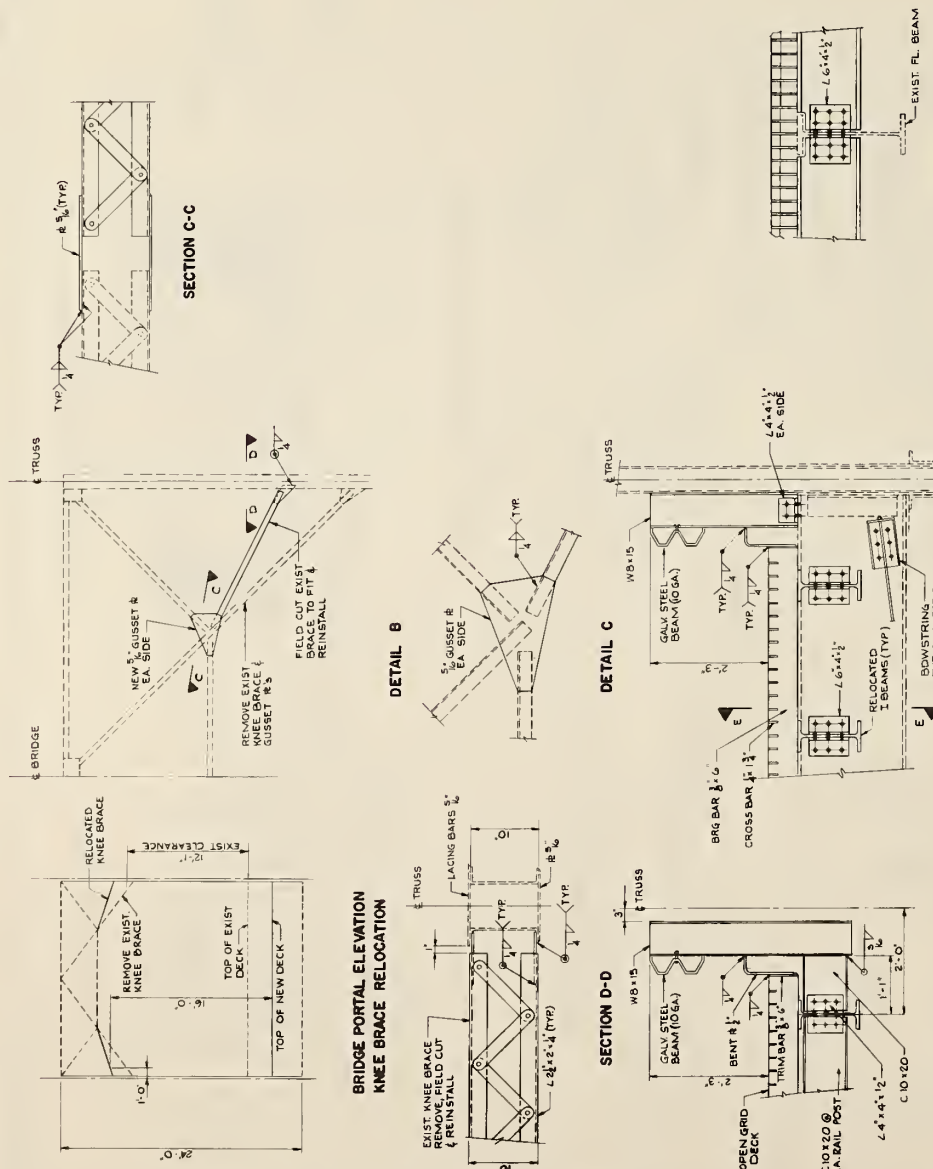
BRIDGE PORTAL ELEVATION  
KNEE BRACE RELOCATION

GUARDRAIL ANCHOR DETAILS
