DOT HS 808 217

Final Report

Final Report of a 1992 Plymouth Voyager into a 50% Left Offset Barrier in Support of CRASH3 Damage Algorithm Reformulation

The purpose of the five (5) 50% left offset barrier impact tests was for research and development in support of the CRASH3 damage algorithm reformulation.

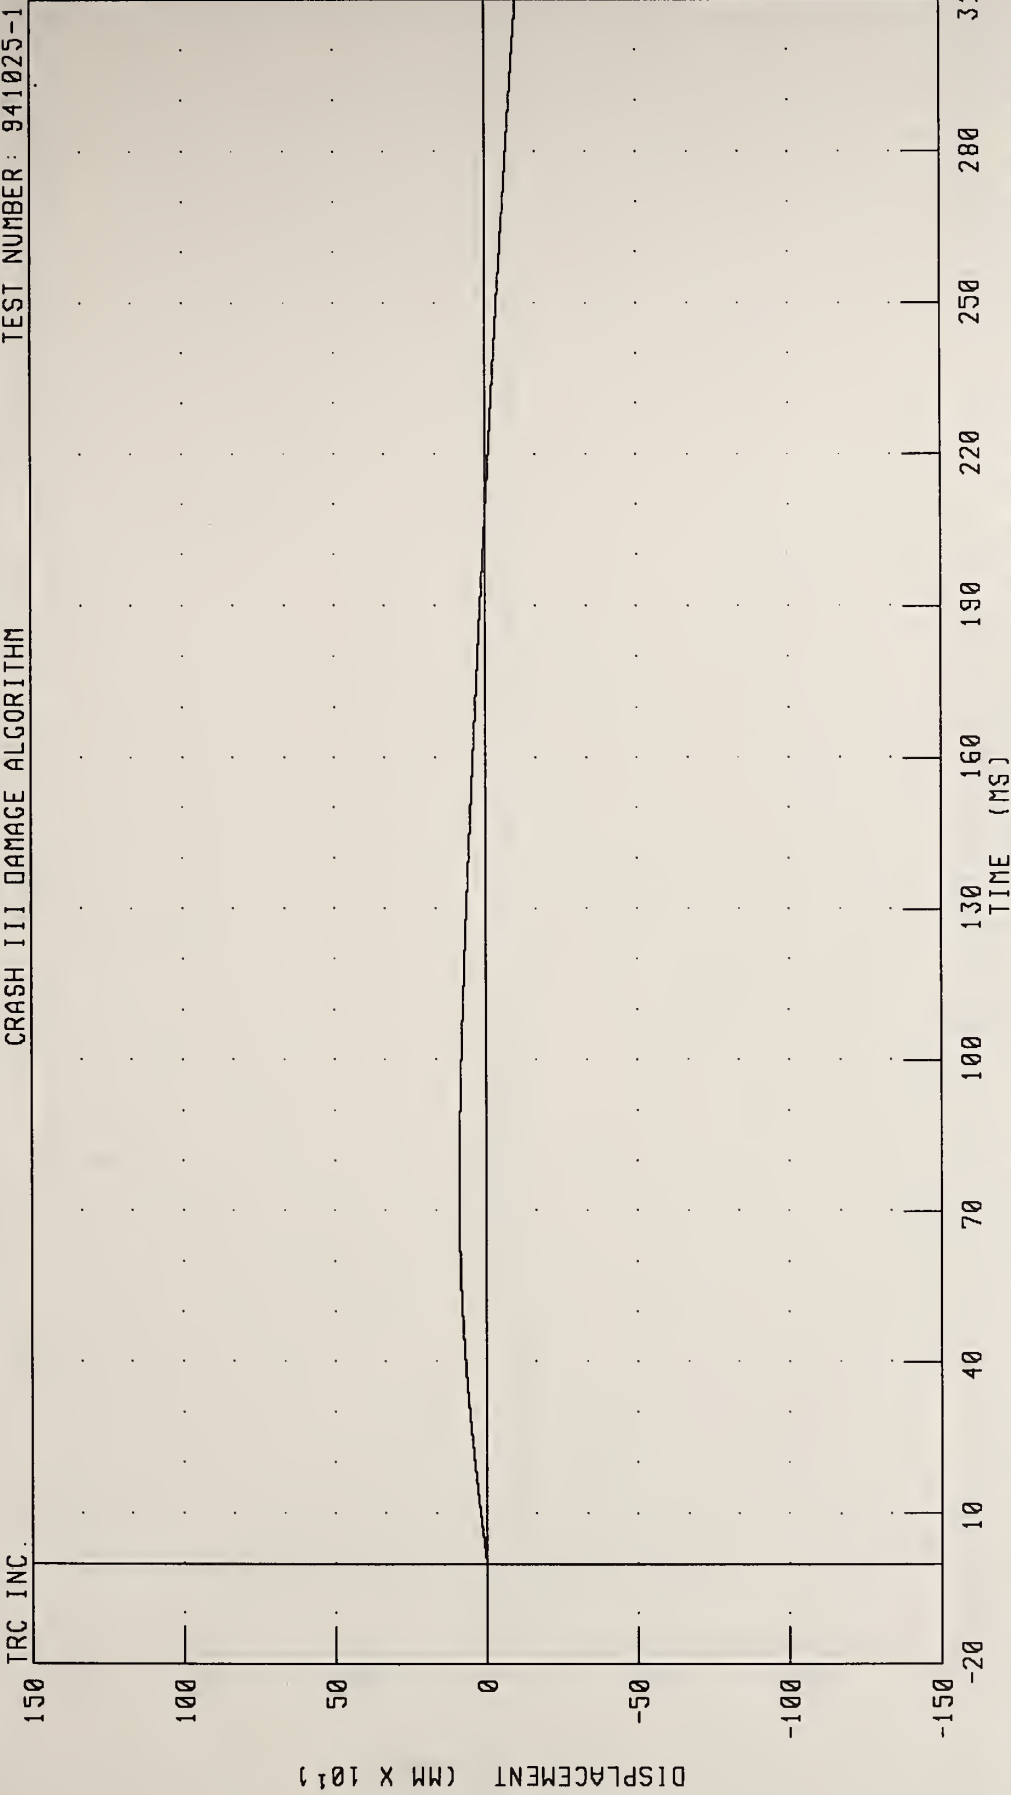
TEST NUMBER: 941025-1

CHANNEL: VCGXD FILTER: CH. CLASS 180

PEAK DATA: 89.88 MM @ 74.64 MS; -103.63 MM @ 310.00 MS

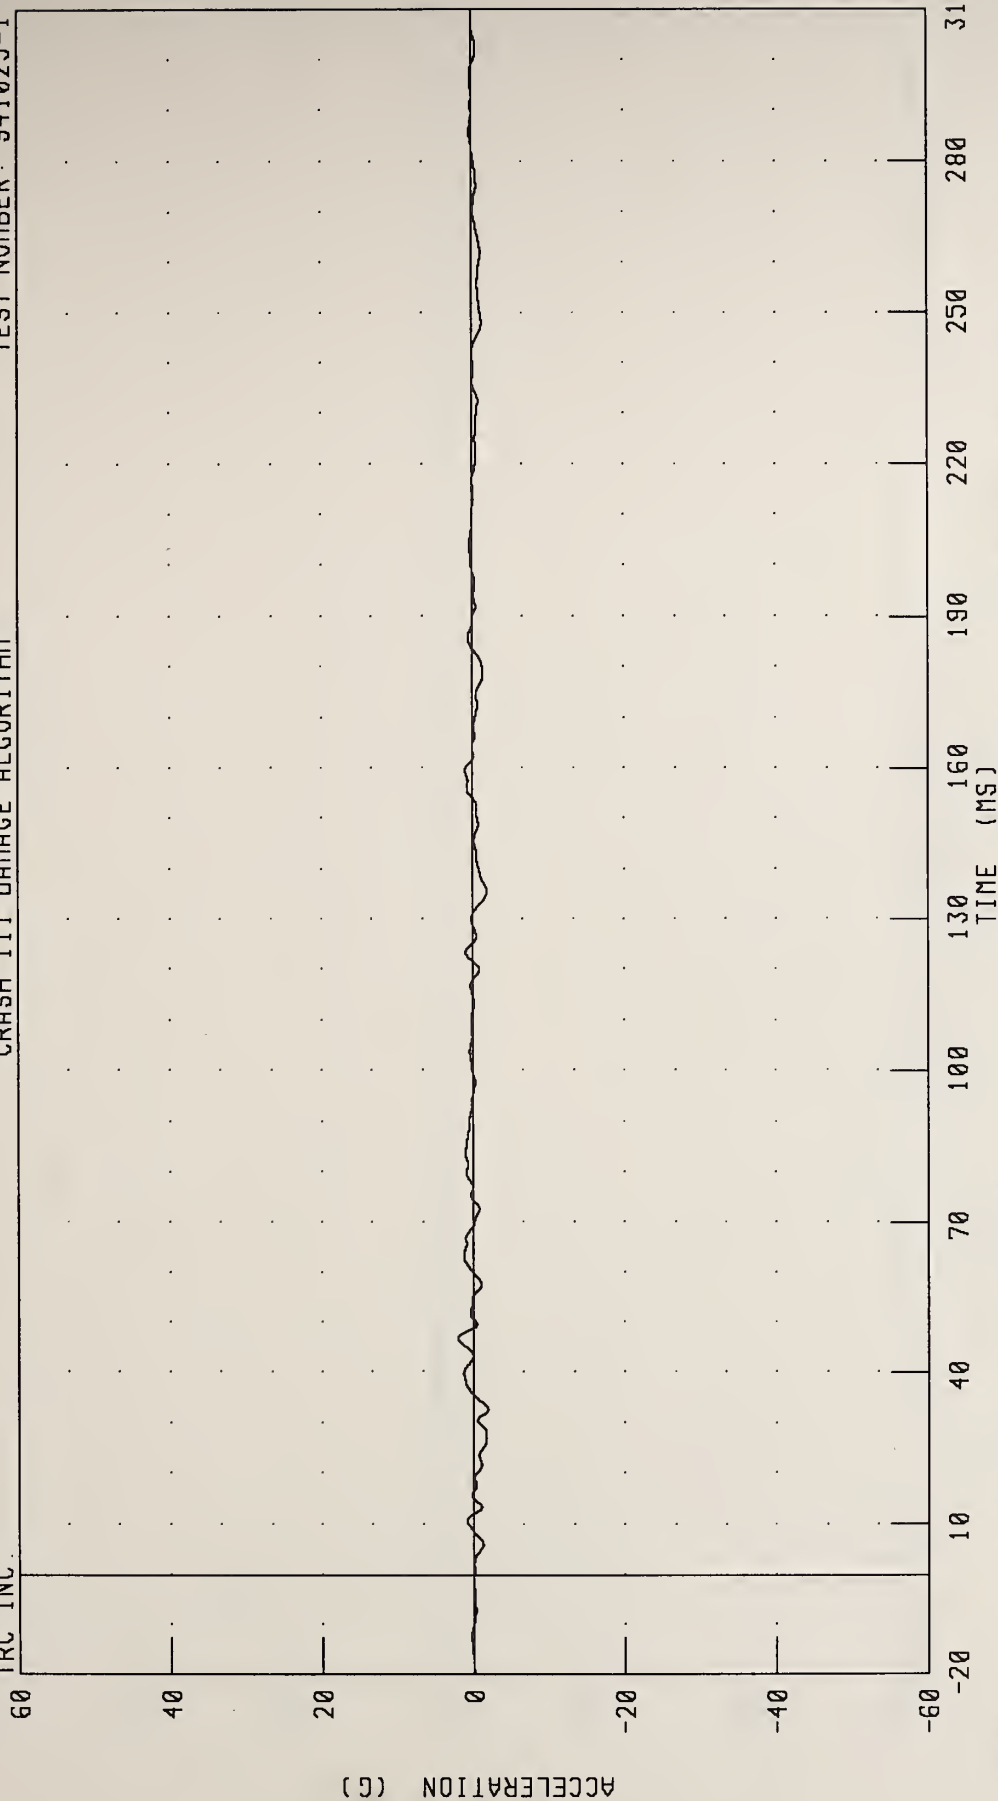
CHANNEL: VCGZG FILTER: CH. CLASS 60

PEAK DATA: 2.06 G @ 46.72 MS; -1.94 G @ 32.72 MS

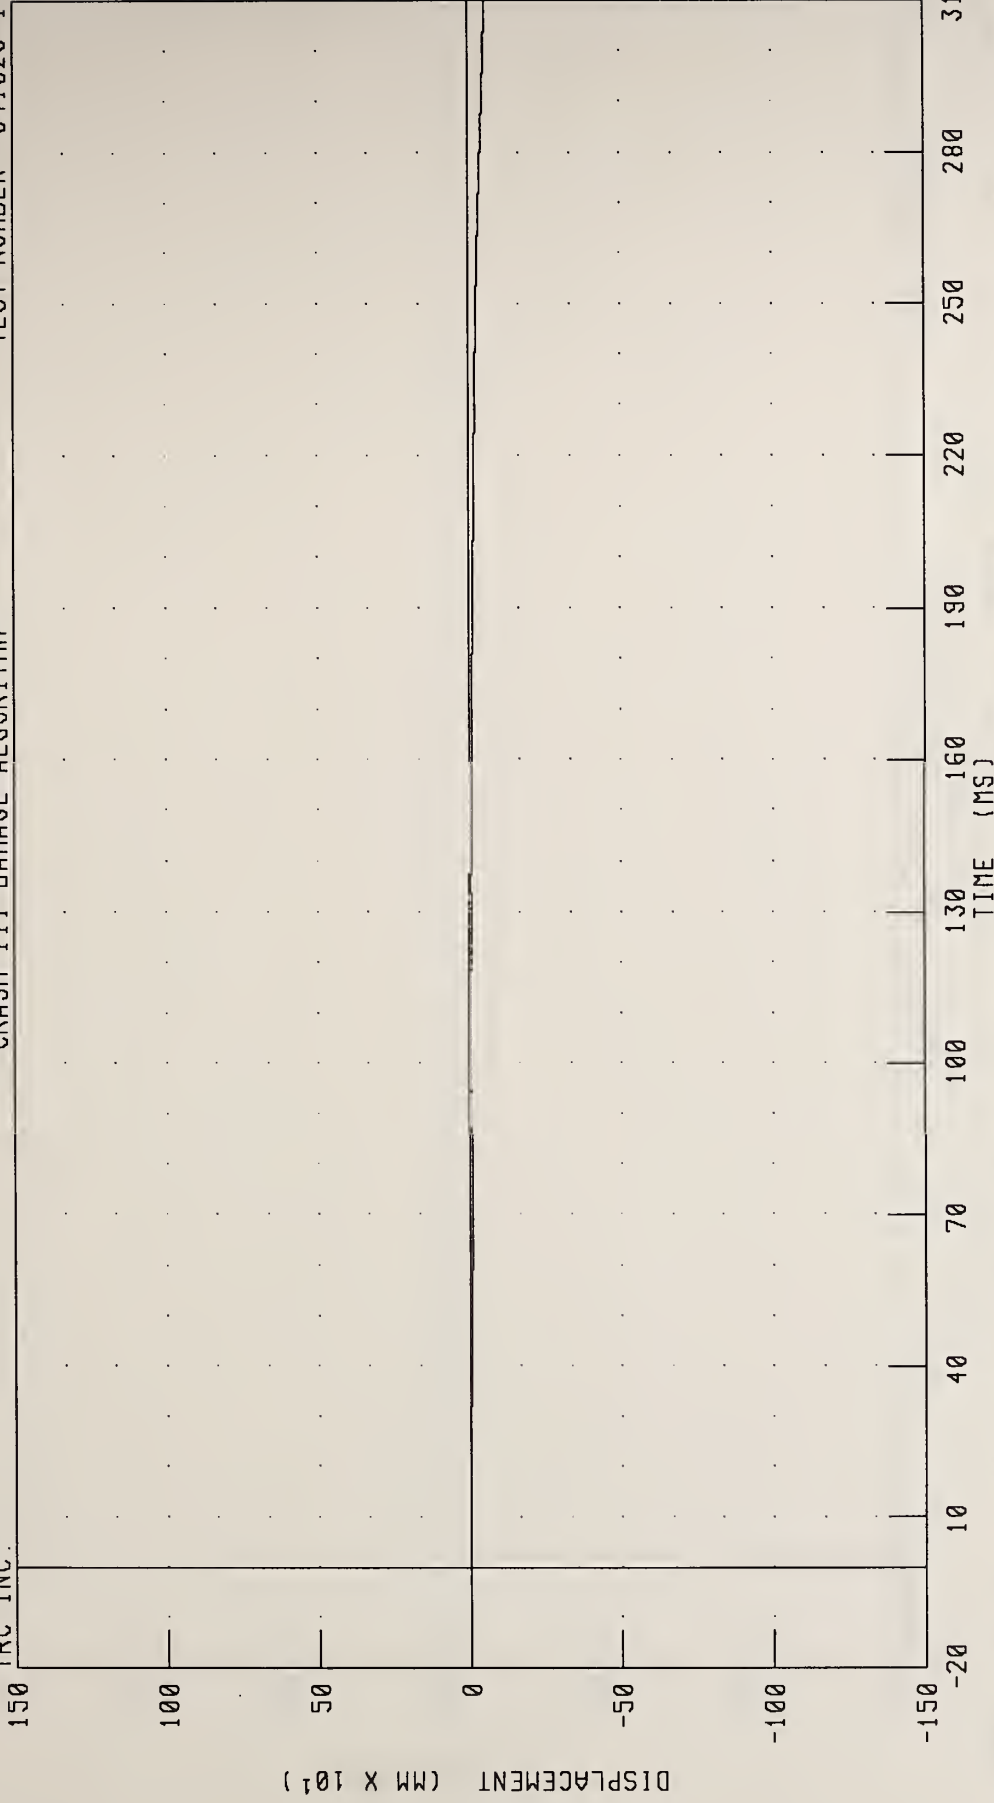
CRASH III DAMAGE ALGORITHM TEST NUMBER: 941025-1

CHANNEL: VCGZD FILTER: CH. CLASS 180

PEAK DATA: 0.00 MM @ 0.56 MS; -56.23 MM @ 310.00 MS

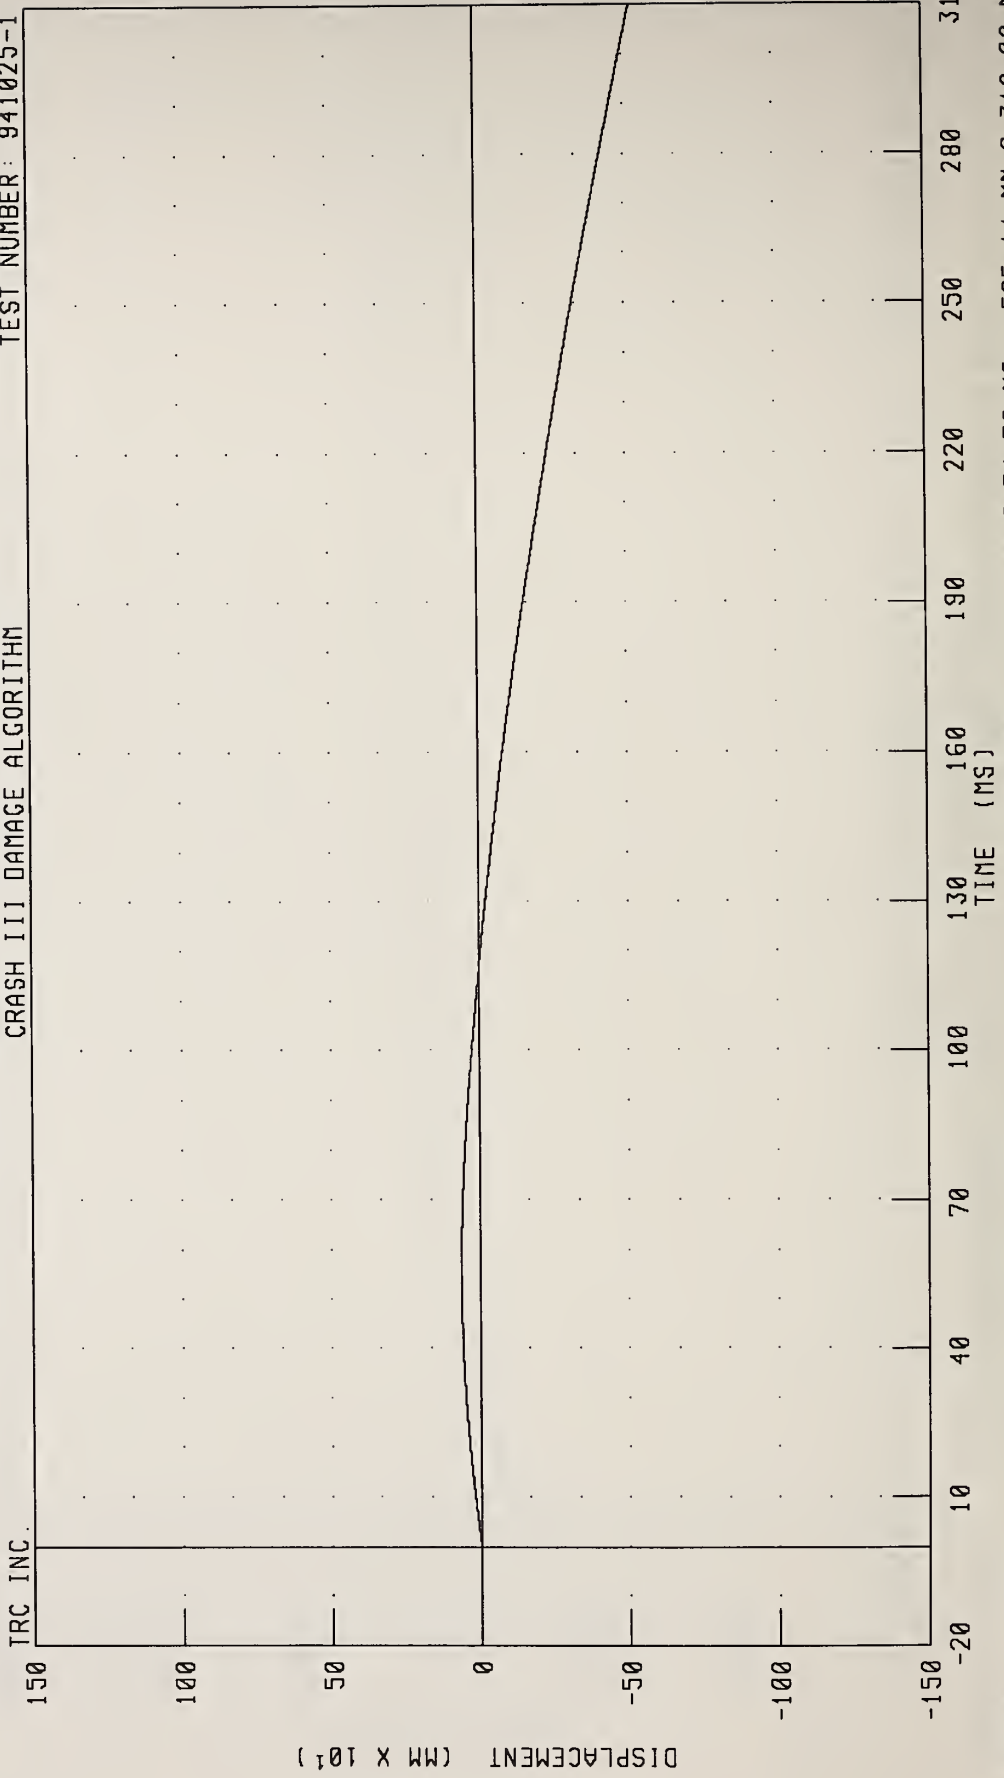
CRASH III DAMAGE ALGORITHM TEST NUMBER: 941025-1

1992 PLYMOUTH VOYAGER INTO 50% LEFT OFFSET BARRIER IMPACT 1 OF 5
VEHICLE CG RESULTANT DISPLACEMENT

CHANNEL: VCGD FILTER: CH. CLASS 180

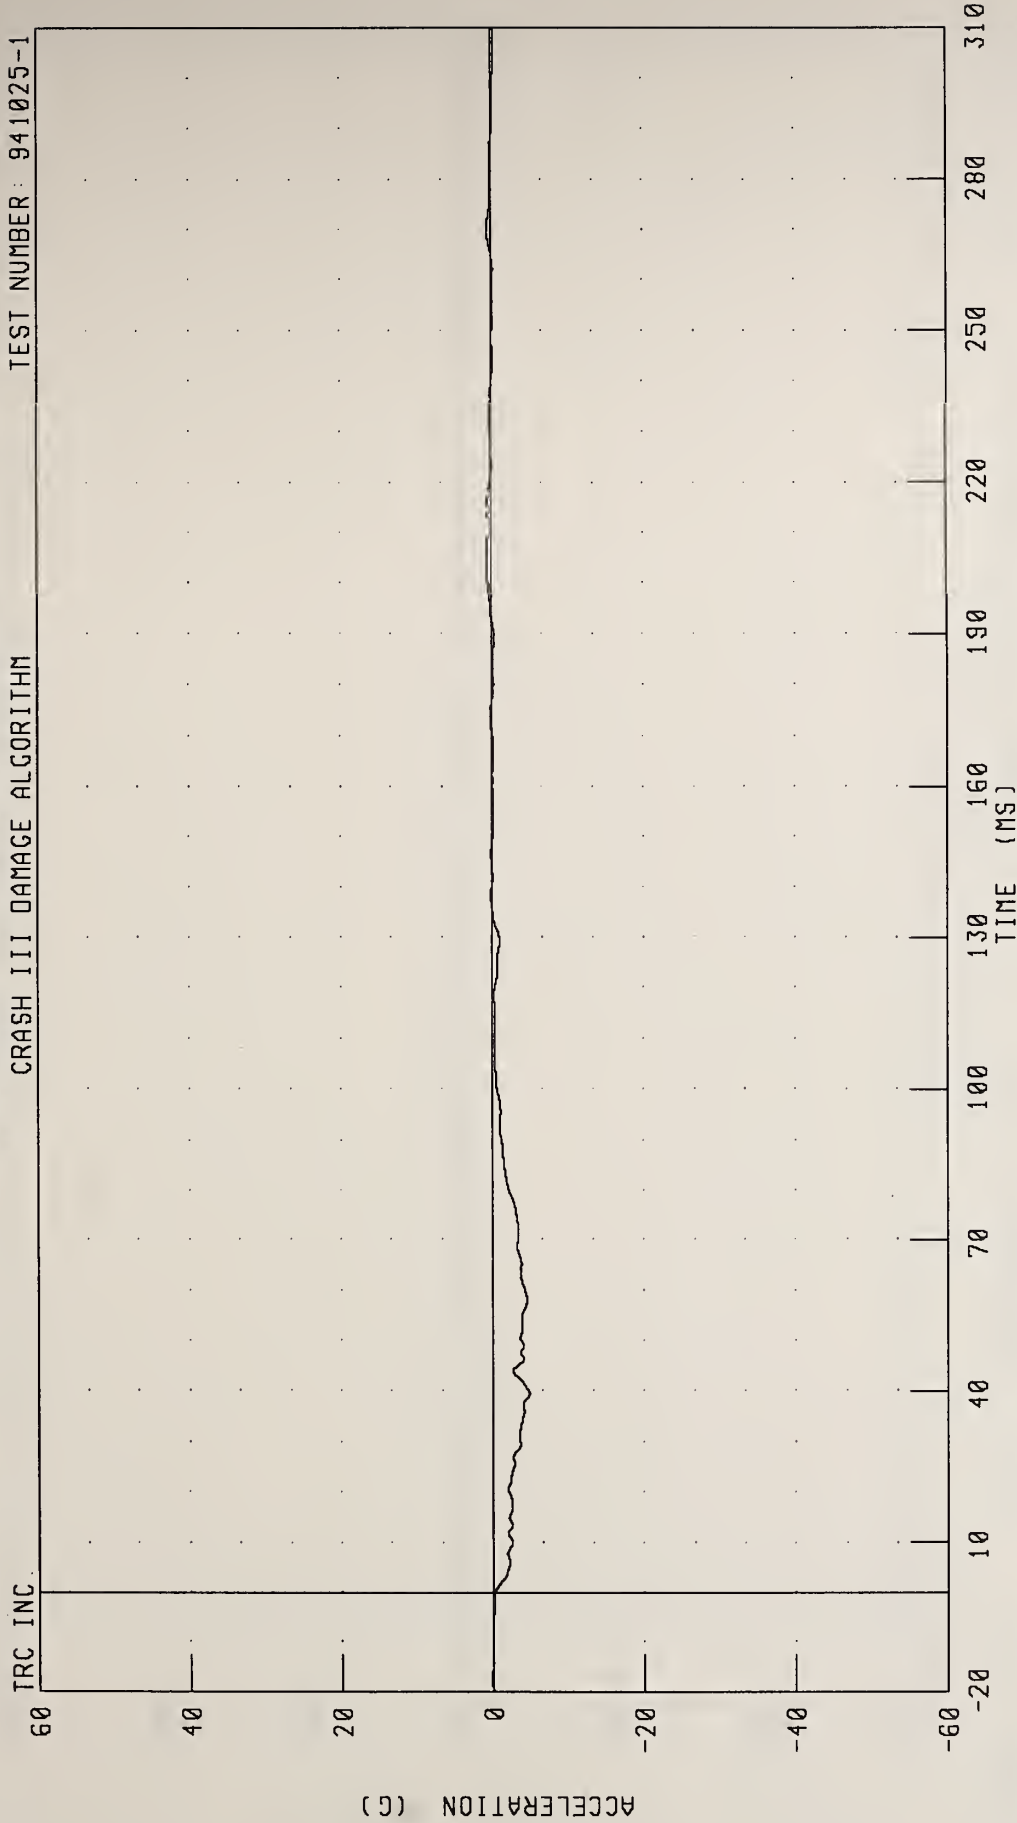
TRC INC. TEST NUMBER: 941025-1

CHANNEL: LFSXG FILTER: CH. CLASS 60

PEAK DATA: 0.58 G @ 270.24 MS; -4.84 G @ 39.36 MS

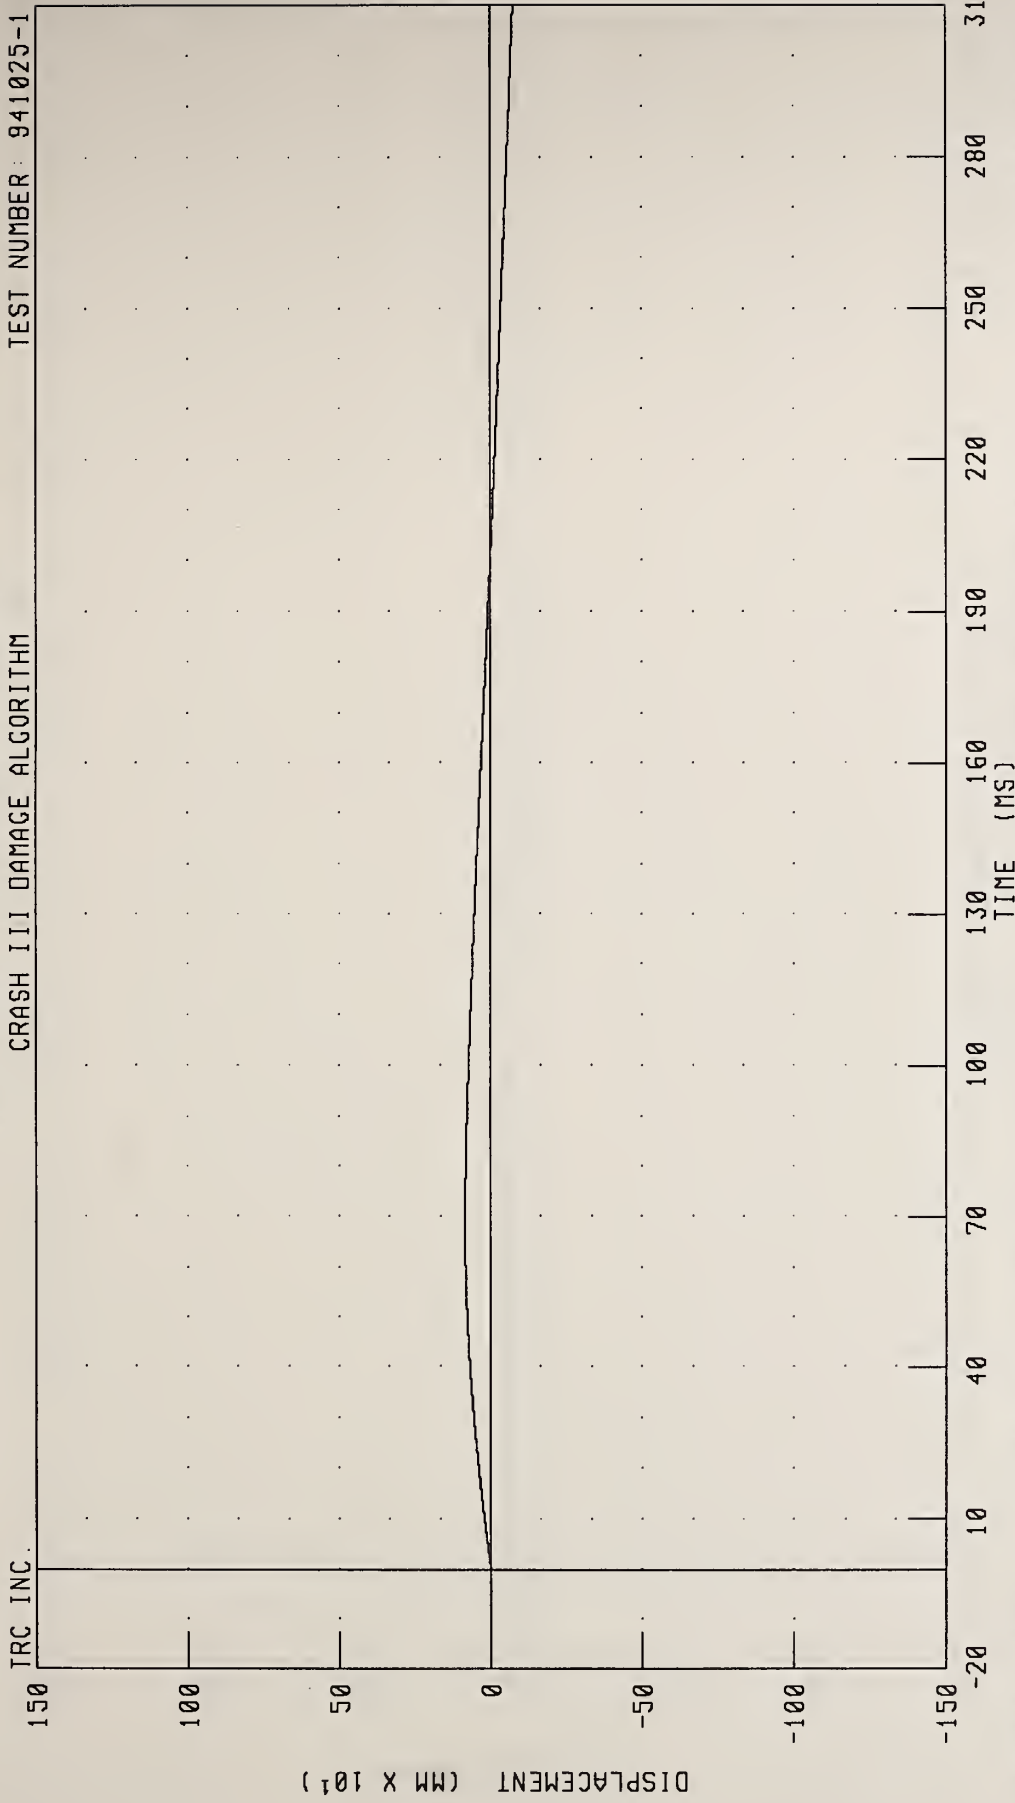
CRASH III DAMAGE ALGORITHM TEST NUMBER: 941025-1

1992 PLYMOUTH VOYAGER INTO 50% LEFT OFFSET BARRIER IMPACT 1 OF 5
LEFT FRONT SILL X-AXIS DISPLACEMENT

TRC INC. CHANNEL: LFSXD FILTER: CH. CLASS 180 PEAK DATA: 84.03 MM @ 68.96 MS; -74.96 MM @ 310.00 MS

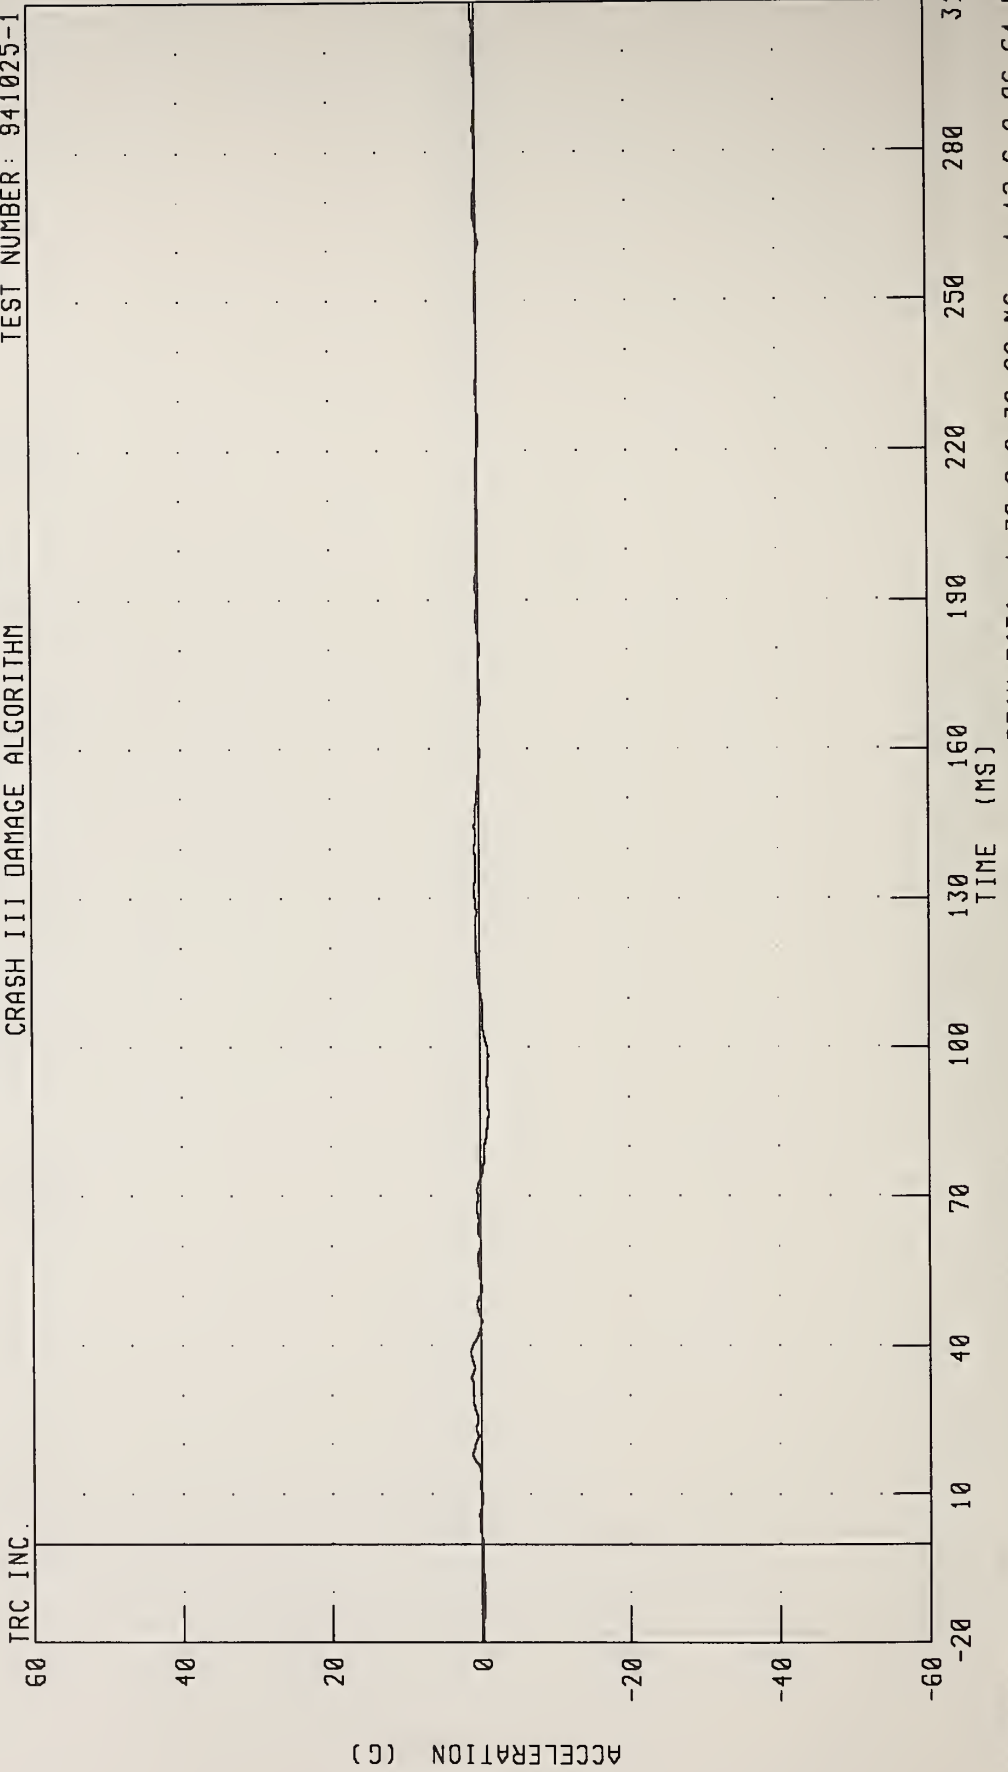
TEST NUMBER: 941025-1

1992 PLYMOUTH VOYAGER INTO 50% LEFT OFFSET BARRIER IMPACT 1 OF 5
RIGHT FRONT SILL Y-AXIS ACCELERATION
CRASH III DAMAGE ALGORITHM

CHANNEL: RFSYG FILTER: CH. CLASS 60

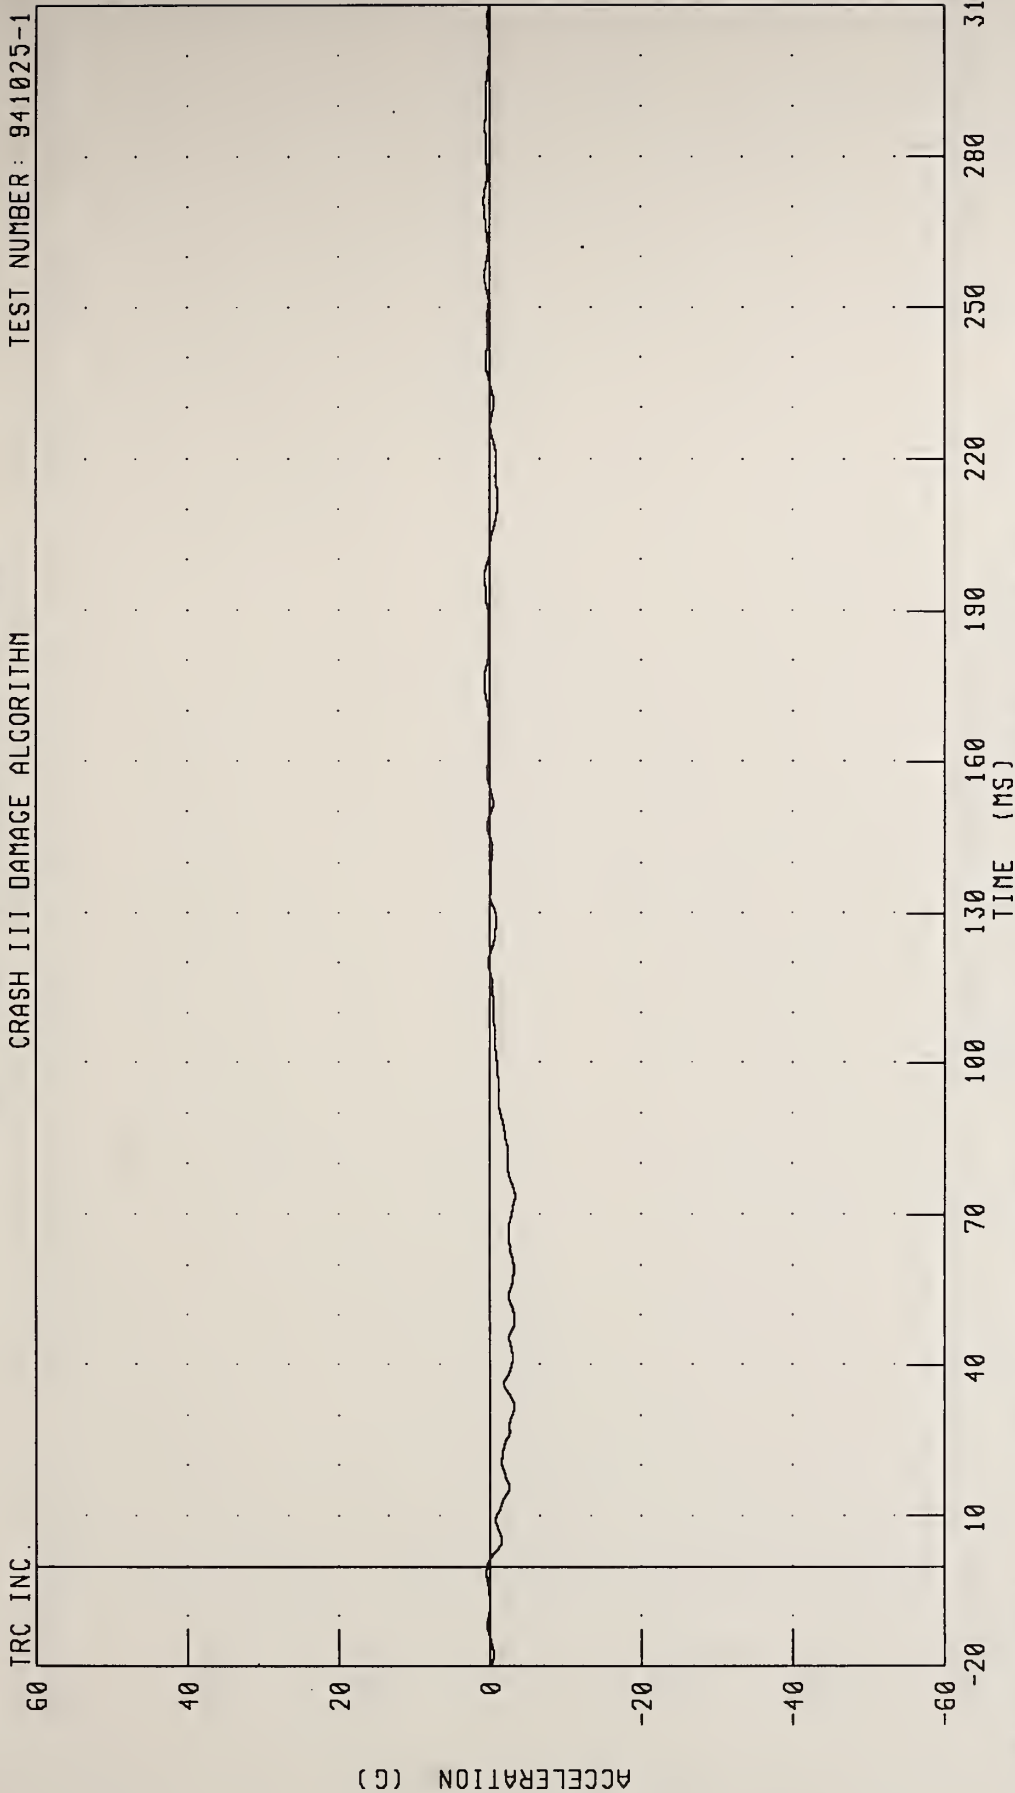
CRASH III DAMAGE ALGORITHM TEST NUMBER: 941025-1

1992 PLYMOUTH VOYAGER INTO 50% LEFT OFFSET BARRIER IMPACT 1 OF 5
RIGHT REAR SILL X-AXIS ACCELERATION

CHANNEL: RRSXG FILTER: CH. CLASS 60 PEAK DATA: 0.79 G @ 271.20 MS; -3.33 G @ 73.68 MS

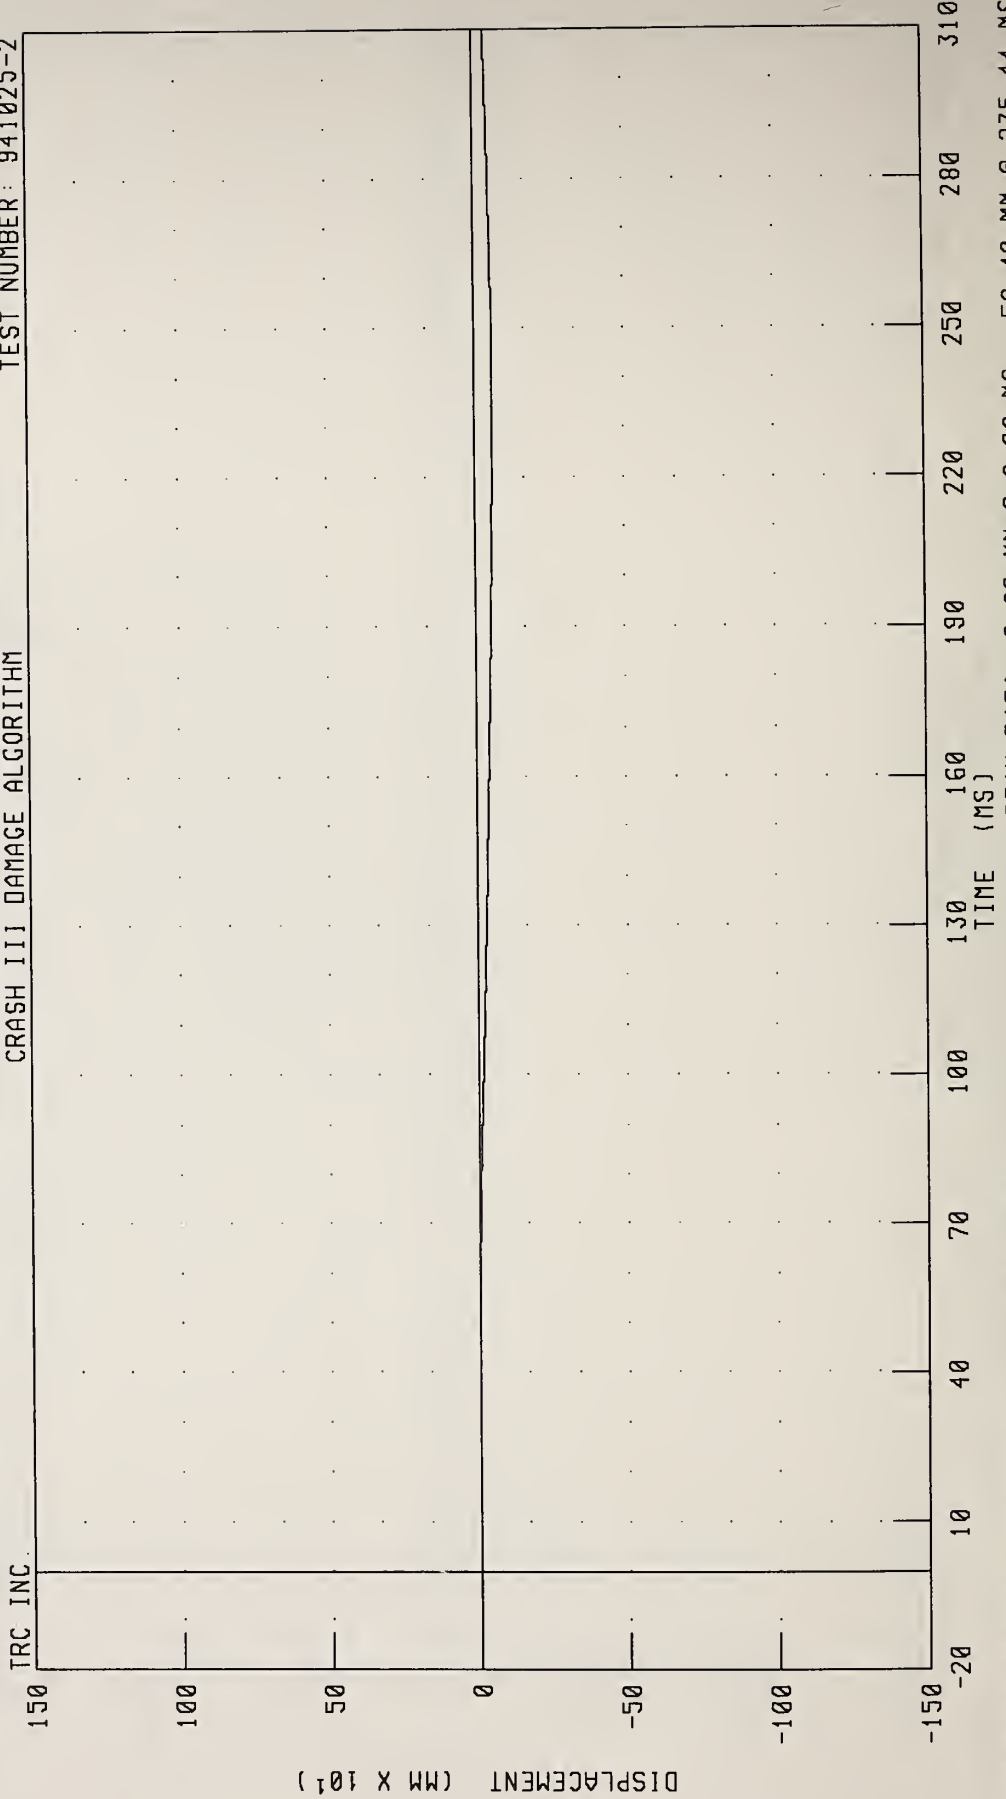
CRASH III DAMAGE ALGORITHM TEST NUMBER: 941025-2

1992 PLYMOUTH VOYAGER INTO 50% LEFT OFFSET BARRIER IMPACT 2 OF 5
LEFT FRONT SILL Y-AXIS DISPLACEMENT

CHANNEL: LFSYD FILTER: CH. CLASS 180 PEAK DATA: 0.00 MM @ 0.00 MS; -59.40 MM @ 235.44 MS

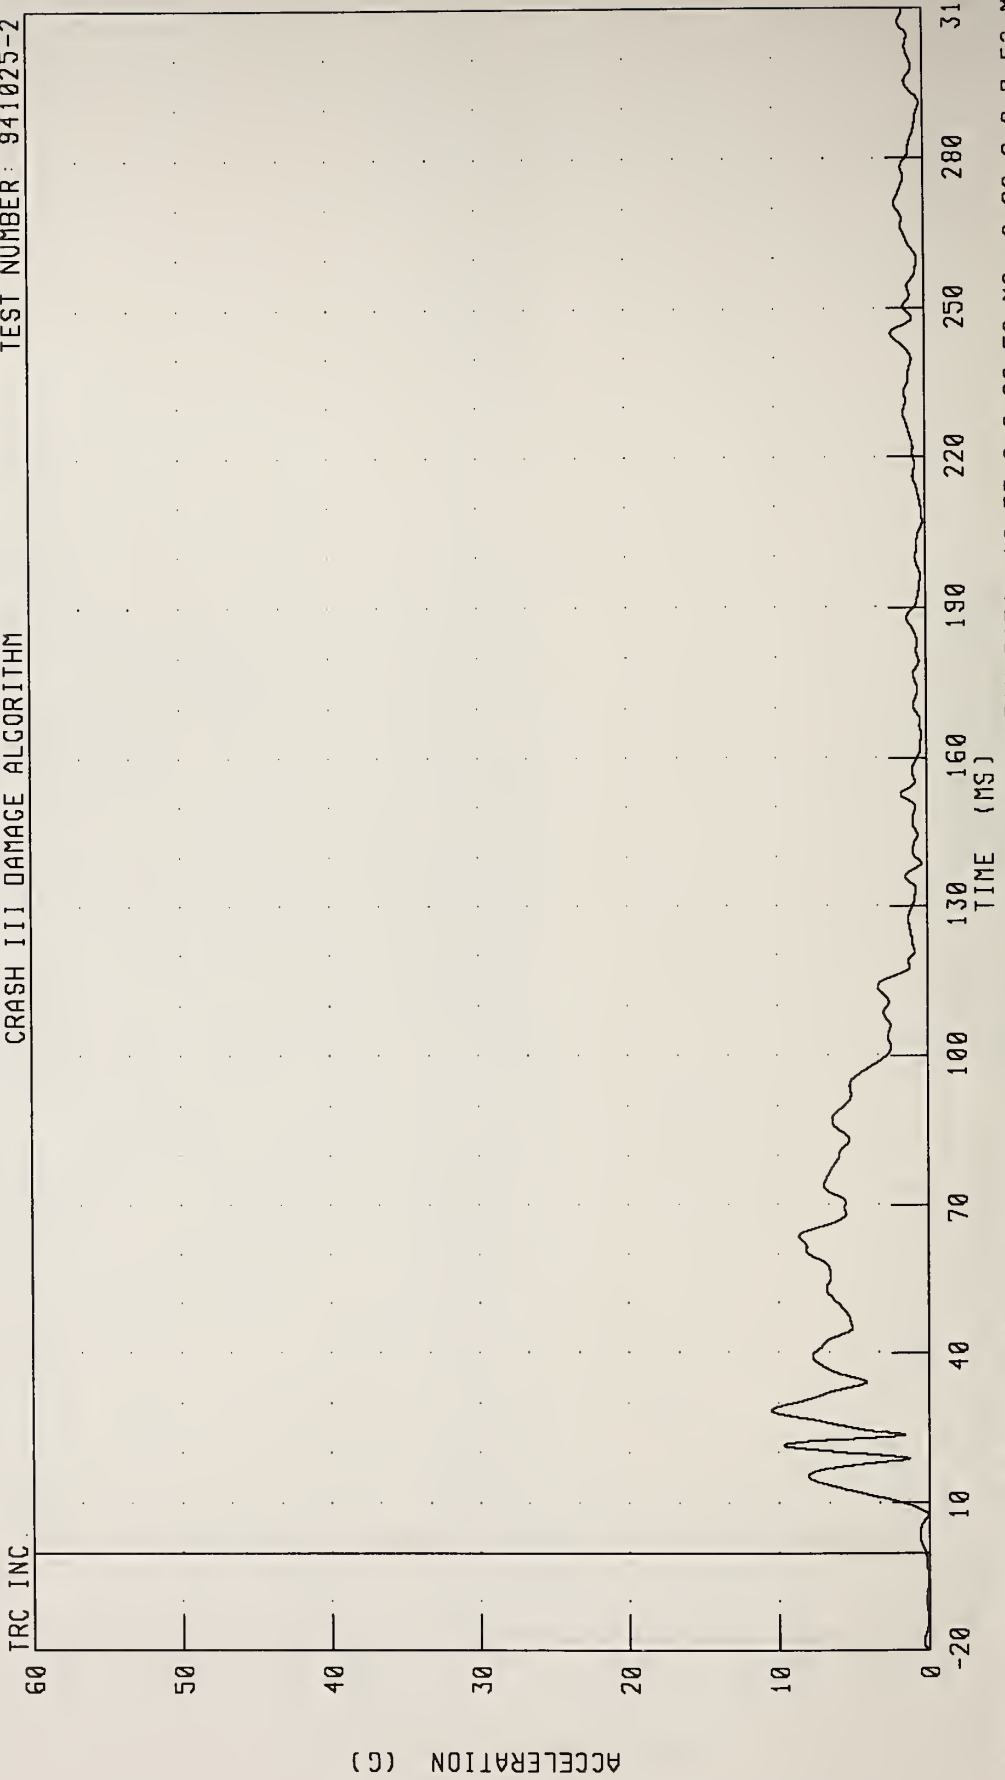
TEST NUMBER: 941025-2

1992 PLYMOUTH VOYAGER INTO 50% LEFT OFFSET BARRIER IMPACT 2 OF 5
VEHICLE CG RESULTANT ACCELERATION
CRASH III DAMAGE ALGORITHM

CHANNEL: VCGRG FILTER: CH. CLASS 60

PEAK DATA: 10.53 G @ 28.56 MS; 0.06 G @ 7.52 MS

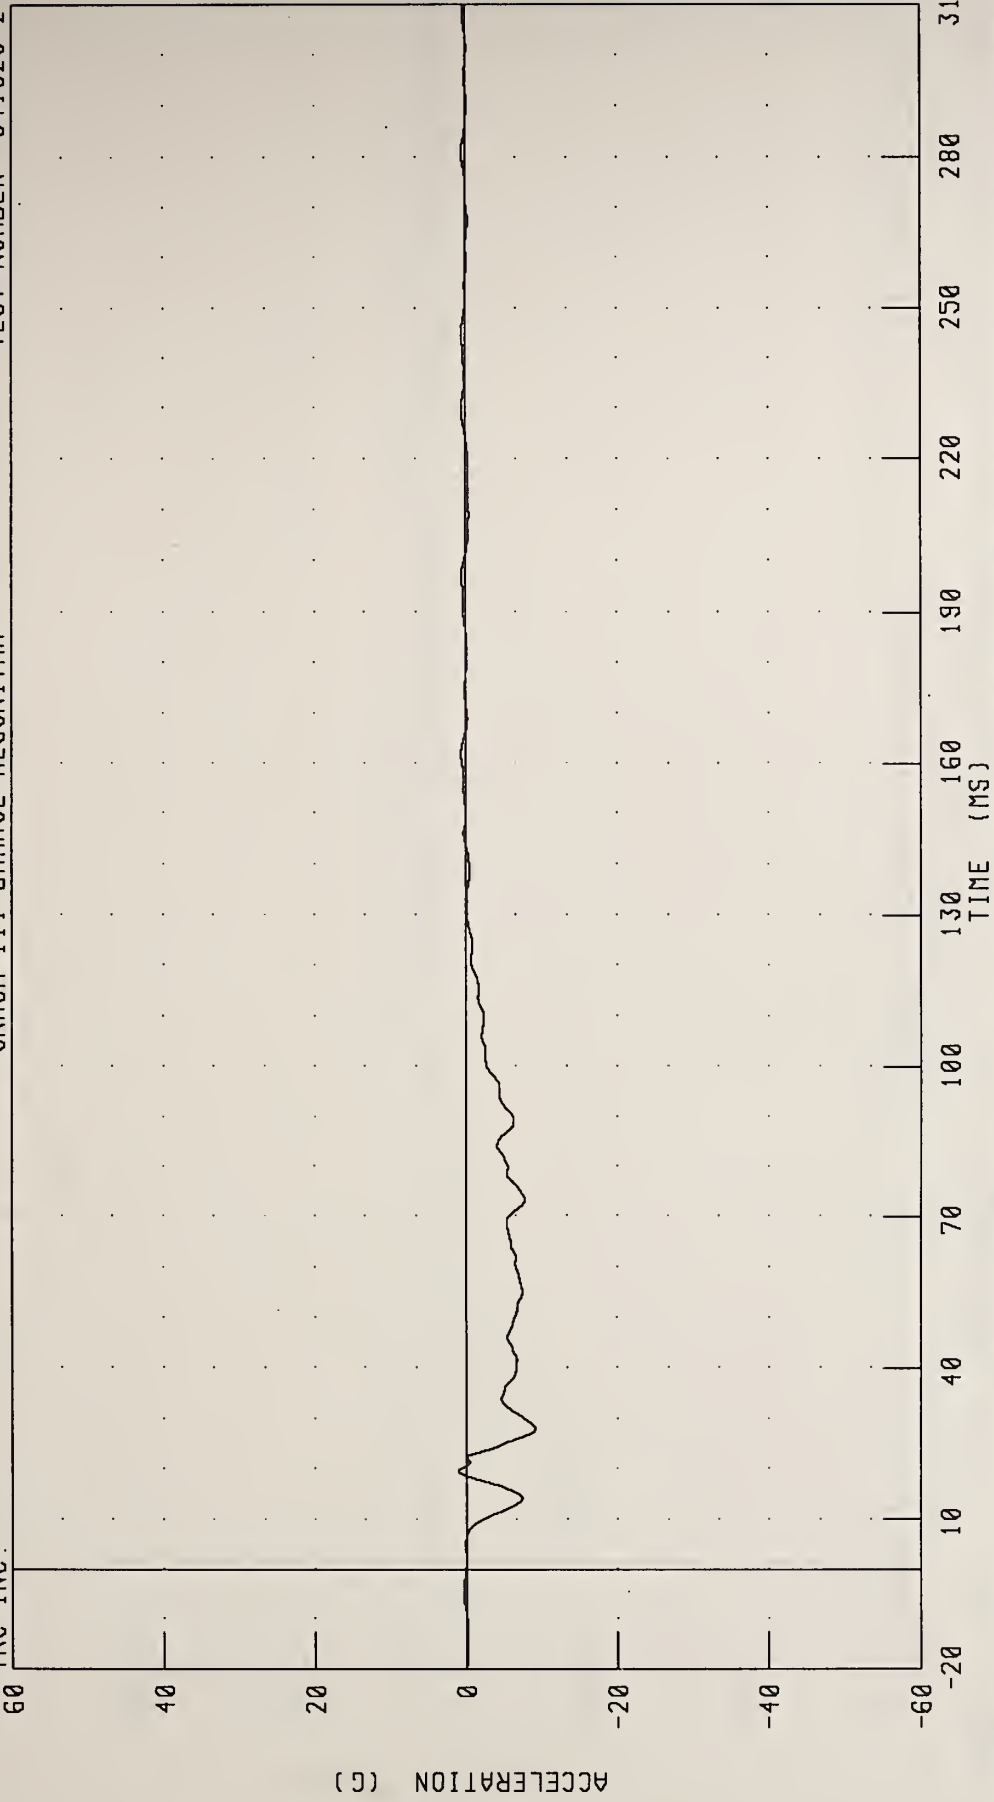
CHANNEL: LFSXG FILTER: CH. CLASS 60

PEAK DATA: 1.07 G @ 19.52 MS; -9.08 G @ 28.00 MS

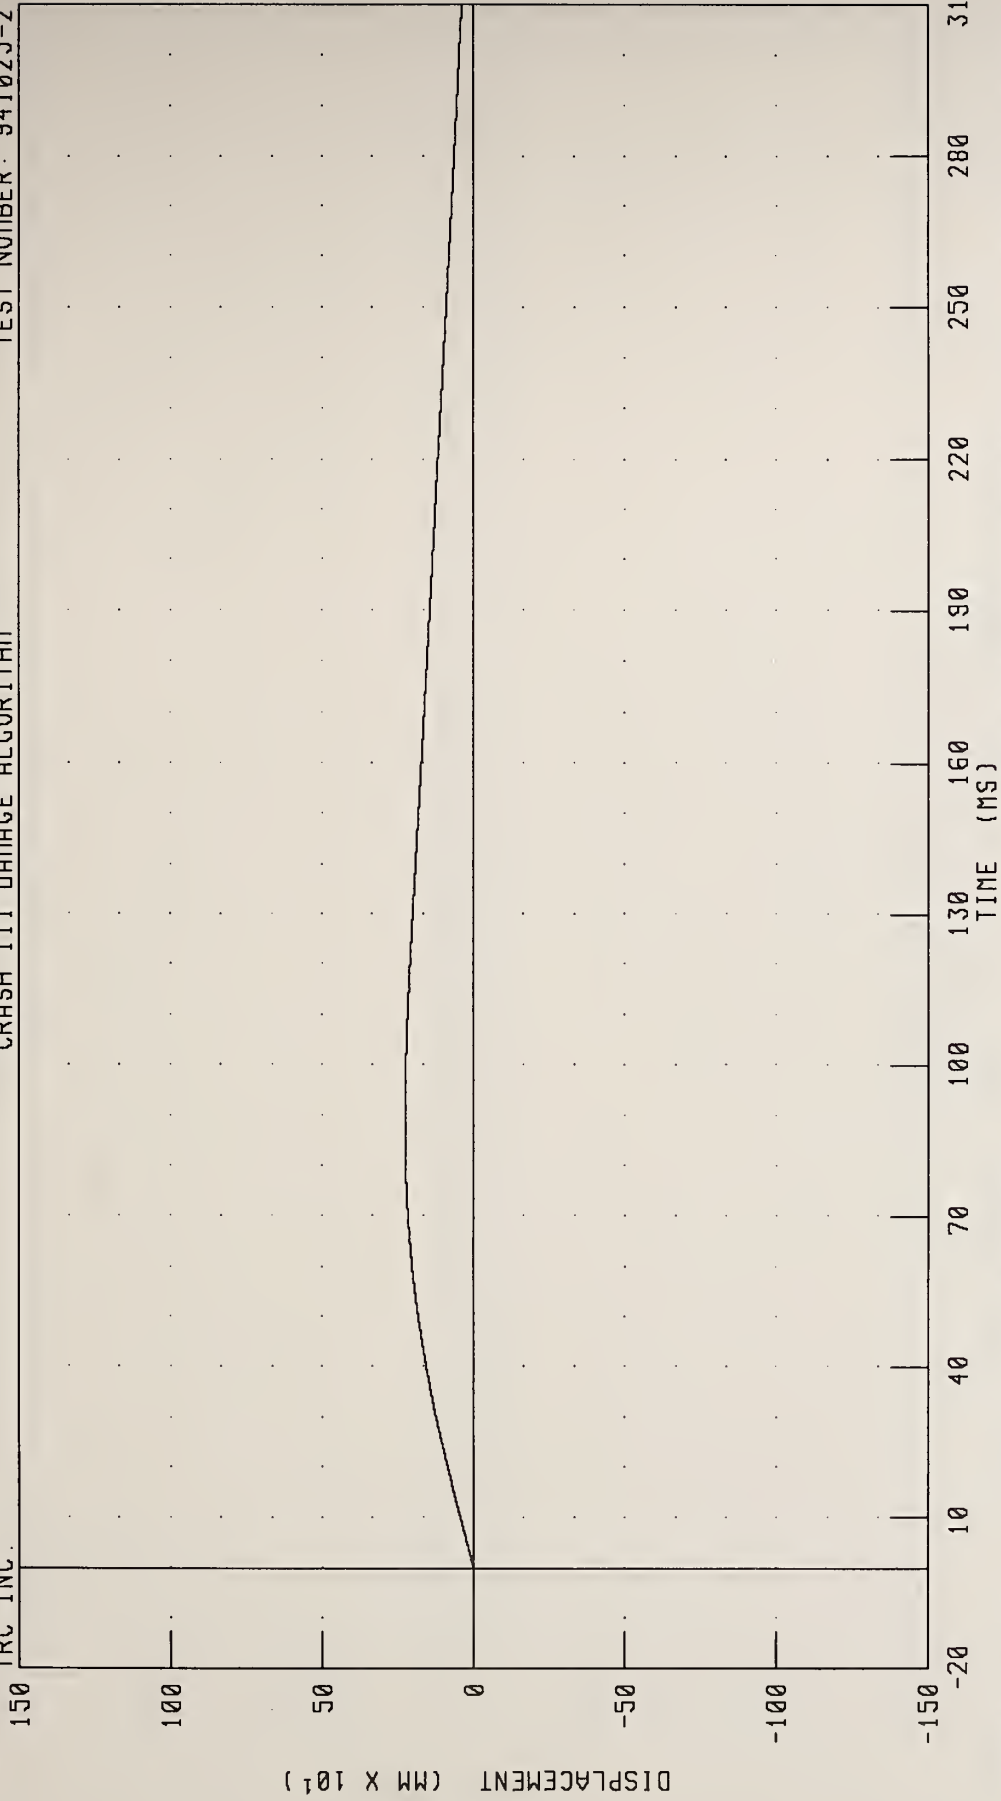
CRASH III DAMAGE ALGORITHM TEST NUMBER: 941025-2

CHANNEL: LFSXD FILTER: CH. CLASS 180

PEAK DATA: 226.46 MM @ 89.28 MS; 0.00 MM @ 0.00 MS
