DOT HS 808 217

Final Report

Final Report of a 1992 Plymouth Voyager into a 50% Left Offset Barrier in Support of CRASH3 Damage Algorithm Reformulation

The purpose of the five (5) 50% left offset barrier impact tests was for research and development in support of the CRASH3 damage algorithm reformulation.

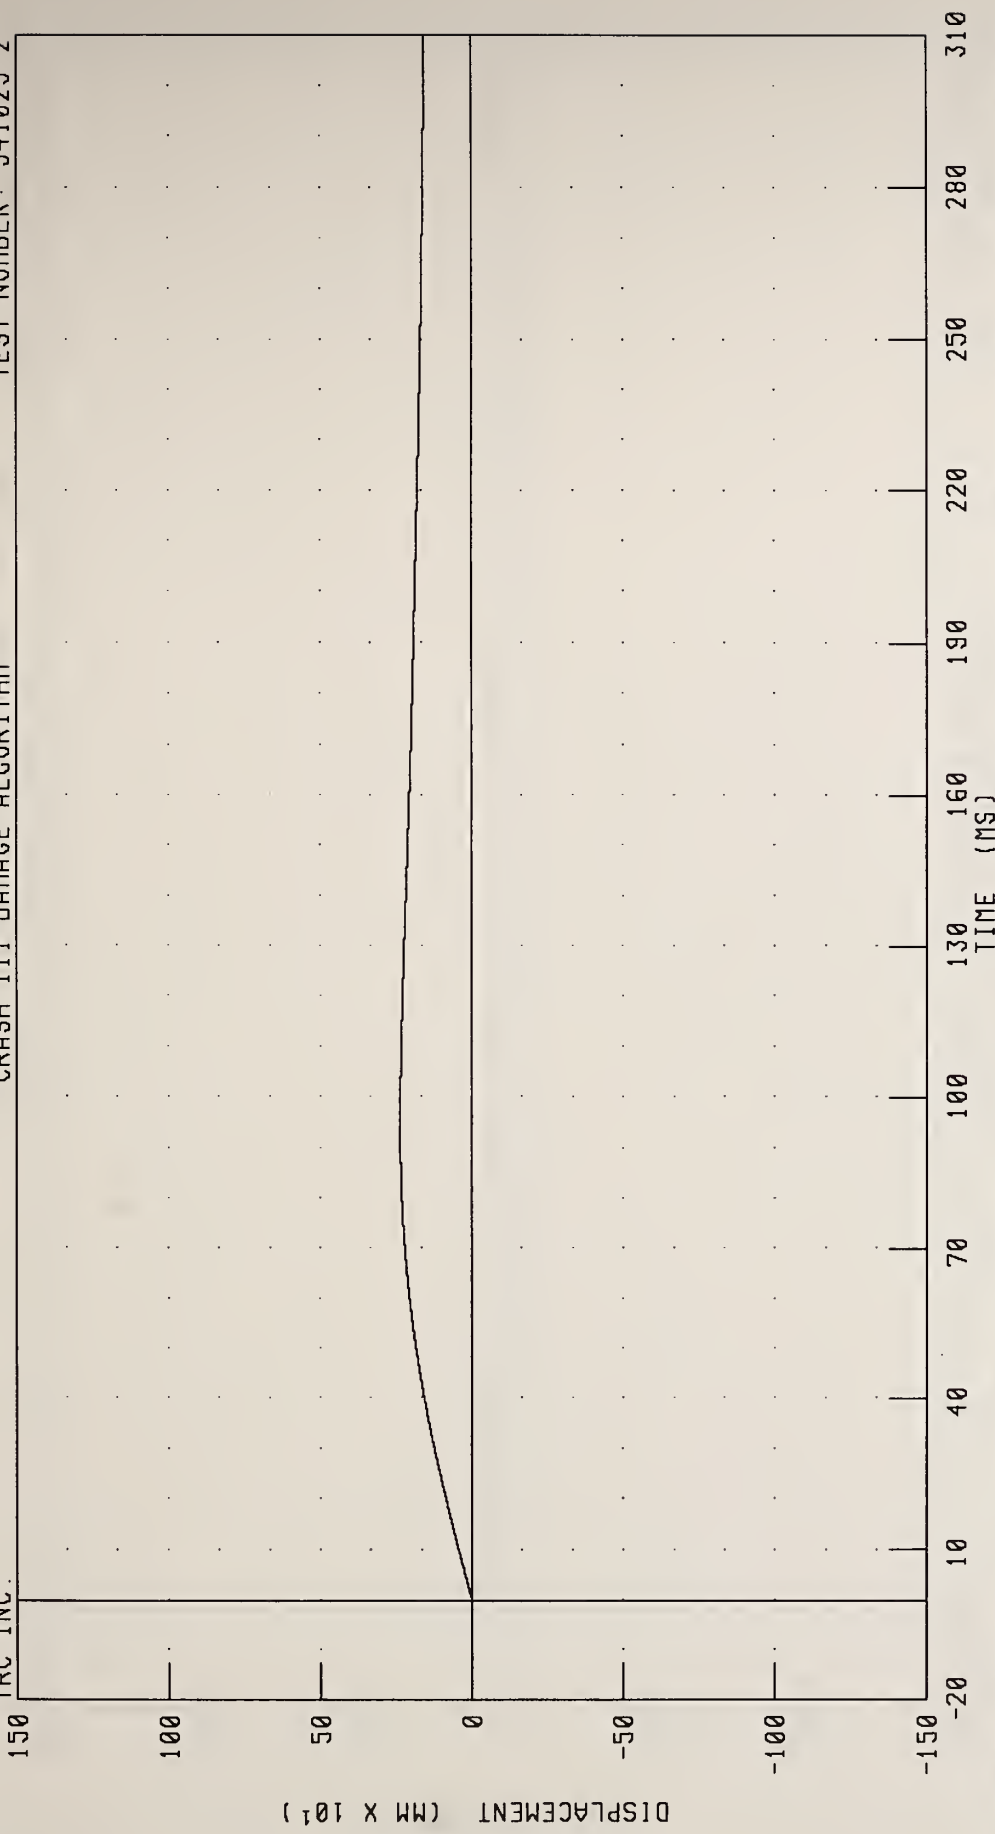
CHANNEL: LRSXD FILTER: CH. CLASS 180 PEAK DATA: 236.57 MM @ 94.64 MS; 0.00 MM @ 0.00 MS

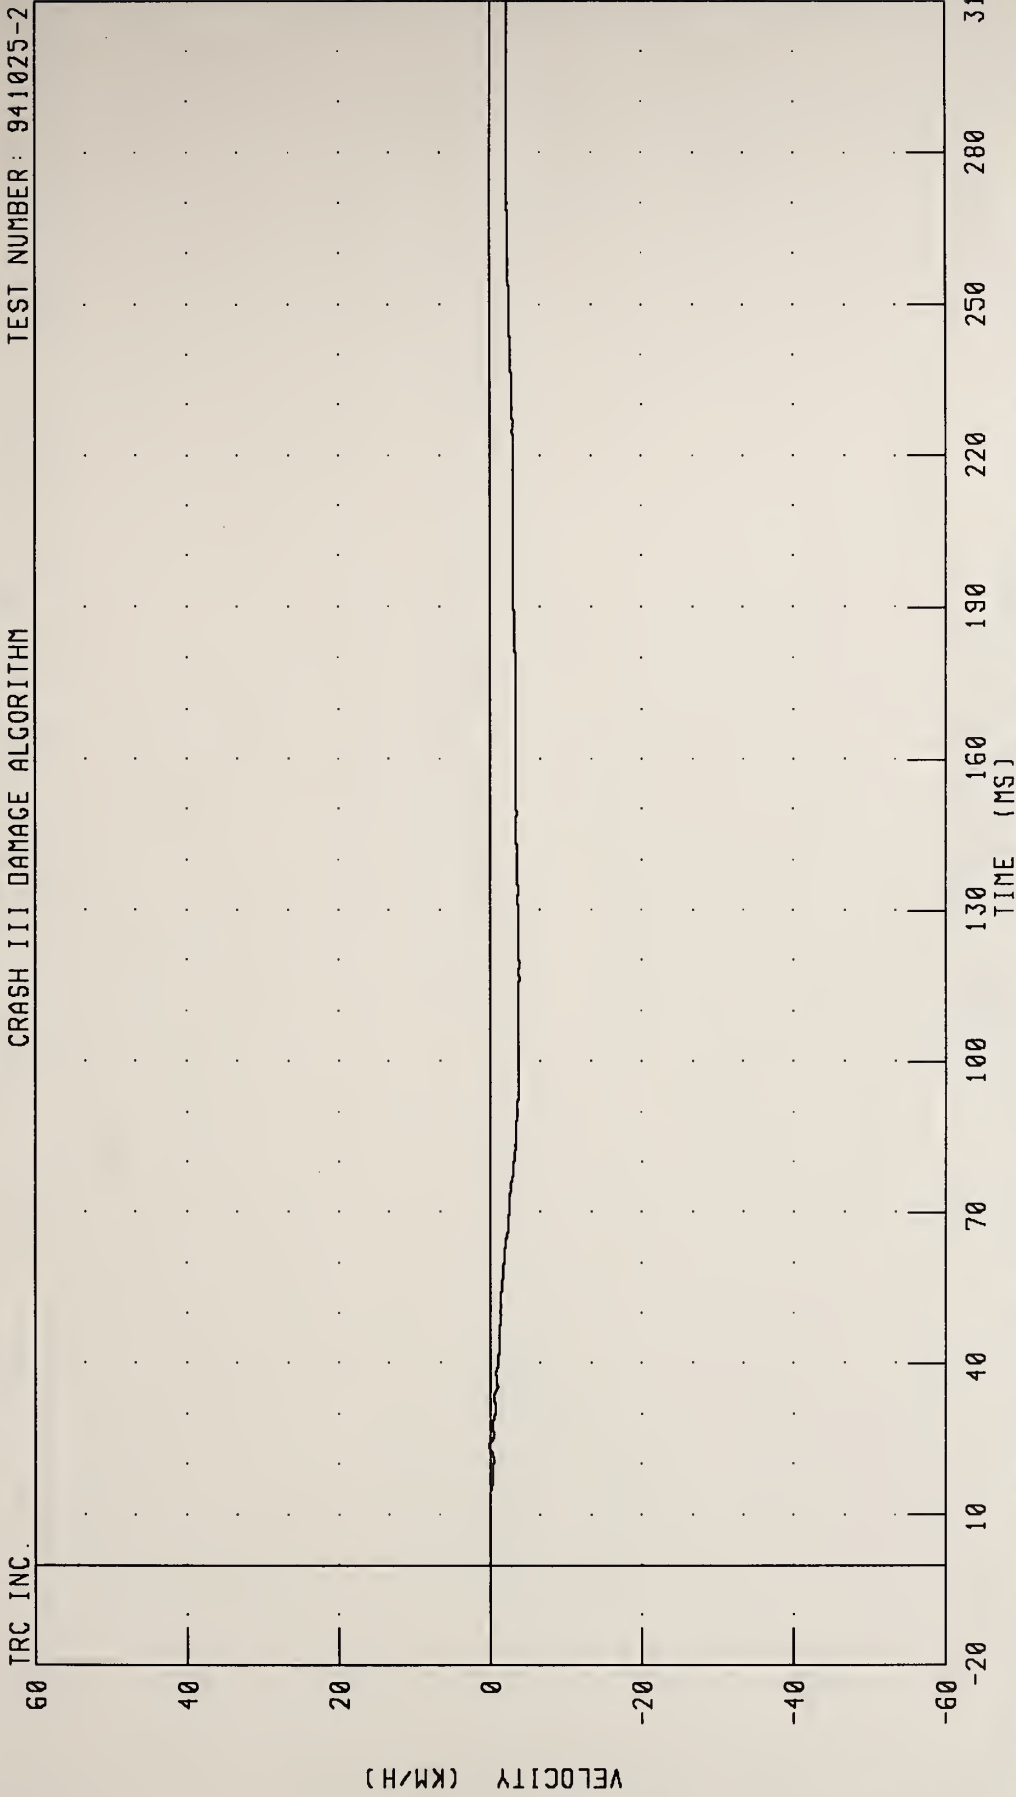
TRC INC. CRASH III DAMAGE ALGORITHM TEST NUMBER: 941025-2

CHANNEL: LRSYV FILTER: CH. CLASS 180

PEAK DATA: 0.21 KM/H @ 23.68 MS; -3.83 KM/H @ 119.28 MS

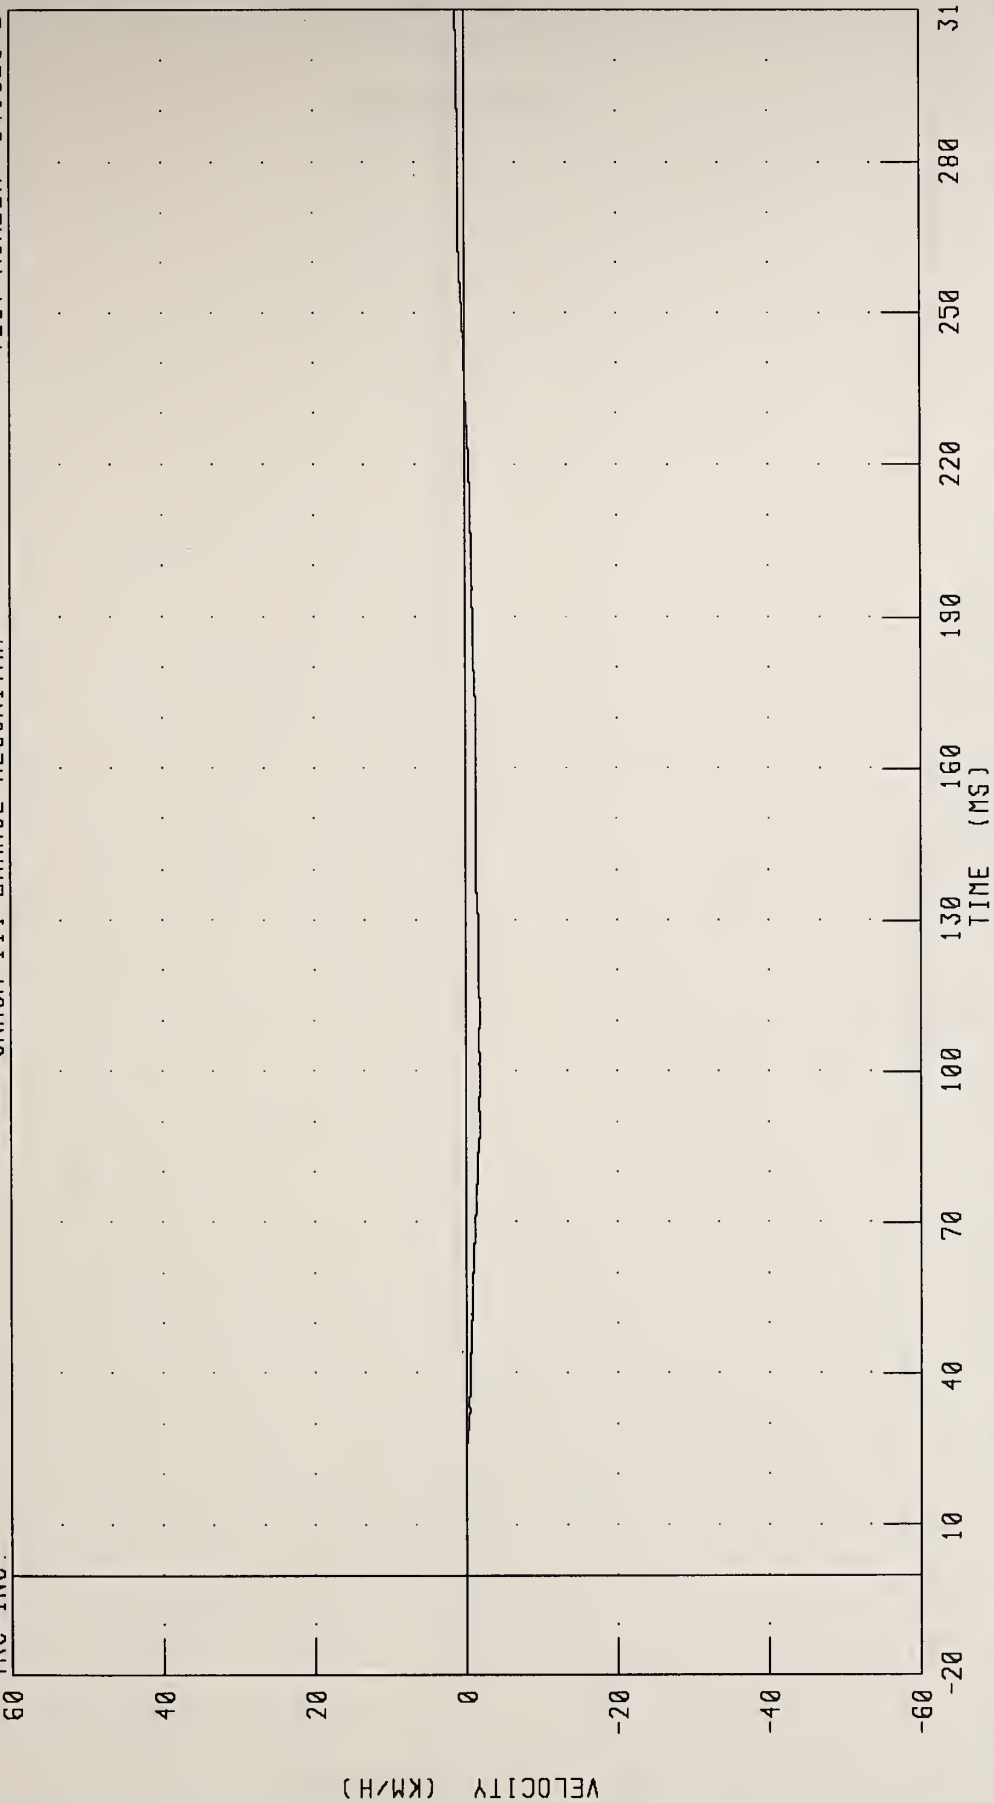
CHANNEL: RRSYV FILTER: CH. CLASS 180

PEAK DATA: 1.22 KM/H @ 310.00 MS; -1.88 KM/H @ 89.20 MS

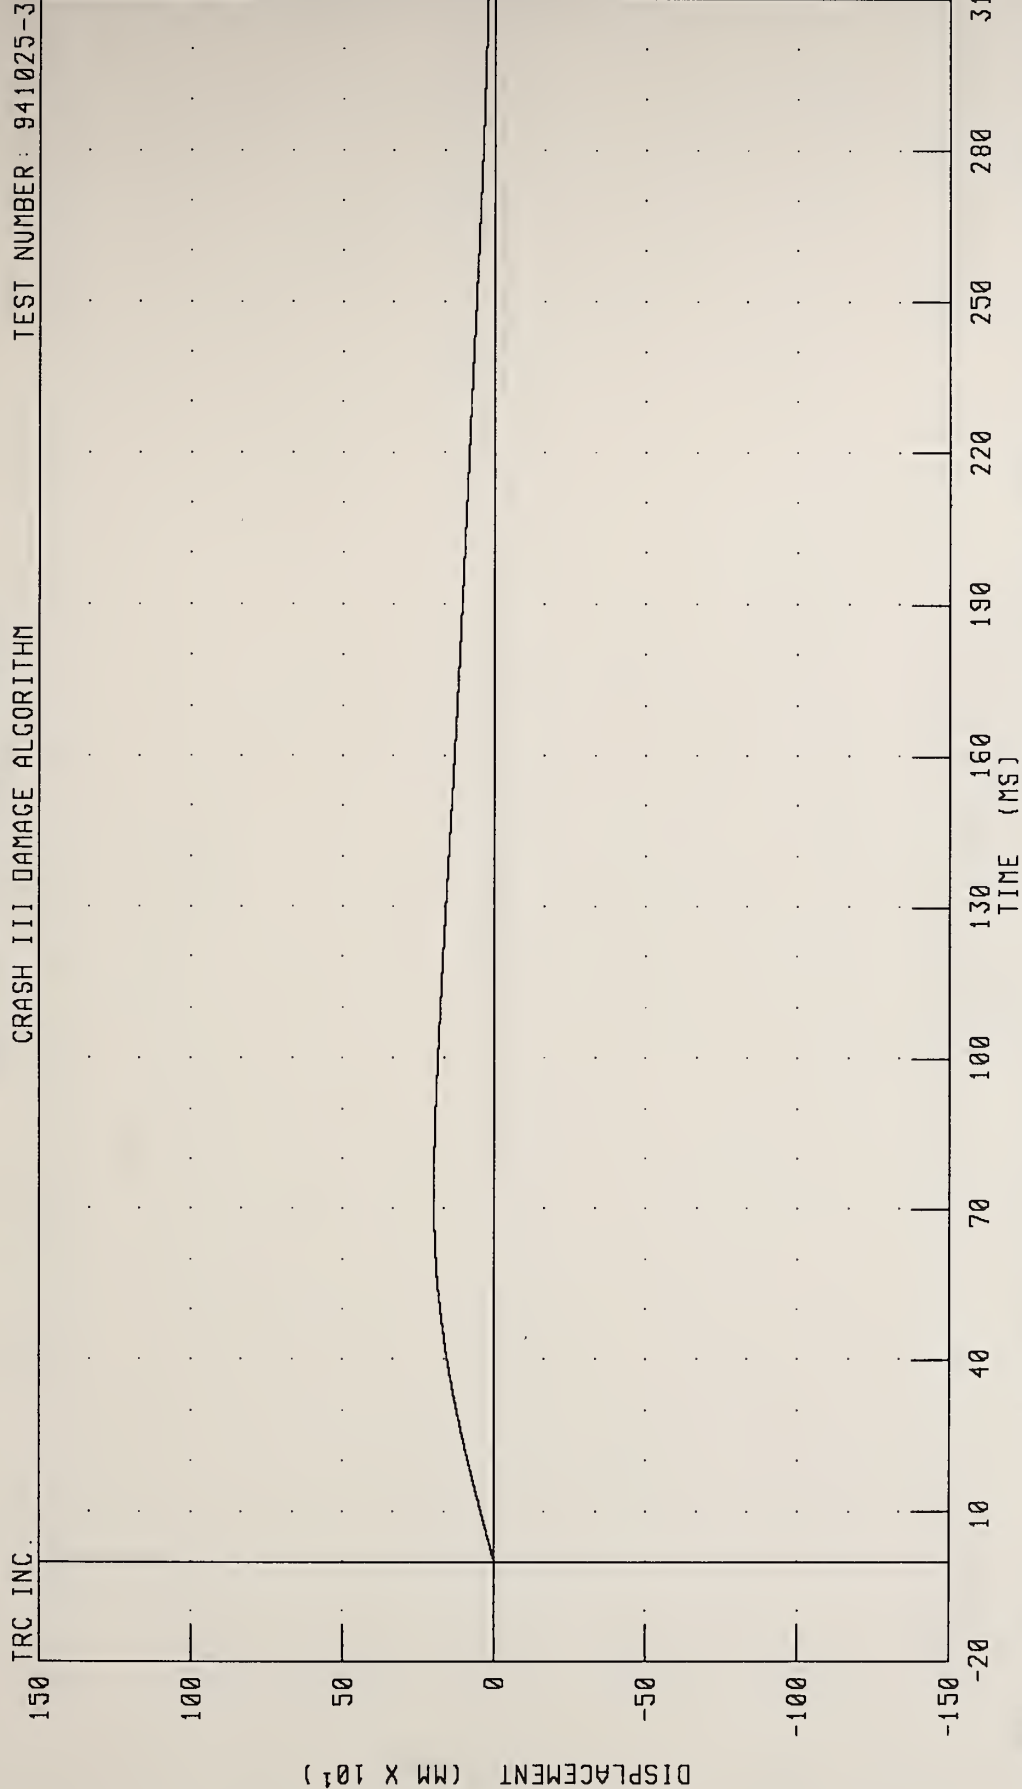
TEST NUMBER: 941025-3

CHANNEL: VCGXD FILTER: CH. CLASS 180

PEAK DATA: 199.07 MM @ 73.36 MS; 0.00 MM @ 0.00 MS

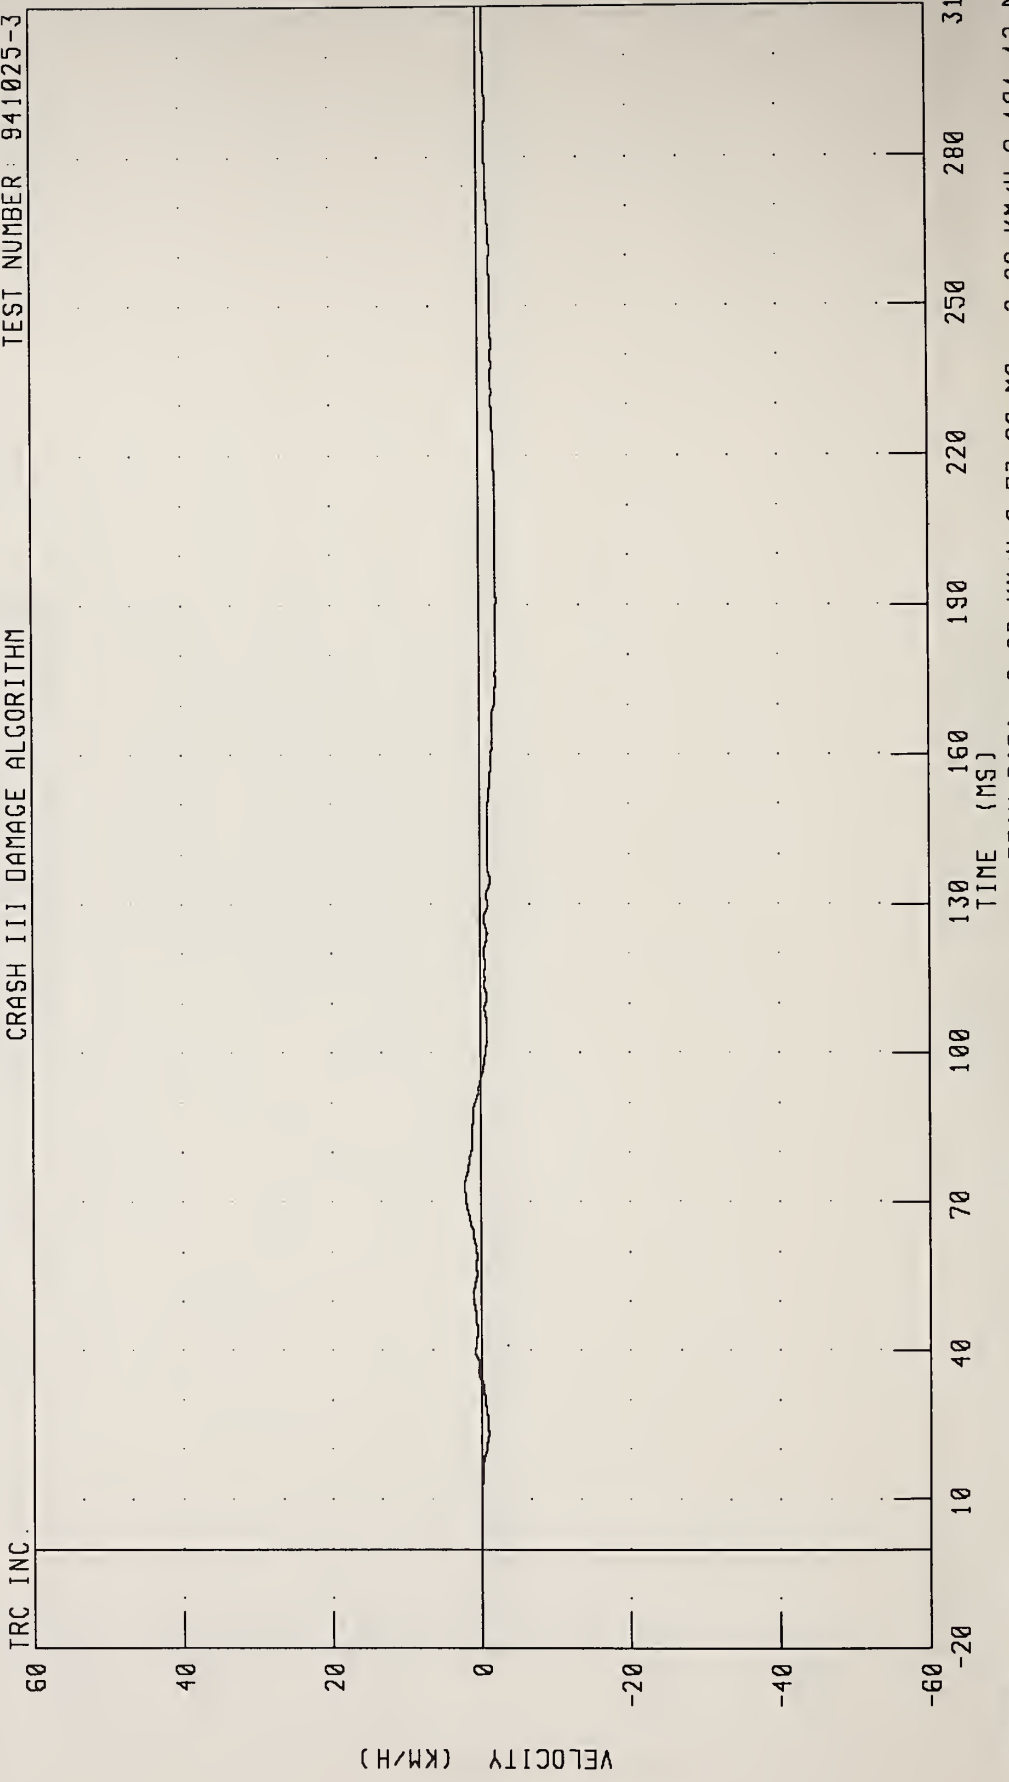
TEST NUMBER: 941025-3

CHANNEL: VCGZV FILTER: CH. CLASS 180

PEAK DATA: 2.20 KM/H @ 73.28 MS, -2.29 KM/H @ 191.12 MS

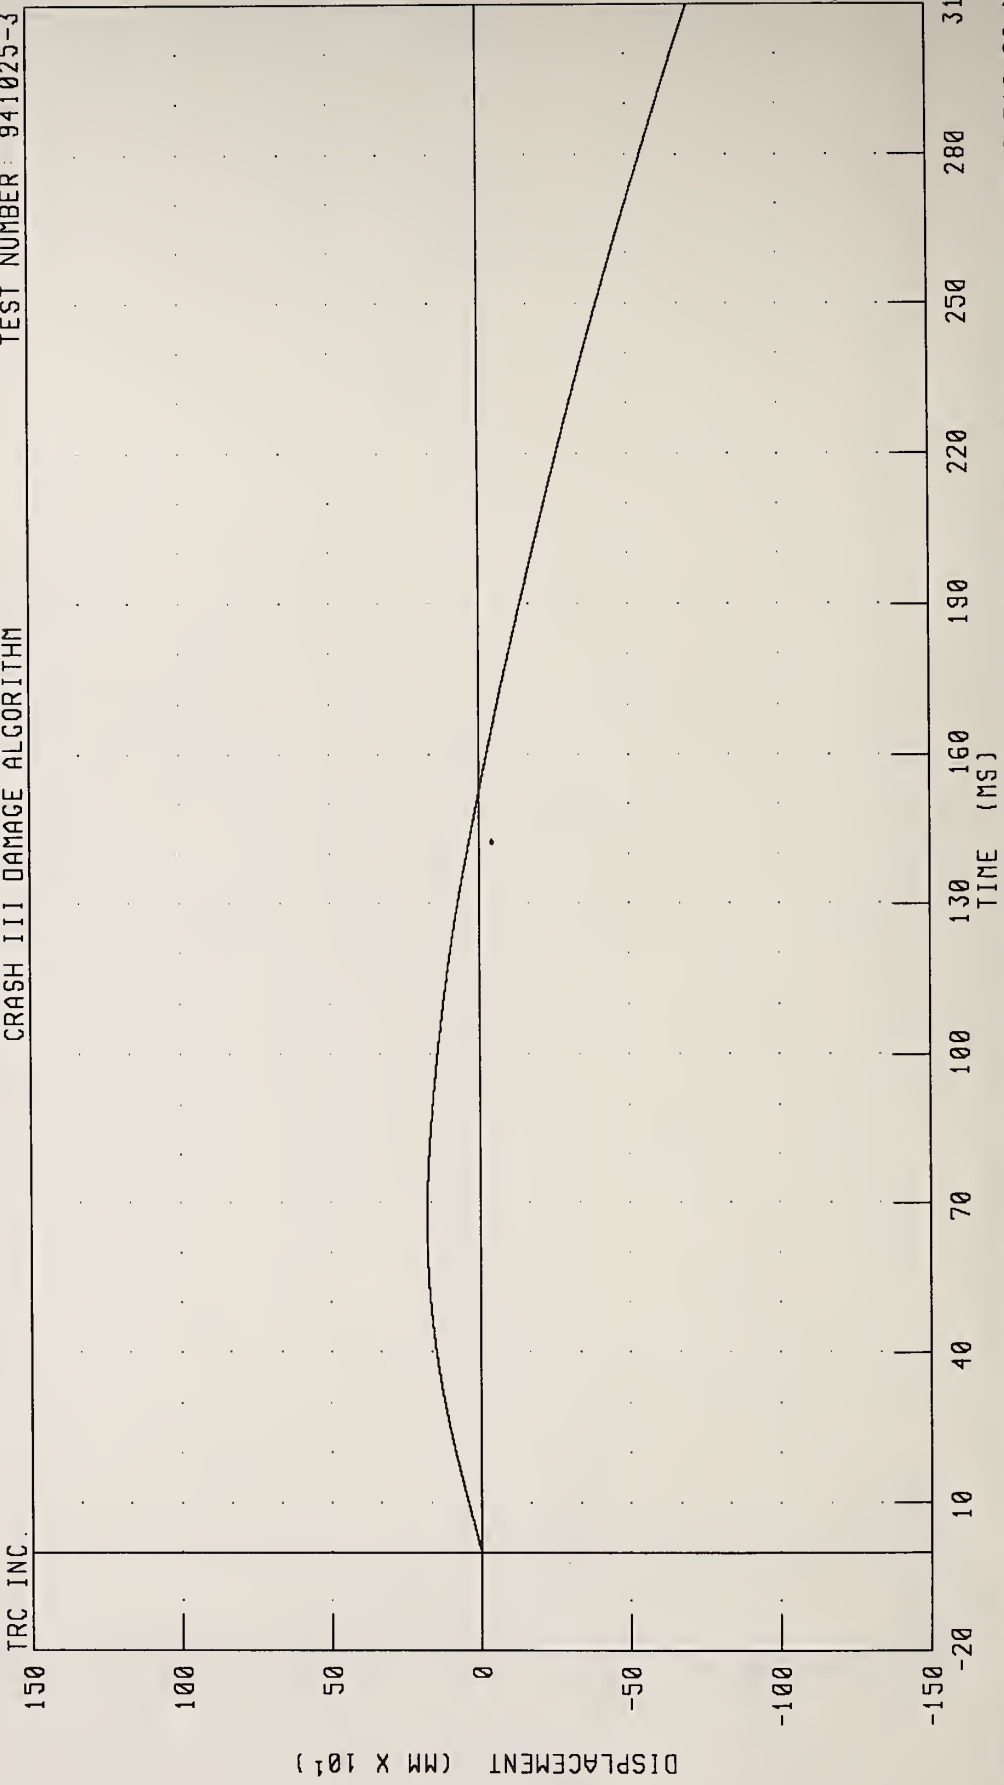
TEST NUMBER: 941025-3

CHANNEL: VCGRD FILTER: CH. CLASS 180

PEAK DATA: 179.40 MM @ 65.44 MS; -707.07 MM @ 310.00 MS

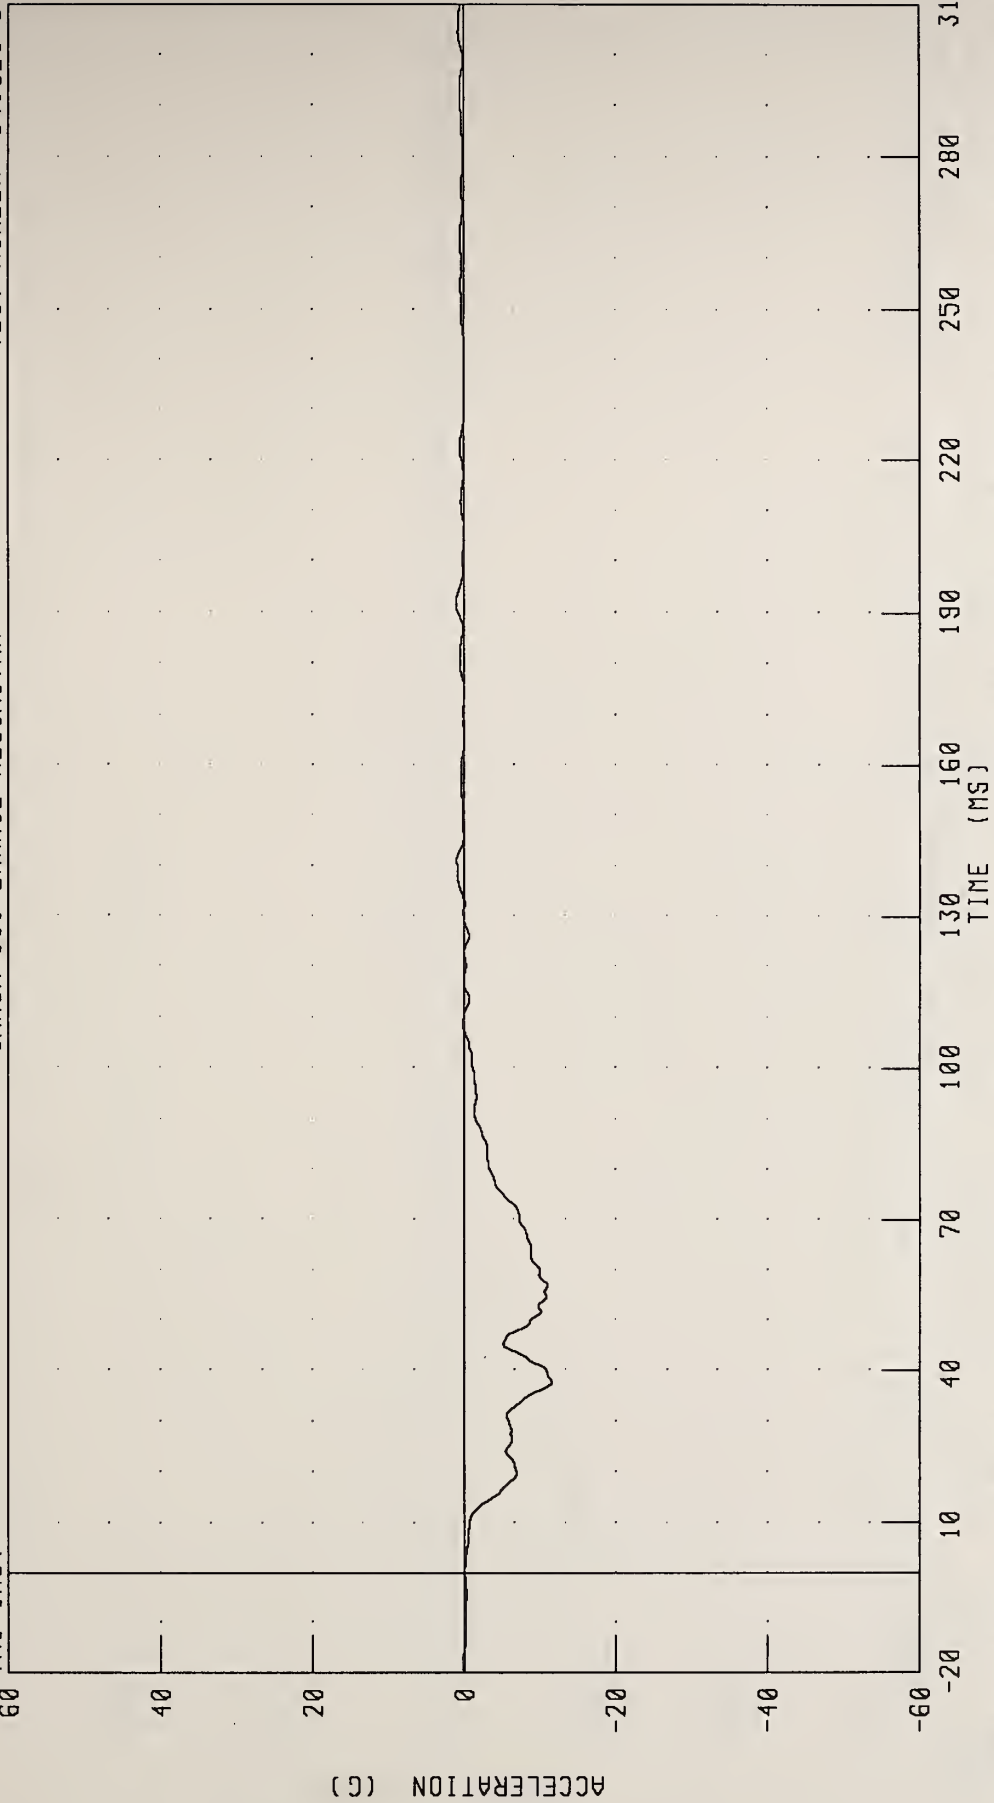
CRASH III DAMAGE ALGORITHM TEST NUMBER: 941025-3

CHANNEL: LFSXG FILTER: CH. CLASS 60

PEAK DATA: 1.06 G @ 191.84 MS; -11.52 G @ 37.68 MS

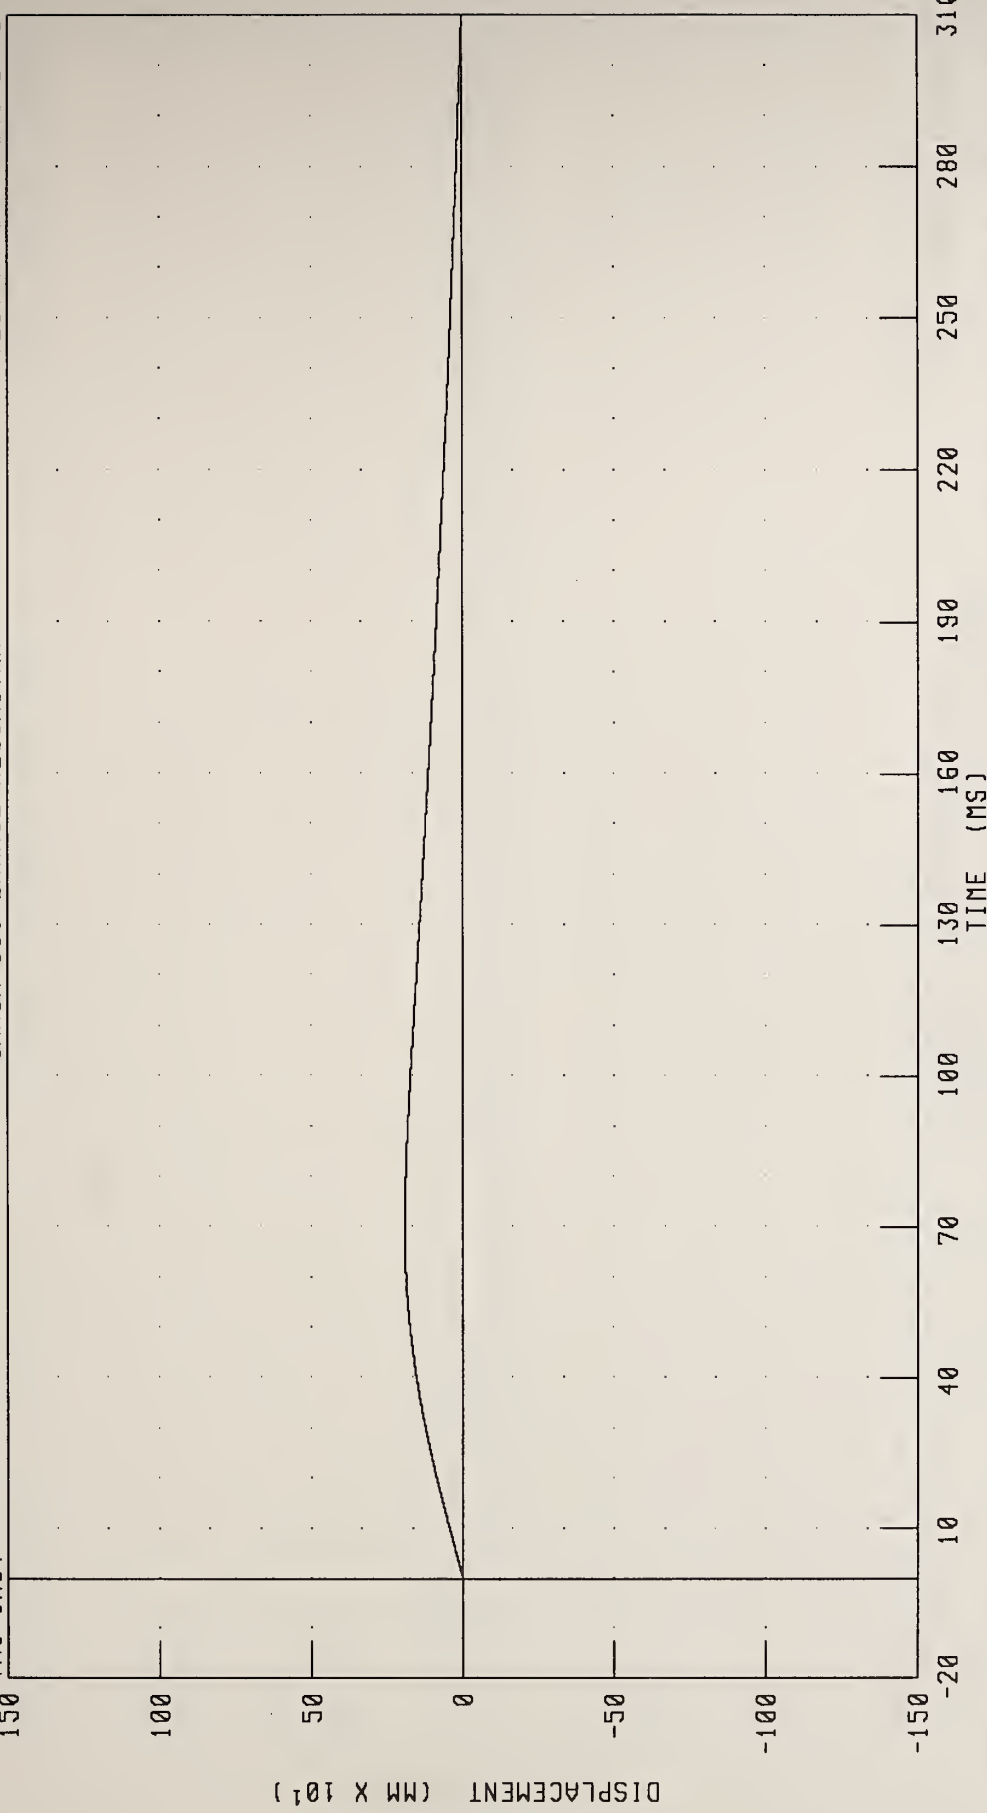
CHANNEL: LFSXD FILTER: CH. CLASS 180

PEAK DATA: 191.91 MM @ 69.84 MS; 0.00 MM @ 0.00 MS

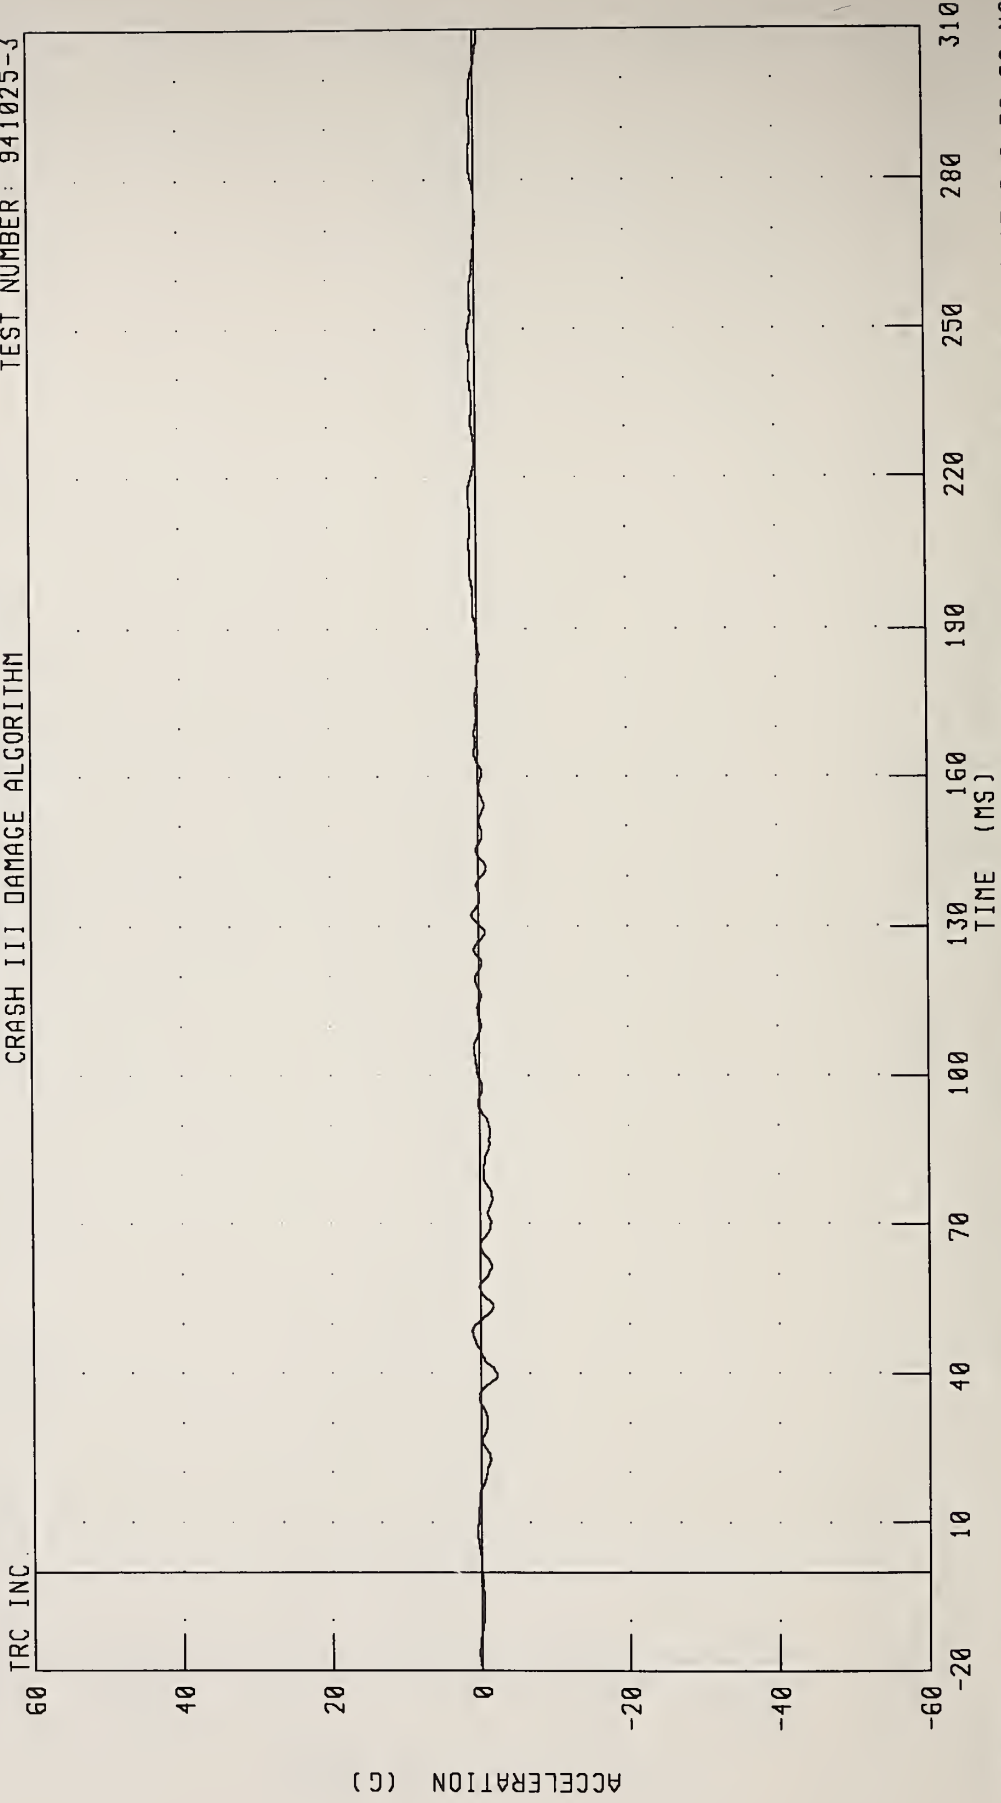
TEST NUMBER: 941025-3

CHANNEL: LFSYG FILTER: CH. CLASS 60

PEAK DATA: 1.12 G @ 48.56 MS, -2.17 G @ 39.68 MS

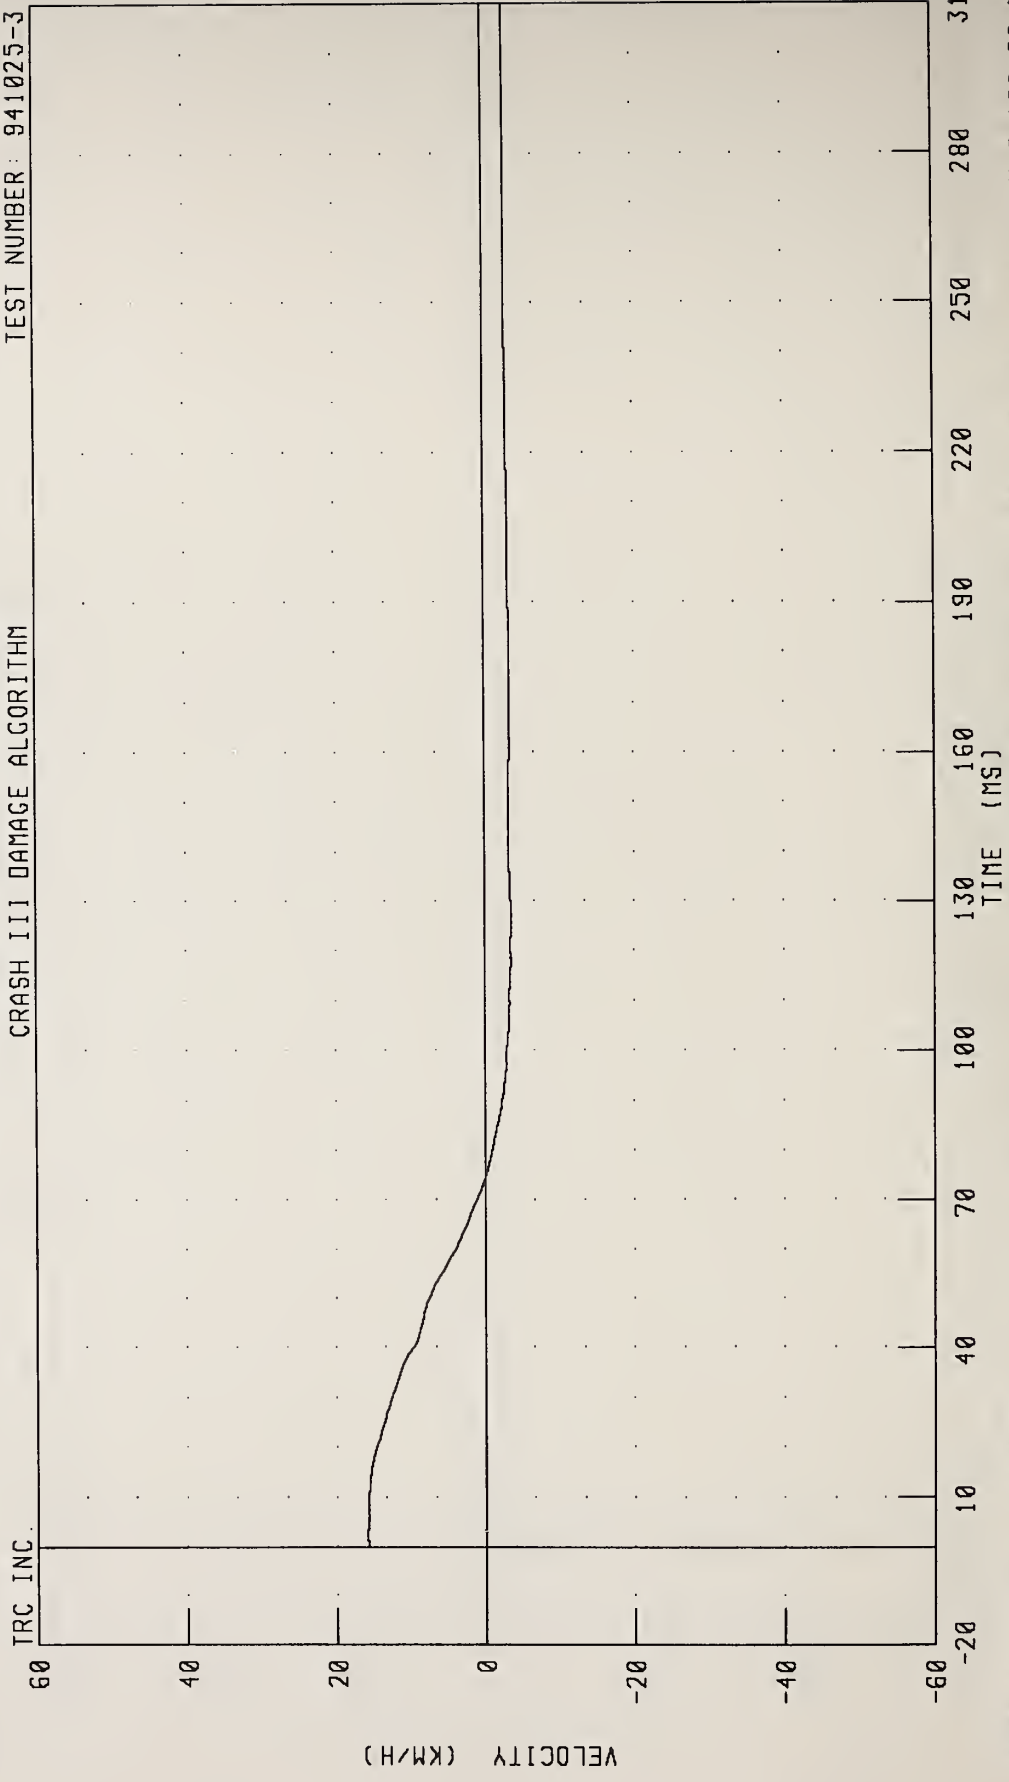
CRASH III DAMAGE ALGORITHM TEST NUMBER: 941025-3

CHANNEL: RFSXY FILTER: CH. CLASS 180

PEAK DATA: 15.86 KM/H @ 2.24 MS; -3.51 KM/H @ 126.96 MS

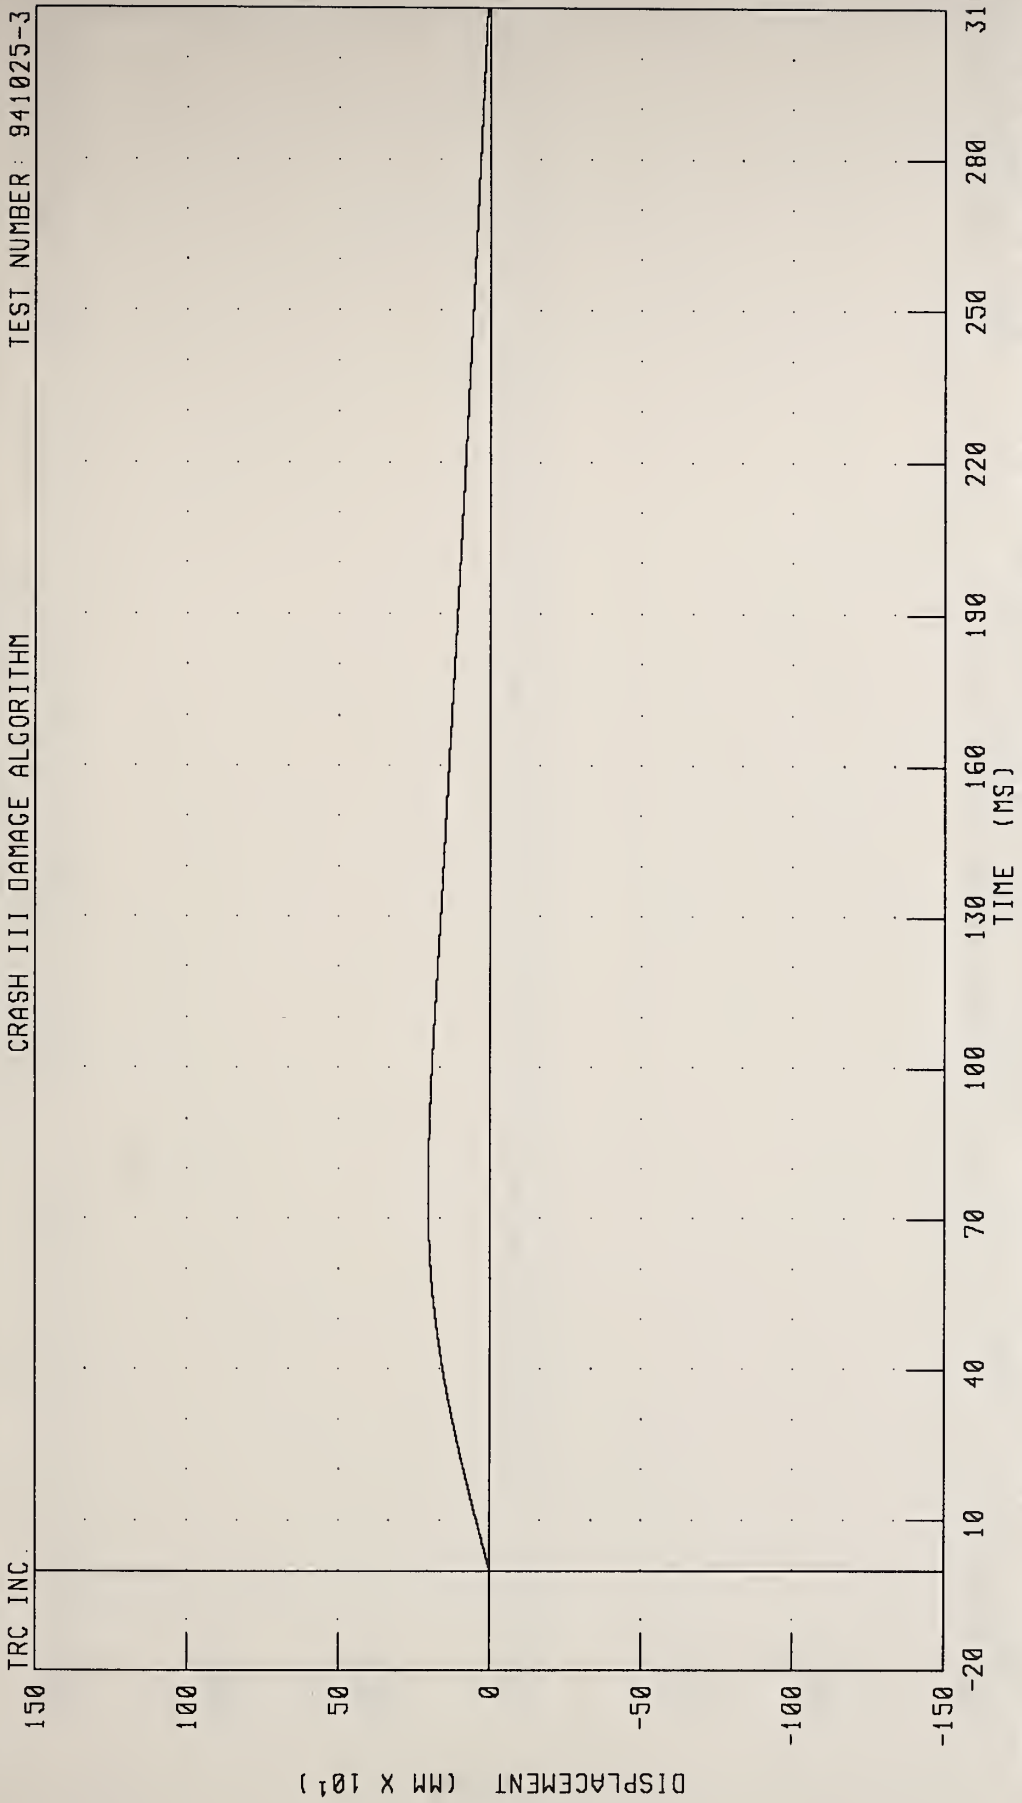
TRC INC. CRASH III DAMAGE ALGORITHM TEST NUMBER: 941025-3

CHANNEL: RFSXD FILTER: CH. CLASS 180

PEAK DATA: 204.38 MM @ 74.56 MS; 0.00 MM @ 0.00 MS

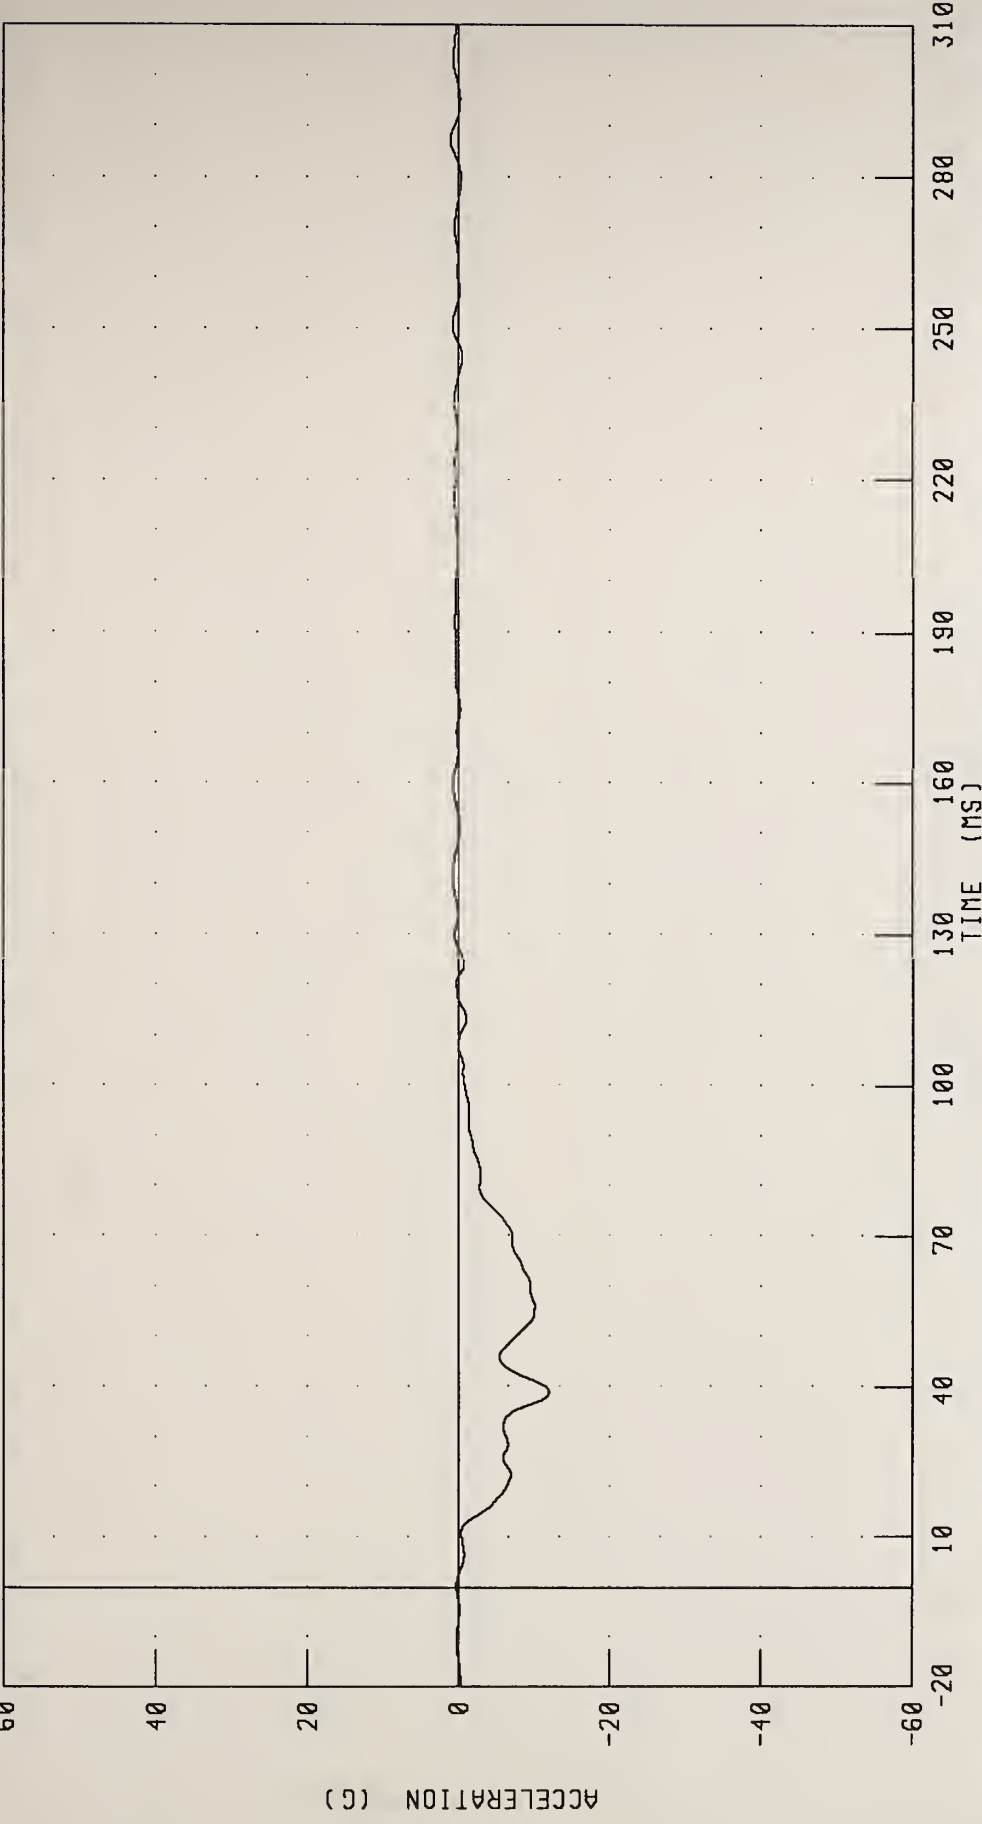
TEST NUMBER: 941025-3

CHANNEL: LRSXG FILTER: CH. CLASS 60

PEAK DATA: 1.09 G @ 287.20 MS; -11.94 G @ 38.96 MS
