DOT HS 808 217

Final Report

Final Report of a 1992 Plymouth Voyager into a 50% Left Offset Barrier in Support of CRASH3 Damage Algorithm Reformulation

The purpose of the five (5) 50% left offset barrier impact tests was for research and development in support of the CRASH3 damage algorithm reformulation.

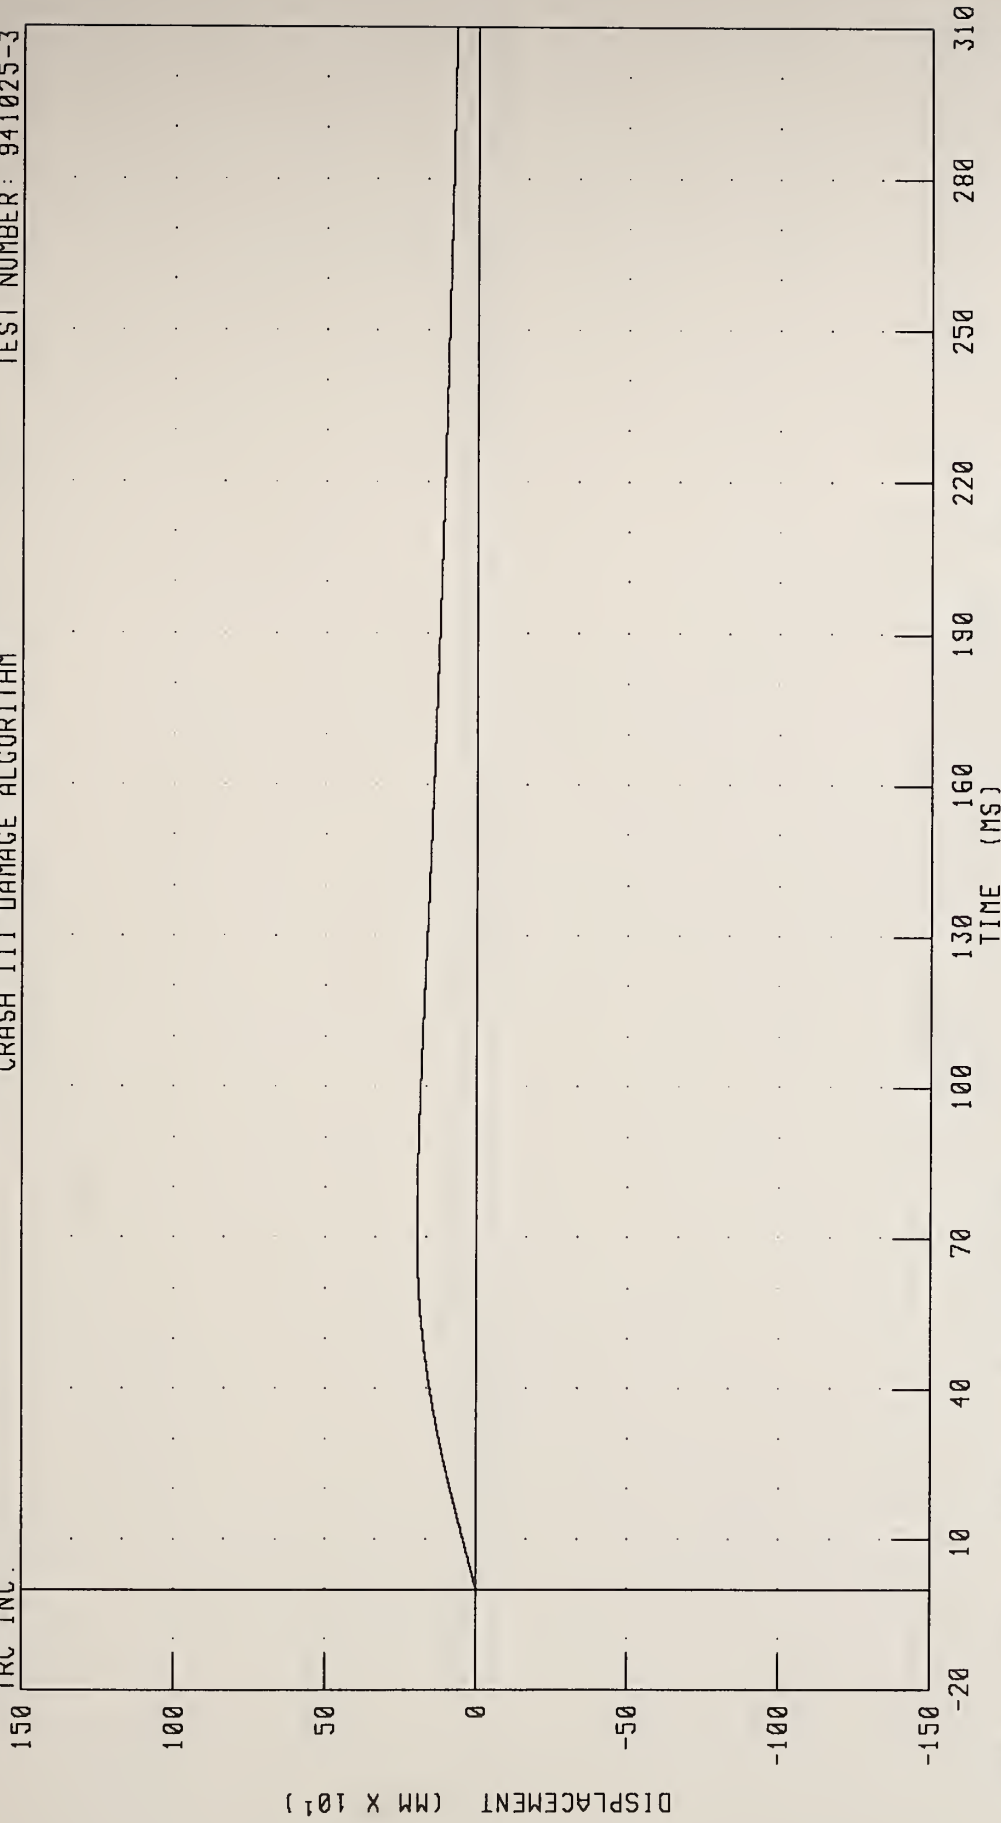
TEST NUMBER: 941025-3

CHANNEL: LRSXD FILTER: CH. CLASS 180

PEAK DATA: 196.82 MM @ 72.64 MS; 0.00 MM @ 0.00 MS

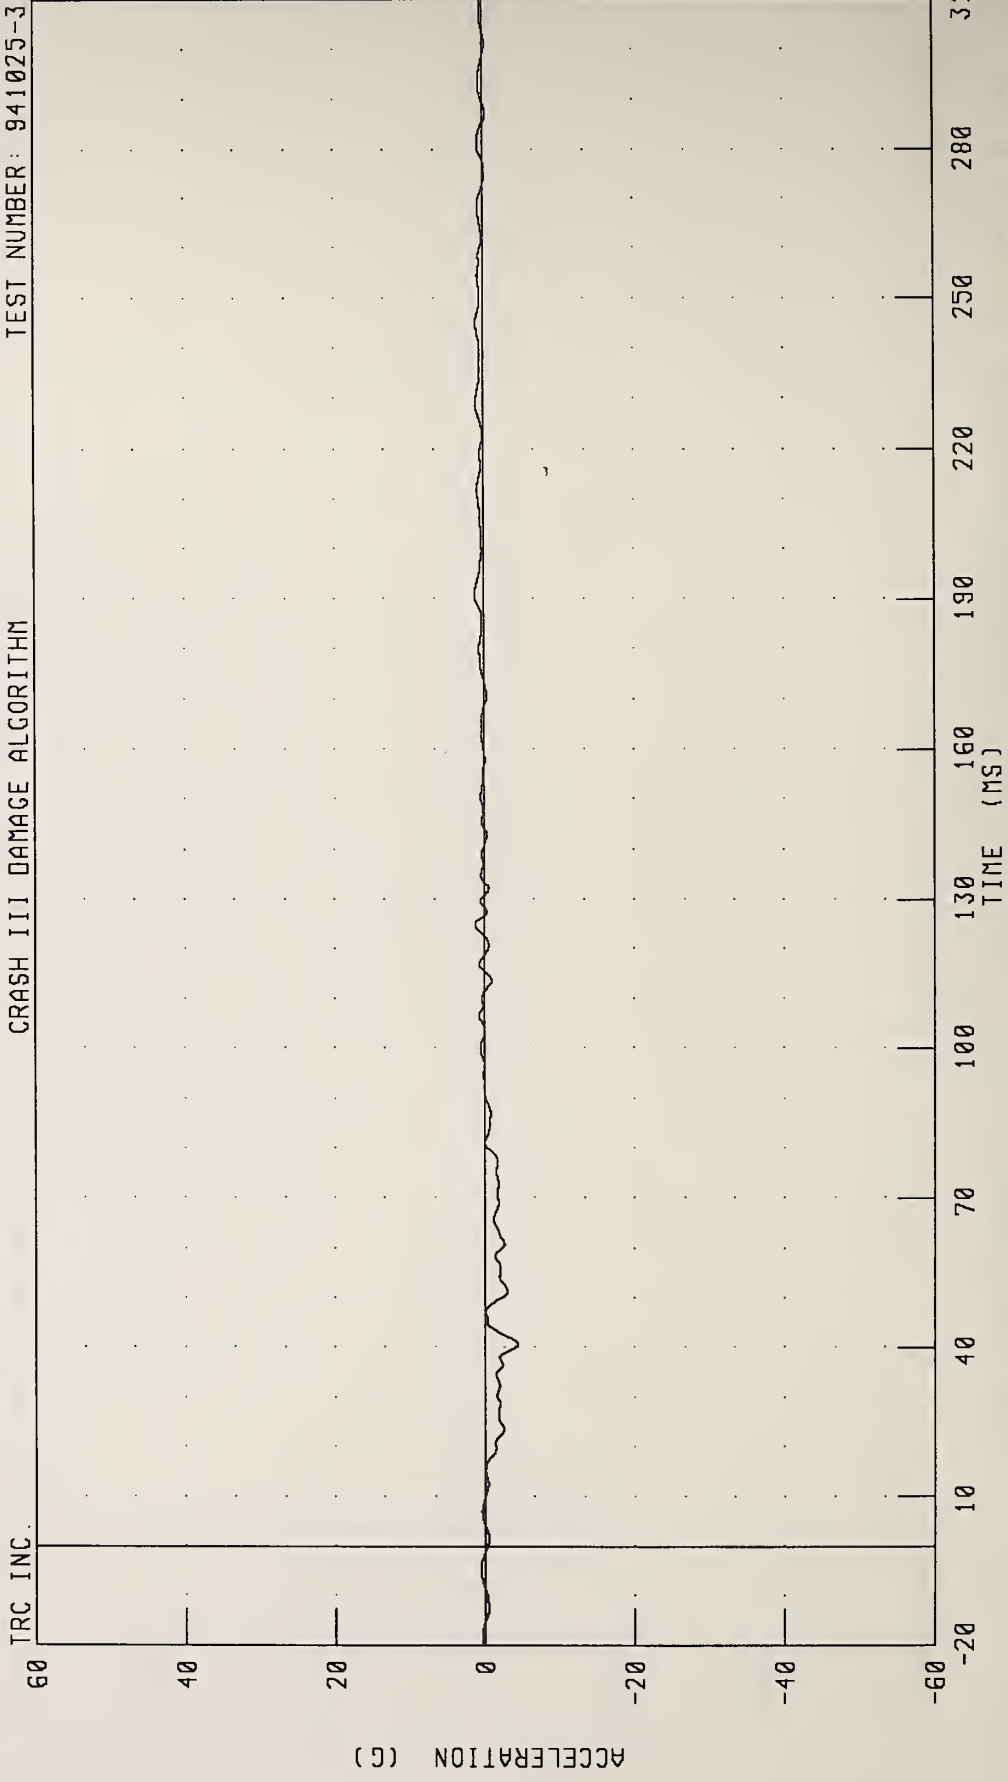
TEST NUMBER: 941025-3

1992 PLYMOUTH VOYAGER INTO 50% LEFT OFFSET BARRIER IMPACT 3 OF 5
LEFT REAR SILL Y-AXIS ACCELERATION
CRASH III DAMAGE ALGORITHM

CHANNEL: LRSYG FILTER: CH. CLASS 60

PEAK DATA: 1.27 G @ 125.04 MS; -4.42 G @ 40.72 MS

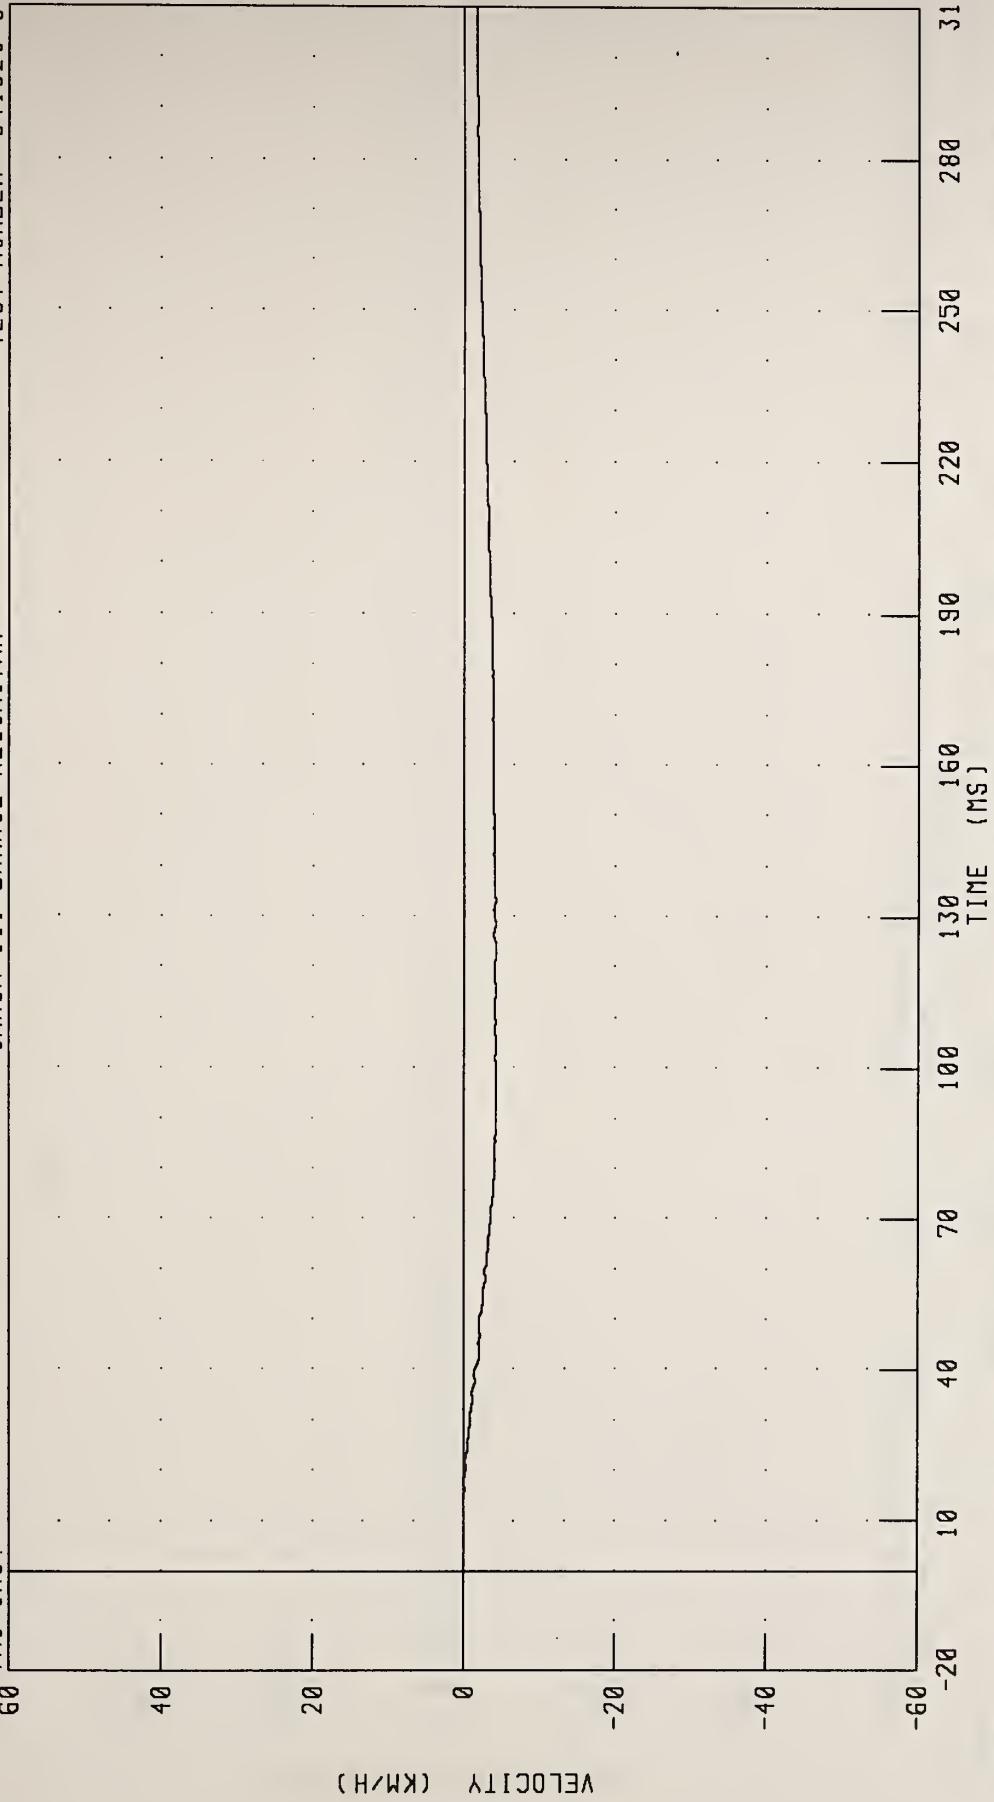
CHANNEL: LRSYV FILTER: CH. CLASS 180

PEAK DATA: 0.01 KM/H @ 11.28 MS; -4.27 KM/H @ 97.92 MS

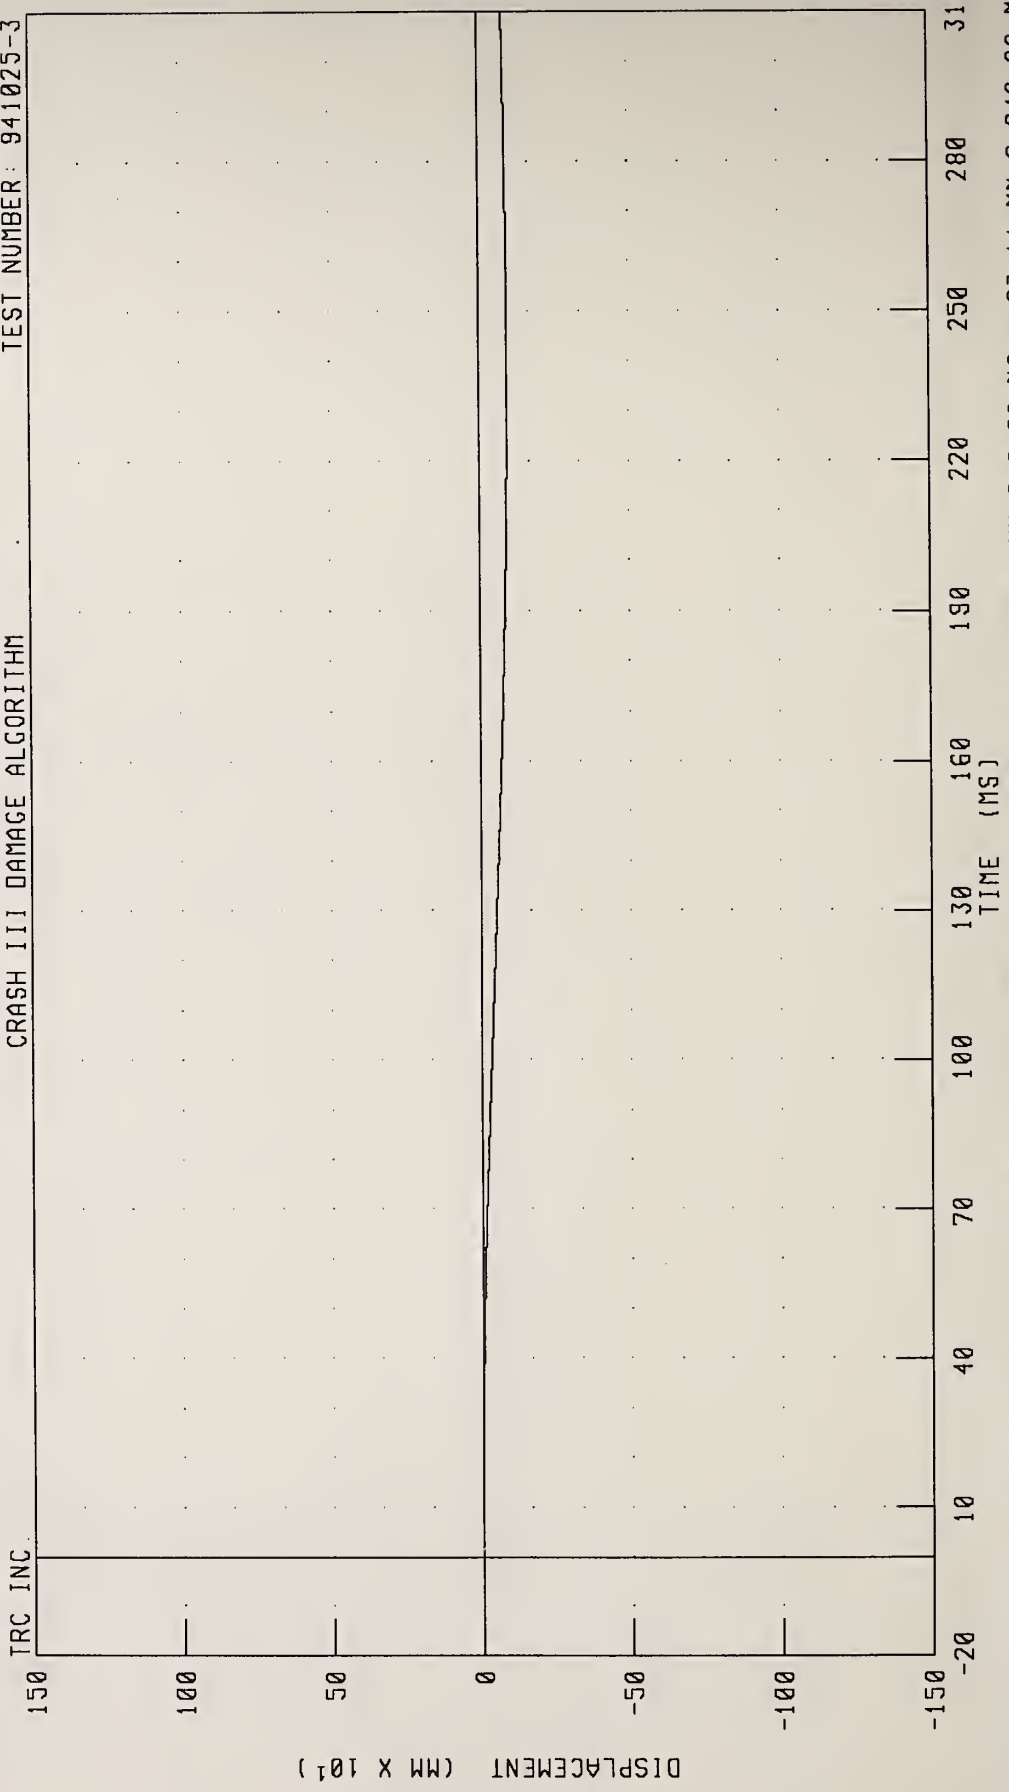
TEST NUMBER: 941025-3

CHANNEL: RRSYD FILTER: CH. CLASS 180

PEAK DATA: 0.11 MM @ 9.68 MS; -93.11 MM @ 240.88 MS

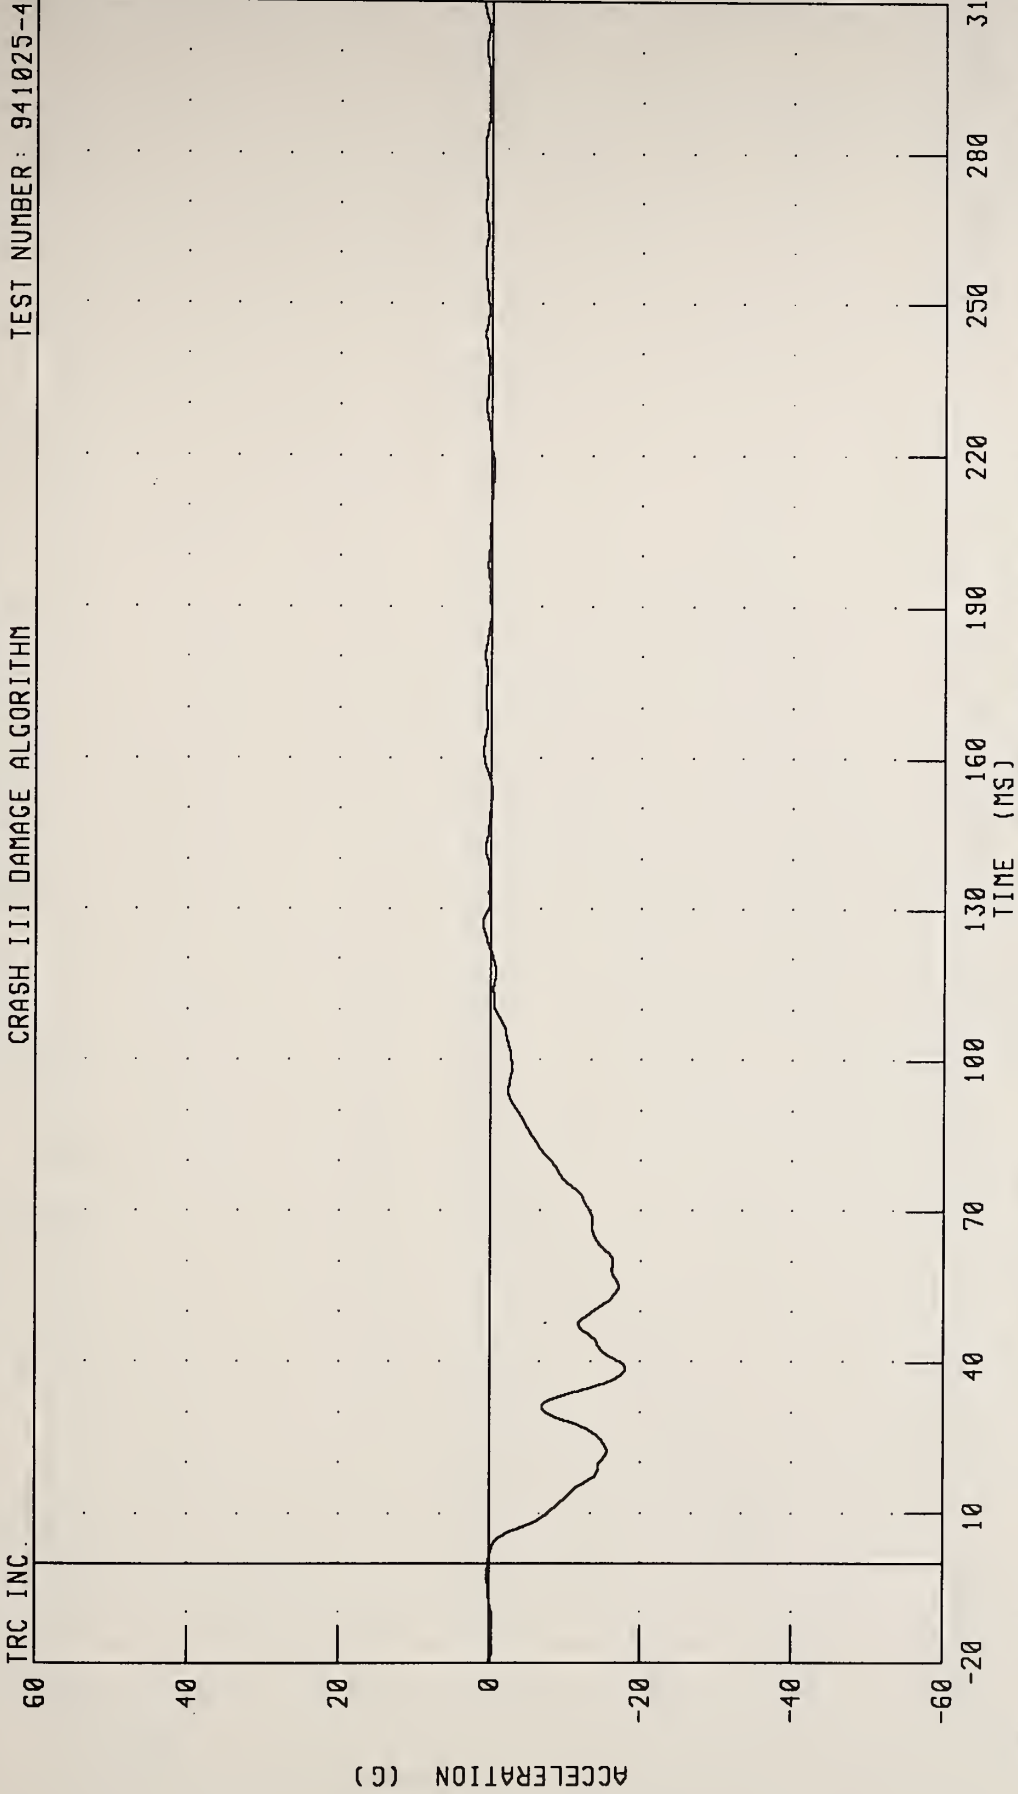
TRC INC. CRASH III DAMAGE ALGORITHM TEST NUMBER: 941025-4

CHANNEL: VCGXG FILTER: CH. CLASS 60

PEAK DATA: 1.08 G @ 127.20 MS, -17.96 G @ 38.80 MS

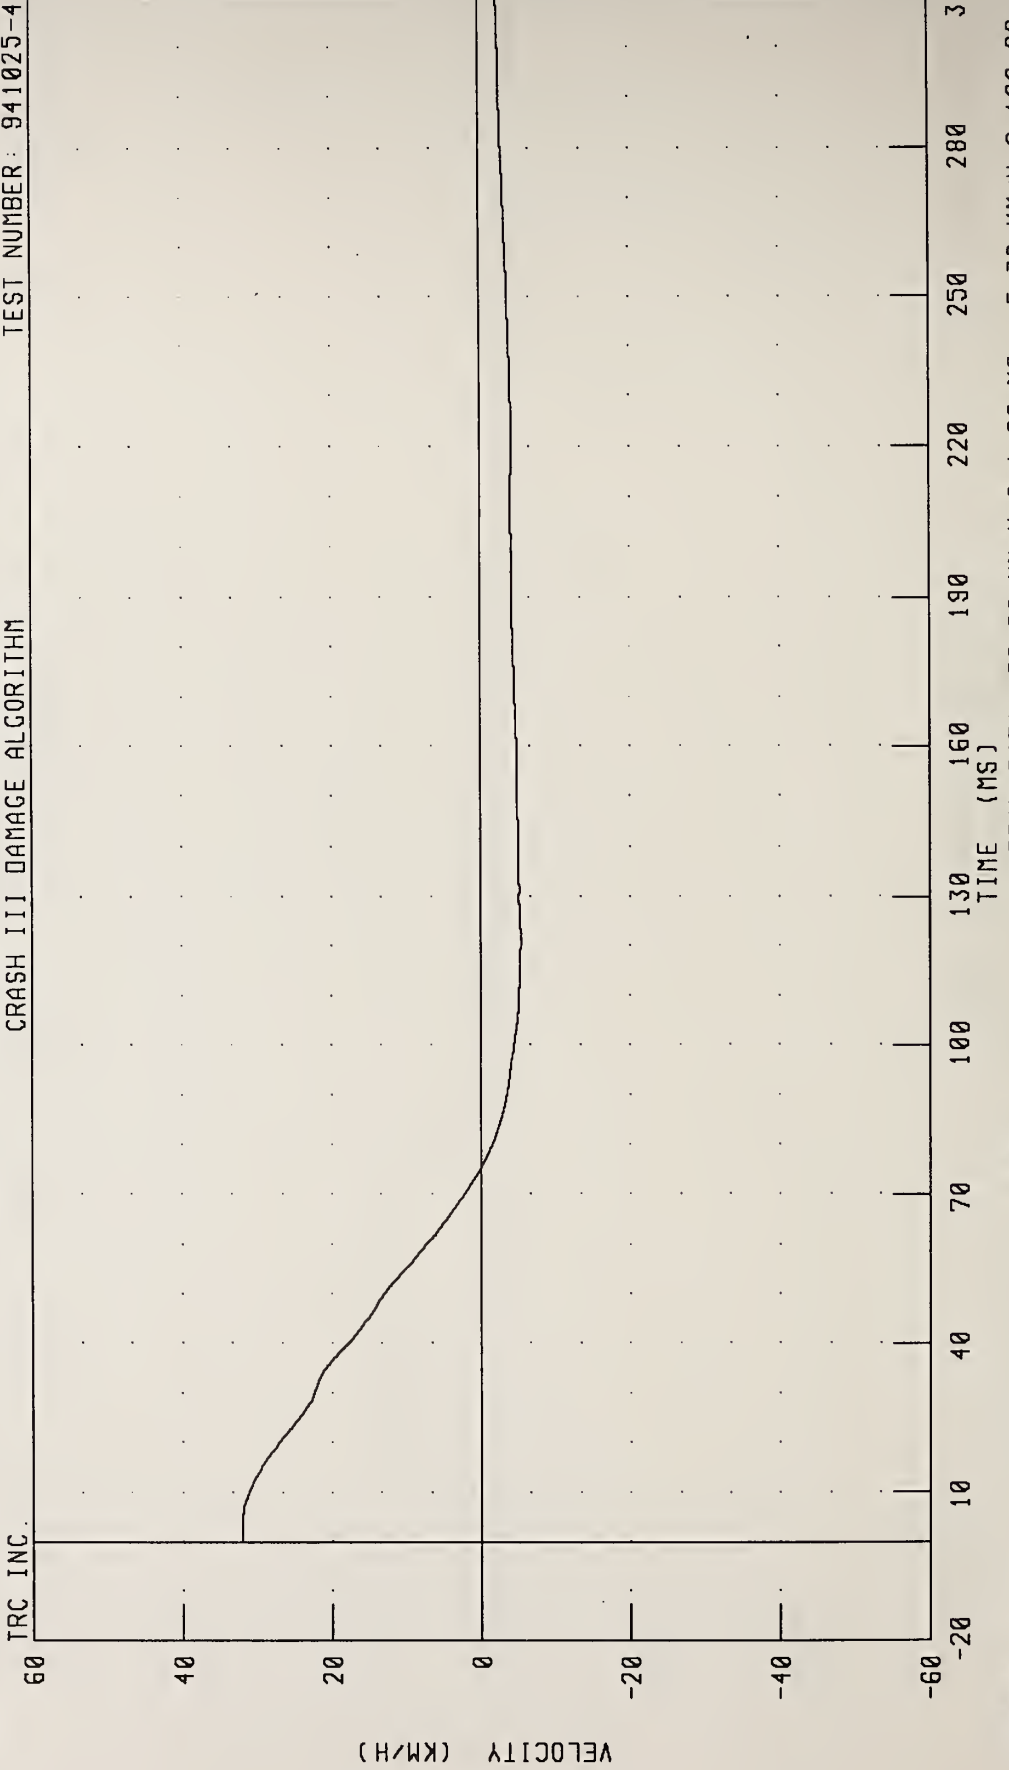
TEST NUMBER: 941025-4

CHANNEL: VCGXY FILTER: CH. CLASS 180

PEAK DATA: 32.02 KM/H @ 1.20 MS; -5.36 KM/H @ 122.00 MS

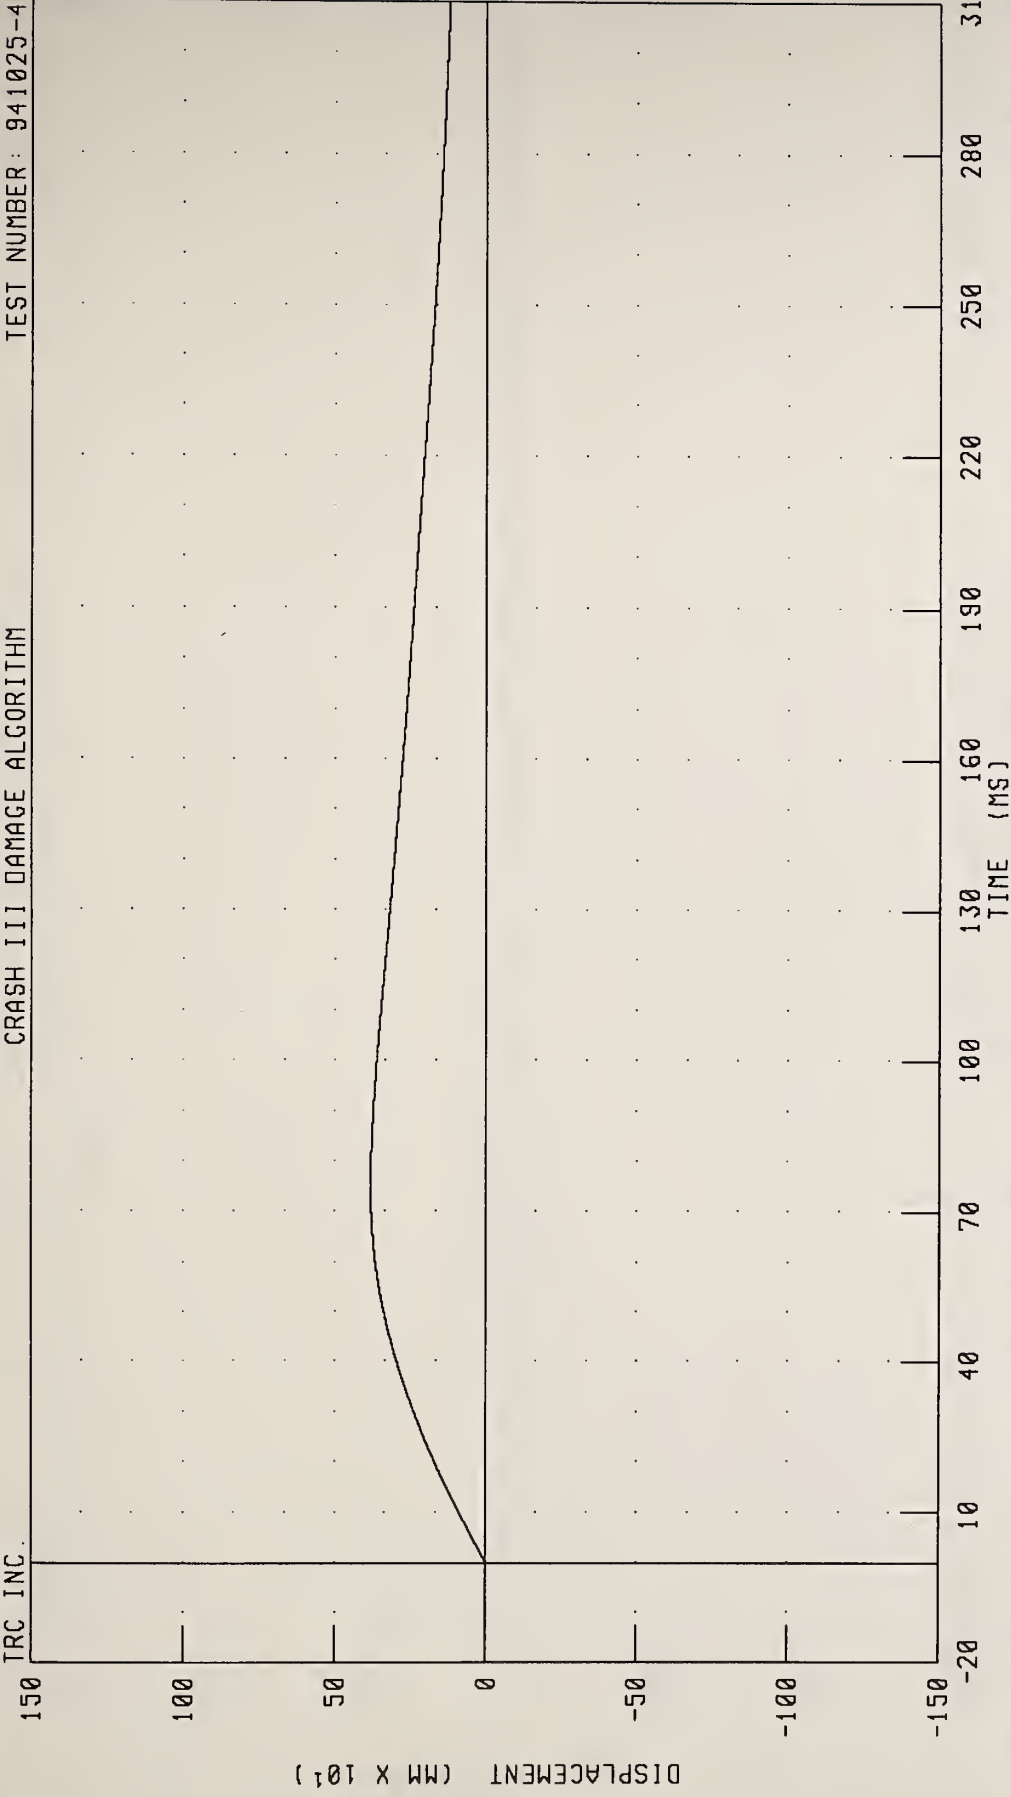
CRASH III DAMAGE ALGORITHM TEST NUMBER: 941025-4

CHANNEL: YCGXD FILTER: CH. CLASS 180

PEAK DATA: 380.99 MM @ 75.36 MS; 0.00 MM @ 0.00 MS

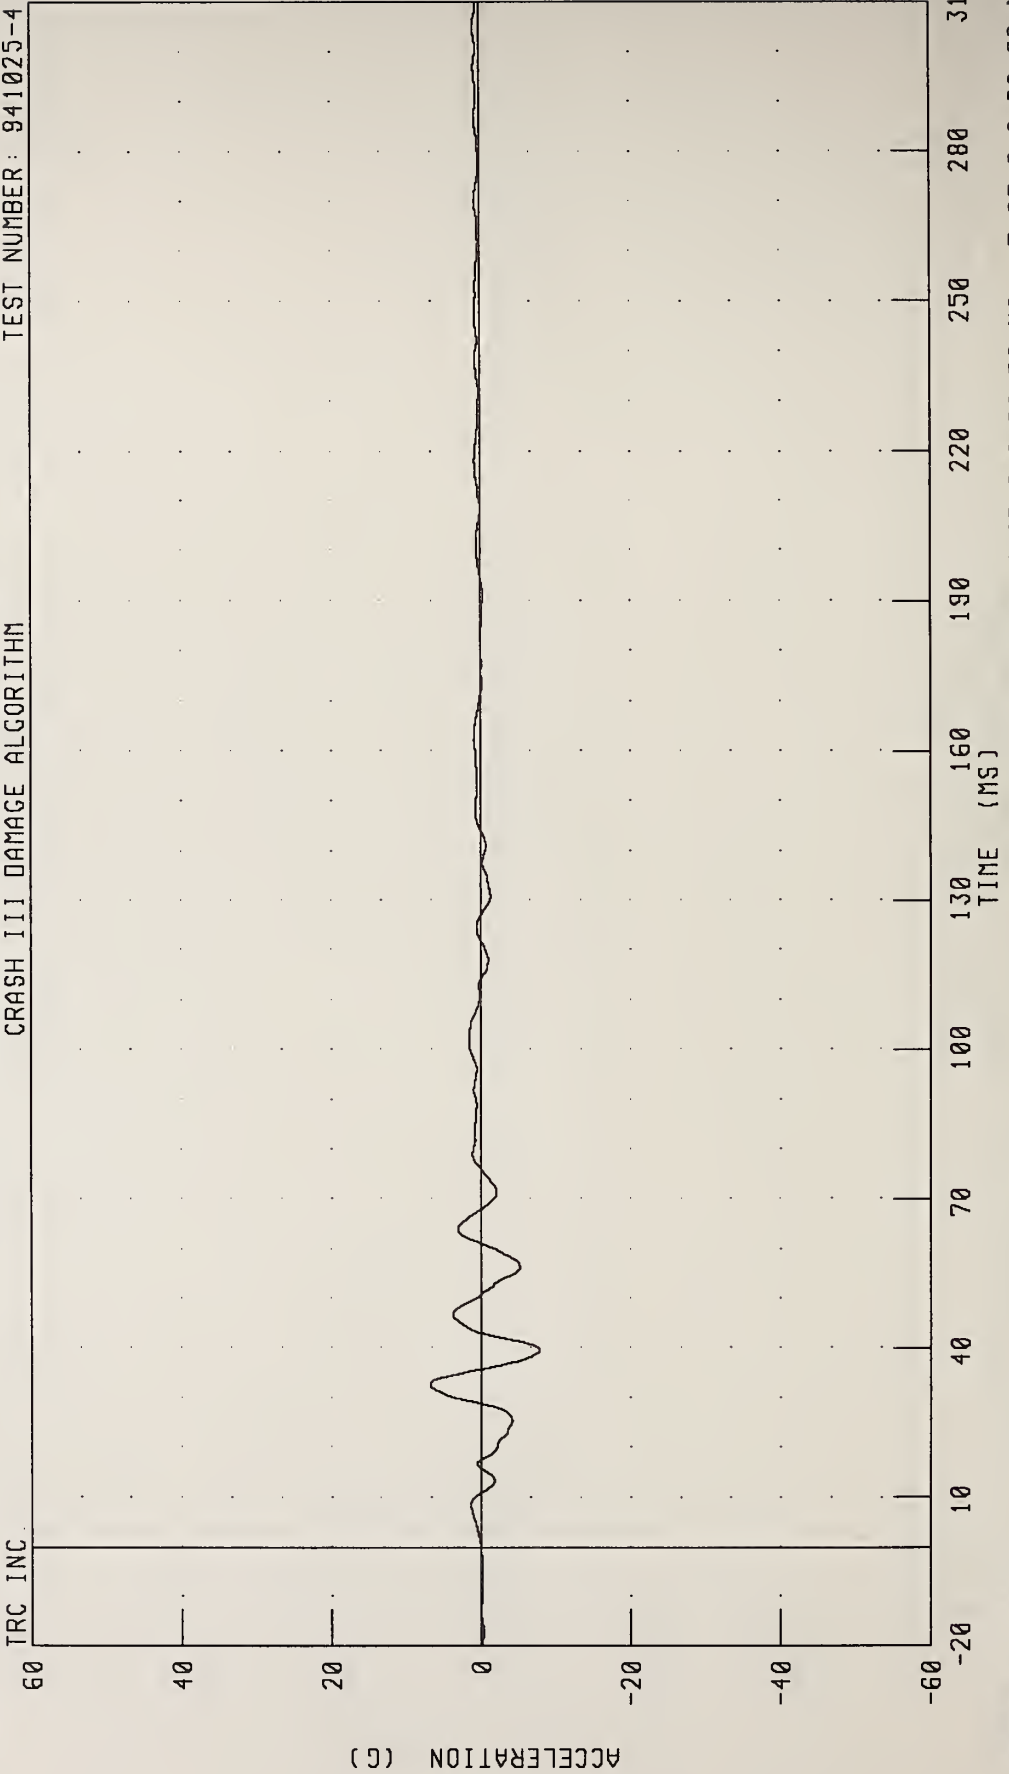
TEST NUMBER: 941025-4

CHANNEL: VCCYG FILTER: CH. CLASS 60

PEAK DATA: 6.85 G @ 32.72 MS; -7.83 G @ 39.68 MS

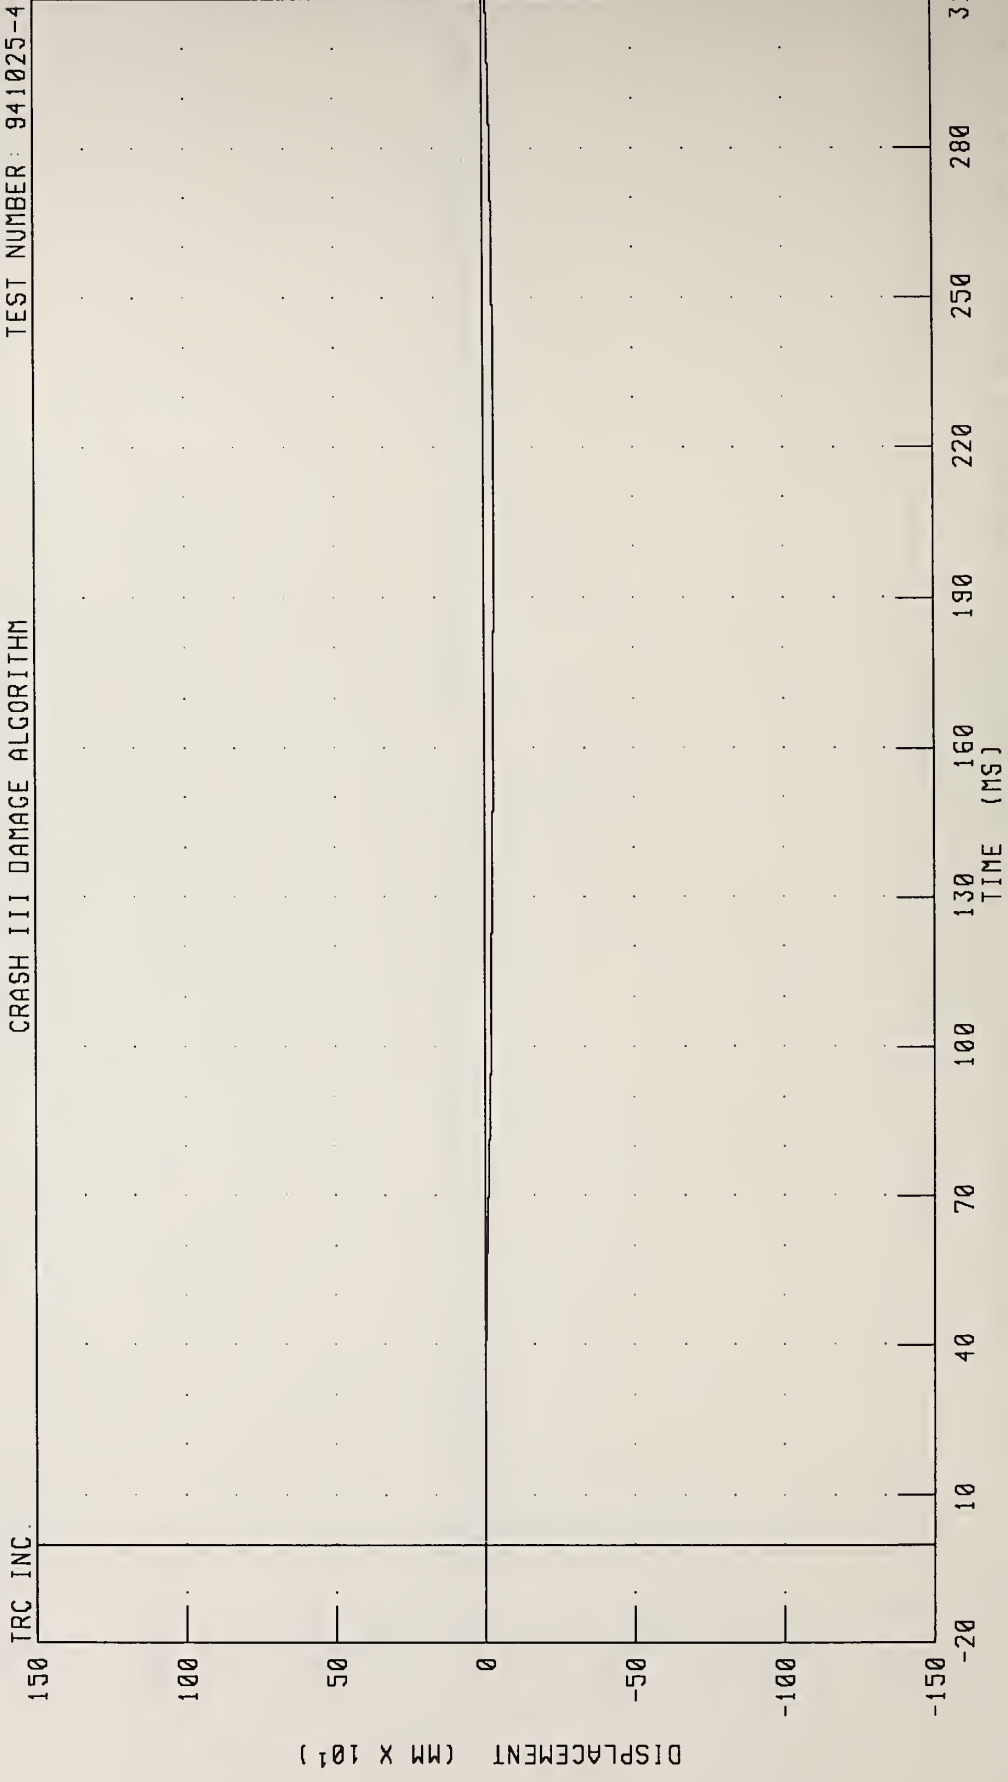
TEST NUMBER: 941025-4

1992 PLYMOUTH VOYAGER INTO 50% LEFT OFFSET BARRIER IMPACT 4 OF 5
VEHICLE CG Y-AXIS DISPLACEMENT
CRASH III DAMAGE ALGORITHM

CHANNEL: VCGYD FILTER: CH. CLASS 180

PEAK DATA: 0.61 MM @ 19.52 MS; -33.63 MM @ 218.40 MS

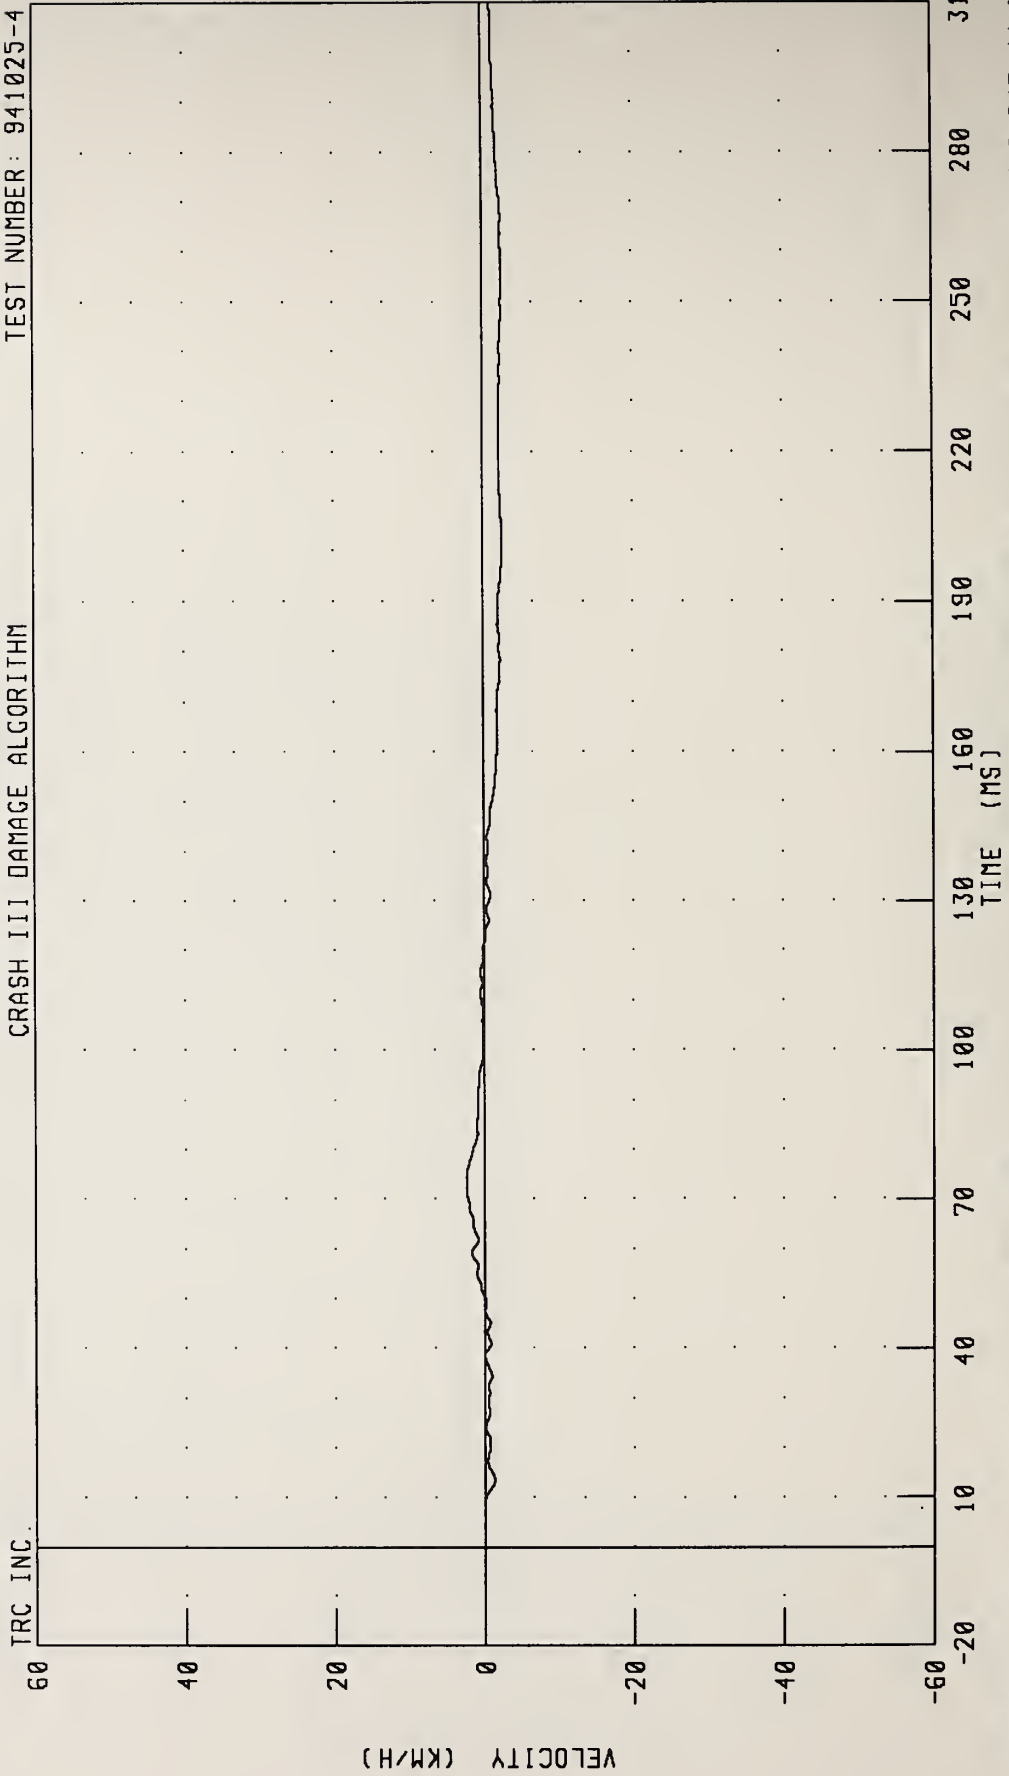
TEST NUMBER: 941025-4

CHANNEL: VCGZY FILTER: CH. CLASS 180

PEAK DATA: 2.38 KM/H @ 71.36 MS; -2.54 KM/H @ 247.44 MS

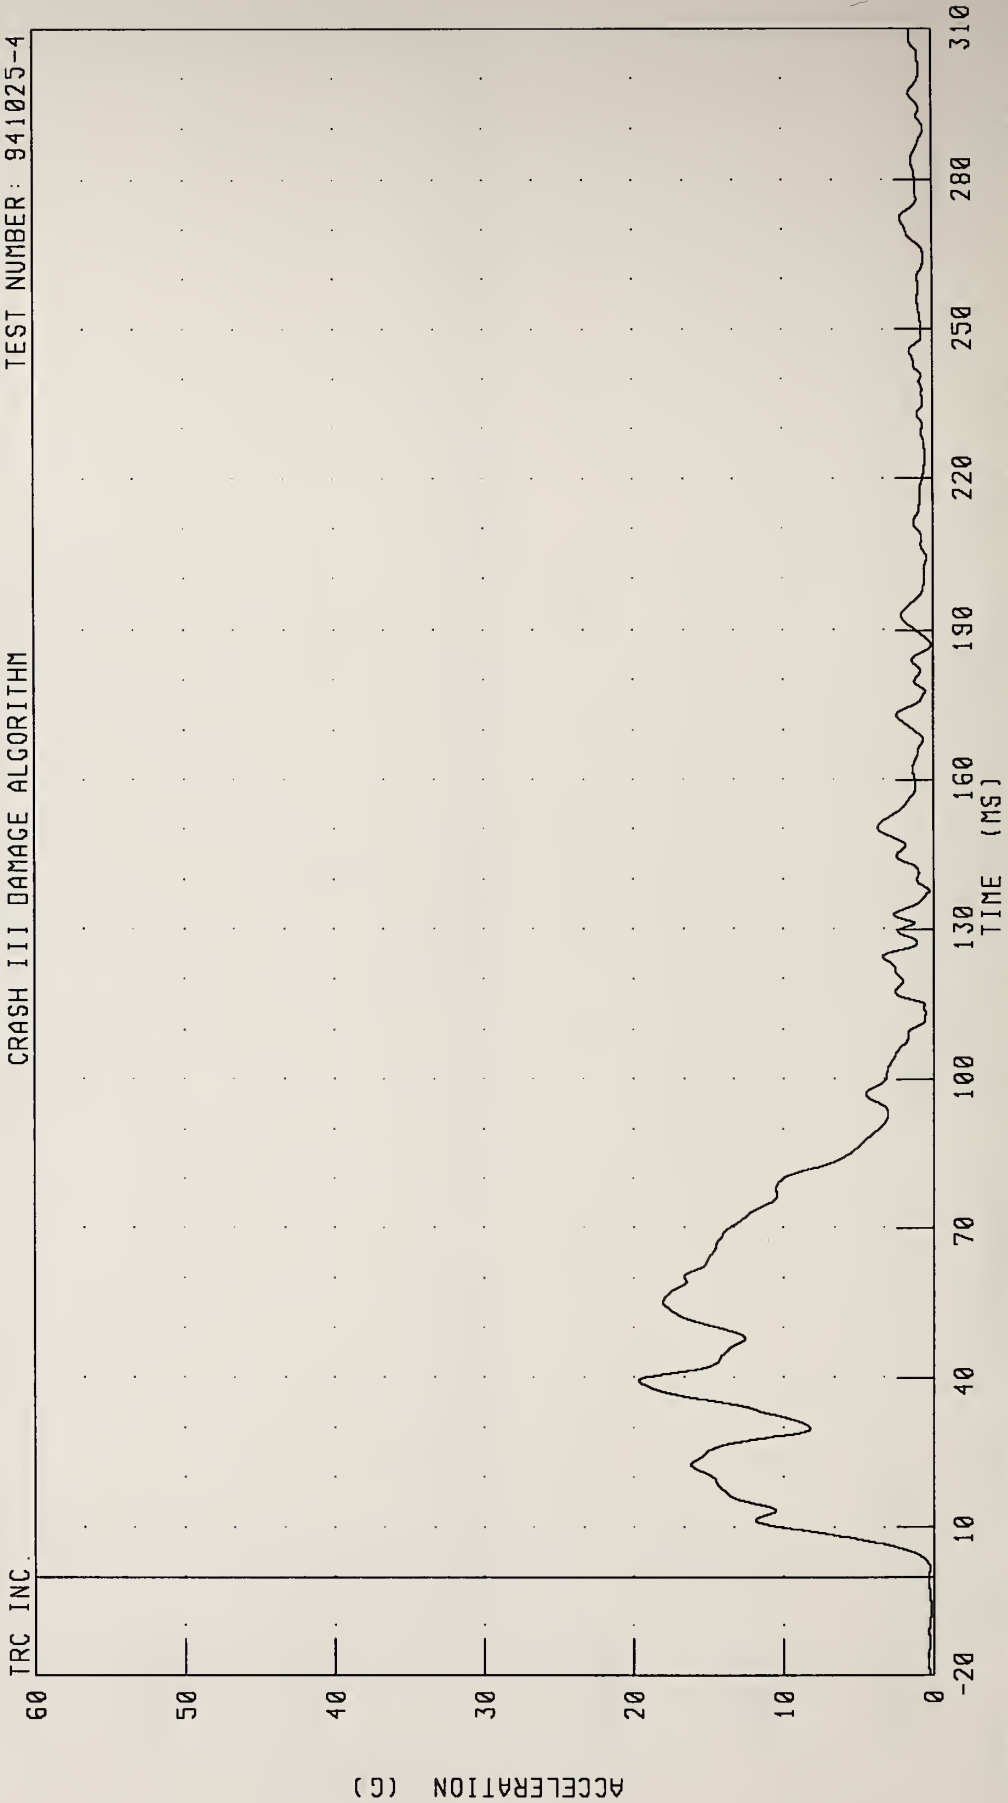
TEST NUMBER: 941025-4

CHANNEL: VCGRG FILTER: CH. CLASS 60

PEAK DATA: 19.71 G @ 39.44 MS; 18.68 G @ 186.88 MS

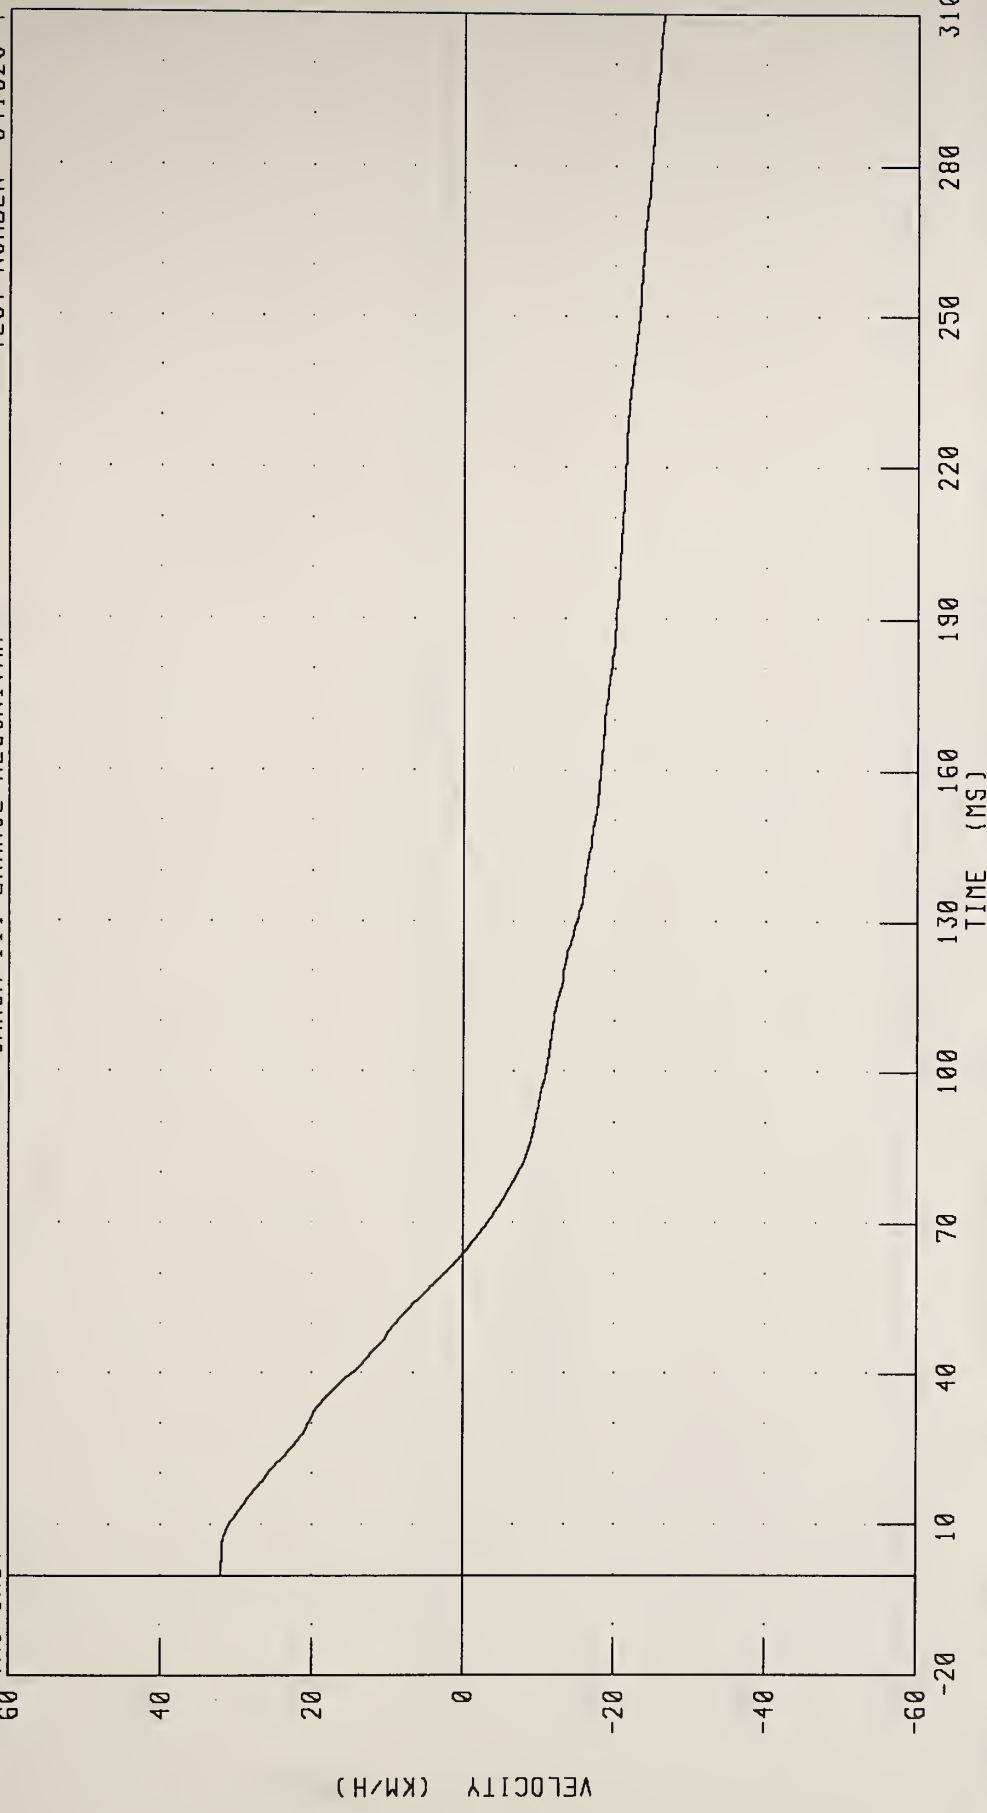
CRASH III DAMAGE ALGORITHM TEST NUMBER: 941025-4

CHANNEL: VCGRV FILTER: CH. CLASS 180

PEAK DATA: 32.00 KM/H @ 0.00 MS; -26.39 KM/H @ 310.00 MS
