DOT HS 808 217

Final Report

Final Report of a 1992 Plymouth Voyager into a 50% Left Offset Barrier in Support of CRASH3 Damage Algorithm Reformulation

The purpose of the five (5) 50% left offset barrier impact tests was for research and development in support of the CRASH3 damage algorithm reformulation.

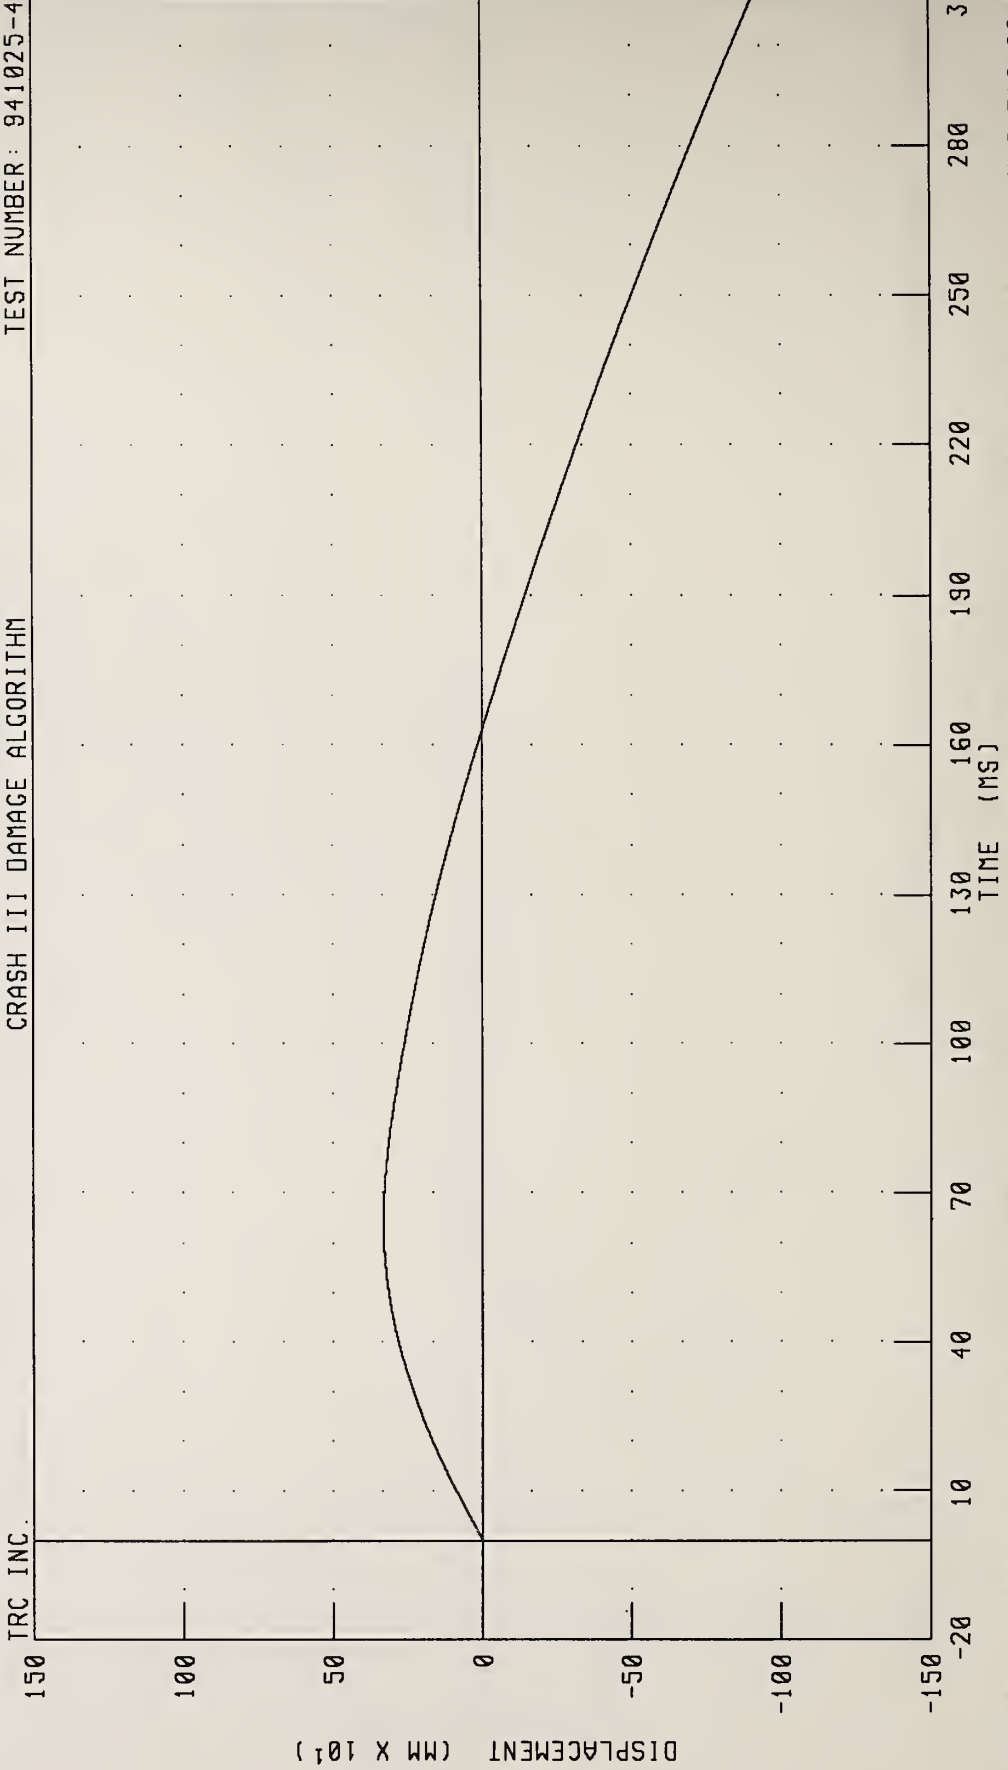
CRASH III DAMAGE ALGORITHM TEST NUMBER: 941025-4

CHANNEL: VCGRD FILTER: CH. CLASS 180

PEAK DATA: 331.15 MM @ 64.00 MS; -913.32 MM @ 310.00 MS

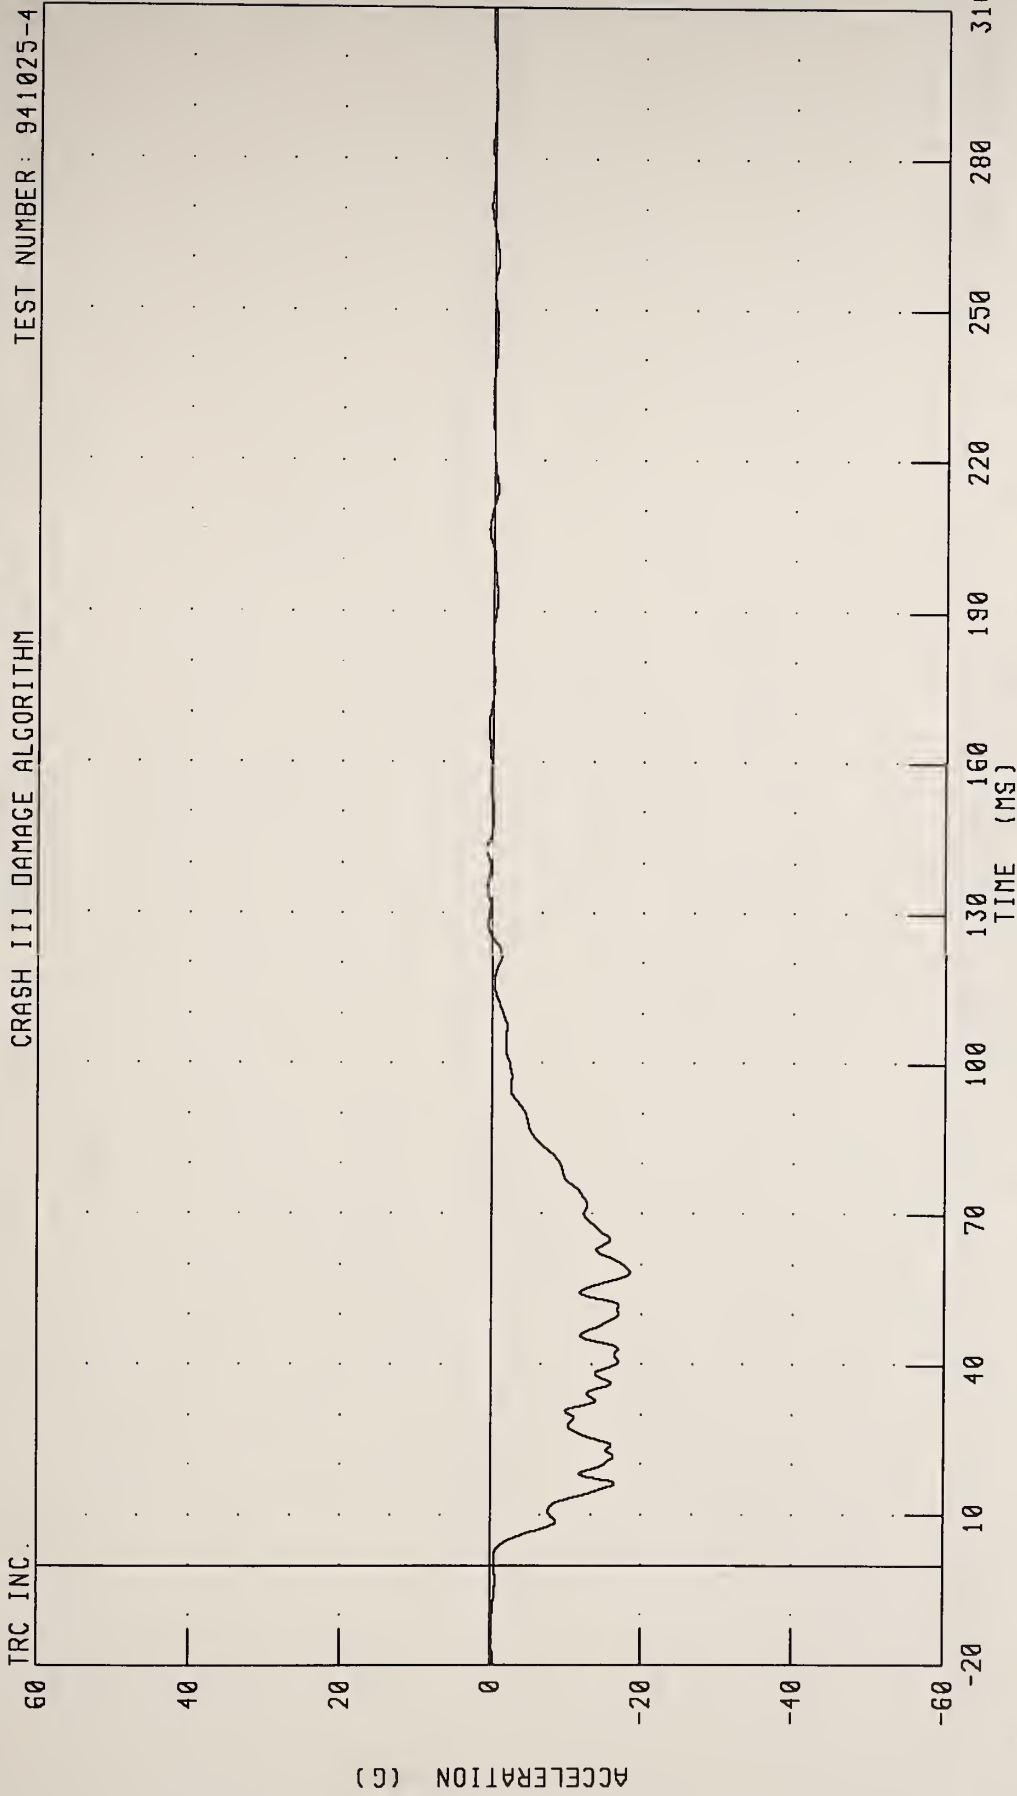
CRASH III DAMAGE ALGORITHM TEST NUMBER: 941025-4

CHANNEL: LFSXG FILTER: CH. CLASS 60

PEAK DATA: 0.72 G @ 143.04 MS; -18.47 G @ 58.56 MS

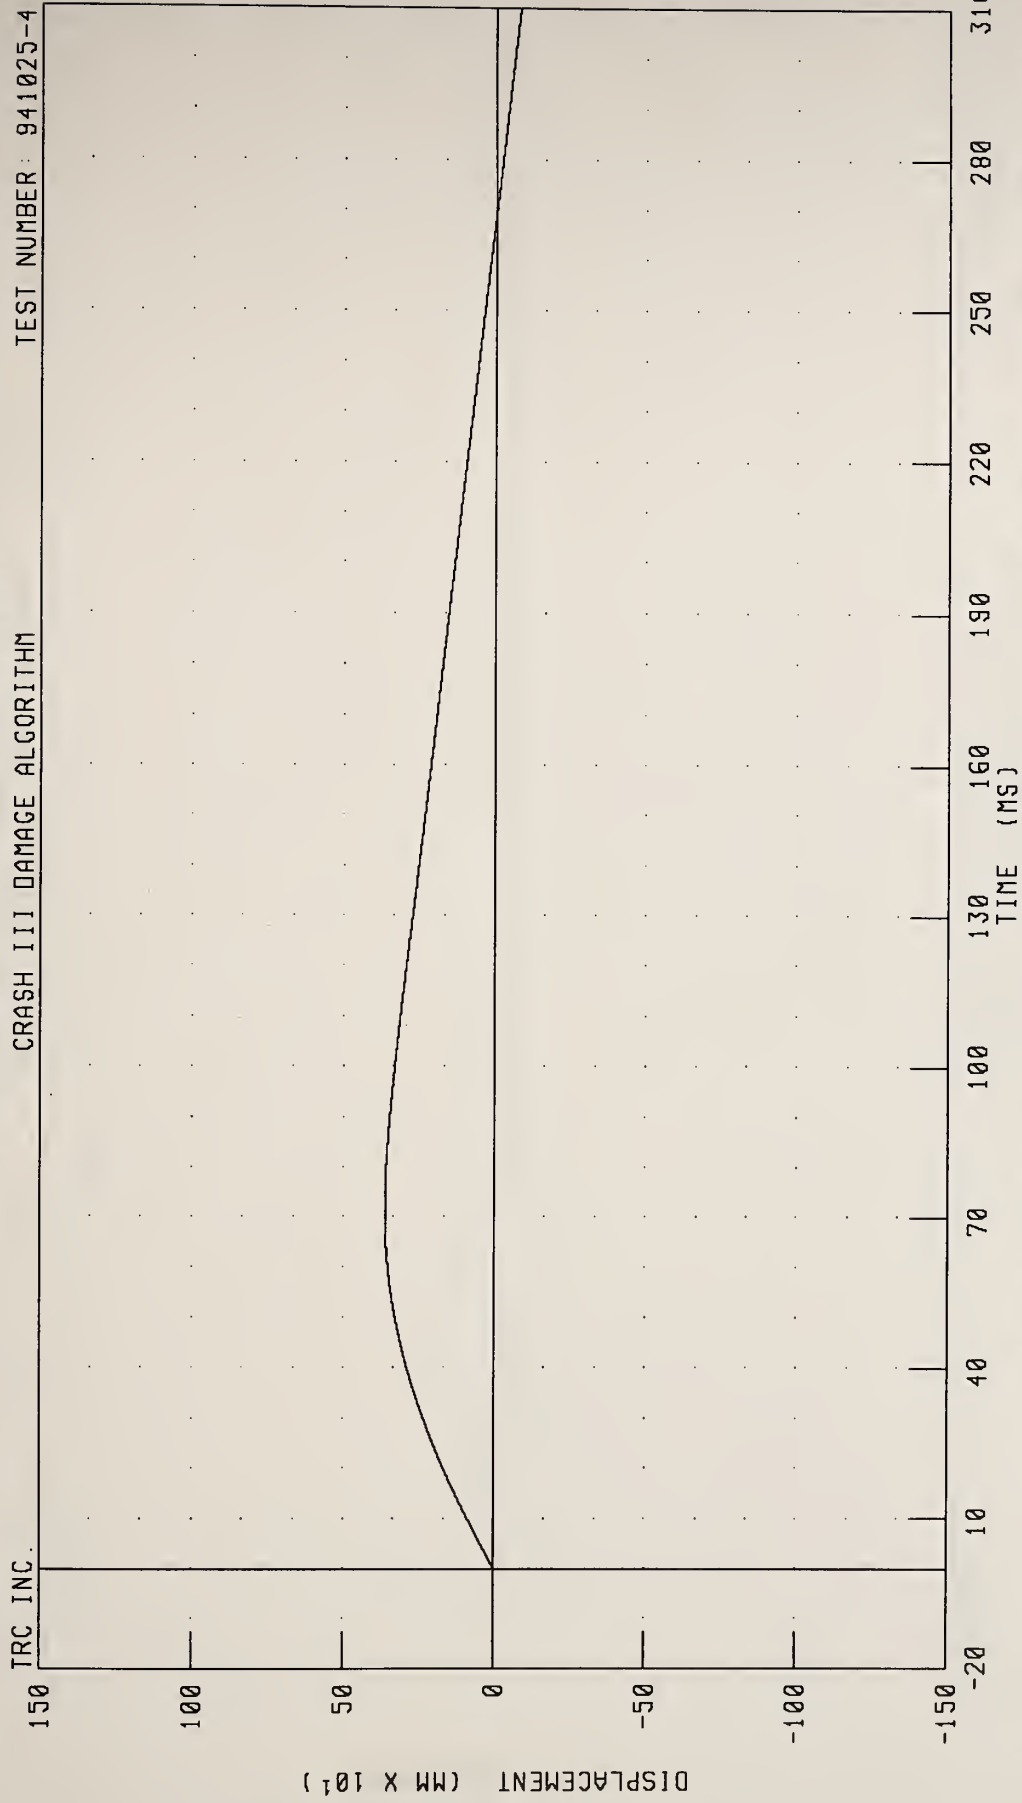
CRASH III DAMAGE ALGORITHM TEST NUMBER: 941025-4

CHANNEL: LFSXD FILTER: CH. CLASS 180

PEAK DATA: 362.11 MM @ 72.00 MS; -80.10 MM @ 310.00 MS

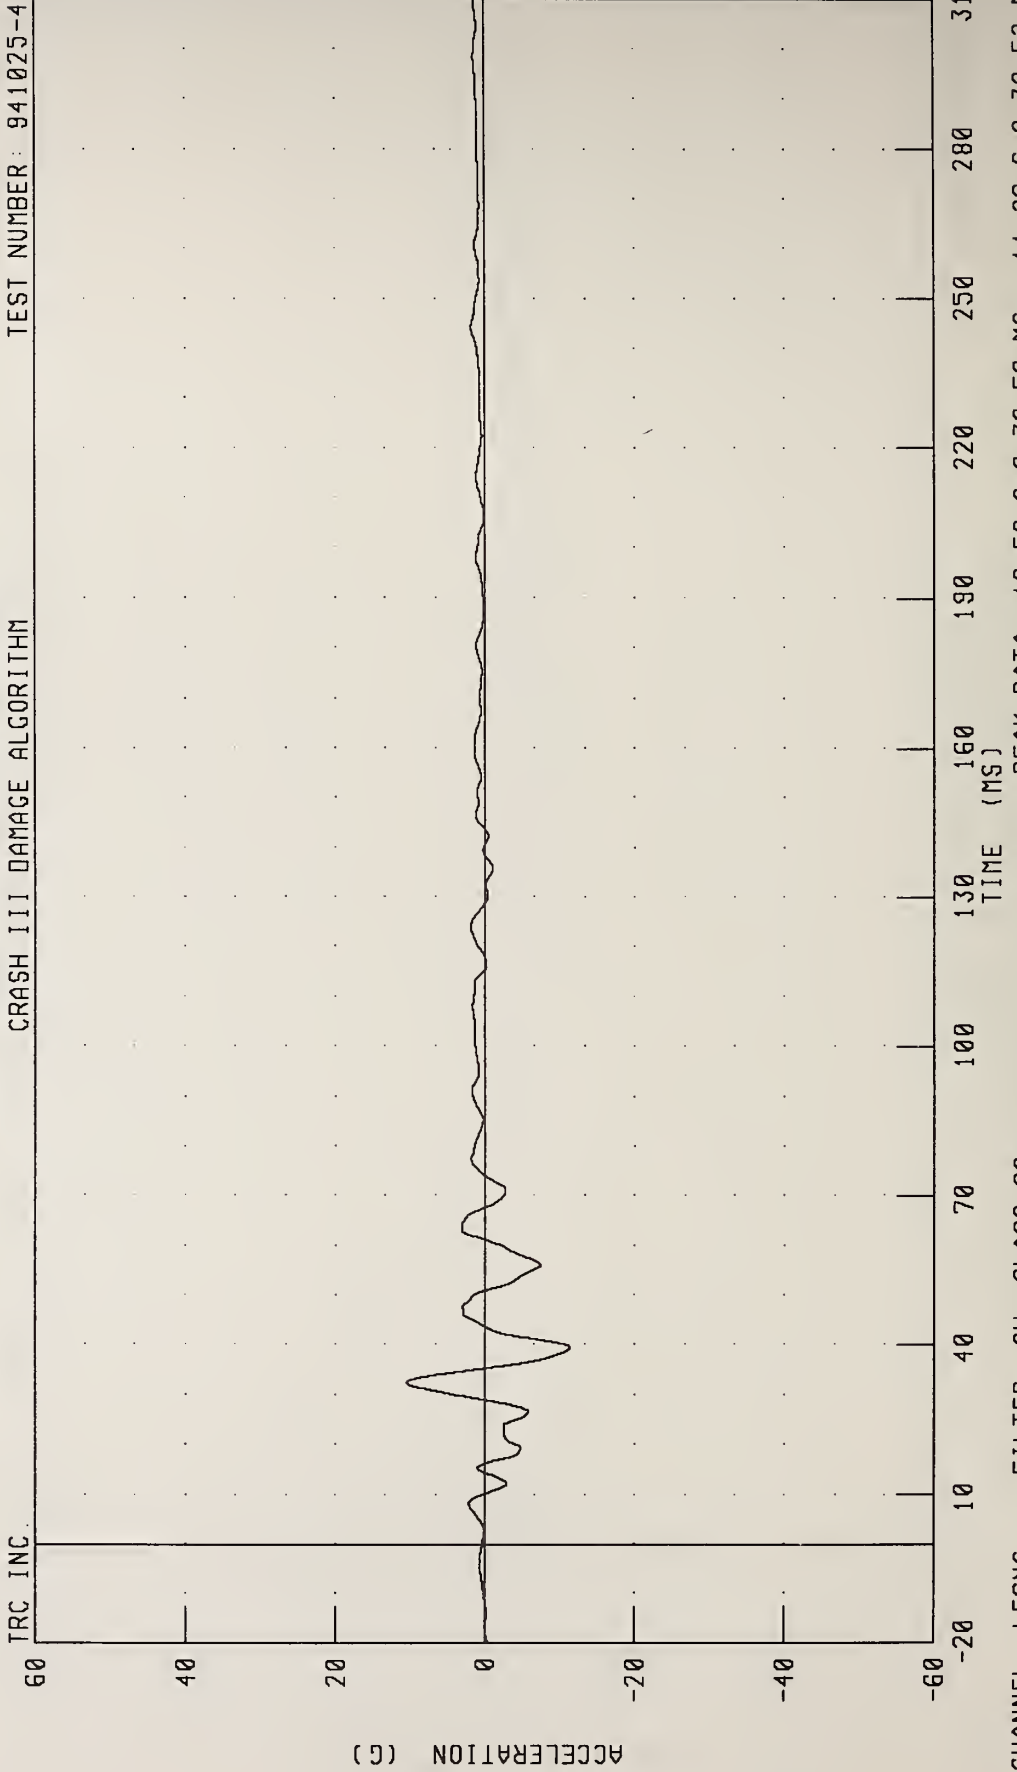
CRASH III DAMAGE ALGORITHM TEST NUMBER: 941025-4

CHANNEL: LFSYG FILTER: CH. CLASS 60

PEAK DATA: 10.56 G @ 32.56 MS; -11.28 G @ 39.52 MS

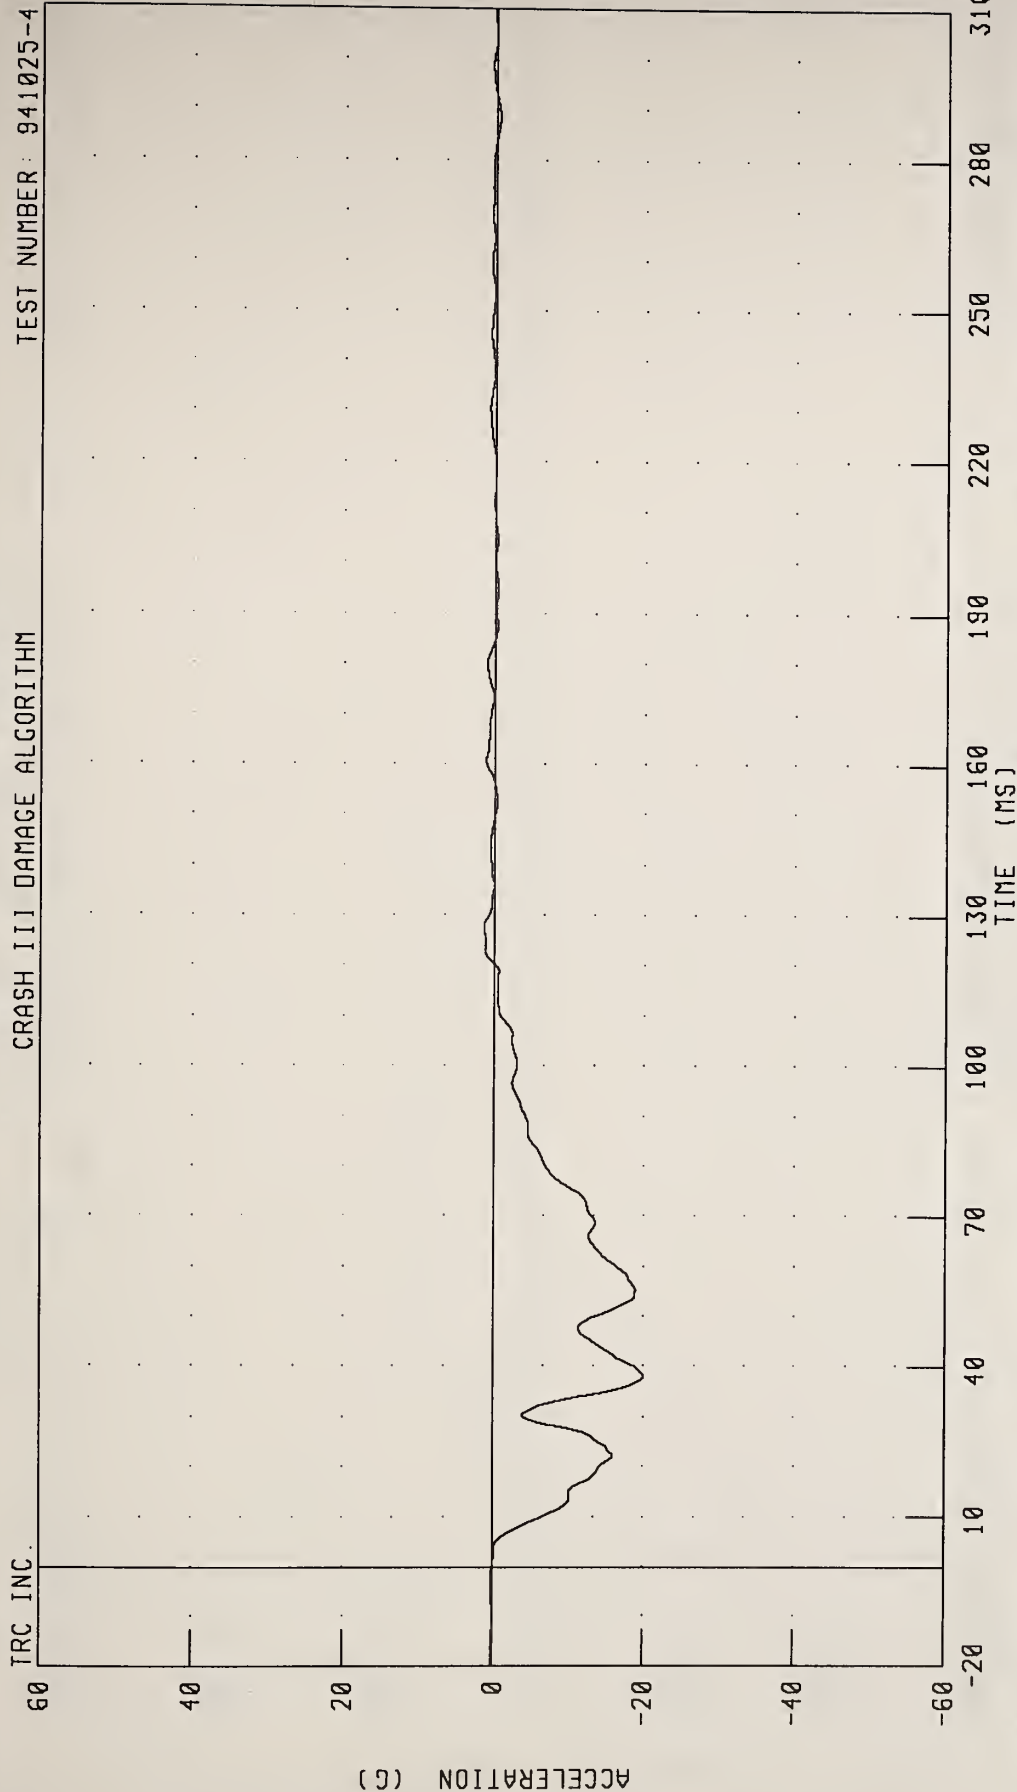
TEST NUMBER: 941025-4

1992 PLYMOUTH VOYAGER INTO 50% LEFT OFFSET BARRIER IMPACT 4 OF 5
RIGHT FRONT SILL X-AXIS ACCELERATION
CRASH III DAMAGE ALGORITHM

CHANNEL: RFSXG FILTER: CH. CLASS 60

PEAK DATA: 1.43 G @ 127.60 MS; -19.96 G @ 38.00 MS

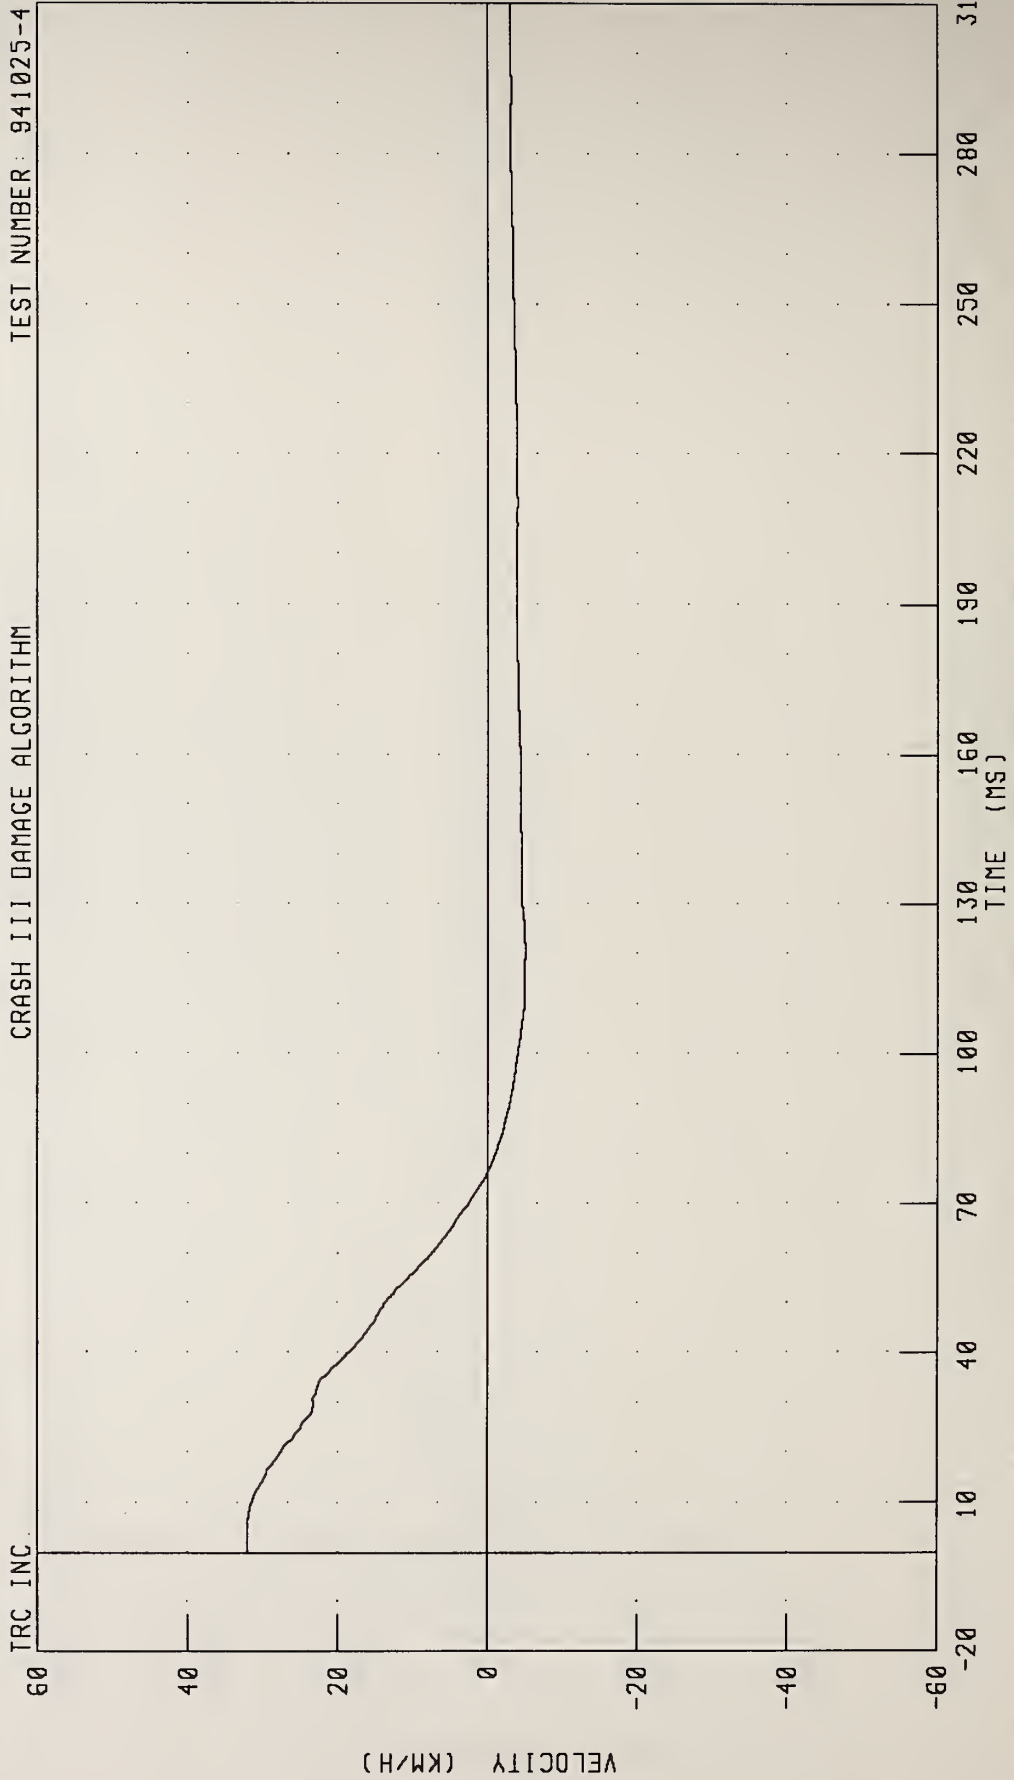
CRASH III DAMAGE ALGORITHM TEST NUMBER: 941025-4

CHANNEL: RFSXV FILTER: CH. CLASS 180

PEAK DATA: 32.00 KM/H @ 1.44 MS; -5.08 KM/H @ 120.64 MS

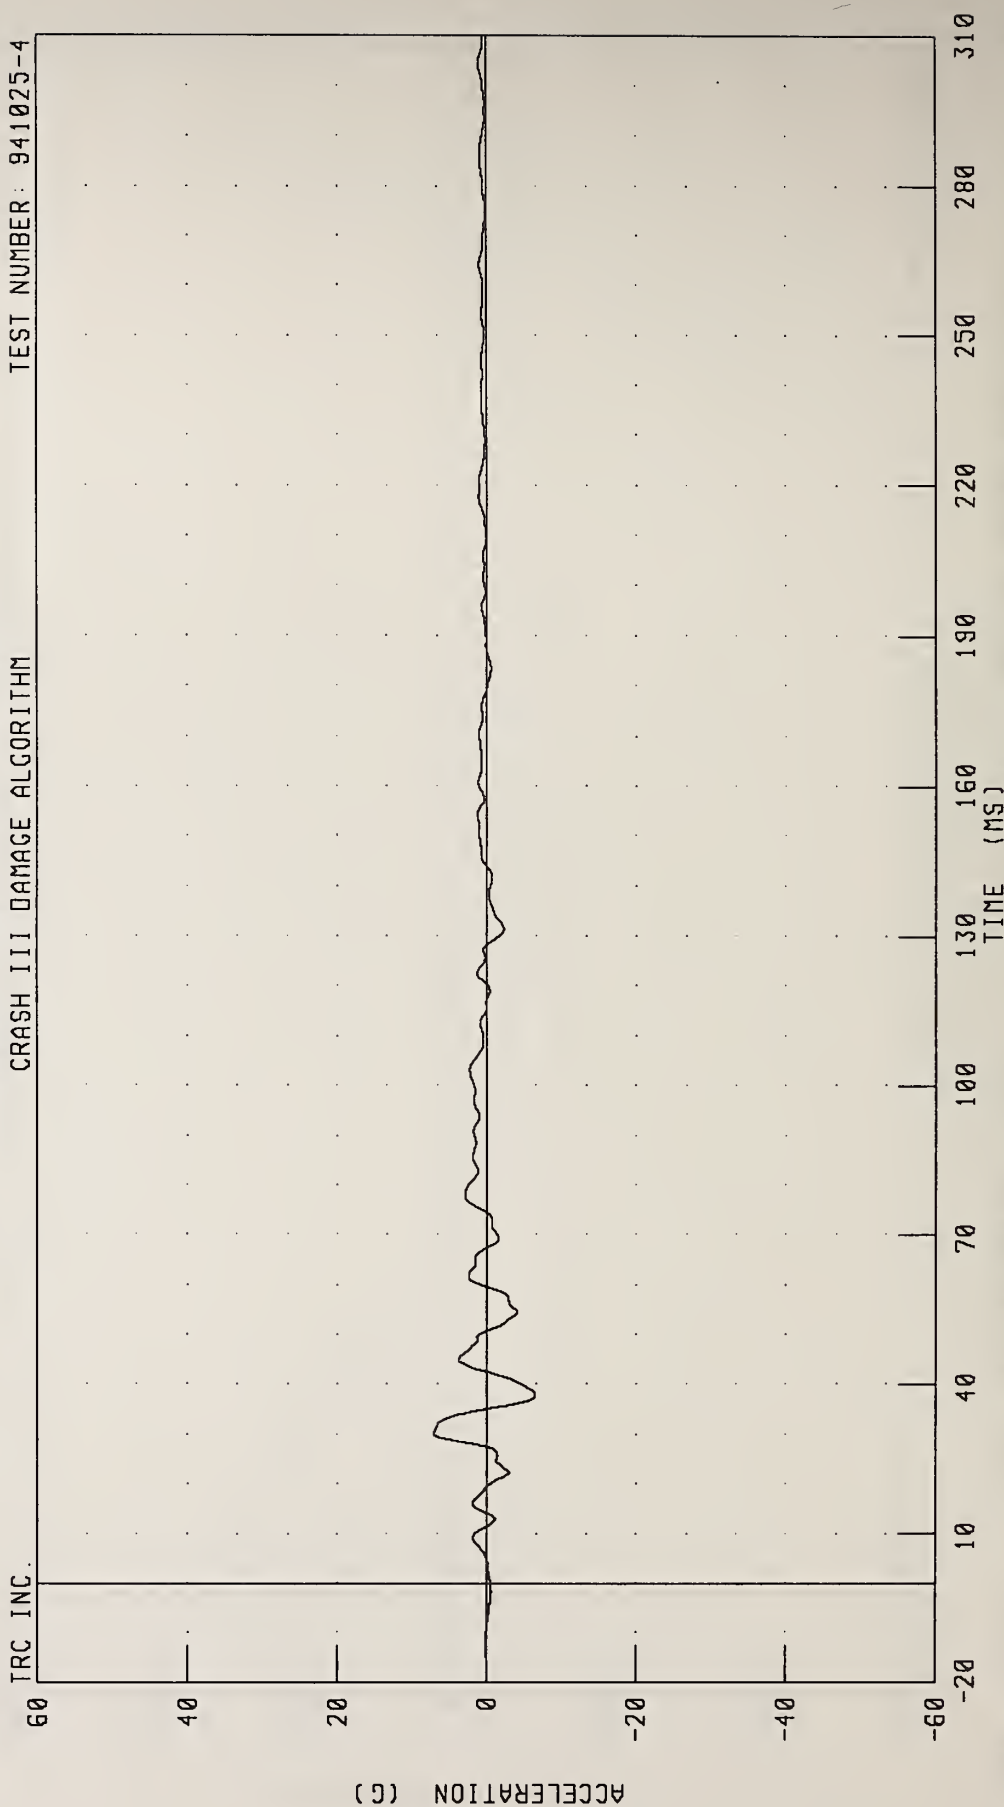
TEST NUMBER: 941025-4

1992 PLYMOUTH VOYAGER INTO 50% LEFT OFFSET BARRIER IMPACT 4 OF 5
RIGHT FRONT SILL Y-AXIS ACCELERATION
CRASH III DAMAGE ALGORITHM

CHANNEL: RFSYG FILTER: CH. CLASS 60

PEAK DATA: 7.13 G @ 30.16 MS; -6.49 G @ 37.92 MS

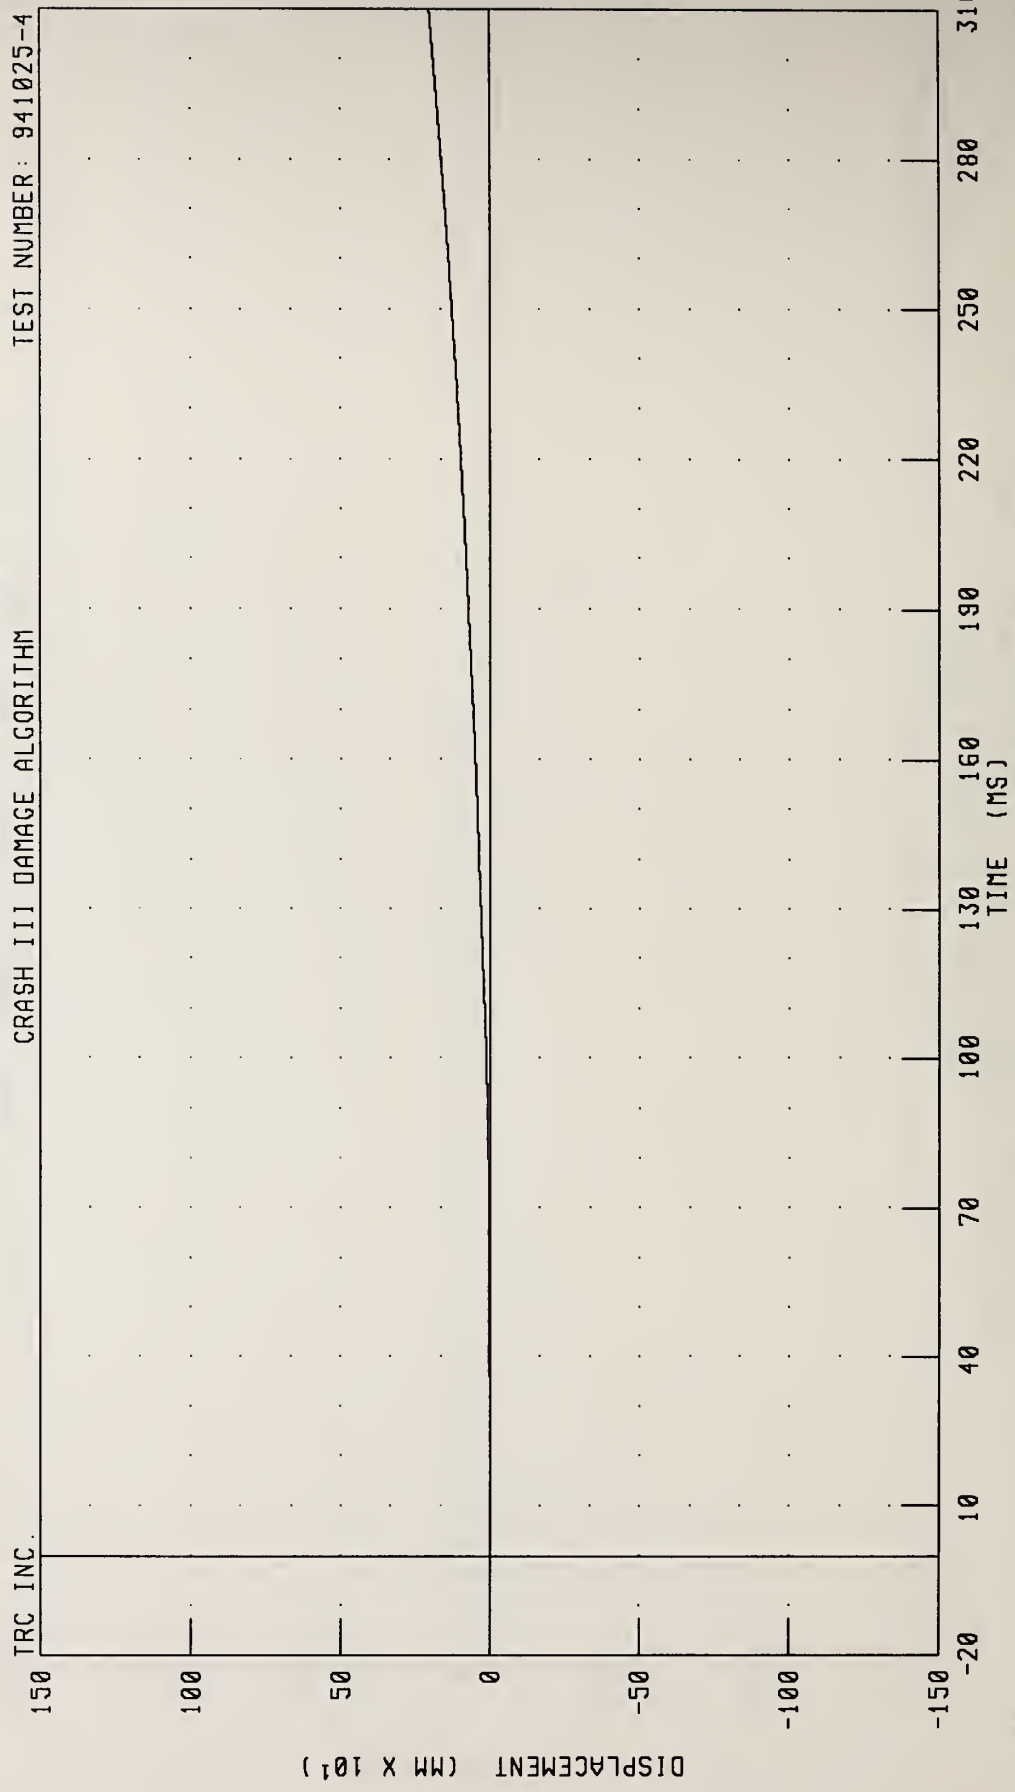
CRASH III DAMAGE ALGORITHM TEST NUMBER: 941025-4

CHANNEL: RFSYD FILTER: CH. CLASS 180

PEAK DATA: 202.39 MM @ 310.00 MS; -0.05 MM @ 8.16 MS

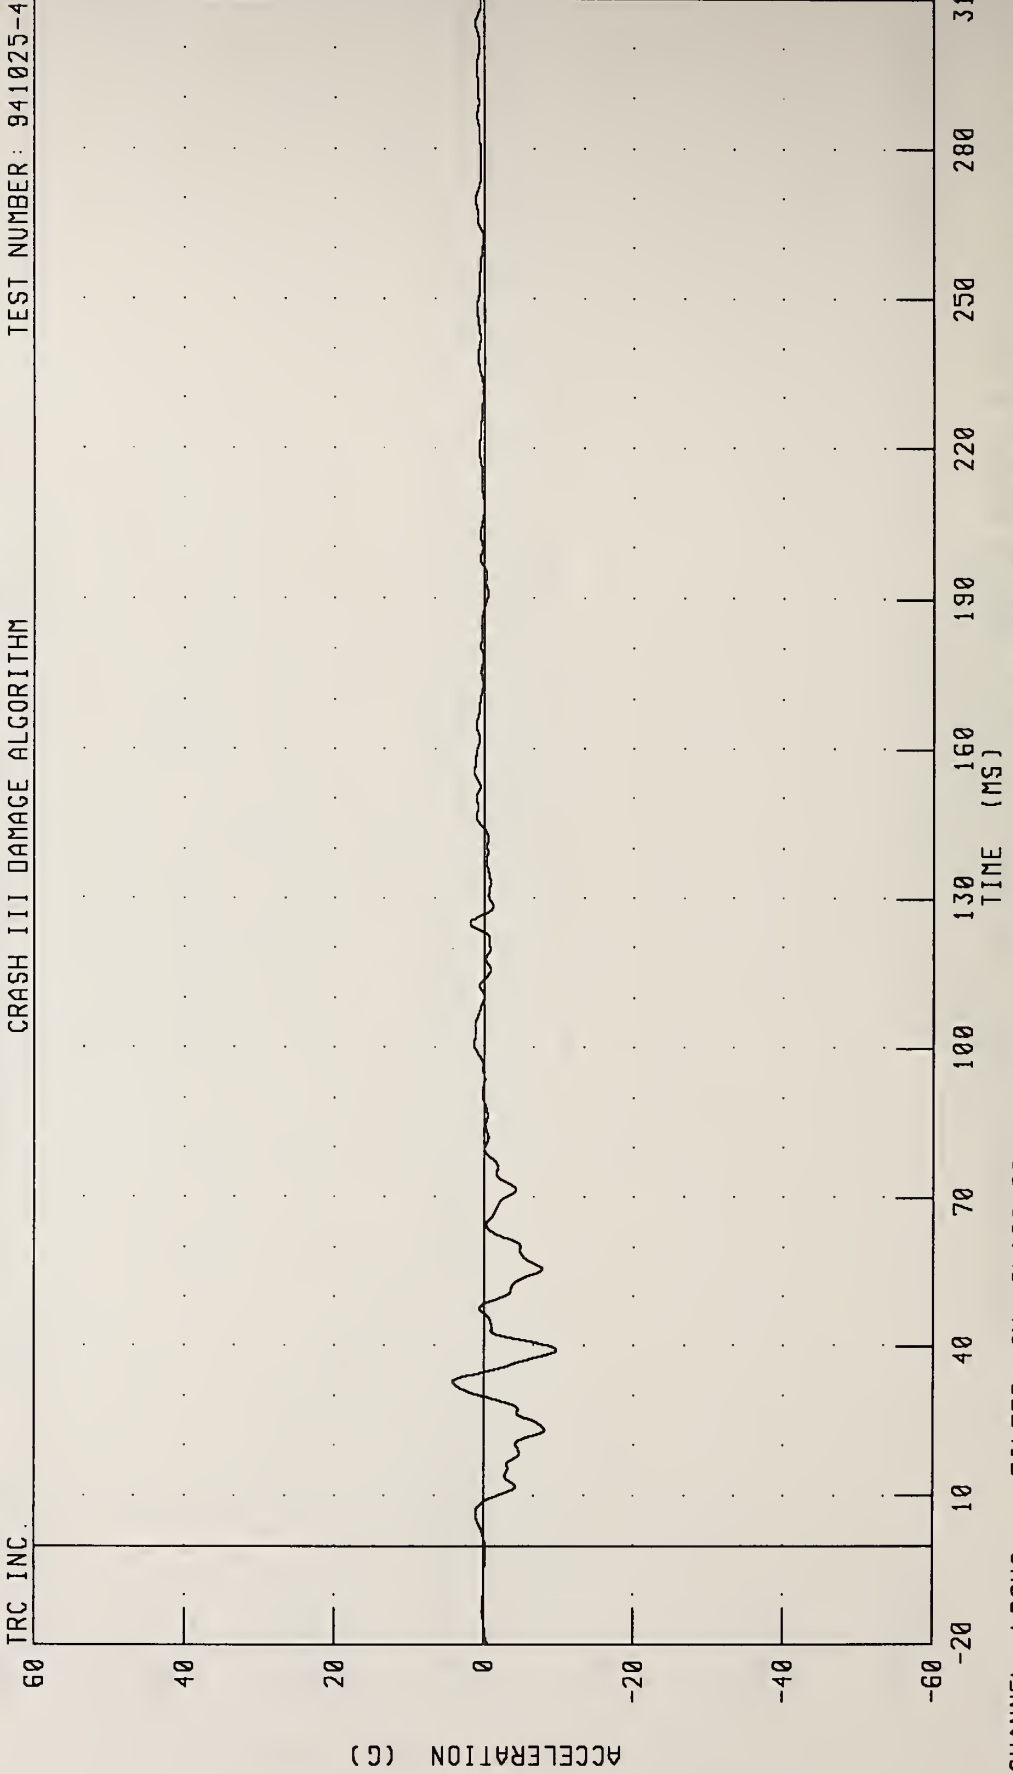
1992 PLYMOUTH VOYAGER INTO 50% LEFT OFFSET BARRIER IMPACT 4 OF 5
LEFT REAR SILL Y-AXIS ACCELERATION
CRASH III DAMAGE ALGORITHM

CHANNEL: LRSYG FILTER: CH. CLASS 60

PEAK DATA: 4.25 G @ 32.80 MS; -9.67 G @ 39.28 MS

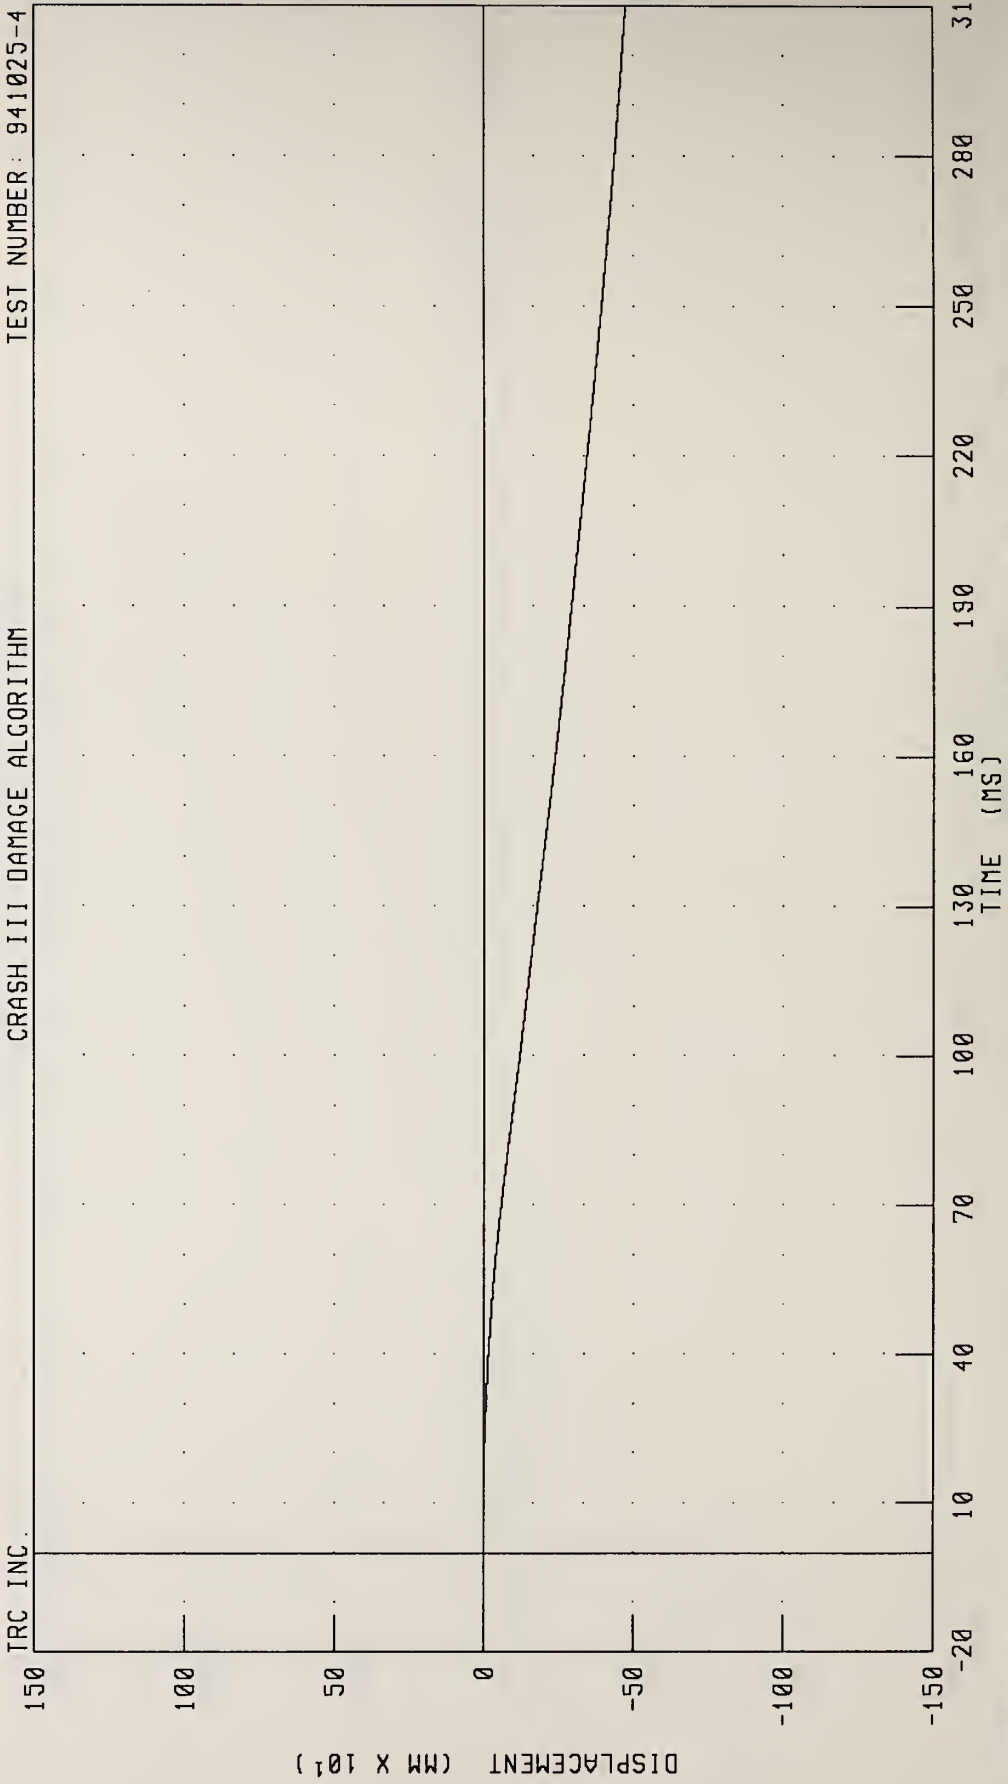
TEST NUMBER: 941025-4

CHANNEL: LRSYD FILTER: CH. CLASS 180

PEAK DATA: 0.24 MM @ 11.44 MS; -474.16 MM @ 310.00 MS

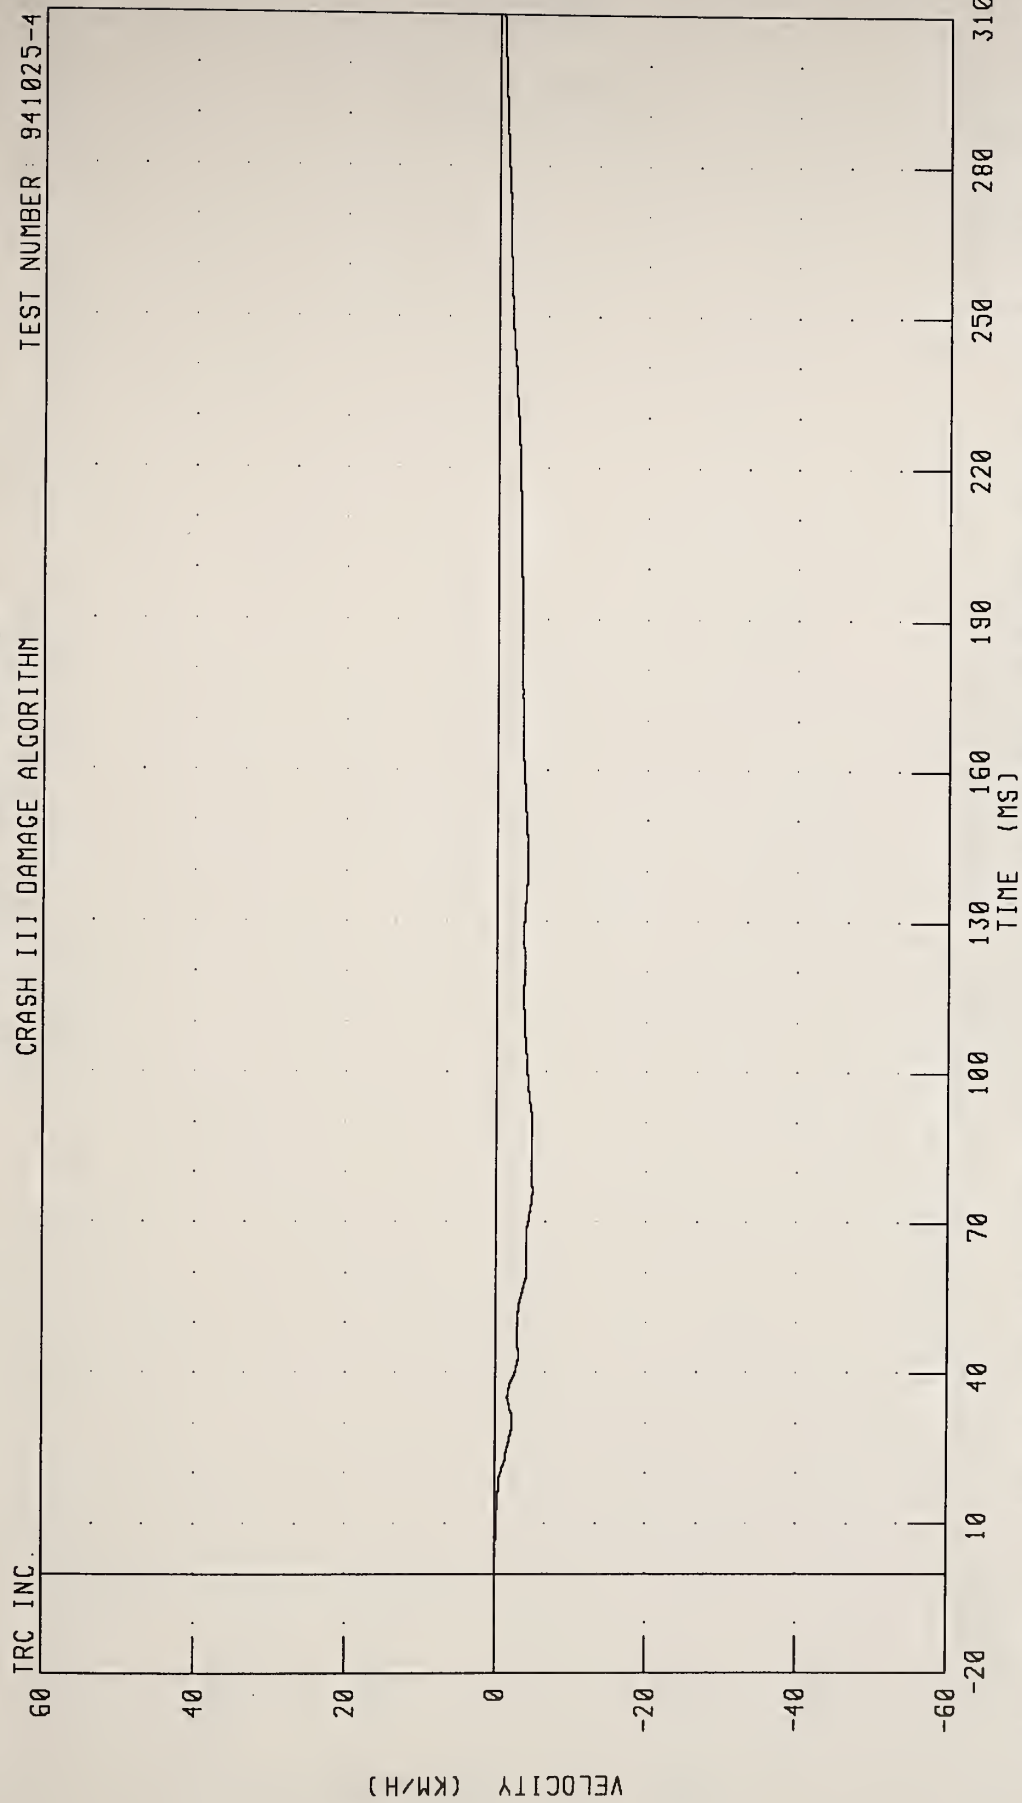
TRC INC. CRASH III DAMAGE ALGORITHM TEST NUMBER: 941025-4

CHANNEL: RRSYV FILTER: CH. CLASS 180

PEAK DATA: 0.02 KM/H @ 1.20 MS; -4.83 KM/H @ 76.16 MS

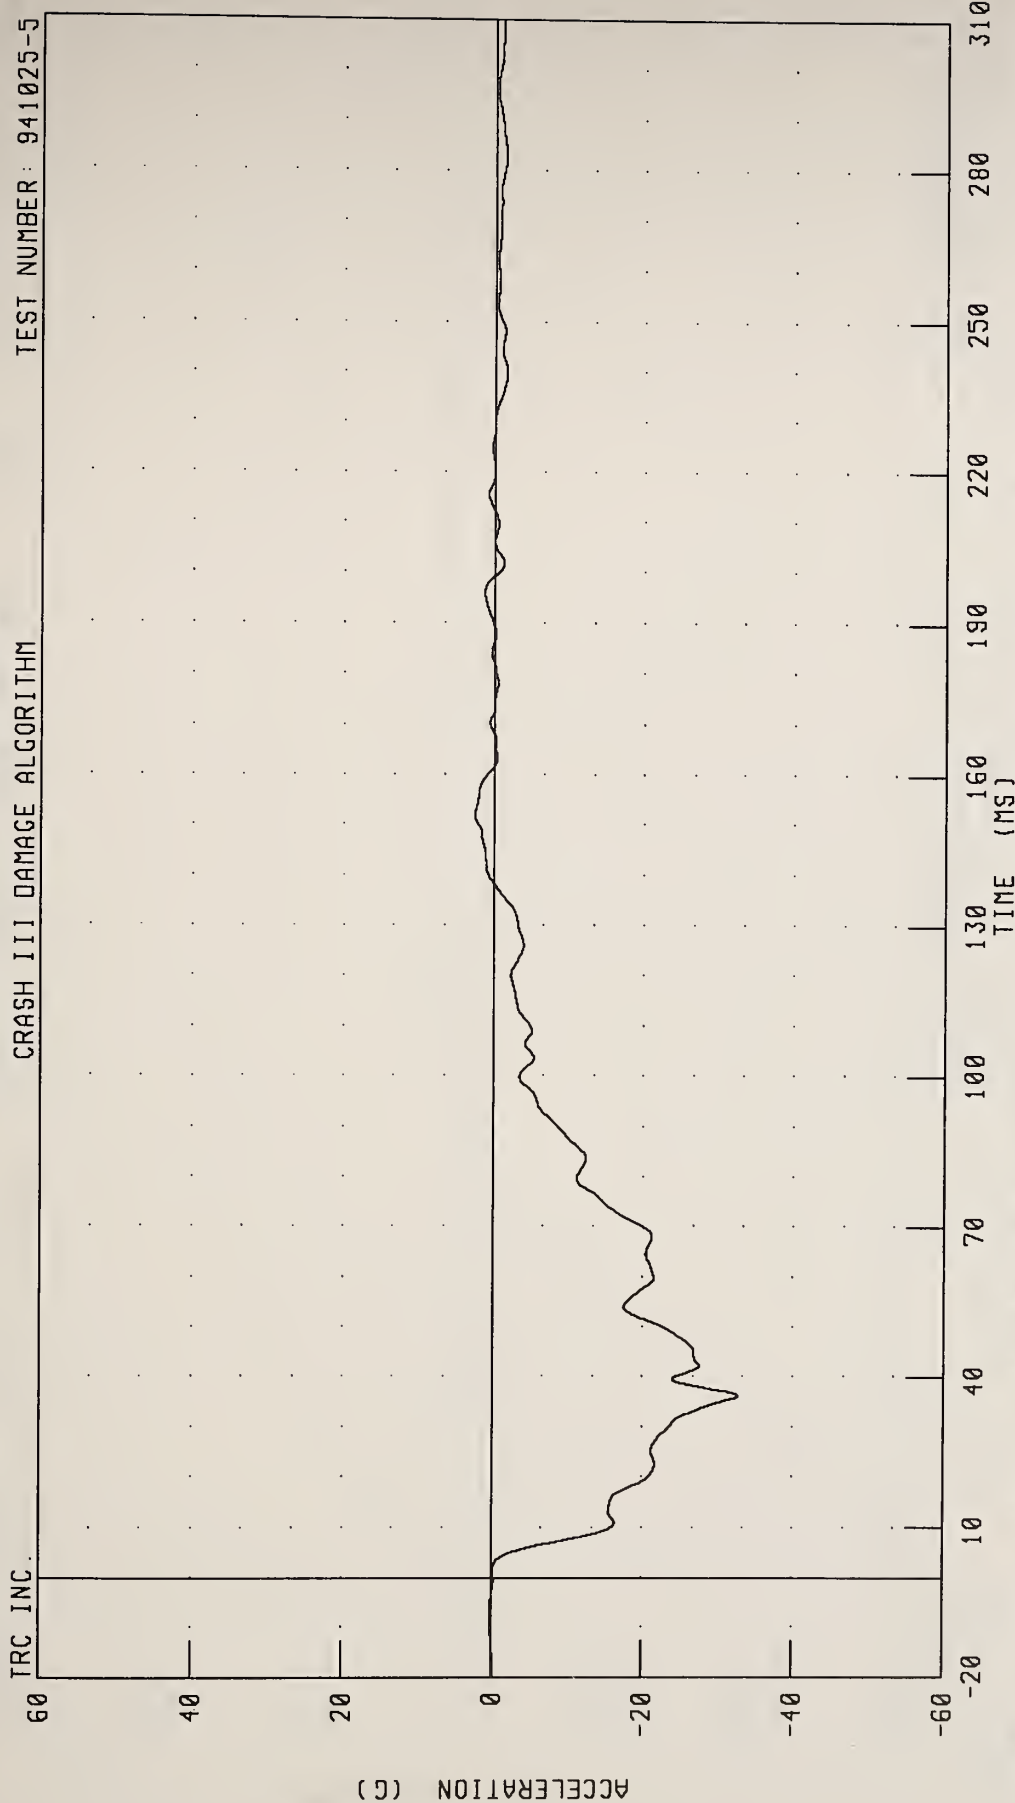
TEST NUMBER: 941025-5

CHANNEL: VCGXG FILTER: CH. CLASS 60
