DOT HS 808 217

Final Report

Final Report of a 1992 Plymouth Voyager into a 50% Left Offset Barrier in Support of CRASH3 Damage Algorithm Reformulation

The purpose of the five (5) 50% left offset barrier impact tests was for research and development in support of the CRASH3 damage algorithm reformulation.

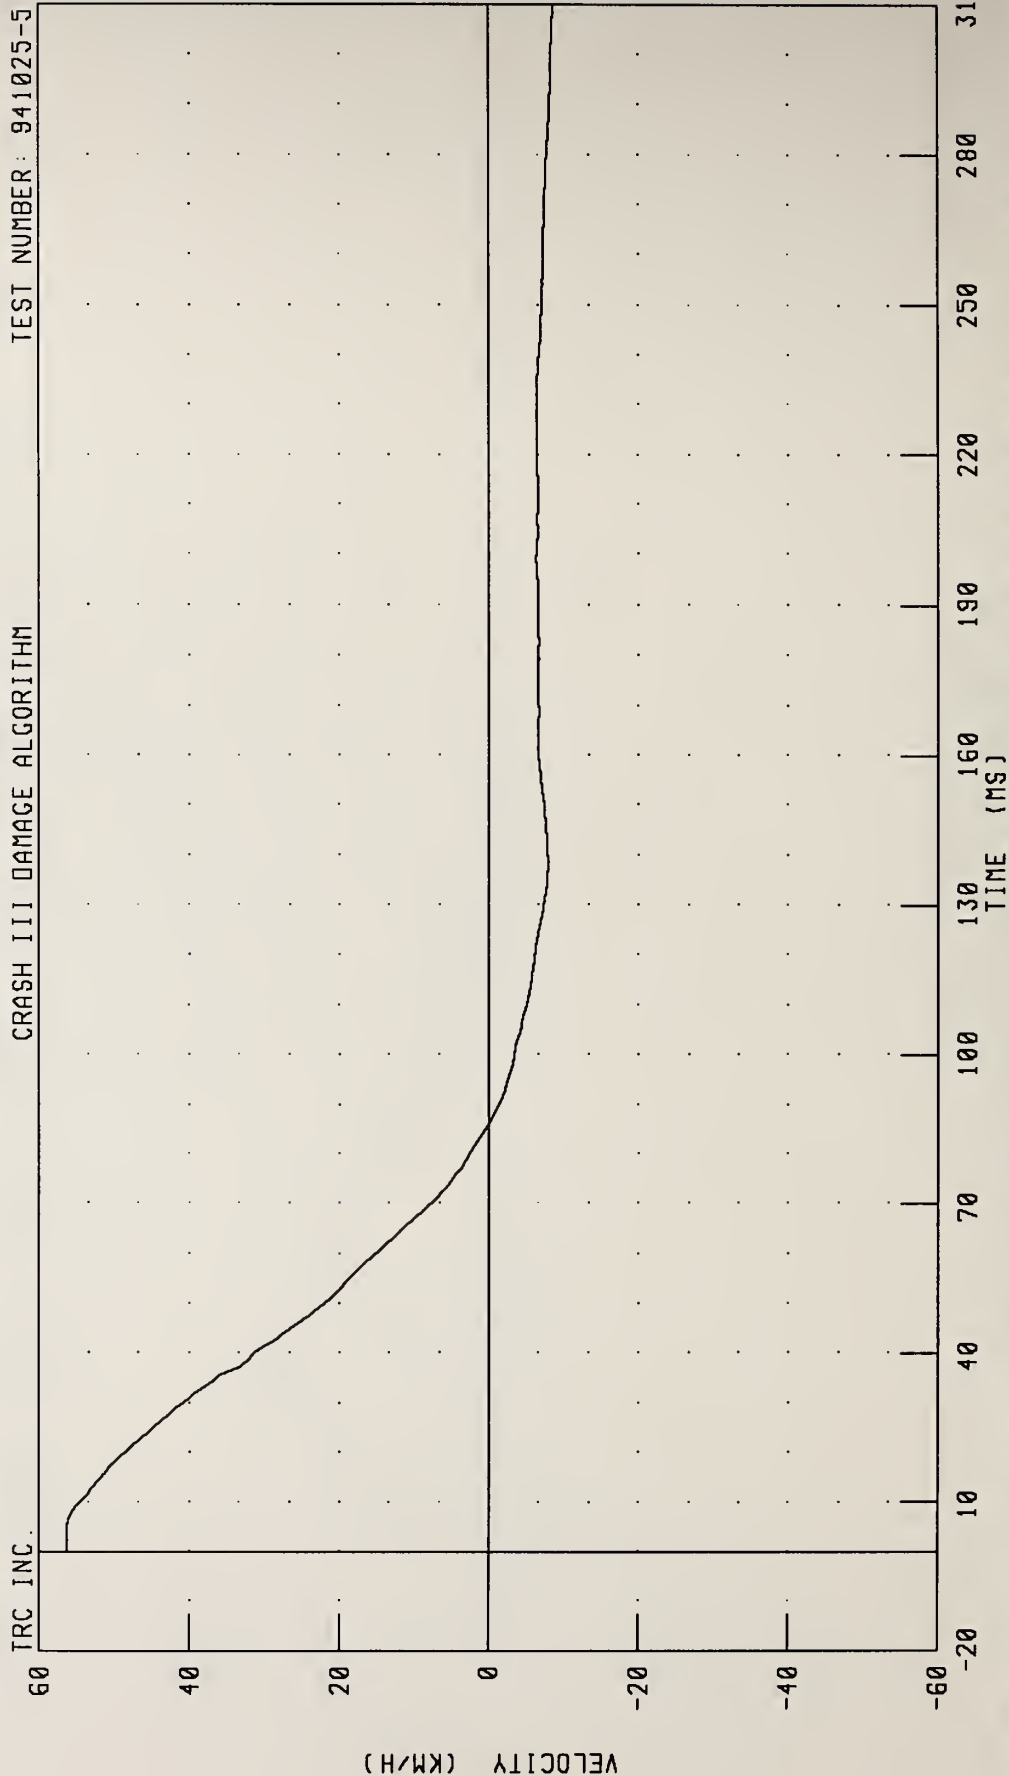
TEST NUMBER: 941025-5

CHANNEL: VCGXV FILTER: CH. CLASS 180

PEAK DATA: 56.30 KM/H @ 0.00 MS; -8.63 KM/H @ 310.00 MS

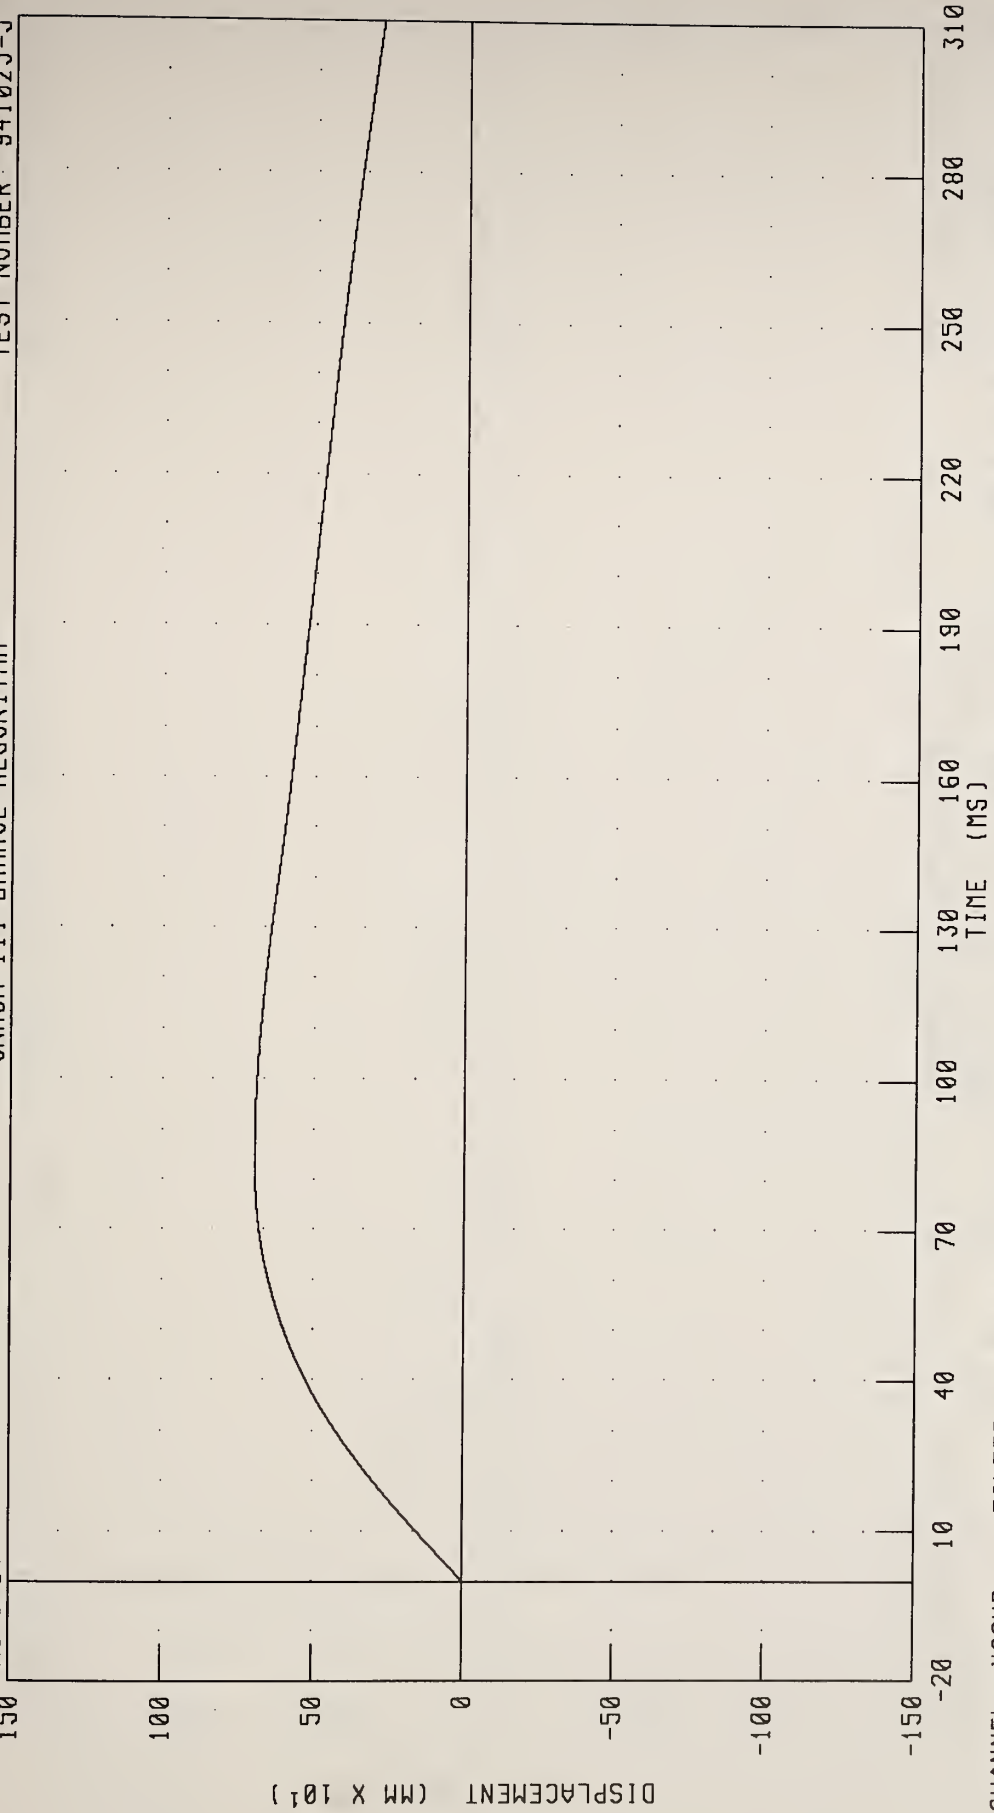
TEST NUMBER: 941025-5

CHANNEL: VCGXD FILTER: CH. CLASS 180

PEAK DATA: 696.72 MM @ 86.08 MS; 0.00 MM @ 0.00 MS

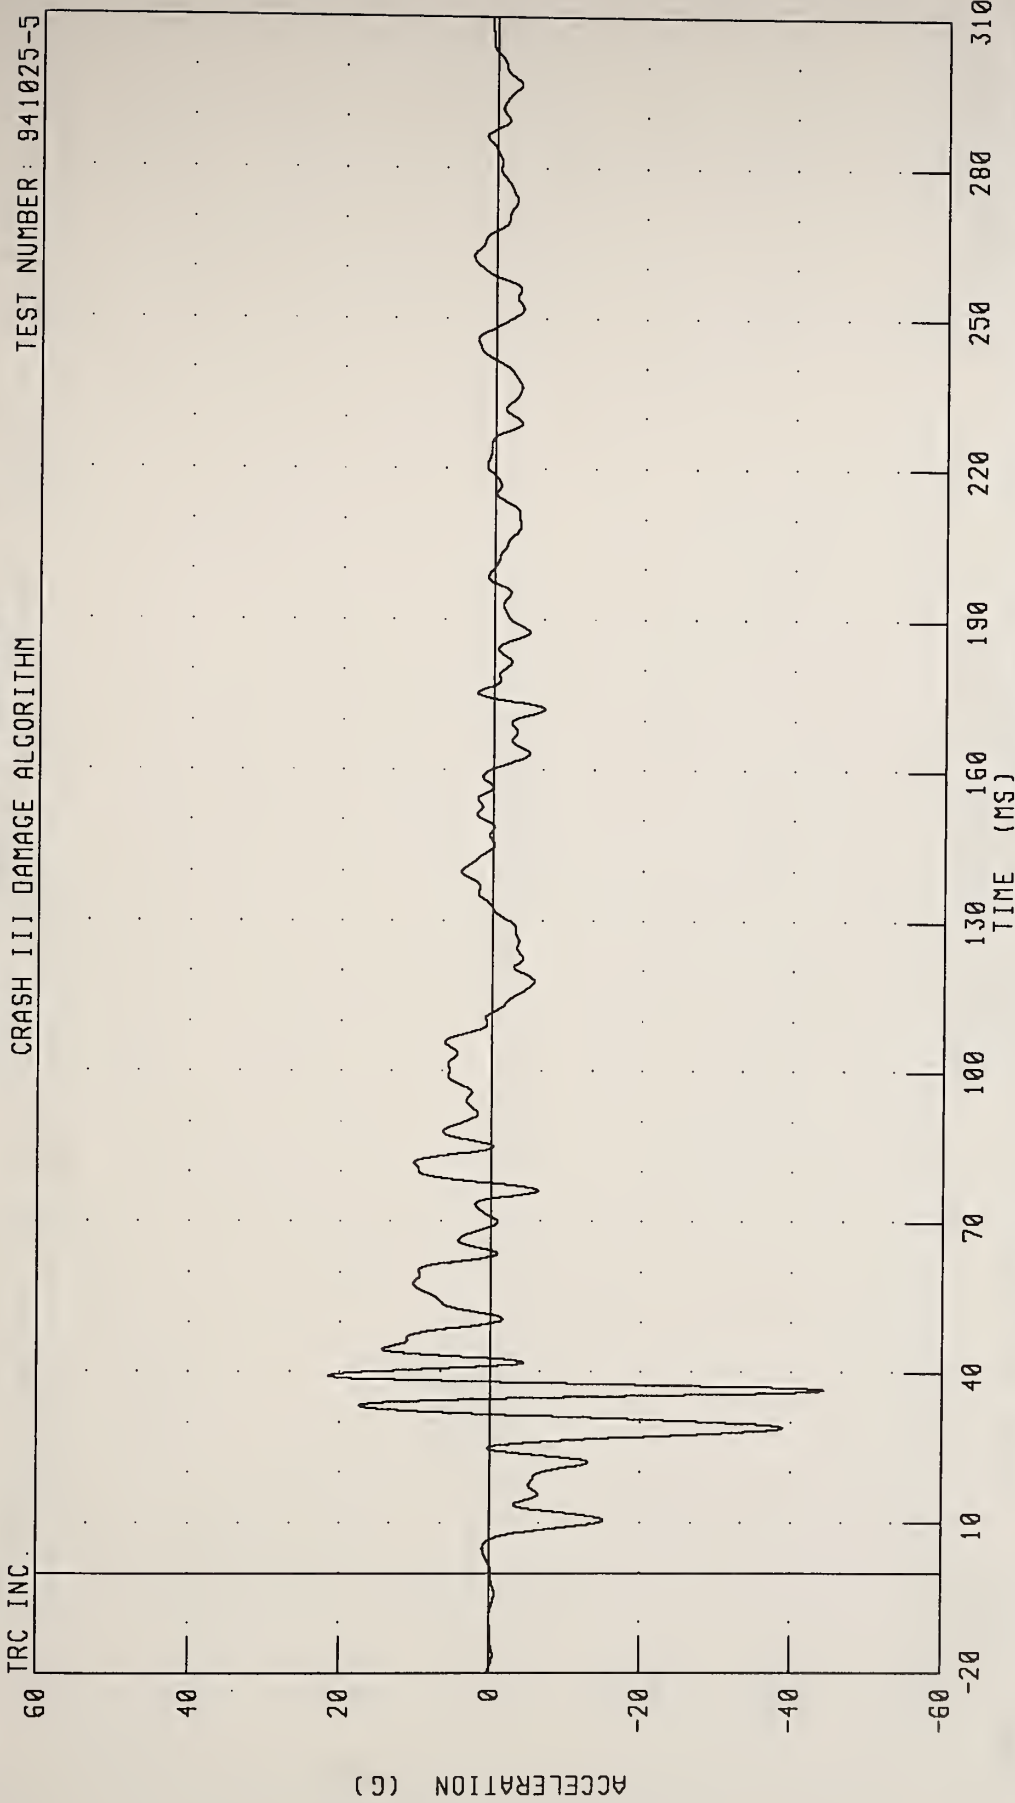
CRASH III DAMAGE ALGORITHM TEST NUMBER: 941025-5

TRC INC. CHANNEL: VCGZG FILTER: CH. CLASS 60

PEAK DATA: 21.52 G @ 39.36 MS, -44.32 G @ 36.48 MS

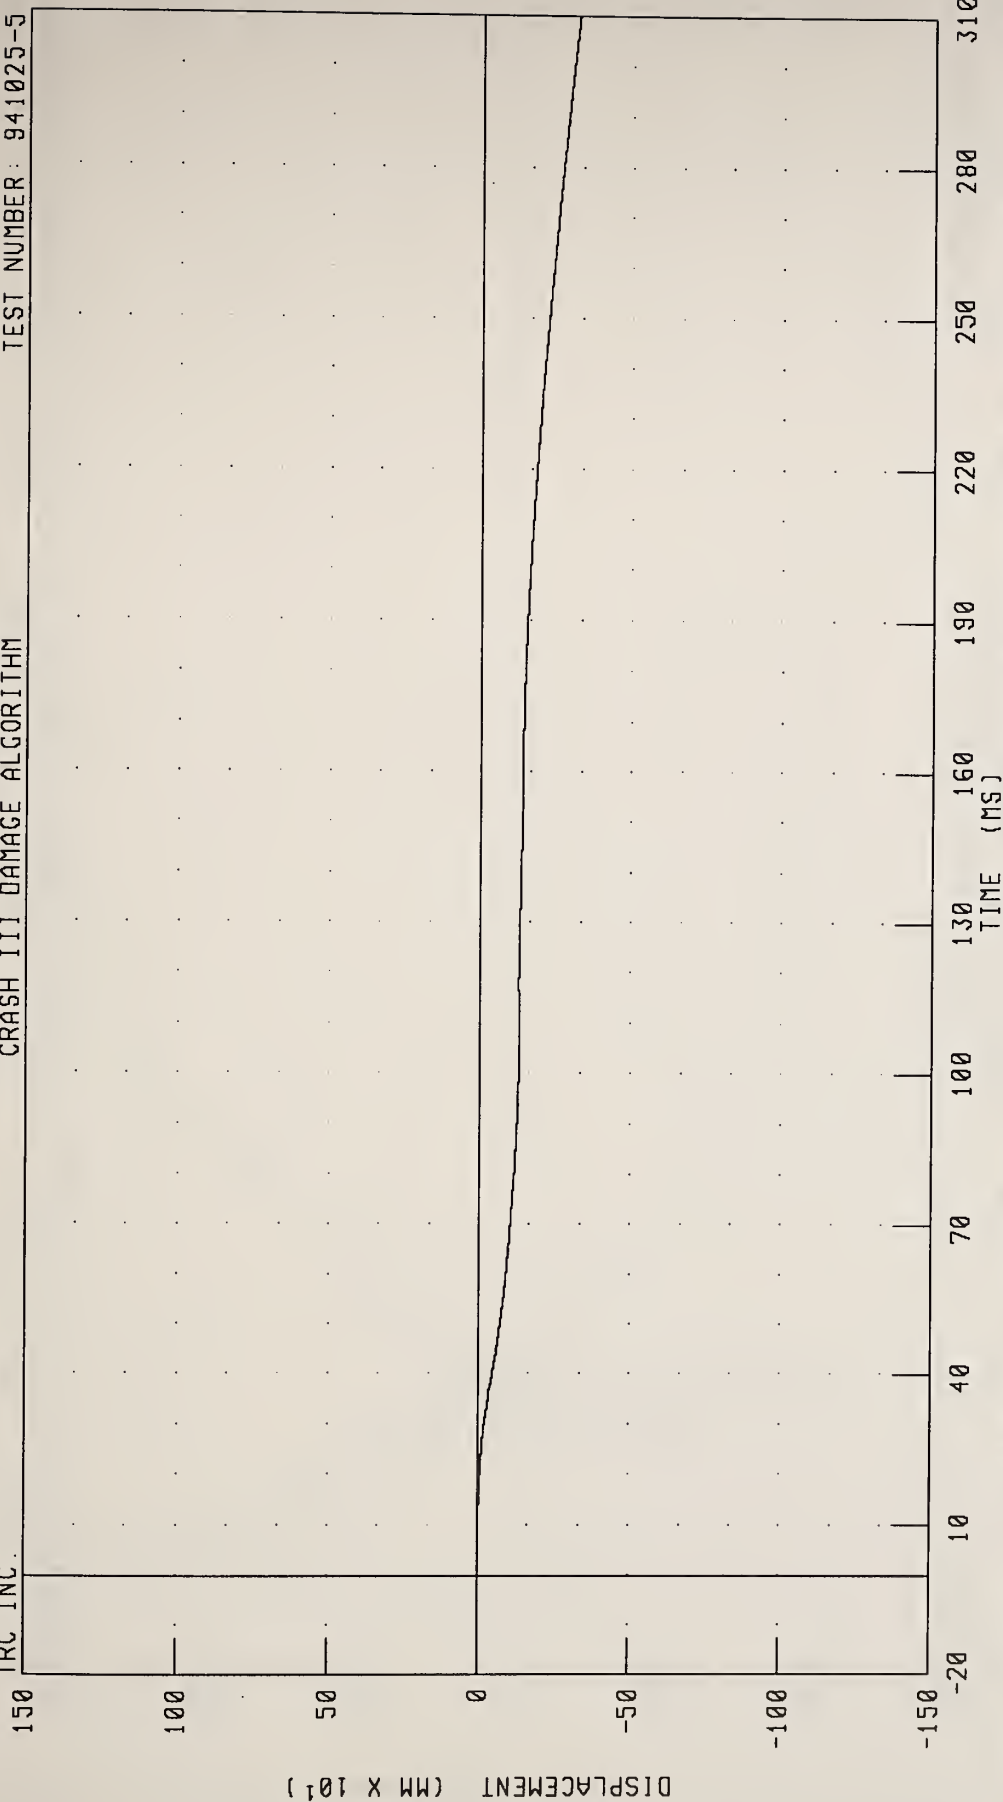
CRASH III DAMAGE ALGORITHM TEST NUMBER: 941025-5

CHANNEL: VCGZO FILTER: CH. CLASS 180

PEAK DATA: 0.03 MM @ 9.44 MS; -319.78 MM @ 310.00 MS

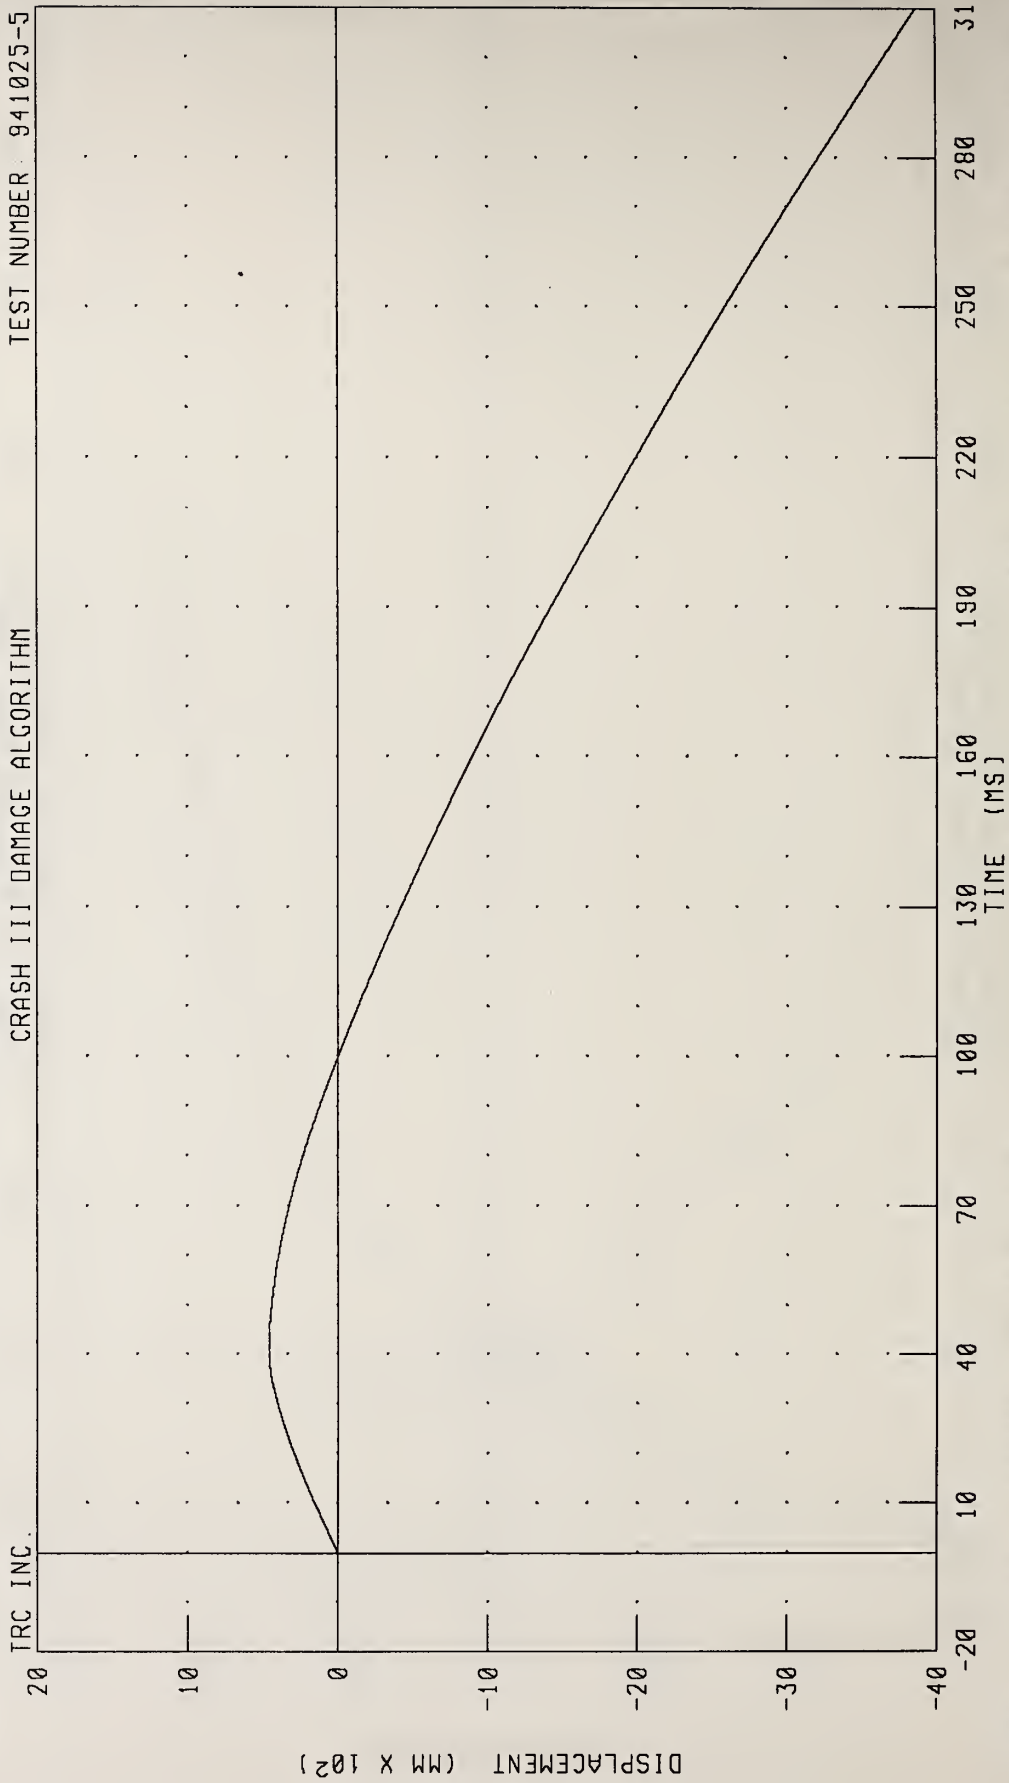
TRC INC. CRASH III DAMAGE ALGORITHM TEST NUMBER 941025-5

CHANNEL: VCGRD FILTER: CH. CLASS 180

PEAK DATA: 459.33 MM @ 41.68 MS; -3863.44 MM @ 310.00 MS

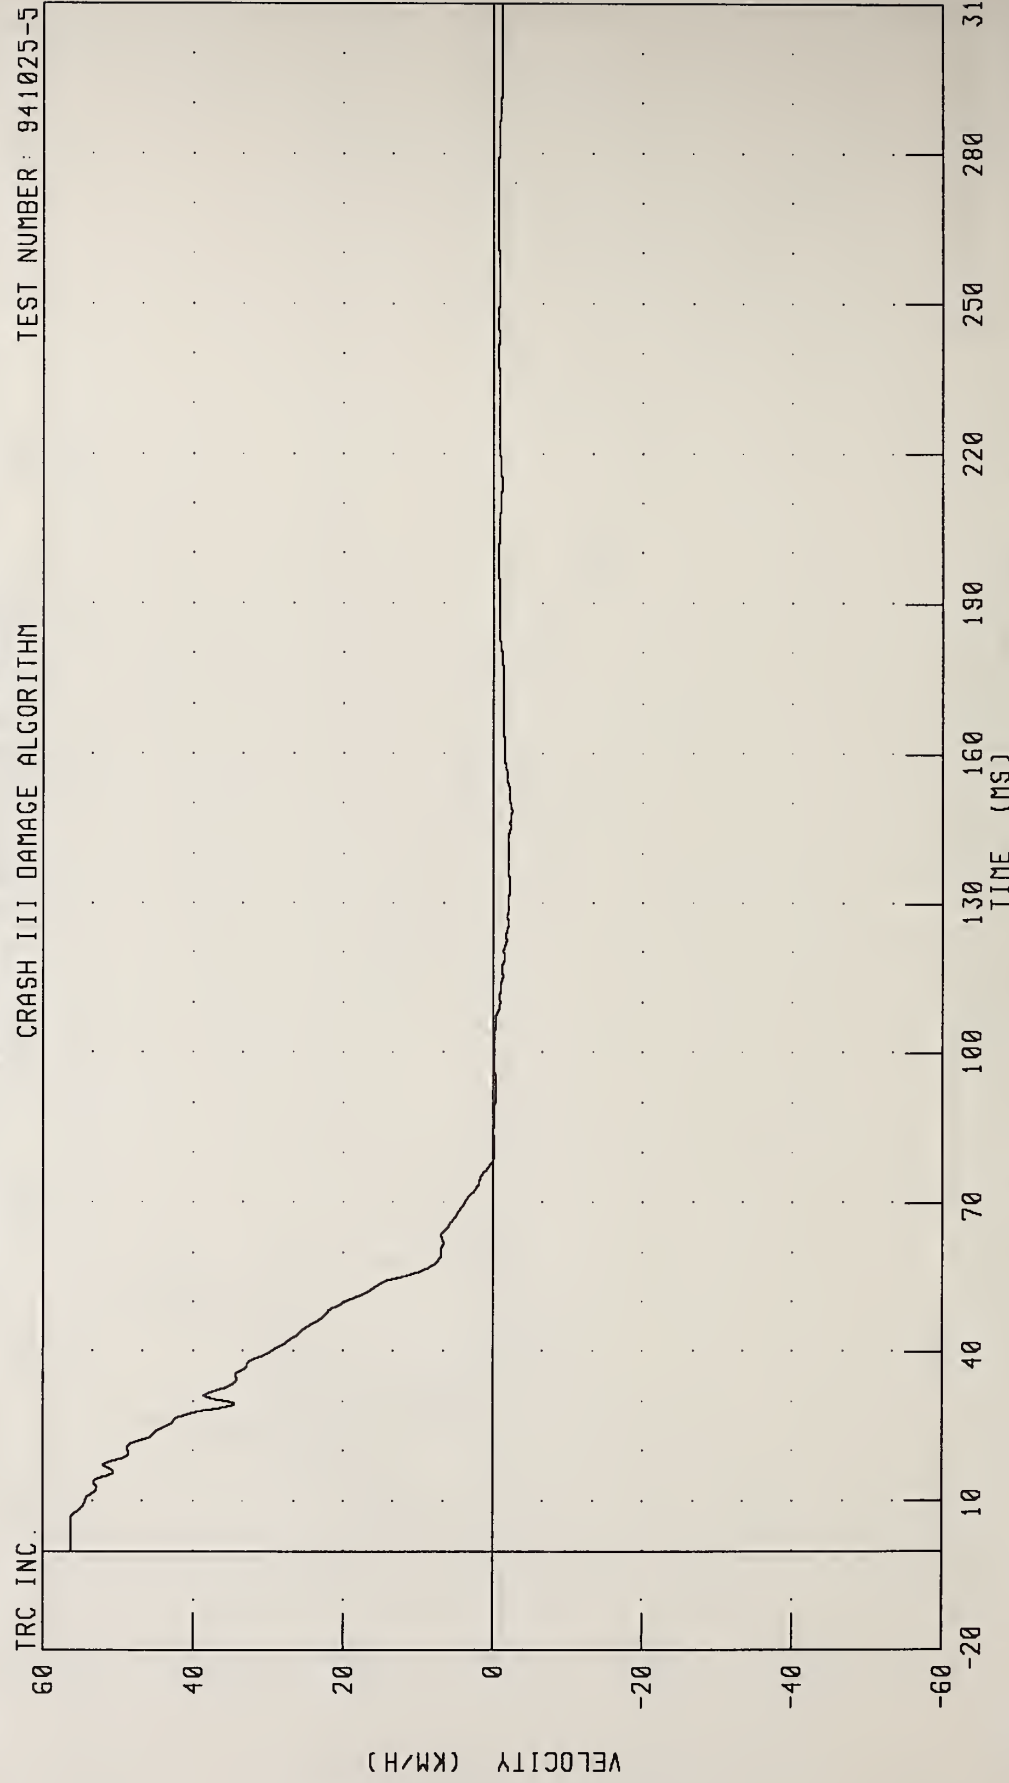
TEST NUMBER: 941025-5

CHANNEL: LFSXV FILTER: CH. CLASS 180

PEAK DATA: 56.31 KM/H @ 6.32 MS; -2.46 KM/H @ 148.64 MS

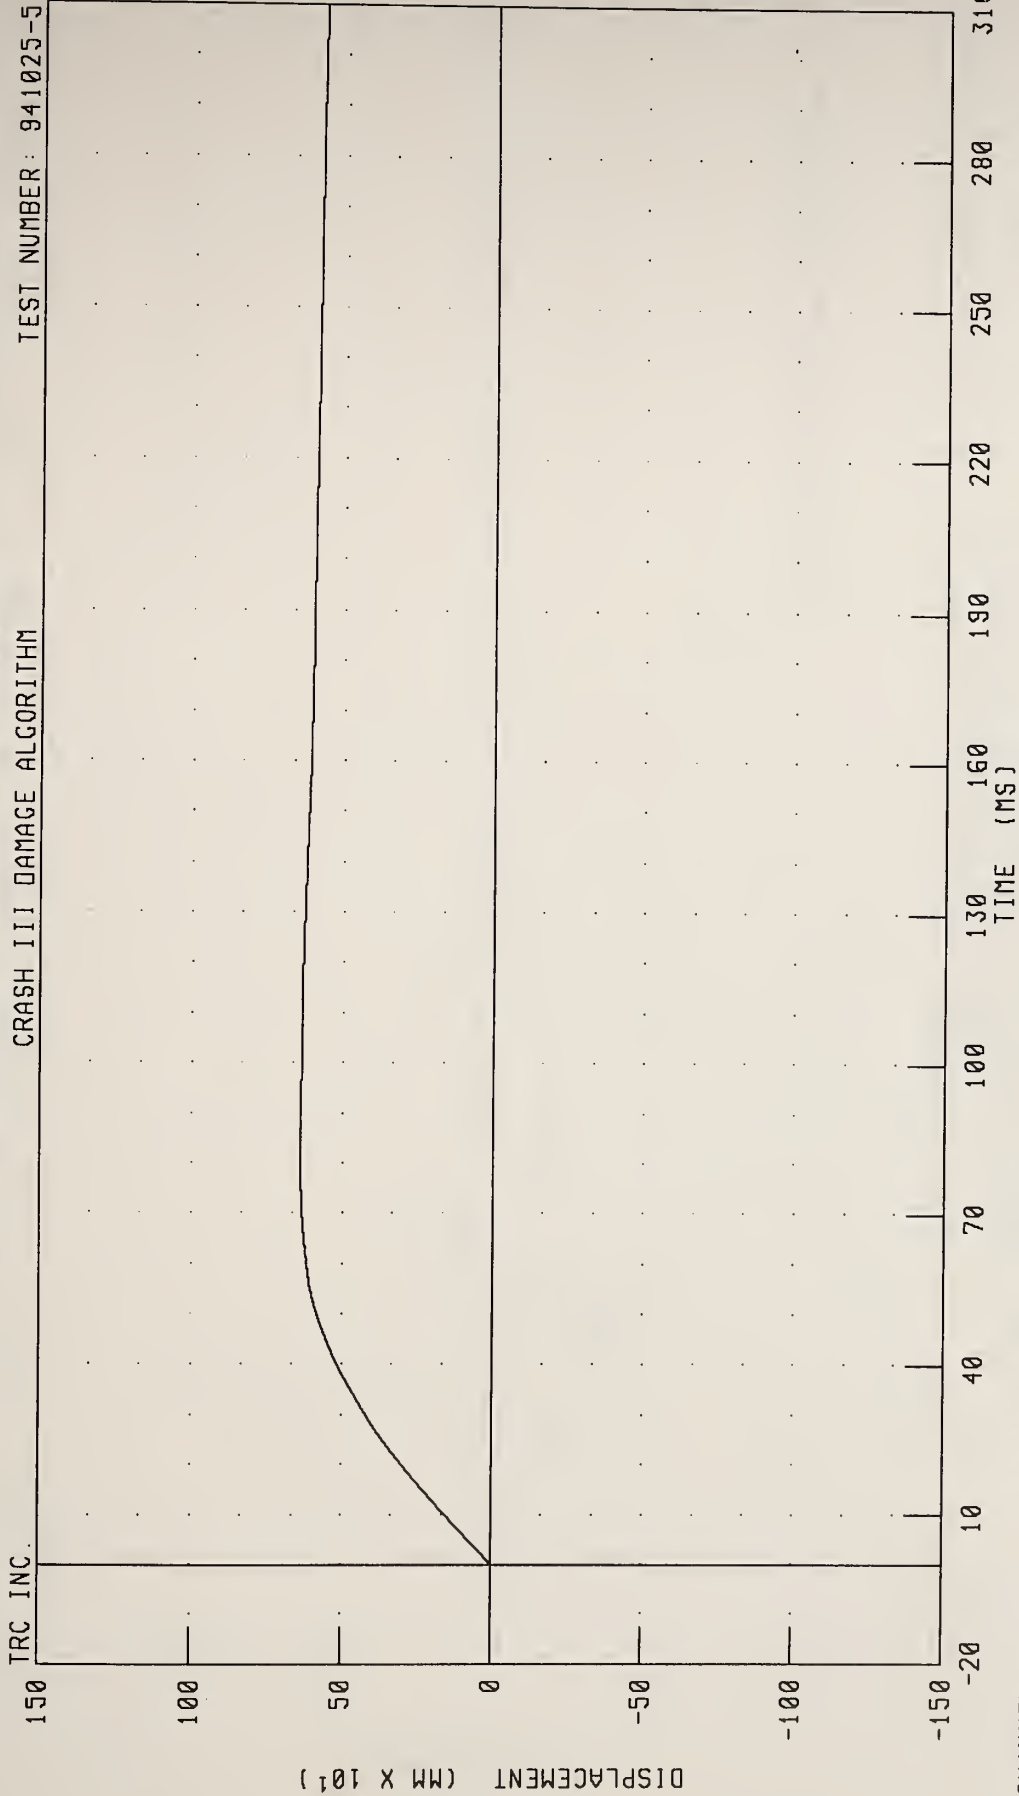
TEST NUMBER: 941025-5

CHANNEL: LFSXD FILTER: CH. CLASS 180

PEAK DATA: 638.43 MM @ 78.48 MS; 0.00 MM @ 0.00 MS

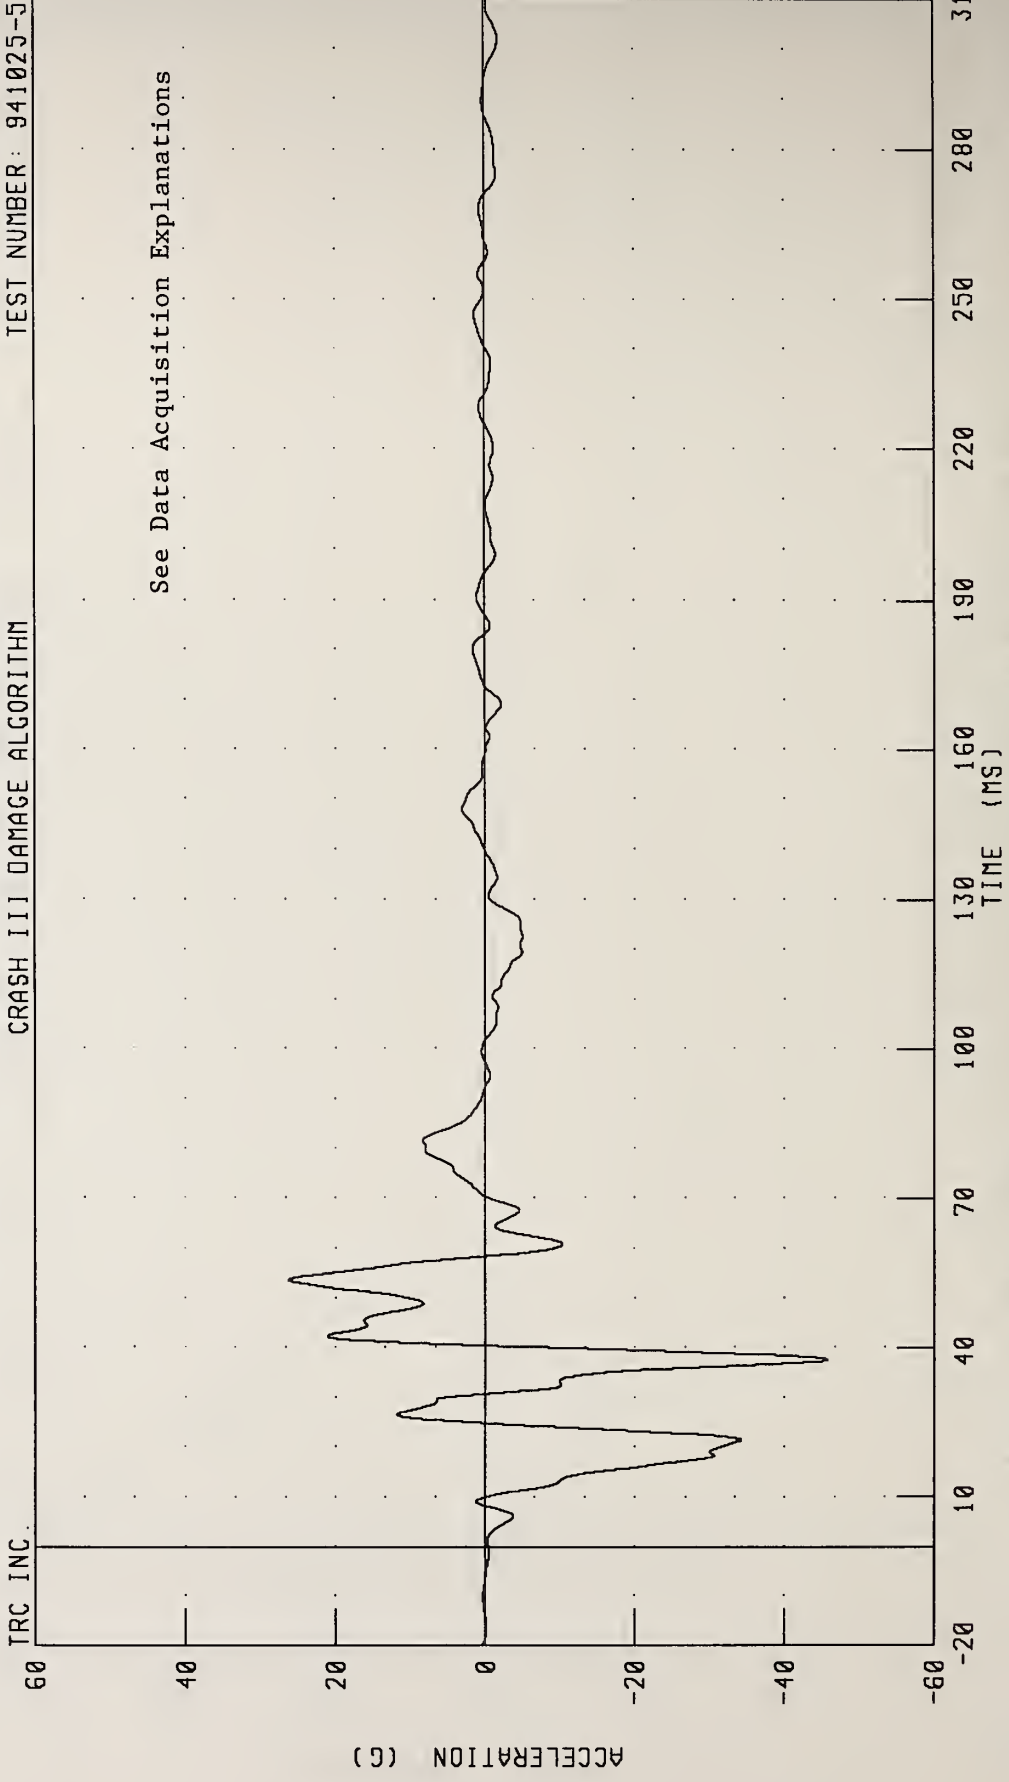
CRASH III DAMAGE ALGORITHM TEST NUMBER: 941025-5

CHANNEL: LFSYG FILTER: CH. CLASS 60

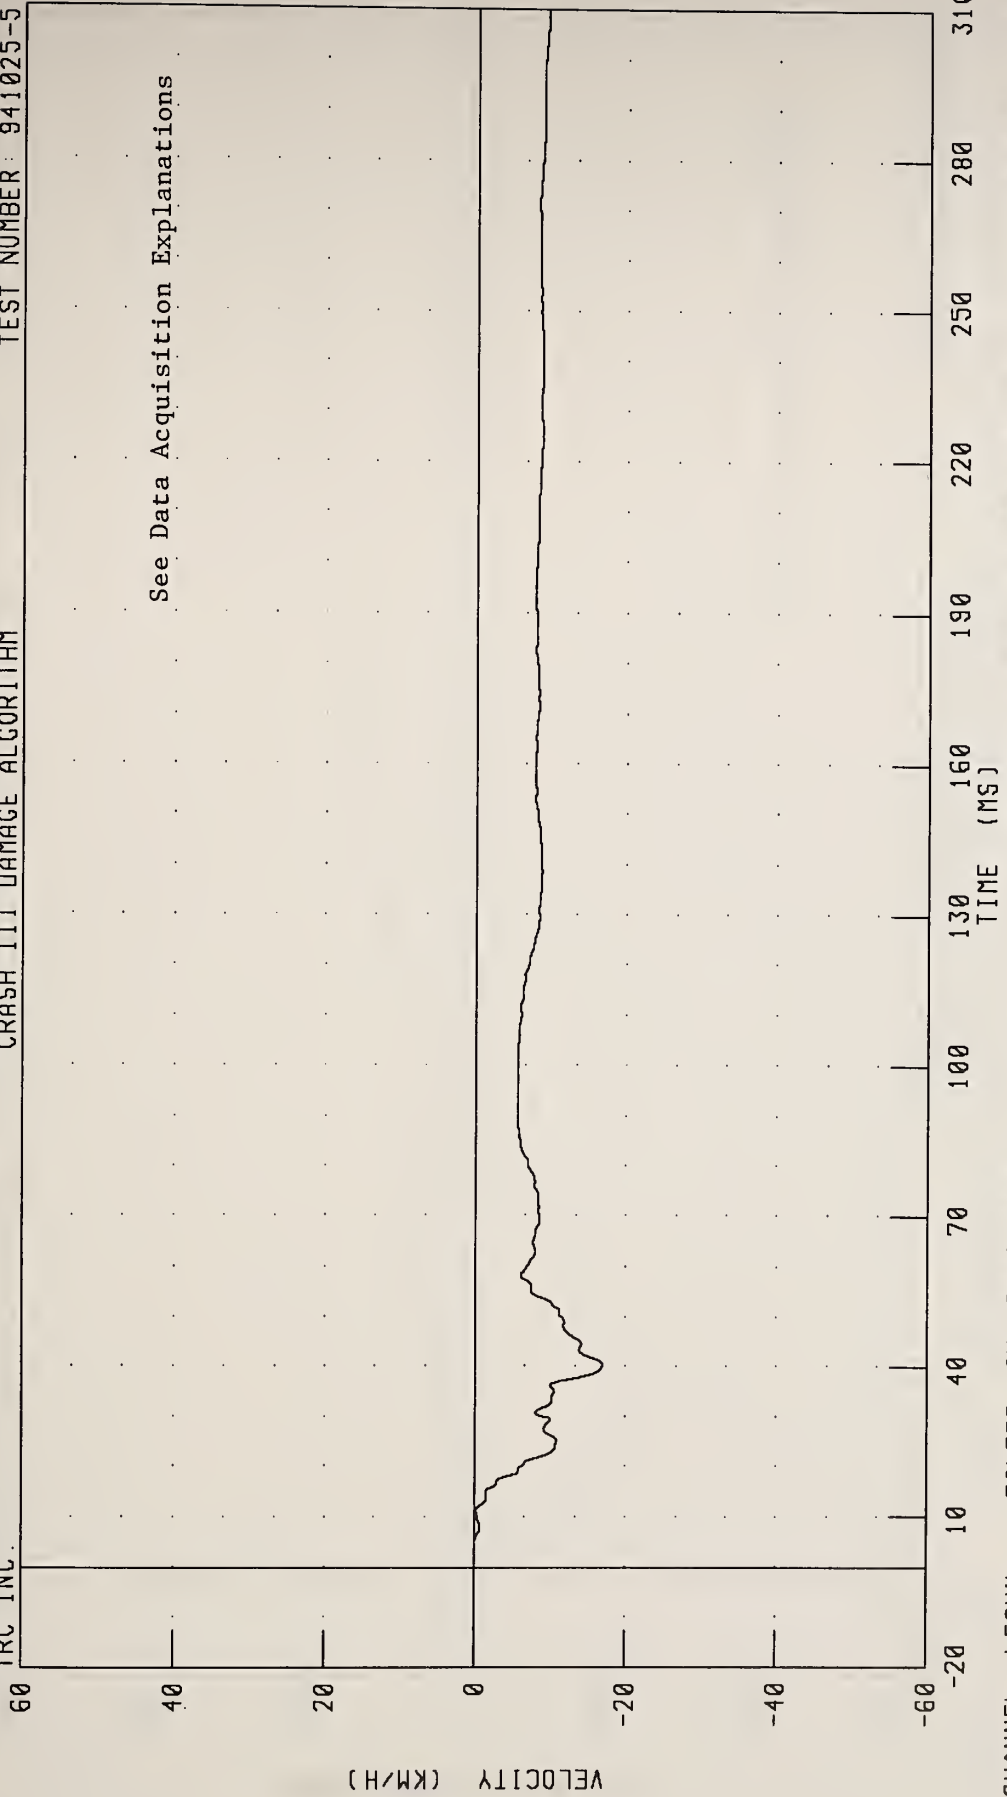
CHANNEL: LFSYV FILTER: CH. CLASS 180

PEAK DATA: 0.00 KM/H @ 0.00 MS; -16.92 KM/H @ 40.32 MS

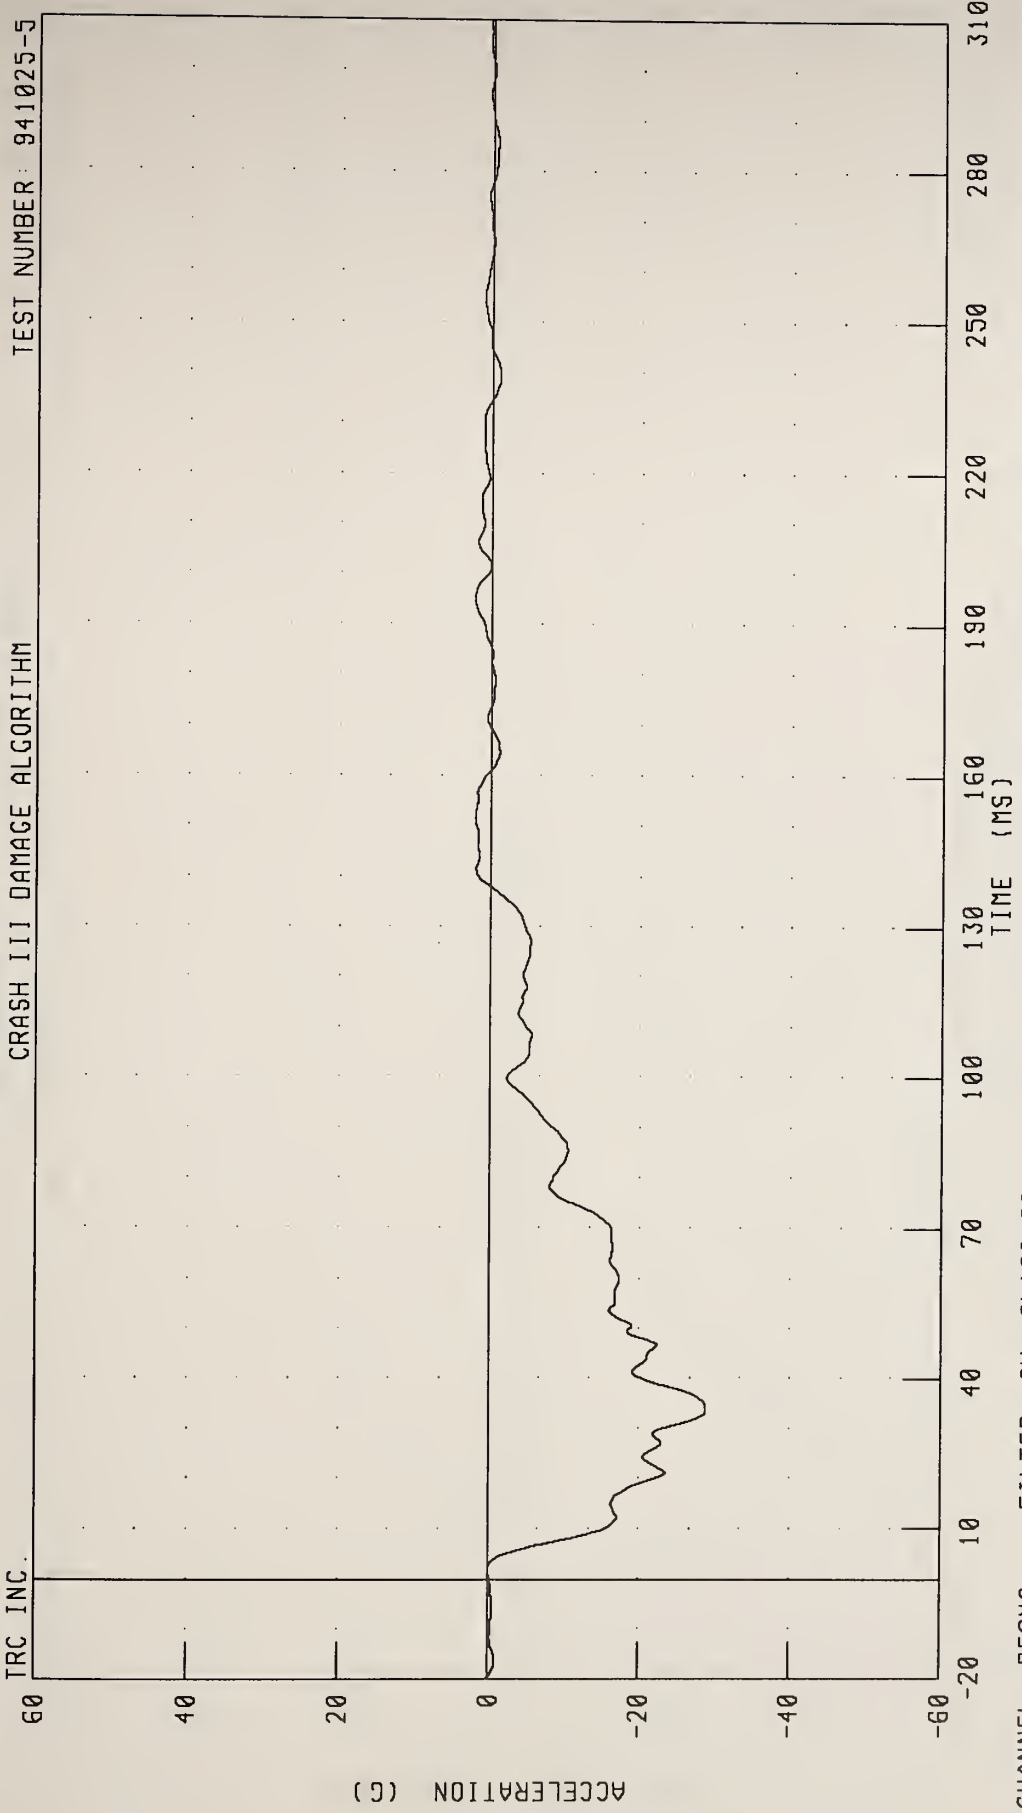
CRASH III DAMAGE ALGORITHM TEST NUMBER: 941025-5

CHANNEL: RFSXG FILTER: CH. CLASS 60

PEAK DATA: 2.19 G @ 194.80 MS; -28.80 G @ 34.32 MS

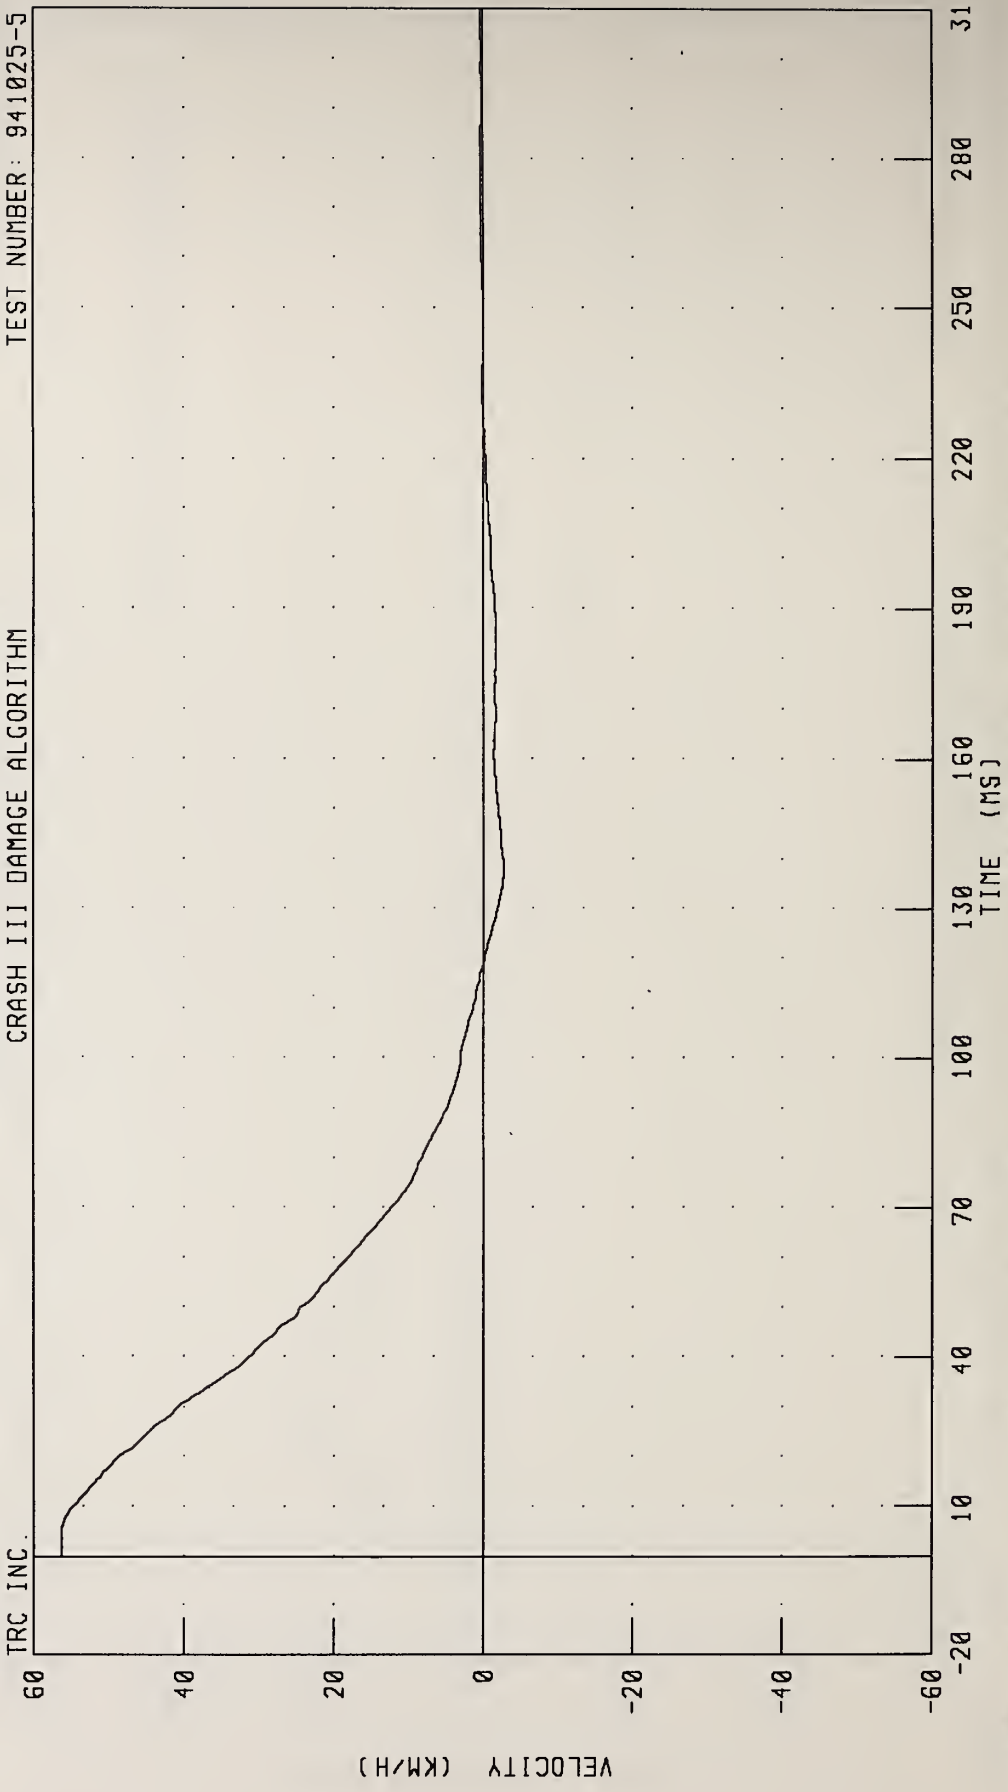
TRC INC. CRASH III DAMAGE ALGORITHM TEST NUMBER: 941025-5

CHANNEL: RFSXV FILTER: CH. CLASS 180

PEAK DATA: 56.30 KM/H @ 0.00 MS; -2.72 KM/H @ 138.48 MS

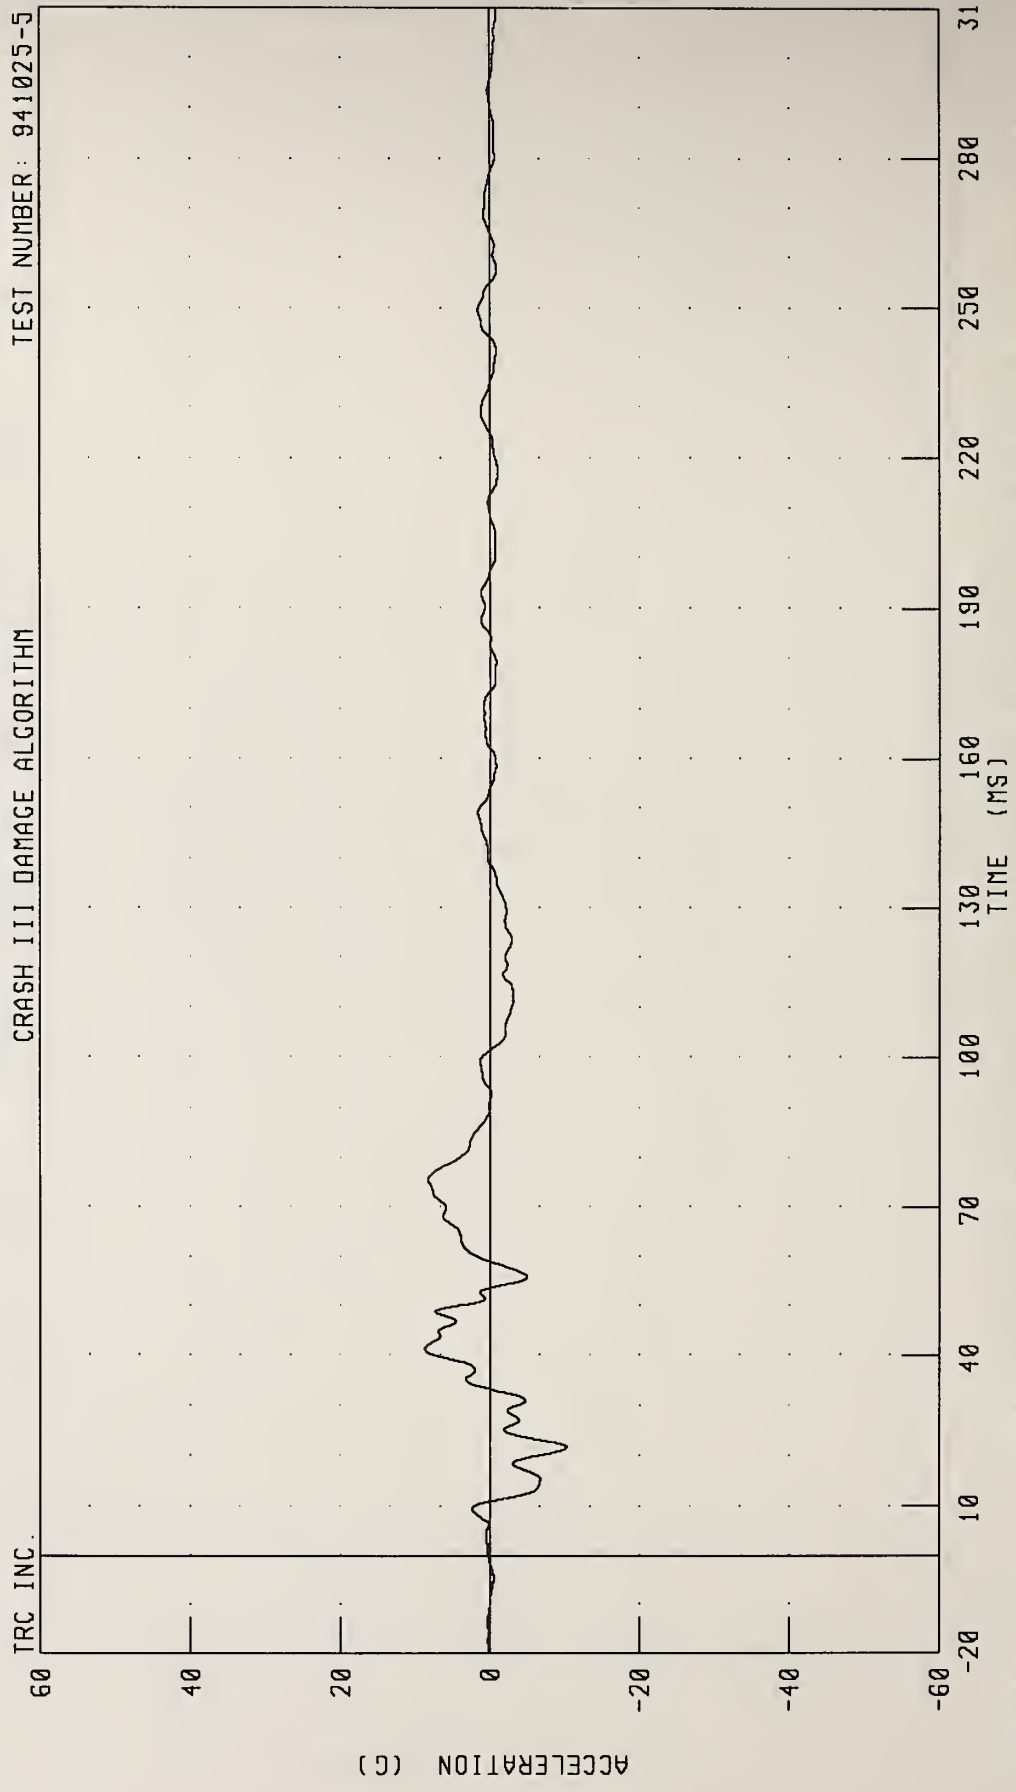
CRASH III DAMAGE ALGORITHM TEST NUMBER: 941025-5

CHANNEL: RFSYG FILTER: CH. CLASS 60

PEAK DATA: 8.77 G @ 41.36 MS, -10.26 G @ 21.76 MS
