DOT HS 808 217

Final Report

Final Report of a 1992 Plymouth Voyager into a 50% Left Offset Barrier in Support of CRASH3 Damage Algorithm Reformulation

The purpose of the five (5) 50% left offset barrier impact tests was for research and development in support of the CRASH3 damage algorithm reformulation.

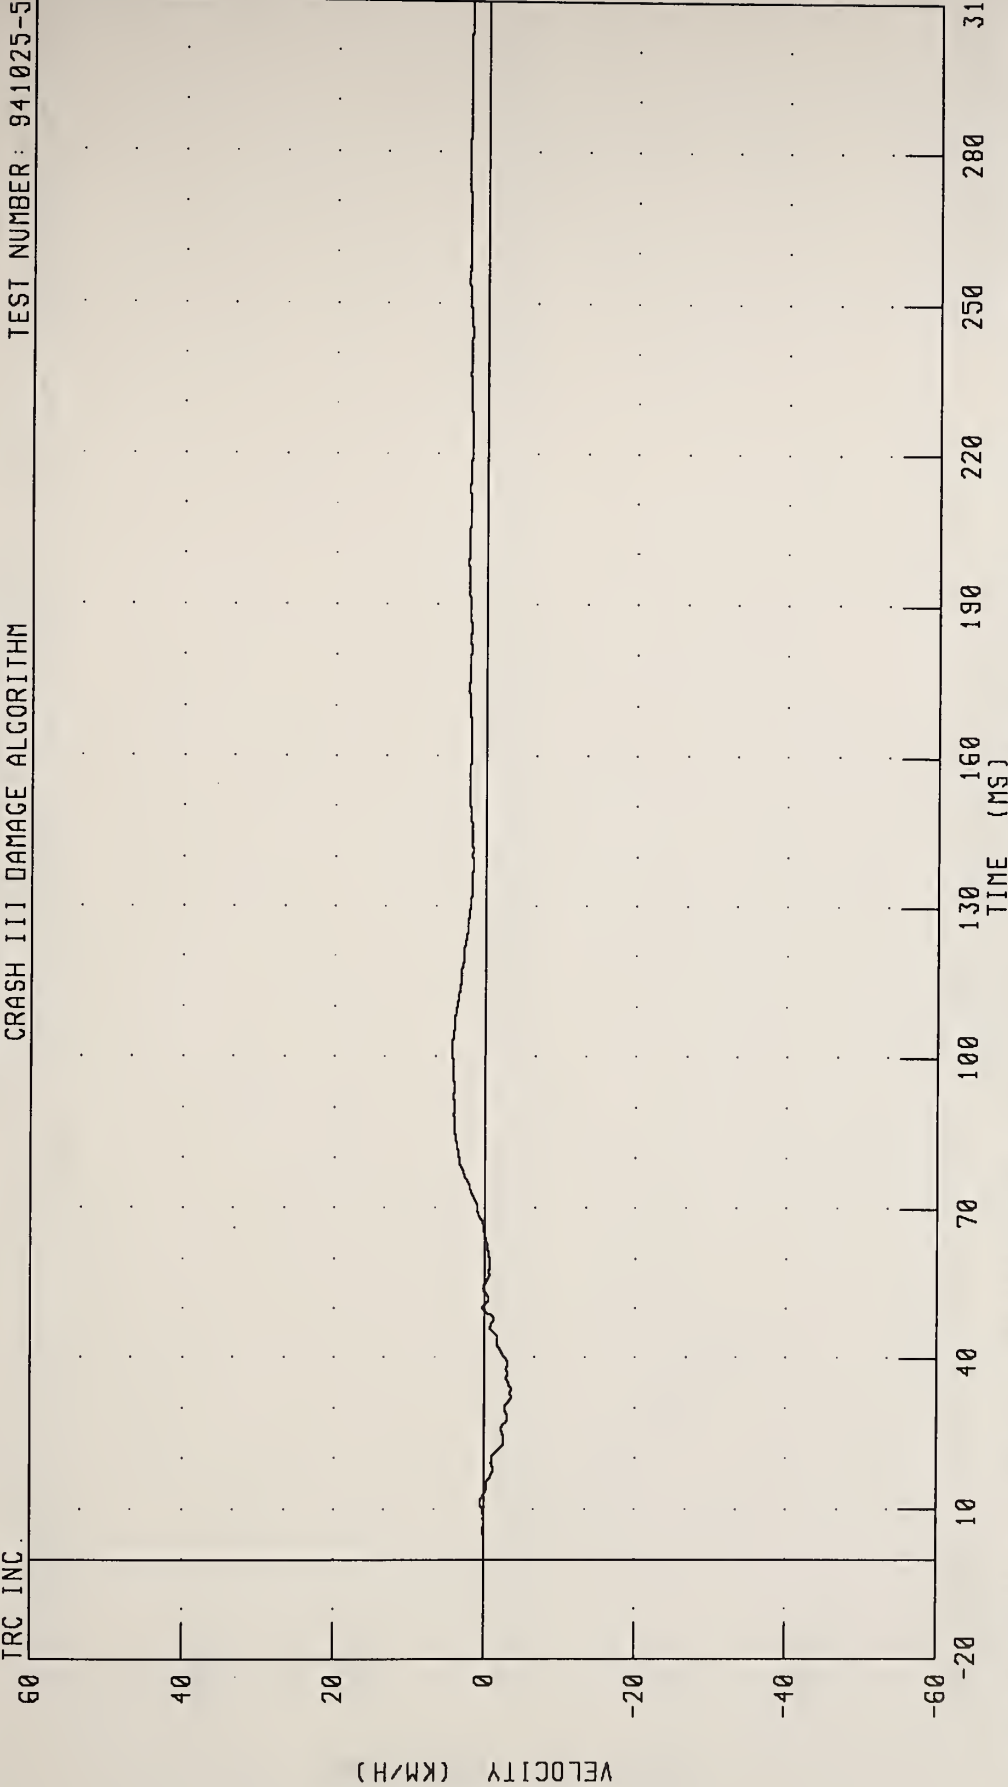
CRASH III DAMAGE ALGORITHM TEST NUMBER : 941025-5

TRC INC. CHANNEL : RFSYV FILTER : CH. CLASS 180

PEAK DATA : 4.42 KM/H @ 100.88 MS; -3.62 KM/H @ 32.32 MS

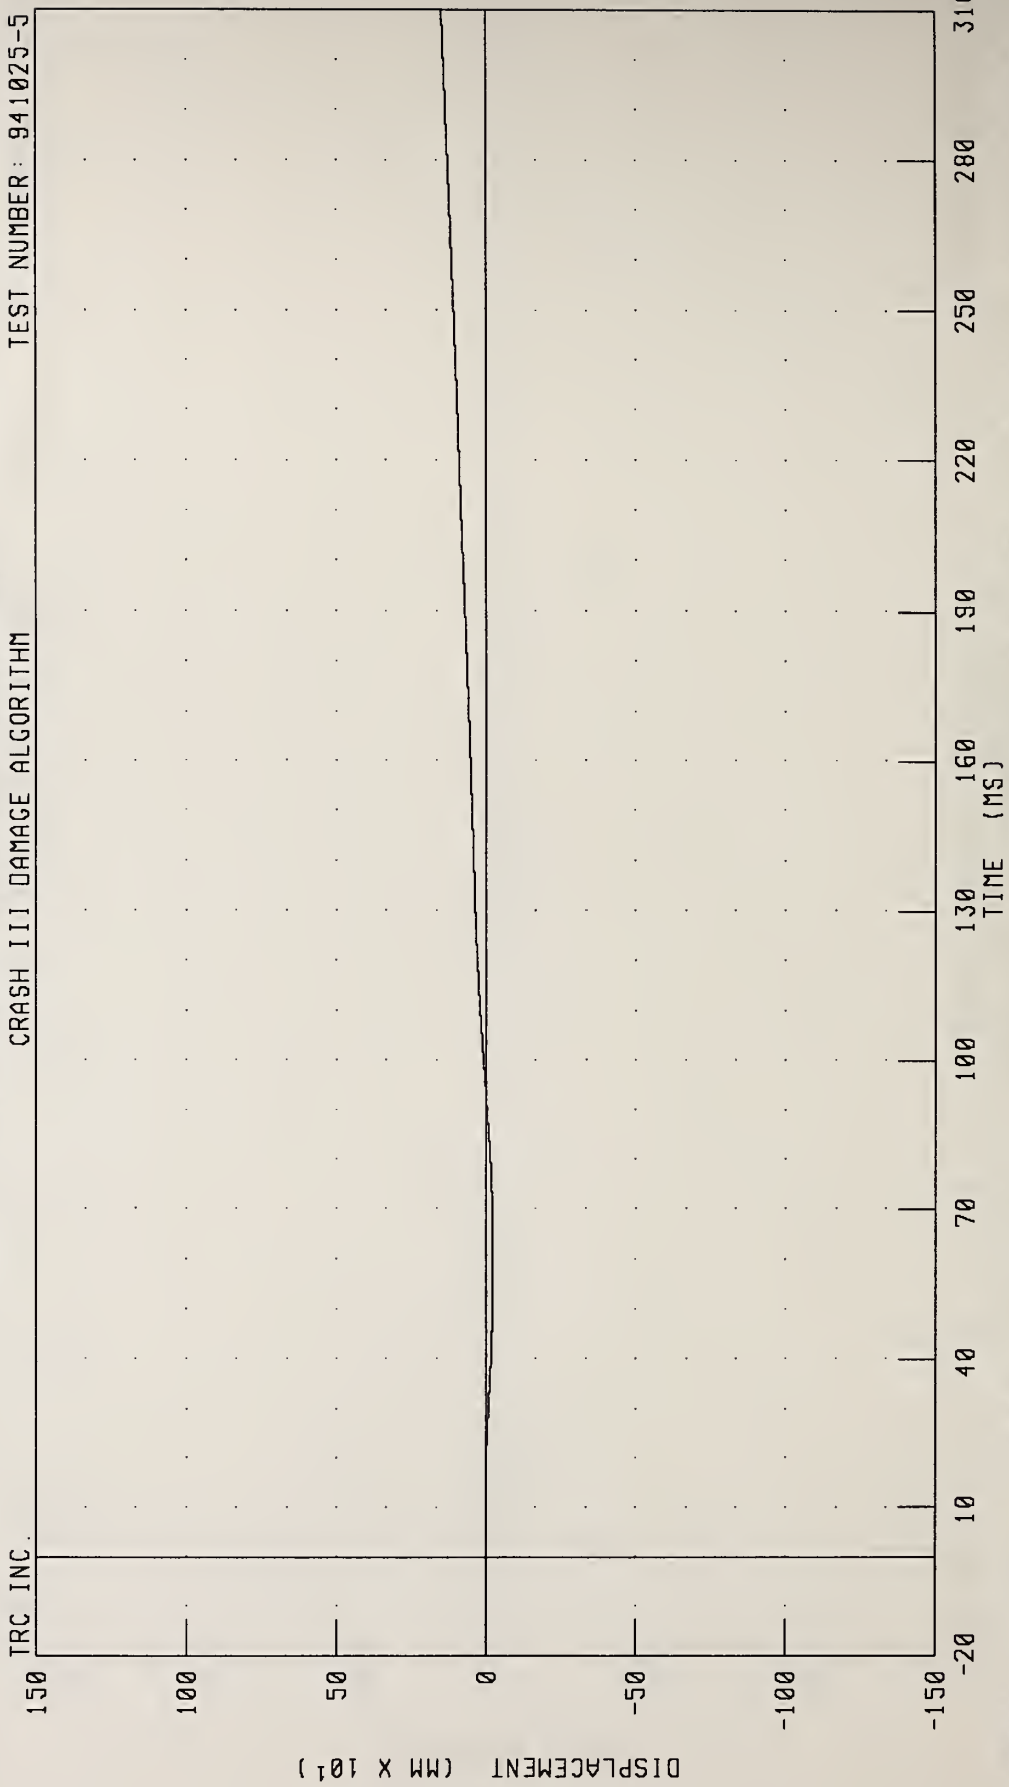
TEST NUMBER: 941025-5

CHANNEL: RFSYD FILTER: CH. CLASS 180

PEAK DATA: 148.19 MM @ 310.00 MS; -20.92 MM @ 64.48 MS

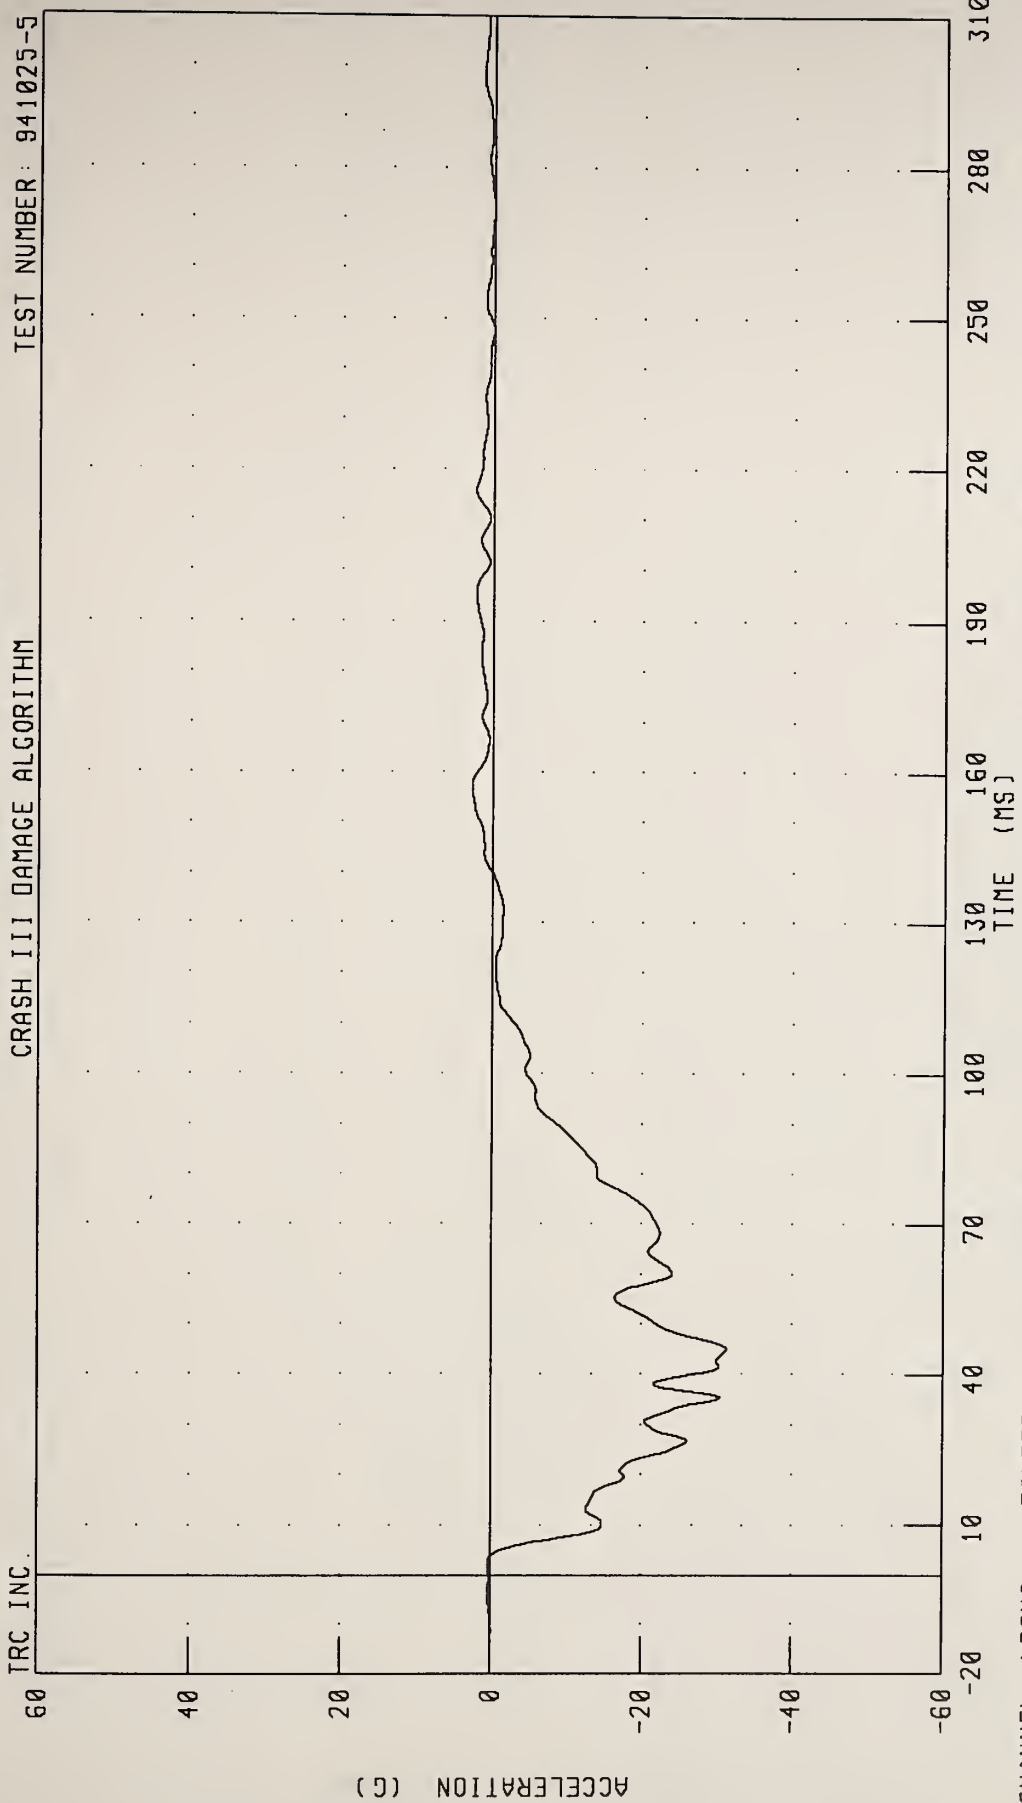
CRASH III DAMAGE ALGORITHM TEST NUMBER: 941025-5

CHANNEL: LRSXG FILTER: CH. CLASS 60

PEAK DATA: 2.77 G @ 157.28 MS; -31.29 G @ 44.96 MS

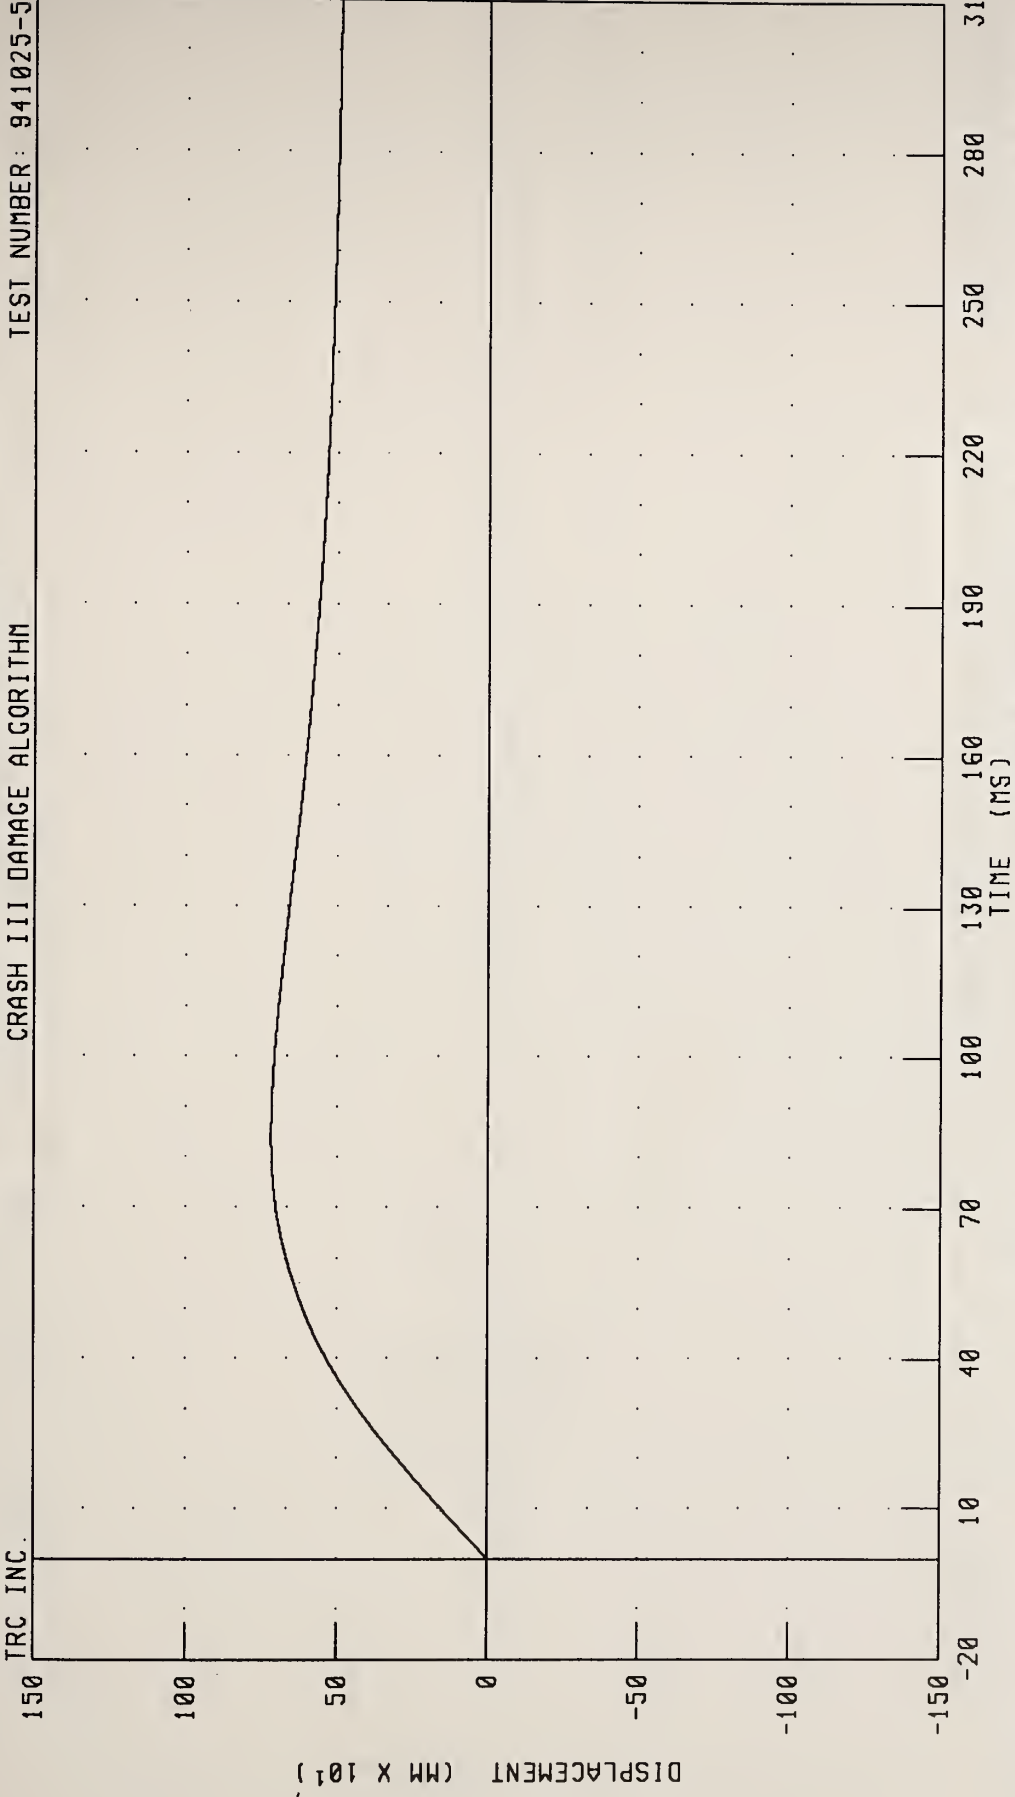
CHANNEL: LRSXD FILTER: CH. CLASS 180

PEAK DATA: 718.05 MM @ 84.48 MS; 0.00 MM @ 0.00 MS

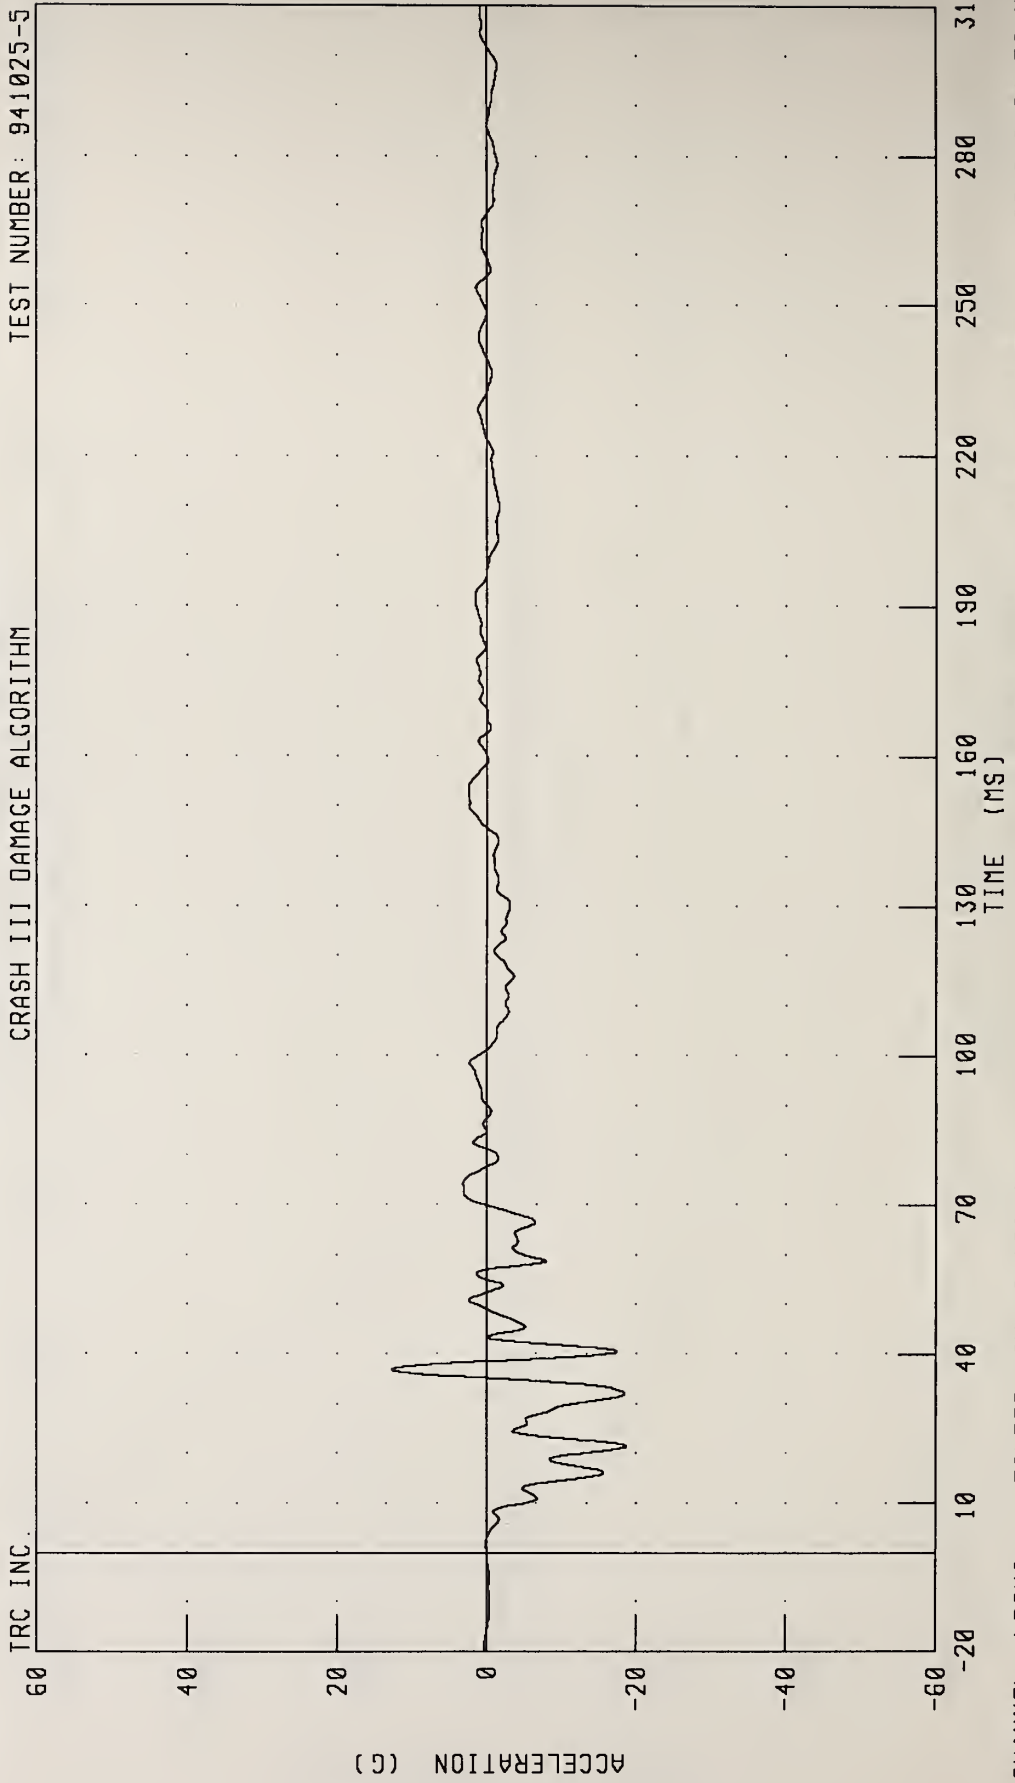
CRASH III DAMAGE ALGORITHM TEST NUMBER: 941025-5

CHANNEL: LRSYG FILTER: CH. CLASS 60

PEAK DATA: 12.77 G @ 37.04 MS; -18.68 G @ 21.52 MS

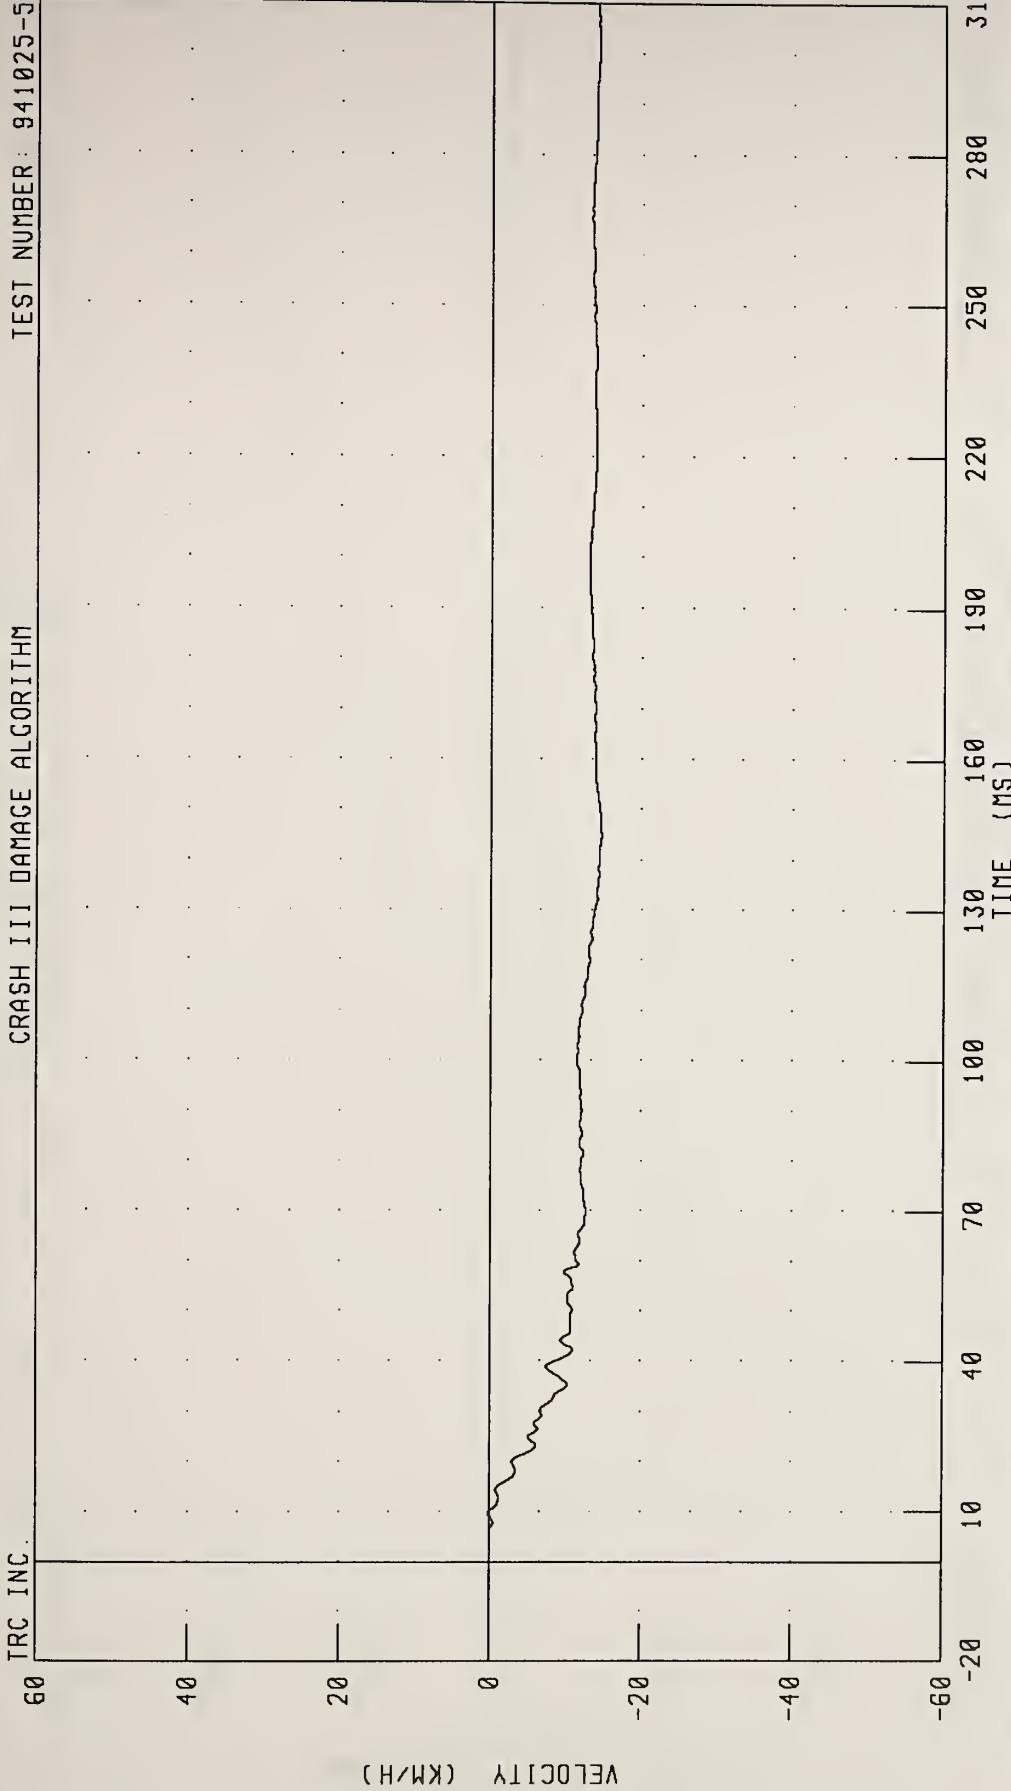
TRC INC. CRASH III DAMAGE ALGORITHM TEST NUMBER: 941025-5

CHANNEL: LRSYV FILTER: CH. CLASS 180

PEAK DATA: 0.21 KM/H @ 9.60 MS; -14.66 KM/H @ 144.88 MS

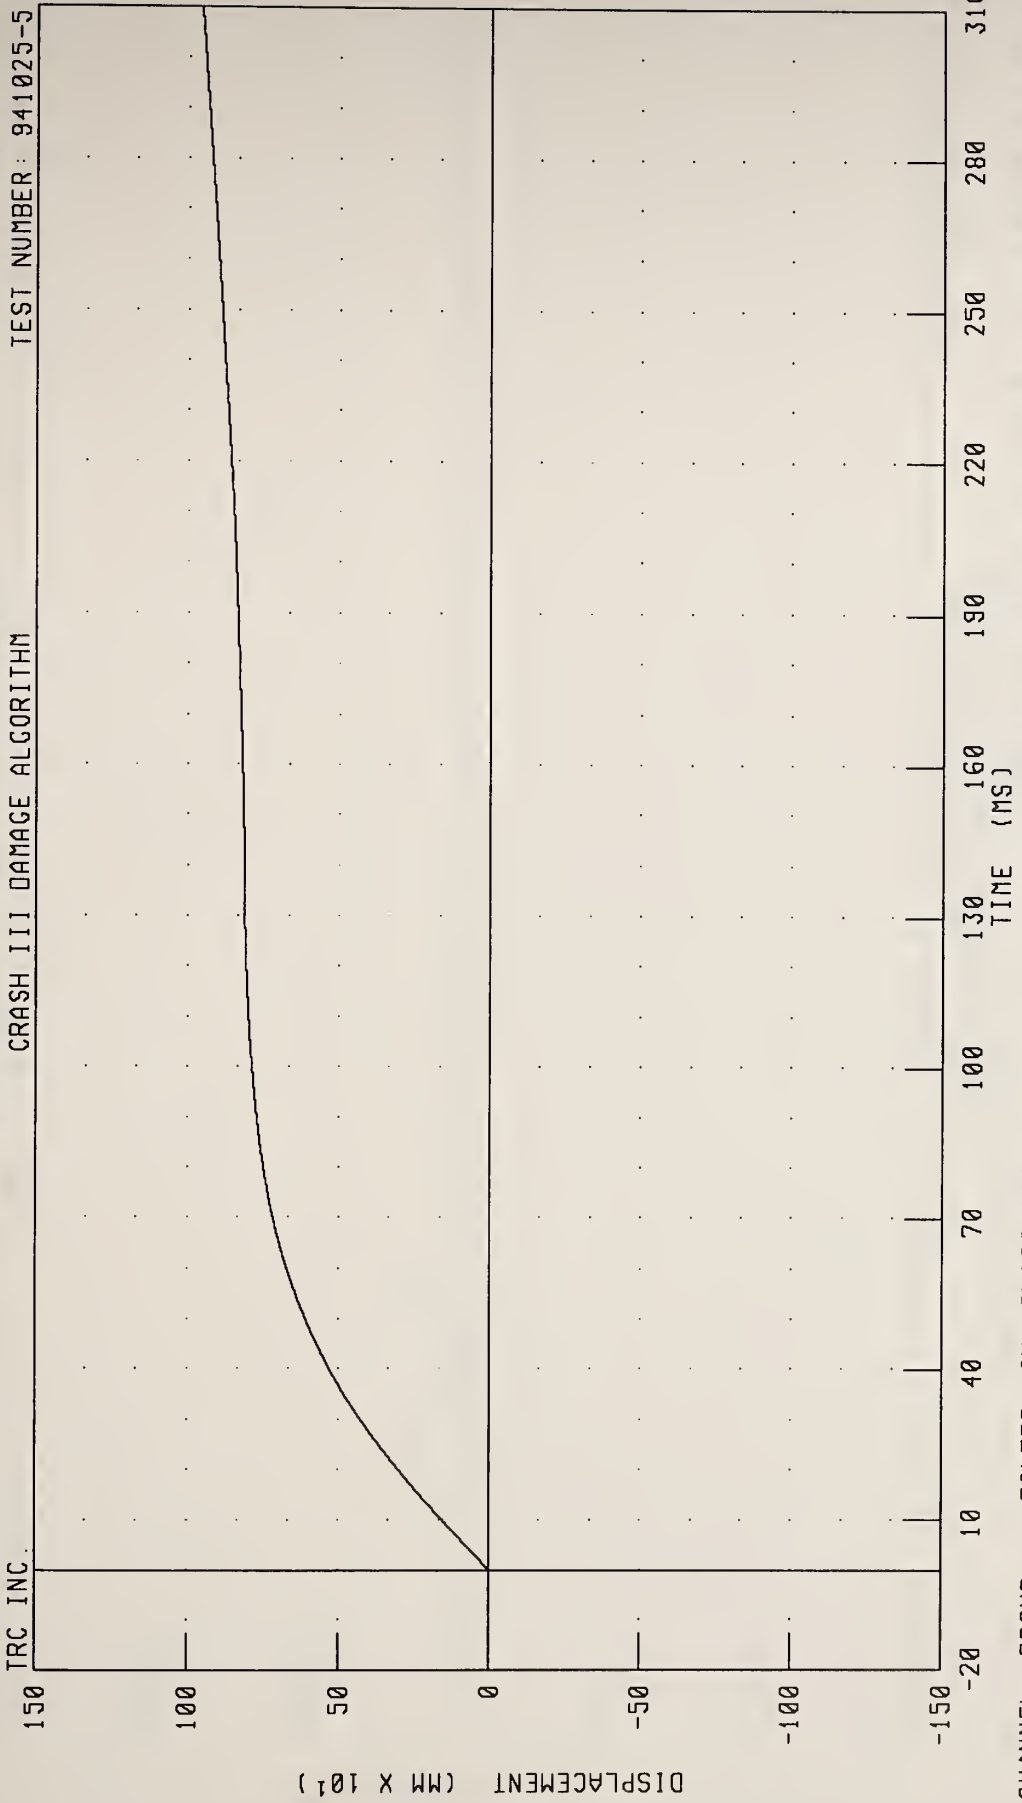
TRC INC. CRASH III DAMAGE ALGORITHM TEST NUMBER: 941025-5

CHANNEL: RRSXD FILTER: CH. CLASS 180

PEAK DATA: 957.10 MM @ 310.00 MS; 0.00 MM @ 0.00 MS

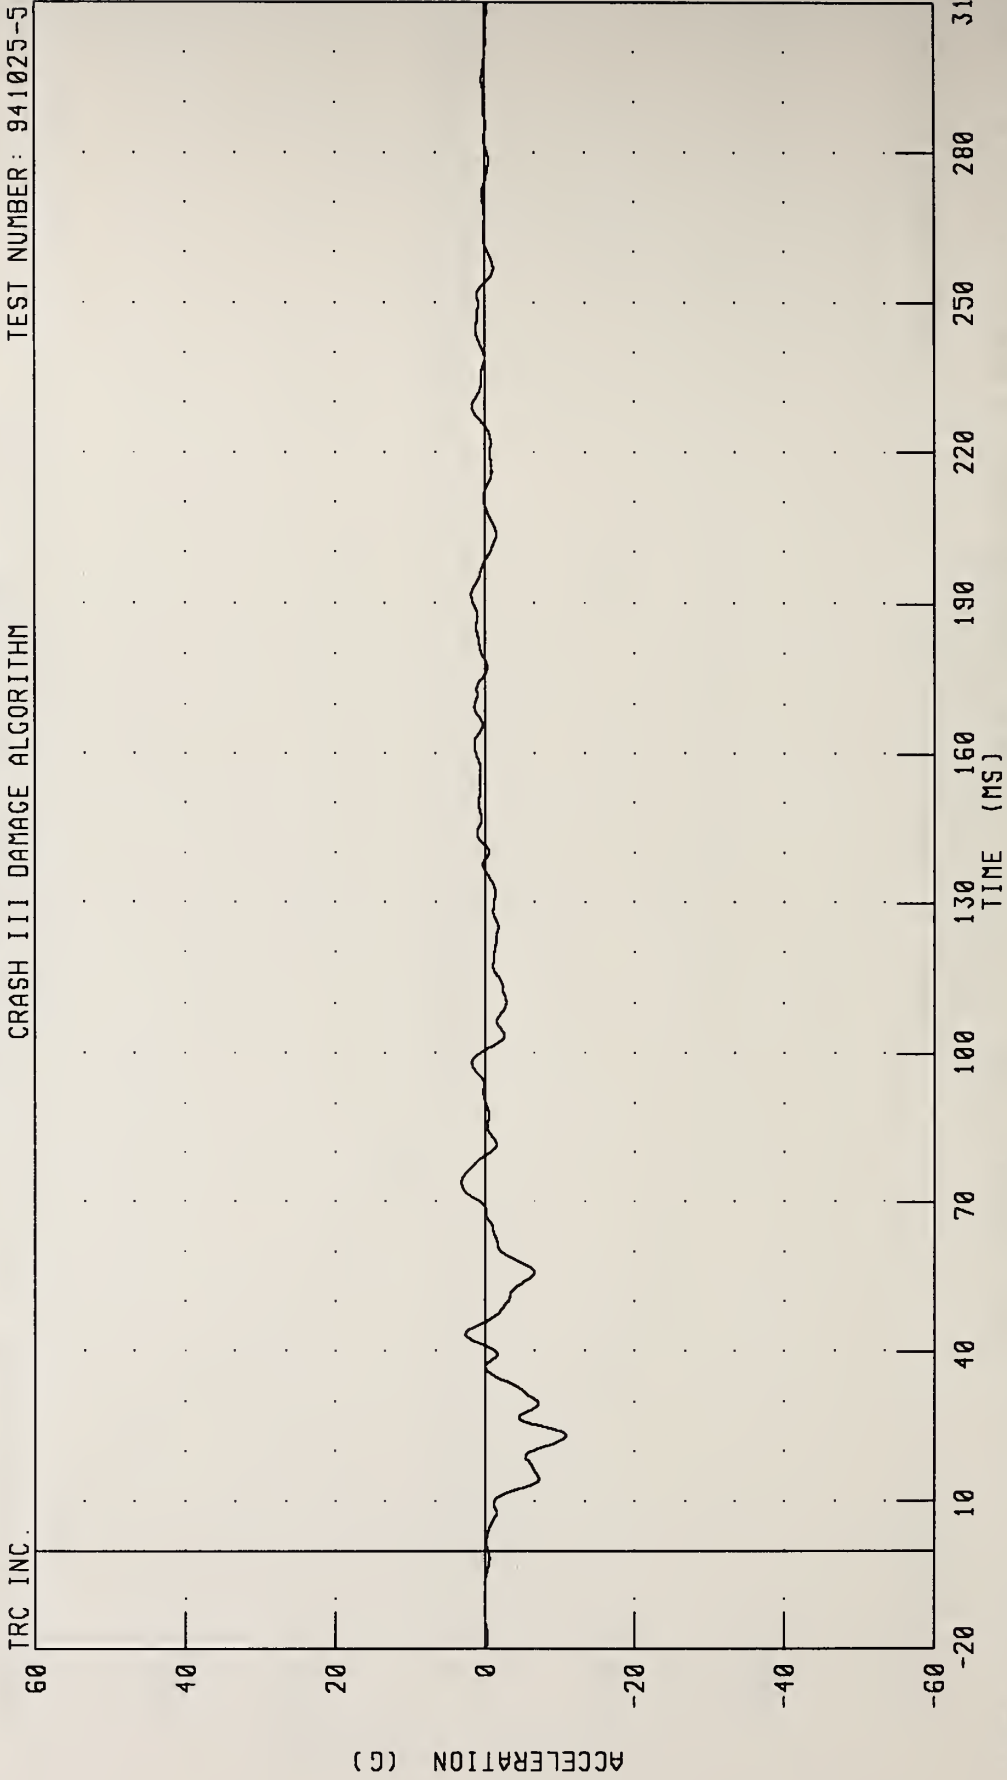
CRASH III DAMAGE ALGORITHM TEST NUMBER: 941025-5

CHANNEL: RRSYG FILTER: CH. CLASS 60

PEAK DATA: 3.16 G @ 73.92 MS; -10.85 G @ 23.20 MS

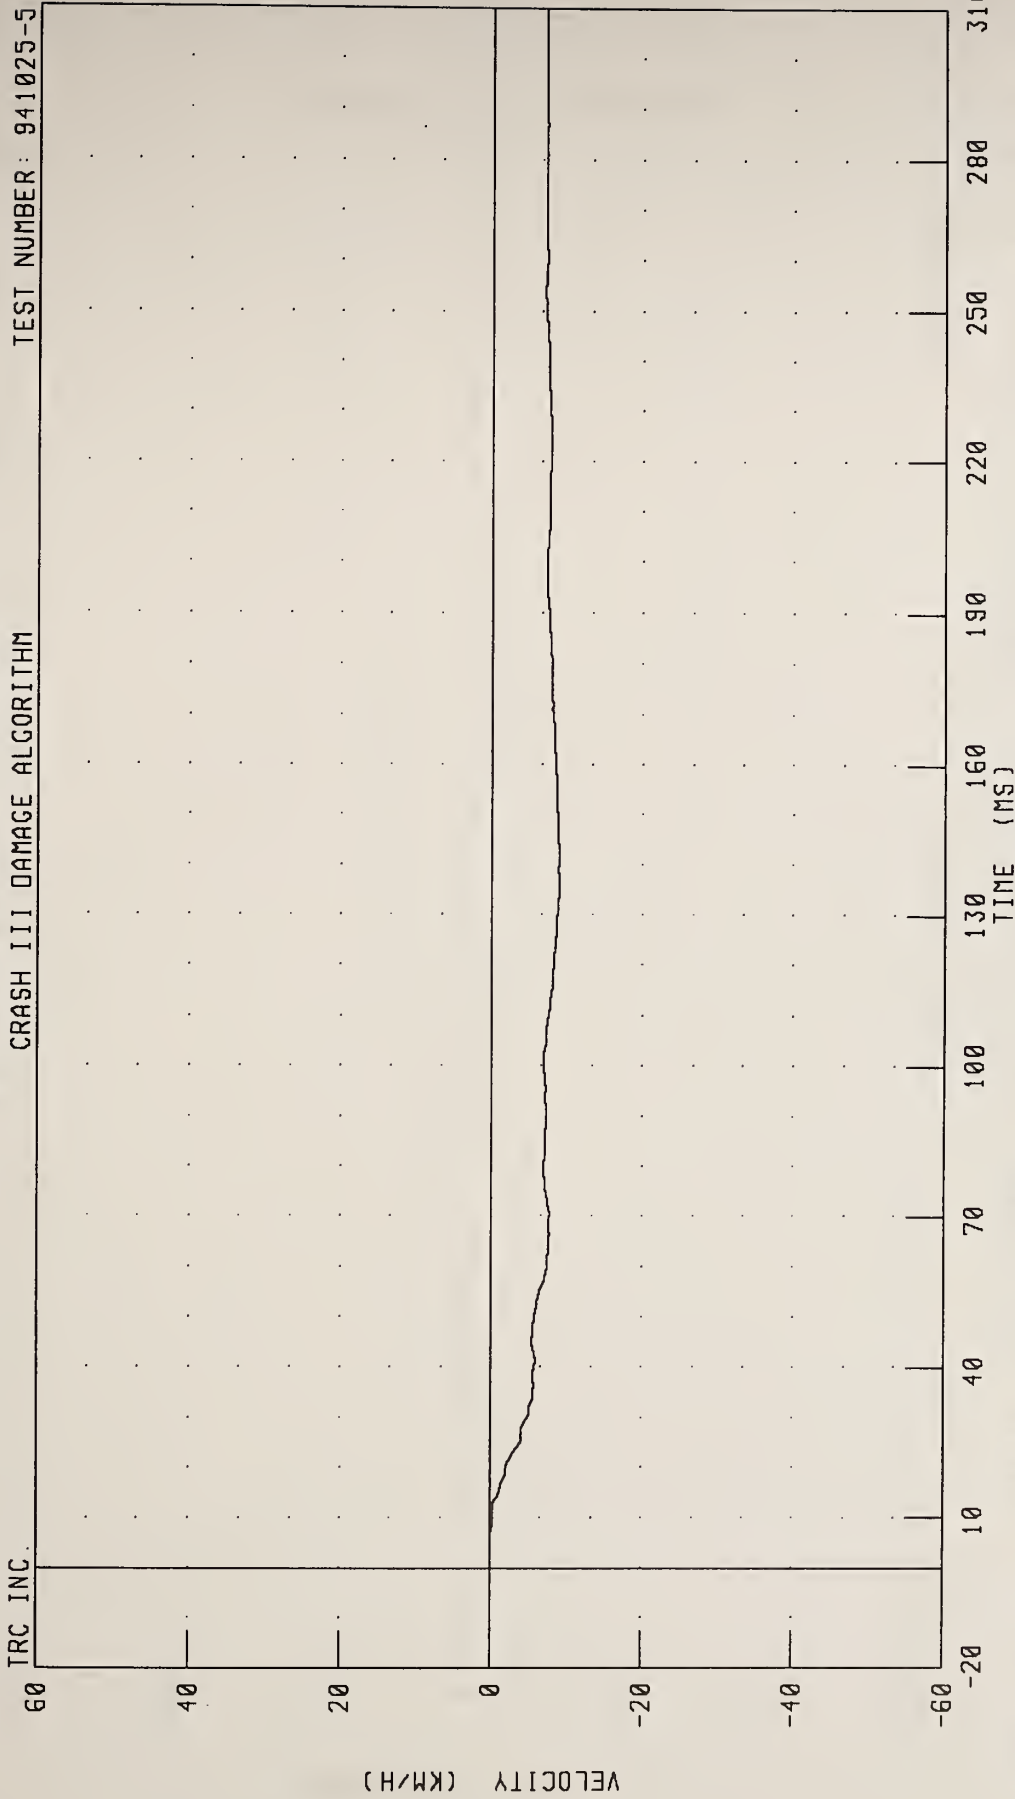
TEST NUMBER: 941025-5

CHANNEL: RRSYV FILTER: CH. CLASS 180

PEAK DATA: 0.02 KM/H @ 1.60 MS; -9.01 KM/H @ 141.60 MS
