U.S. Department
of Transportation

**National Highway
Traffic Safety
Administration**

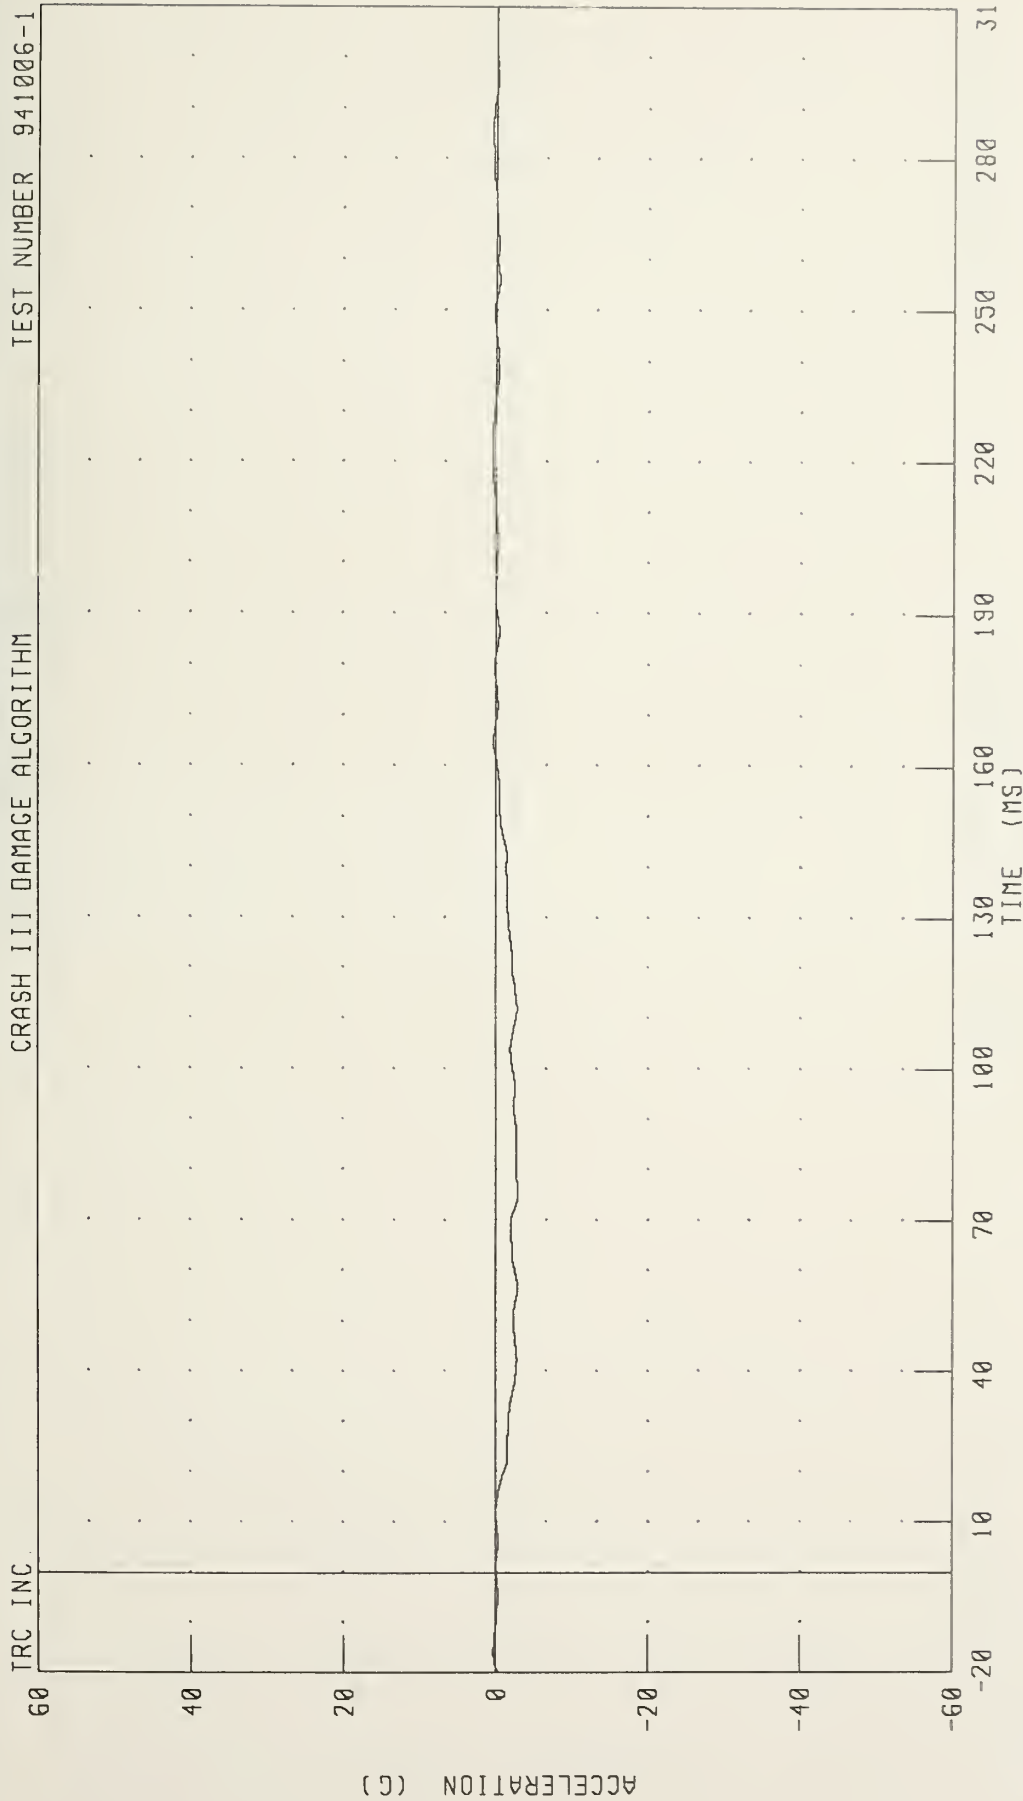
CHANNEL: VCGXG1 FILTER: CH. CLASS 60

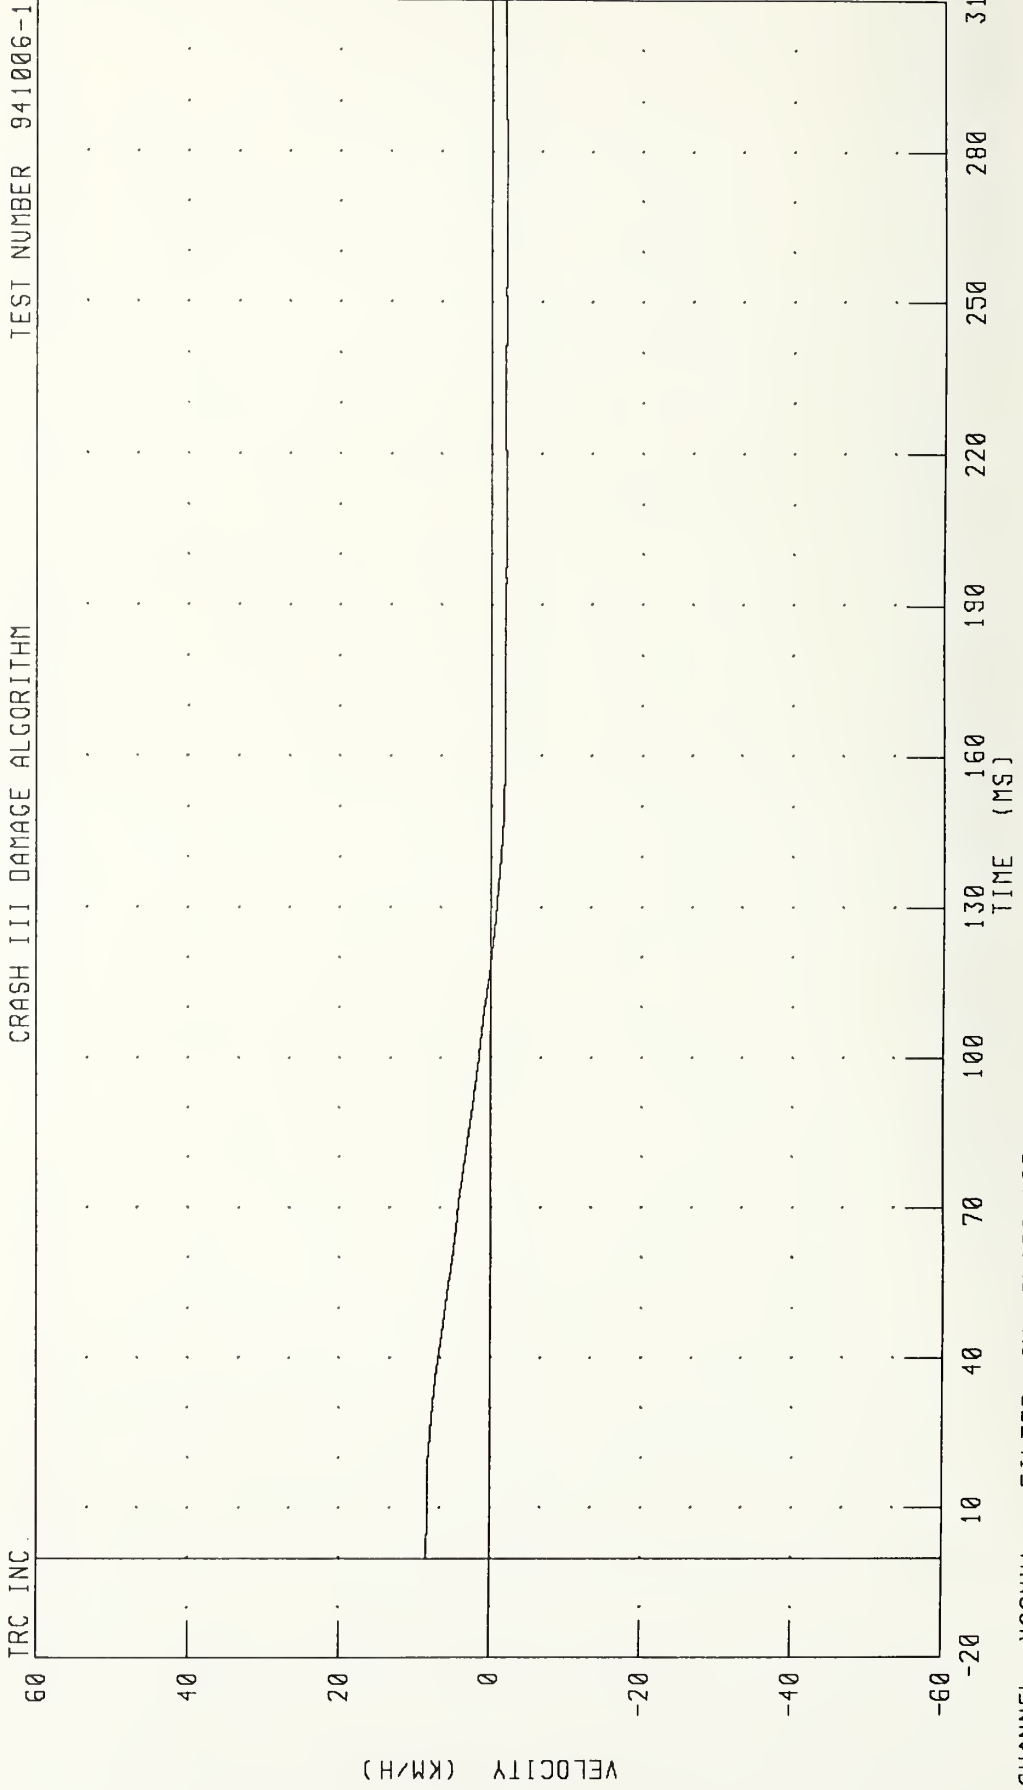
1992 CHEVROLET CAPRICE INTO 305 MM POLE
 VEHICLE CG X-AXIS DISPLACEMENT
 CRASH III DAMAGE ALGORITHM

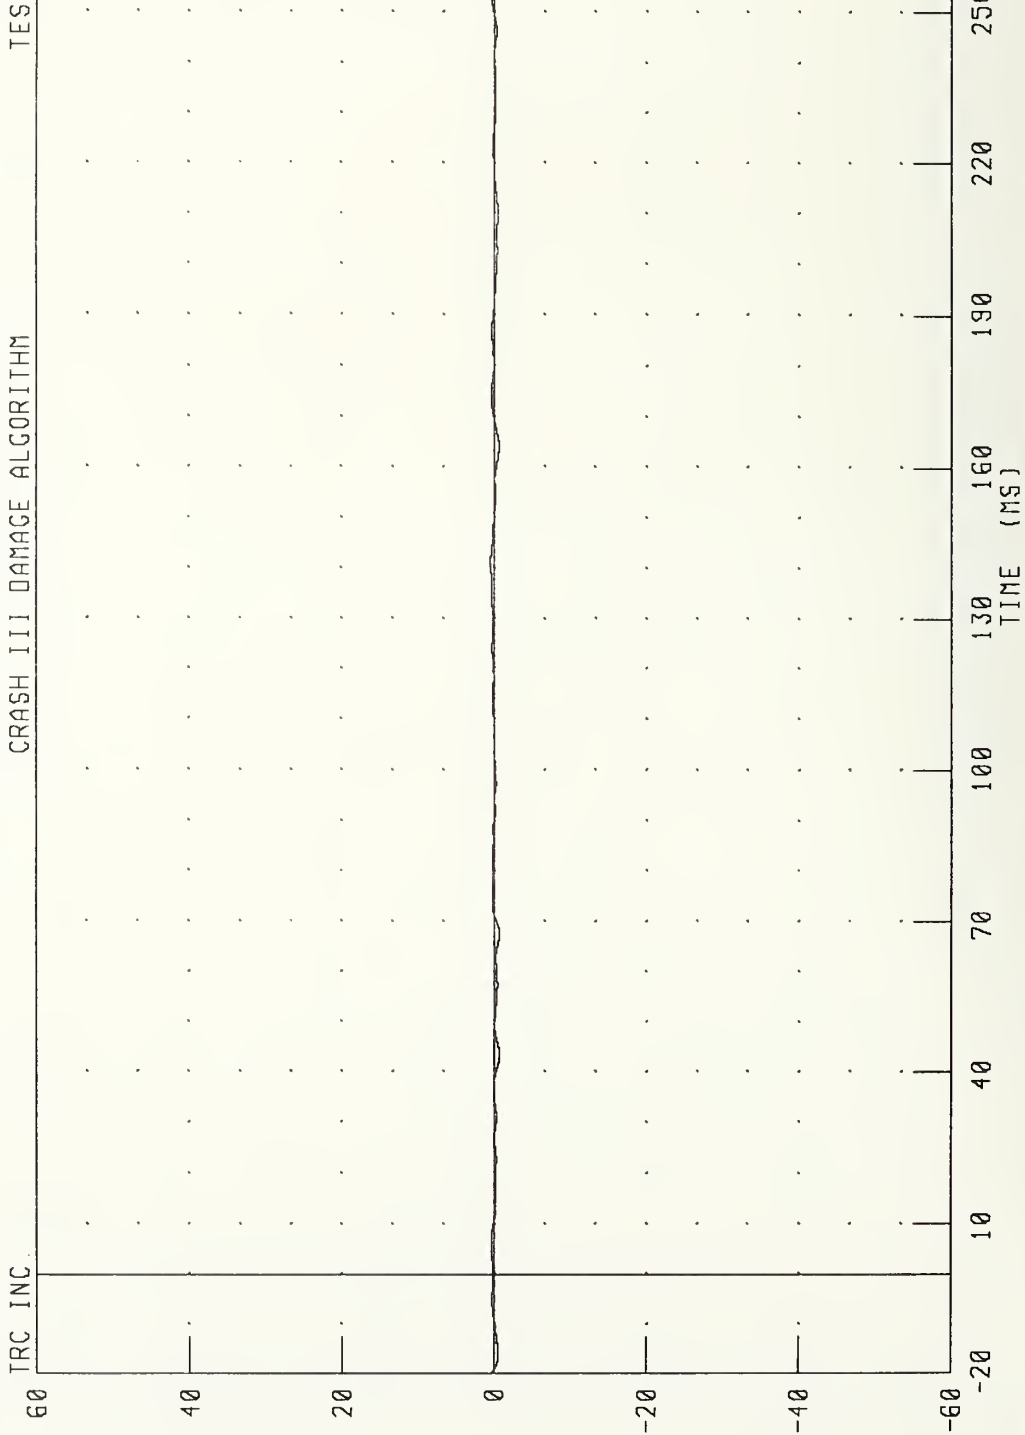
TRC INC. CHANNEL: VCGY61 FILTER: CH. CLASS 60
PEAK DATA: 0.55 G @ 254.72 MS; -0.72 G @ 43.52 MS

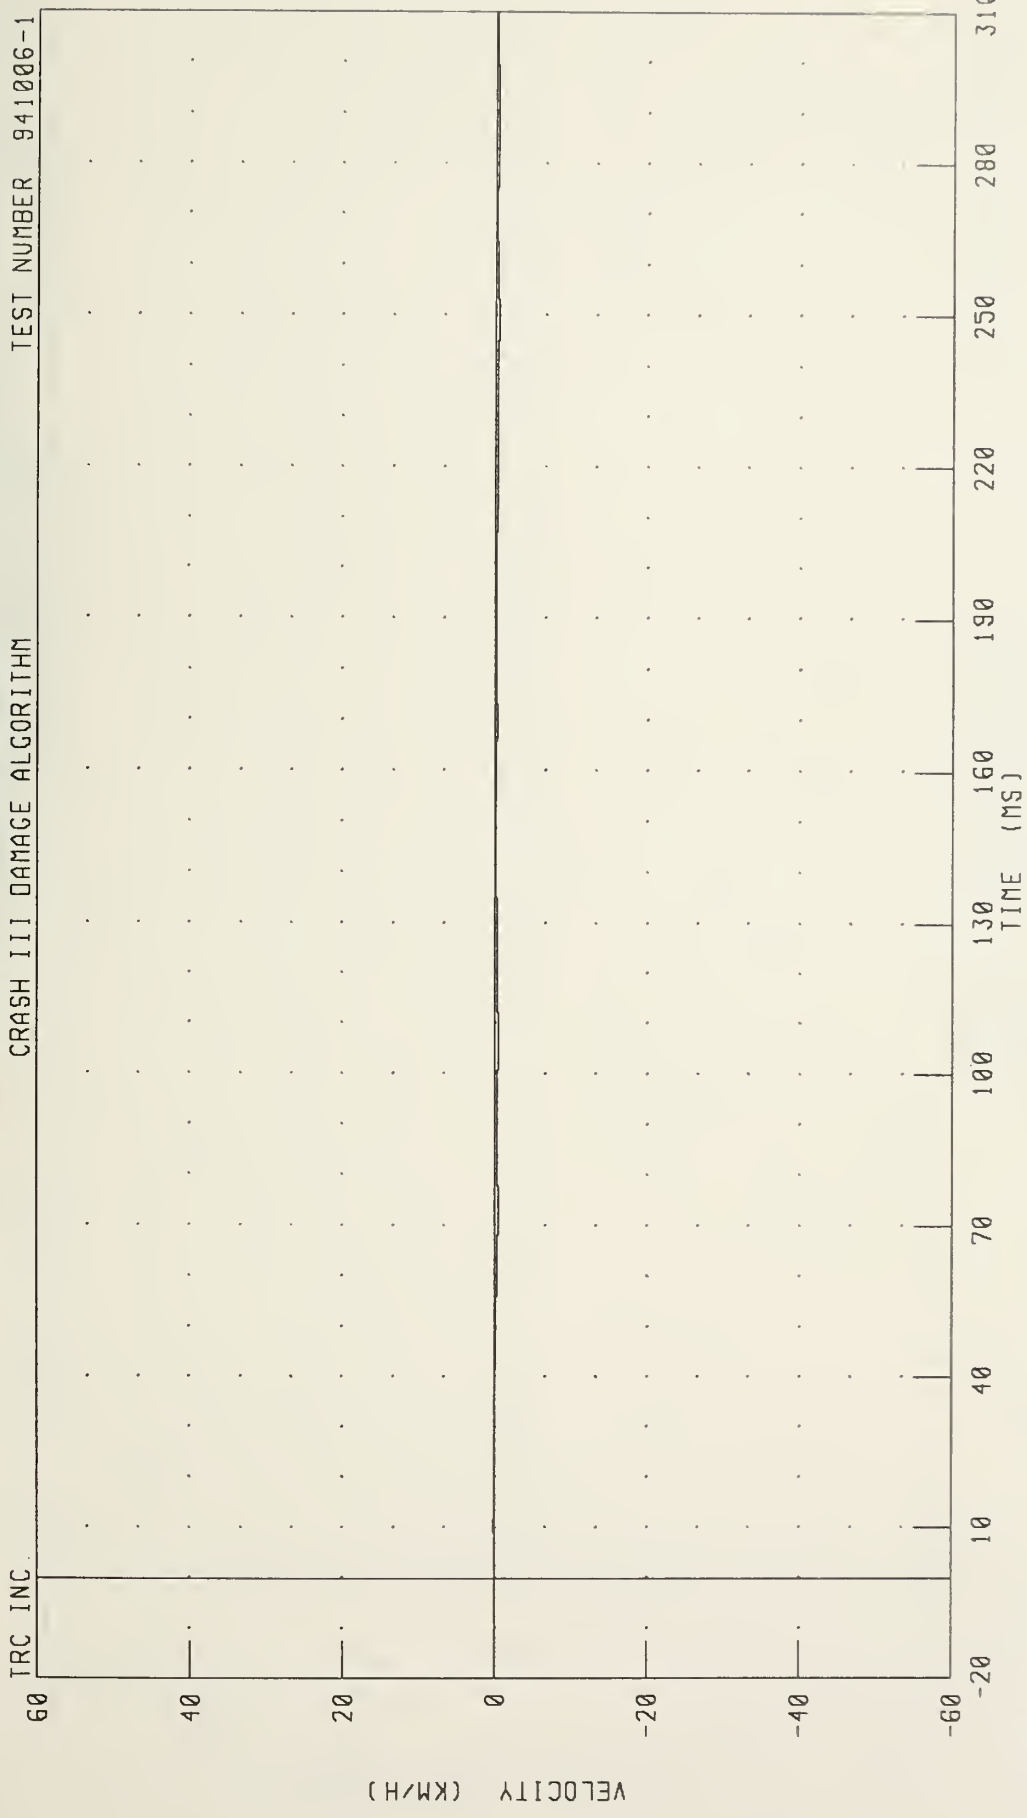
CHANNEL: VCGYV1 FILTER: CH. CLASS 180 PEAK DATA: 0.11 KM/H @ 10 48 MS; -0 45 KM/H @ 71 36 MS

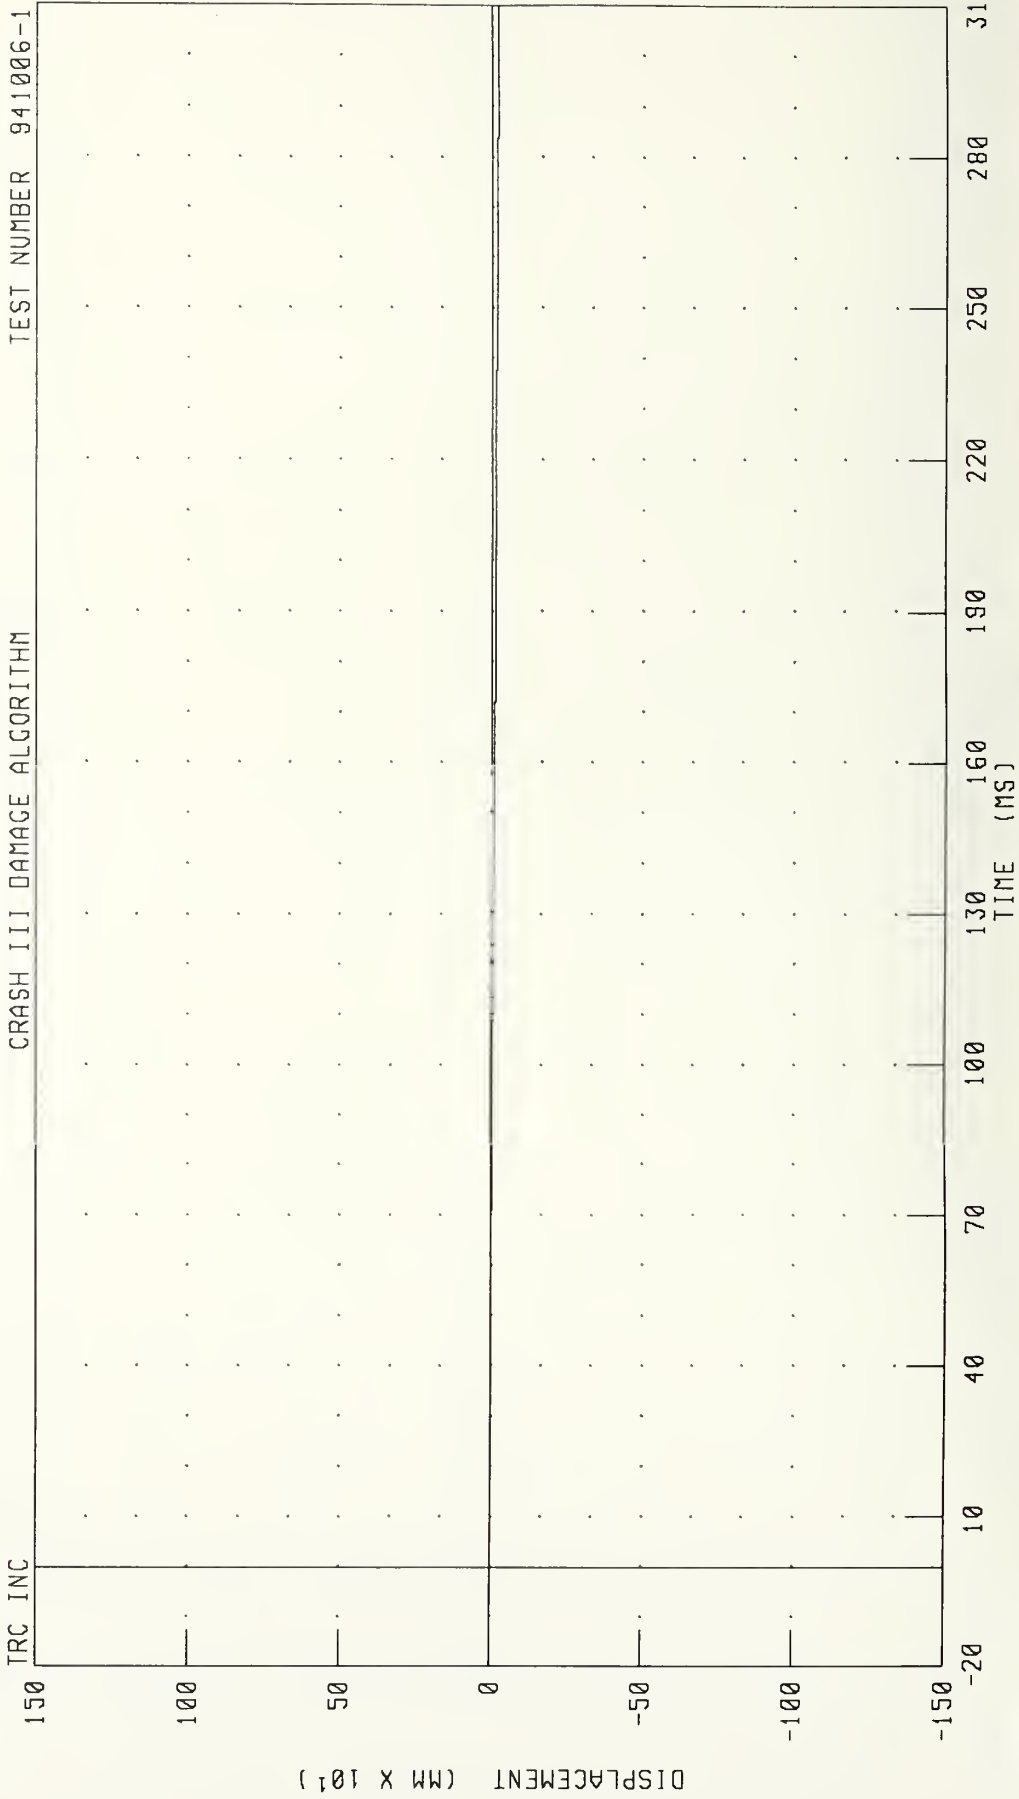
CHANNEL: VCGYD1 FILTER: CH. CLASS 180

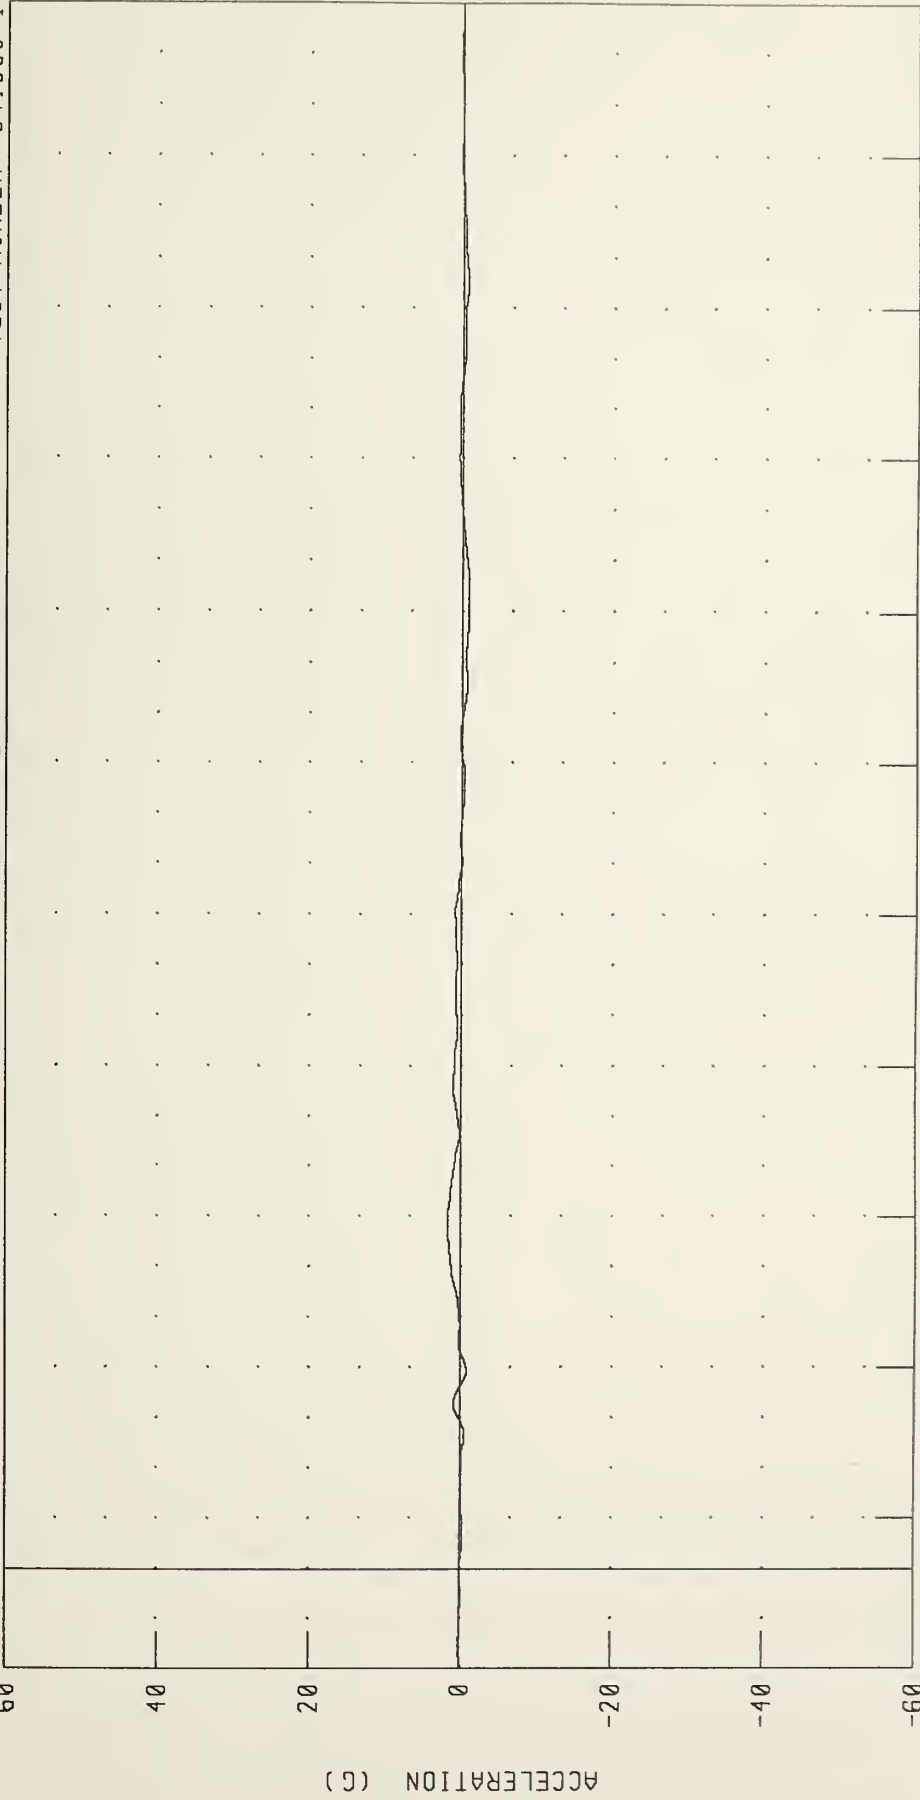
CHANNEL VCGZG1 FILTER CH. CLASS 60
PEAK DATA: 1 73 G @ 67 52 MS, -0 89 G @ 188 56 MS

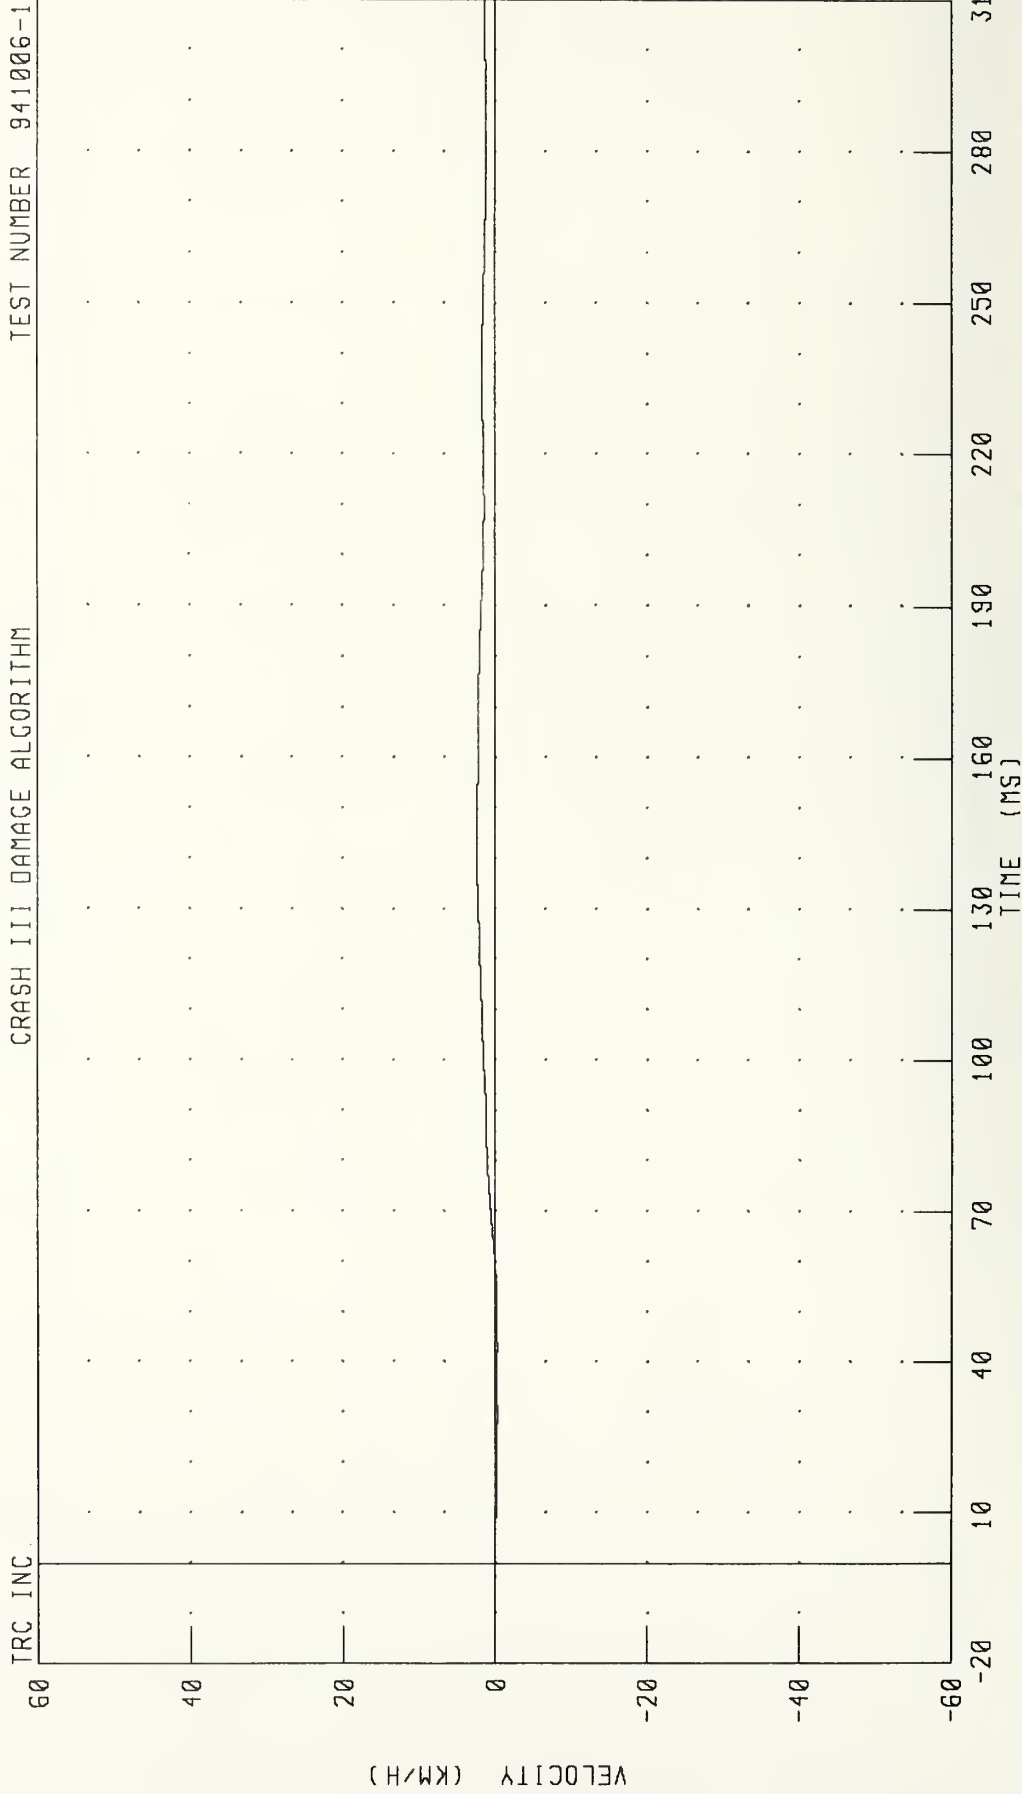
CHANNEL: YCGZV1 FILTER: CH. CLASS 180
PEAK DATA: 2.35 KM/H @ 146.56 MS; -0.27 KM/H @ 296.60 MS

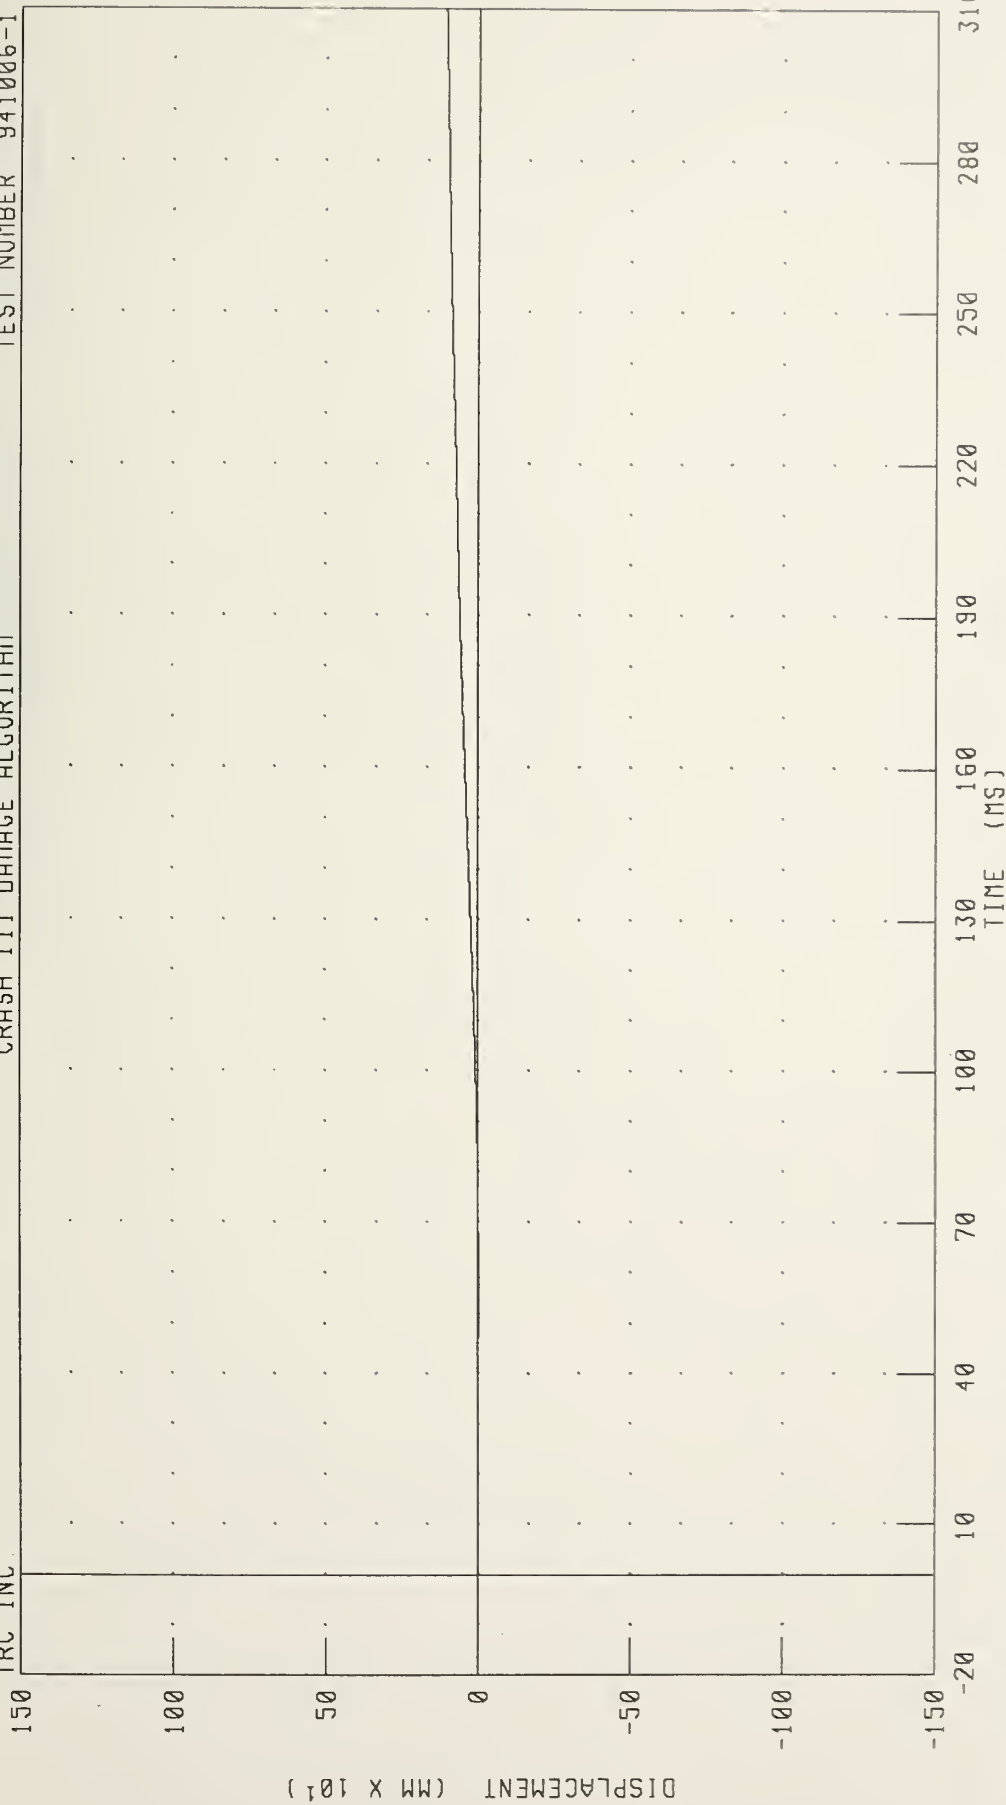
CHANNEL: VCGZ01 FILTER: CH. CLASS 180 PEAK DATA: 108.32 MM @ 310.00 MS, -2.44 MM @ 59.28 MS

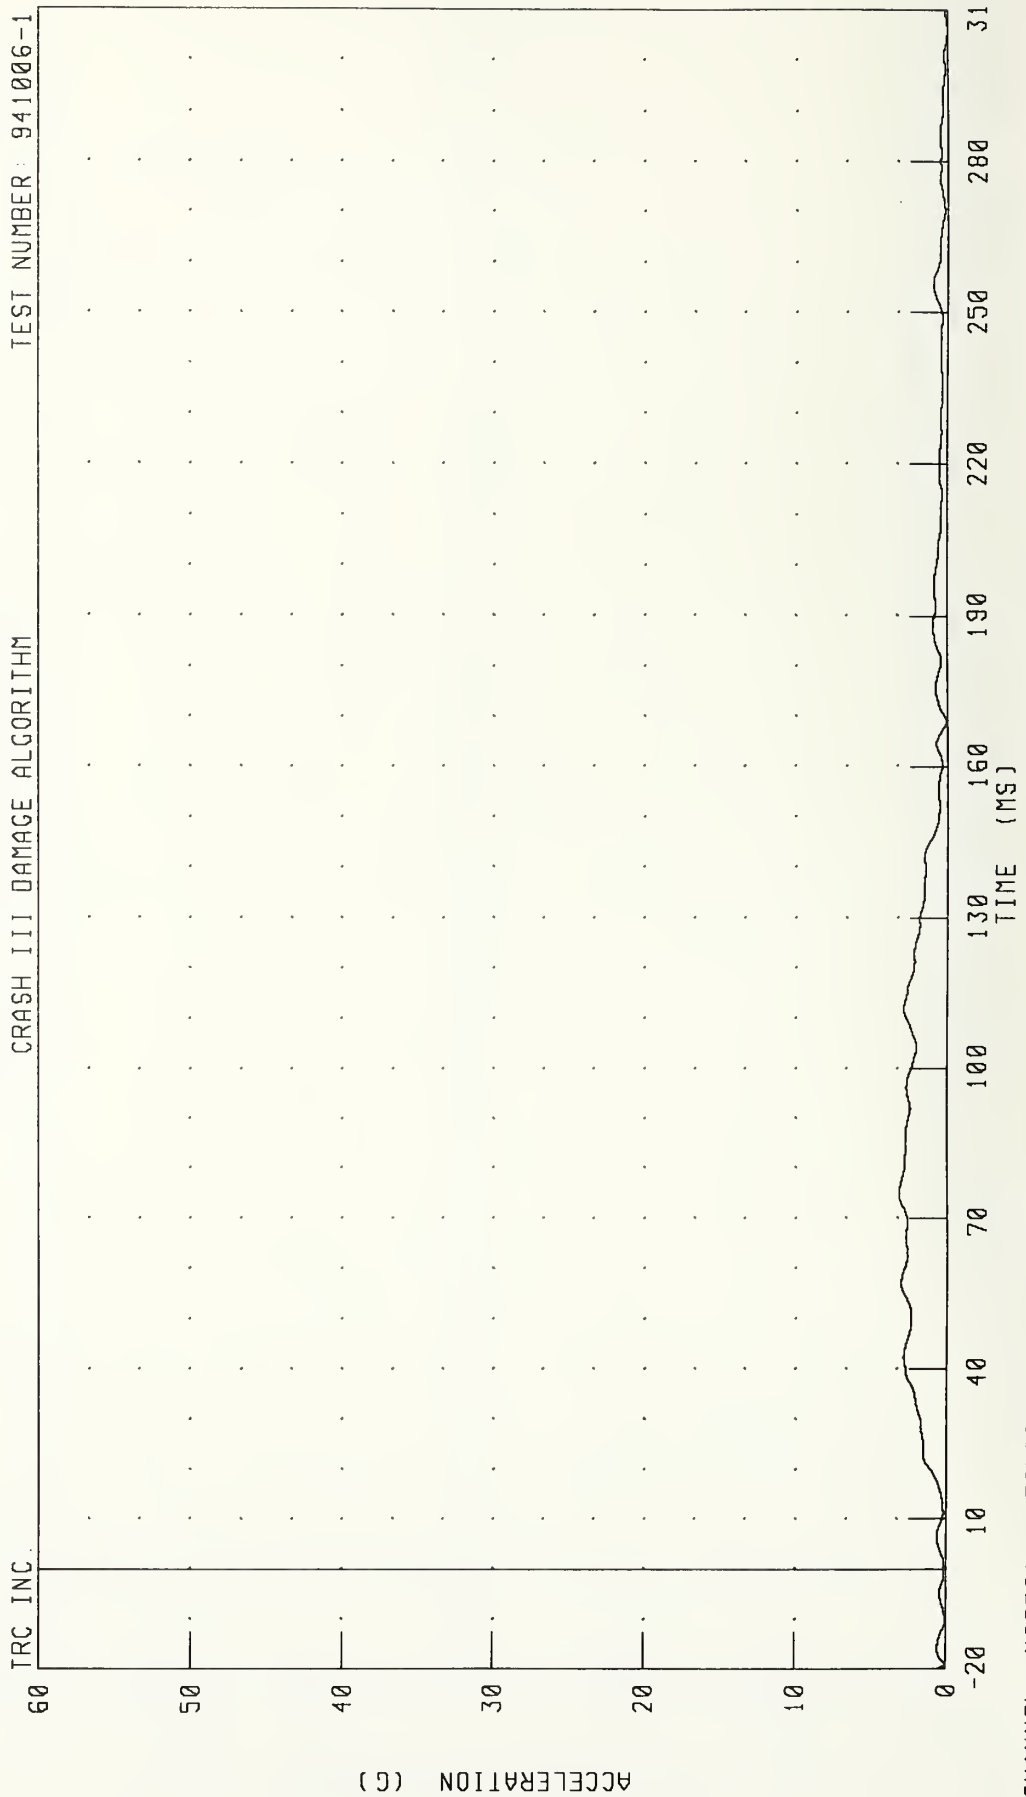
CHANNEL: VCGRG1 FILTER: CH. CLASS 60 PEAK DATA: 3.20 G @ 74.56 MS; 0.06 G @ 306.32 MS

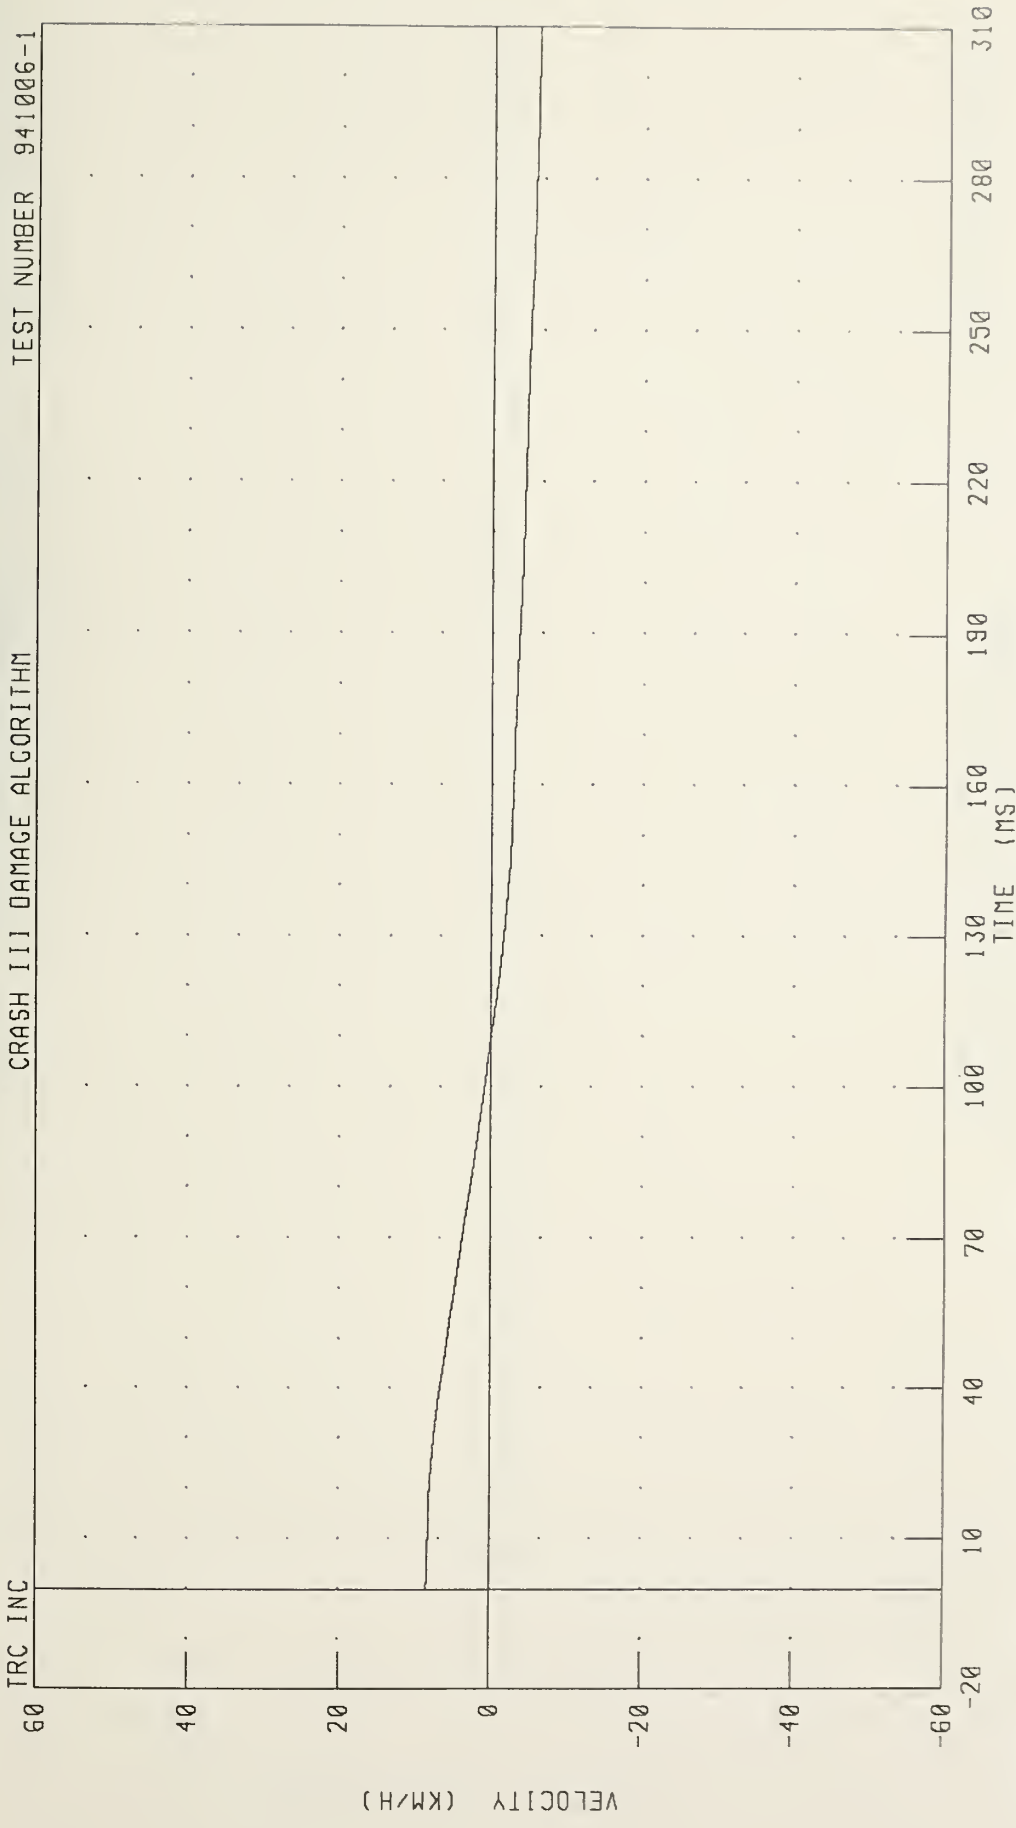
1992 CHEVROLET CAPRICE INTO 305 MM POLE
VEHICLE CG RESULTANT DISPLACEMENT
CRASH III DAMAGE ALGORITHM

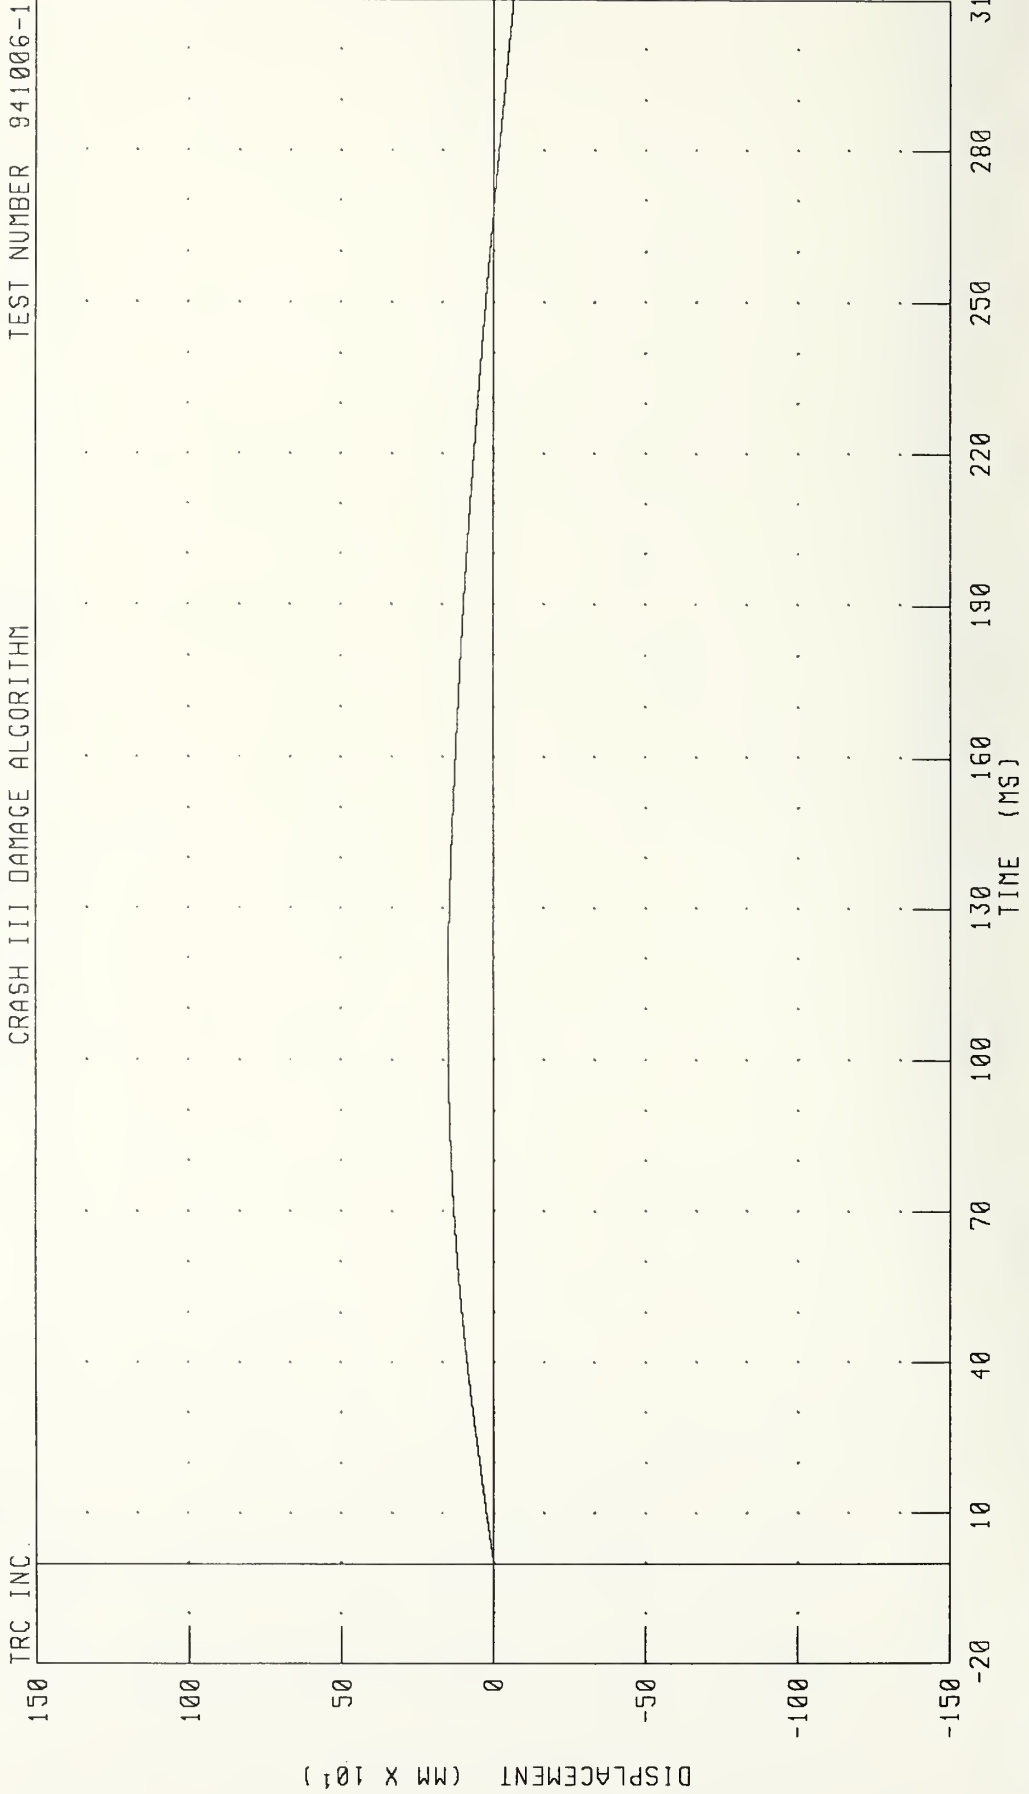
CHANNEL: VCGRD1 FILTER: CH. CLASS 180 PEAK DATA: 150.15 MM @ 109.92 MS, -65.49 MM @ 310.00 MS

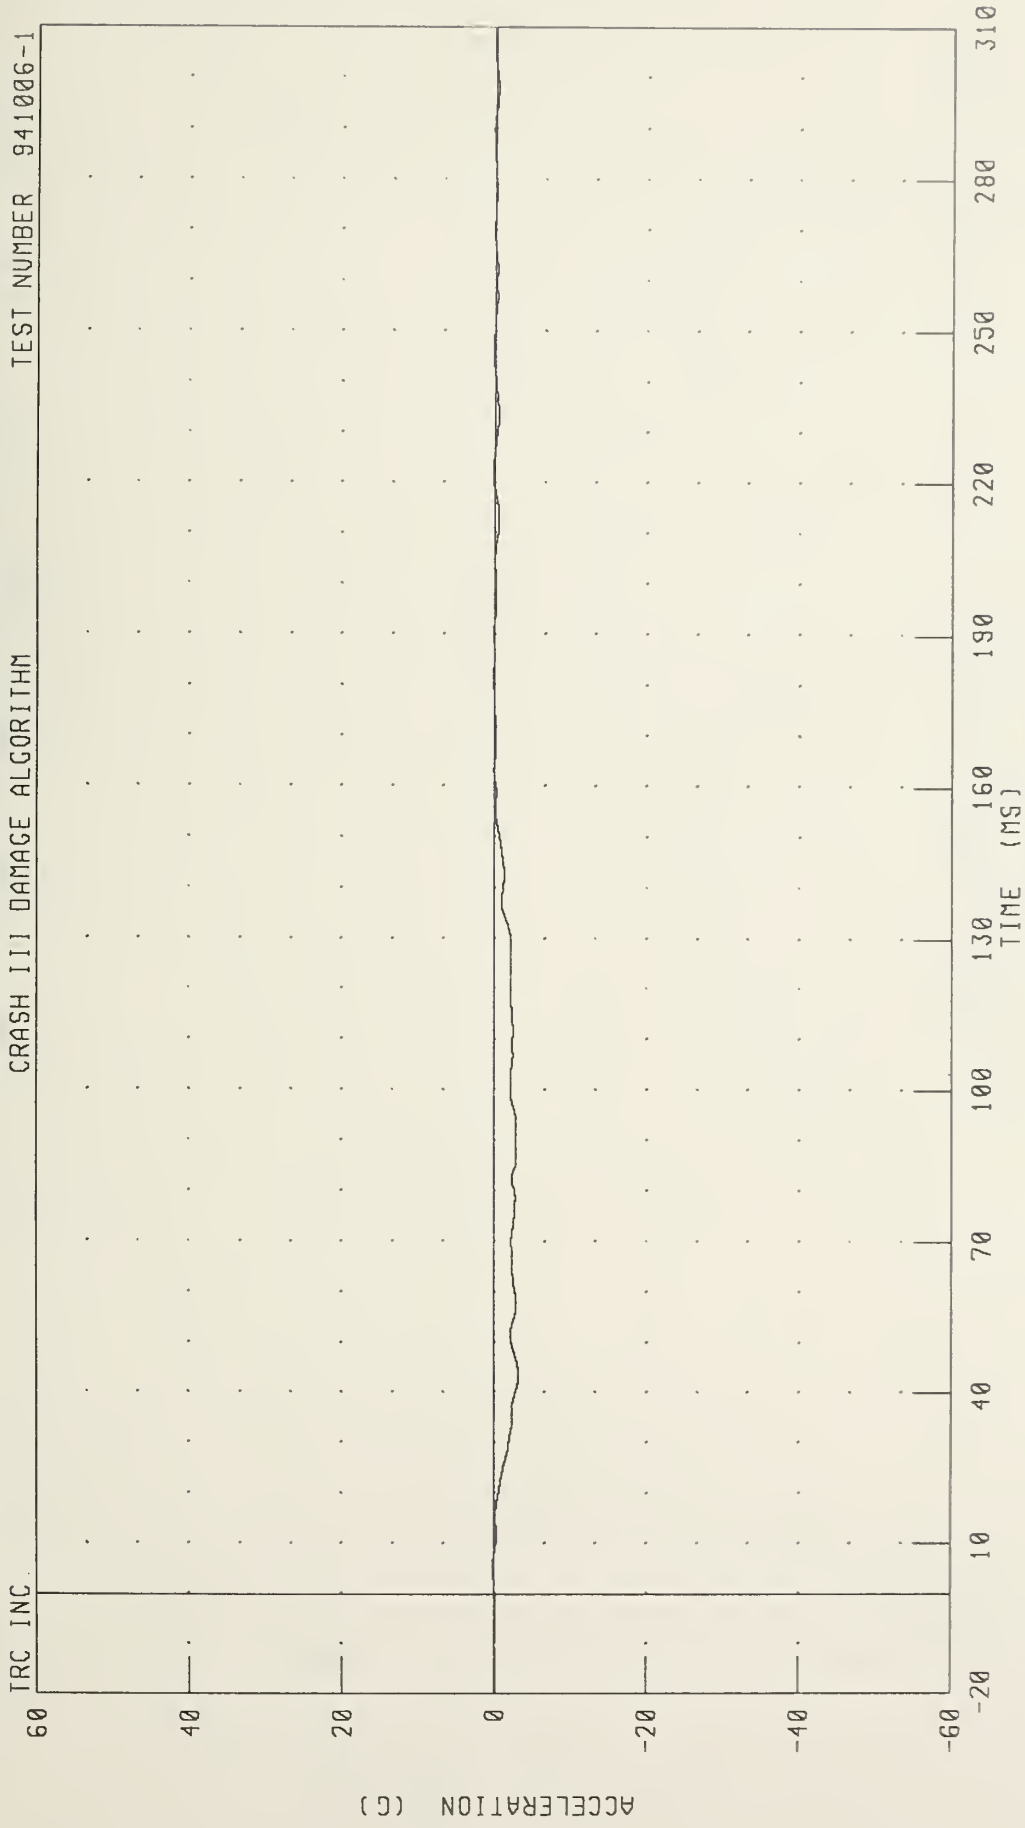
CHANNEL LFSXG1 FILTER: CH. CLASS 60 PEAK DATA 0.27 G @ 289.76 MS, -3.21 G @ 43.36 MS
