U.S. Department
of Transportation

**National Highway
Traffic Safety
Administration**

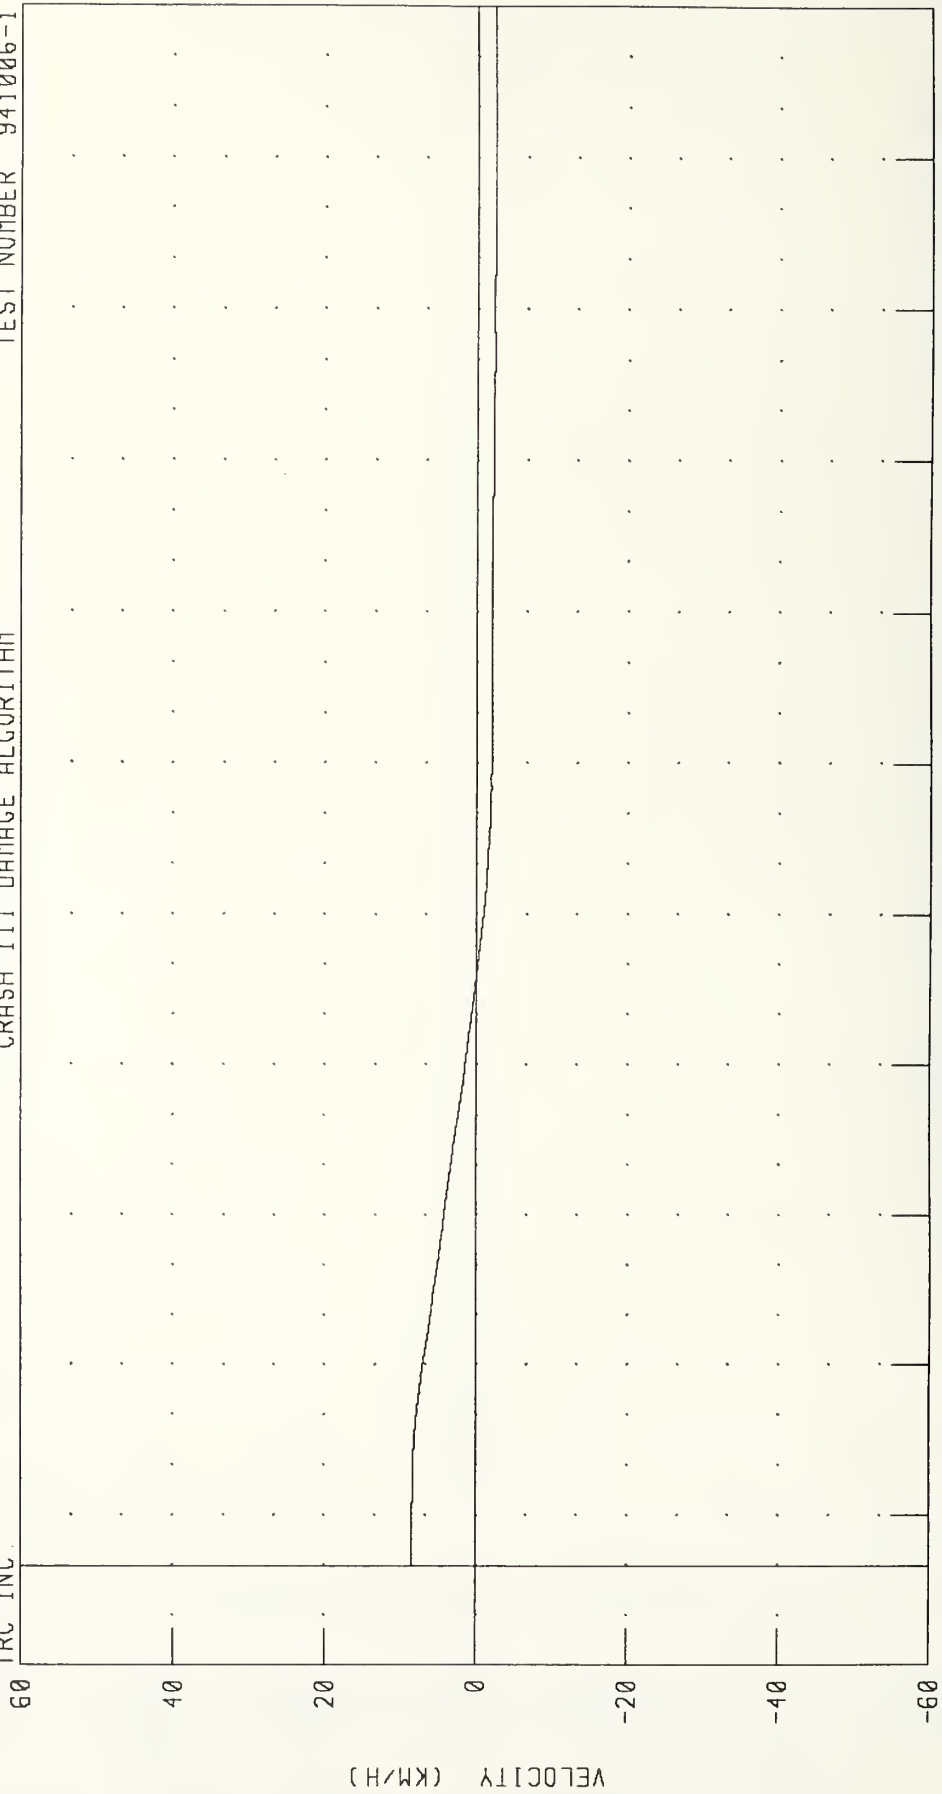
CHANNEL: LFSXV1 FILTER: CH. CLASS 180
PEAK DATA: 8.43 KM/H @ 6.88 MS; -2.36 KM/H @ 267.92 MS

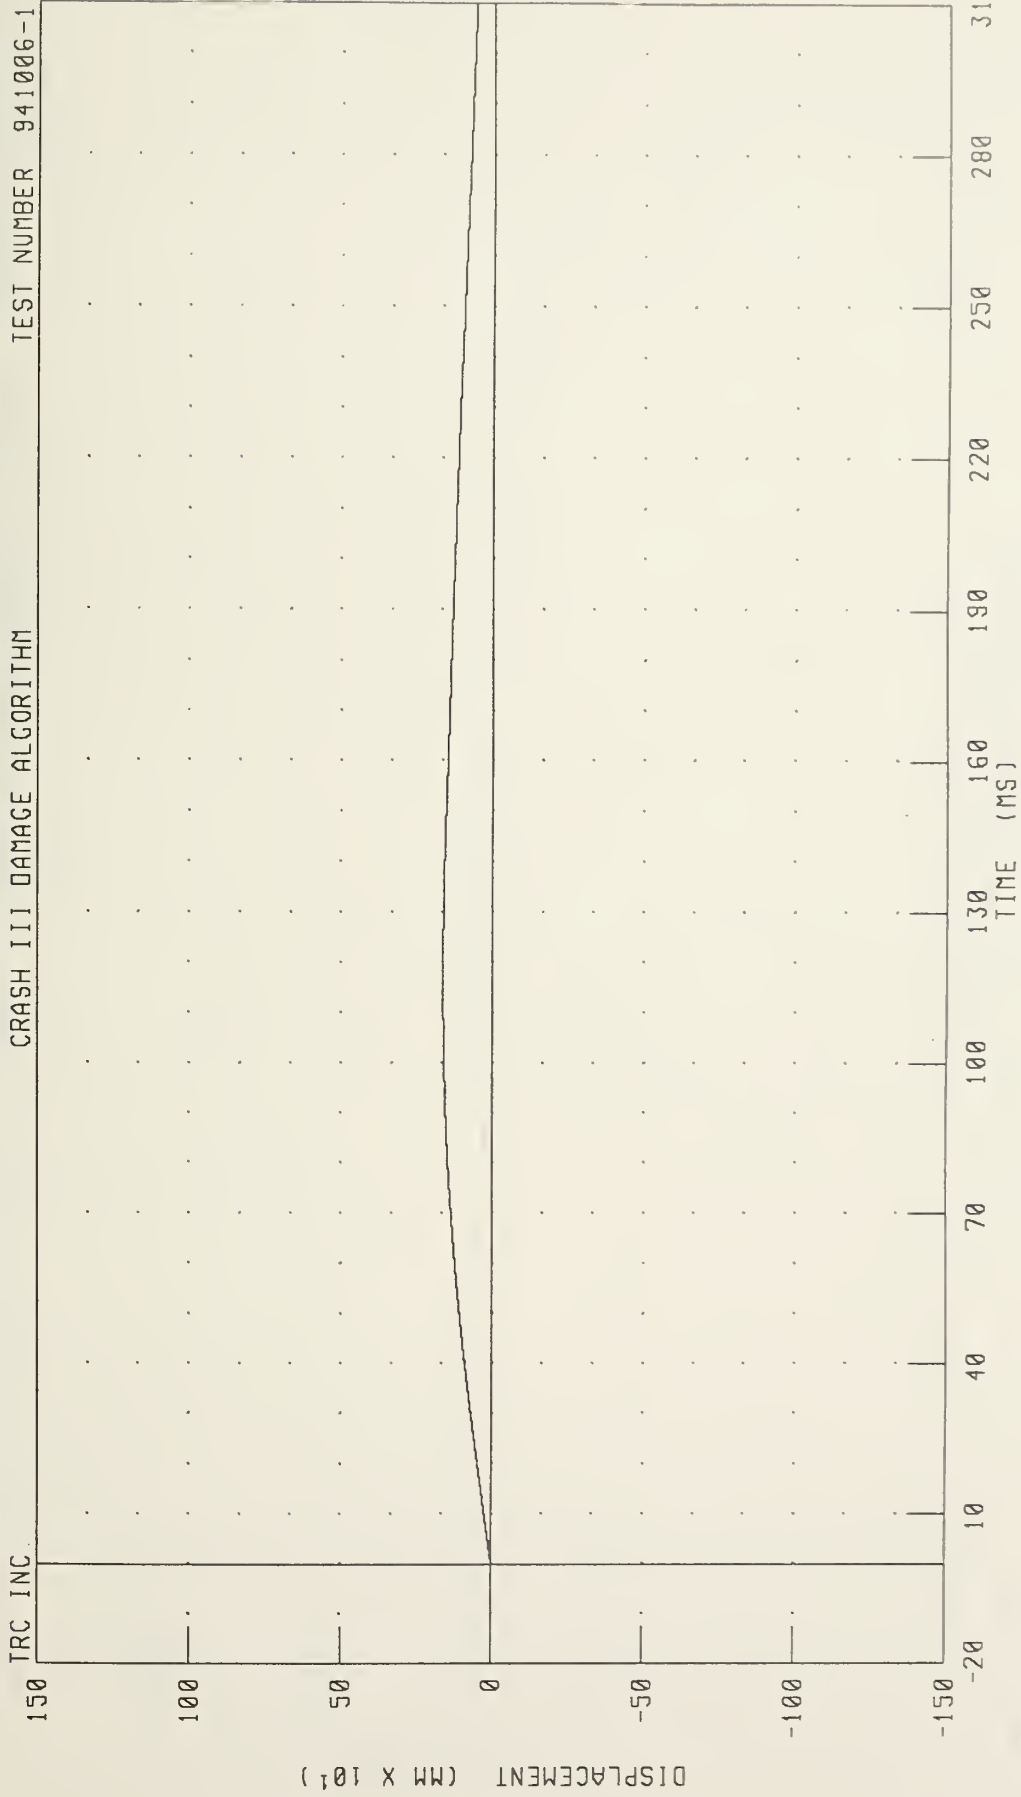
CHANNEL LFSX01 FILTER CH CLASS 180 PEAK DATA 164 20 MM @ 117 60 MS, 0 00 MM @ 0 00 MS

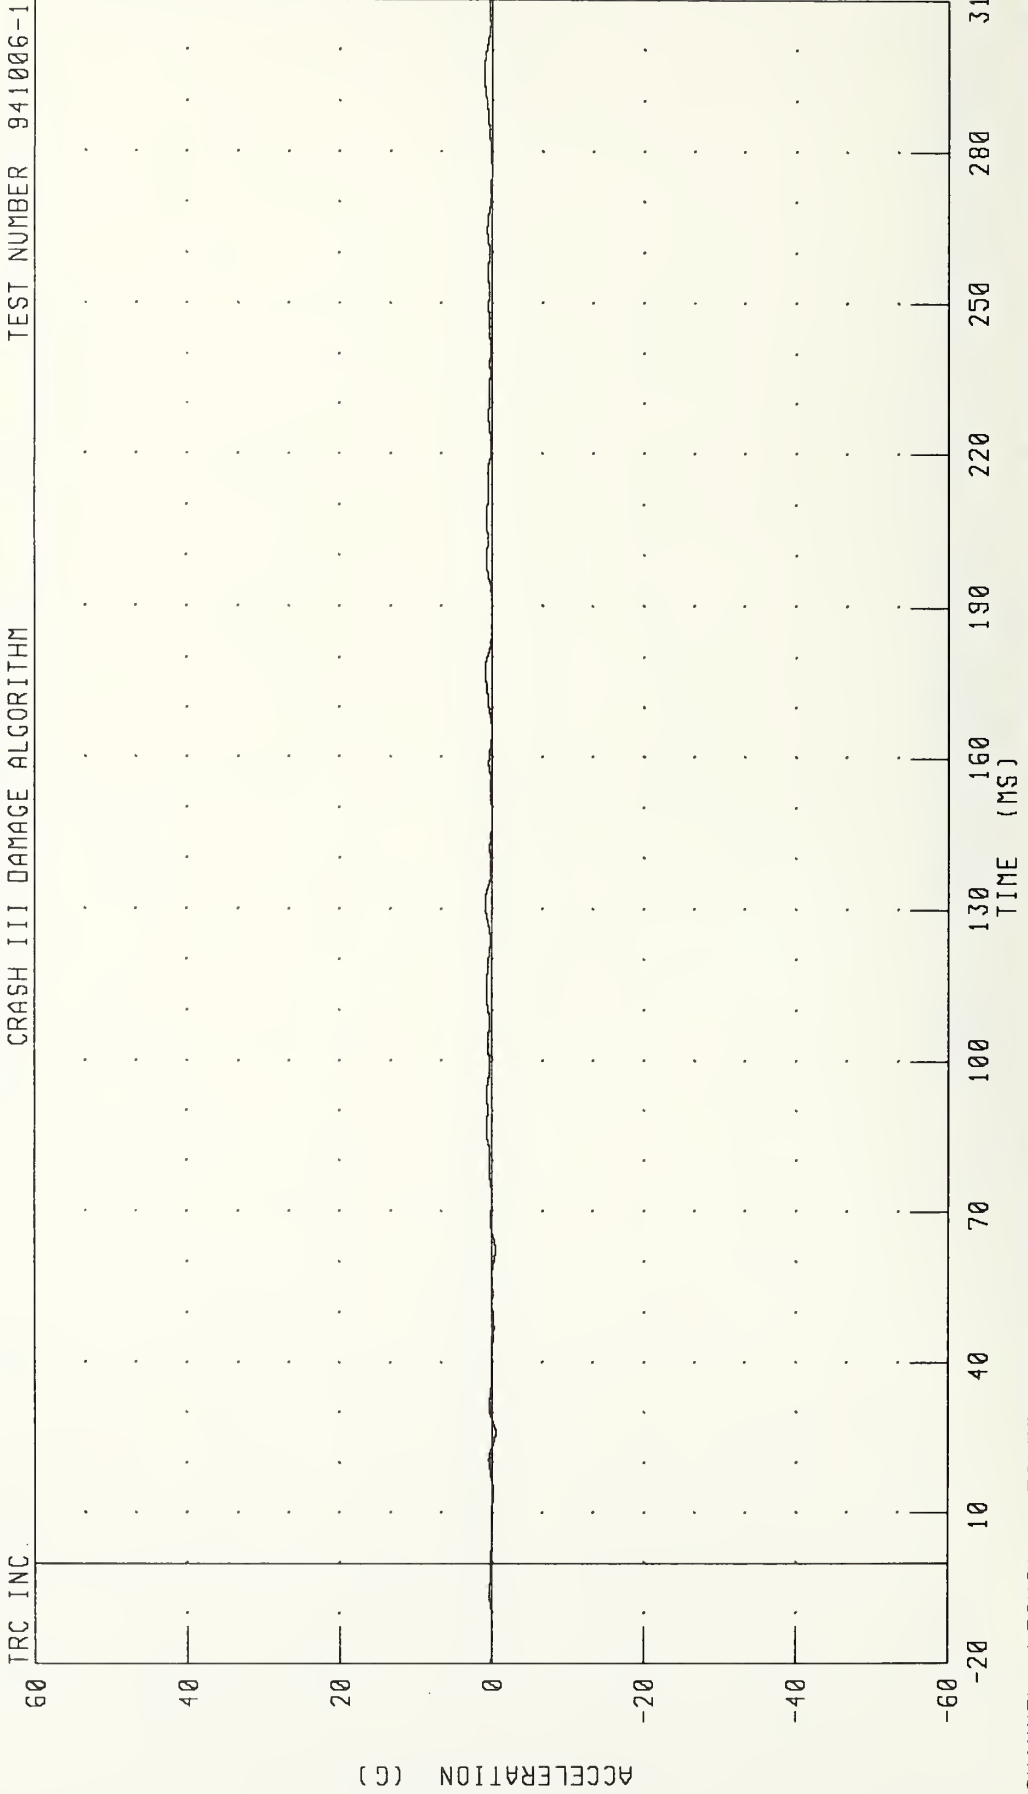
CHANNEL: LFSYG1 FILTER: CH. CLASS 60

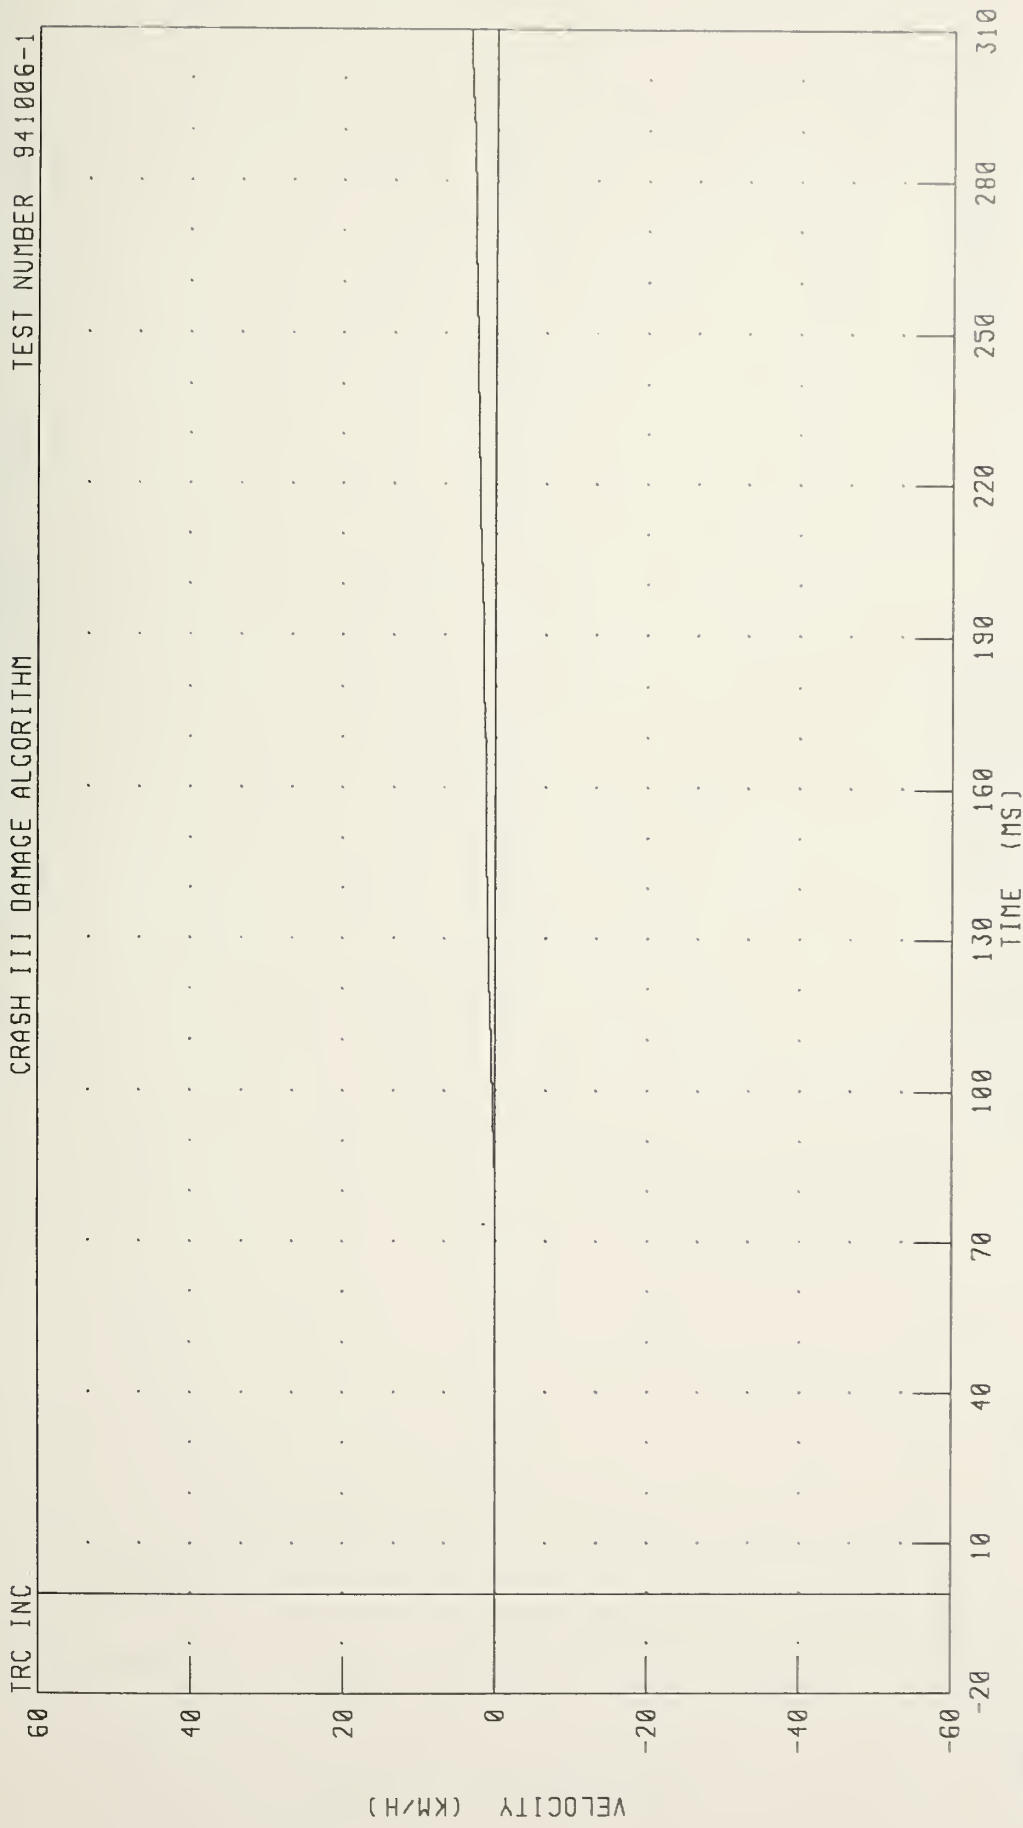
CHANNEL: LFSYV1 FILTER: CH CLASS 180 PEAK DATA: 3.41 KM/H @ 310.00 MS, -0.06 KM/H @ 65.68 MS

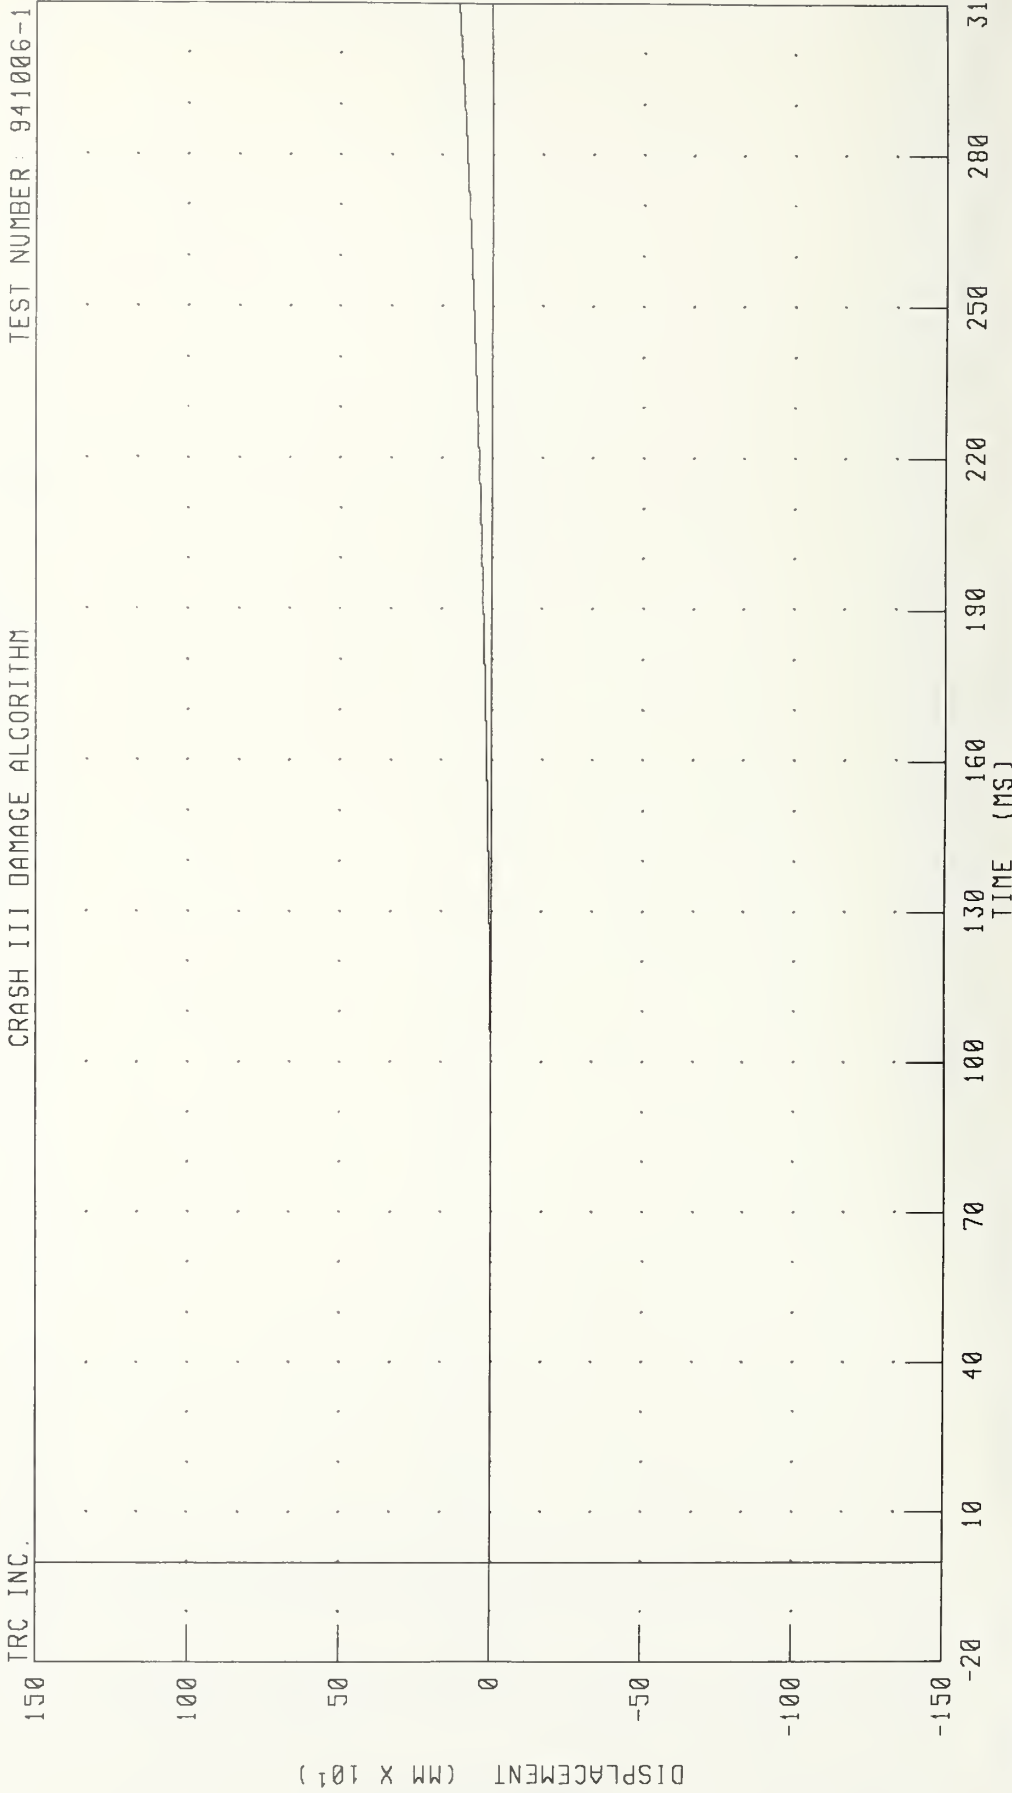
CHANNEL: LFSYD1 FILTER: CH. CLASS 180

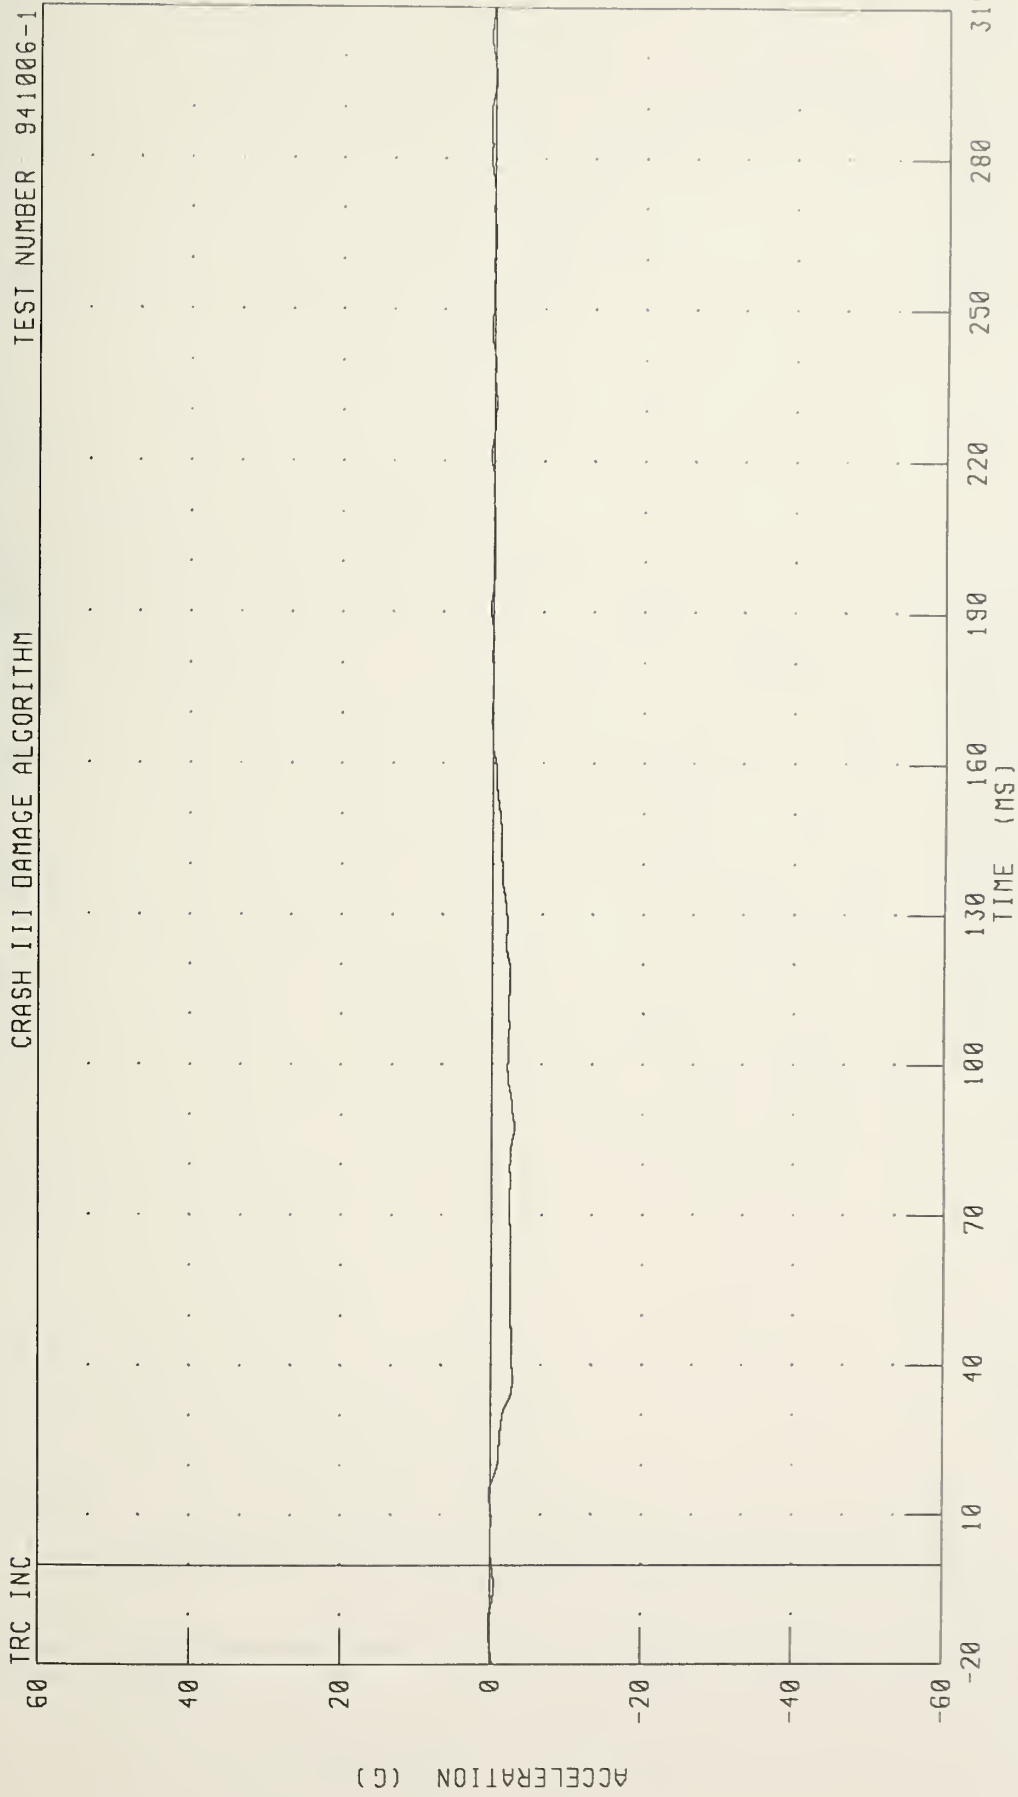
PEAK DATA 0 53 G @ 280 00 MS, -3 07 G @ 87 52 MS

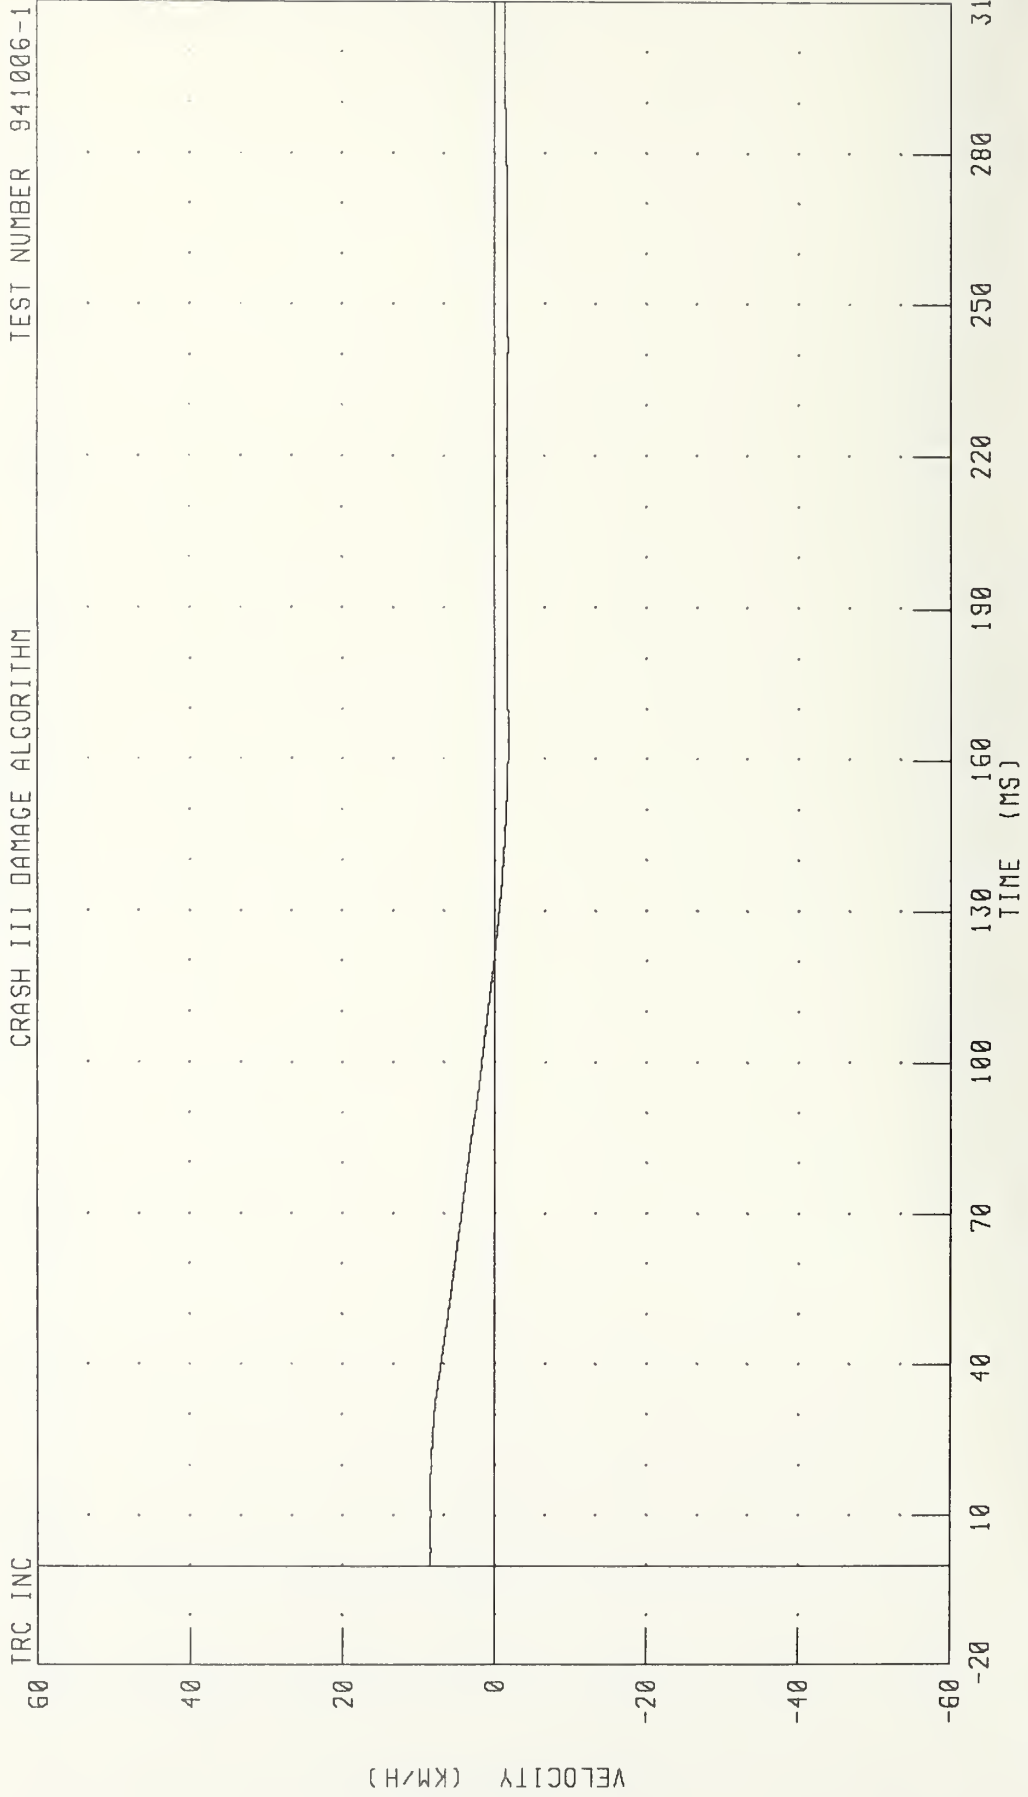
CHANNEL: RFSXV1 FILTER: CH. CLASS 180

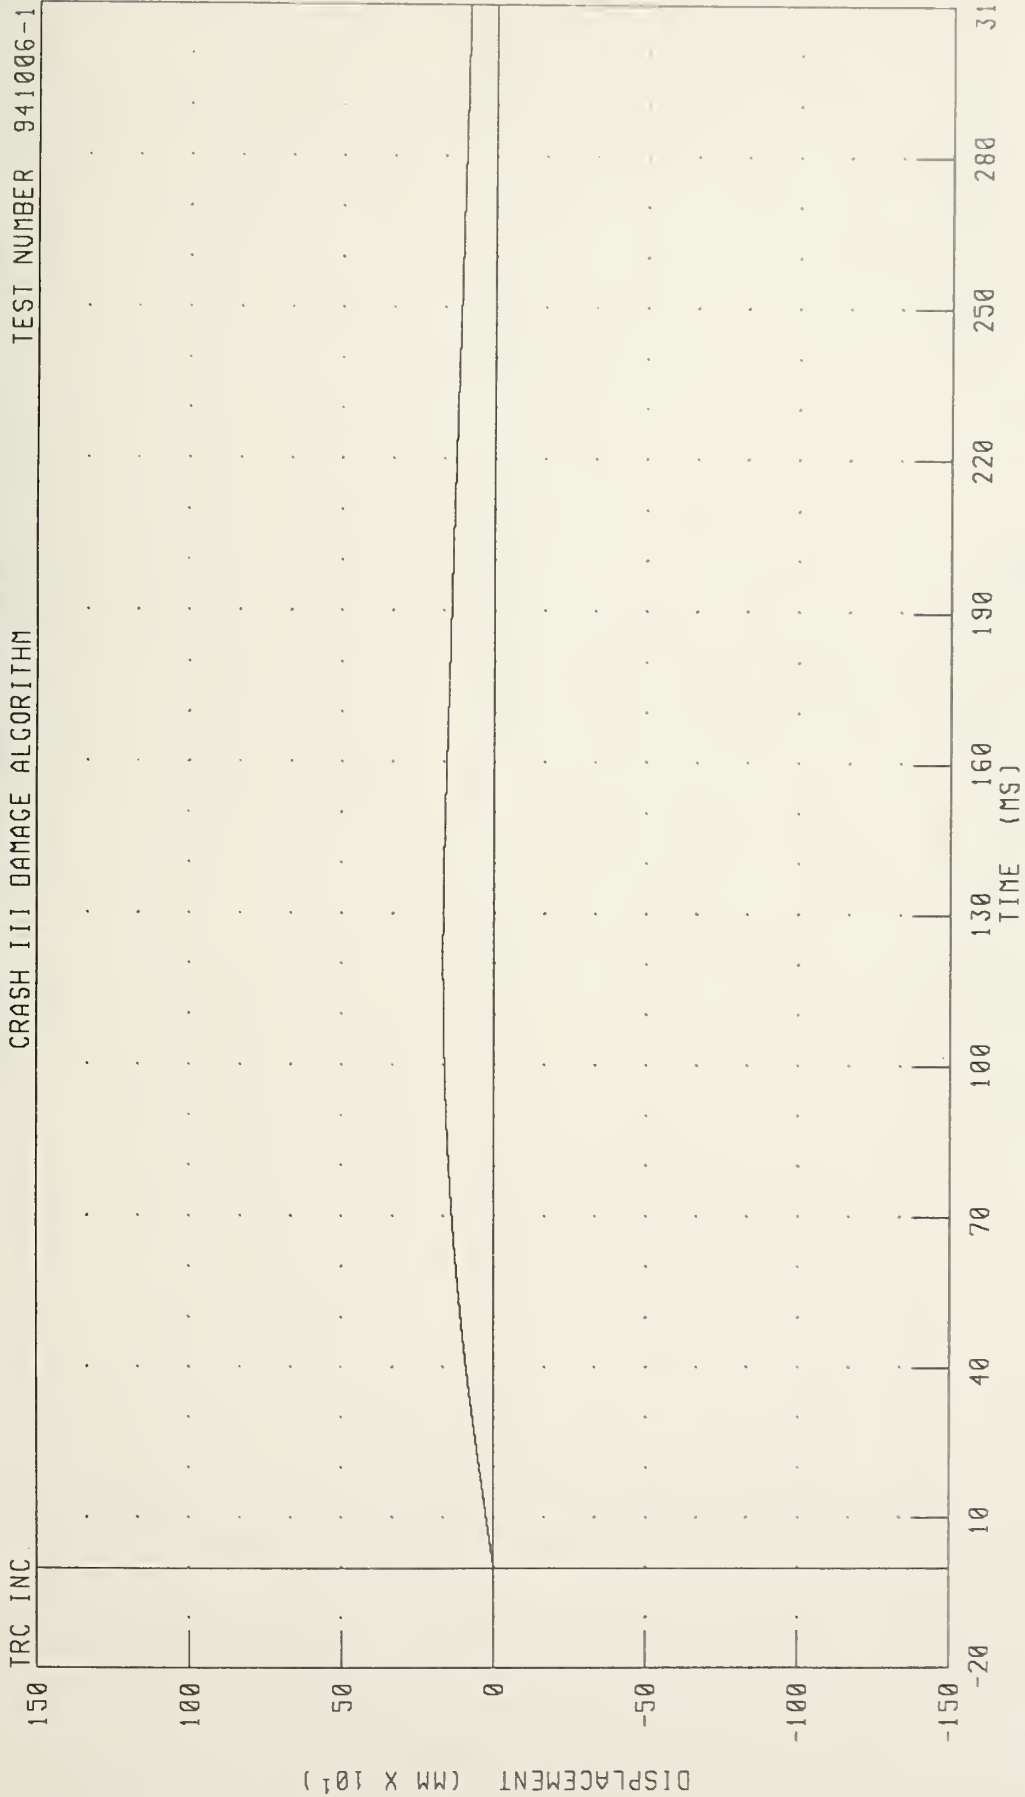
CHANNEL: RFSXD1 FILTER: CH CLASS 180 PEAK DATA: 167.69 MM @ 121.04 MS, 0.00 MM @ 0.00 MS

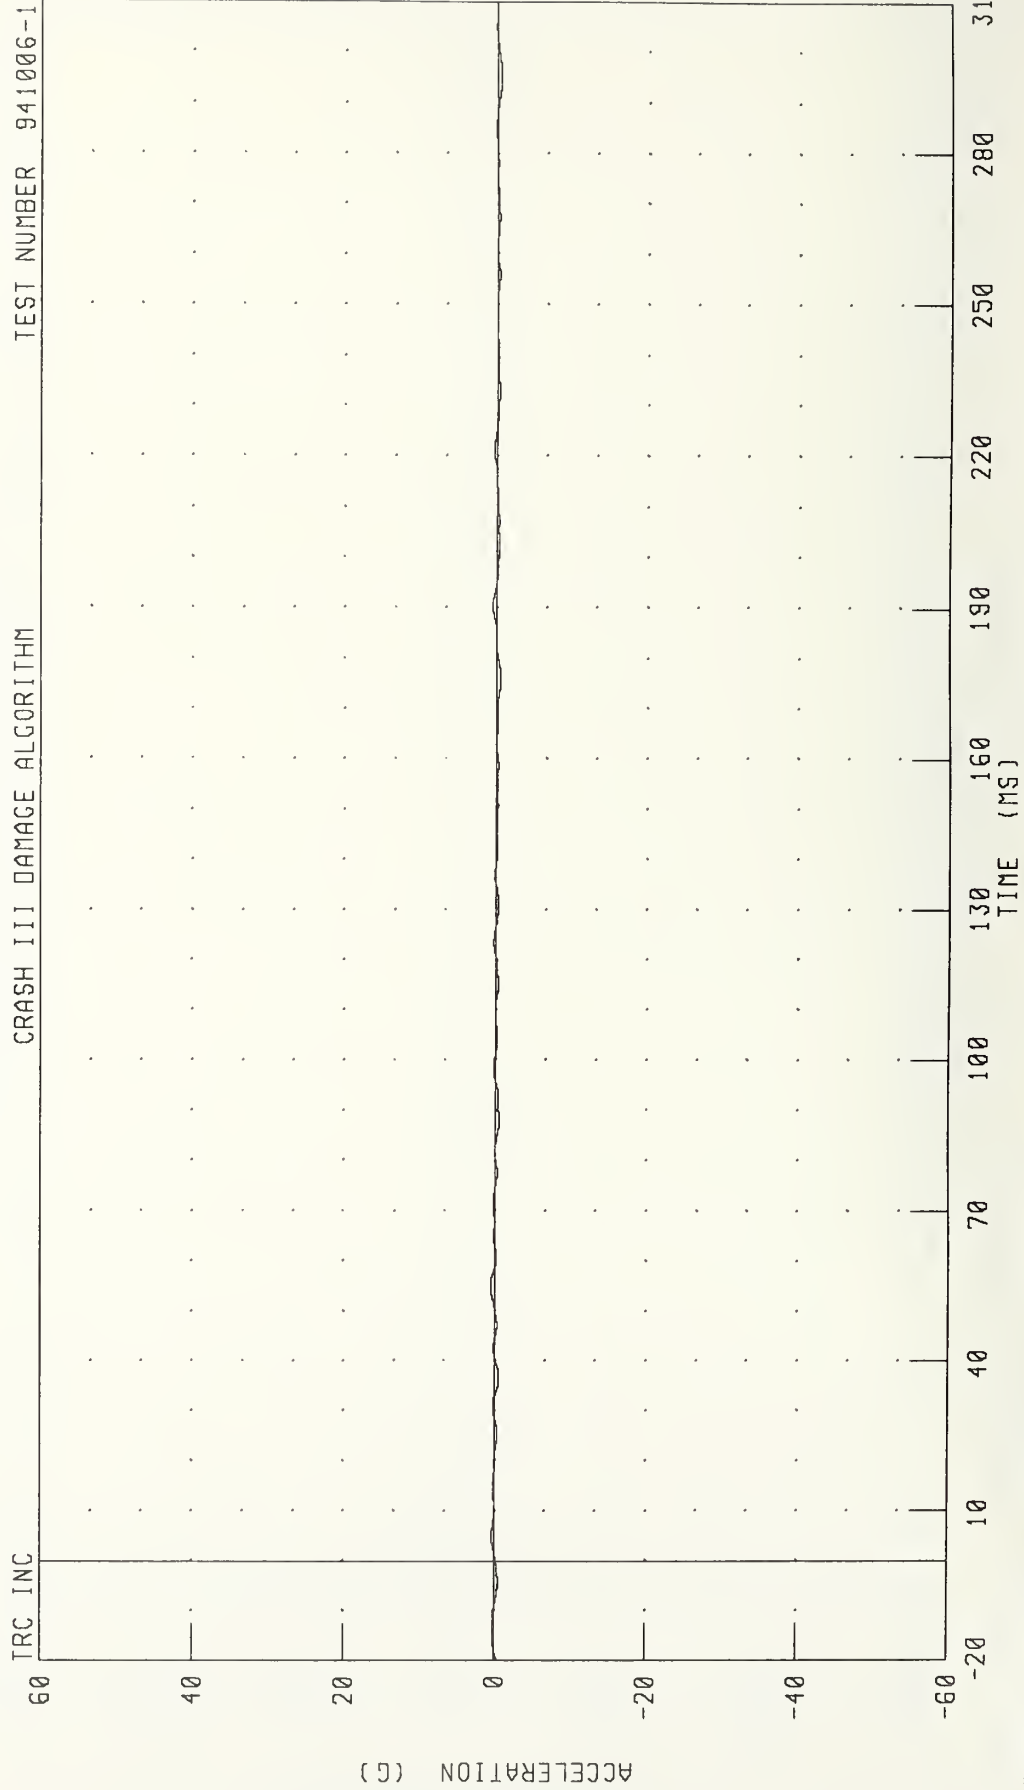
CHANNEL: RFSYG1 FILTER: CH. CLASS 60

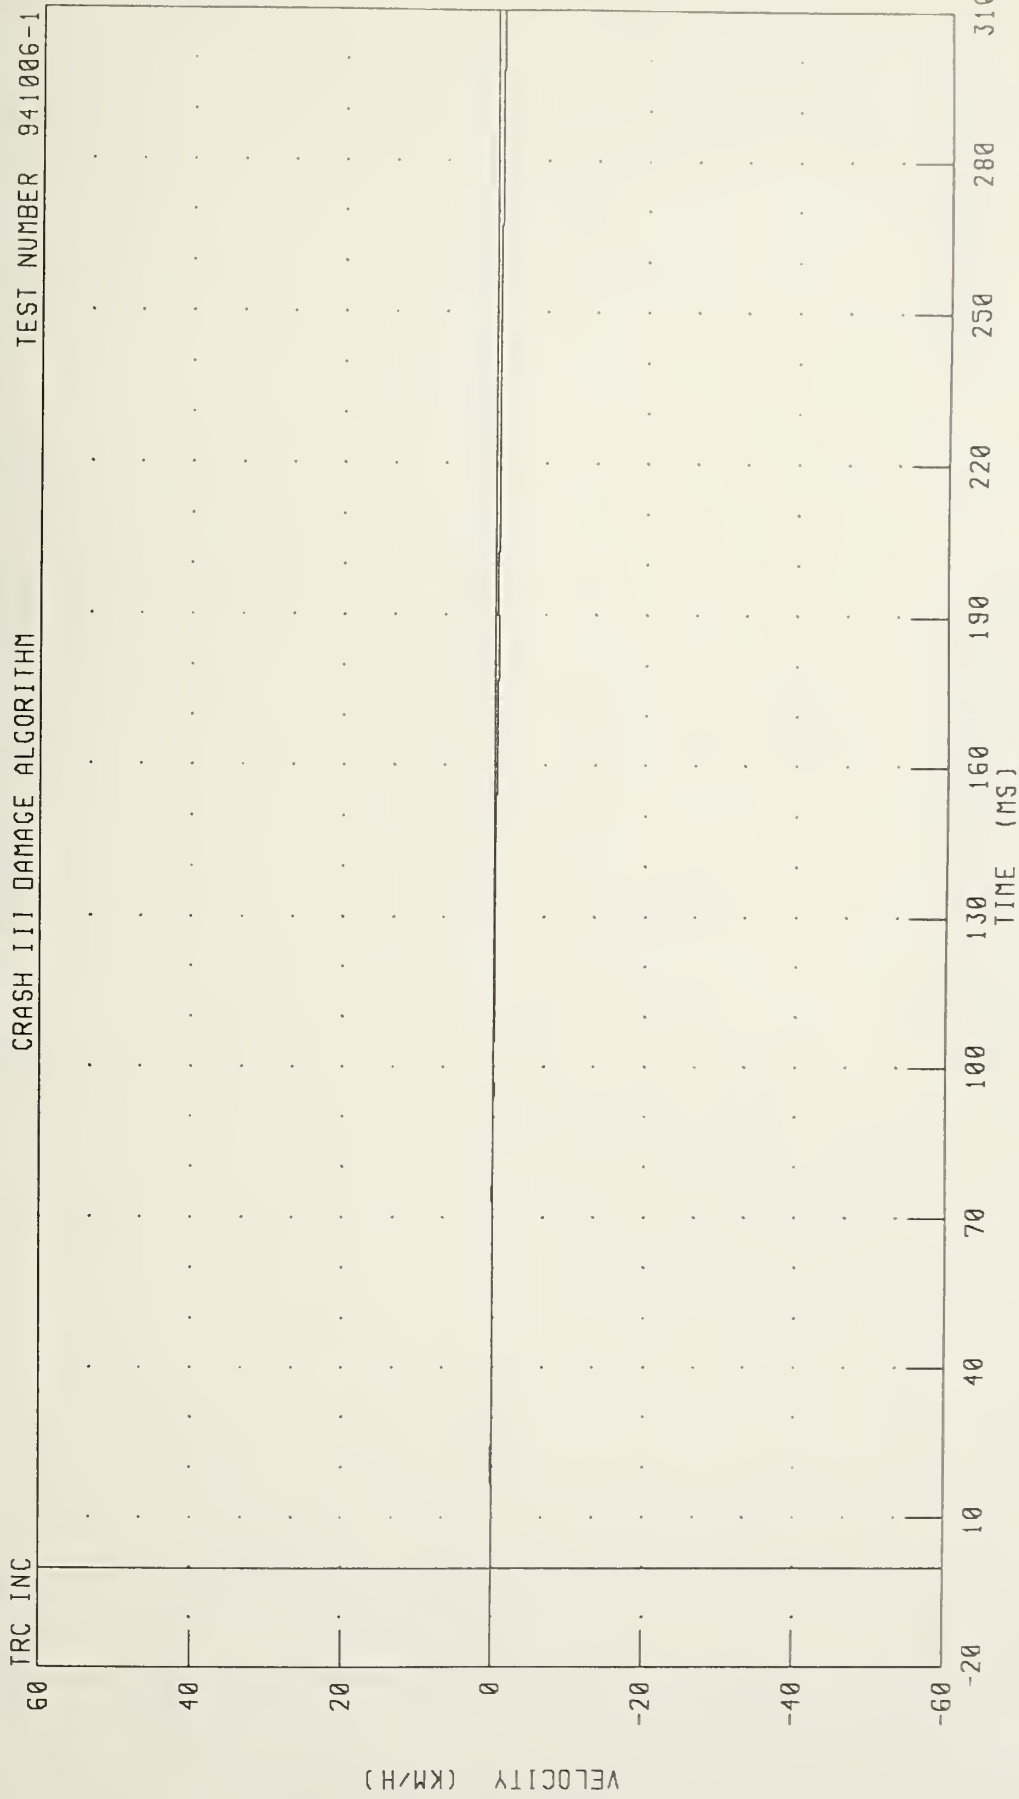
1992 CHEVROLET CAPRICE INTO 305 MM POLE
 RIGHT FRONT SILL Y-AXIS DISPLACEMENT
 CRASH III DAMAGE ALGORITHM

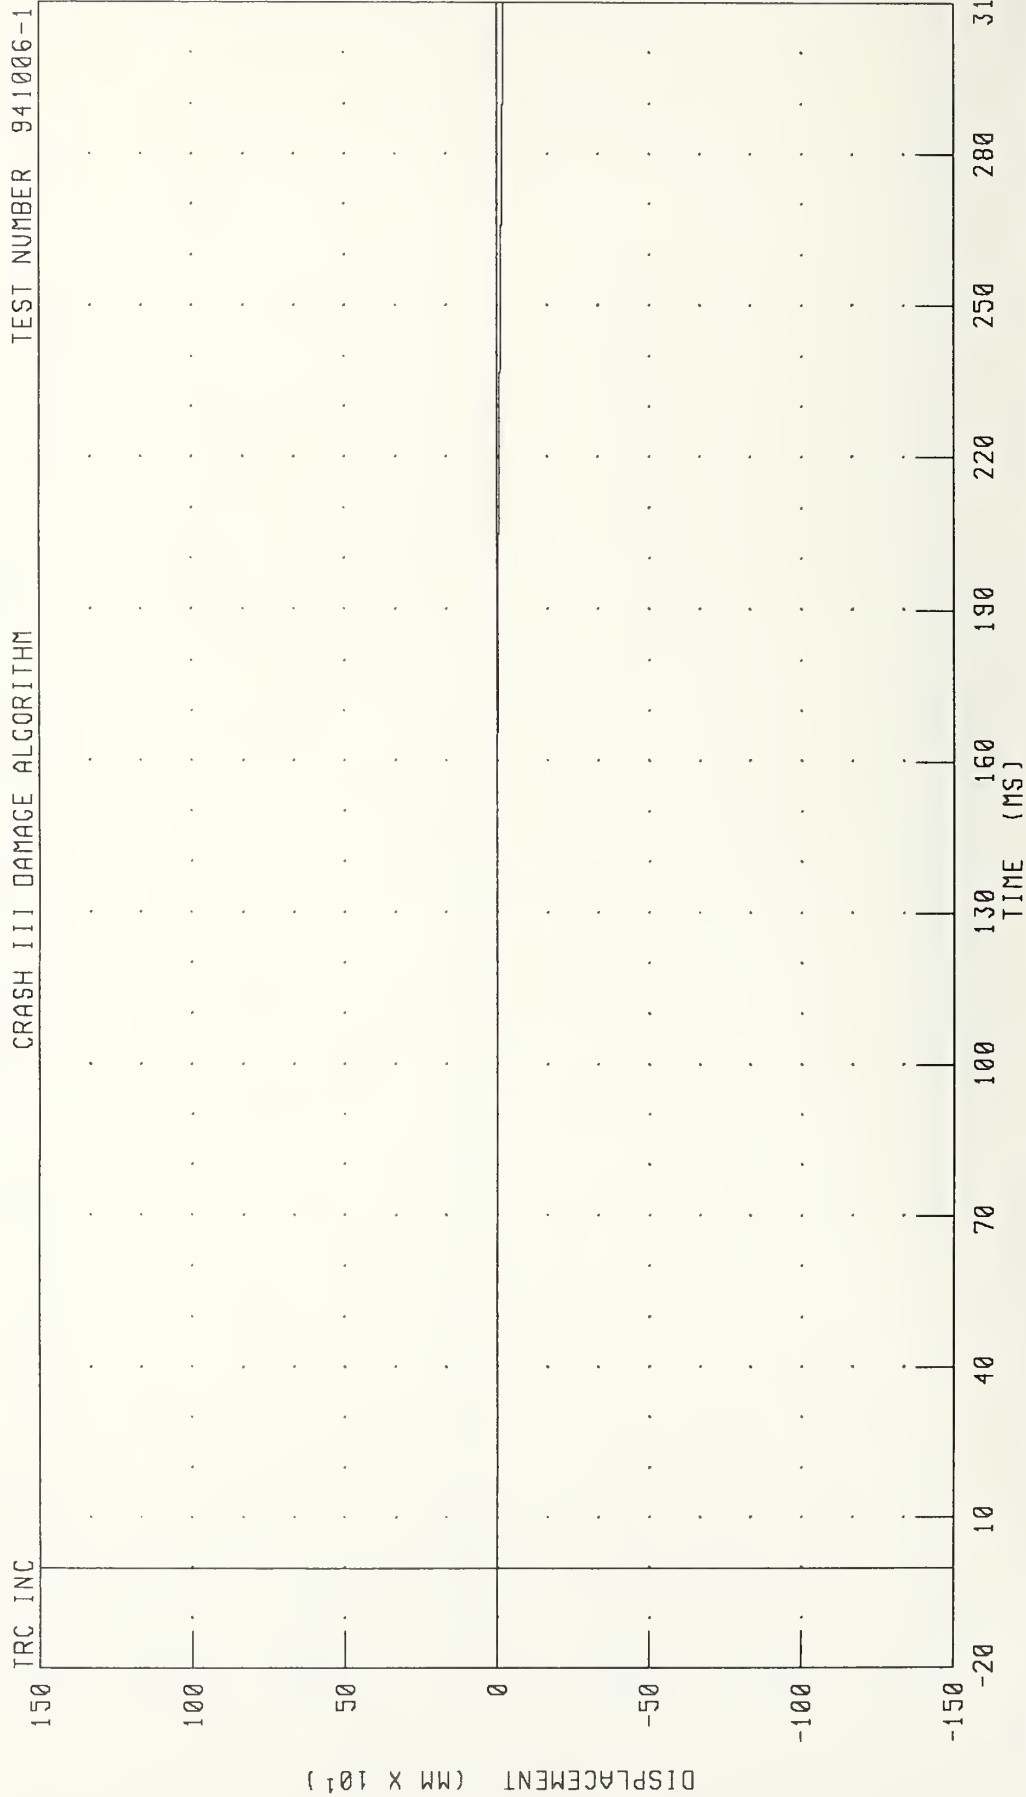
CHANNEL: RFSYD1 FILTER: CH. CLASS 180 PEAK DATA: 1.16 MM @ 88.00 MS; -22.87 MM @ 310.00 MS

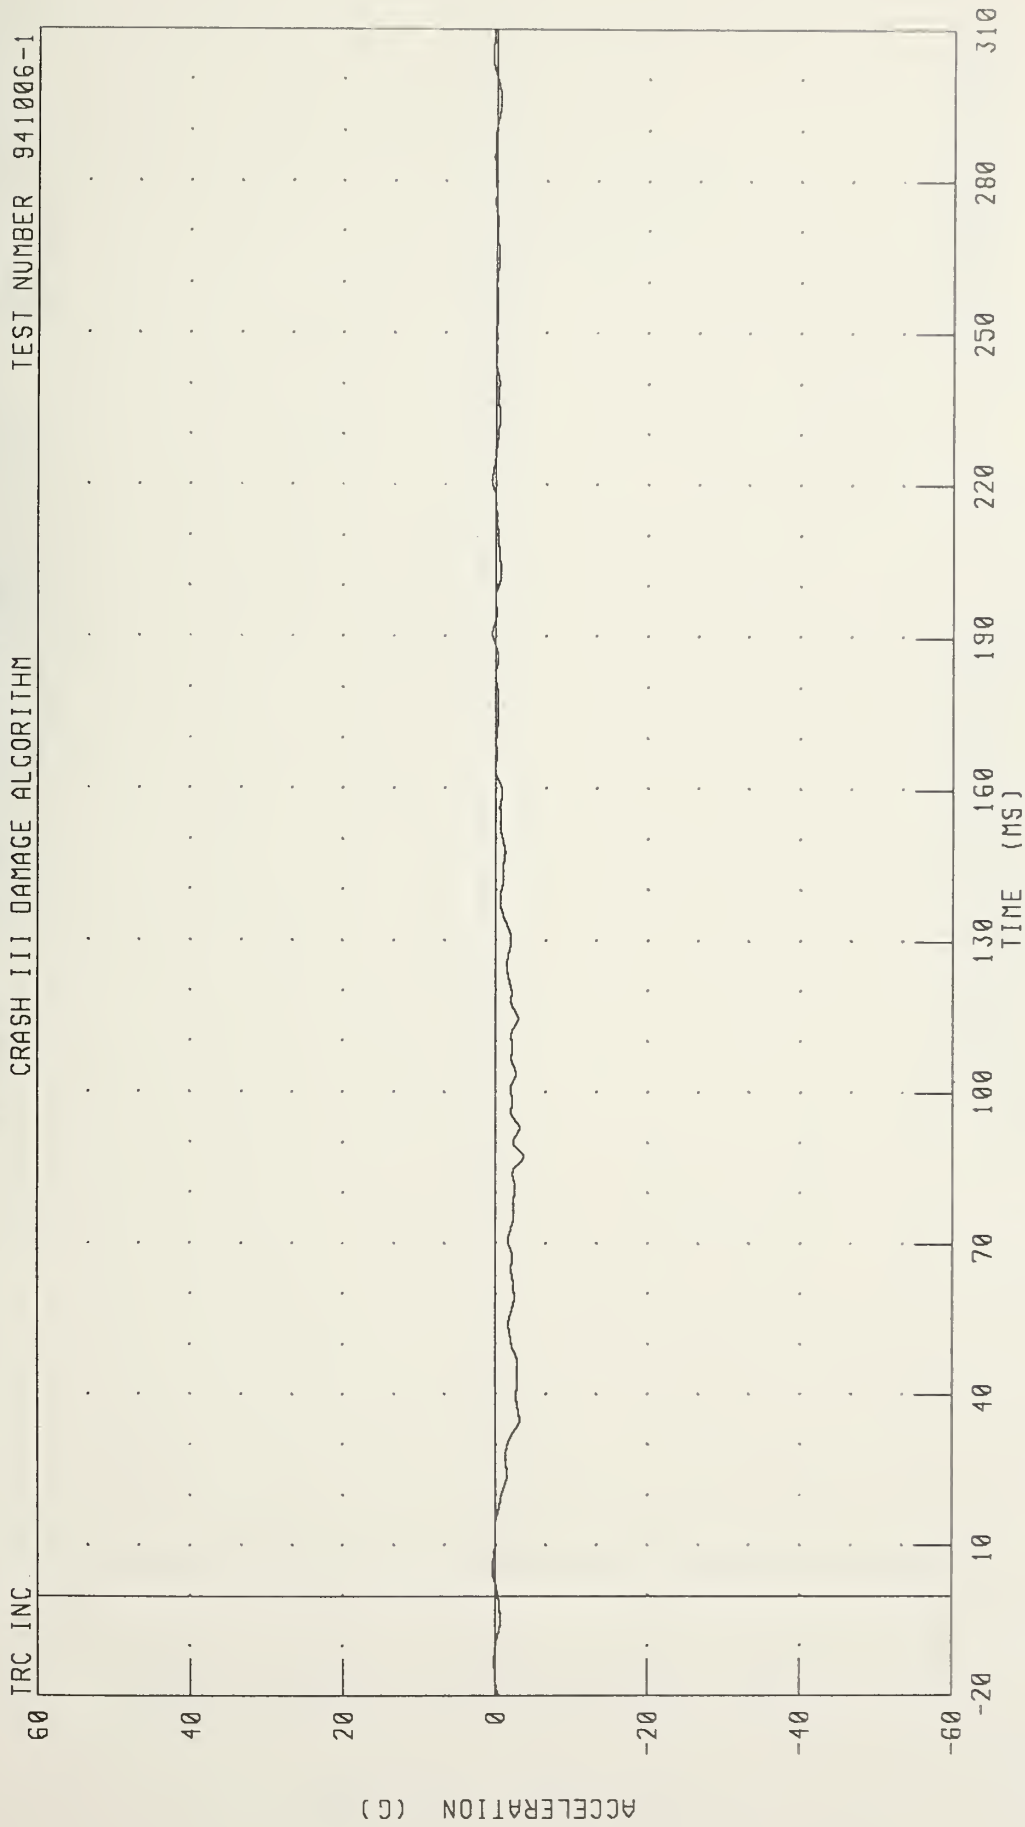
TRC INC
60
40
20
0
-20
-40
-60
10 40 70 100 130 160 190 220 250 280 310
CHANNEL: TLRXG1 FILTER: CH. CLASS 60
PEAK DATA 0.57 G @ 305.04 MS, -3.68 G @ 87.36 MS
