U.S. Department
of Transportation

**National Highway
Traffic Safety
Administration**

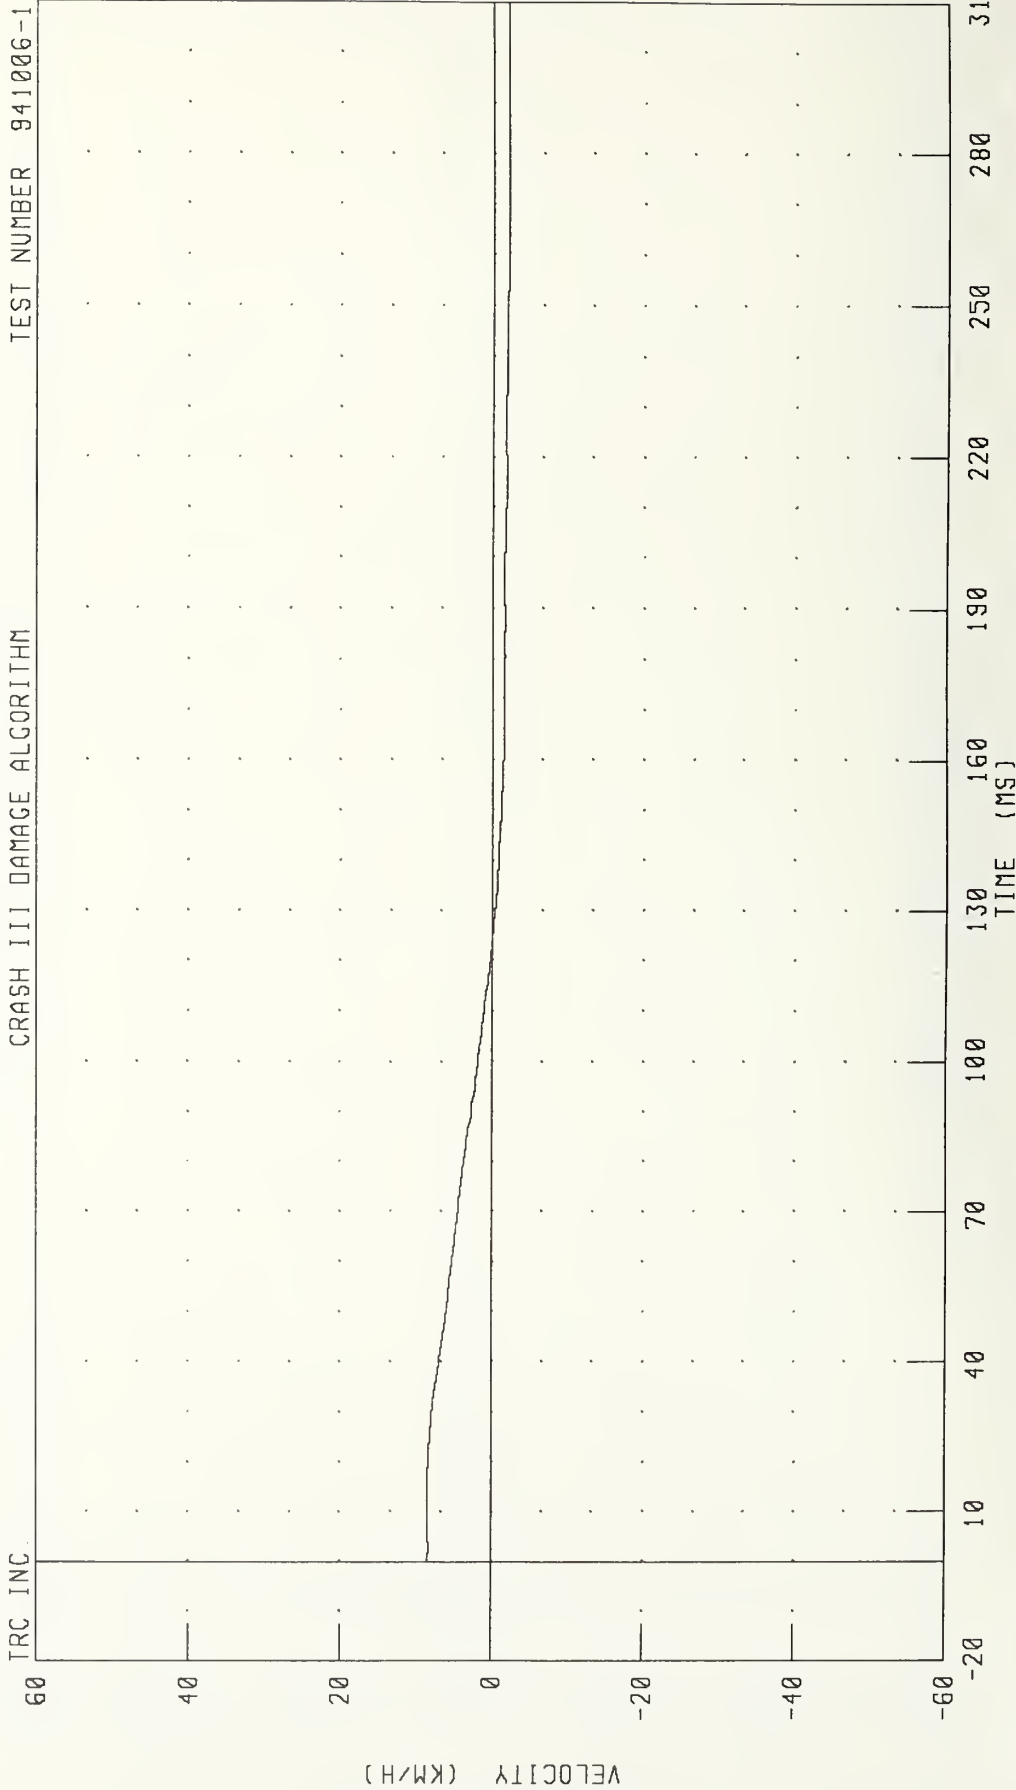
CHANNEL: TLRXV1 FILTER: CH CLASS 180
PEAK DATA: 8.45 KM/H @ 15.28 MS; -2.10 KM/H @ 300.56 MS

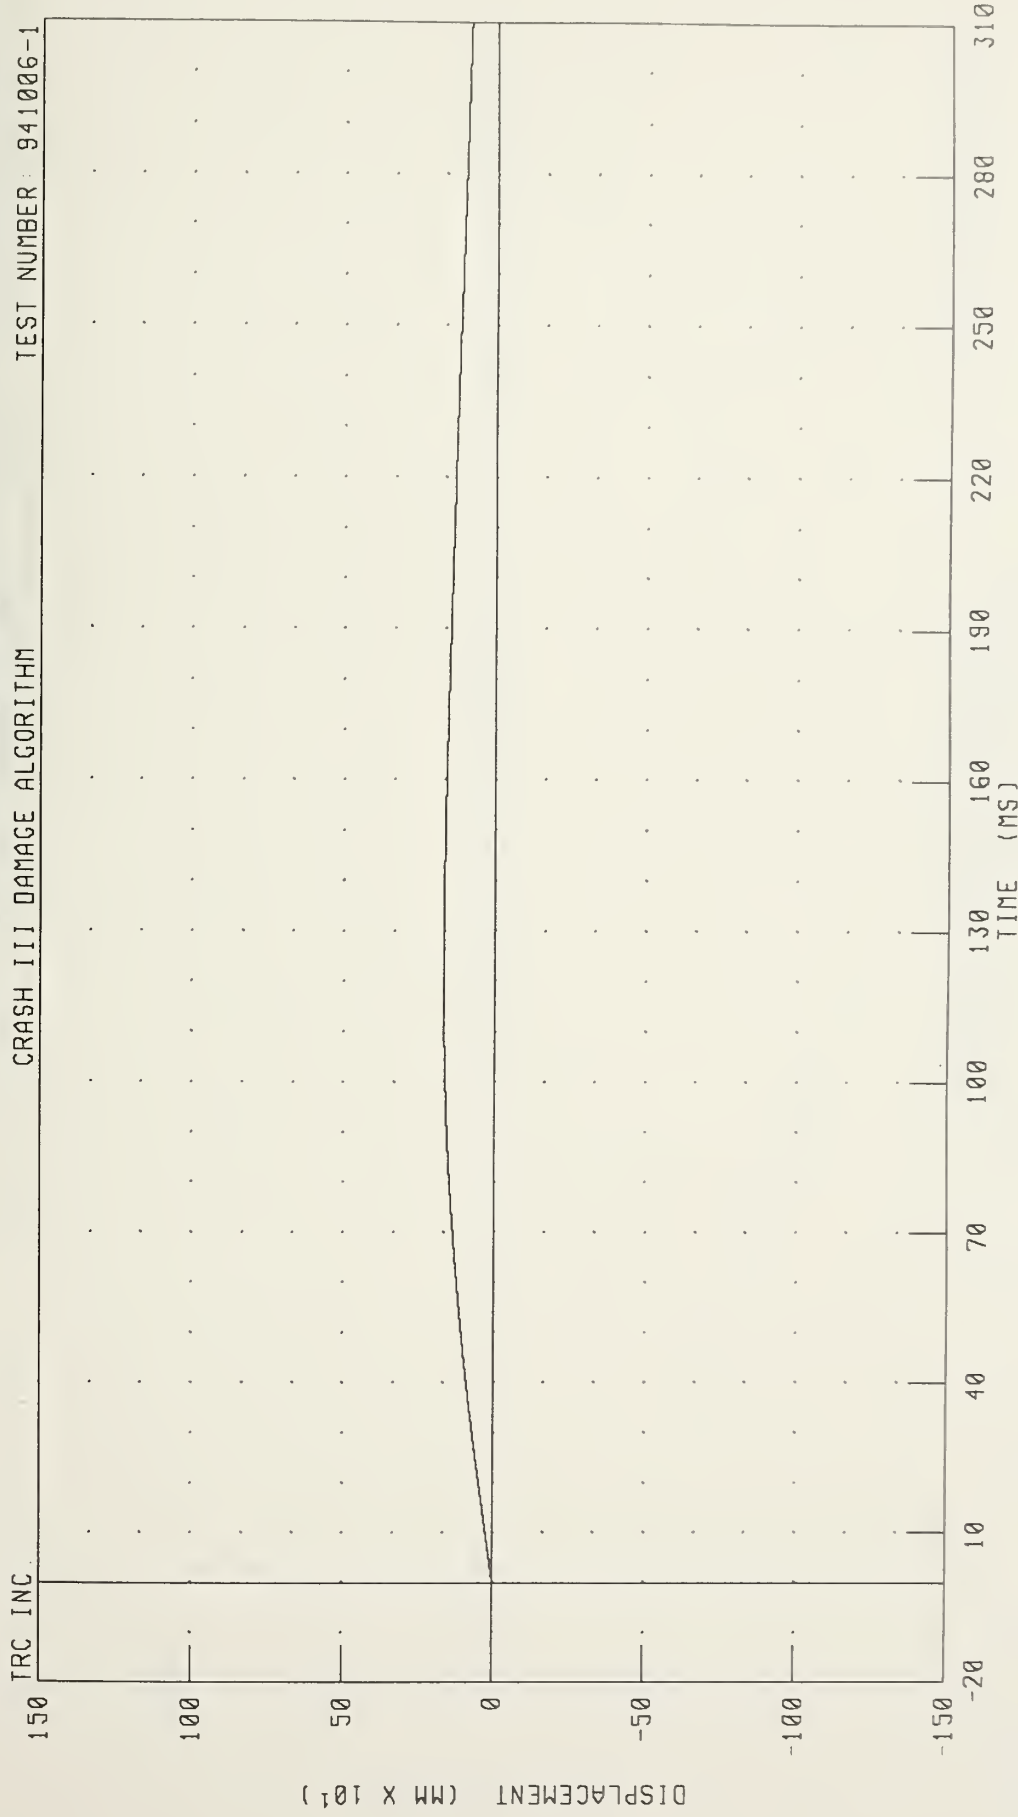
CHANNEL: TLRXD1 FILTER: CH. CLASS 180
PEAK DATA: 170 45 MM @ 123 84 MS, 0 00 MM @ 0 00 MS

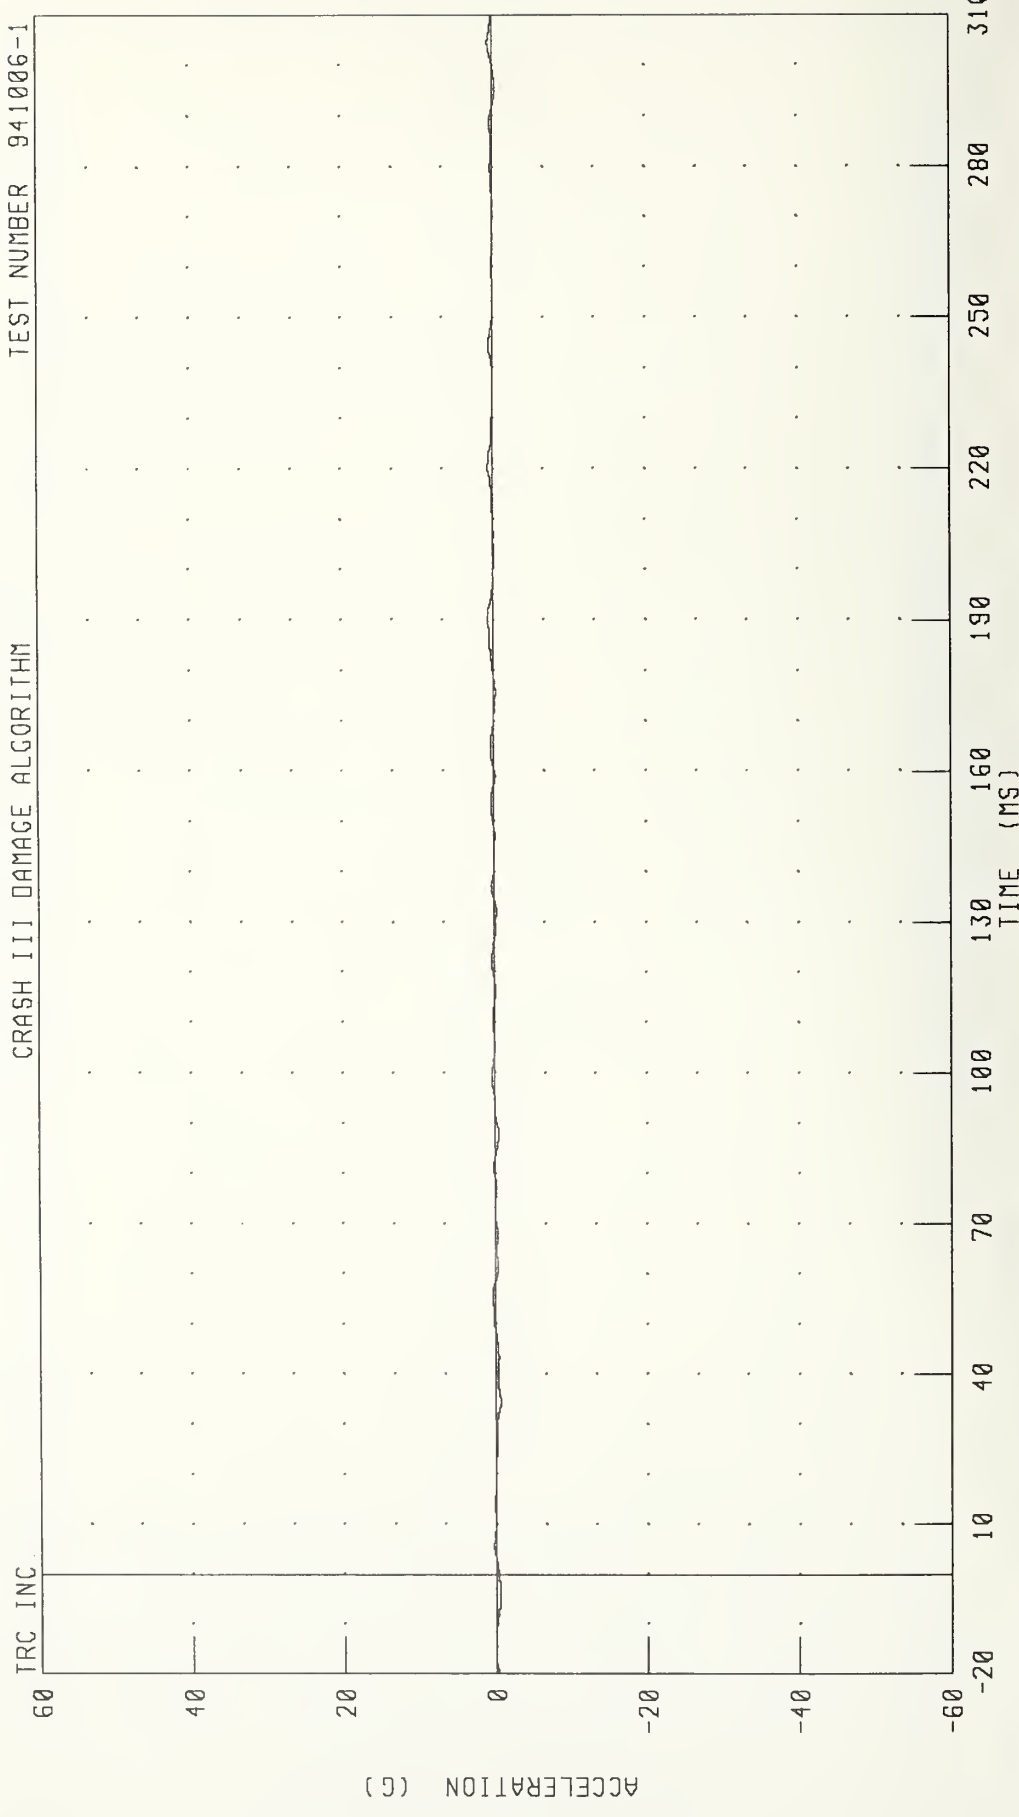
TRC INC. CHANNEL: TLRYG1 FILTER: CH. CLASS 60
PEAK DATA: 0.76 G @ 190.56 MS, -0.68 G @ 34.32 MS

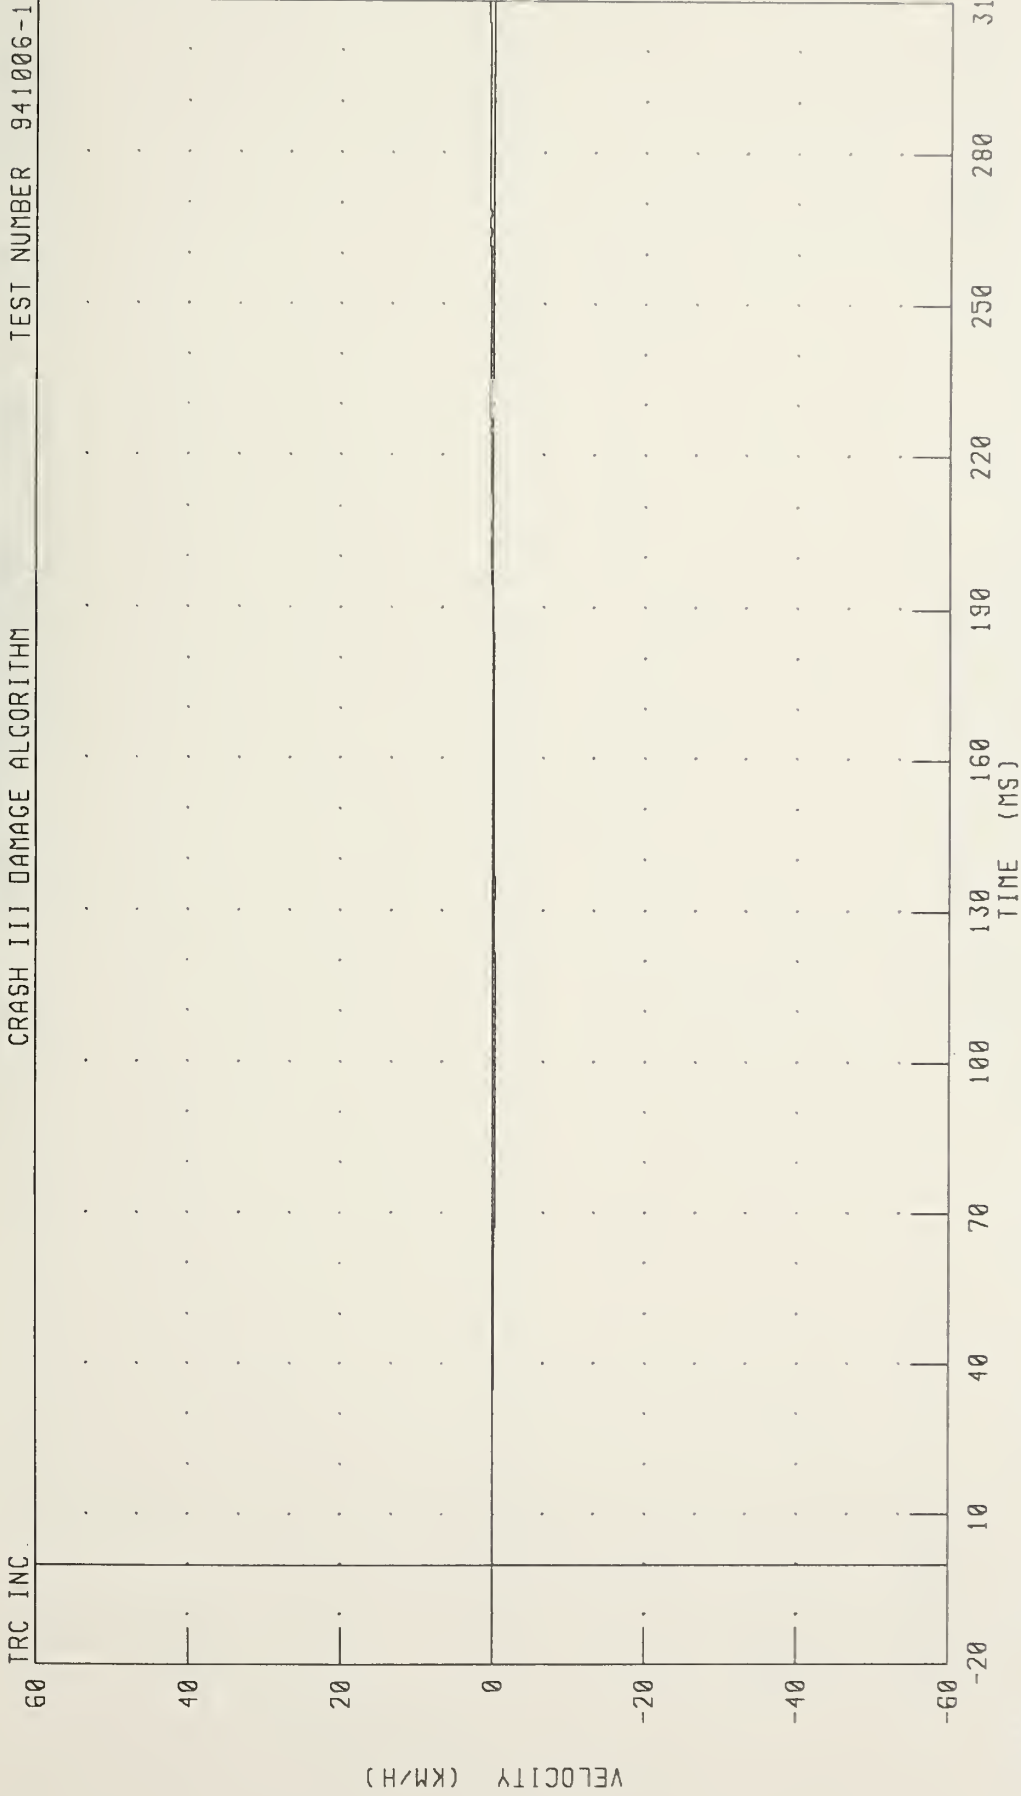
CHANNEL TLRYV1 FILTER CH CLASS 180 PEAK DATA 0 63 KM/H @ 309 12 MS, -0 38 KM/H @ 95 36 MS

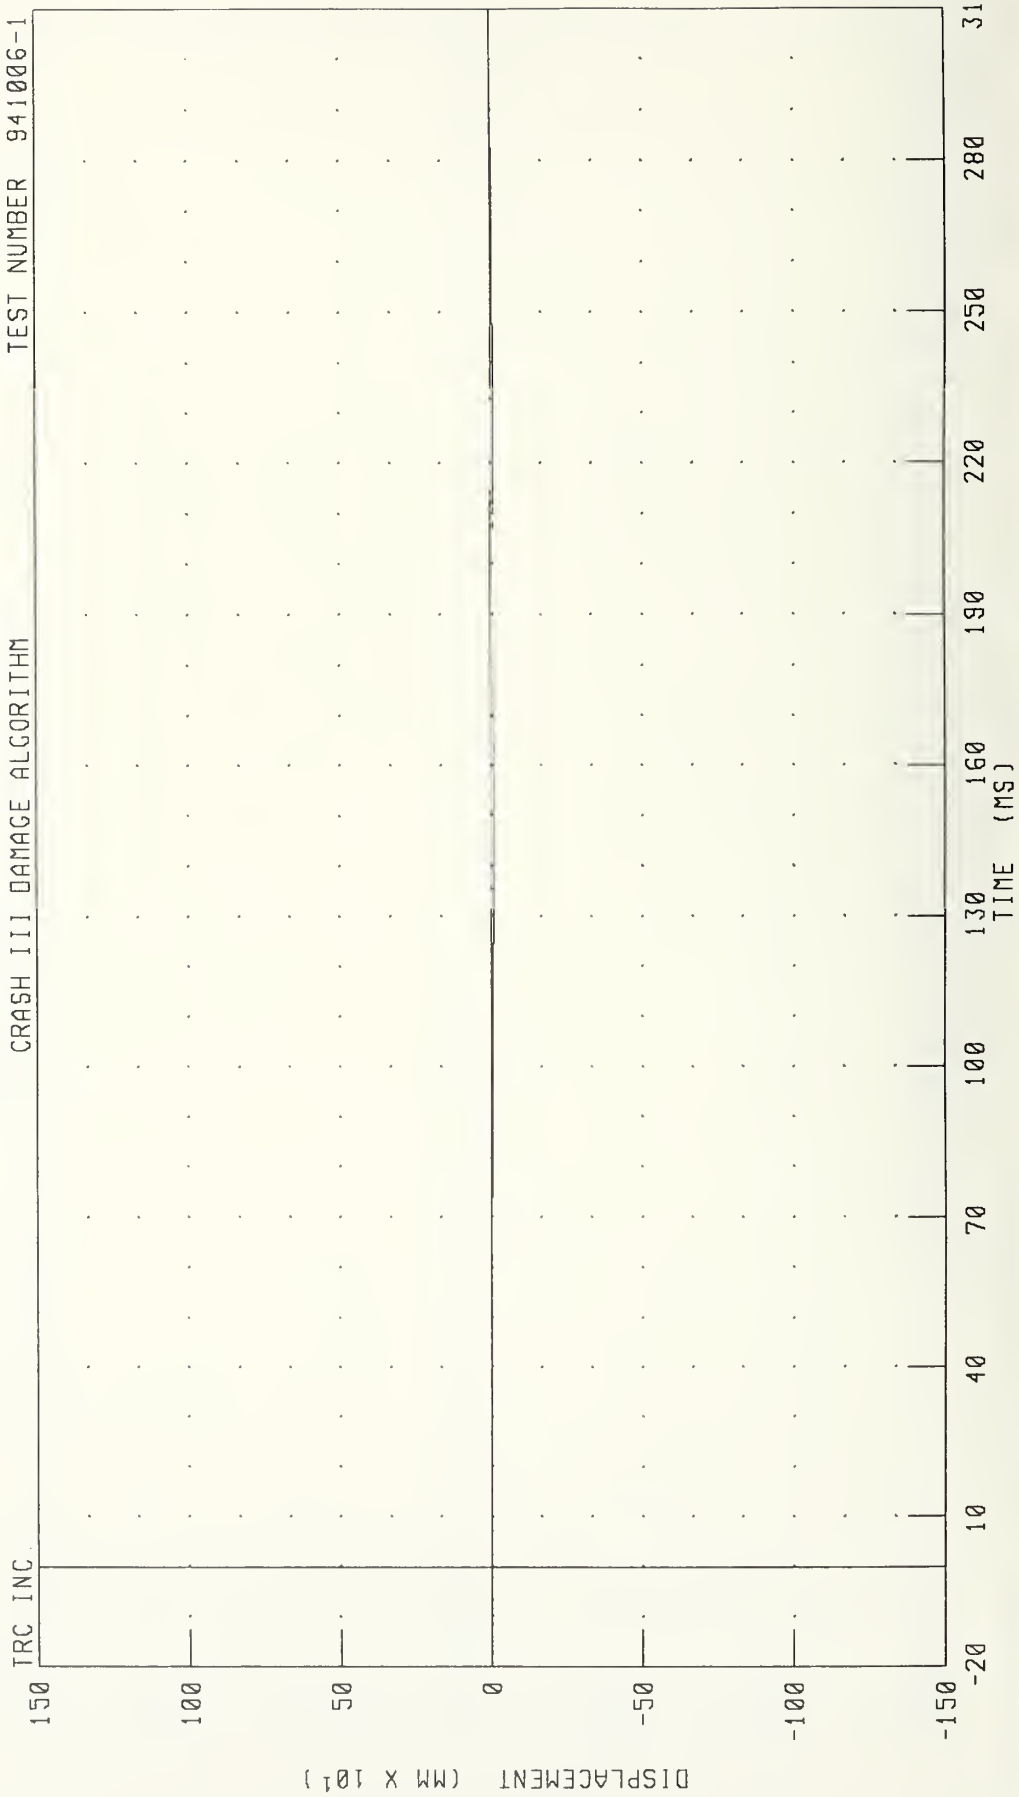
CHANNEL: TLRYD1 FILTER: CH. CLASS 180 PEAK DATA: 2.29 MM @ 310.00 MS; -9.13 MM @ 189.92 MS

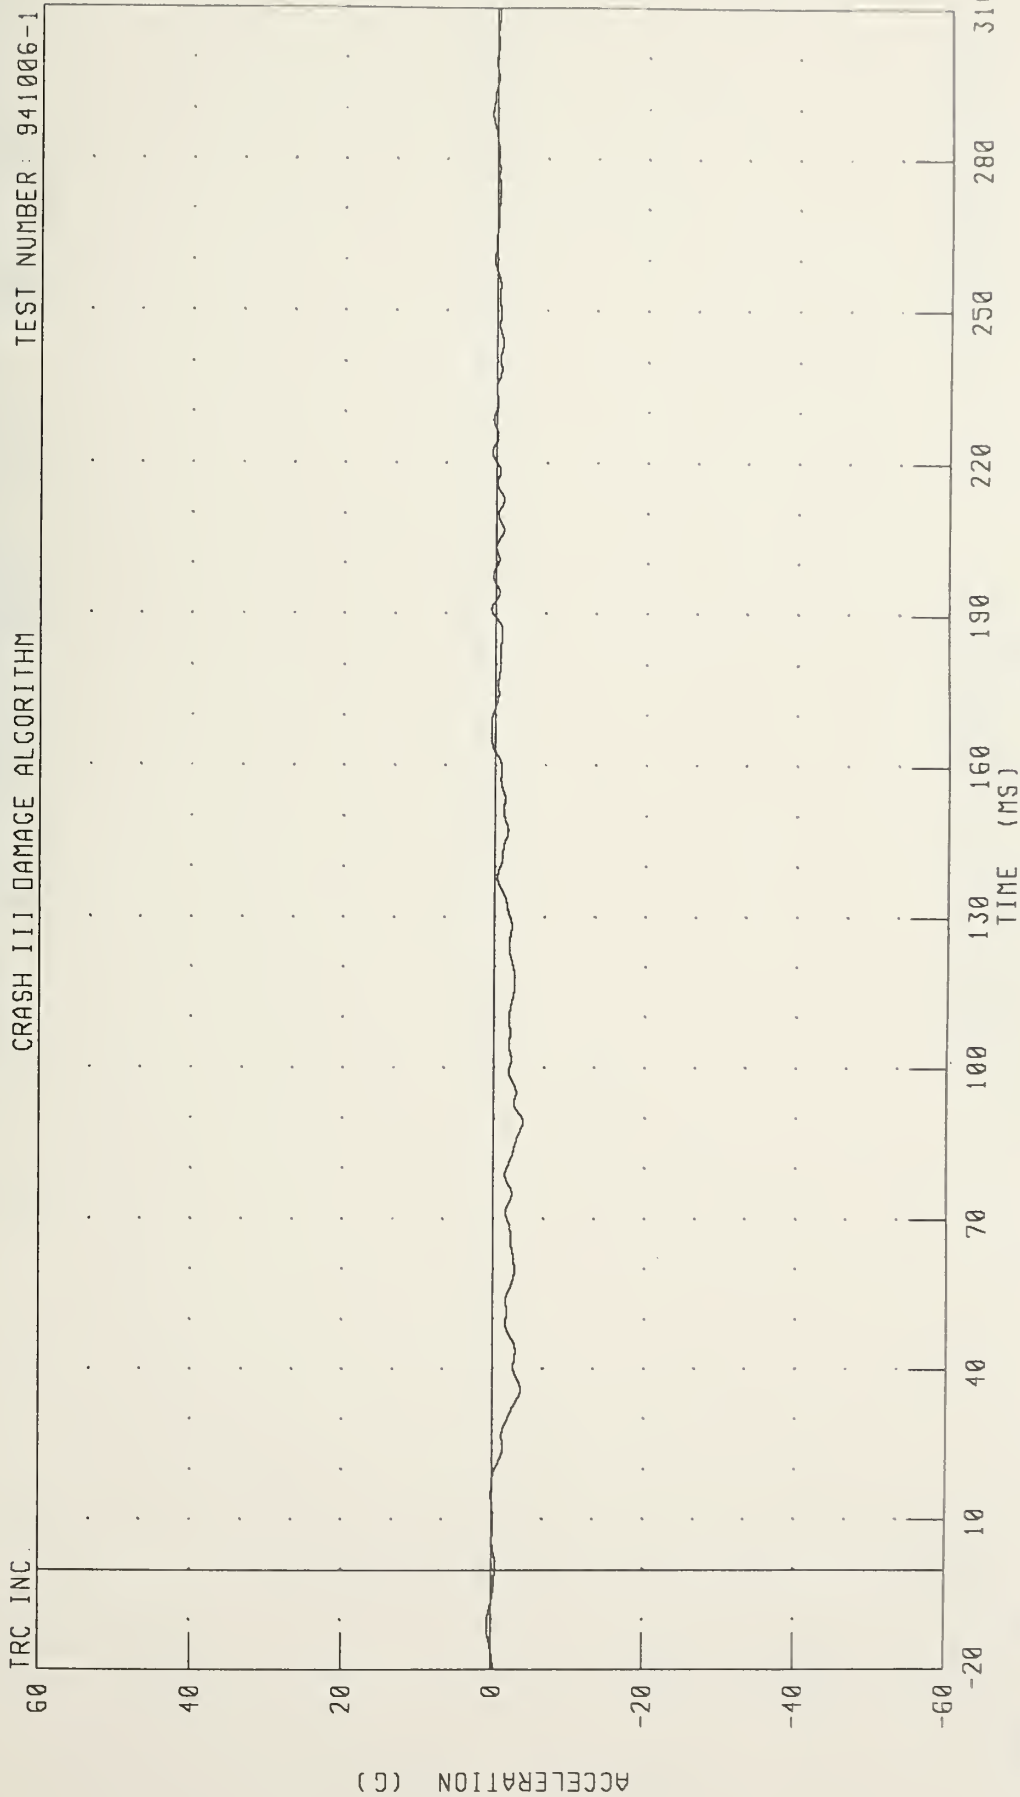
CHANNEL TRRXG1 FILTER CH. CLASS 60 PEAK DATA 0 63 G @ 289 12 MS, -3 89 G @ 89 36 MS

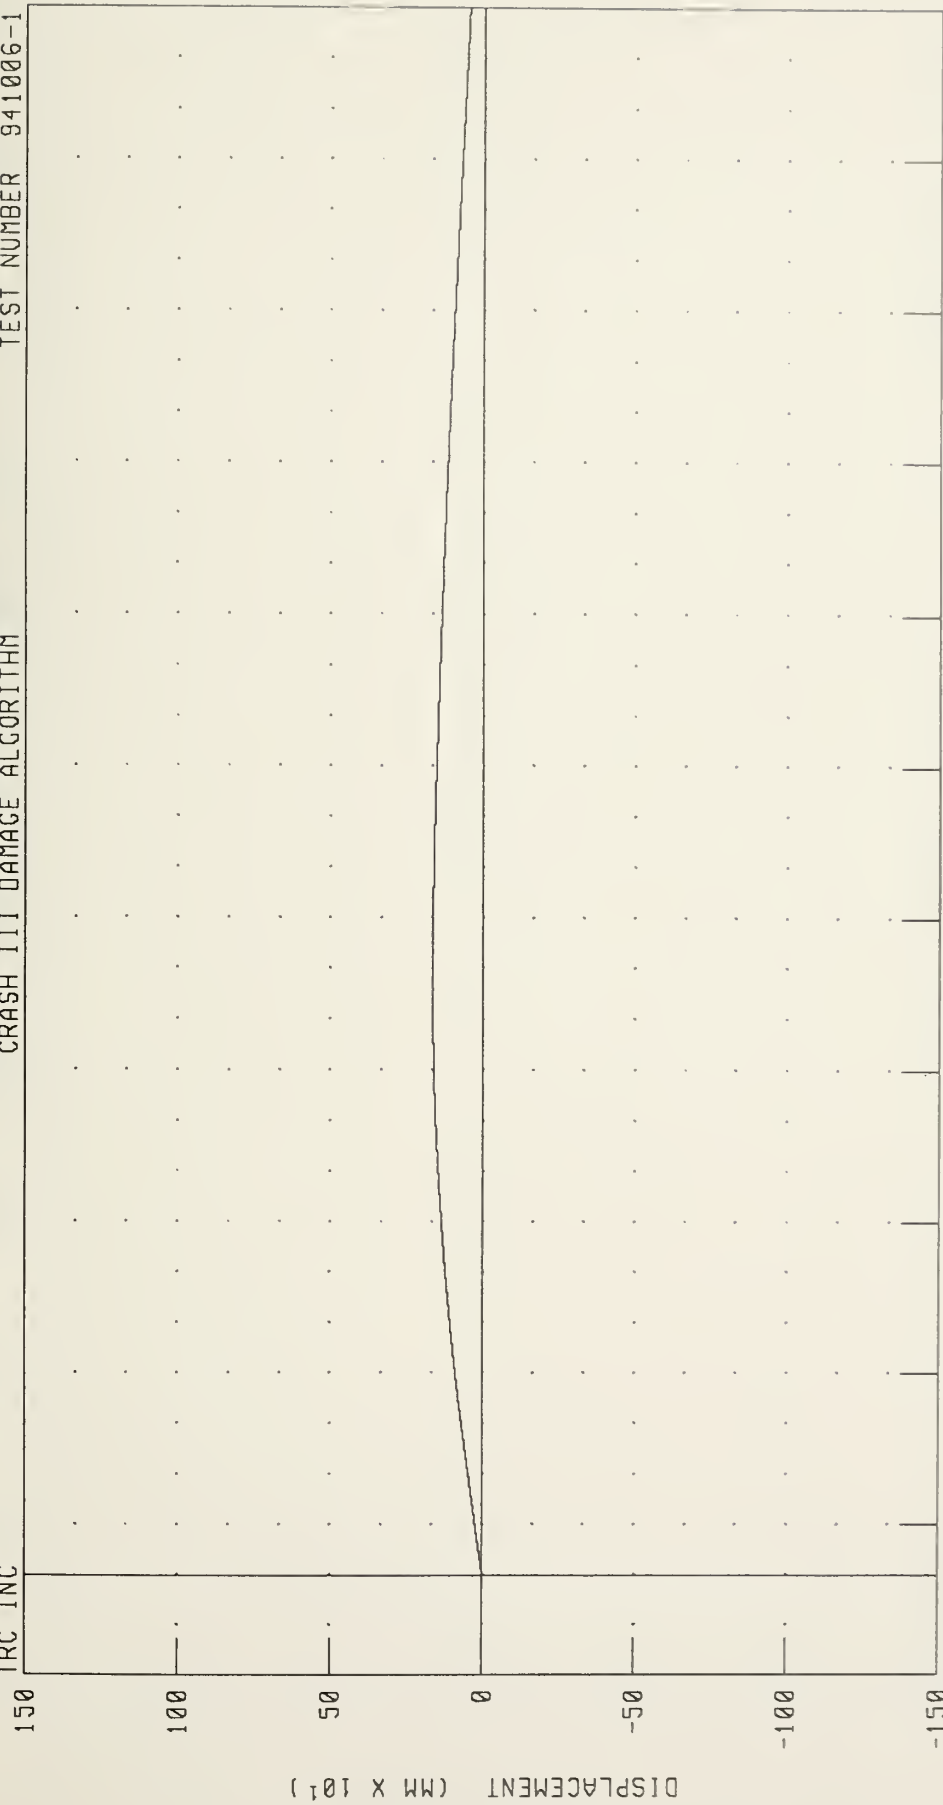
CHANNEL: TRRX01 FILTER: CH CLASS 180

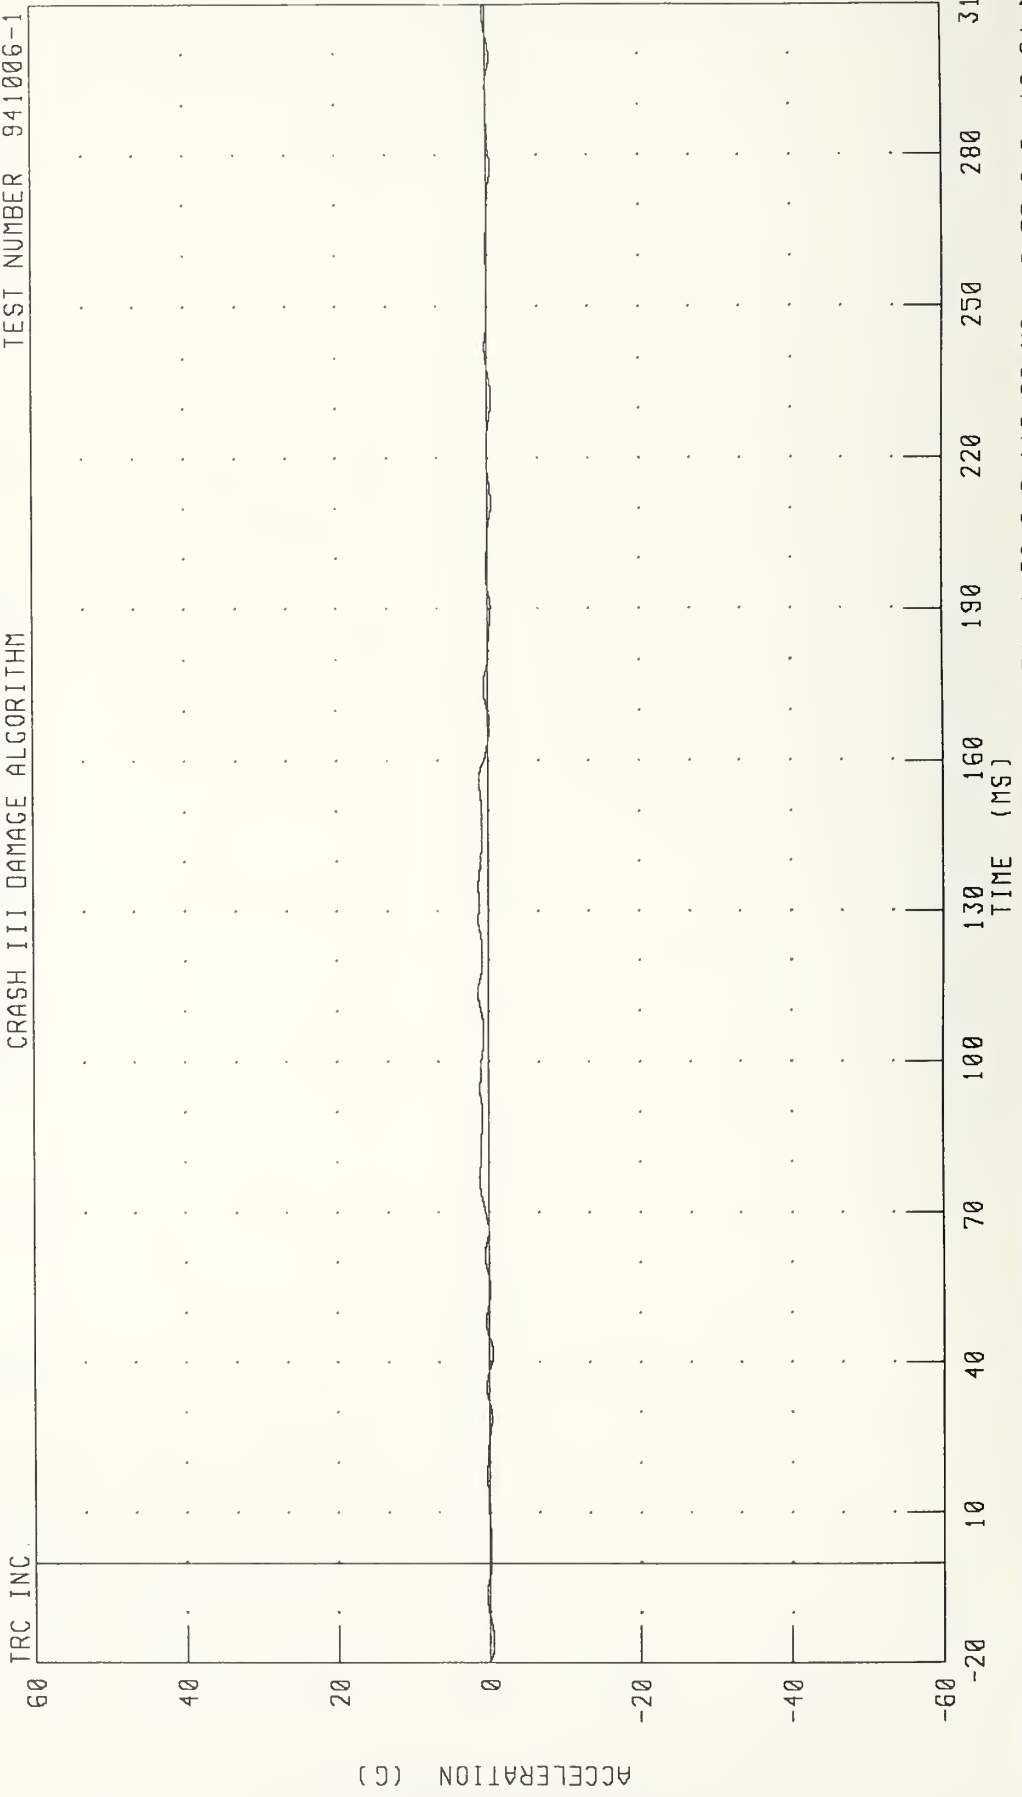
CHANNEL: TRRYG1 FILTER: CH. CLASS 60

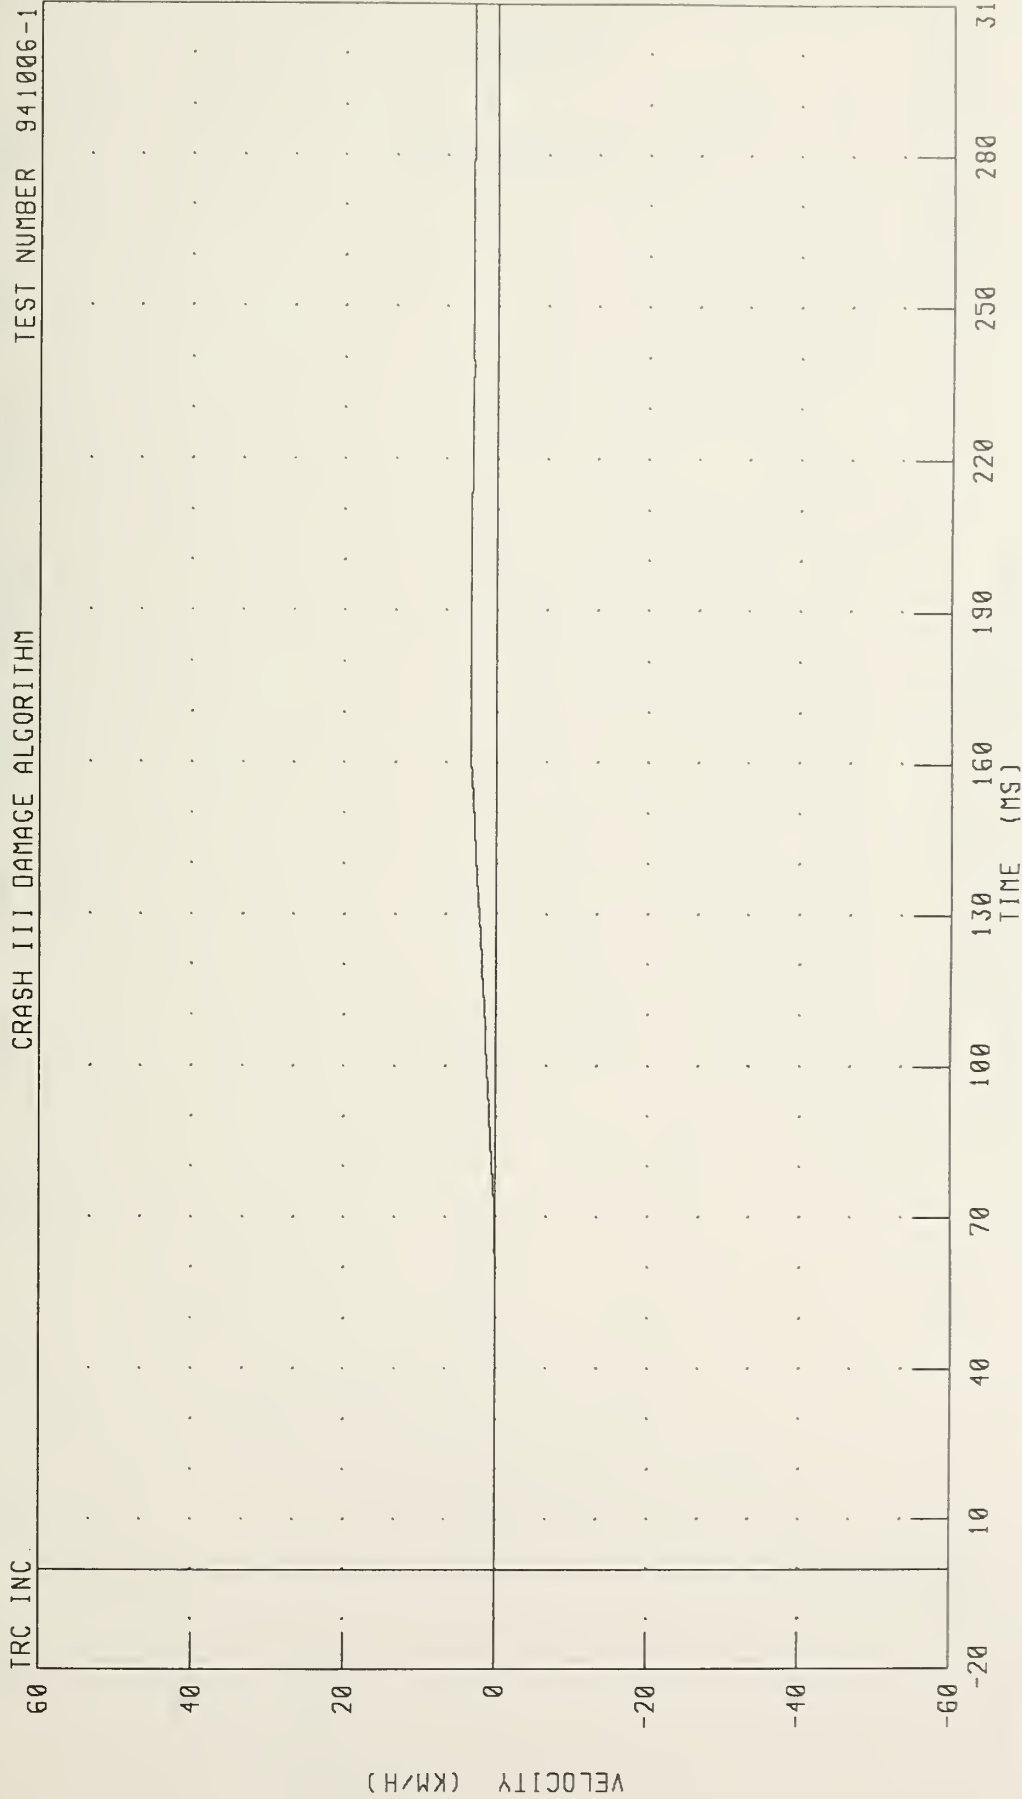
TRC INC. CHANNEL: TRRYV1 FILTER: CH. CLASS 180
 PEAK DATA: 3.46 KM/H @ 178.88 MS, -0.03 KM/H @ 8.72 MS

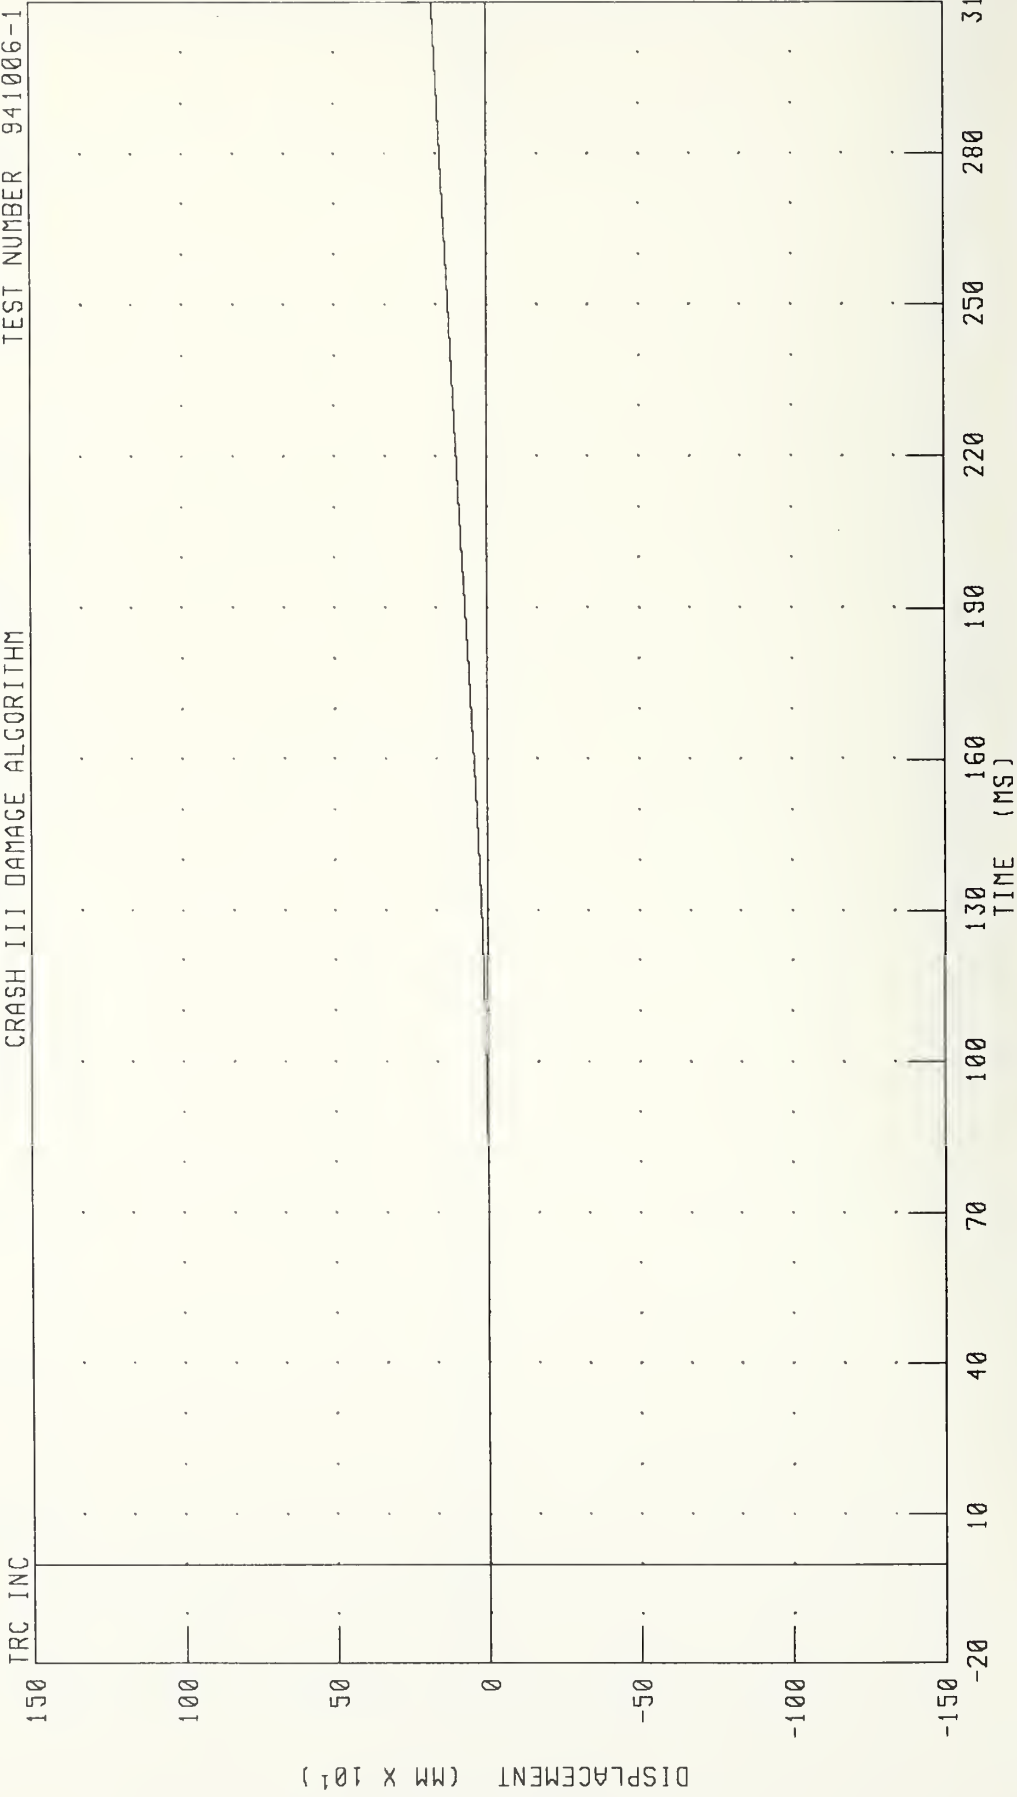
CHANNEL: TRRYD1 FILTER: CH. CLASS 180

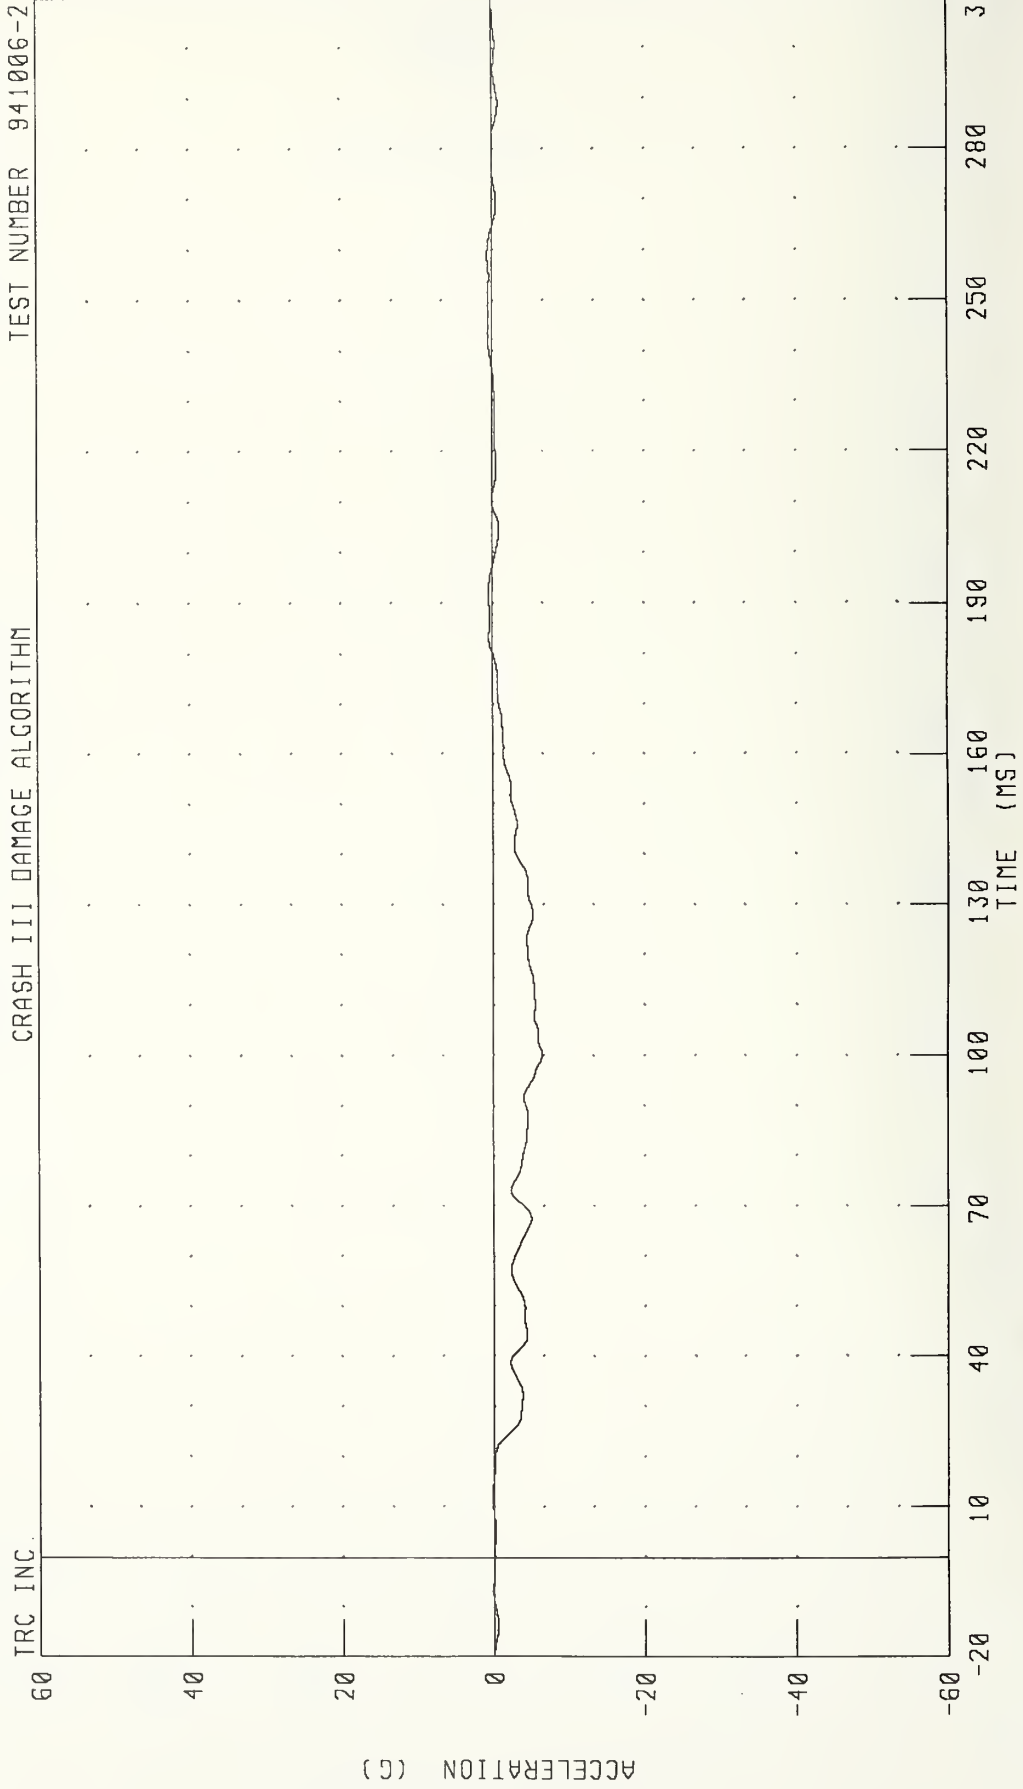
1992 CHEVROLET CAPRICE INTO 305 MM POLE
VEHICLE CC X-AXIS VELOCITY
CRASH III DAMAGE ALGORITHM

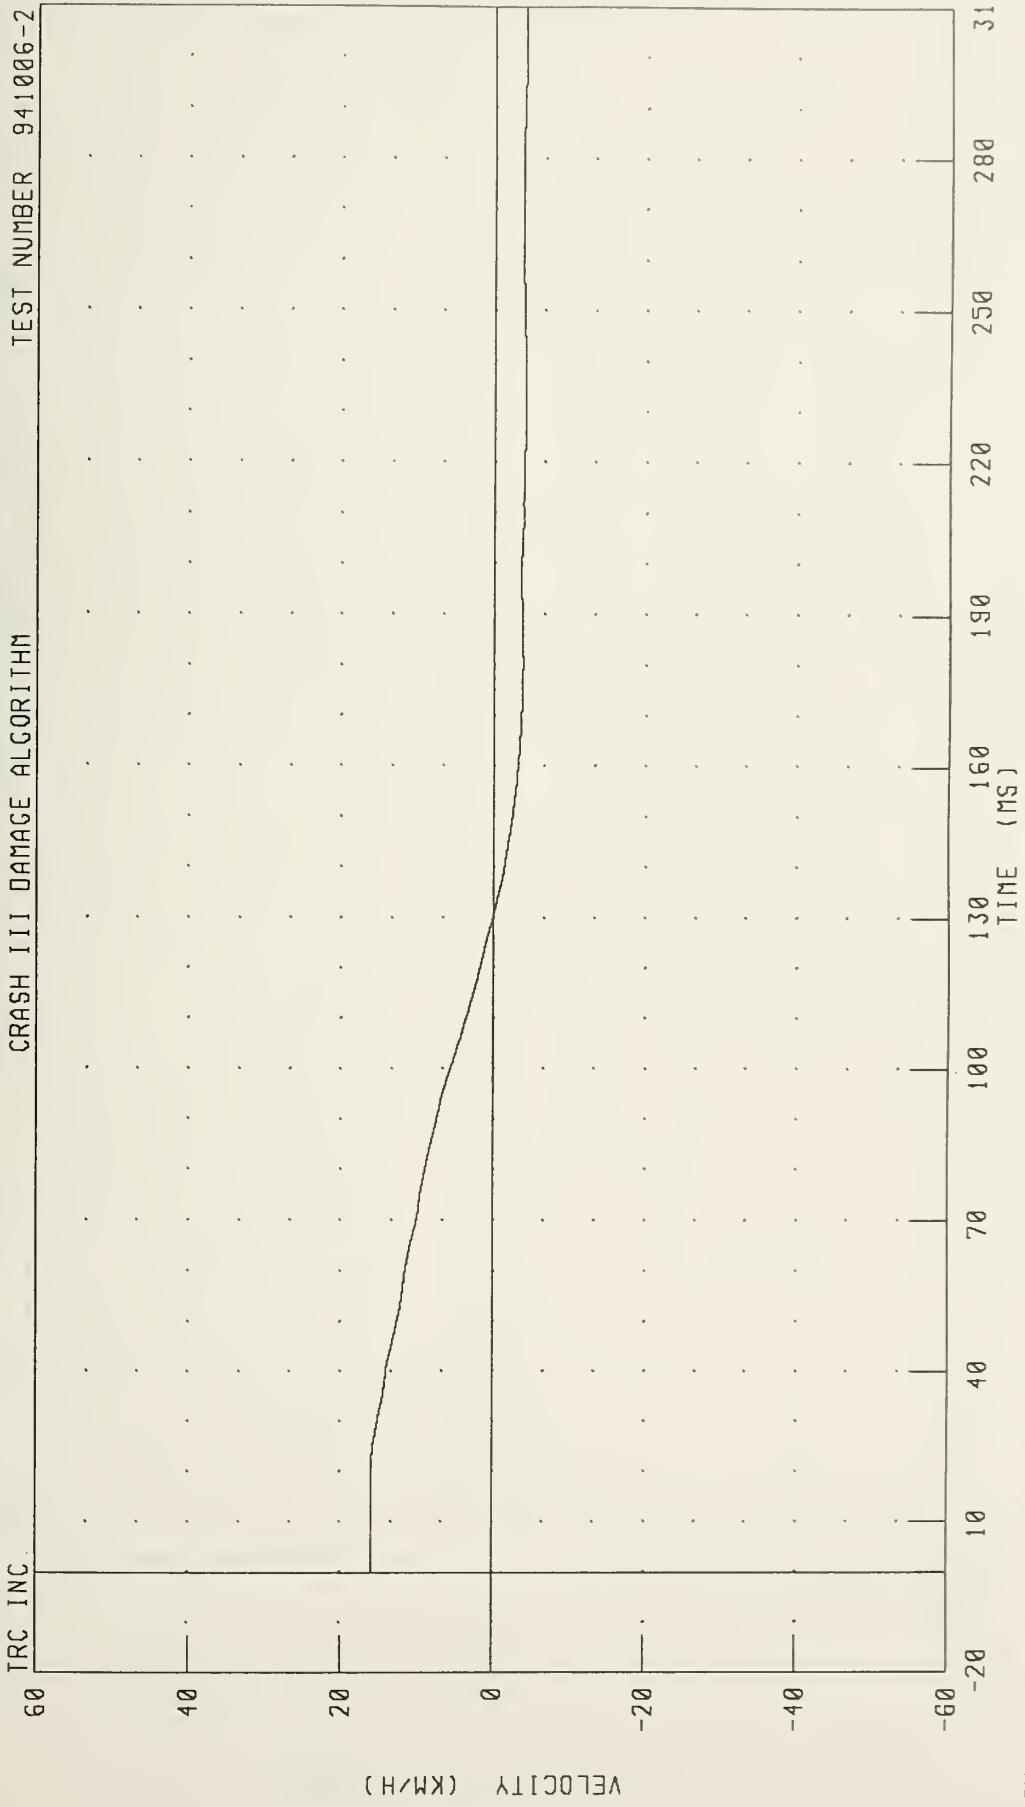
CHANNEL VCGXV1 FILTER CH CLASS 180 PEAK DATA 15.91 KM/H @ 16.32 MS, -4.10 KM/H @ 236.96 MS
