U.S. Department
of Transportation

**National Highway
Traffic Safety
Administration**

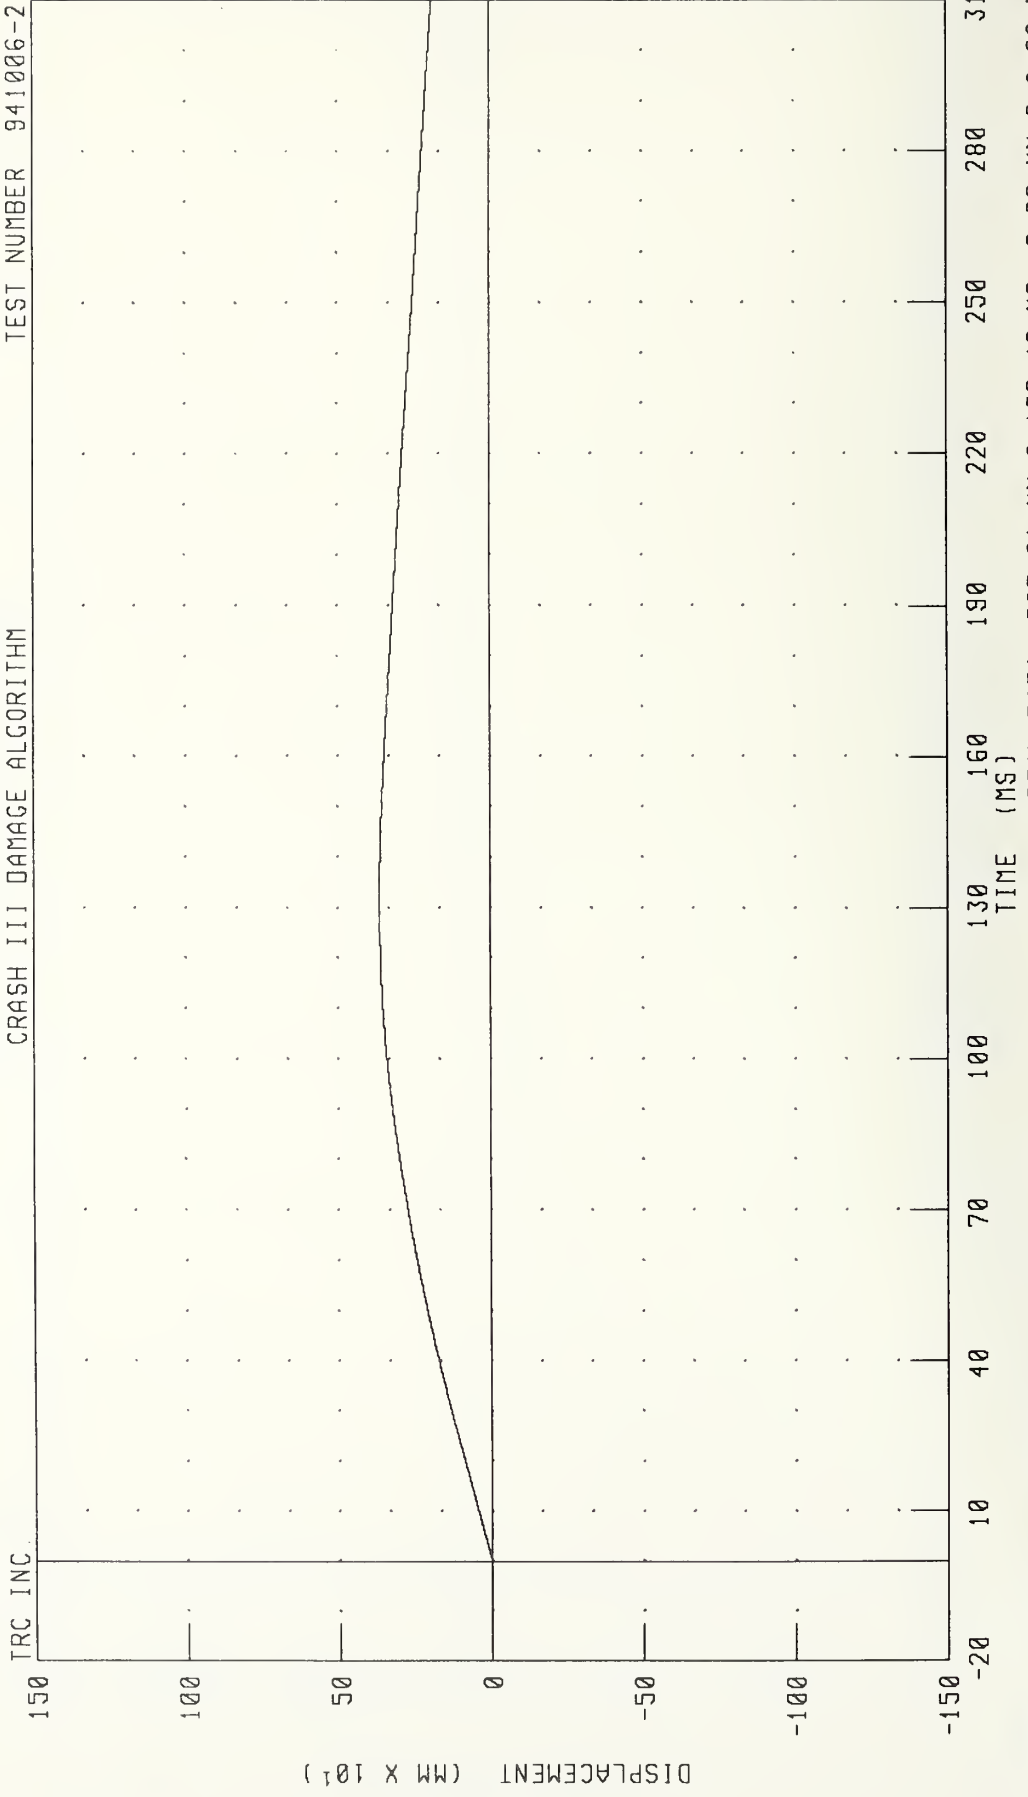
CHANNEL: VCGXD1 FILTER: CH. CLASS 180

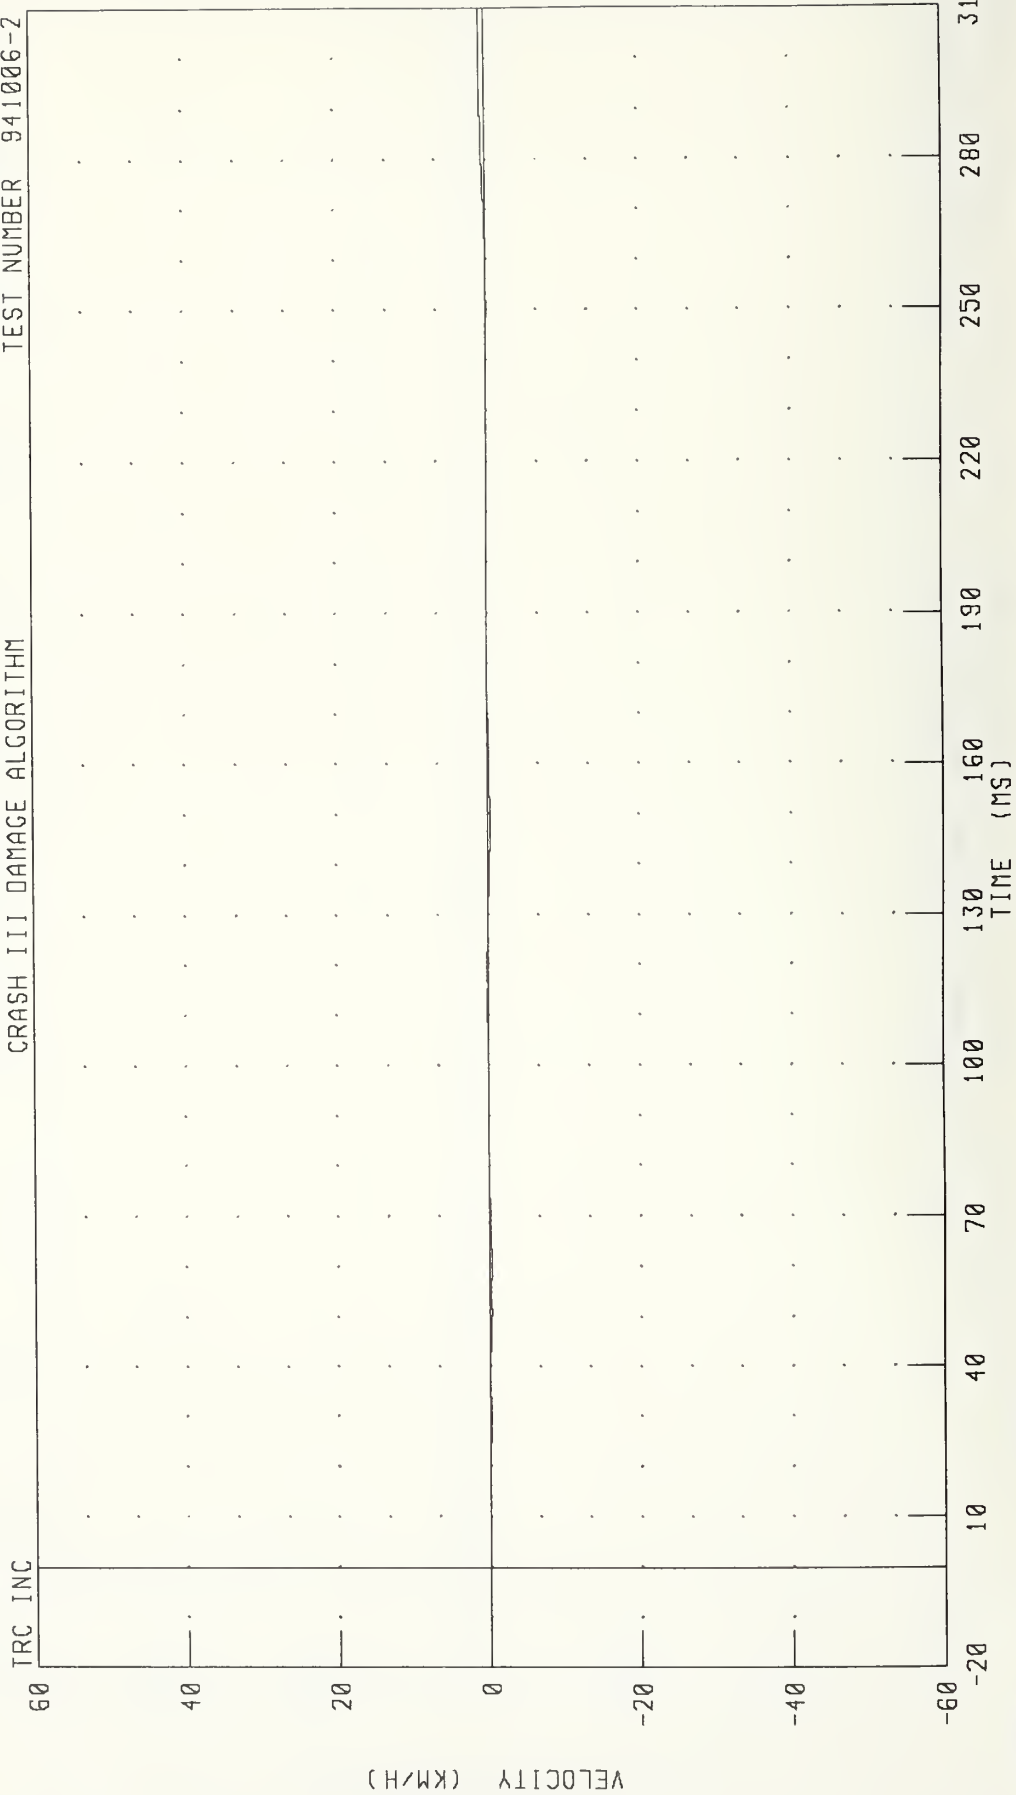
CHANNEL: VCGYV1 FILTER: CH. CLASS 180

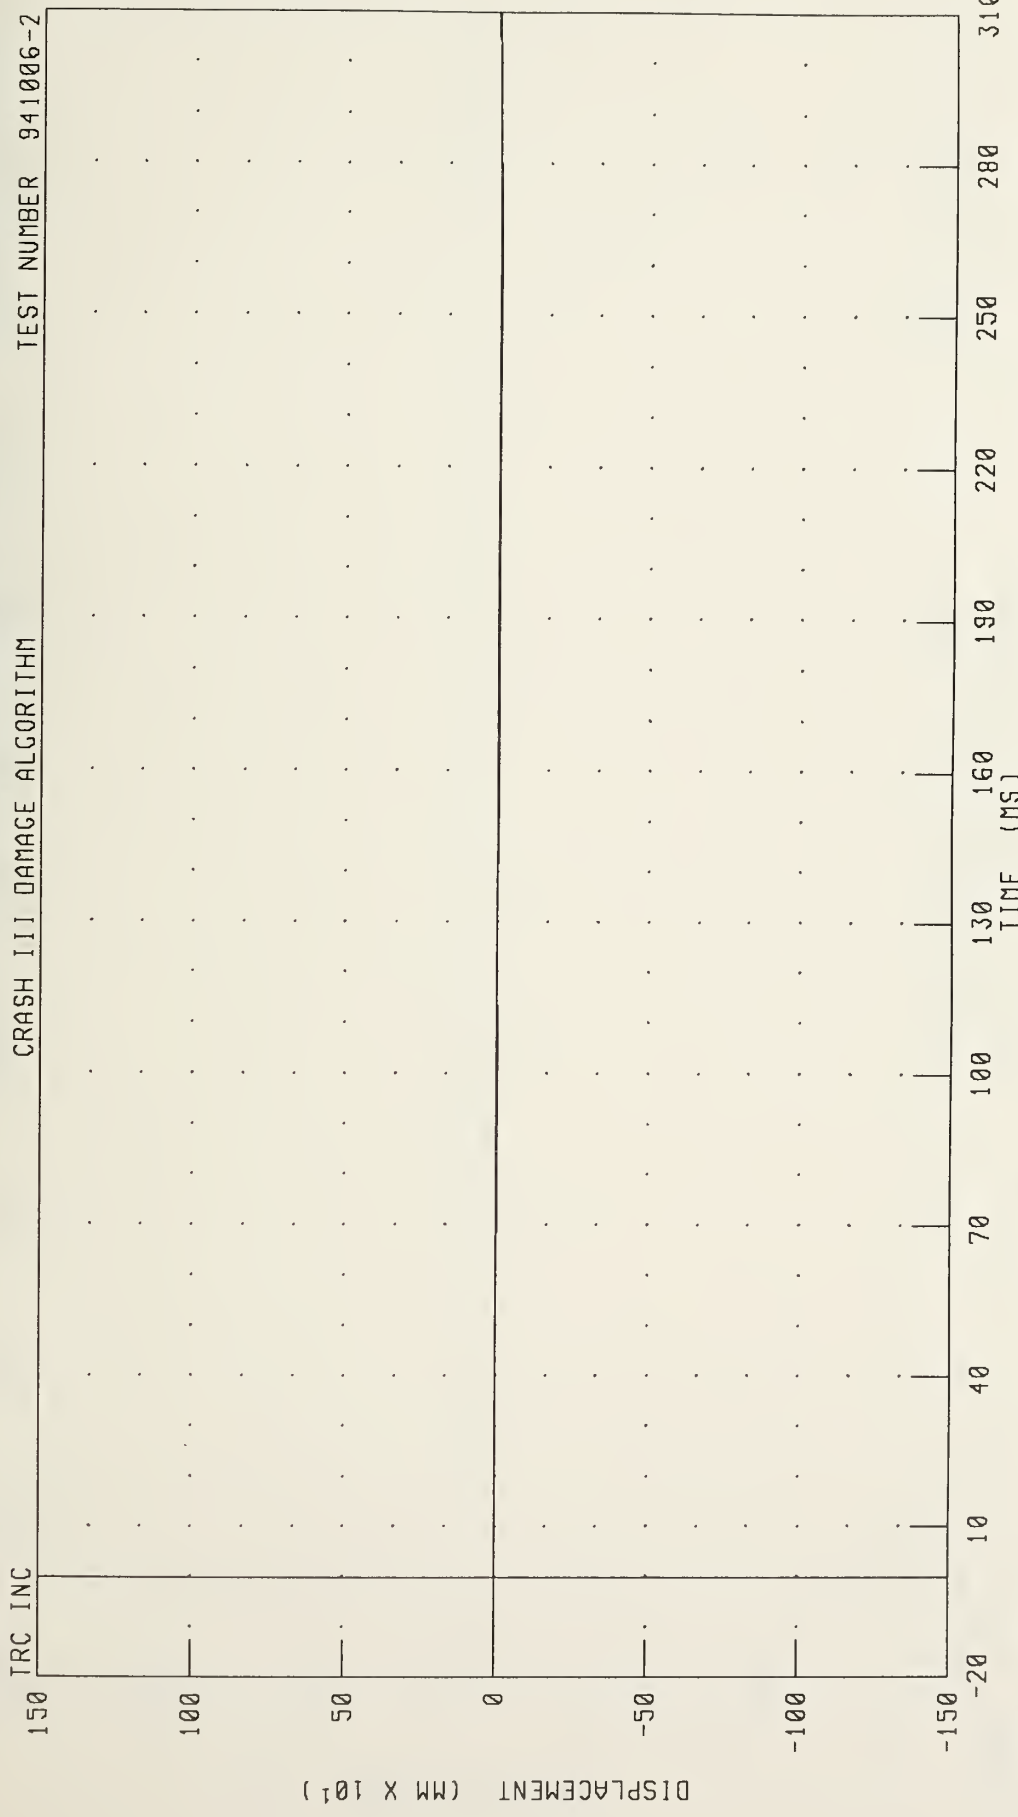
CHANNEL: VCGYD1 FILTER: CH. CLASS 180
 PEAK DATA: 3.46 MM @ 310 00 MS; -3.57 MM @ 179.76 MS

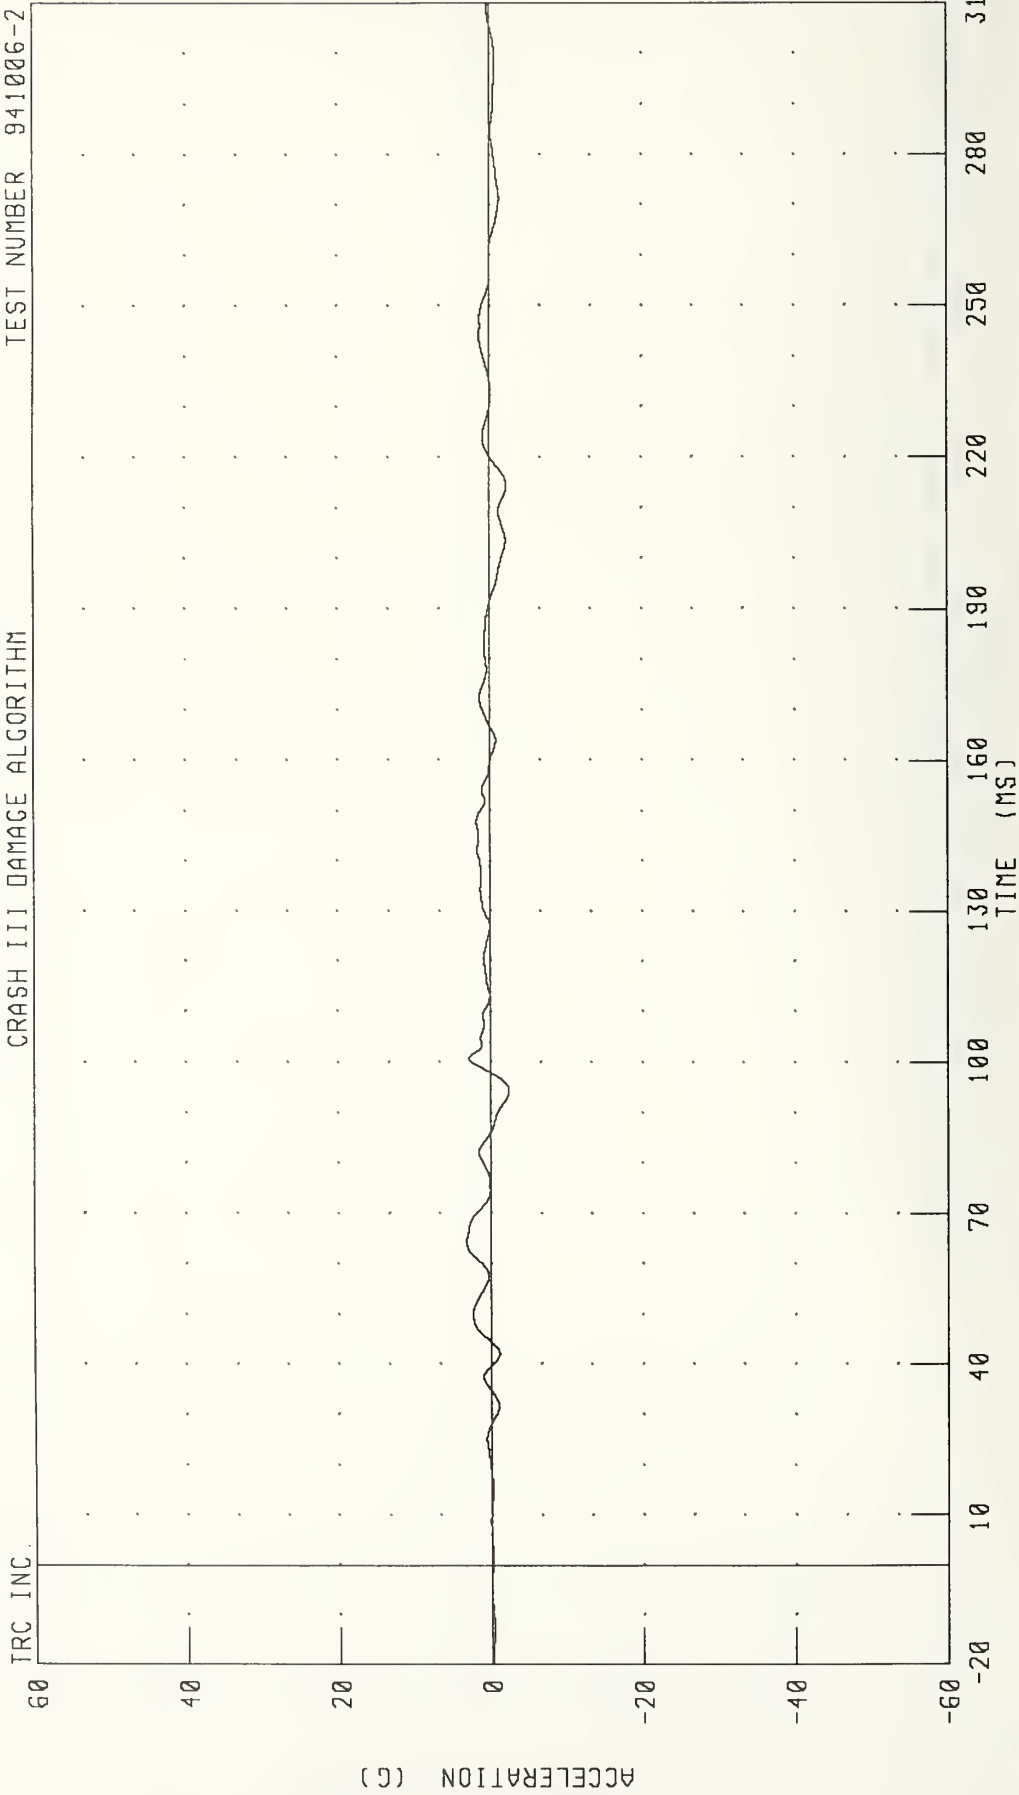
CHANNEL: VCCZG1 FILTER: CH. CLASS 60

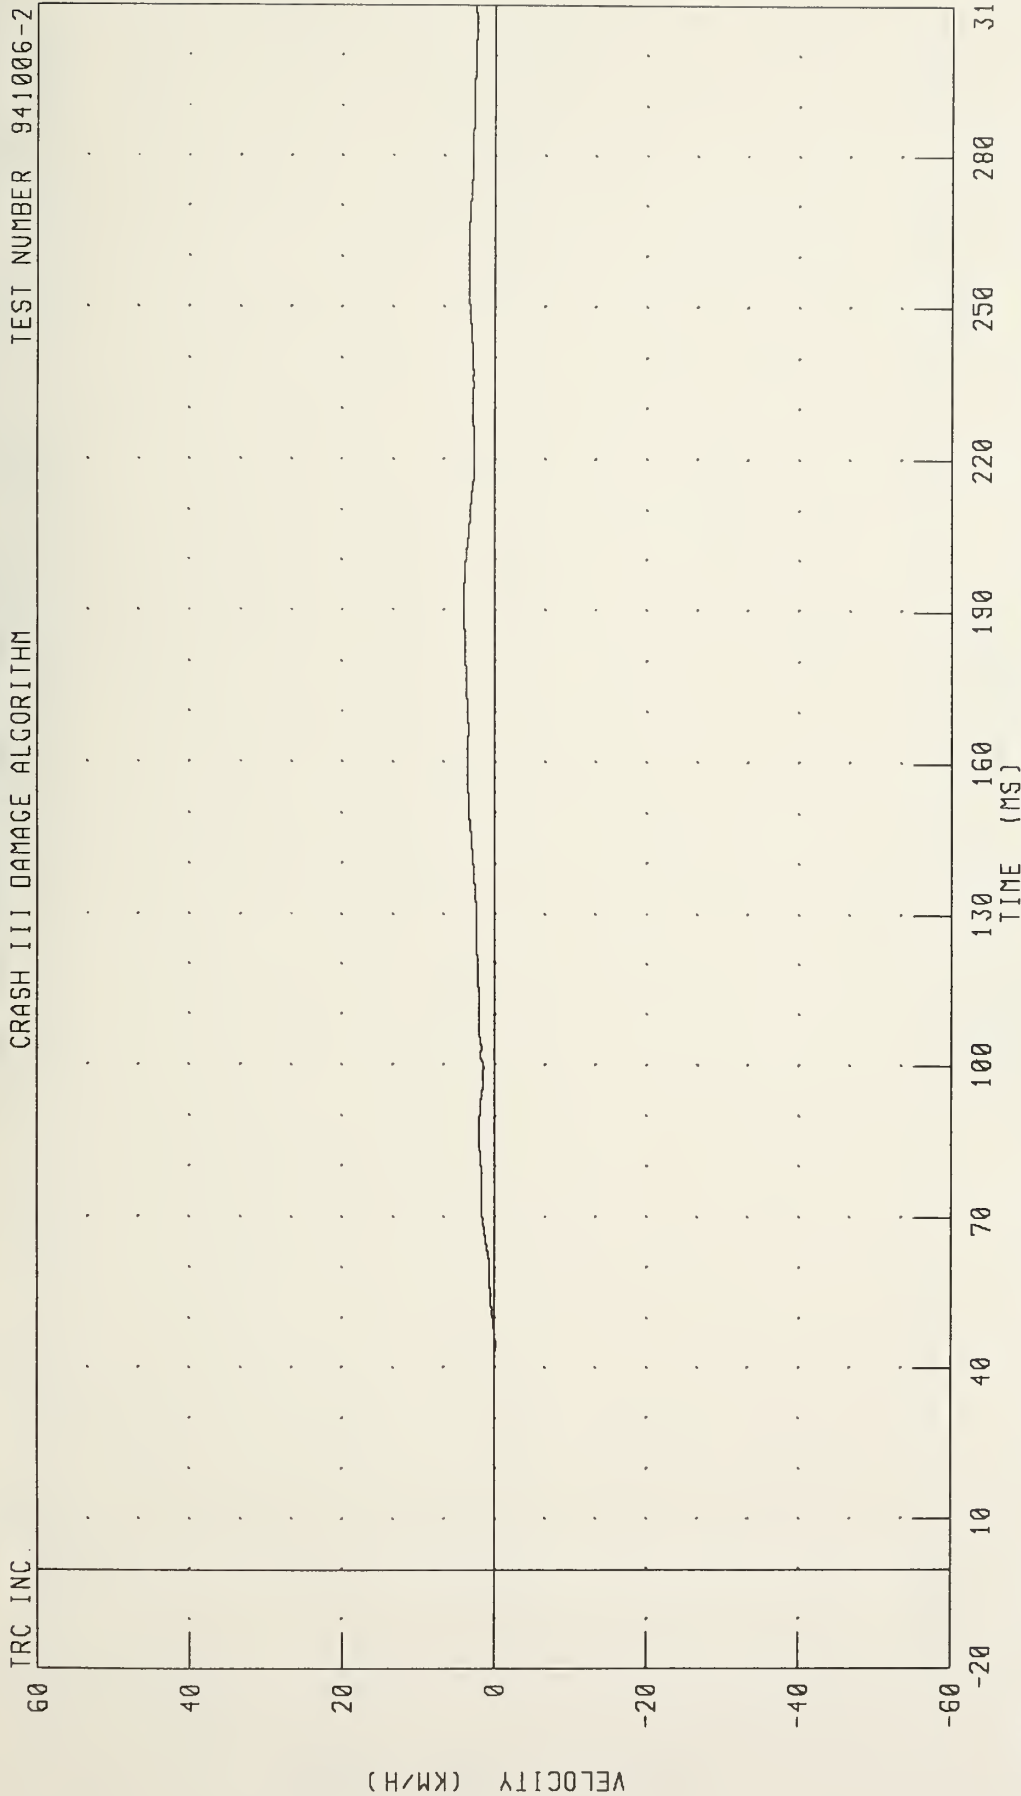
CHANNEL: VCGZV1 FILTER: CH. CLASS 180 PEAK DATA: 4.06 KM/H @ 191.76 MS; -0.09 KM/H @ 44.96 MS

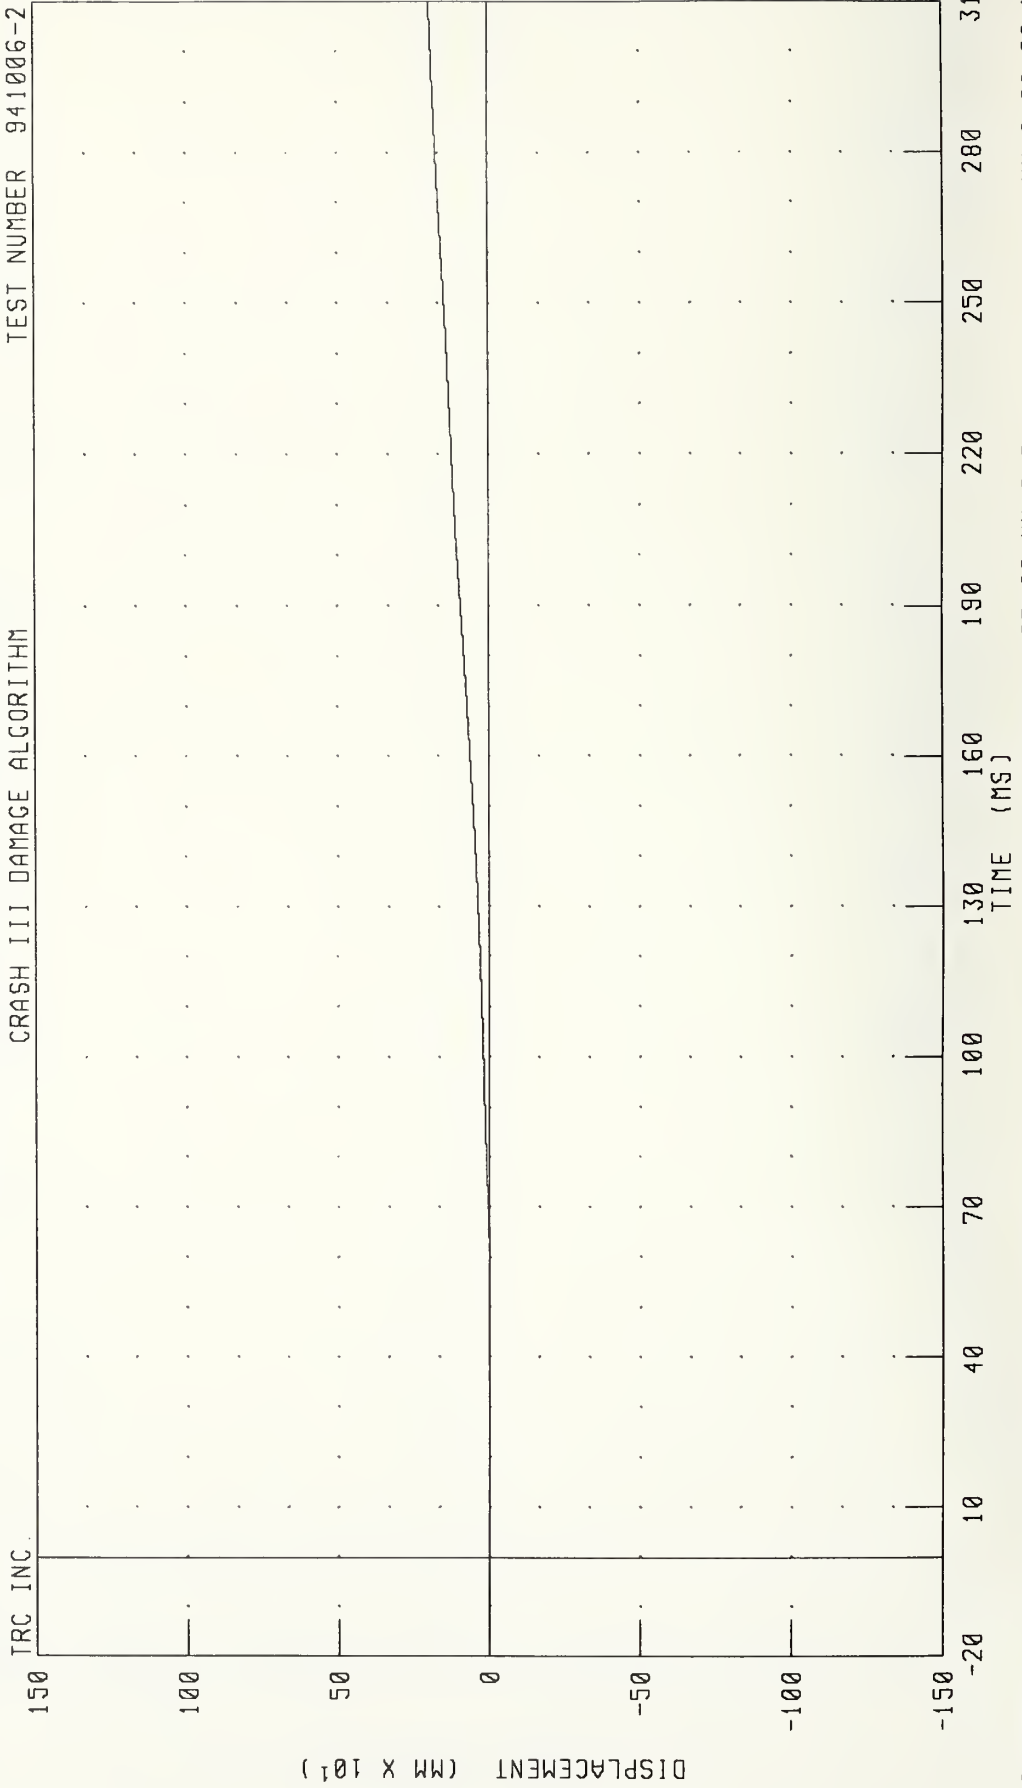
CHANNEL: VCGZD1 FILTER: CH CLASS 180

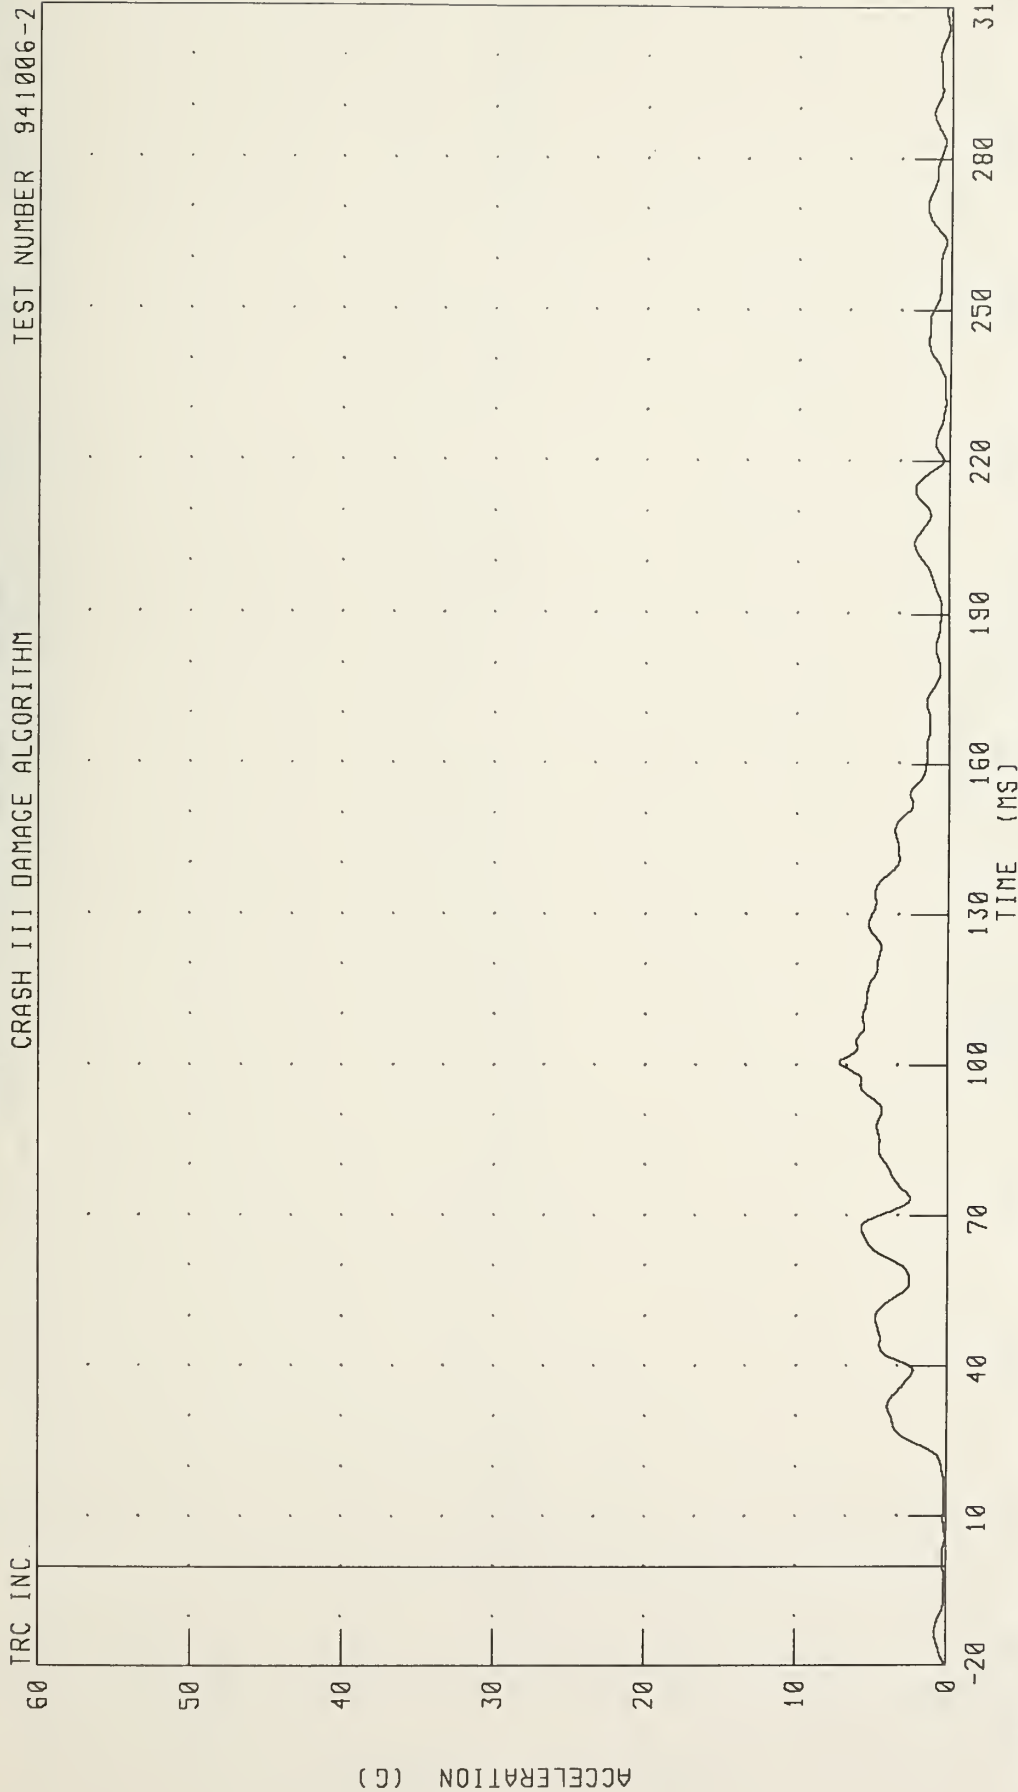
CHANNEL: VCGRG1 FILTER: CH. CLASS 60 PEAK DATA: 7.13 G @ 100.56 MS; 0.10 G @ -20.00 MS

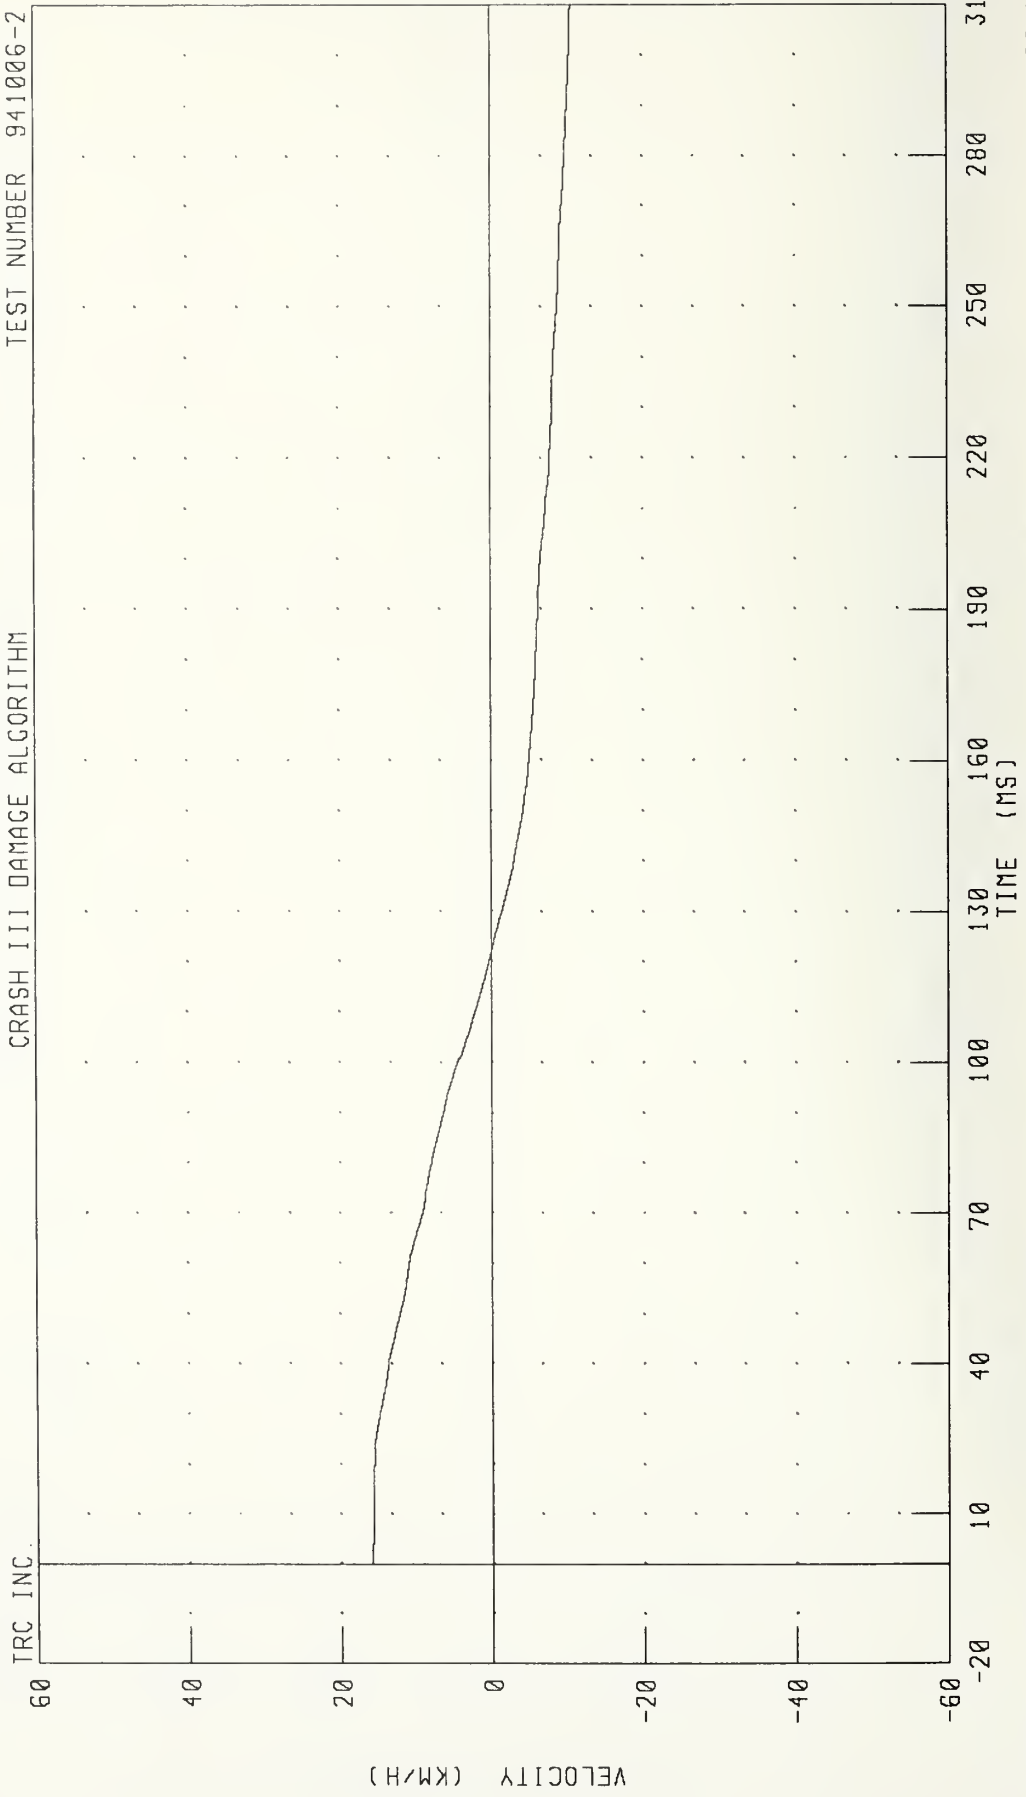
CHANNEL: VCGRV1 FILTER: CH. CLASS 180

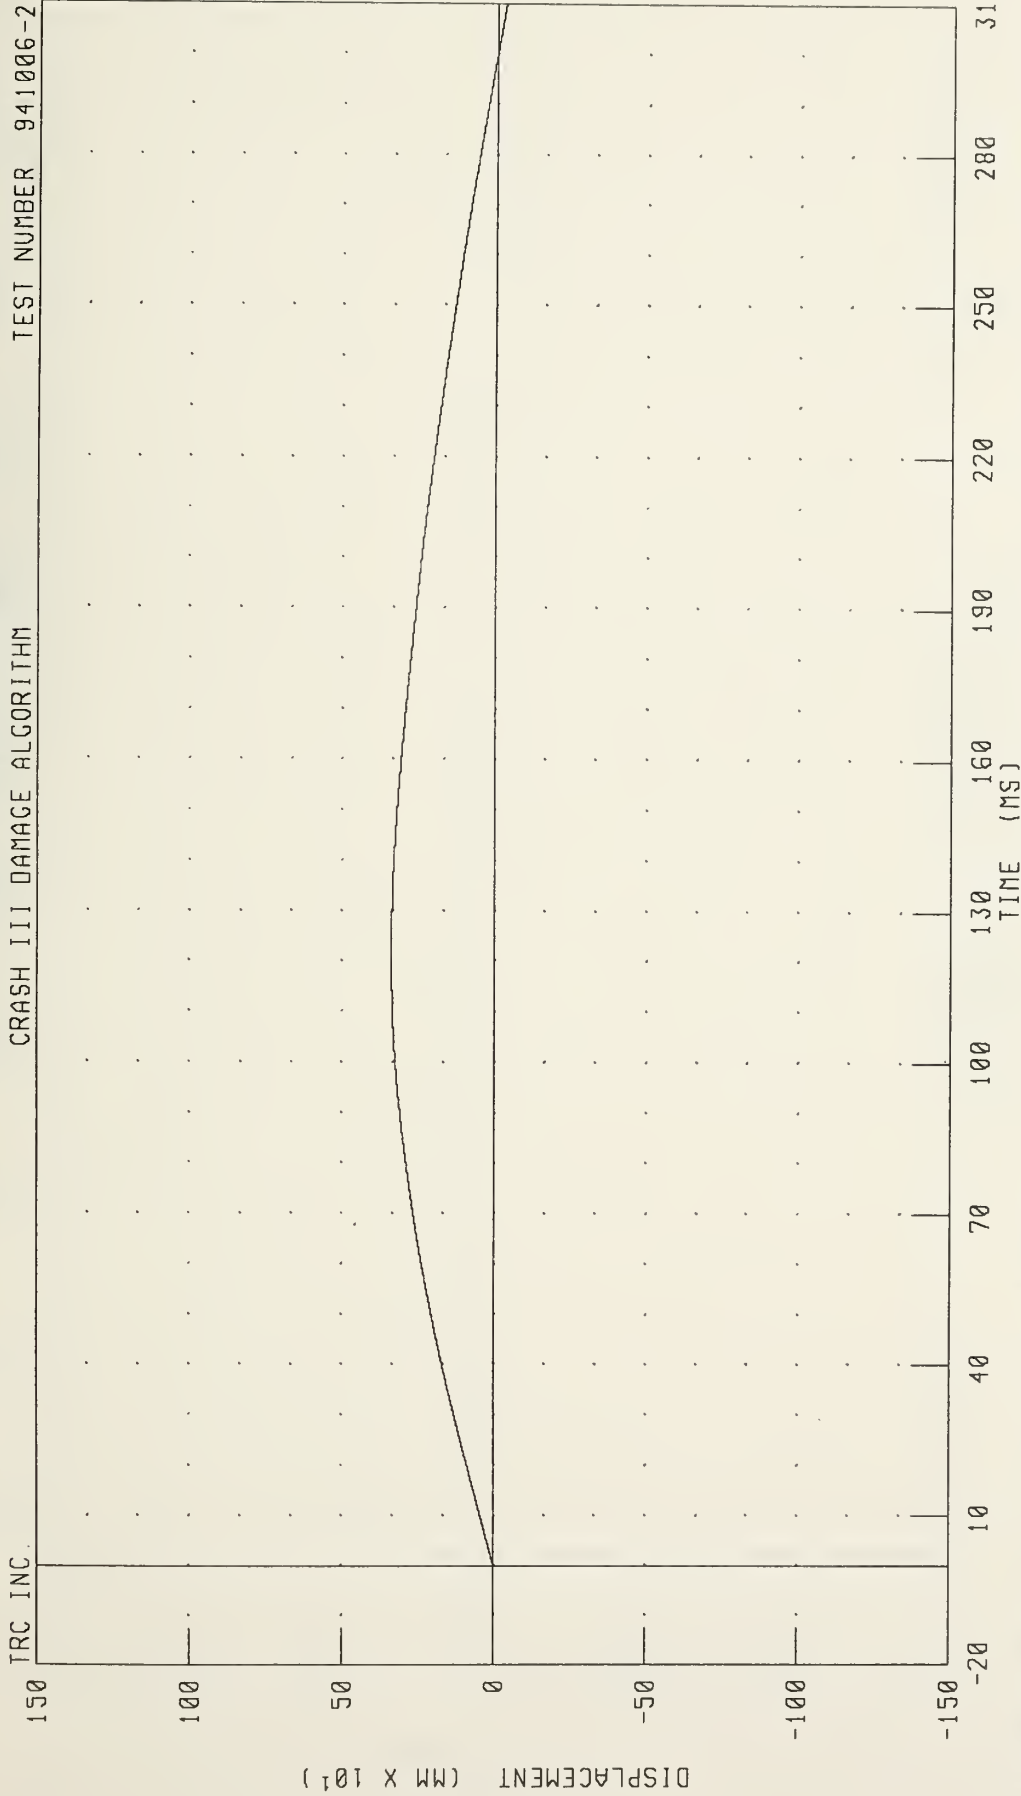
CHANNEL: VCGRD1 FILTER: CH. CLASS 180 PEAK DATA: 338.35 MM @ 122.08 MS, -28.54 MM @ 310.00 MS

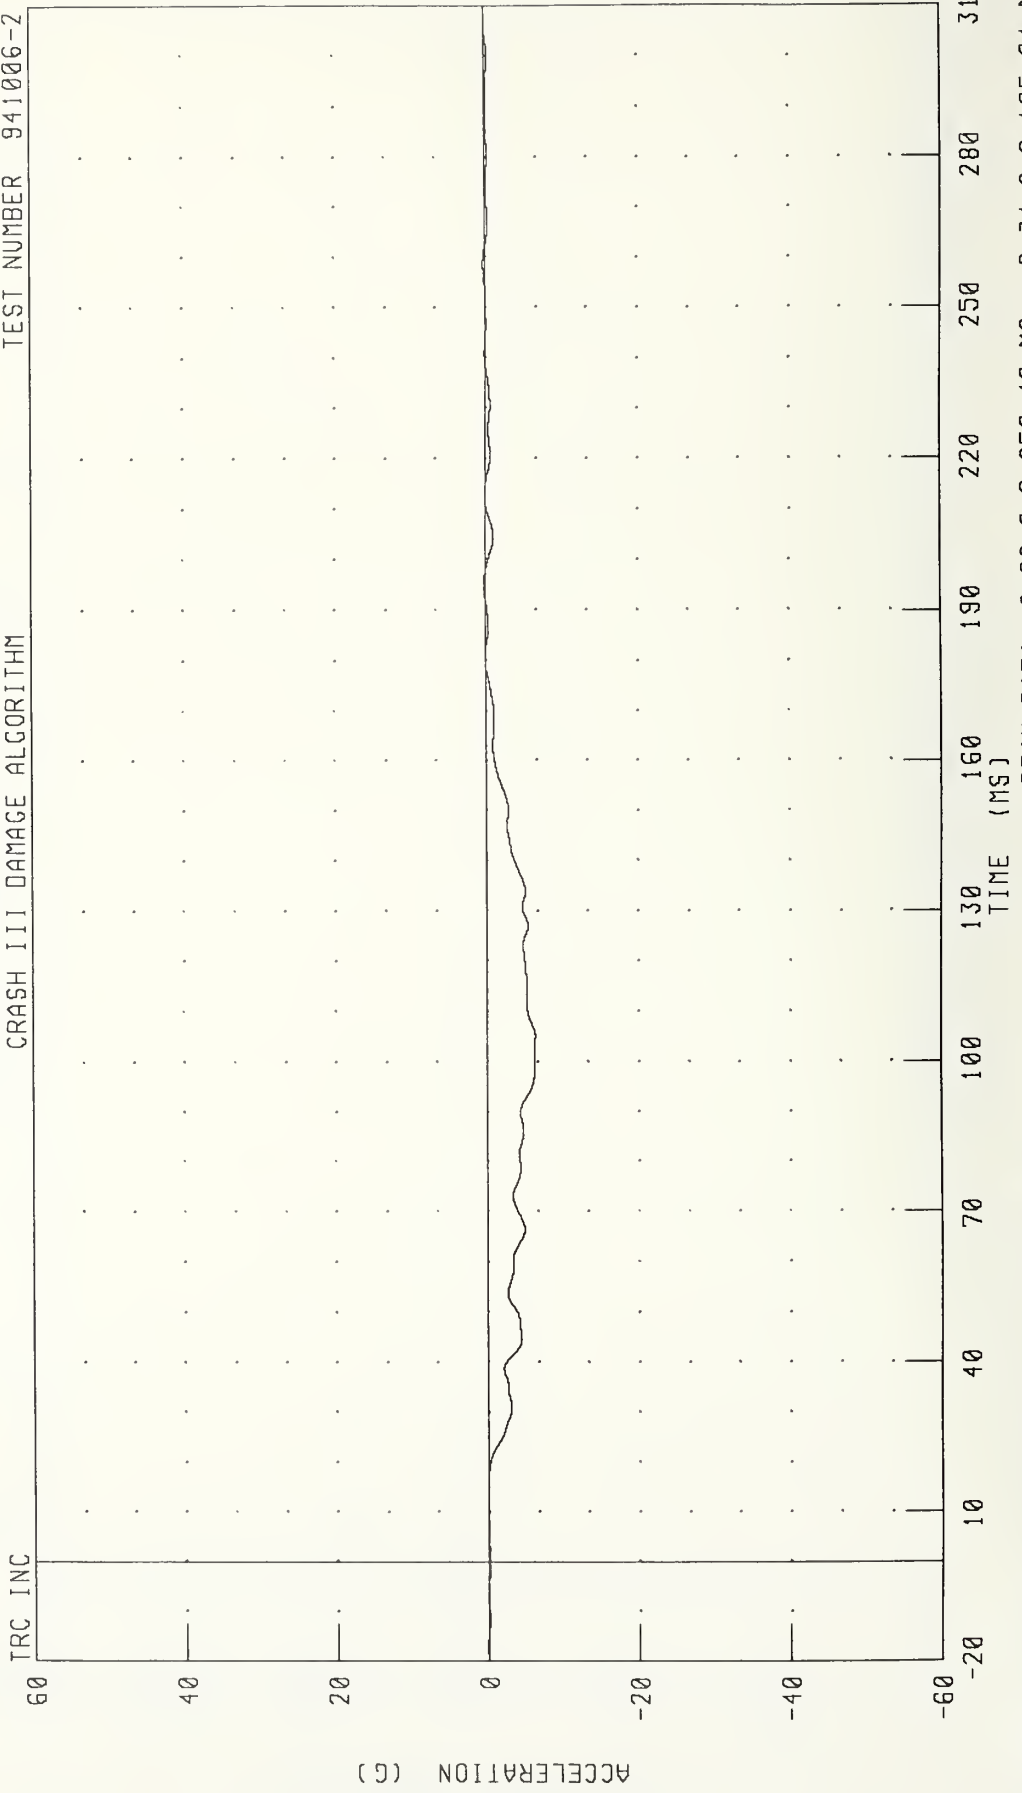
CHANNEL: LFSXG1 FILTER: CH CLASS 60

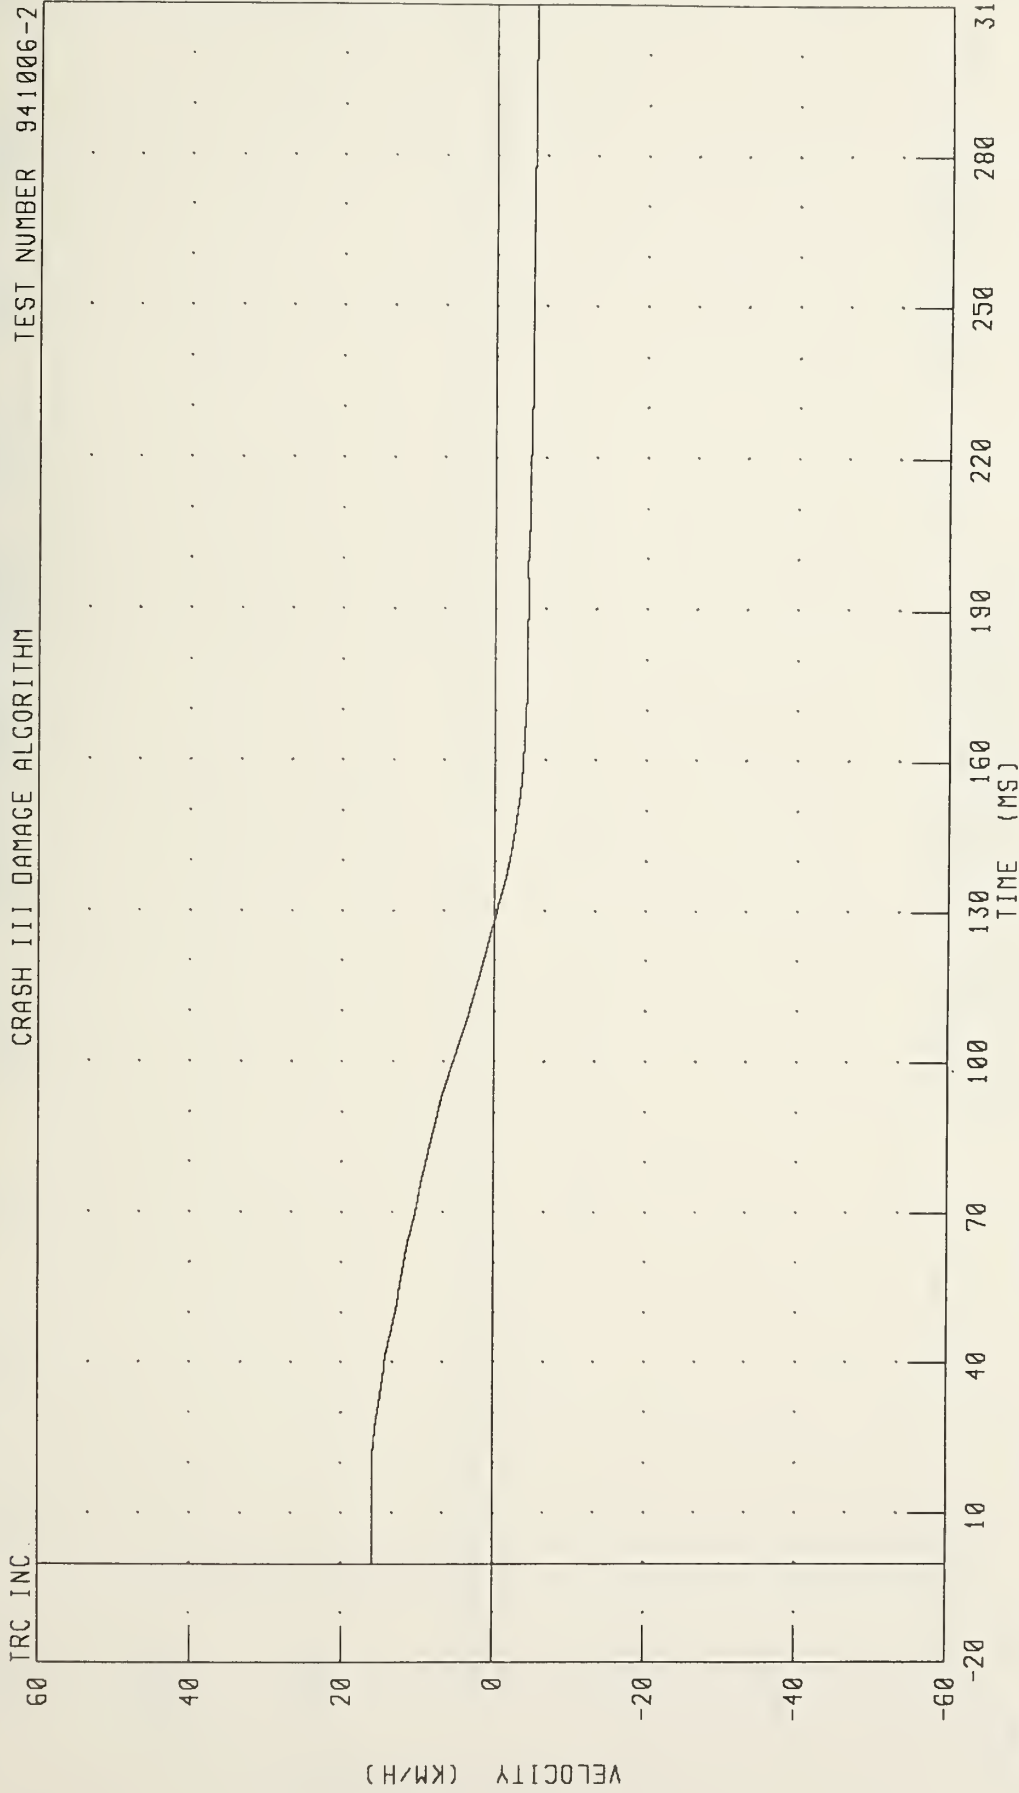
CHANNEL: LFSXV1 FILTER: CH. CLASS 180

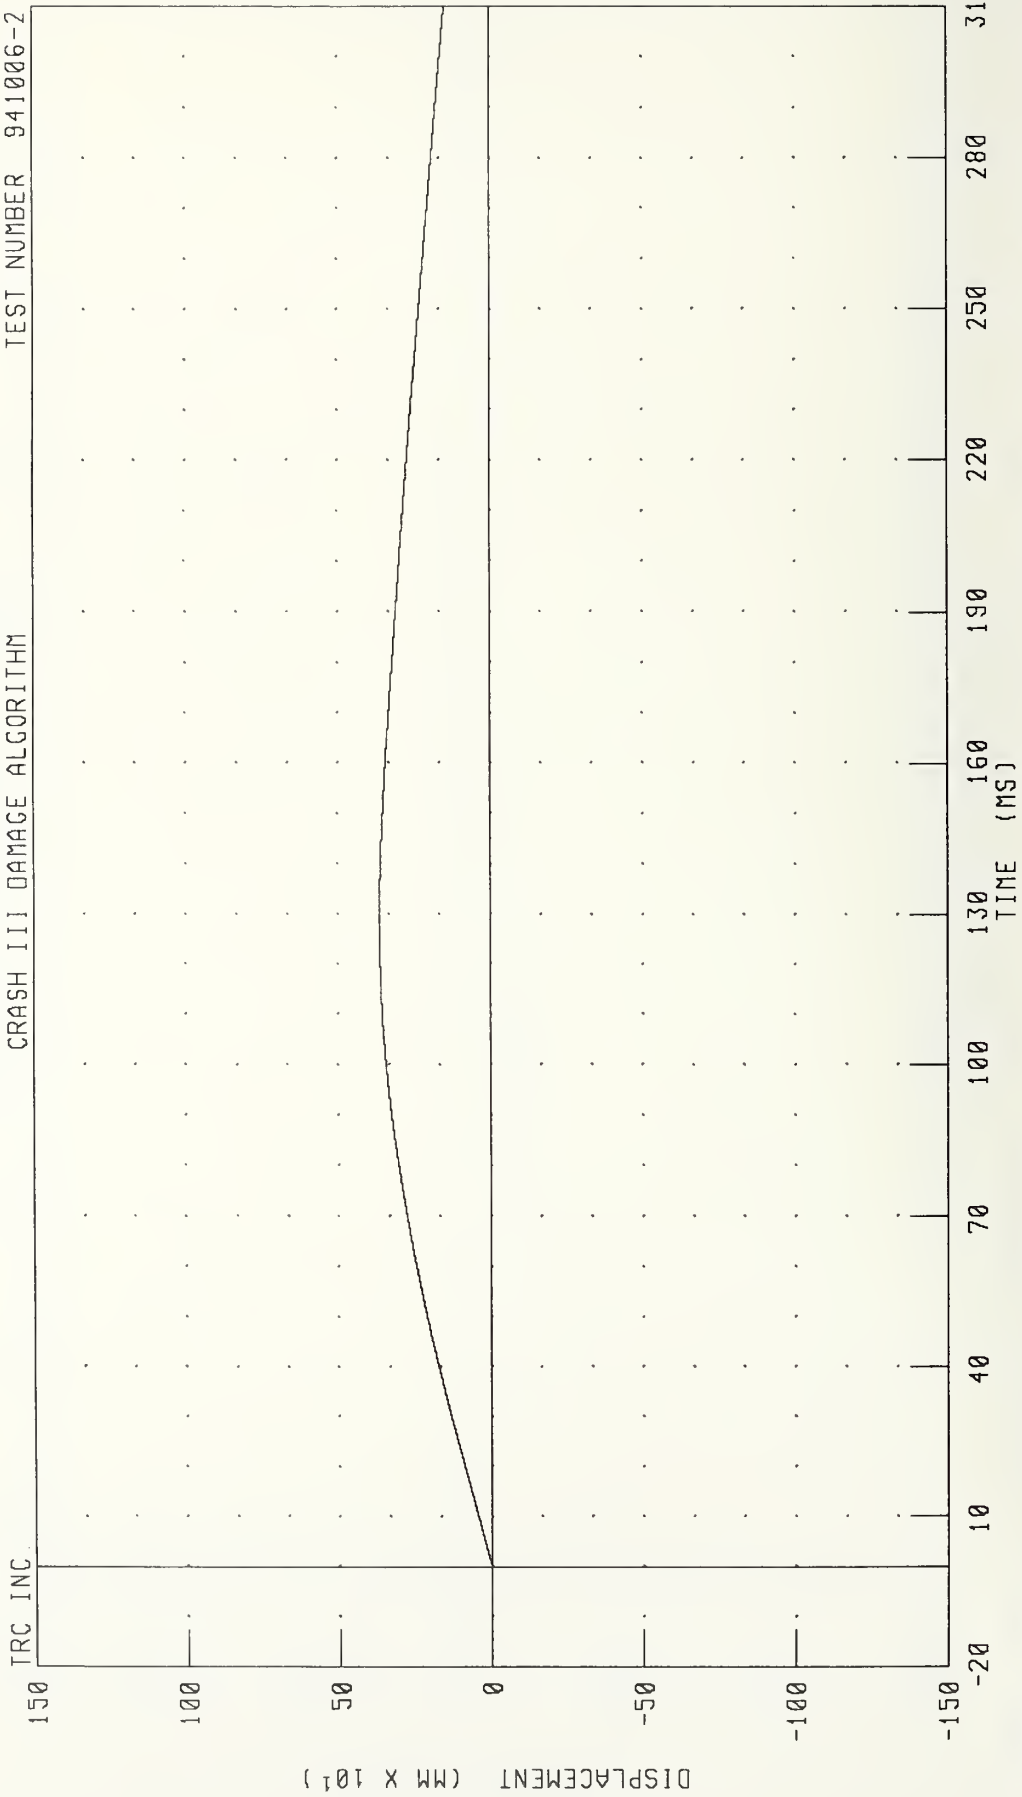
CHANNEL: LFSXD1 FILTER: CH. CLASS 180
