U.S. Department
of Transportation

**National Highway
Traffic Safety
Administration**

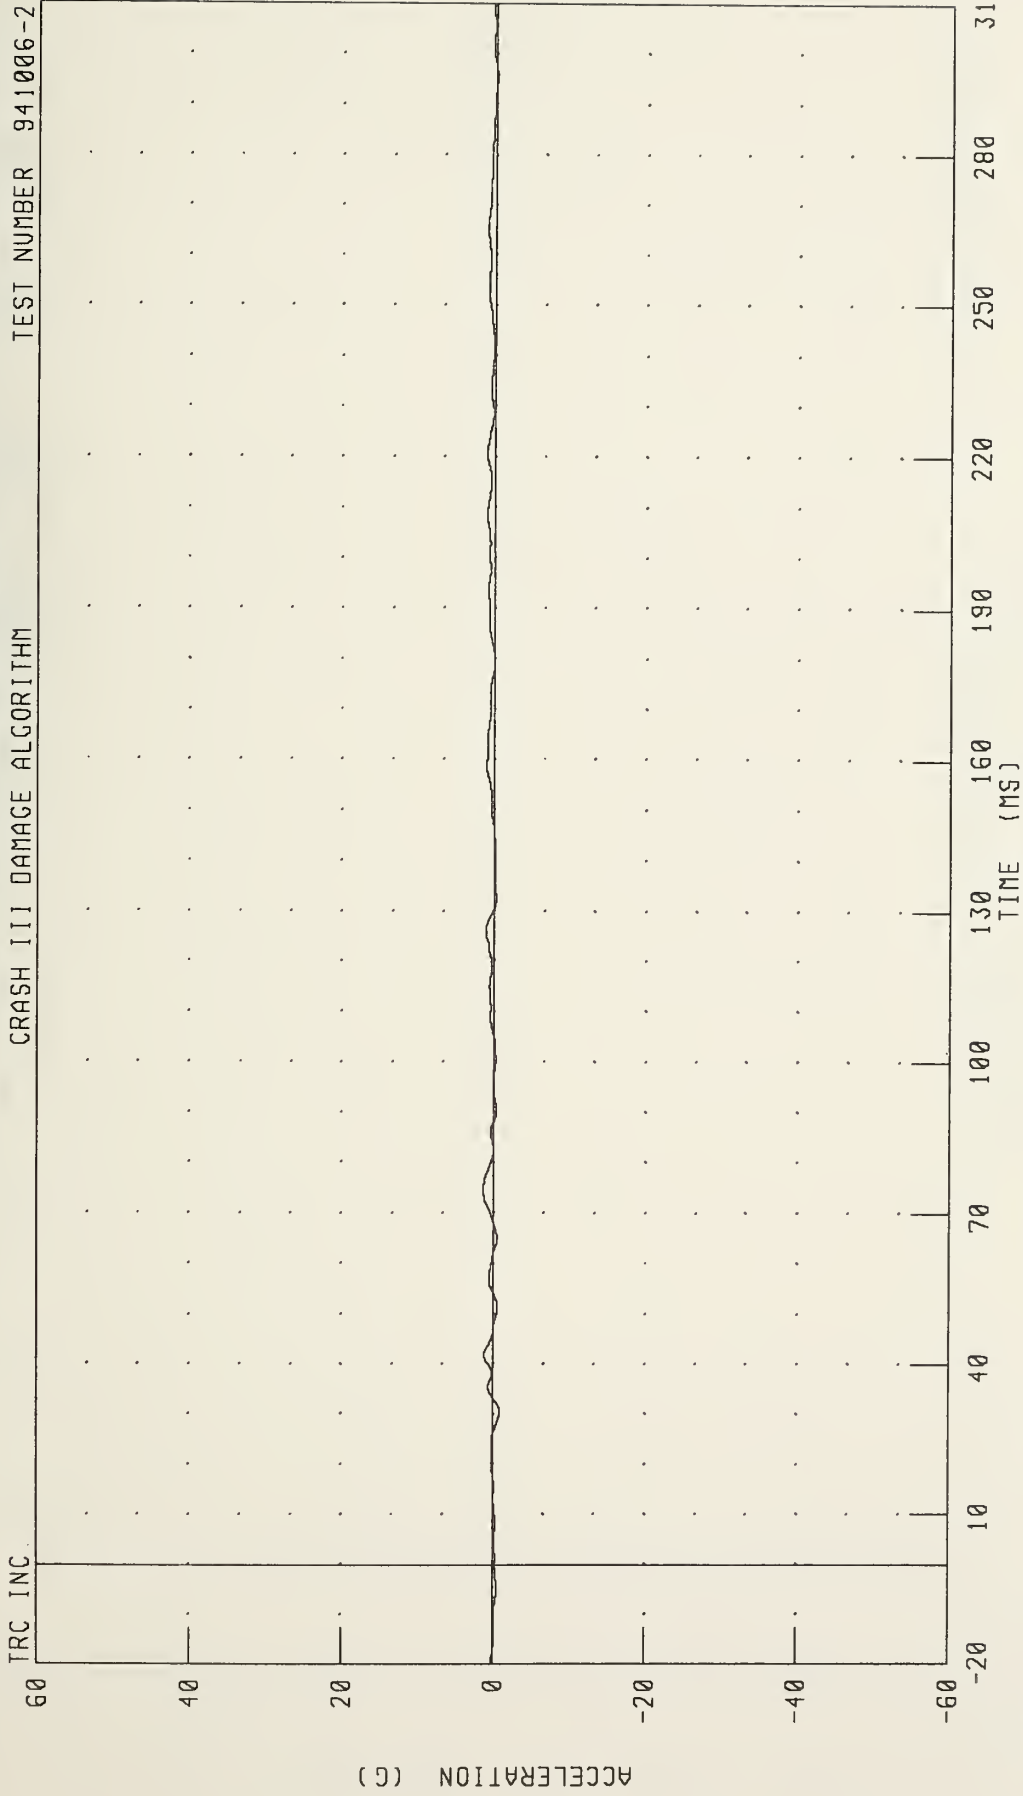
CHANNEL: LFSYG1 FILTER: CH. CLASS 60 PEAK DATA: 1.32 G @ 74.56 MS; -0.86 G @ 30.48 MS

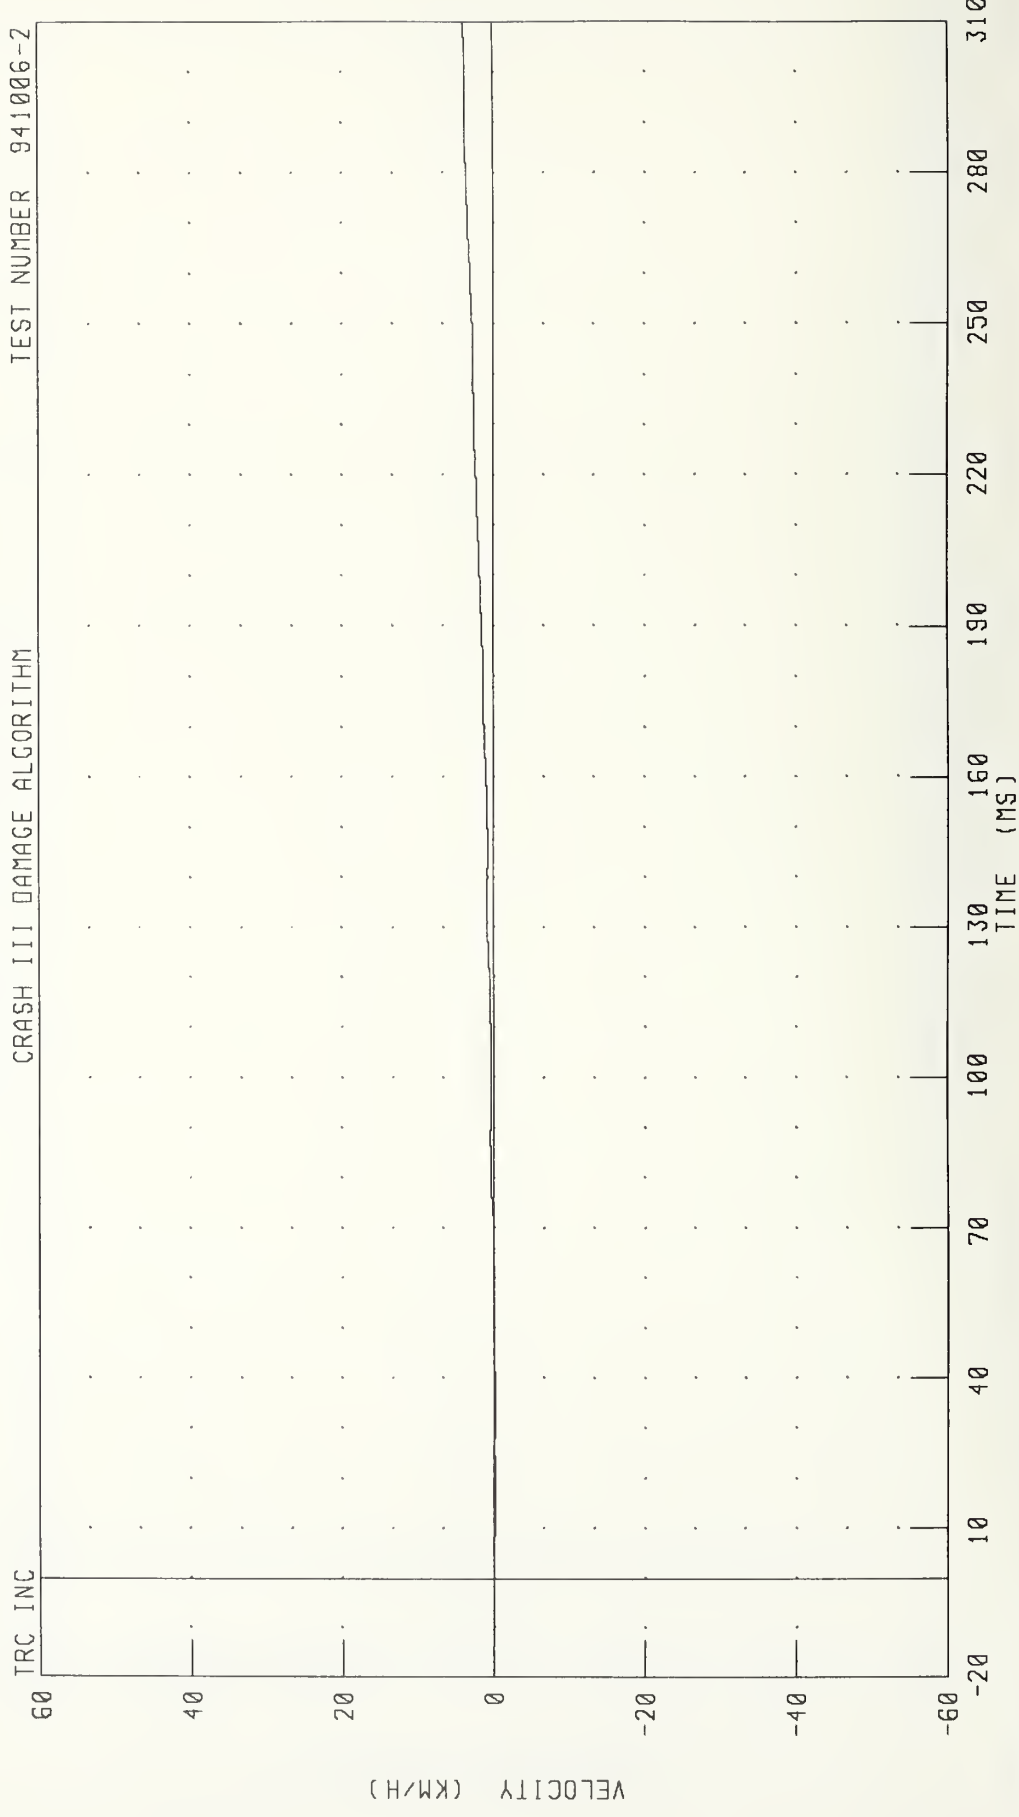
CHANNEL: LFSYV1 FILTER: CH. CLASS 180
 PEAK DATA: 3.85 KM/H @ 310.00 MS, -0.21 KM/H @ 32.96 MS

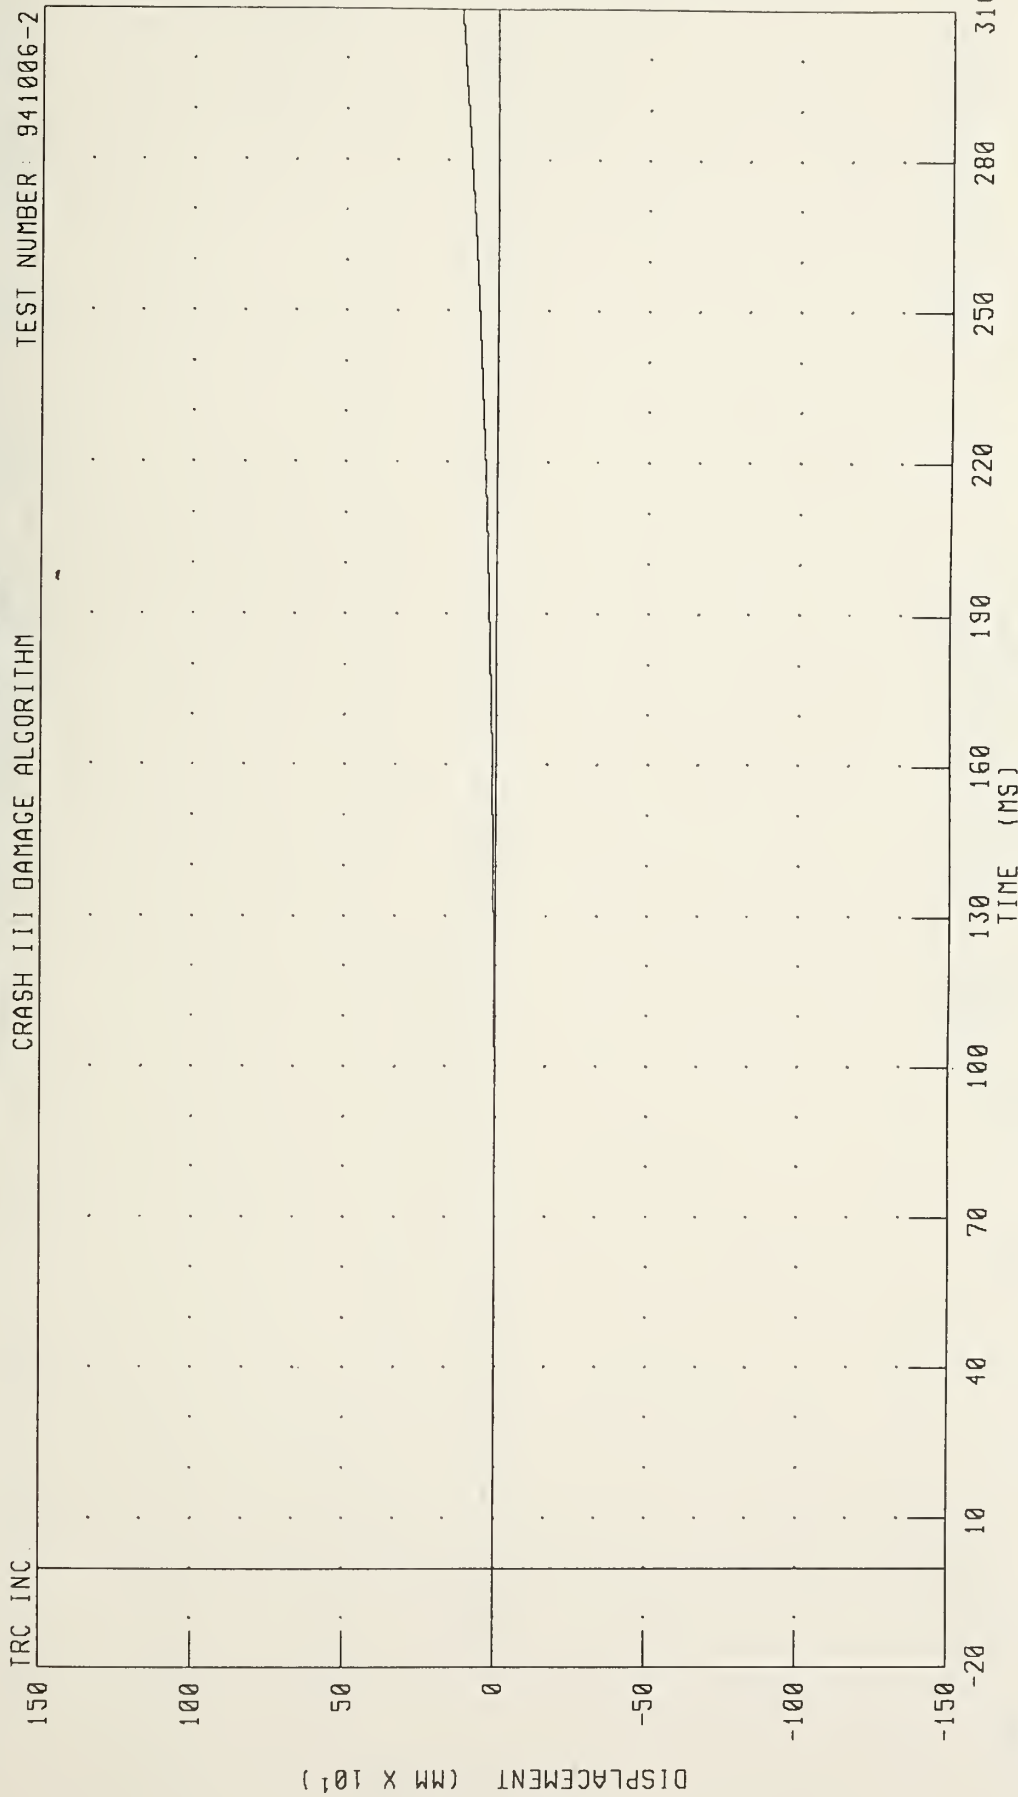
CHANNEL: LFSYD1 FILTER: CH. CLASS 180 PEAK DATA: 119.87 MM @ 310.00 MS, -1.12 MM @ 42.32 MS

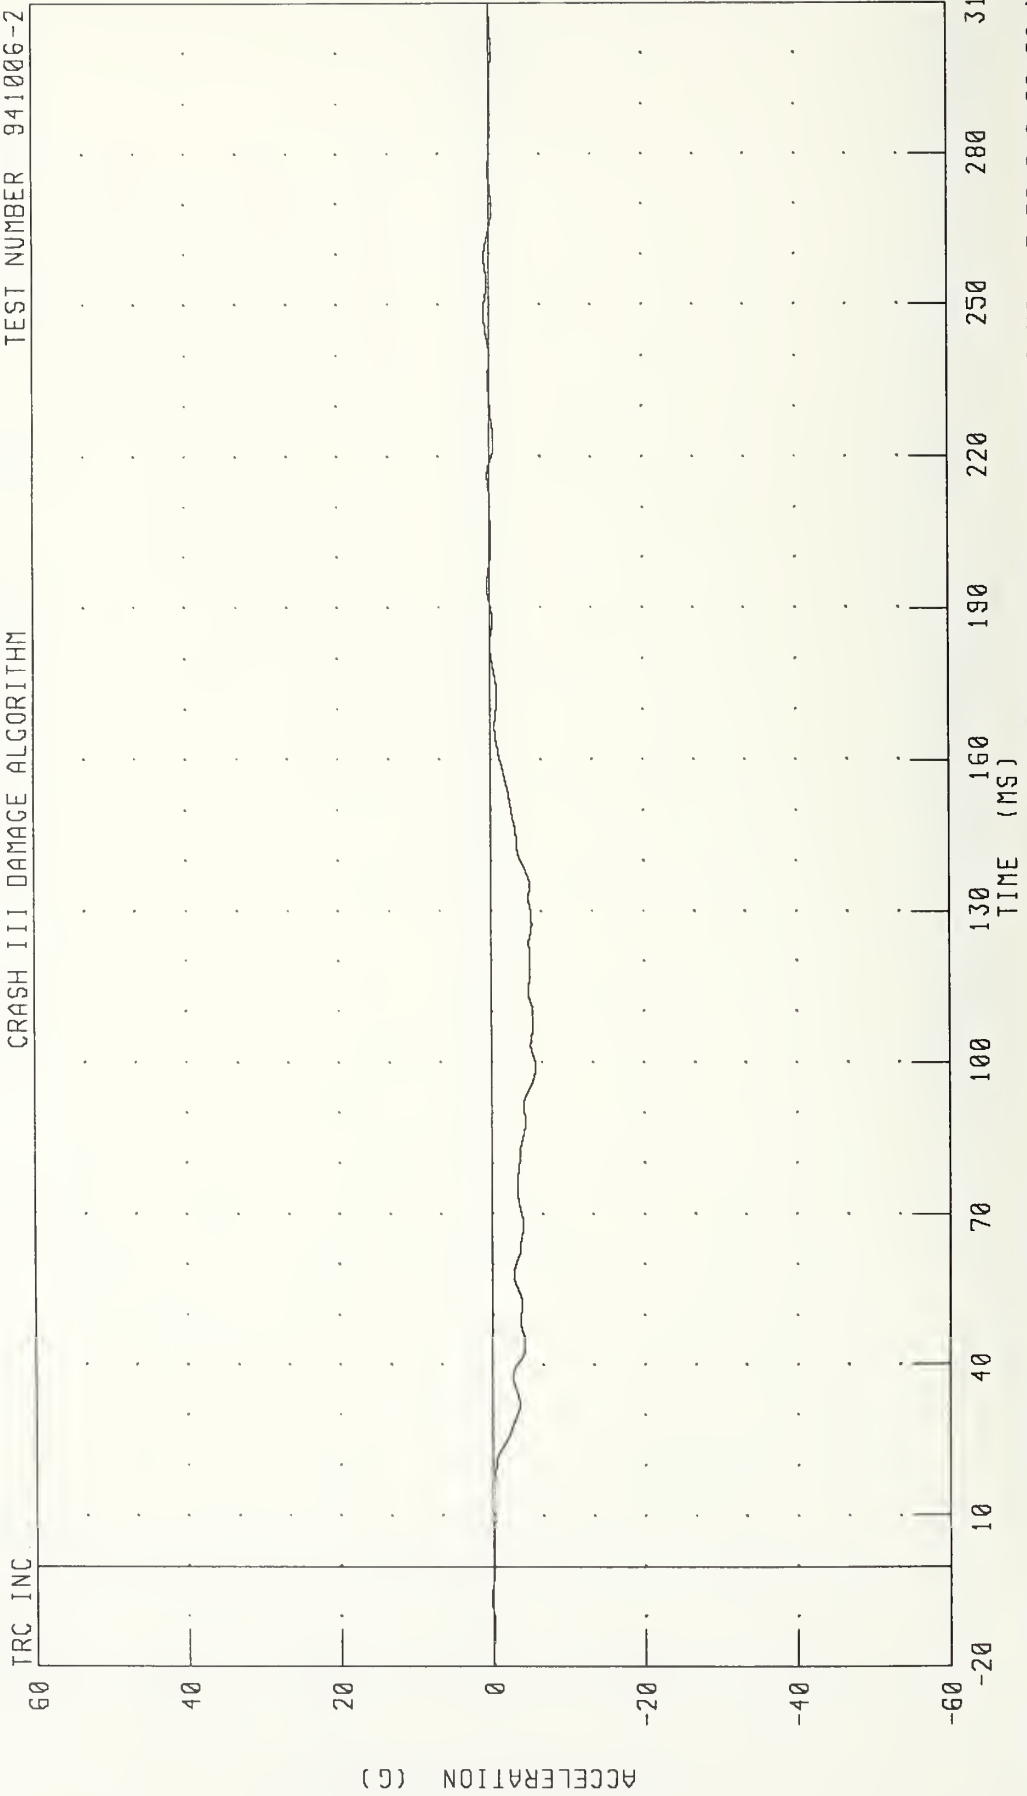
CHANNEL: RFSXG1 FILTER: CH. CLASS 60

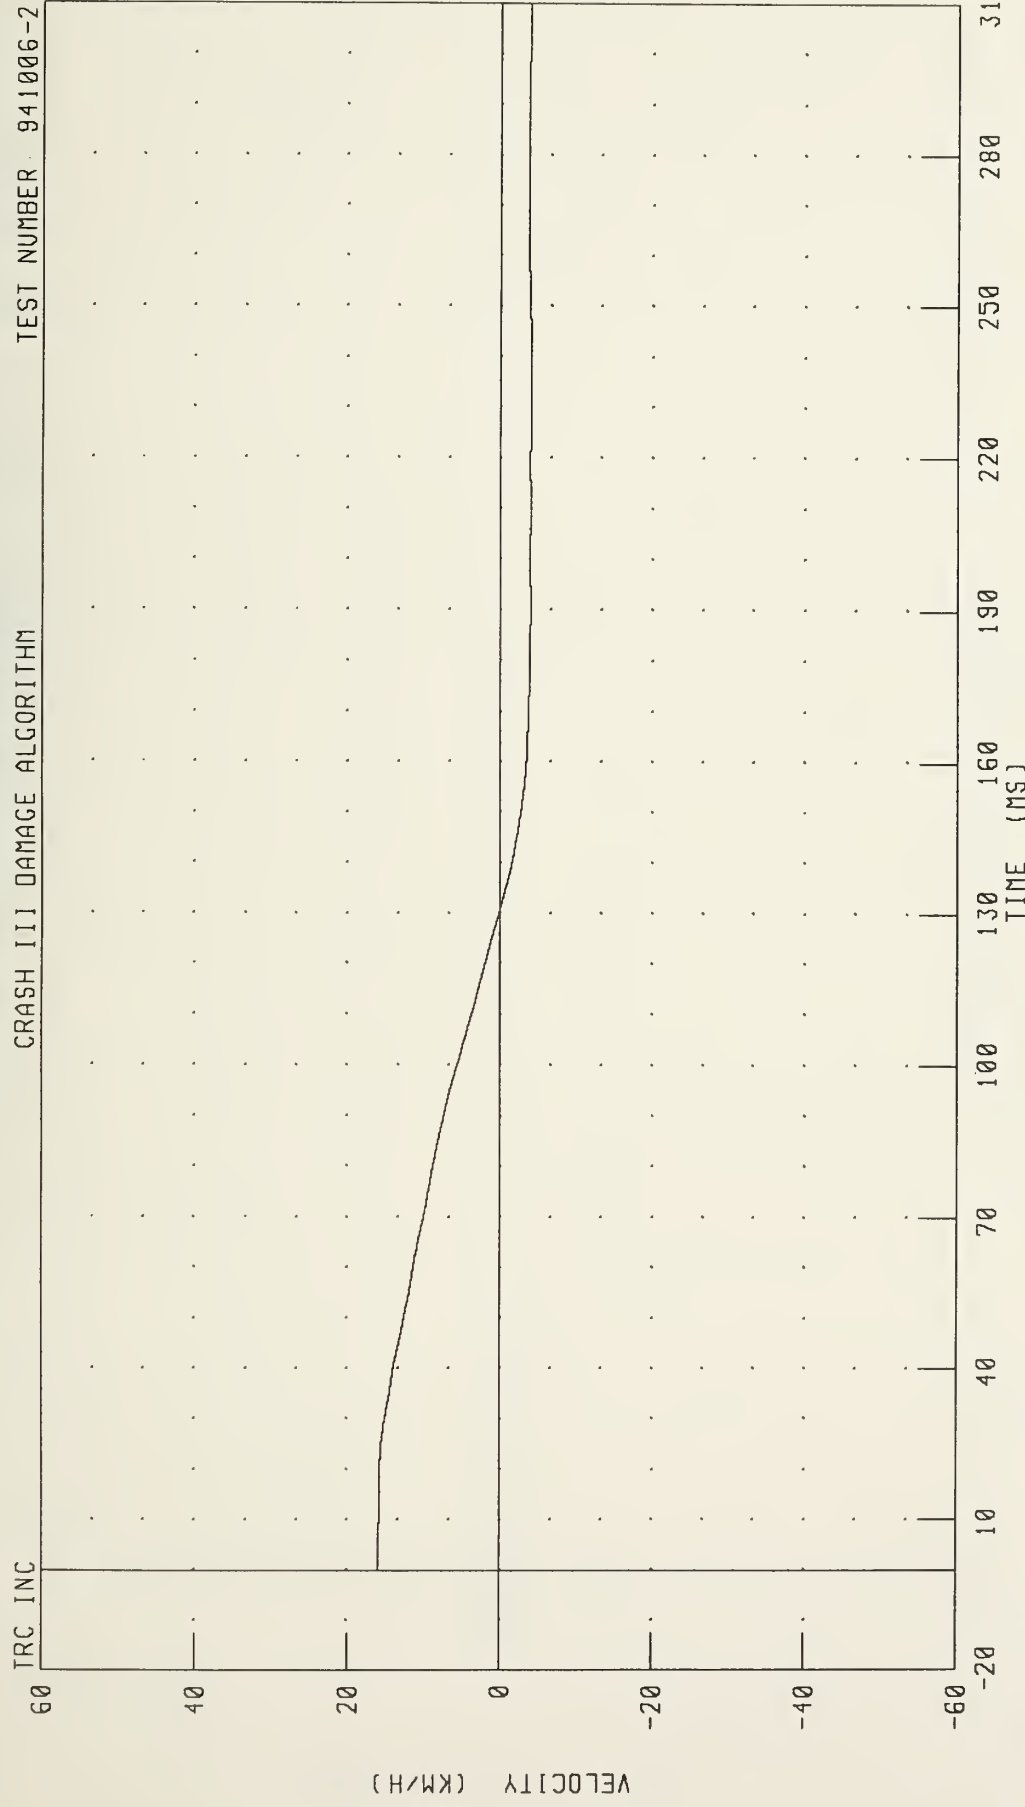
CHANNEL: RFSXV1 FILTER: CH. CLASS 180 PEAK DATA: 15.90 KM/H @ 0.00 MS; -4.08 KM/H @ 232.96 MS

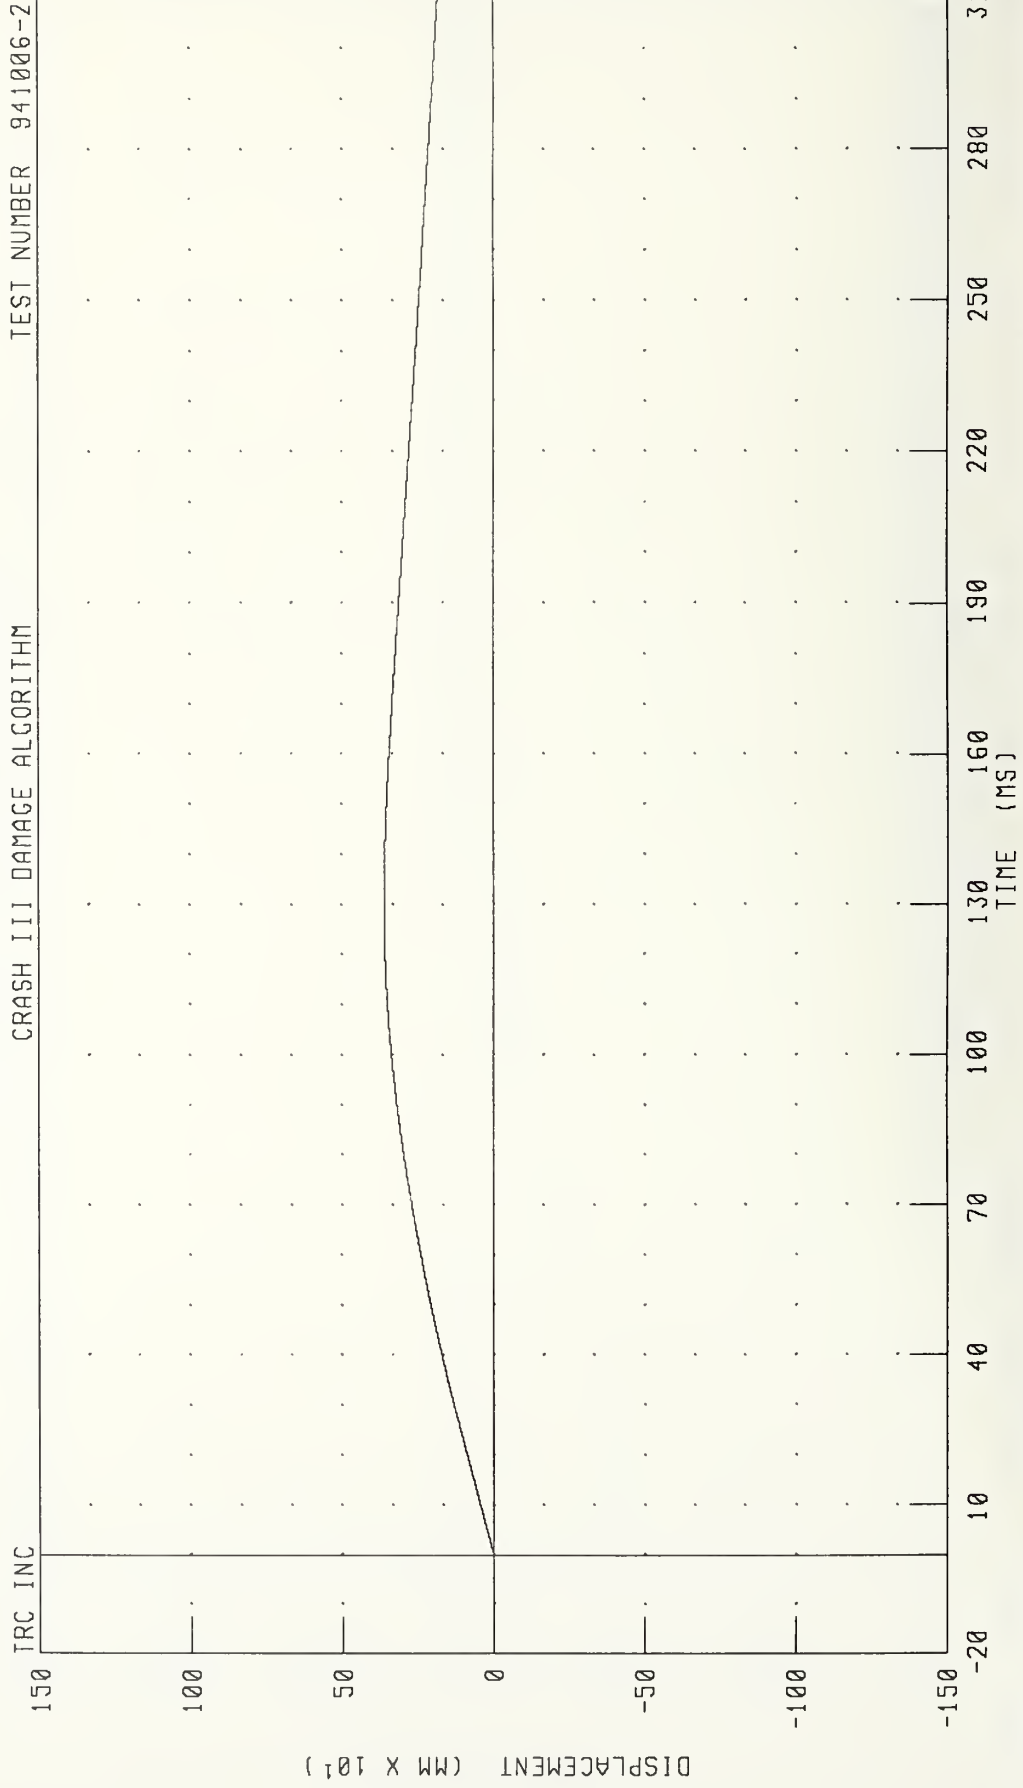
CHANNEL: RFSXD1 FILTER: CH. CLASS 180

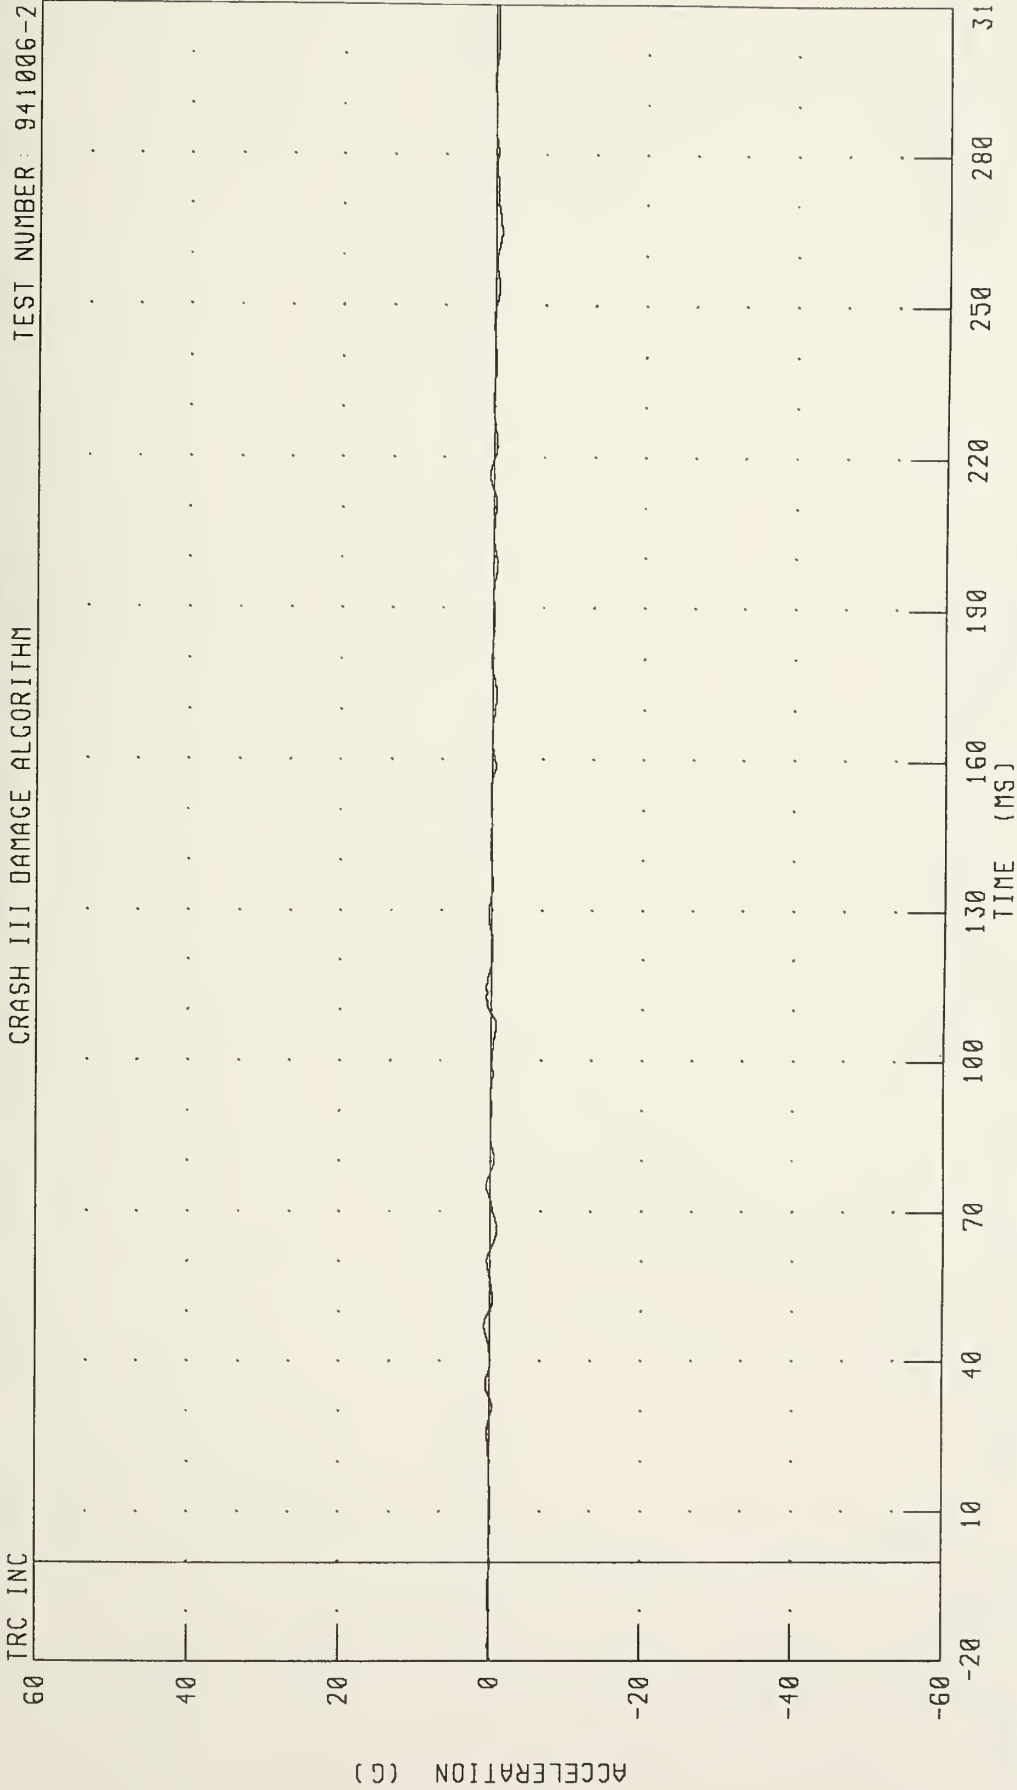
CHANNEL: RFSYGI FILTER: CH. CLASS 60

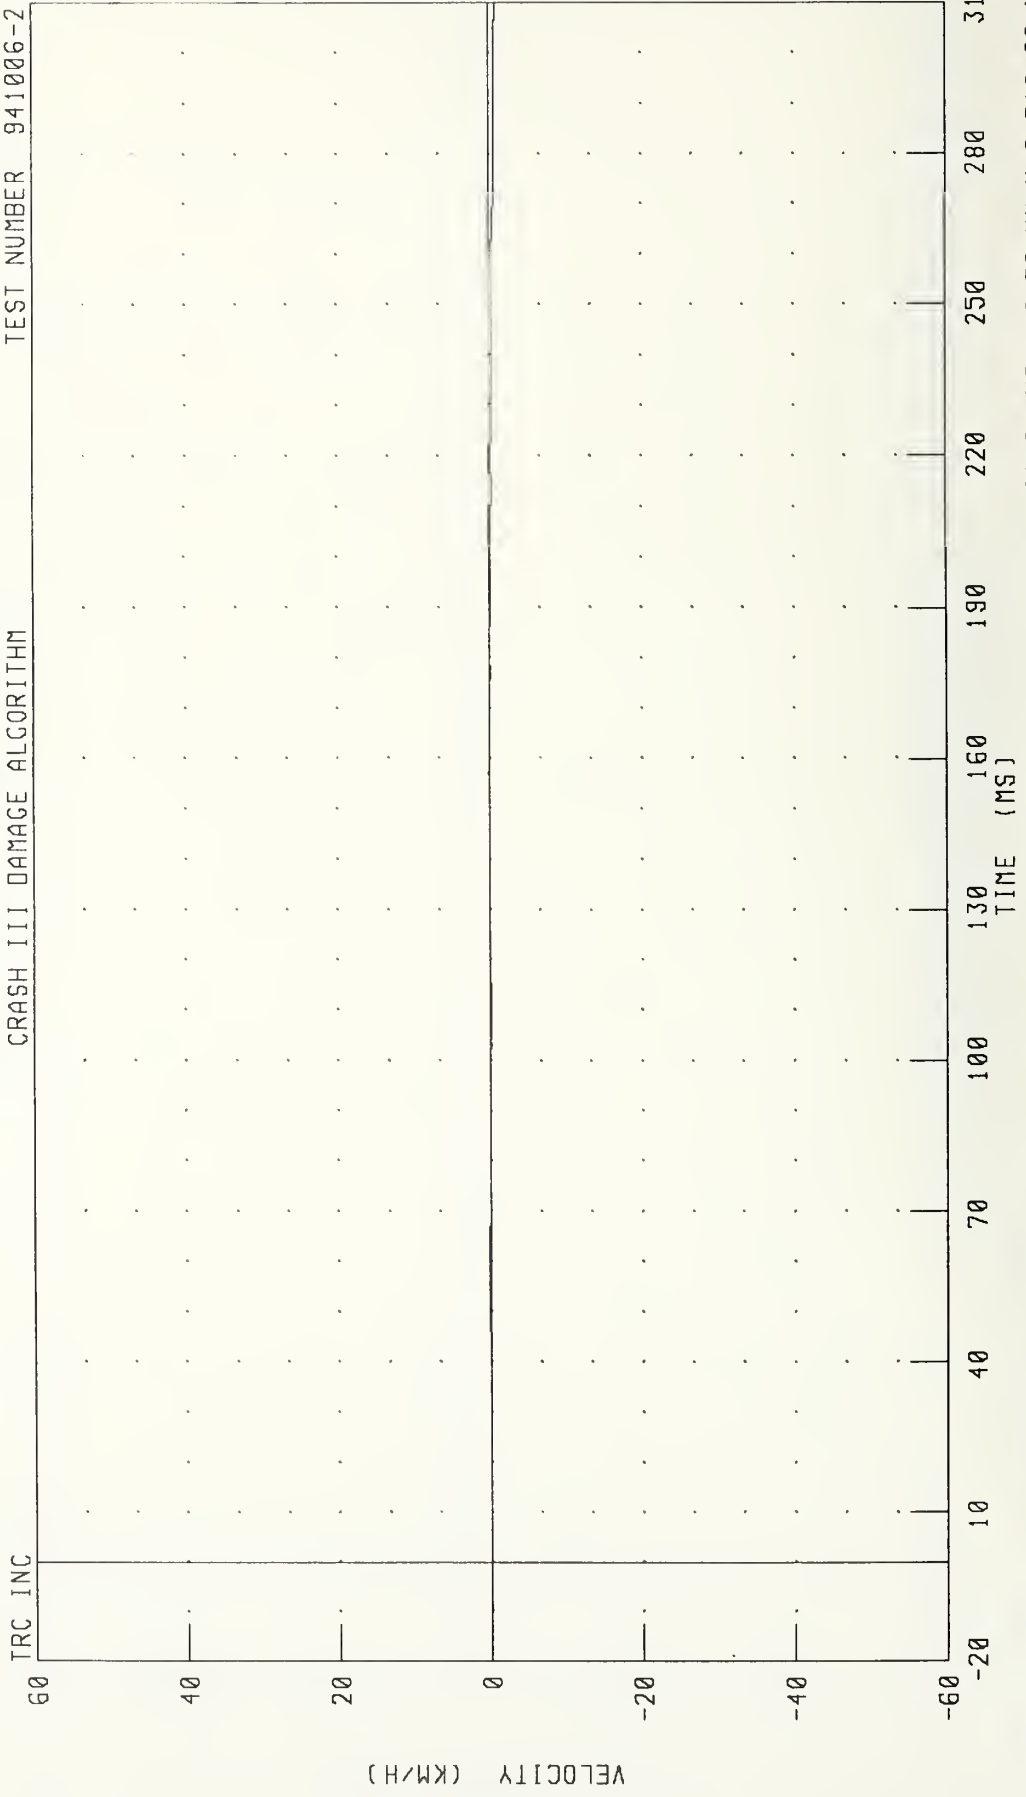
1992 CHEVROLET CAPRICE INTO 305 MM POLE
RIGHT FRONT SILL Y-AXIS DISPLACEMENT
CRASH III DAMAGE ALGORITHM

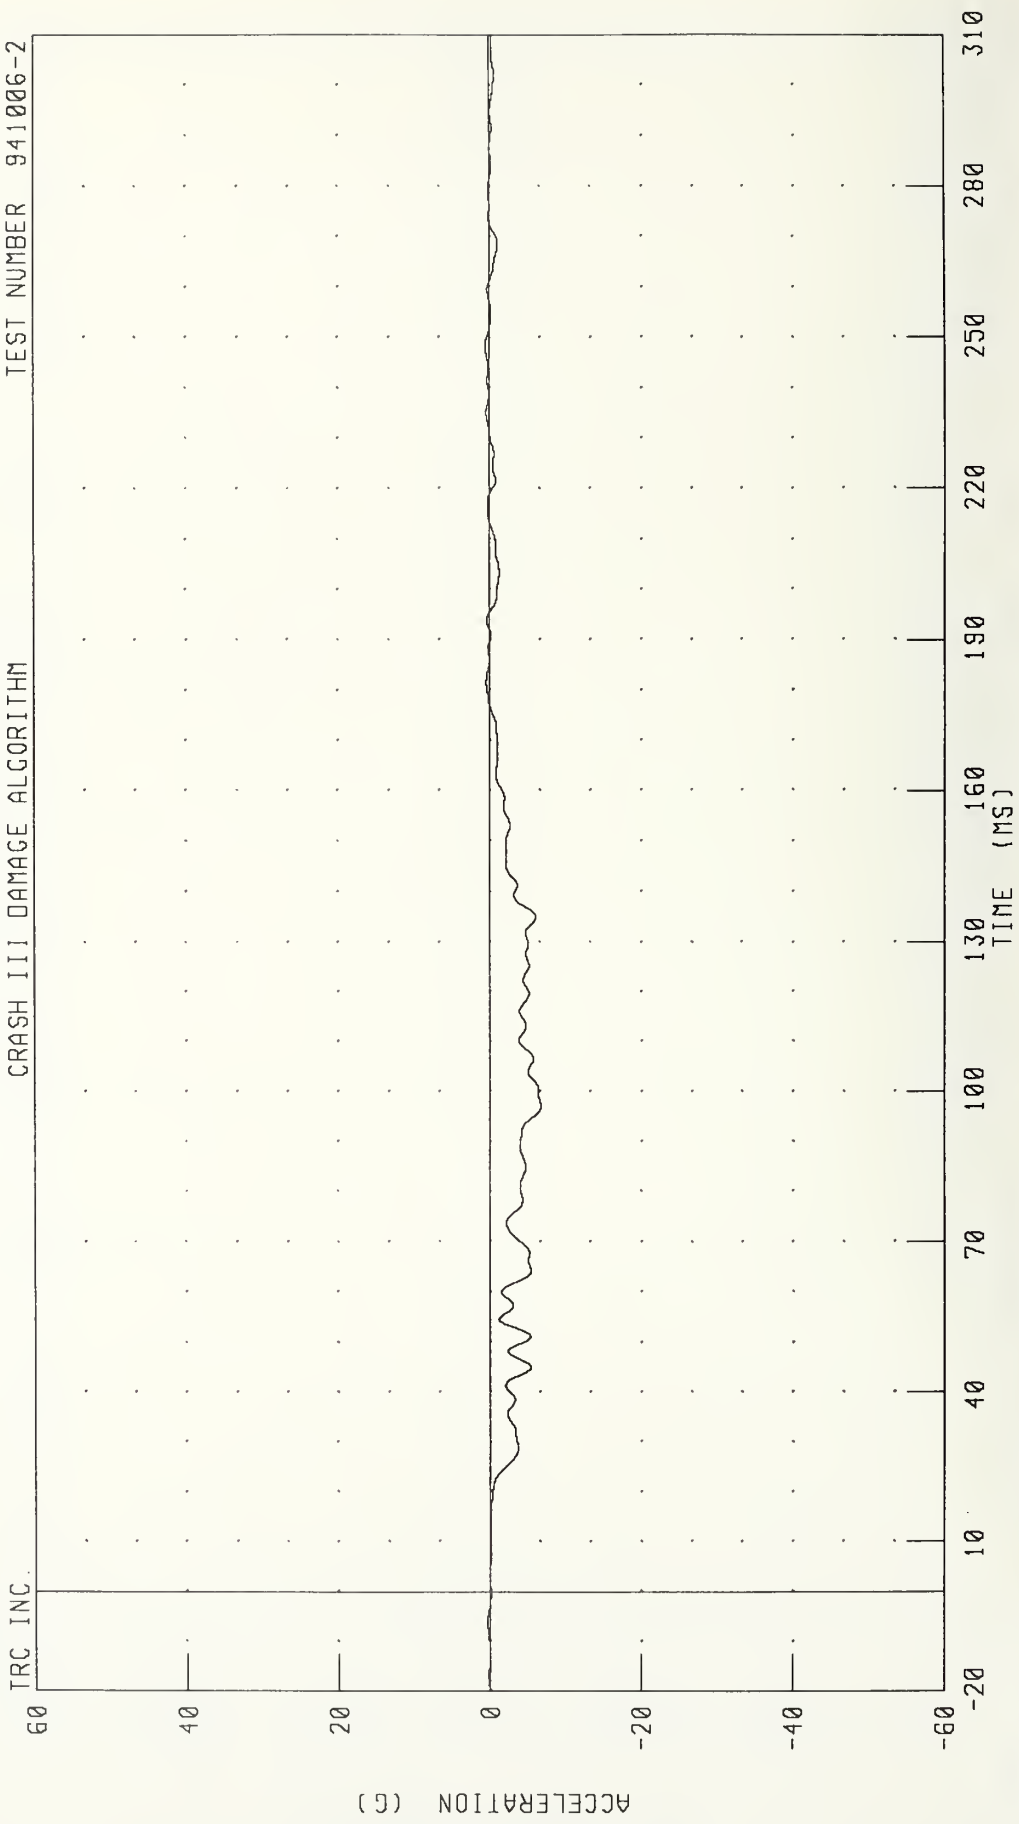
CHANNEL: TLRXG1 FILTER: CH. CLASS 60

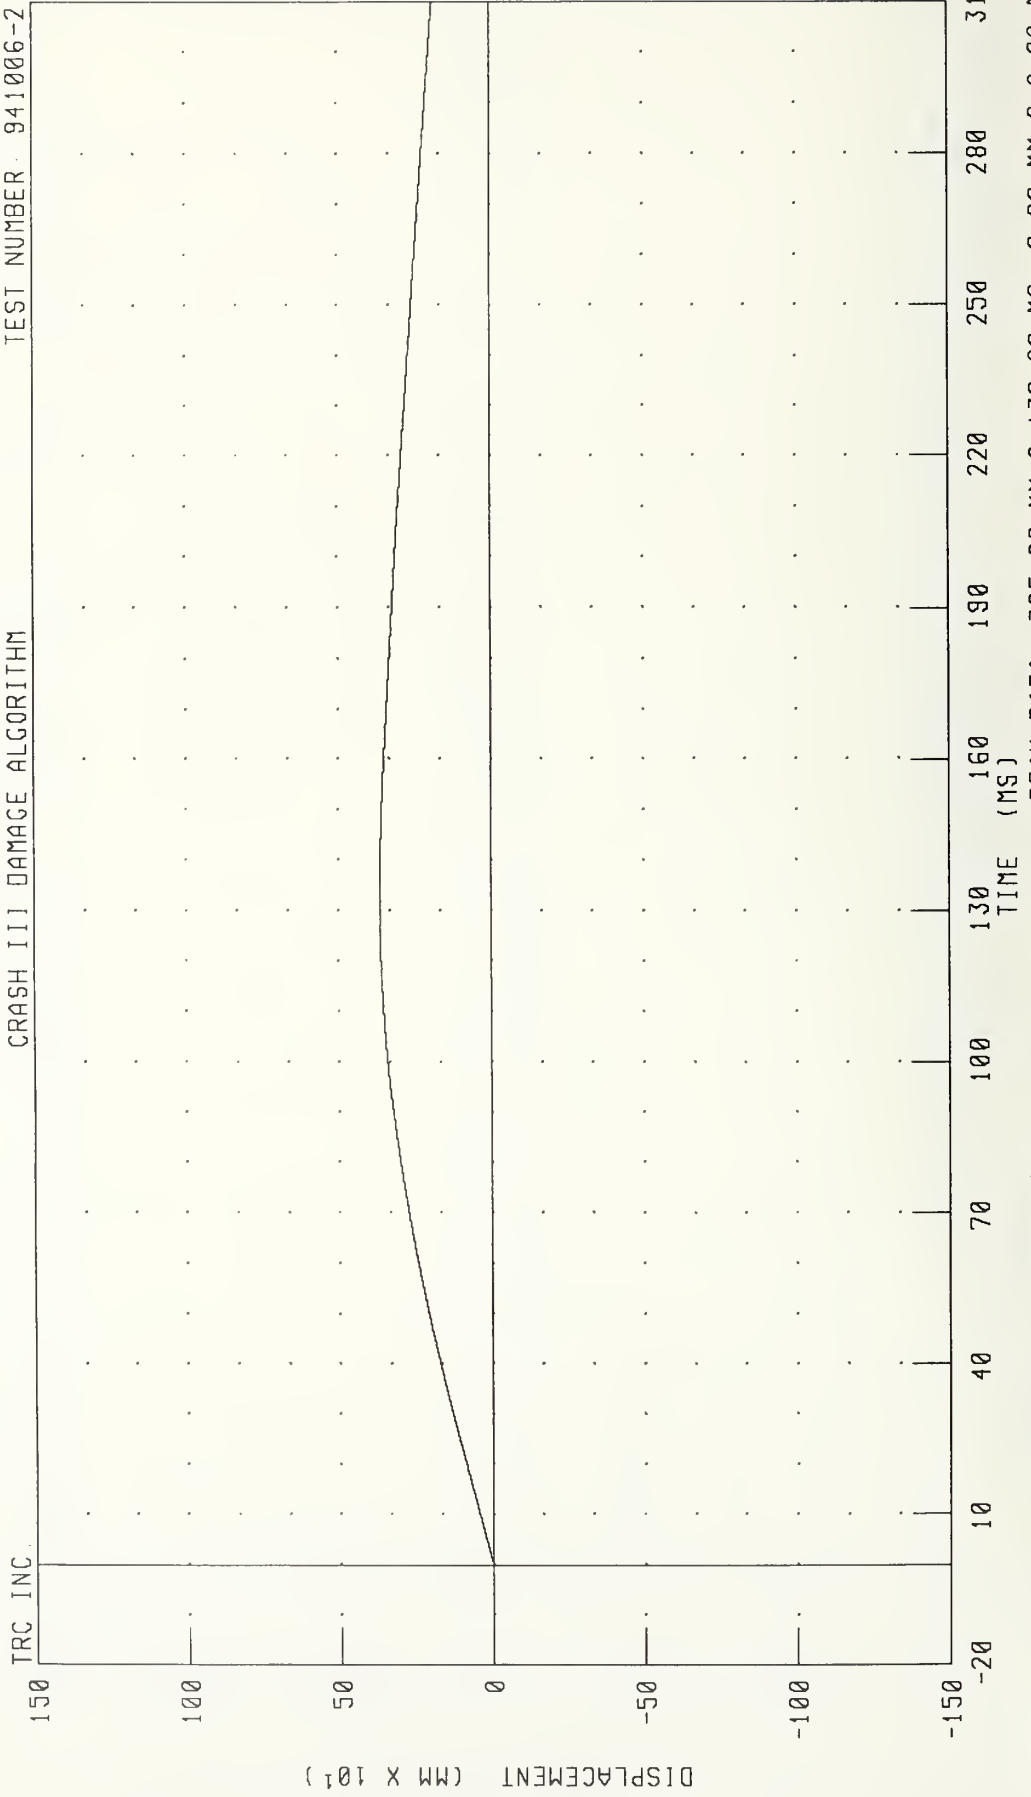
CHANNEL: TLRXD1 FILTER: CH. CLASS 180

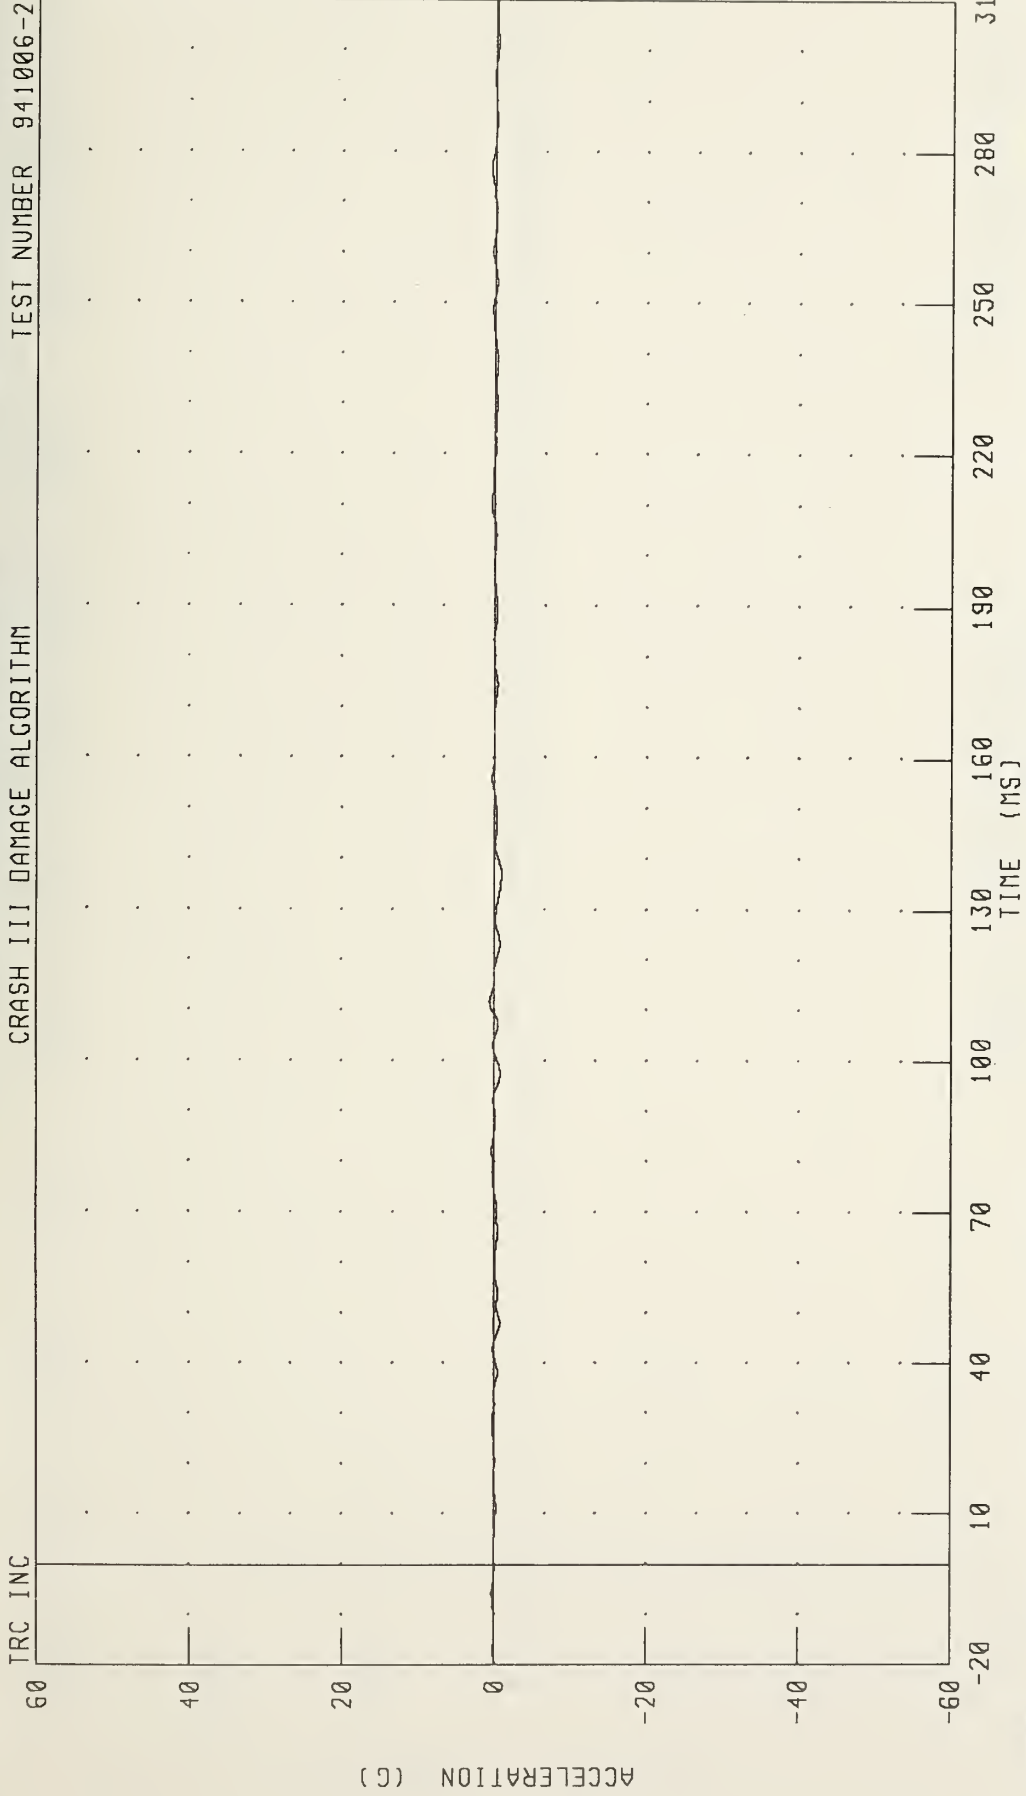
CHANNEL: TLRYG1 FILTER: CH. CLASS 60 PEAK DATA: 0.61 G @ 111.76 MS, -1.07 G @ 137.12 MS

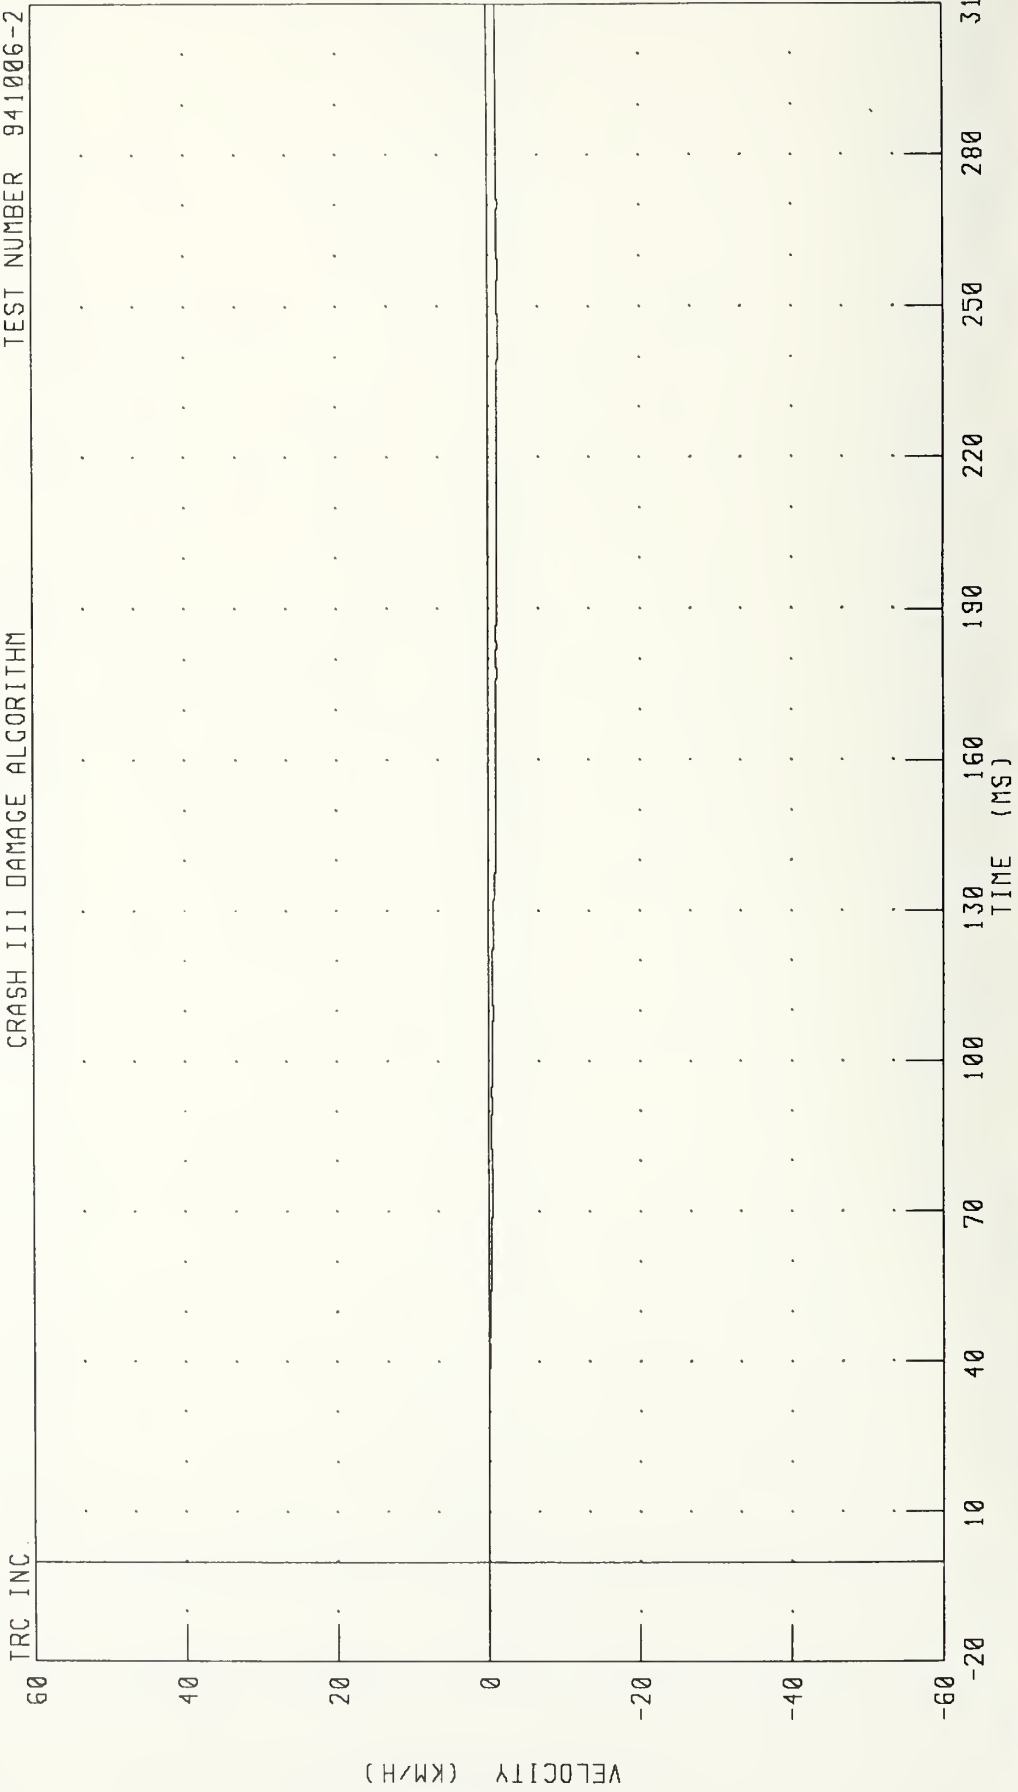
CHANNEL: TLRYV1 FILTER: CH. CLASS 180
