U.S. Department
of Transportation

**National Highway
Traffic Safety
Administration**

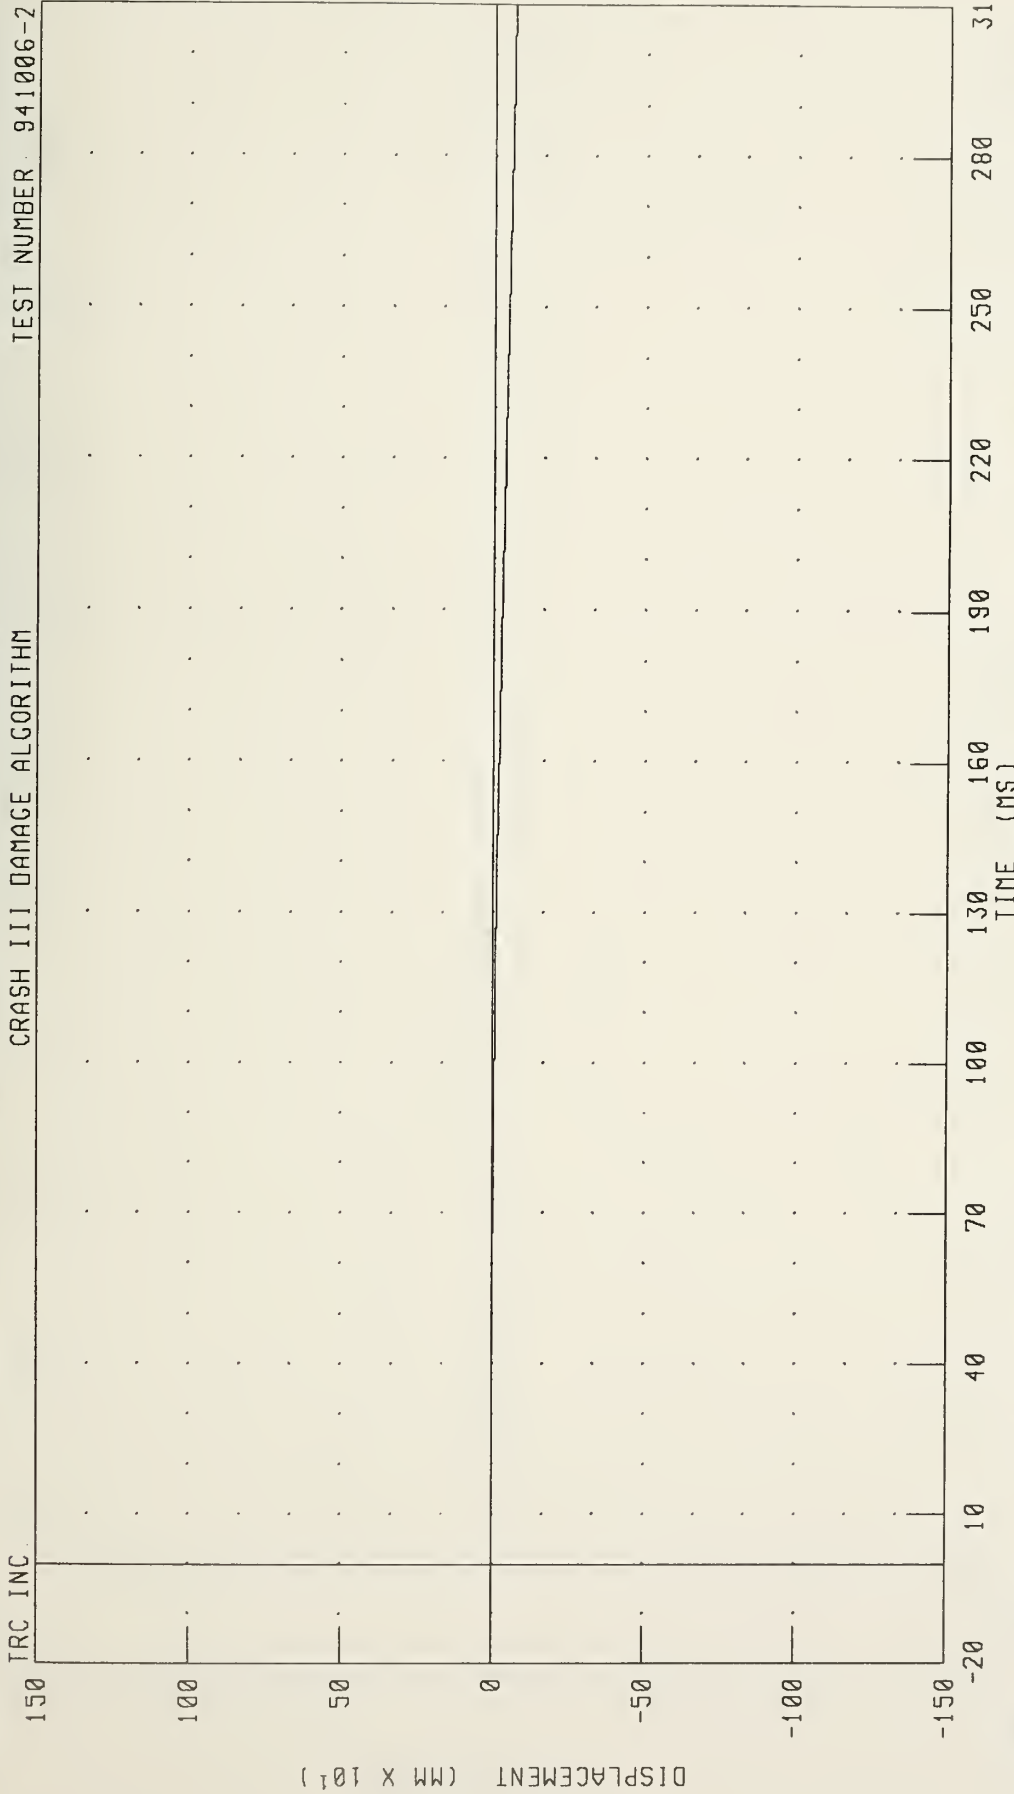
CHANNEL: TLRYD1 FILTER: CH CLASS 180 PEAK DATA: 0.01 MM @ 6.40 MS; -67.44 MM @ 310.00 MS

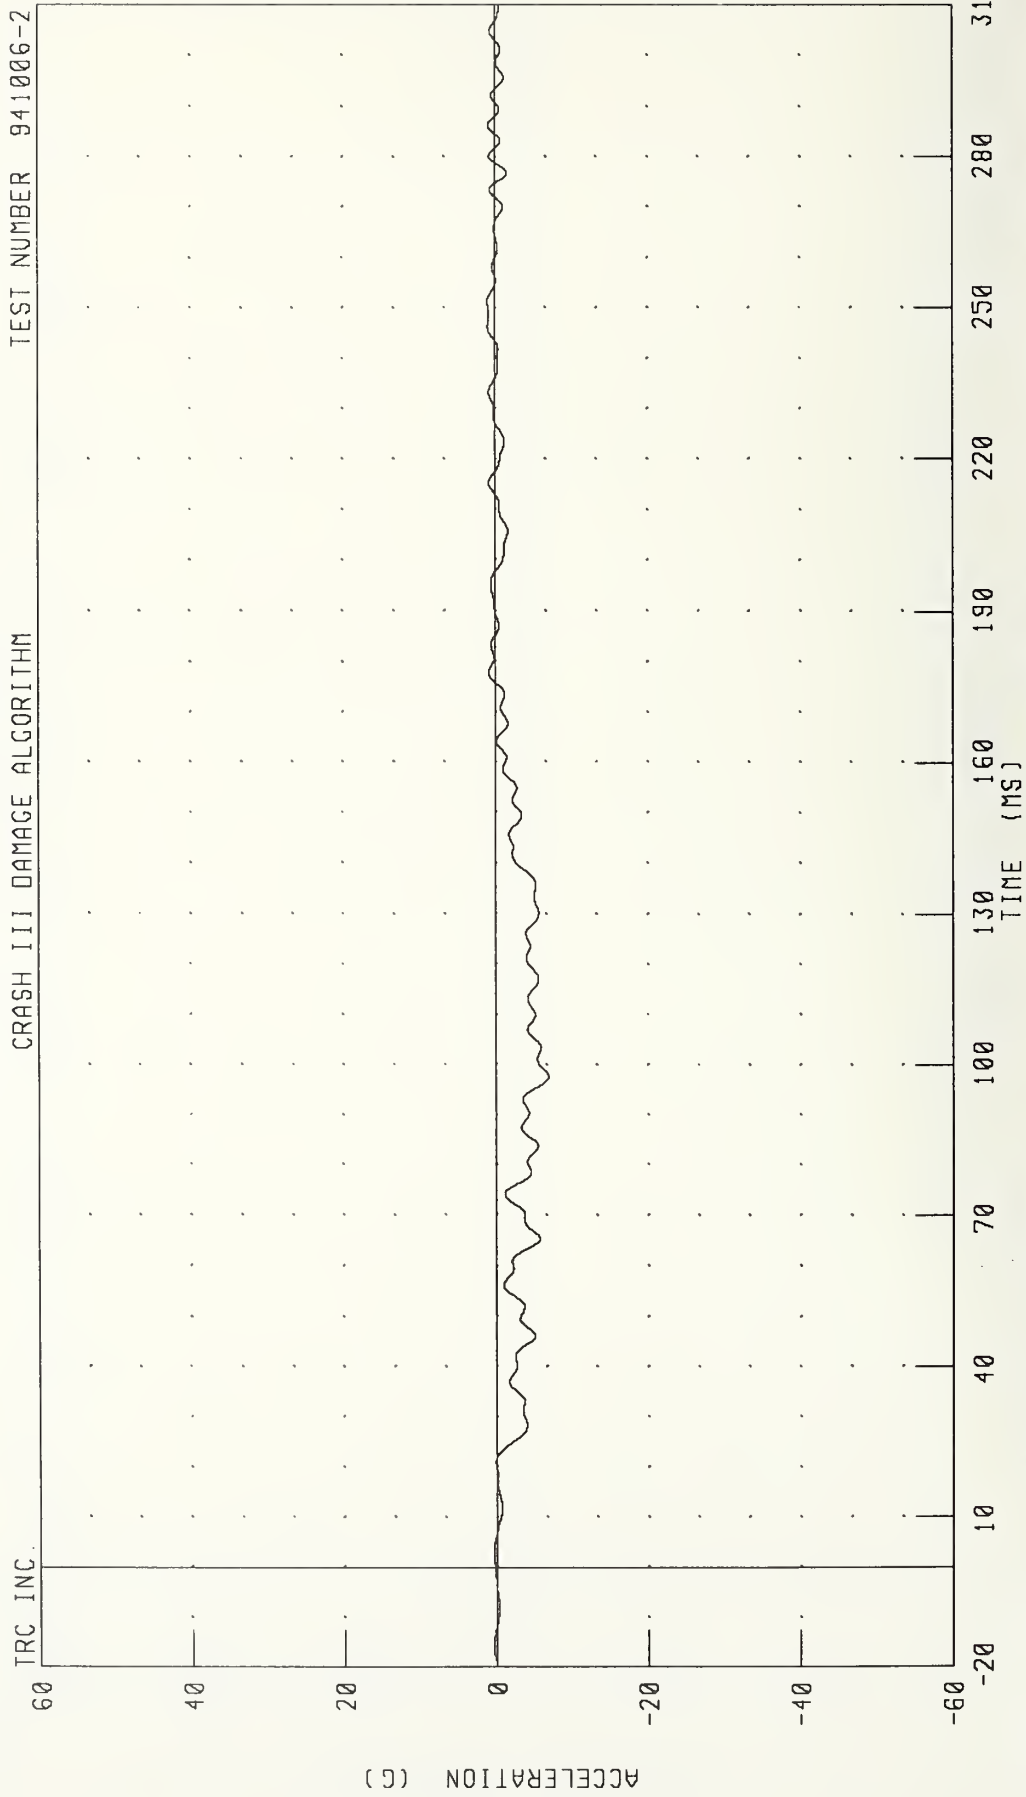
CHANNEL: TRRXG1 FILTER: CH. CLASS 60

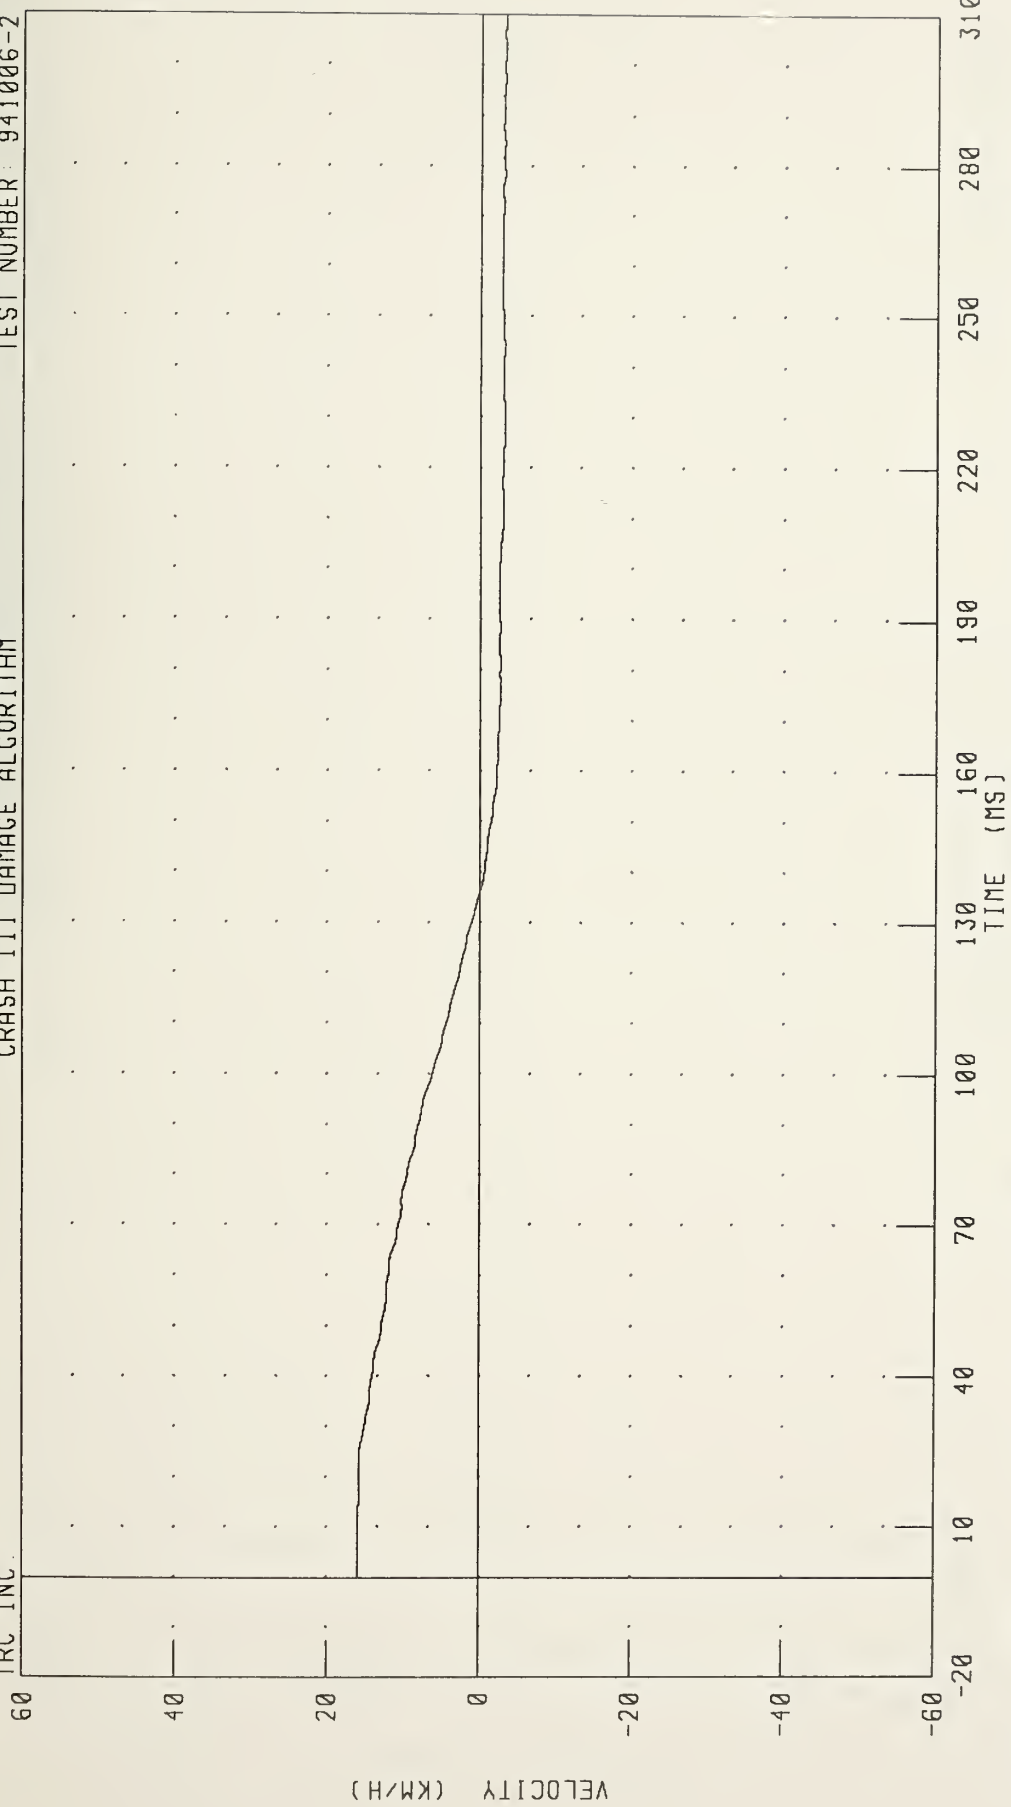
CHANNEL: TRRXV1 FILTER: CH. CLASS 180

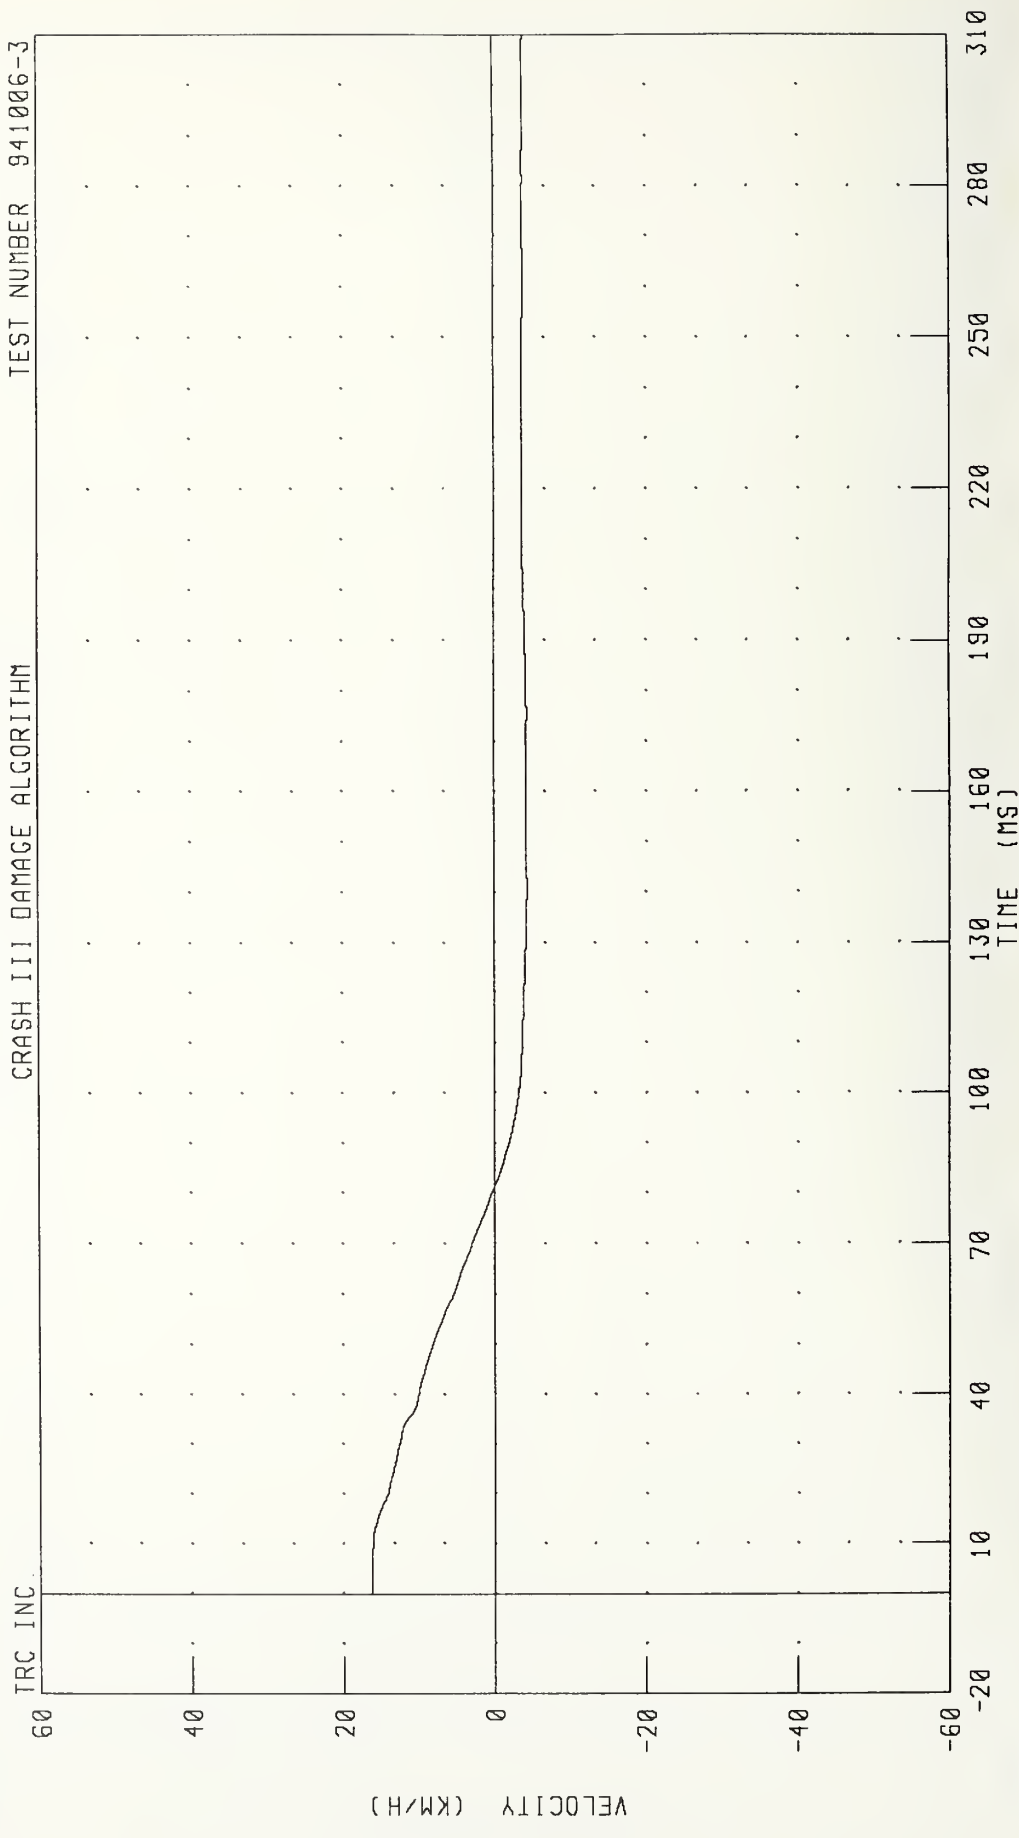
CHANNEL: RFSXV1 FILTER: CH. CLASS 180 PEAK DATA: 16.33 KM/H @ 0.56 MS; -4.33 KM/H @ 140.32 MS

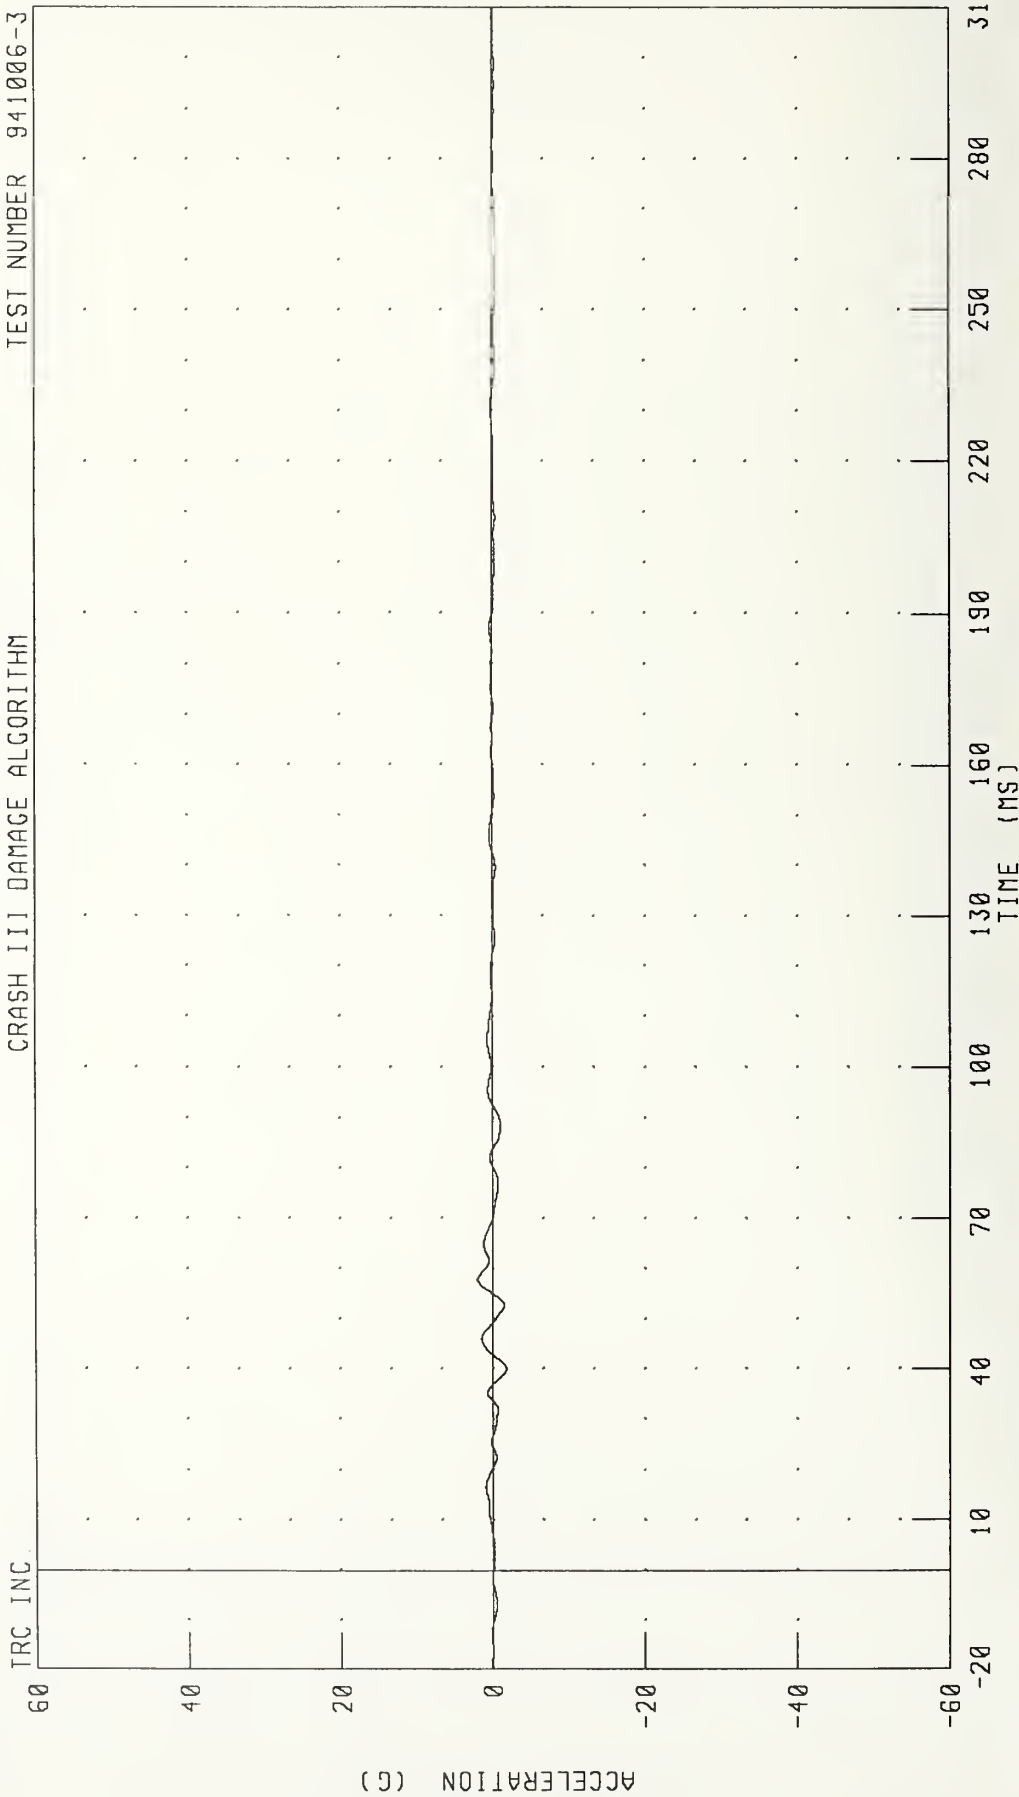
TRC INC
CHANNEL: RFSYG1 FILTER: CH. CLASS 60

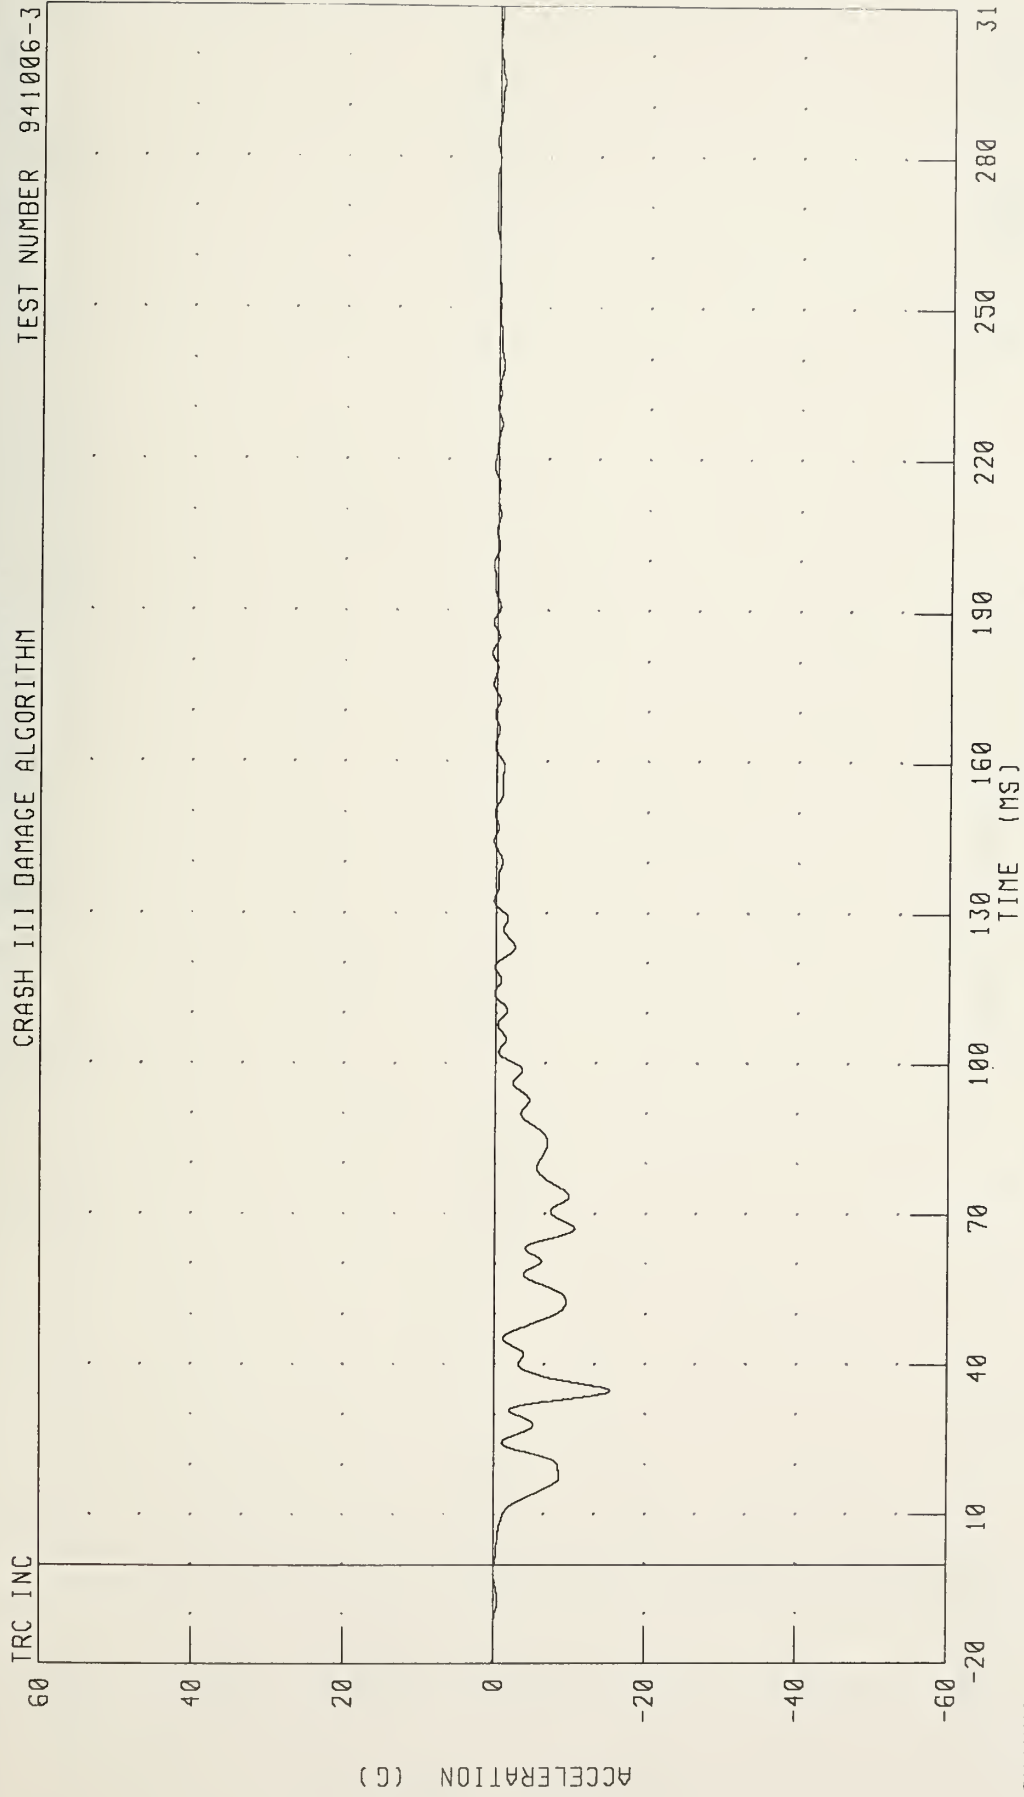
CHANNEL: TLRXG1 FILTER: CH. CLASS 60

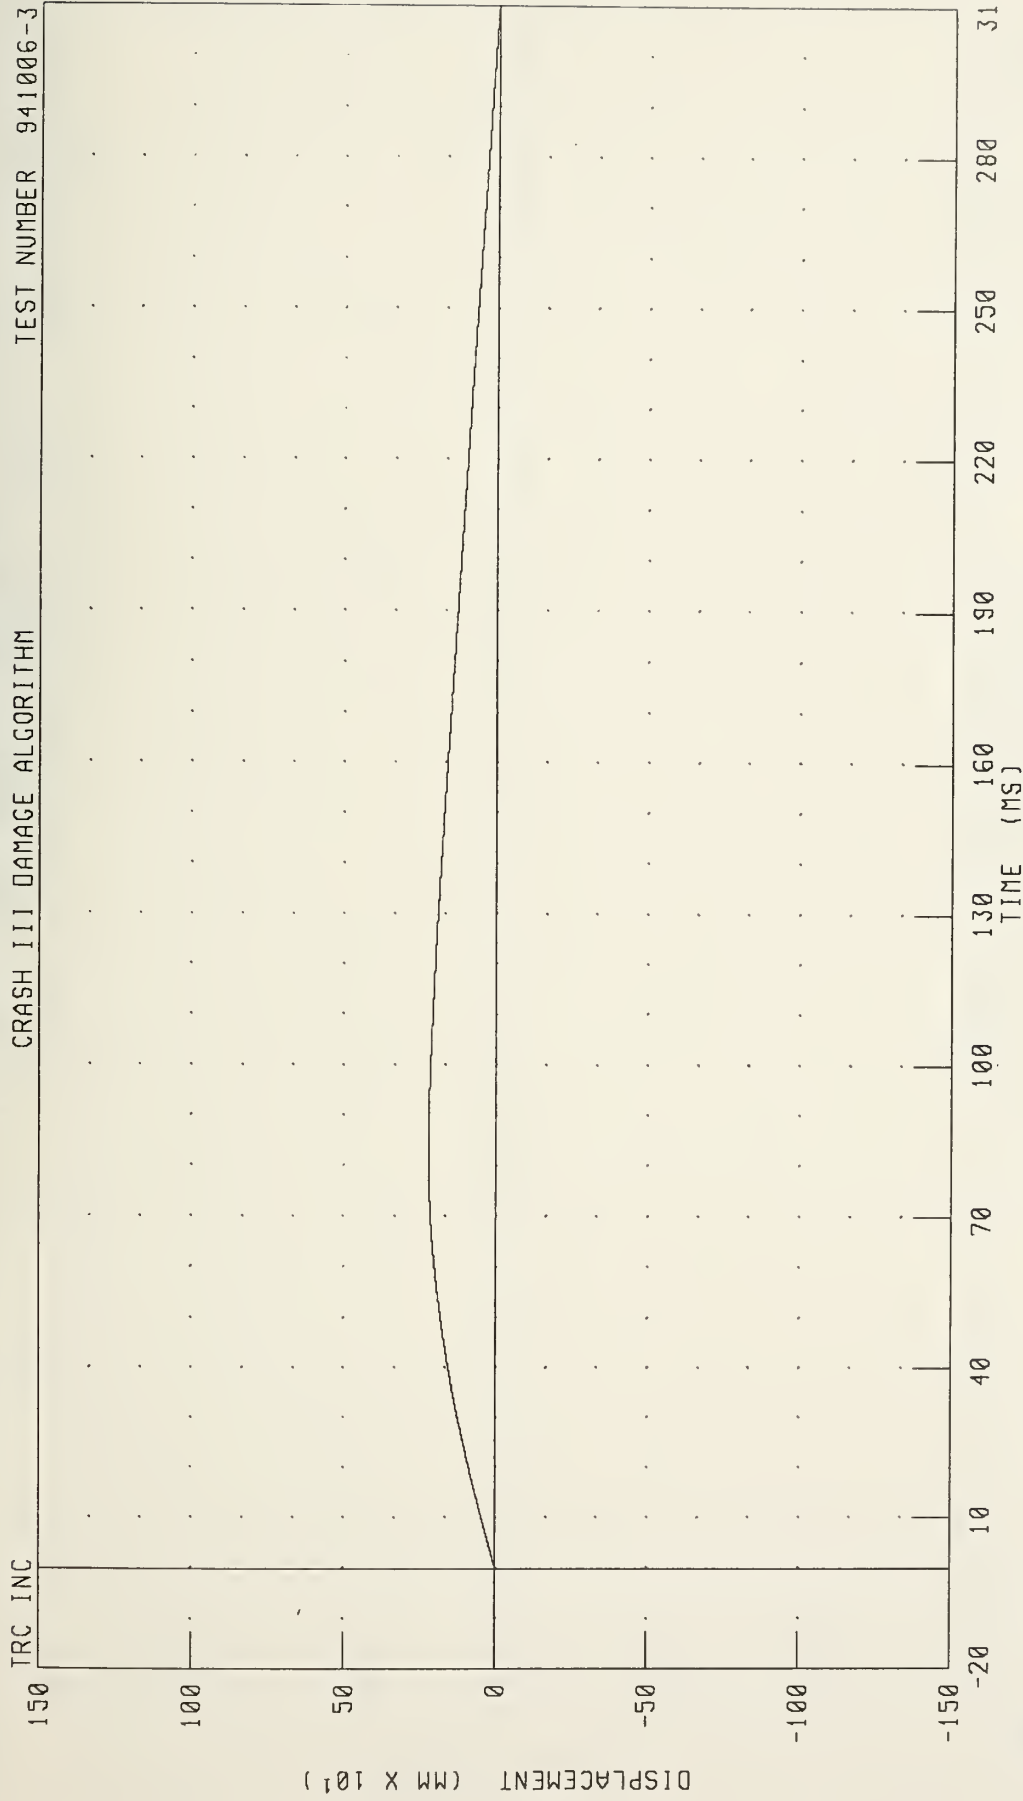
CHANNEL: TLRXD1 FILTER: CH. CLASS 180

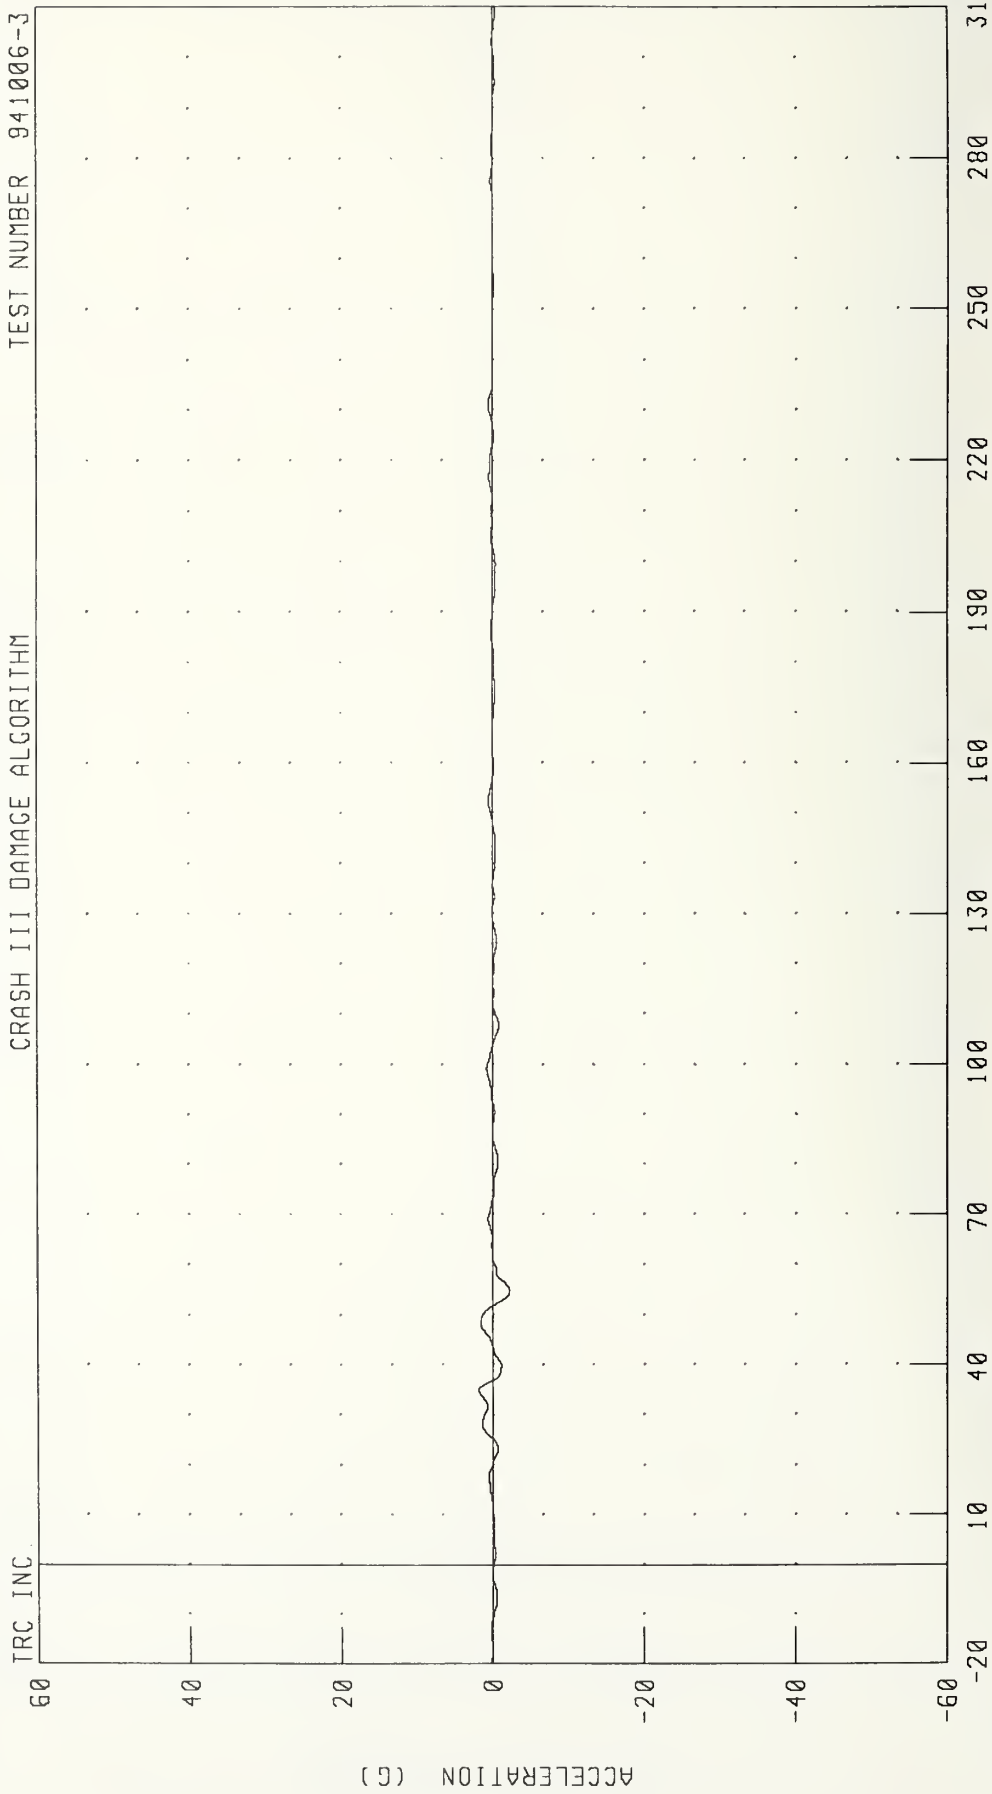
CHANNEL: TLRYG1 FILTER: CH CLASS 60 PEAK DATA: 1.88 G @ 34.96 MS, -2.27 G @ 54.56 MS

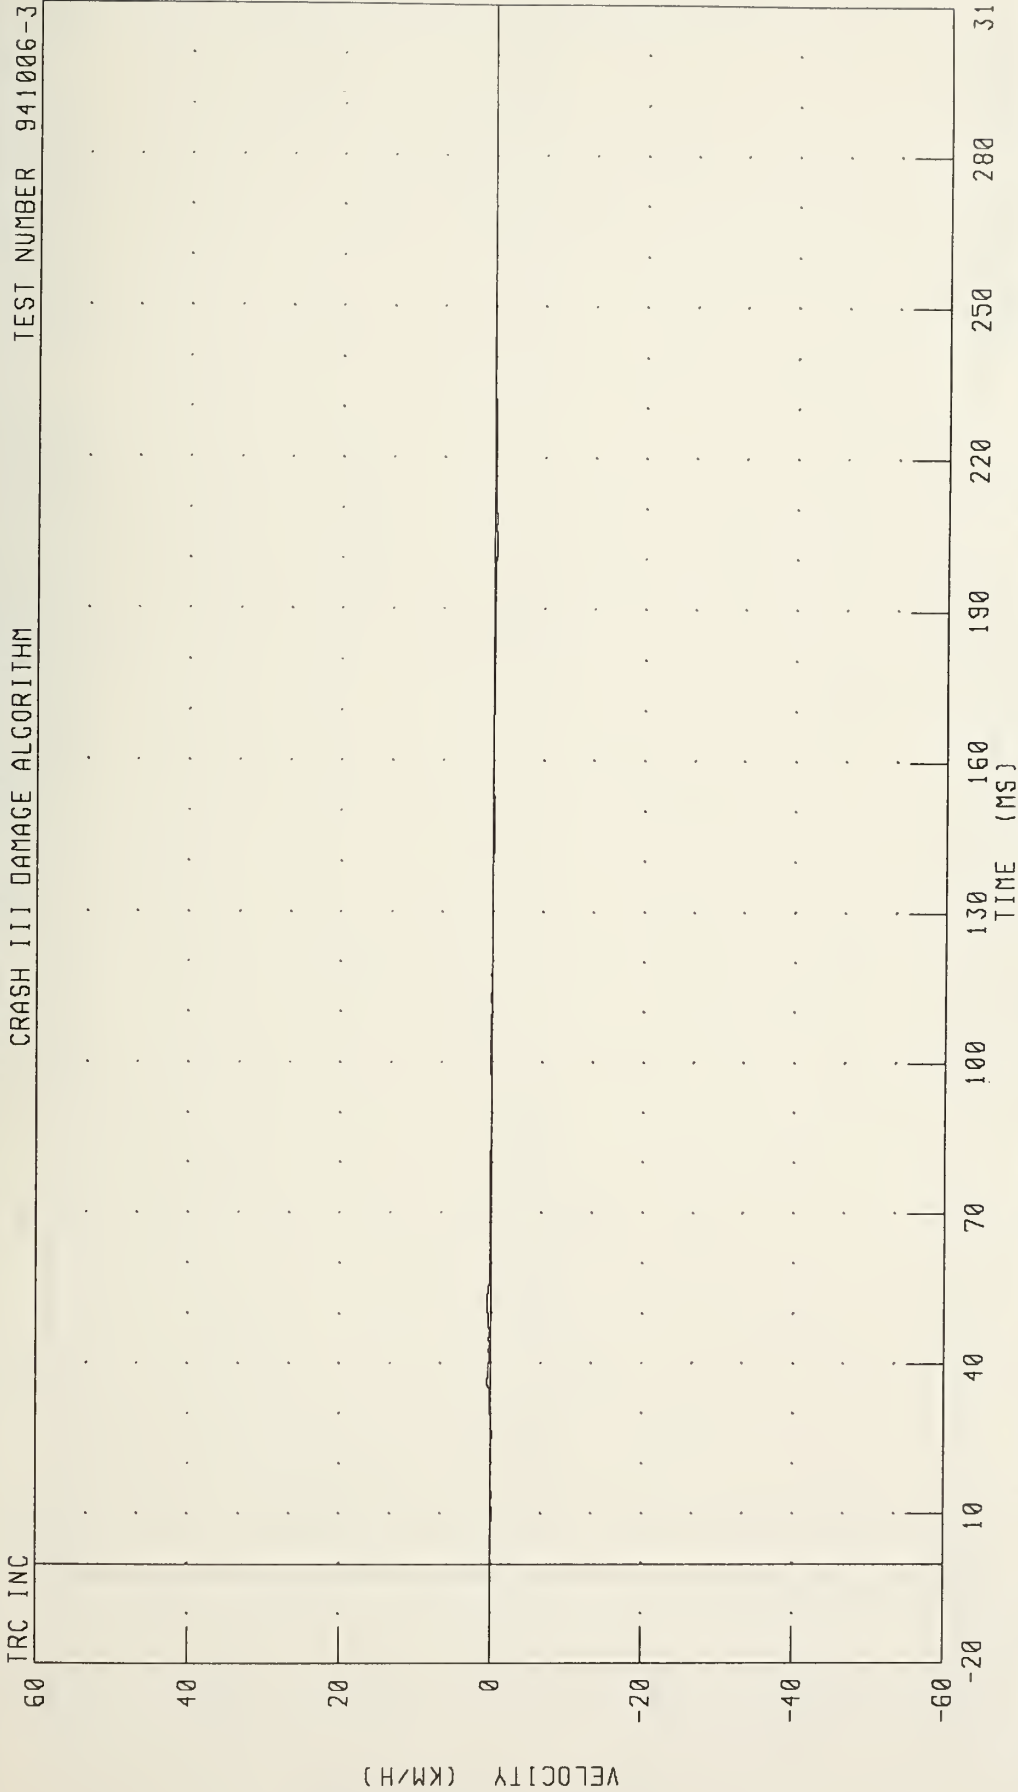
CHANNEL: TLRYV1 FILTER: CH CLASS 180 PEAK DATA: 0 54 KM/H @ 52 56 MS; -0 28 KM/H @ 202 40 MS

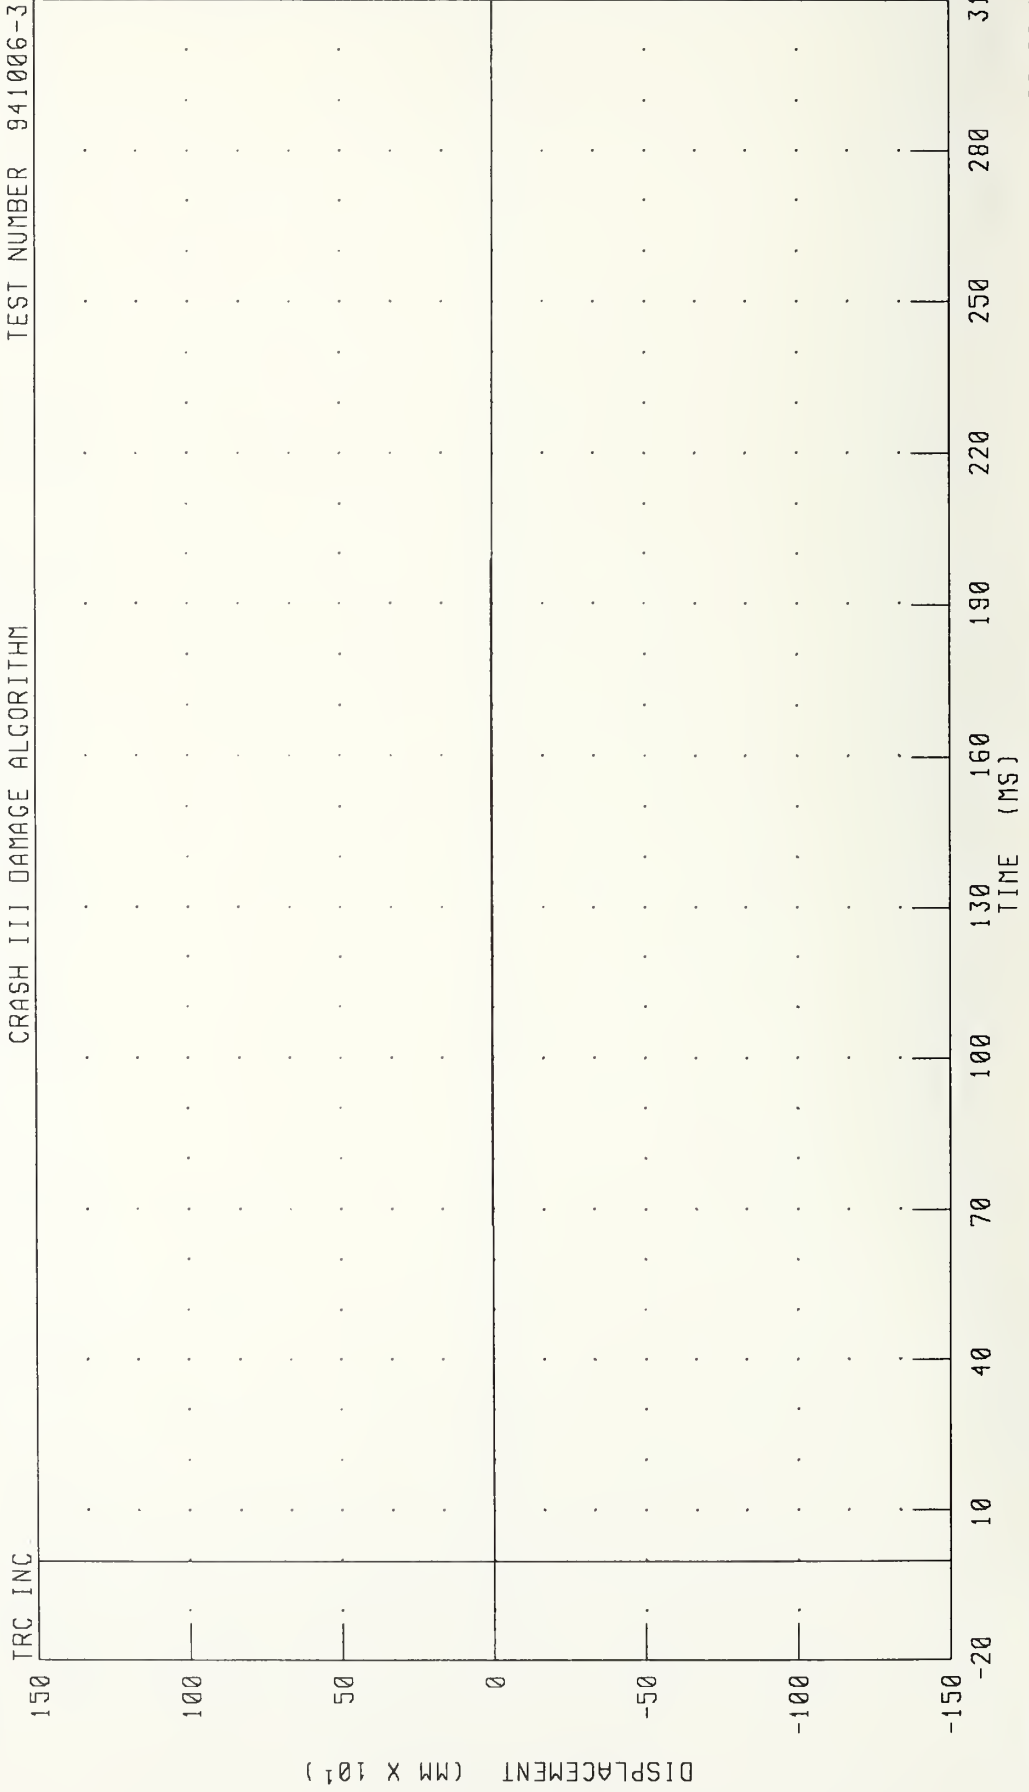
CHANNEL: TLRYD1 FILTER: CH. CLASS 180 PEAK DATA: 4.50 MM @ 126.16 MS; -0.34 MM @ 27.28 MS

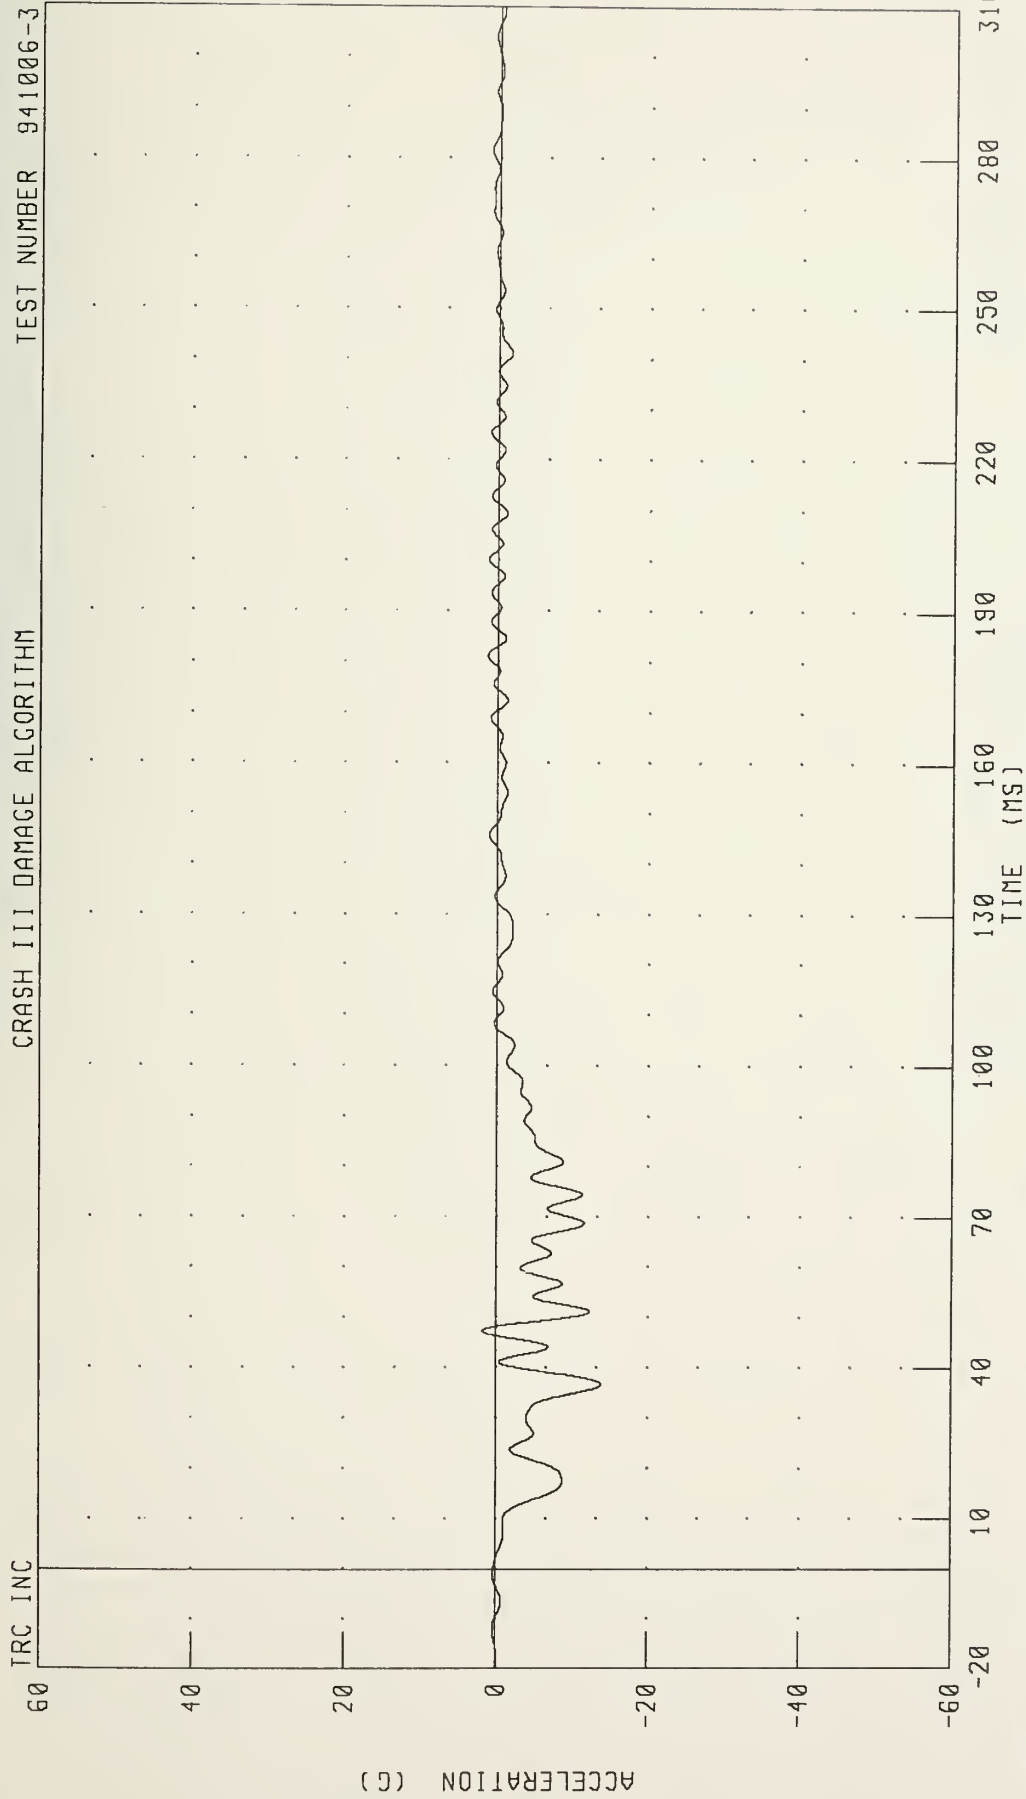
1992 CHEVROLET CAPRICE INTO 305 MM POLE
RIGHT REAR SEAT X-AXIS VELOCITY
CRASH III DAMAGE ALGORITHM

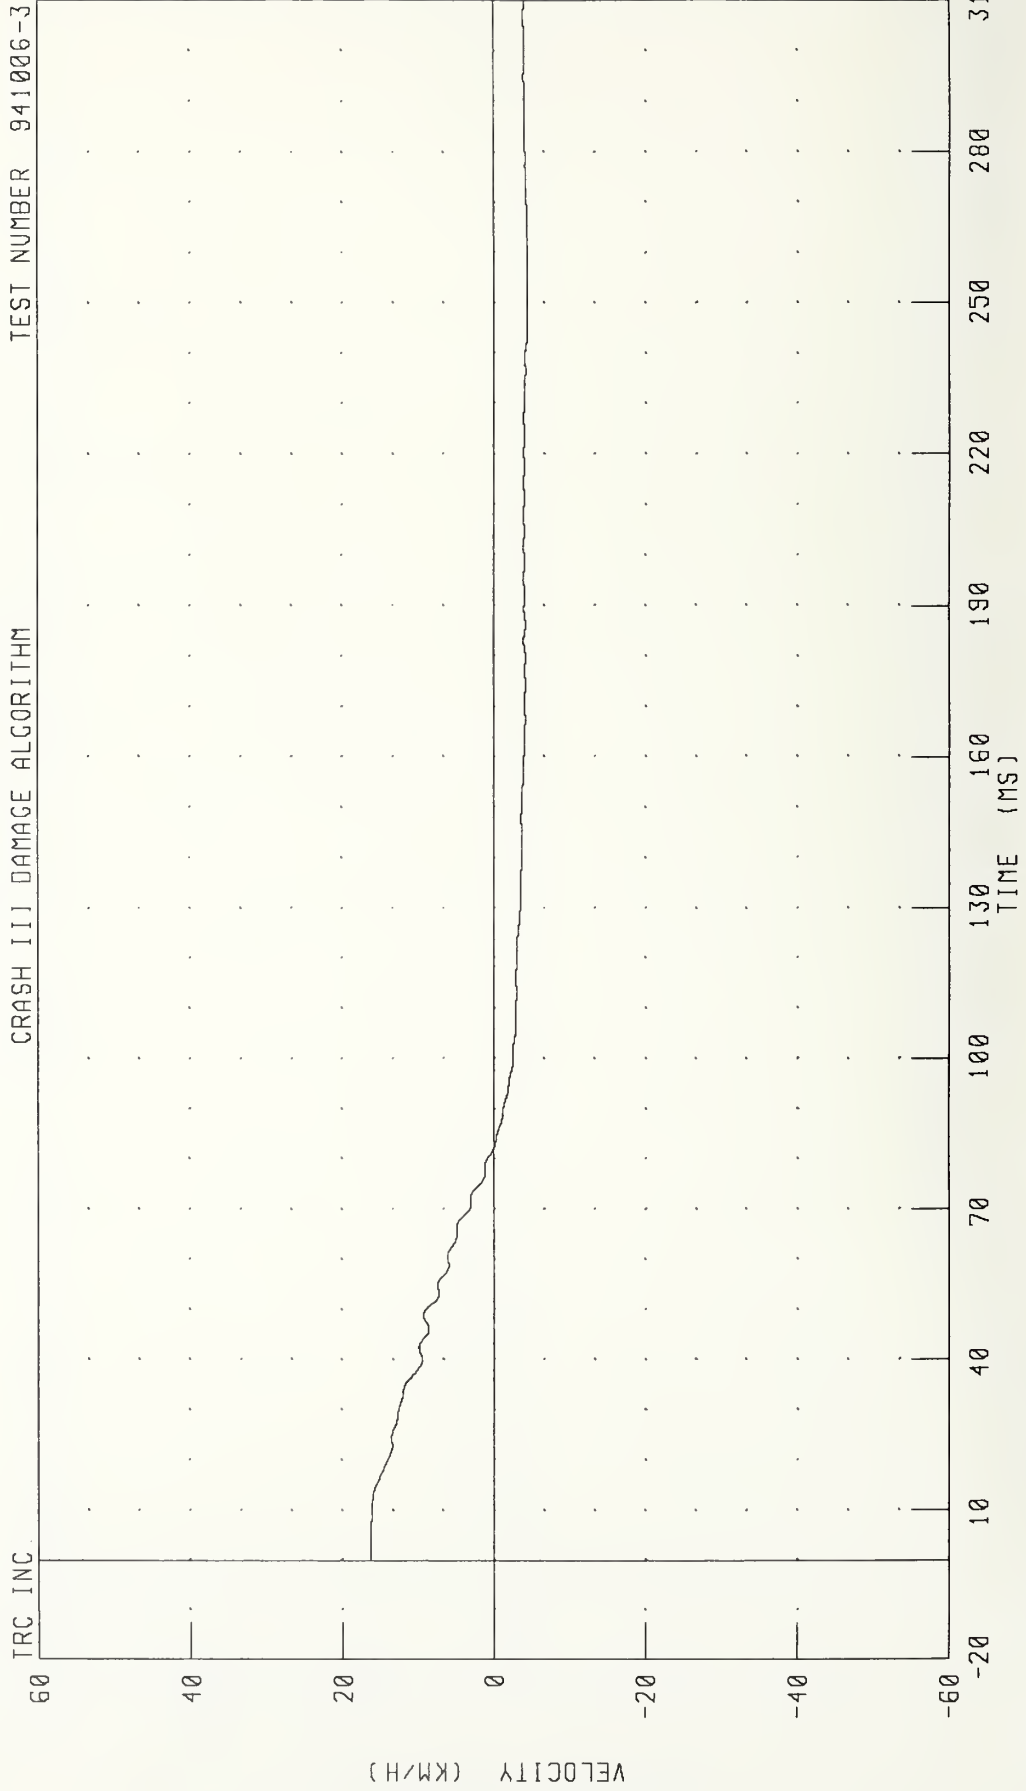
CHANNEL: TRRXV1 FILTER: CH CLASS 180
