U.S. Department
of Transportation

**National Highway
Traffic Safety
Administration**

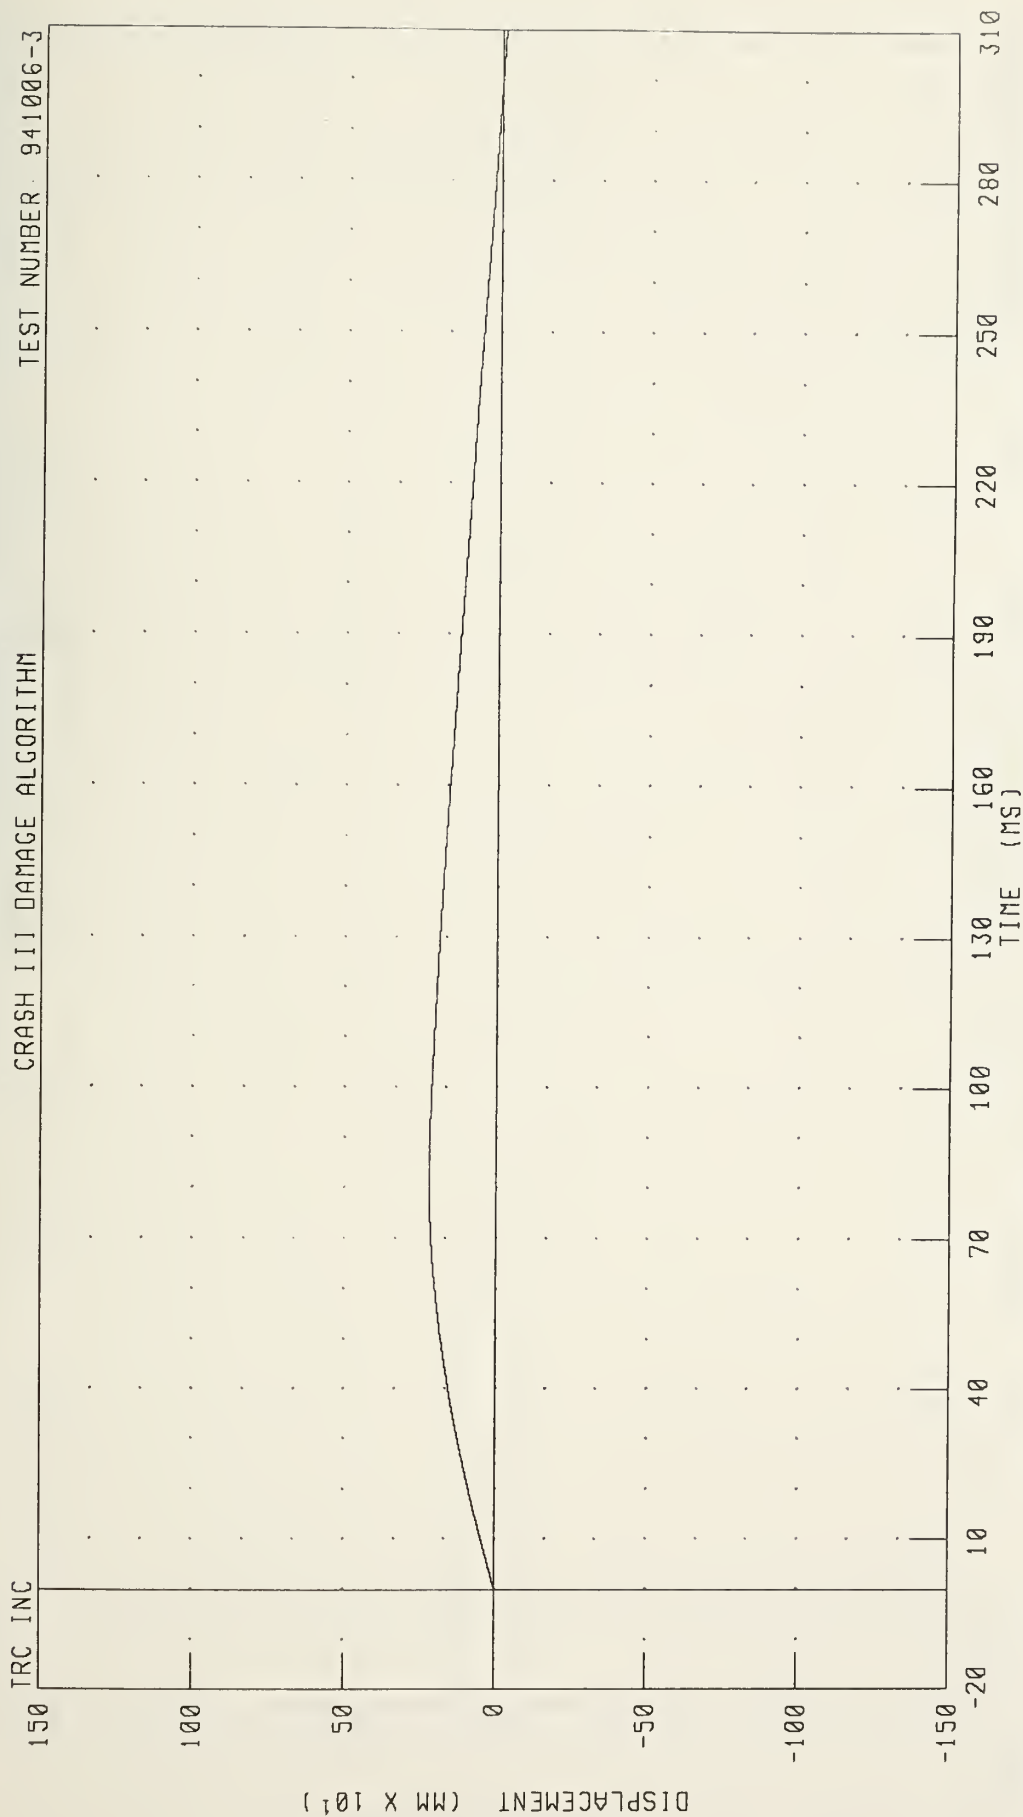
CHANNEL: TRRXD1 FILTER: CH. CLASS 180

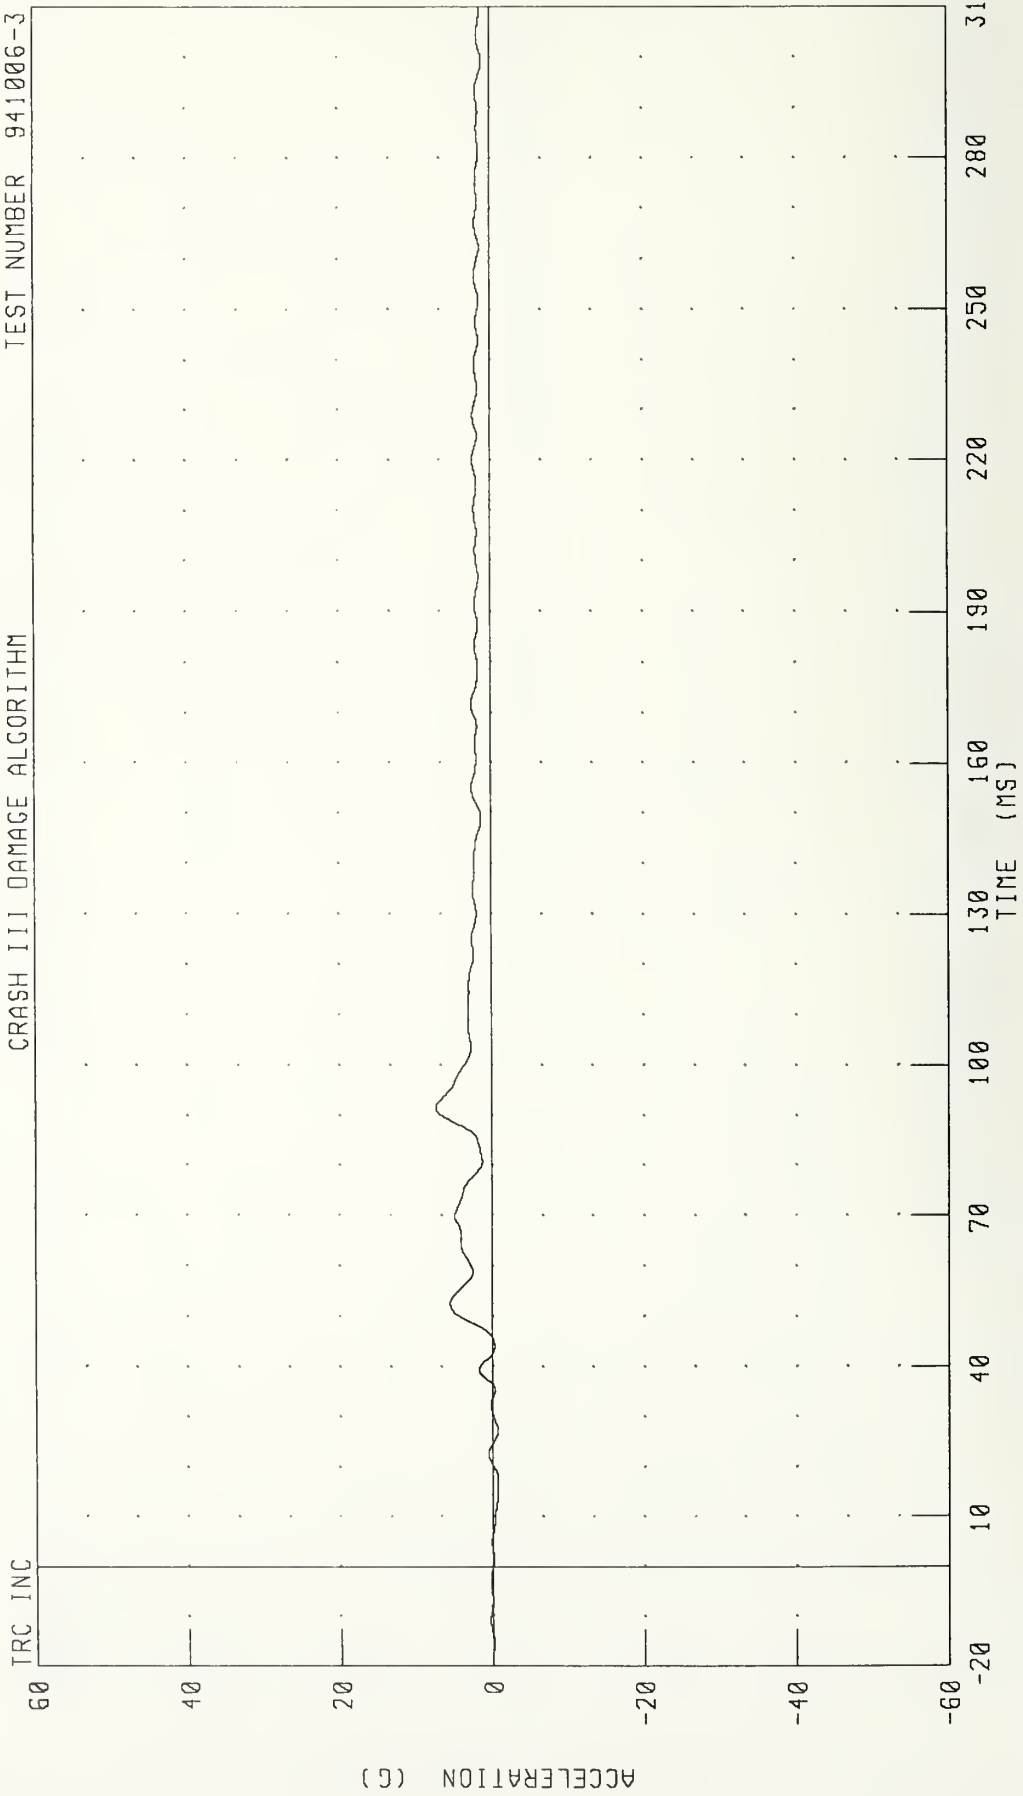
CHANNEL: TRRYG1 FILTER: CH. CLASS 60

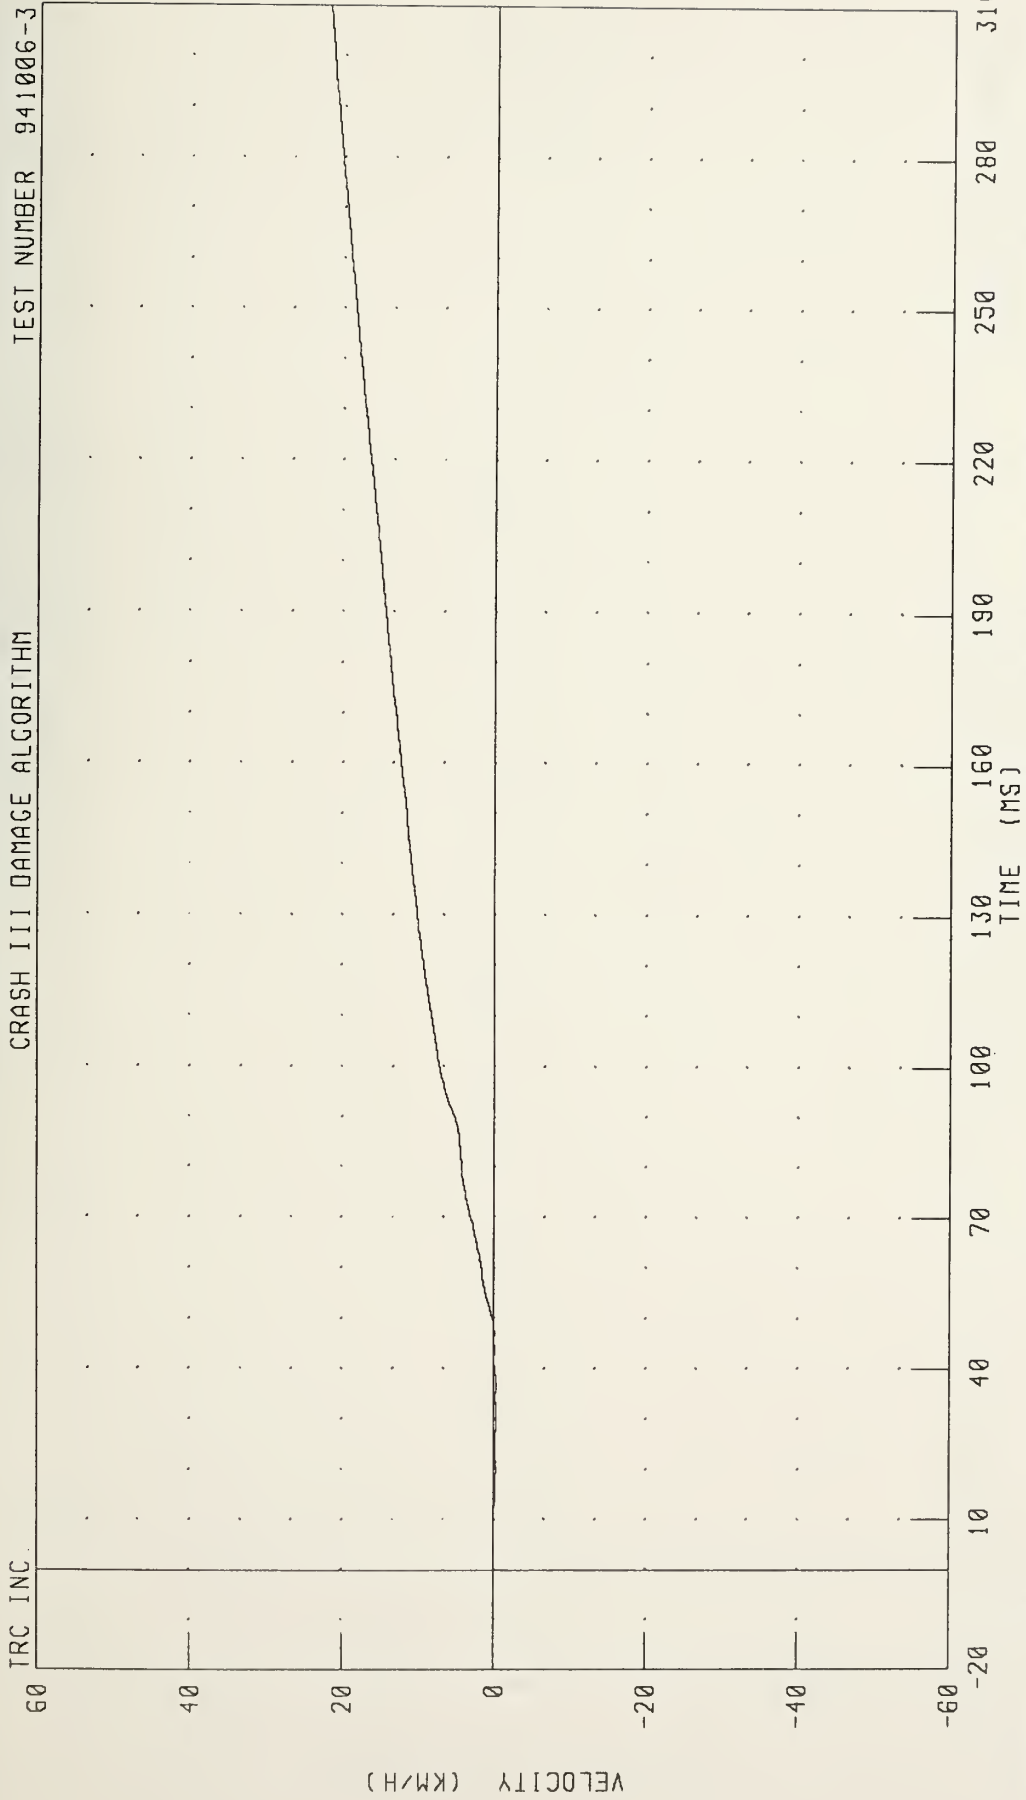
CHANNEL: TRRYV1 FILTER: CH. CLASS 180 PEAK DATA: 22.01 KM/H @ 310.00 MS; -0.33 KM/H @ 37.36 MS

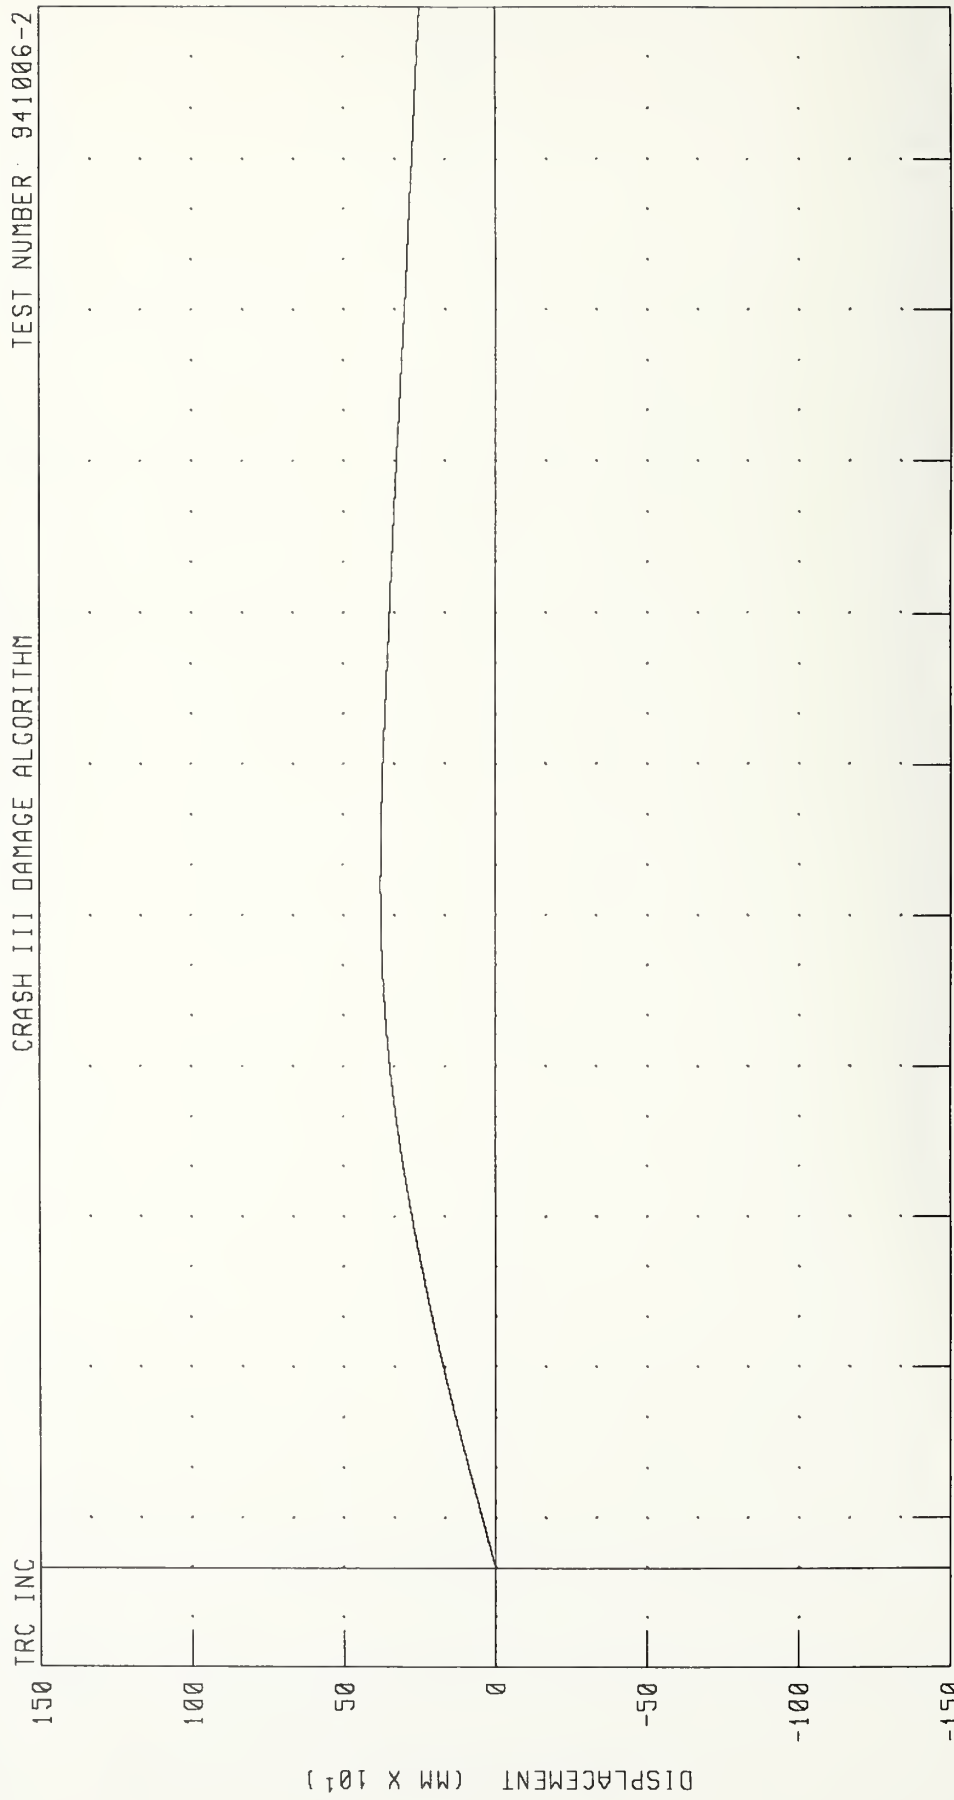
CRASH III DAMAGE ALGORITHM

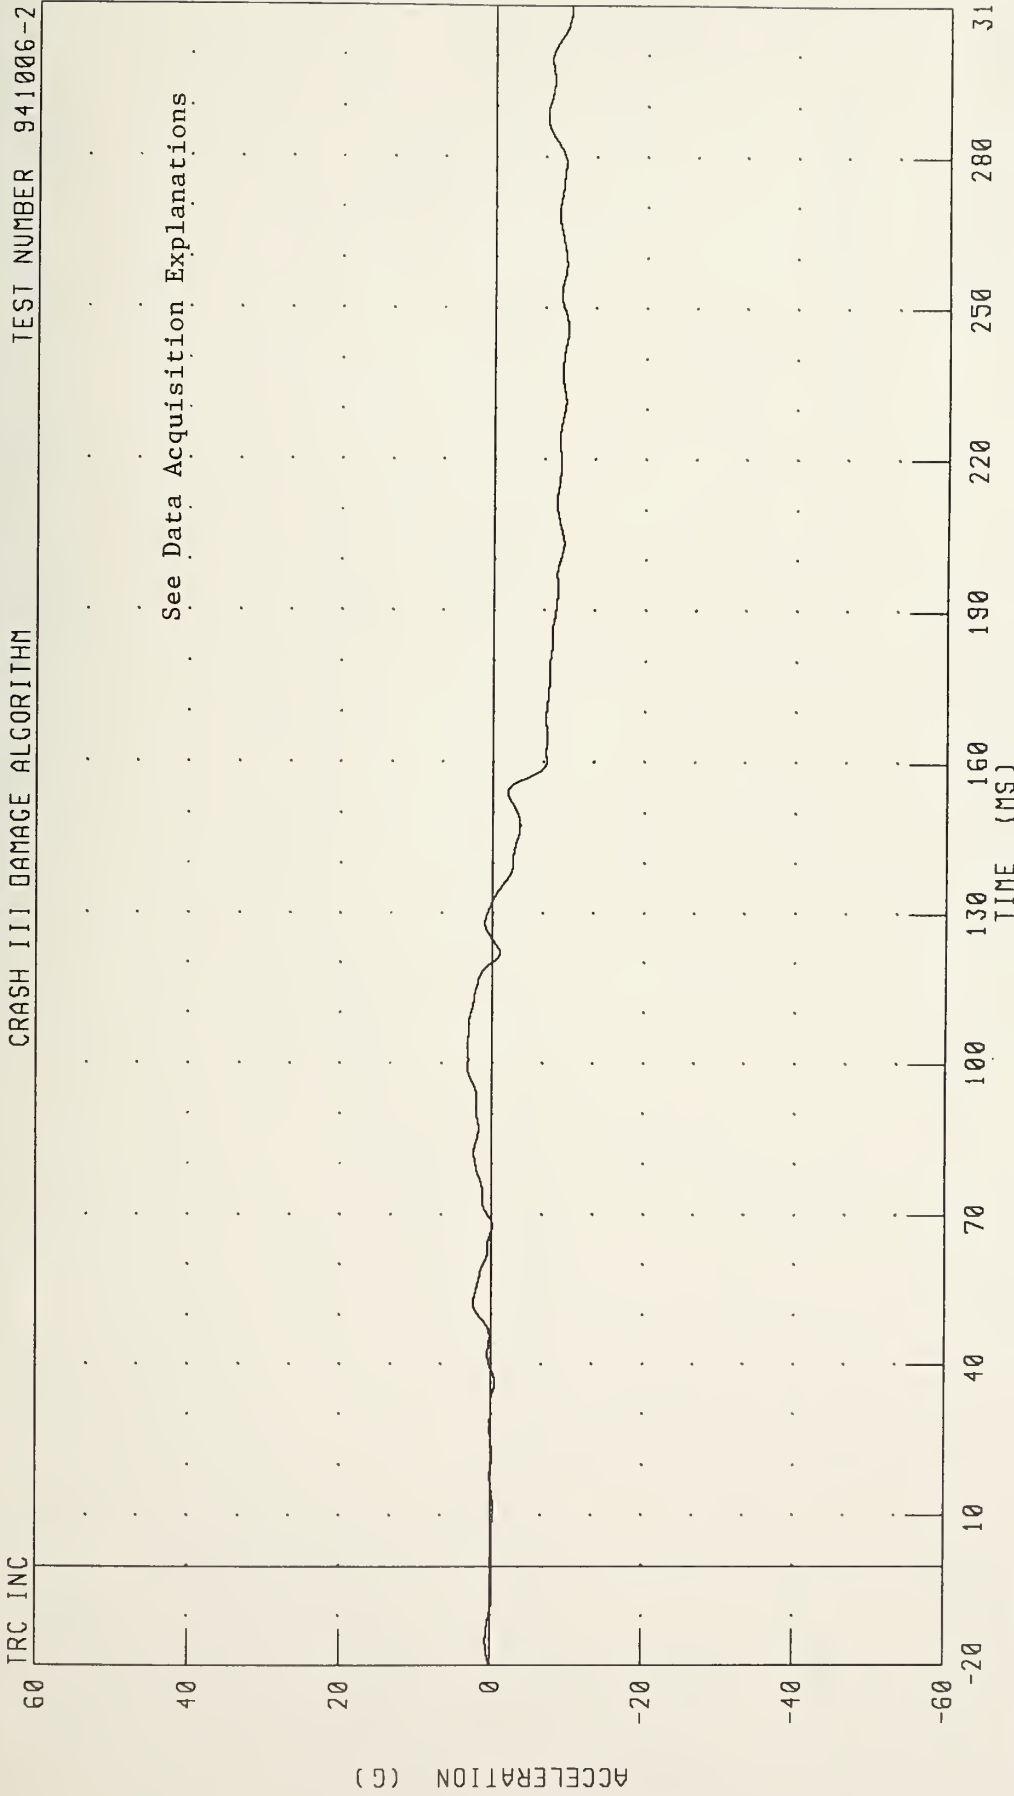
CHANNEL: TRRYG1 FILTER: CH. CLASS 60

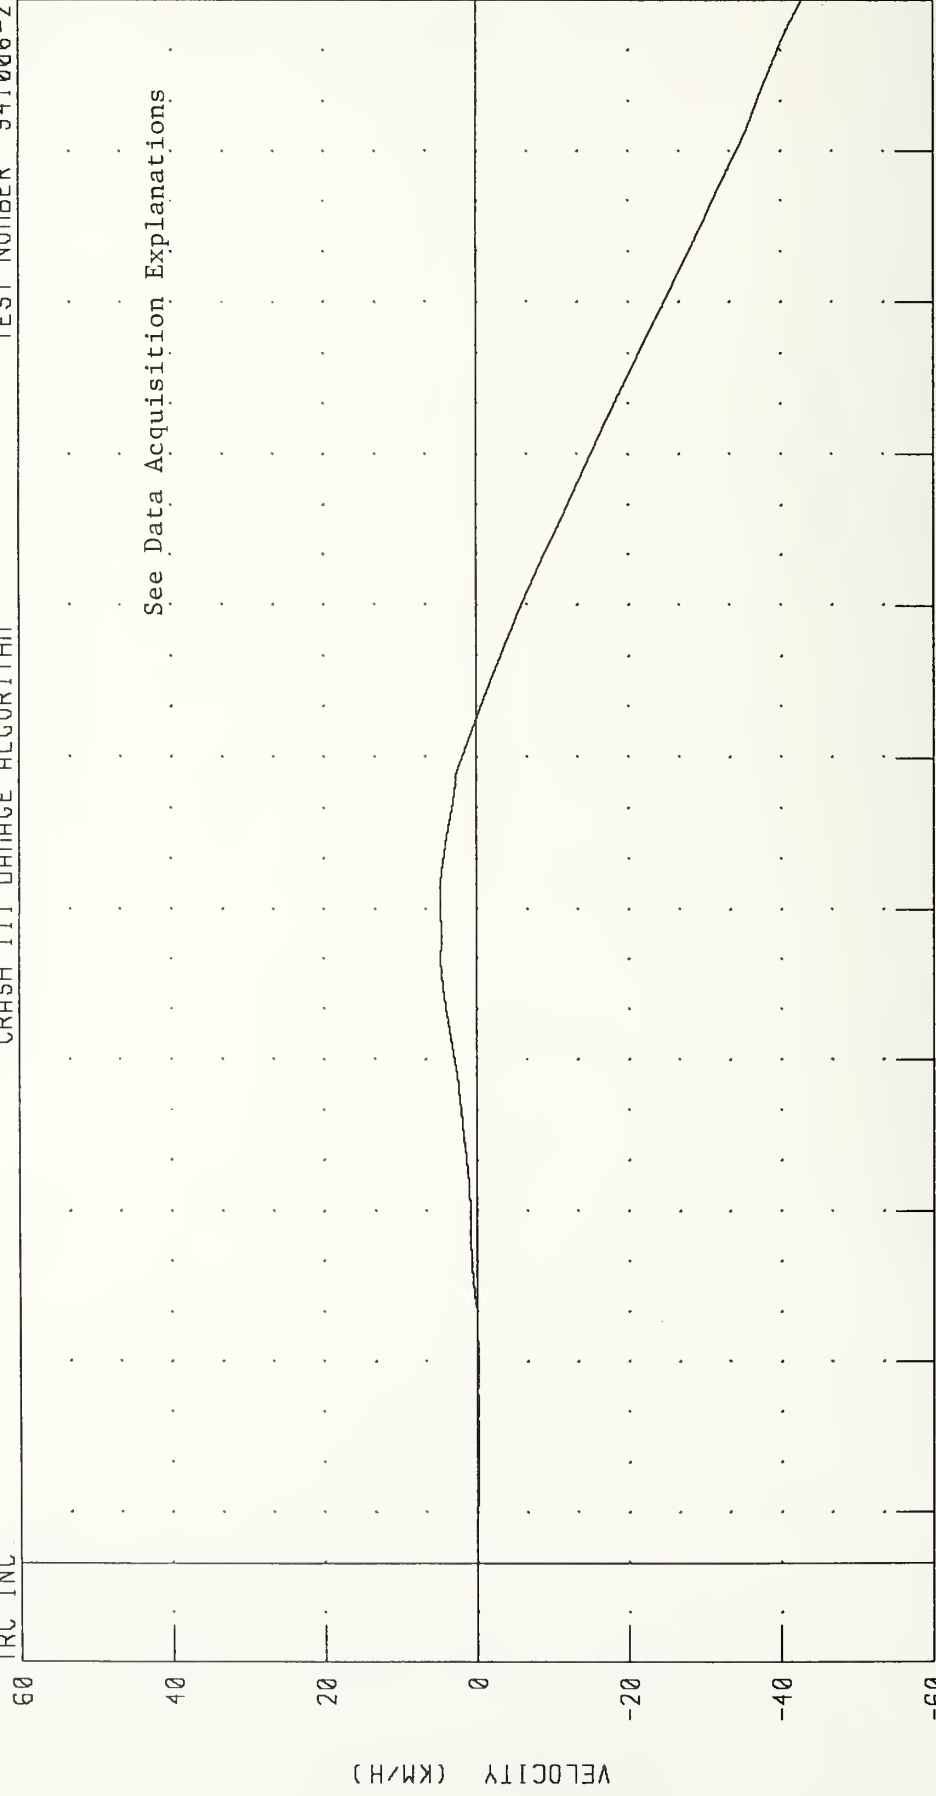
60
40
20
0
-20
-40
-60

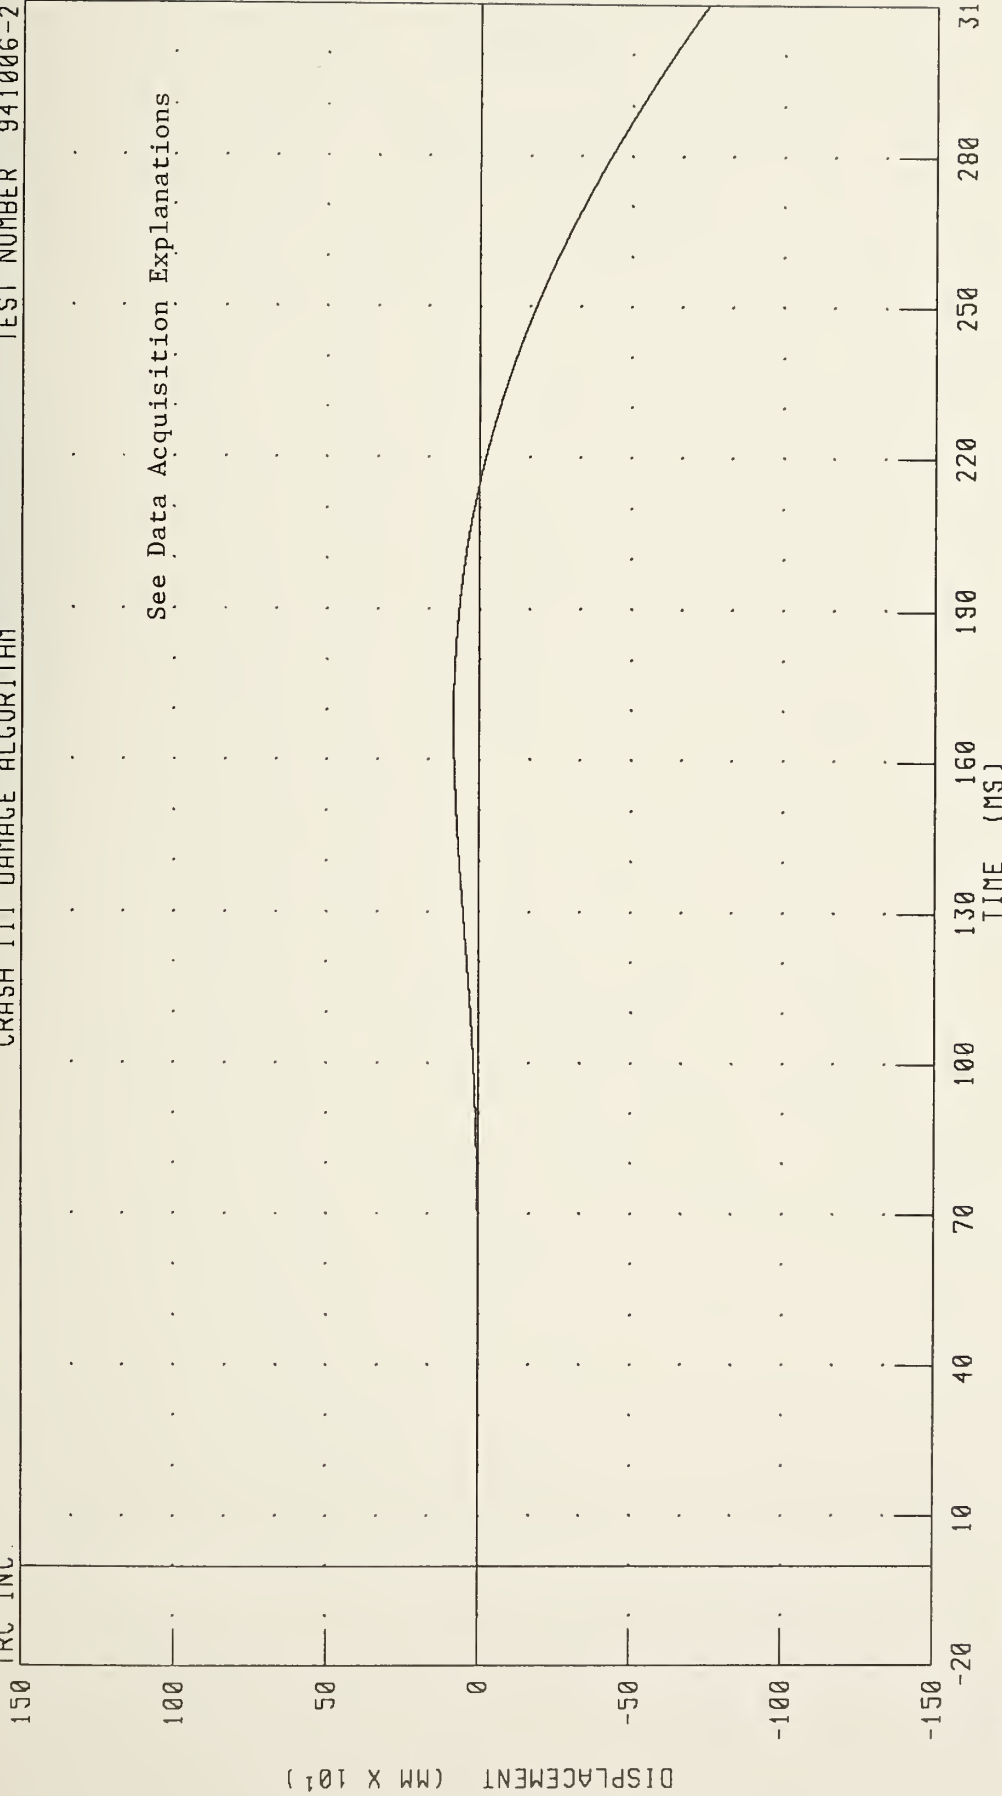
See Data Acquisition Explanations

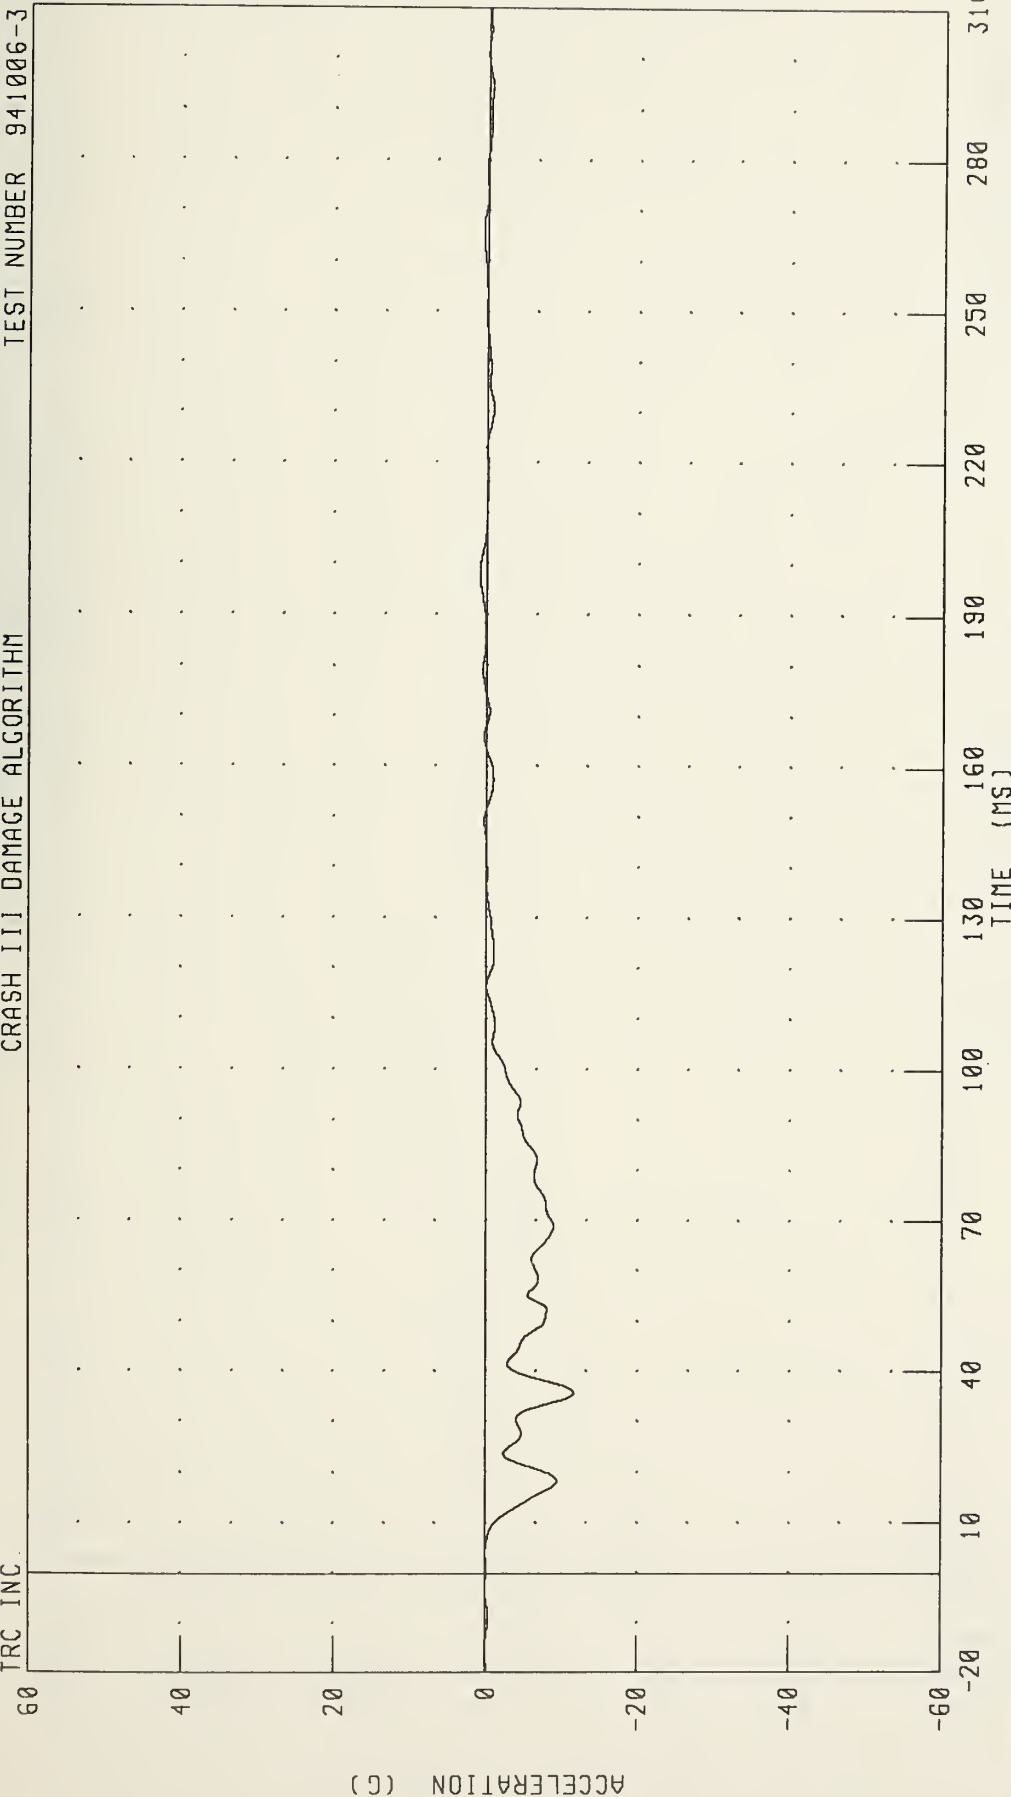
CHANNEL: VCGXG1 FILTER: CH. CLASS 60 PEAK DATA: 0.93 G @ 198.08 MS, -11.64 G @ 35.68 MS

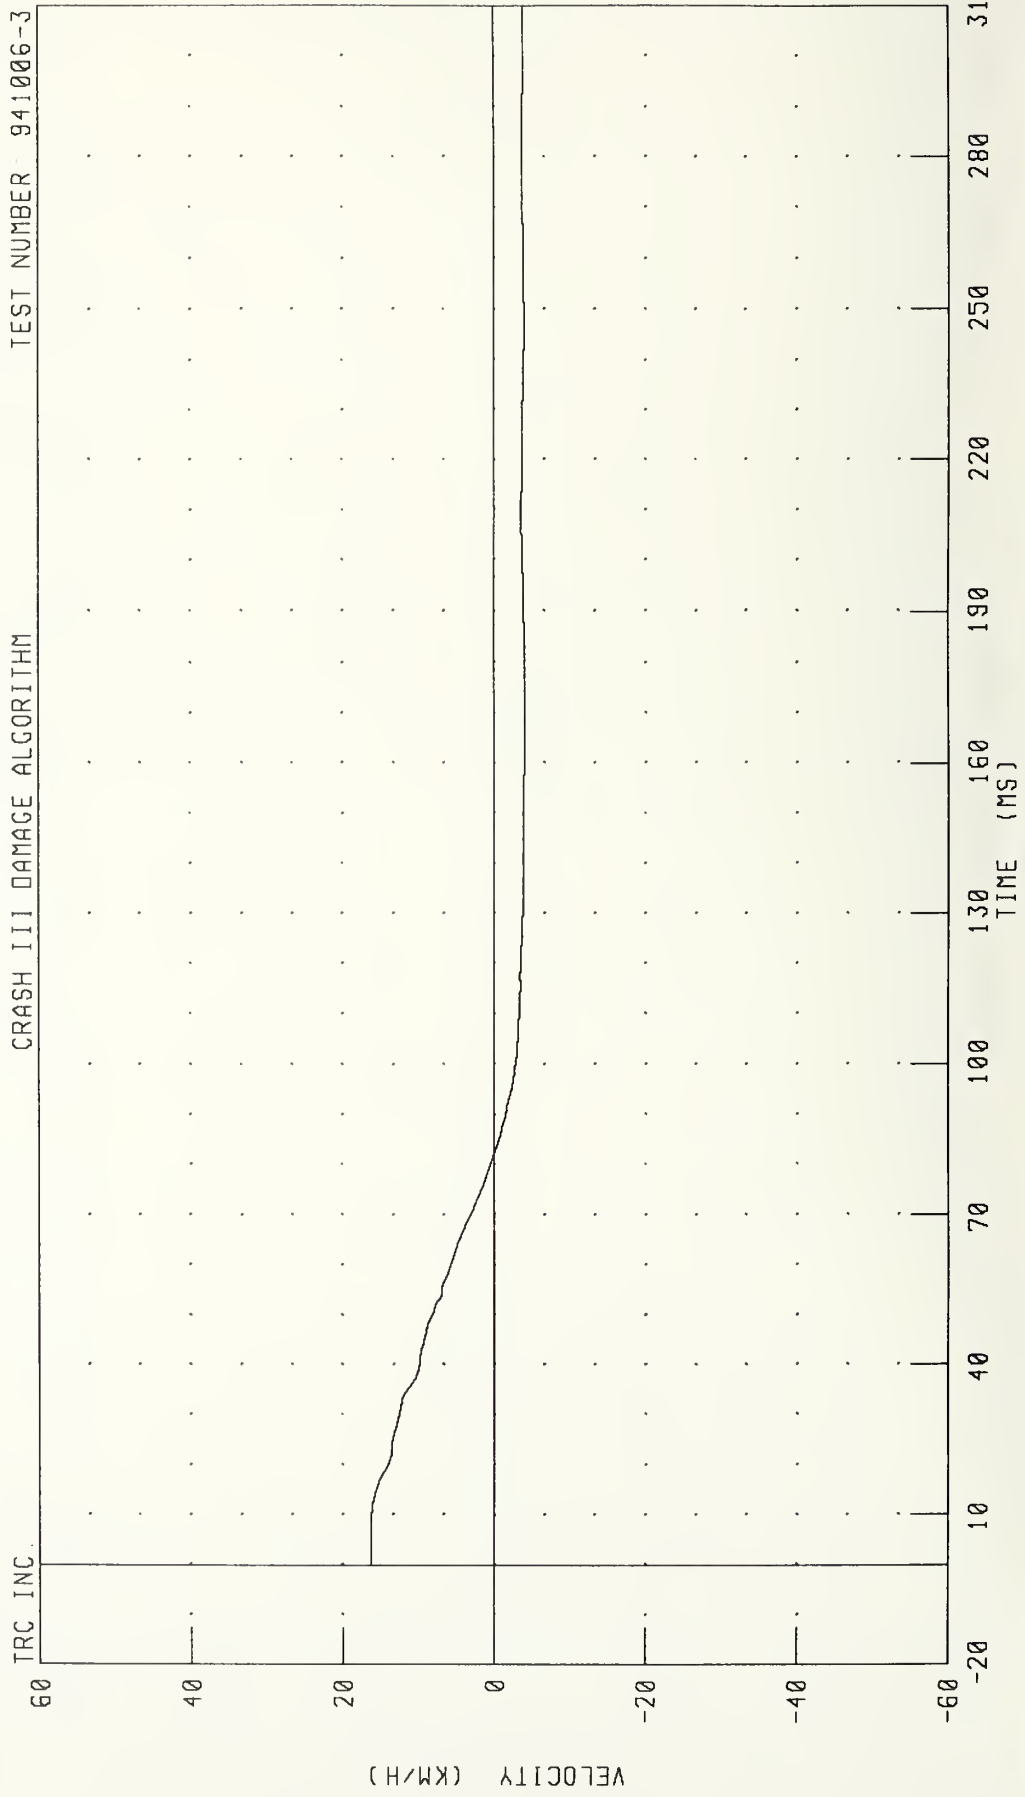
CHANNEL: VCCXVI FILTER: CH. CLASS 180

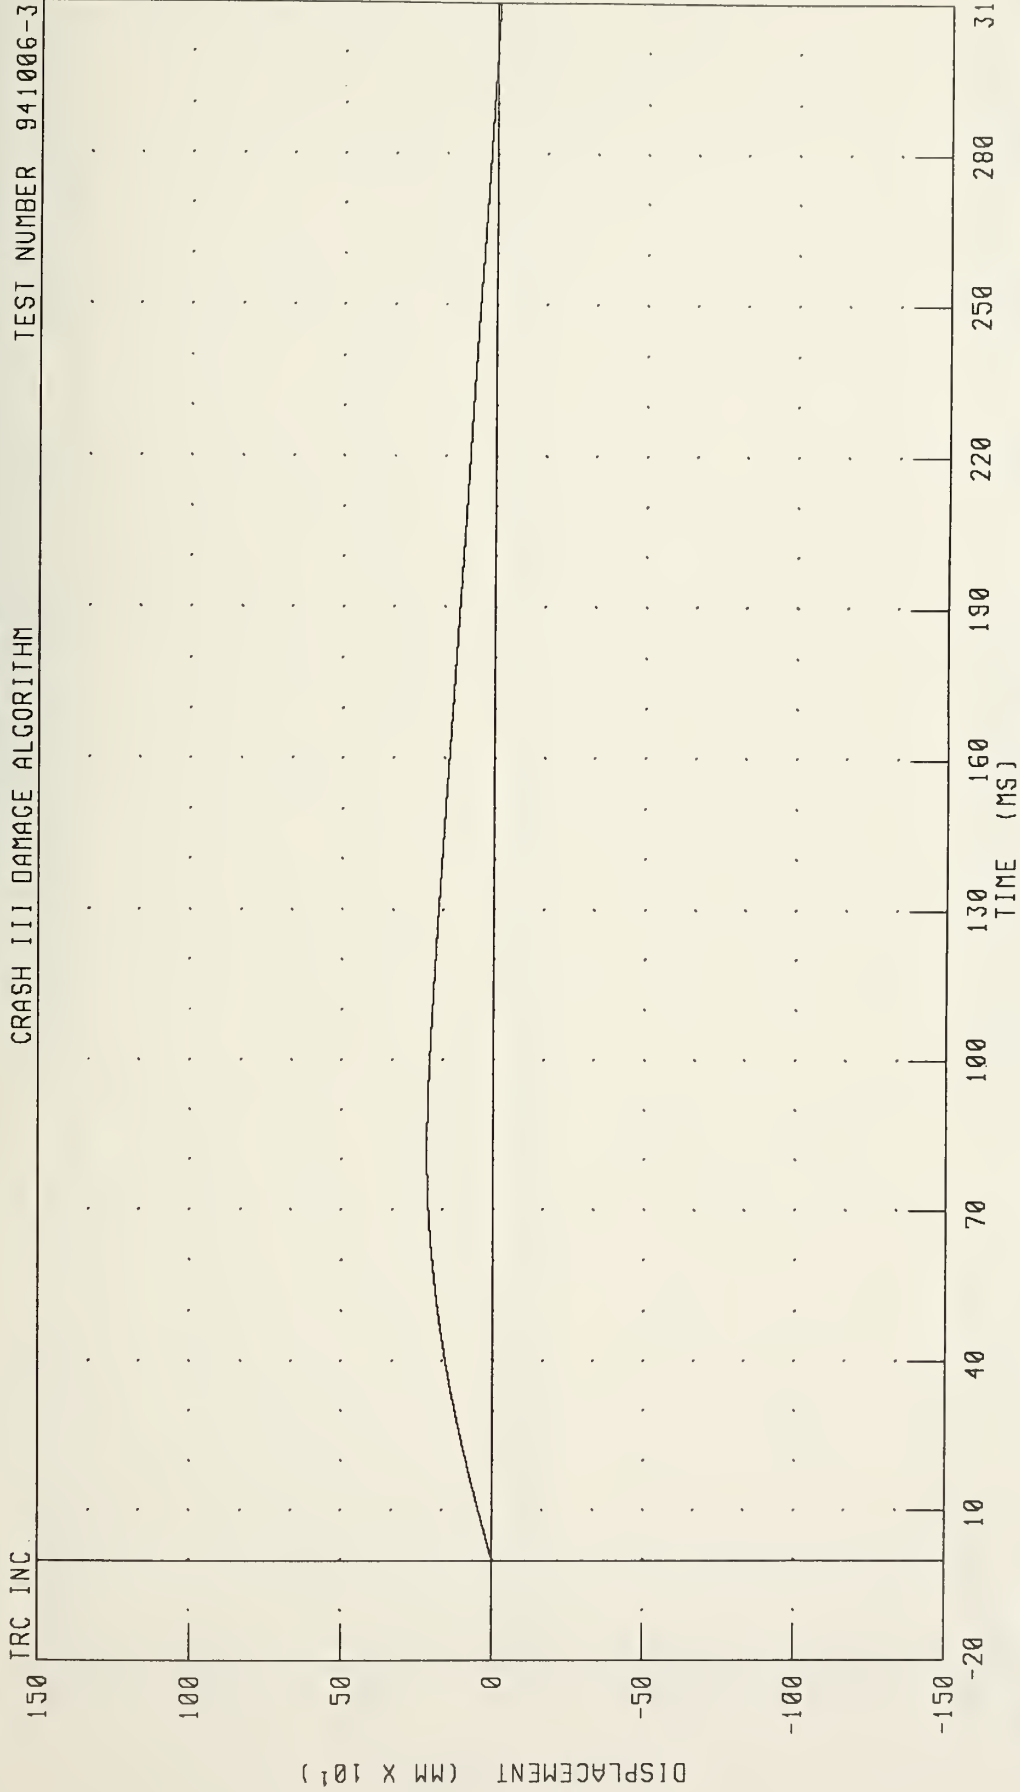
CHANNEL: VCGXD1 FILTER: CH. CLASS 180

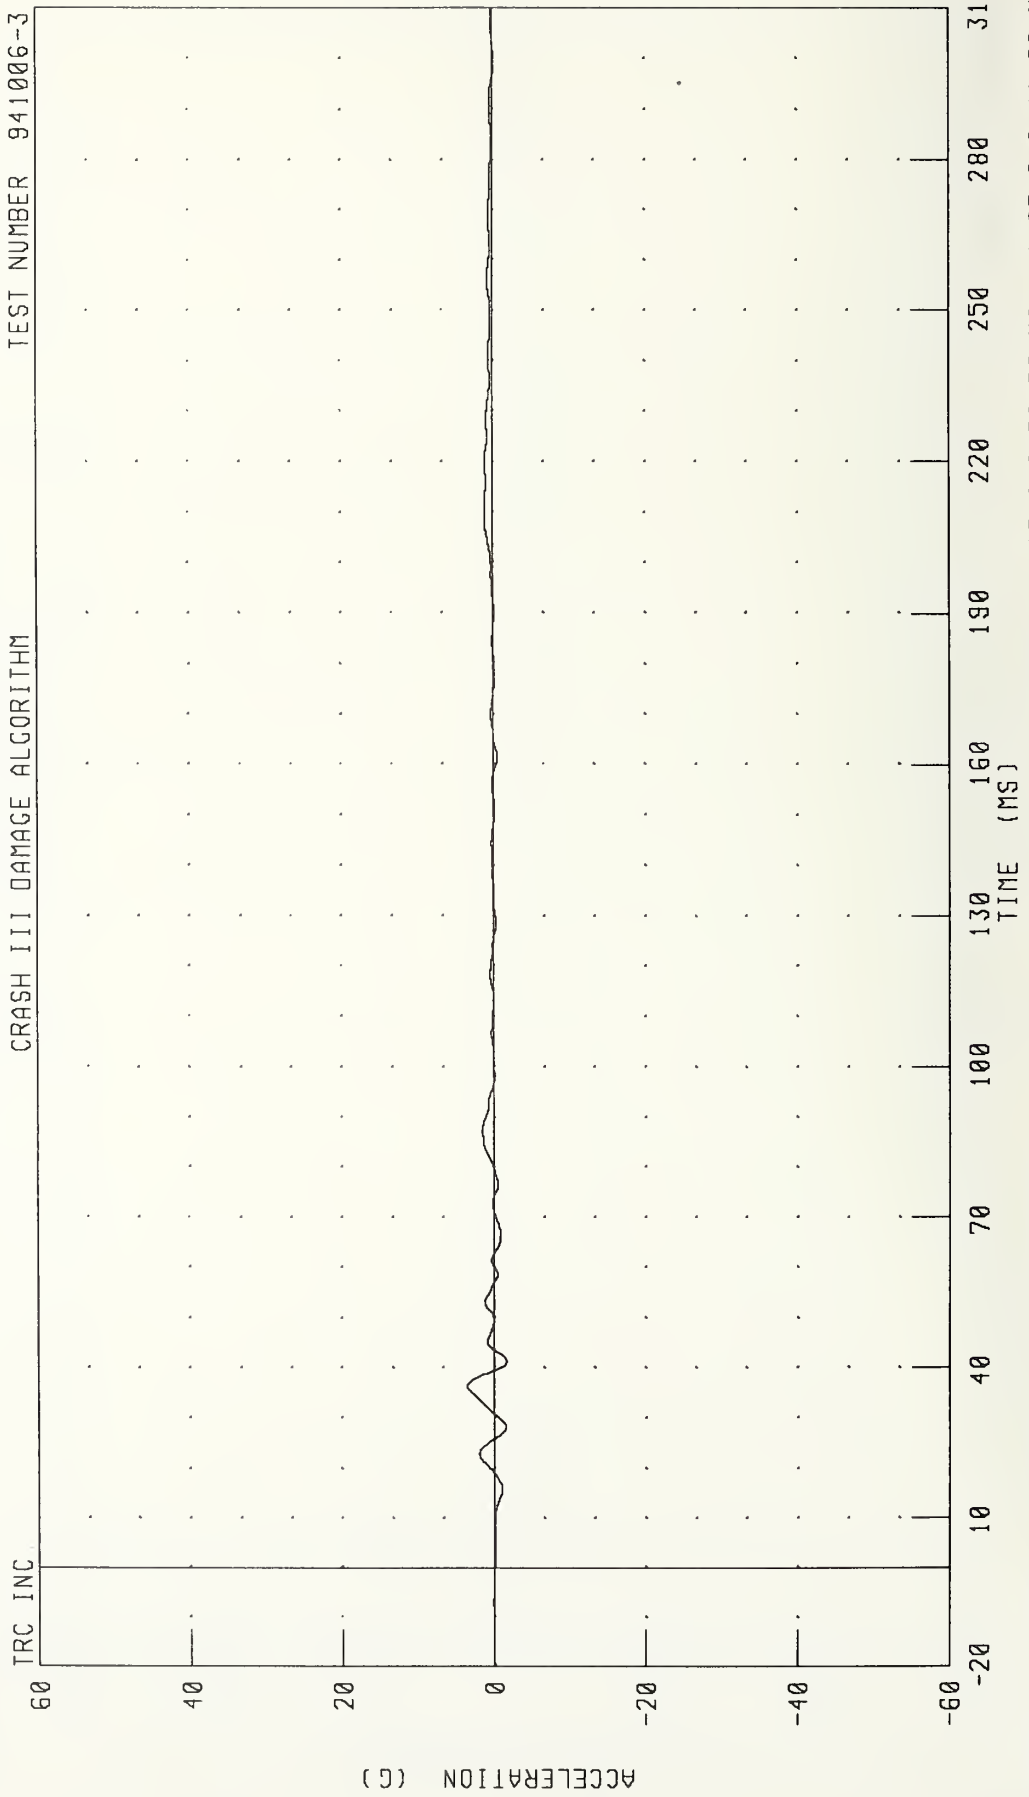
CHANNEL: YCGY61 FILTER: CH. CLASS 60

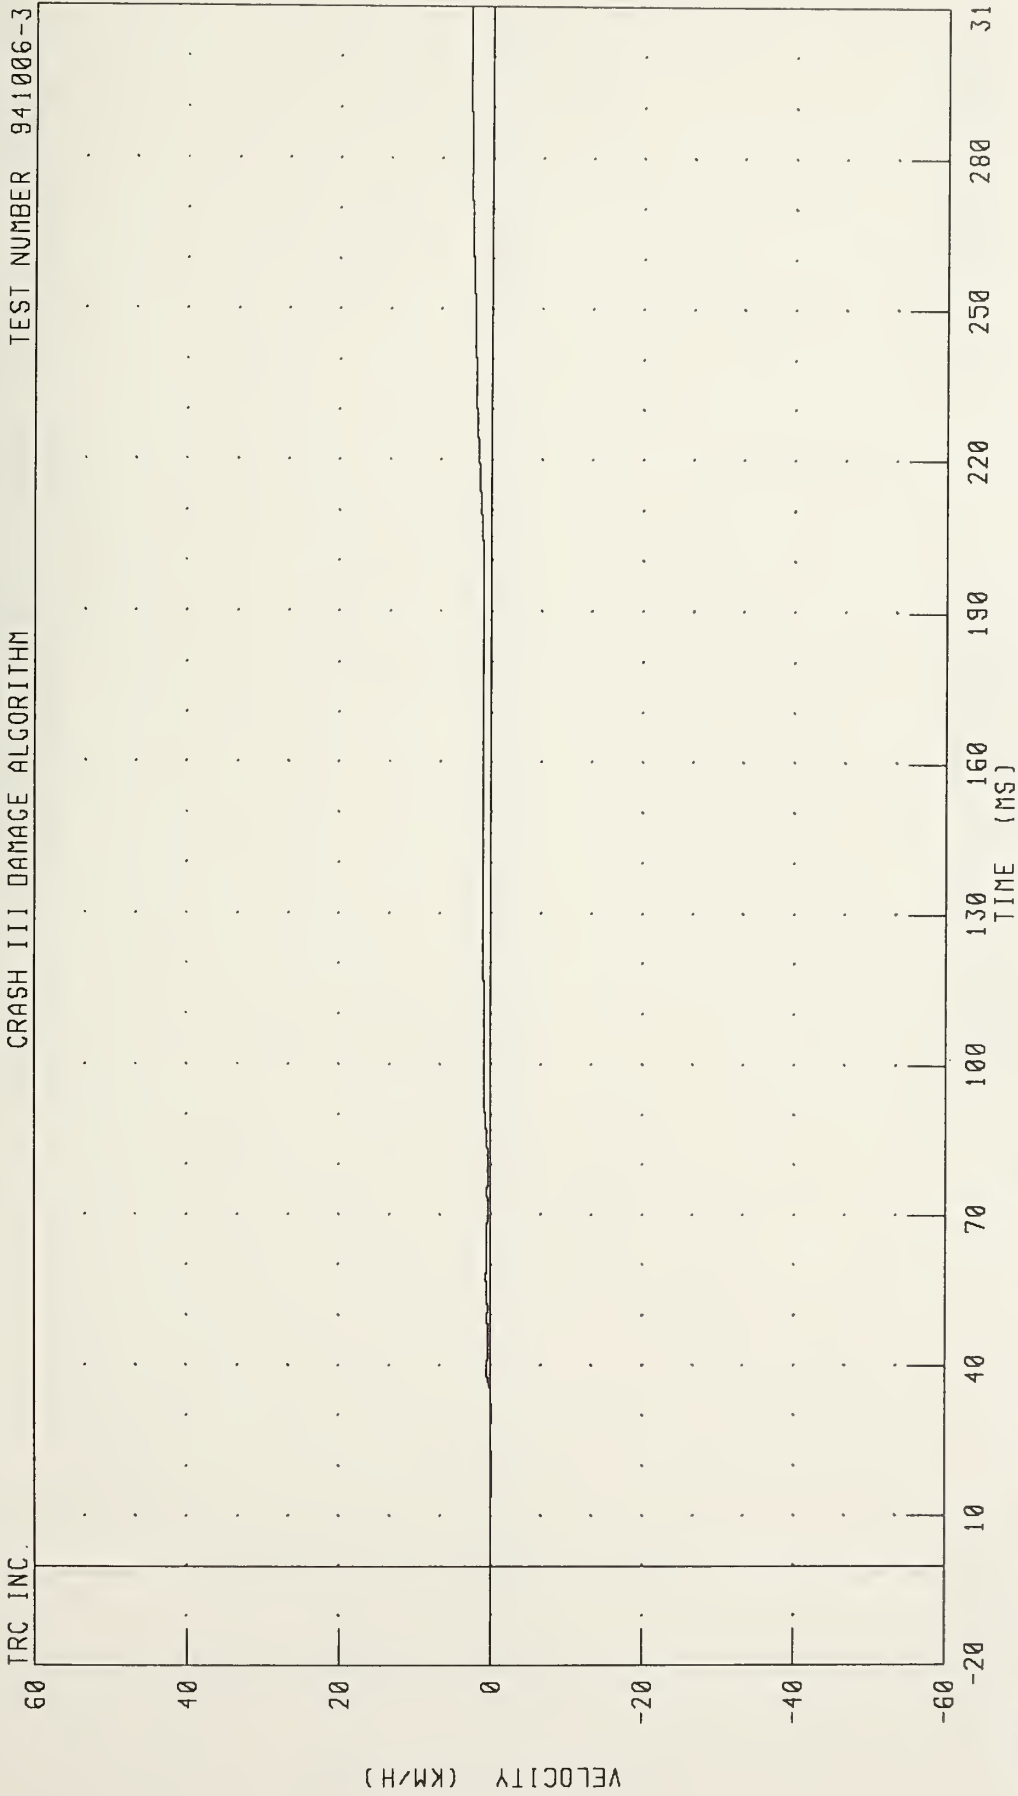
CHANNEL: VCGYV1 FILTER: CH. CLASS 180 PEAK DATA: 2.88 KM/H @ 310.00 MS; -0.24 KM/H @ 19.68 MS
