U.S. Department
of Transportation

**National Highway
Traffic Safety
Administration**

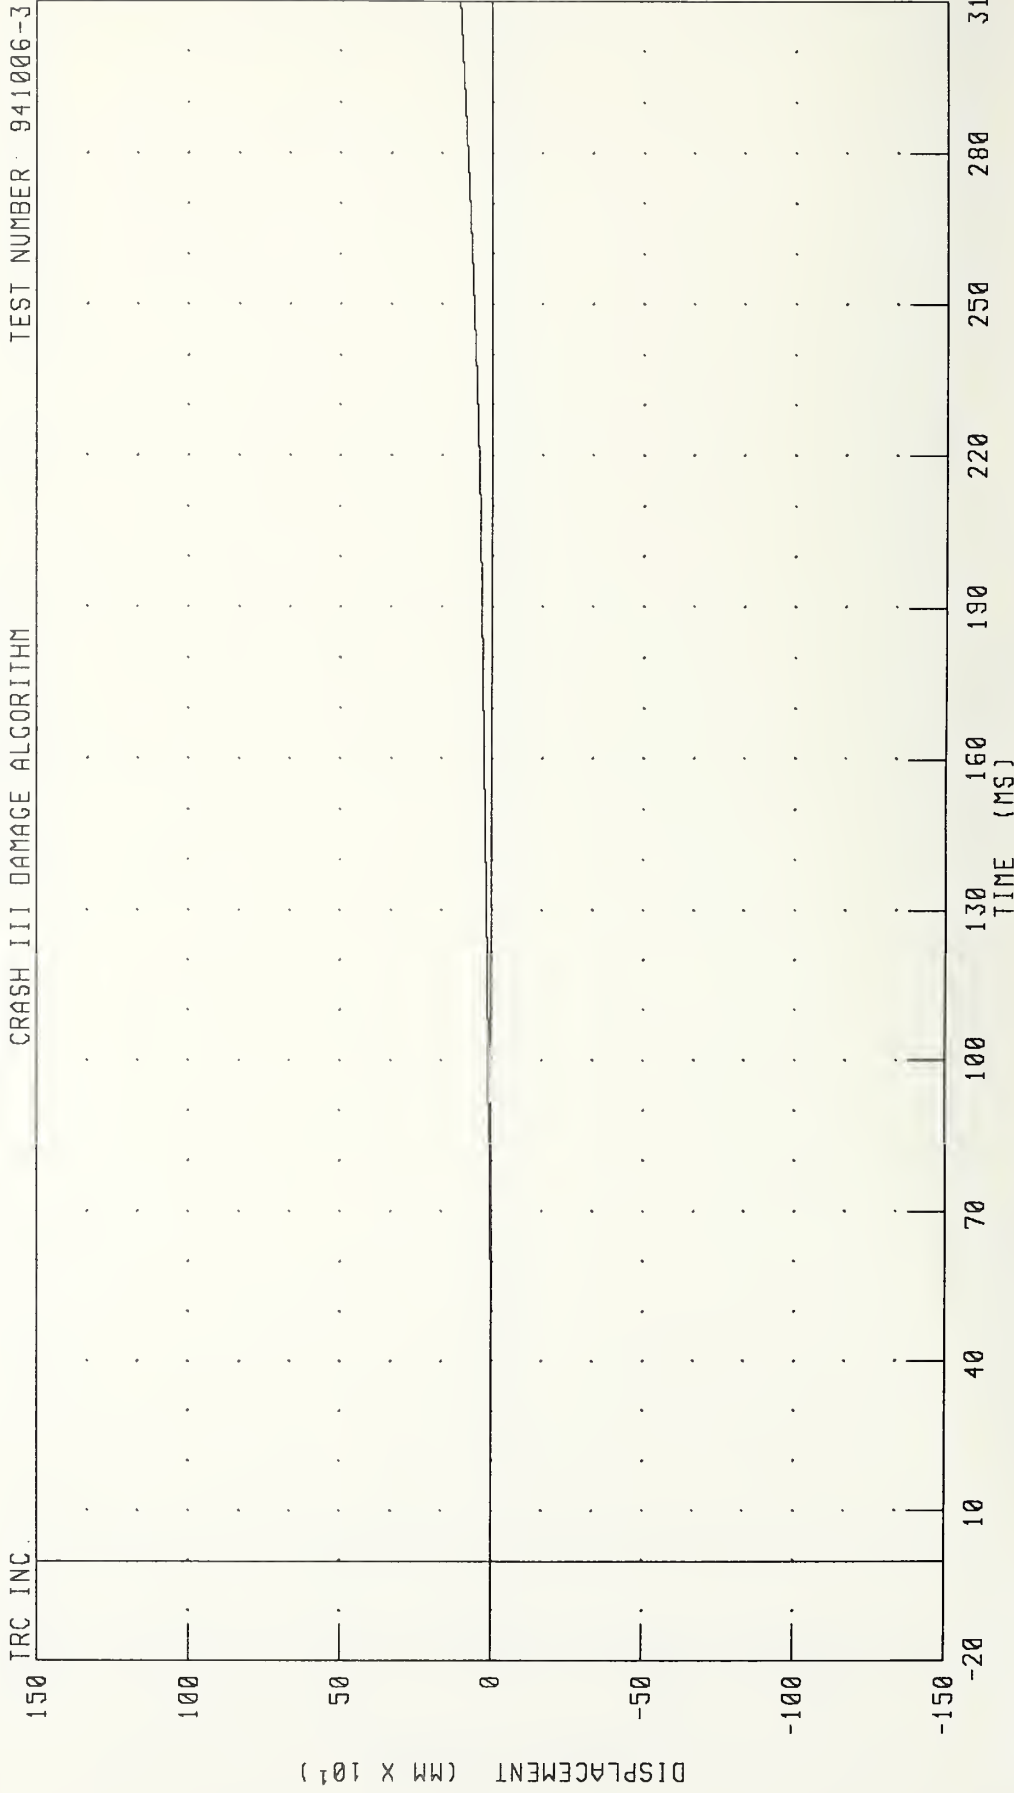
CHANNEL: VCGYD1 FILTER: CH. CLASS 180 PEAK DATA: 105.02 MM @ 310.00 MS, -0.71 MM @ 34.16 MS

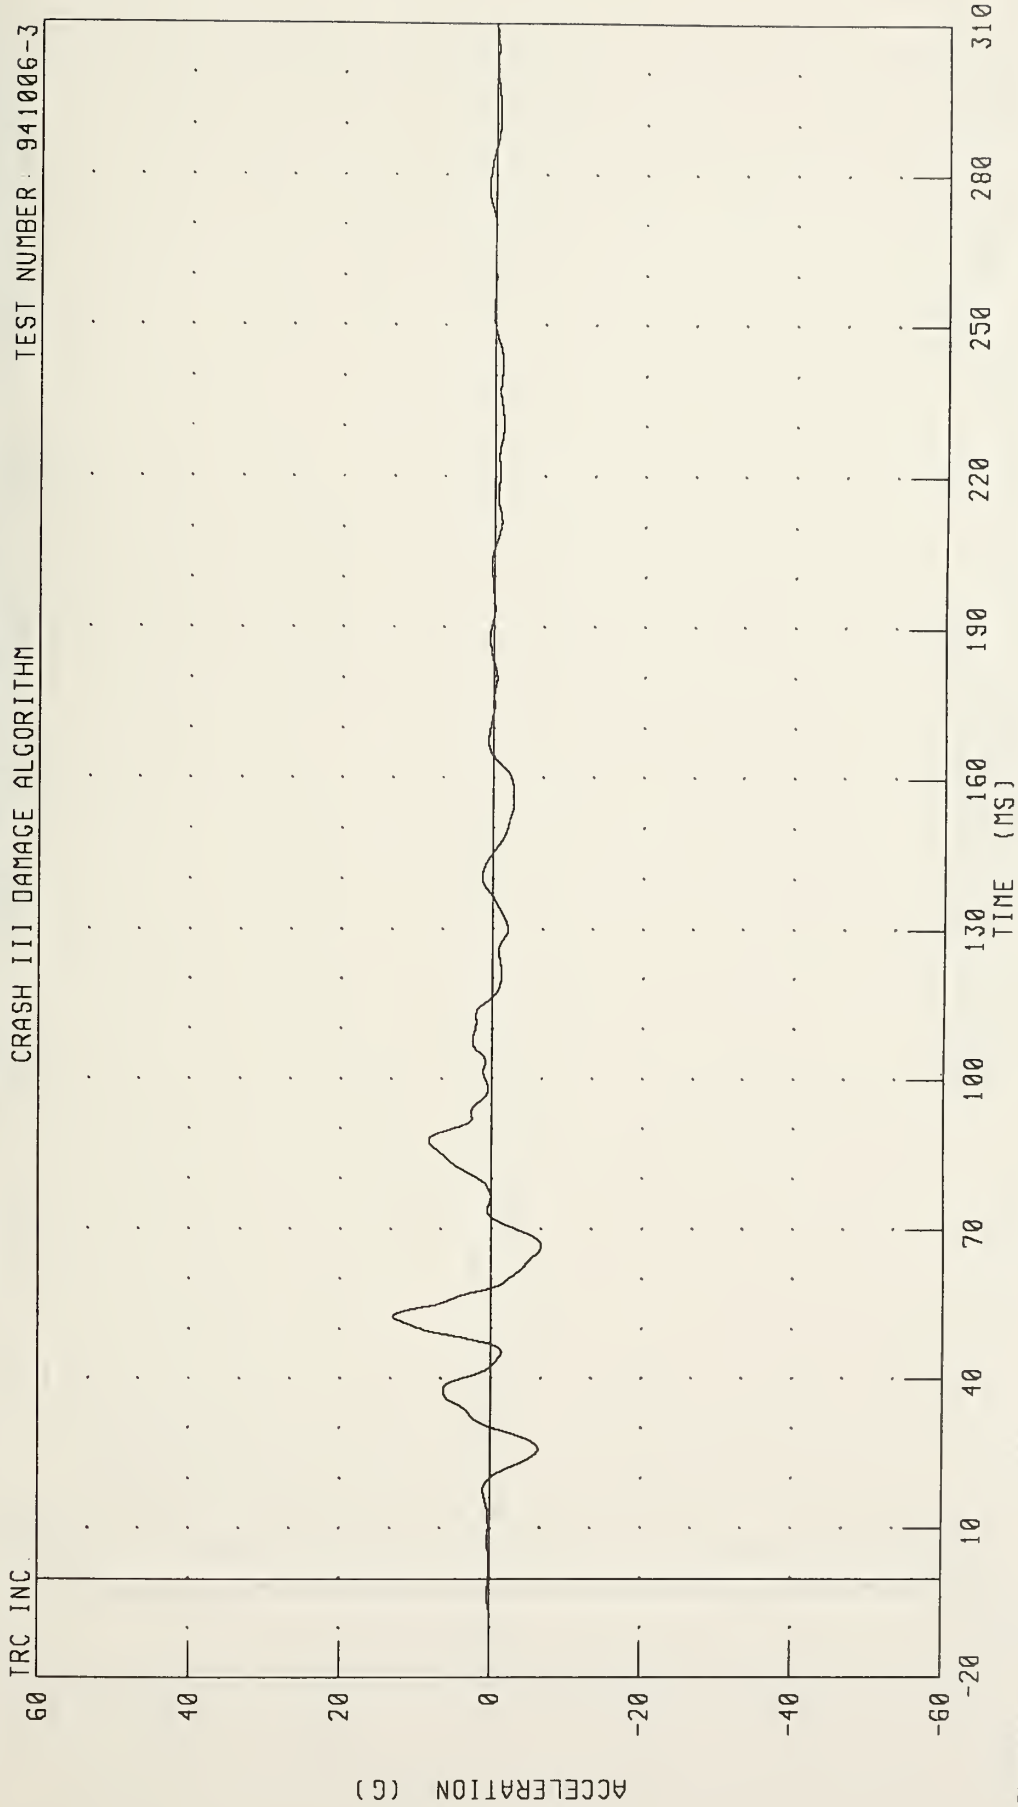
TEST NUMBER: 941006-3

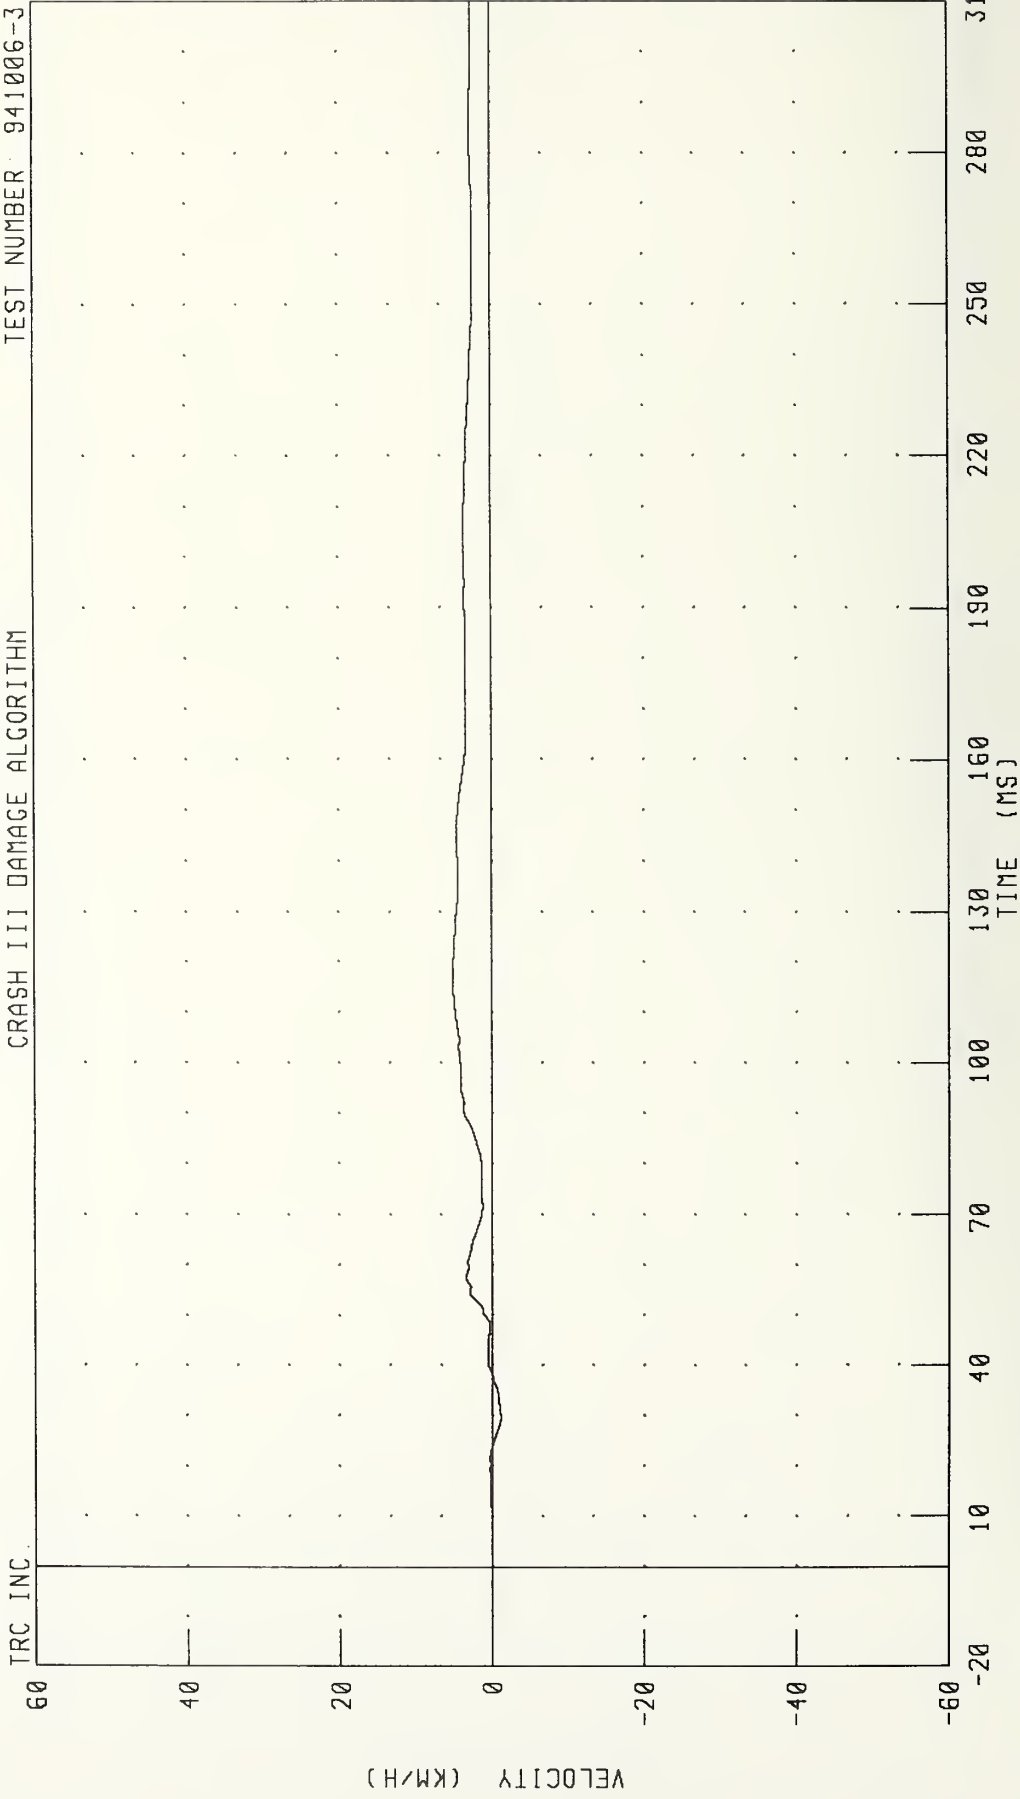
CHANNEL: VCGZY1 FILTER: CH. CLASS 180

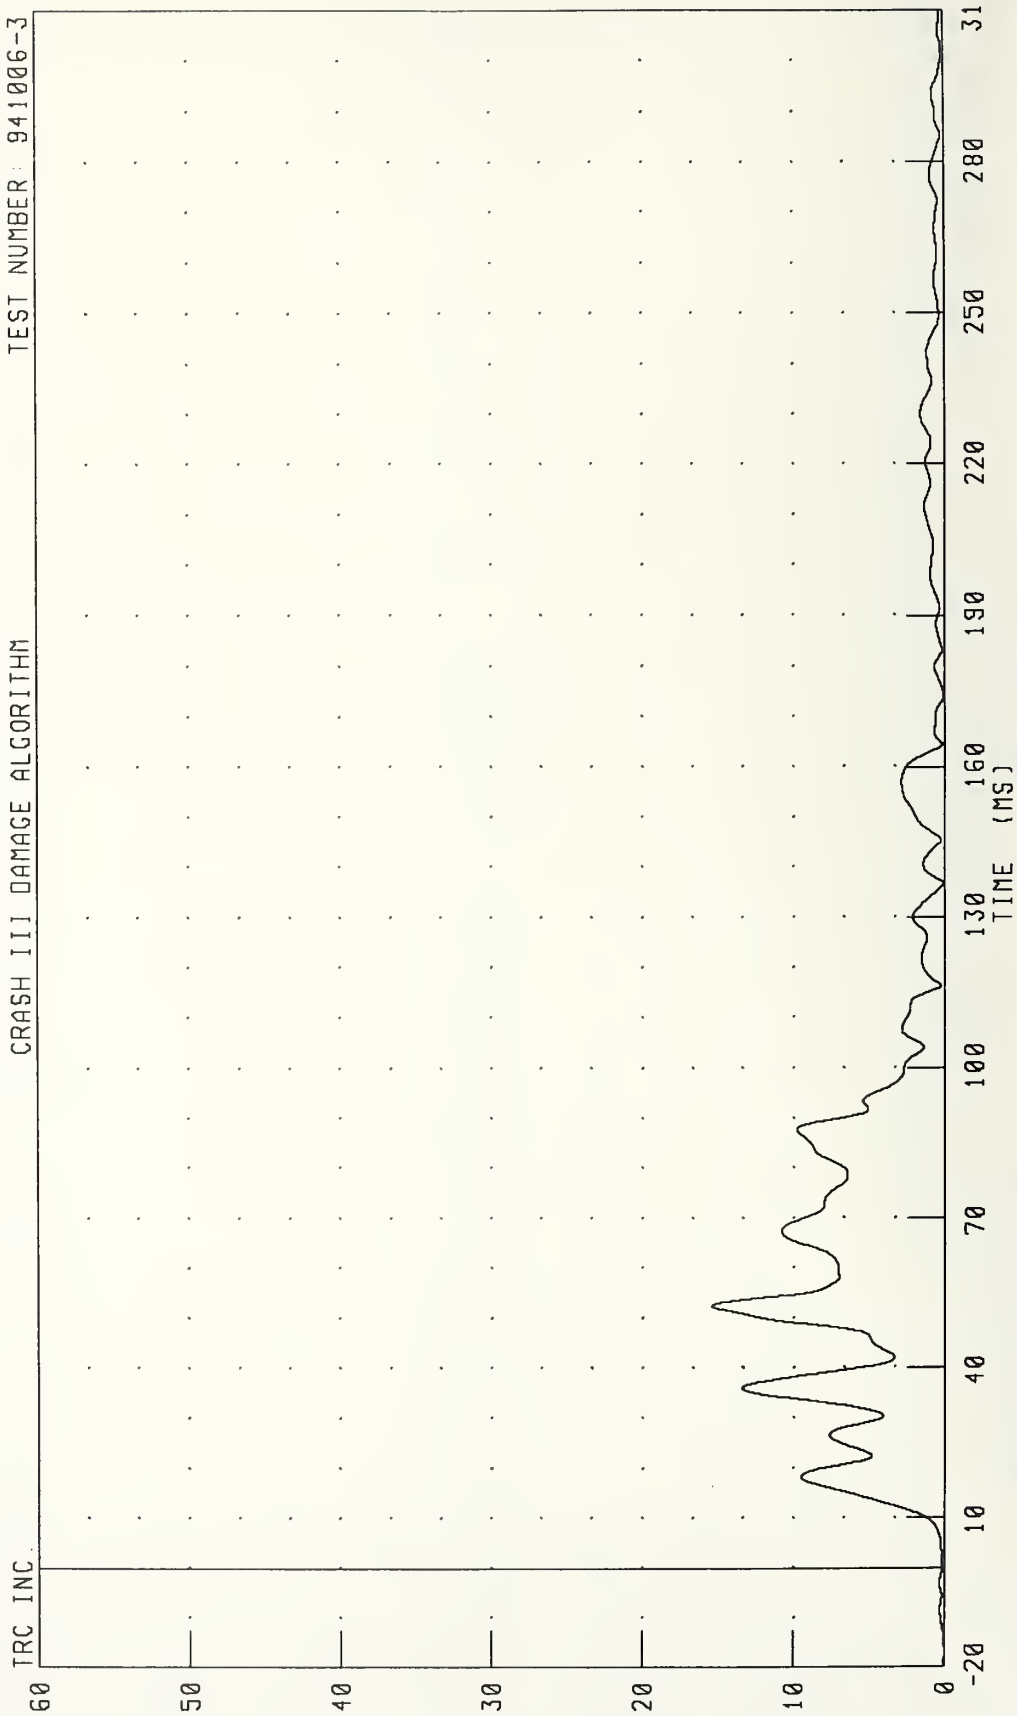
TEST NUMBER: 941006-3

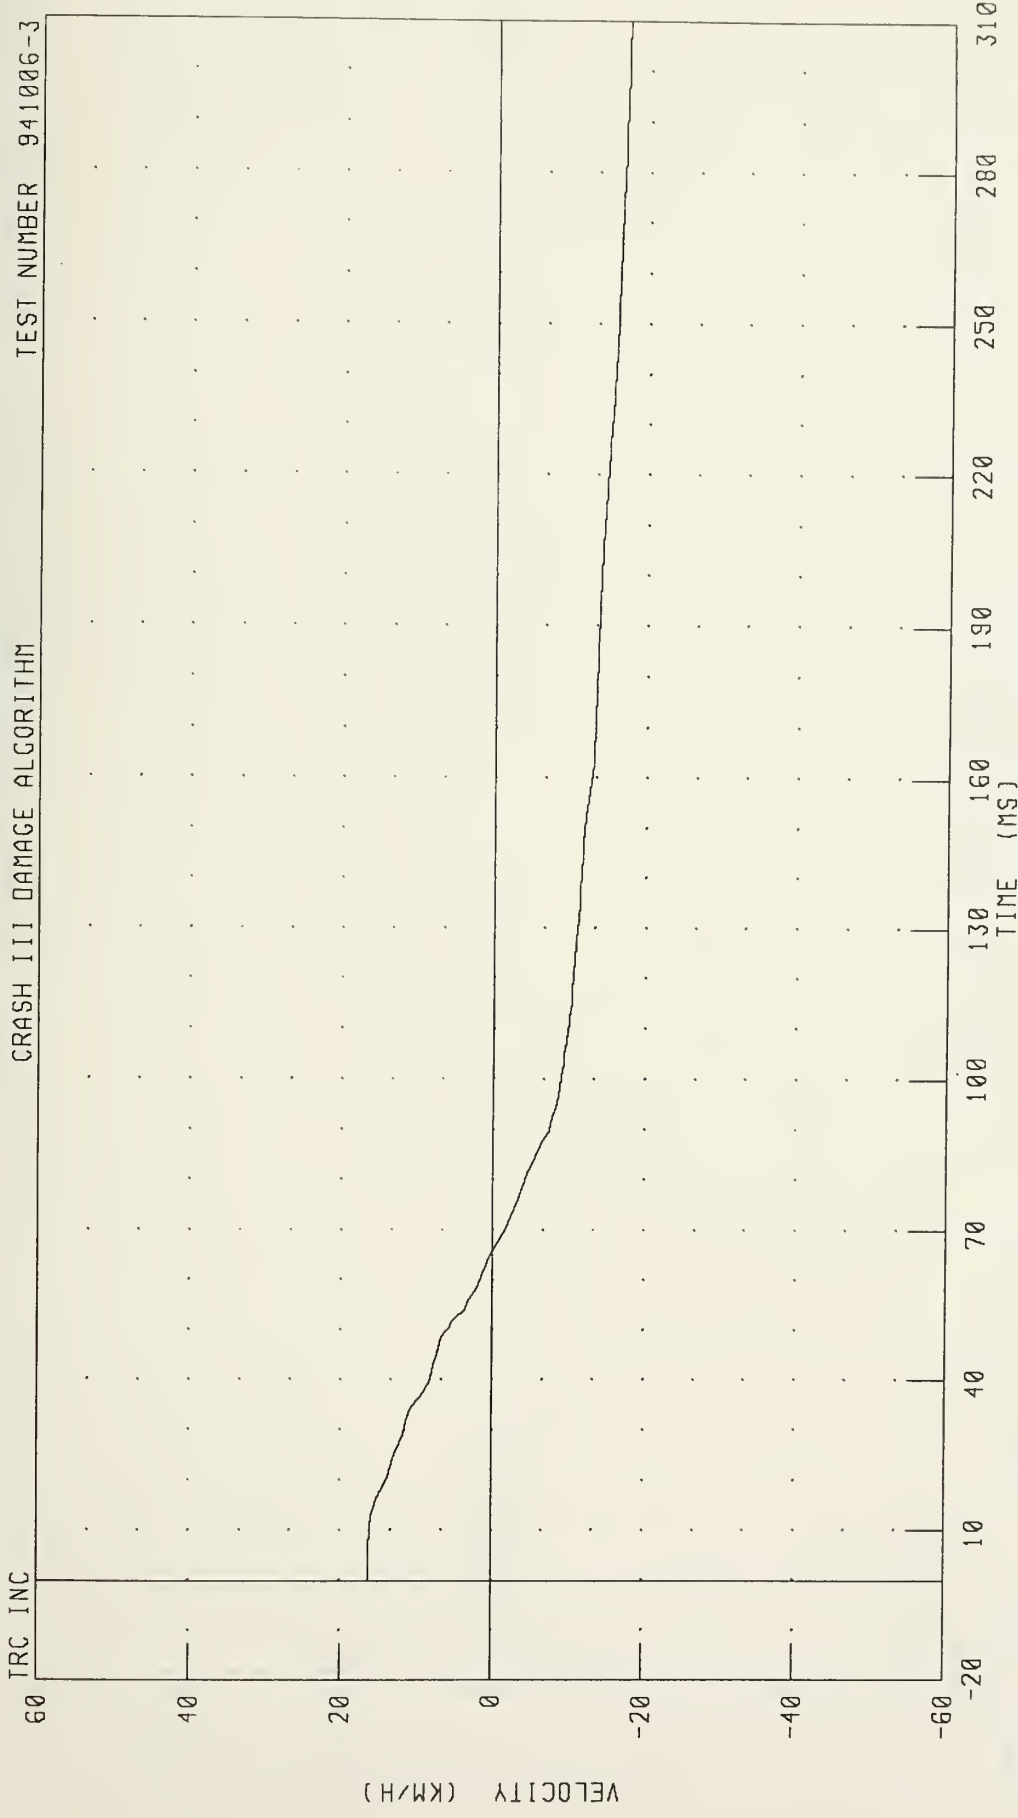
CHANNEL: VCGRV1 FILTER: CH. CLASS 180
PEAK DATA 16 30 KM/H @ 0.00 MS; -17.21 KM/H @ 310 00 MS

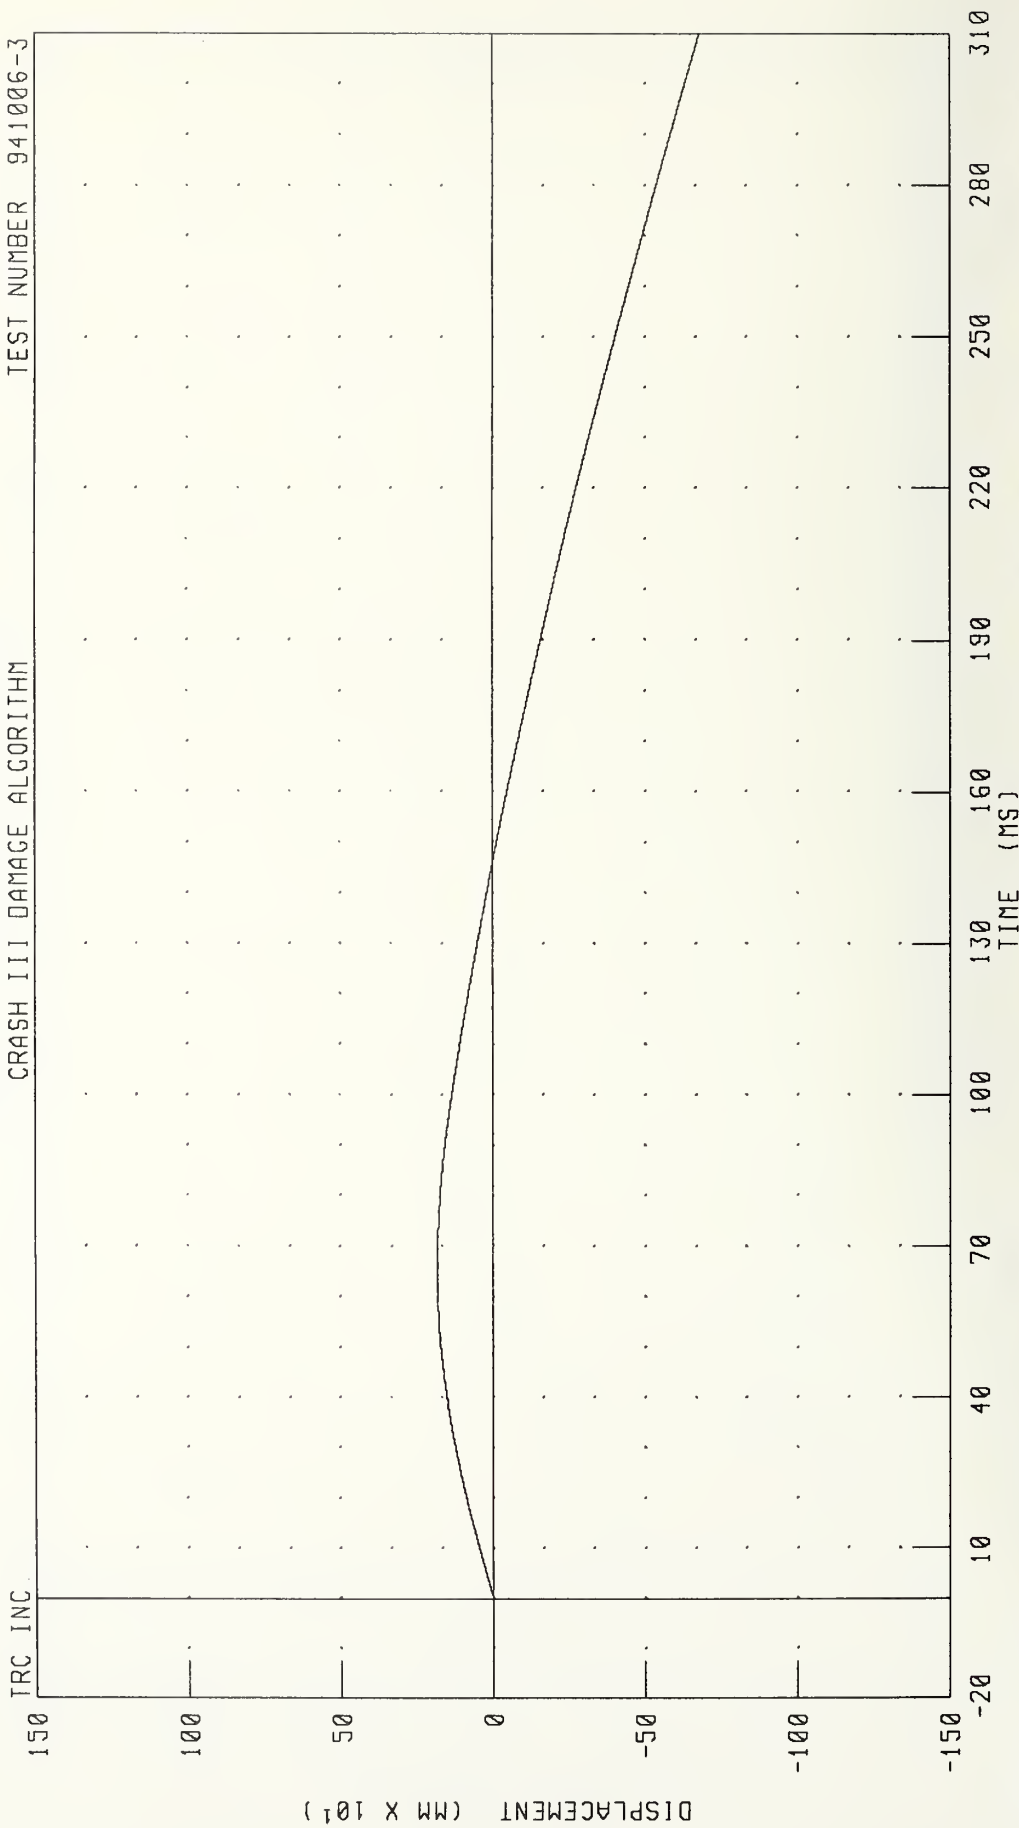
CHANNEL: VCGRD1 FILTER: CH CLASS 180
PEAK DATA: 183.25 MM @ 65.76 MS; -678.92 MM @ 310.00 MS

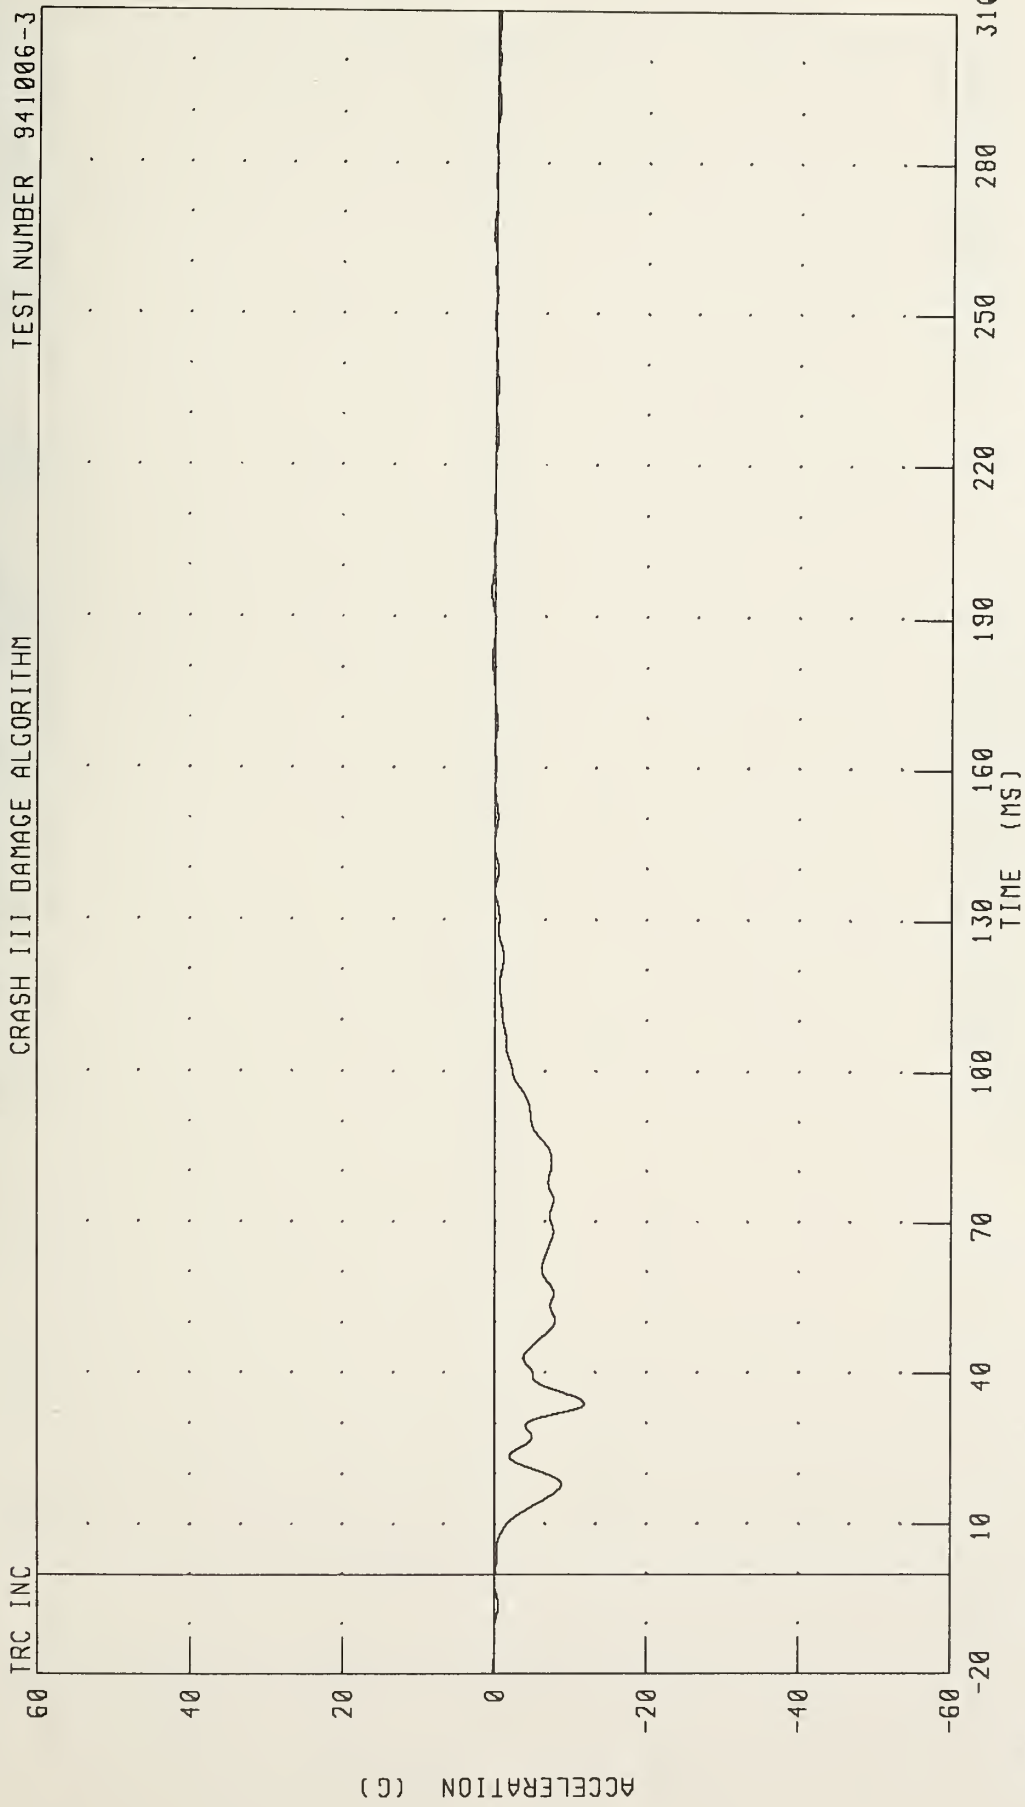
CHANNEL: LFSXG1 FILTER: CH. CLASS 60

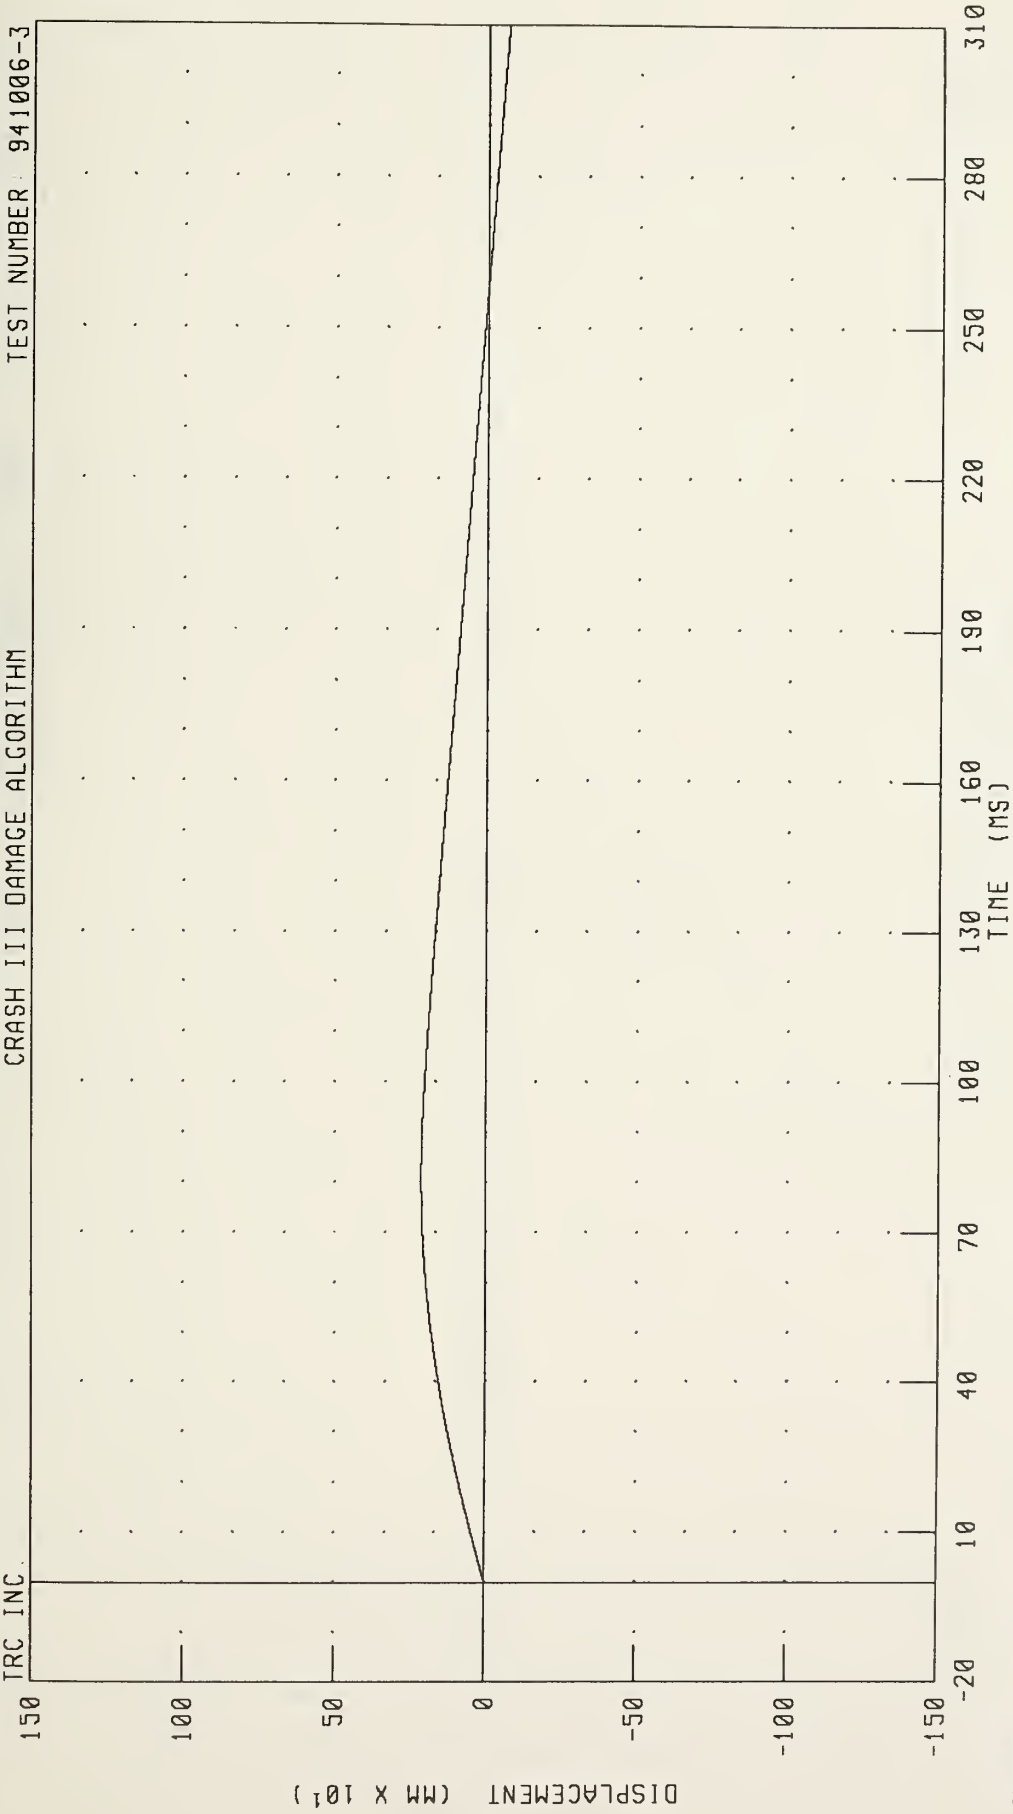
CHANNEL: LFSXD1 FILTER: CH. CLASS 180 PEAK DATA: 214.37 MM @ 80.88 MS; -68.45 MM @ 310.00 MS

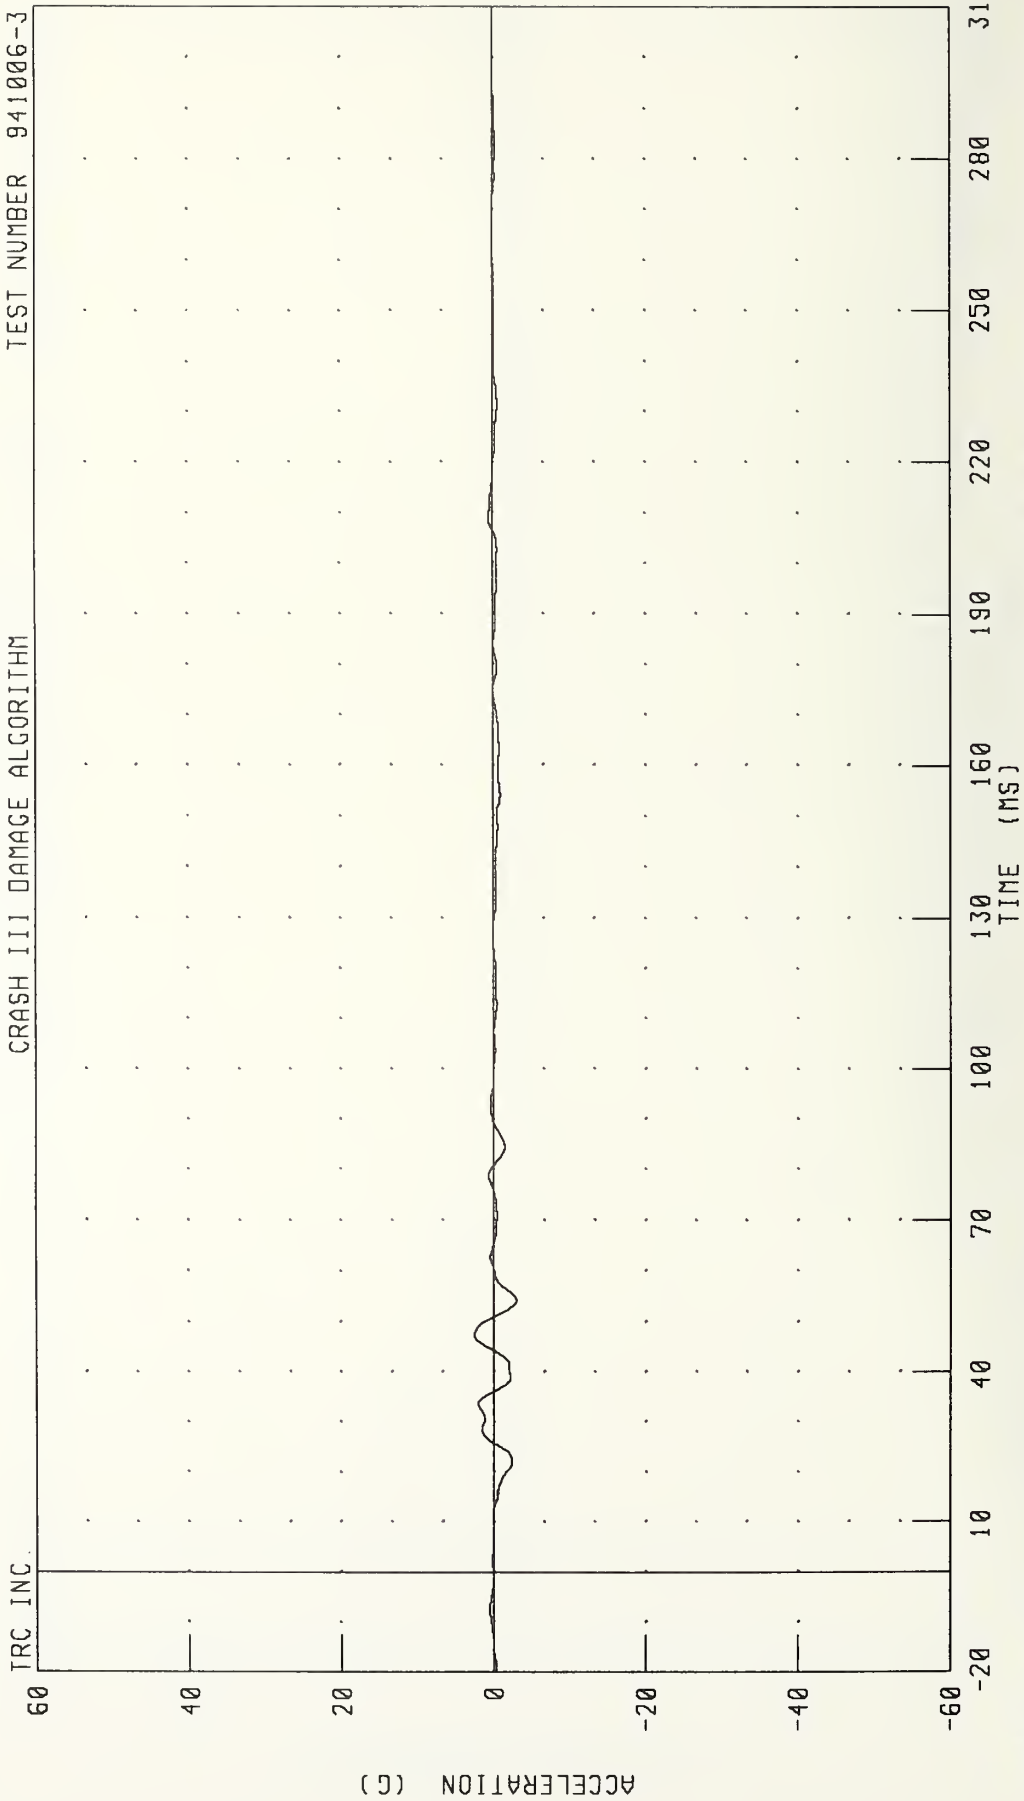
CHANNEL: LFSYG1 FILTER: CH. CLASS 60

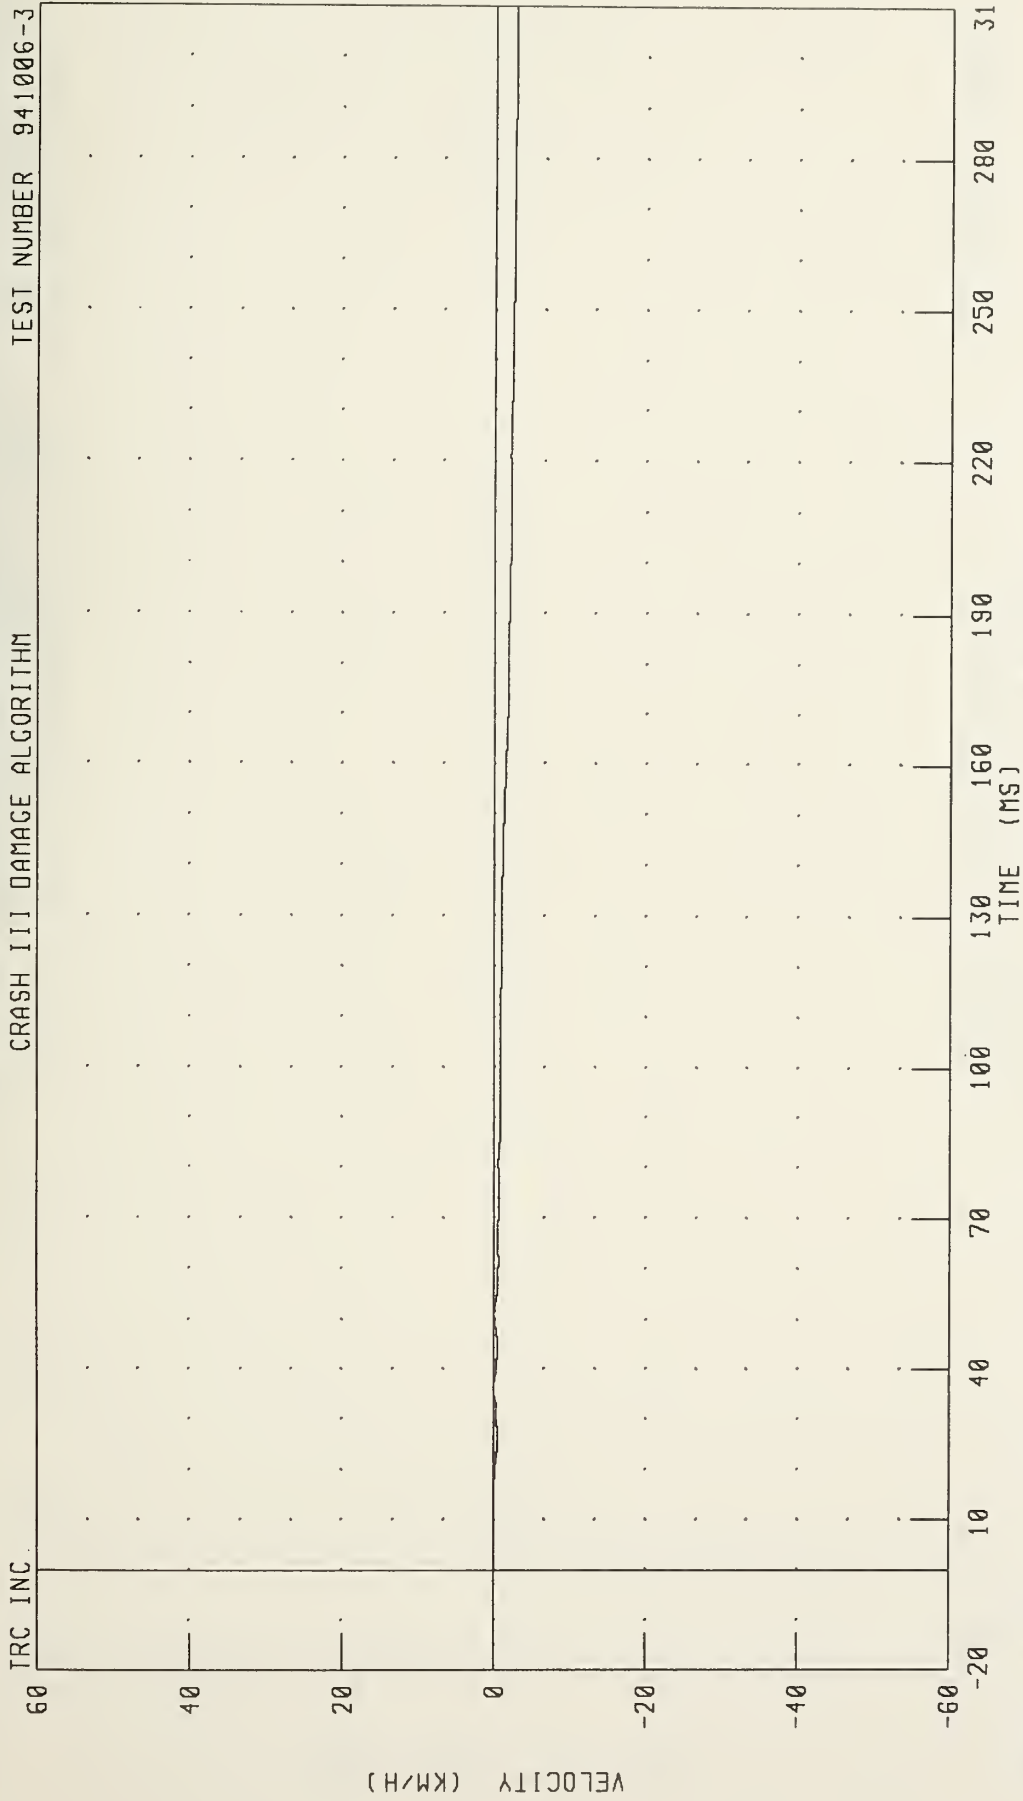
CHANNEL: LFSYV1 FILTER: CH. CLASS 180

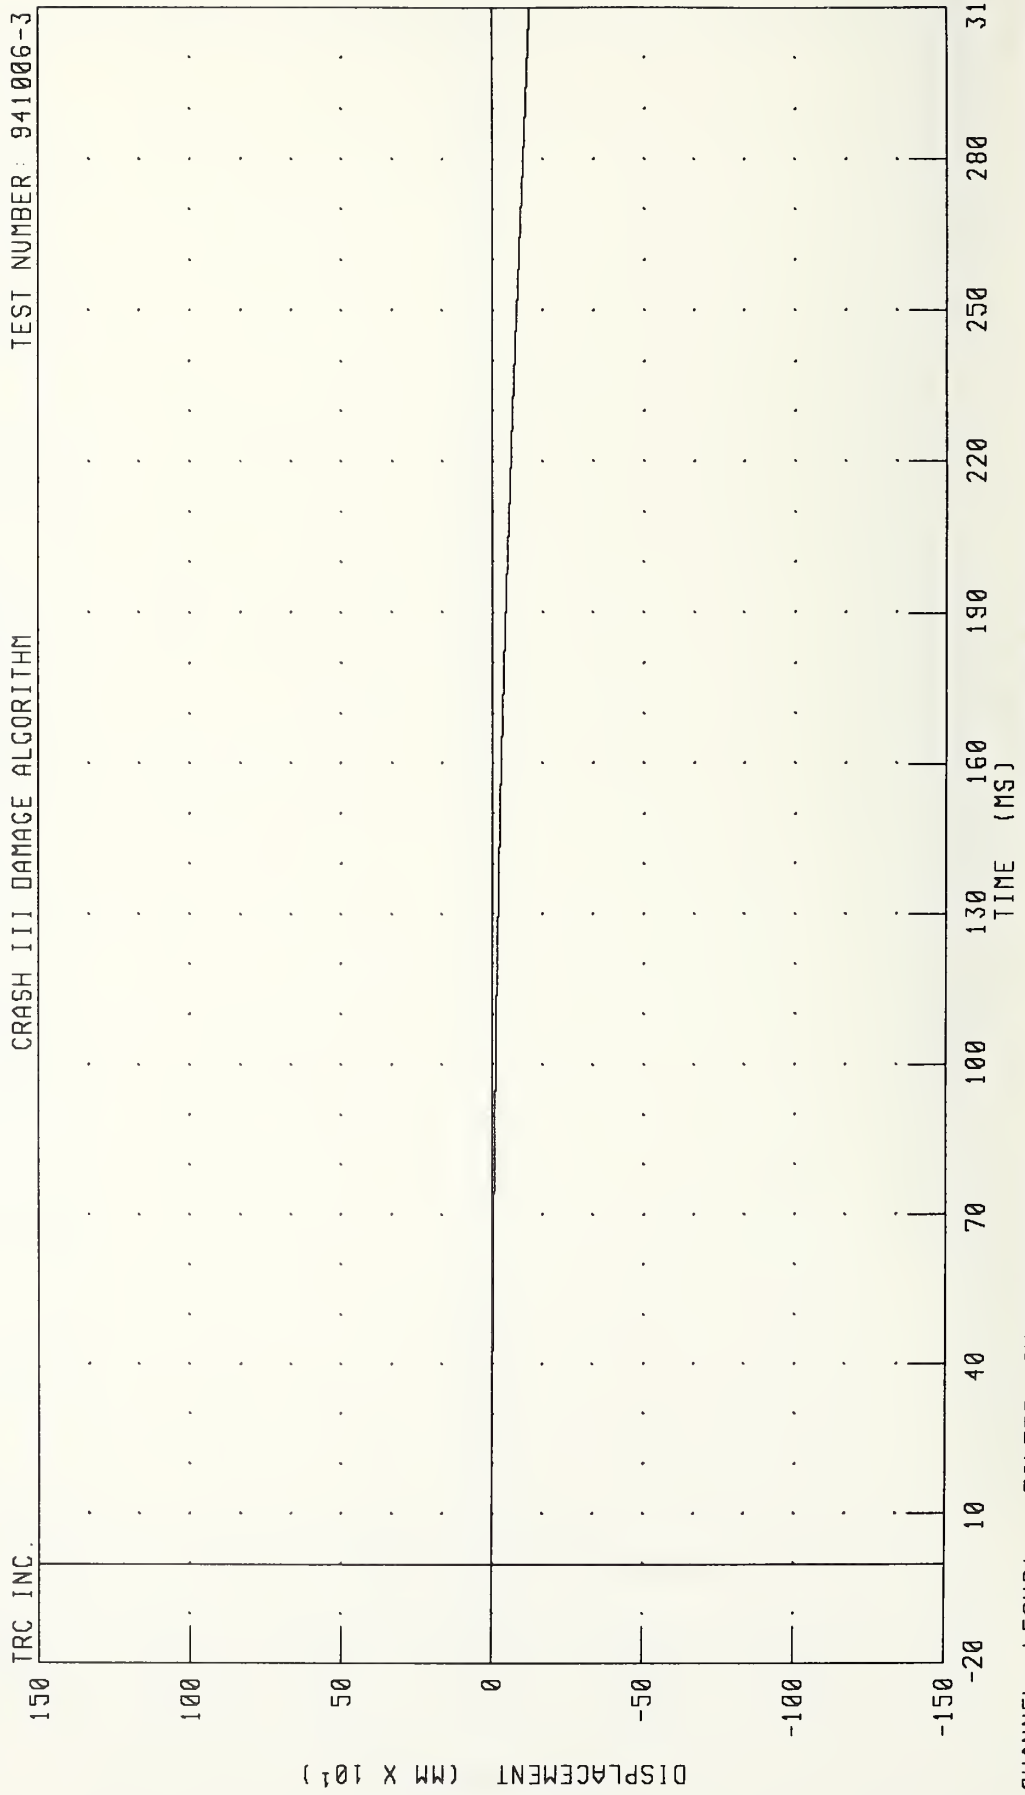
CHANNEL: LFSYD1 FILTER: CH. CLASS 180

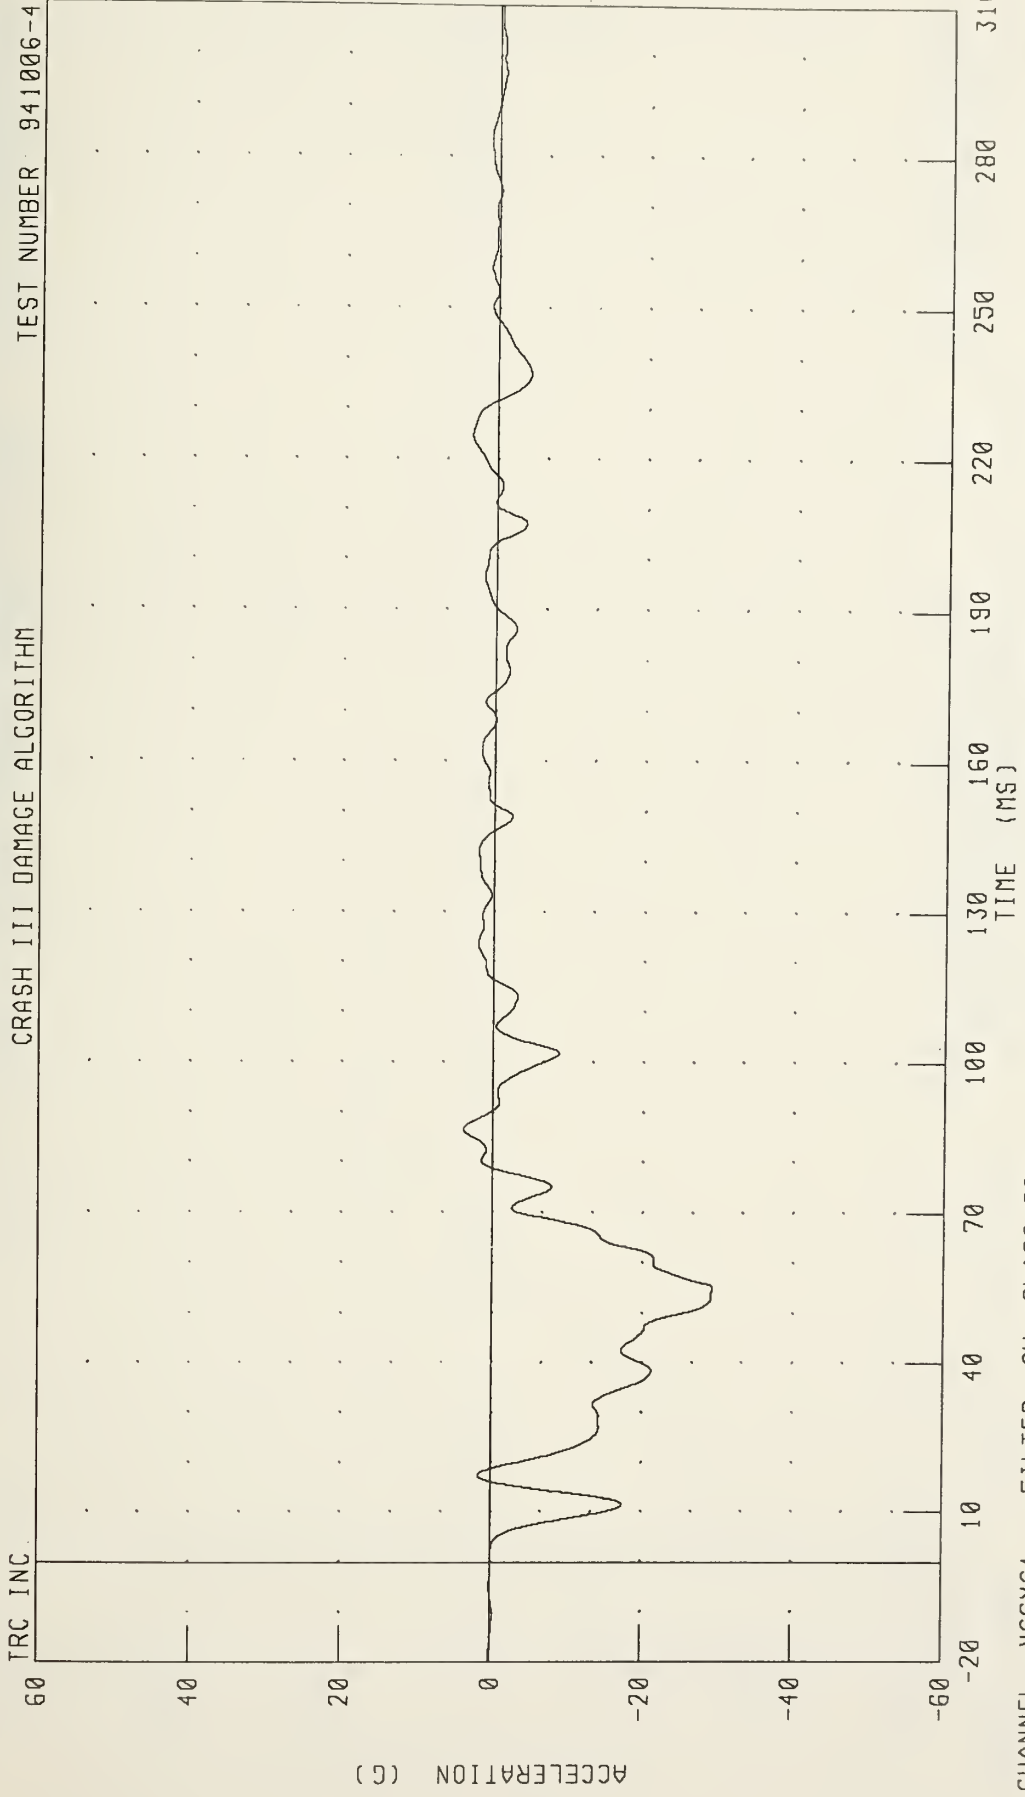
CHANNEL VCGXG1 FILTER: CH. CLASS 60
PEAK DATA: 390 G @ 86.64 MS; -2936 G @ 55.04 MS
