U.S. Department
of Transportation

**National Highway
Traffic Safety
Administration**

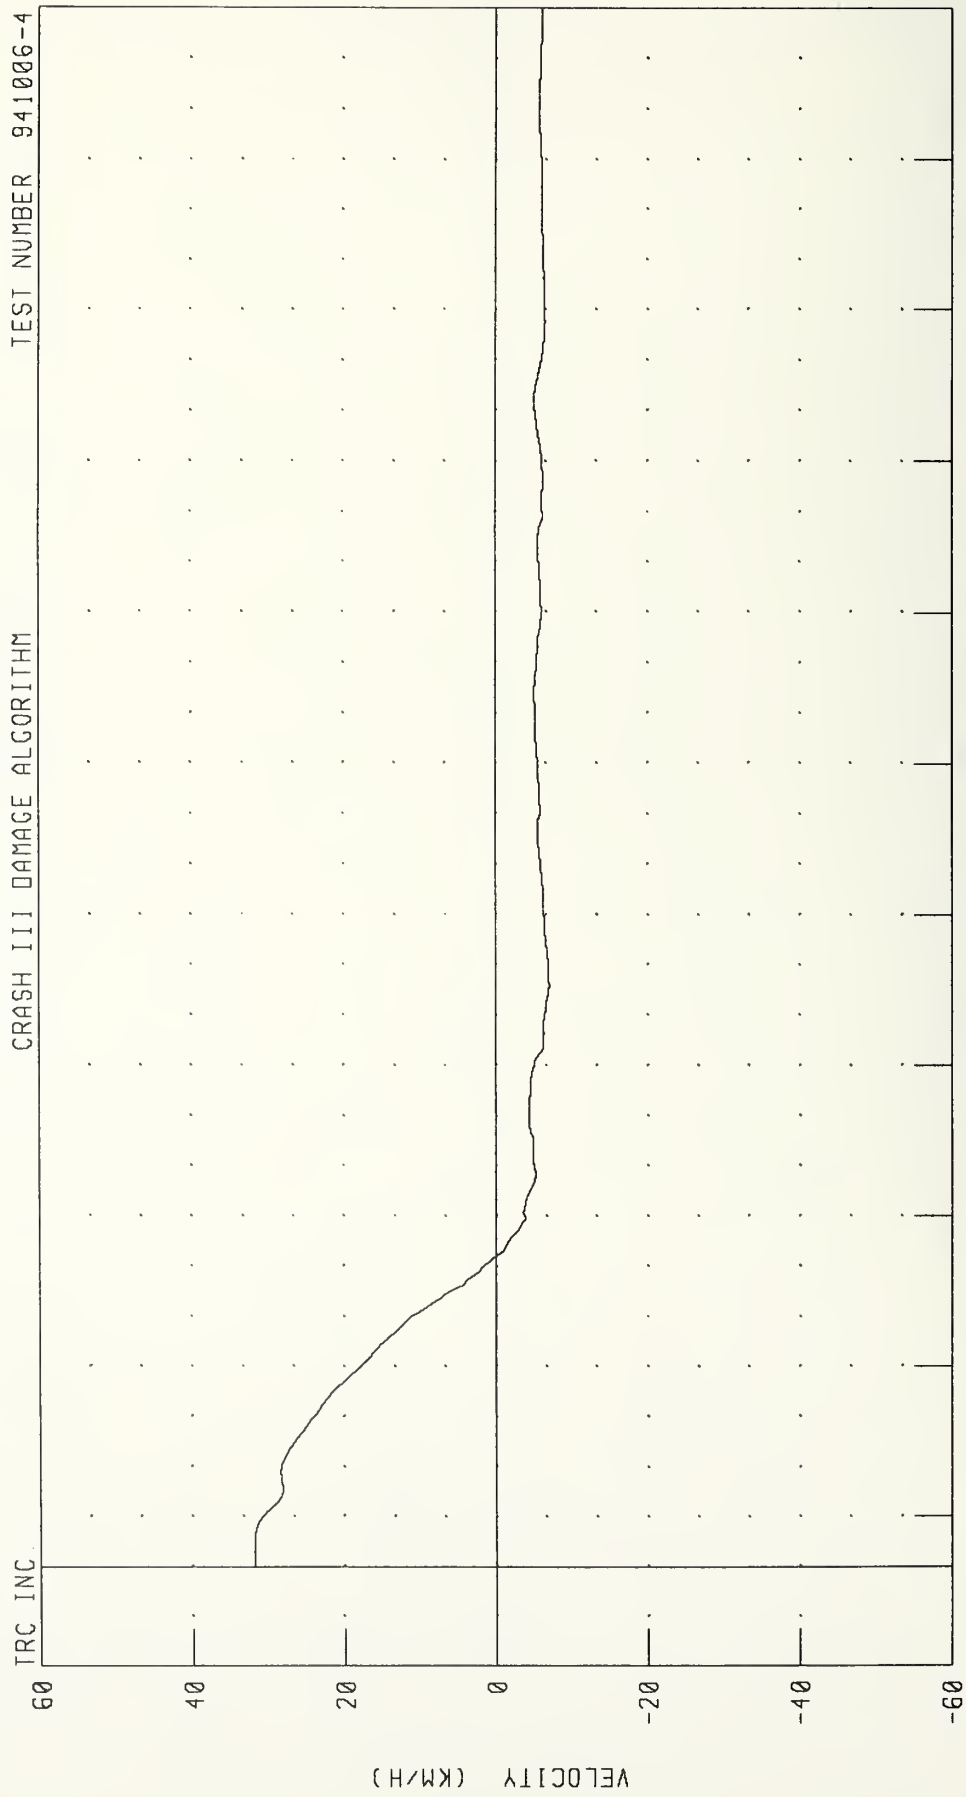
CHANNEL: VCGYV1 FILTER: CH. CLASS 180

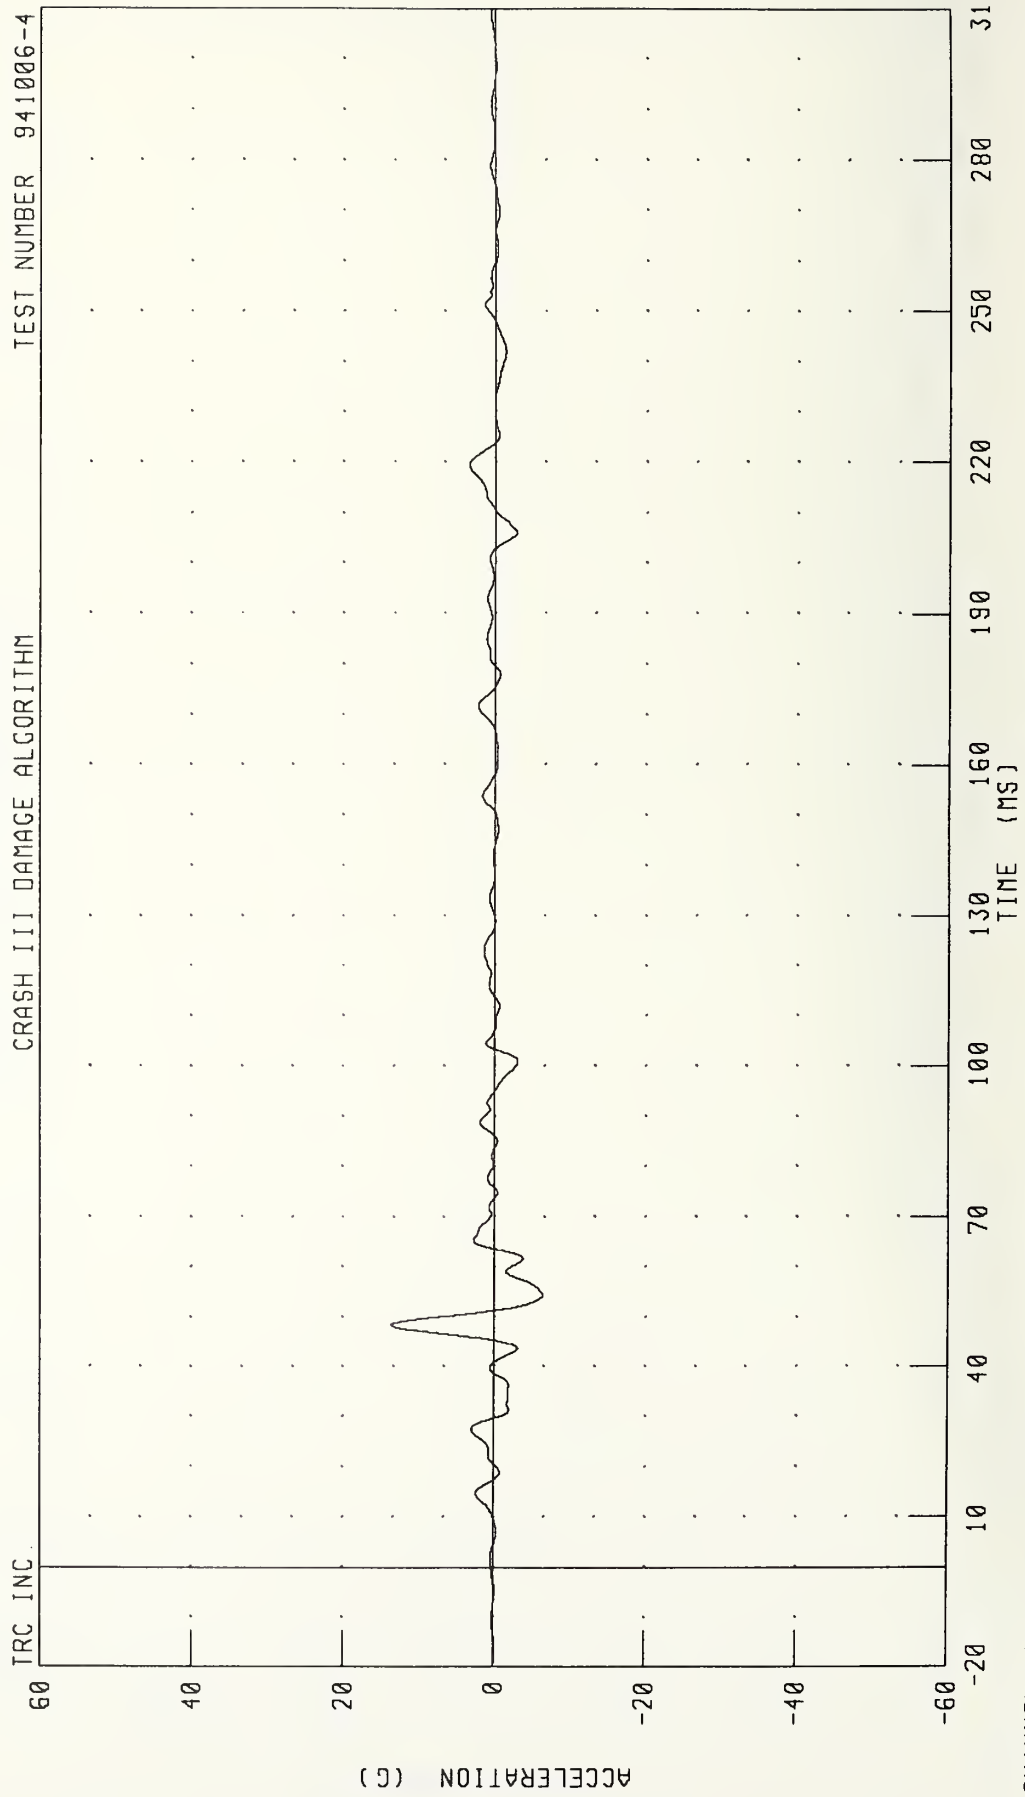
CHANNEL VCGY61 FILTER CH. CLASS 60

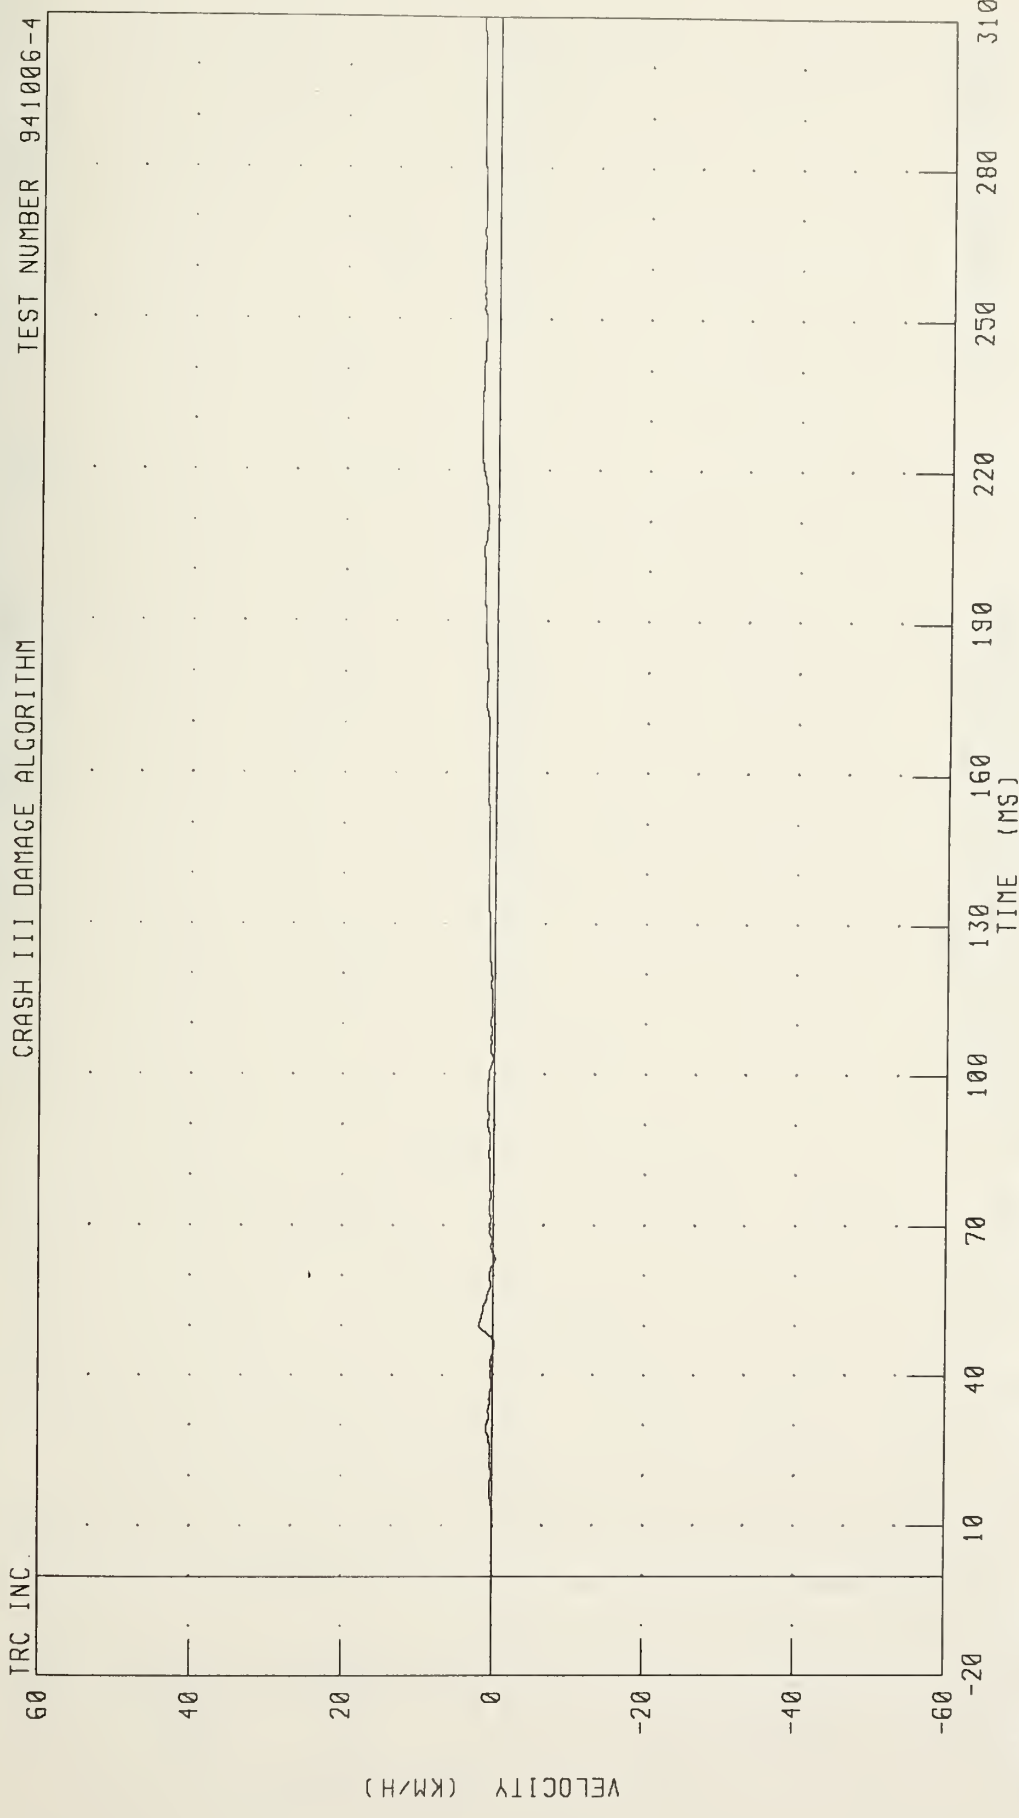
TRC INC. CHANNEL: VCGYV1 FILTER: CH CLASS 180
PEAK DATA: 2.24 KM/H @ 223.20 MS; -0.26 KM/H @ 63.44 MS

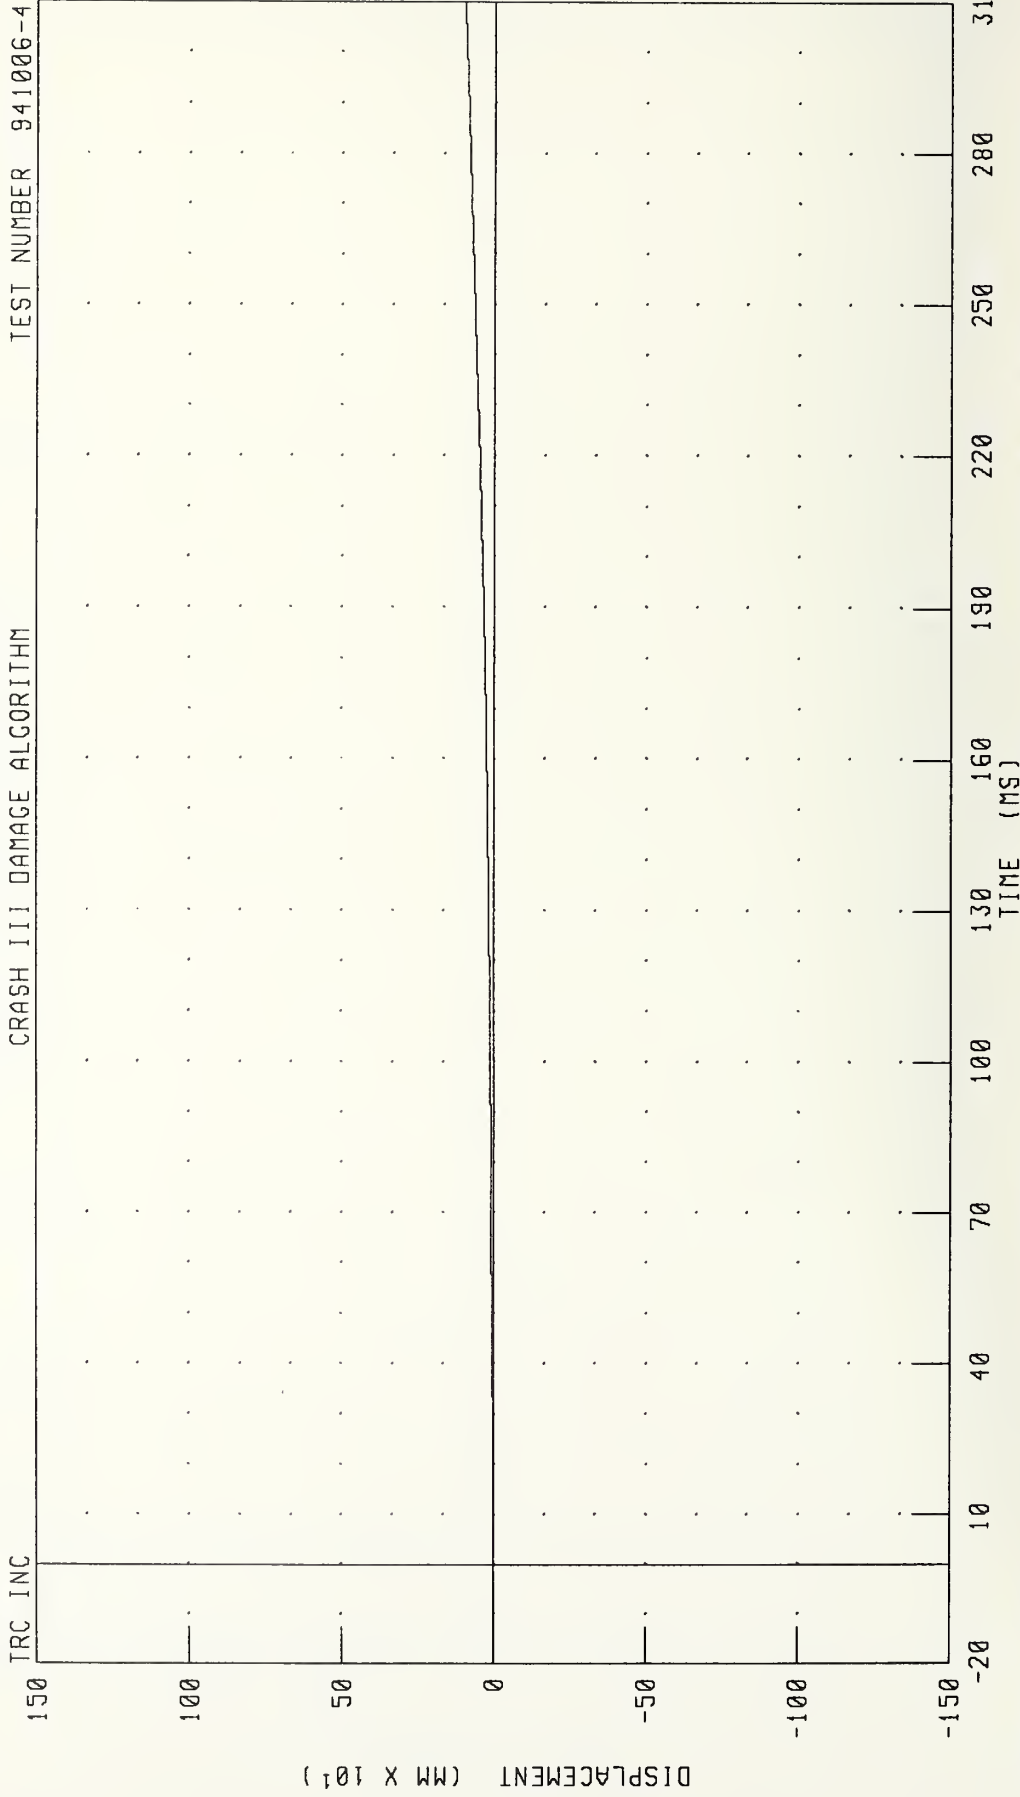
CHANNEL: VCCYD1 FILTER: CH CLASS 180 PEAK DATA: 98.02 MM @ 310.00 MS, 0.00 MM @ 0.00 MS

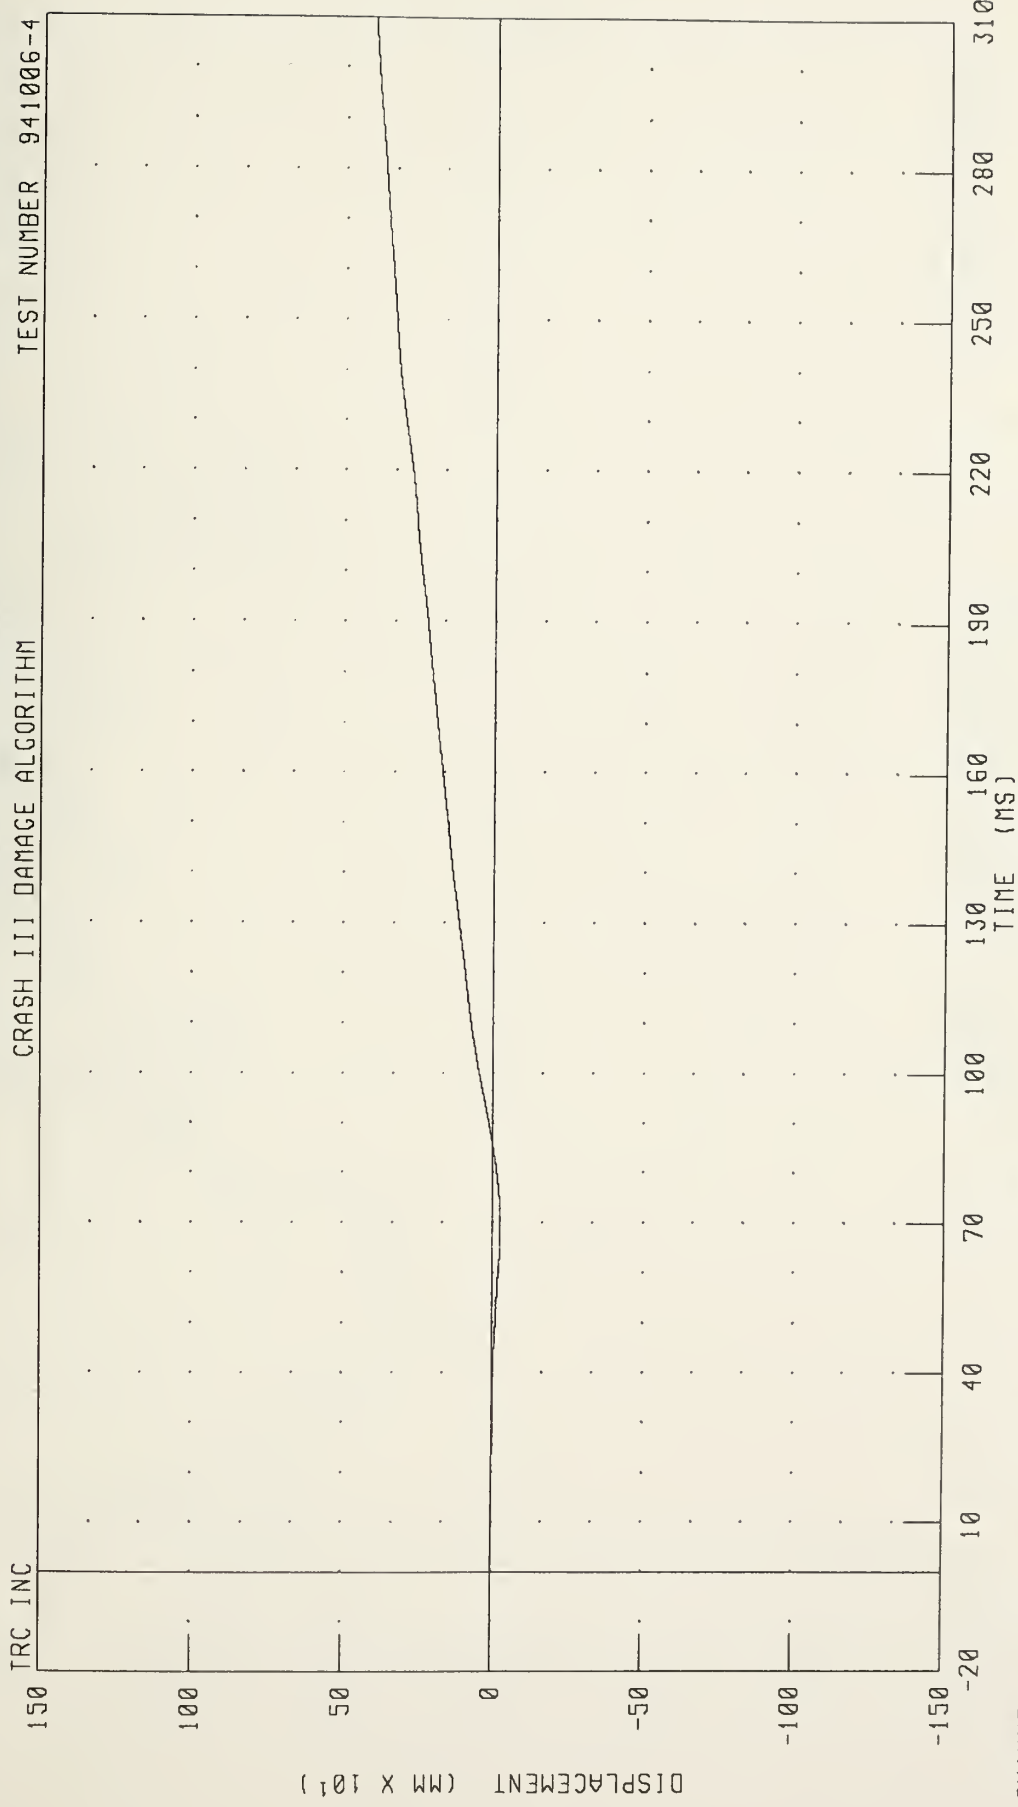
CHANNEL: VCGZ01 FILTER: CH CLASS 180 PEAK DATA: 408 37 MM @ 310 00 MS, -27 13 MM @ 69 04 MS

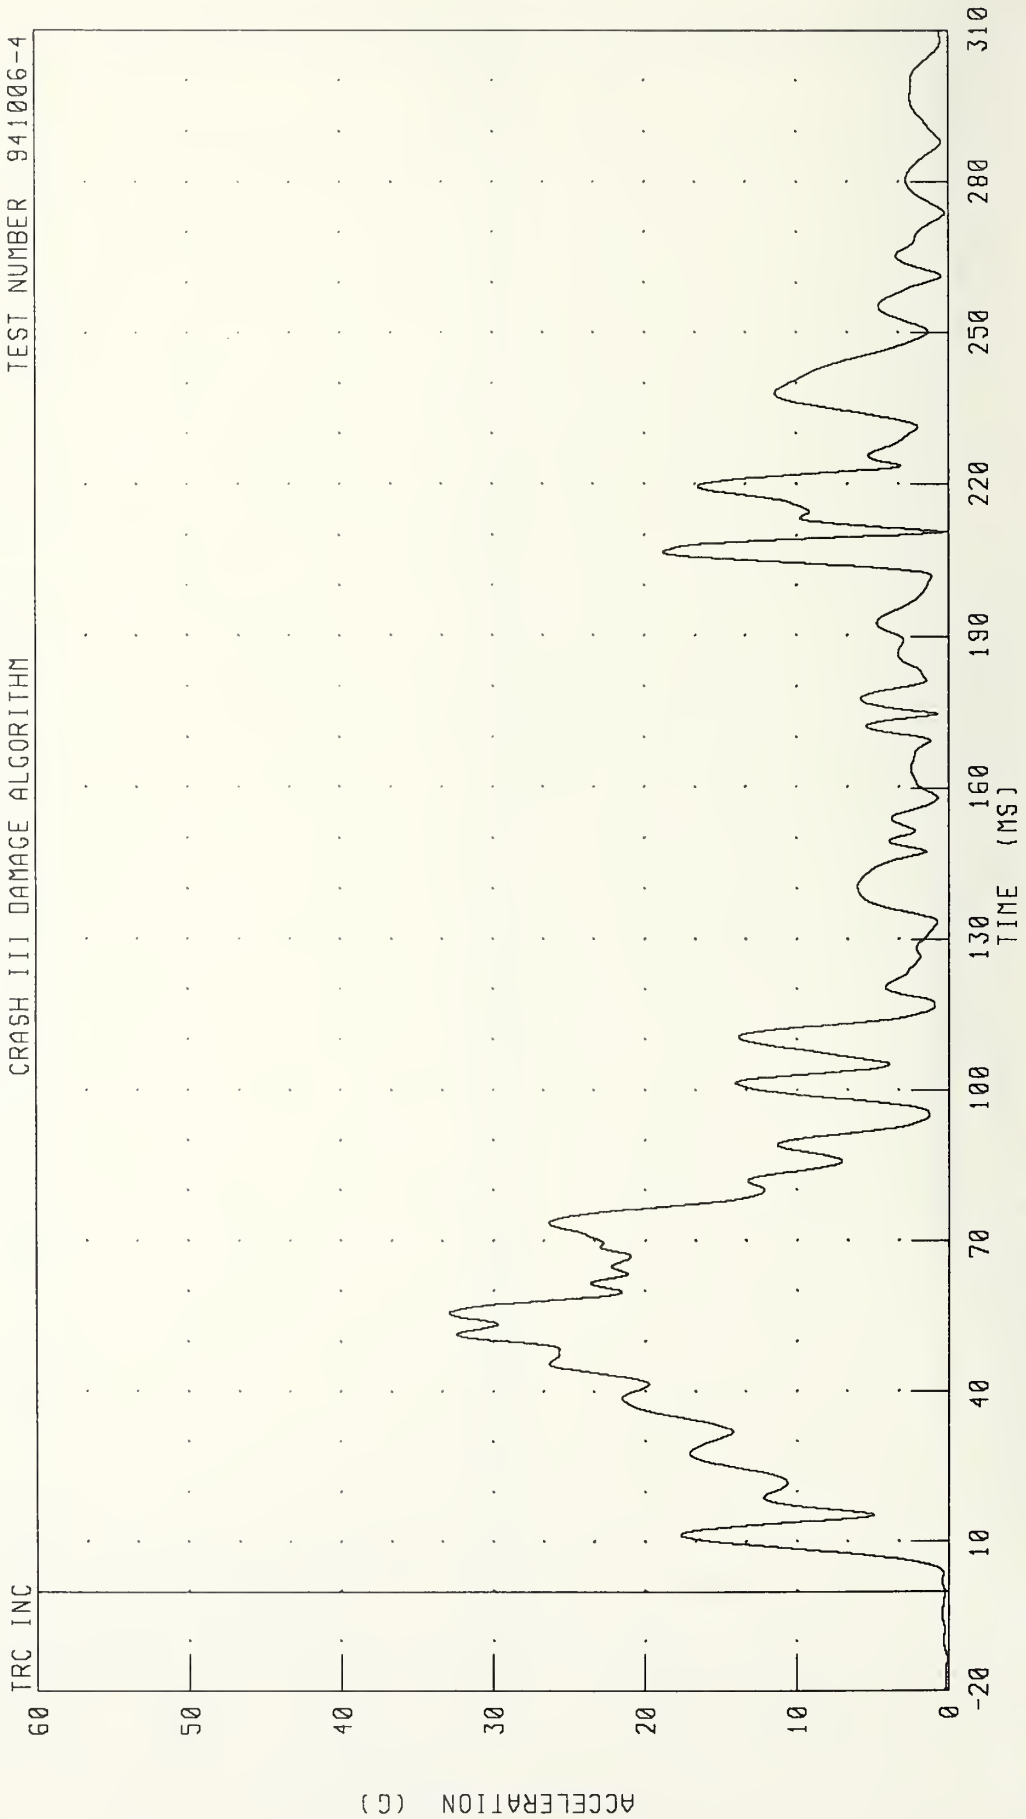
CHANNEL: VCGRG1 FILTER: CH CLASS 60

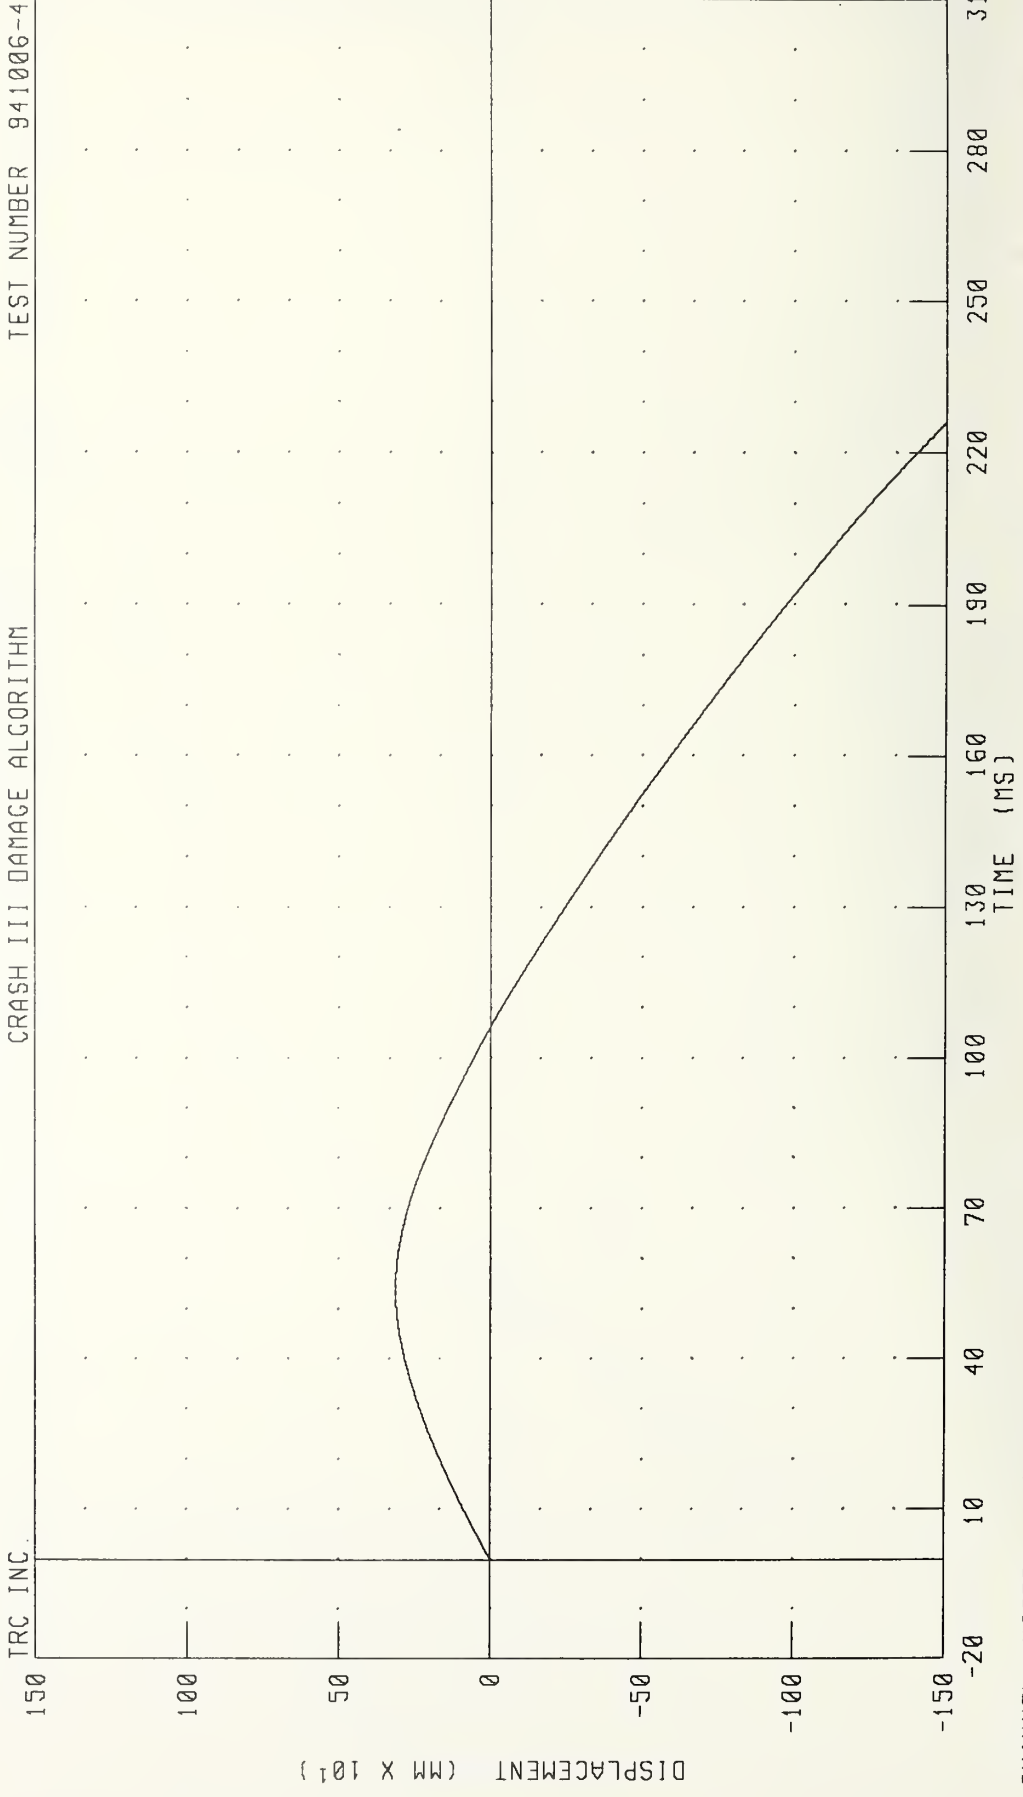
CHANNEL: VCGRD1 FILTER: CH. CLASS 180

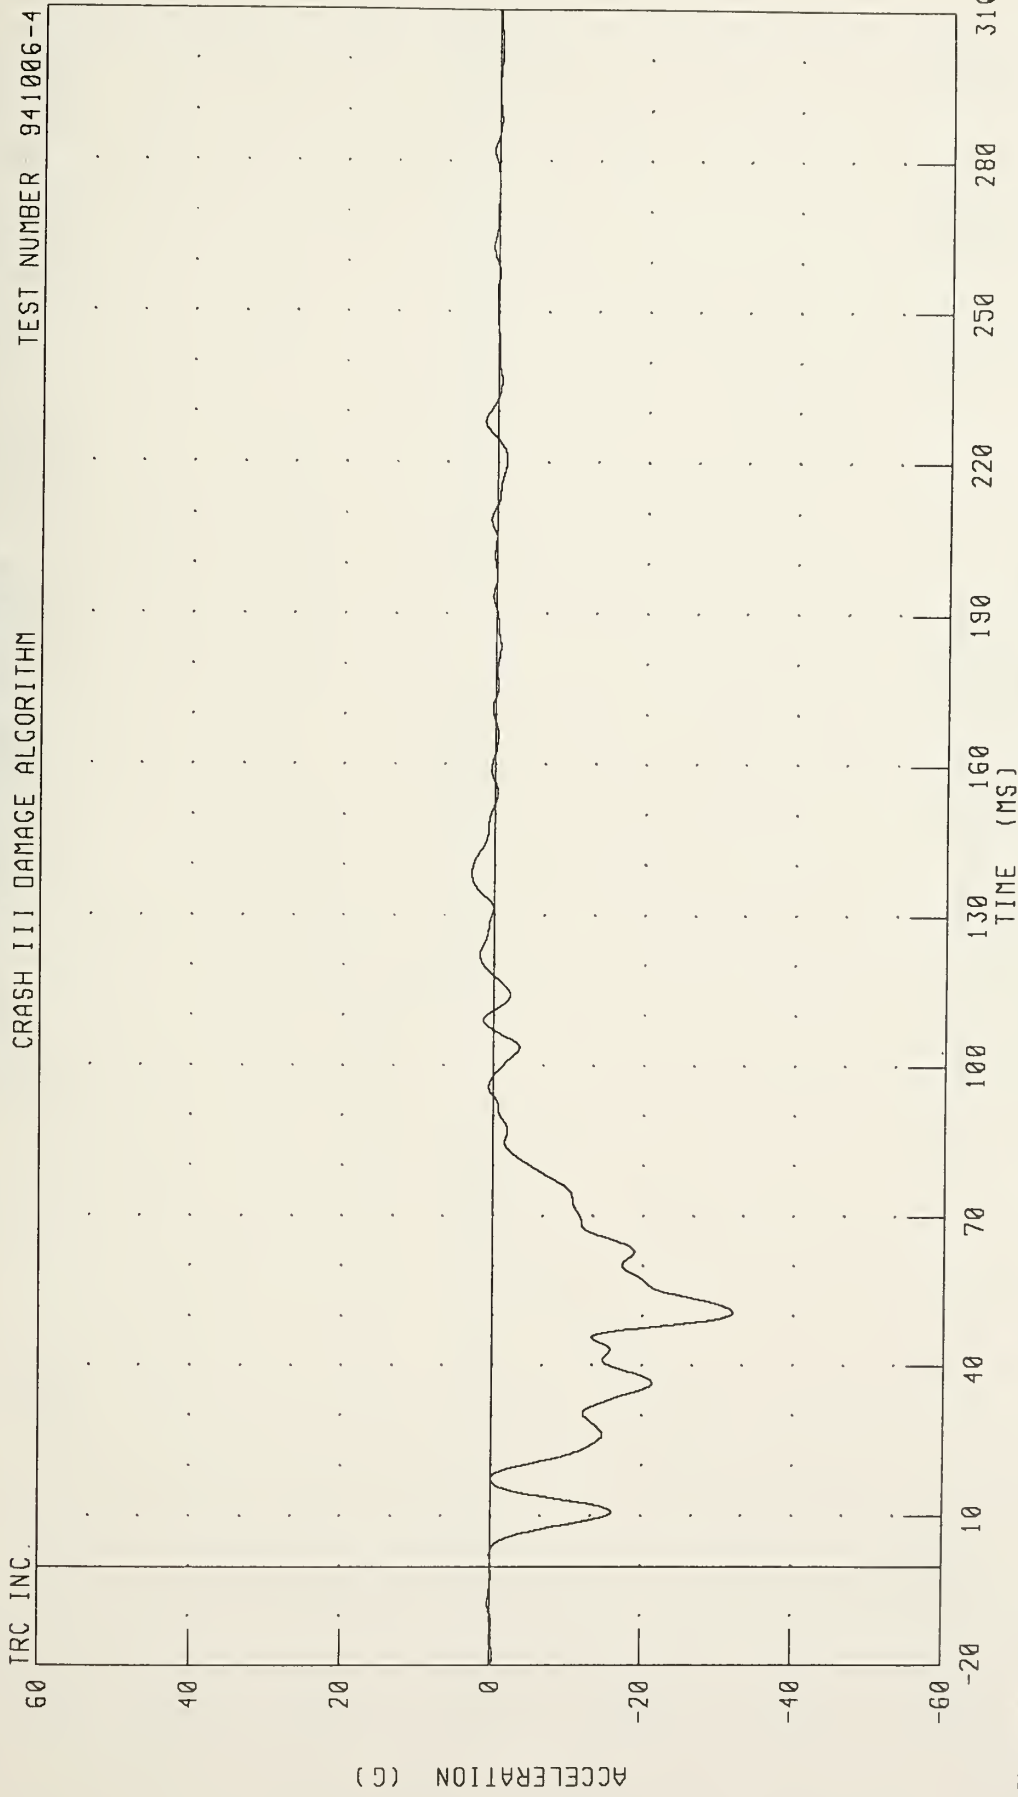
CHANNEL: LFSXG1 FILTER: CH CLASS 60

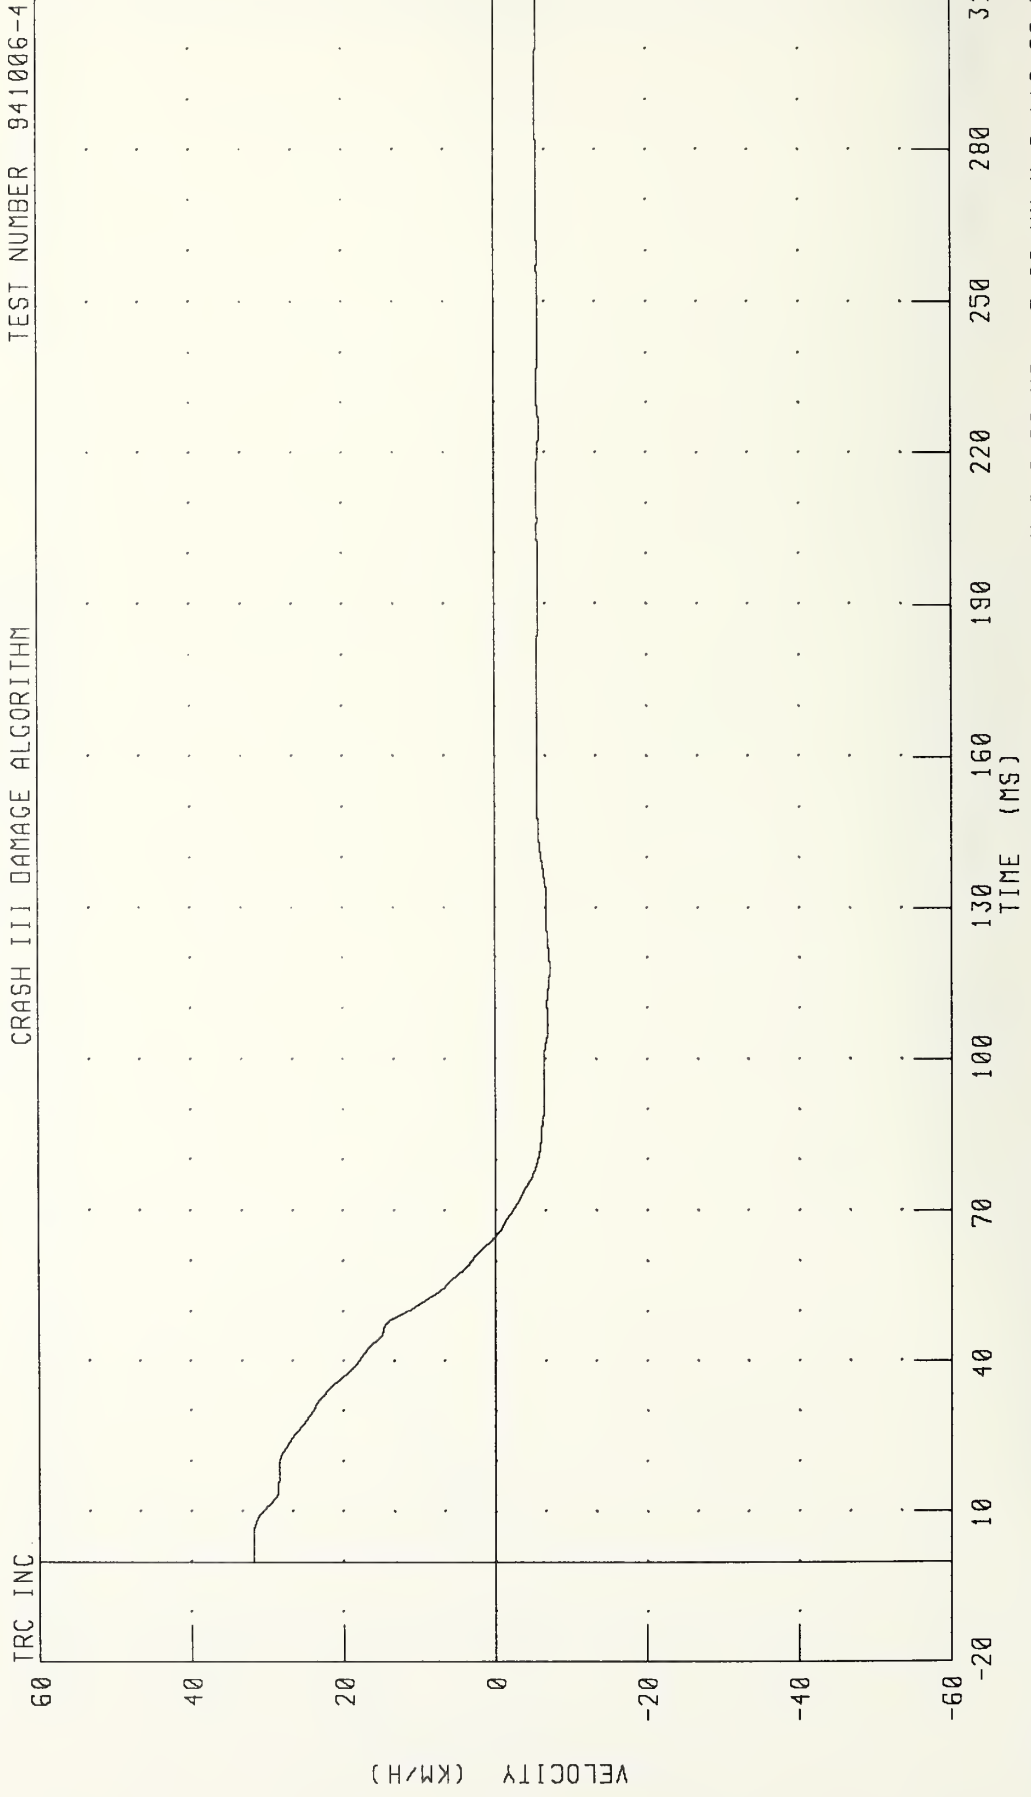
CHANNEL: LFSXV1 FILTER: CH. CLASS 180

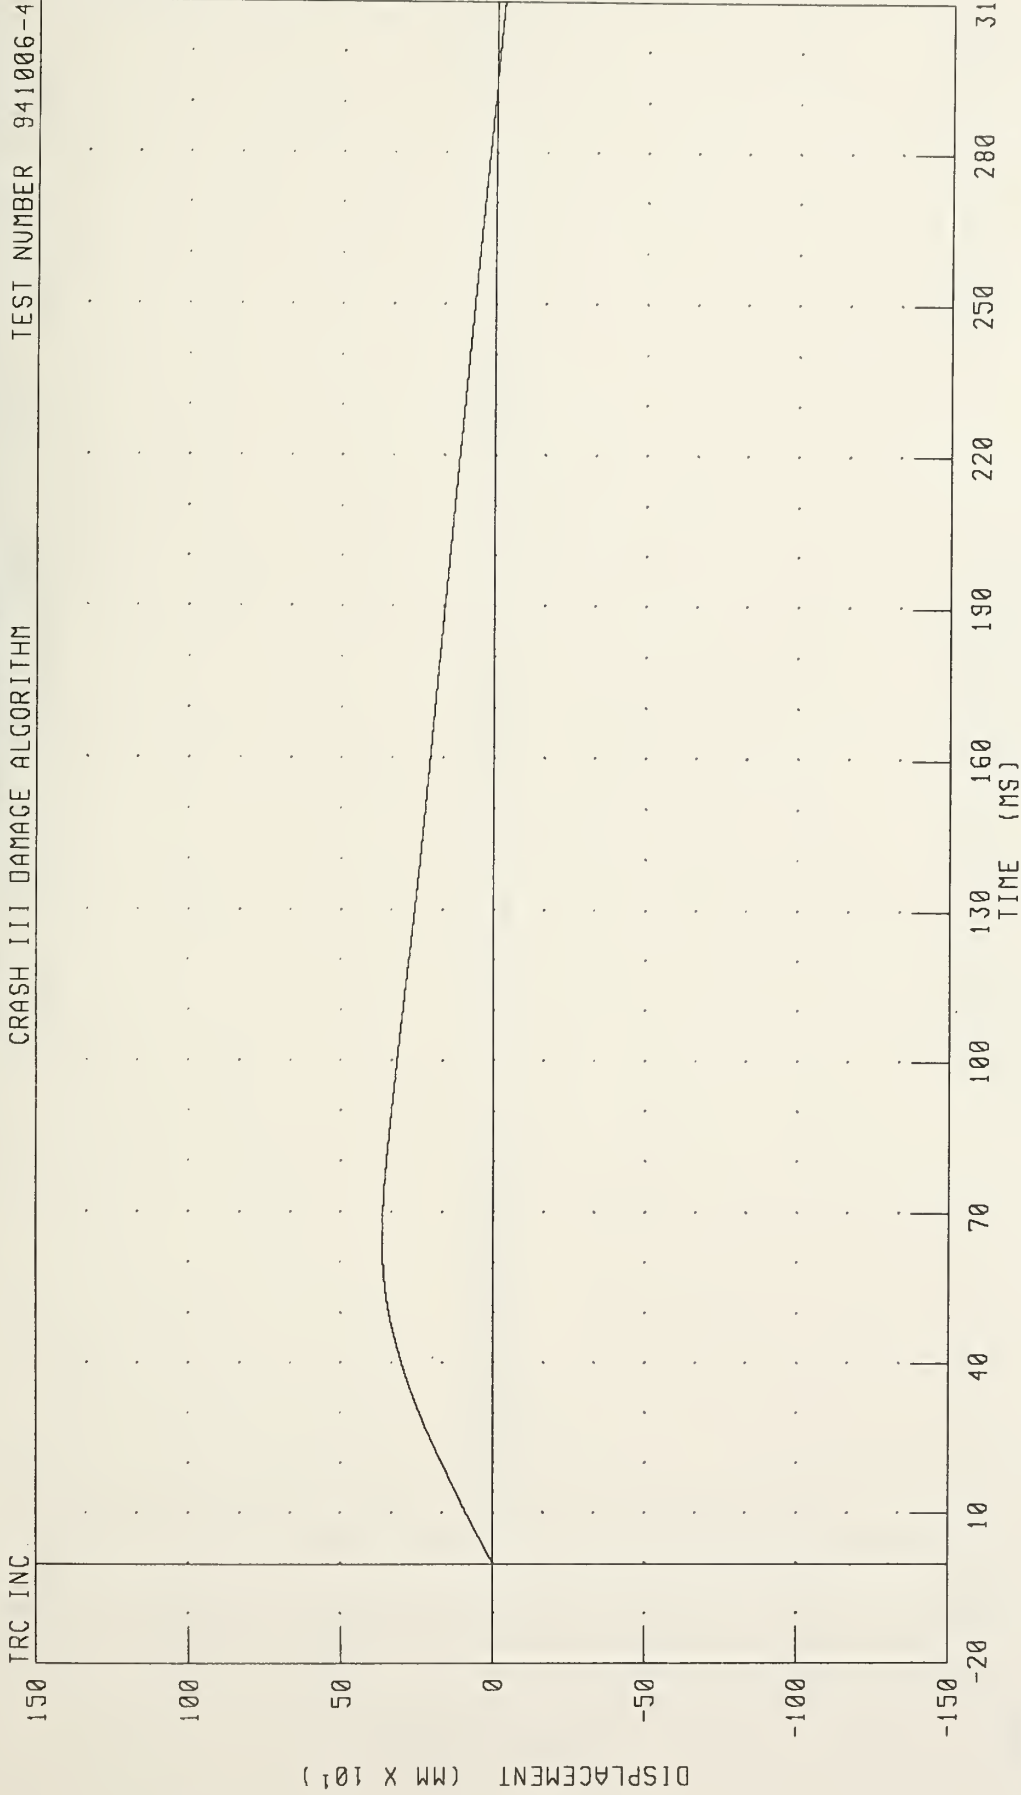
CHANNEL: LFSXD1 FILTER: CH. CLASS 180

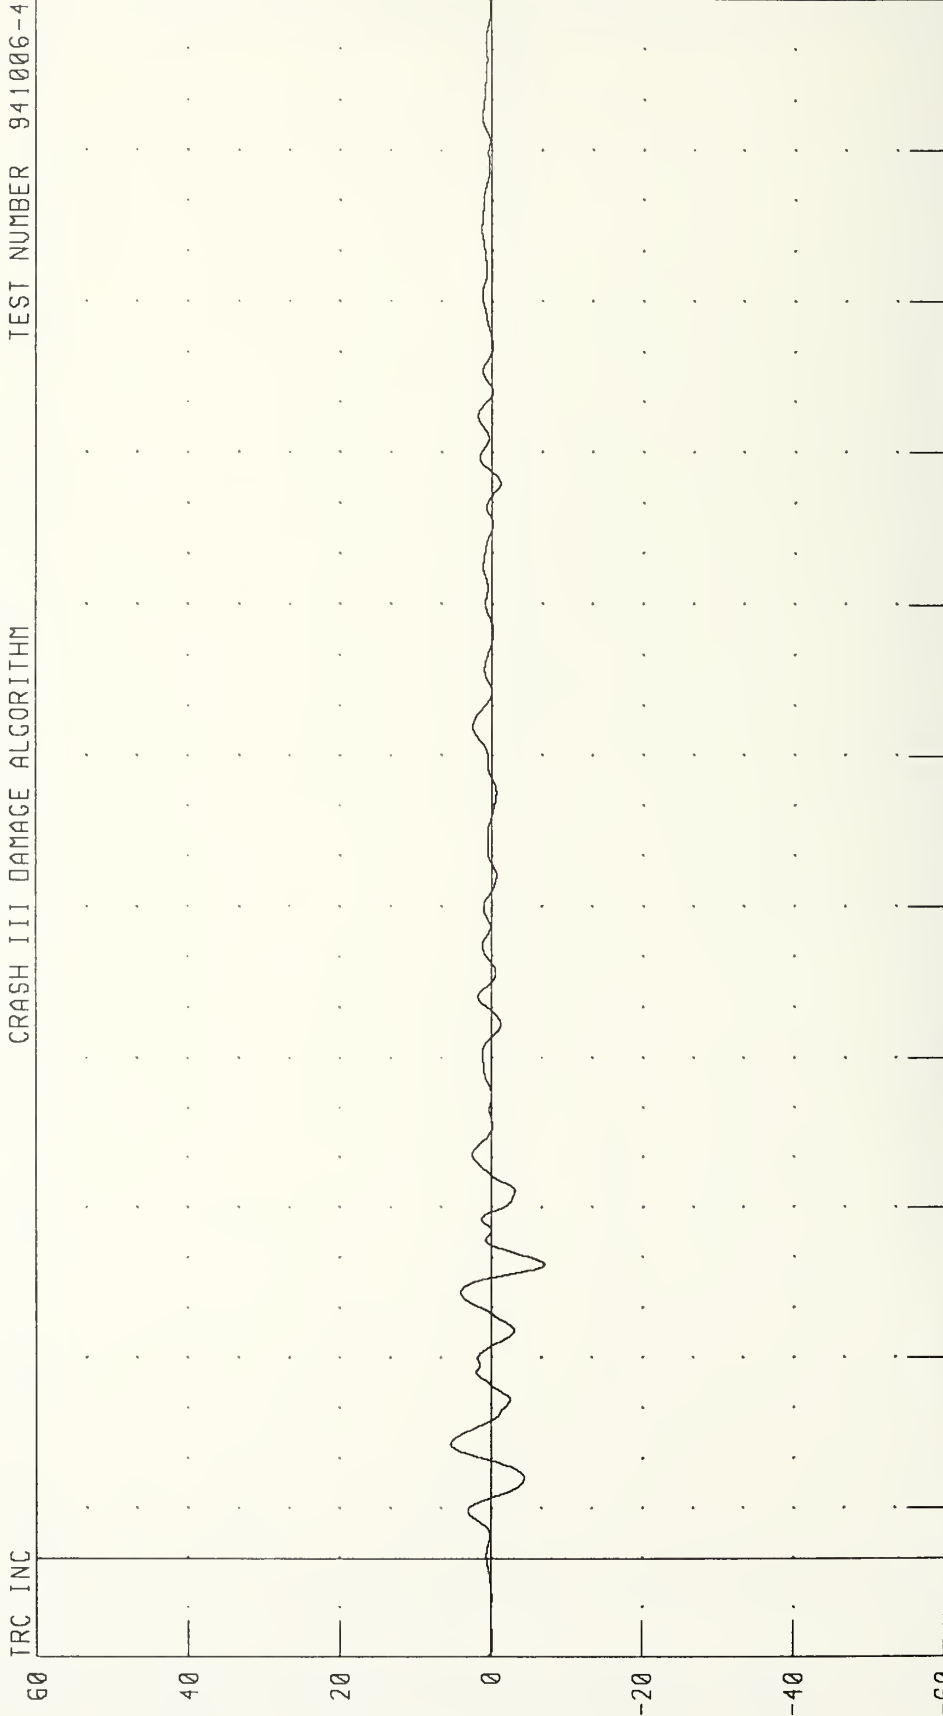
CHANNEL: LFSYG1 FILTER: CH. CLASS 60

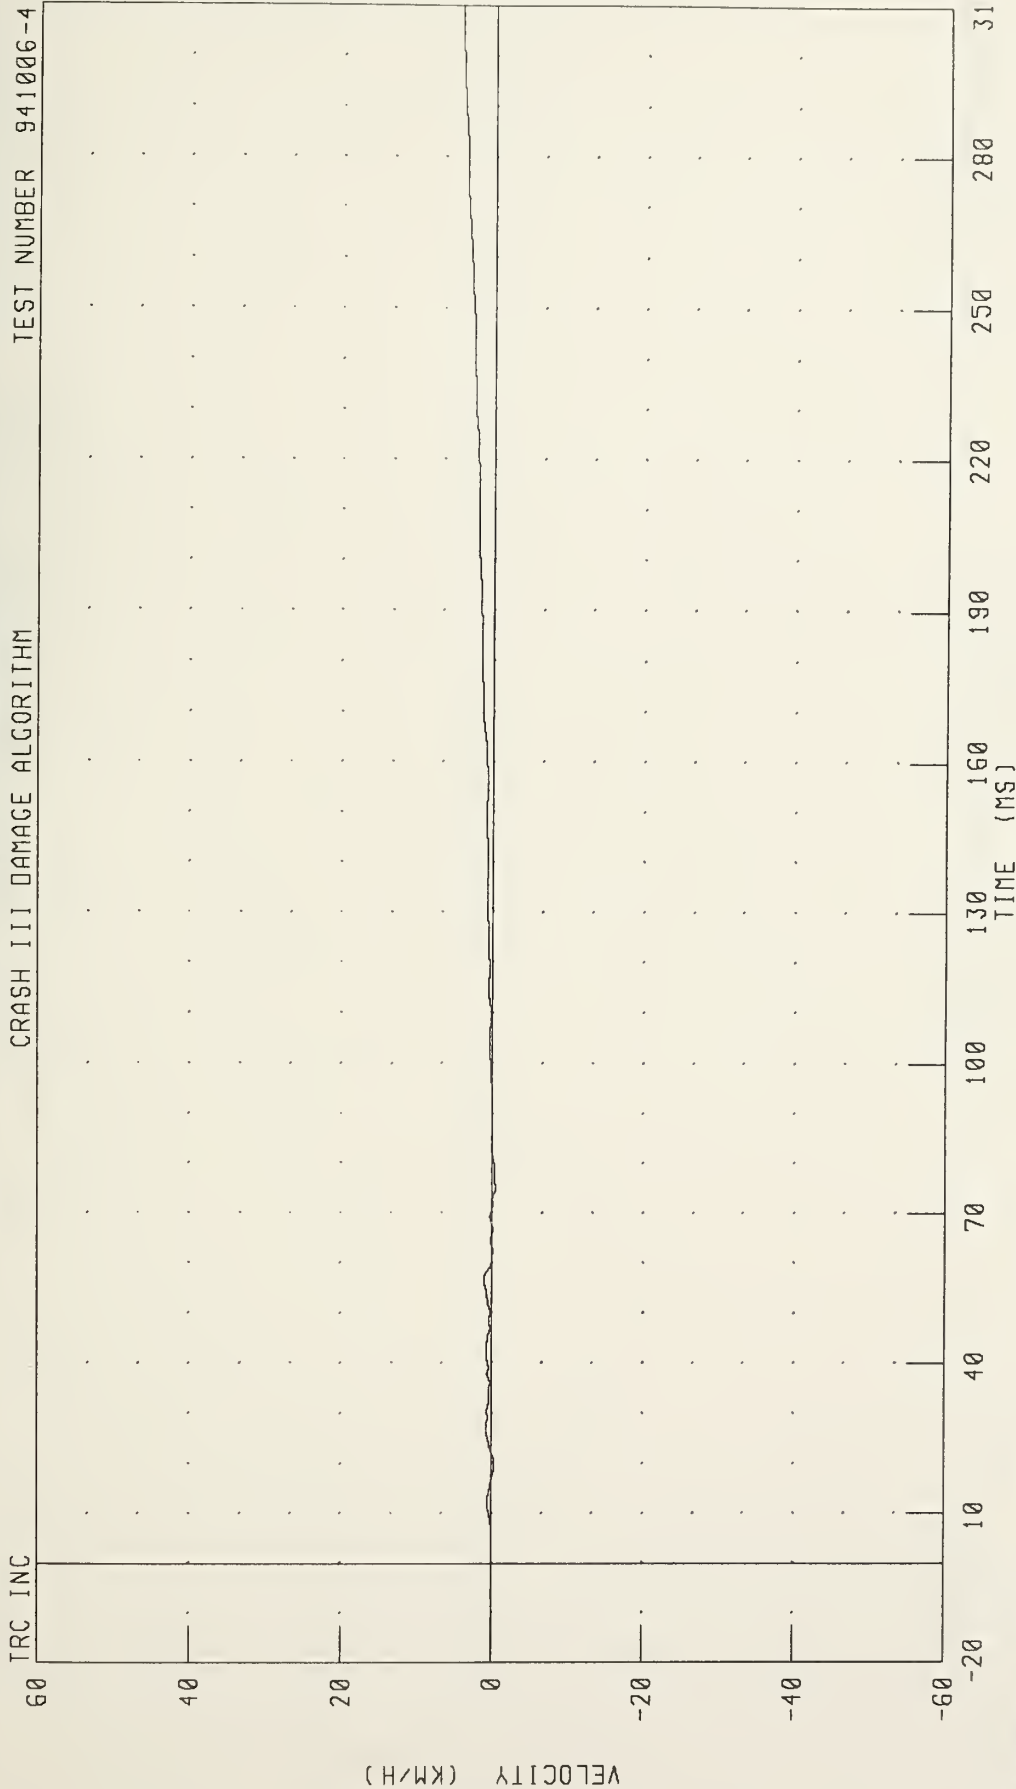
CHANNEL: LFSYV1 FILTER: CH. CLASS 180
