U.S. Department
of Transportation

**National Highway
Traffic Safety
Administration**

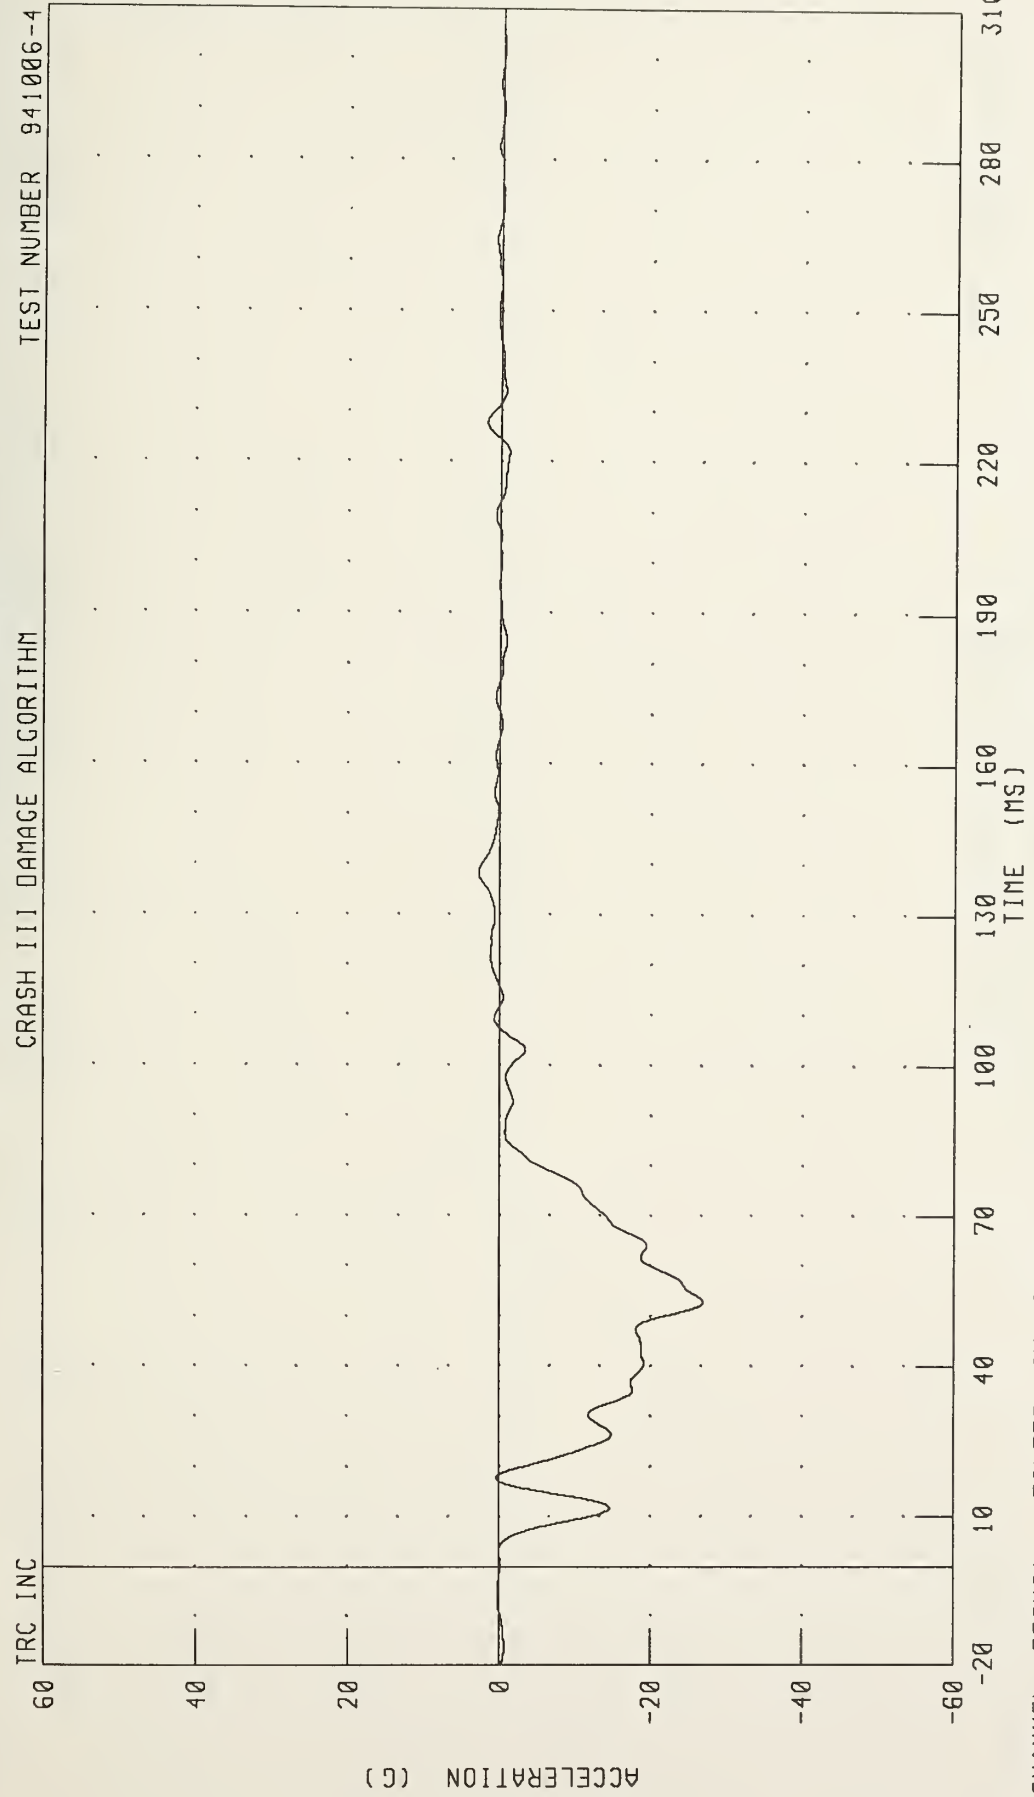
CHANNEL: RFSXG1 FILTER: CH. CLASS 60

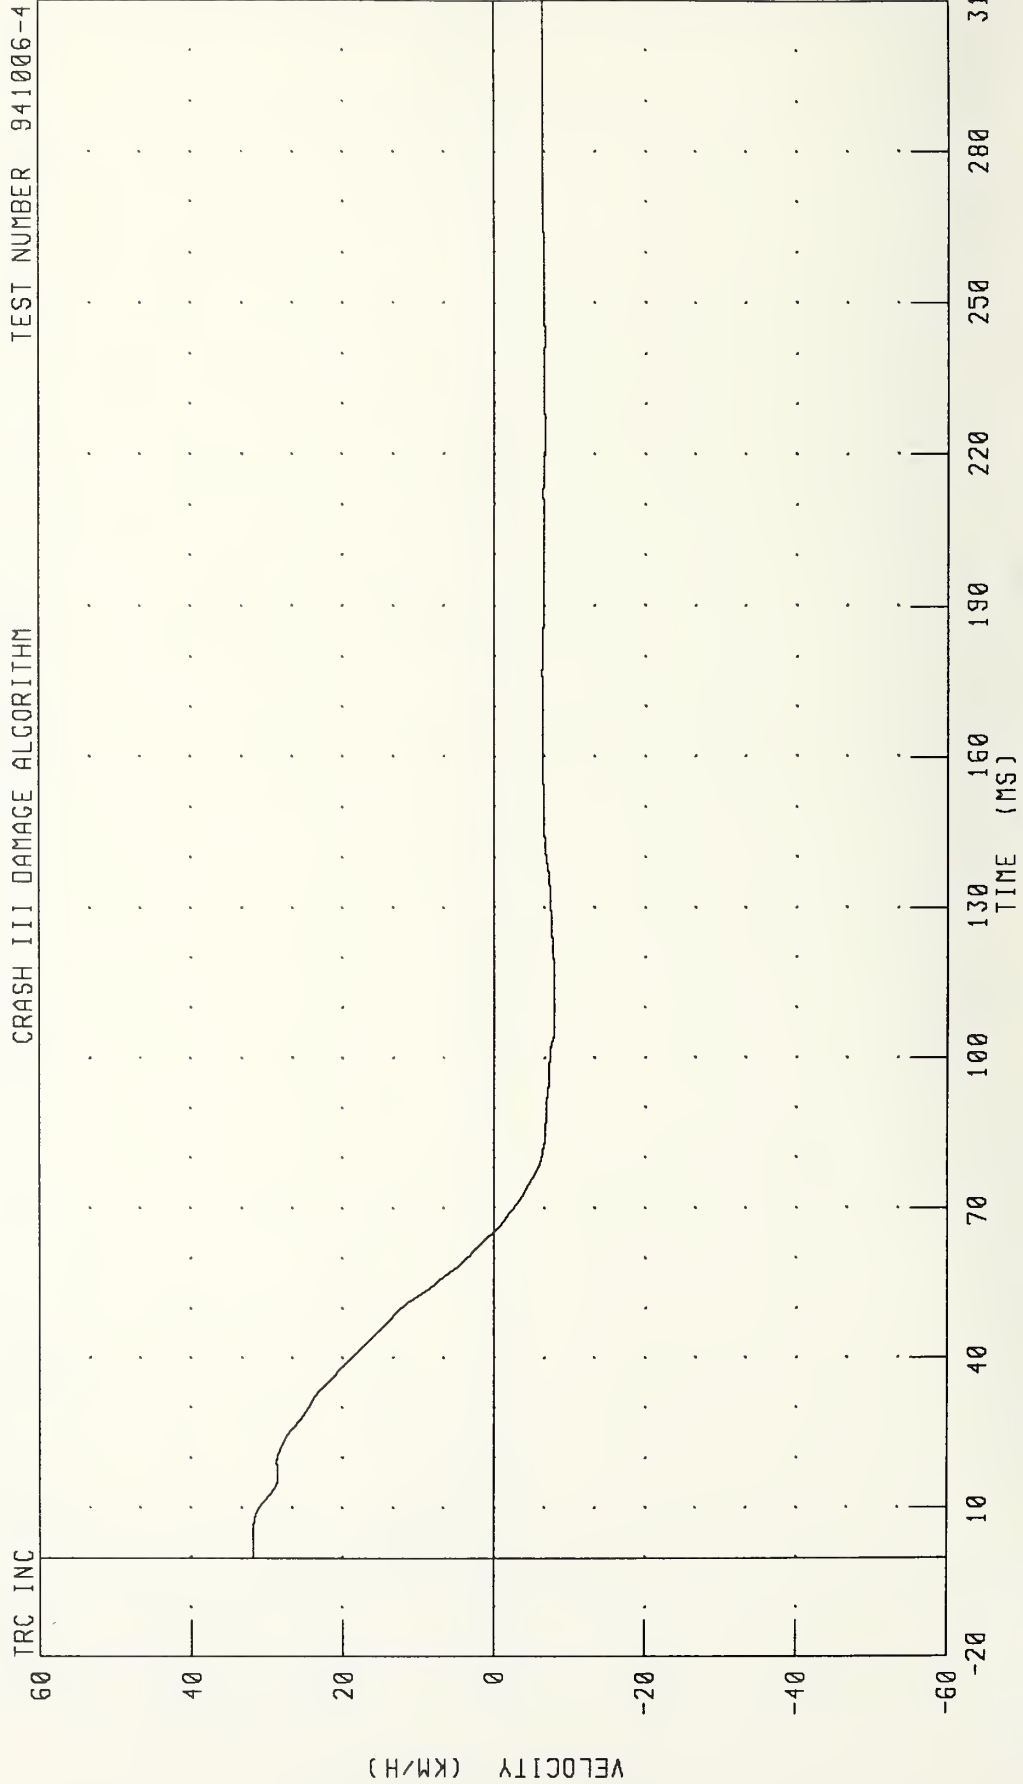
CHANNEL : RFSXV1 FILTER : CH. CLASS 180 PEAK DATA : 31.90 KM/H @ 0.00 MS; -7.99 KM/H @ 107.92 MS

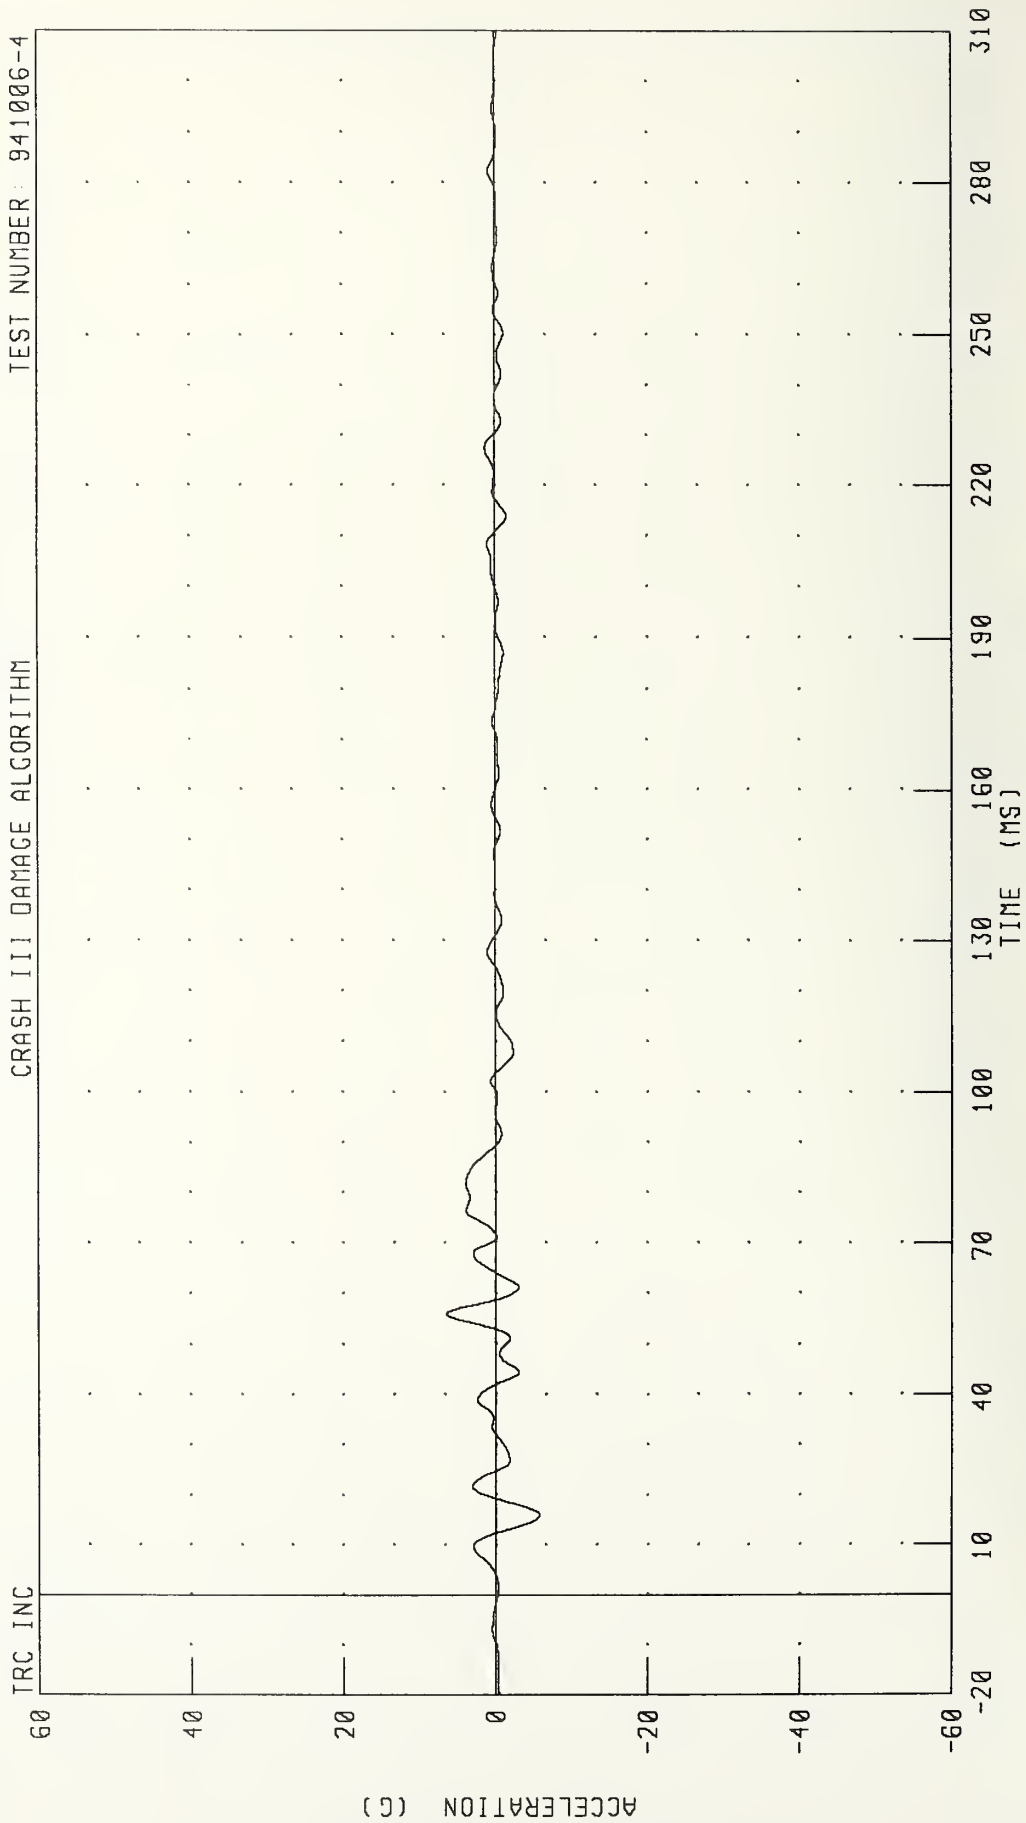
CHANNEL: RFSYG1 FILTER: CH. CLASS 60 PEAK DATA: 6.52 G @ 56.00 MS; -5.75 G @ 15.92 MS

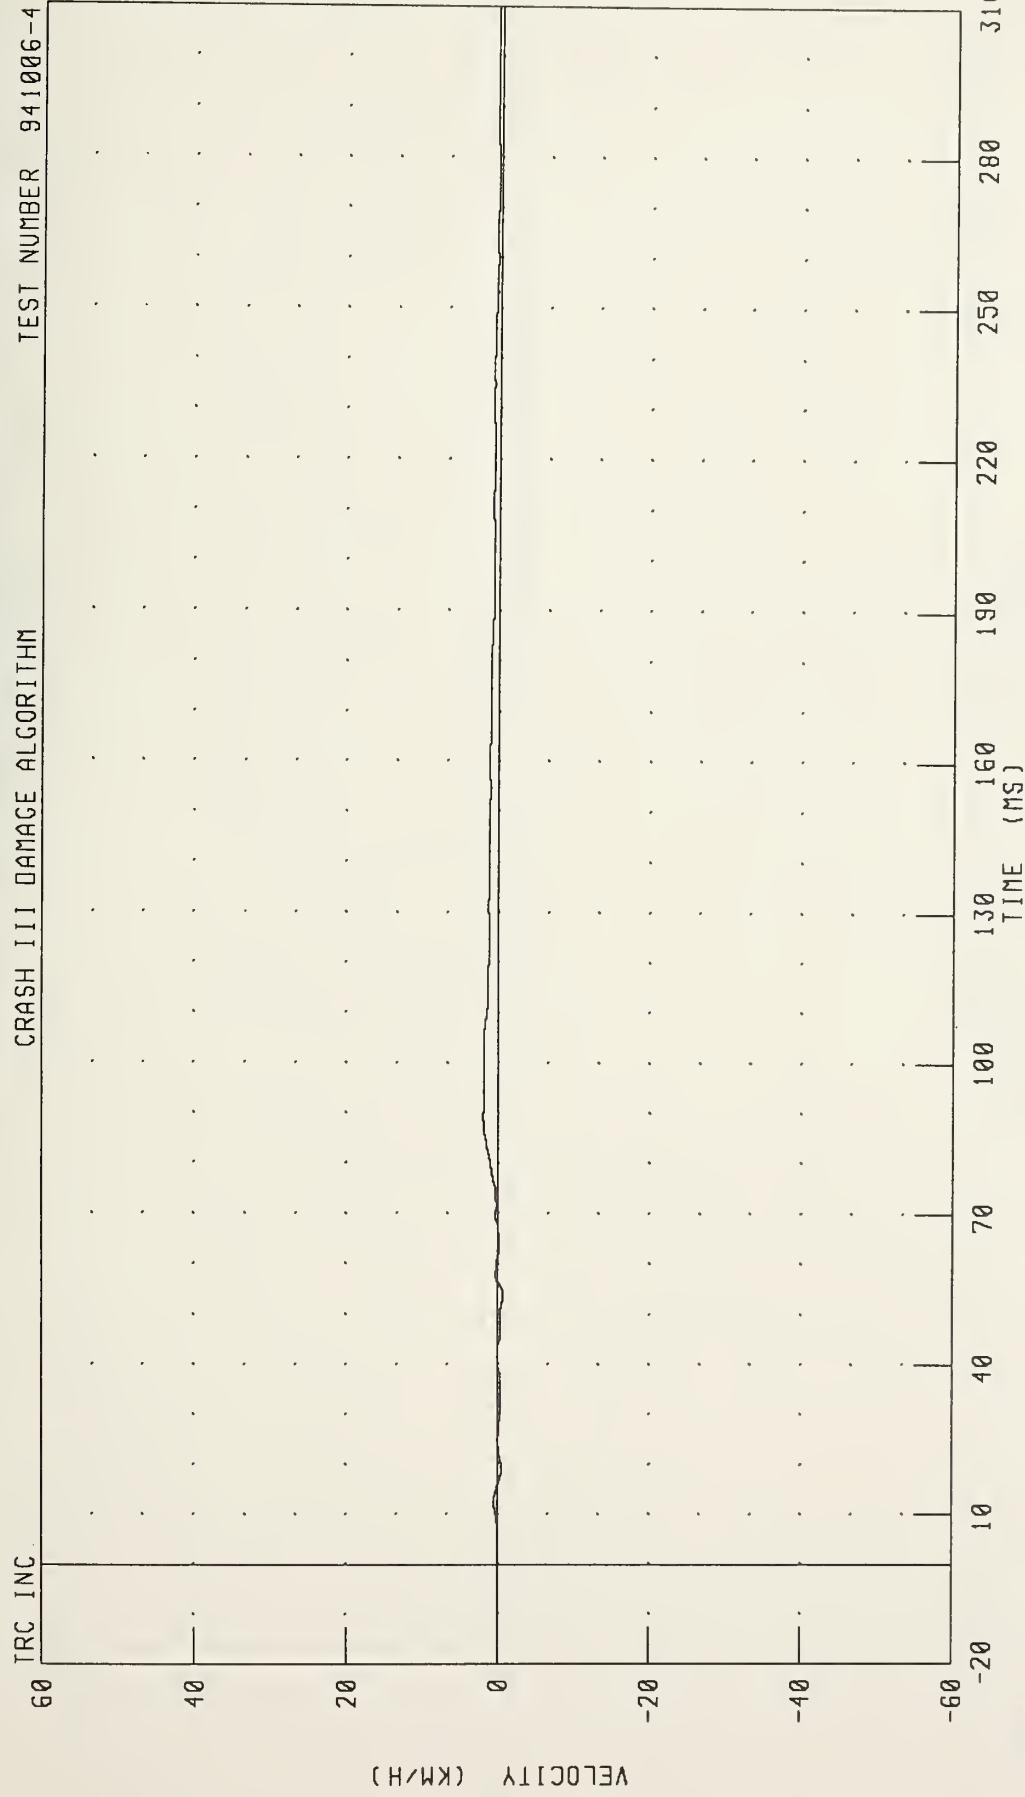
CHANNEL: RFSYV1 FILTER: CH. CLASS 180

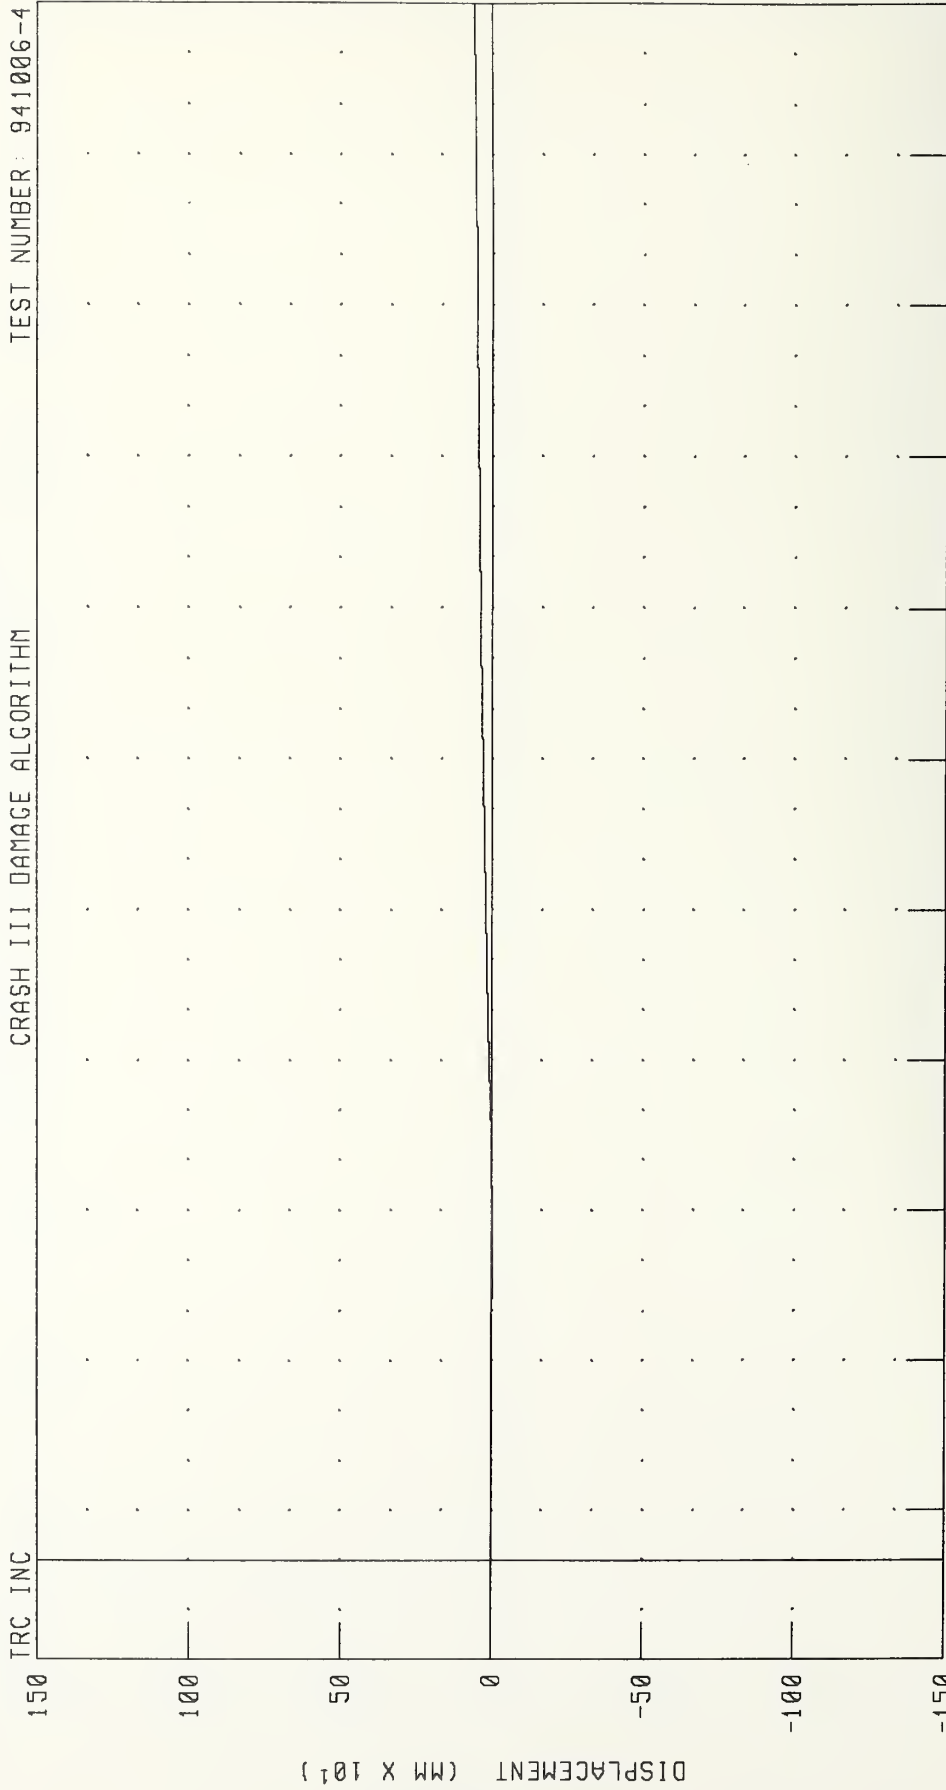
CHANNEL: RFSYD1 FILTER: CH. CLASS 180

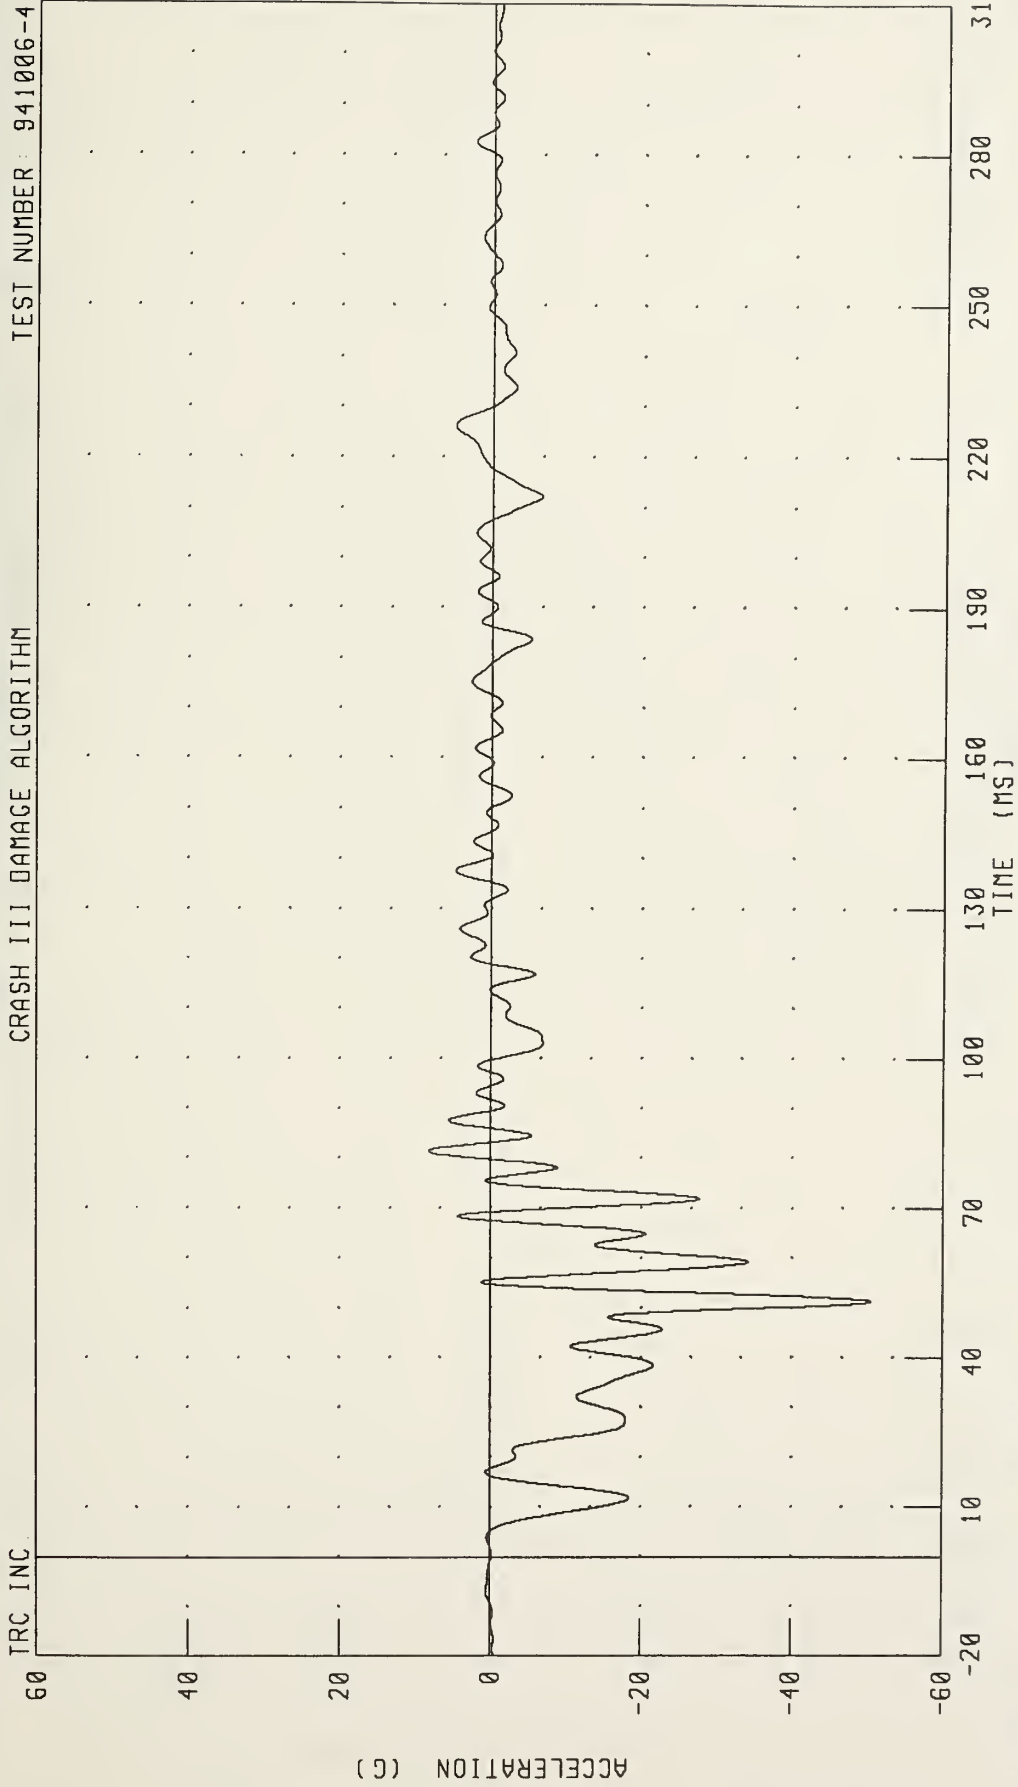
CHANNEL: TLRXG1 FILTER: CH. CLASS 60

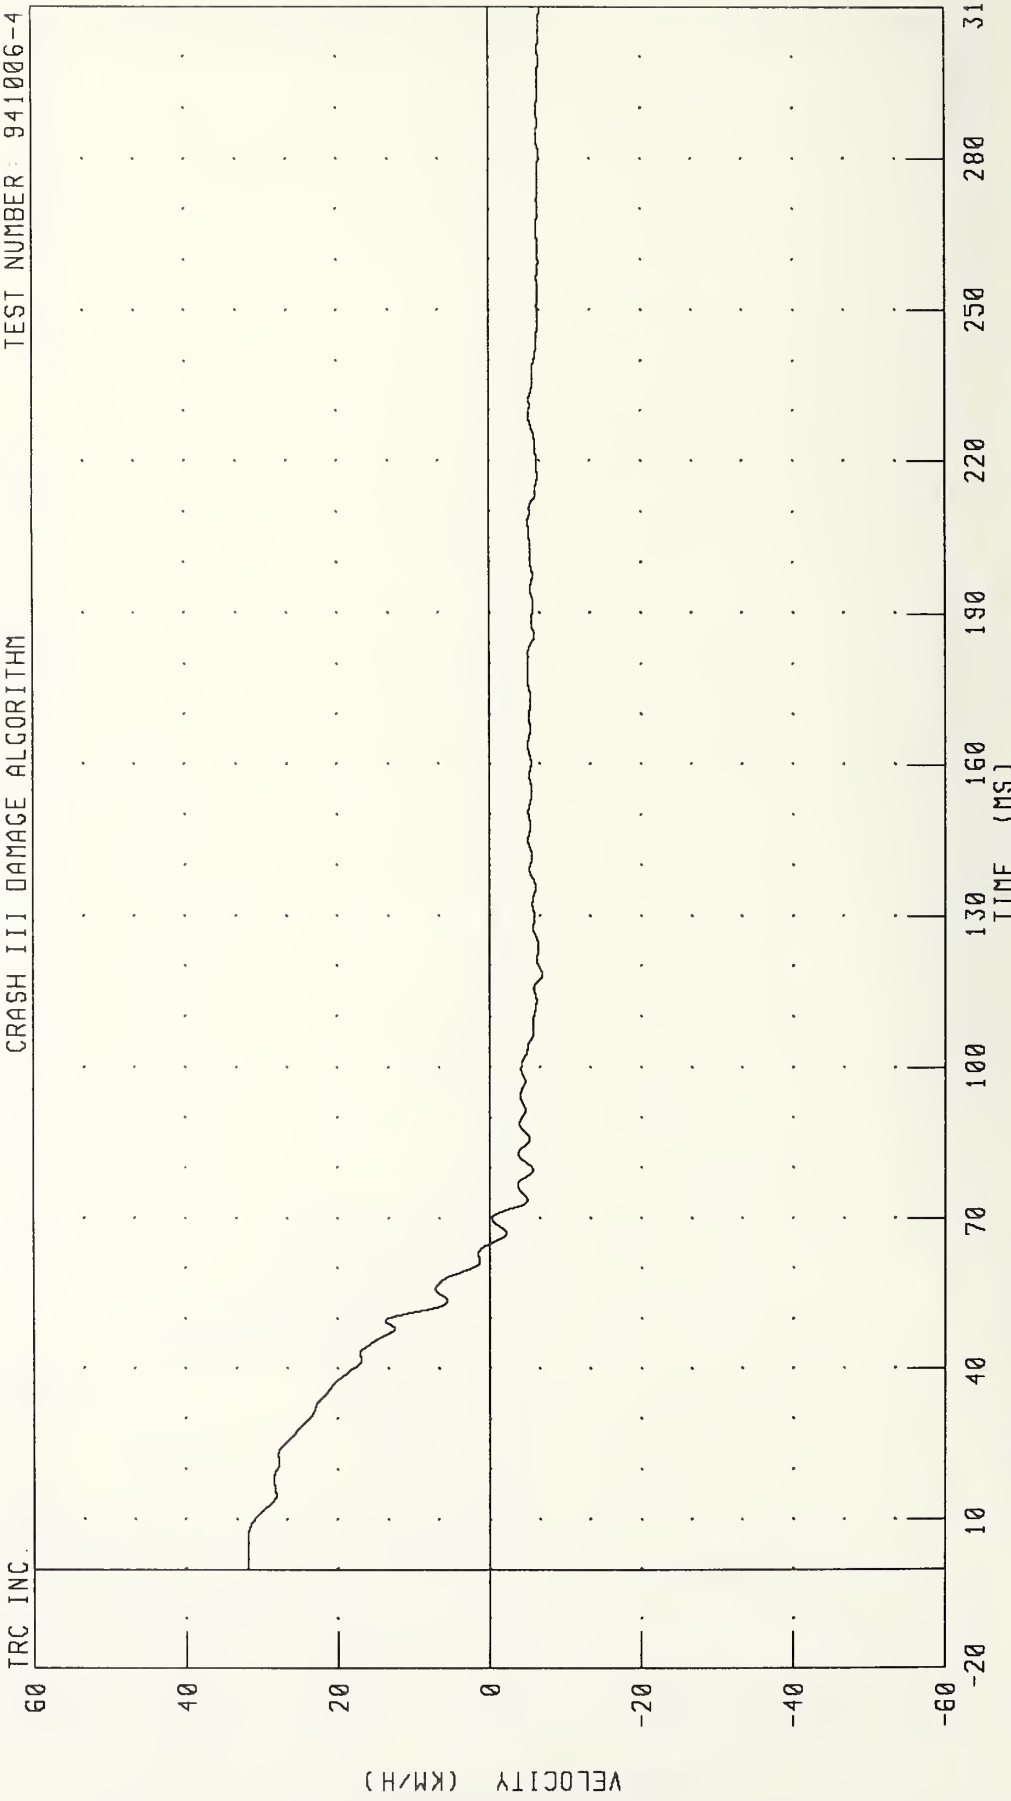
CHANNEL: TLRXV1 FILTER: CH. CLASS 180

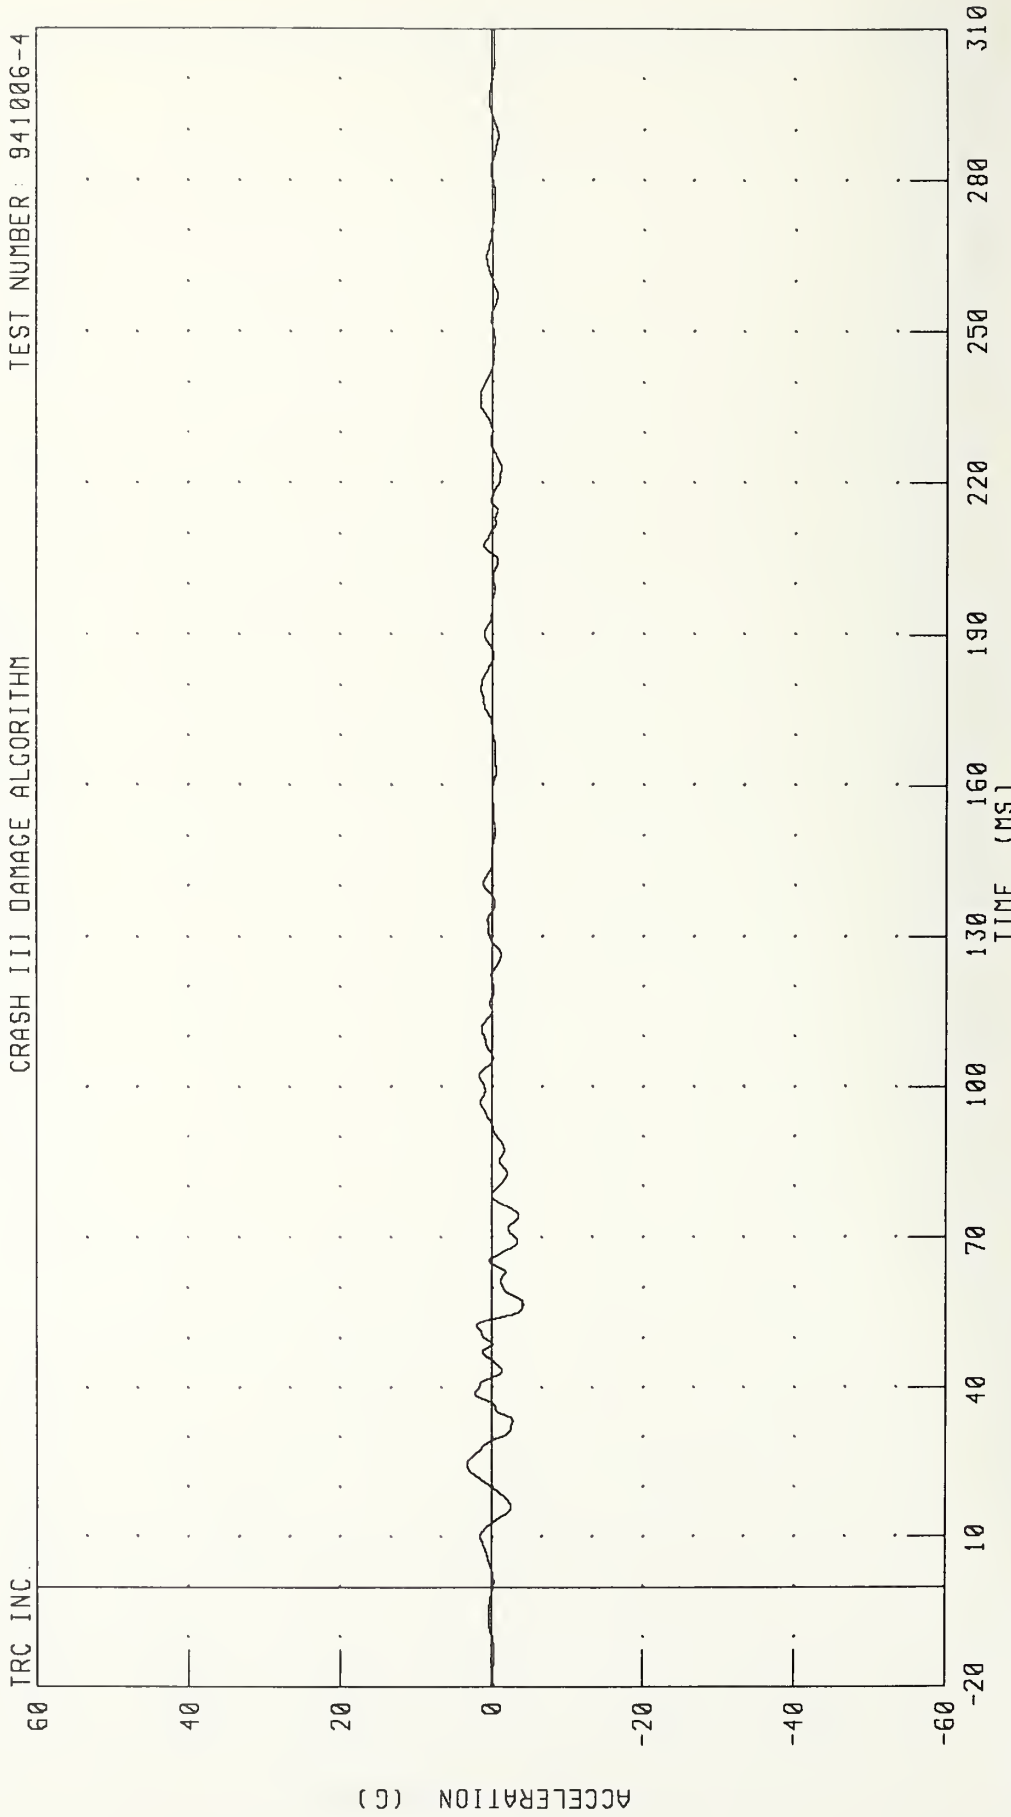
TEST NUMBER: 941006-4

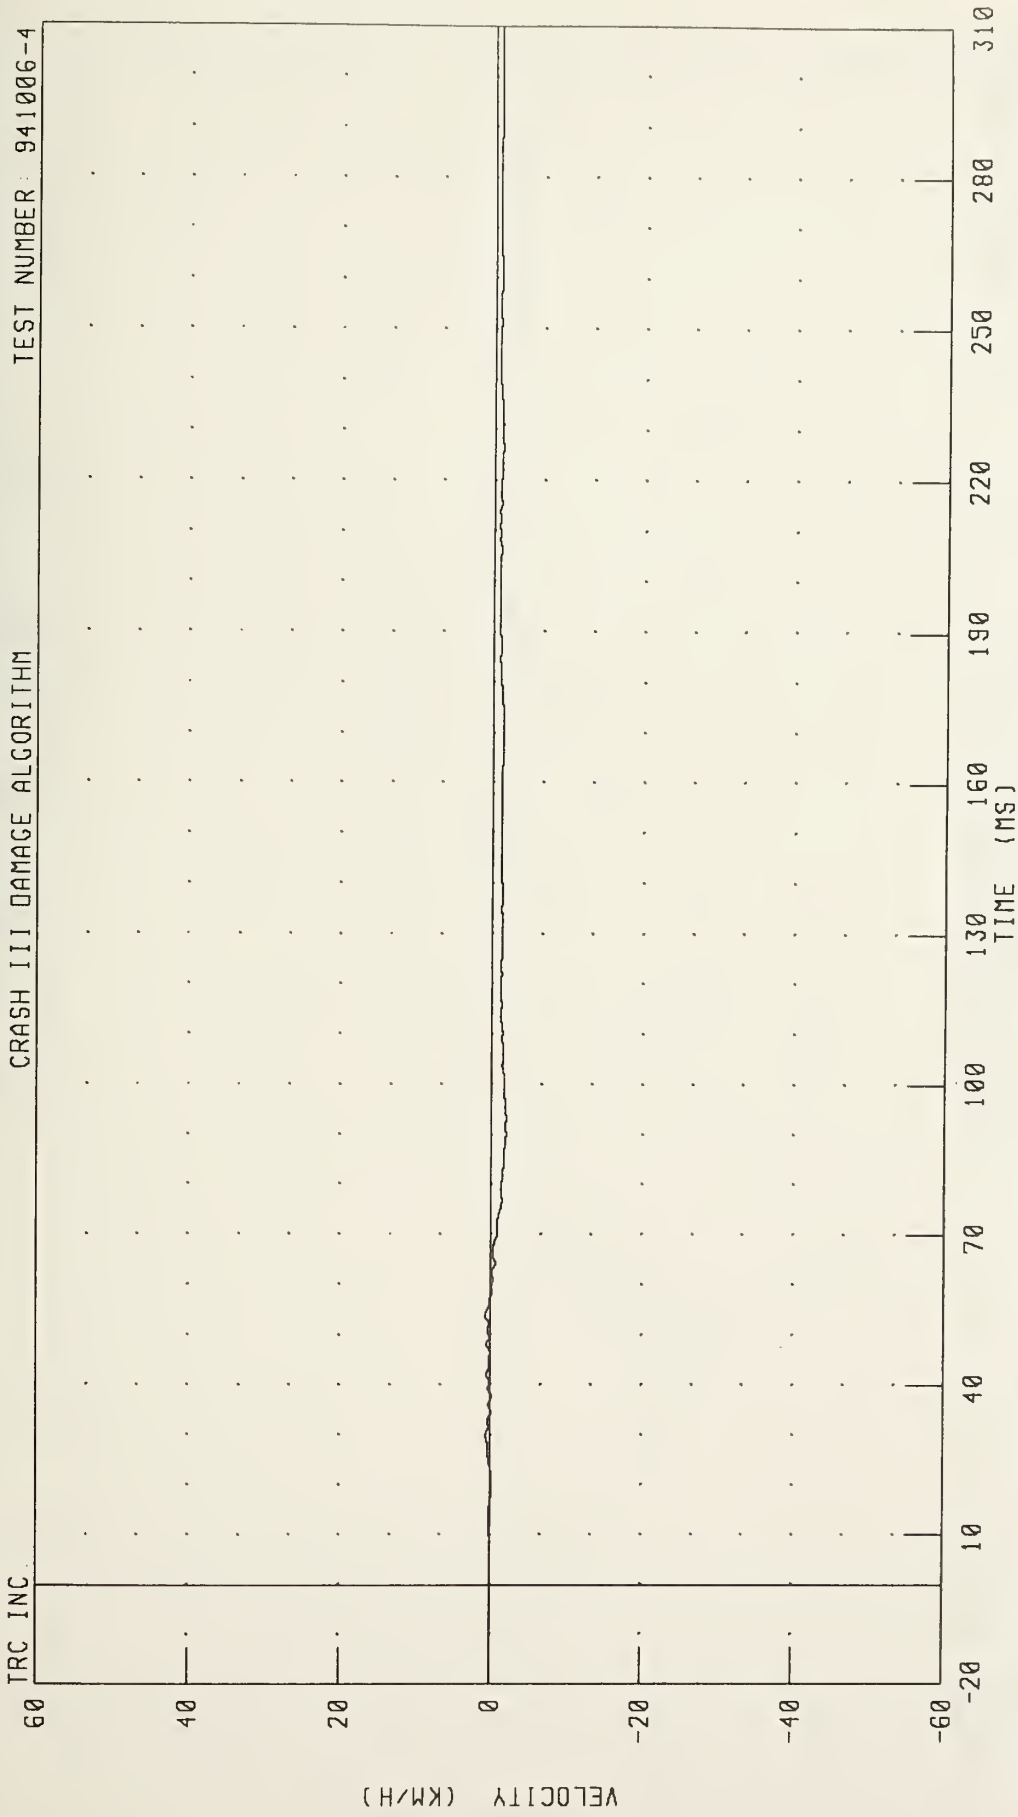
CRASH III DAMAGE ALGORITHM TEST NUMBER: 941006-4

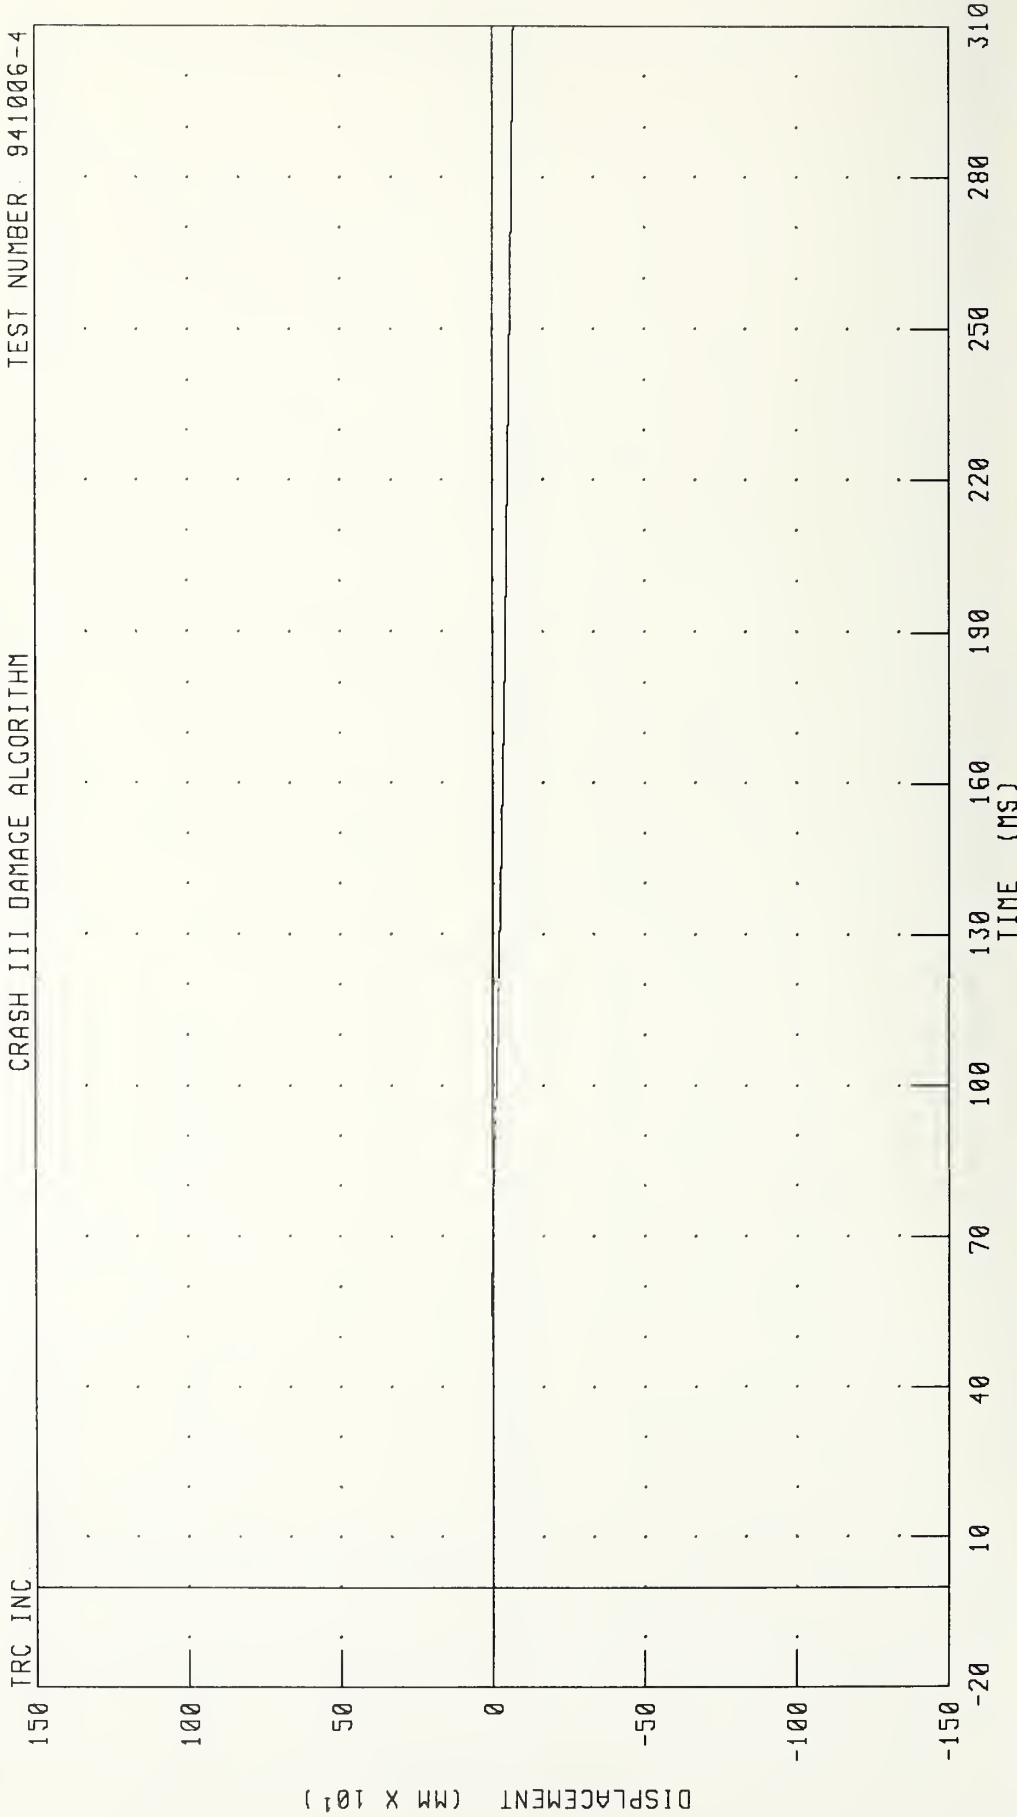
CHANNEL: TLRD1 FILTER: CH. CLASS 180

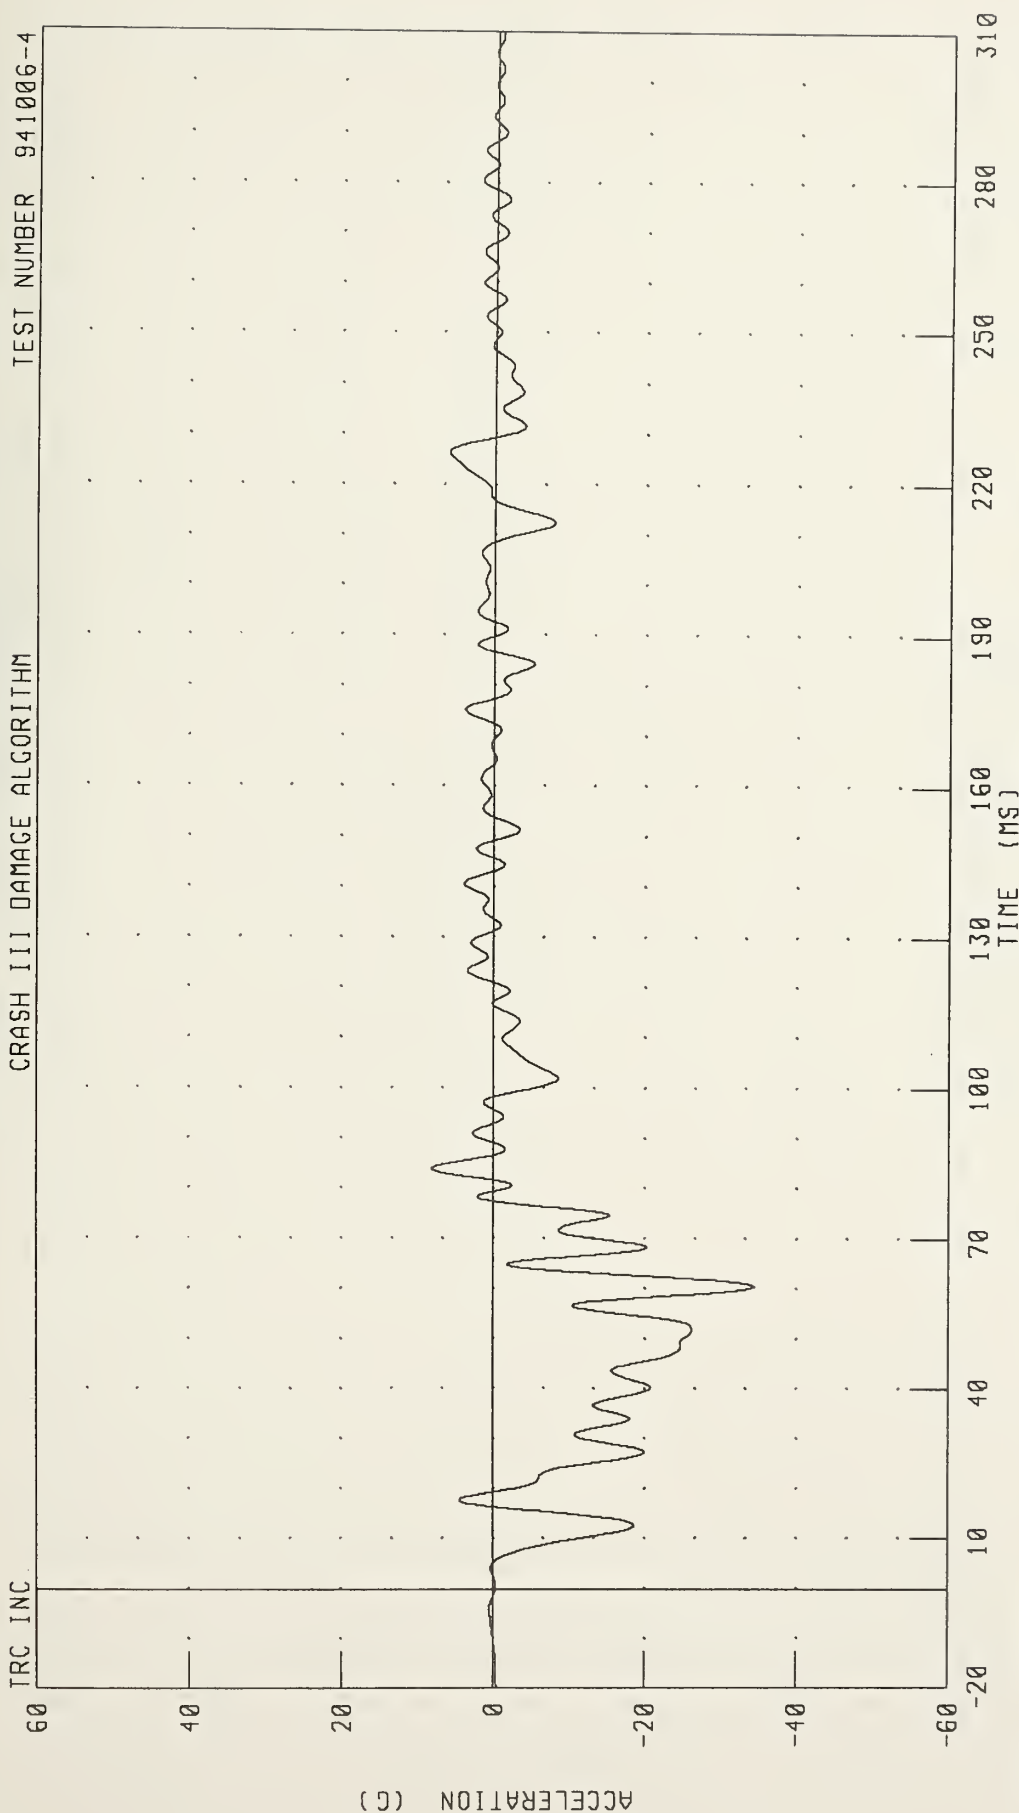
CHANNEL: TRRXG1 FILTER: CH. CLASS 60

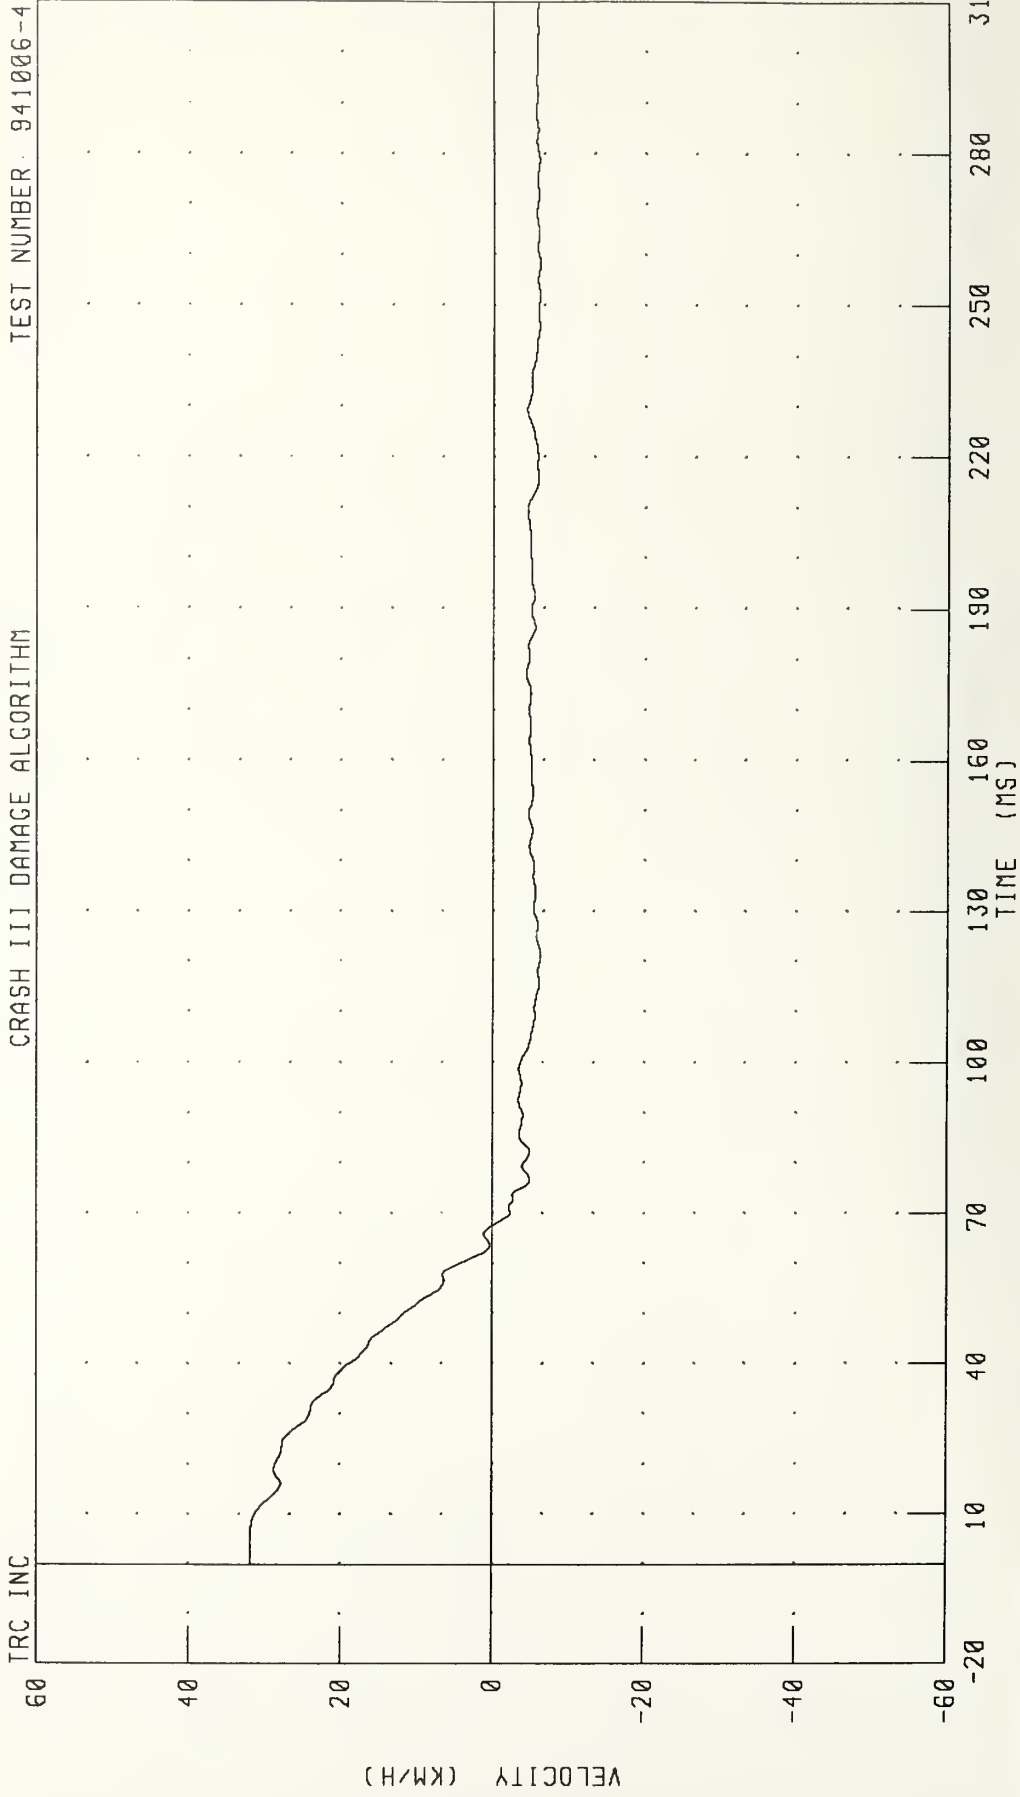
CHANNEL: TRRXV1 FILTER: CH. CLASS 180
