U.S. Department
of Transportation

**National Highway
Traffic Safety
Administration**

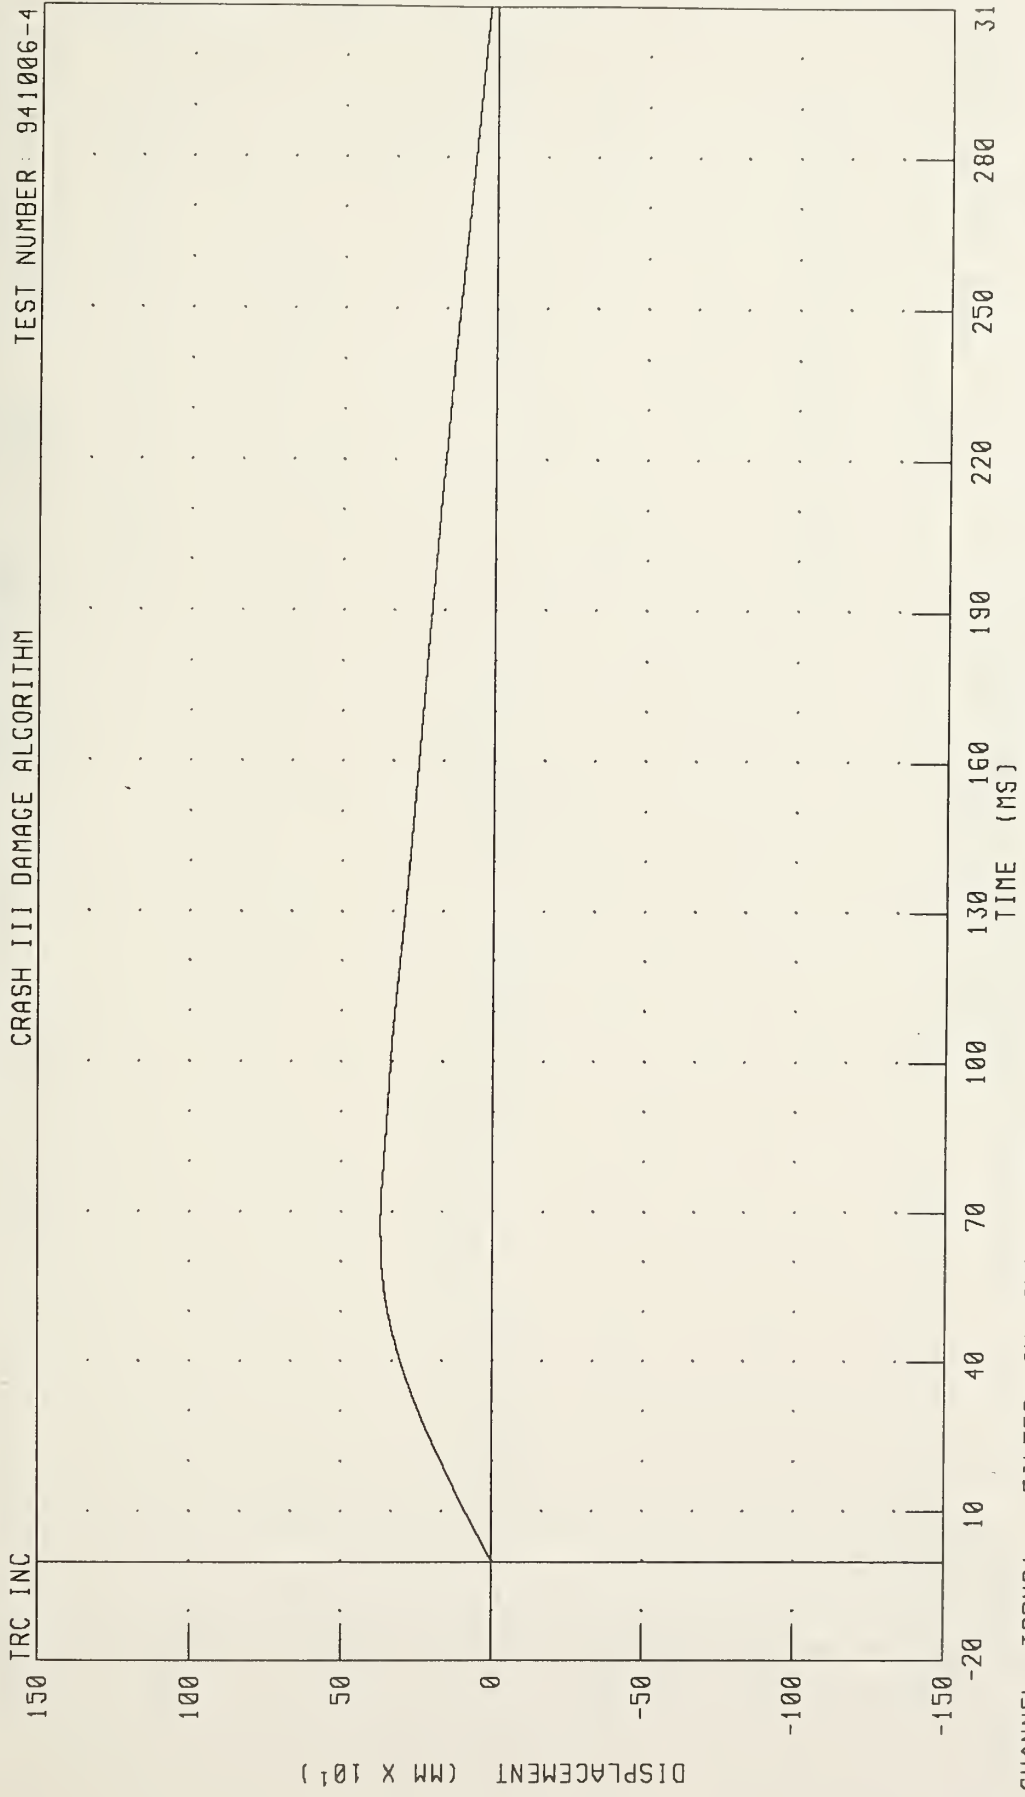
CHANNEL: TRRXD1 FILTER: CH. CLASS 180

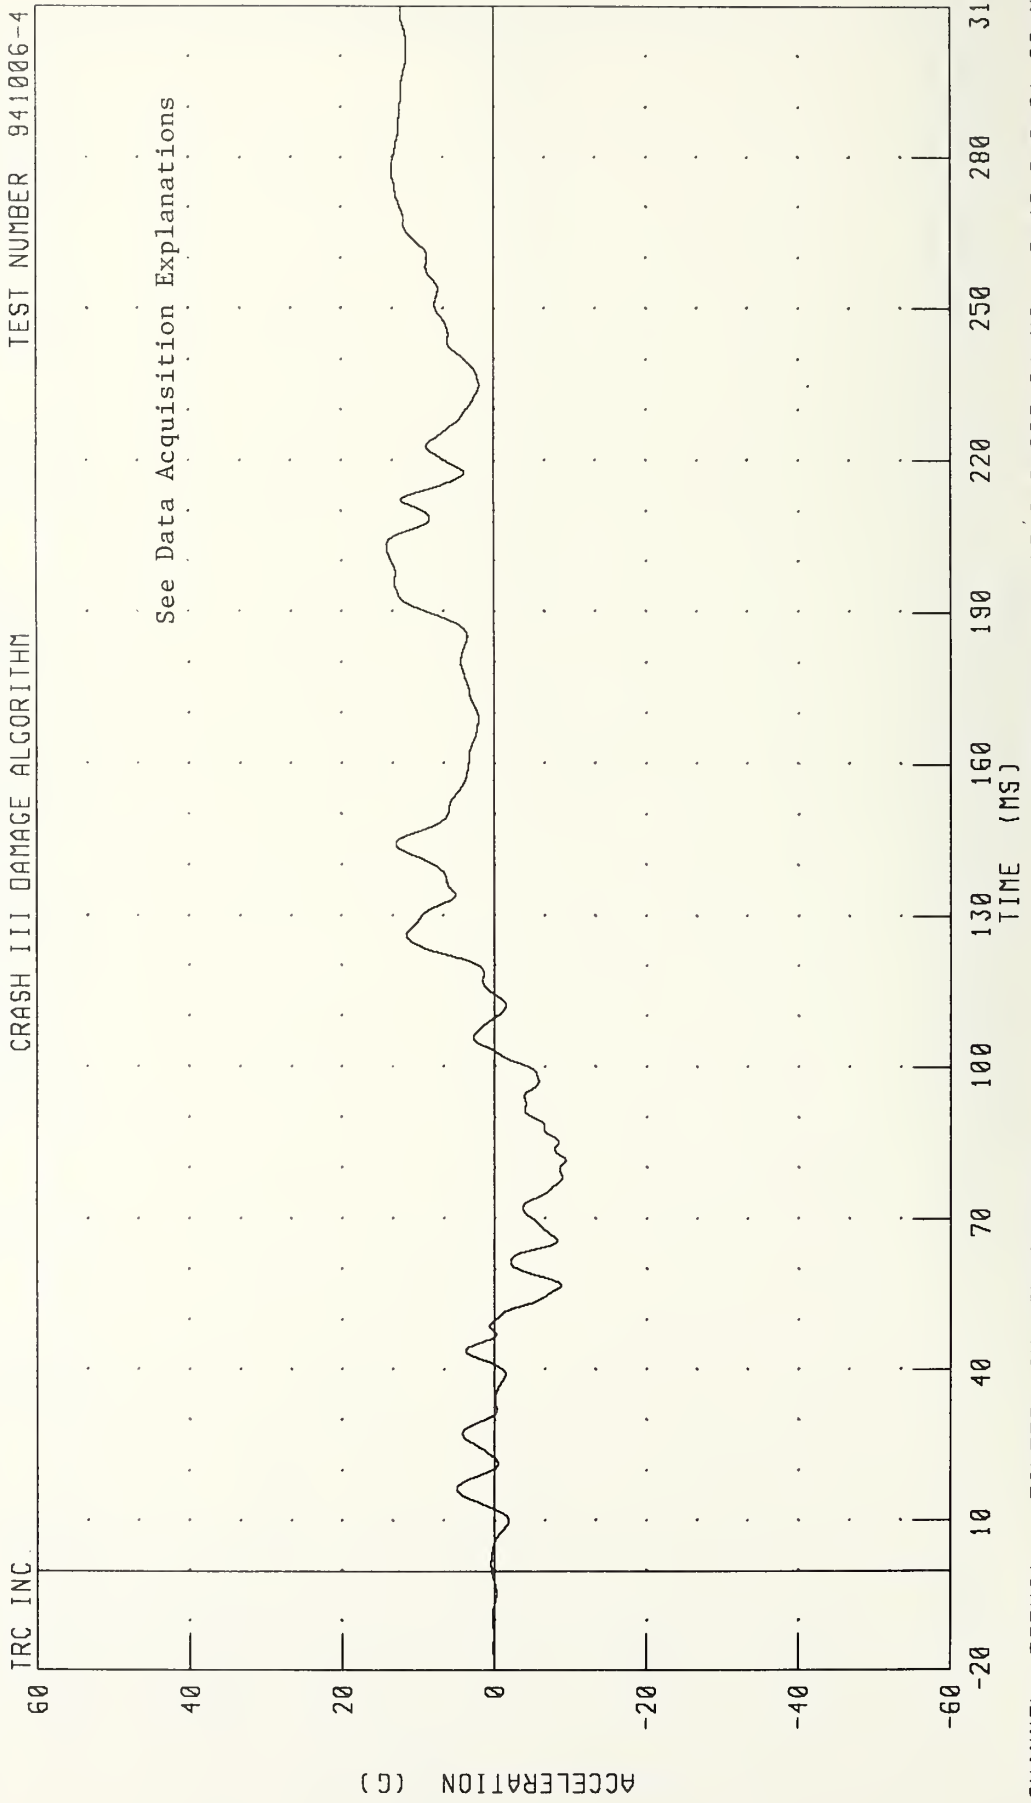
CHANNEL: TRRYG1 FILTER: CH CLASS 60

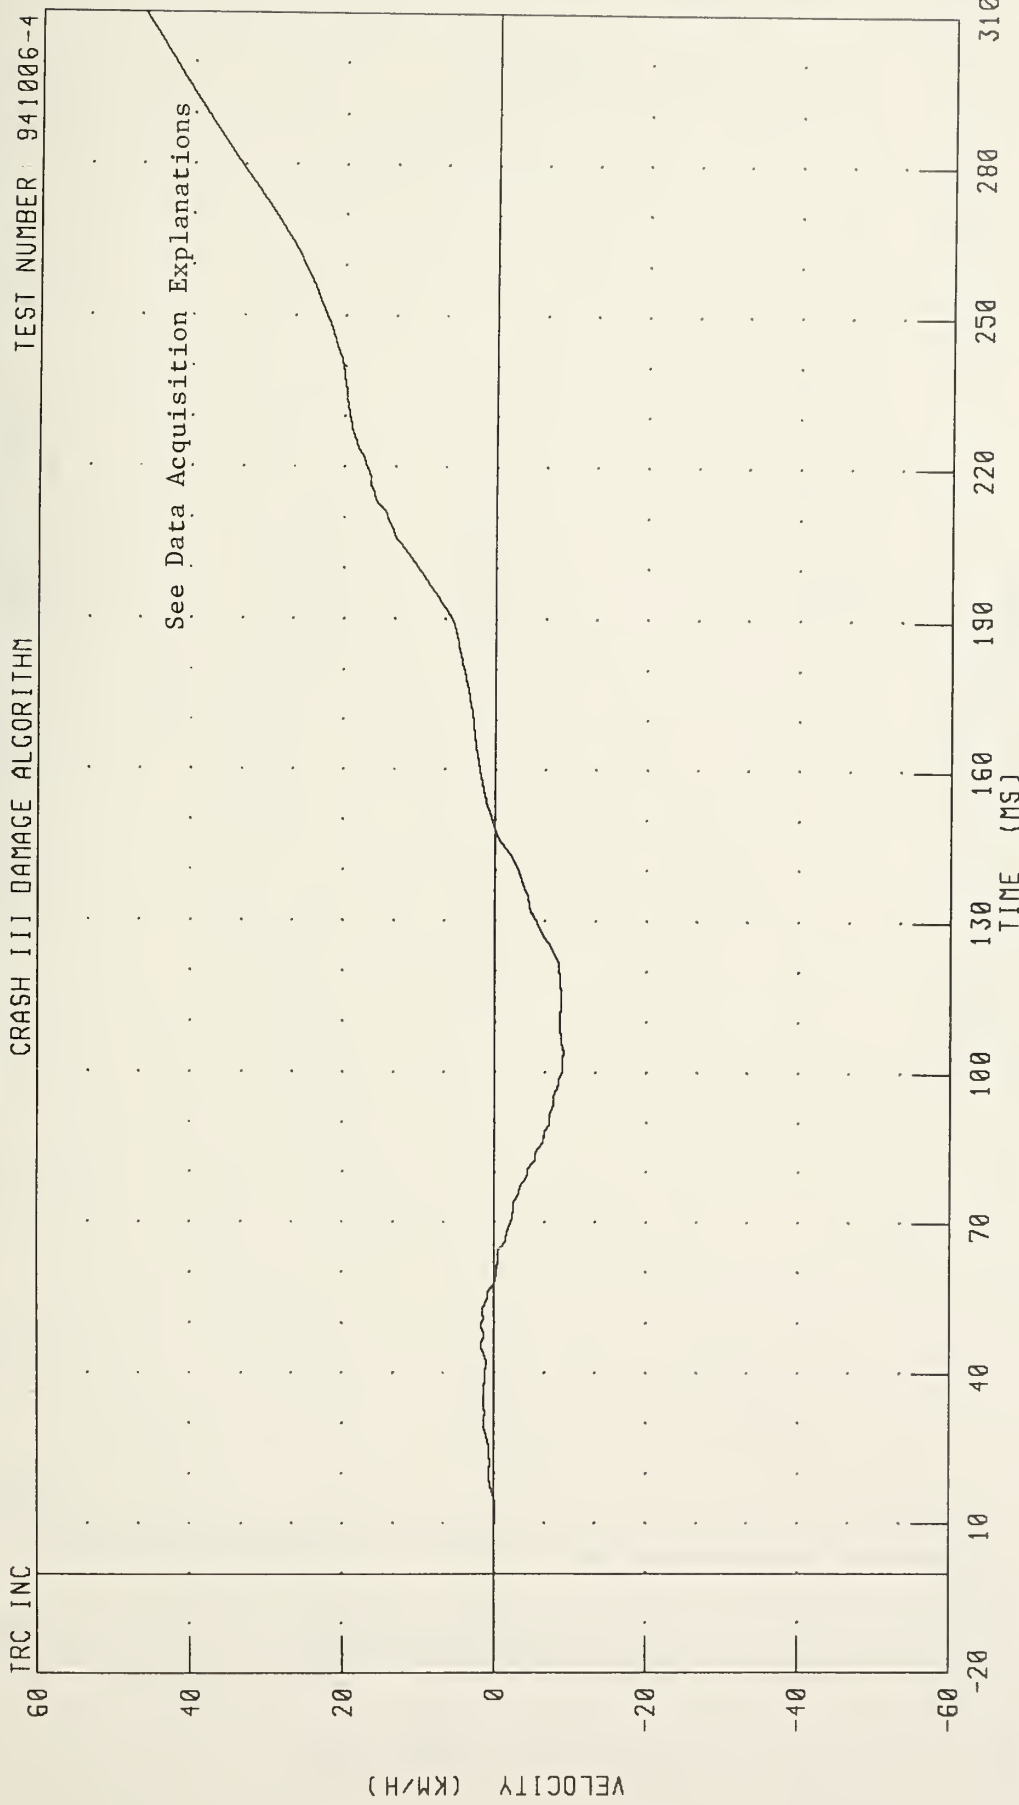
CHANNEL: TRRYV1 FILTER: CH. CLASS 180

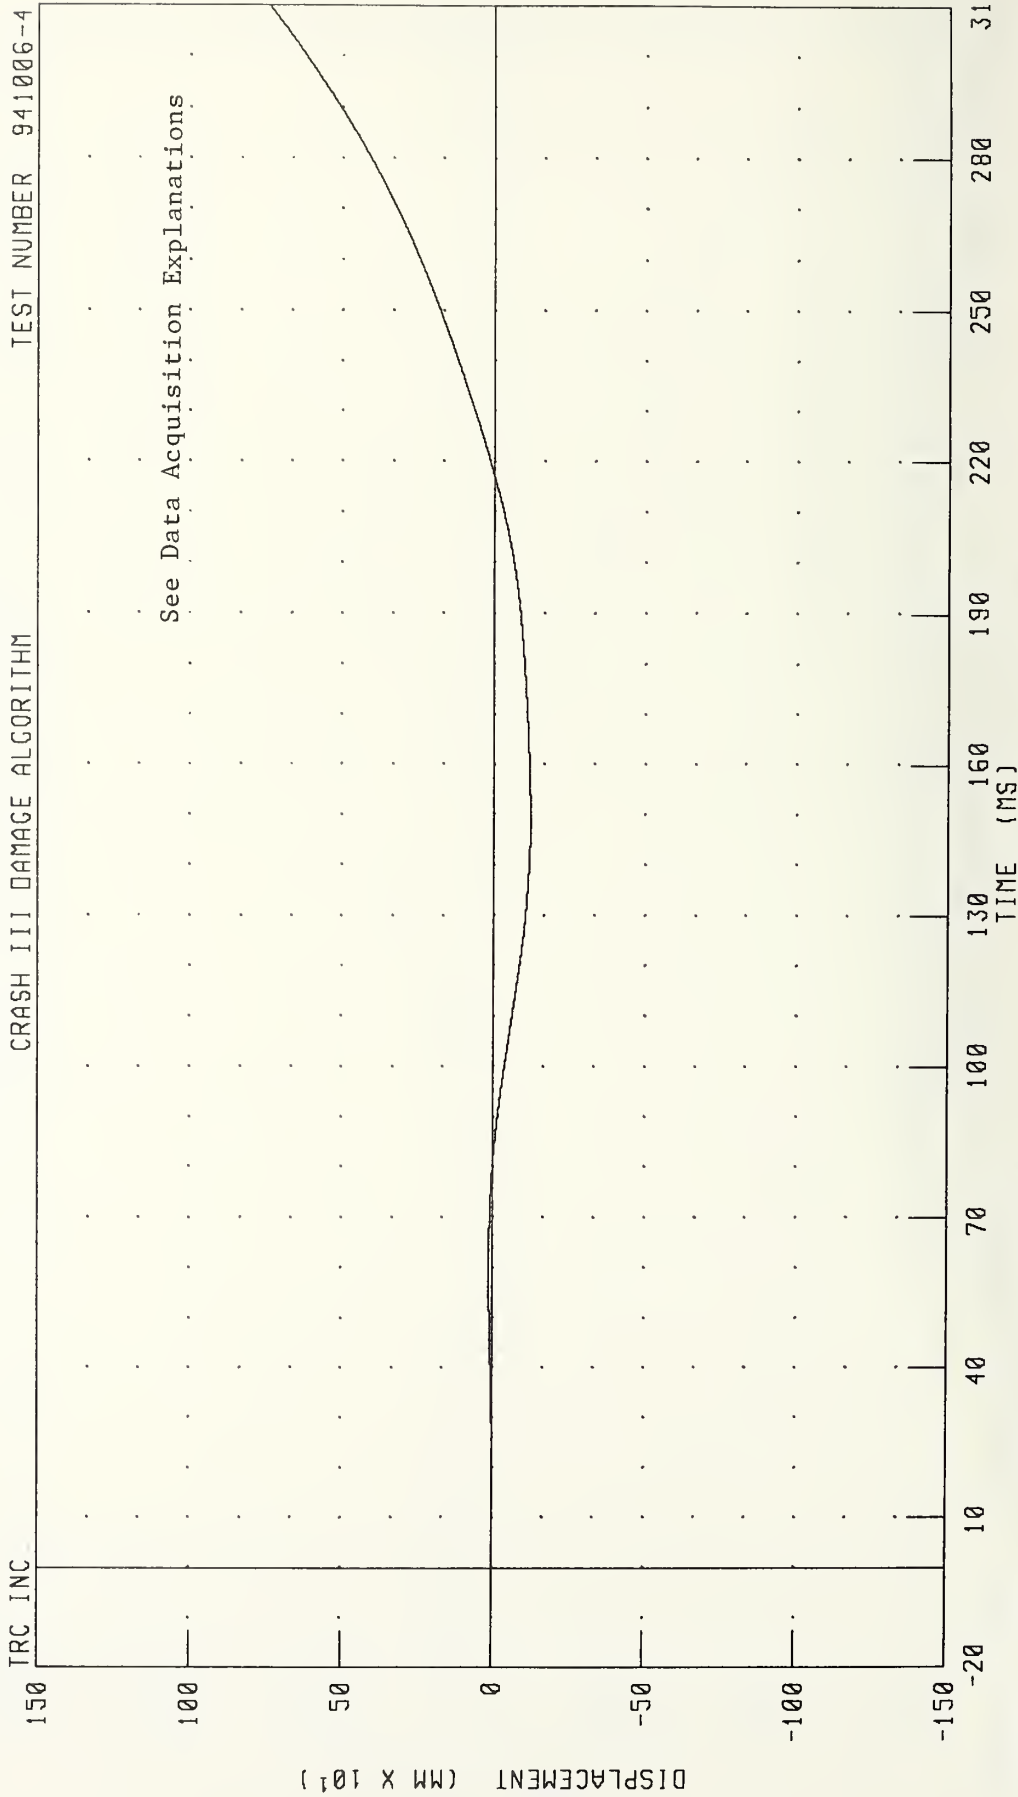
CHANNEL: TRRYD1 FILTER: CH. CLASS 180 PEAK DATA: 743.73 MM @ 310.00 MS; -121.31 MM @ 148.40 MS

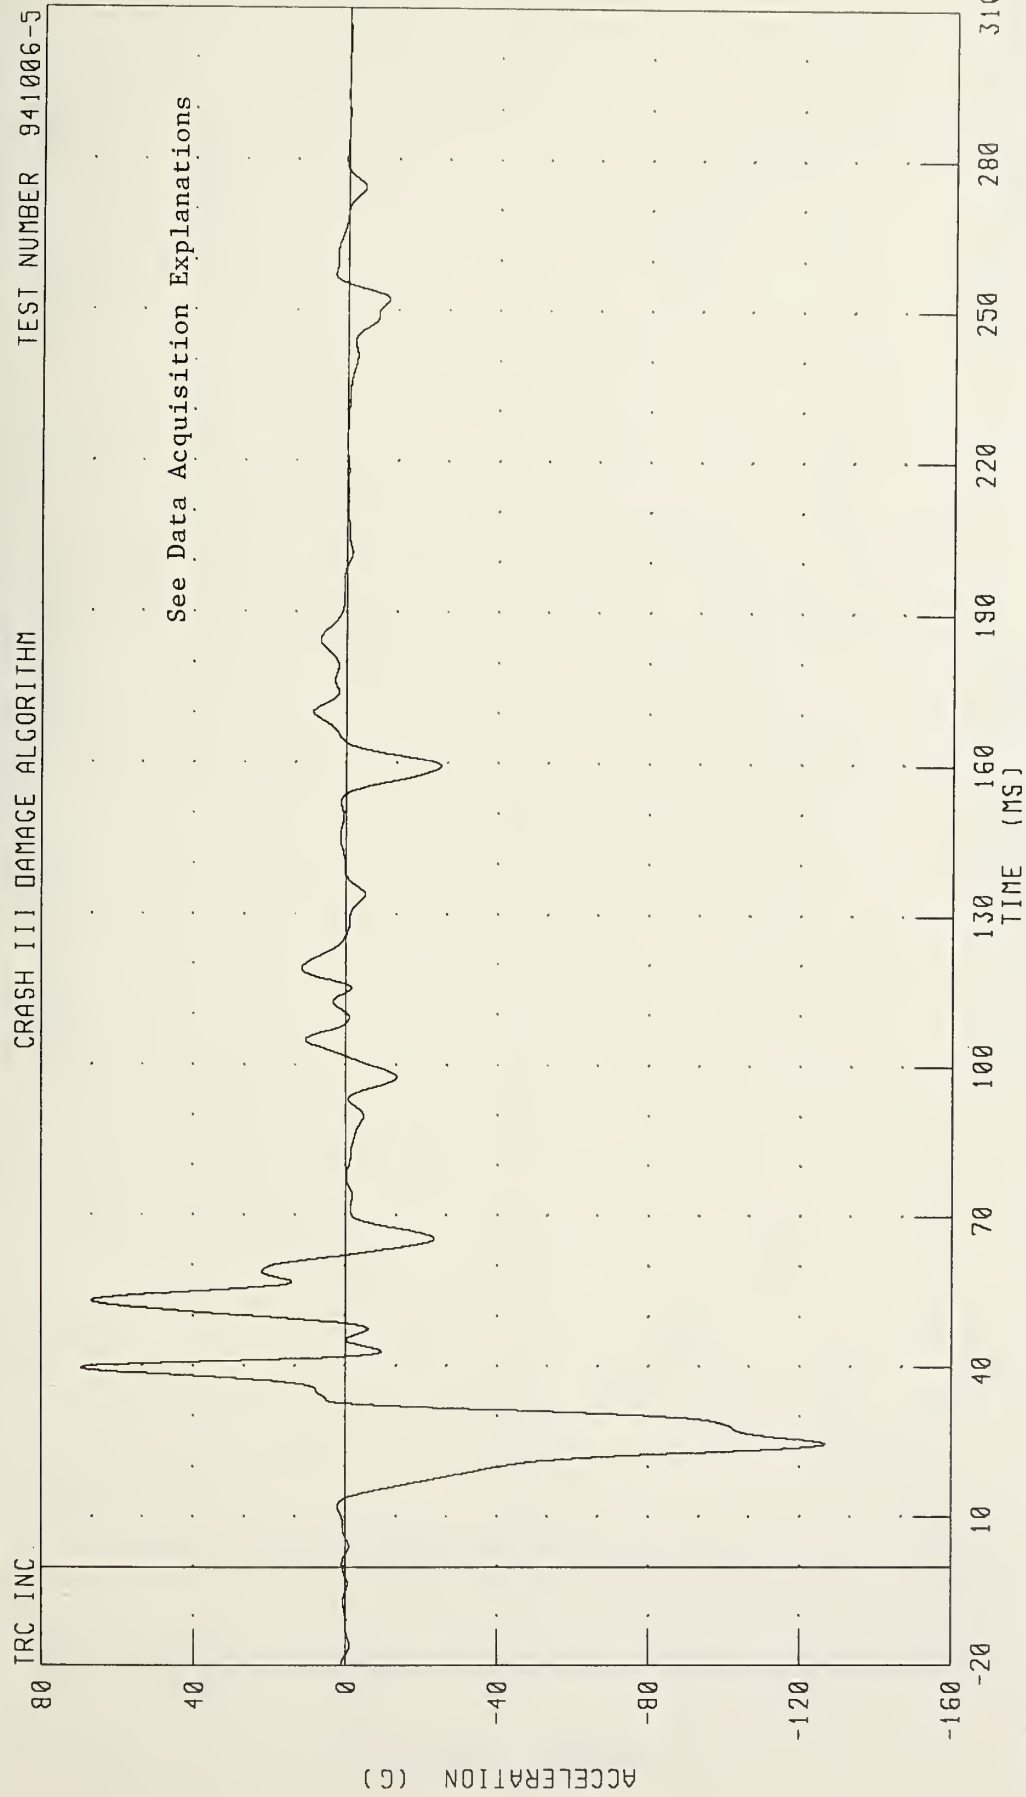
CHANNEL: VCGXG1 FILTER: CH CLASS 60

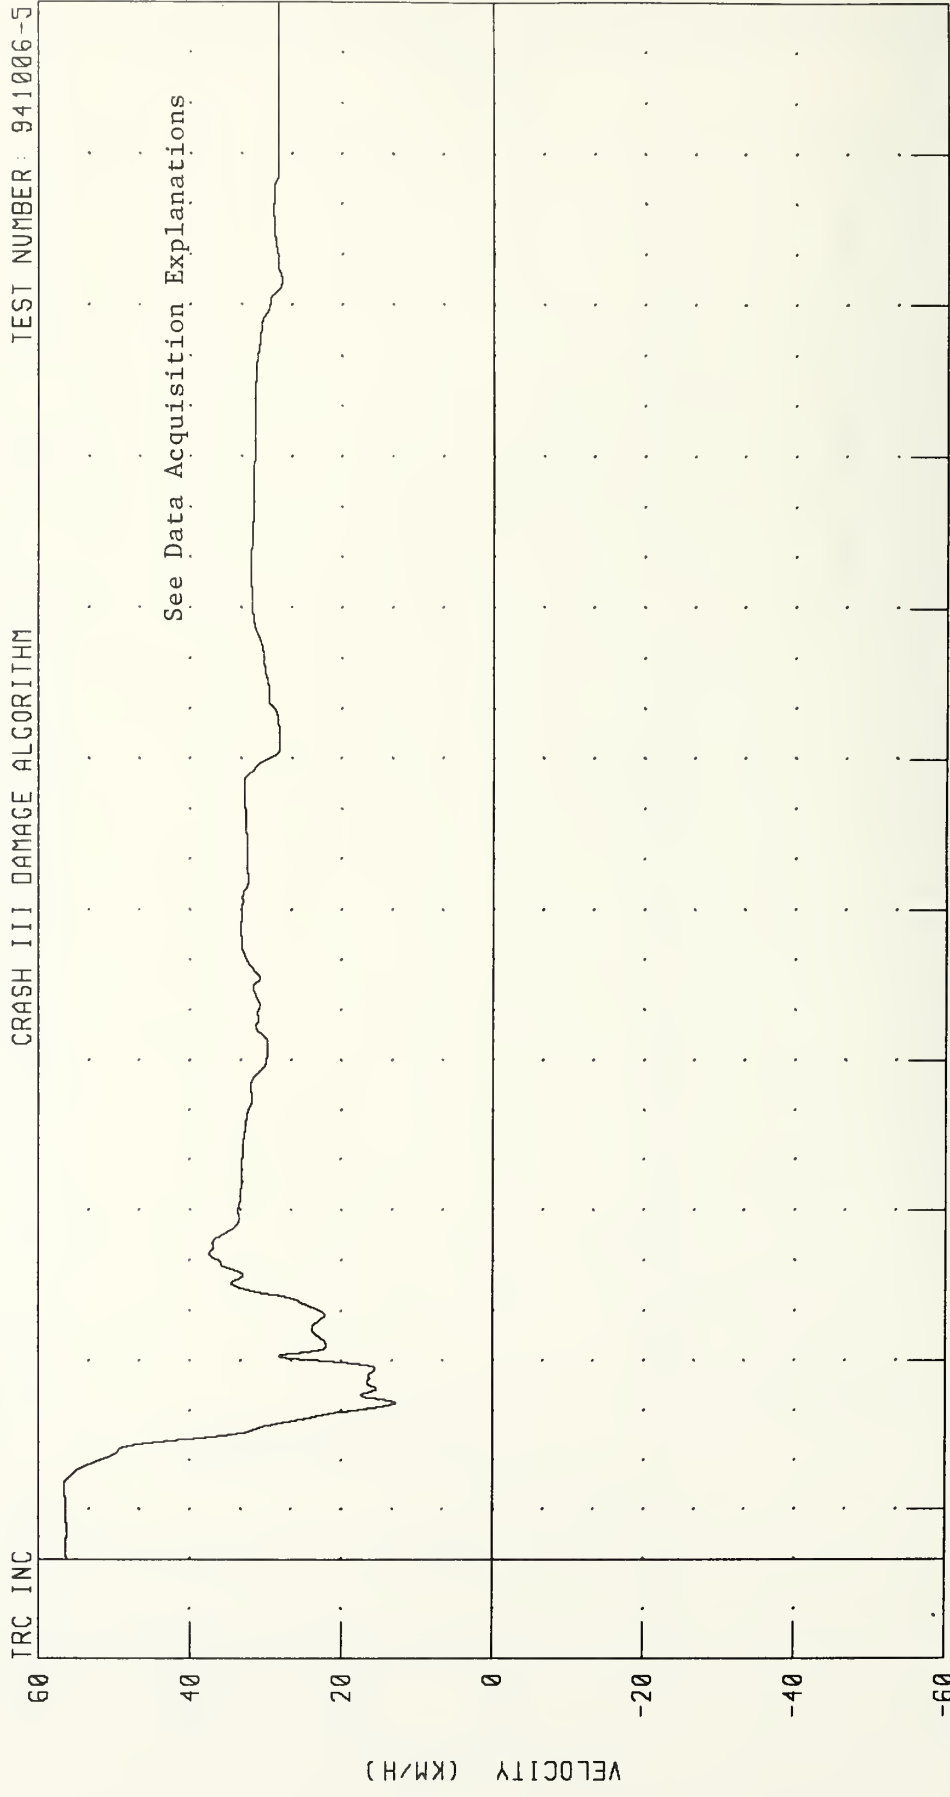
CHANNEL: VCGXV1 FILTER: CH. CLASS 180 PEAK DATA: 56.63 KM/H @ 14.56 MS; 12.88 KM/H @ 31 60 MS

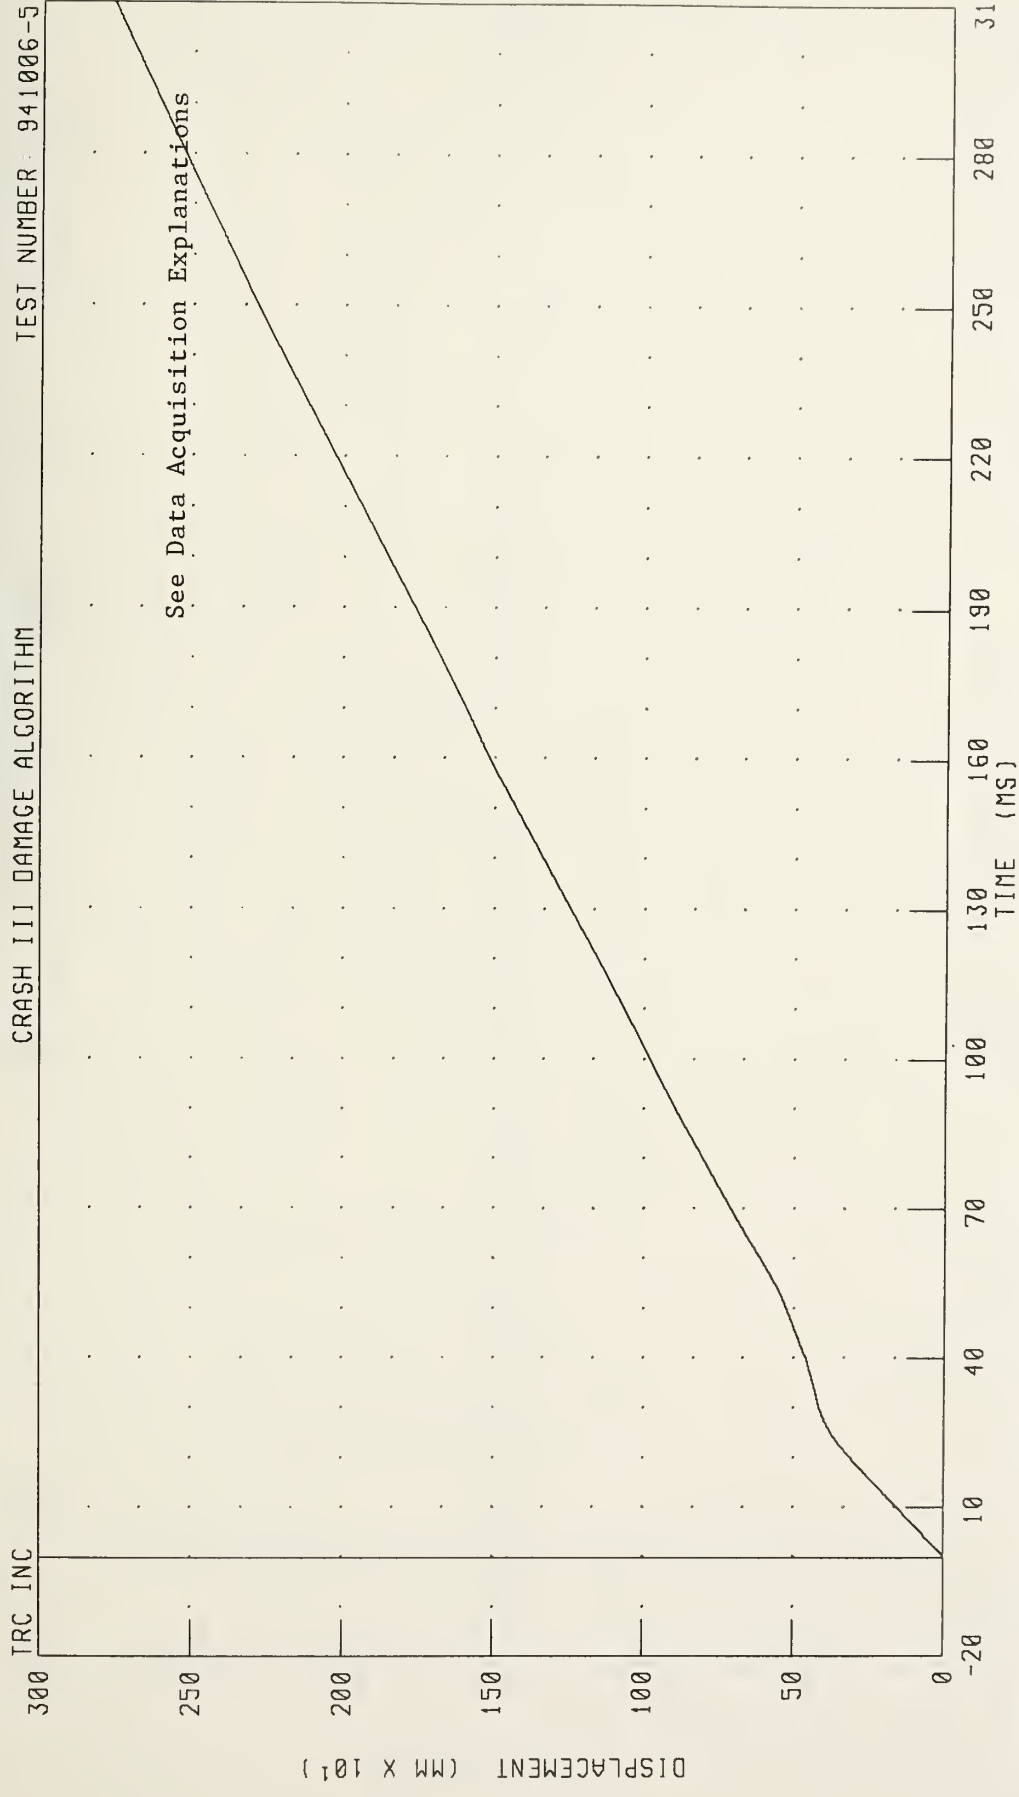
CHANNEL: VCGXD1 FILTER: CH. CLASS 180

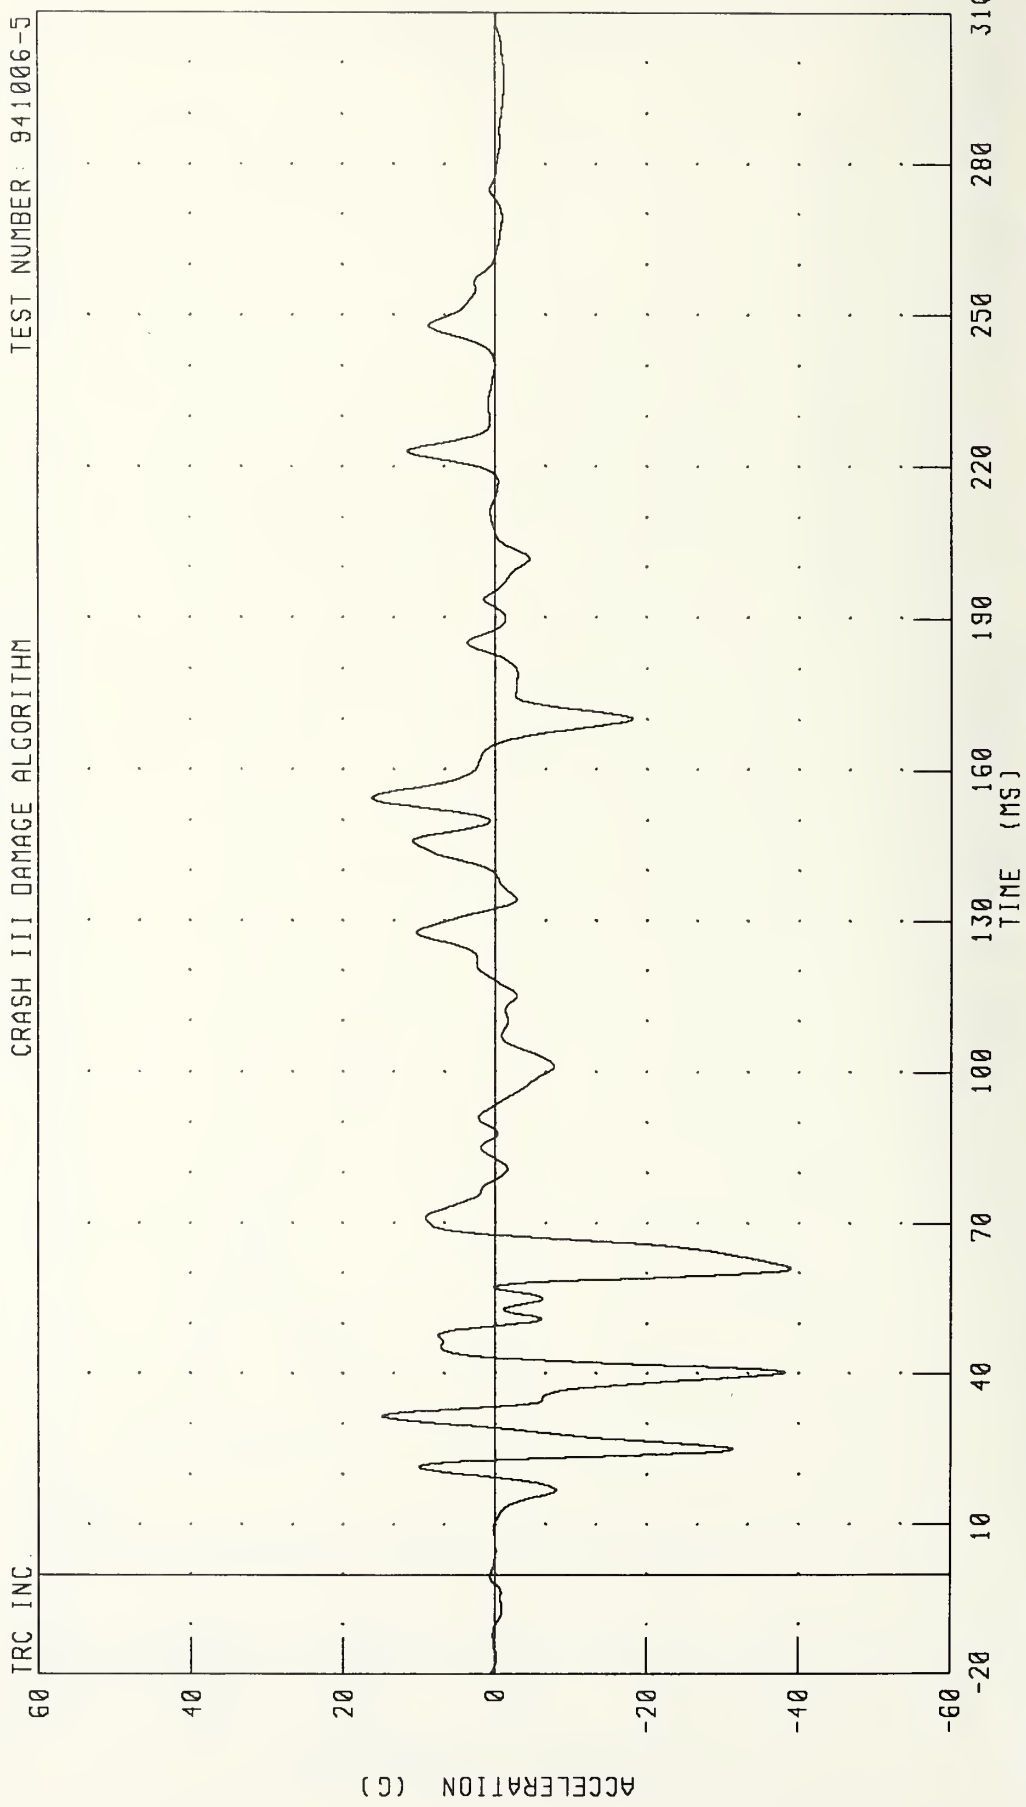
CHANNEL: VCGYG1 FILTER: CH. CLASS 60

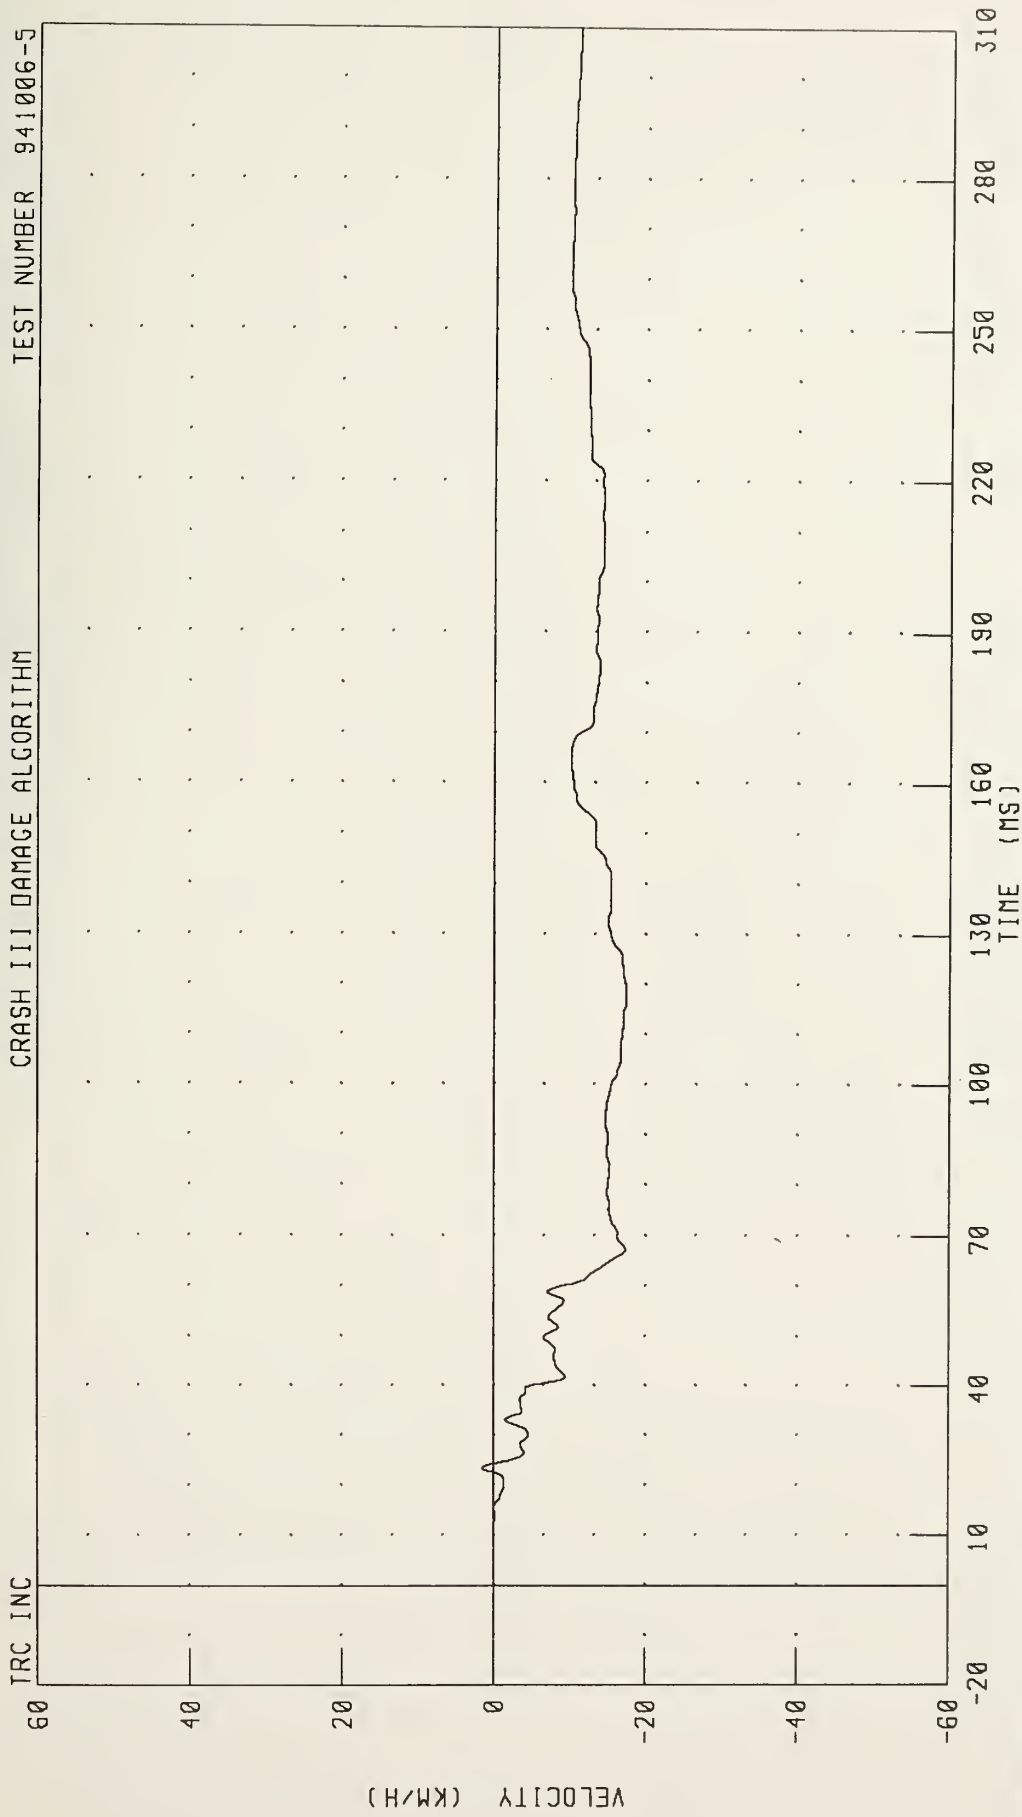
CHANNEL: VCGYV1 FILTER: CH. CLASS 180
PEAK DATA: 1.53 KM/H @ 23.44 MS, -17.47 KM/H @ 116.32 MS

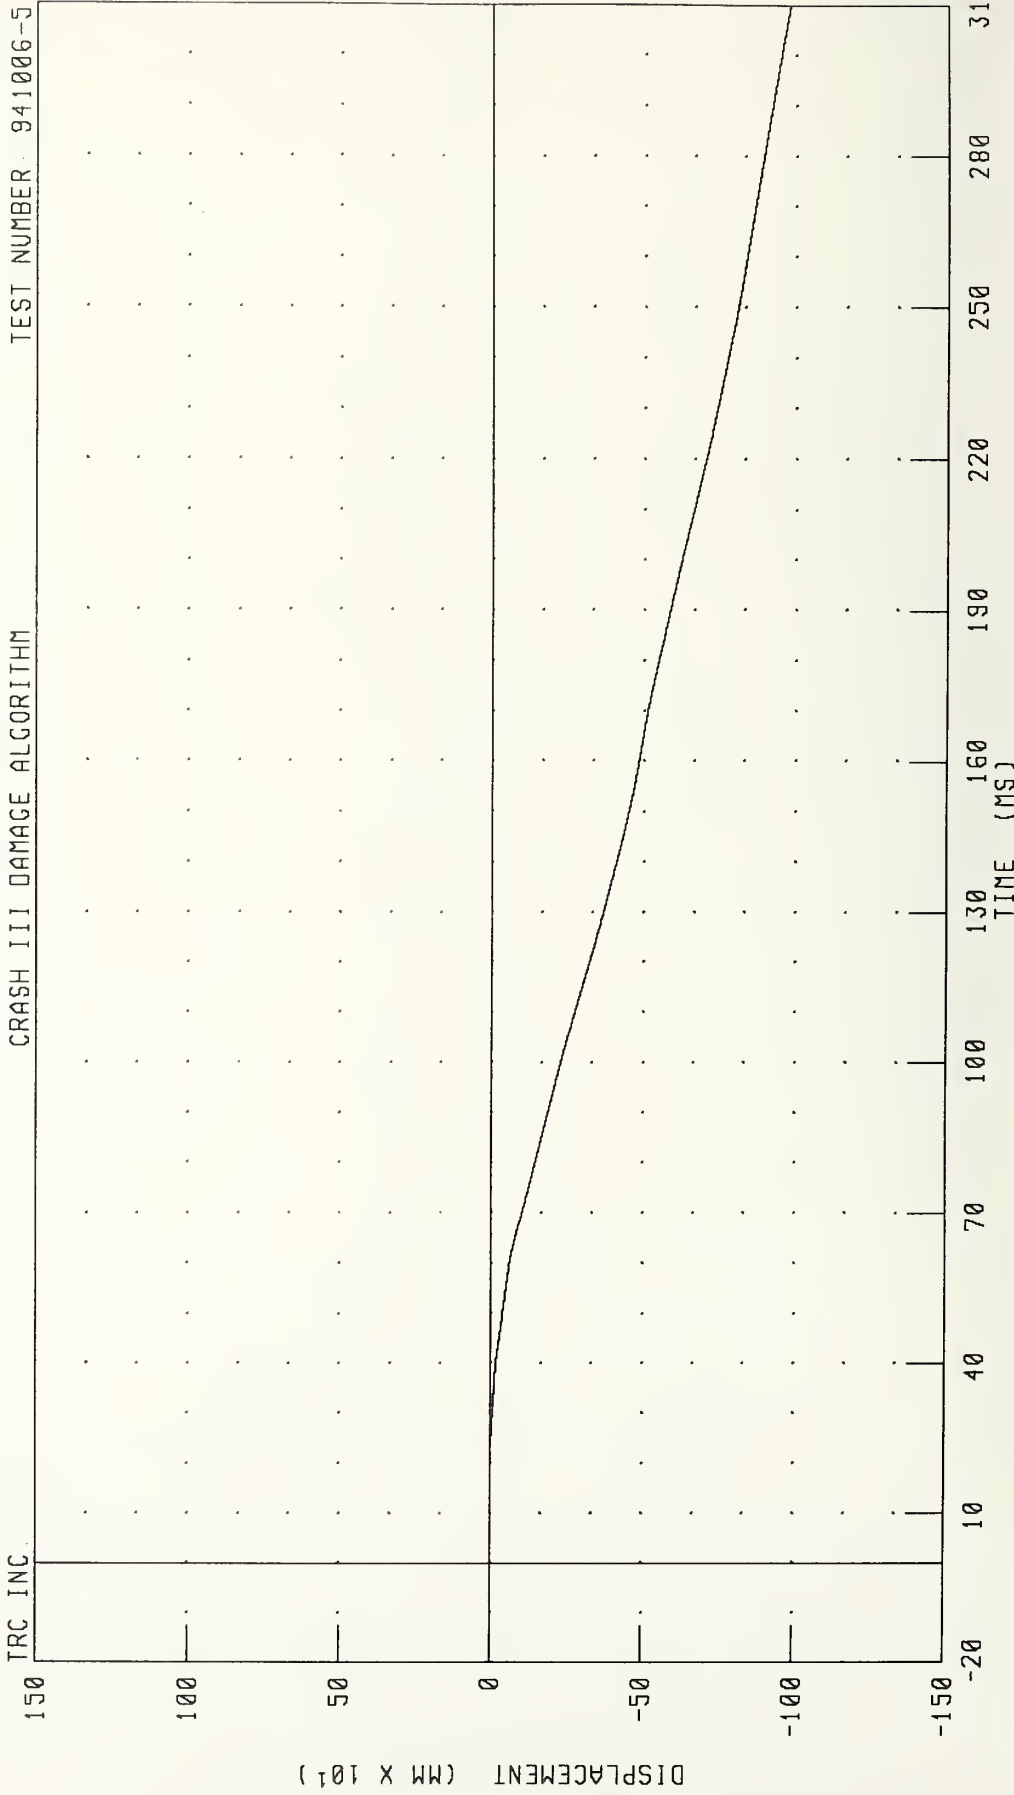
CHANNEL: VCGYD1 FILTER: CH. CLASS 180

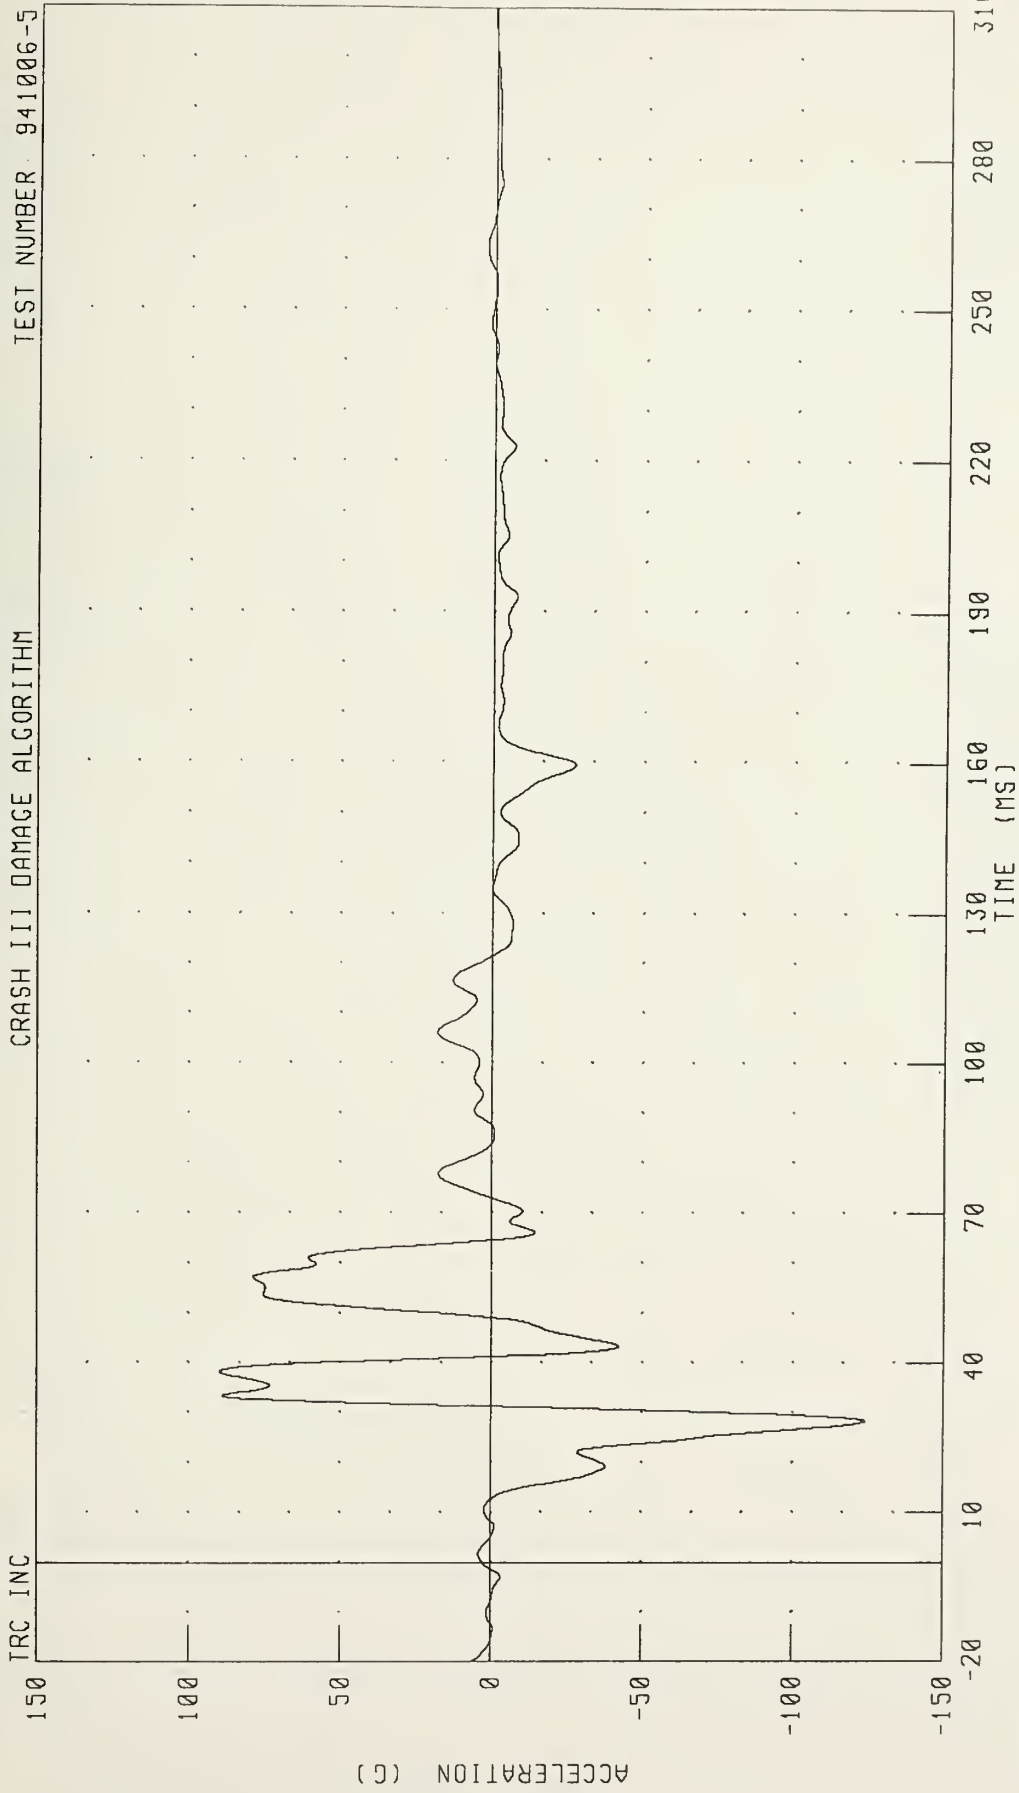
CHANNEL VCGZG1 FILTER: CH. CLASS 60 PEAK DATA: 89.75 G @ 38 24 MS; -124.10 G @ 28 32 MS

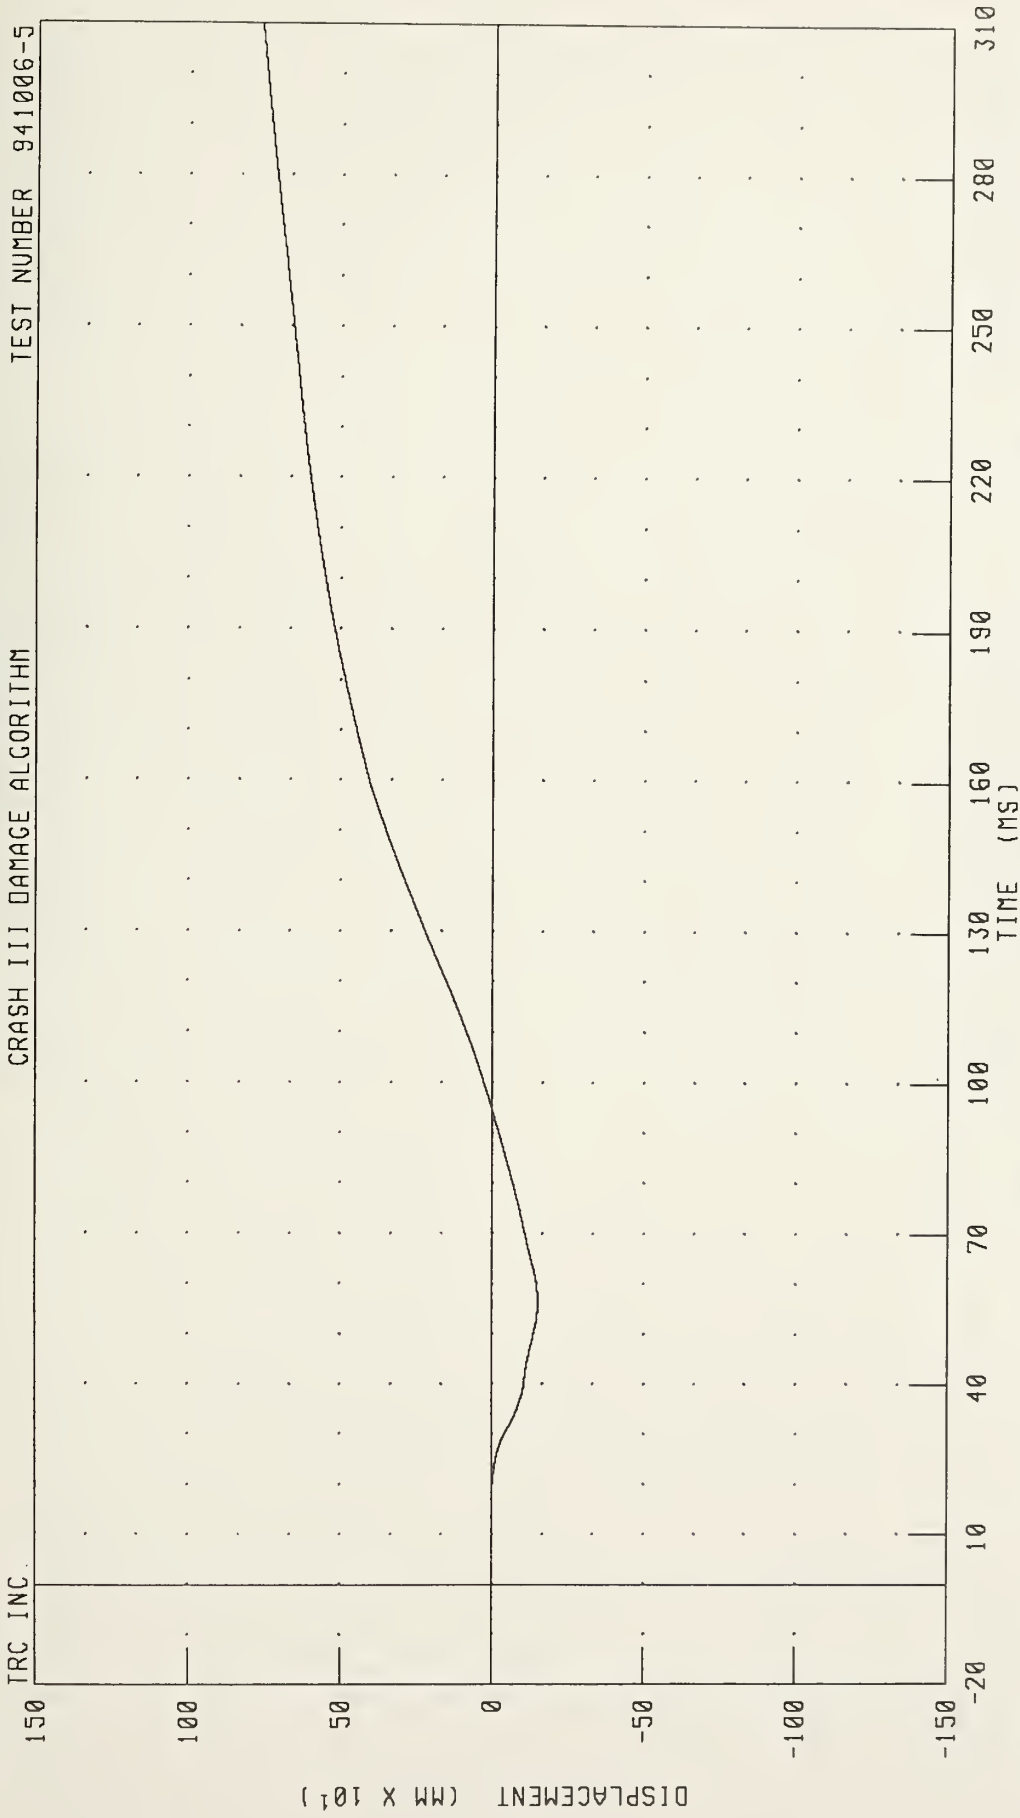
CHANNEL: VCGZ01 FILTER: CH. CLASS 180
