U.S. Department
of Transportation

**National Highway
Traffic Safety
Administration**

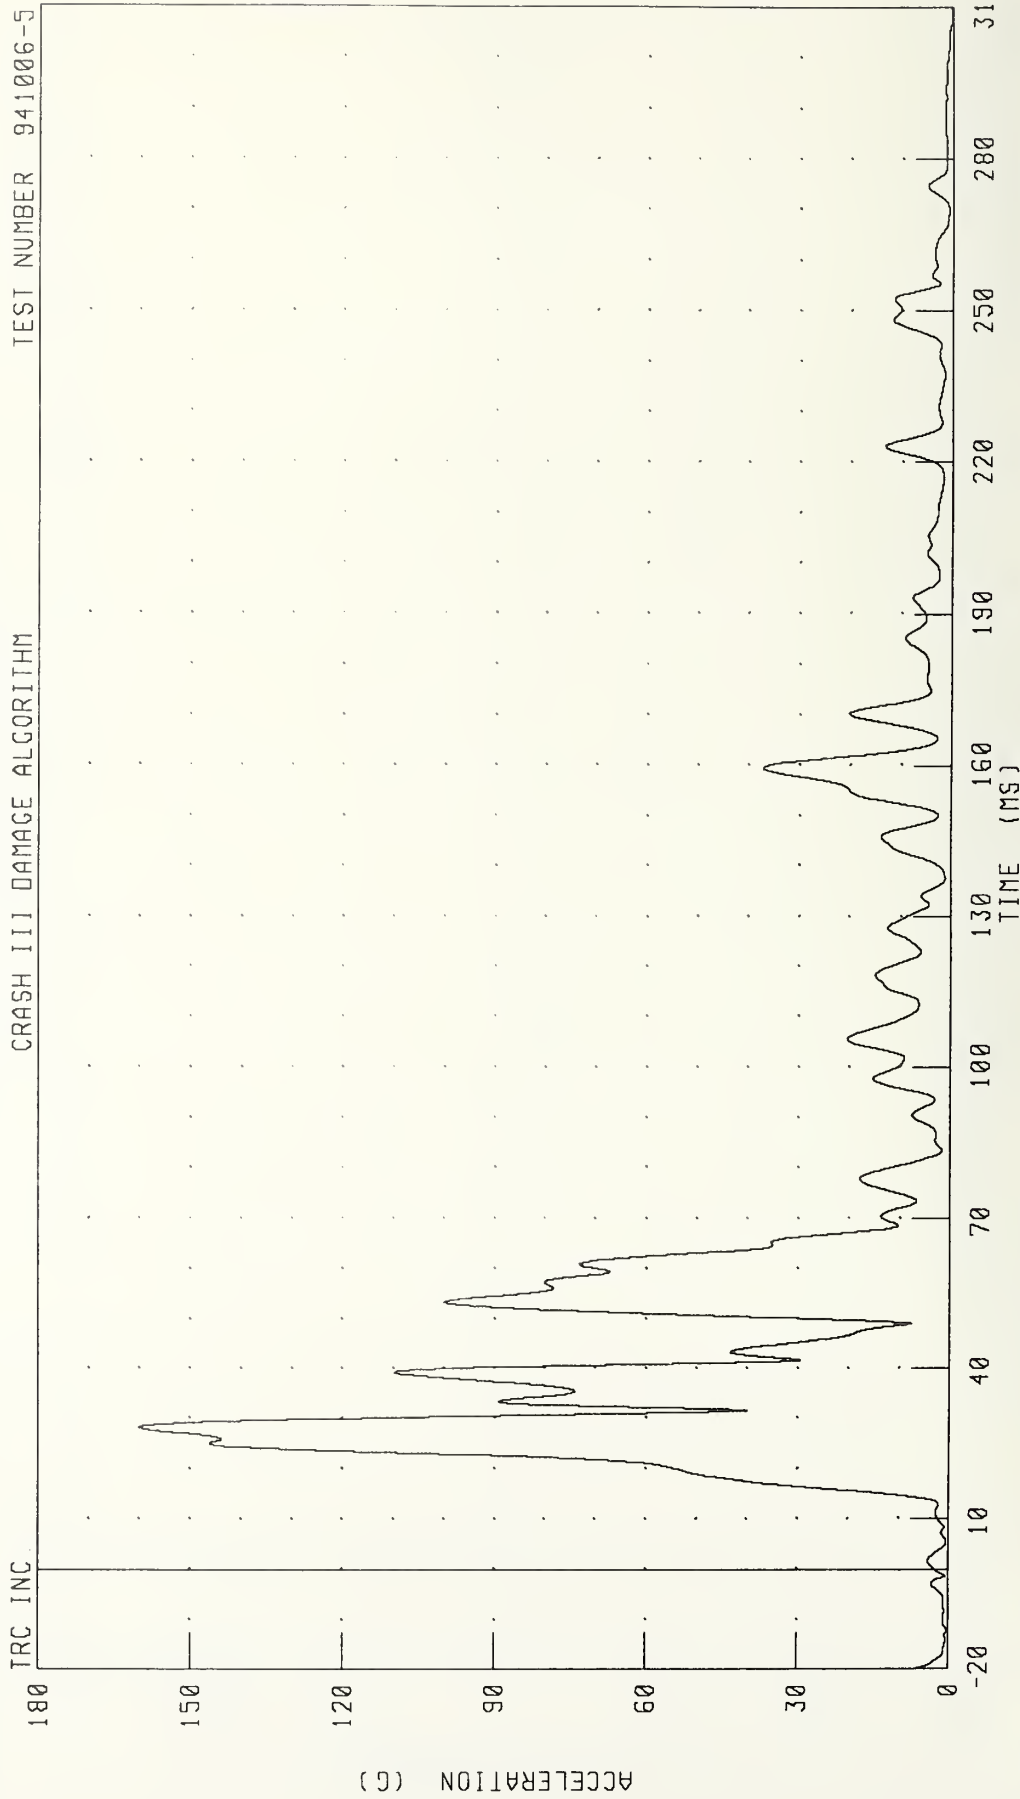
CHANNEL: VCGRG1 FILTER: CH CLASS 60

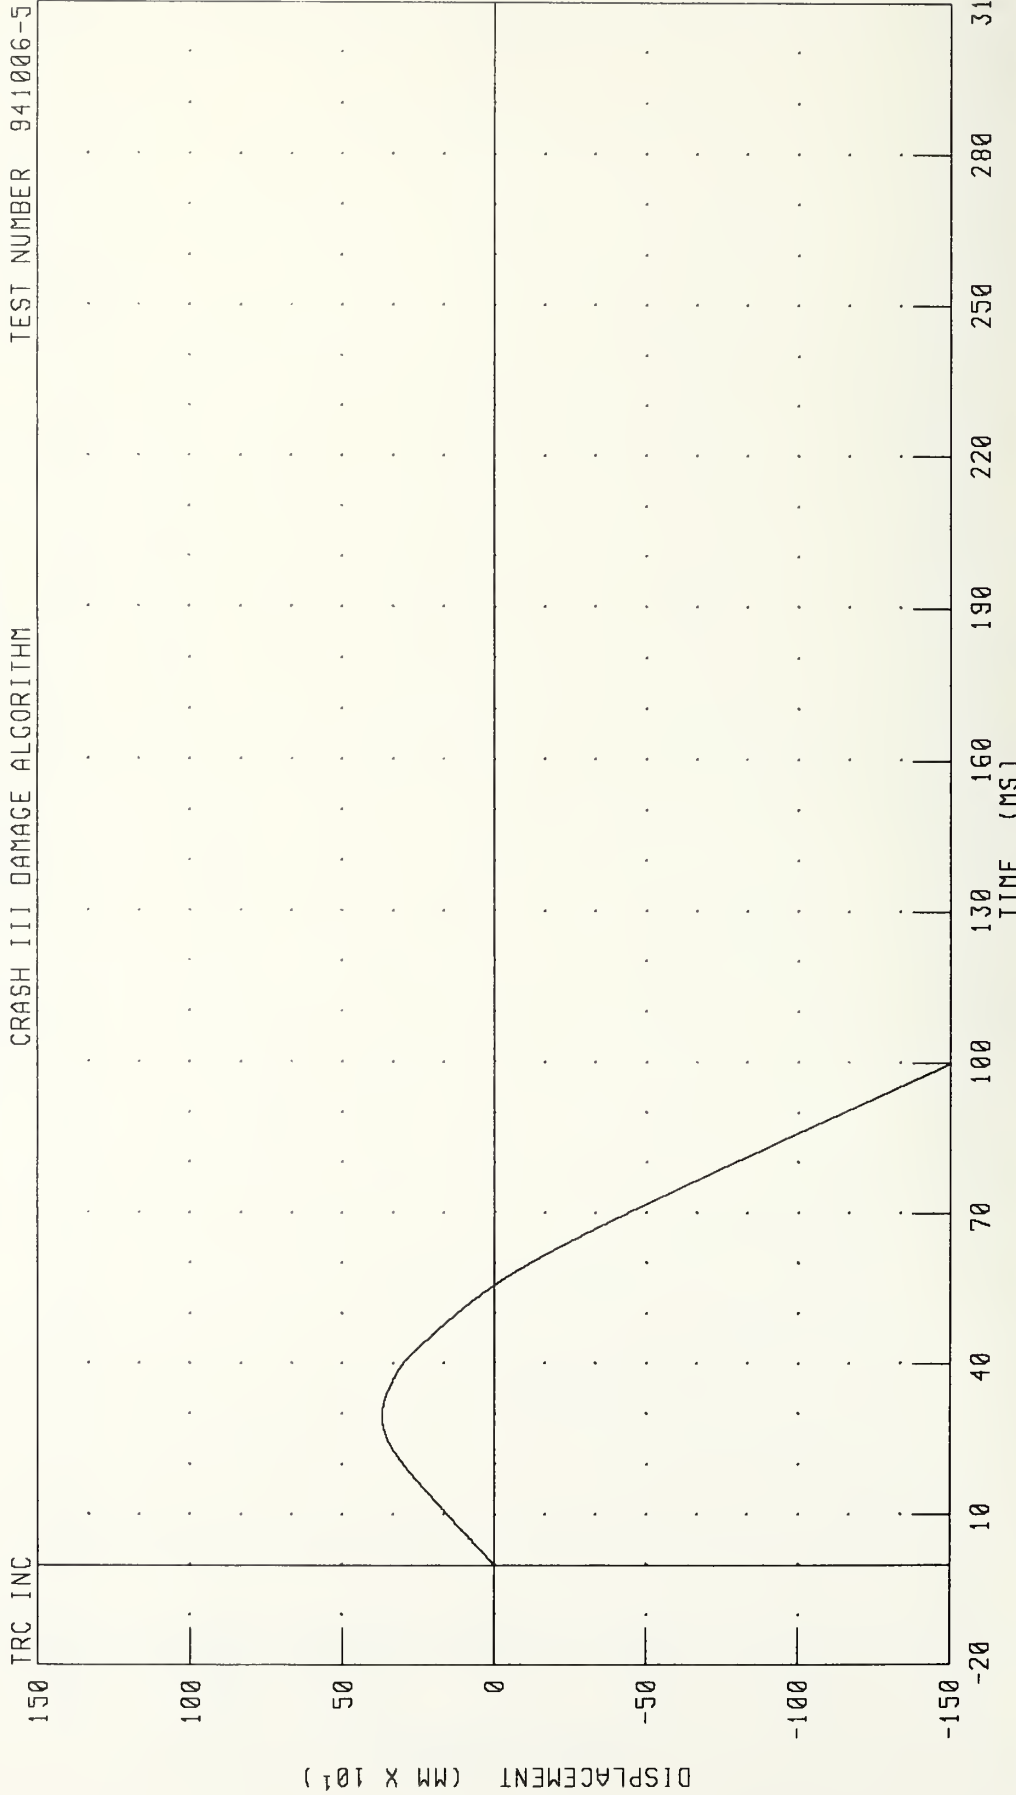
CHANNEL: VCGRD1 FILTER: CH. CLASS 180

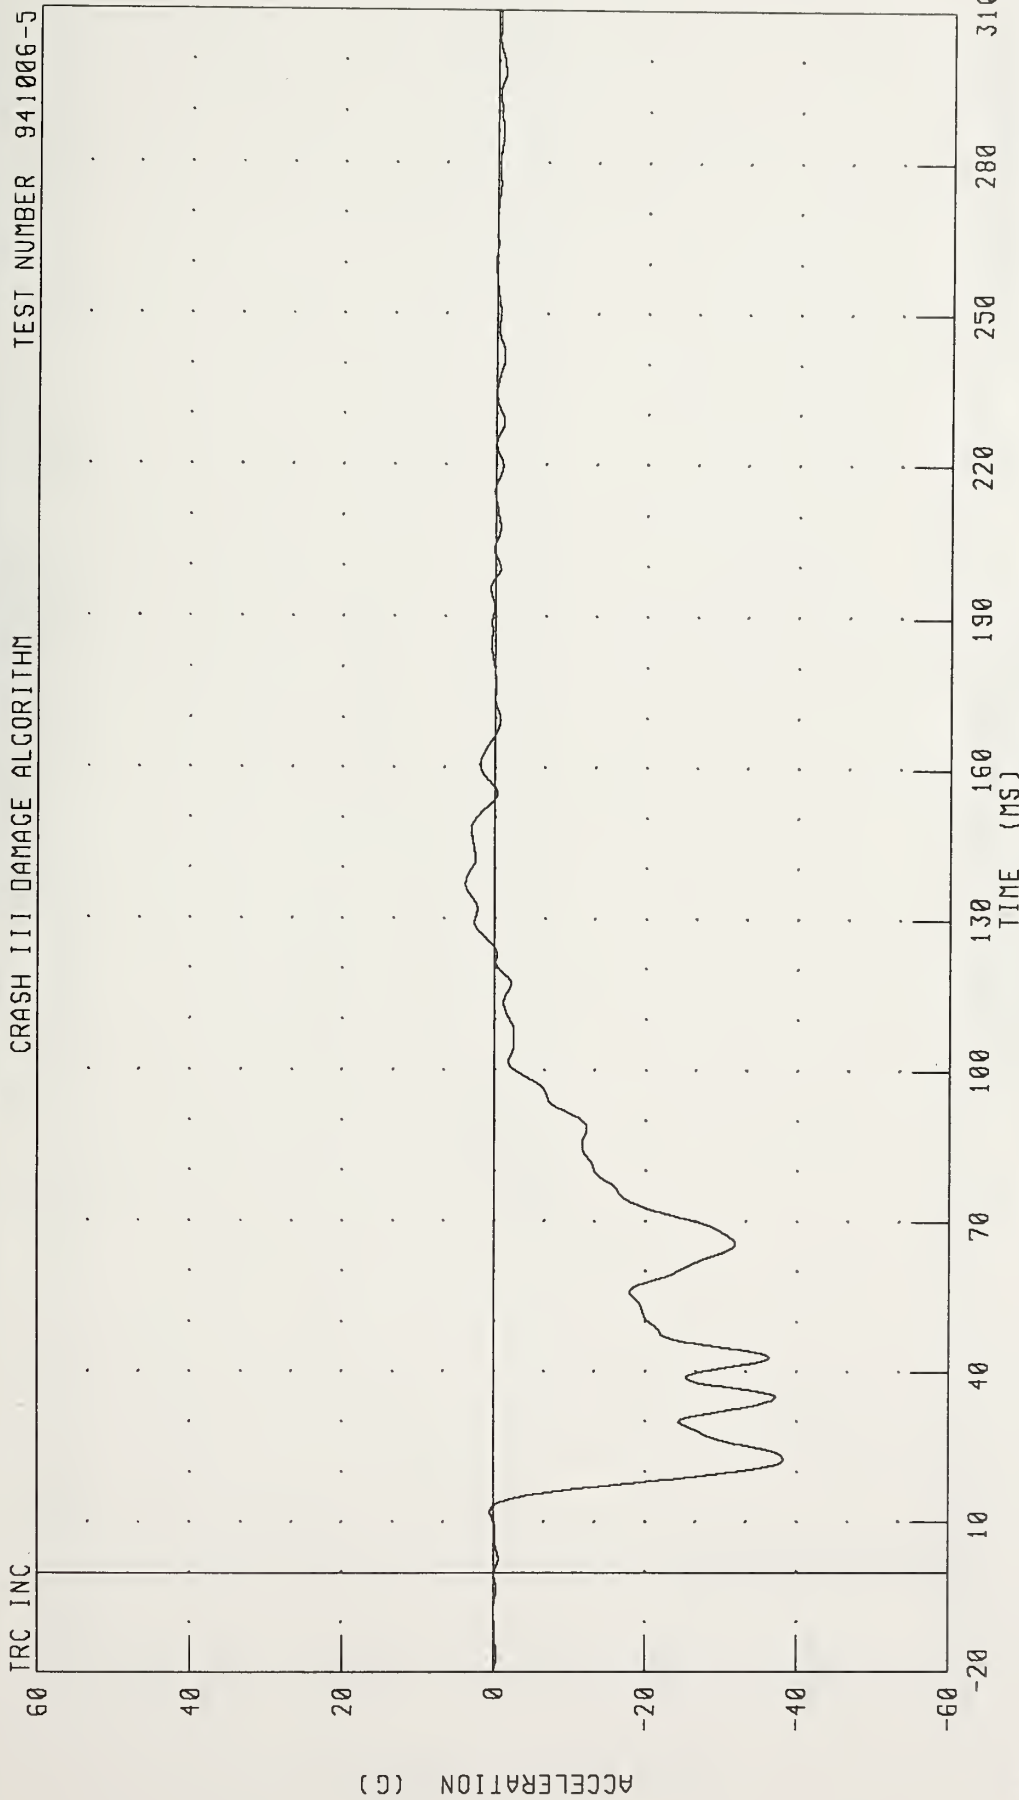
CHANNEL: LFSXG1 FILTER: CH CLASS 60

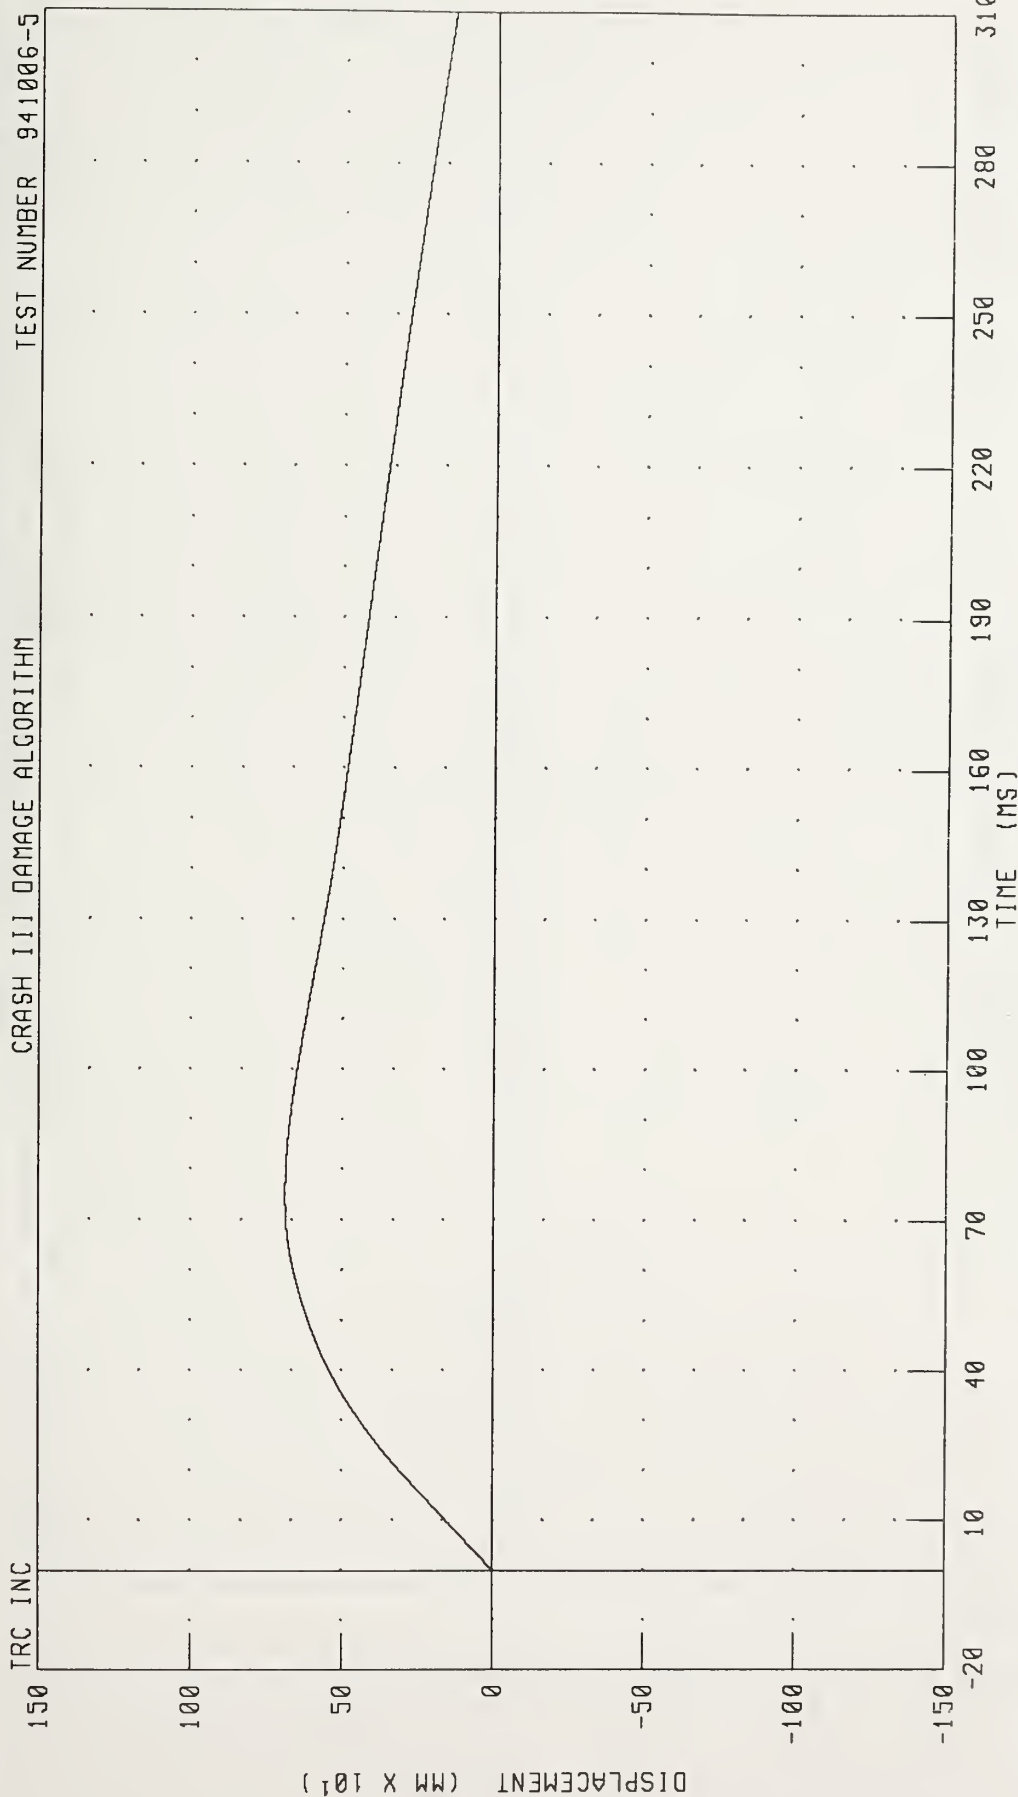
CHANNEL: LFSXD1 FILTER: CH CLASS 180 PEAK DATA: 688.56 MM @ 75.12 MS; 0 00 MM @ 0 00 MS

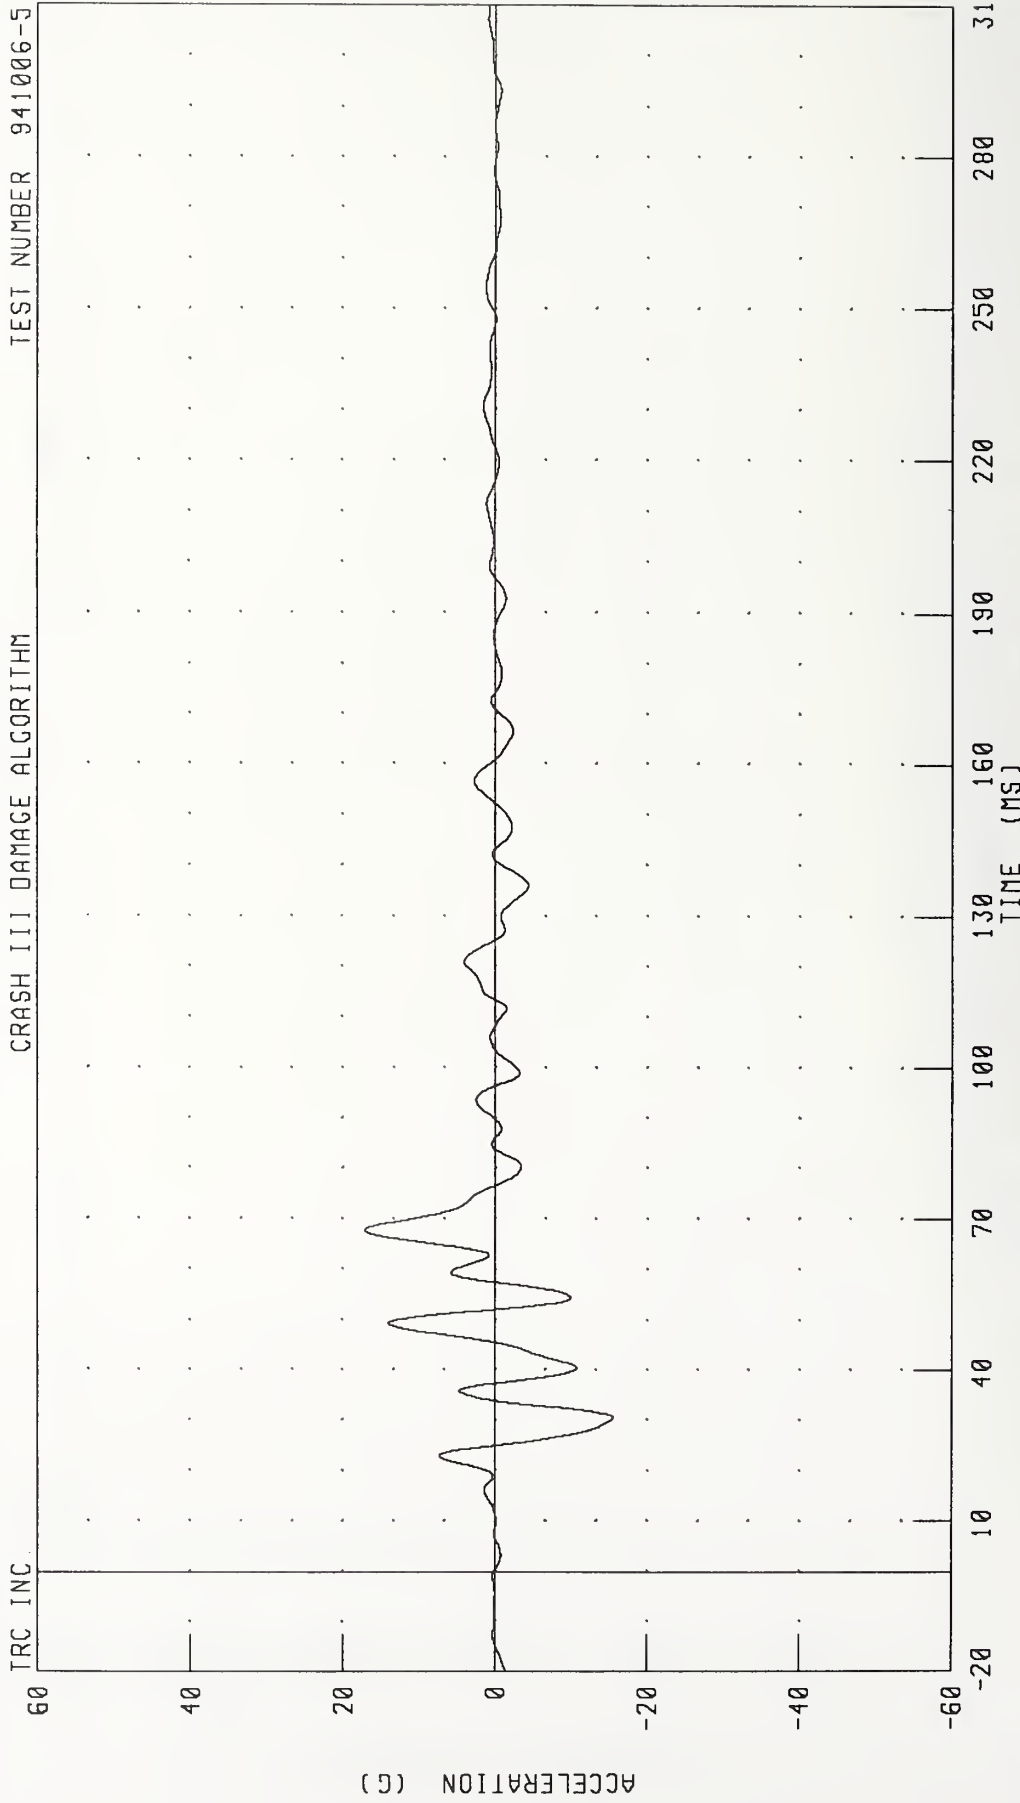
CHANNEL: LFSYG1 FILTER: CH CLASS 60

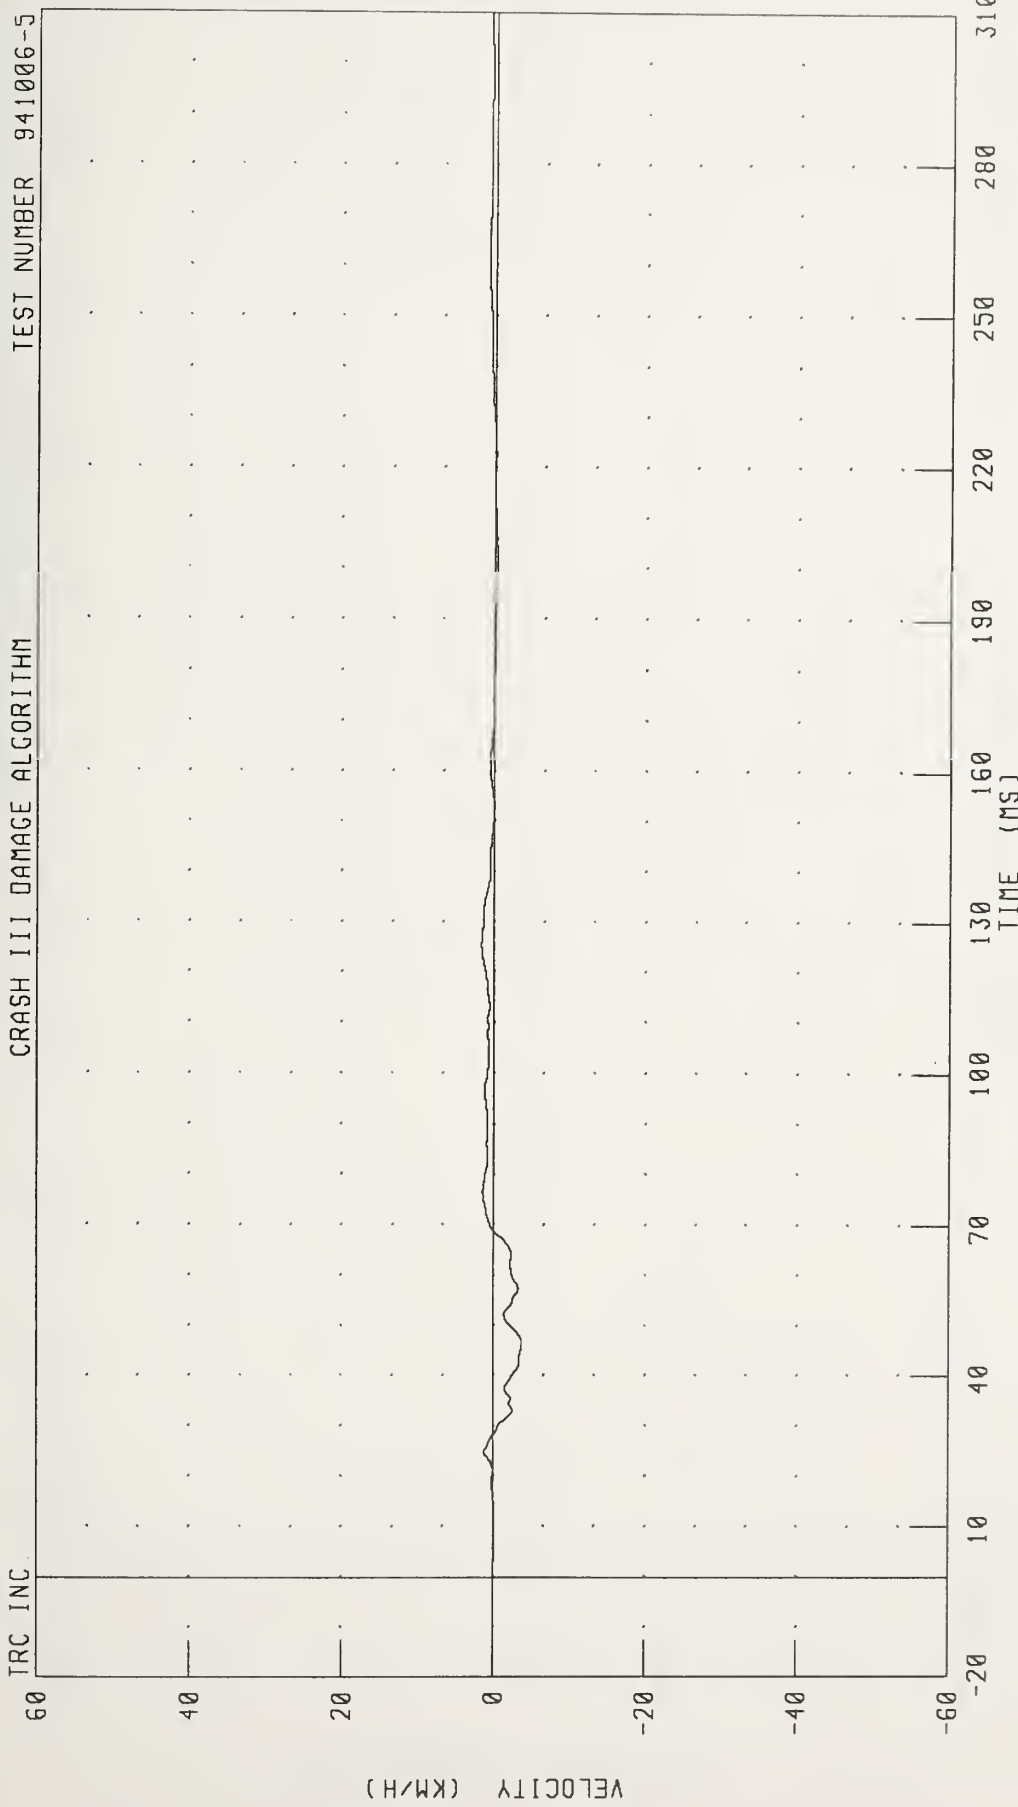
1992 CHEVROLET CAPRICE INTO 305 MM POLE
LEFT FRONT SILL Y-AXIS VELOCITY
CRASH III DAMAGE ALGORITHM

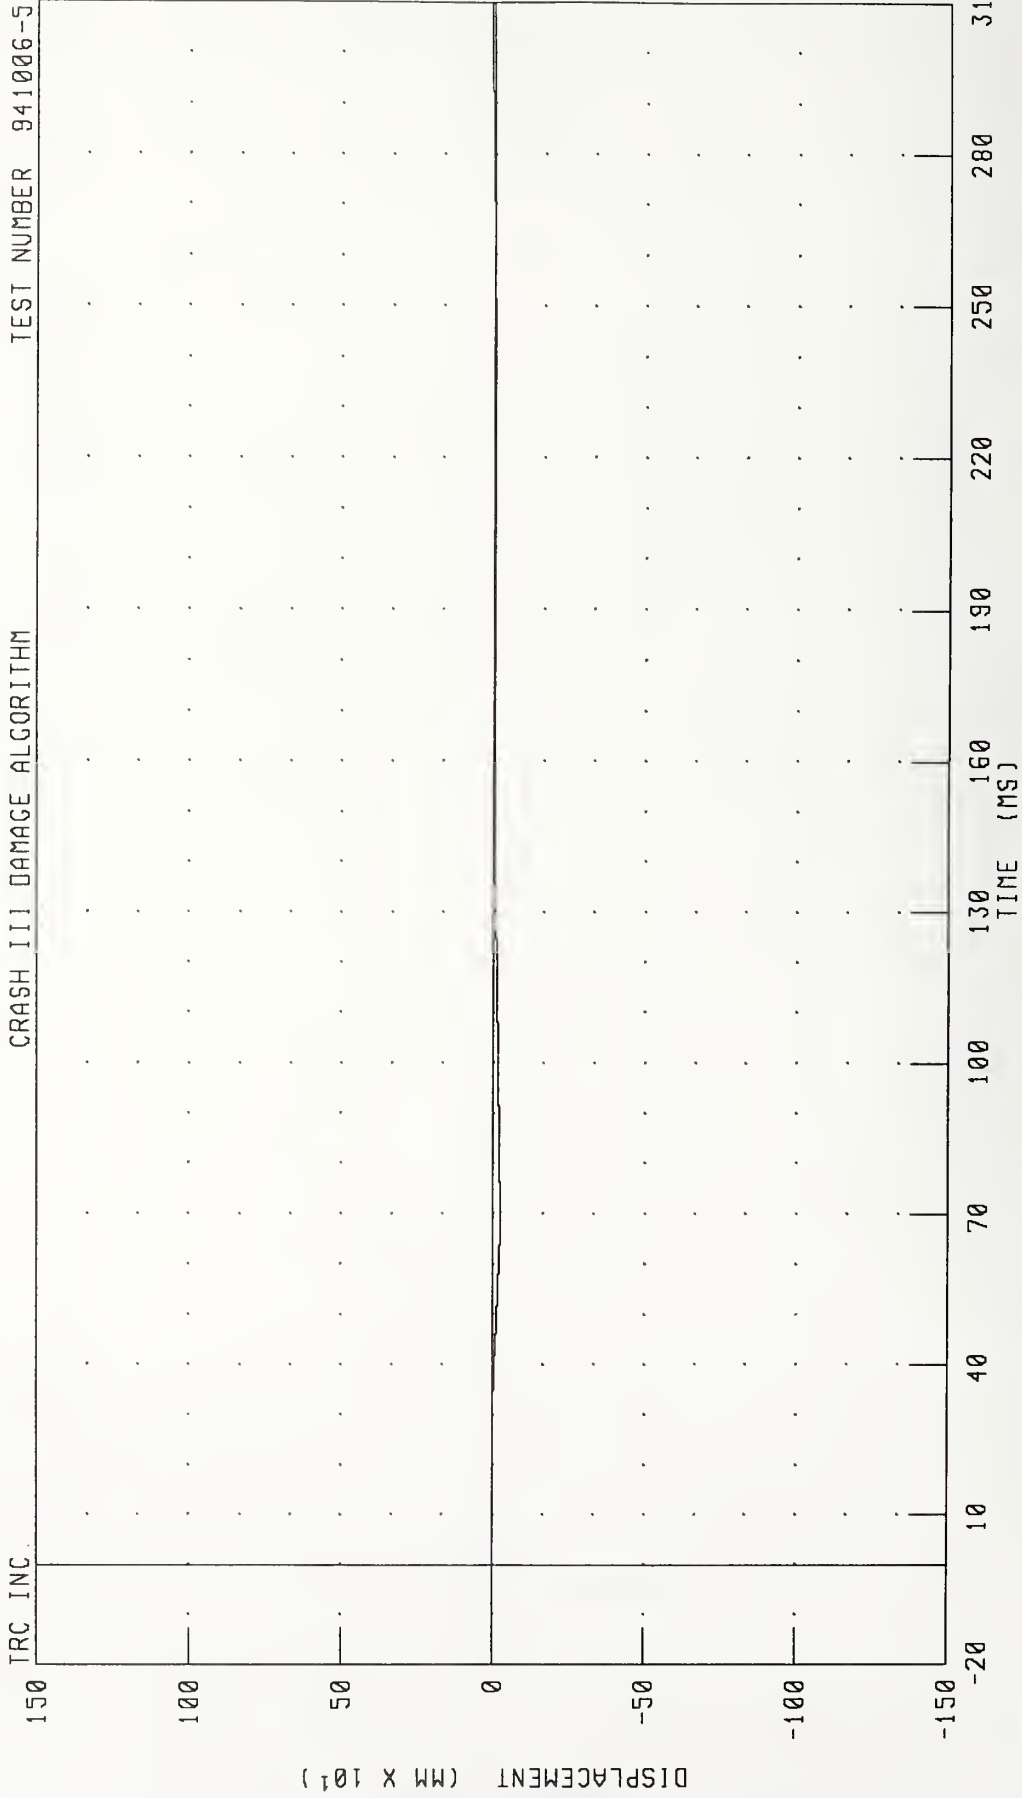
CHANNEL: LFSYD1 FILTER: CH CLASS 180
PEAK DATA: 9.54 MM @ 310.00 MS; -24.95 MM @ 68.72 MS

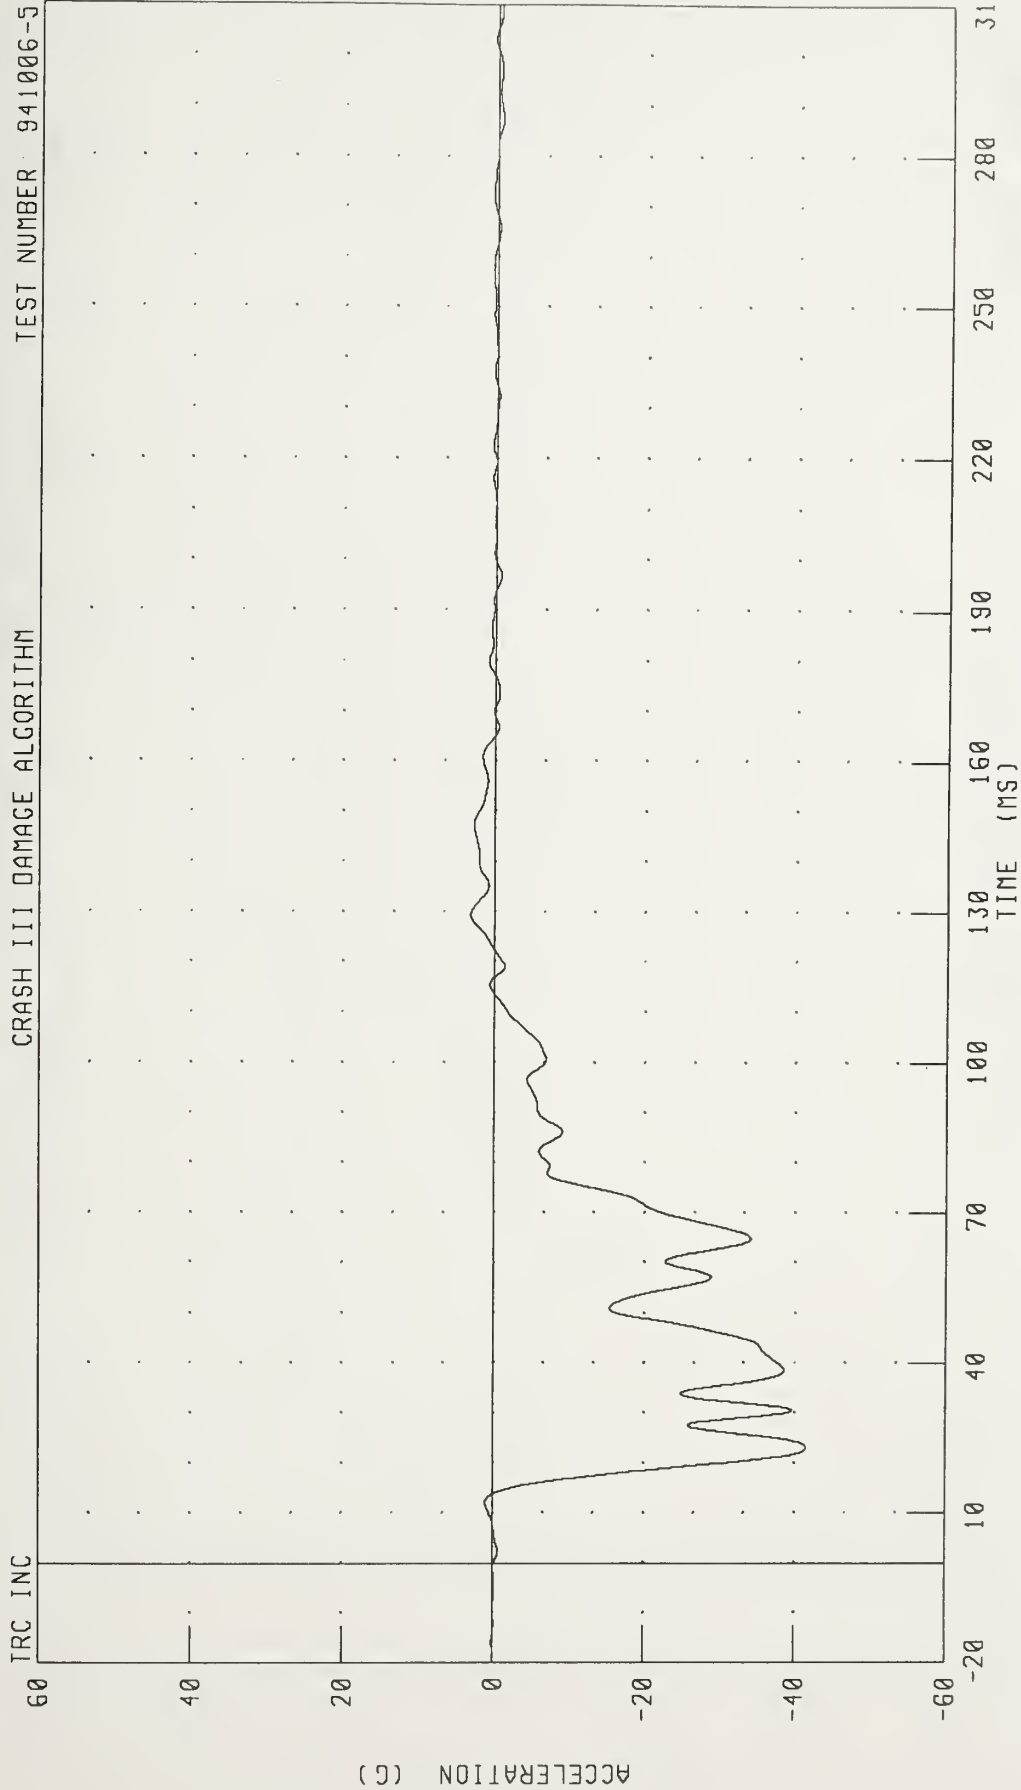
CHANNEL RFSXG1 FILTER: CH. CLASS 60 PEAK DATA: 3.16 G @ 129.36 MS, -41.53 G @ 23.04 MS

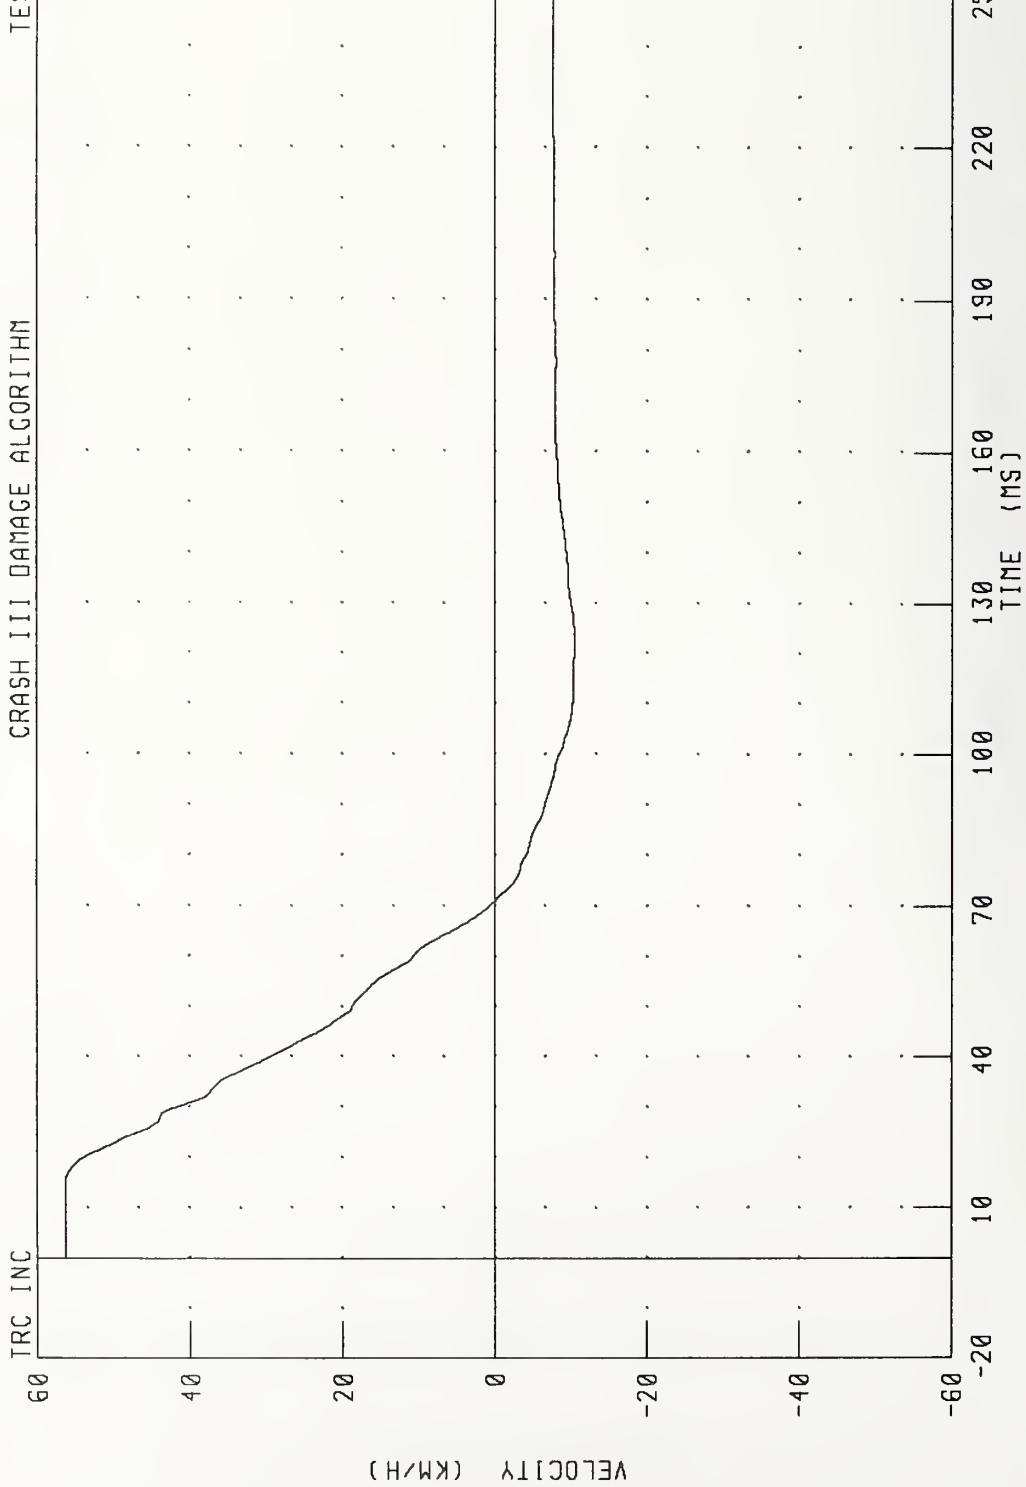
CHANNEL : RFSXV1 FILTER : CH. CLASS 180
PEAK DATA : 56.31 KM/H @ 0.56 MS, -10.48 KM/H @ 120.08 MS

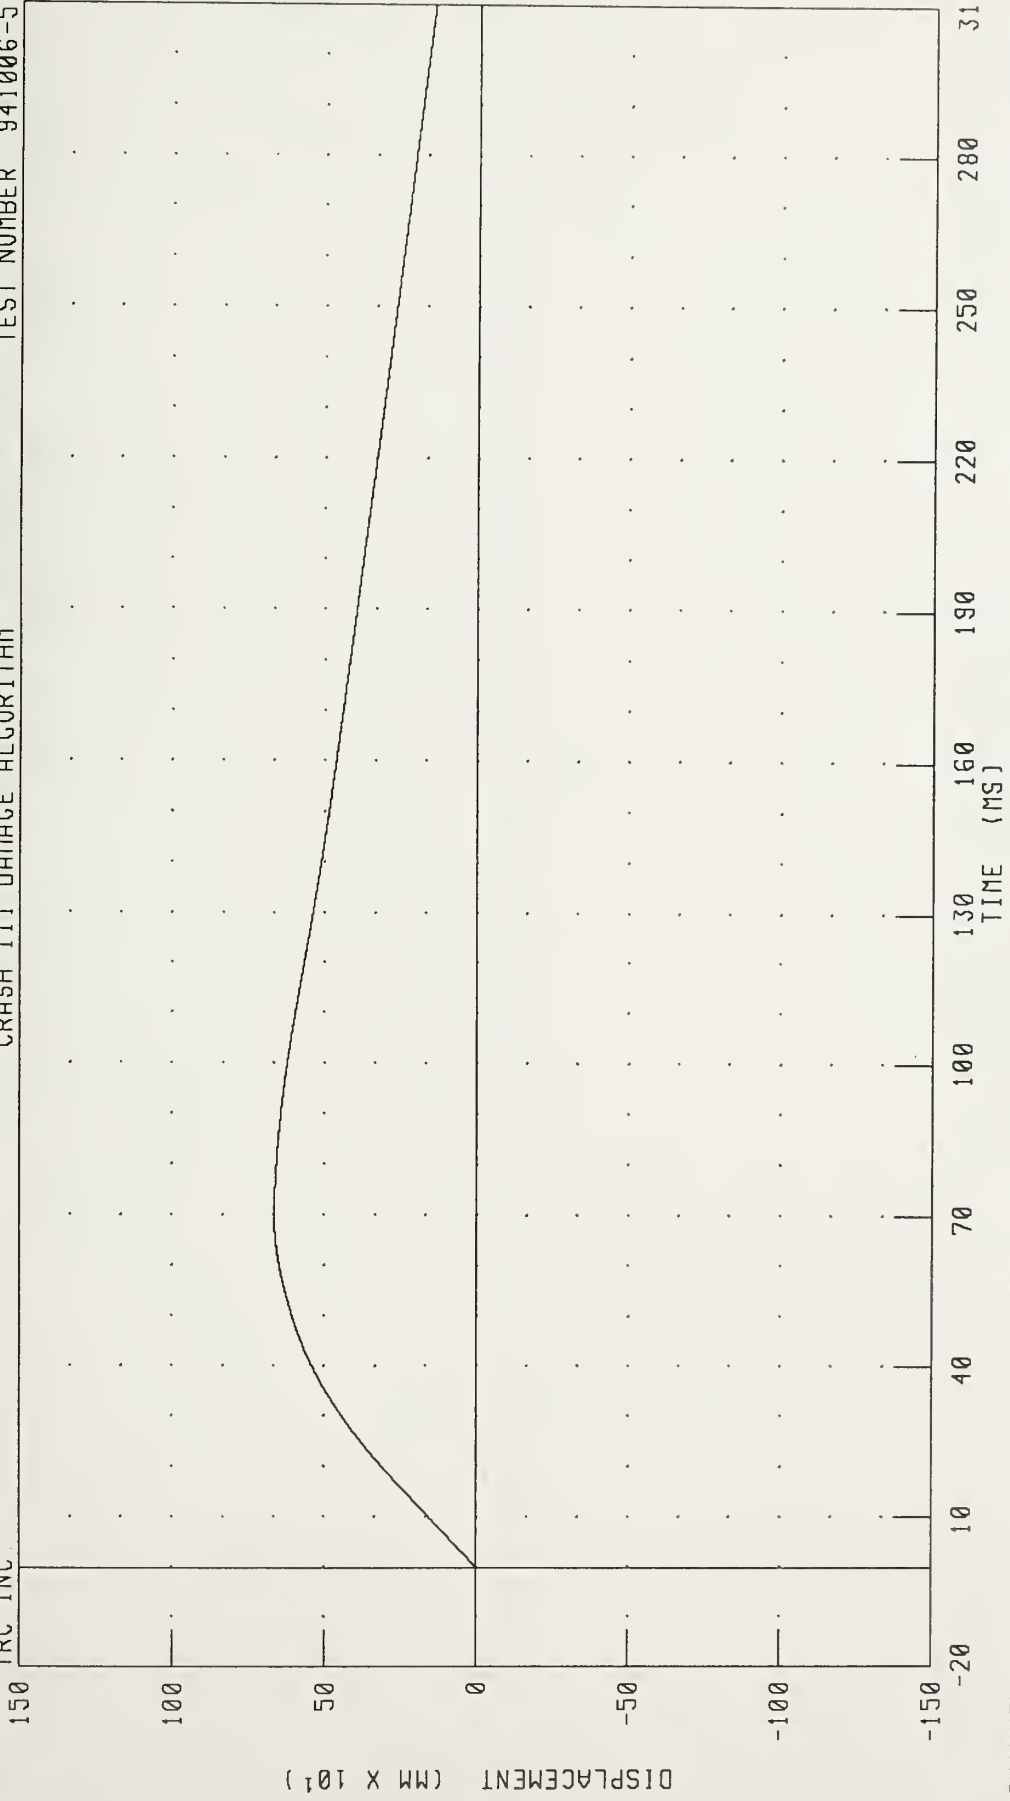
CHANNEL: RFSXD1 FILTER: CH. CLASS 180

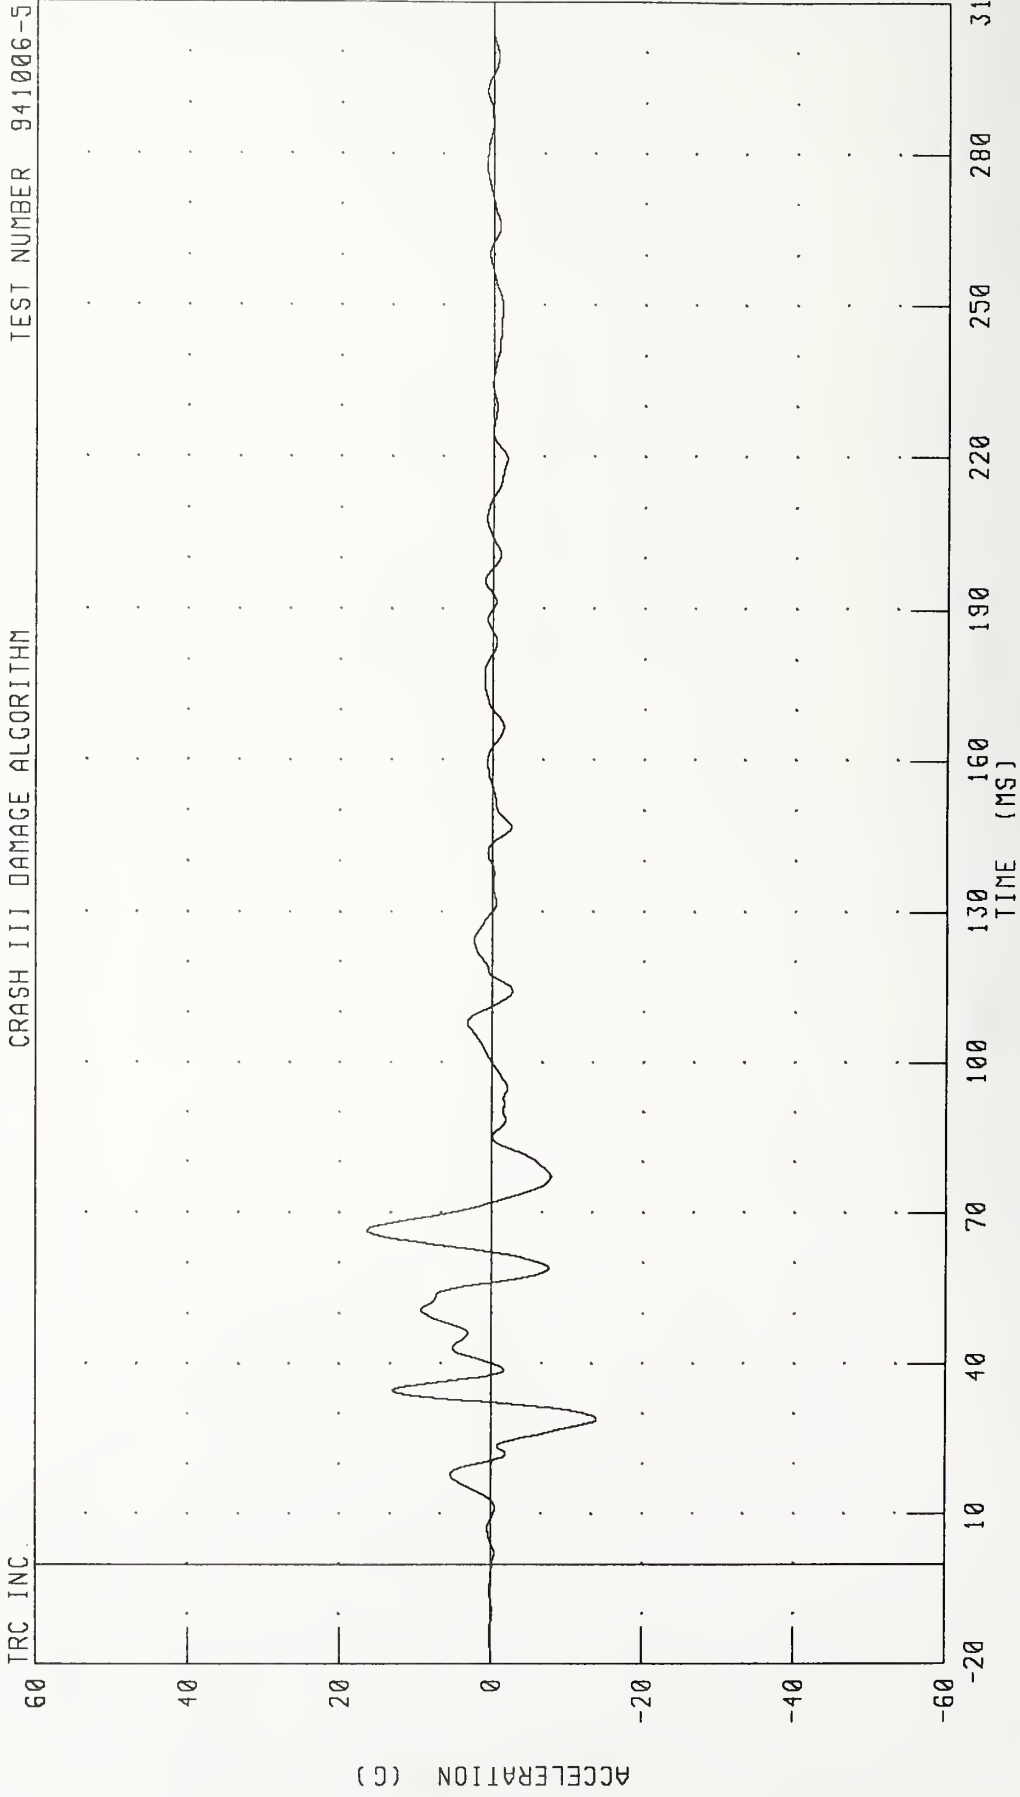
CHANNEL: RFSYG1 FILTER: CH. CLASS 60

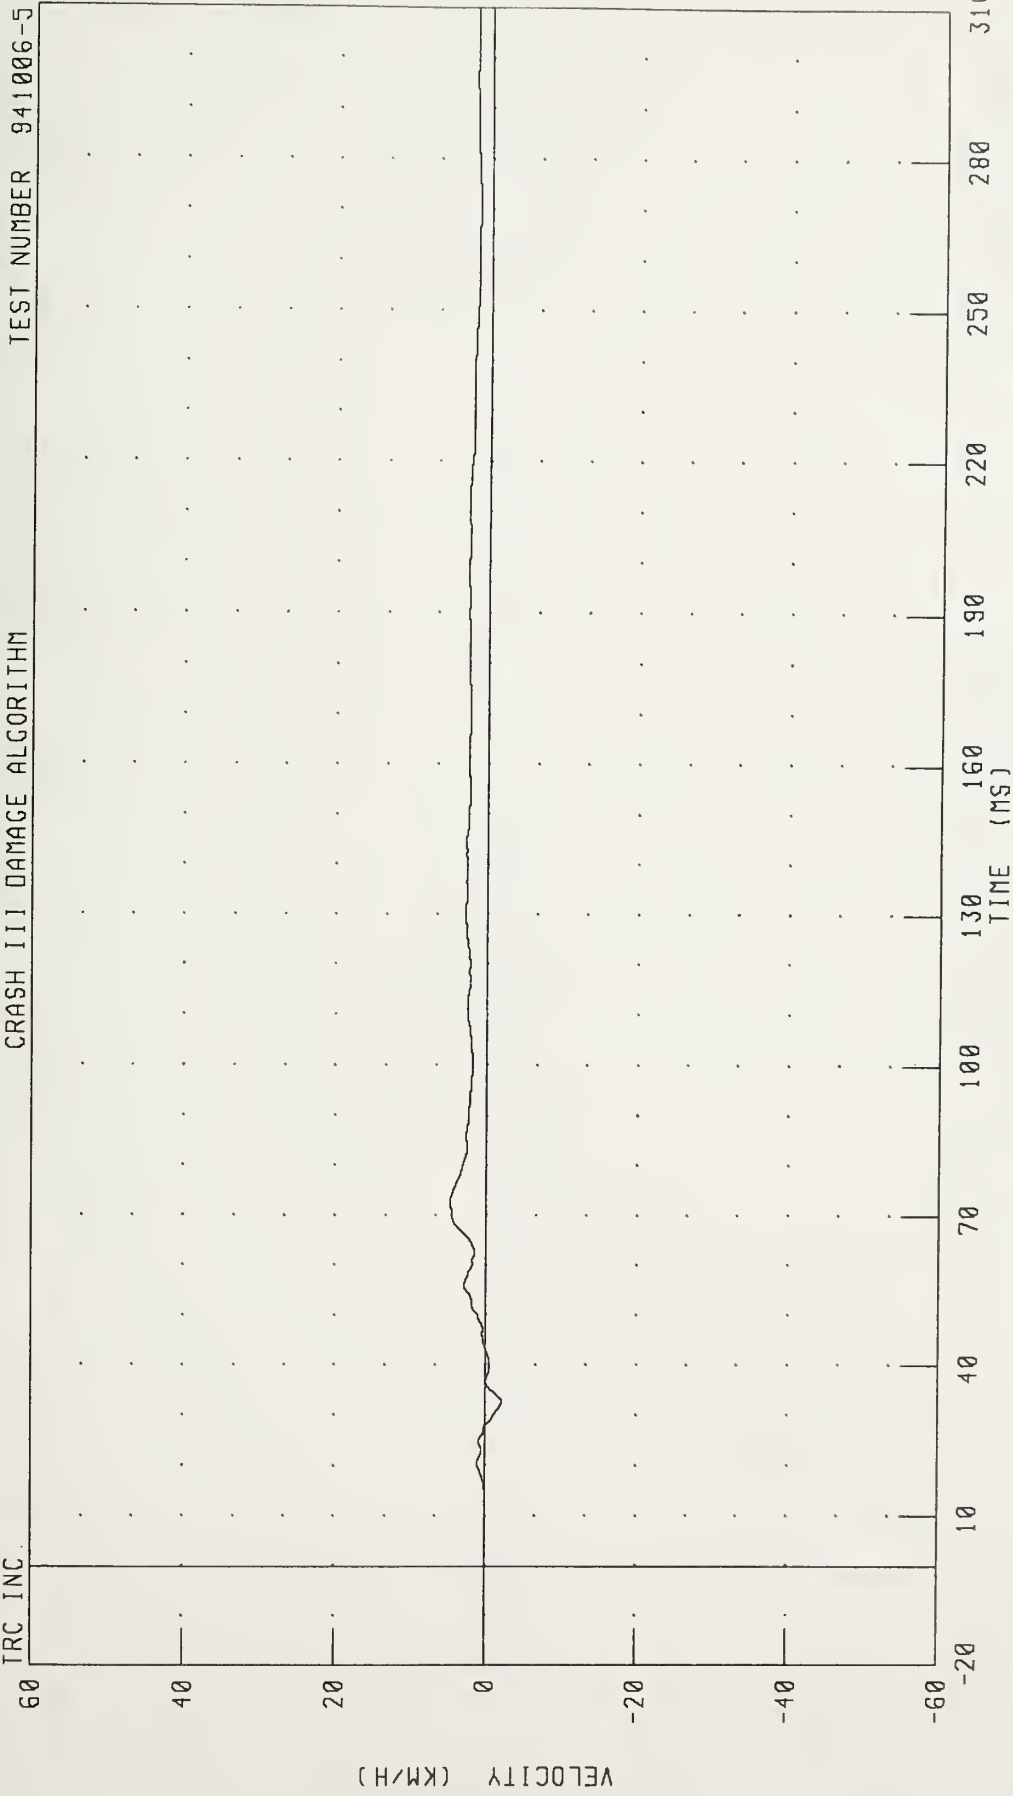
CHANNEL: RFSYV1 FILTER: CH. CLASS 180
