U.S. Department
of Transportation

**National Highway
Traffic Safety
Administration**

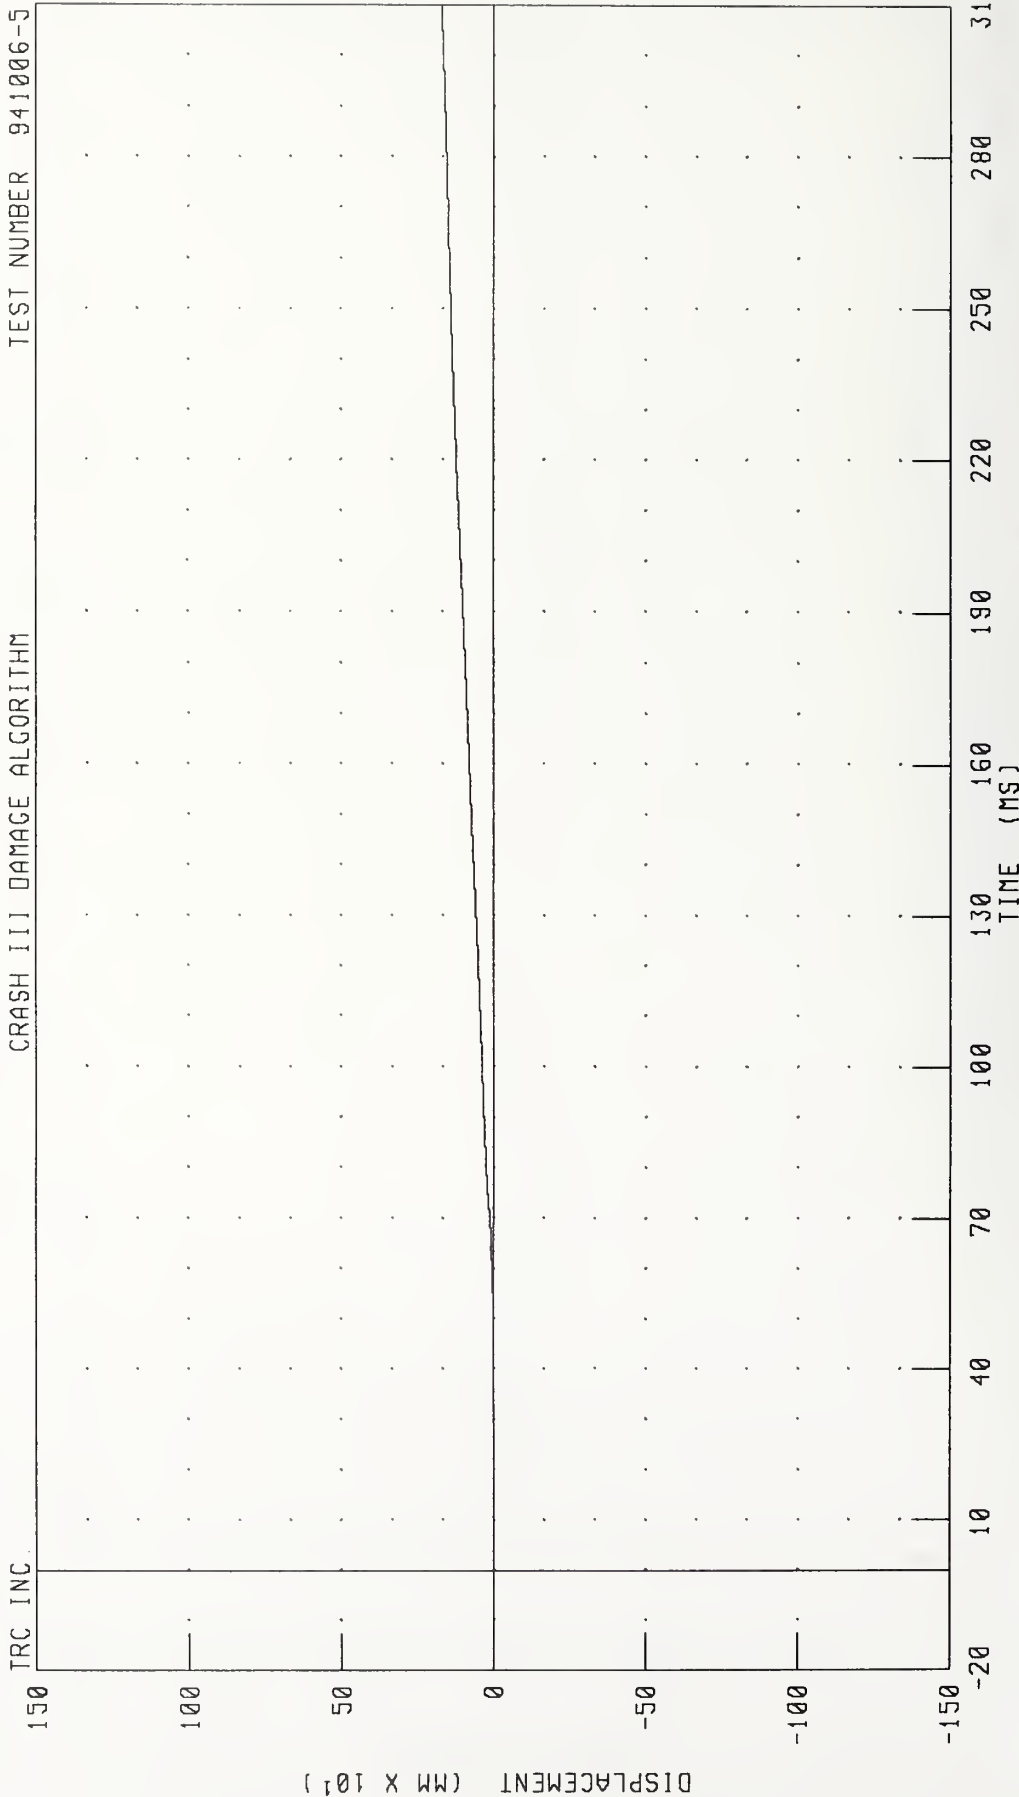
CHANNEL: RFSY01 FILTER: CH. CLASS 180

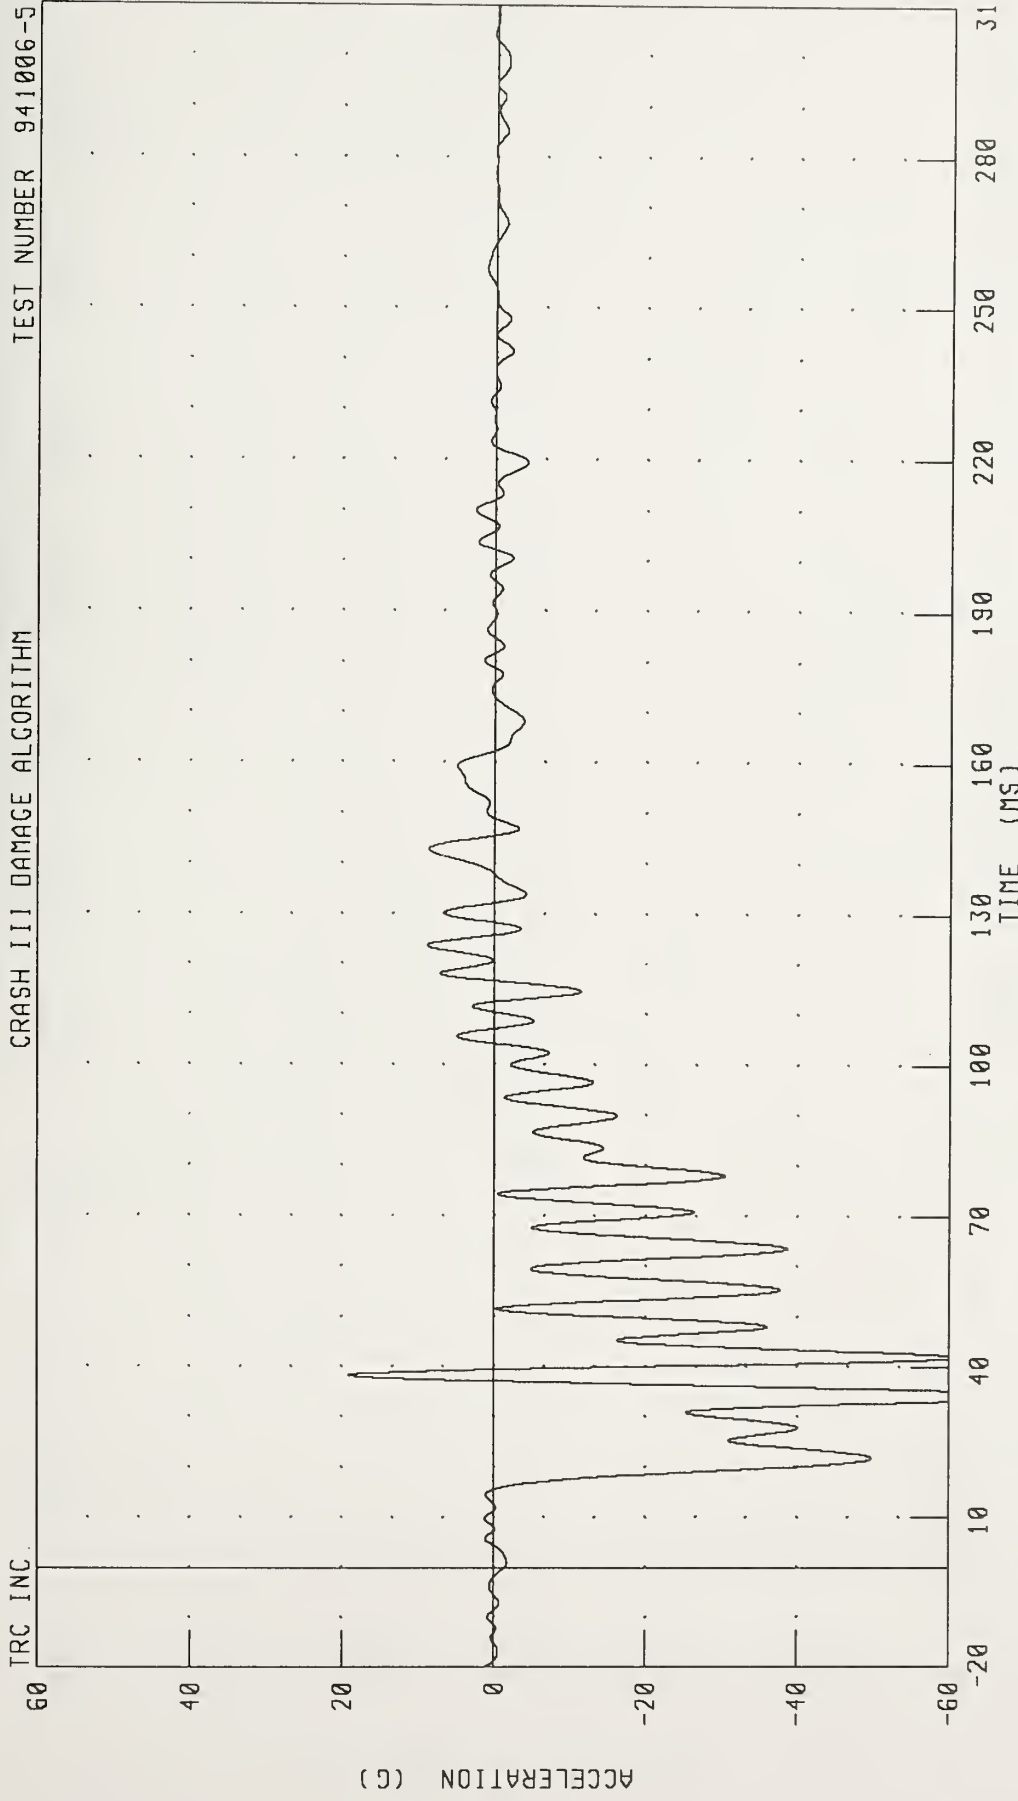
CHANNEL: TLRXG1 FILTER: CH. CLASS 60

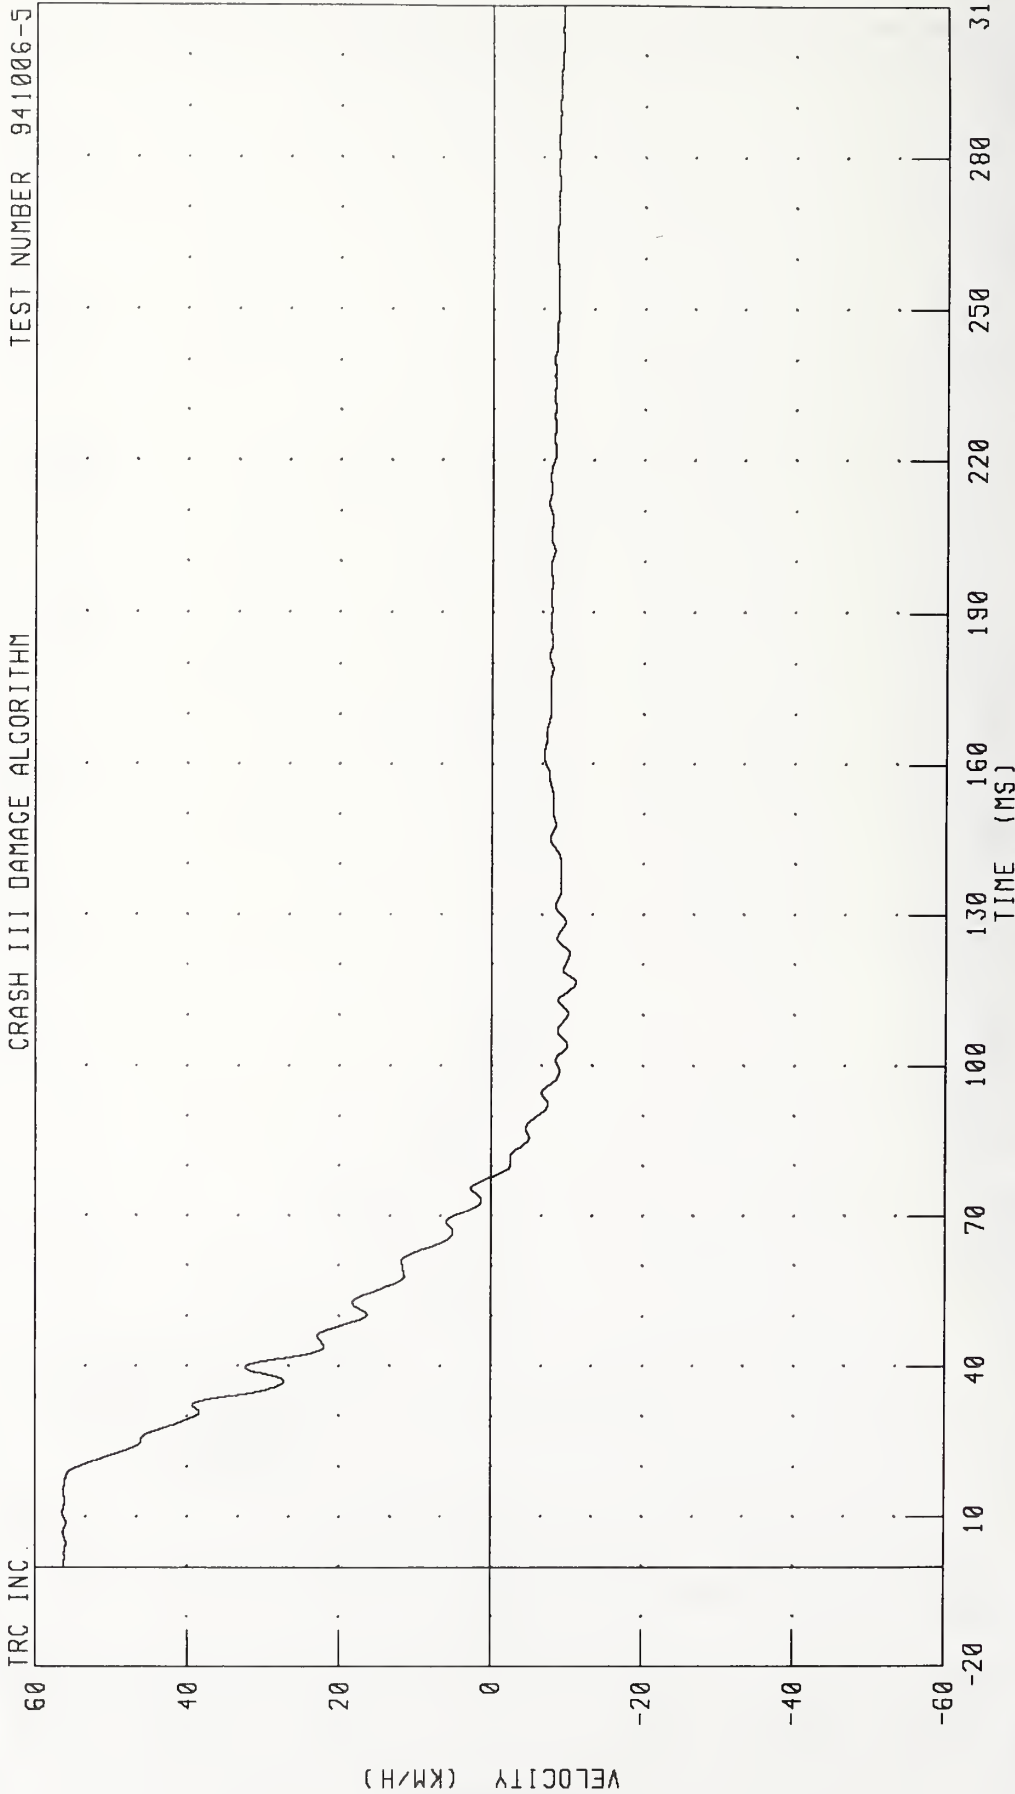
1992 CHEVROLET CAPRICE INTO 305 MM POLE
LEFT REAR SEAT X-AXIS DISPLACEMENT

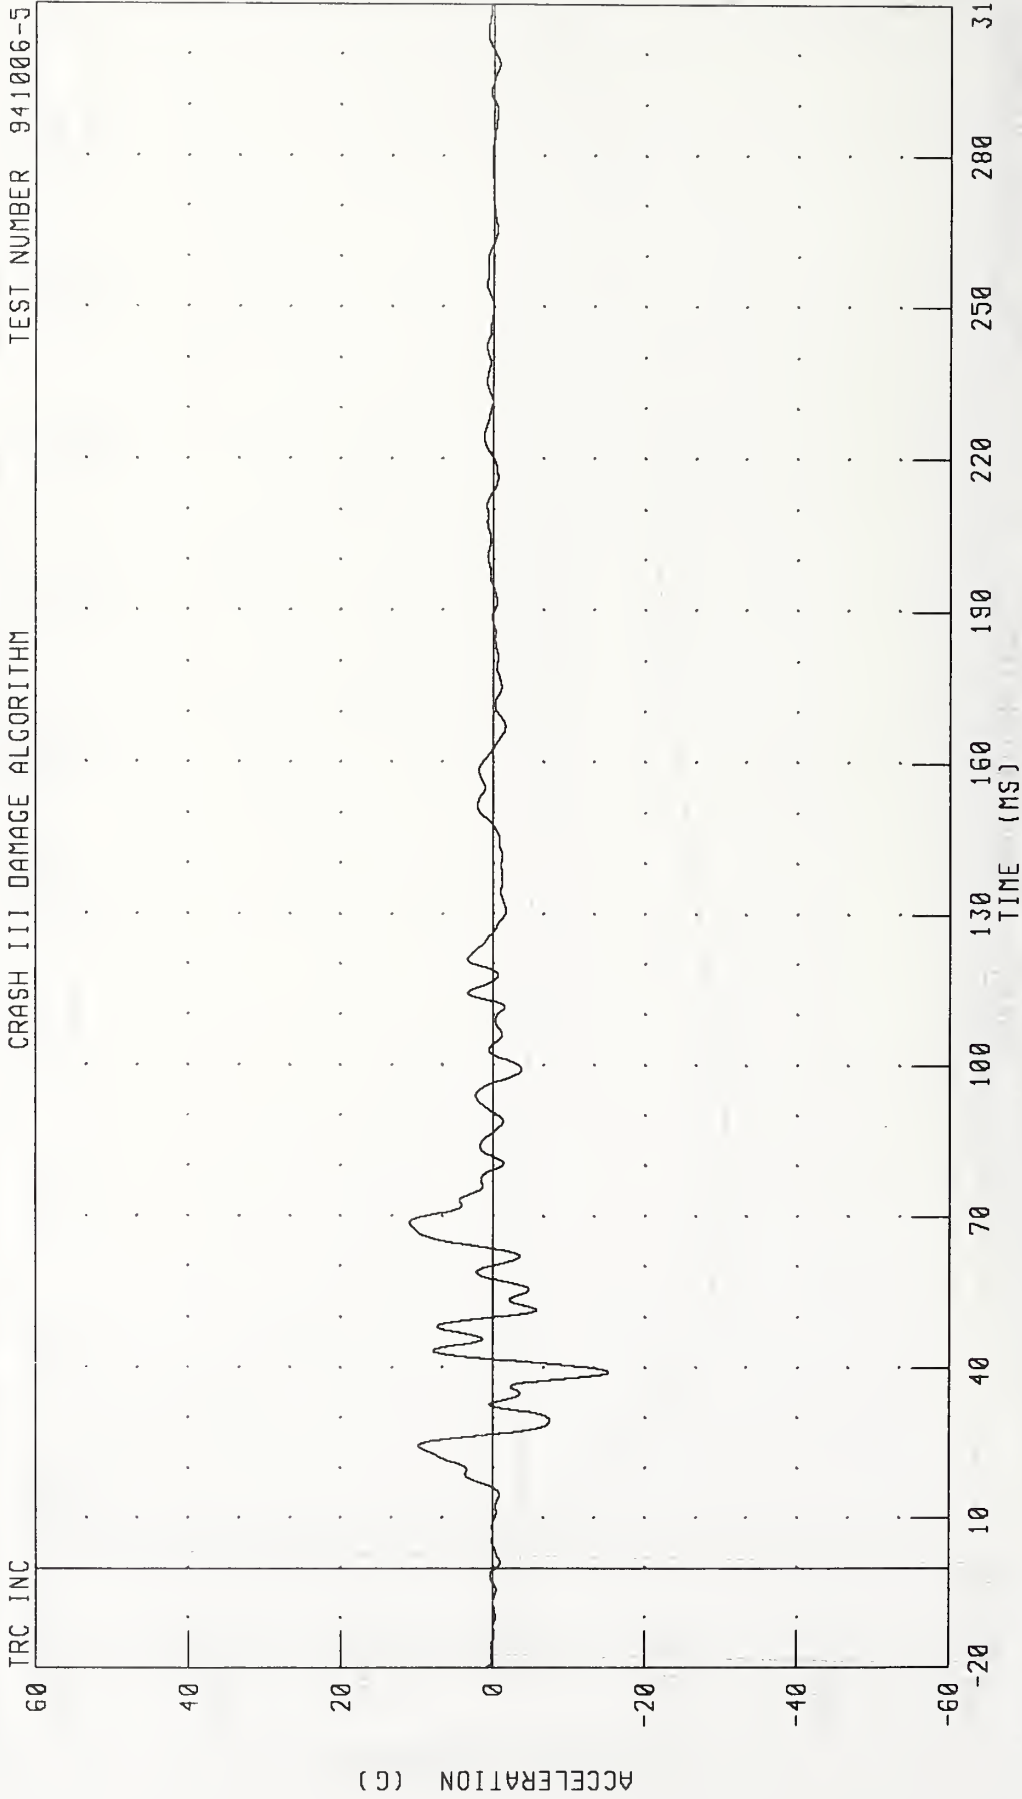
CHANNEL: TLRYG1 FILTER: CH. CLASS 60

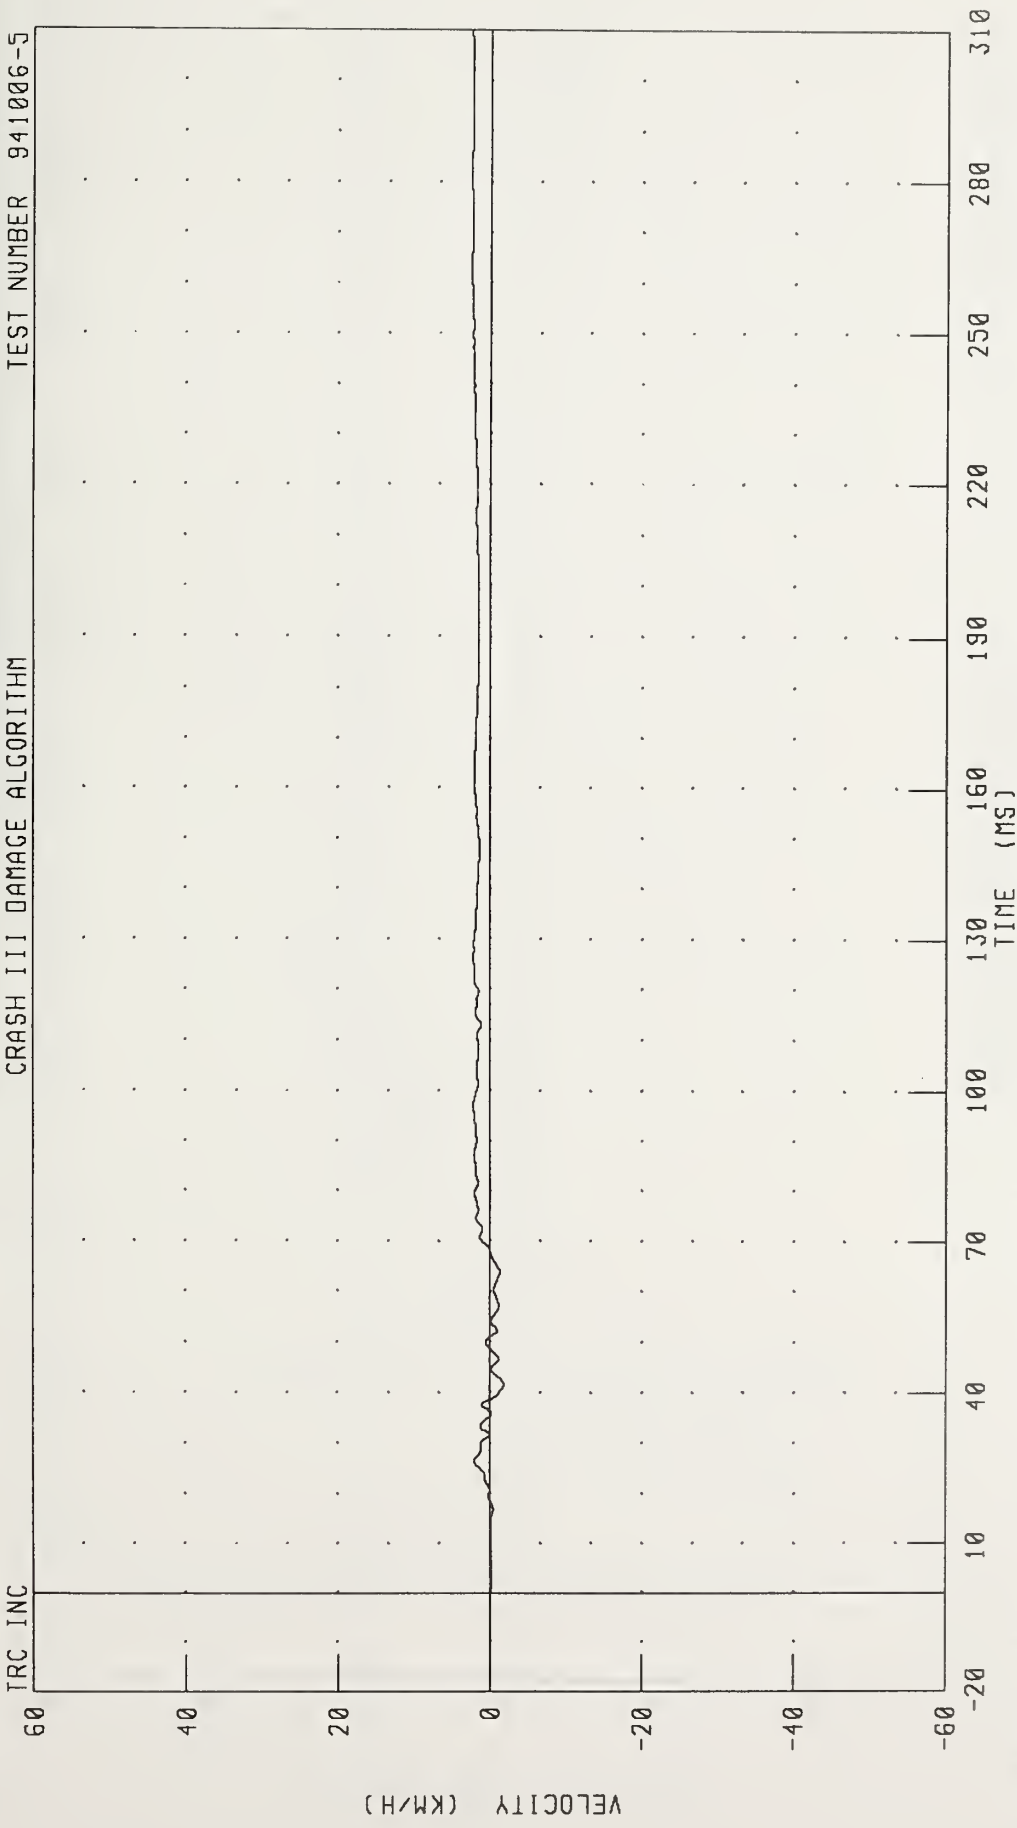
CHANNEL: TLRYV1 FILTER: CH. CLASS 180 PEAK DATA: 2.53 KM/H @ 261.68 MS; -1.84 KM/H @ 41.52 MS

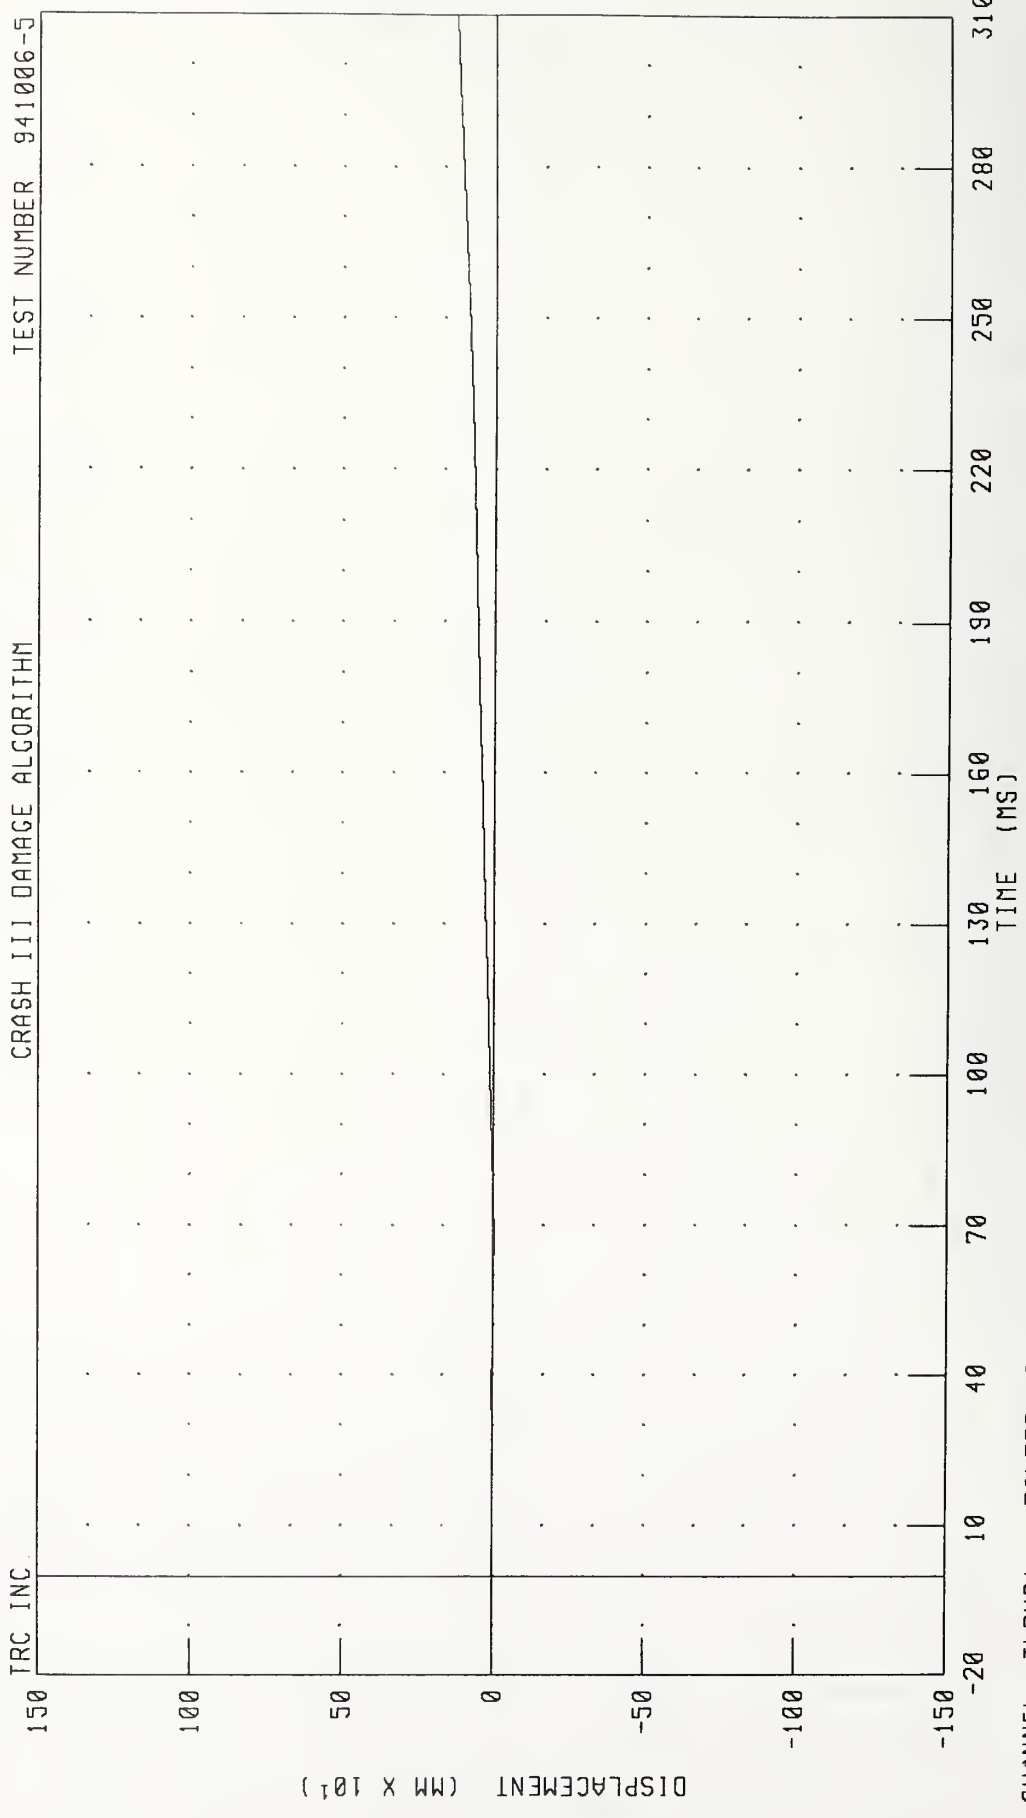
CHANNEL TLR01 FILTER: CH. CLASS 180

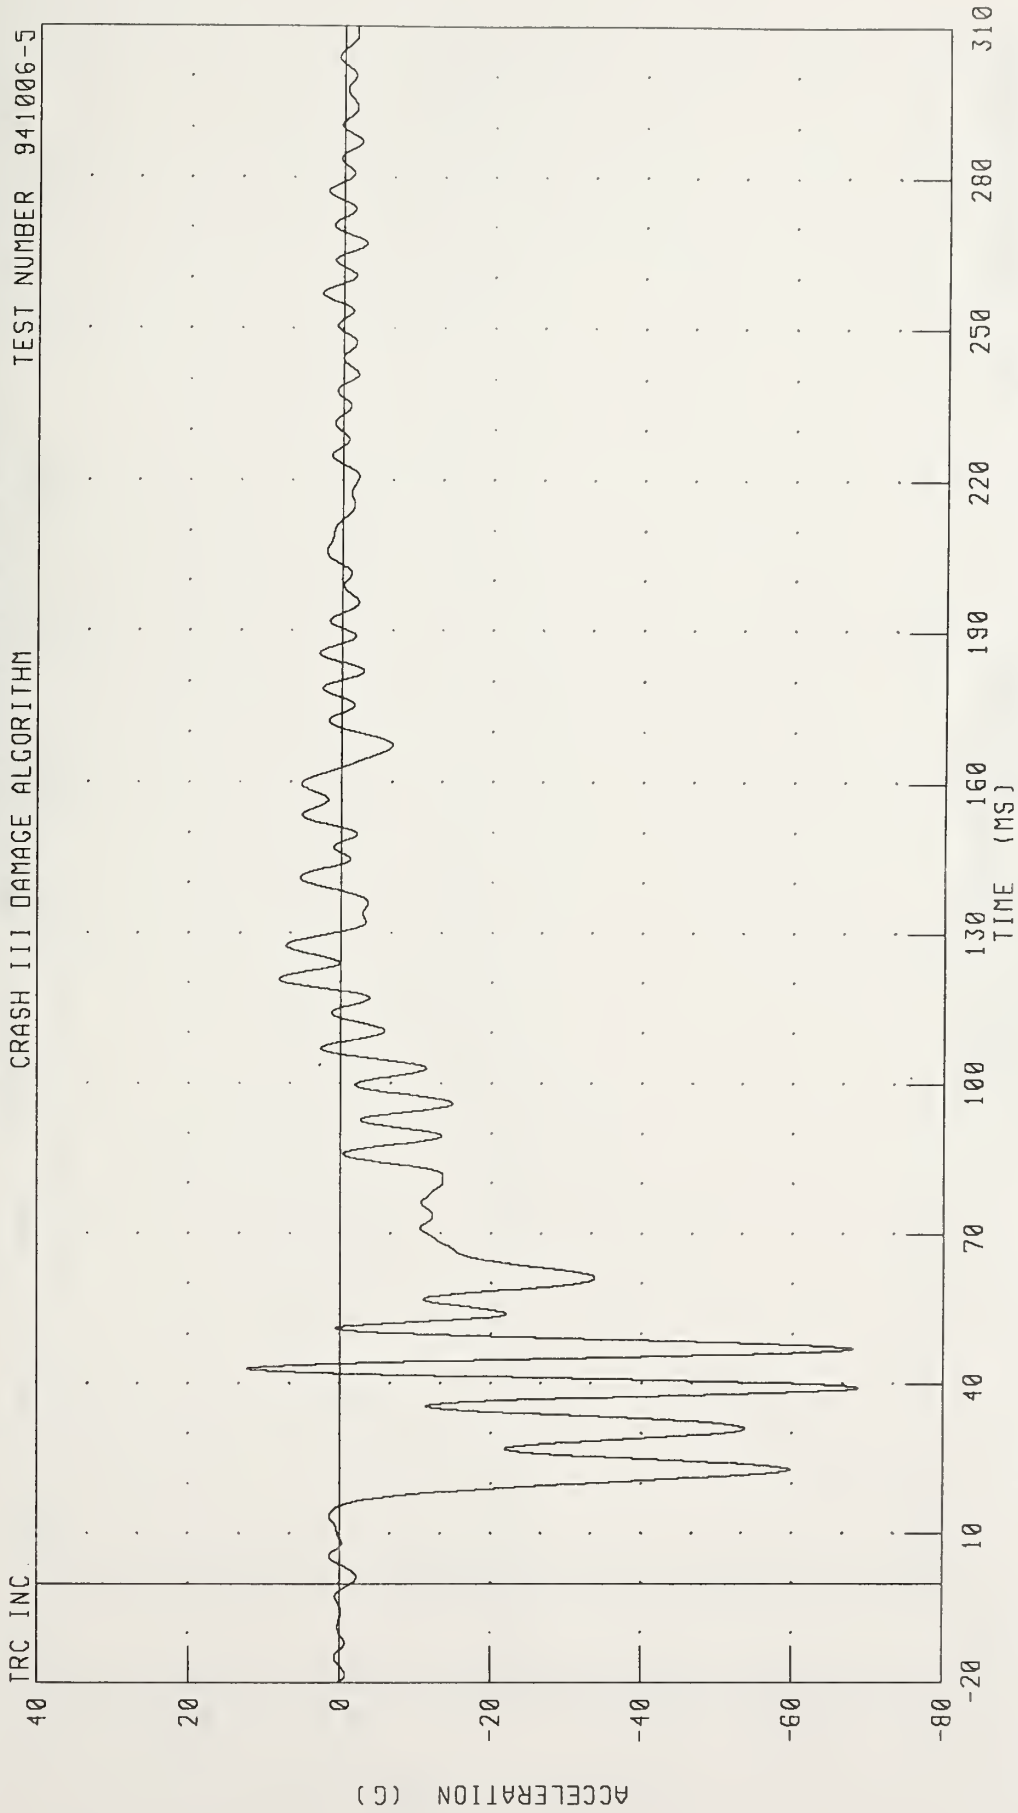
CHANNEL TRRXG1 FILTER CH CLASS 60

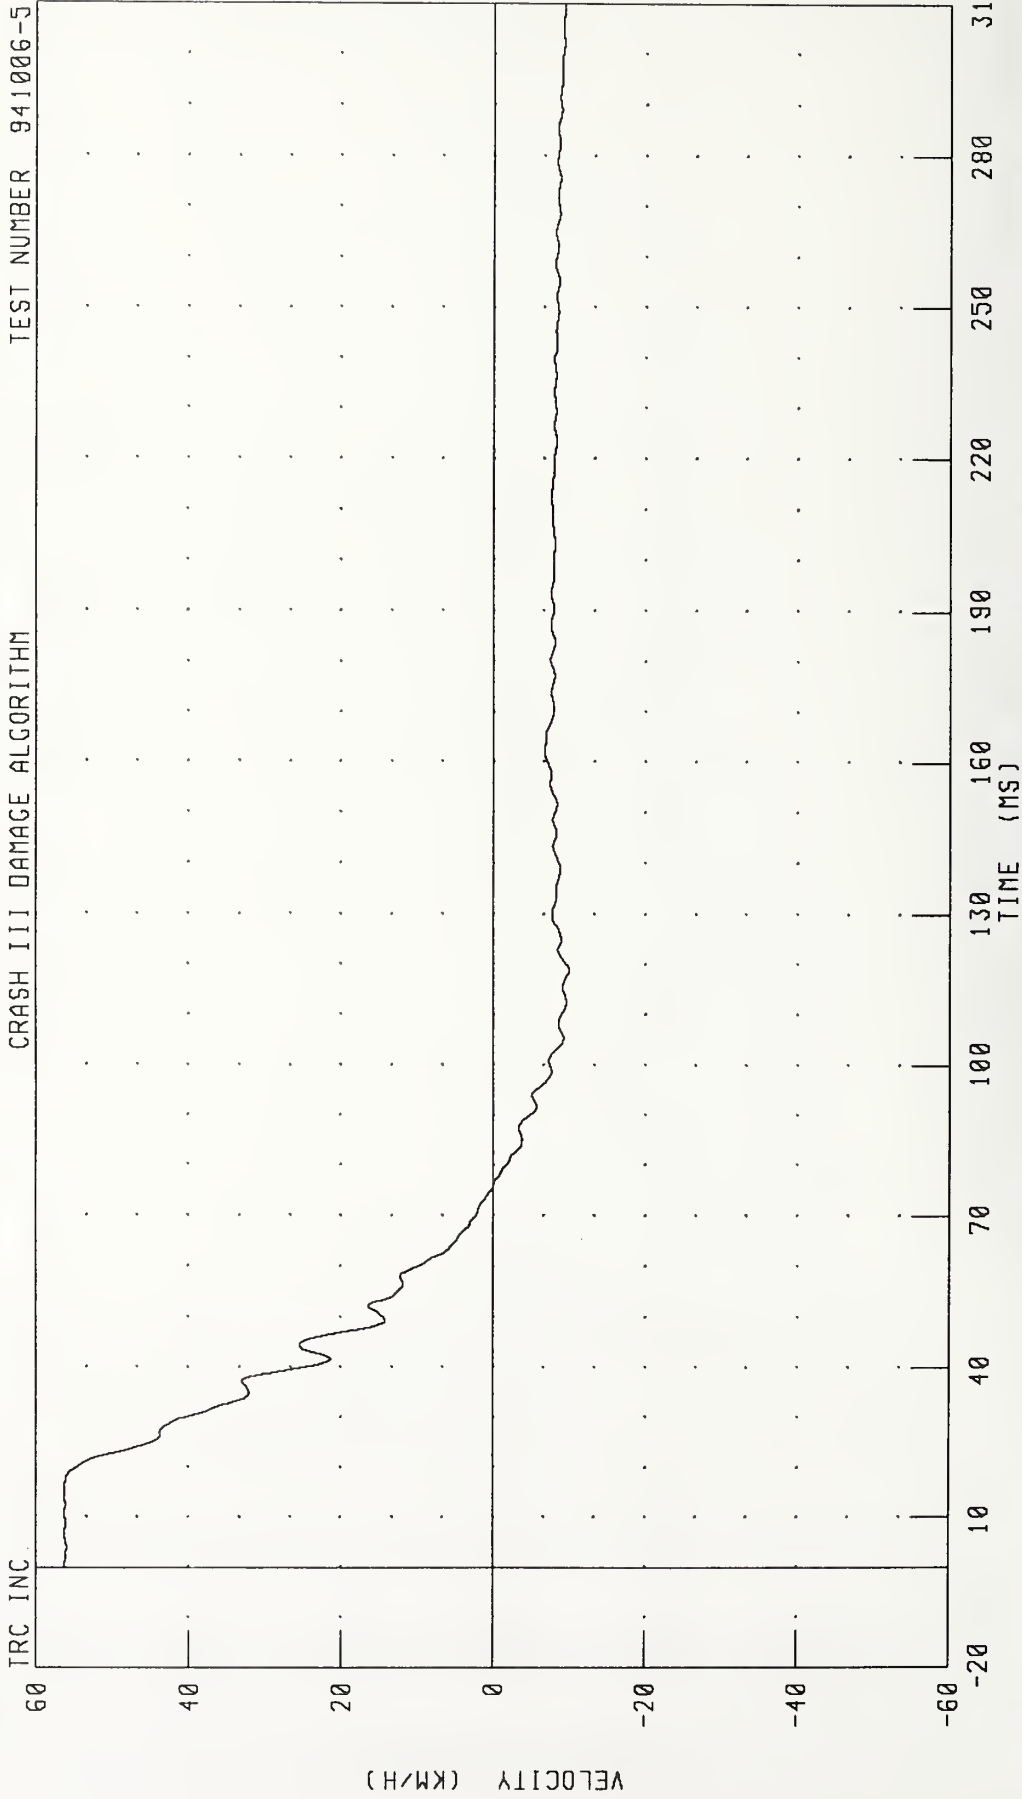
CHANNEL: TRRXV1 FILTER: CH. CLASS 180

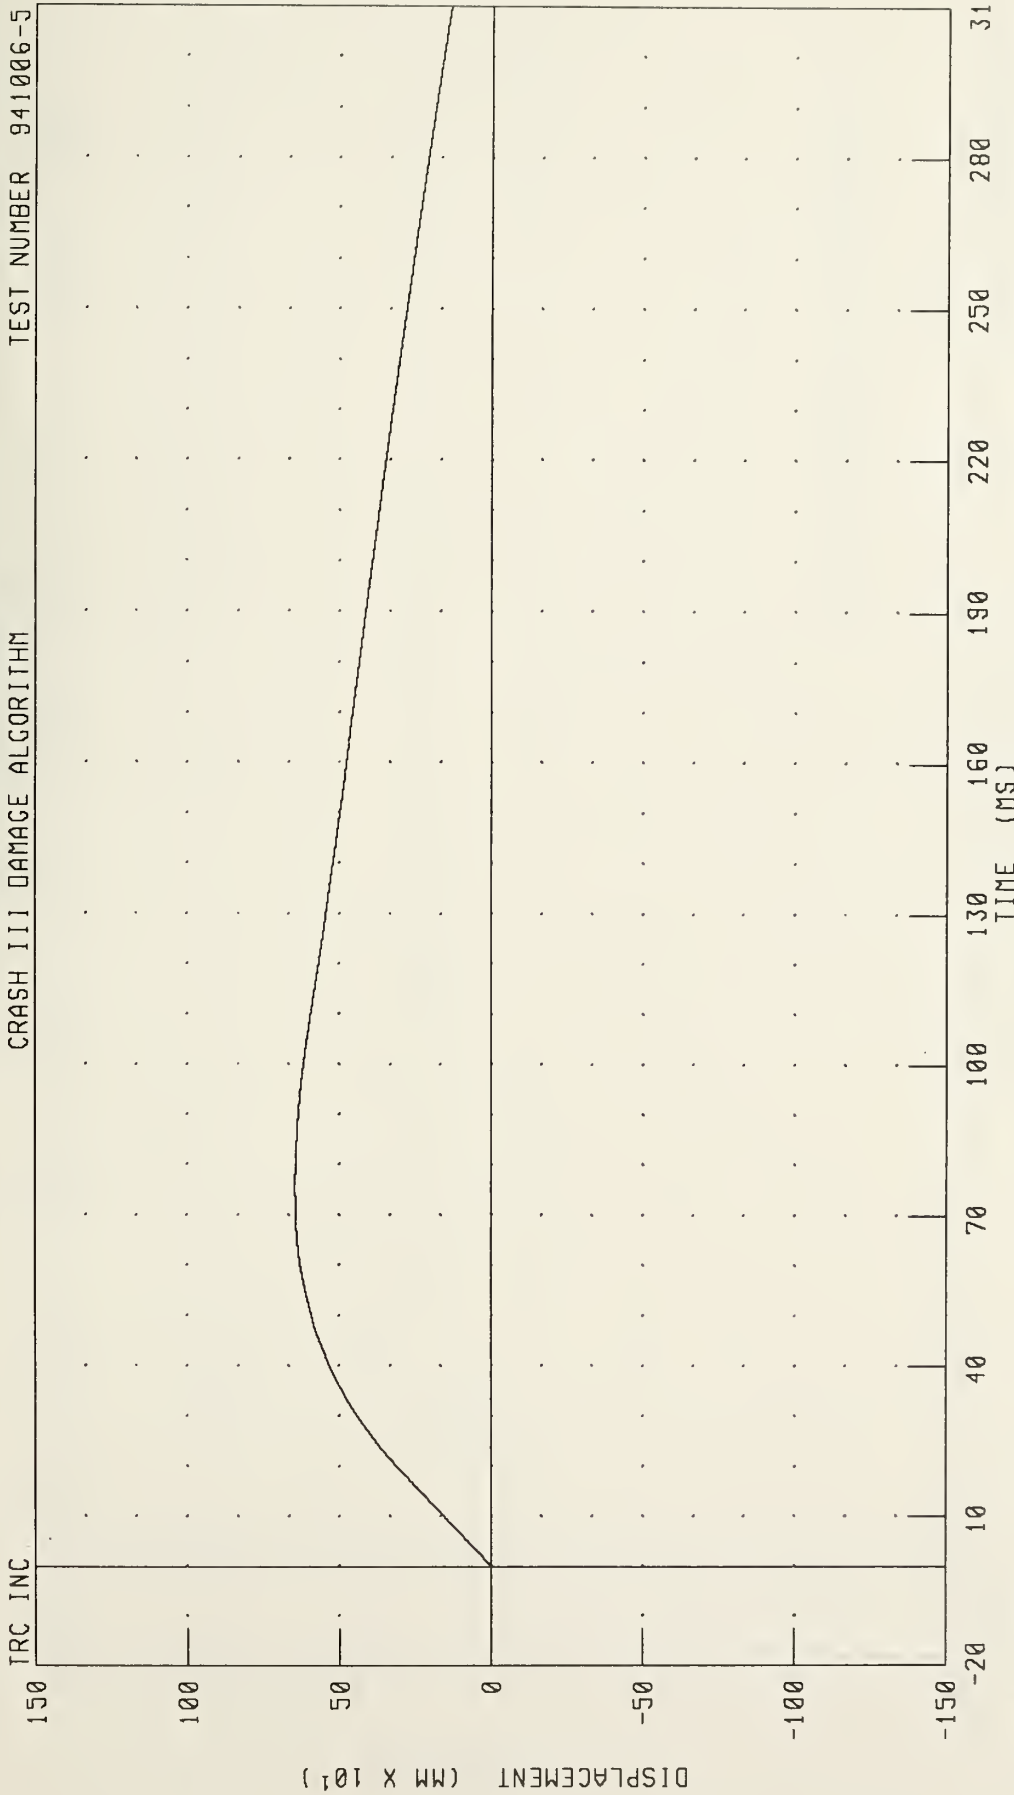
CHANNEL: TRRXD1 FILTER: CH. CLASS 180

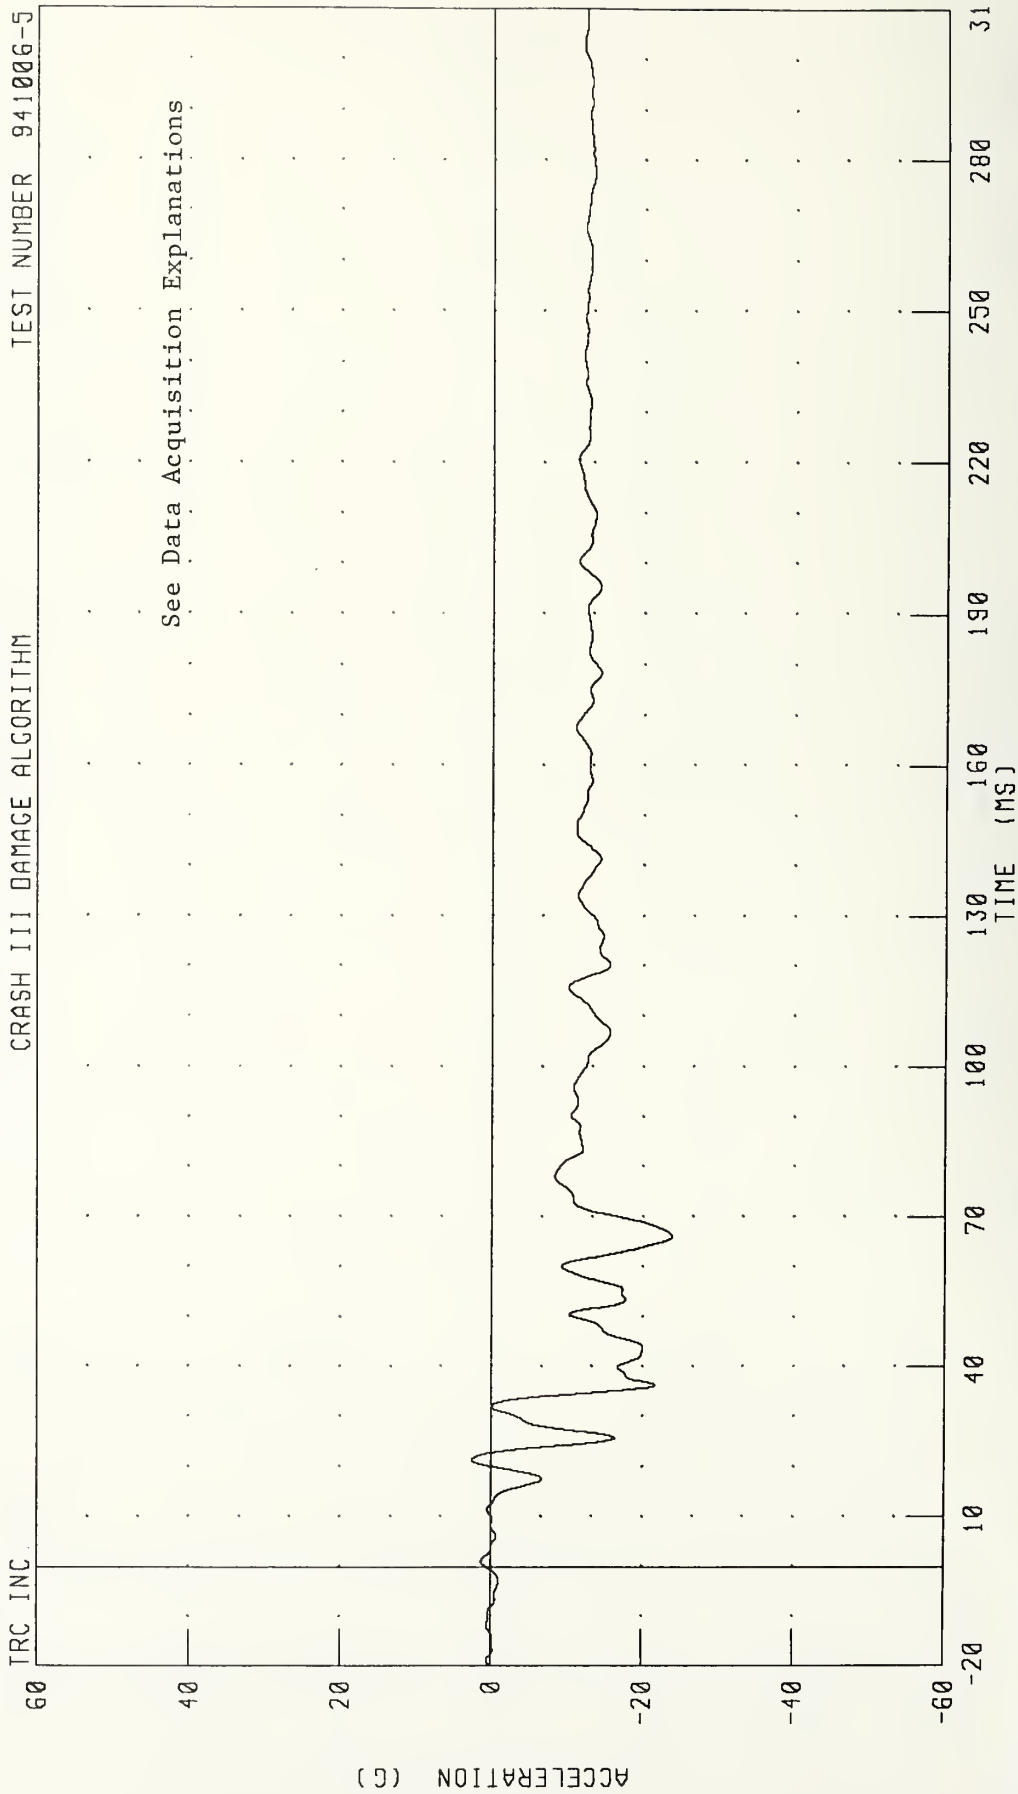
CHANNEL: TTRYG1 FILTER: CH CLASS 60

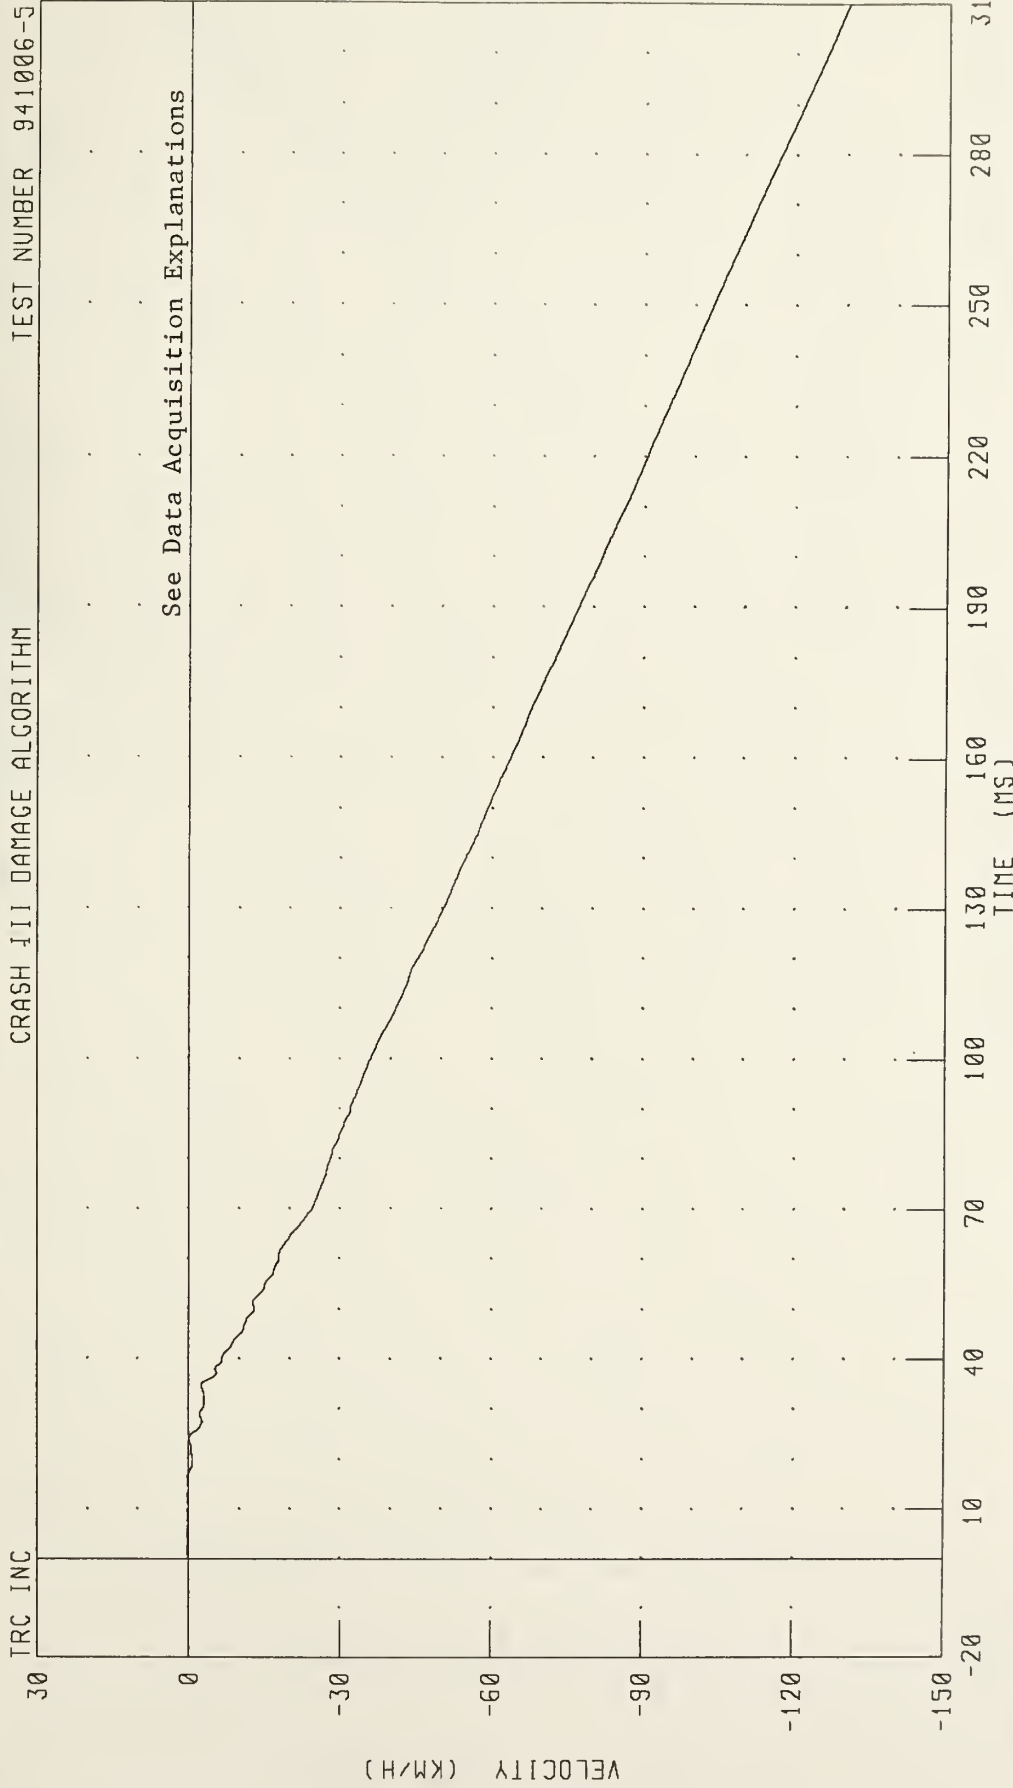
CHANNEL: TRRYV1 FILTER: CH CLASS 180

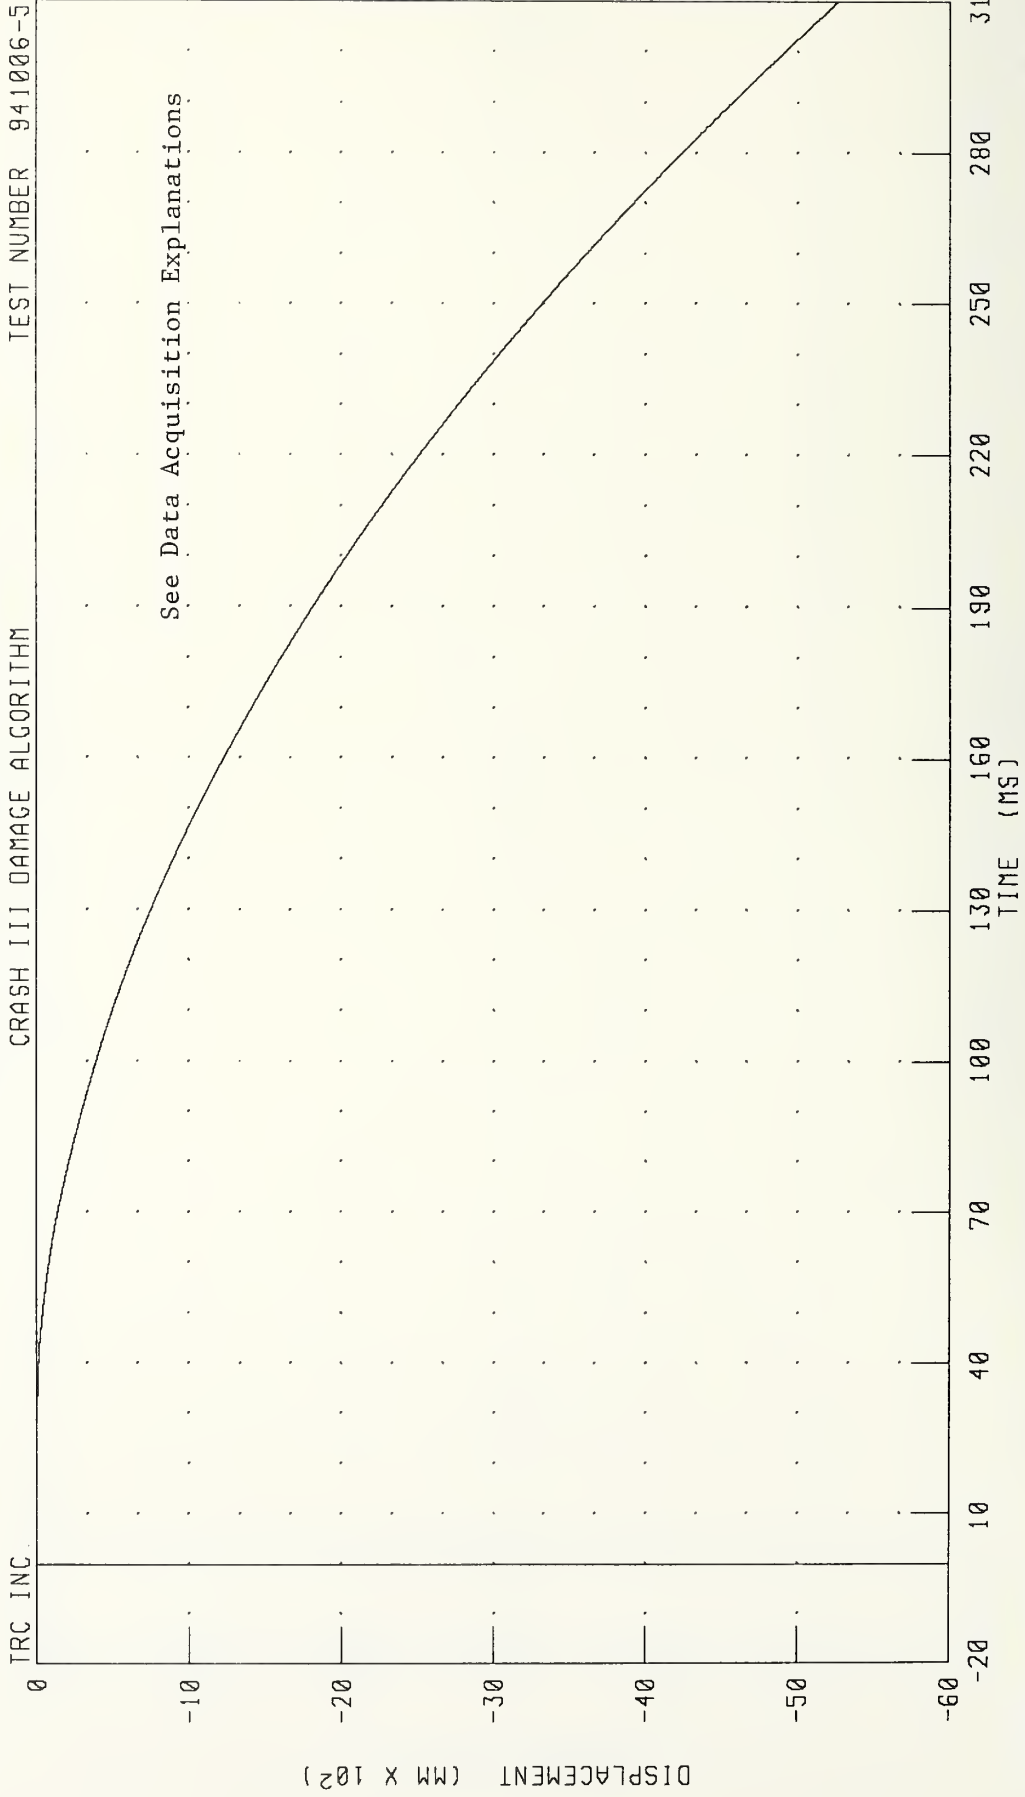
CHANNEL: TRRYD1 FILTER: CH. CLASS 180
