DOT HS 807 438

May 1989

Final Report

Final Report of 270° Contoured Moving Barrier Impact into a 1983 Ford Tempo 4-Door Sedan in Support of Crash III Damage Algorithm Reformation

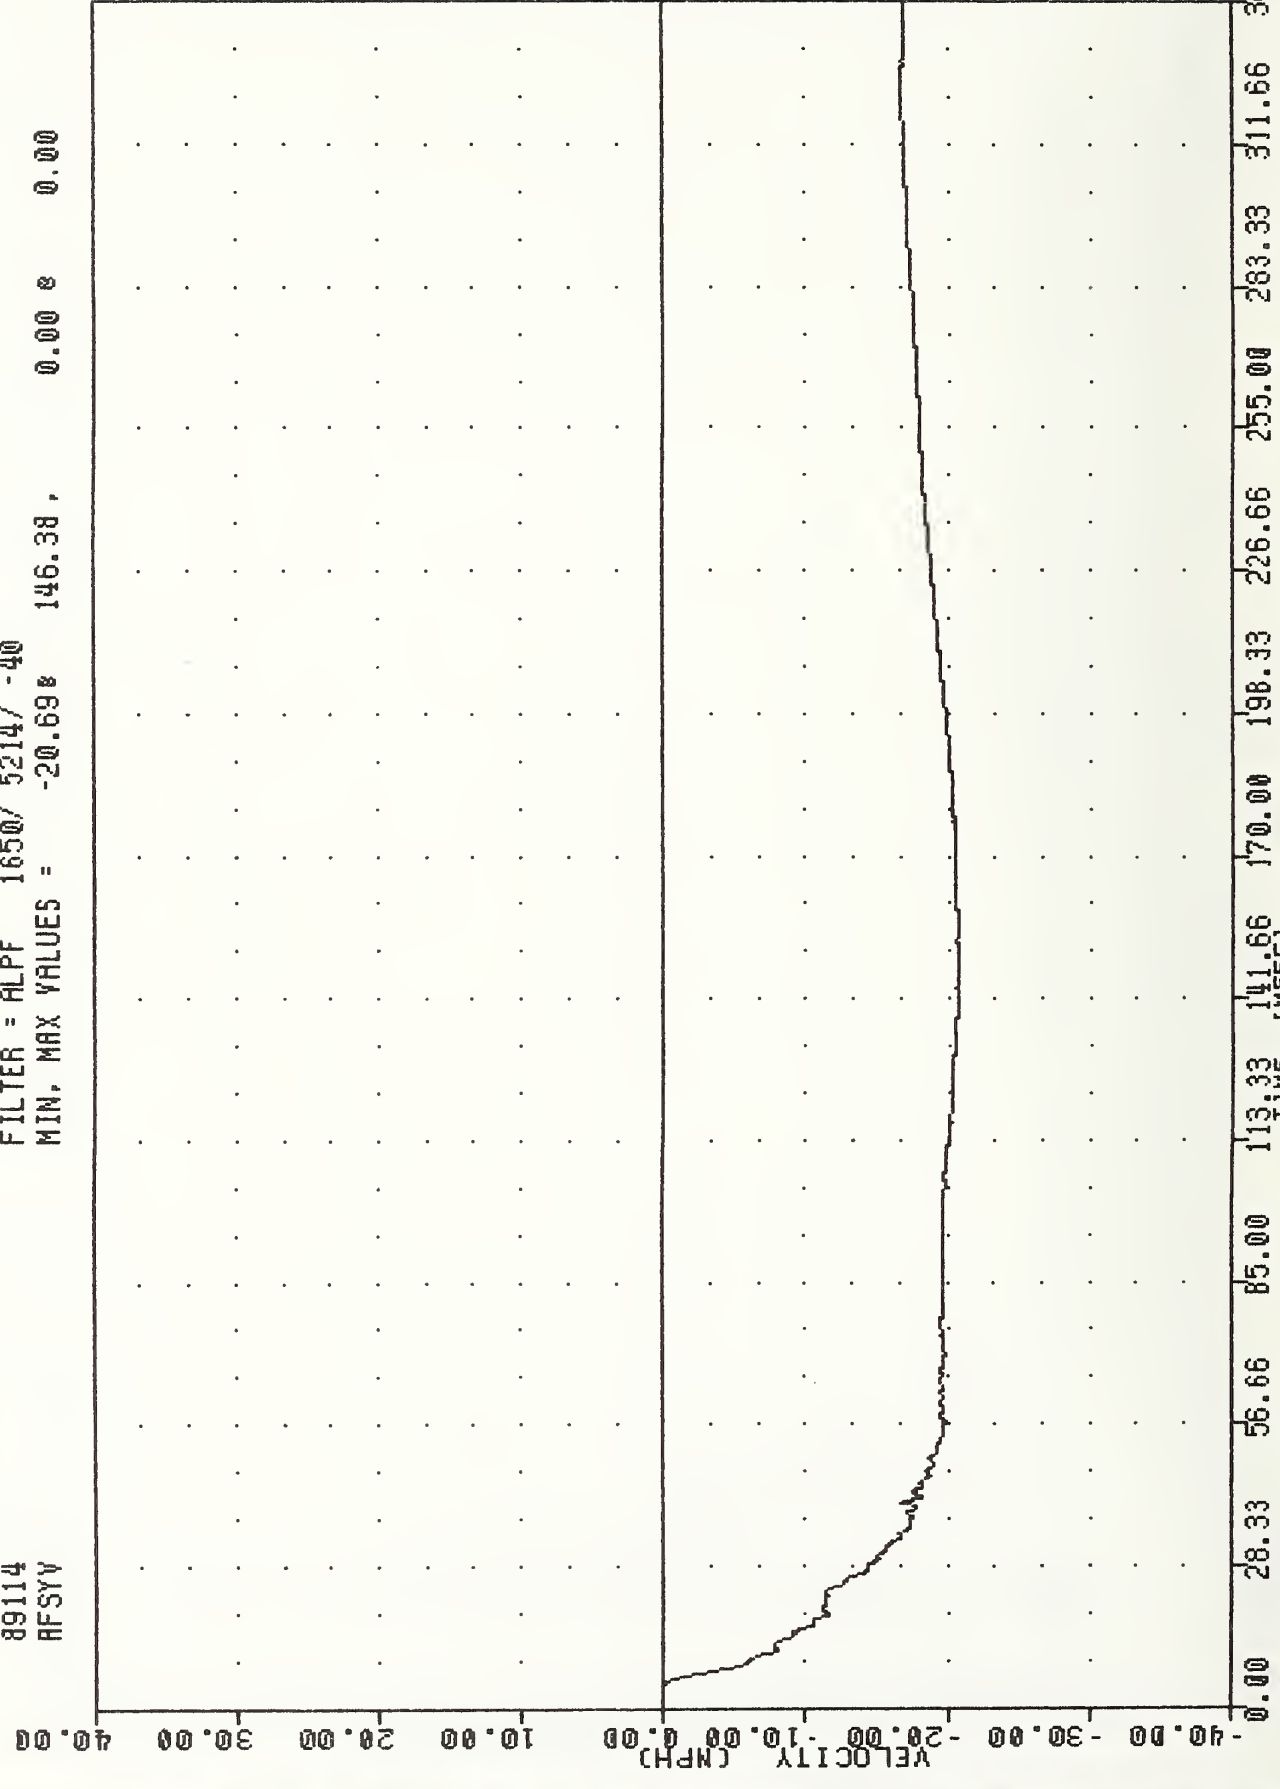
FILTER = ALPF 1650/ 5214/ -40
 MIN, MAX VALUES = -20.698 146.38 , 0.00 e 0.00

CONTOURED MOVING BARRIER INTO 270 DEG 1983 FORD TEMPO AT 37.6 MPH #2
 VEHICLE RIGHT FRONT SILL Y AXIS VELOCITY
