U.S. Department
of Transportation
**National Highway
Traffic Safety
Administration**

DOT HS 807 352

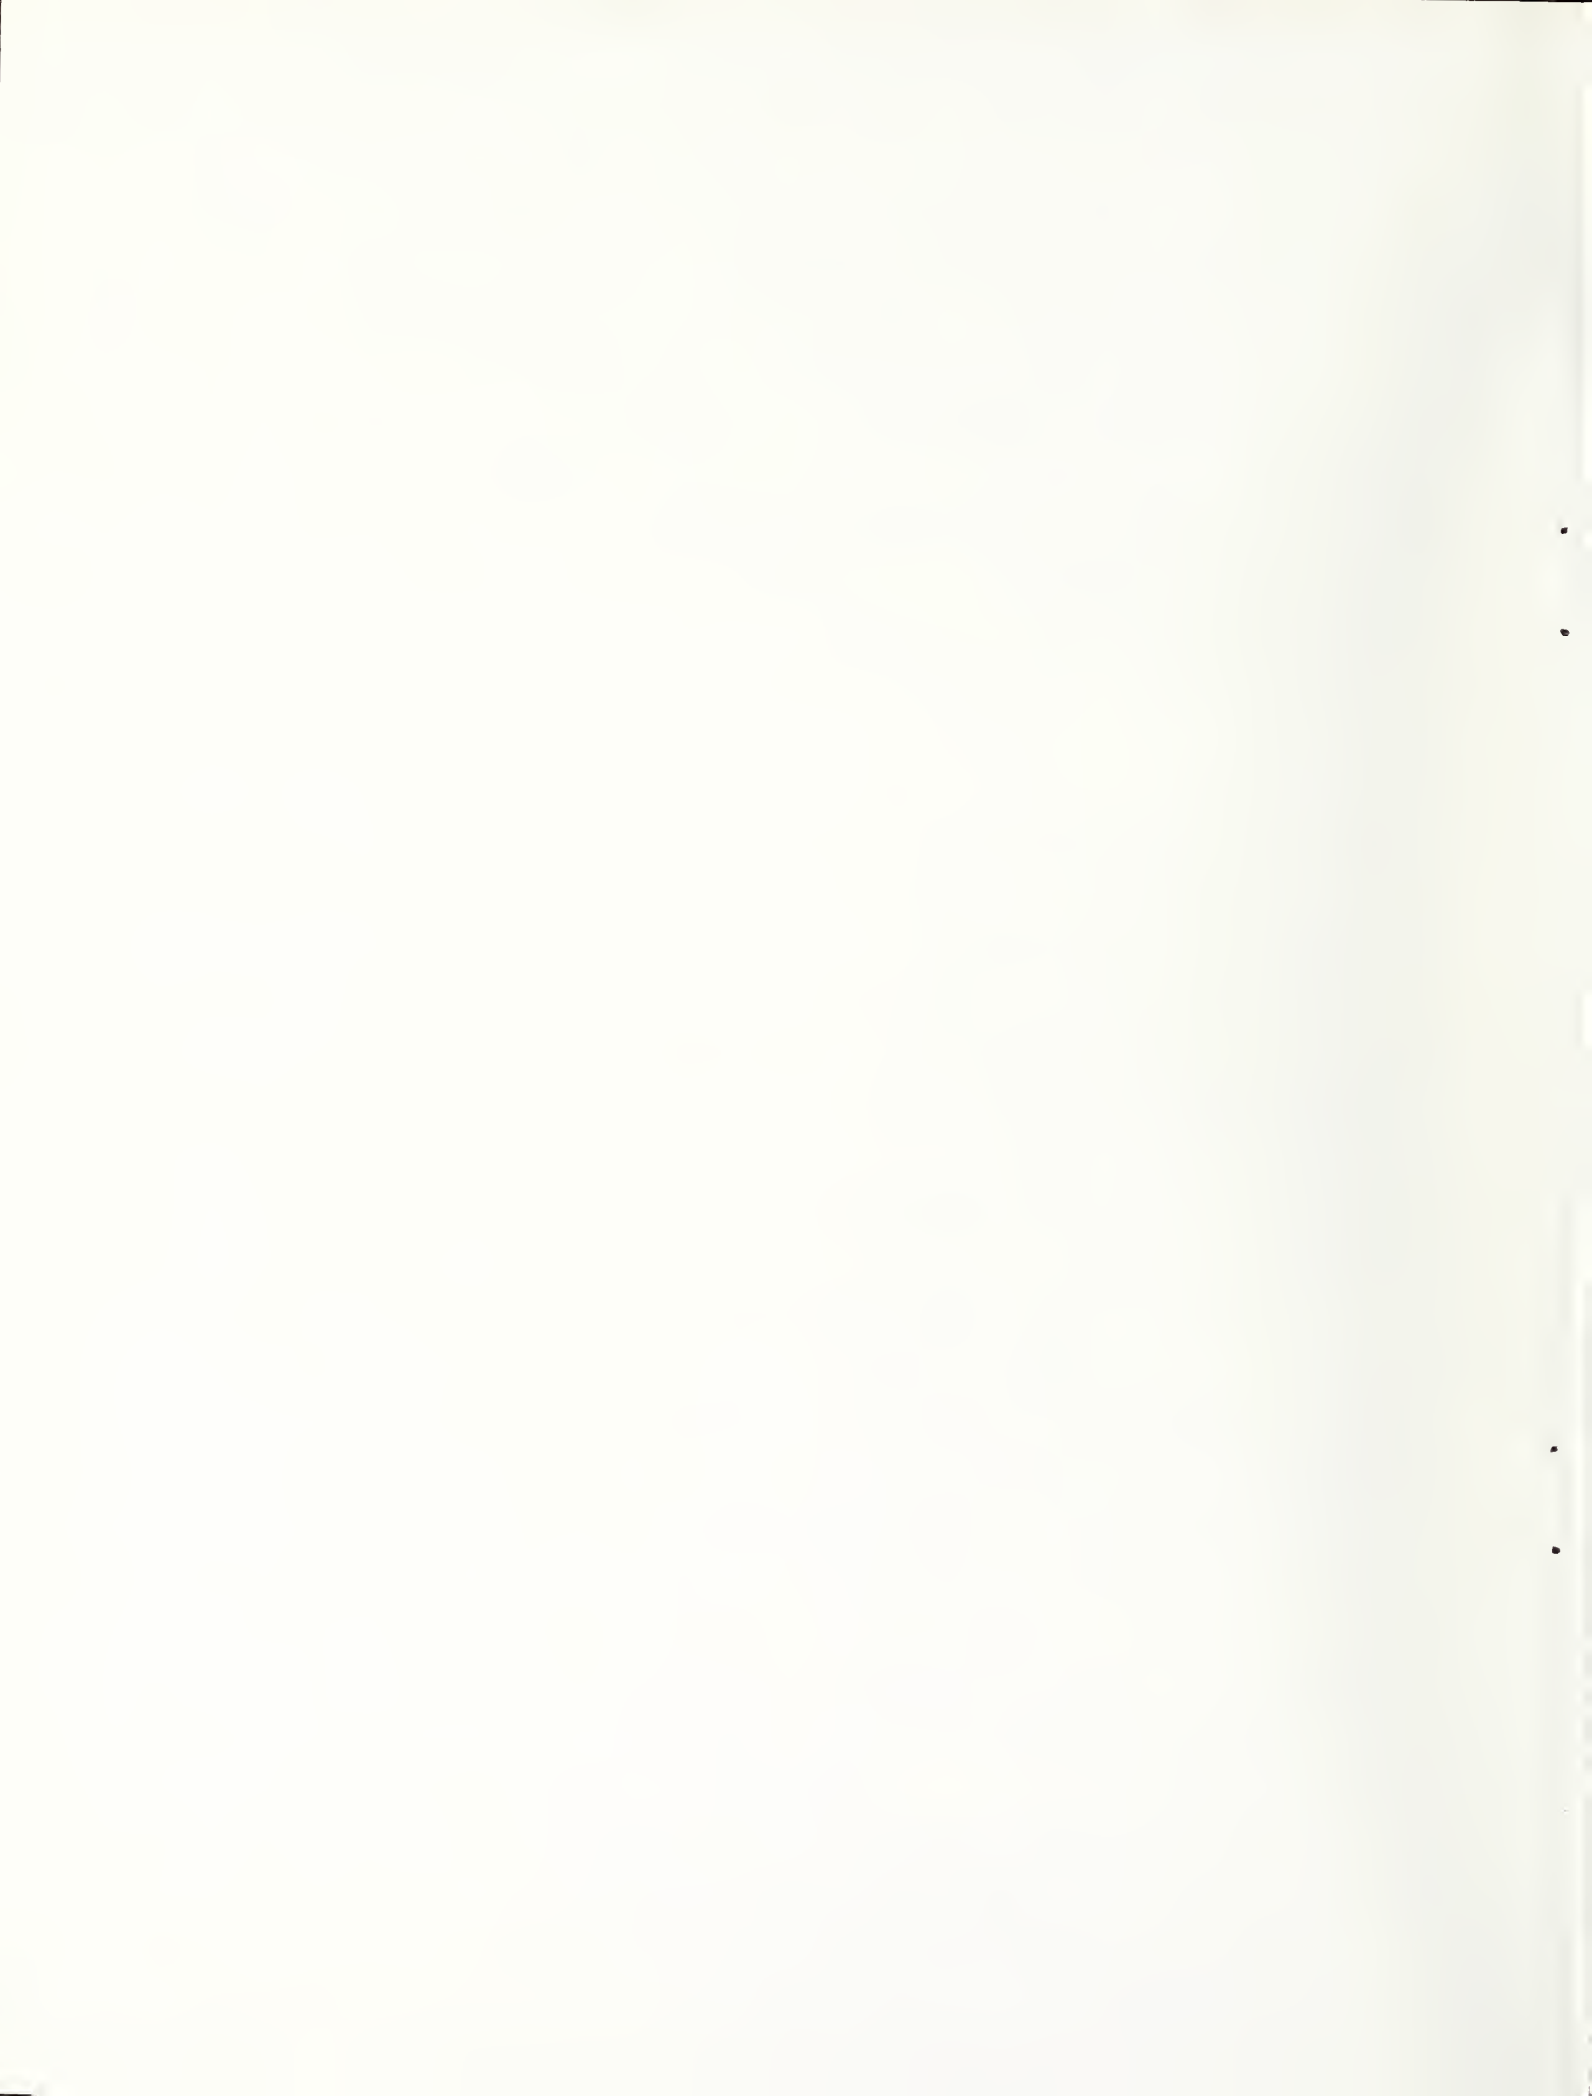
Final Report of Frontal Barrier Impacts of a 1985 Ford Escort 3-Door Hatchback in Support of Crash III Damage Algorithm Reformation

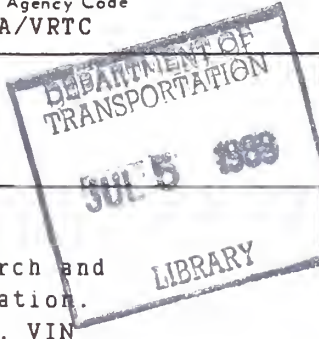
TEST NO.	DATE	TIME	SPEED (mph)	AVERAGE CUMULATIVE CRUSH																																				
880928-1	9/28/88	0910	10.1	2.5																																				
880928-2	9/28/88	1000	19.8	11.4																																				
880928-3	9/28/88	1050	19.9	17.0																																				
880928-4	9/28/88	1135	18.2	21.1																																				
880928-5	9/28/88	1305	19.3	28.2																																				
880928-6	9/28/88	1400	30.0	52.3																																				
17. Key Words Flat Frontal Impact Crash III Damage Algorithm Reformation.			16. Distribution Statement This document is available to the public from the National Technical Information Service, Springfield, VA 22161																																					
19. Security Classif. (of this report) Unclassified		20. Security Classif. (of this page) Unclassified		21. No. of Pages 154	22. Price

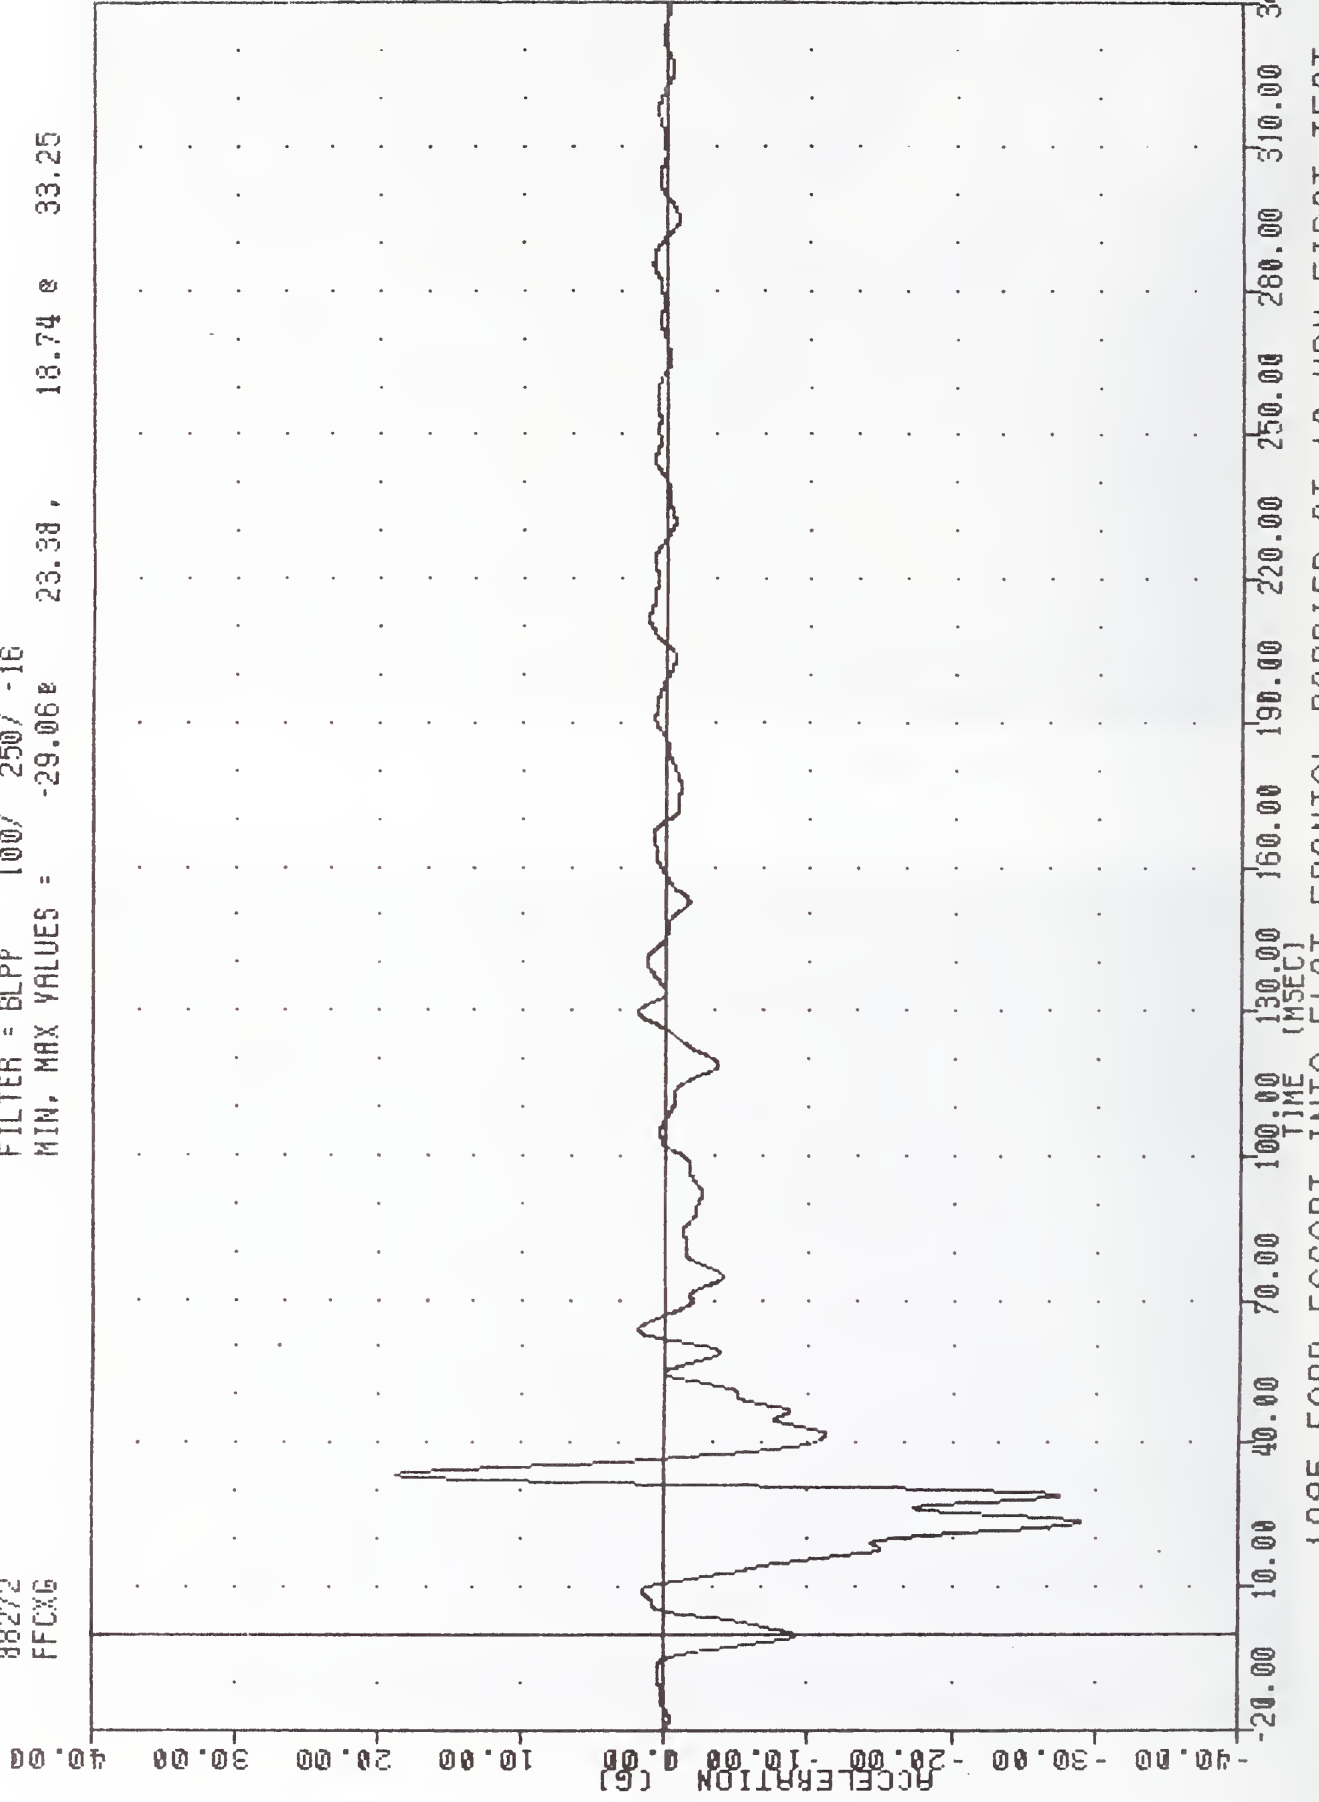
1985 FORD ESCORT INTO FLAT FRONTAL BARRIER AT 10 MPH FIRST TEST
VEHICLE FRONT FRAME CROSSMEMBER BOTTOM X AXIS ACCELERATION

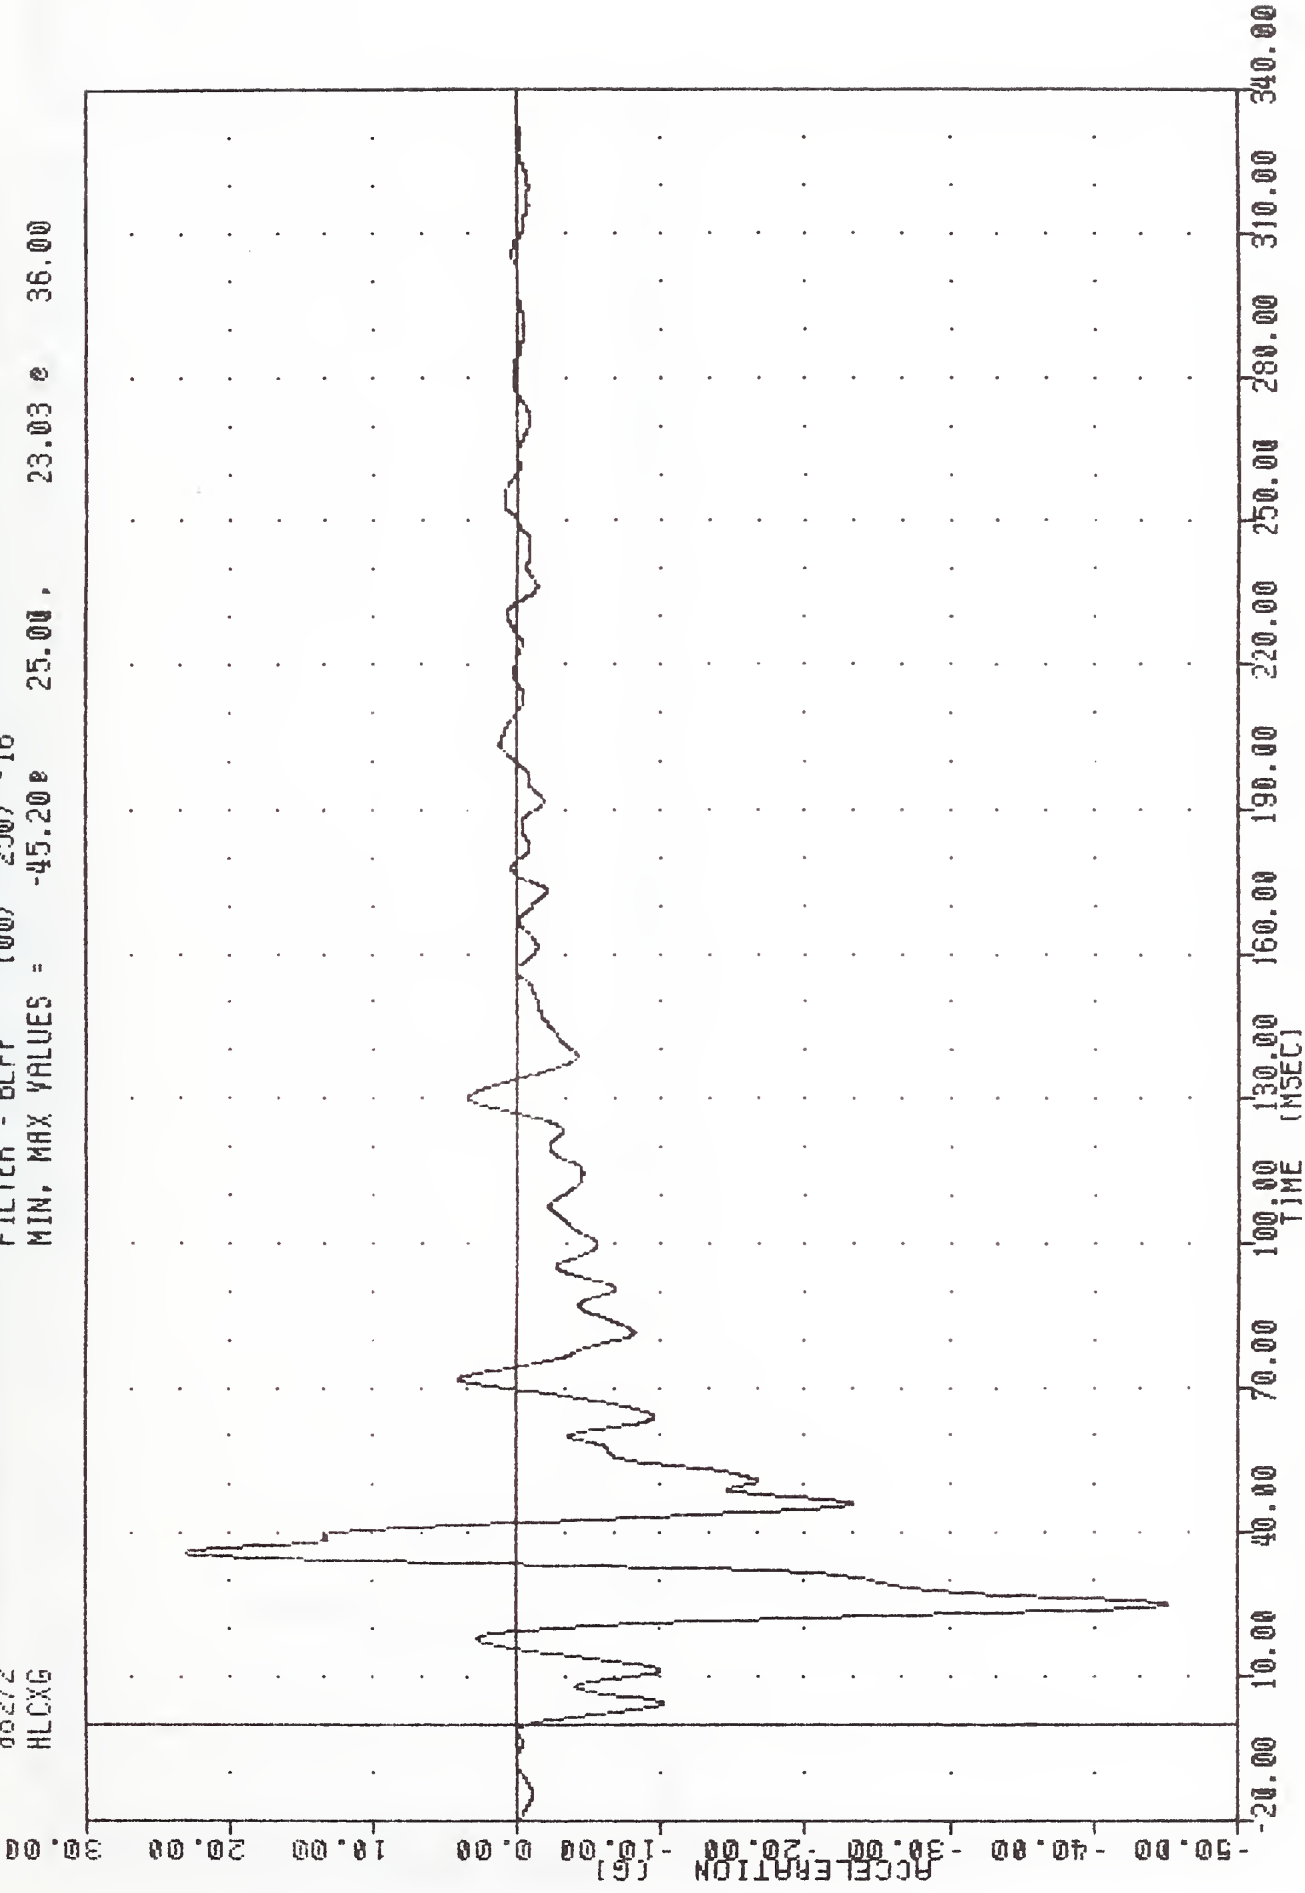
1985 FORD ESCORT INTO FLAT FRONTAL BARRIER AT 10 MPH FIRST TEST
VEHICLE HOOD LATCH CROSSMEMBER X AXIS ACCELERATION

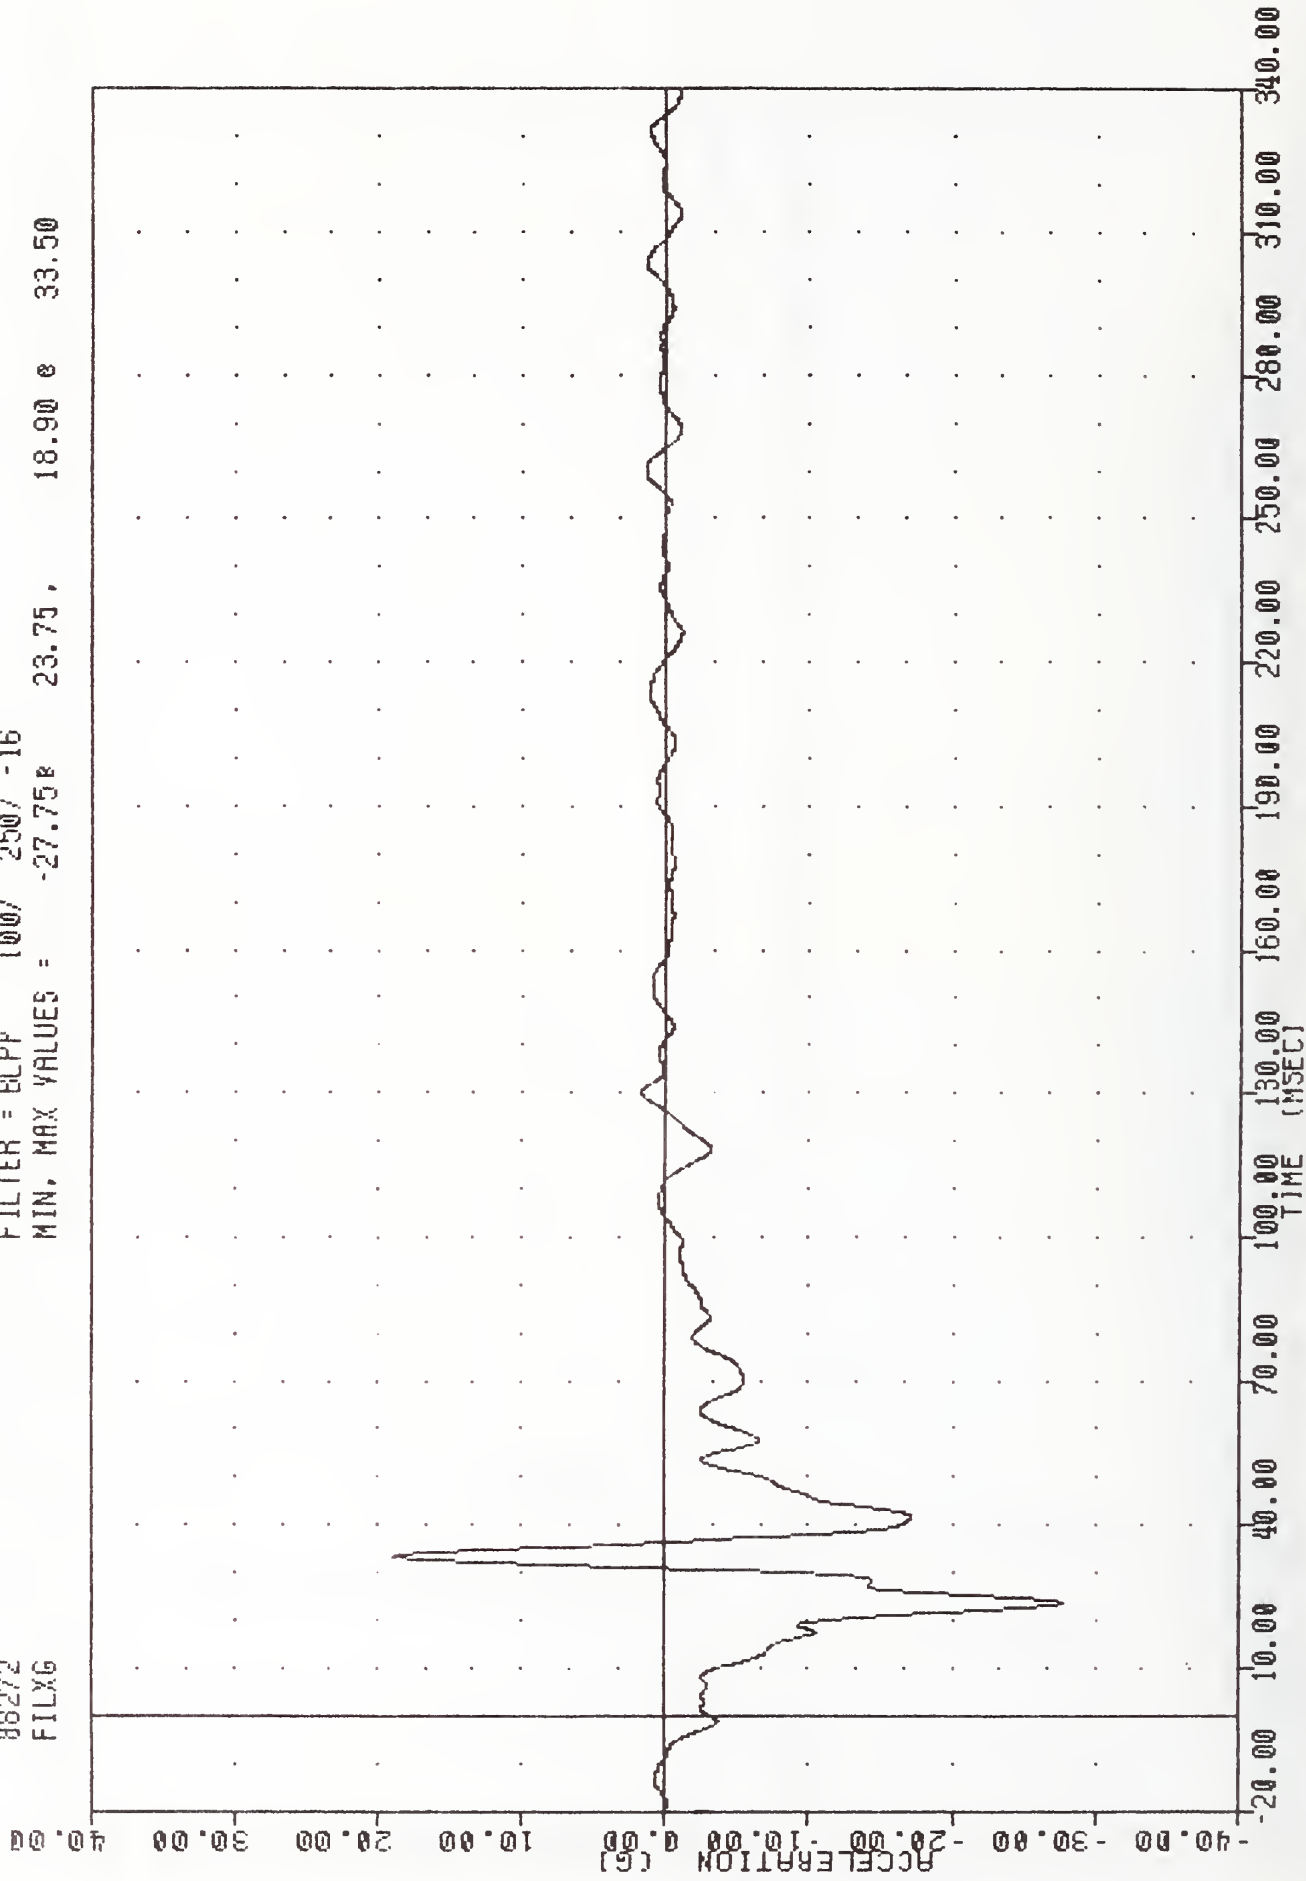
1985 FORD ESCORT INTO FLAT FRONTAL BARRIER AT 10 MPH FIRST TEST
VEHICLE LEFT FENDER WELL INSIDE X AXIS ACCELERATION

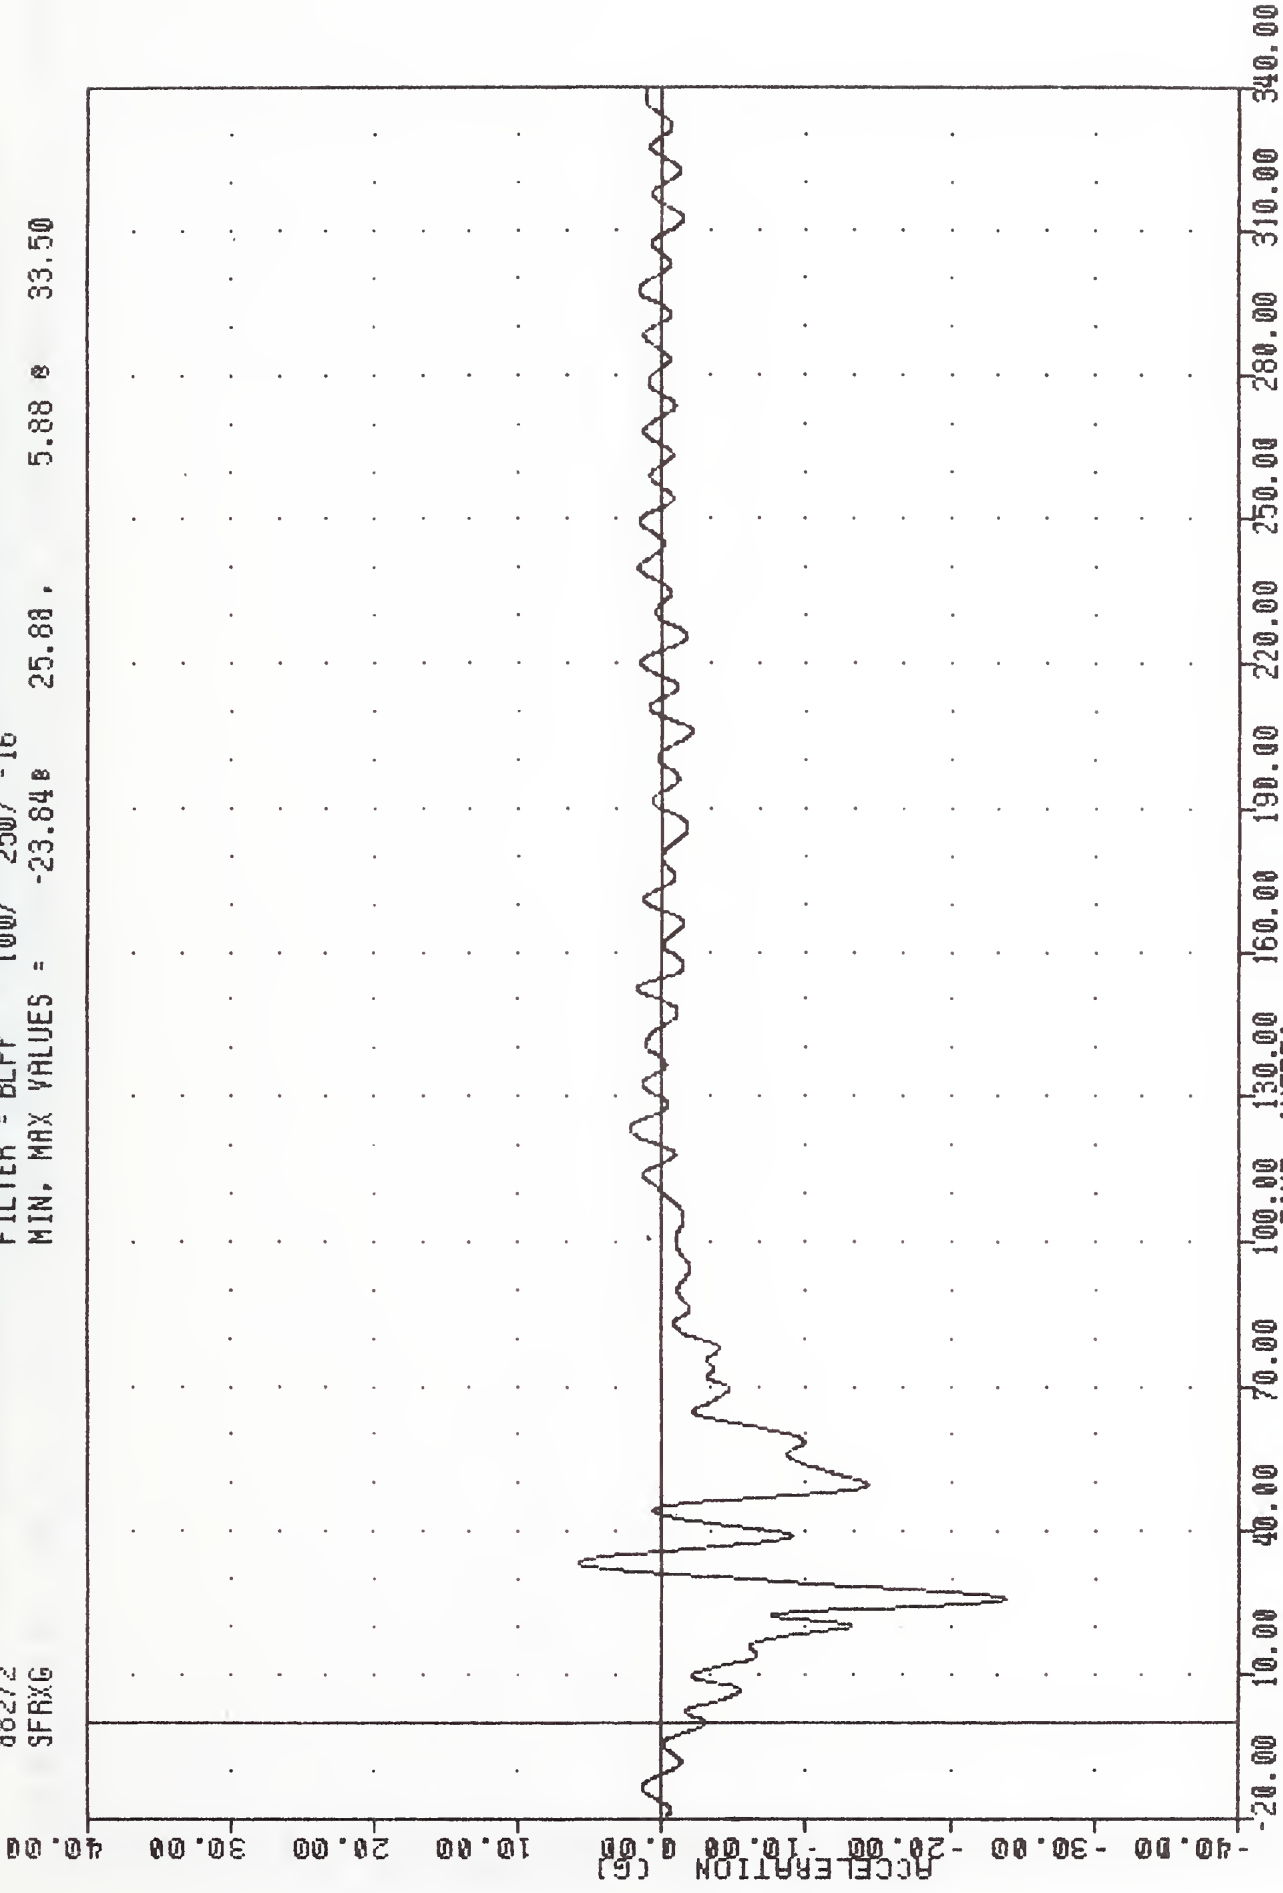
1985 FORD ESCORT INTO FLAT FRONTAL BARRIER AT 10 MPH FIRST TEST
VEHICLE SUSPENSION FRONT RIGHT X AXIS ACCELERATION

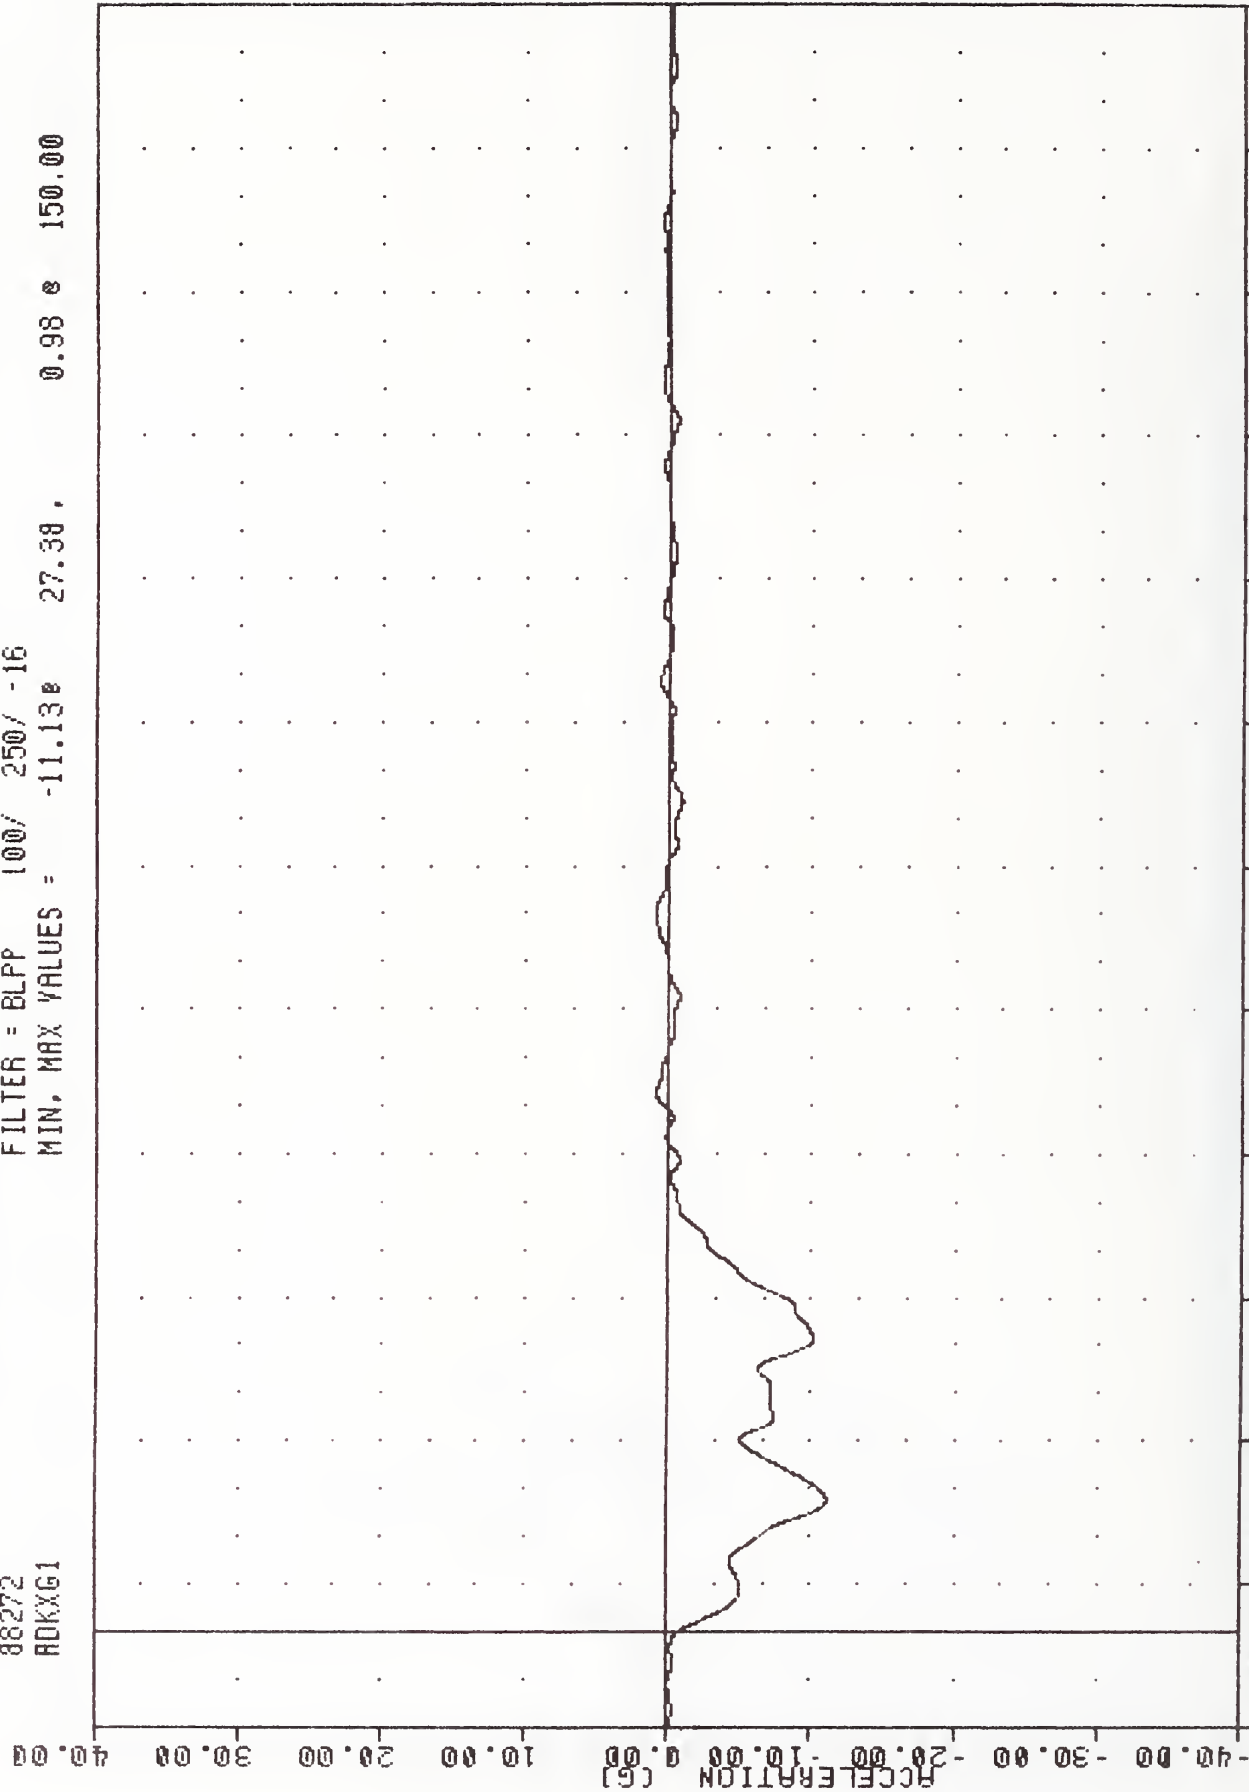
1985 FORD ESCORT INTO FLAT FRONTAL BARRIER AT 10 MPH FIRST TEST
VEHICLE REAR DECK X AXIS ACCELERATION

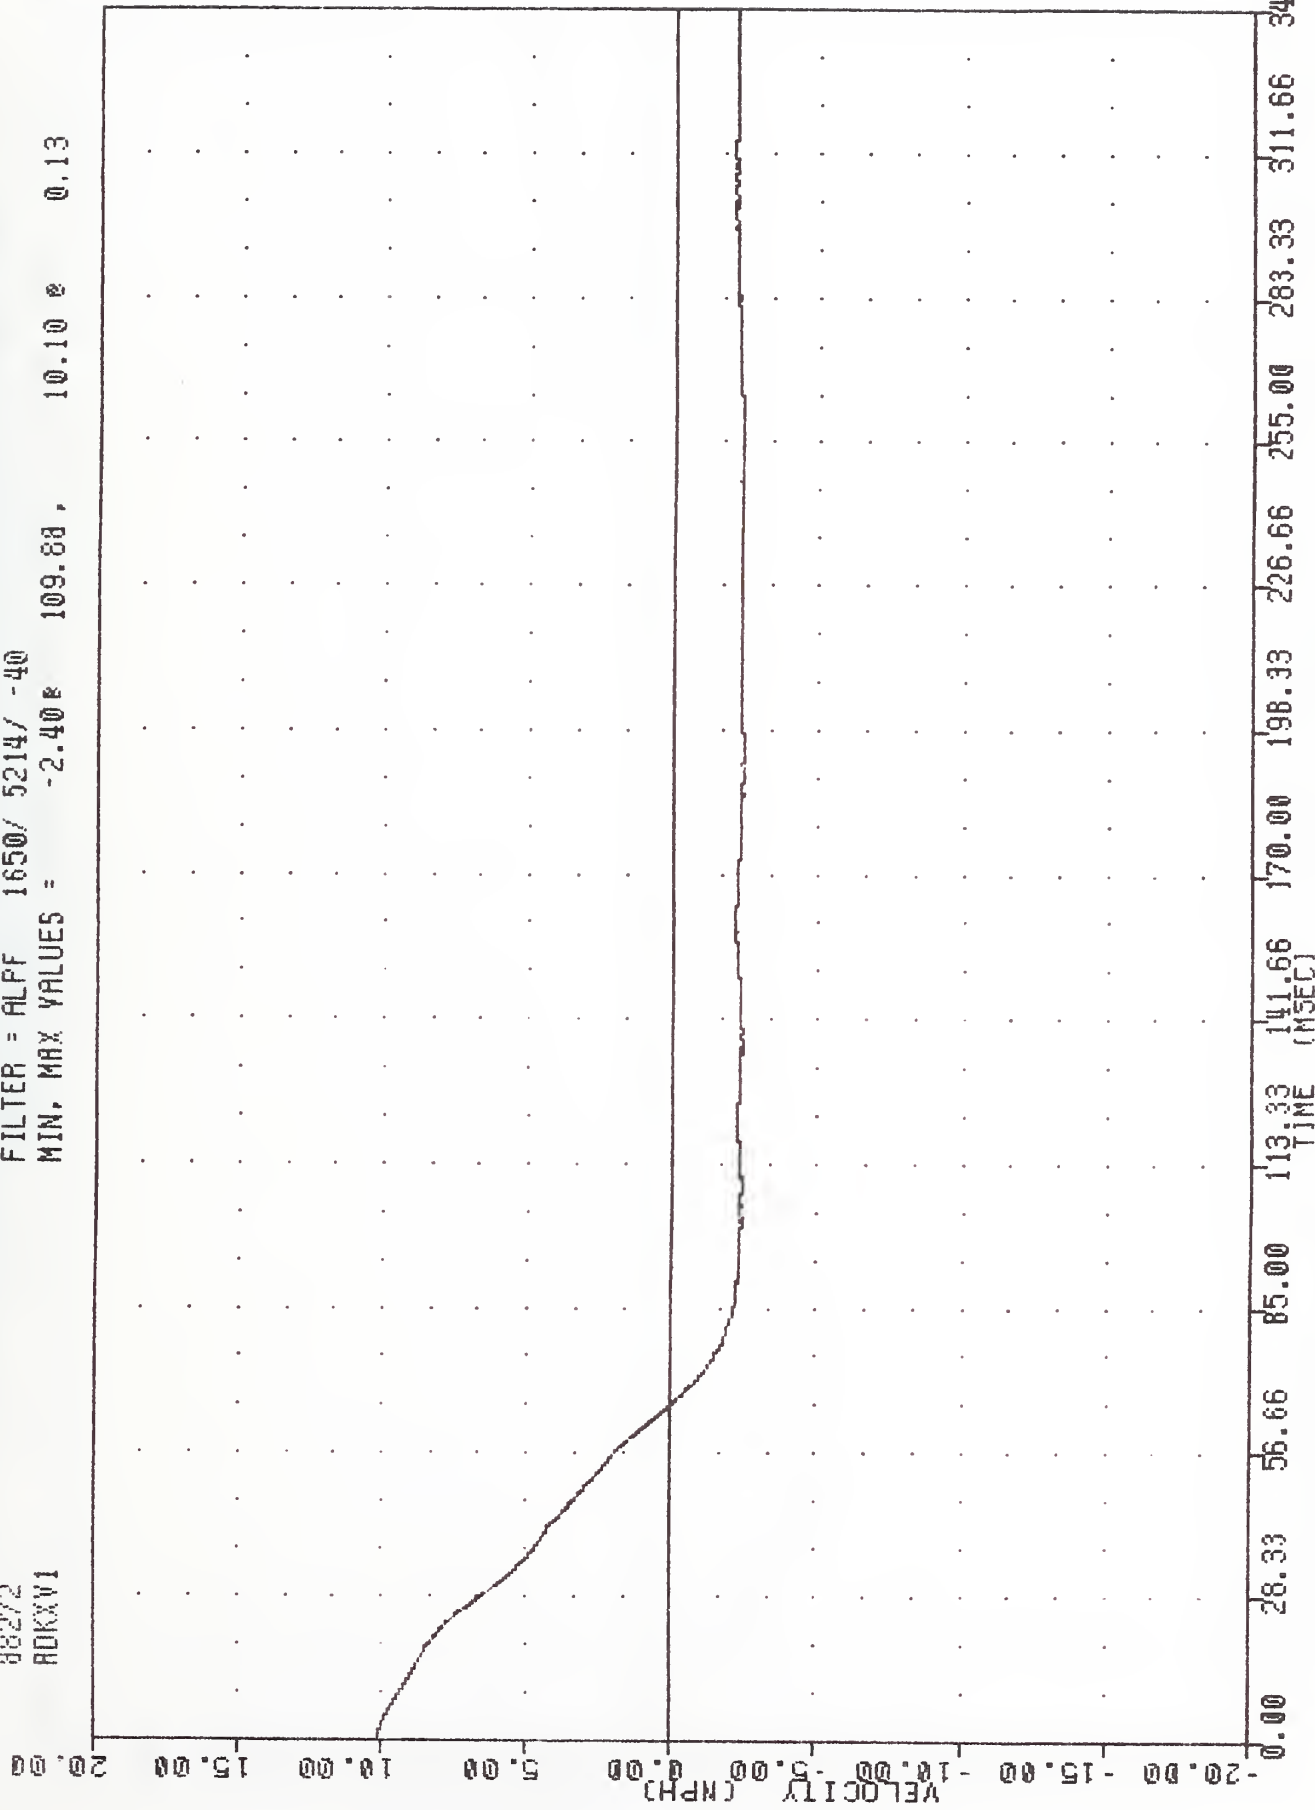
1985 FORD ESCORT INTO FLAT FRONTAL BARRIER AT 10 MPH FIRST TEST
VEHICLE REAR DECK X AXIS VELOCITY

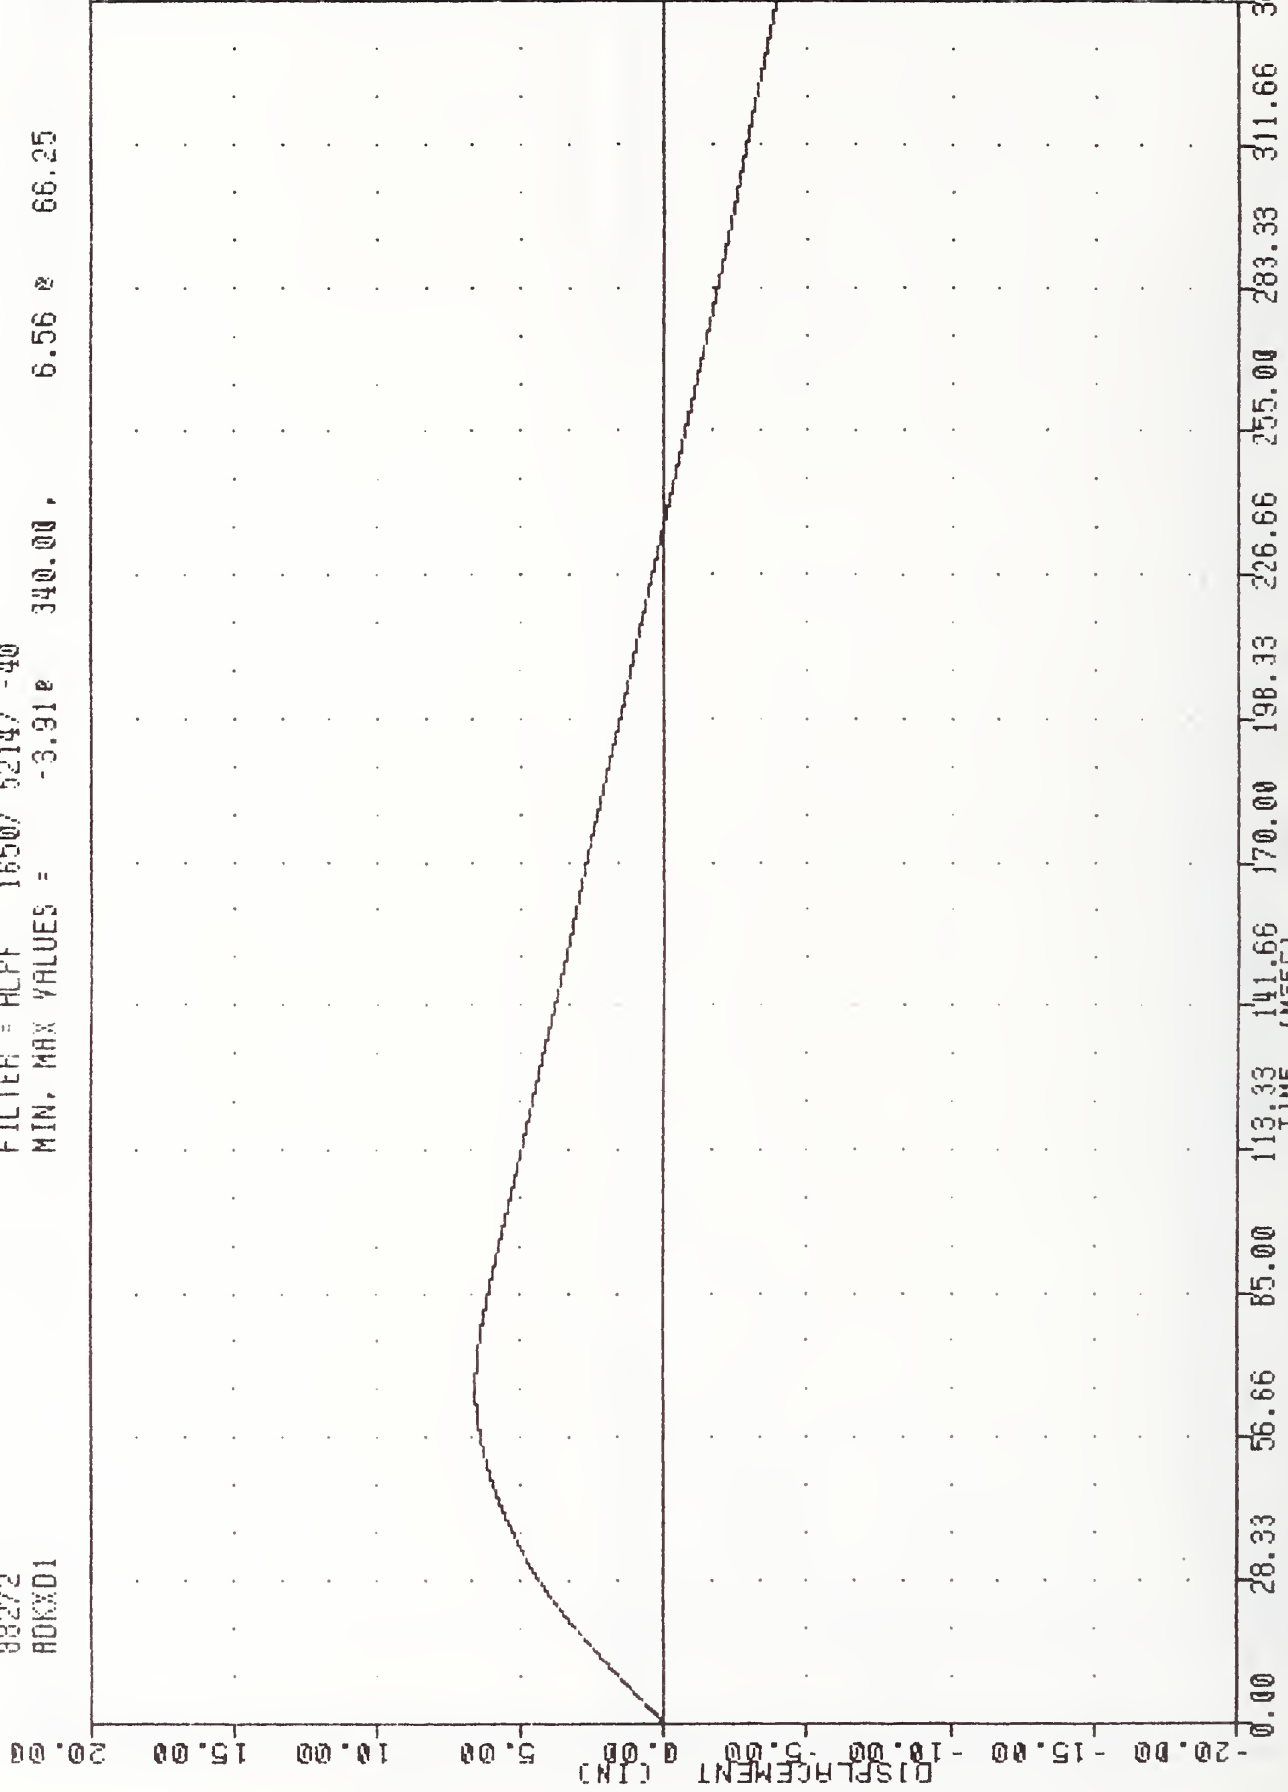
1985 FORD ESCORT INTO FLAT FRONTAL BARRIER AT 10 MPH FIRST TEST
 VEHICLE REAR DECK X AXIS DISPLACEMENT

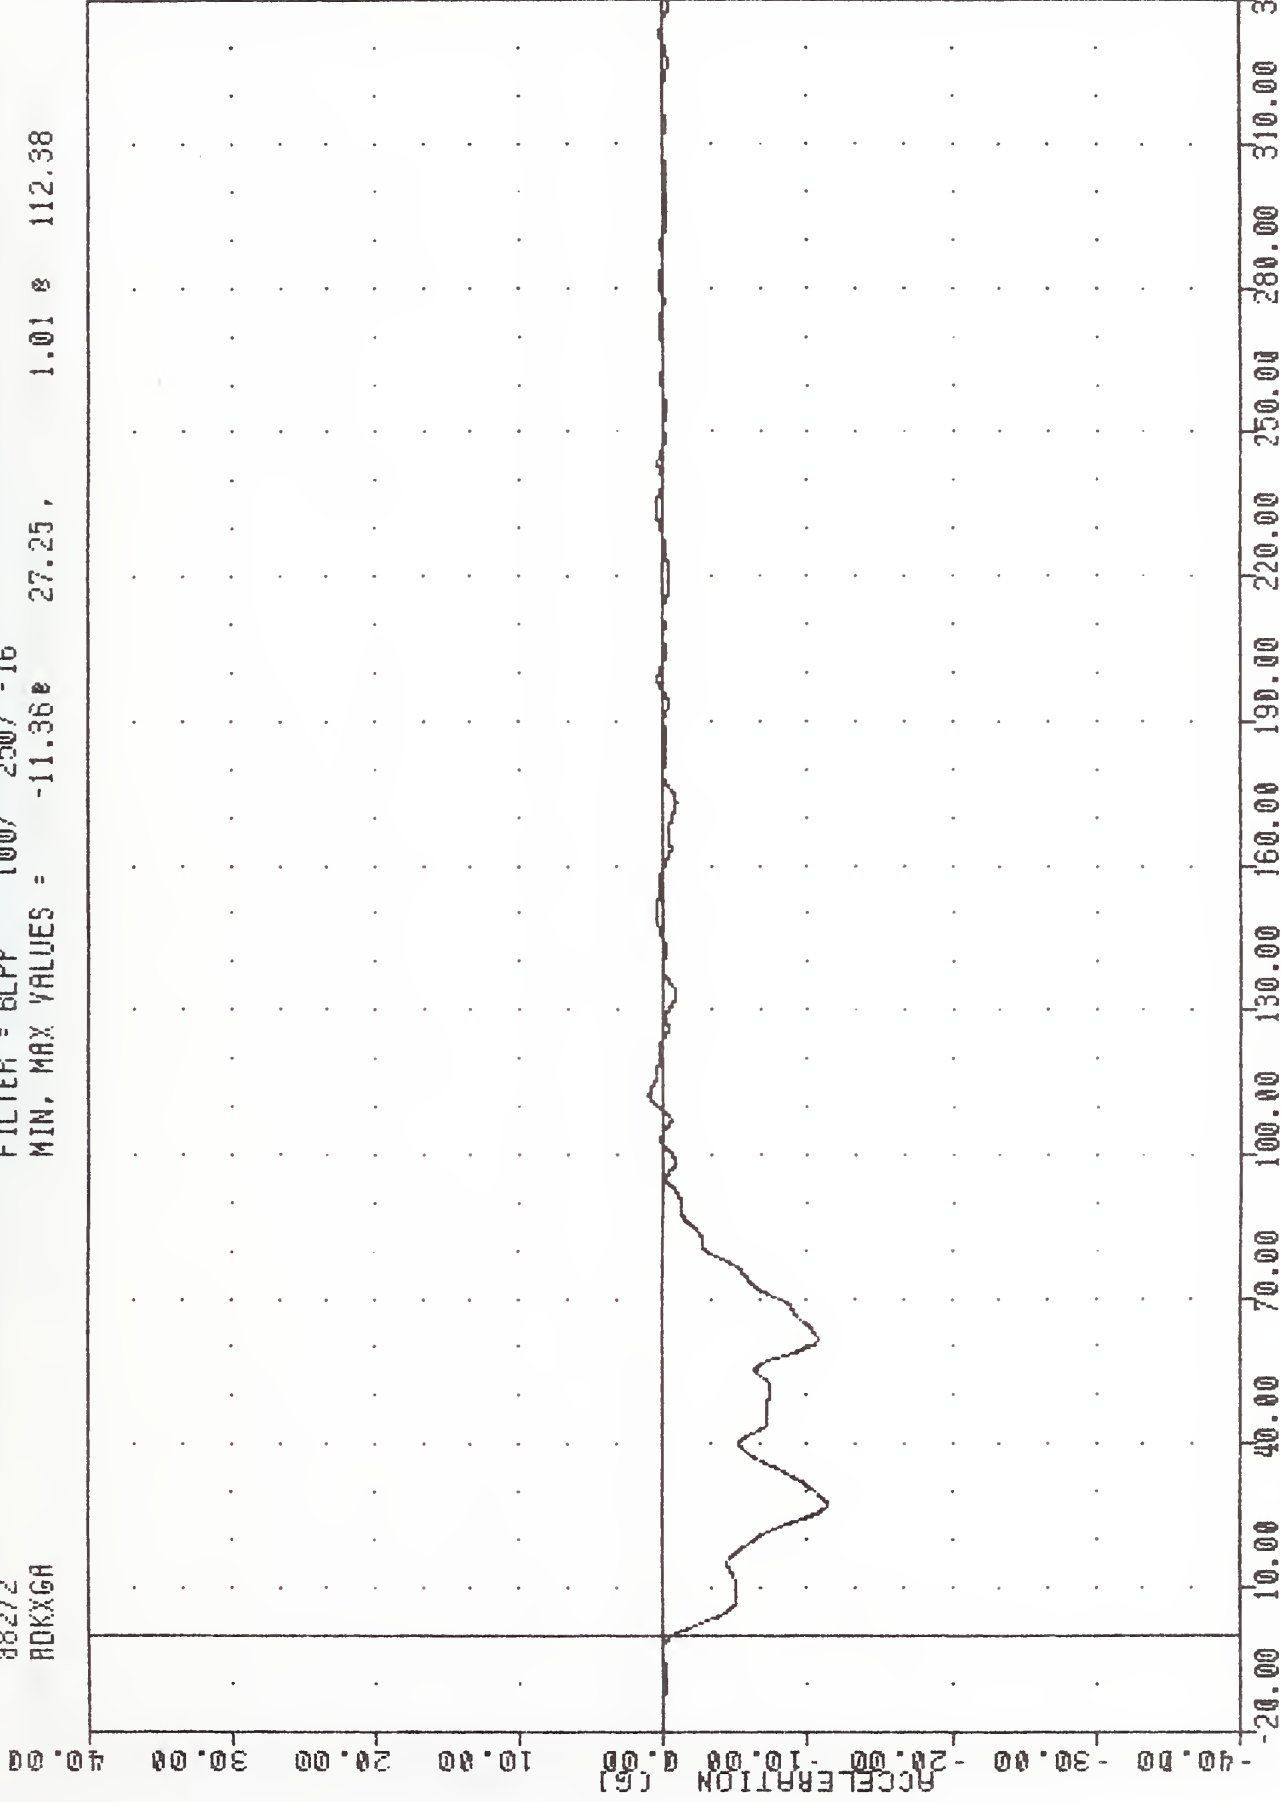
1985 FORD ESCORT INTO FLAT FRONTAL BARRIER AT 10 MPH FIRST TEST
VEHICLE REAR DECK X AXIS REDUNDANT ACCELERATION
