U.S. Department
of Transportation
**National Highway
Traffic Safety
Administration**

DOT HS 807 352

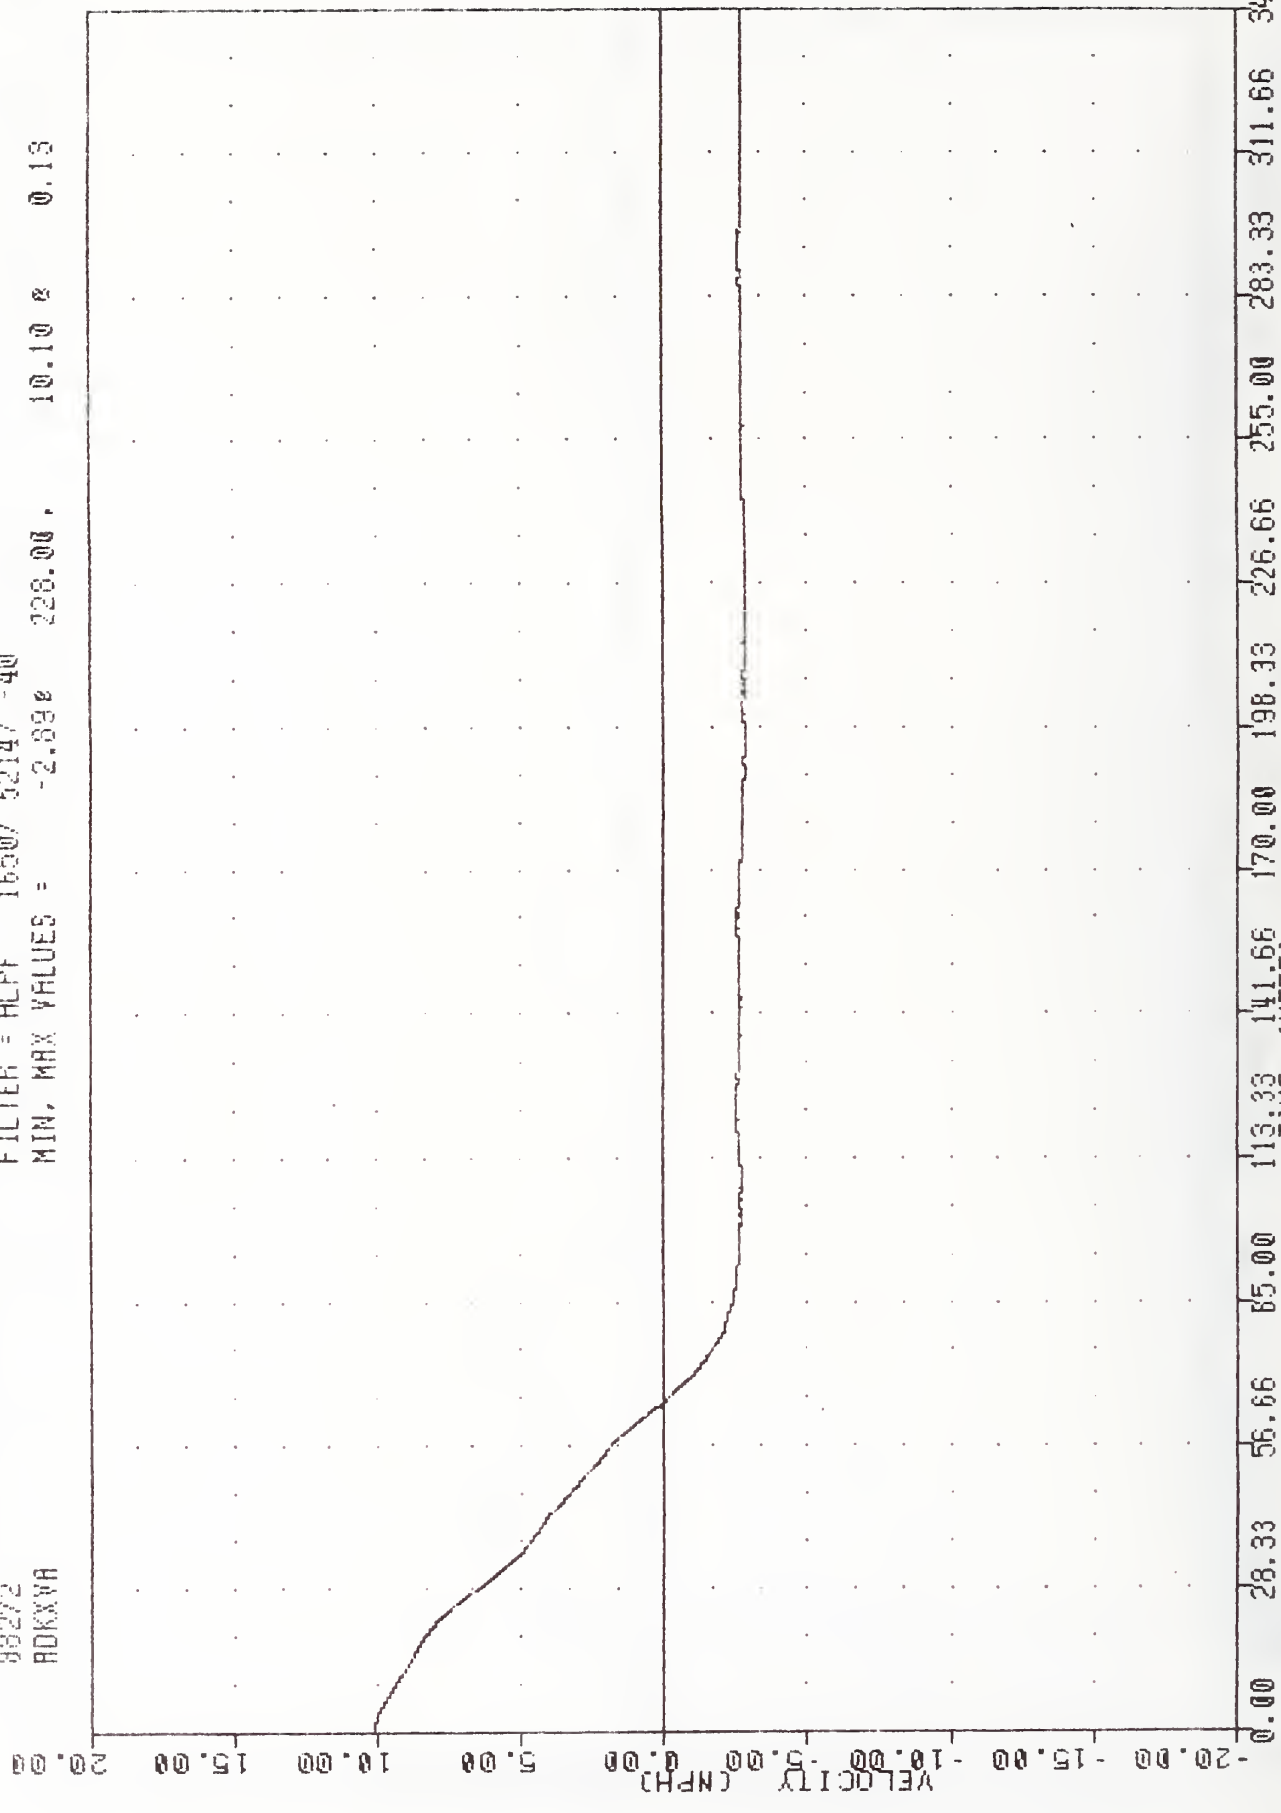
1985 FORD ESCORT INTO FLAT FRONTAL BARRIER AT 10 MPH FIRST TEST
 VEHICLE REAR DECK X AXIS VELOCITY REDUNDANT

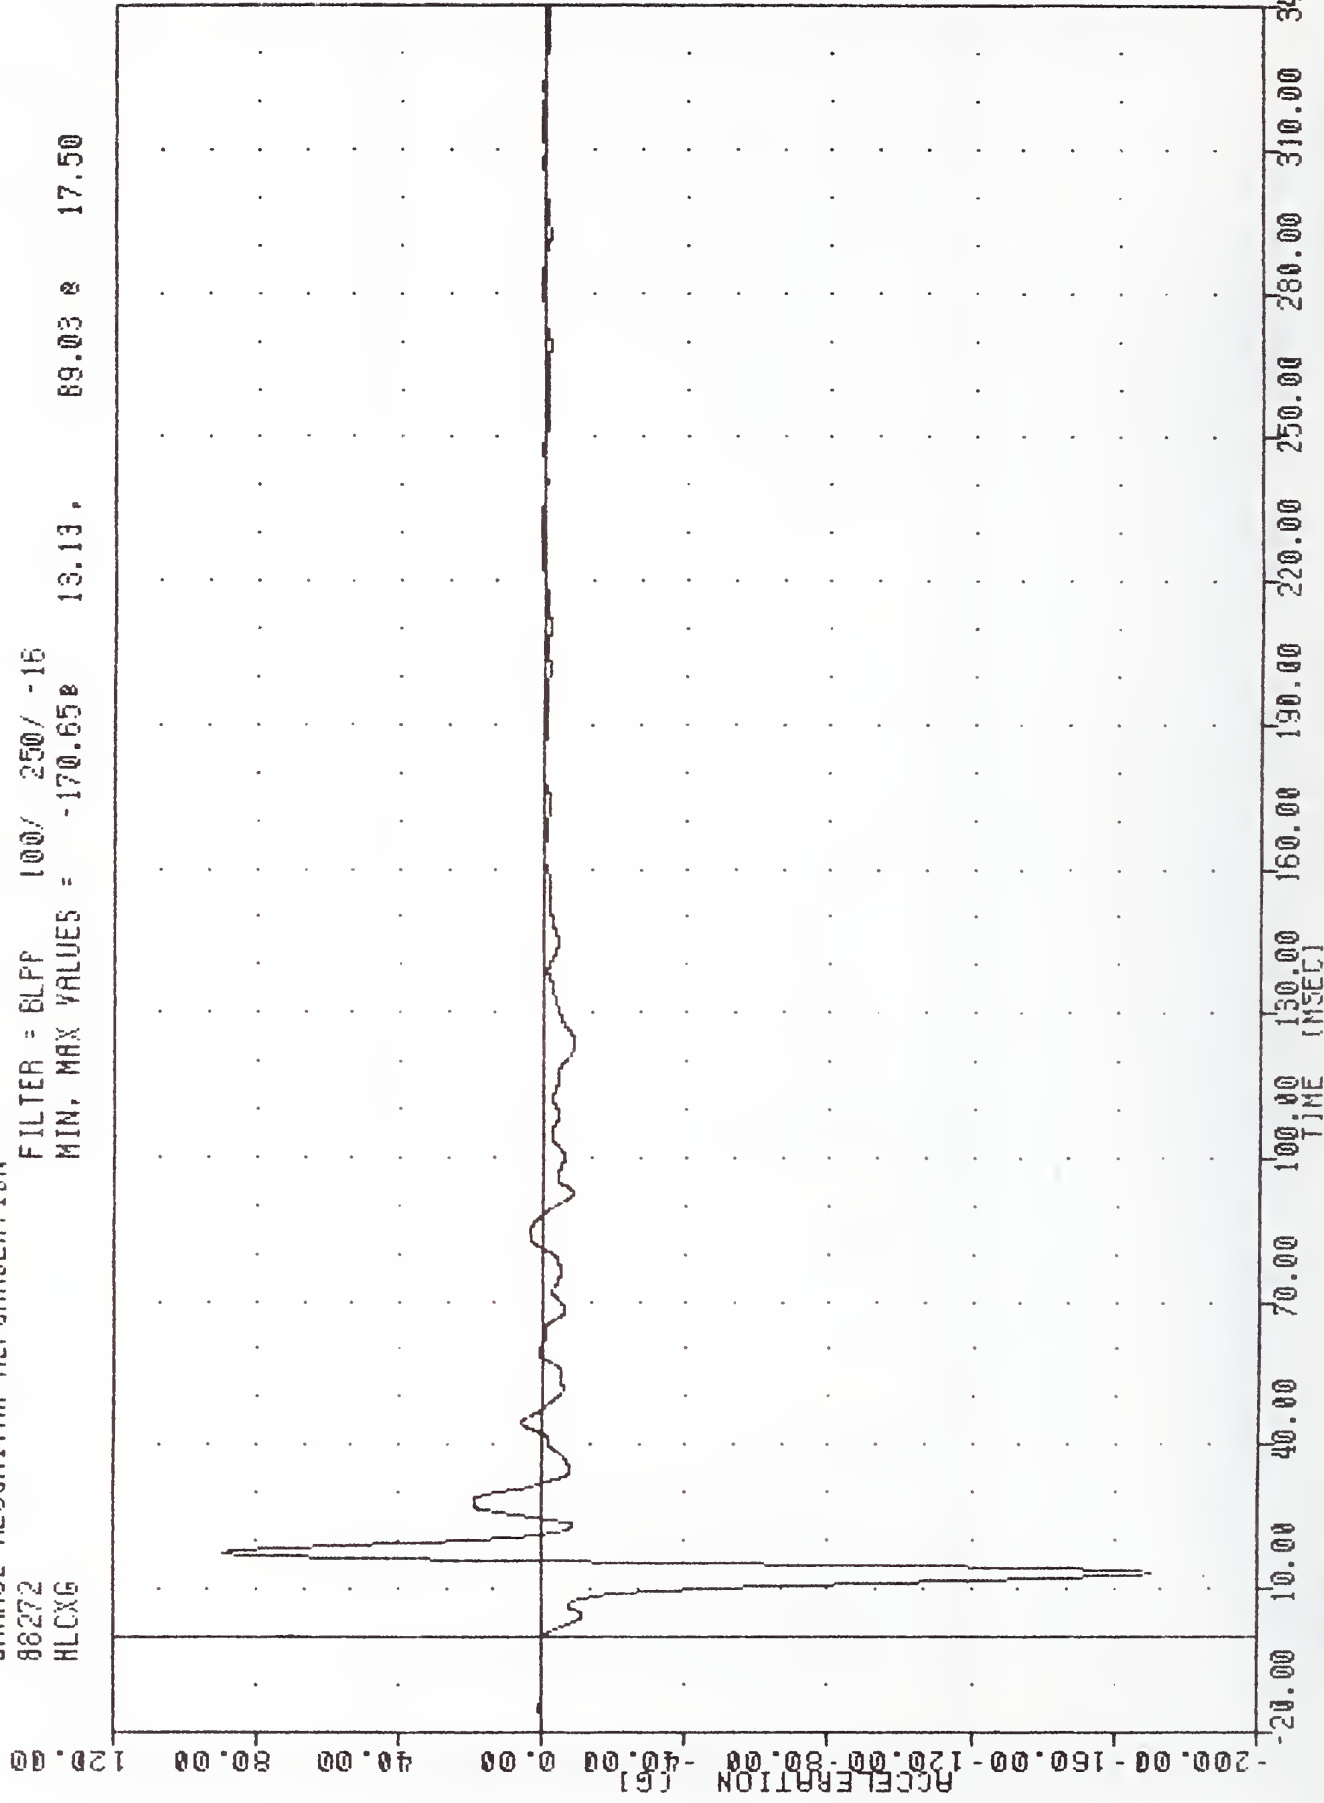
1985 FORD ESCORT INTO FLAT FRONTAL BARRIER AT 20 MPH SECOND TEST
VEHICLE HOOD LATCH CROSSMEMBER X AXIS ACCELERATION

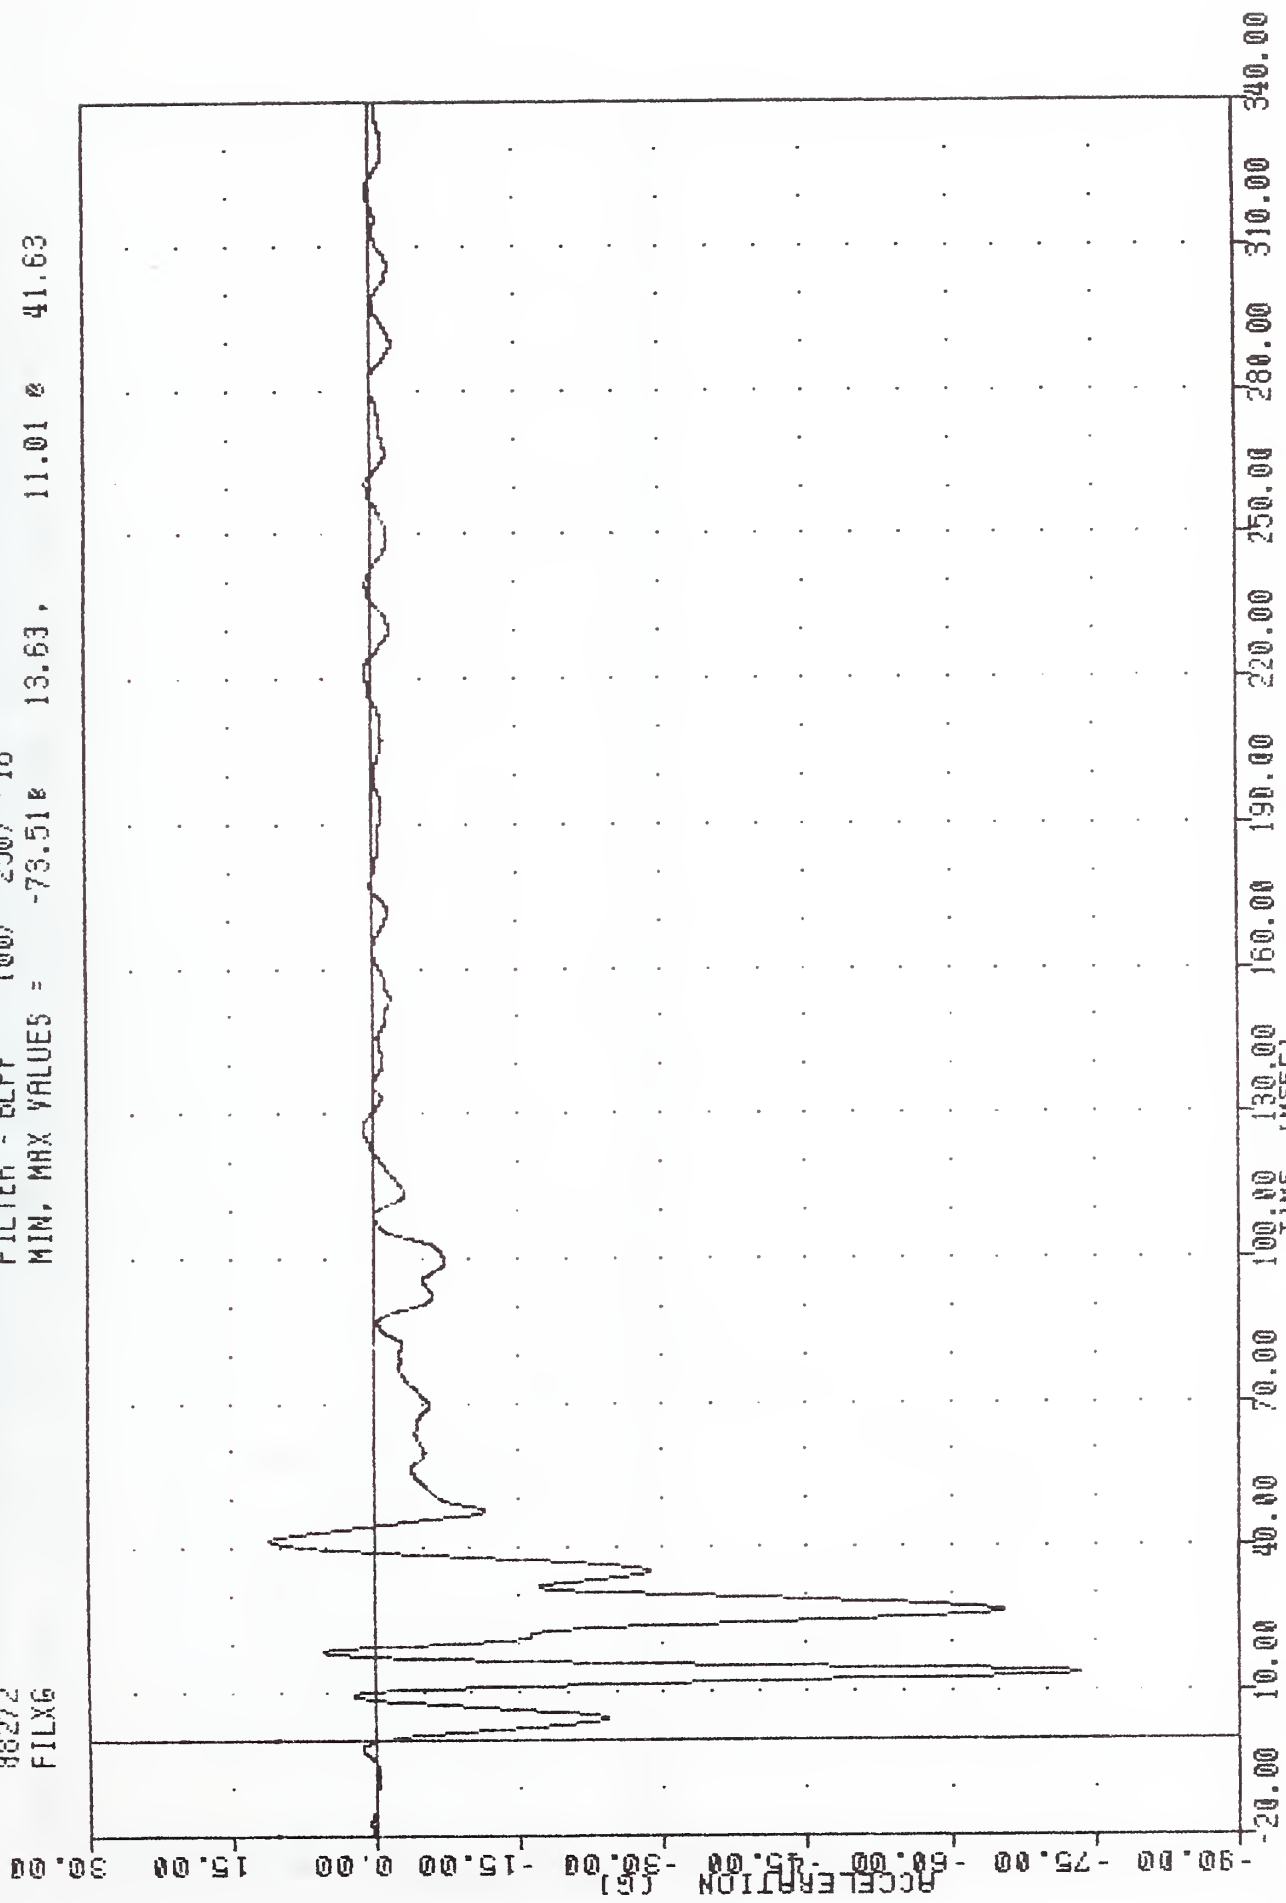
1985 FORD ESCORT INTO FLAT FRONTAL BARRIER AT 20 MPH SECOND TEST
VEHICLE LEFT FENDER WELL INSIDE X AXIS ACCELERATION

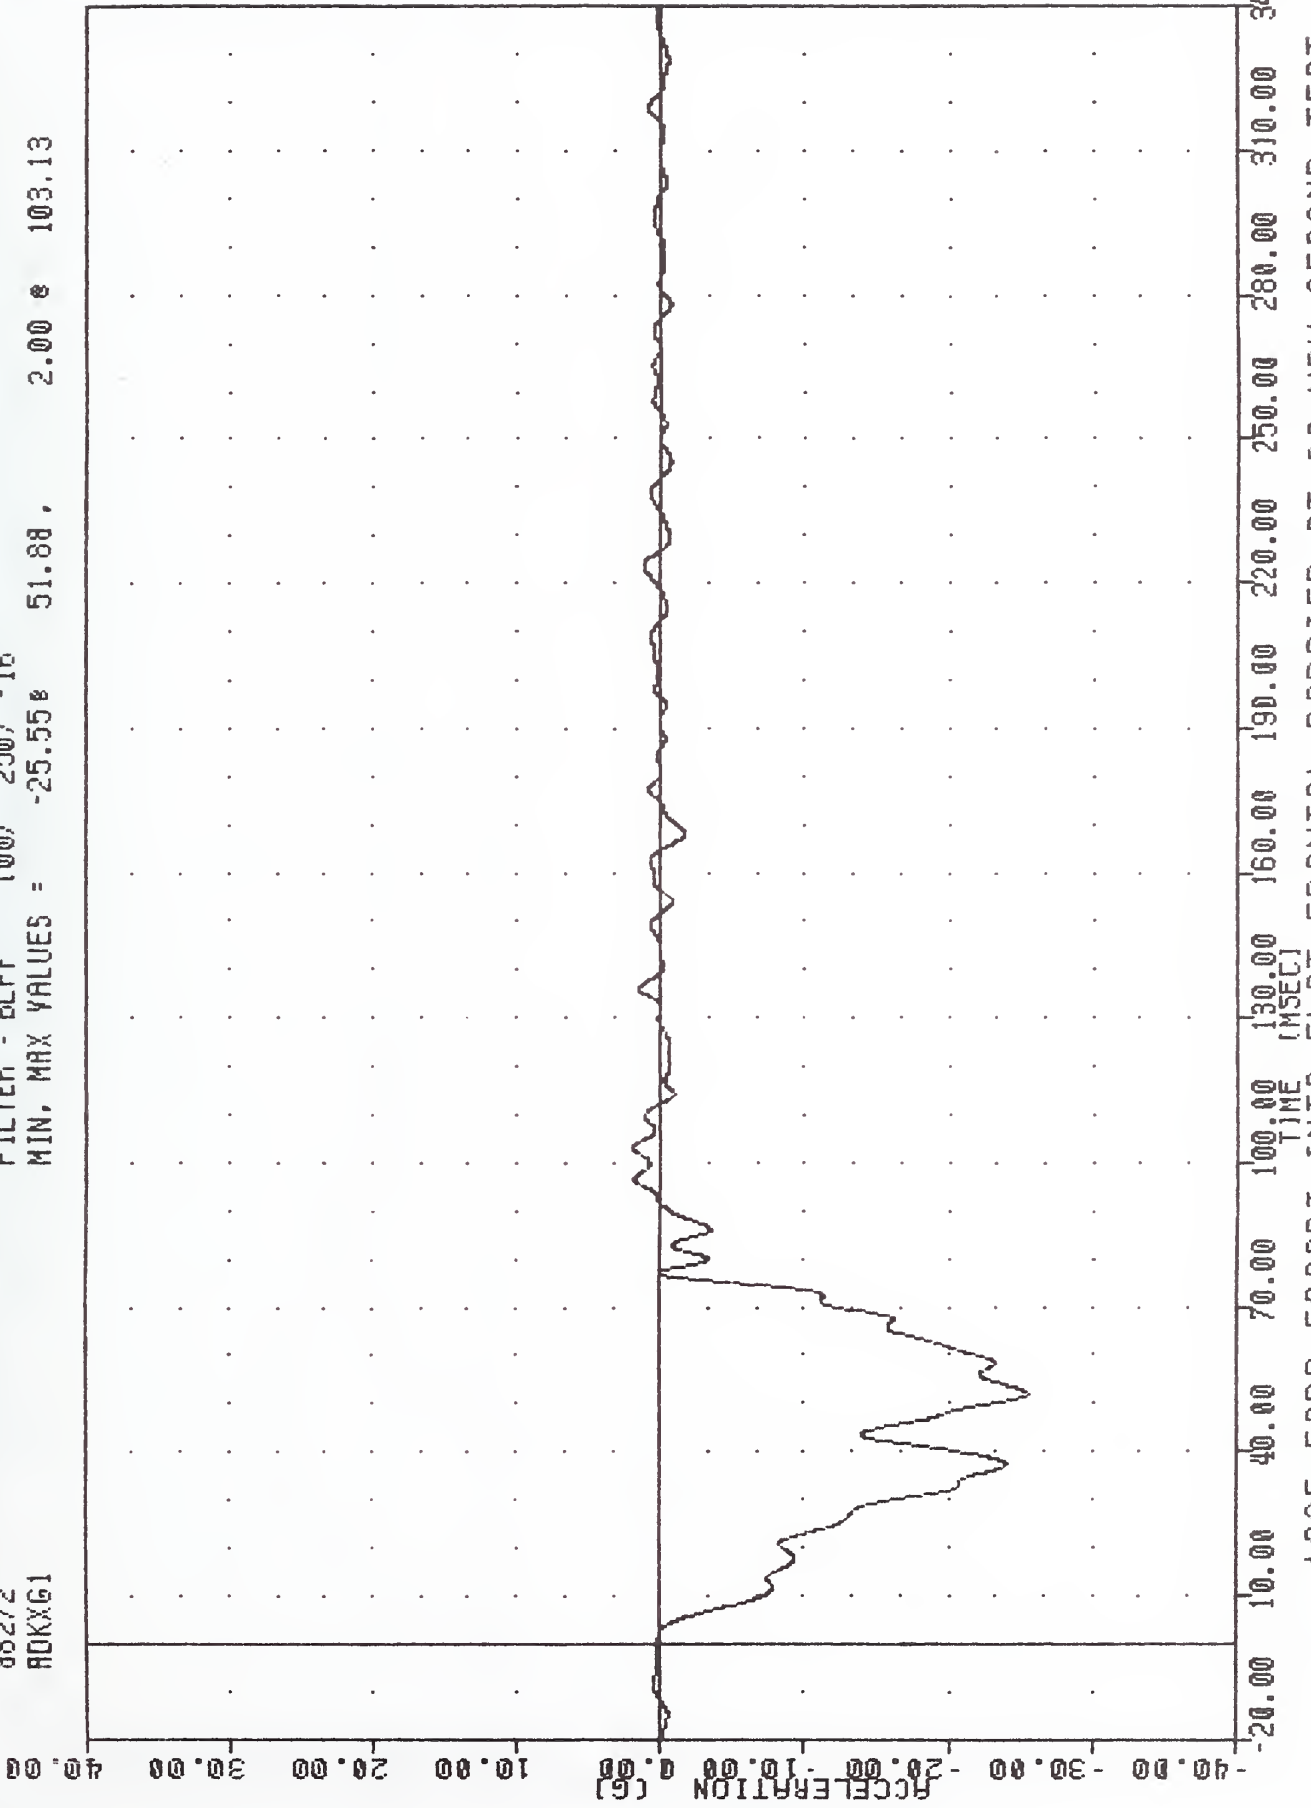
1985 FORD ESCORT INTO FLAT FRONTAL BARRIER AT 20 MPH SECOND TEST
VEHICLE REAR DECK X AXIS ACCELERATION

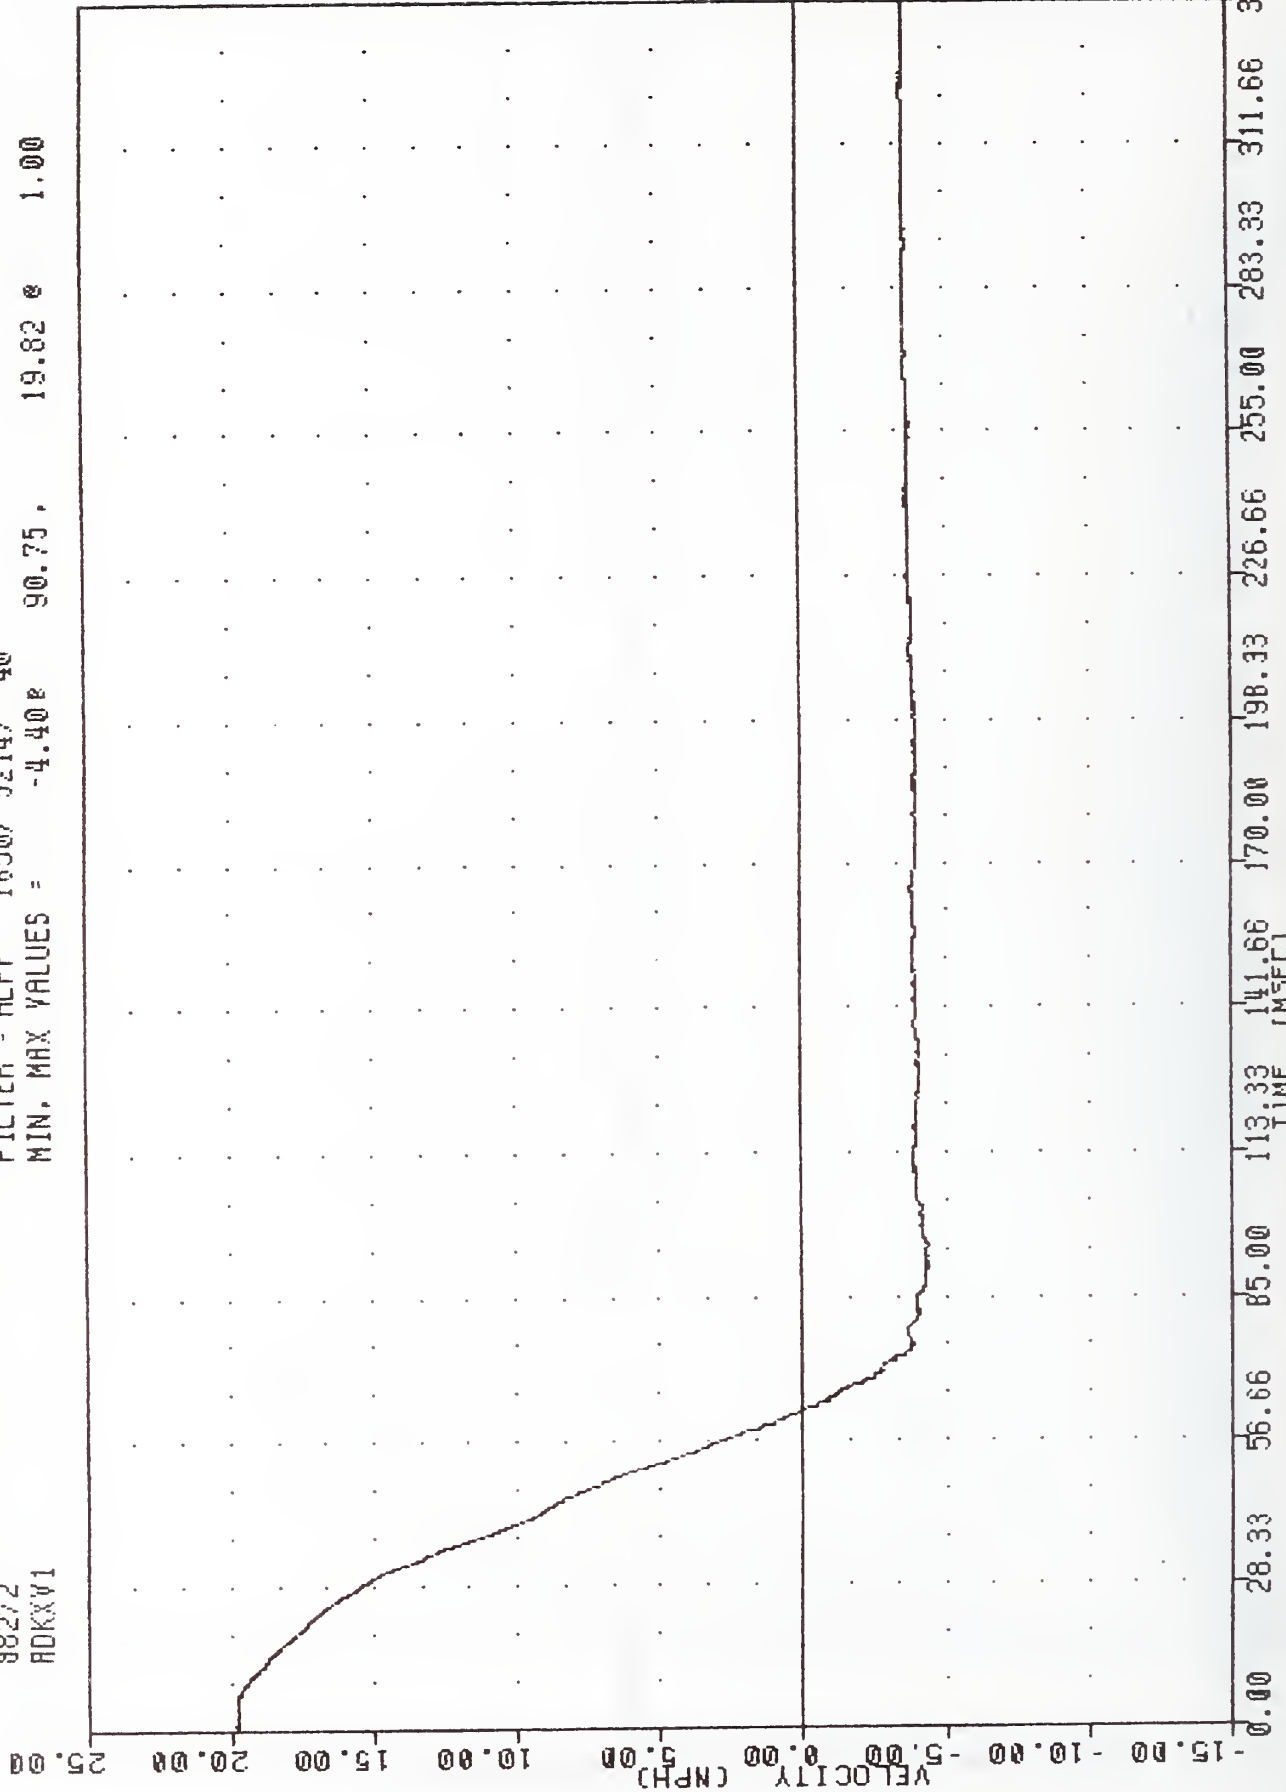
1985 FORD ESCORT INTO FLAT FRONTAL BARRIER AT 20 MPH SECOND TEST
 VEHICLE REAR DECK X AXIS VELOCITY

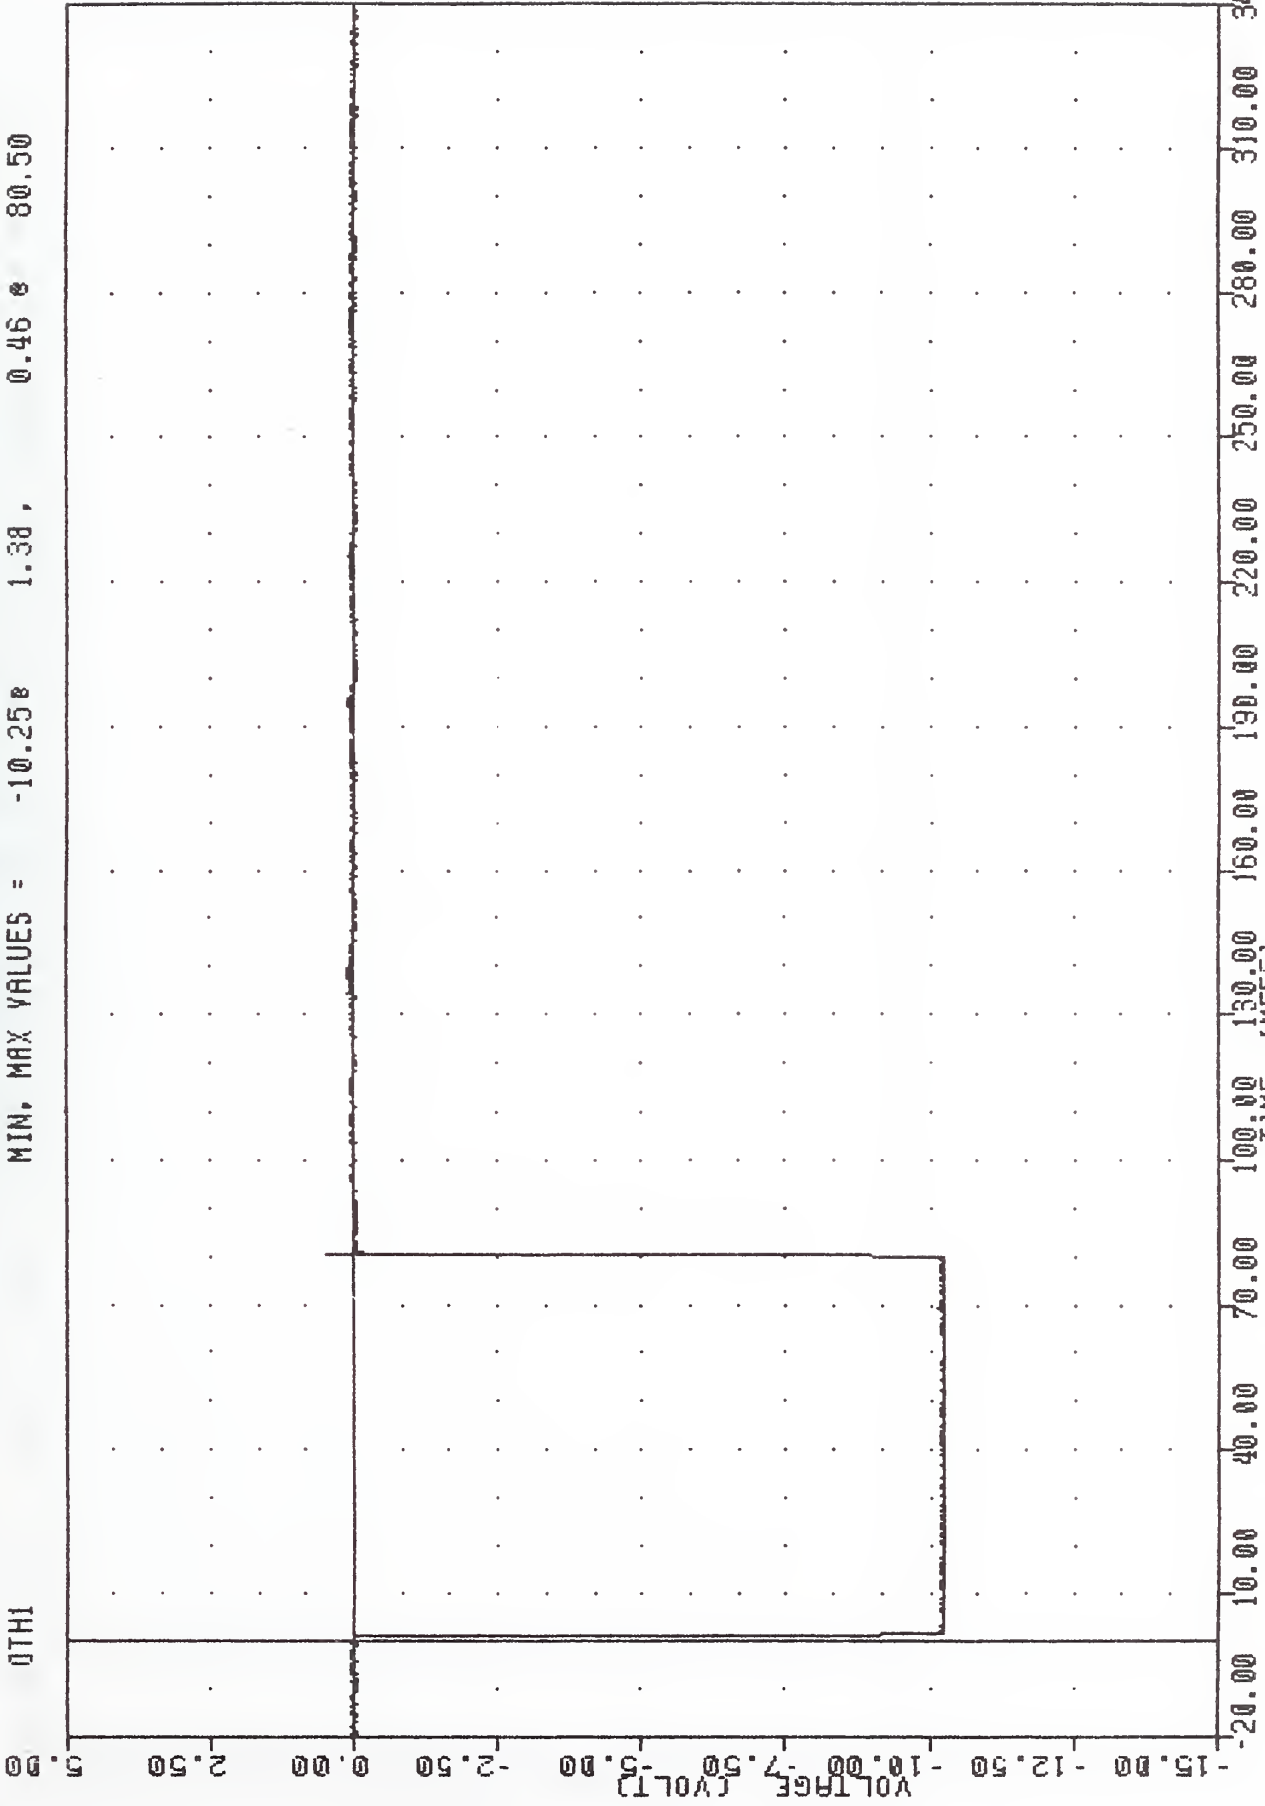
1985 FORD ESCORT INTO FLAT FRONTAL BARRIER AT 20 MPH SECOND TEST
VEHICLE CONTACT SWITCH - LEFT

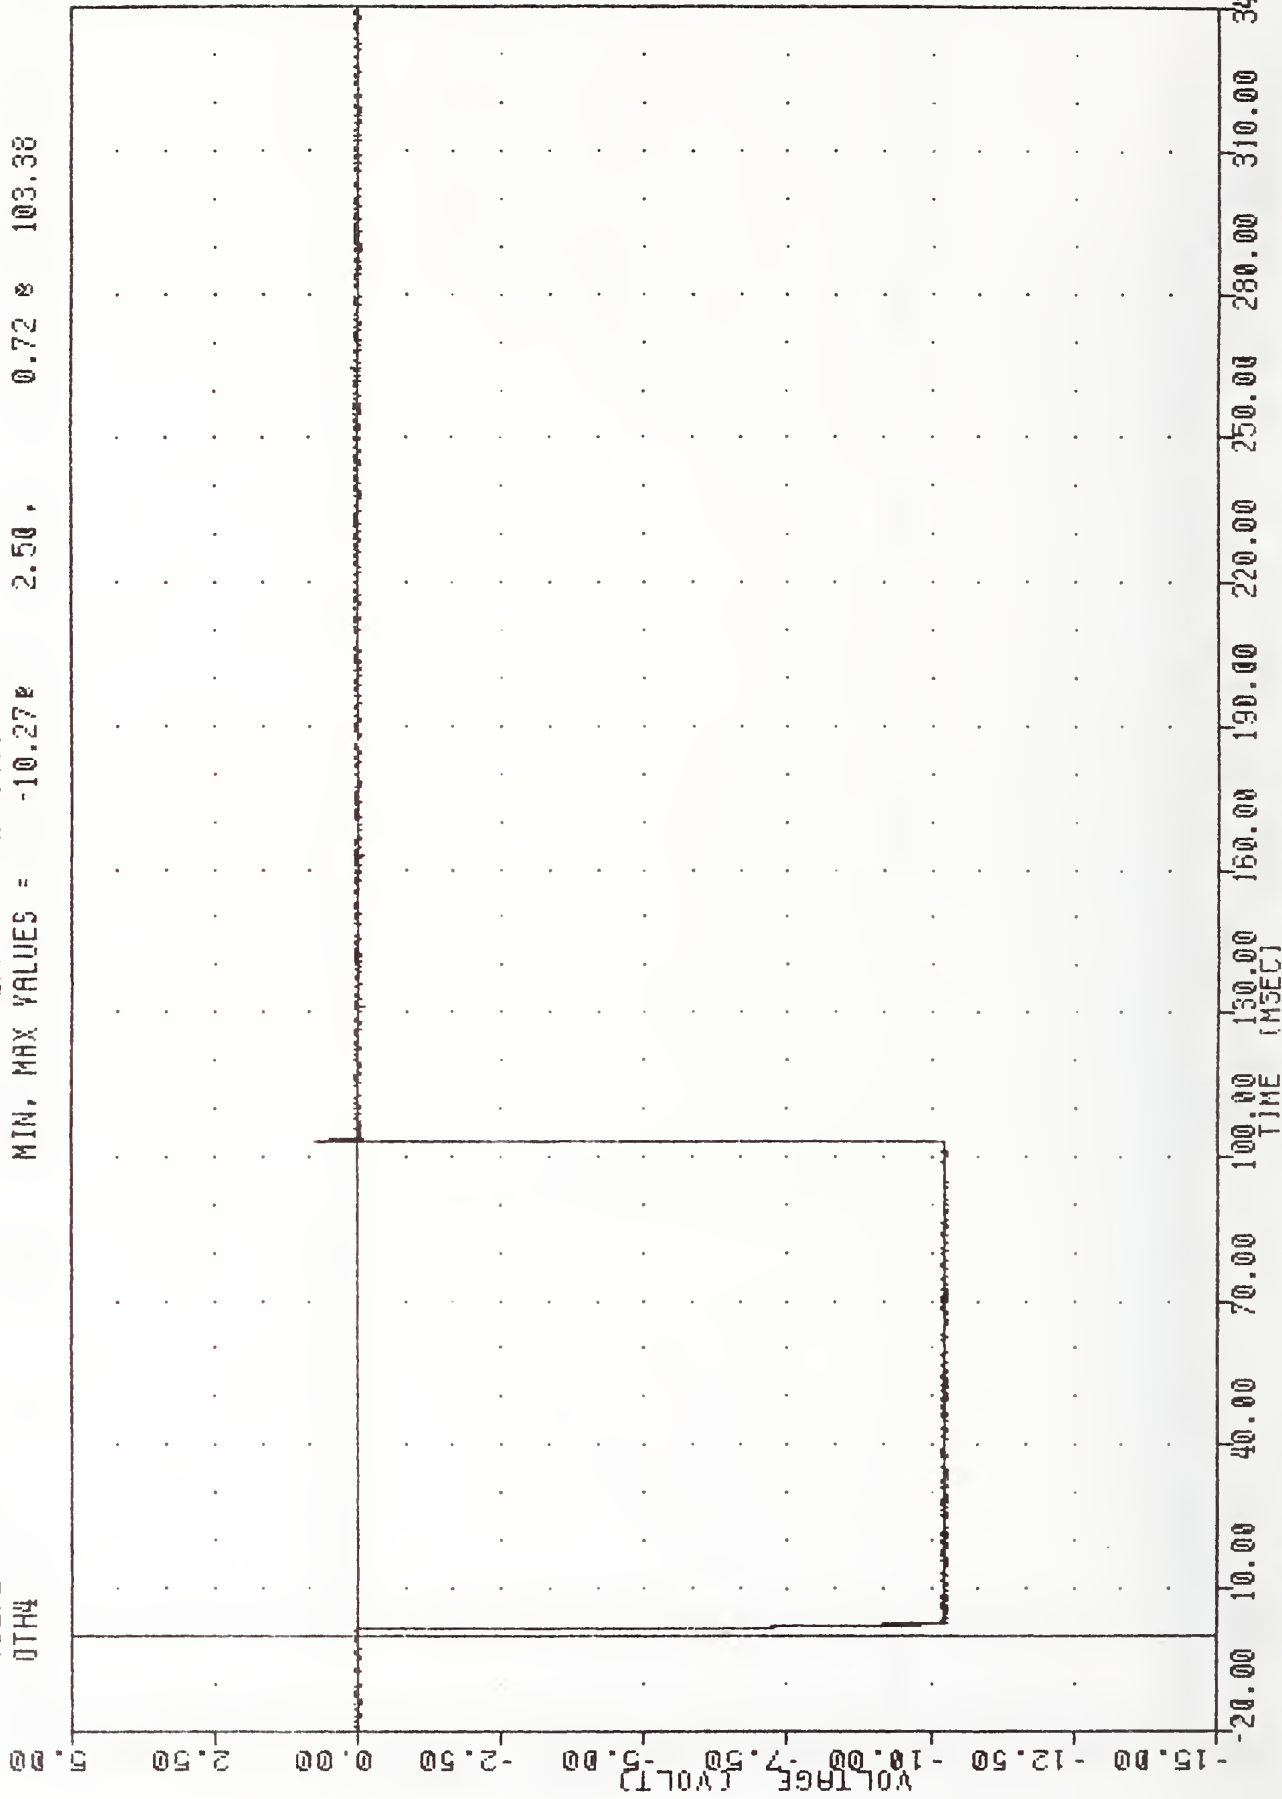
1985 FORD ESCORT INTO FLAT FRONTAL BARRIER AT 20 MPH SECOND TEST
BARRIER CONTACT SWITCH - LEFT

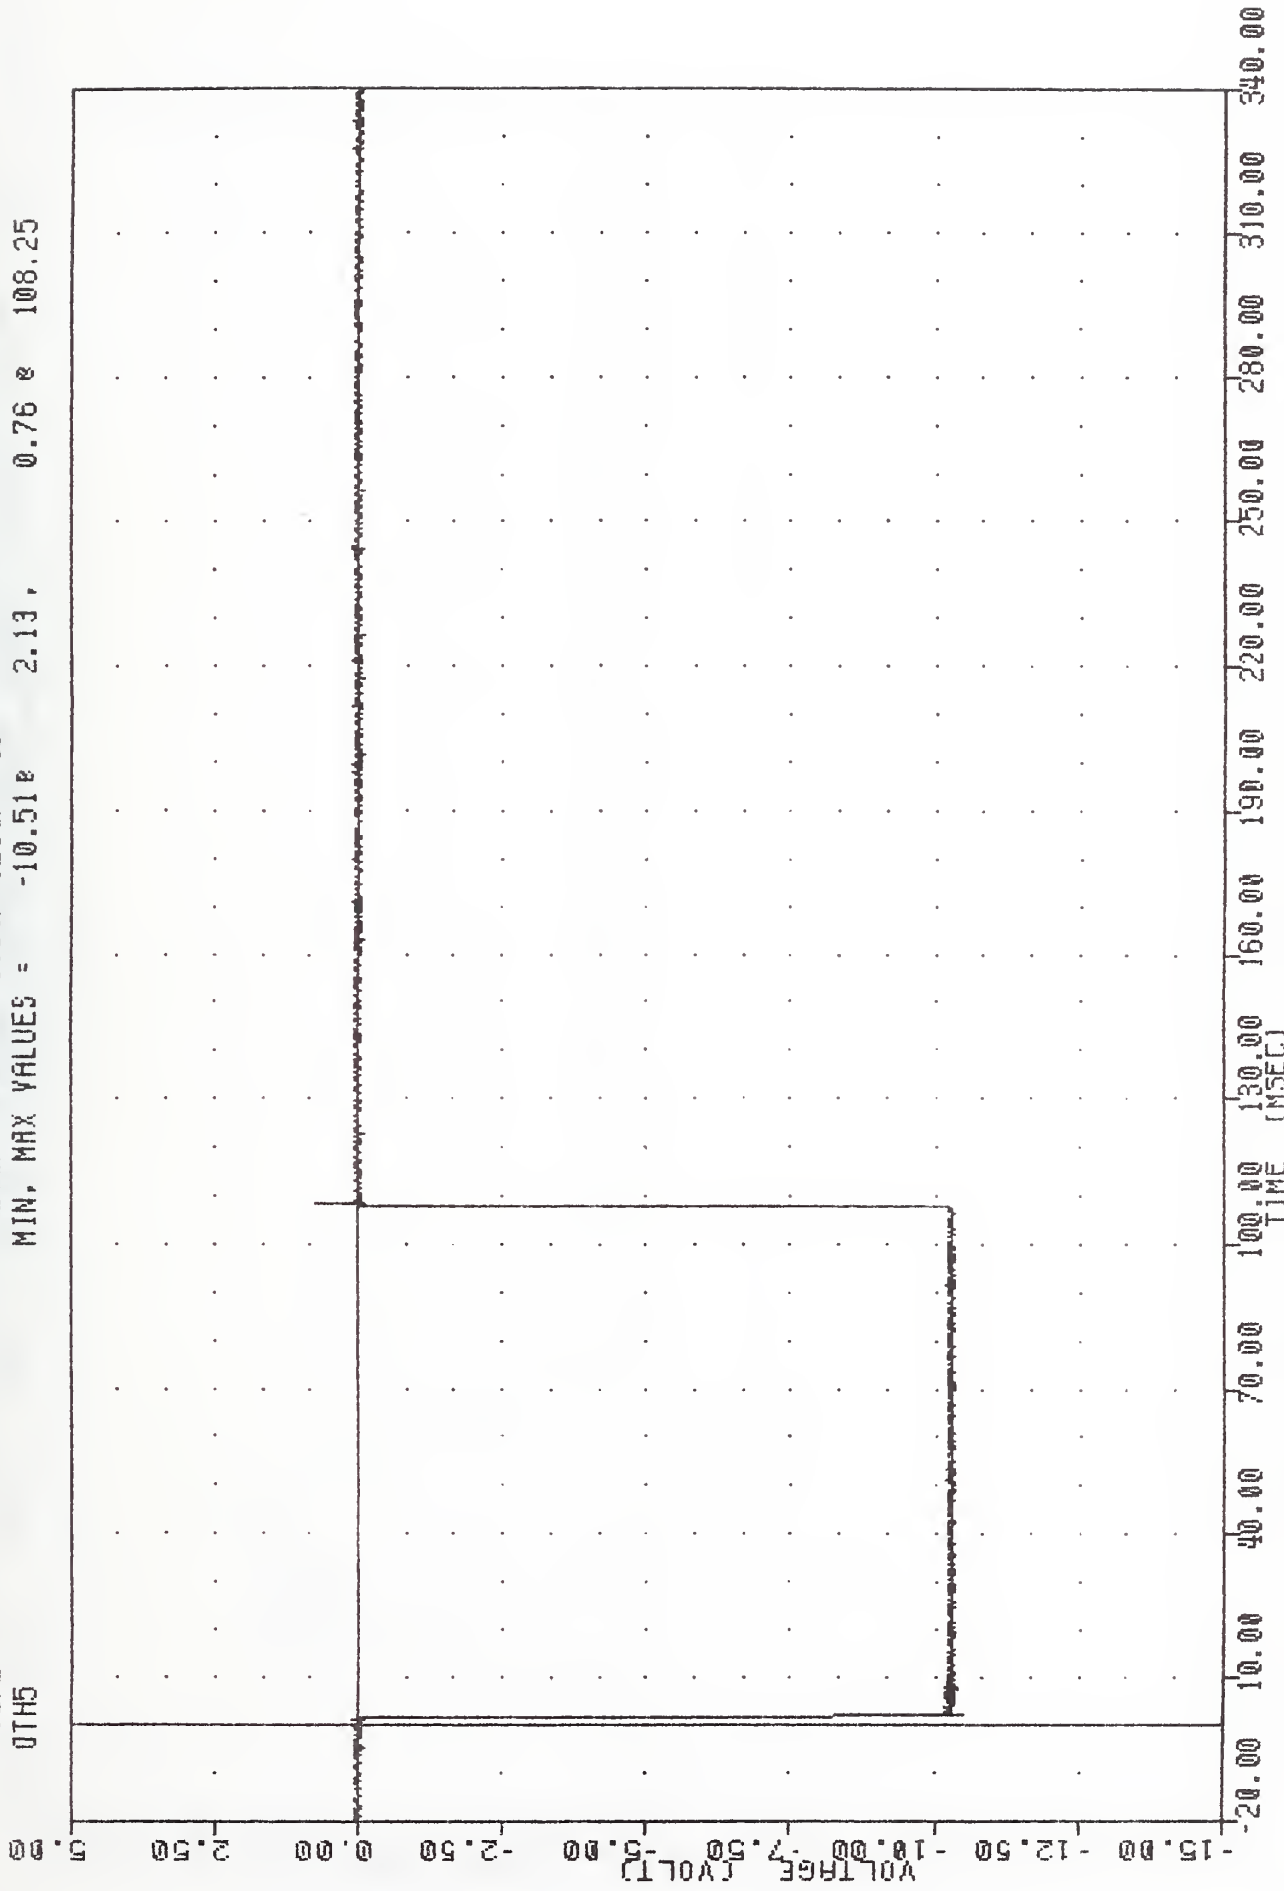
1985 FORD ESCORT INTO FLAT FRONTAL BARRIER AT 20 MPH SECOND TEST
BARRIER CONTACT SWITCH - RIGHT

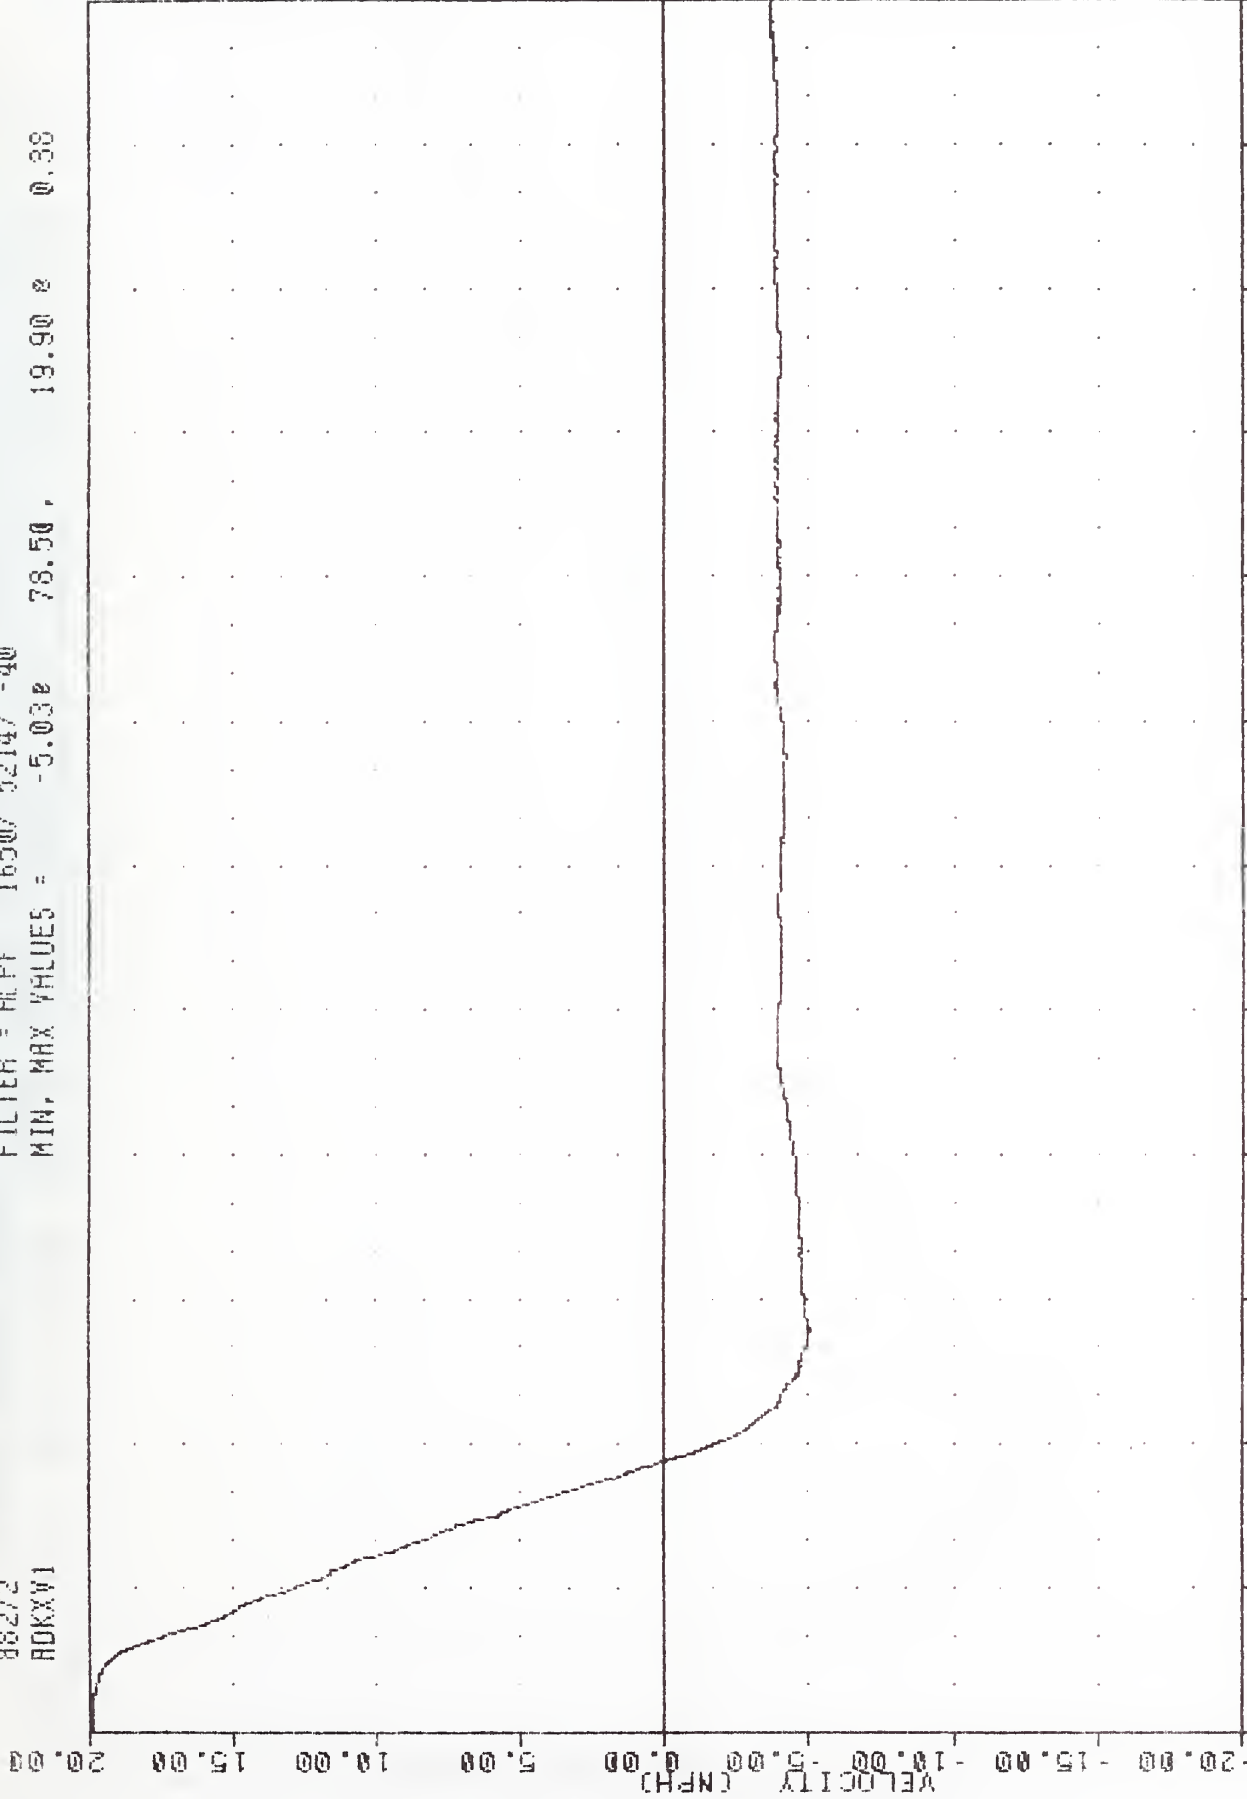
1985 FORD ESCORT INTO FLAT FRONTAL BARRIER AT 20 MPH THIRD TEST
 VEHICLE REAR DECK X AXIS VELOCITY
