U.S. Department
of Transportation
**National Highway
Traffic Safety
Administration**

DOT HS 807 352

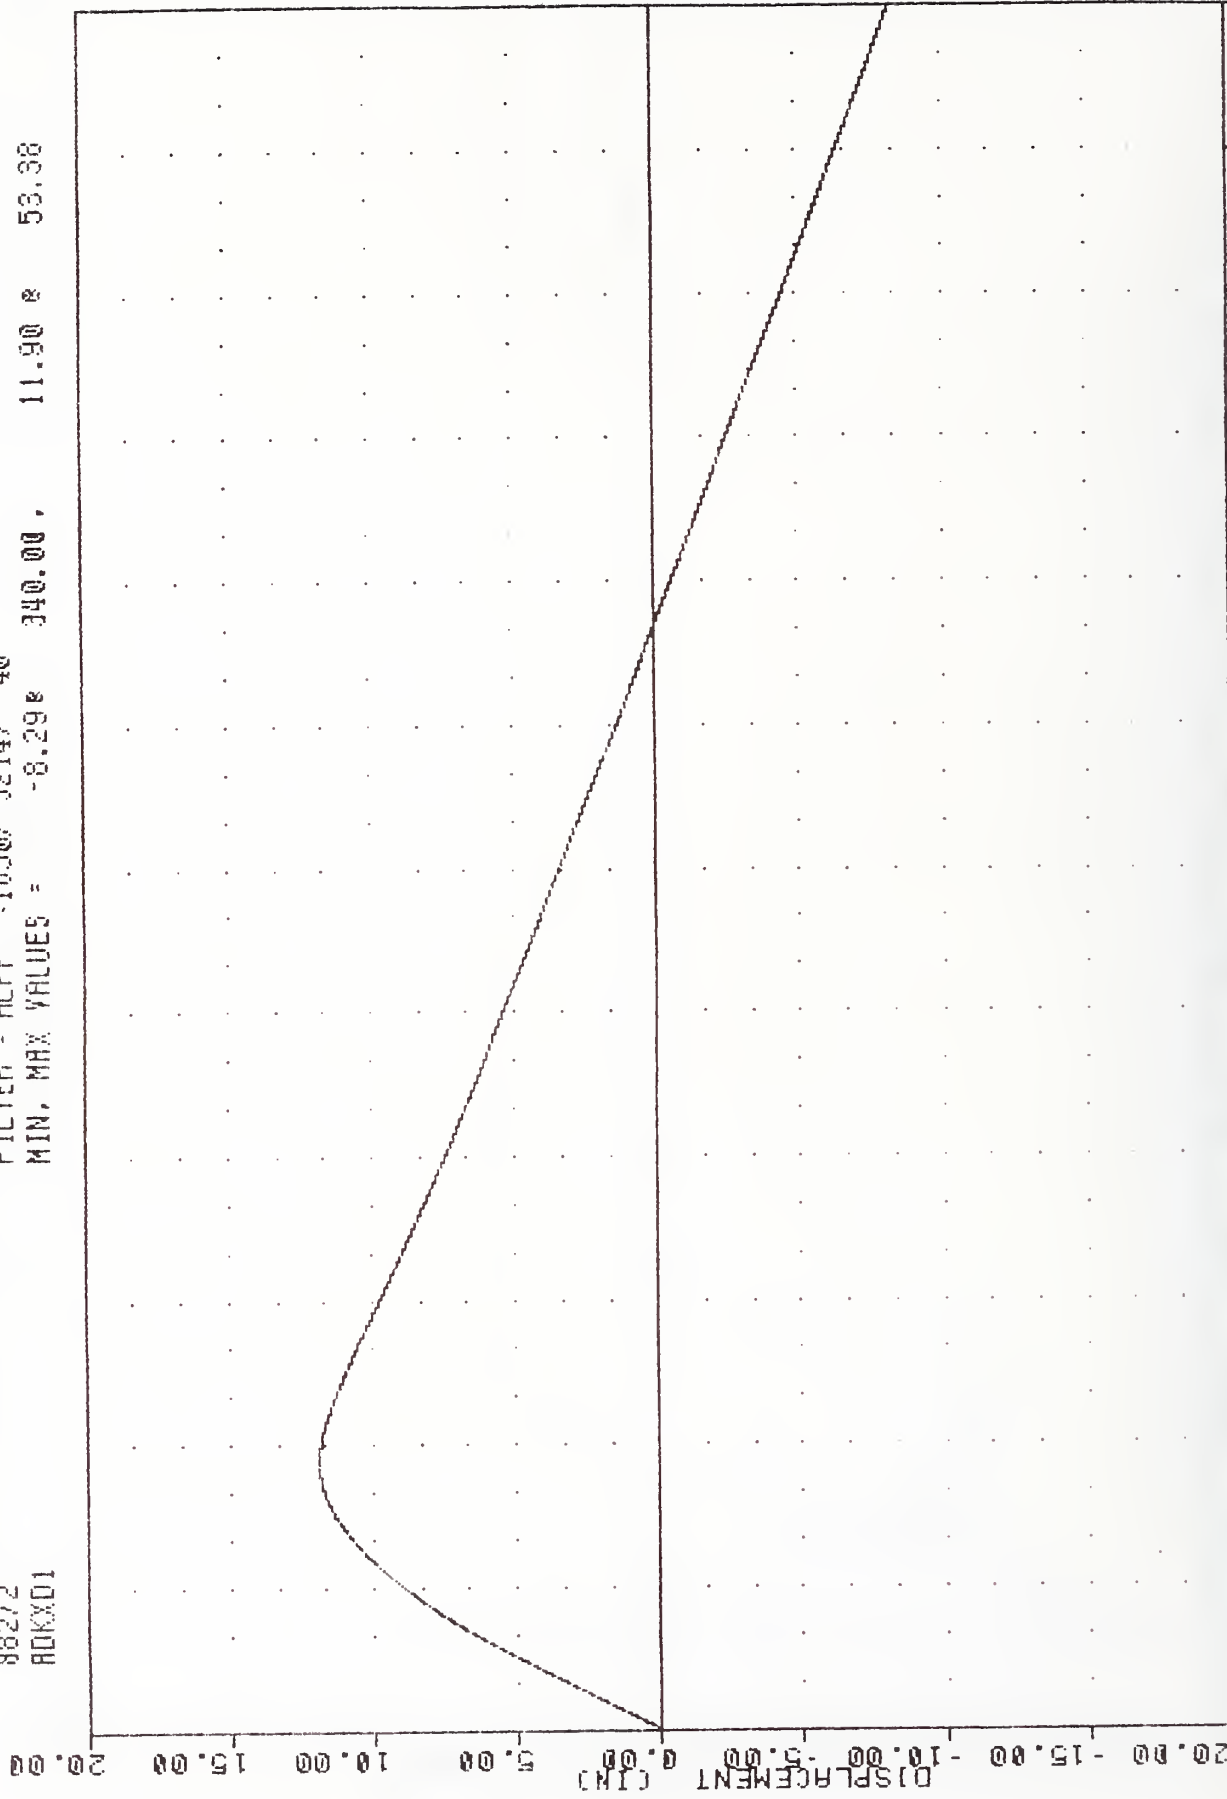
1985 FORD ESCORT INTO FLAT FRONTAL BARRIER AT 20 MPH THIRD TEST
 VEHICLE REAR DECK X AXIS DISPLACEMENT

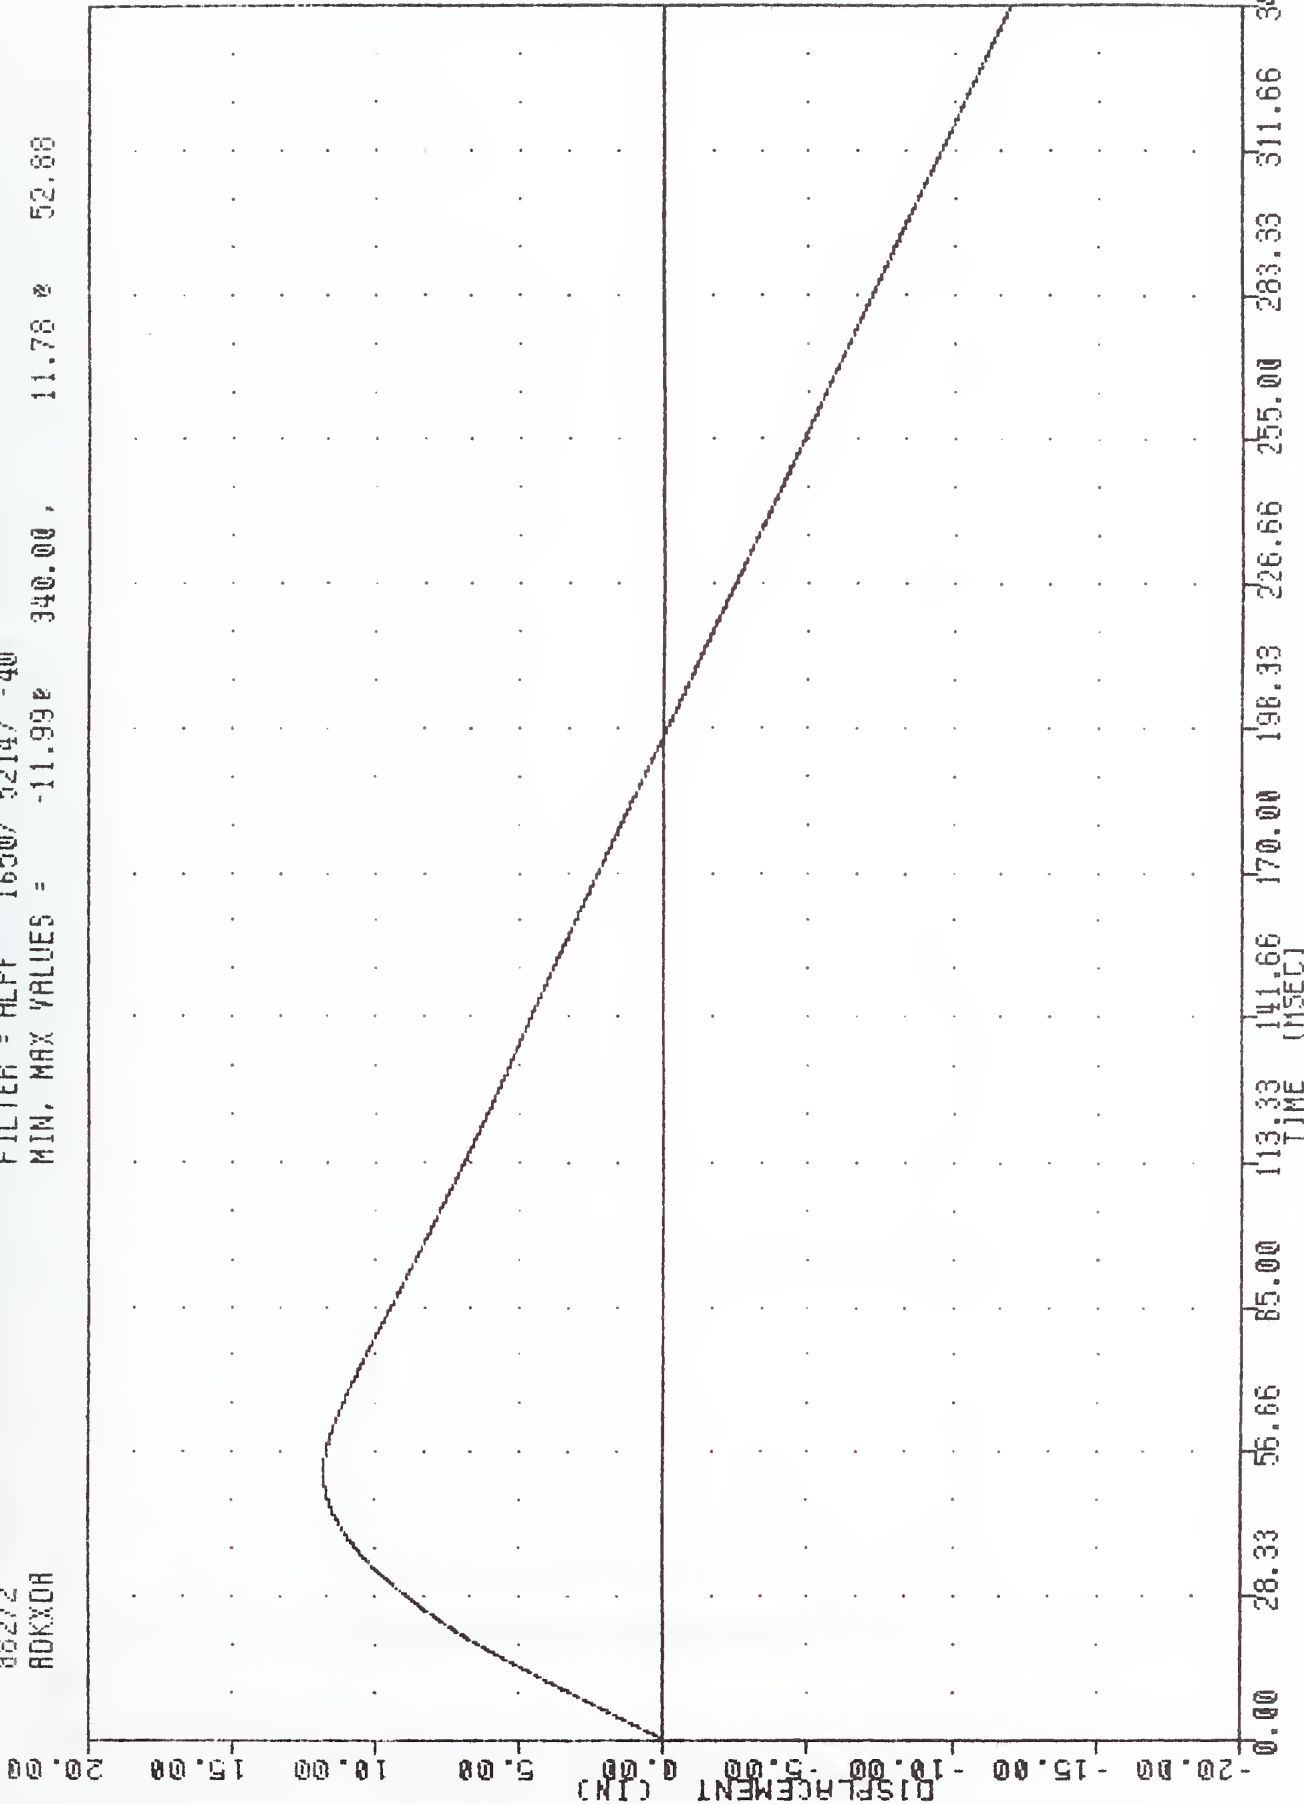
1985 FORD ESCORT INTO FLAT FRONTAL BARRIER AT 20 MPH THIRD TEST
VEHICLE REAR DECK X AXIS DISPLACEMENT REDUNDANT

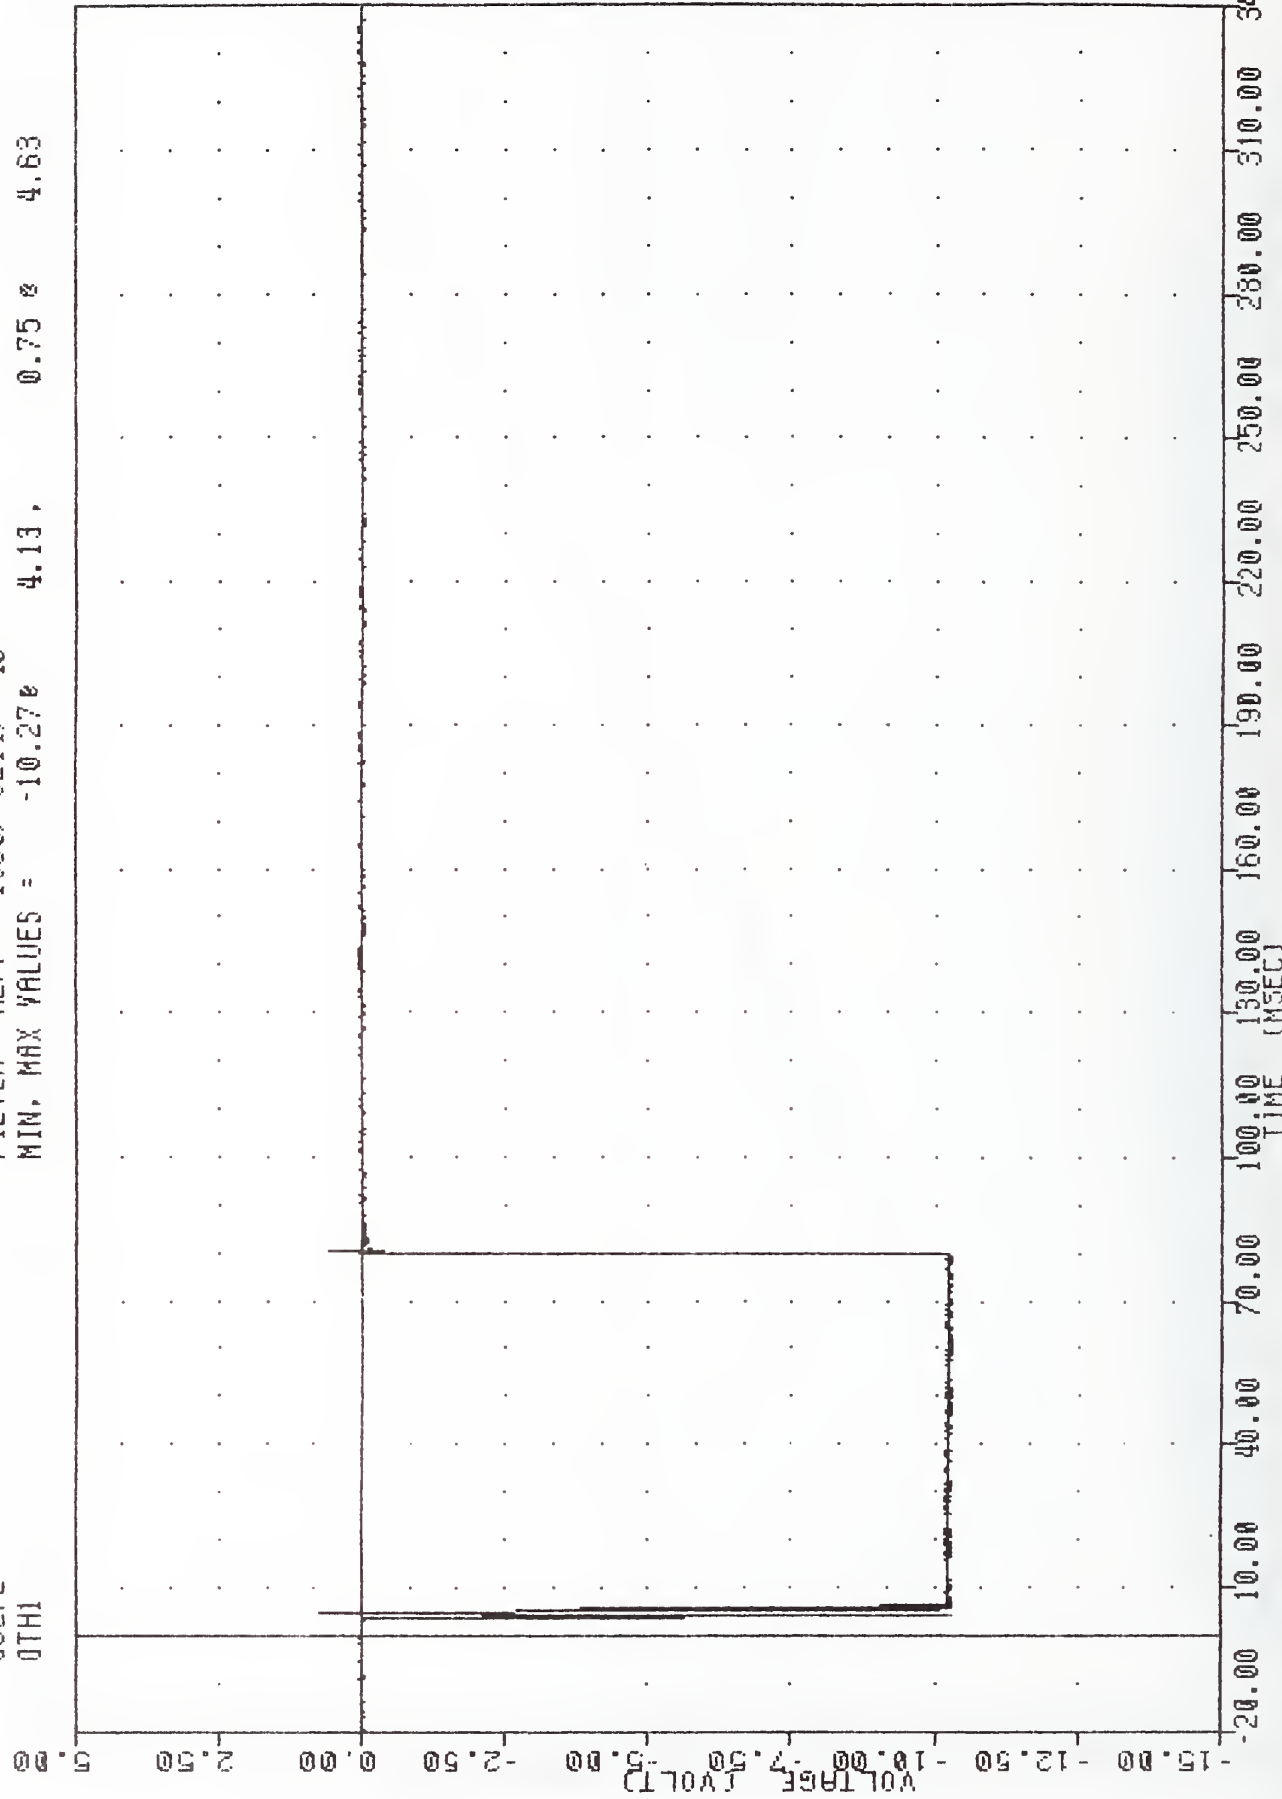
1985 FORD ESCORT INTO FLAT FRONTAL BARRIER AT 20 MPH THIRD TEST
VEHICLE CONTACT SWITCH - LEFT

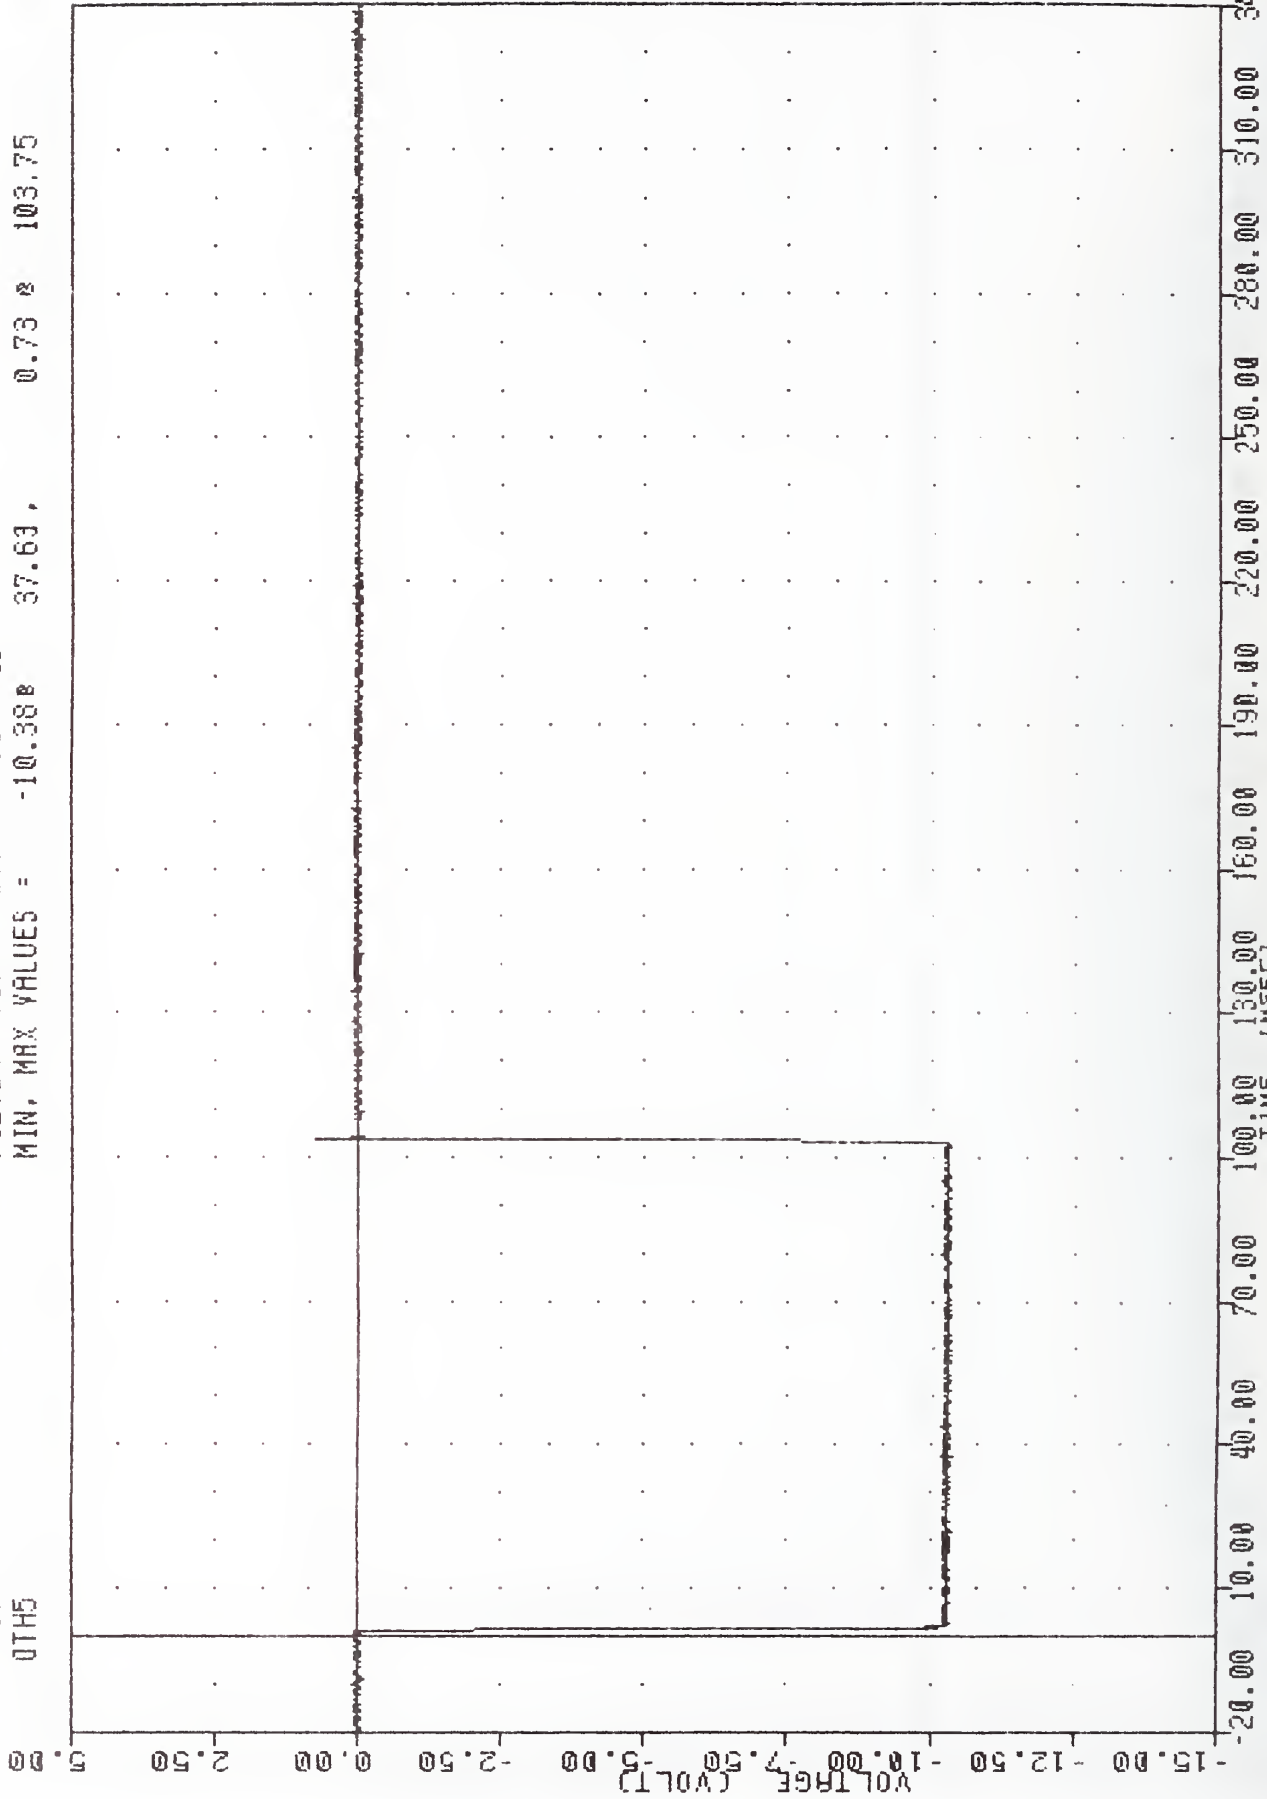
1985 FORD ESCORT INTO FLAT FRONTAL BARRIER AT 20 MPH THIRD TEST
BARRIER CONTACT SWITCH - RIGHT

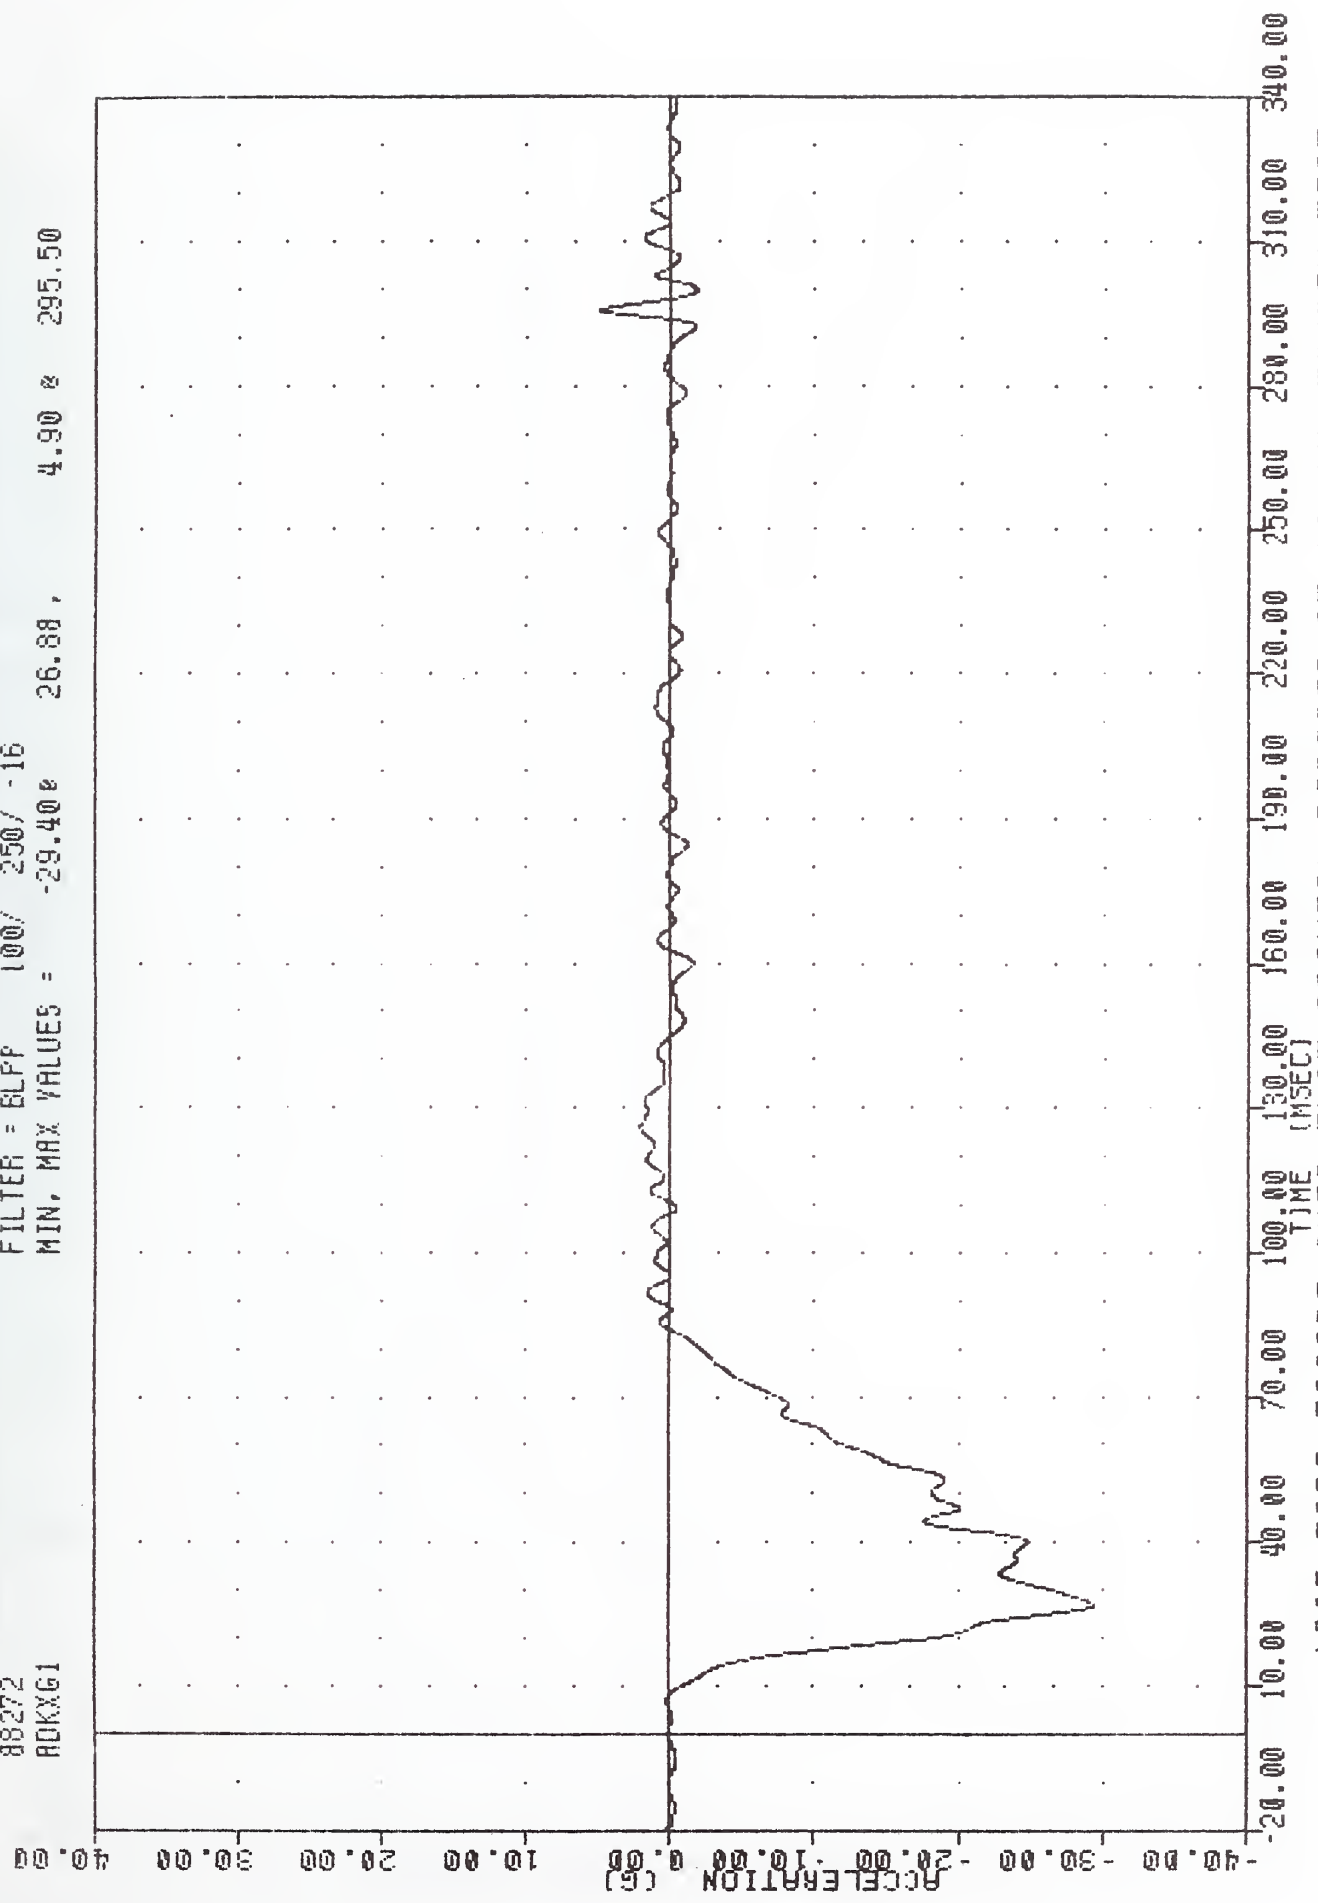
1985 FORD ESCORT INTO FLAT FRONTAL BARRIER AT 18 MPH FOURTH TEST
VEHICLE REAR DECK X AXIS ACCELERATION

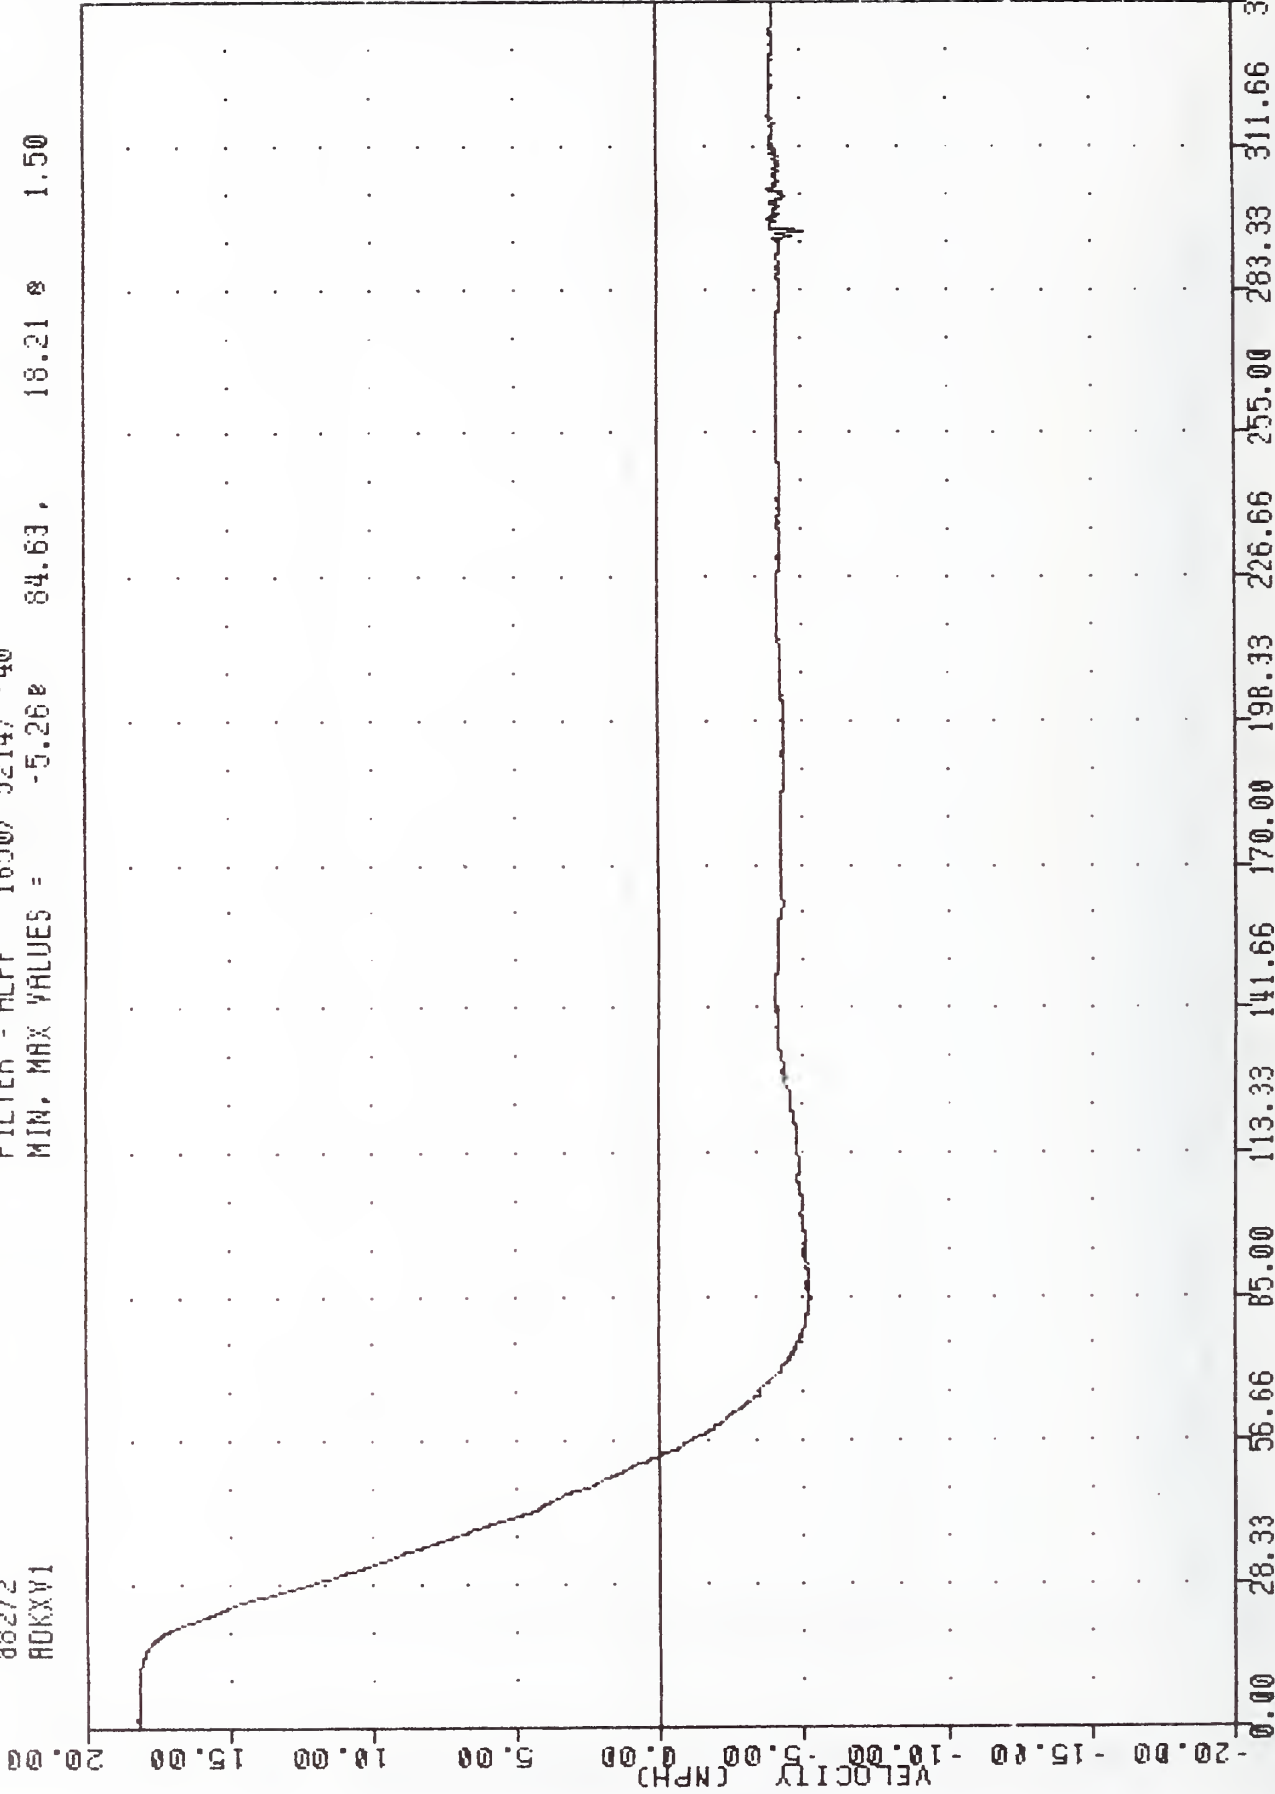
1985 FORD ESCORT INTO FLAT FRONTAL BARRIER AT 18 MPH FOURTH TEST
VEHICLE REAR DECK X AXIS VELOCITY

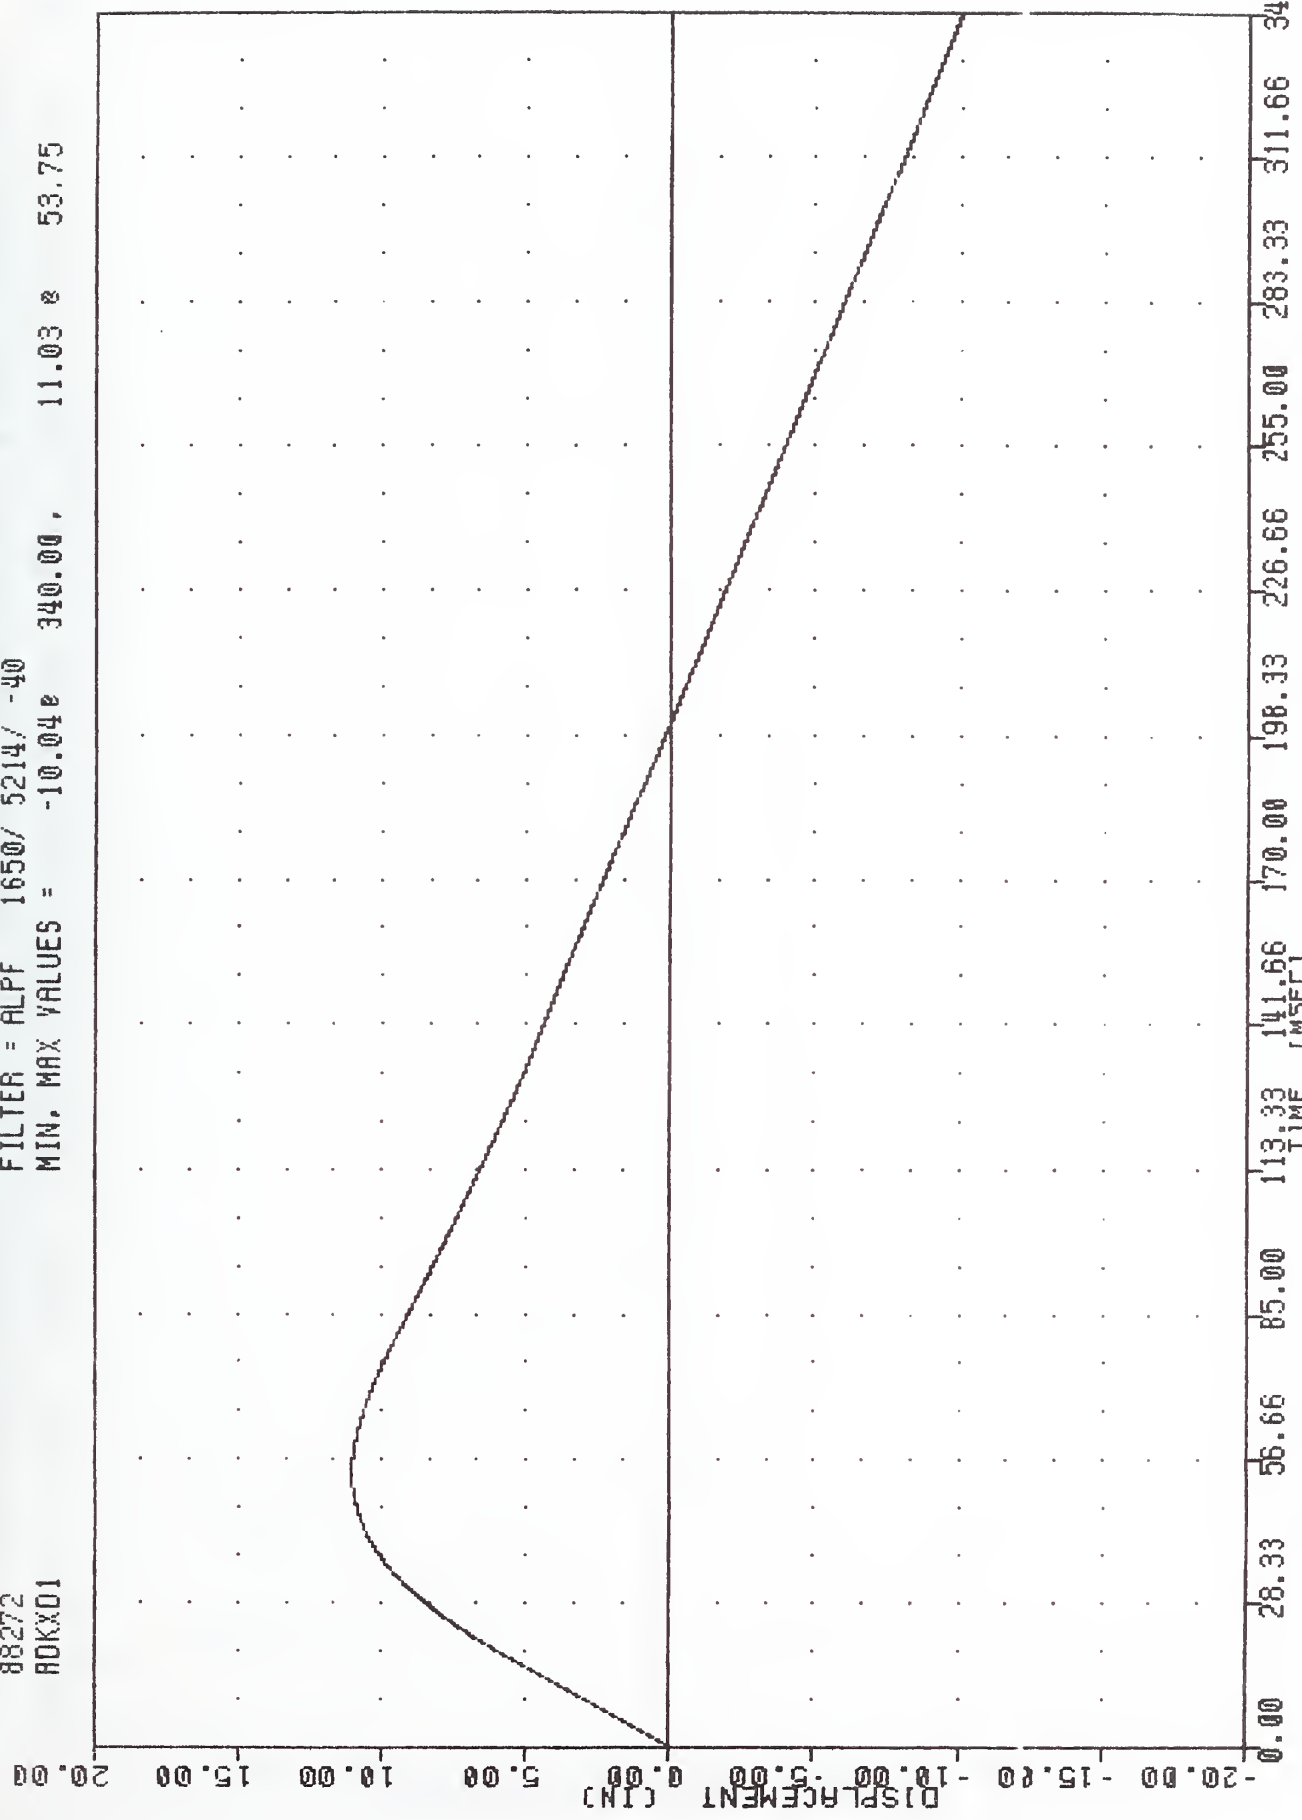
1985 FORD ESCORT INTO FLAT FRONTAL BARRIER AT 18 MPH FOURTH TEST
VEHICLE REAR DECK X AXIS DISPLACEMENT

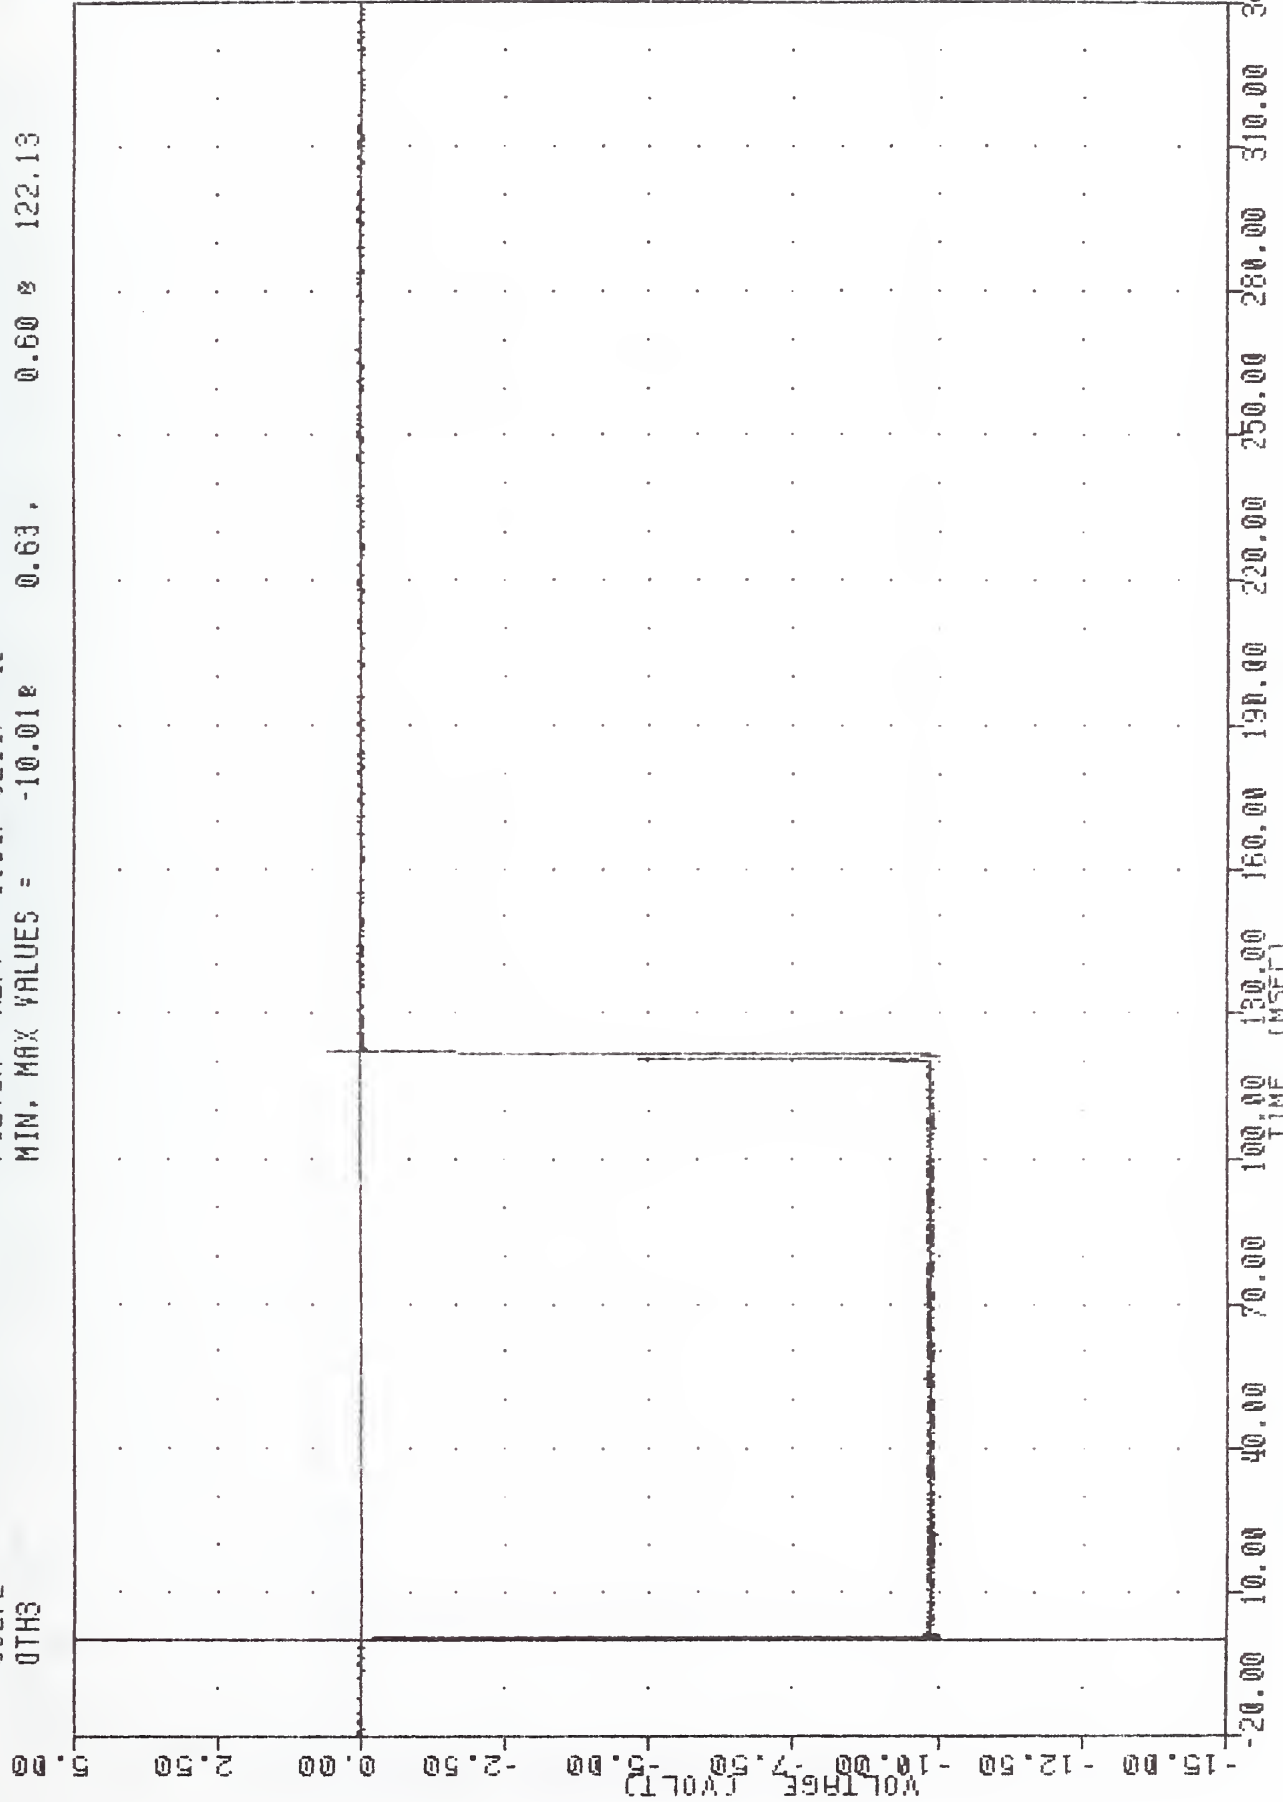
1985 FORD ESCORT INTO FLAT FRONTAL BARRIER AT 18 MPH FOURTH TEST
VEHICLE CONTACT SWITCH - RIGHT

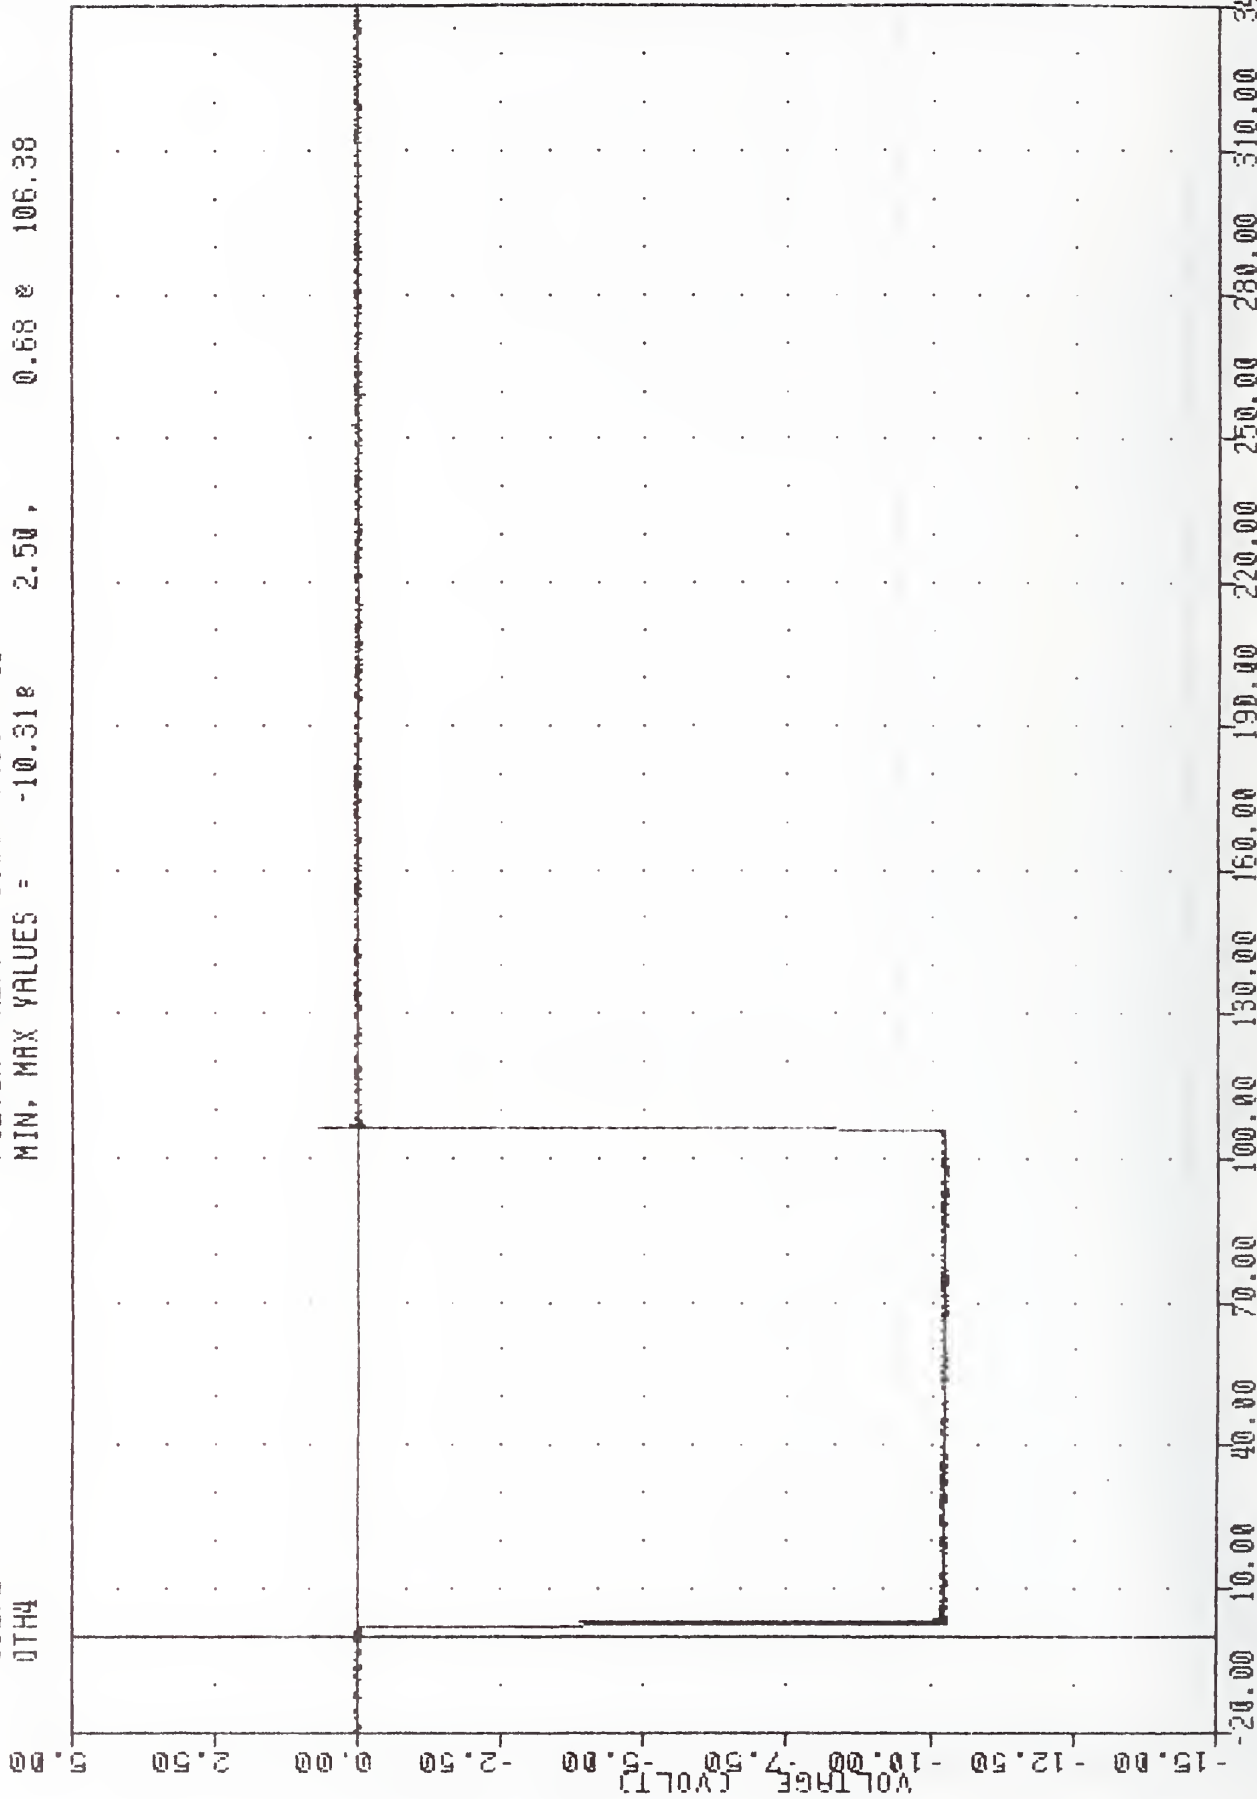
1985 FORD ESCORT INTO FLAT FRONTAL BARRIER AT 18 MPH FOURTH TEST
BARRIER CONTACT SWITCH - LEFT

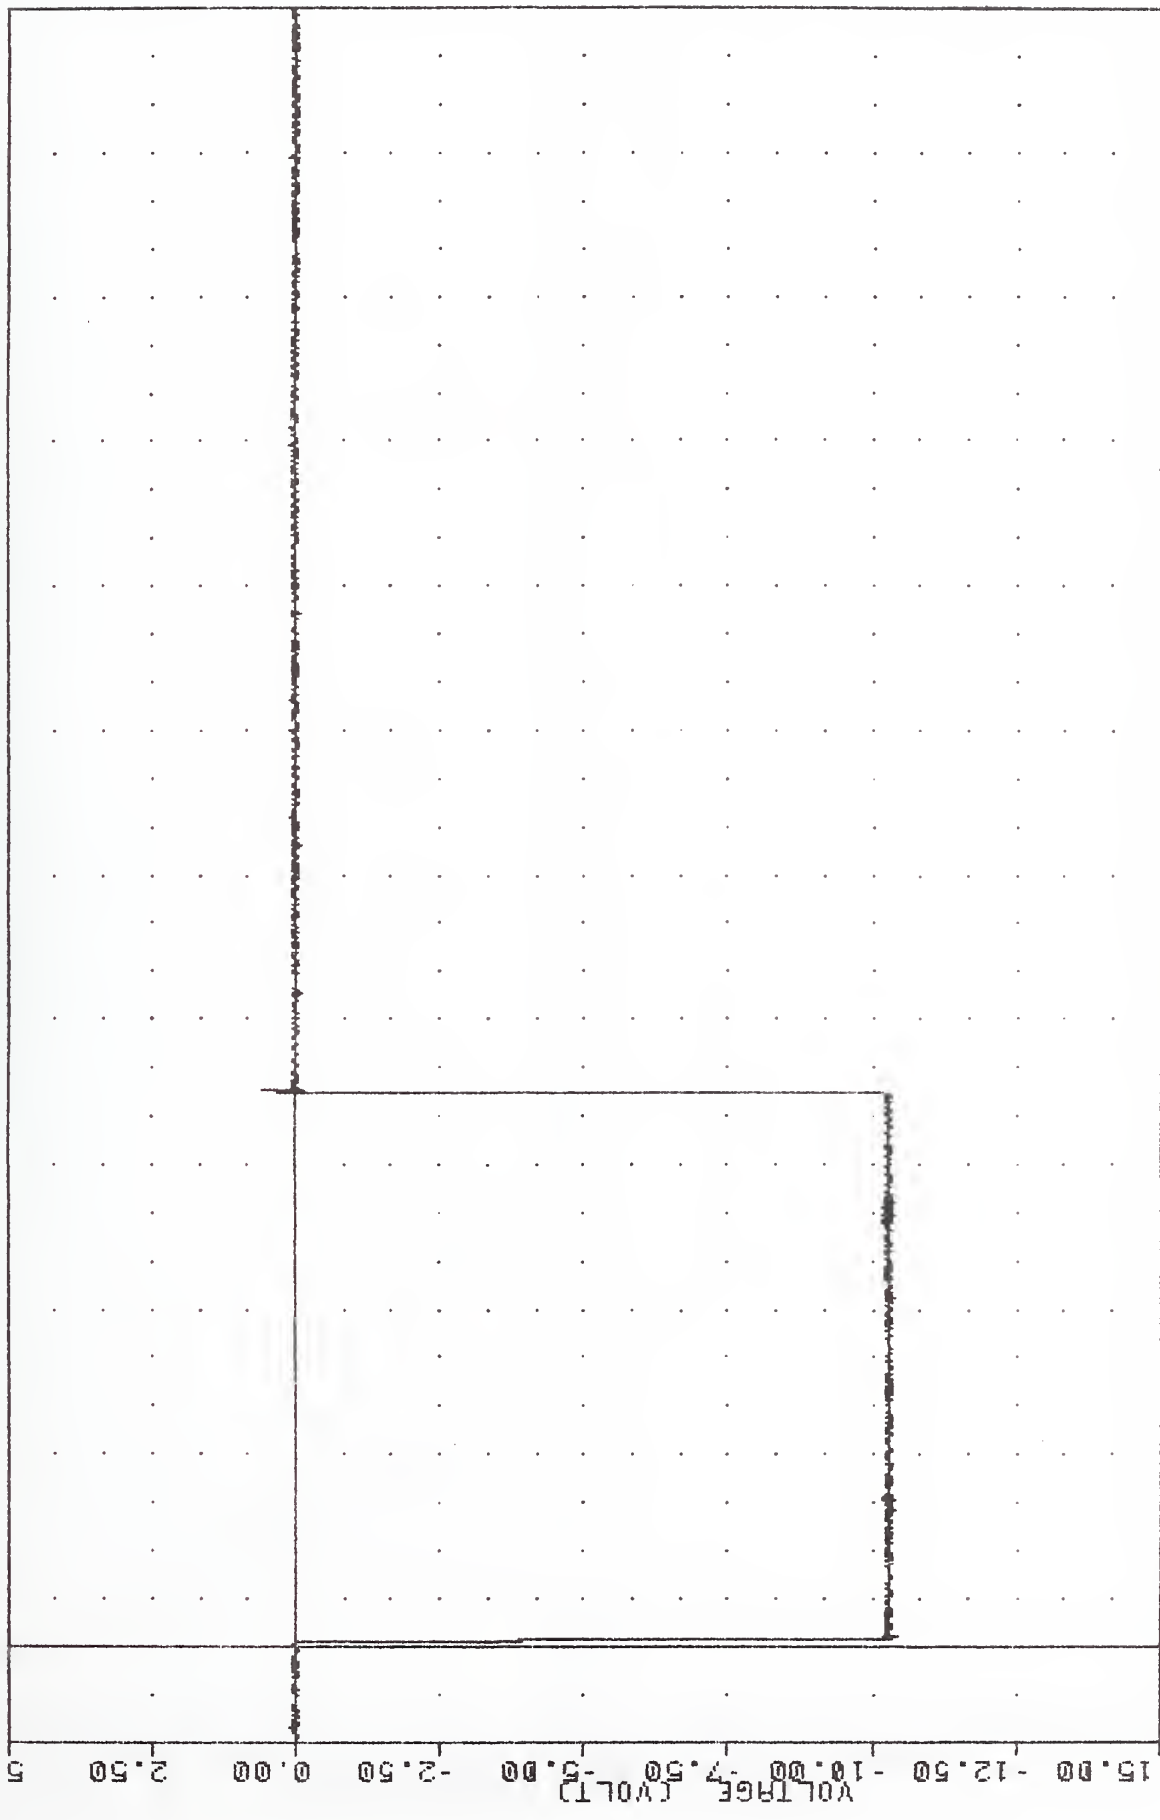
1985 FORD ESCORT INTO FLAT FRONTAL BARRIER AT 18 MPH FOURTH TEST
BARRIER CONTACT SWITCH - RIGHT
