U.S. Department
of Transportation
**National Highway
Traffic Safety
Administration**

DOT HS 807 352

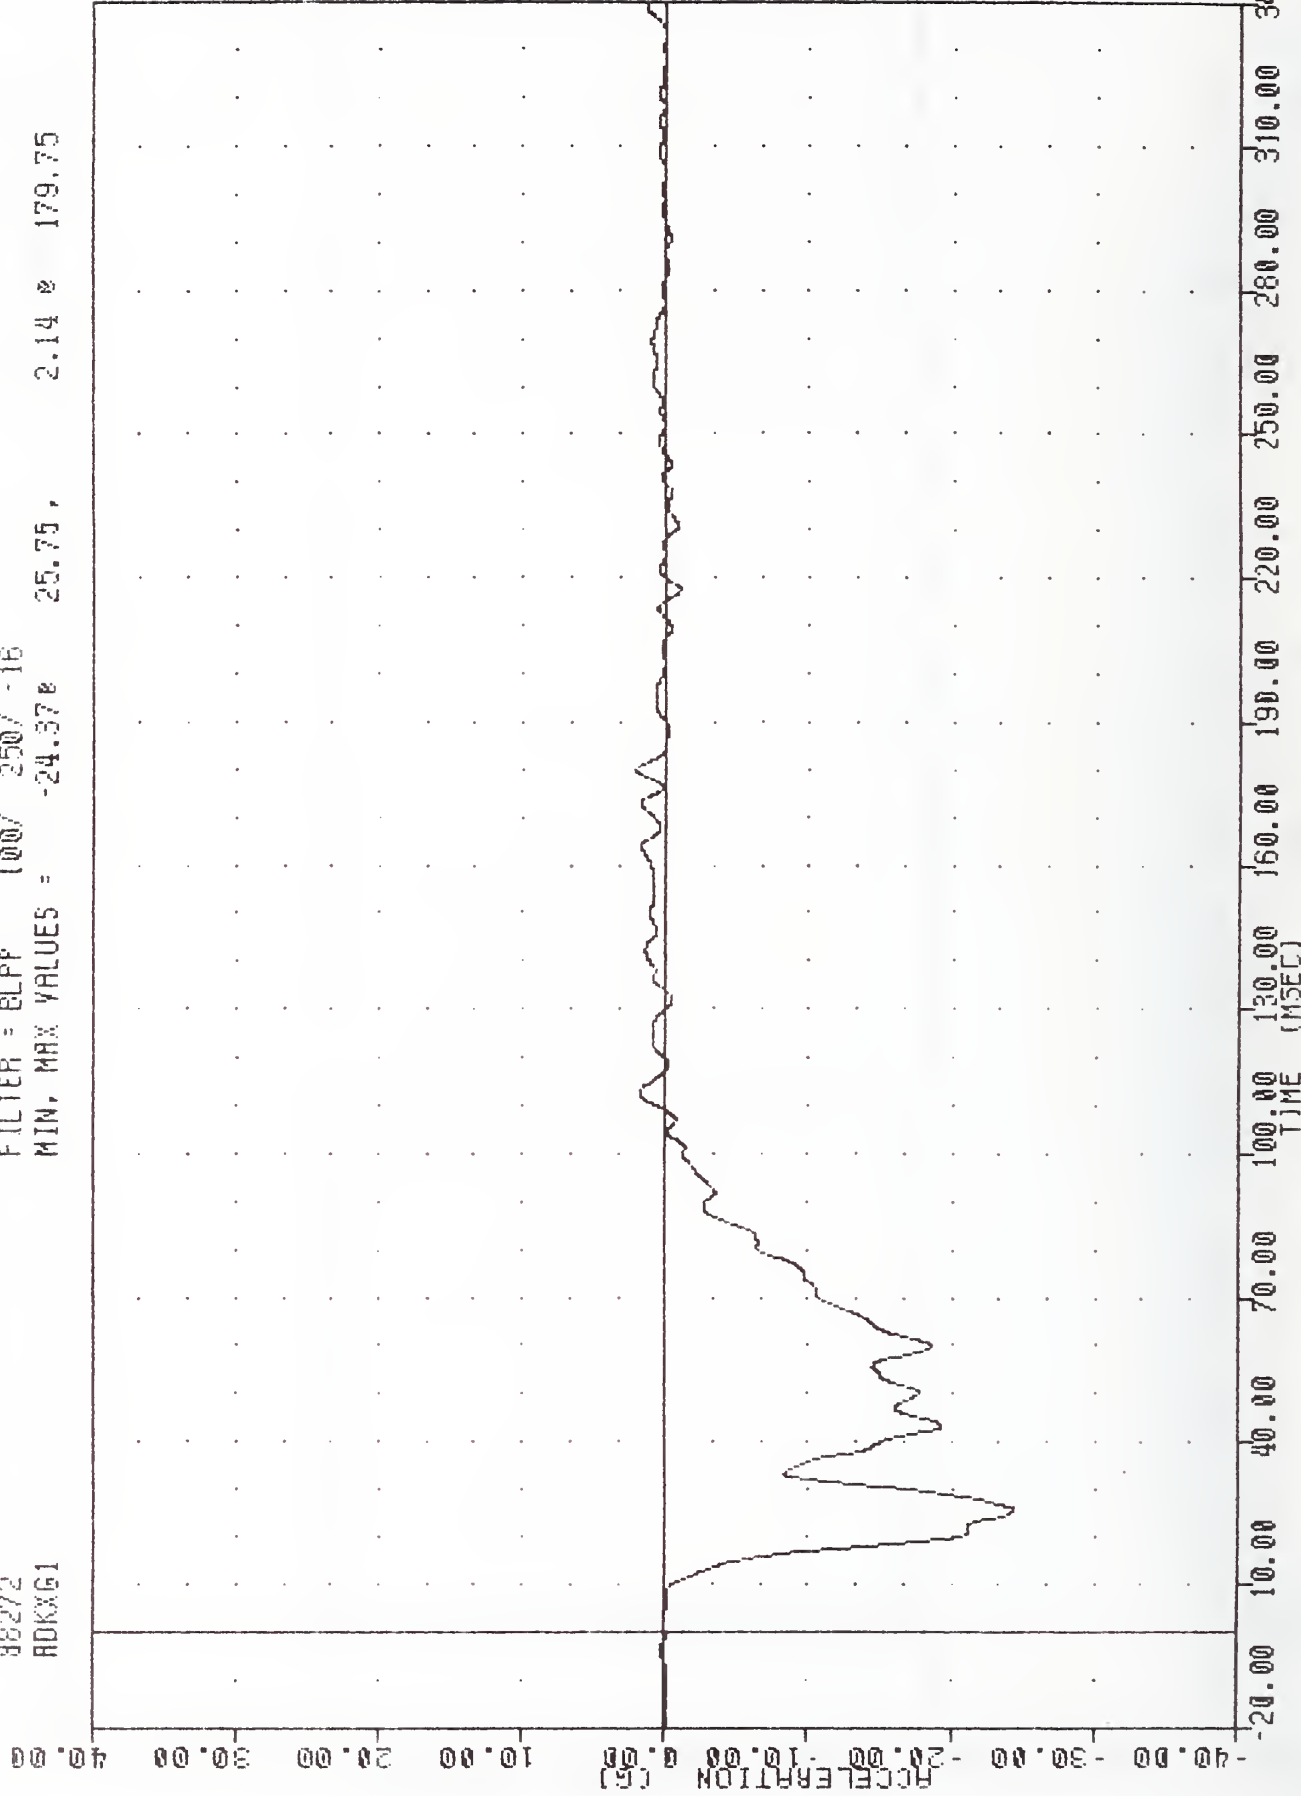
1985 FORD ESCORT INTO FLAT FRONTAL BARRIER AT 20 MPH FIFTH TEST
VEHICLE REAR DECK X AXIS ACCELERATION

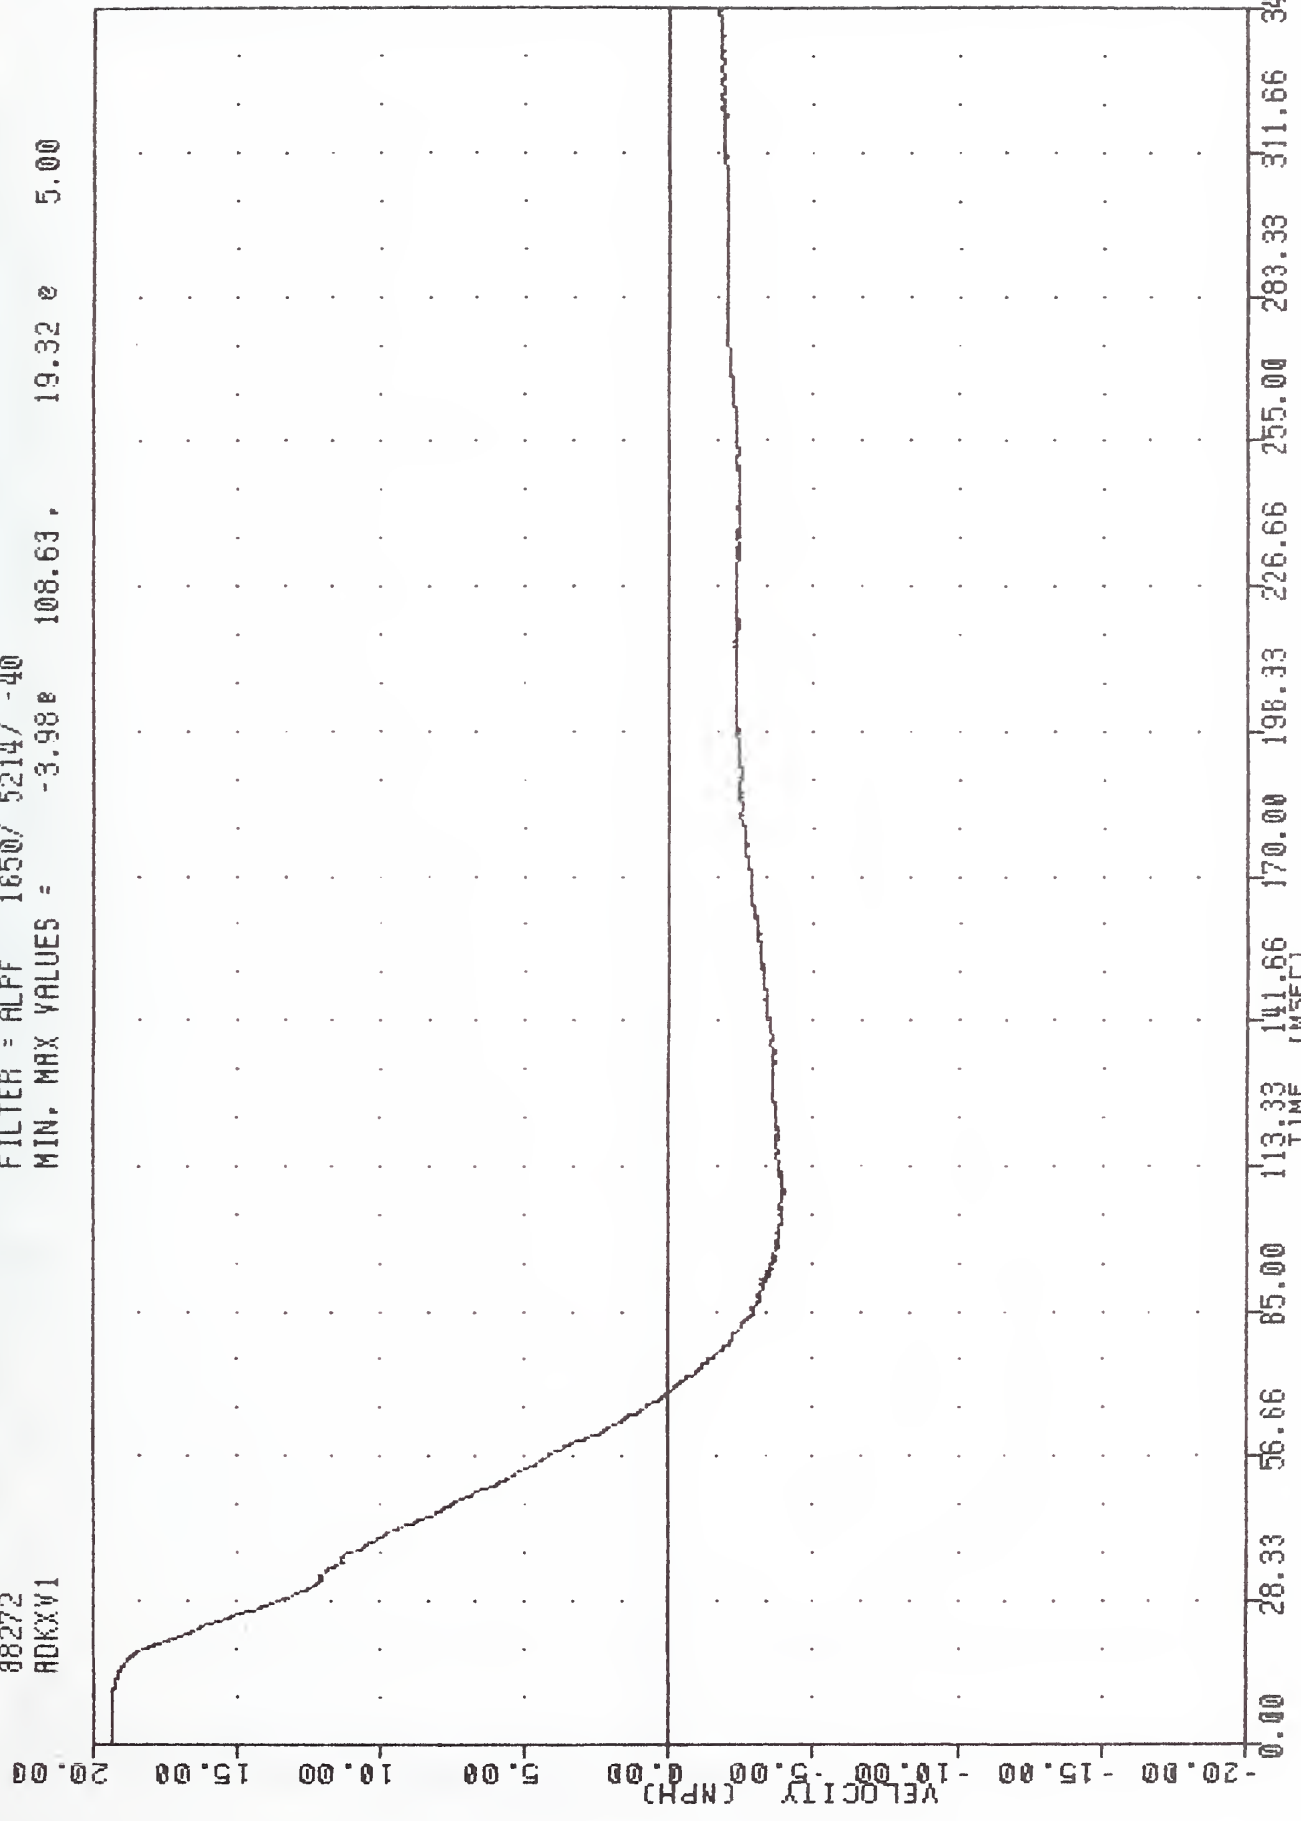
1985 FORD ESCORT INTO FLAT FRONTAL BARRIER AT 20 MPH FIFTH TEST
 VEHICLE REAR DECK X AXIS VELOCITY

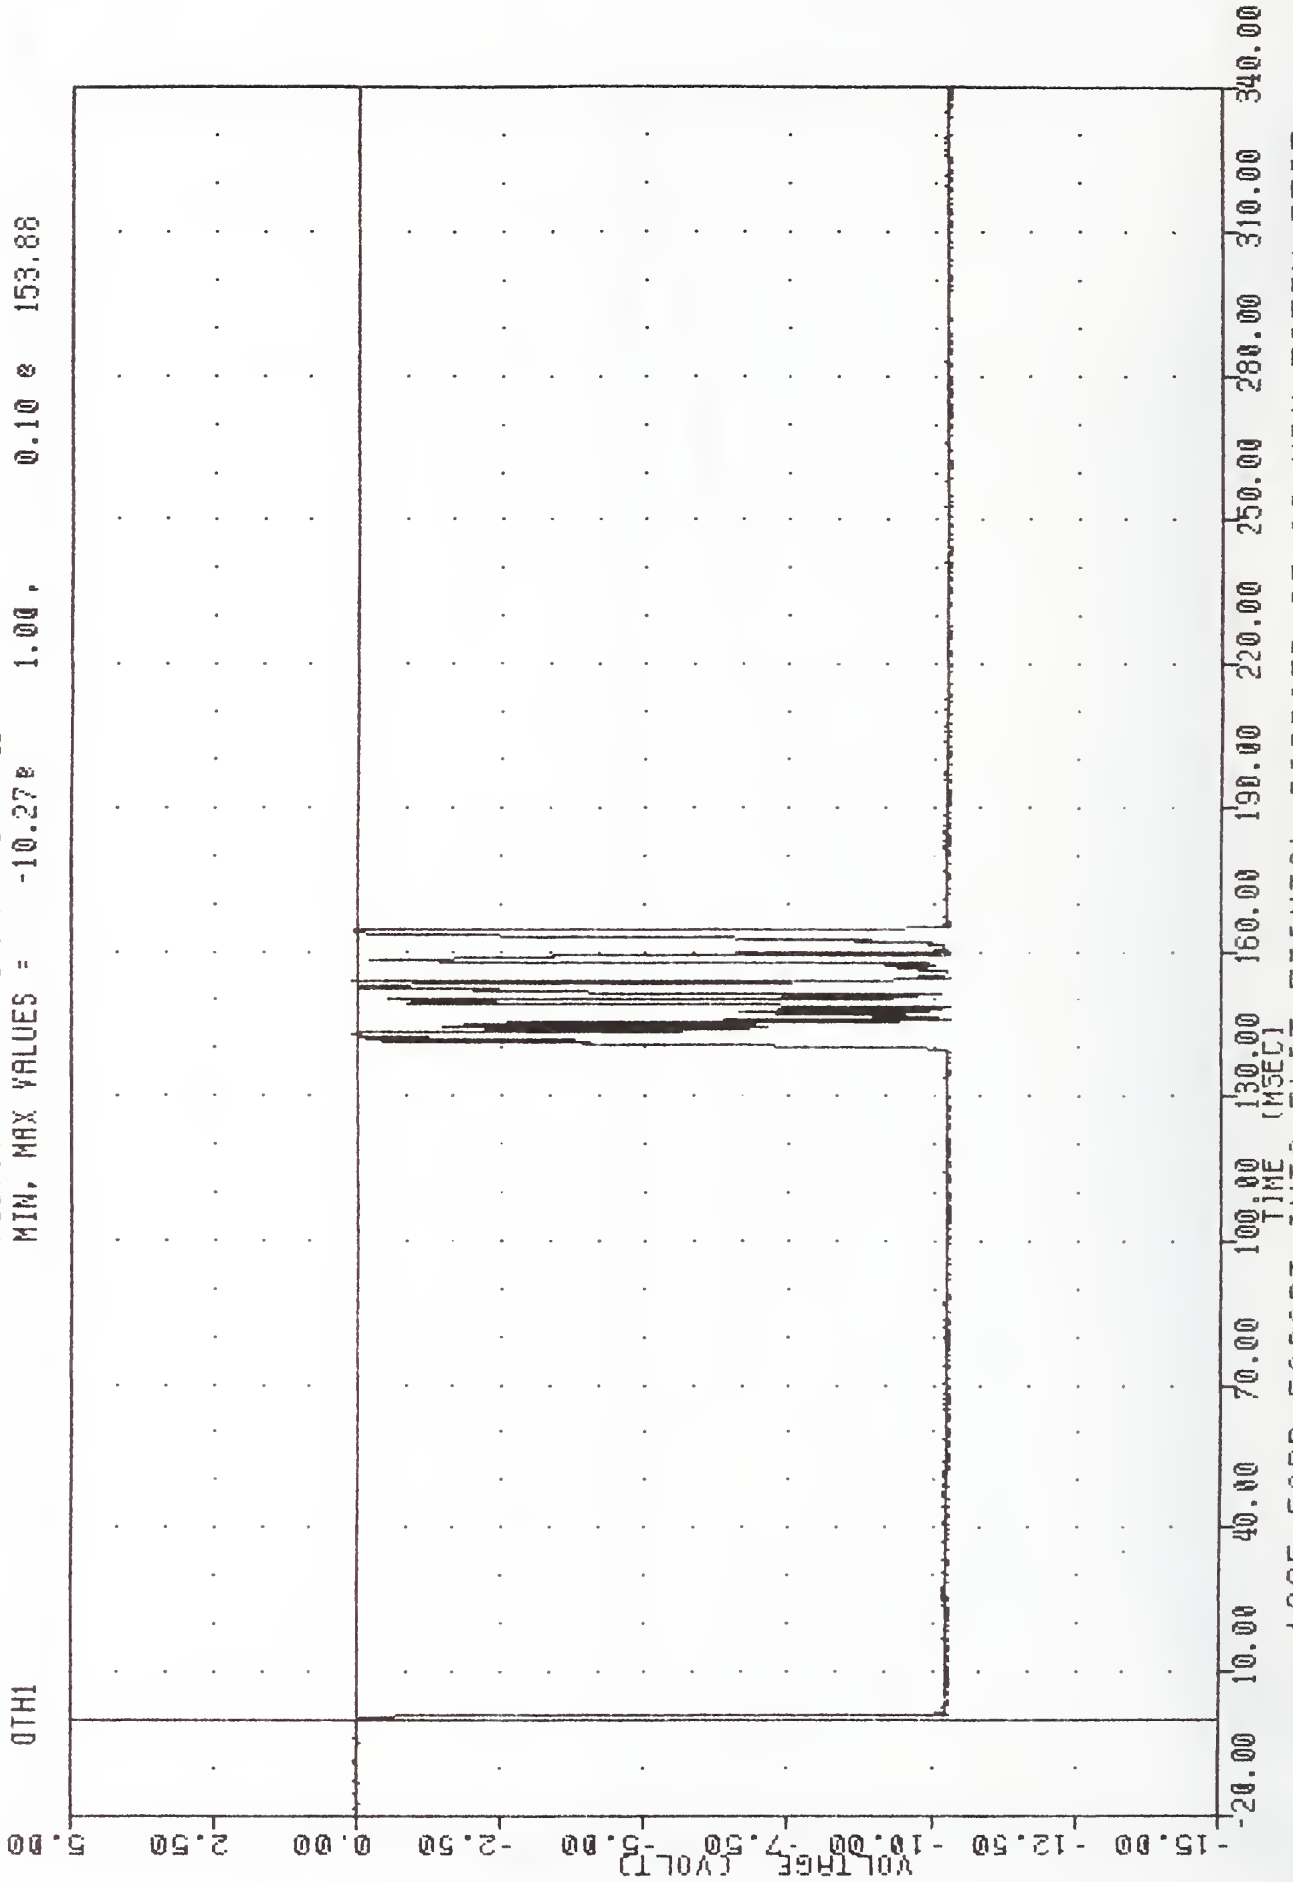
1985 FORD ESCORT INTO FLAT FRONTAL BARRIER AT 20 MPH FIFTH TEST
VEHICLE CONTACT SWITCH - LEFT

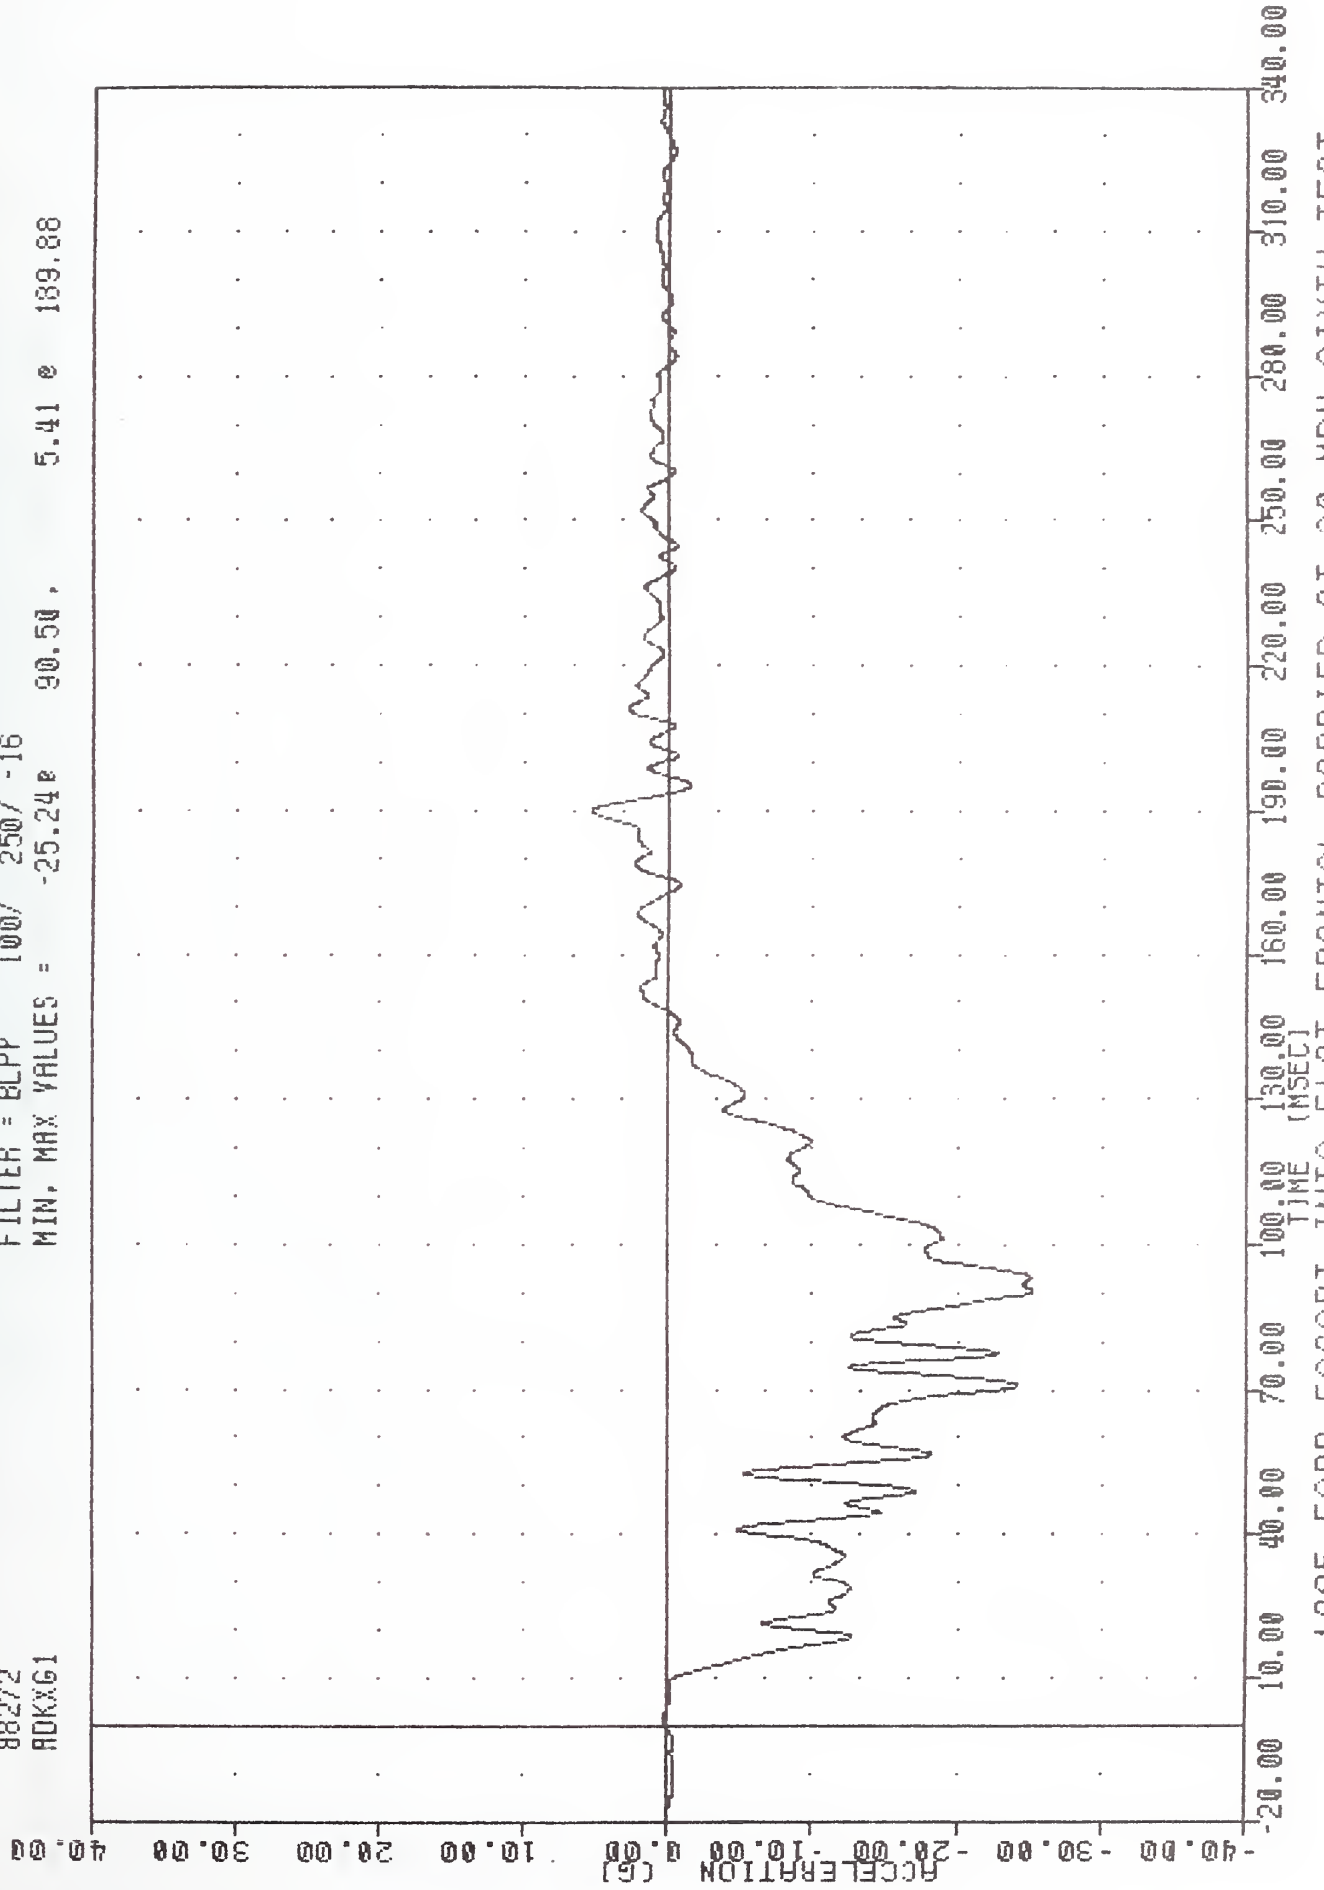
1985 FORD ESCORT INTO FLAT FRONTAL BARRIER AT 30 MPH SIXTH TEST
VEHICLE REAR DECK X AXIS ACCELERATION

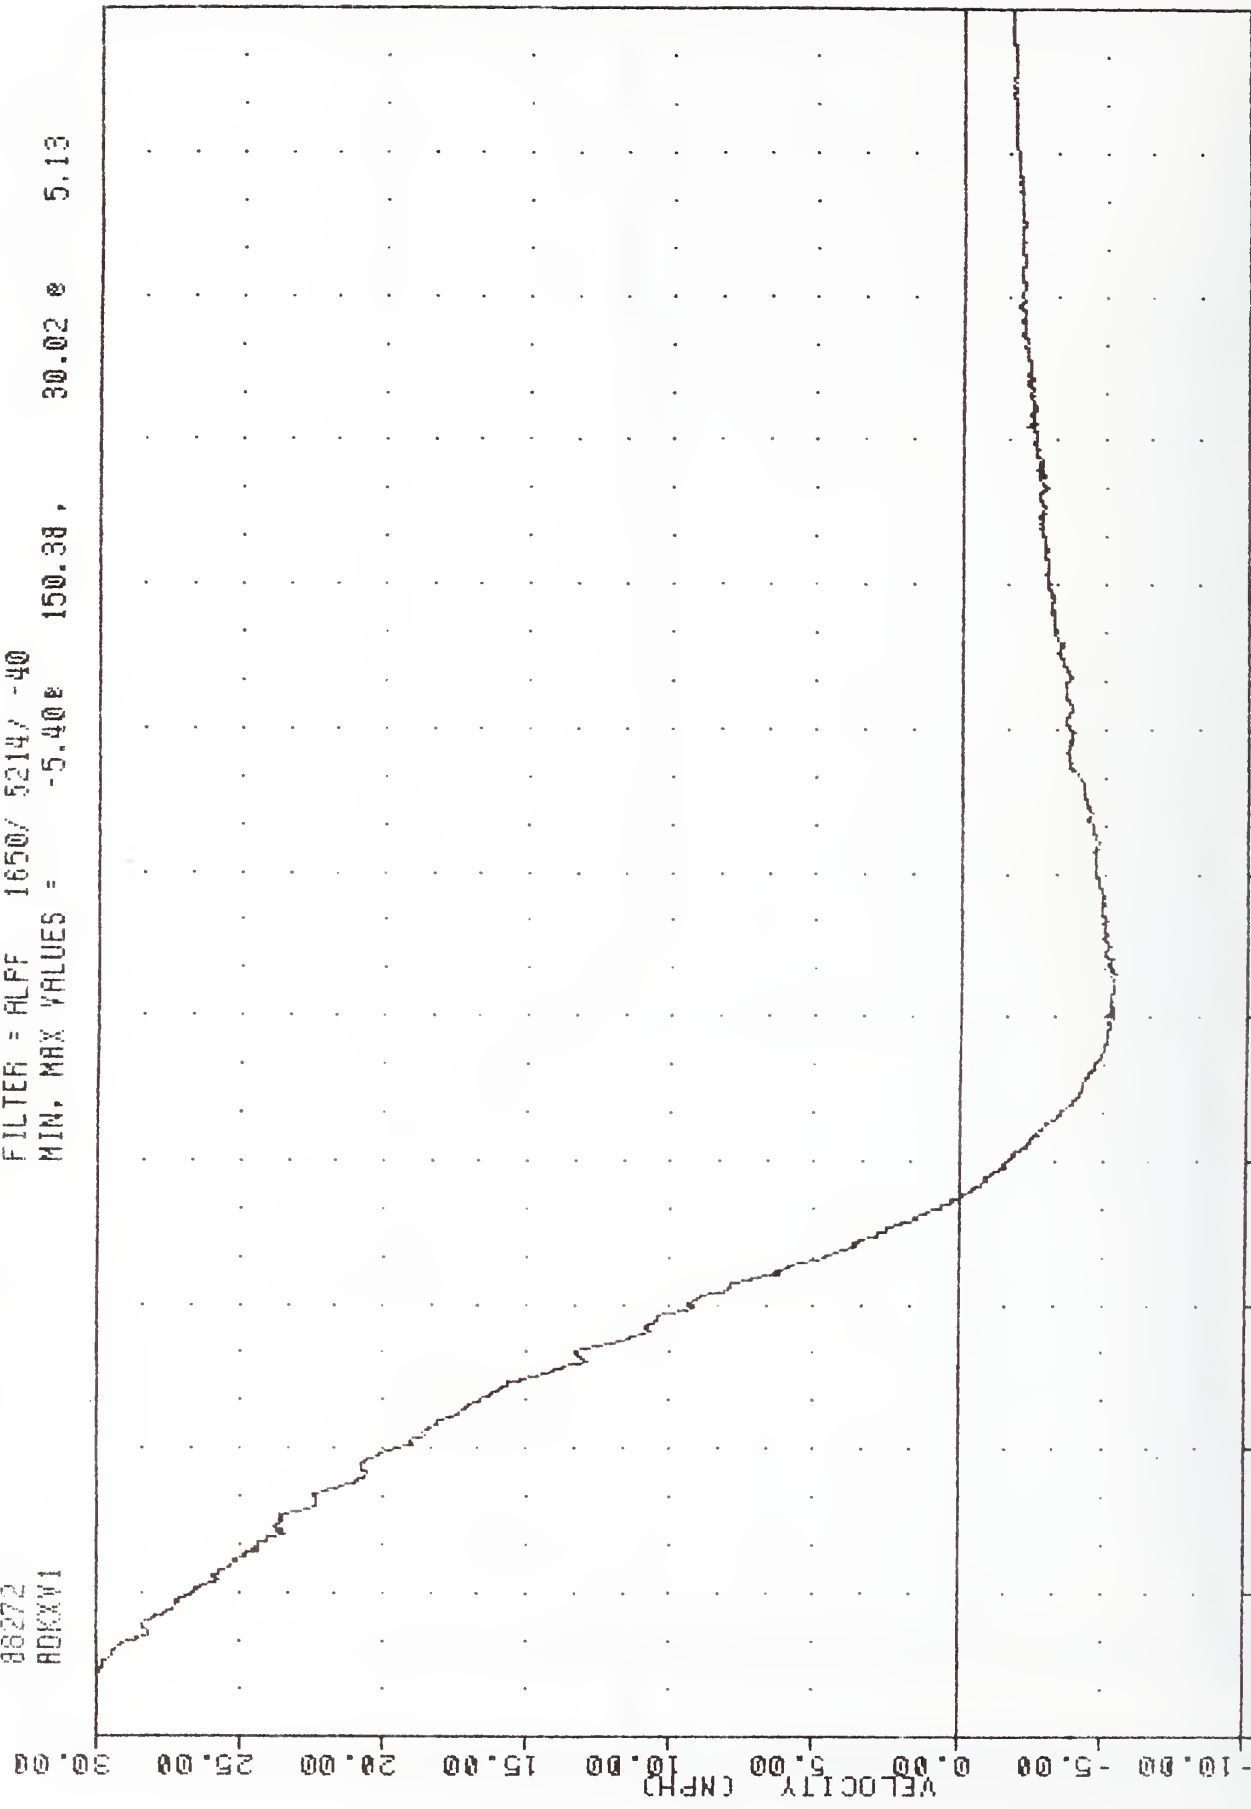
1985 FORD ESCORT INTO FLAT FRONTAL BARRIER AT 30 MPH SIXTH TEST
VEHICLE REAR DECK X AXIS VELOCITY
