DOT HS 808 229

July 1994

Final Report

Final Report of a Non-Deformable Crabbed Impactor into a 1990 Honda Civic SI in Support of Crash3 Damage Algorithm Reformulation

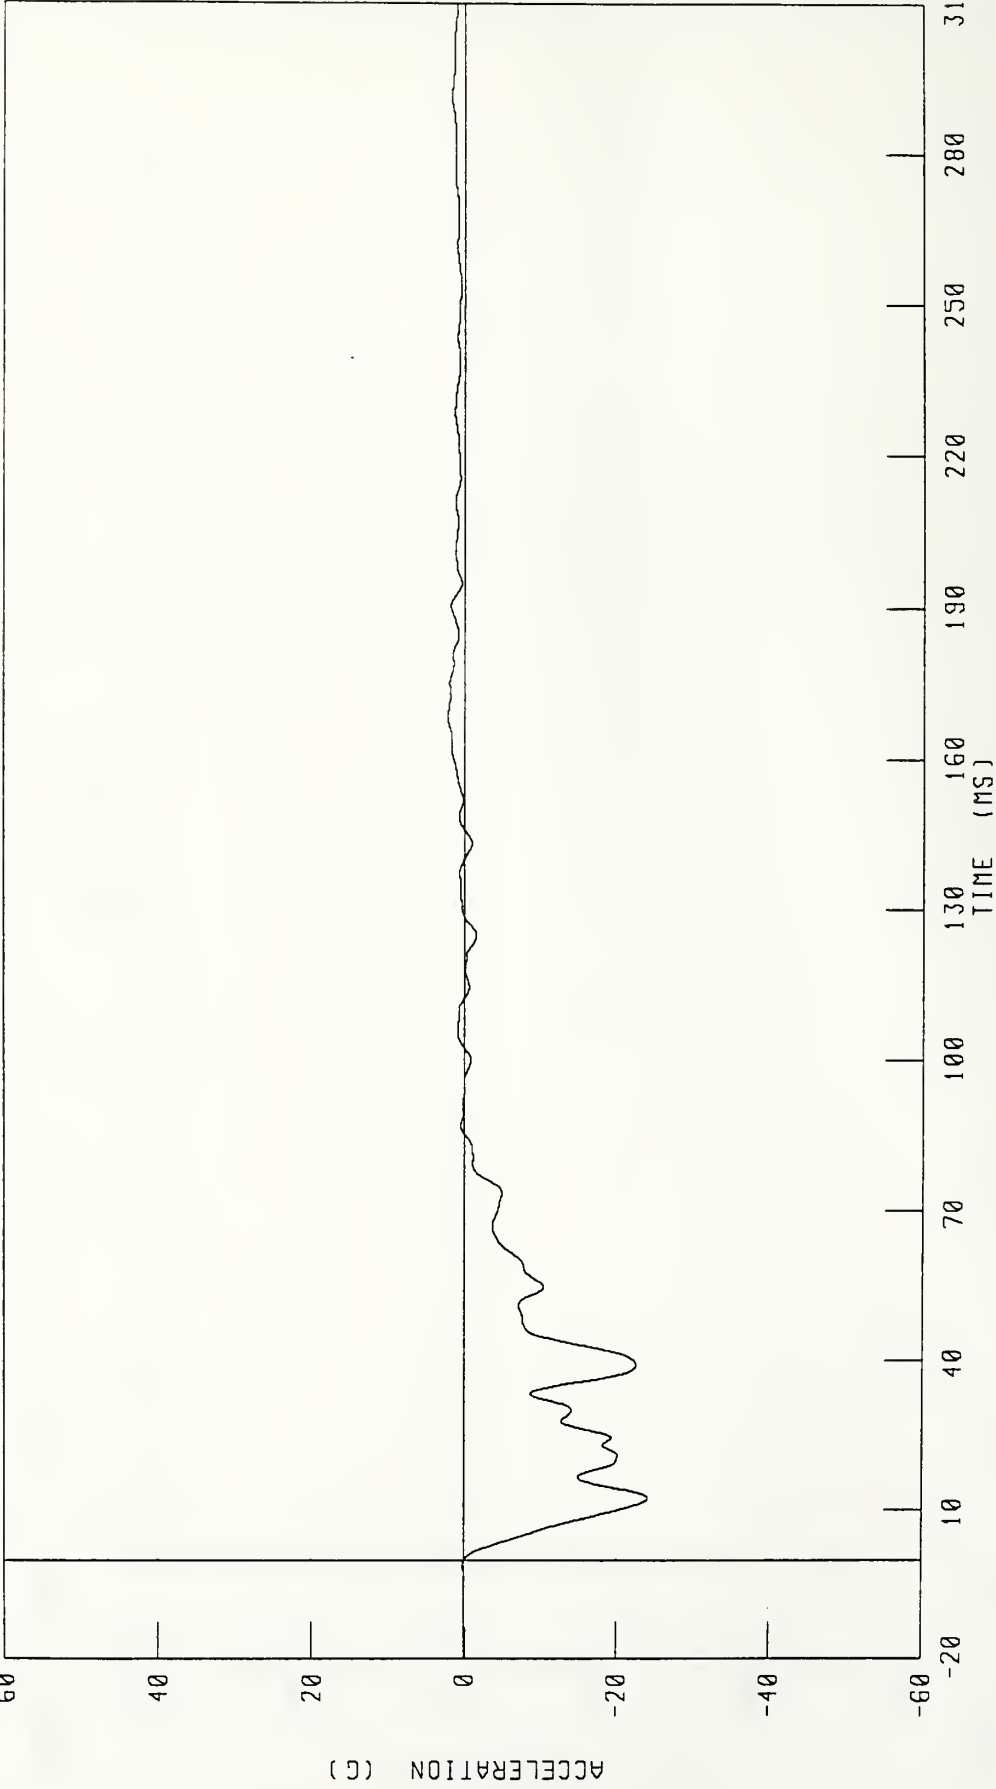
NON-DEFORMABLE CRABBED IMPACTOR INTO 1990 HONDA CIVIC 3-DOOR HATCHBACK
VEHICLE CC Y-AXIS ACCELERATION
48/24 KPH SIDE IMPACT

CHANNEL VCCYG1 FILTER CH CLASS 60

PEAK DATA 2 19 G @ 168 16 MS, -24 11 G @ 12 40 MS

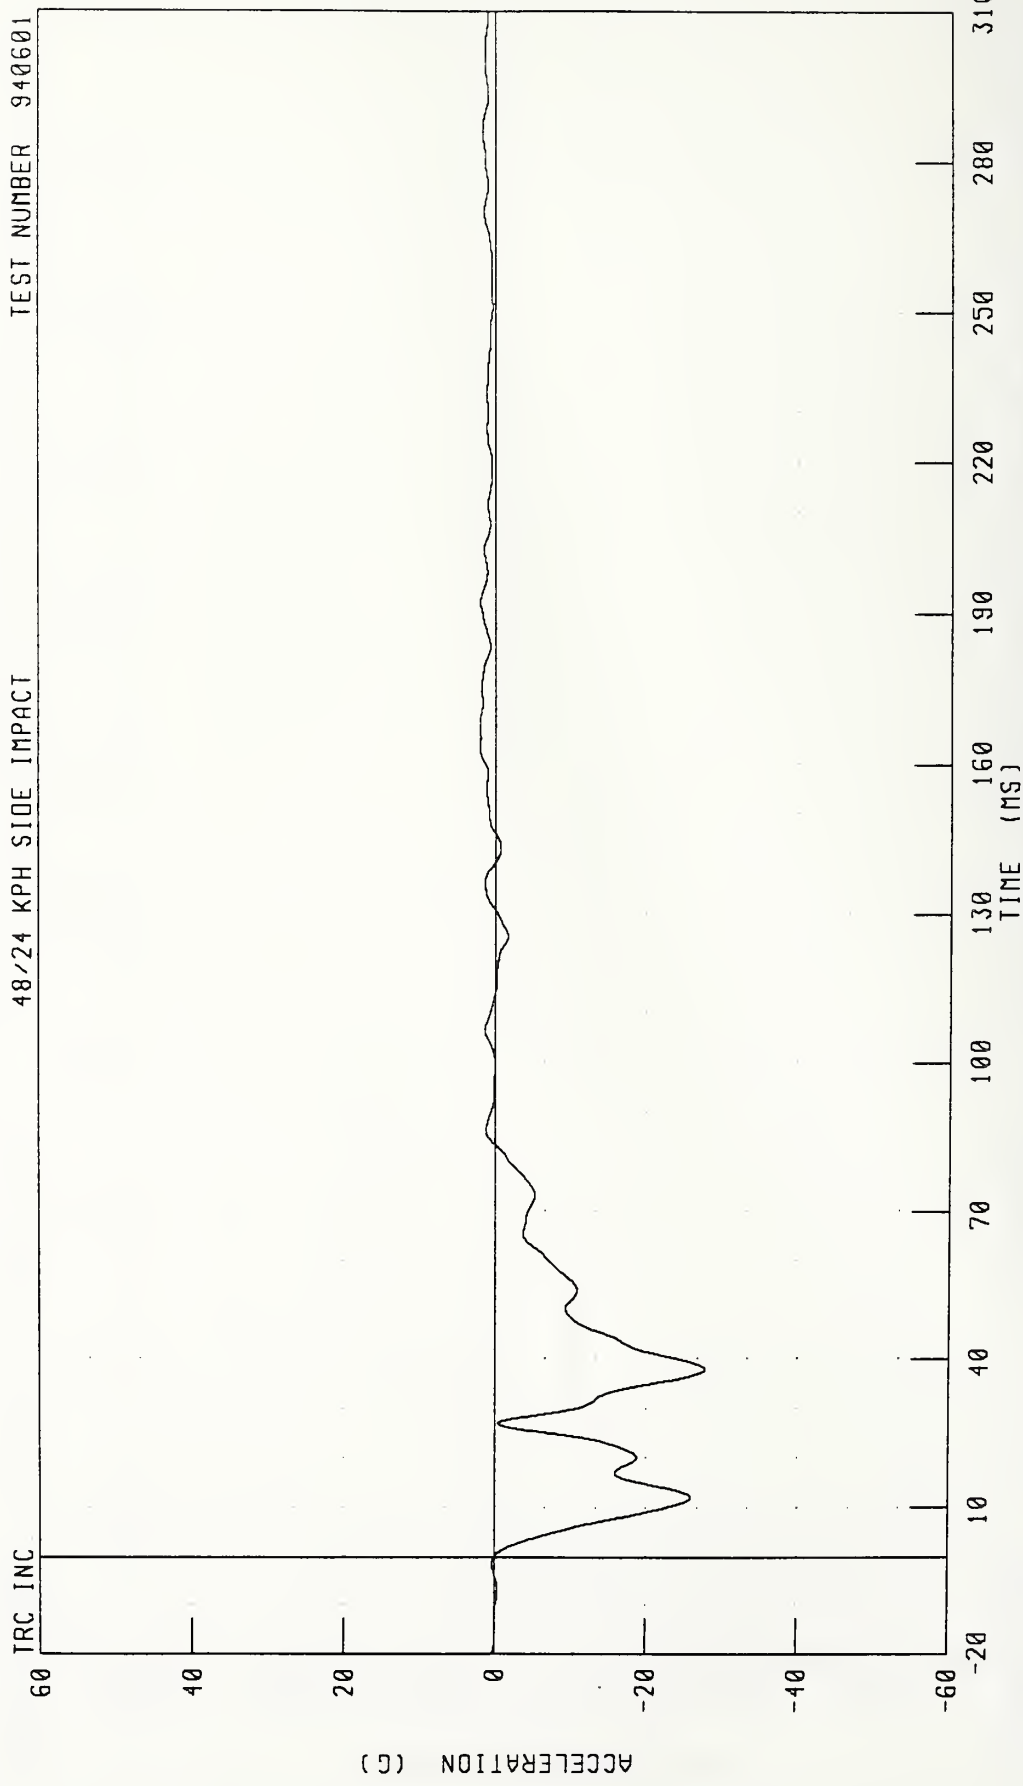
NON-DEFORMABLE CRABBED IMPACTOR INTO 1990 HONDA CIVIC 3-DOOR HATCHBACK
RIGHT REAR SILL Y-AXIS ACCELERATION
48/24 KPH SIDE IMPACT

CHANNEL: RRSYG1 FILTER: CH CLASS 60

PEAK DATA: 2 07 G @ 163 04 MS, -27 70 G @ 37 92 MS
