DOT HS 808 398

June 1995

Final Report

Final Report of a Non-Deformable Impactor into a 1990 Honda Civic 3-Door Hatchback in Support of CRASH3 Damage Algorithm Reformulation

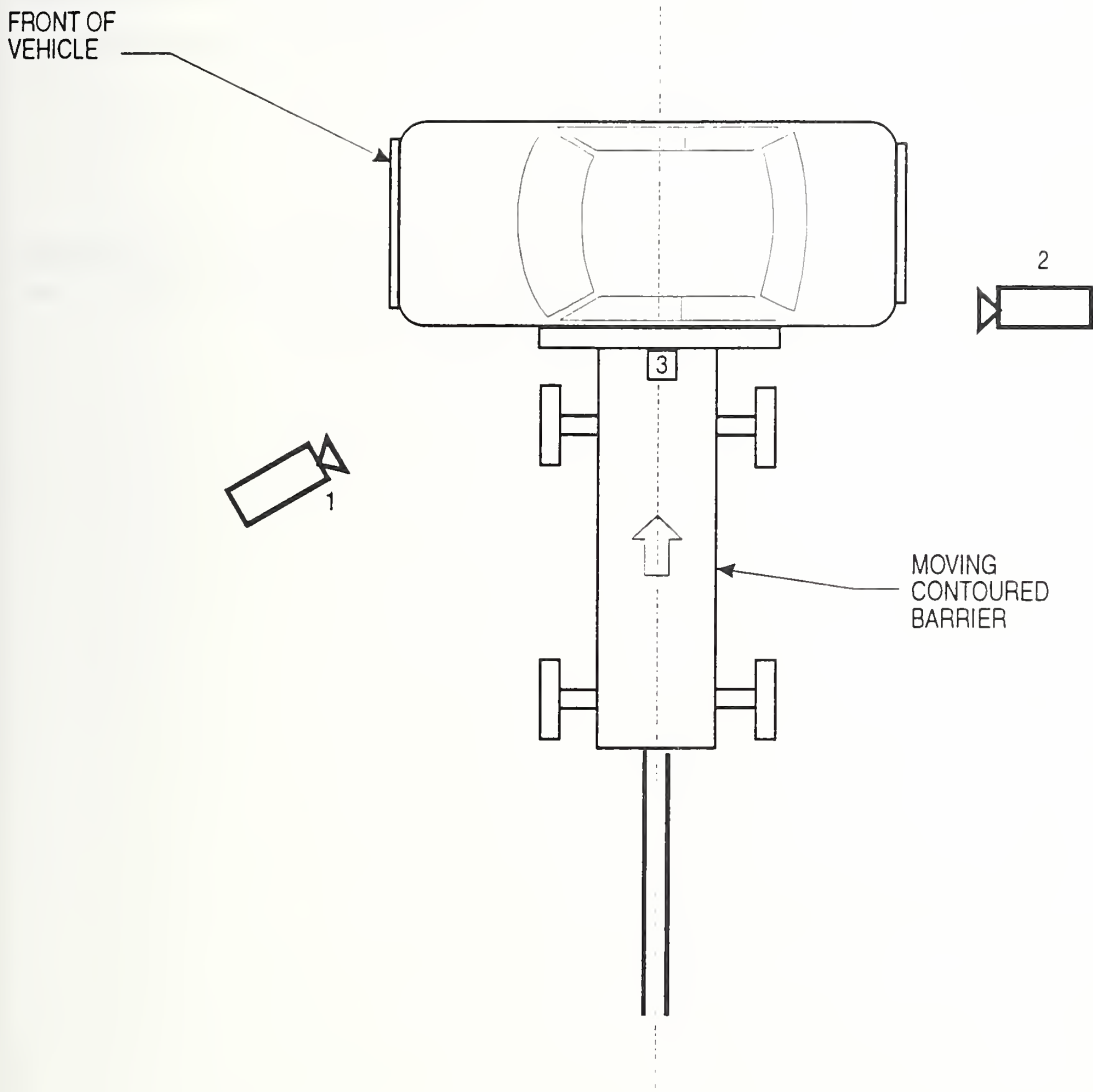
Figure 3 Camera Positions

Each crash test event was recorded by three (3) high-speed motion picture cameras operating at approximately 500 frames per second.

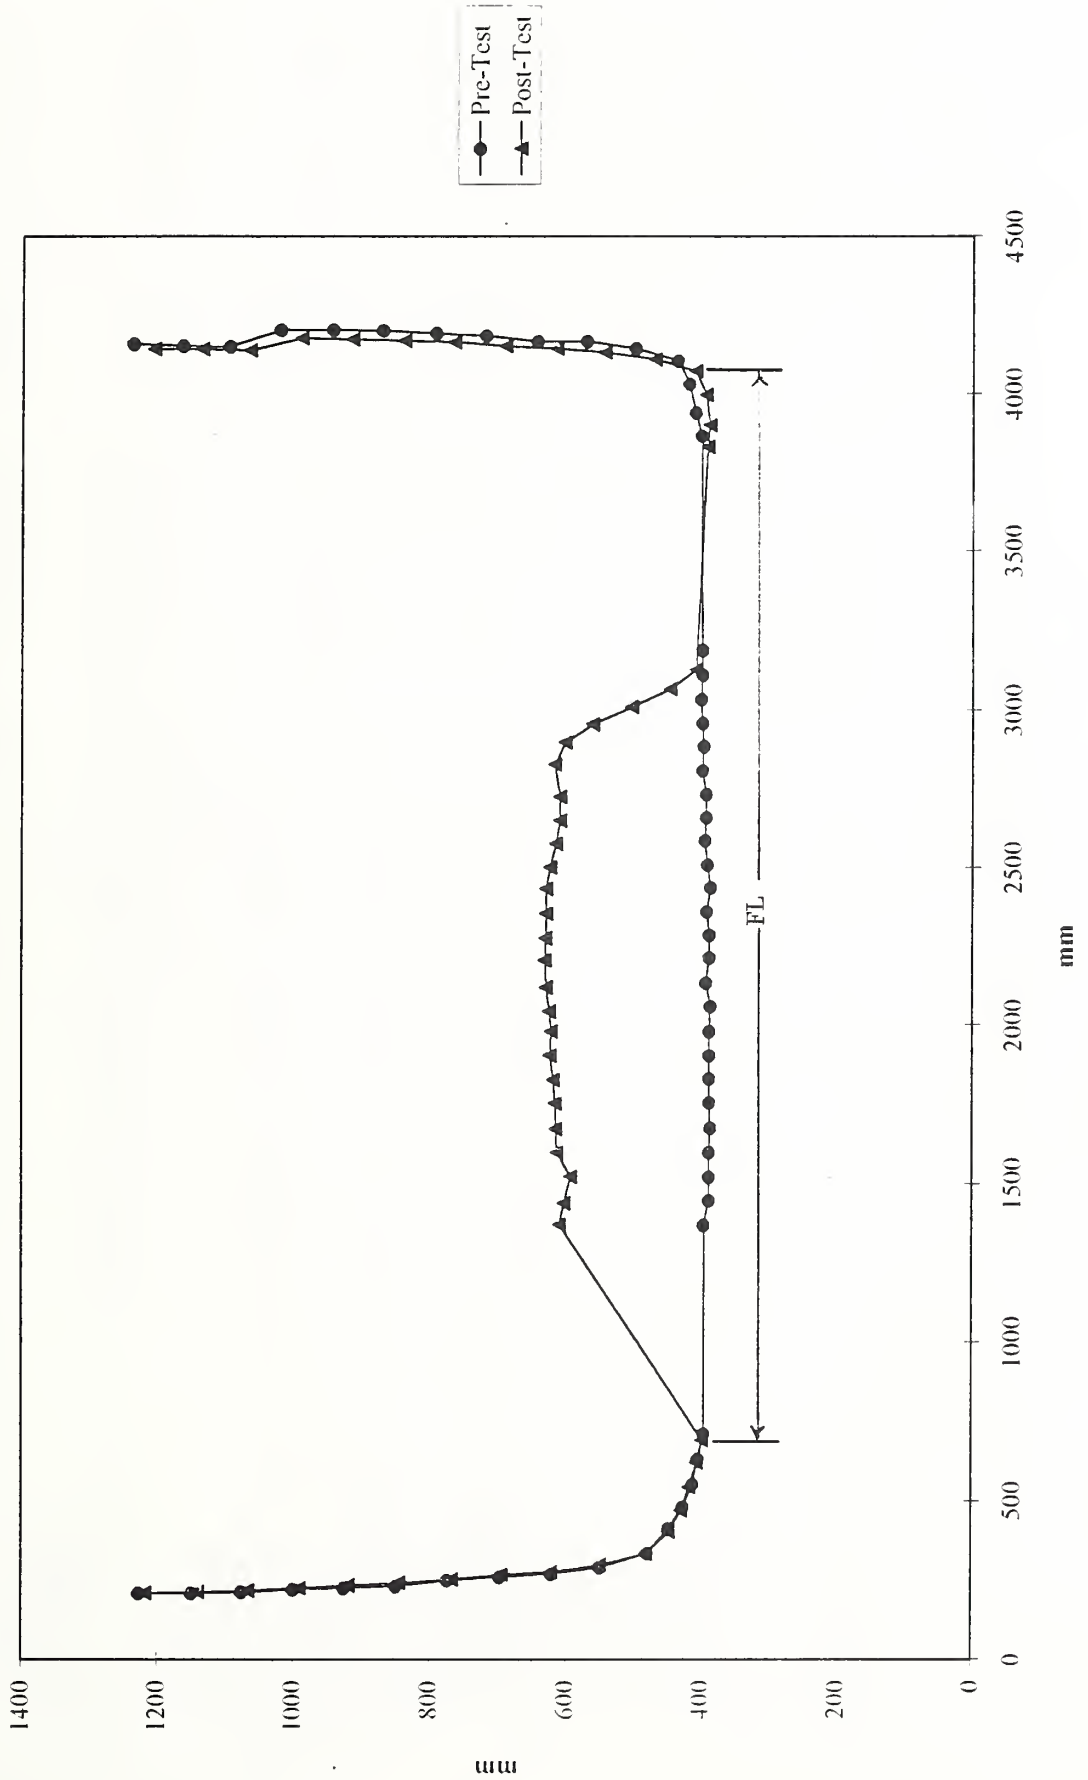
Vehicle Profile At Maximum Crush Height
Test No.950518-1

Measurements C1 - C6 were spaced equally apart over the post-impact length of the damaged surface. This distance is defined as length "FL" on the vehicle crush profile plot.

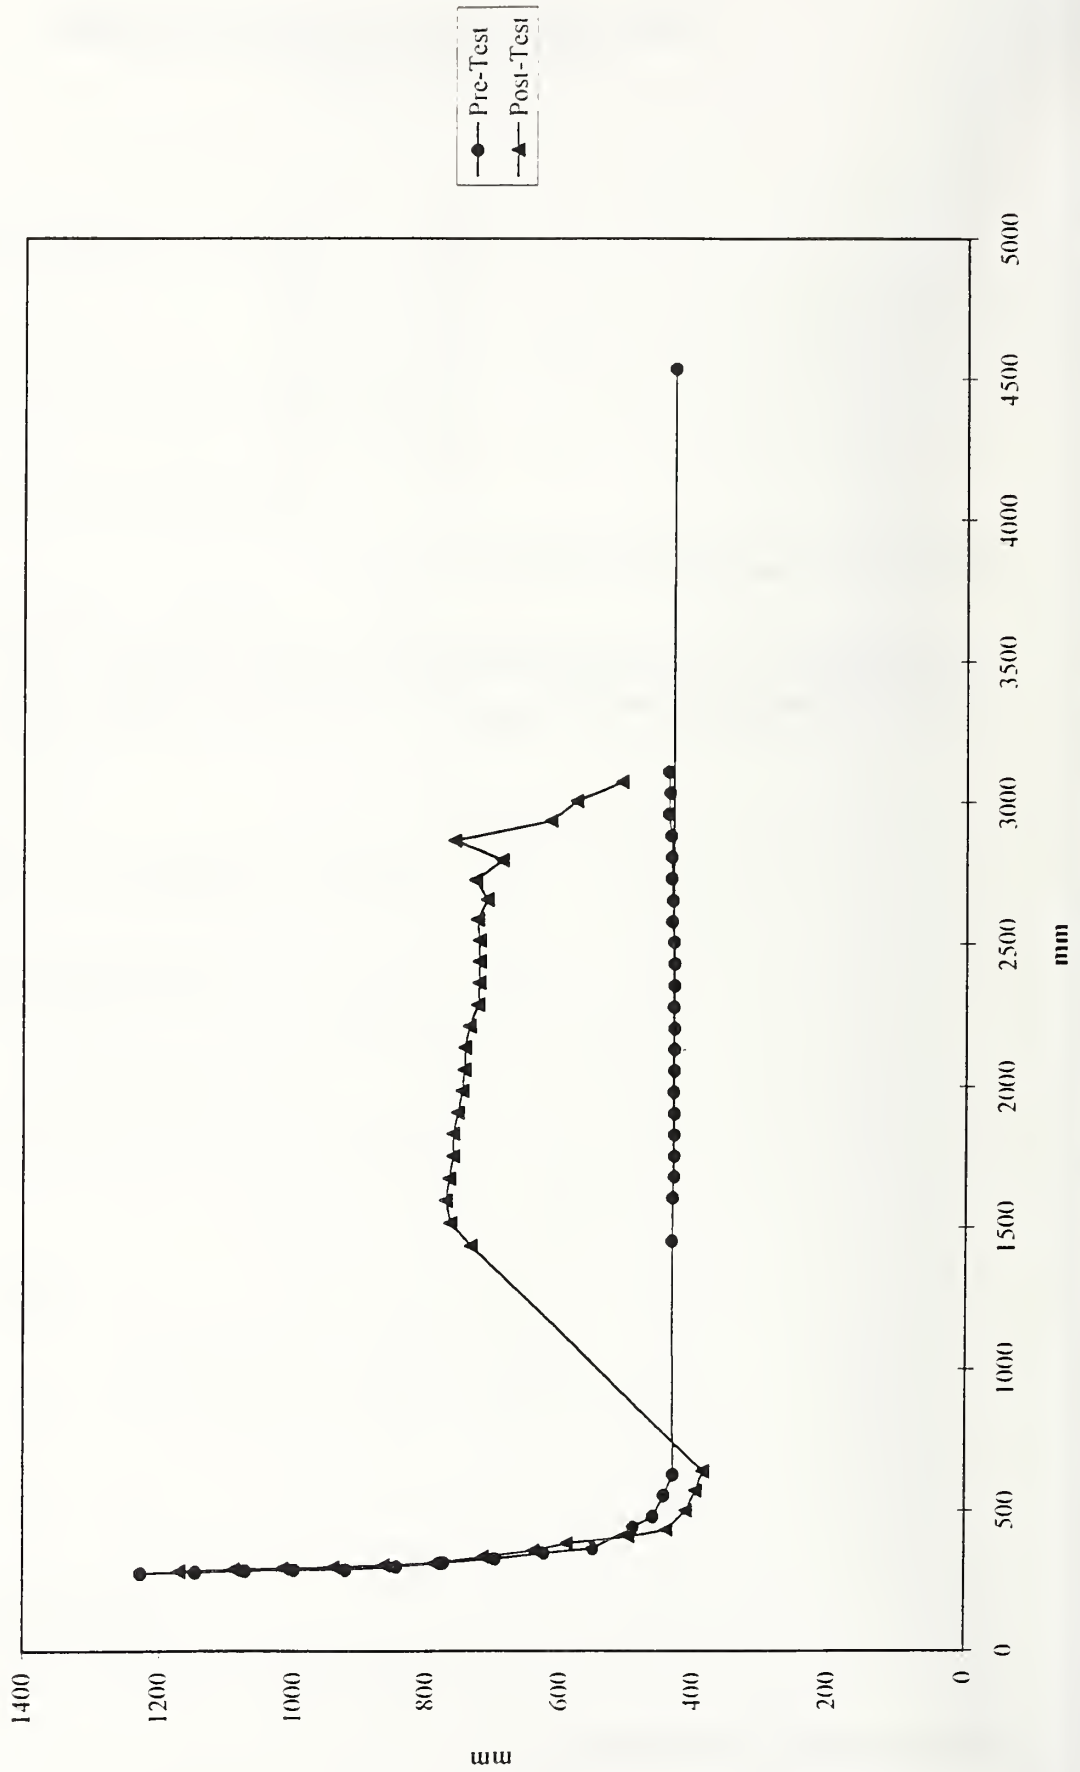
Vehicle Profile At Side Sill Height
Test No. 950518-3

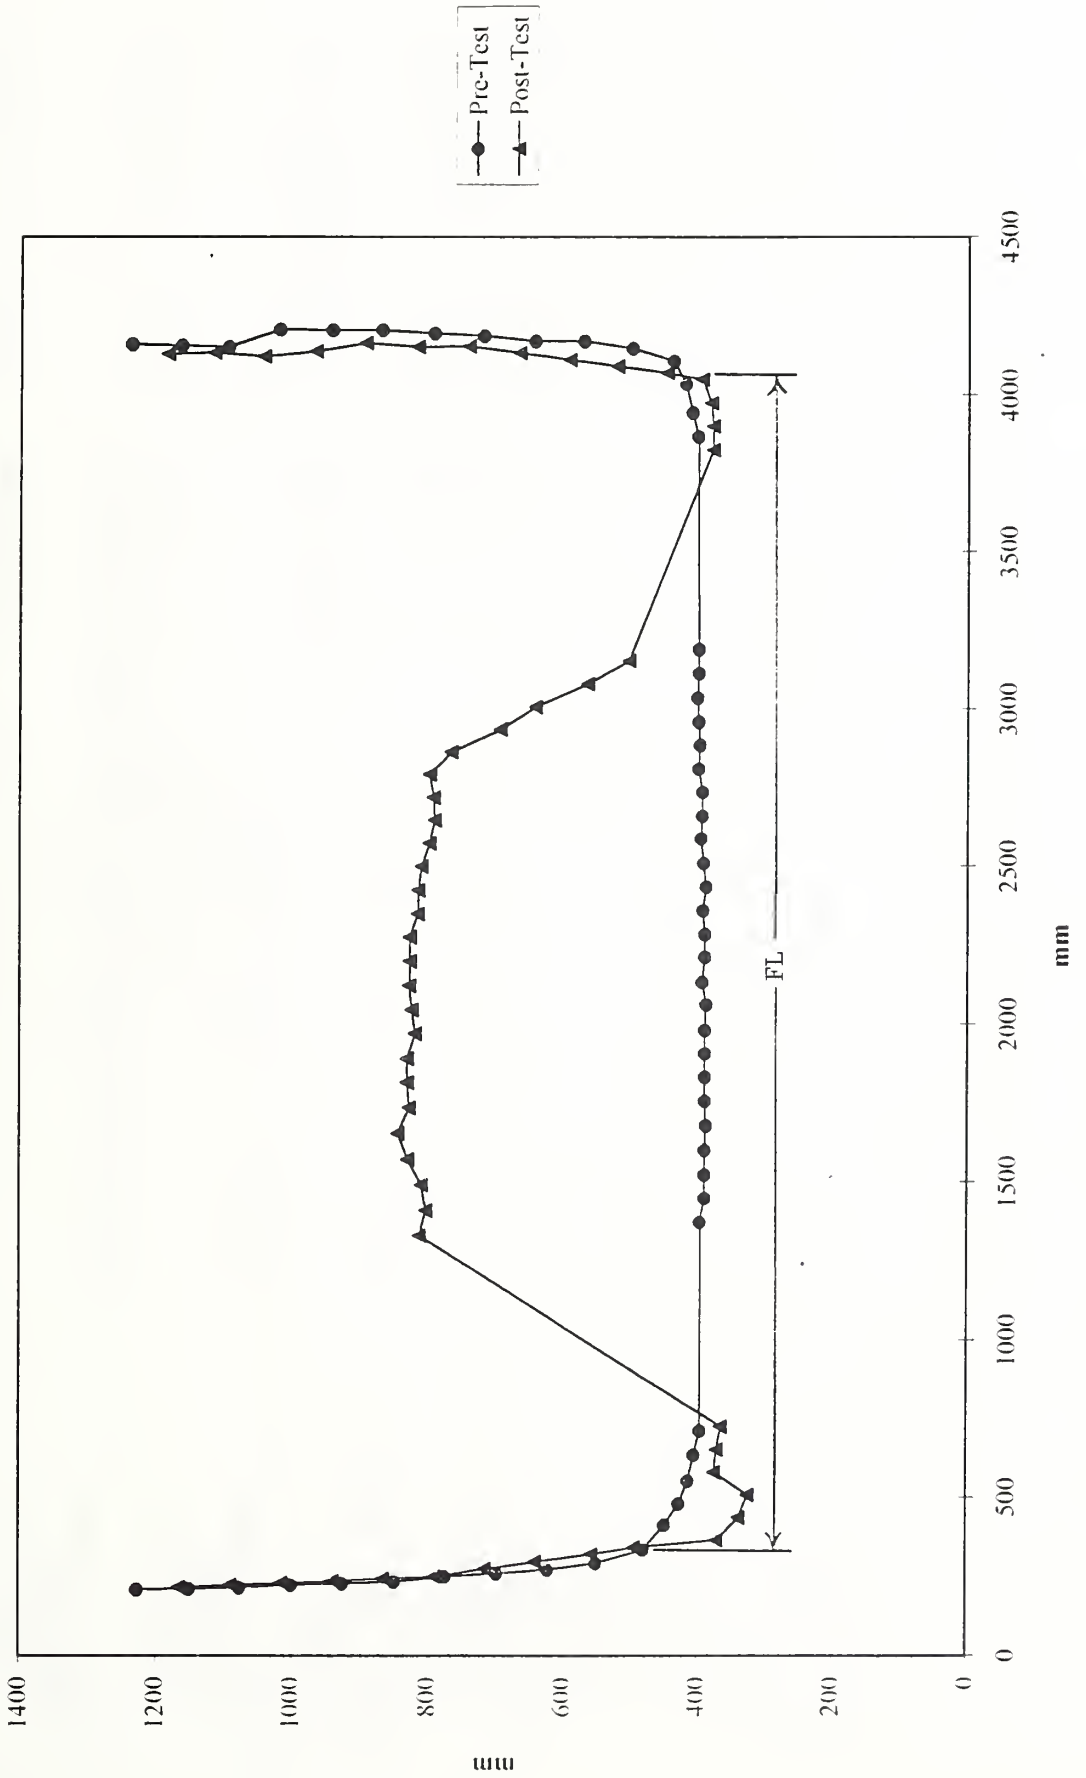
Figure 9

Vehicle Profile At Maximum Crush Height
Test No. 950518-3

Measurements C1 - C6 were spaced equally apart over the post-impact length of the damaged surface. This distance is defined as length "FL" on the vehicle crush profile plot.

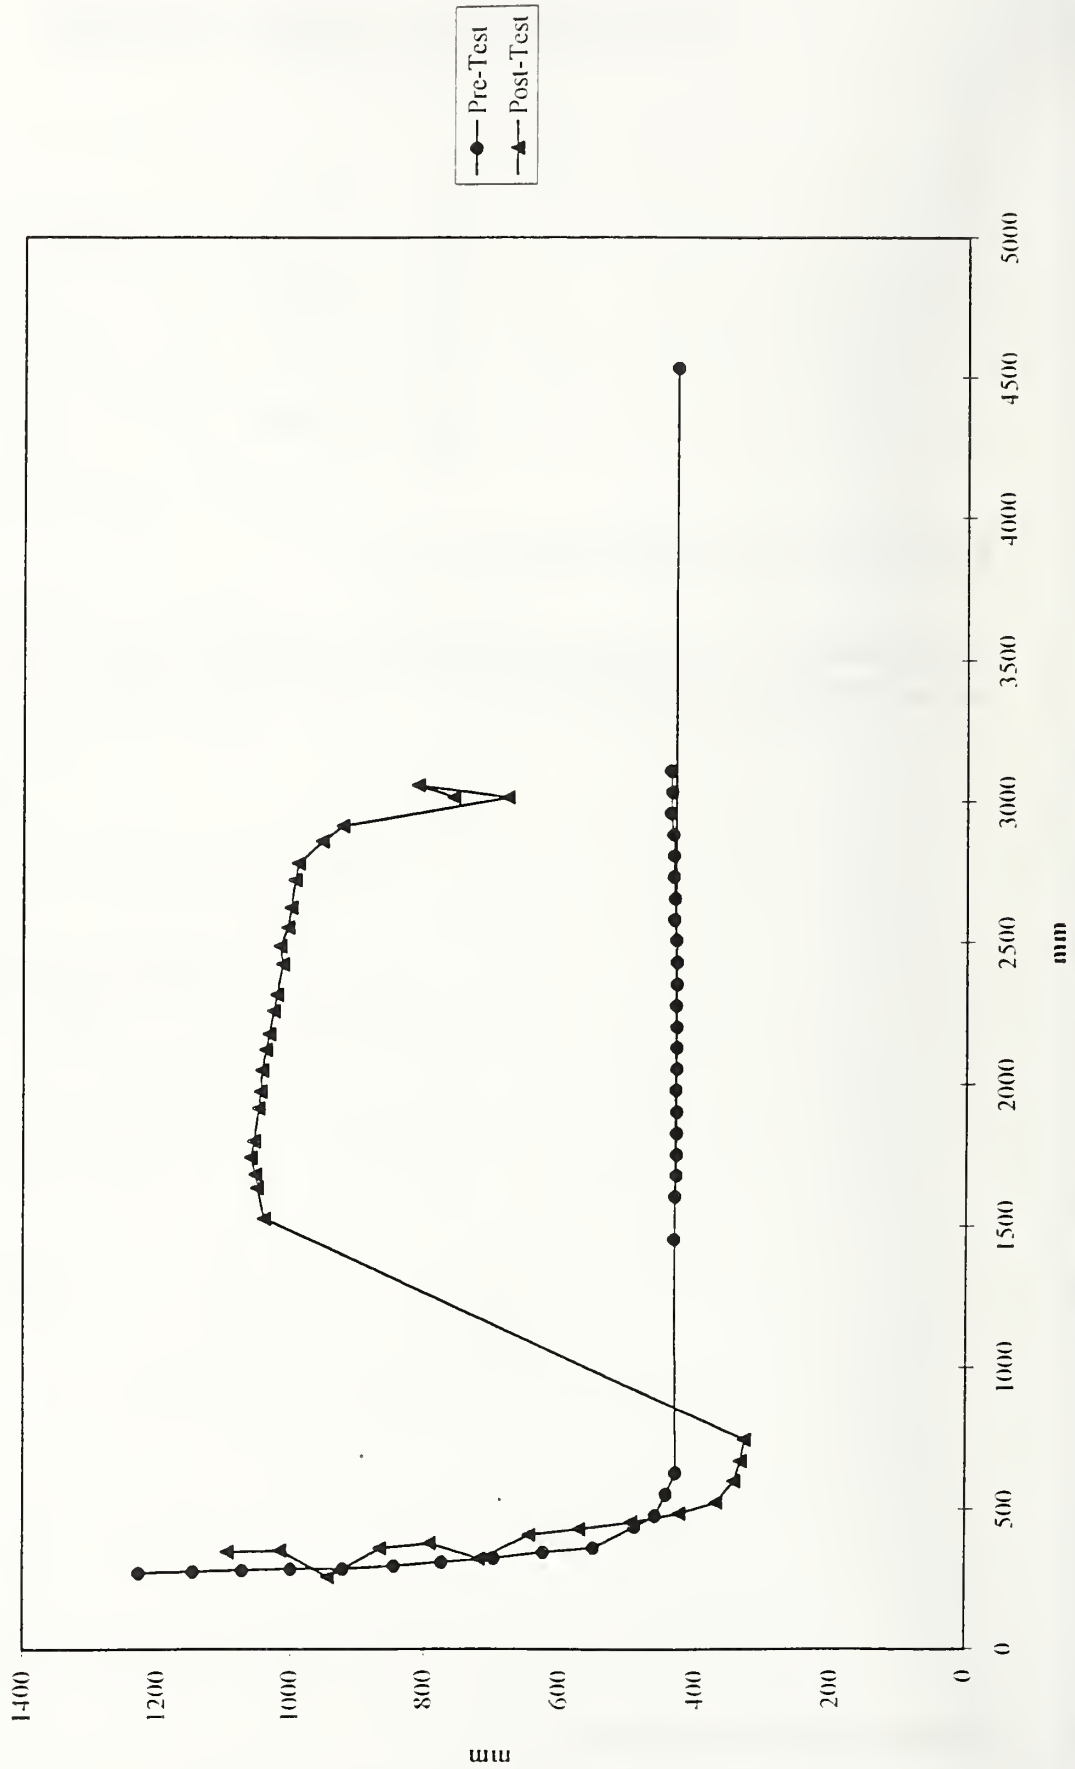
Vehicle Profile At Side Sill Height
Test No. 950518-4

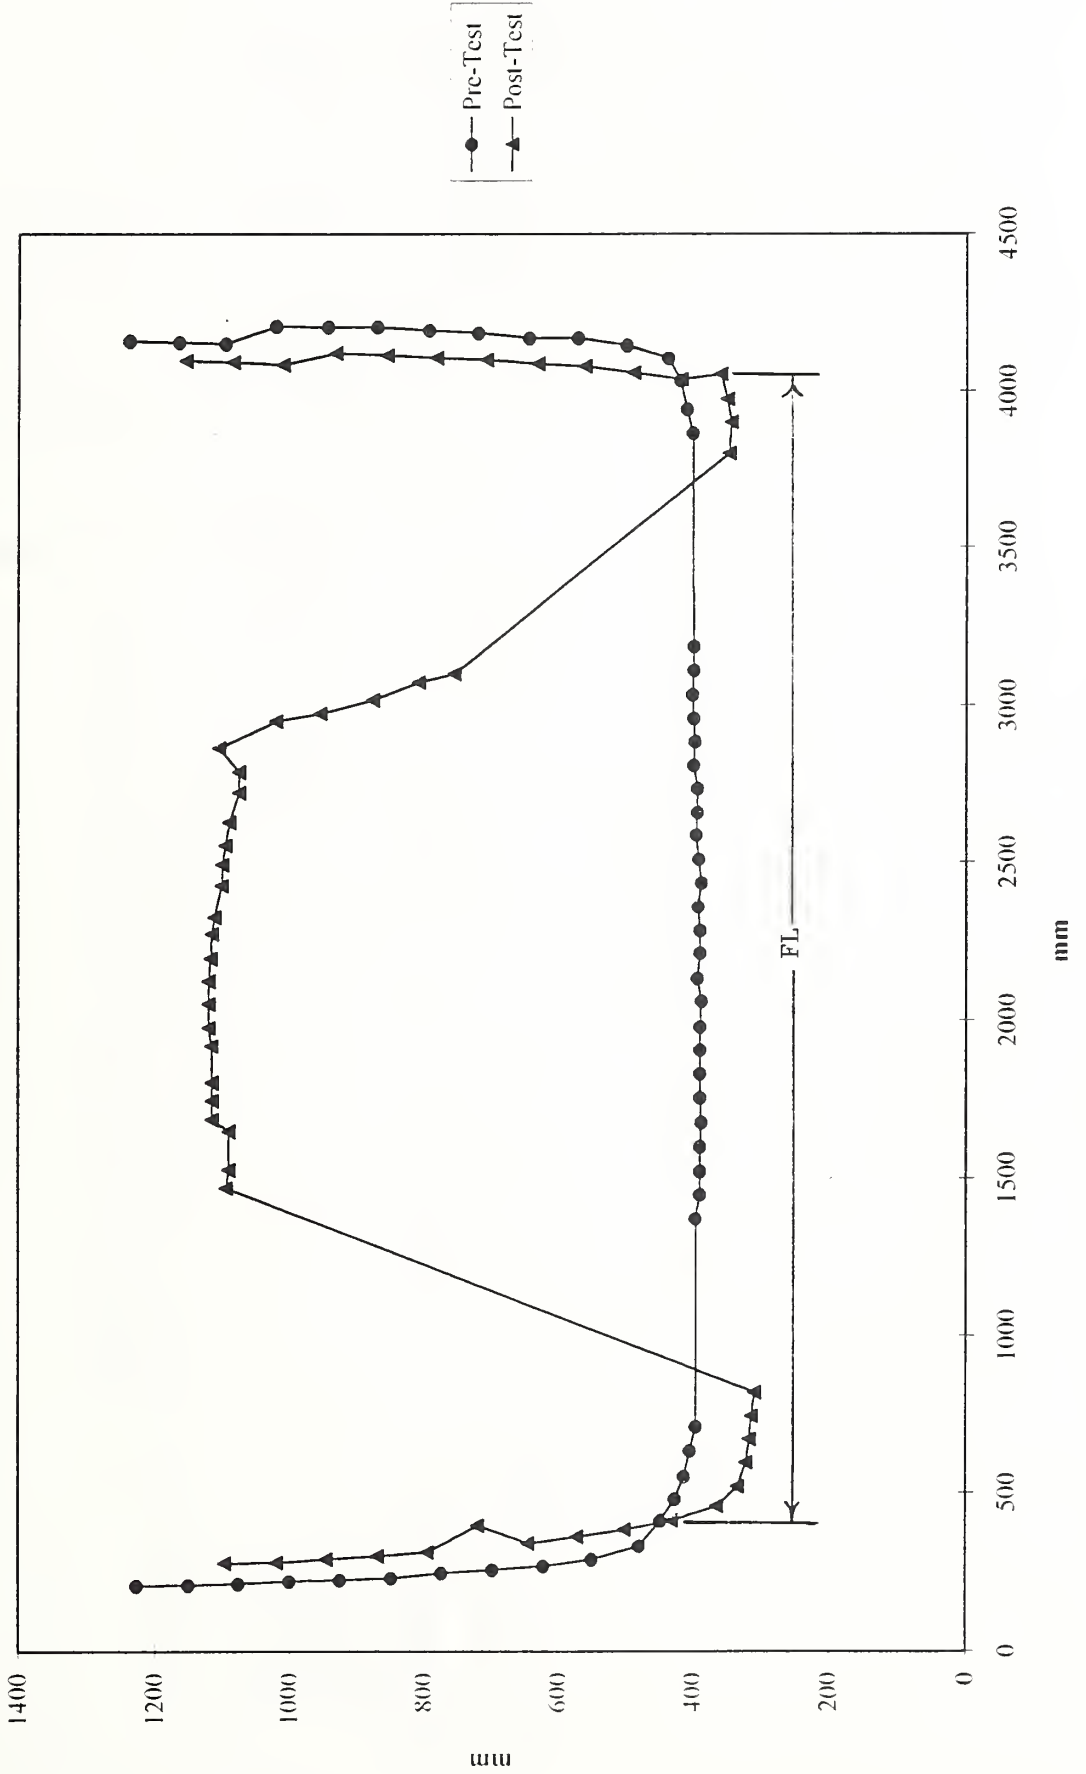
Figure 11

Vehicle Profile At Maximum Crush Height
Test No. 950518-4

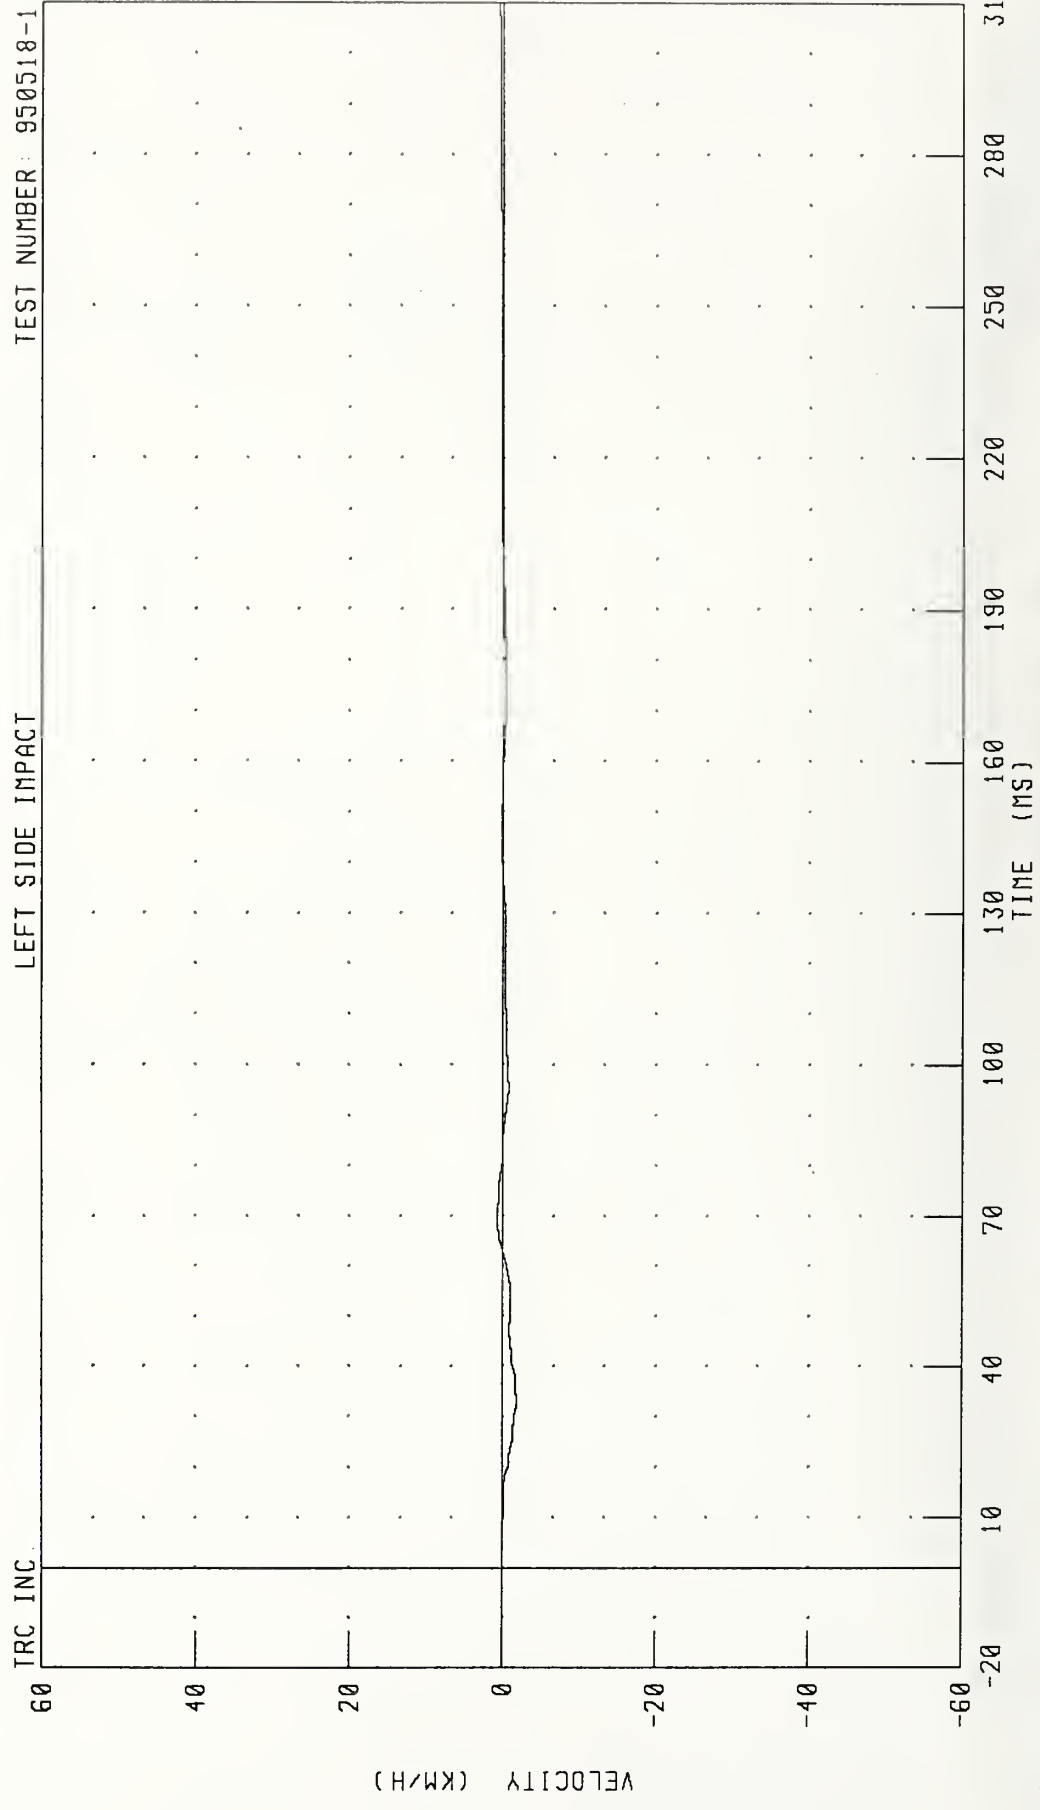
NON-DEFORMABLE CONTOURED FACE IMPACTOR INTO LEFT SIDE OF 1990 HONDA CIVIC
VEHICLE CC X-AXIS VELOCITY

CHANNEL: VCGXV1 FILTER: CH. CLASS 180 PEAK DATA 0.72 KM/H @ 69.44 MS, -1.86 KM/H @ 33.12 MS

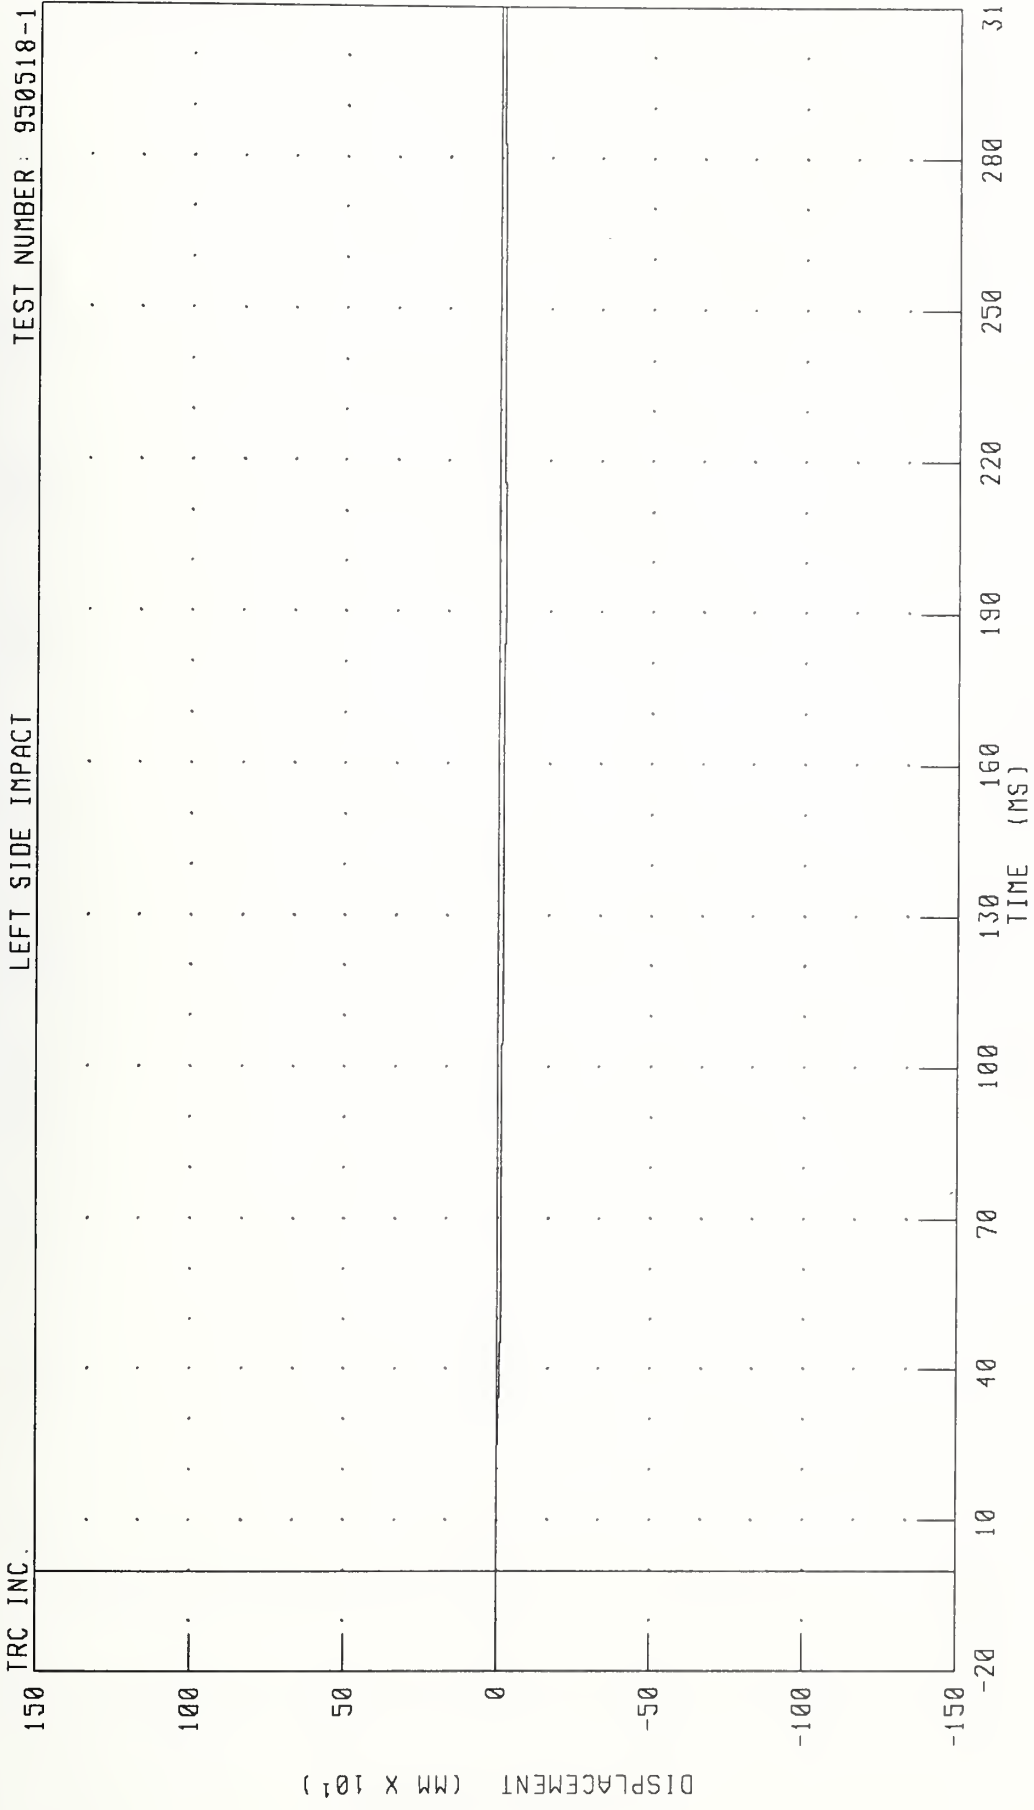
NON-DEFORMABLE CONTOURED FACE IMPACTOR INTO LEFT SIDE OF 1990 HONDA CIVIC
 VEHICLE CG X-AXIS DISPLACEMENT

CHANNEL VCGXD1 FILTER CH. CLASS 180 PEAK DATA: 0 03 MM @ 9.36 MS, -19.32 MM @ 197.84 MS

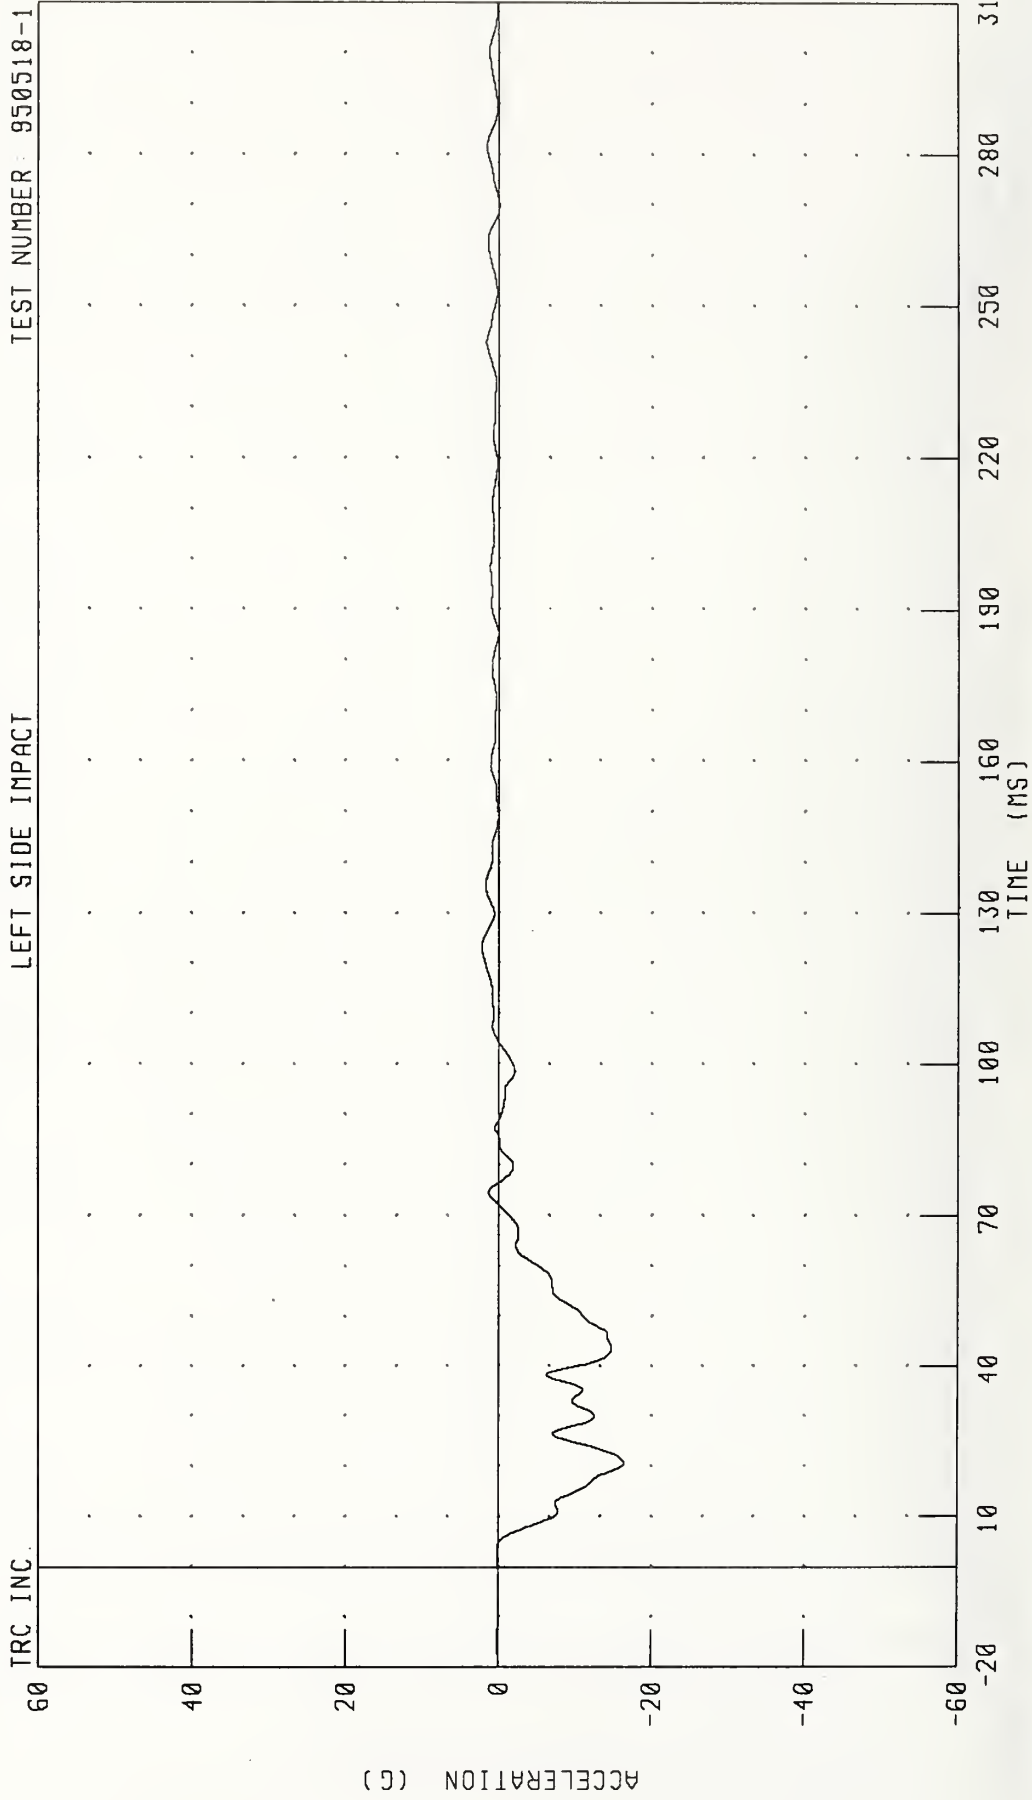
NON-DEFORMABLE CONTOURED FACE IMPACTOR INTO LEFT SIDE OF 1990 HONDA CIVIC
VEHICLE CG Y-AXIS ACCELERATION
LEFT SIDE IMPACT

CHANNEL: VCGYG1 FILTER: CH. CLASS 60 PEAK DATA: 2.22 G @ 123.28 MS, -16.39 G @ 20.56 MS

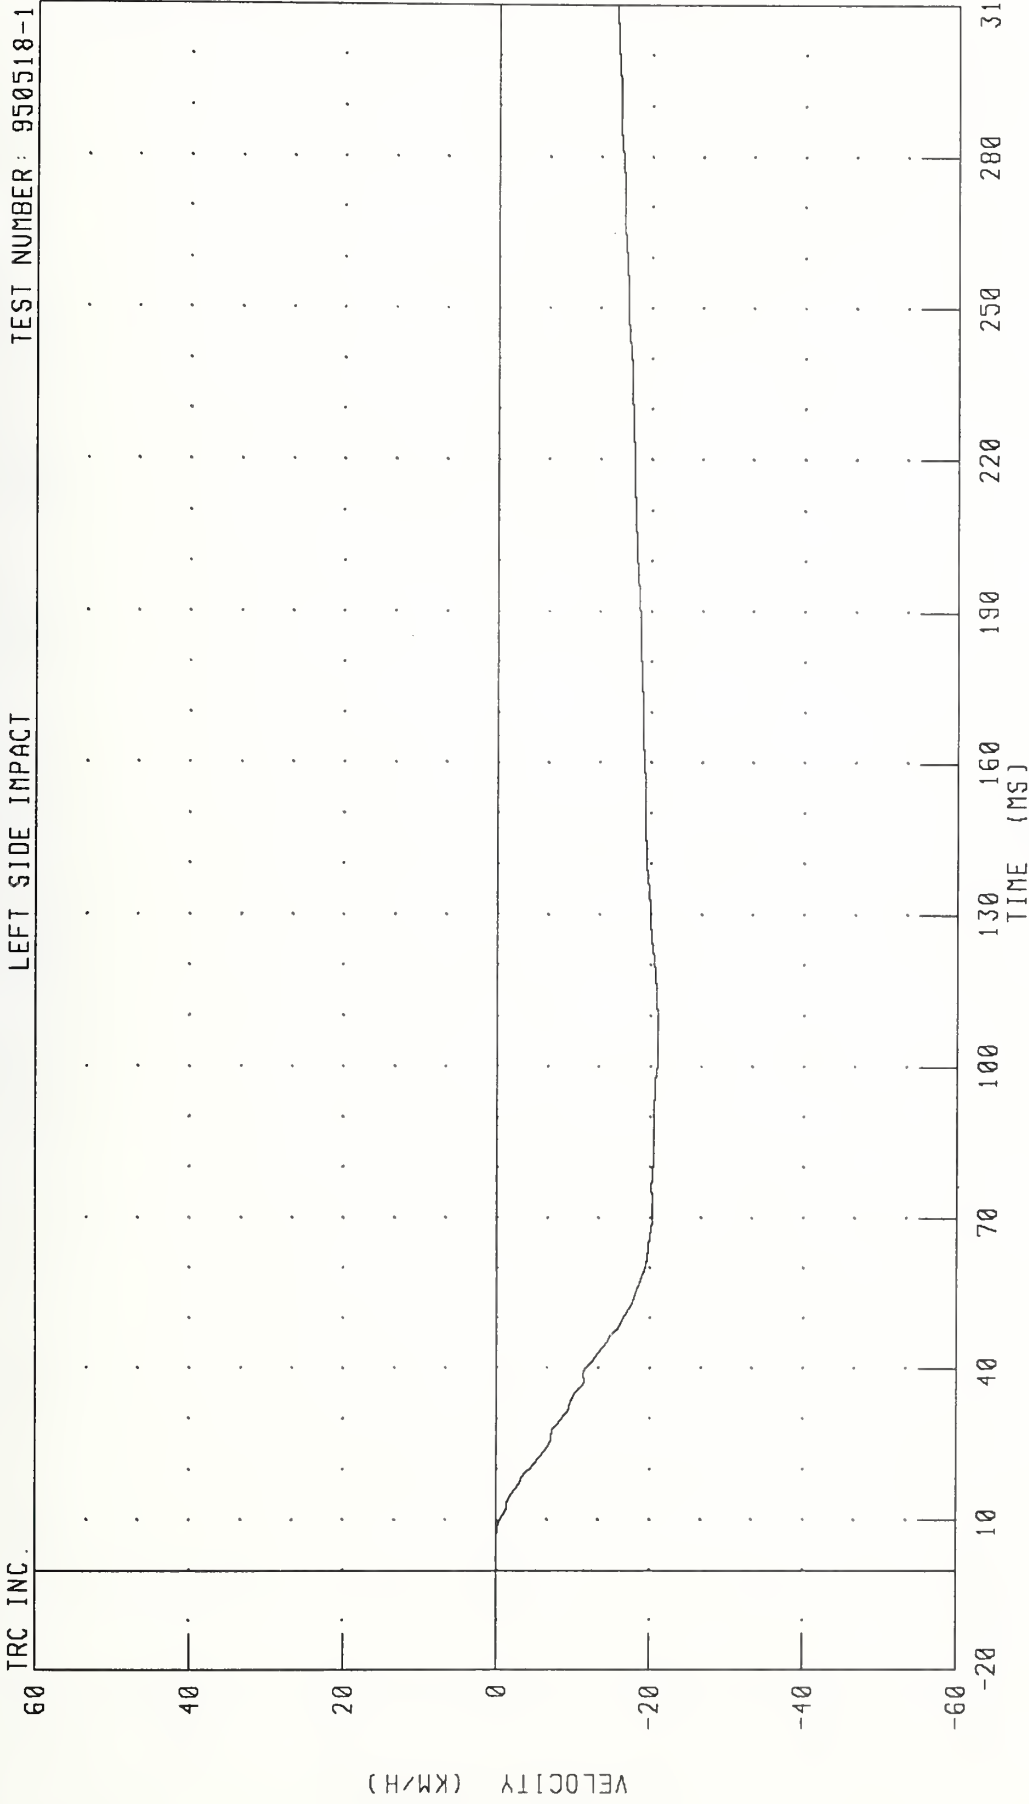
NON-DEFORMABLE CONTOURED FACE IMPACTOR INTO LEFT SIDE OF 1990 HONDA CIVIC
VEHICLE CG Y-AXIS VELOCITY

CHANNEL VCGYV1 FILTER: CH. CLASS 180

PEAK DATA: 0 02 KM/H @ 6.08 MS; -21 05 KM/H @ 104 00 MS

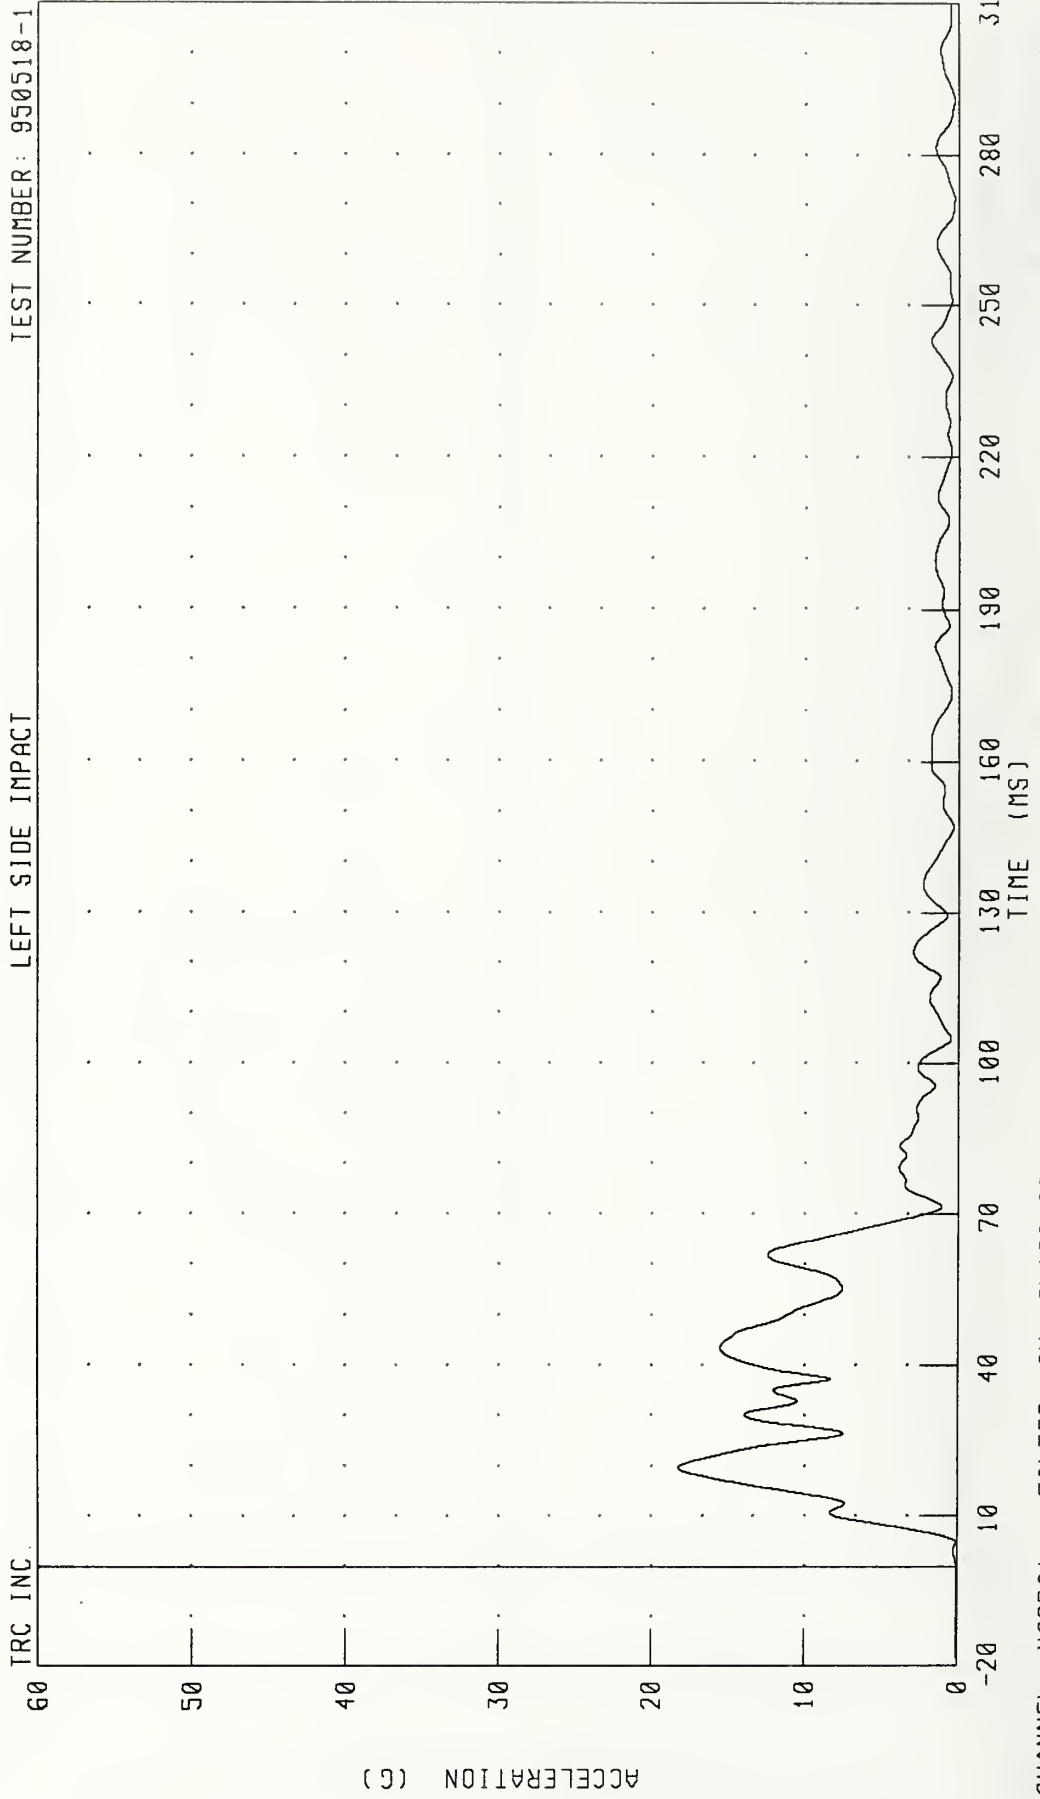
NON-DEFORMABLE CONTOURED FACE IMPACTOR INTO LEFT SIDE OF 1990 HONDA CIVIC
VEHICLE CG RESULTANT ACCELERATION

CHANNEL: VCGRG1 FILTER: CH CLASS 60

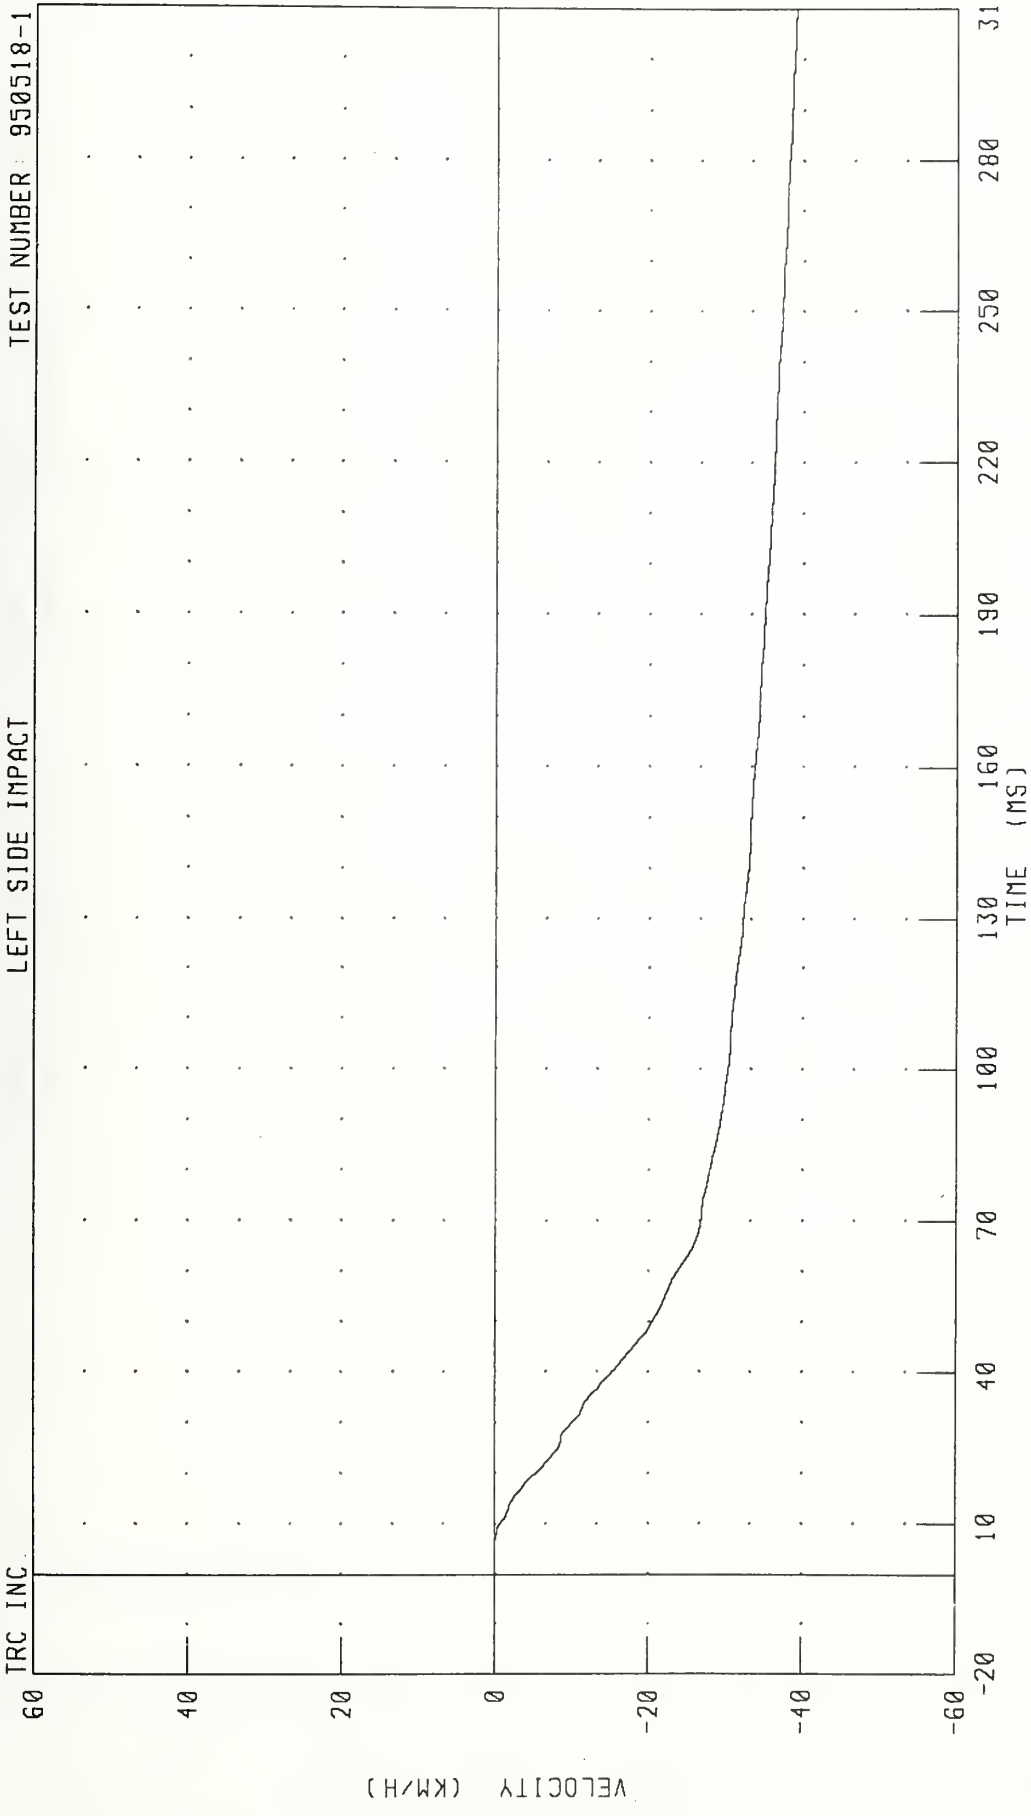
NON-DEFORMABLE CONTOURED FACE IMPACTOR INTO LEFT SIDE OF 1990 HONDA CIVIC
VEHICLE CC RESULTANT VELOCITY

CHANNEL VCGRV1 FILTER CH CLASS 180

PEAK DATA: 0 00 KM/H @ 0 00 MS; -39 05 KM/H @ 310 00 MS
