DOT HS 808 398

June 1995

Final Report

Final Report of a Non-Deformable Impactor into a 1990 Honda Civic 3-Door Hatchback in Support of CRASH3 Damage Algorithm Reformulation

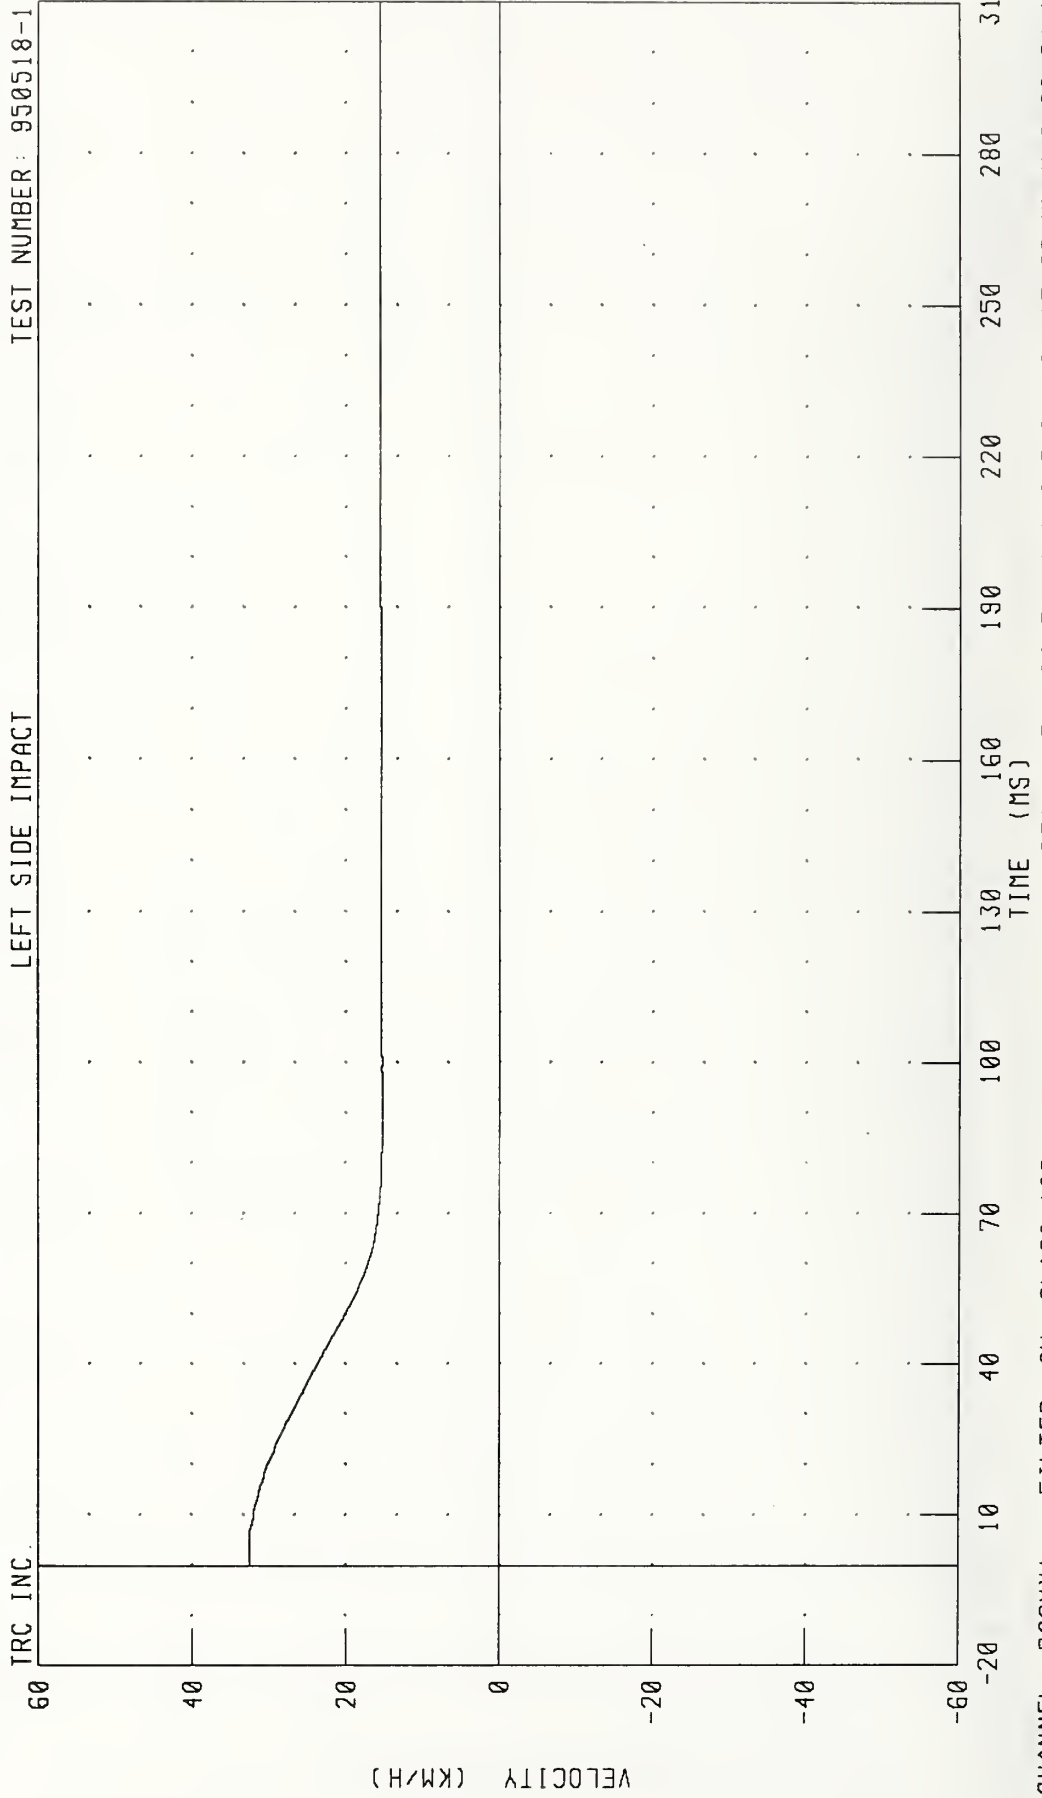
NON-DEFORMABLE CONTOURED FACE IMPACTOR INTO LEFT SIDE OF 1990 HONDA CIVIC
IMPACTOR CENTER OF GRAVITY X-AXIS VELOCITY

CHANNEL: BCGXV1 FILTER: CH CLASS 180

PEAK DATA: 32.51 KM/H @ 5.36 MS, 15.28 KM/H @ 86.24 MS

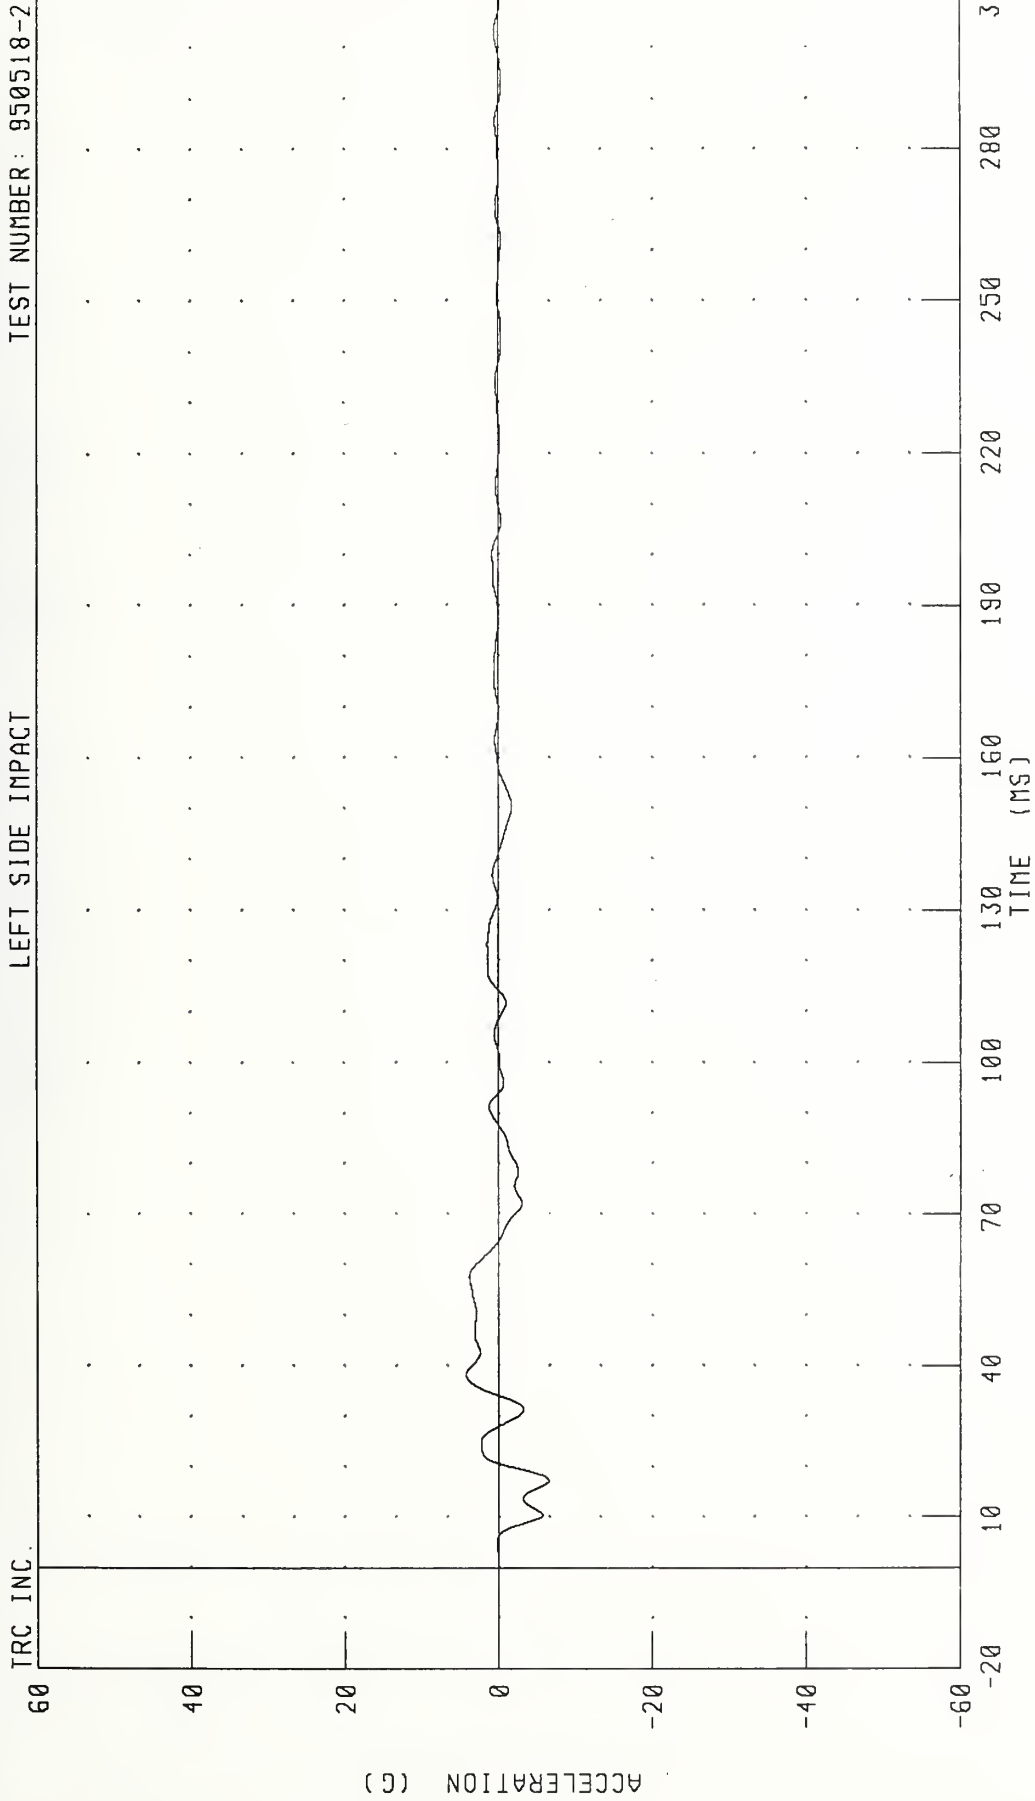
NON-DEFORMABLE CONTOURED FACE IMPACTOR INTO LEFT SIDE OF 1990 HONDA CIVIC
VEHICLE CG X-AXIS ACCELERATION

CHANNEL: VCGXG1 FILTER: CH CLASS 60

PEAK DATA 4 23 G @ 38.32 MS, -6.55 G @ 17.28 MS
