LIGHT TRUCK AGGRESSIVITY STUDY- TEST REPORT 3- TRUCK-TO-CAR RIGHT OFFSET IMPACT TESTS

DECEMBER 1978
FINAL REPORT

| 15. Supplementary Notes Tests No. 5 and 6 of a series of 7 tests. | | | | 13. Type of Report and Period Covered FINAL REPORT Oct - Dec 1978 | |

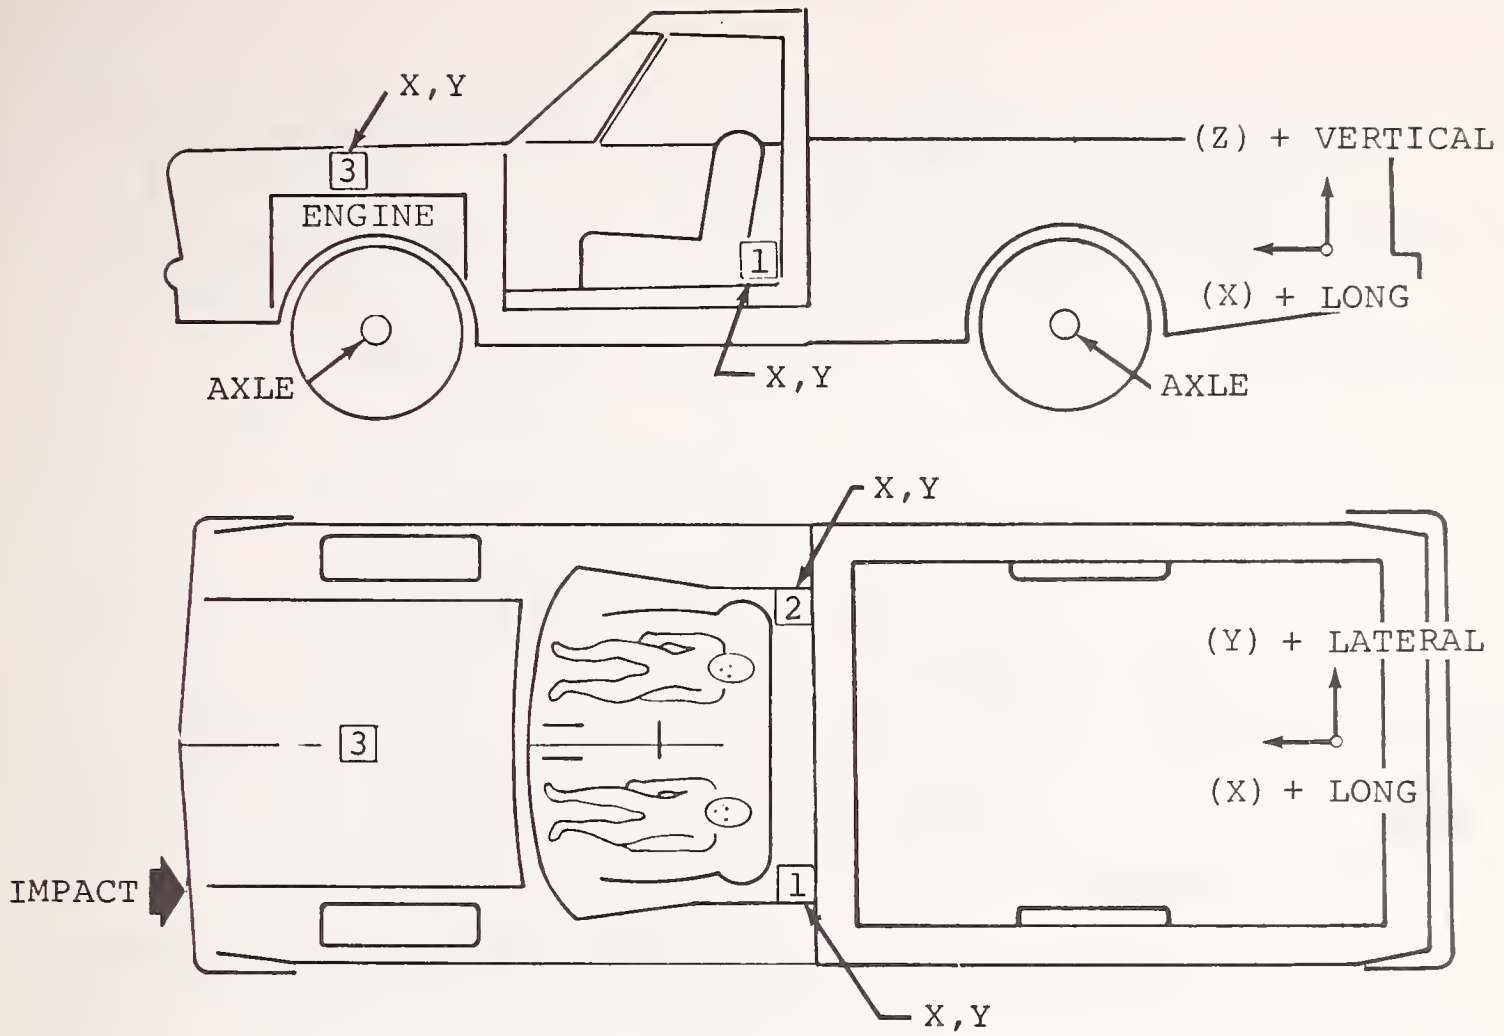
*G
 **Reference points:
 X - Direction - Centerline of rear bumper
 Y - Direction - Centerline of vehicle - left centerline (-), right centerline (+)
 Z - Direction - Ground level

Figure 2-1. 1979 Chevrolet C-10 Truck Accelerometer Instrumentation (Test 3051-5).

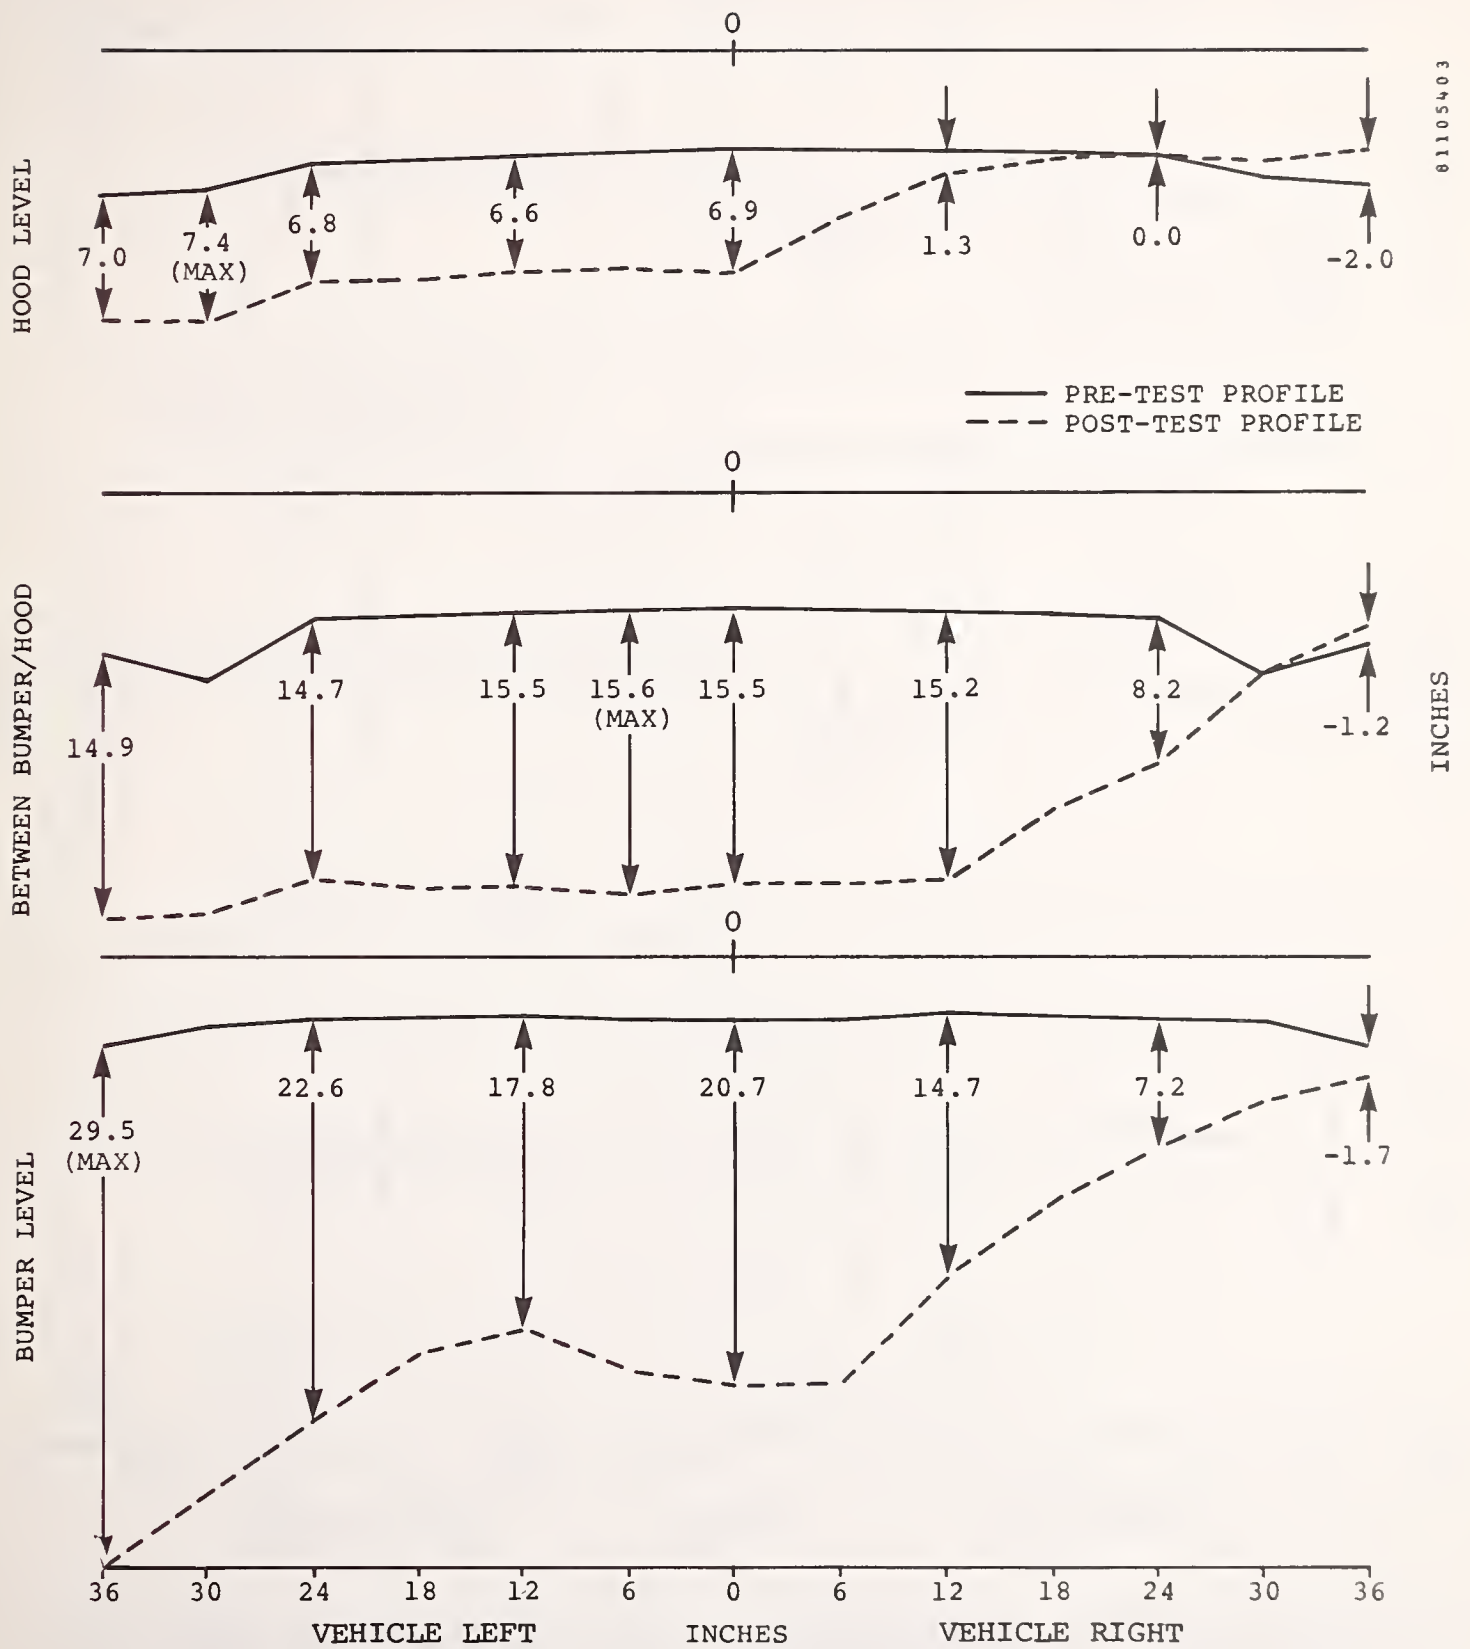
Figure 2-8. Chevrolet C-10 Truck Exterior Static Crush (Test 3051-5).

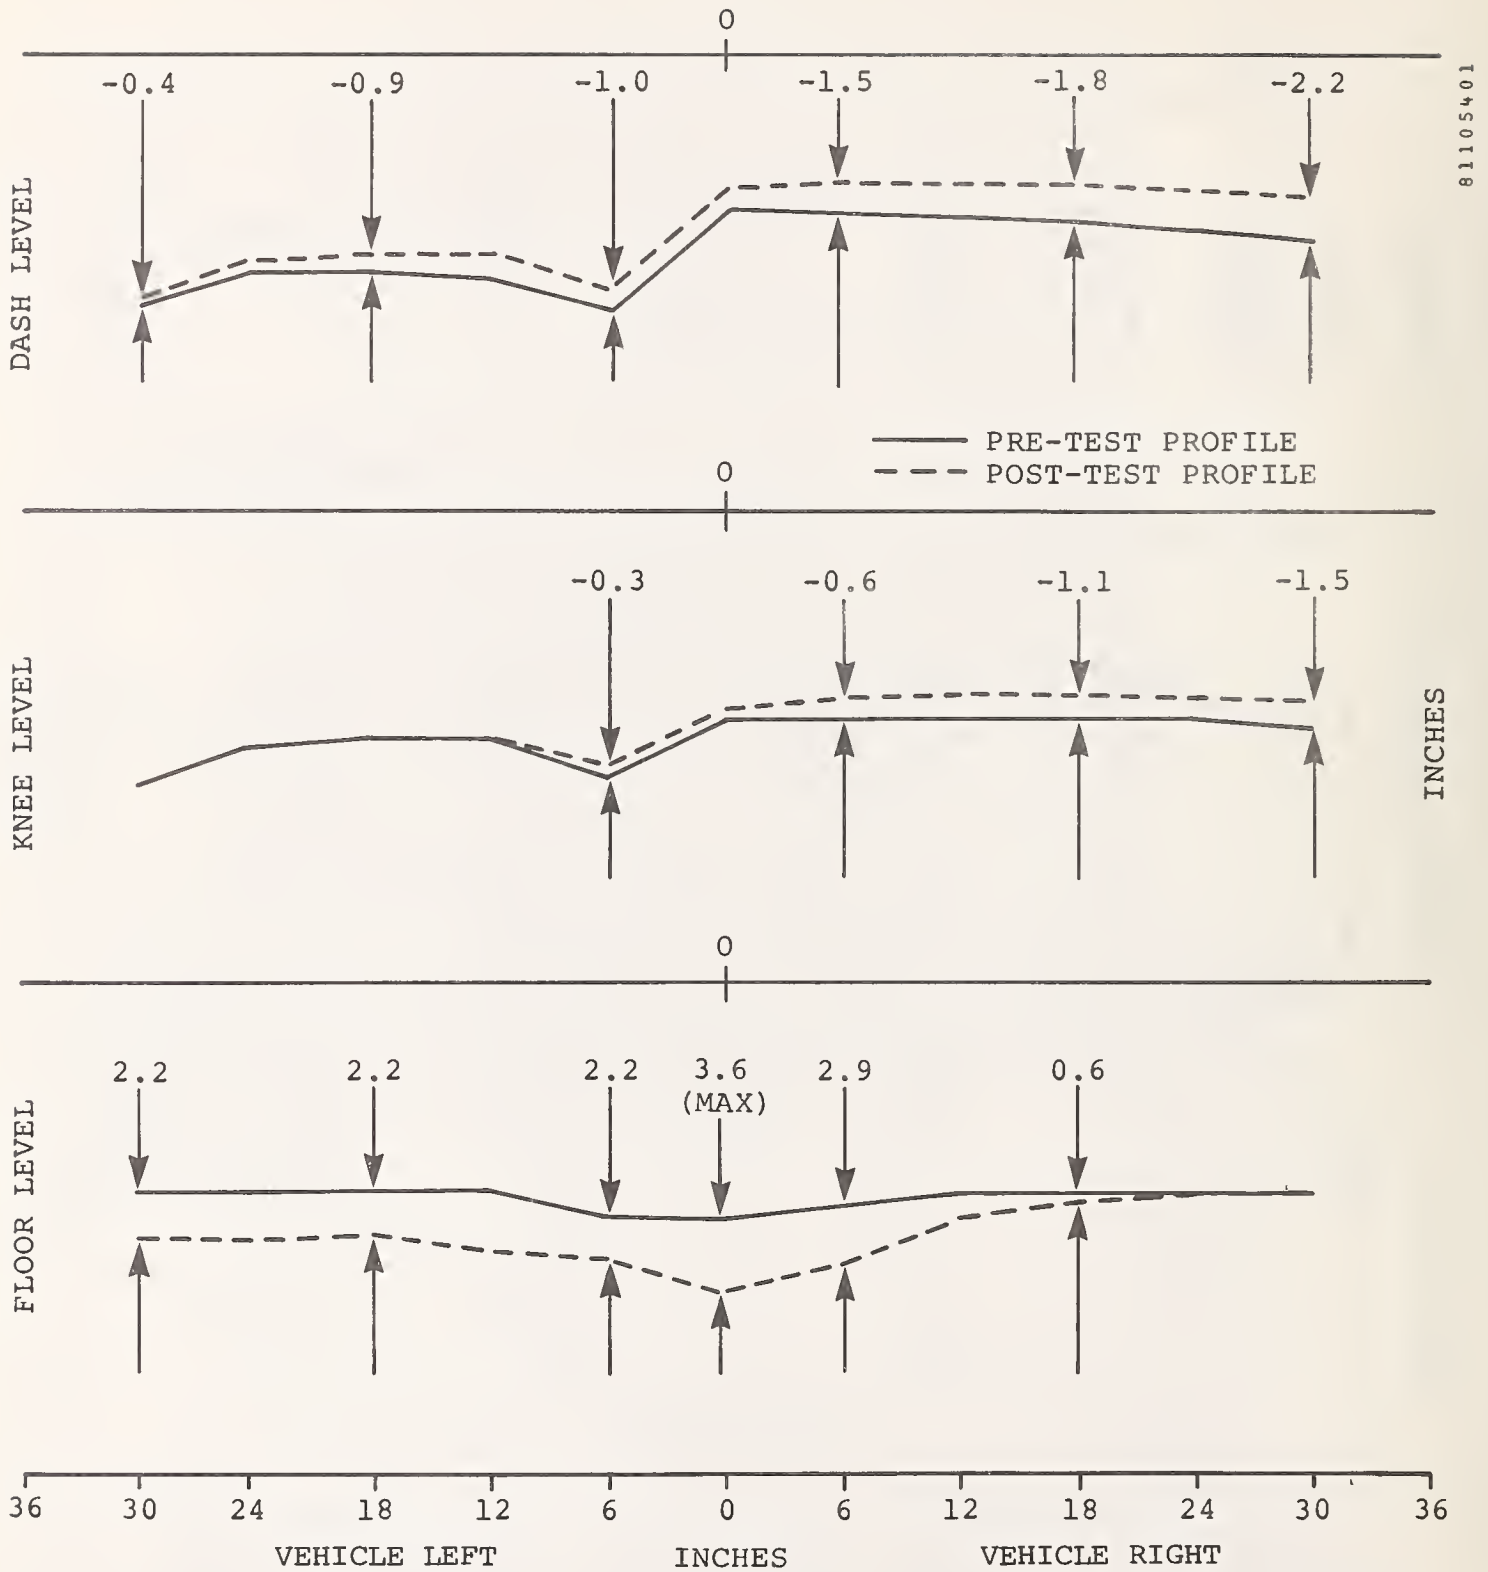
Figure 2-9. Chevrolet C-10 Truck Interior Intrusion (Test 3051-5).

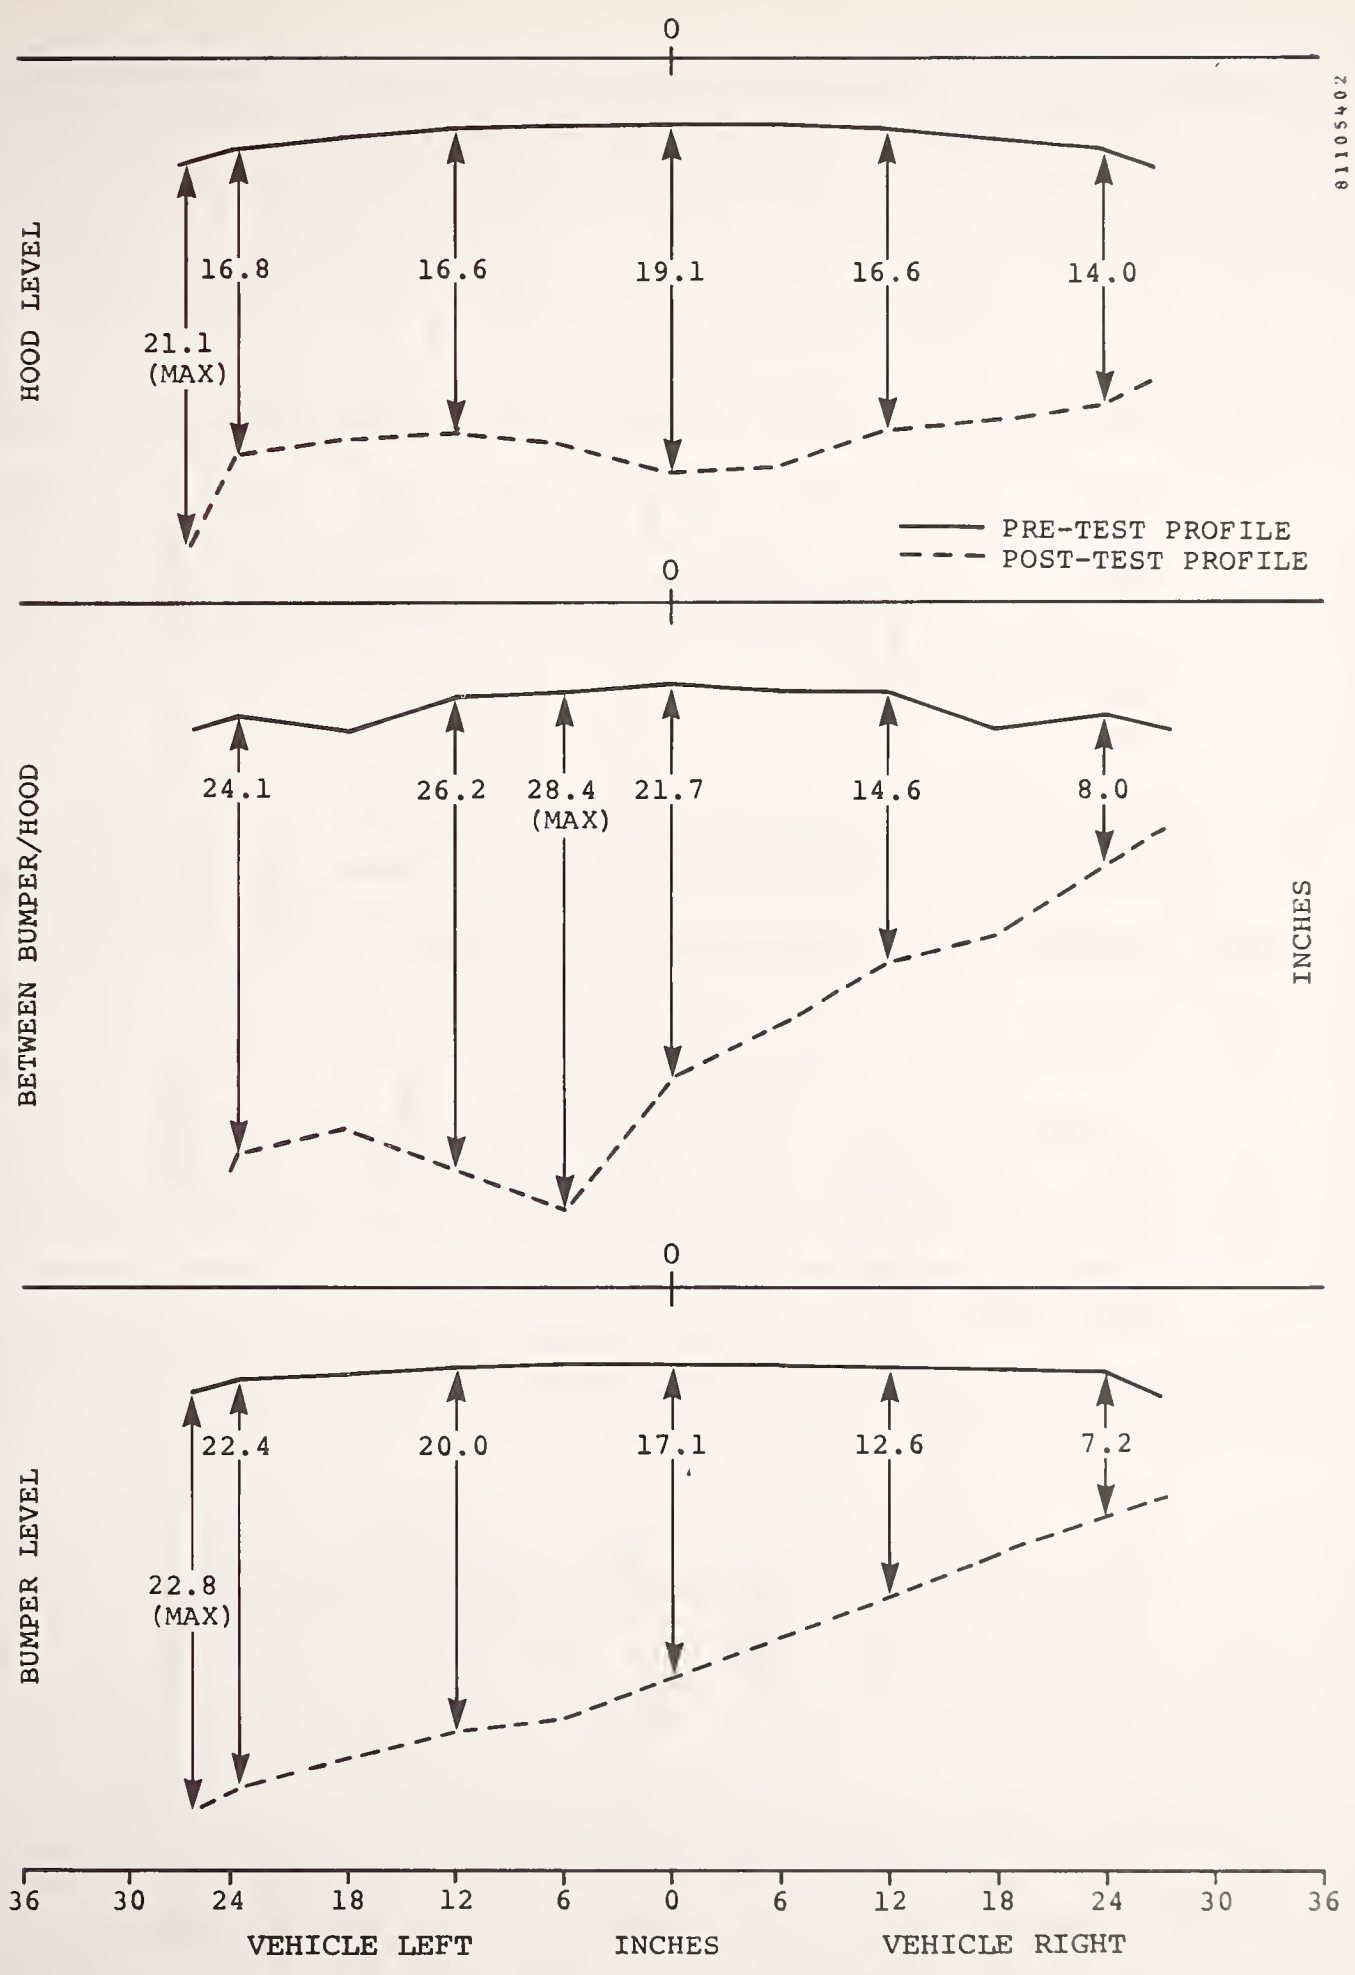
Figure 2-10. Plymouth Horizon Exterior Static Crush (Test 3051-5).

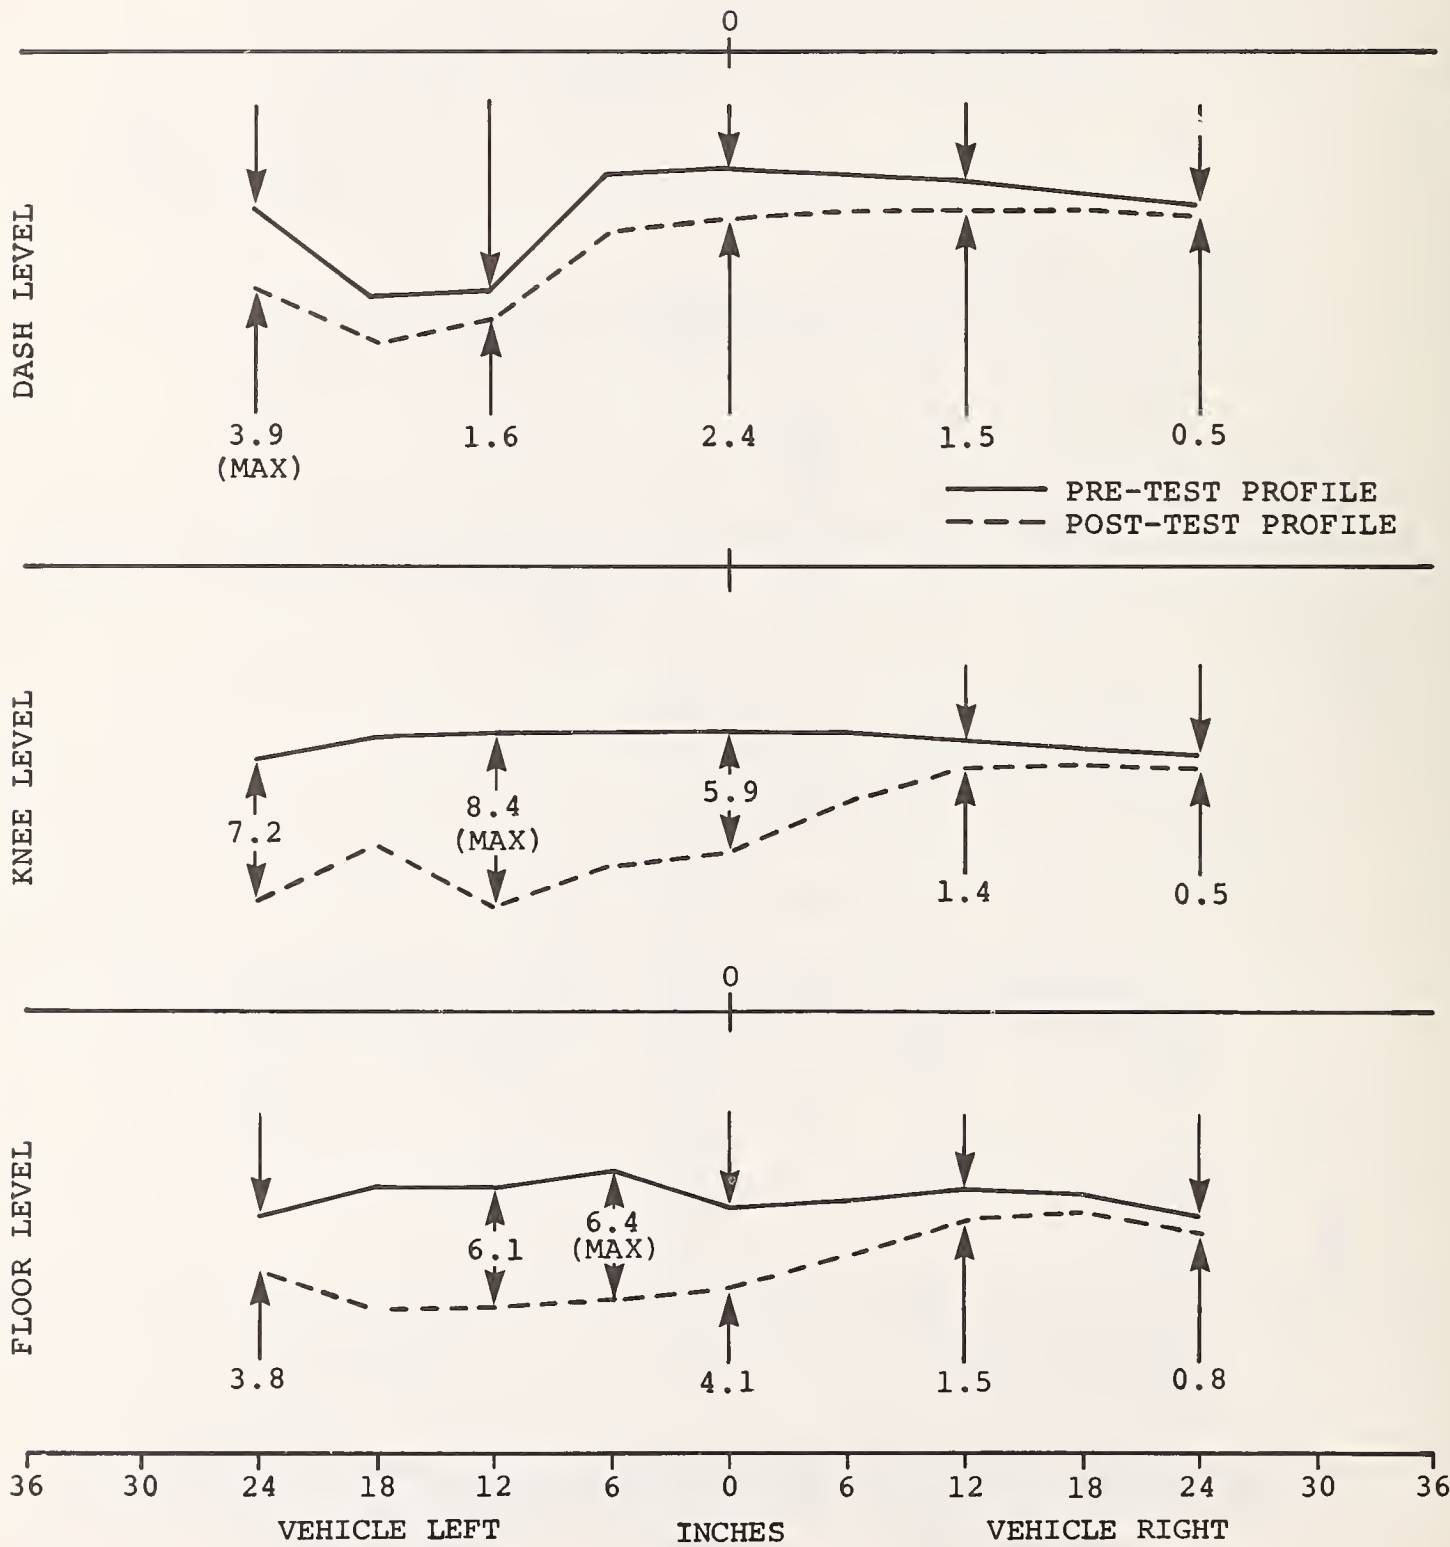
Figure 2-11. Plymouth Horizon Interior Intrusion (Test 3051-5).

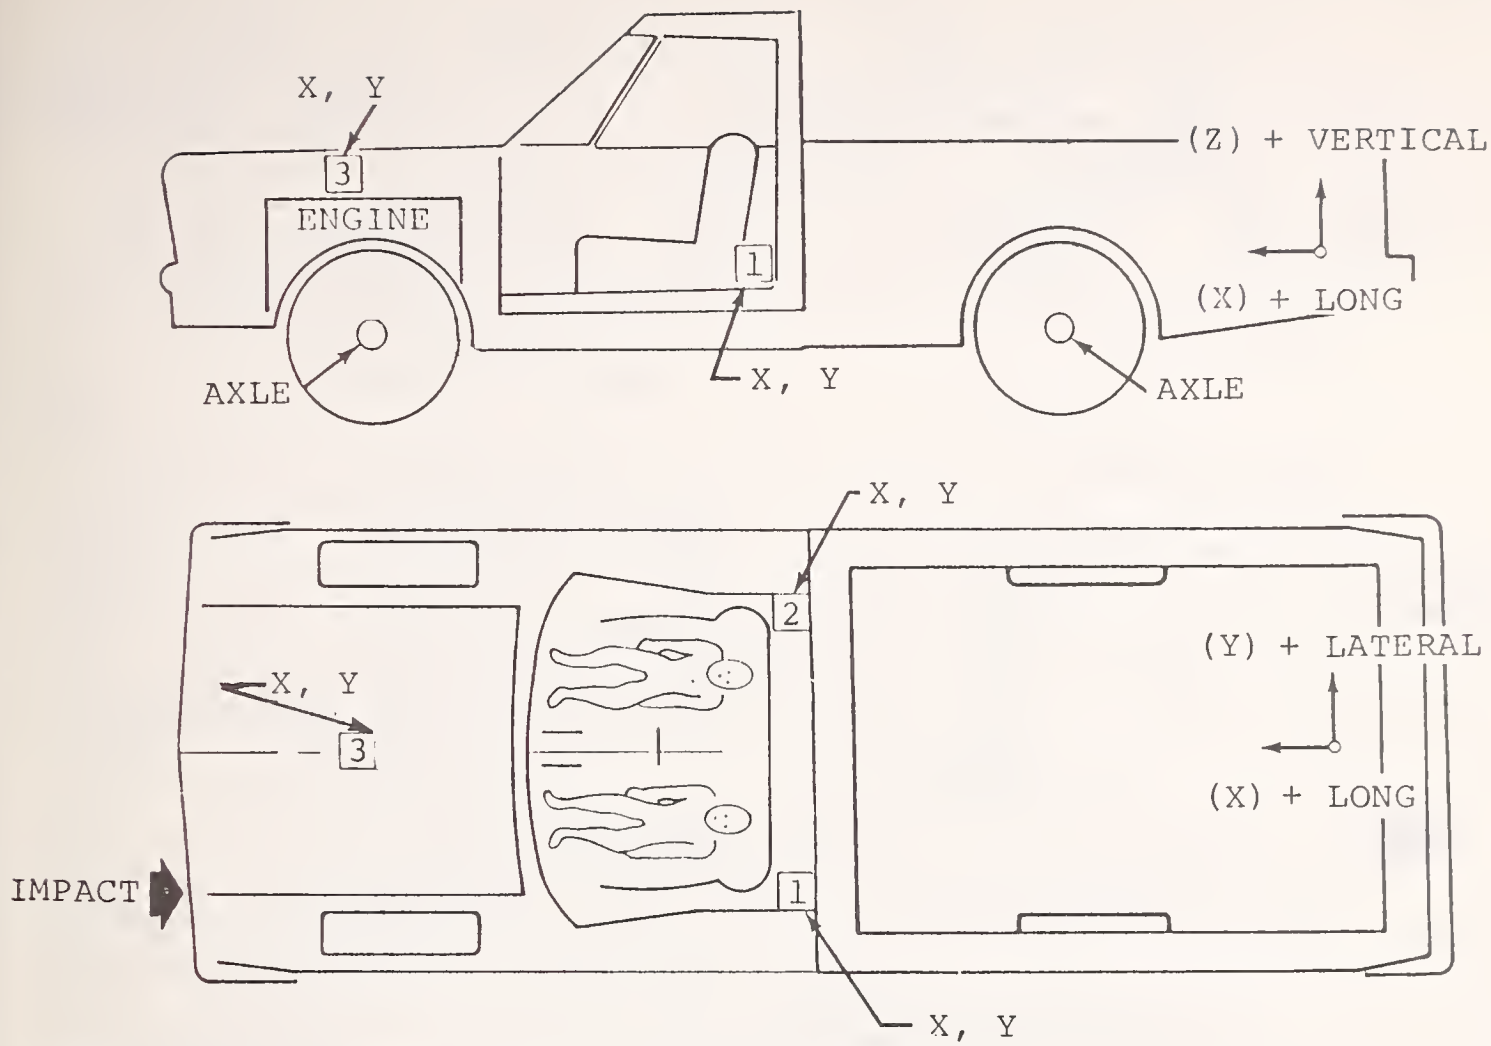
Figure 3-1. 1979 Chevrolet C-10 Truck Accelerometer Instrumentation (Test 3051-6).

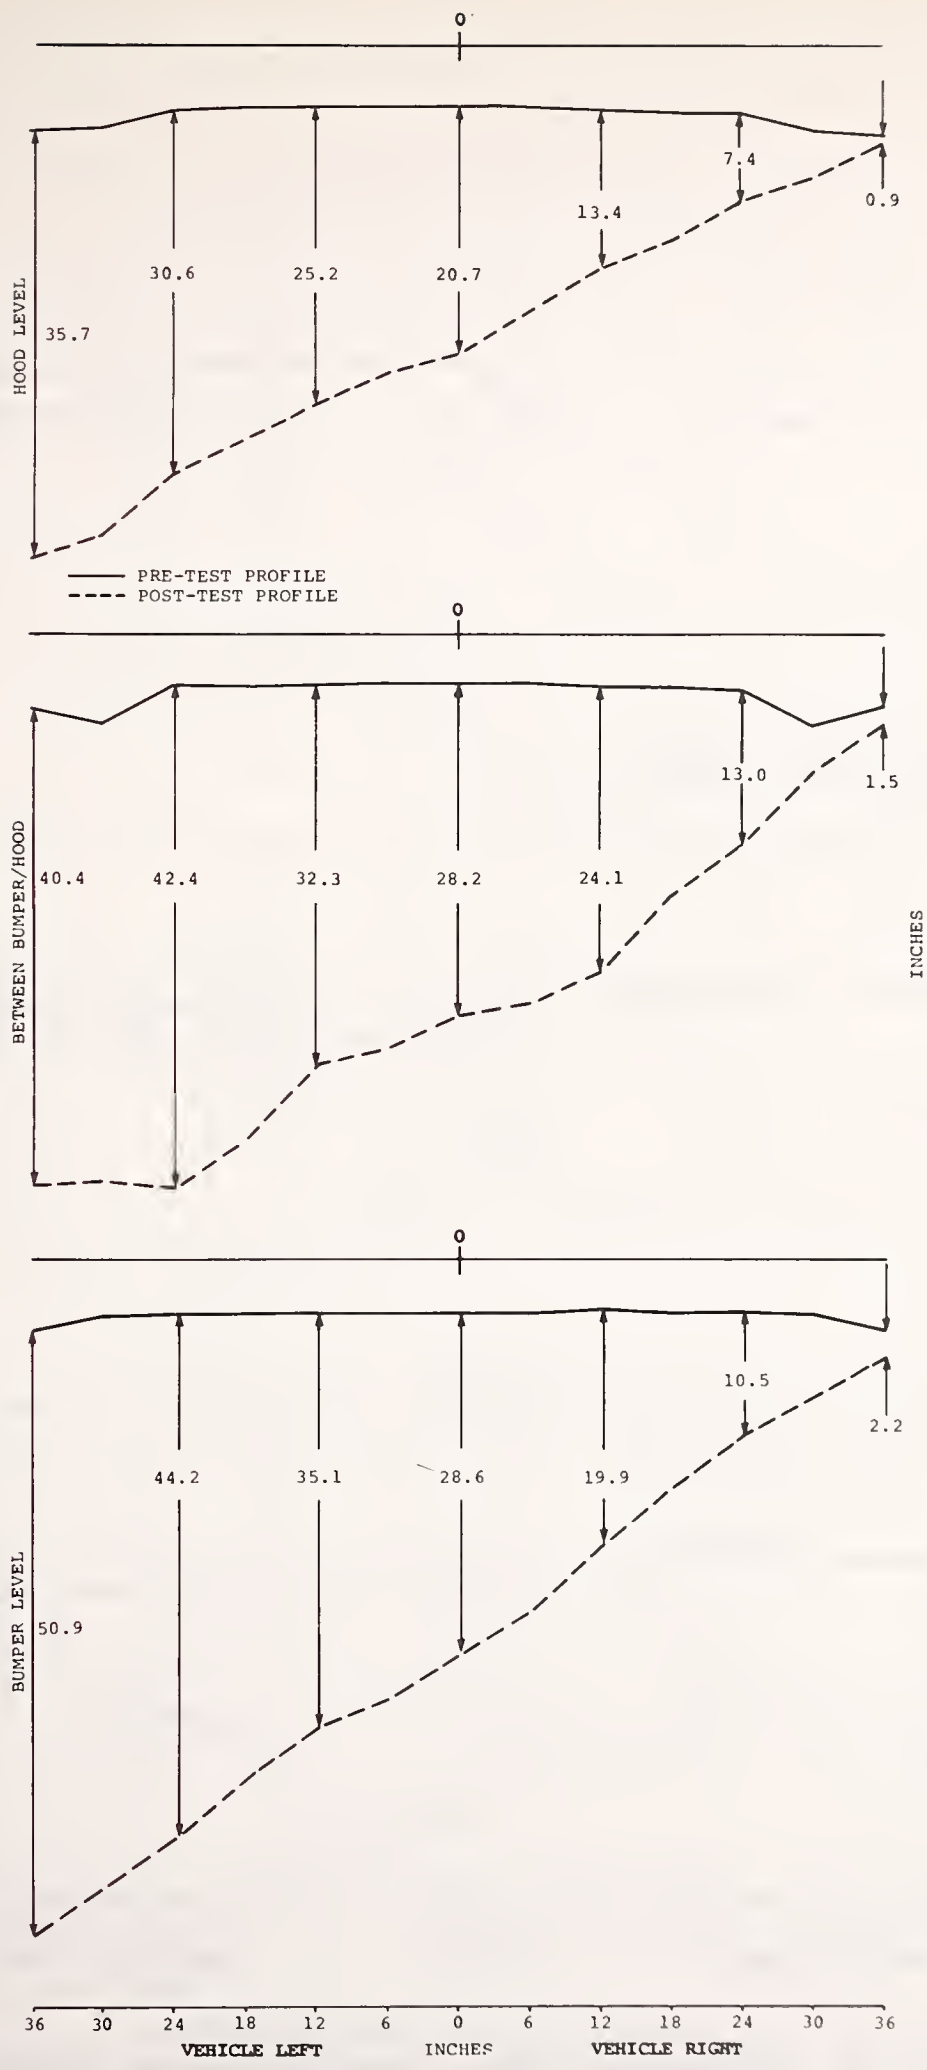
Figure 3-8. Chevrolet C-10 Truck Exterior Static Crush (Test 3051-6).

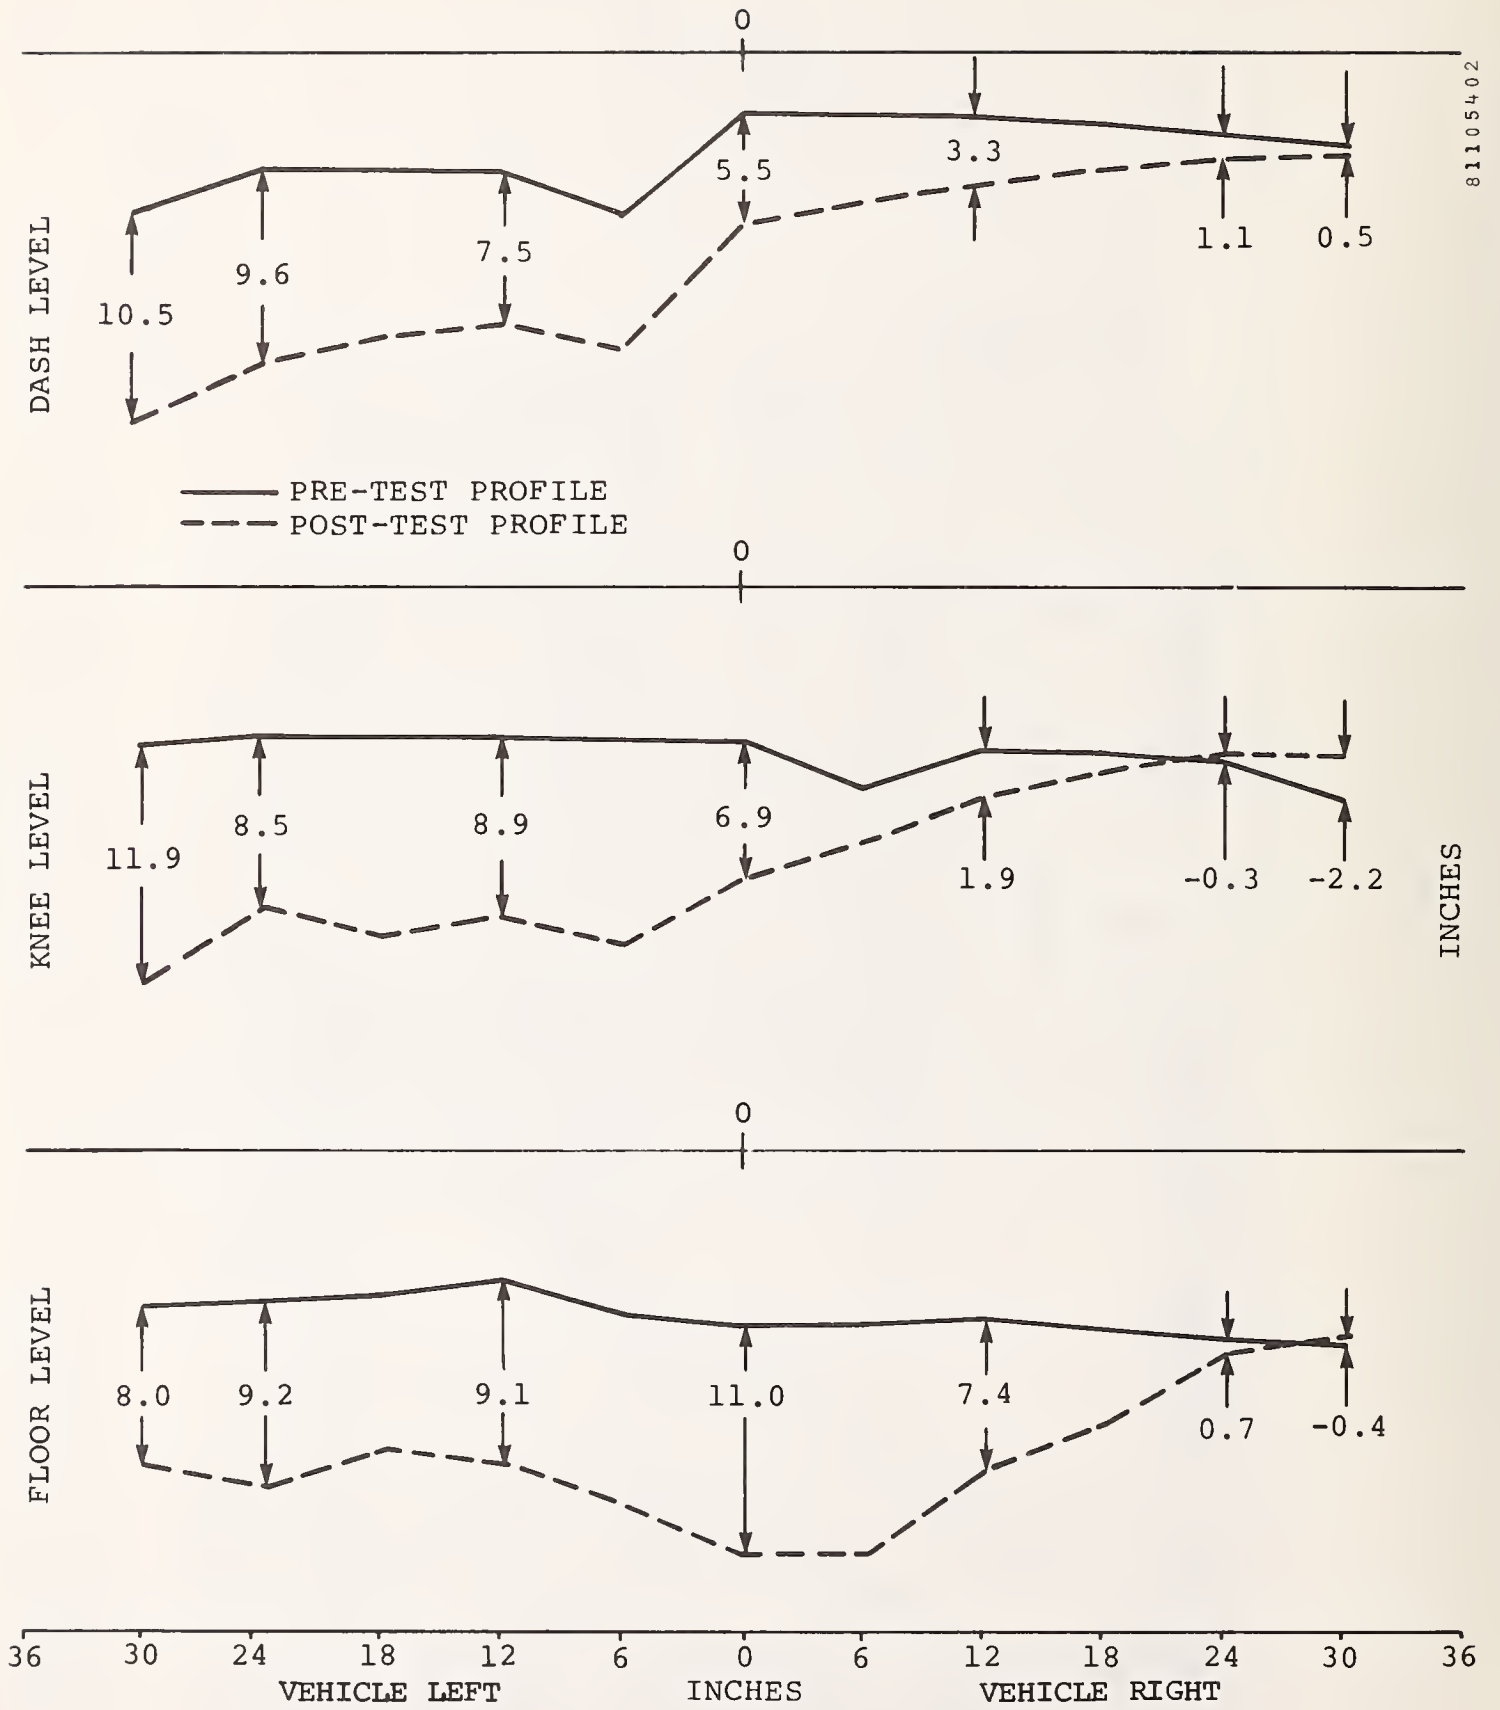
Figure 3-9. Chevrolet C-10 Truck Interior Intrusion (Test 3051-6).

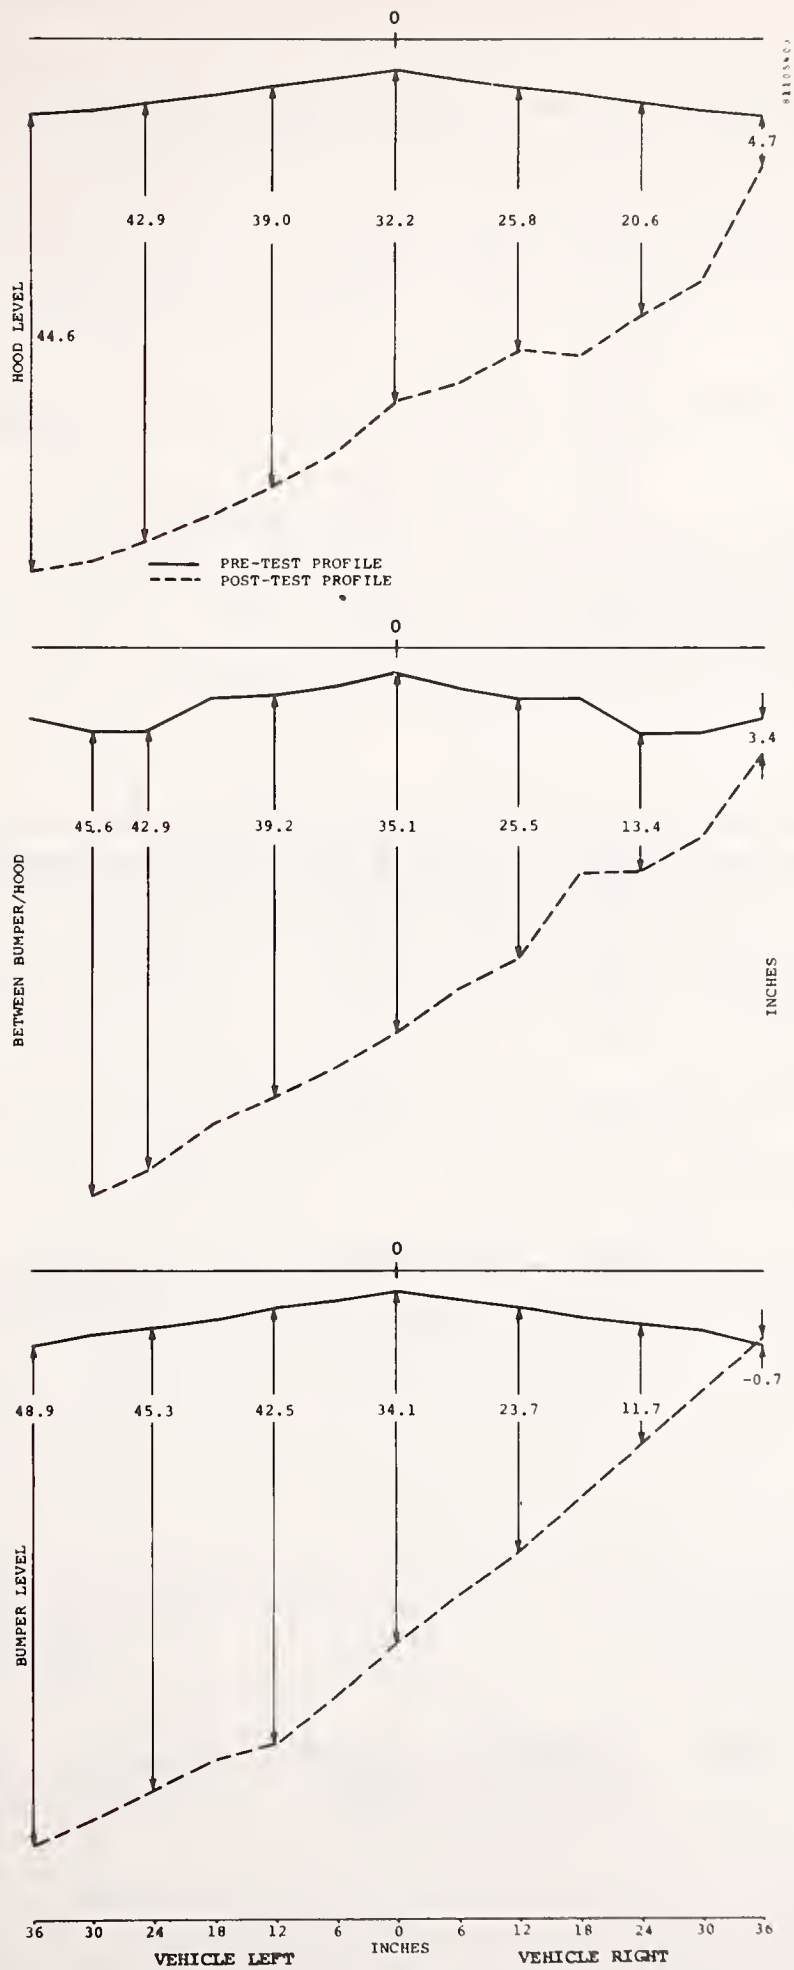
Figure 3-10. Chevrolet Impala Exterior Static Crush (Test 3051-6).

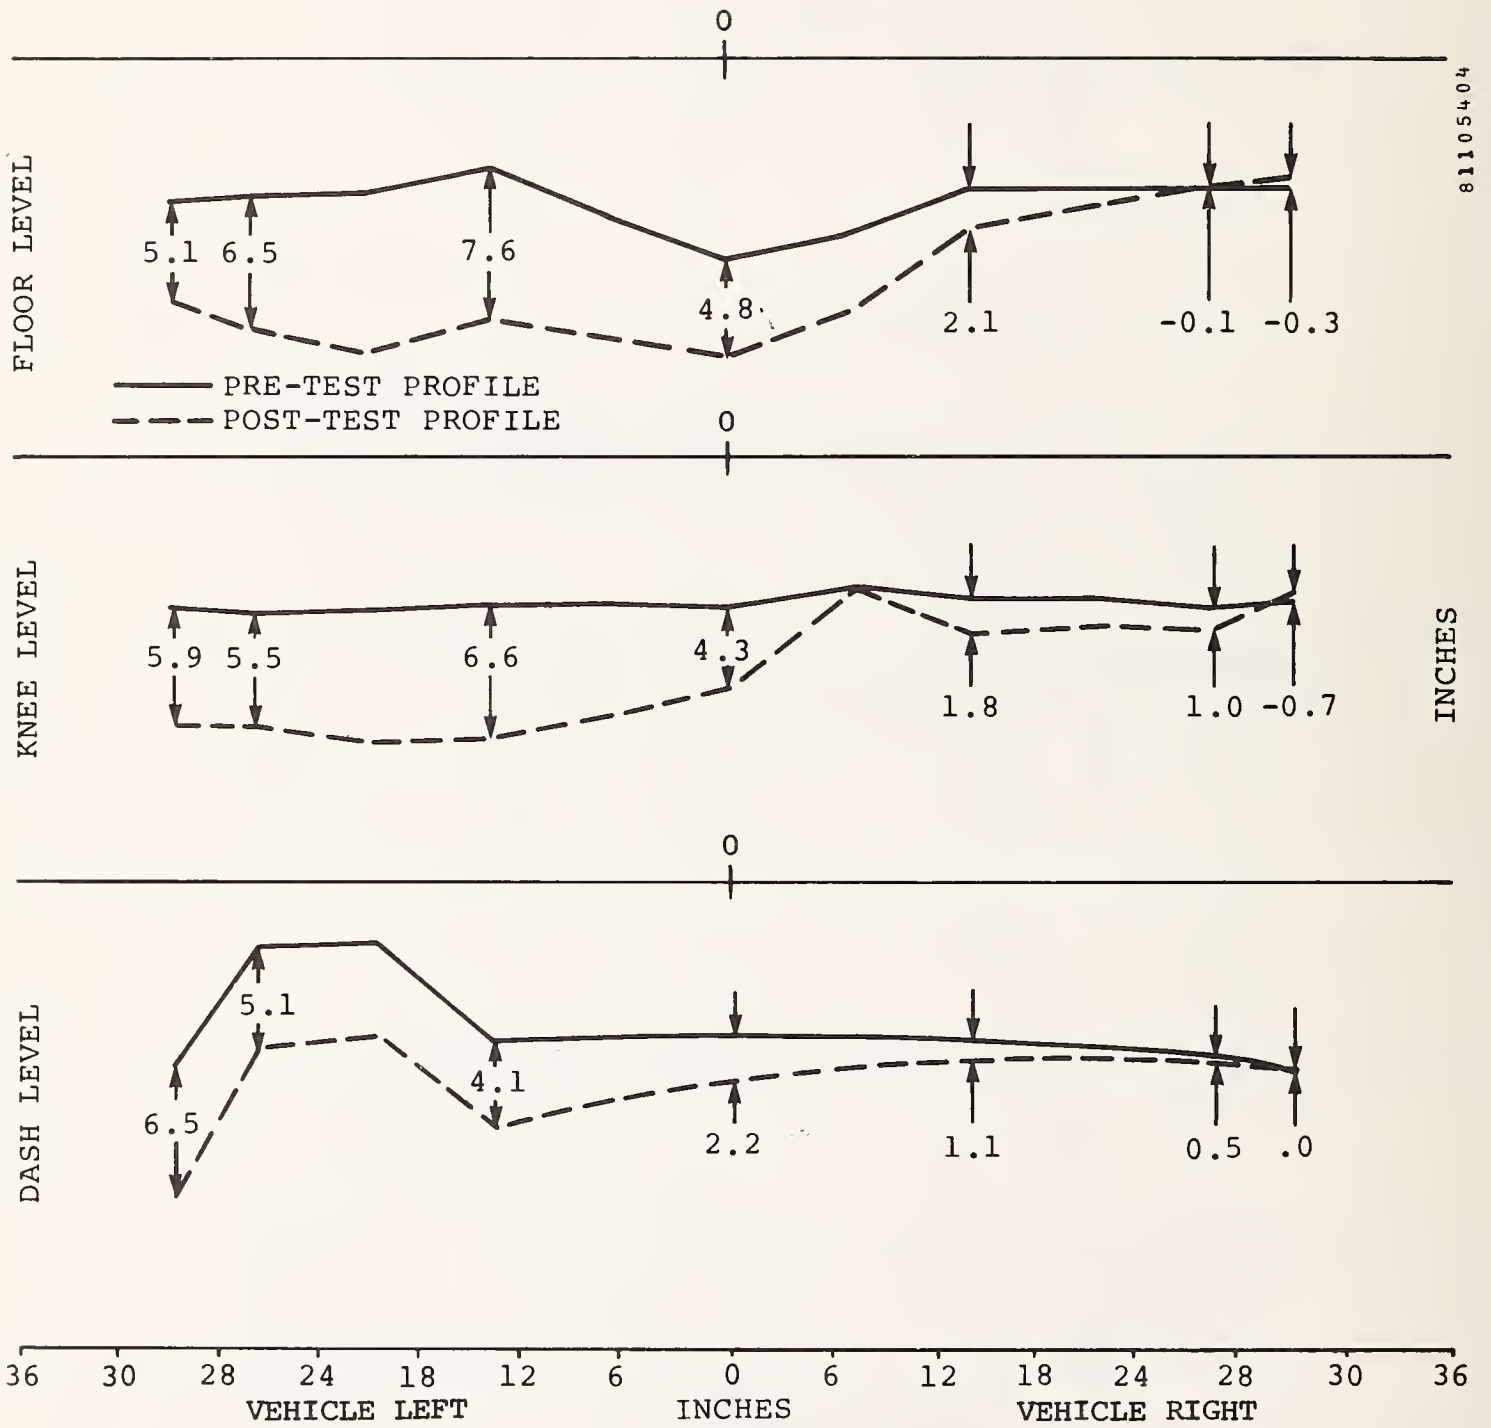
Figure 3-11. Chevrolet Impala Interior Intrusion (Test 3051-6).

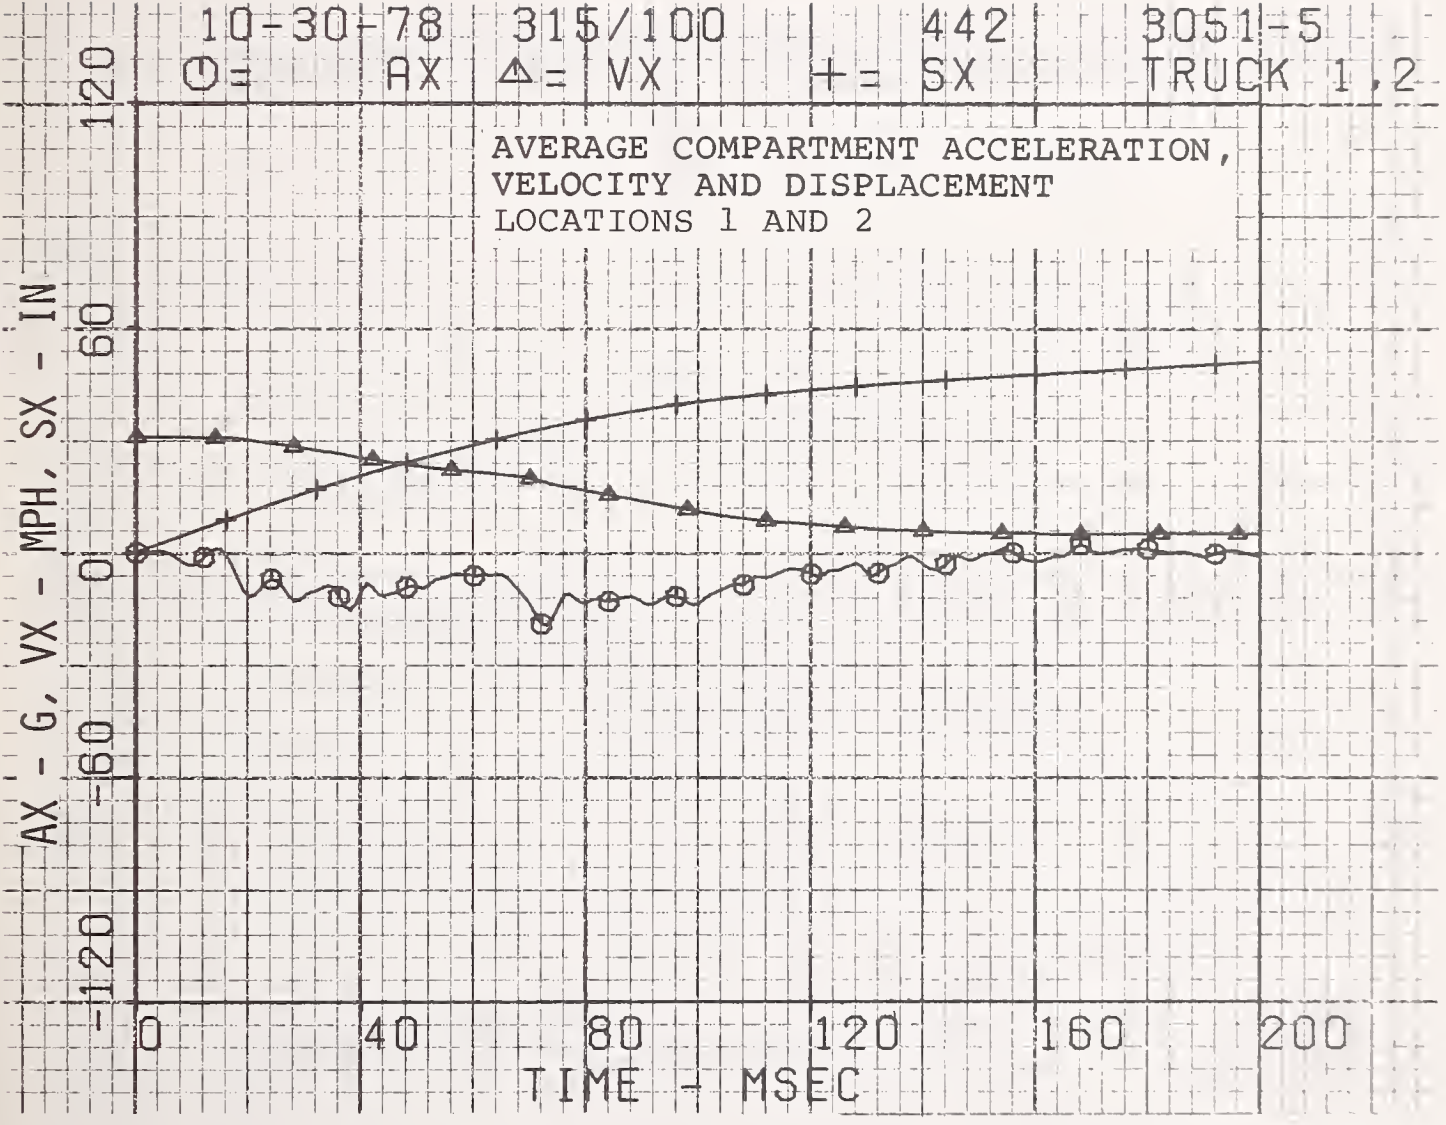
10-30-78 315/100 442 3051-5
 O = AX Δ = VX + = SX TRUCK 1,2

AVERAGE COMPARTMENT ACCELERATION,
 VELOCITY AND DISPLACEMENT
 LOCATIONS 1 AND 2
