LIGHT TRUCK AGGRESSIVITY STUDY- TEST REPORT 3- TRUCK-TO-CAR RIGHT OFFSET IMPACT TESTS

DECEMBER 1978
FINAL REPORT

| 15. Supplementary Notes Tests No. 5 and 6 of a series of 7 tests. | | | | 13. Type of Report and Period Covered FINAL REPORT Oct - Dec 1978 | |

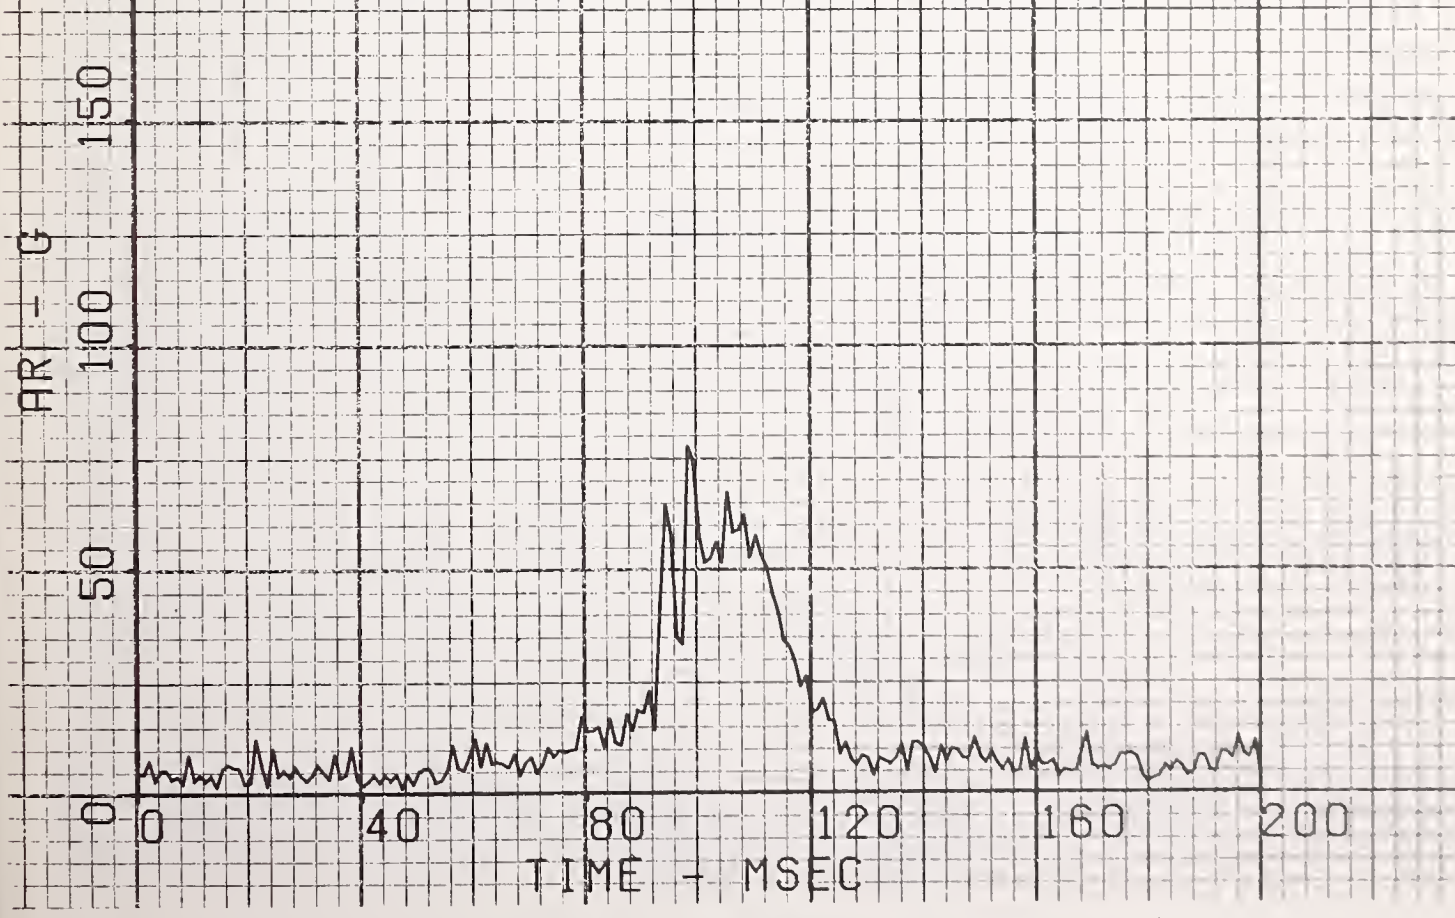
601 CHEV TRUCK

LEFT FRONT OCCUPANT HEAD
RESULTANT ACCELERATION

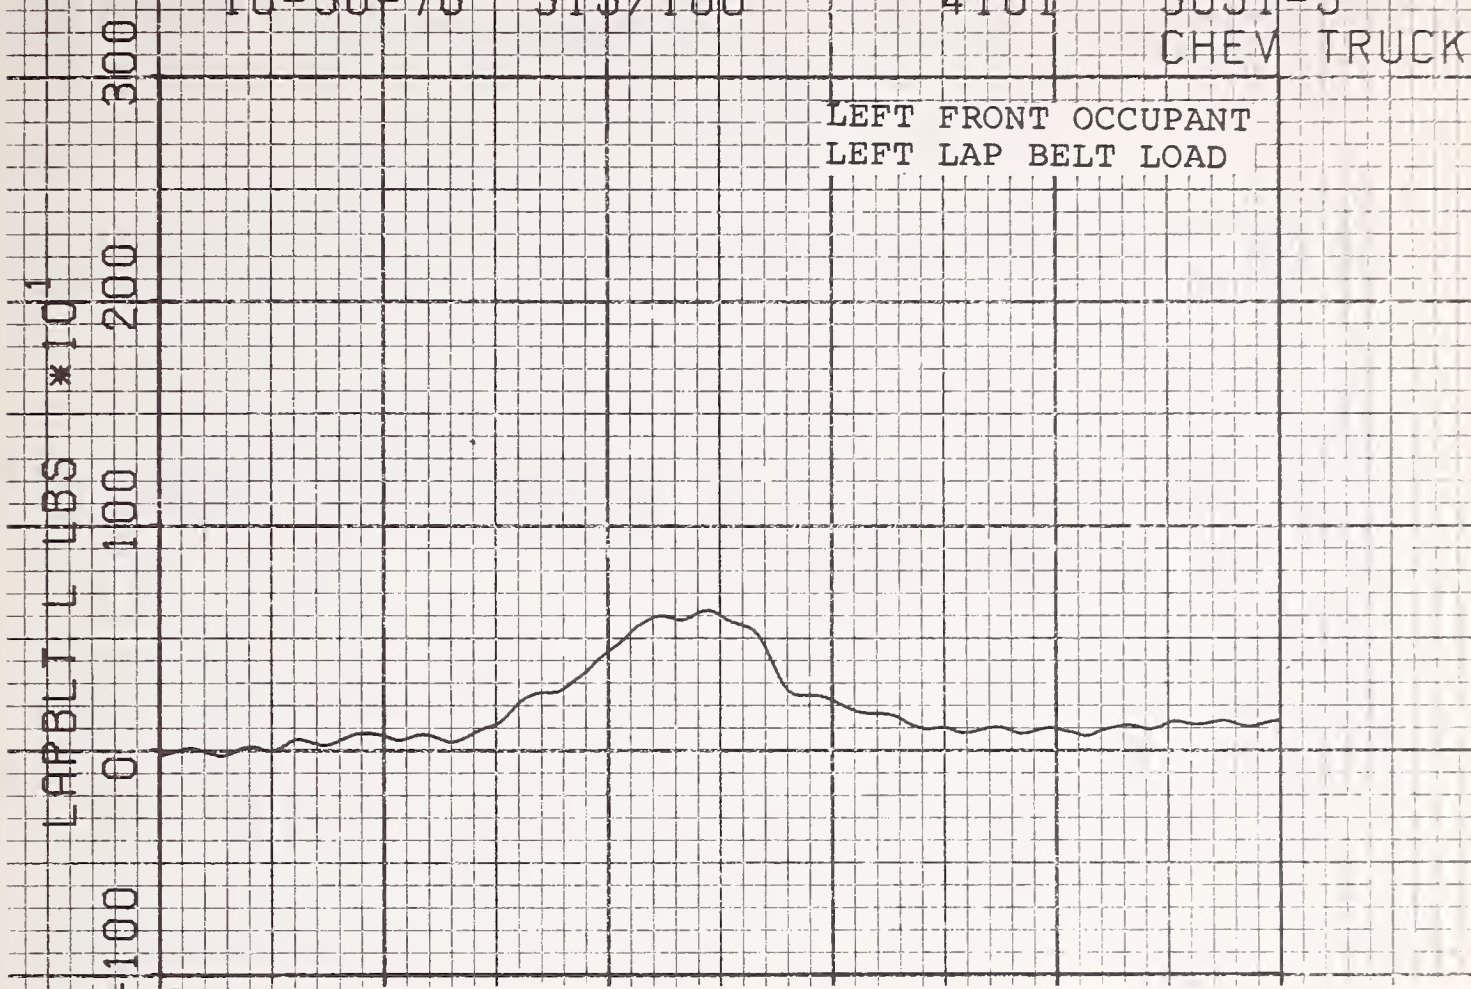
LEFT FRONT OCCUPANT
LEFT LAP BELT LOAD

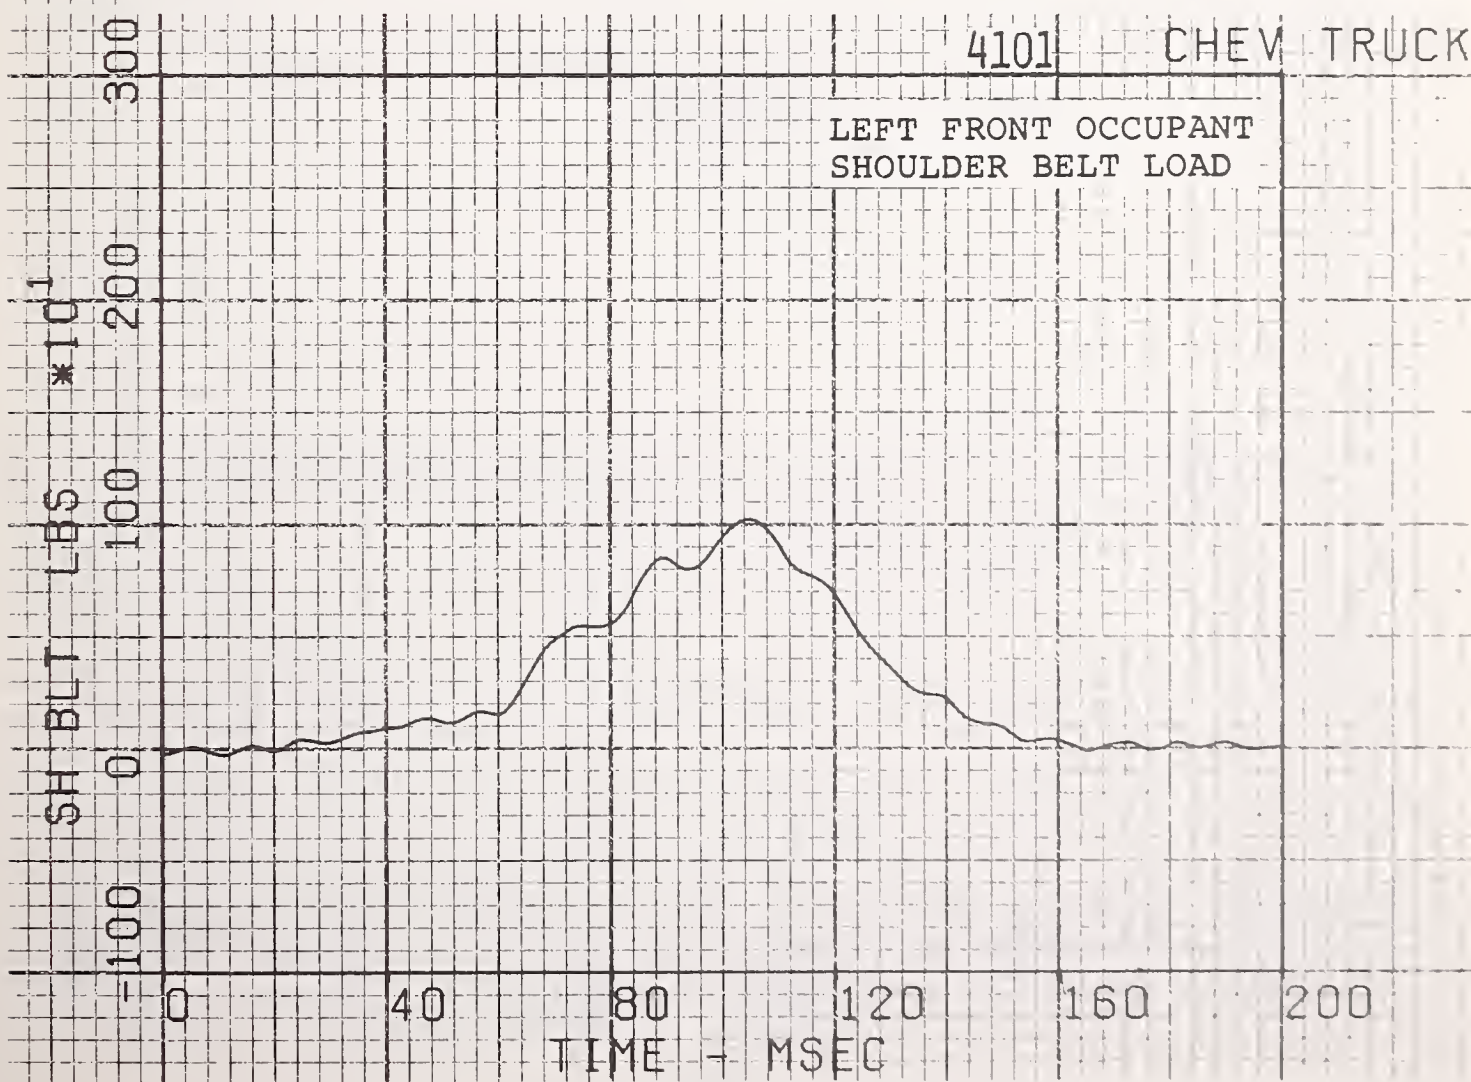
LEFT FRONT OCCUPANT
SHOULDER BELT LOAD

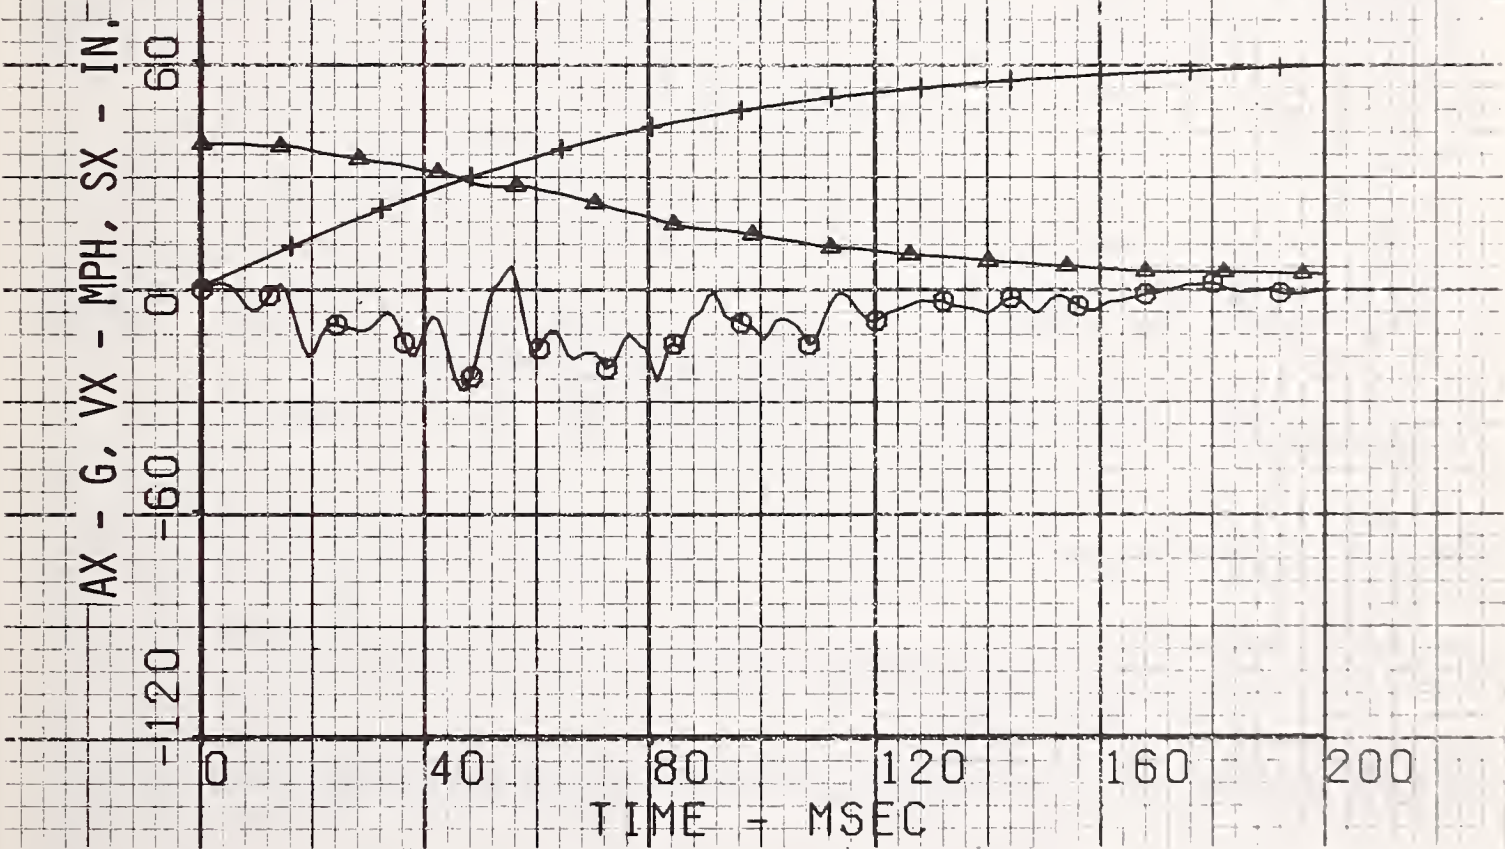
| 120178 | DATE | FILTER | LOCATION | TEST NO |
| | 11-28-78 | 315/100 | 442 | 3051-6 |
| | O = AX | Δ = VX | + = SX | TRUCK 1, 2 |

AVERAGE COMPARTMENT ACCELERATION,
VELOCITY AND DISPLACEMENT
LOCATIONS 1 AND 2

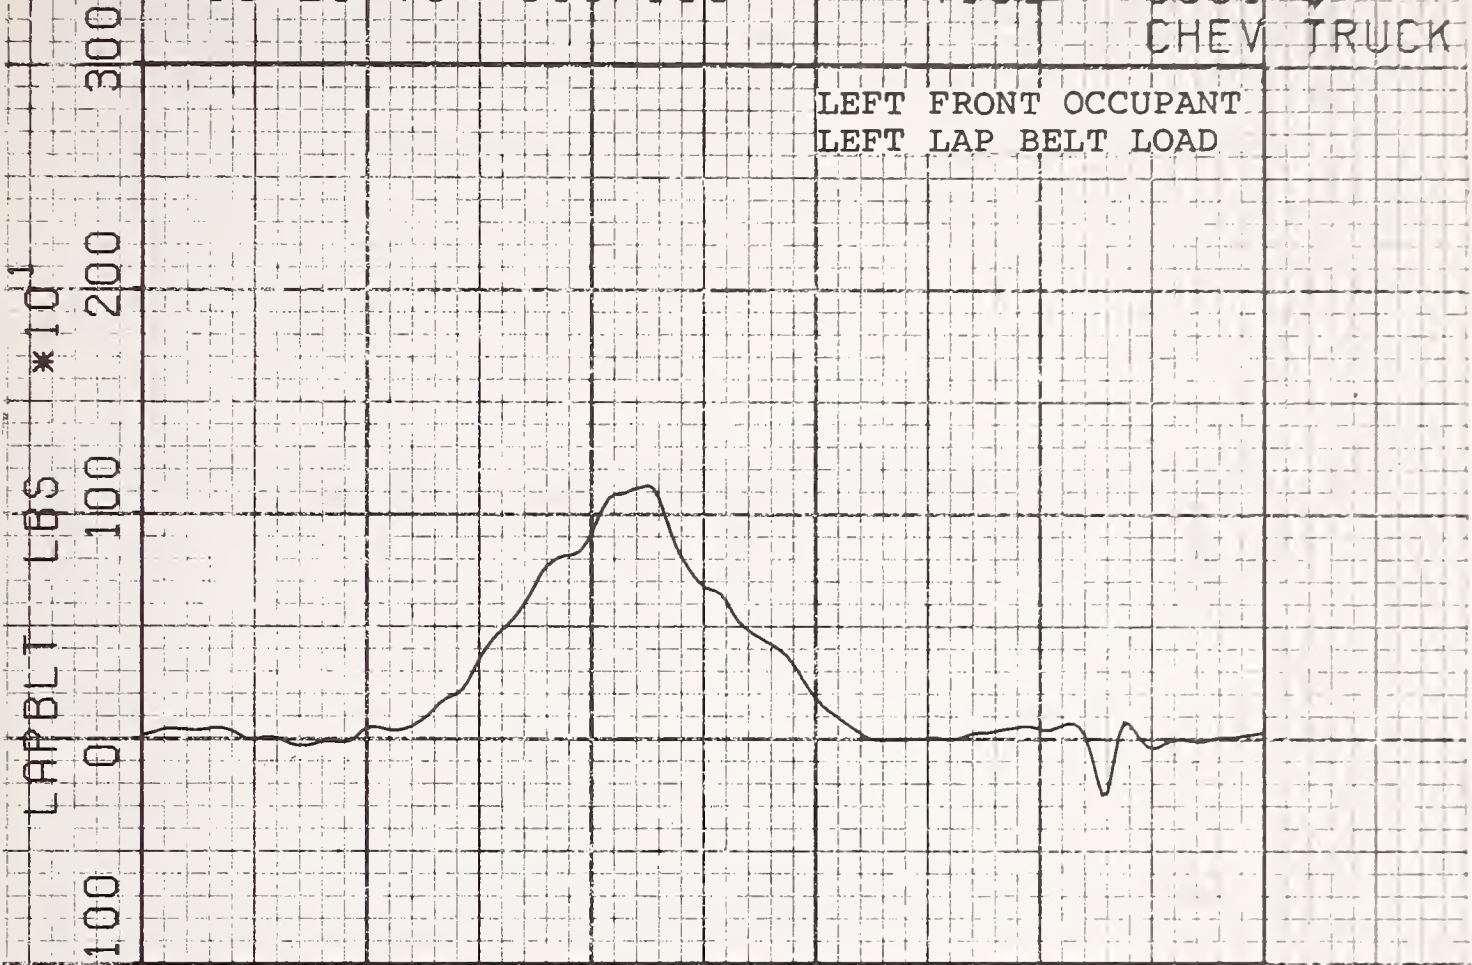
LEFT FRONT OCCUPANT
LEFT LAP BELT LOAD

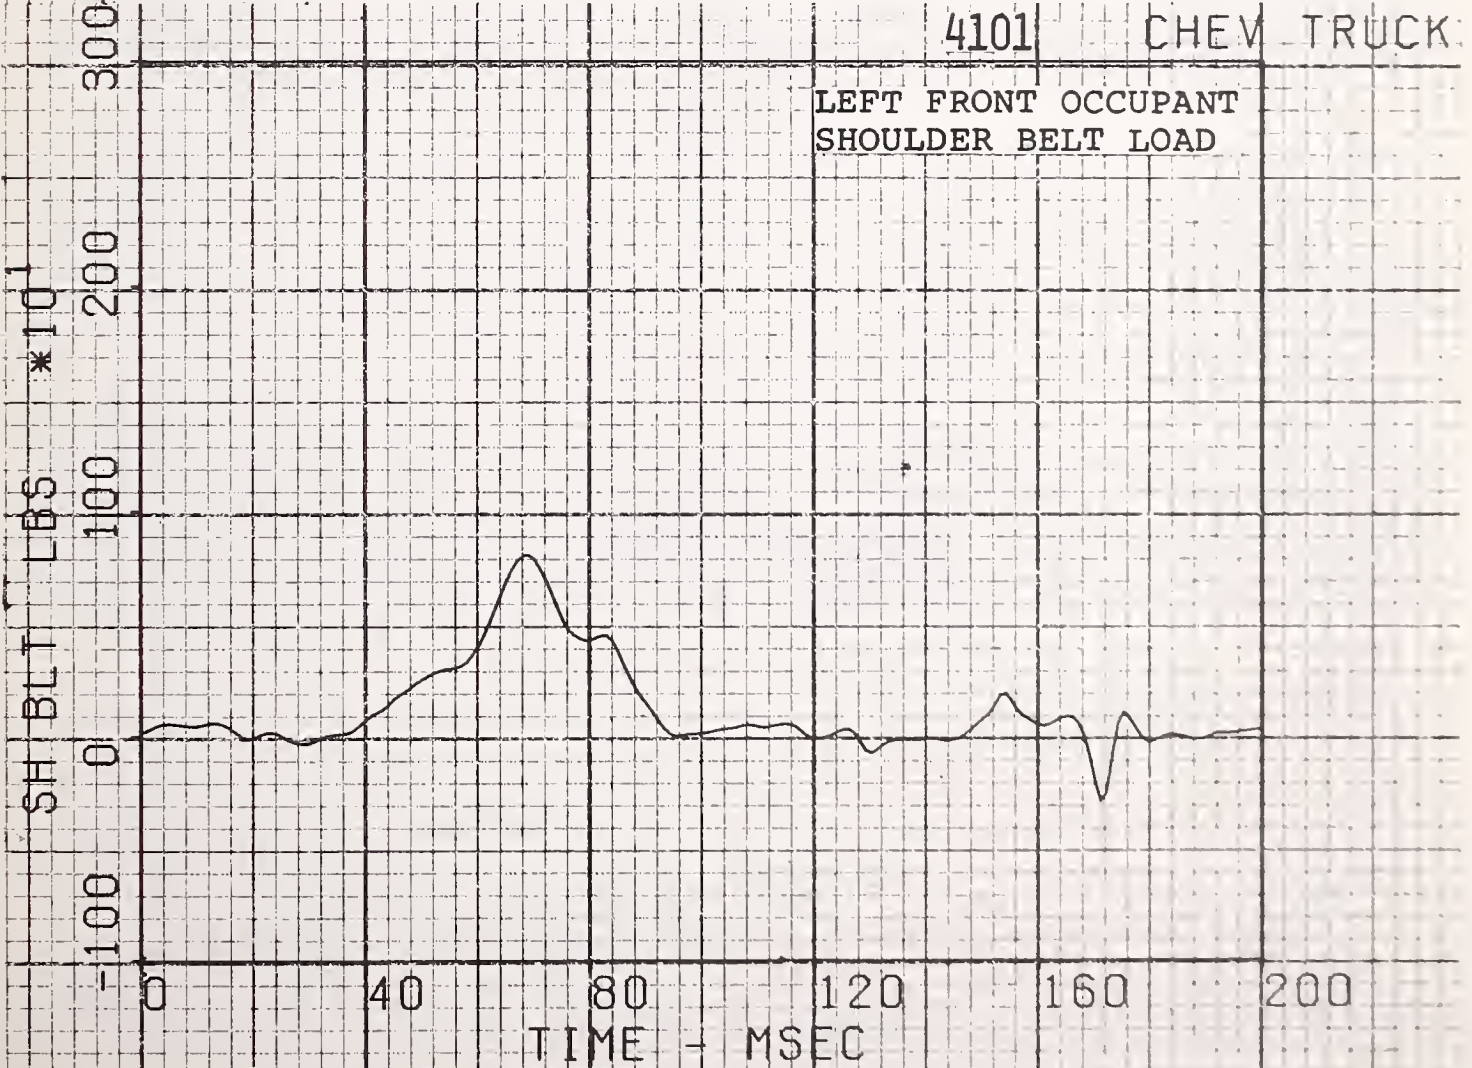
LEFT FRONT OCCUPANT
SHOULDER BELT LOAD

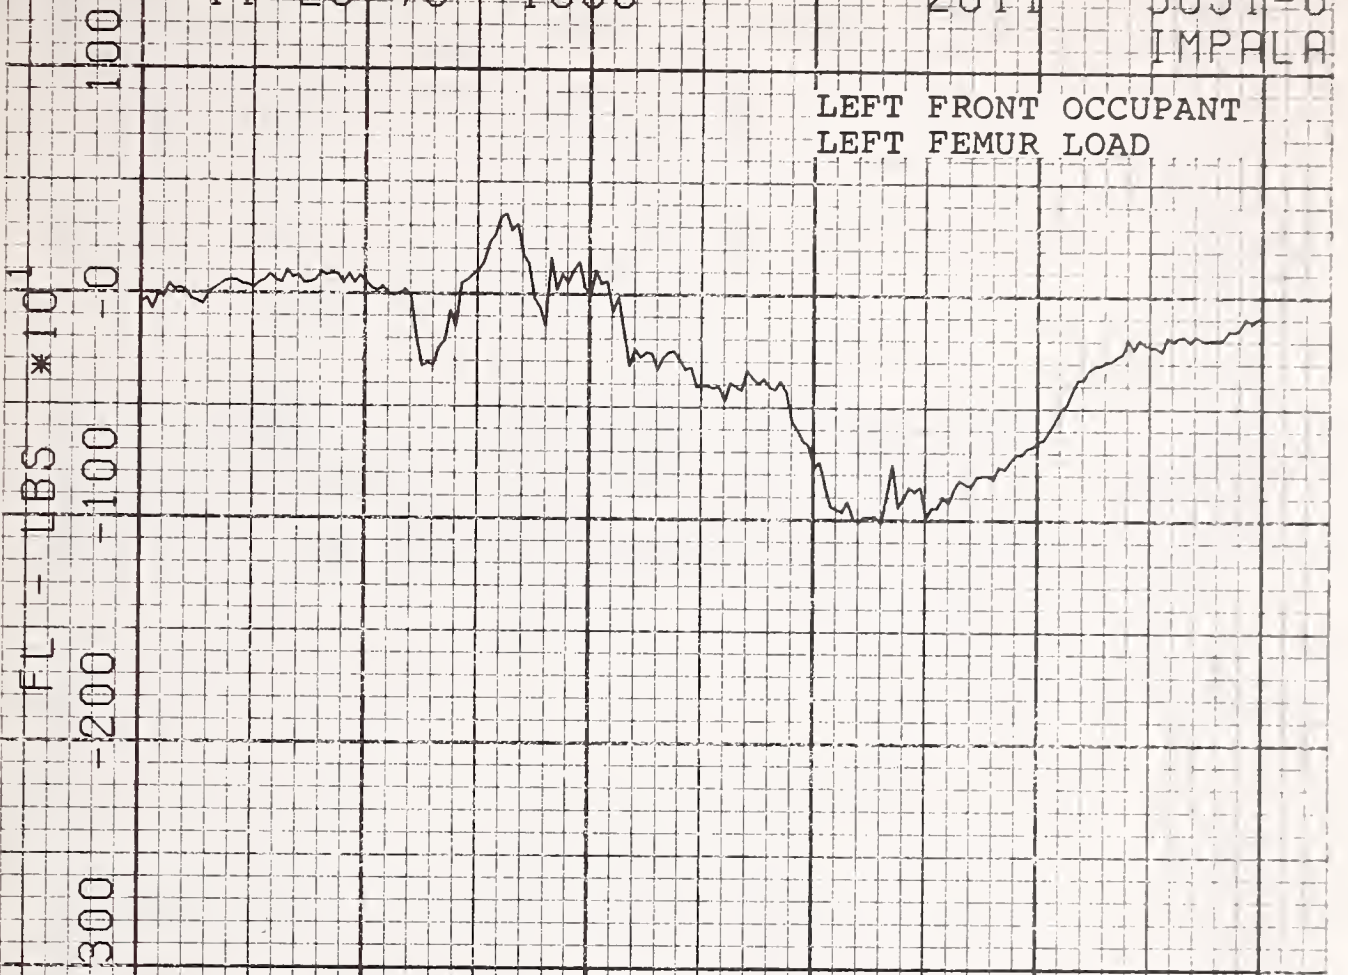
LEFT FRONT OCCUPANT
LEFT FEMUR LOAD

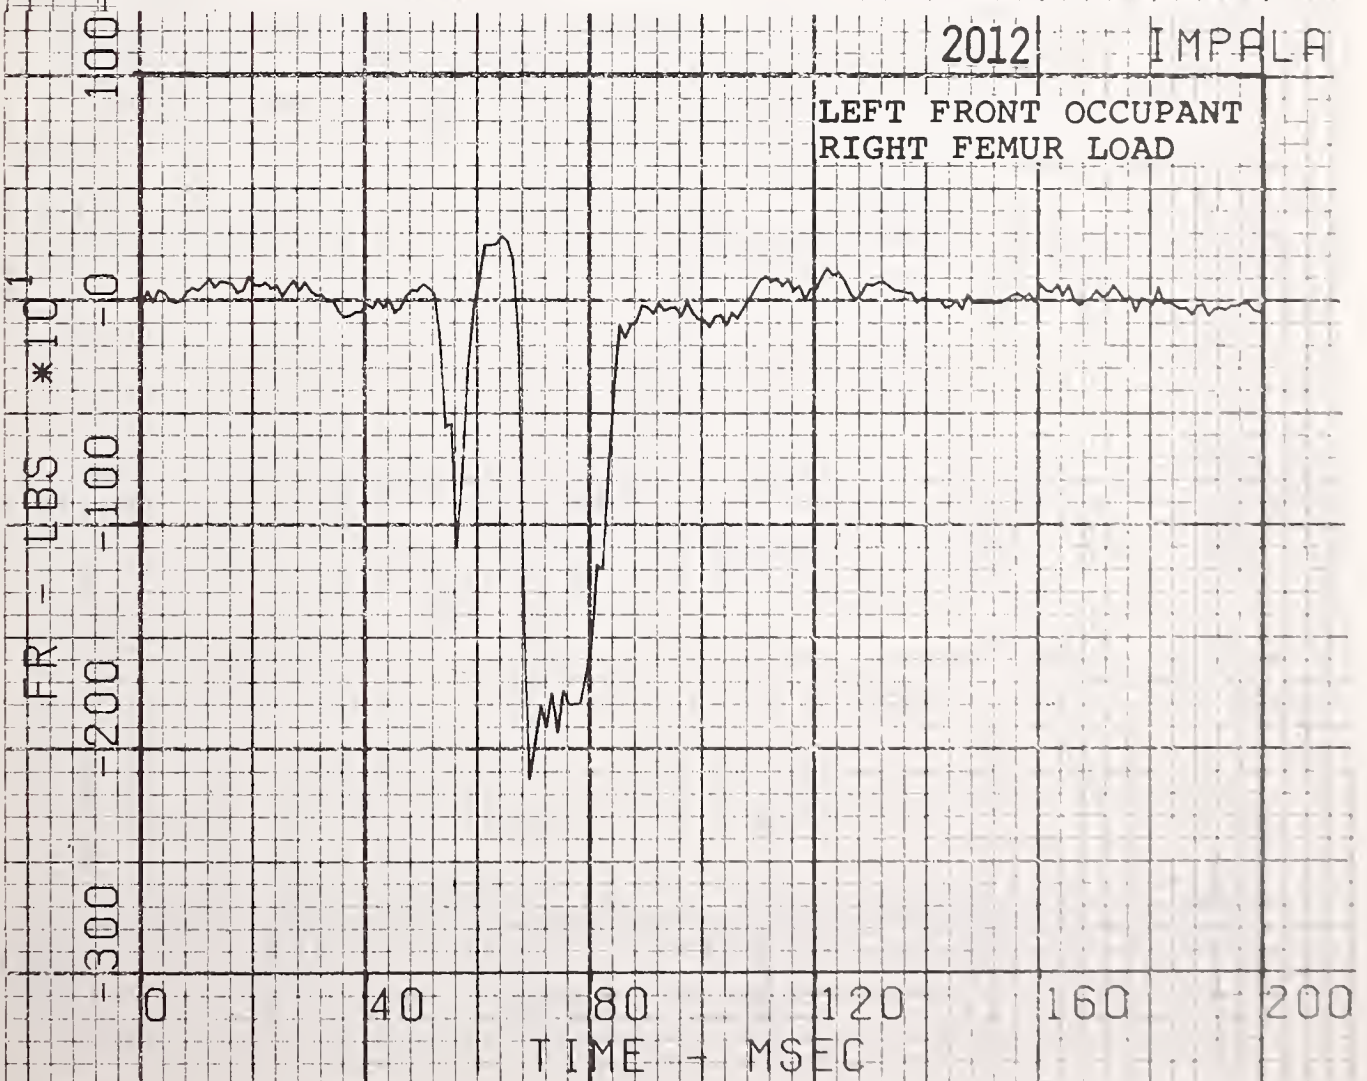
LEFT FRONT OCCUPANT
RIGHT FEMUR LOAD

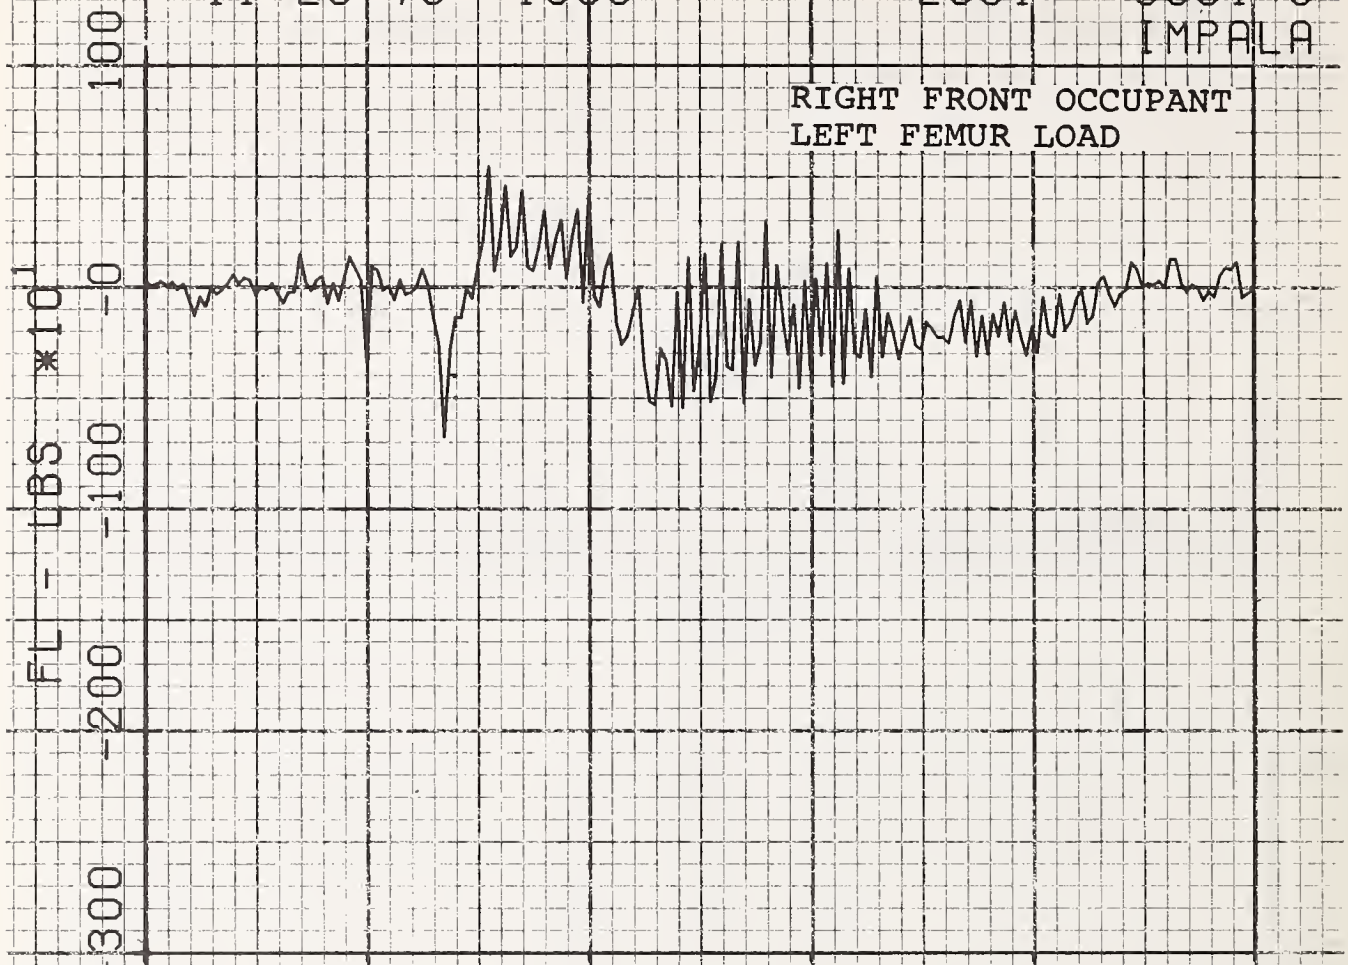
RIGHT FRONT OCCUPANT
LEFT FEMUR LOAD

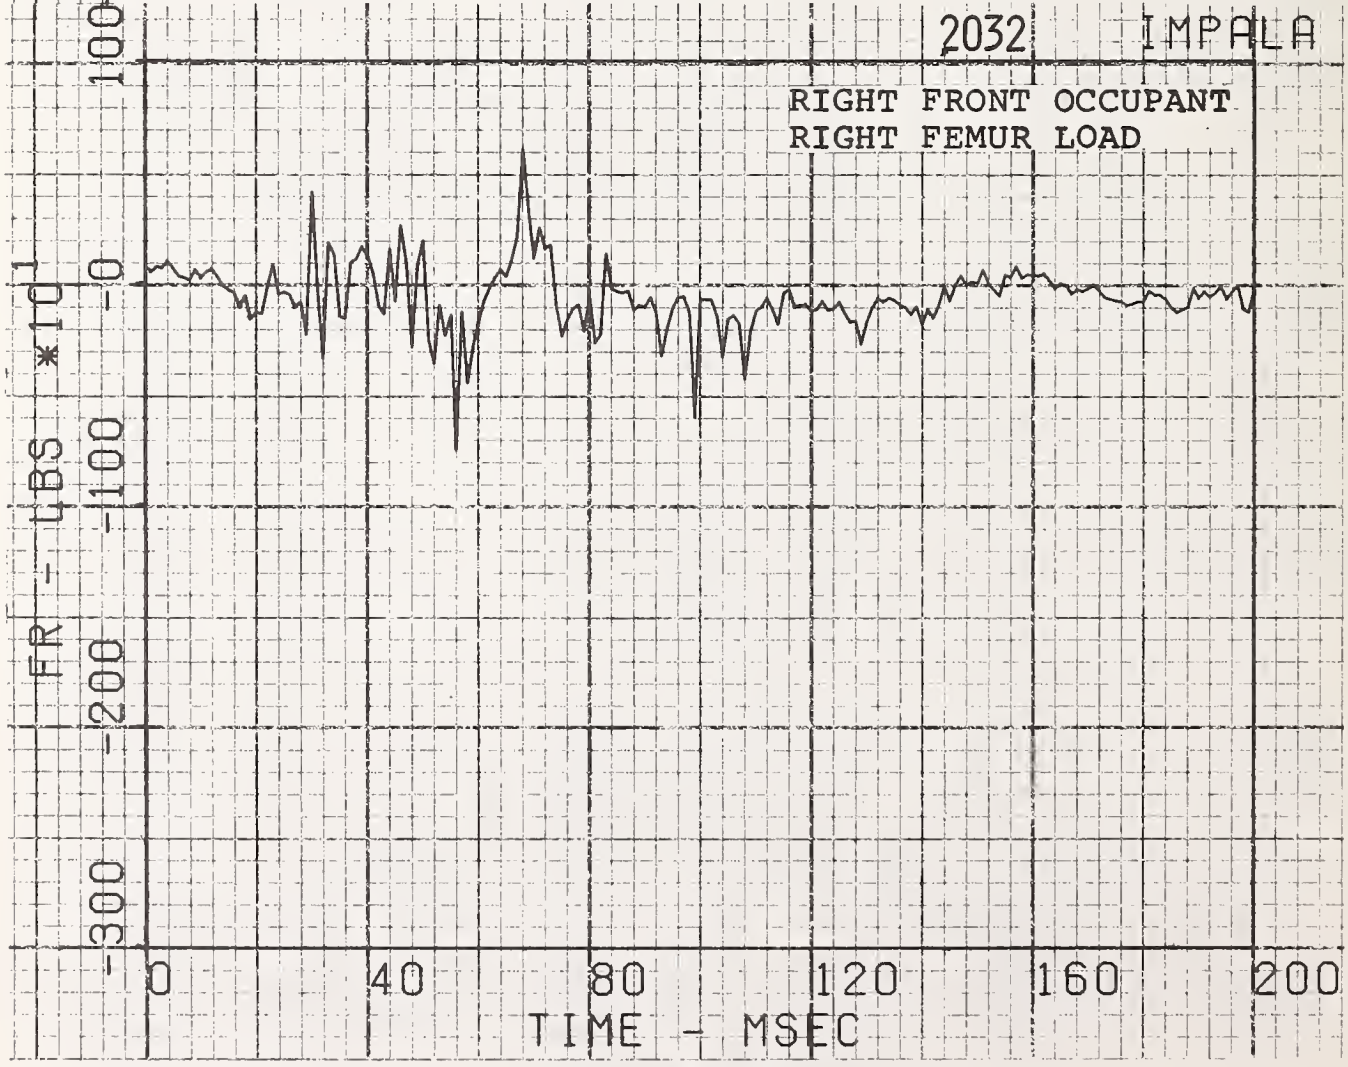
RIGHT FRONT OCCUPANT
RIGHT FEMUR LOAD
