# LIGHT TRUCK AGGRESSIVITY STUDY- TEST REPORT 4- TRUCK-TO-CAR REAR-END IMPACT TEST

Dynamic Science, Inc.  
A Talley Industries Company  
1850 West Pinnacle Peak Road  
Phoenix, Arizona 85027

FEBRUARY 1979  
FINAL REPORT

This section of the report presents the results of Test 3051-7, a symmetric rear-end impact crash test between a 1979 Chevrolet C-10 pickup truck (bullet vehicle) and a 1978 Plymouth Horizon 4-door sedan (target vehicle).

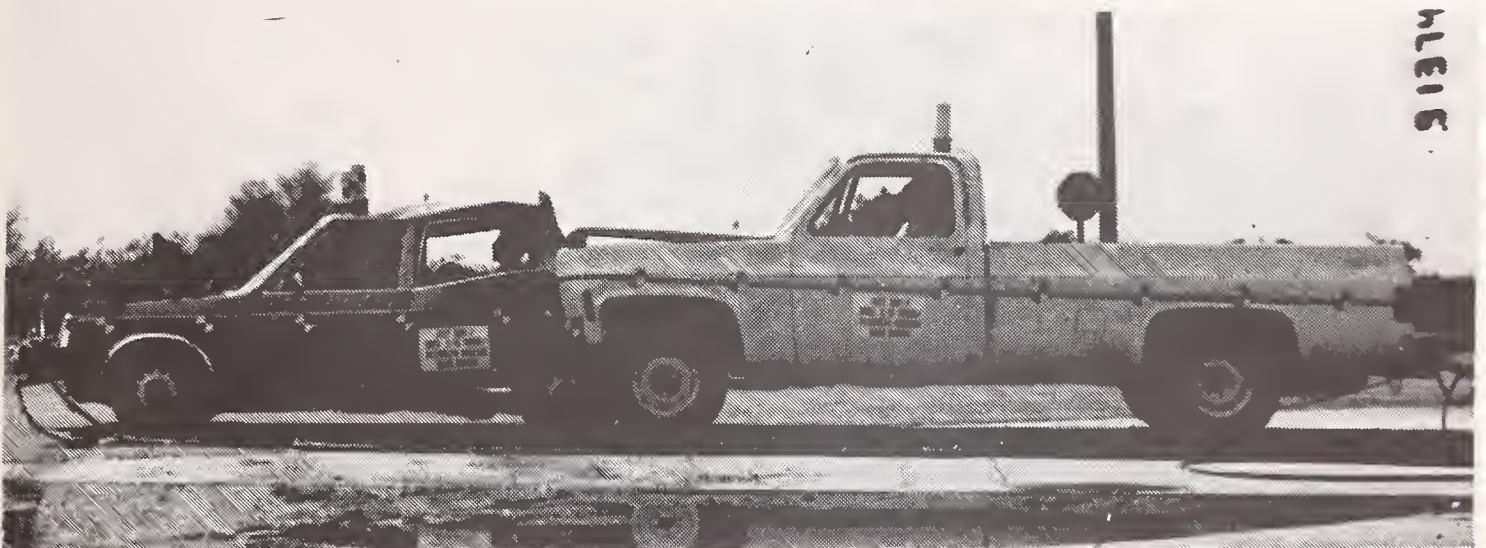
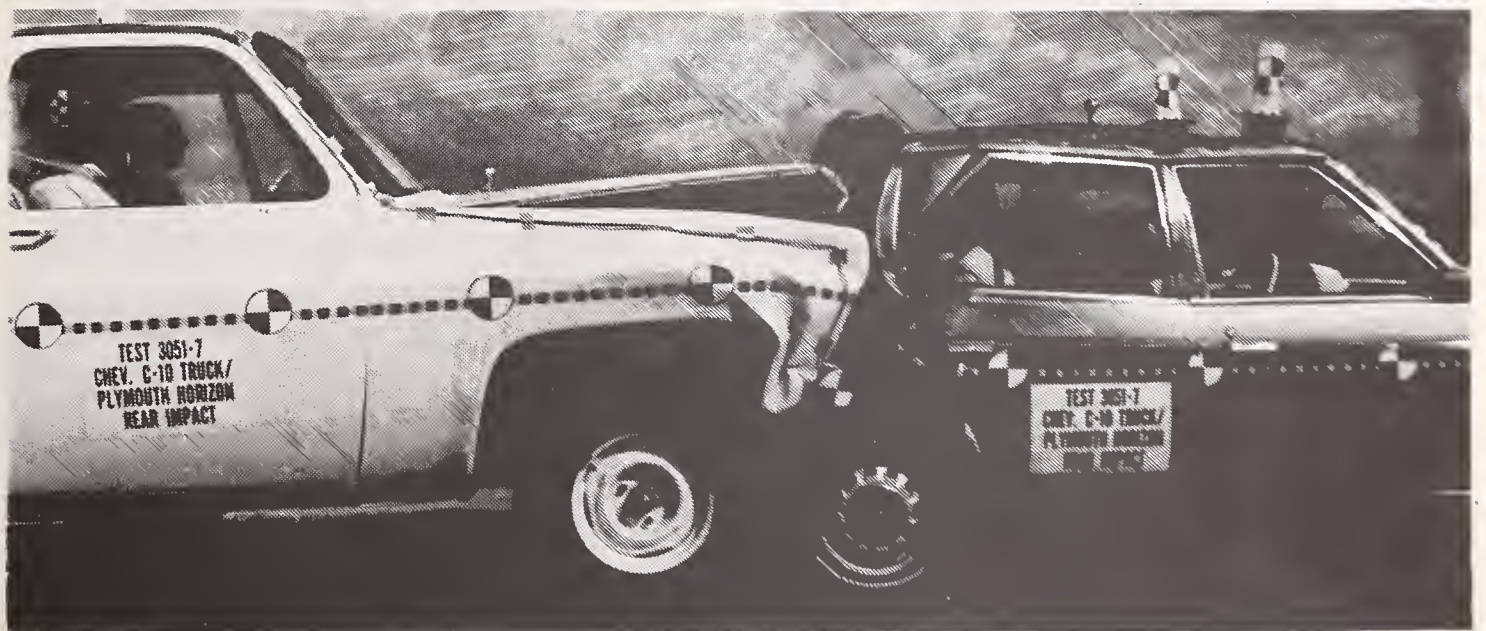
Figure 2-3. Pre- and Post-test Vehicle Configuration (Test 3051-7).

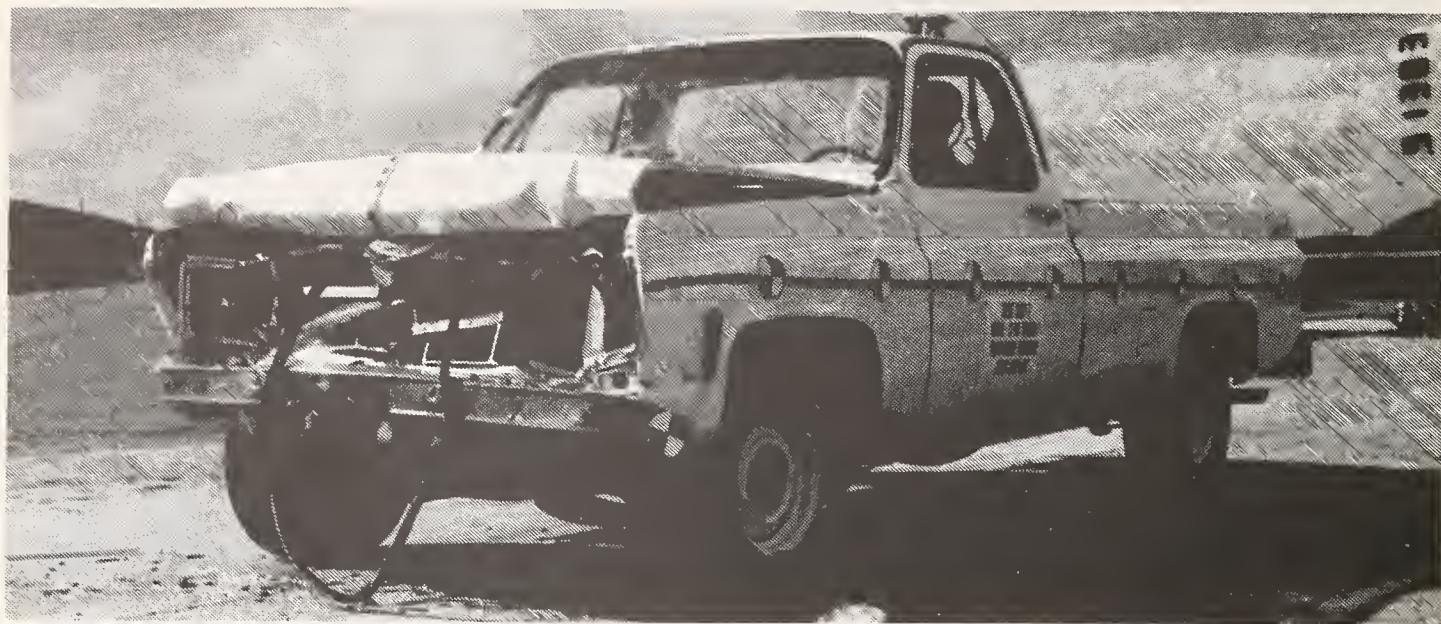
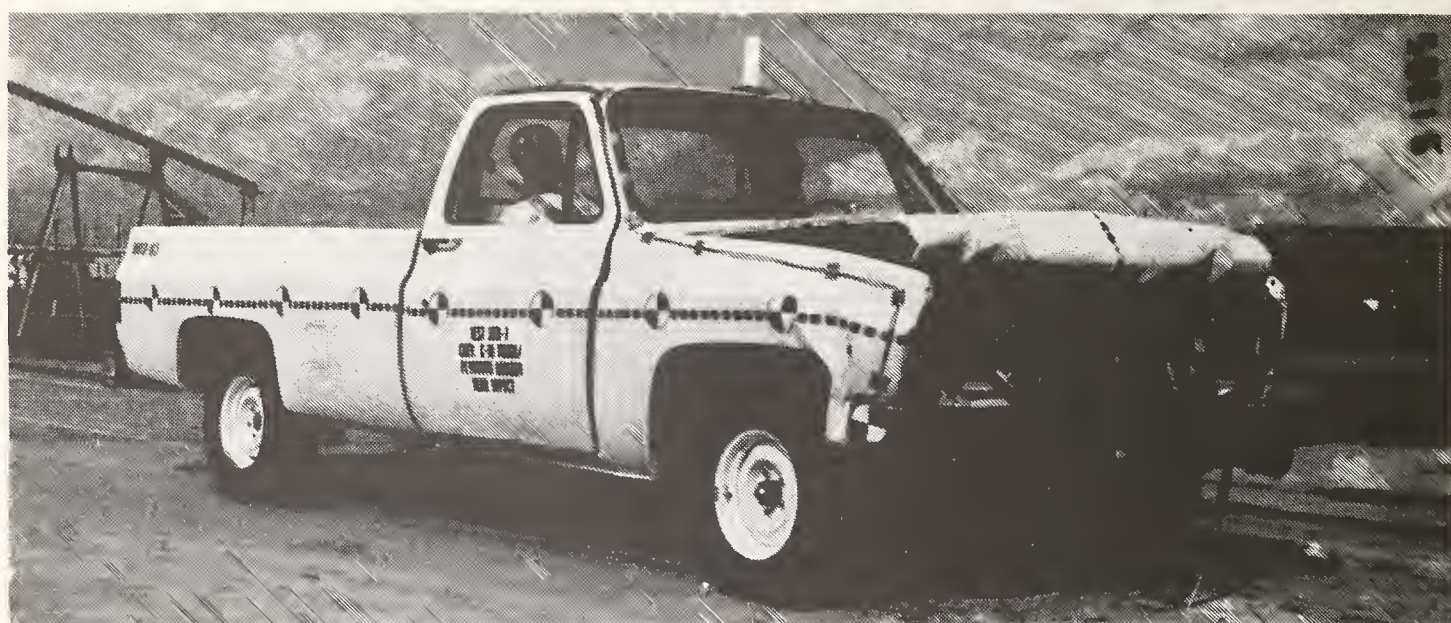
Figure 2-4. Post-test Chevrolet C-10 Truck Configuration (Test 3051-7).

General Observations: Truck abort brakes applied 76 ft from impact. Truck came to rest 77.5 ft from impact. Hood latch failed.

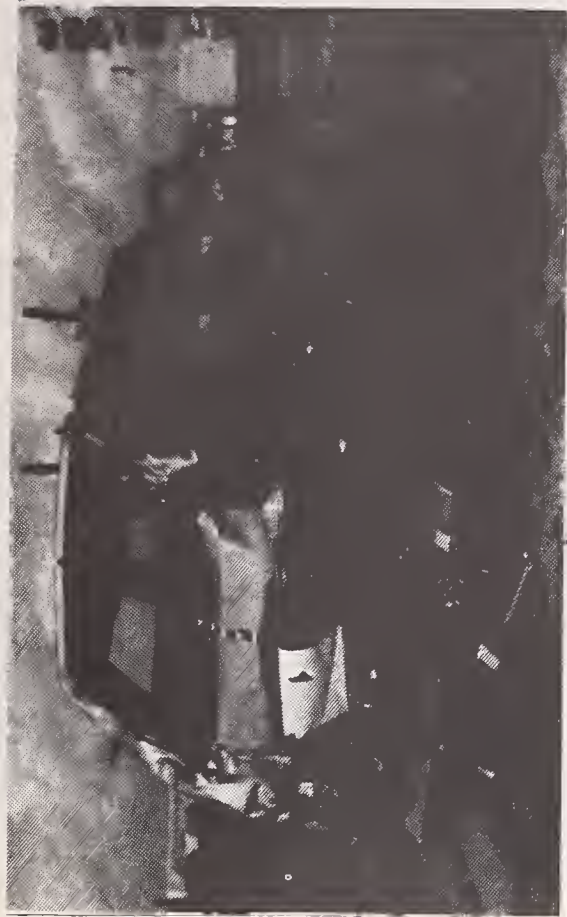
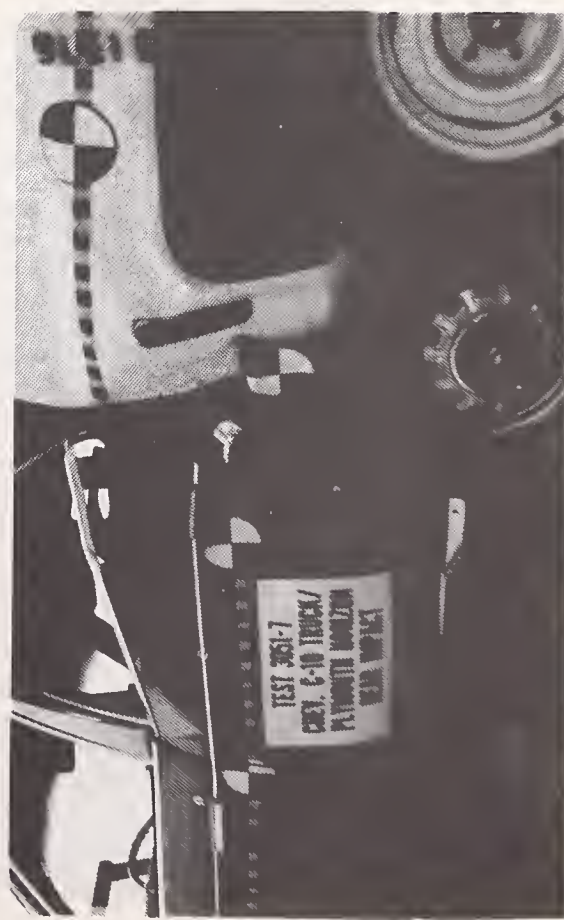
Figure 2-5. Post-test Plymouth Horizon Configuration (Test 3051-7).

Seat Belt Anchorages and Restraints: Driver seat back bent back and seat was pulled from right side track. Rear seat right side latch and hinge failed.

General Observations: Vehicle pushed off concrete onto oval track. Rear of car 77.5 ft from impact. Driver headrest came off. Abort brakes applied 34.5 ft from impact.

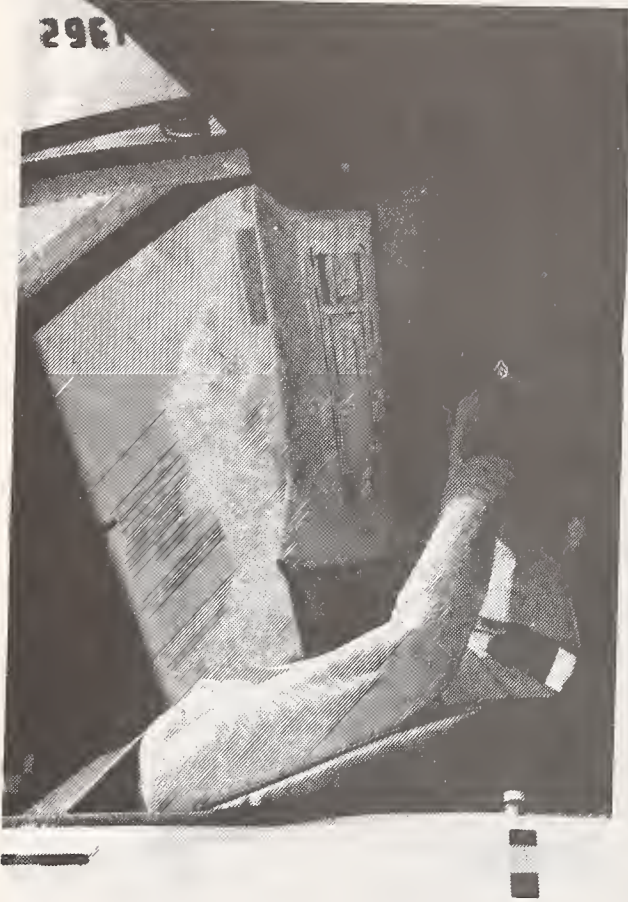
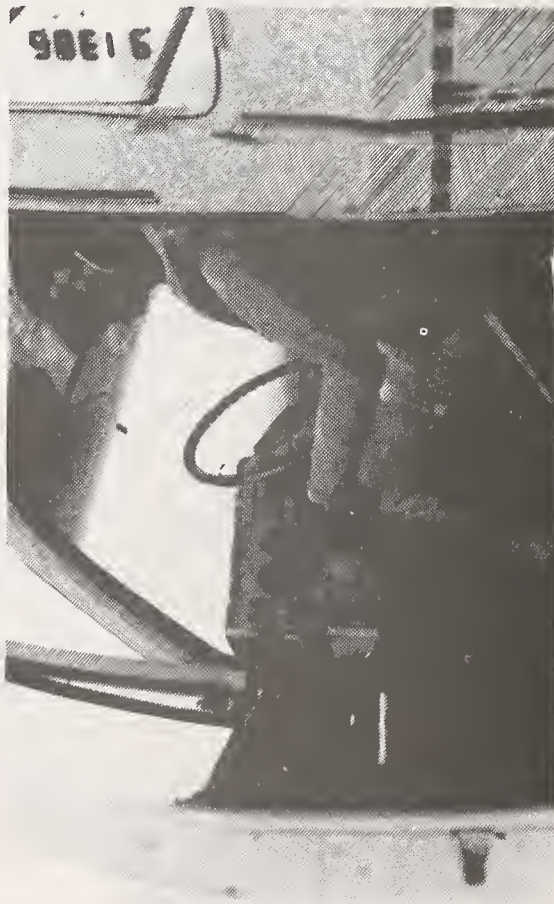
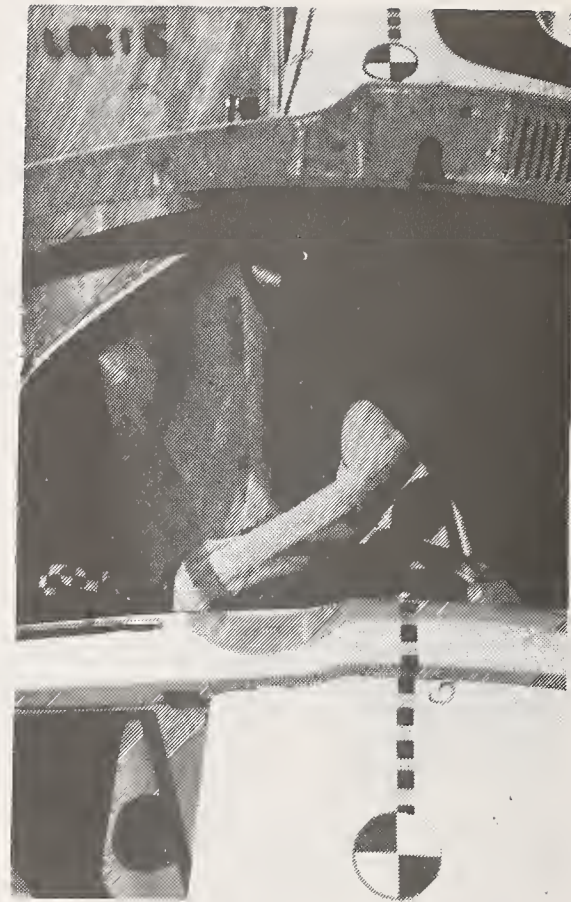
Figure 2-6. Chevrolet C-10 Truck Dummy Configuration (Test 3051-7).

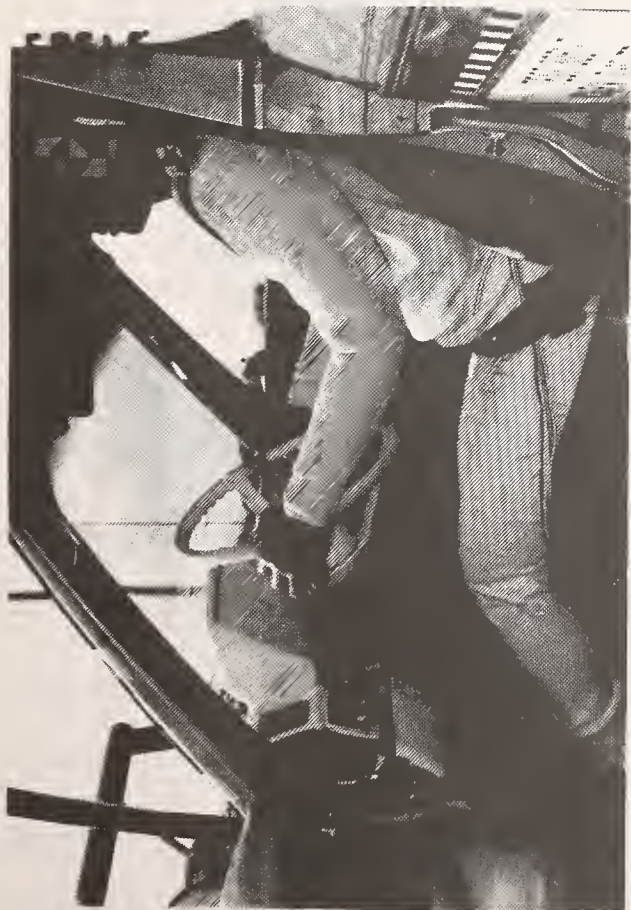
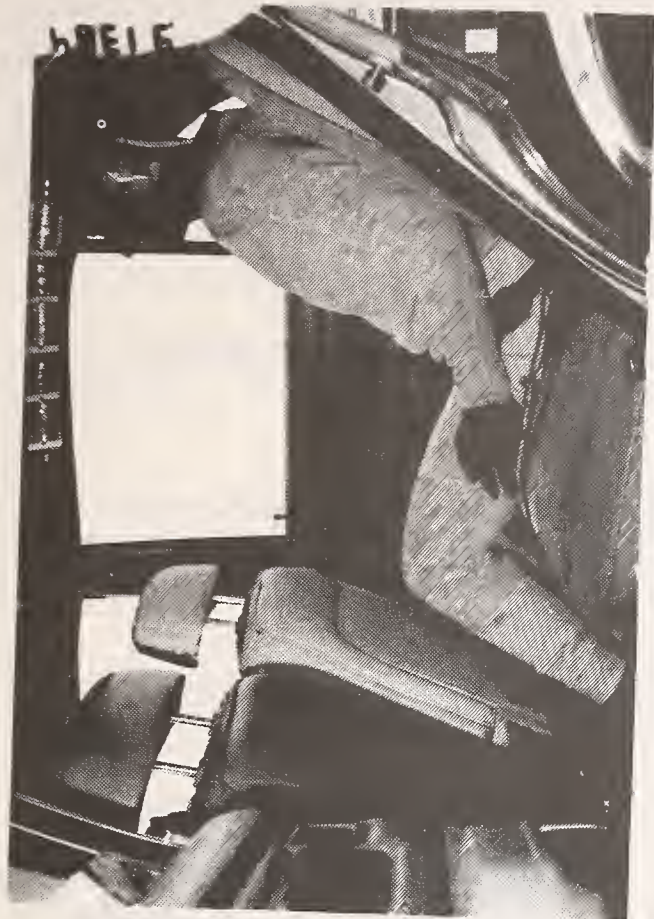
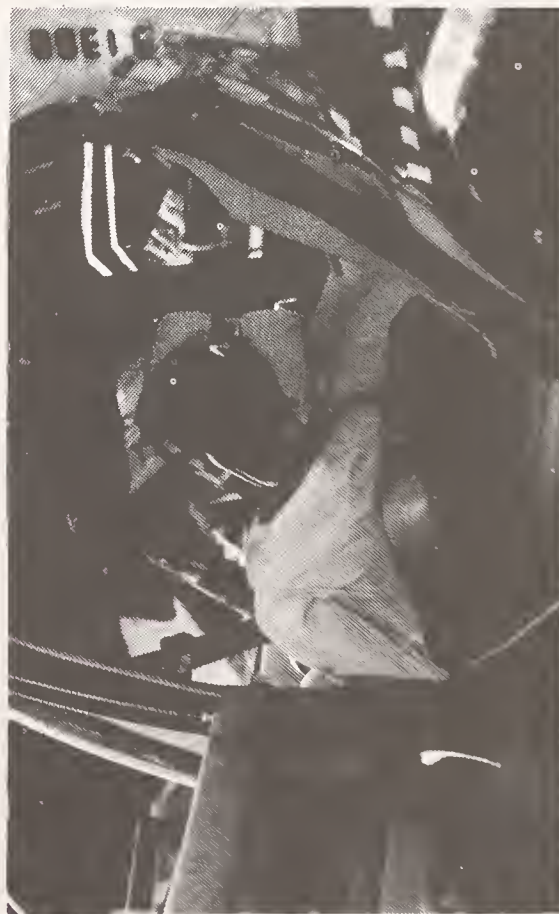
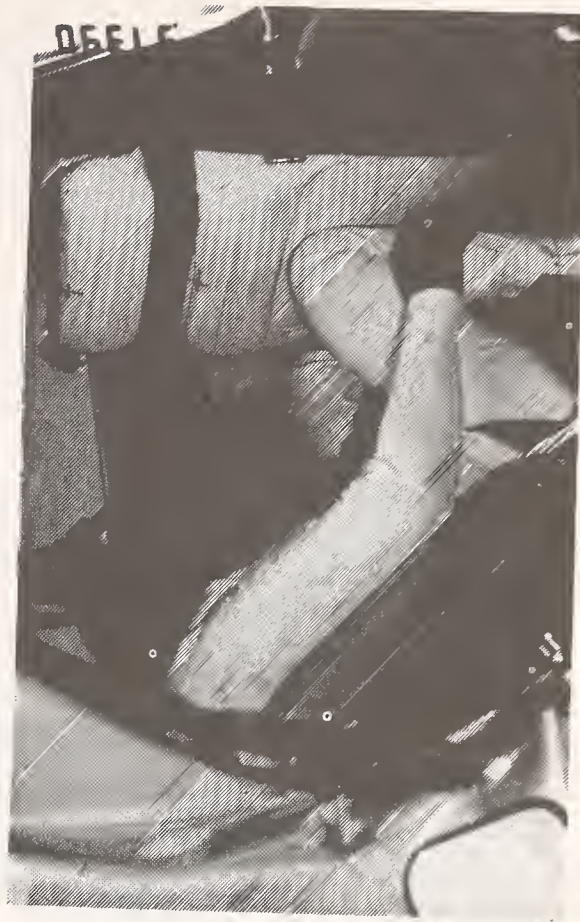
Figure 2-7. Plymouth Horizon Dummy Configuration (Test 3051-7).
