# LIGHT TRUCK AGGRESSIVITY STUDY- TASK 3 ANALYSIS REPORT

Dynamic Science, Inc.  
A Talley Industries Company  
1850 West Pinnacle Peak Road  
Phoenix, Arizona 85027

APRIL 1979  
FINAL REPORT

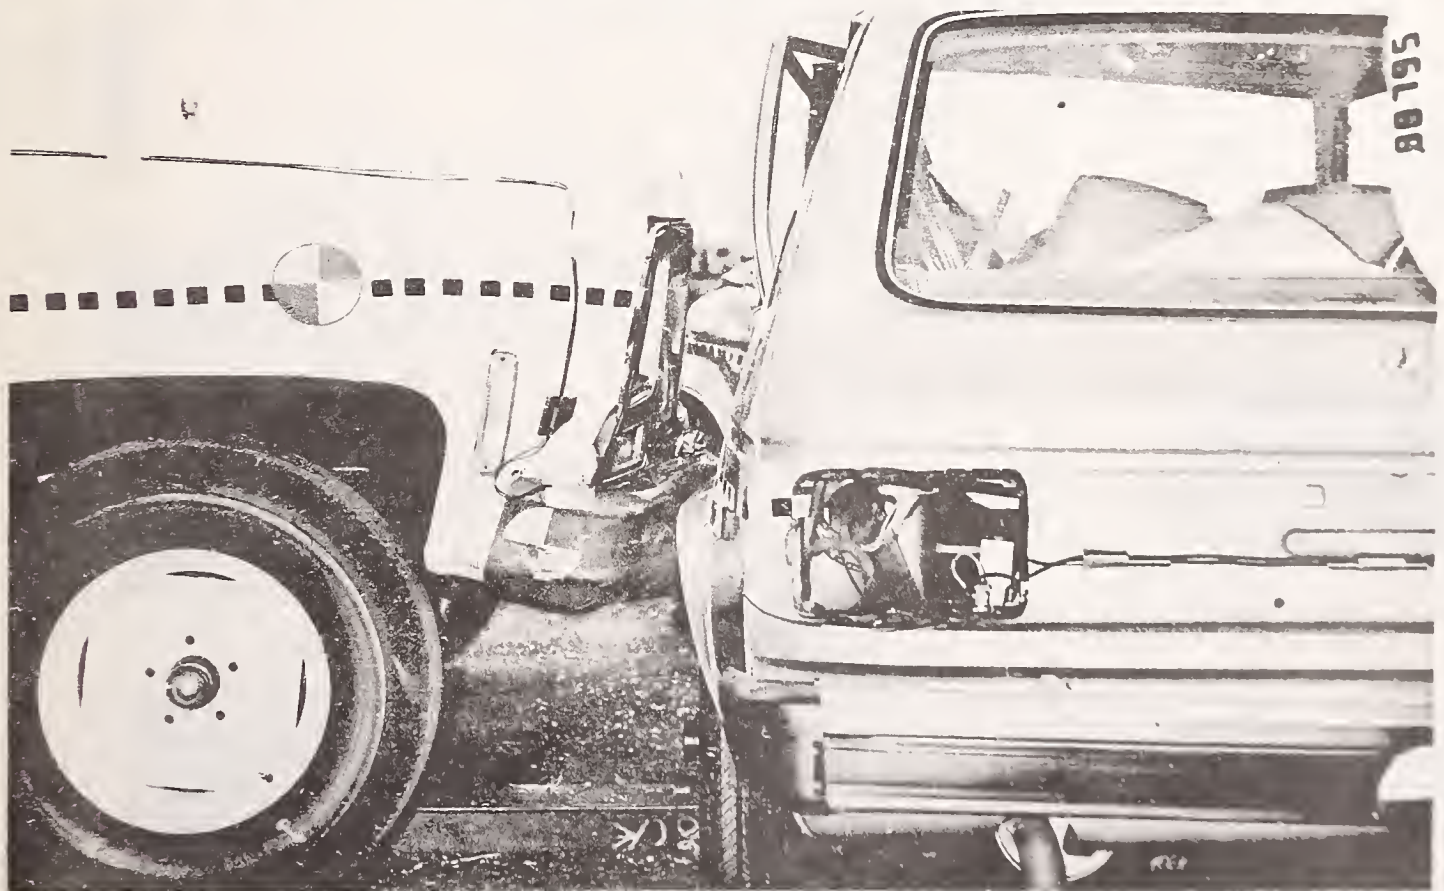
Figure 3-3. Chevrolet C-10 Truck Bumper-to-Plymouth Horizon Side Matchup (Test 3051-3).

a) Pre-test

b) Post-test

Vehicle geometry differences between the vehicles used in the two light truck side impact test conditions are shown in Figures 3-1 and 3-2. The dimensional parameters used in determining the possible architectural aggressivity are presented in Table 3-2. Close-ups of C-10 truck bumper-to-vehicle side interface are shown in Figure 3-3 for Test 3051-3 and in Figure 3-4 for Test 3051-4.

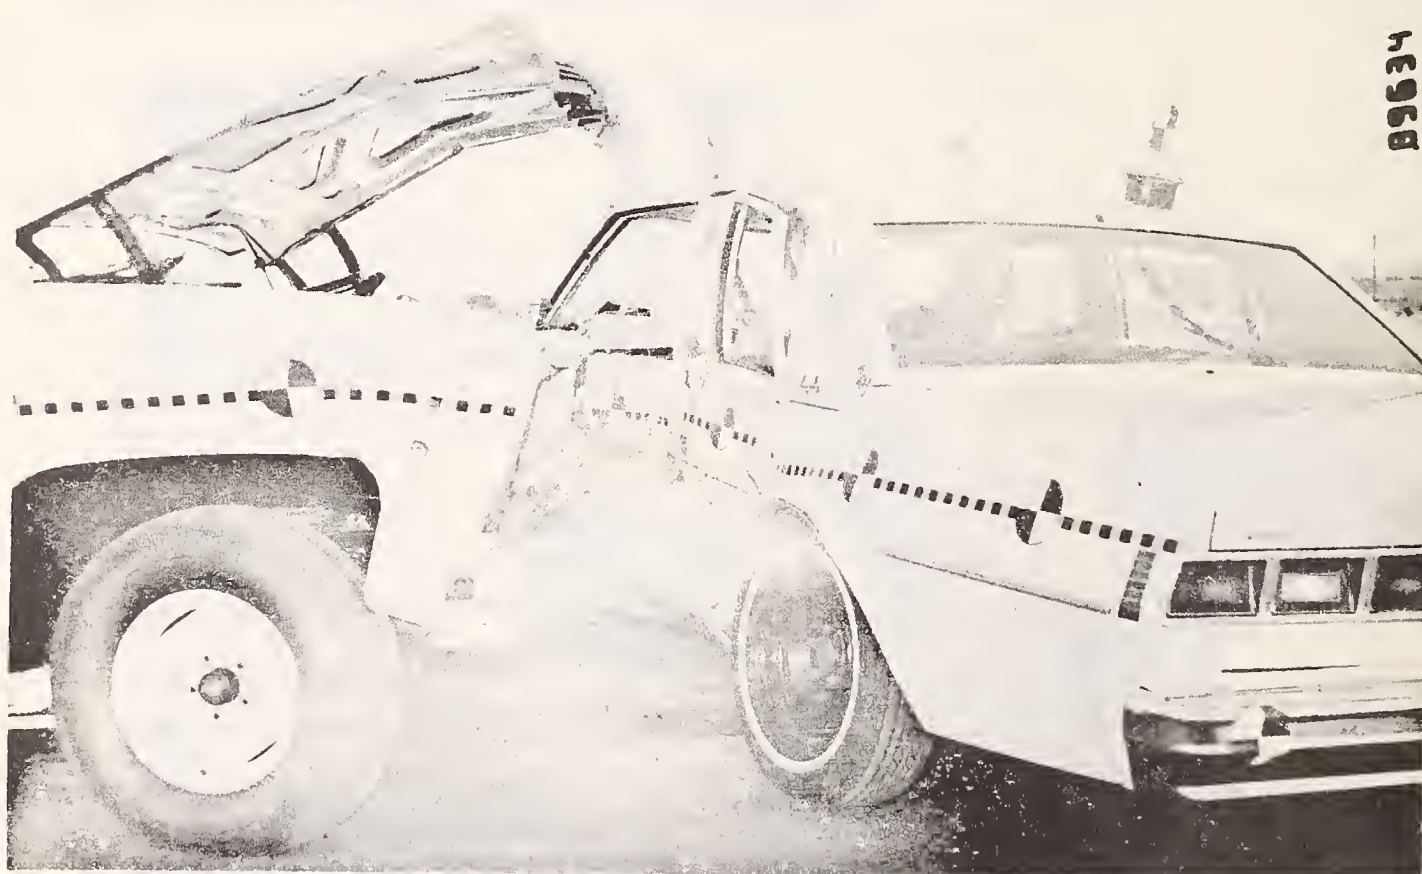
Figure 3-4. Chevrolet C-10 Truck Bumper-to-Chevrolet Impala Side Matchup (Test 3051-4).

a) Pre-test

b) Post-test

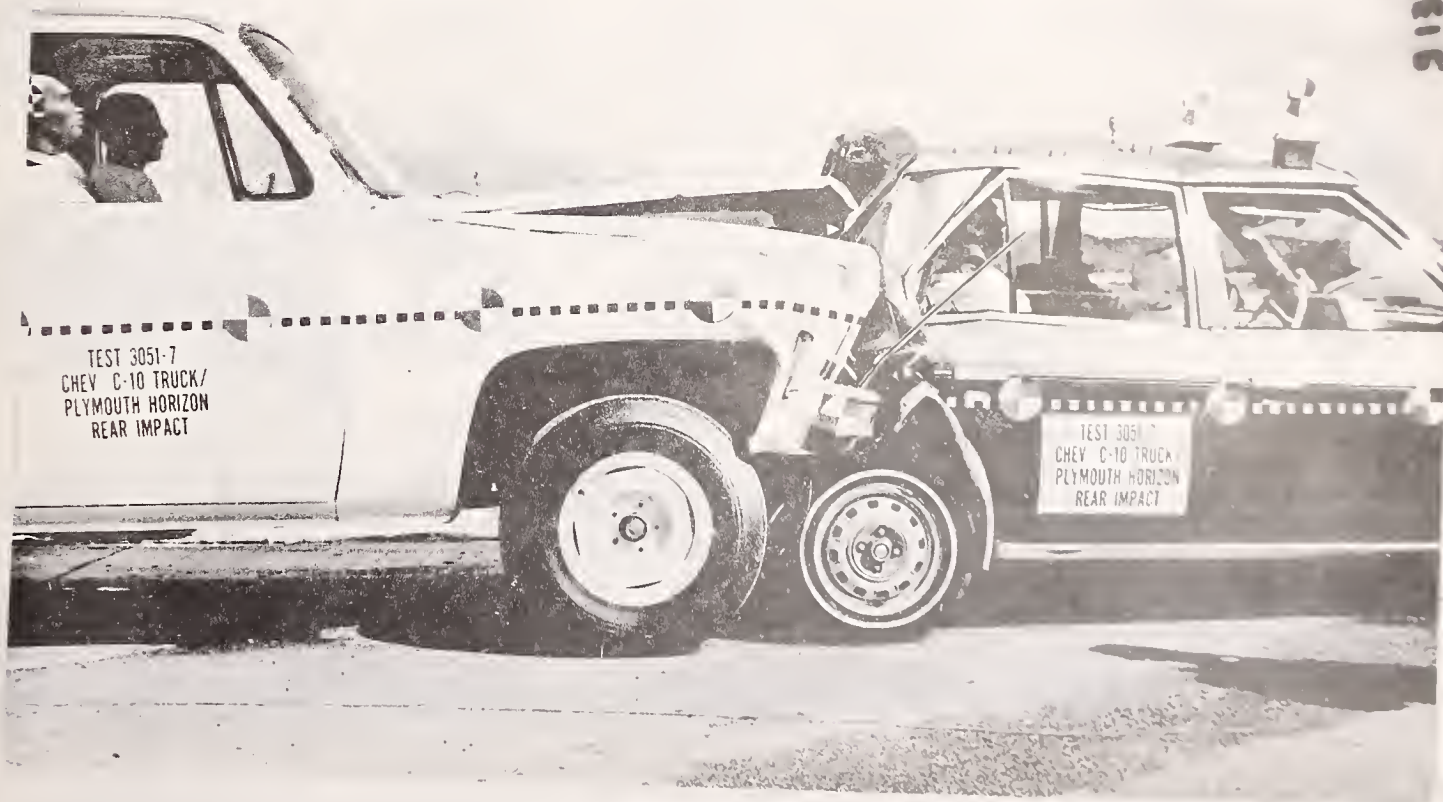
Figure 5-3. Chevrolet C-10 Truck Front/Plymouth Horizon Rear Bumper Matchup (Test 3051-7).

a) Pre-test

b) Post-test
