**Final Project Report:**  
**Three Integrated Projects to Enhance Non-Contact Rail Inspection  
Technology for Application to Substructure Health Evaluation on Both  
Rail and Road Bridges**

NCITEC Project No. 2012-24

January 2014

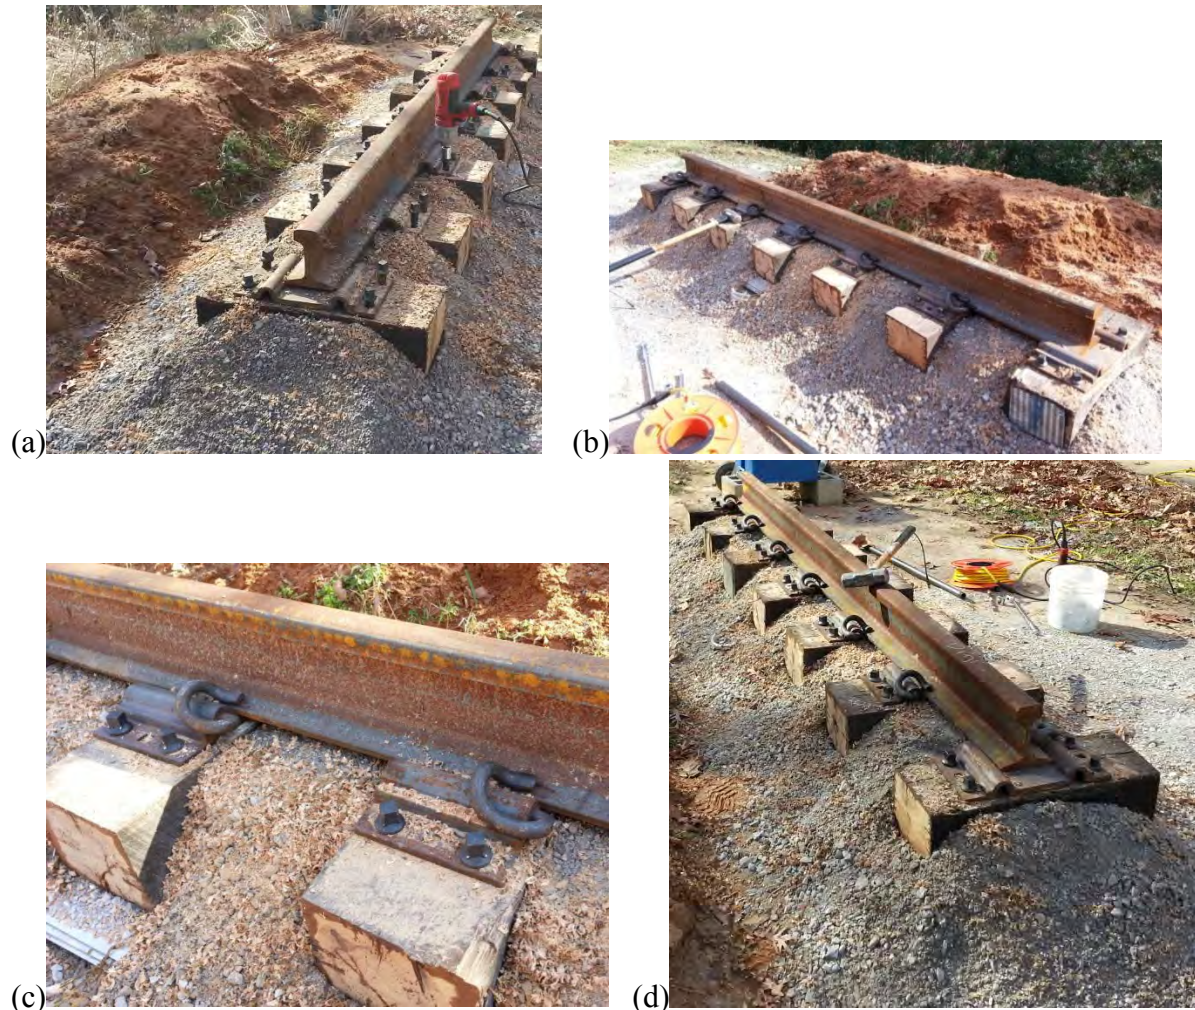
**Figure 3. The completed rail setup.**

Typical railroad ties were cut in half and then placed on the bed starting at center over the stainless steel plates. They were spaced 19.5" on center, the industry standard. The remaining limestone filled between and was compacted even with the tops of the 6" tall ties, bringing the total depth to 24". The tie plates were placed on top of the wooden ties. The rail was placed in the saddle of all seven tie plates. With the tie plates now properly located, holes for the screw spikes were predrilled in the ties. The screw spikes were installed four per plate with an electric impact wrench. Two e-clips were installed on each tie plate to hold the rail, with the exception of the ends where only one clip could be installed. The result is shown in Figure 3.

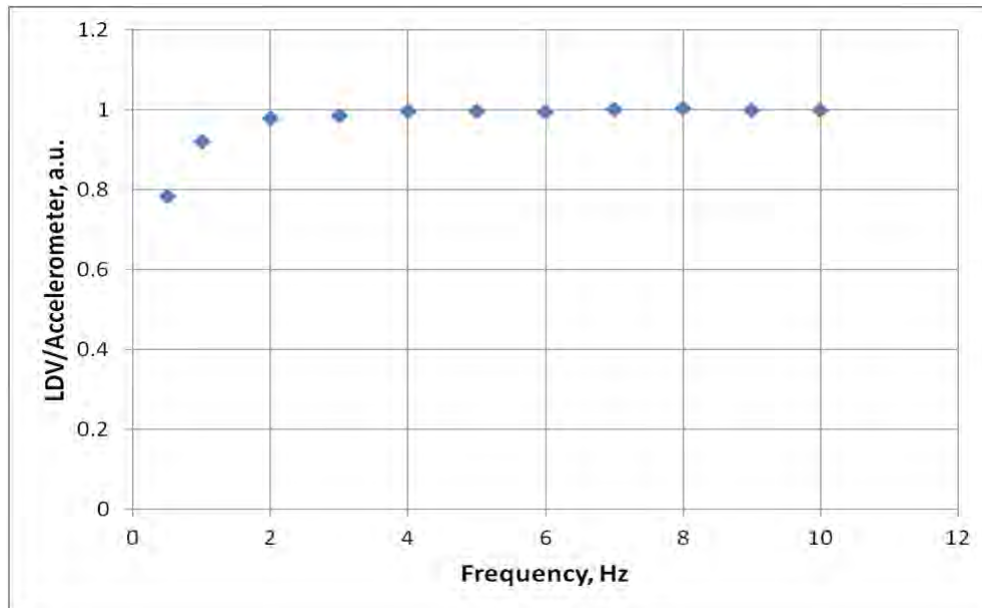
**Figure 4. Frequency response of the LDV PDV100 in the frequency range from 0.5 to 10 Hz.**

The frequency response of LDV Model PDV100 (Polytec, Inc.) in the frequency range from 0.5 Hertz (Hz) to 10 Hz was measured. A standard accelerometer (PCB 356B18) mounted on a shaker has been used as reference sensor. The accelerometer has a constant frequency response from 0.3 Hz to 5000 Hz. The shaker vibration was measured simultaneously by the LDV and the accelerometer. The normalized ratio of vibration velocity measured by the LDV and accelerometer versus frequency is shown in Figure 4. This reveals the excellent news that LDV provides good response correlation, specifically after 2 Hz.

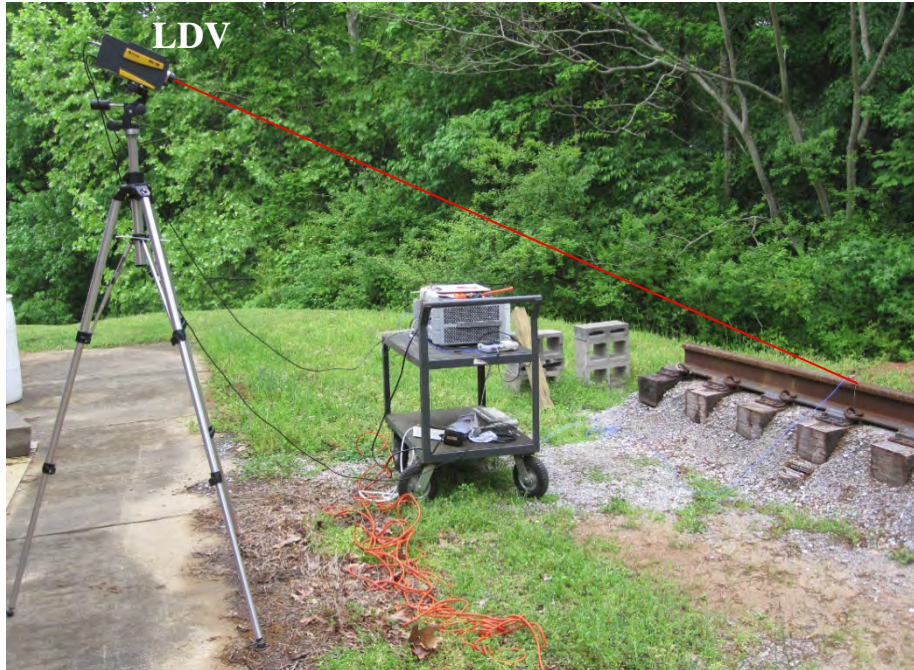
**Figure 5. Photograph of the instrumented rail experiment for LDV sensitivity.**

Vibration of the rail excited by impact has been recorded using both the LDV and the accelerometer. Photographs of the experimental setup are shown in Figures 5 and 6. The LDV was positioned on a concrete pavement at 340 cm distance from the rail. The LDV height was 198 mm, and its sensitivity was  $5 \times 10^{-3} \text{ m/s/V}$ . The LDV sensitivity to out-of-plane vibration was reduced by half because the angle between the vertical and the laser beam was 30.4 degrees. The accelerometer sensitivity was  $9.8 \times 10^{-6} \text{ m/s}^2/\text{V}$  ( $102 \text{ mV}/(\text{m/s}^2)$ ). The accelerometer was mounted on the rail as shown in Figure 2; the beam of the LDV mounted on a tripod was incident onto the rail surface close to the accelerometer. Retroreflective tape on the rail surface enhanced reflectivity. The rail vibration was excited with a single plastic hammer impact. Note that plastic material lowers the high frequency content of the signal so that lower frequencies were better observed.

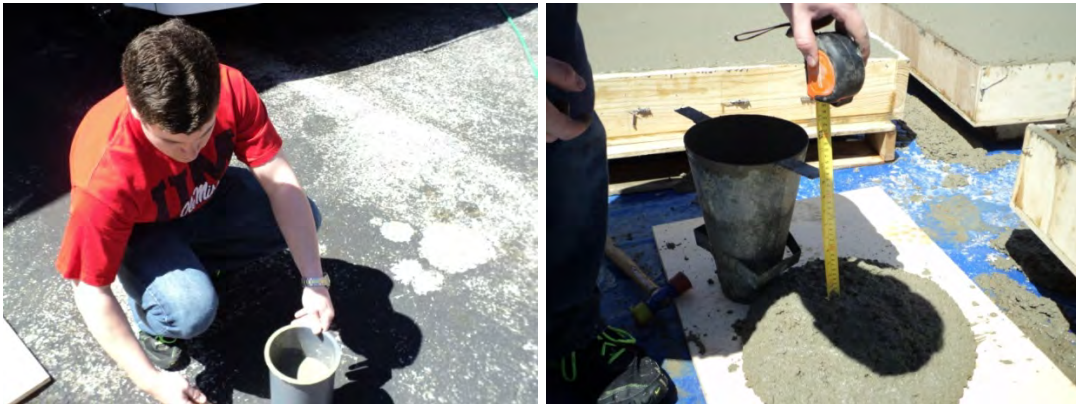
**Figure 21. Cylinder casting and slump test.**

Two 6x12 inch cylinders were also cast during the pour for compressive strength and Young's modulus testing. Sampling of the concrete was conducted in accordance with ASTM C 172 *Standard Practice for Sampling Freshly Mixed Concrete*. As shown in Figure 21, a slump test was also conducted in accordance with ASTM C 143 *Standard Test Method for Slump of Hydraulic-Cement Concrete*. The slump test yielded a slump of about 9.25 inches. According to the standard, a slump greater than about nine inches may not be adequately cohesive for the test to have significance. This slump does, however, indicate that the samples cast in the cylinders can be rodded since the slump was over one-inch. The concrete was sampled from the middle of the load and scooped into the cylinders. The concrete was then consolidated with a tamping rod in three separate layers with the sides of the cylinders being tapped with a mallet after each layer in order to close any insertion holes from the rod. The cylinders were then placed on a flat surface and allowed to cure for seven days before being removed and immersed in water until testing.

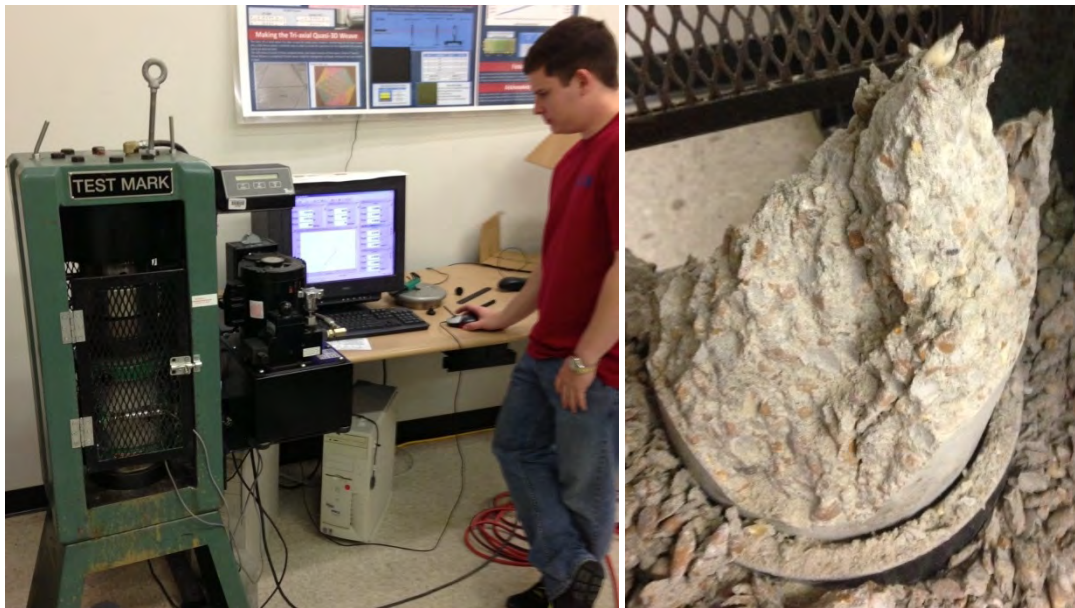
**Figure 22. Testing of a cylinder and the resulting break.**

with a compressometer to measure average strain during testing, the cylinders were loaded at a virtually static rate of 1000 pounds per second and were subjected to this increasing vertical axial stress until breakage (Figure 22).

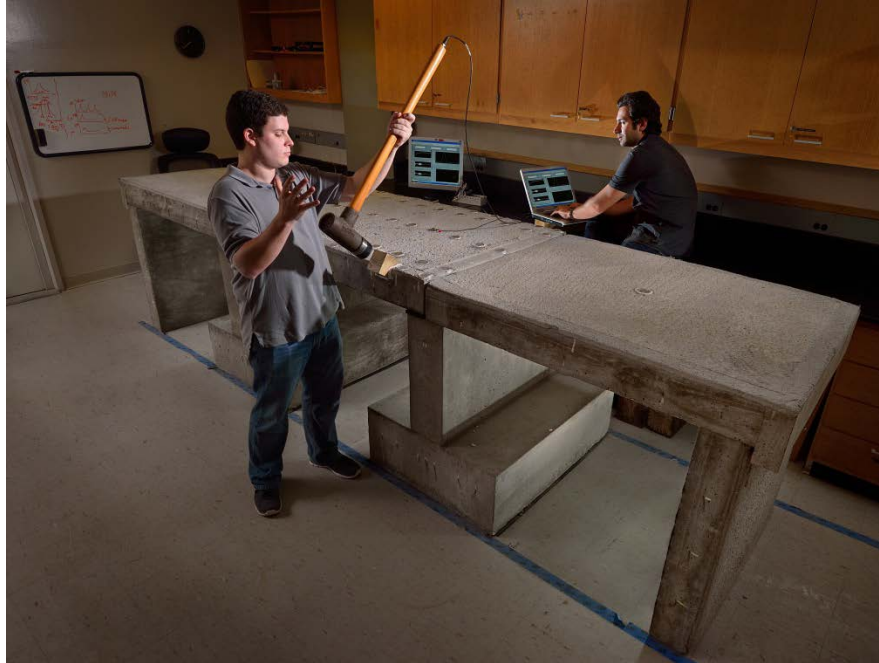
**Figure 25. Impact hammer testing with Steven Worley and labmate Farhad Sedaghati.**

Weighing approximately 1270 pounds, the 60”x42”x6” center slab is the target of the vibration testing. Shown in Figure 25, a twelve-pound PCB sledge hammer impacts the wood block on the bridge, inducing multi-dimensional vibrations. A Dytran tri-axial accelerometer on a level epoxy pad measures these nearly imperceptible motions, and this is repeated for 57 spatially diverse locations. These measurements take about 3 hours to perform and must be repeated for each damage case. A National Instruments CompactDAQ records the signals via NI LabVIEW, and the comma-separated text files are loaded into the MATLAB structural health algorithm for post-processing. Fast Fourier transforms are calculated, and modal peaks are identified for every damage case as well as the baseline. Note that natural frequency identification and mode correlation can be quite subjective: mode shape plots assist in these tasks, but time must be expended to analyze each potential resonance. Also, severe damage prevents modal coordination because the frequency response has experienced major shifts. This caused the damaged cases to be altered by using thinner rubber to represent joint damage. The origin and the associated 57 measurement locations are provided in Figure 26: note that two measurements are each approach slab, which proved very helpful in separating dissimilar modes. The other 55 measurements provide a grid that will allow for mode visualization in all three directions.

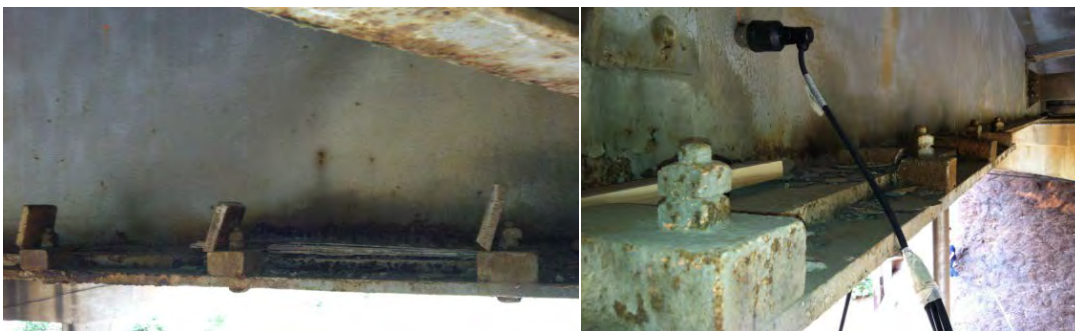
**Figure 30. 3 of 4 broken plate clamps (left) and an undisturbed setup on Beam 2 (right).**

Testing on the visible bridge deck proceeded as planned. However, a serious problem was visually identified underneath the bridge. From the ground, all structural members and joints seemed reasonable for a 70-year-old bridge. Significant corrosion and abutment washes were detected, but the overall bridge appeared in good condition. The deficiency occurred in the steam plates or mending plates at nearly mid-span. The plates are trapping water that is from leaking expansion joints. The result is severe corrosion and broken clamps: these large, heavy plates may fall into traffic. This problem is illustrated in the next figure, which was provided to all authorities immediately following the inspection.

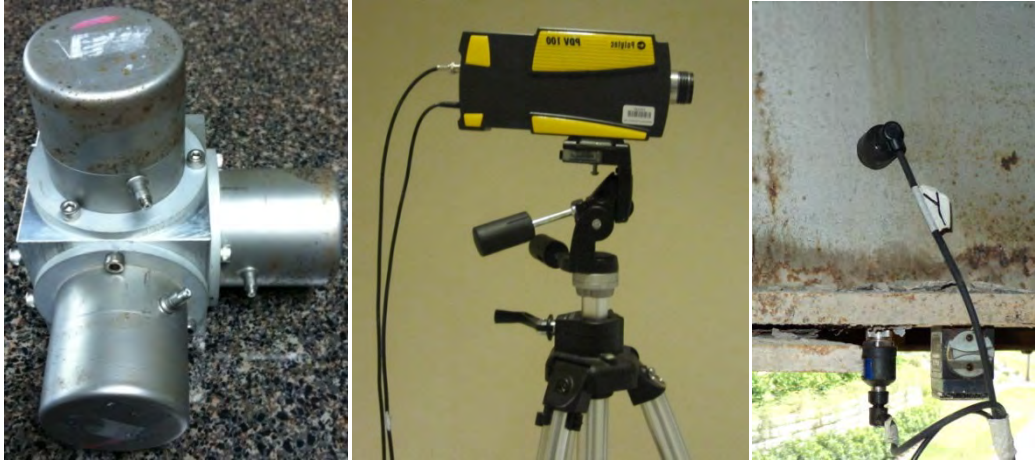
**Figure 31. Tri-axial accelerometer (left), laser Doppler vibrometer (middle), and magnetic accelerometers and corner cube reflector array (right).**

vibrometer (LDV) was also used on both the top and bottom of the bridge to capture surface vibration. The aluminum cube also had attached a reflector on one of its sides which the LDV utilized when measuring velocities at an angle from bridge abutments. Magnetic sensors were used for underside measurements of the full-scale bridge. Magnetic bases were attached to two seismic accelerometers, and a prism corner cube array was glued to a magnetic base.

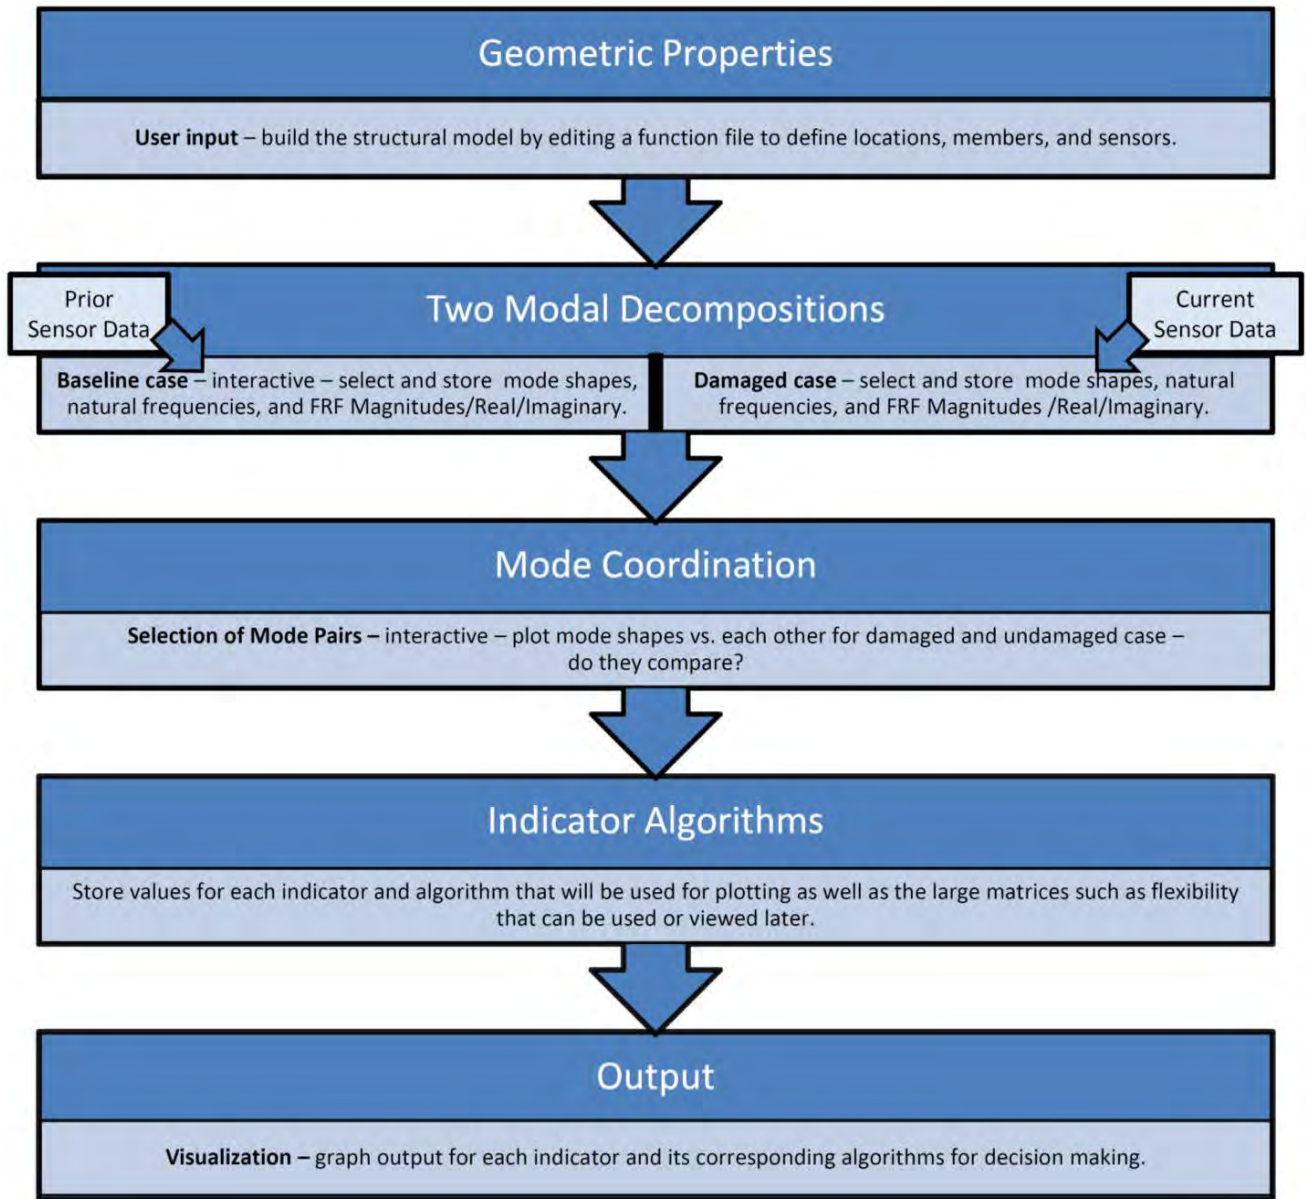
Figure 37. Flowchart of comprehensive structural health program.

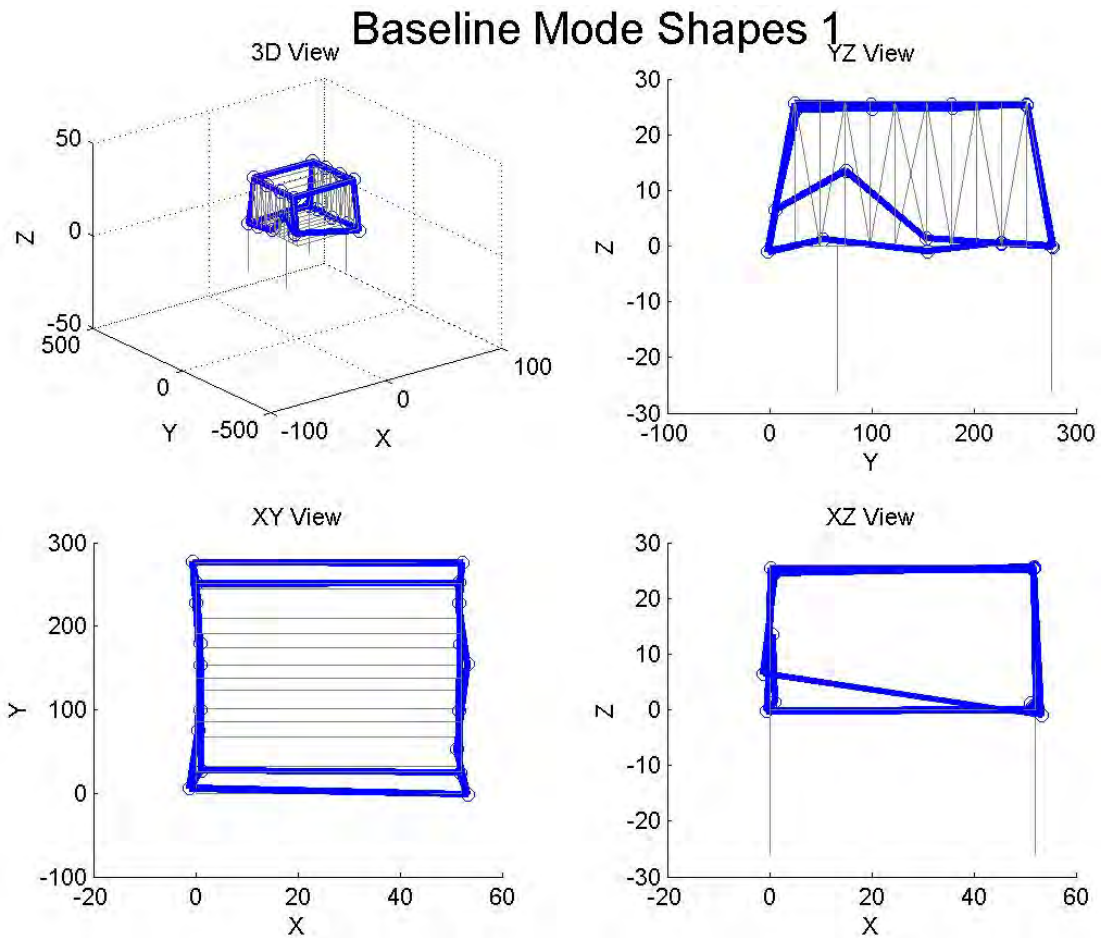
Figure 39. Example of mode shape visualization. Baseline Mode 1 is the lifting of one ground support pier.

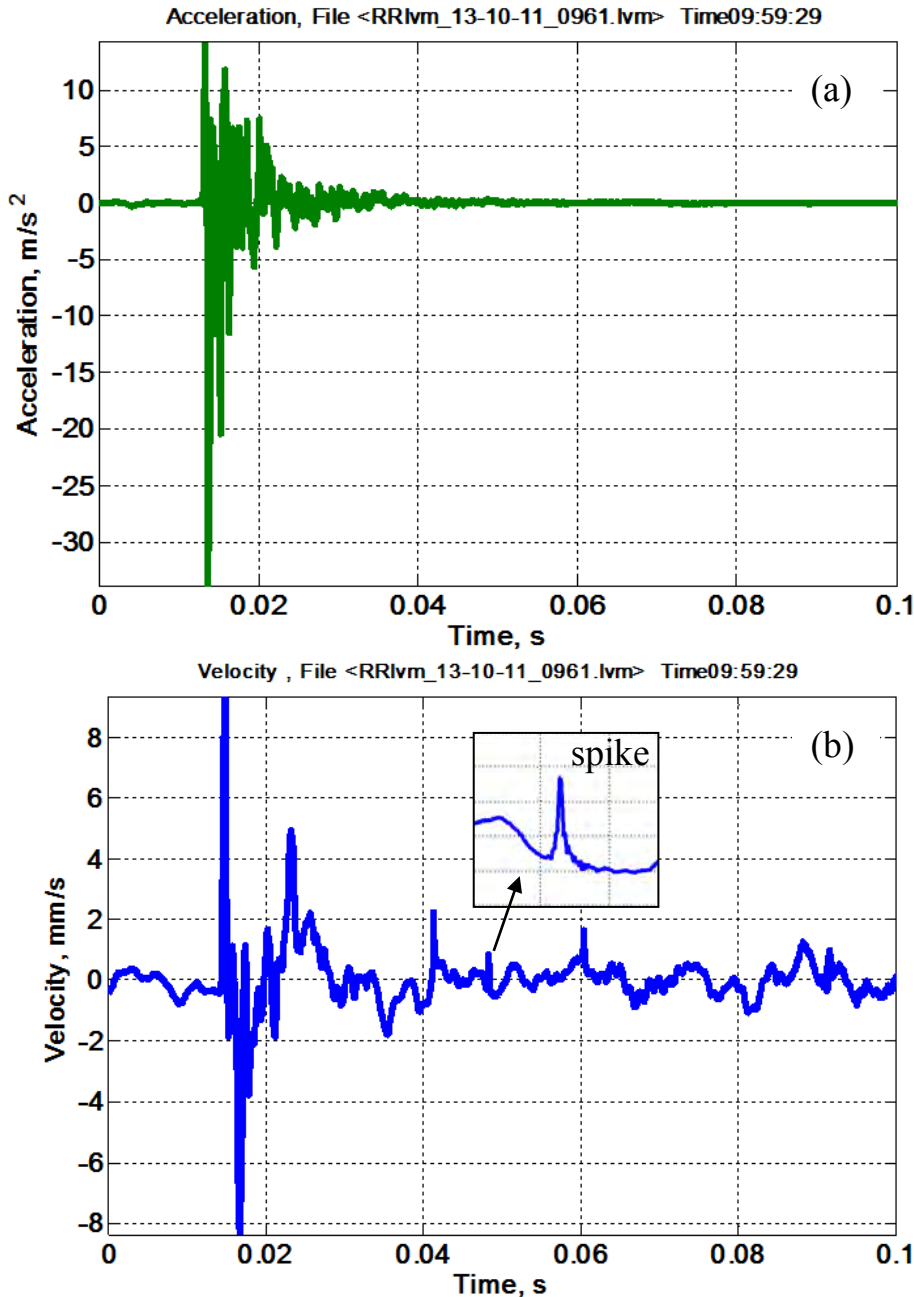
Figure 46. Examples of the railway track response to impact excitation recorded with (a) an accelerometer and (b) a continuously moving LDV at 20 mm/s.

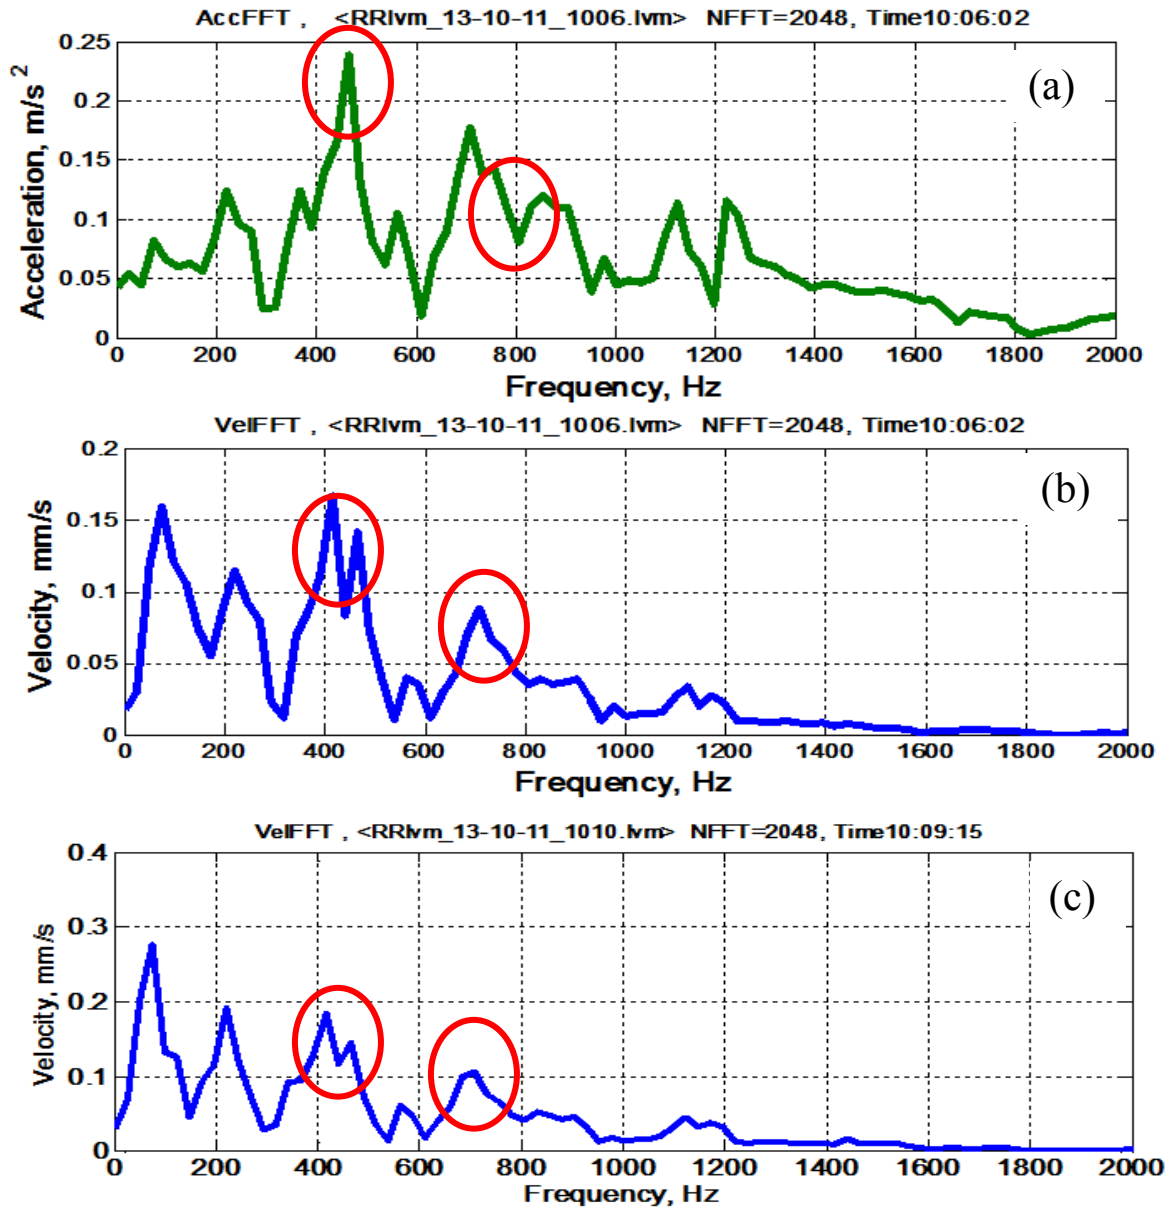
Figure 49. Frequency spectra for the rail with two loose screws in center tie plate: (a) accelerometer, (b) still LDV, (c) moving LDV.

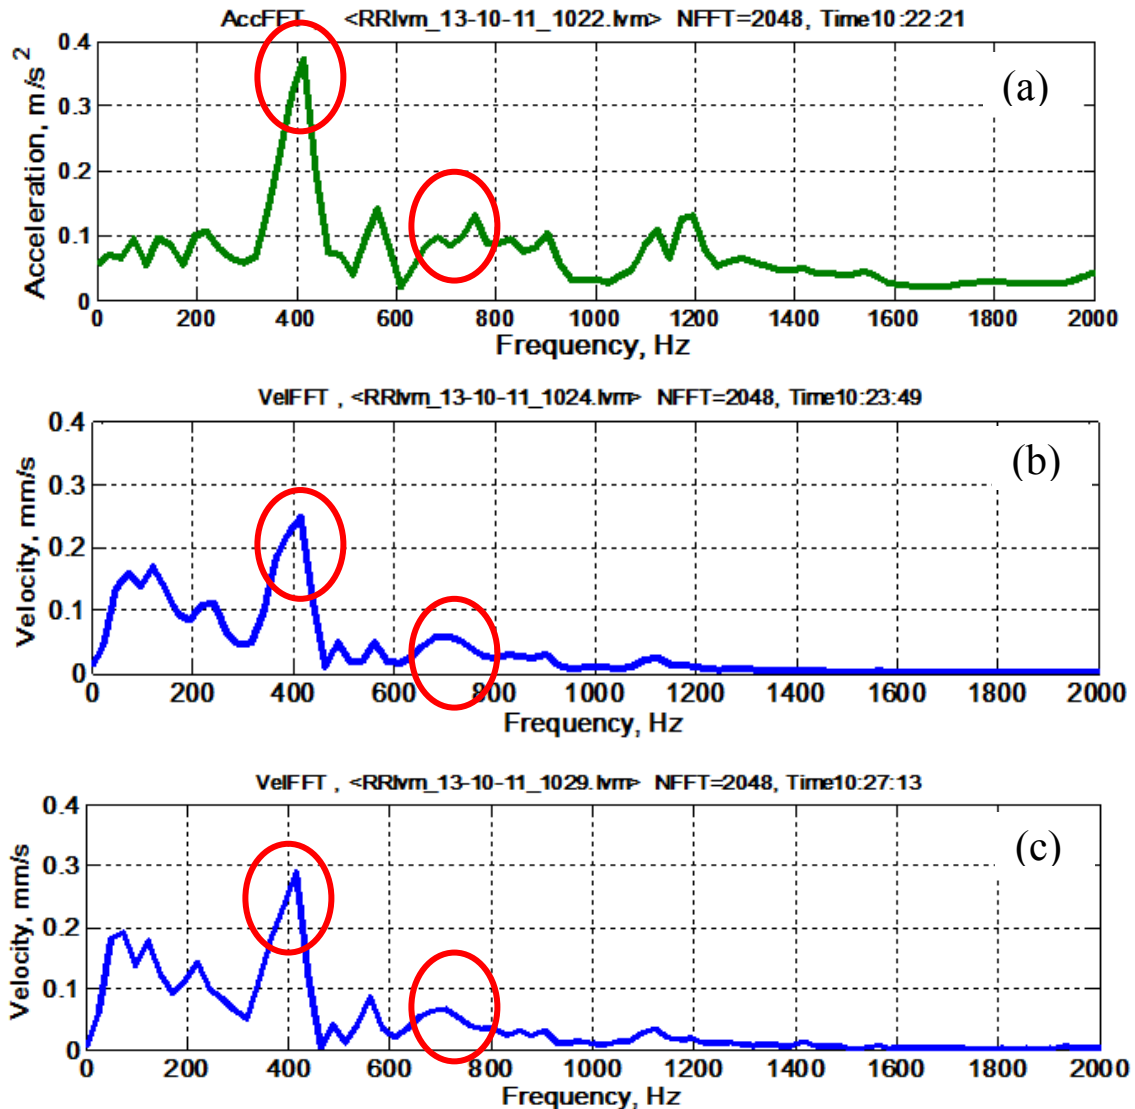
Figure 50. Frequency spectra for the rail with four loose screws in center tie plate: (a) accelerometer, (b) still LDV, (c) moving LDV.

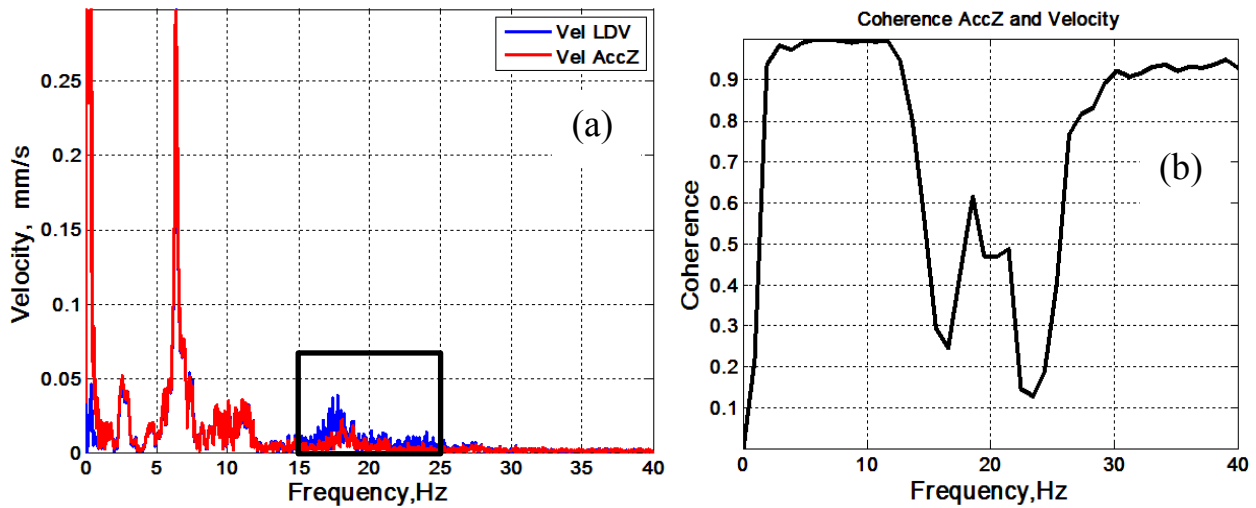
**Figure 67. Quantitative comparison for Point 45 via (a) velocity spectrum with the LDV (blue) and as calculated from the acceleration spectra (red) and (b) their coherence function.**
