**Final Project Report:**  
**Rapid Non-contact Measurement using Multiple Point Laser Doppler  
Vibrometry for Health Evaluation of Rail and Road Bridges**

NCITEC Project No. 2013-27

January 2015

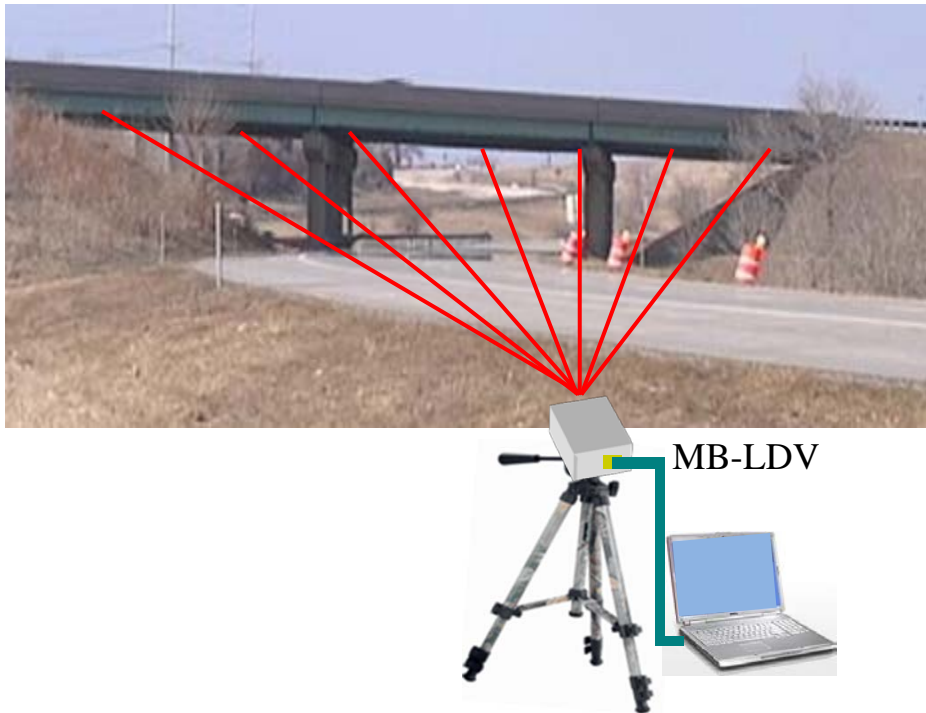
In this project, a new method for structural vibration measurements on bridges will be implemented. The overarching idea is that parallel vibration measurements at multiple points will enhance non-contact bridge inspection technology. The technique will eventually advance to implementation on a bridge at a distance on the order of hundreds of meters. Figure 1 shows a concept of bridge inspection. The laser beams are configured in a linear array and are directed onto different locations of the bridge. The devices can be located either under the bridge and measure vertical vibrations, or it could be mounted on the ground away from the bridge and measure horizontal vibrations (shown).

**Figure 1. Concept of enhanced bridge inspection; I-55 over I-74 in Bloomington, IL (16).**

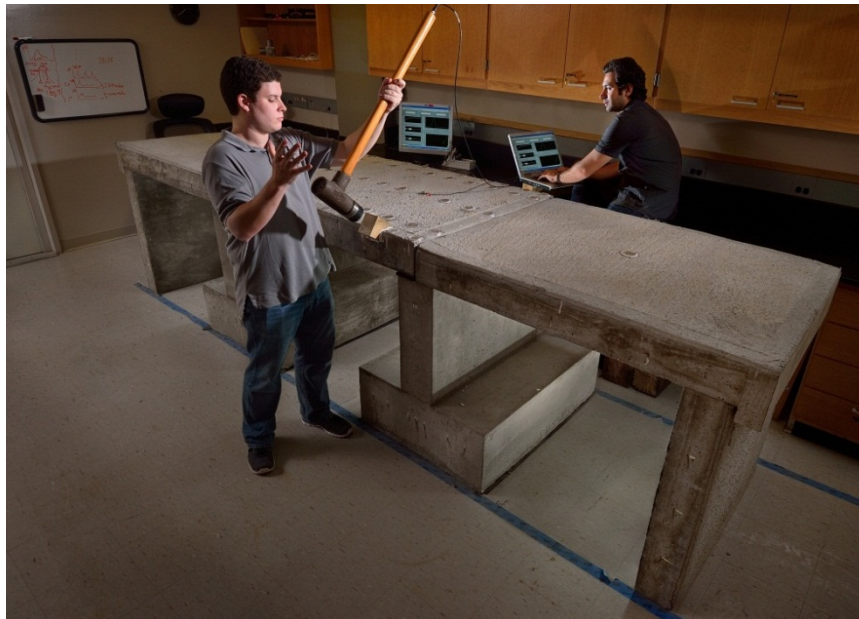
**Figure 2. Impact hammer testing with Steven Worley and labmate Farhad Sedaghati.**

Weighing approximately 1270 pounds, the 60"x42"x6" center slab is the target of the vibration testing. A 12-pound PCB sledge hammer impacts the wood block on the bridge, inducing multi-dimensional vibrations. A Dytran tri-axial accelerometer on a level deck pad at the center point (Point 28) was used as a stationary control during all testing.

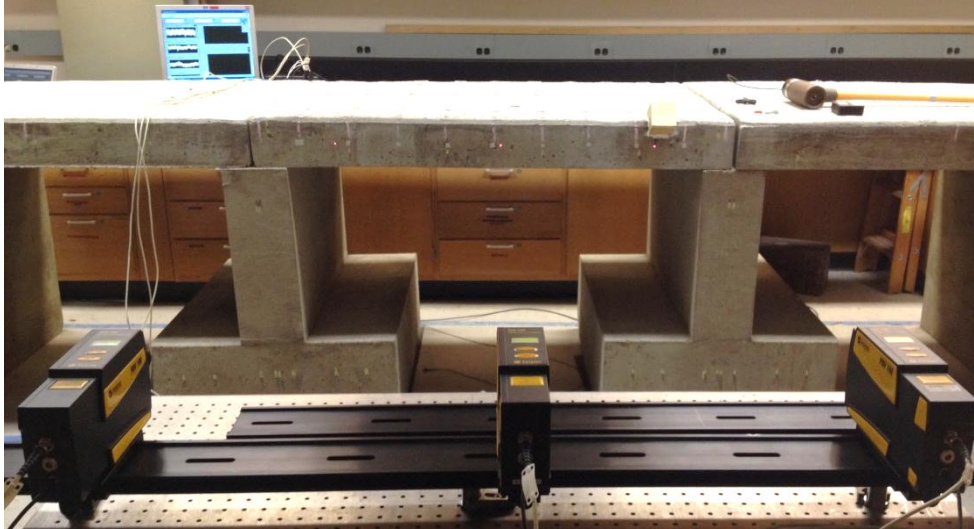
Shown in Figure 3, the preliminary test setup captured horizontal vibrations. Required optical equipment included an isolated table with mounted sliding beams. The purpose was to

**Figure 3. Preliminary test setup with three LDVs shooting target slab vibrations.**

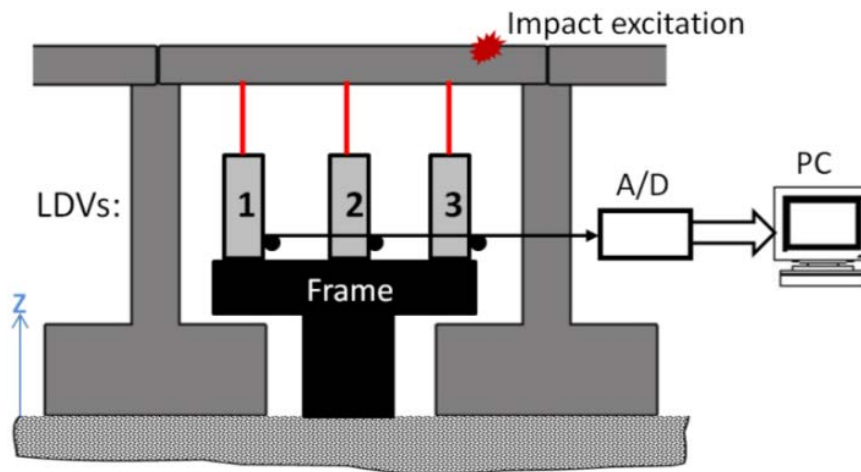
Vertical Z-direction vibrations will provide the characteristic beam bending modes of the slab. In order to capture this direction, a frame had to be built to insert under the bridge. The base isolation of the LDVs is essential to obtain absolute measurements. The floor-mounted frame will reduced measurement noise by a factor of 10 versus attaching the frame to the footings. Figure 4 presents a schematic of this overall setup. Vibration of all three interrogated points are measured simultaneously and recorded by the data acquisition system into computer memory.

**Figure 4. Schematic diagram of vertical instrumentation.**

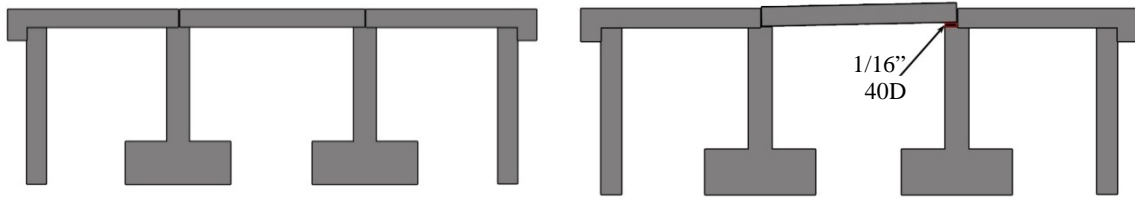
Production runs included the two cases sketched in Figure 5. The concrete connections represent the “undamaged” case as a basis for comparison. To create a “damaged” case, a 1/16-inch thick 40-durometer Buna-N rubber bearing was inserted at the top of the right t-shaped pier. Laser measurements were made for each case at the forty-five points shown in Figure 6. Note that the boundary points on the piers could not be captured as there was no space underneath the slab.

Figure 5. Baseline with concrete connections (left) and damaged case with one rubber bearing (right).

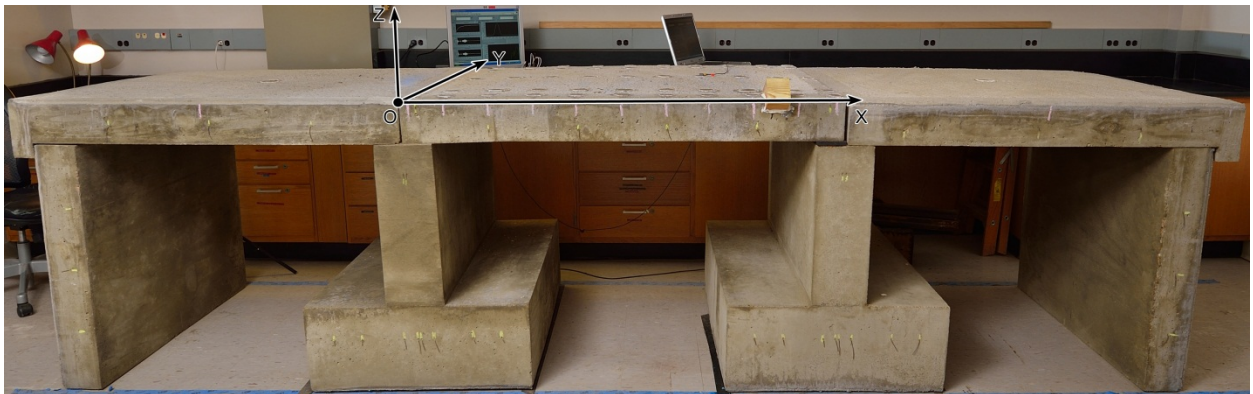
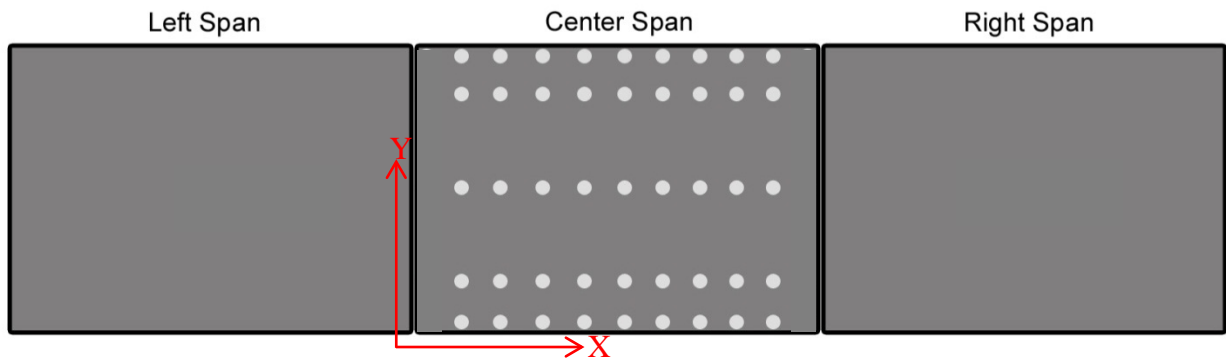
Figure 6. Forty-five data points measured underneath the center slab via laser velocity measurement.

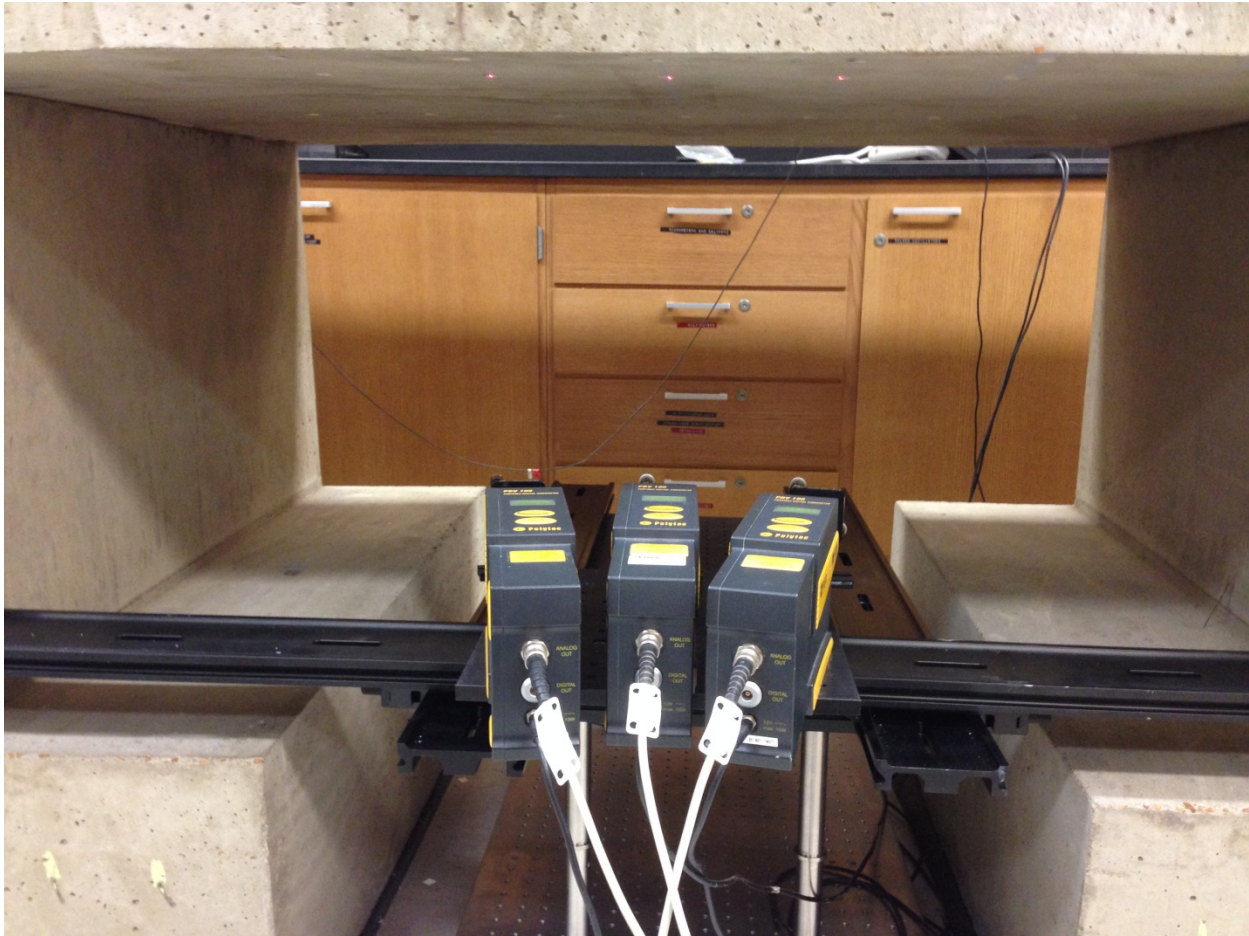
The three Laser Doppler Vibrometer apparatus used to make simultaneous non-contact velocity measurements sits underneath the bridge in Figure 7. The measurement grid of 45 points underneath the slab are fitted with retro-reflective tape. As a hammer strikes the bridge inducing three-dimensional excitation, the LDVs measure the simultaneous vibration response in real-time for three different points.

**Figure 7. Experimental setup in place underneath the center slab.**

measurements. Only macro-movement of the breadboard along the rails is needed. Figure 7 shows the three beams on the bottom of the bridge deck.

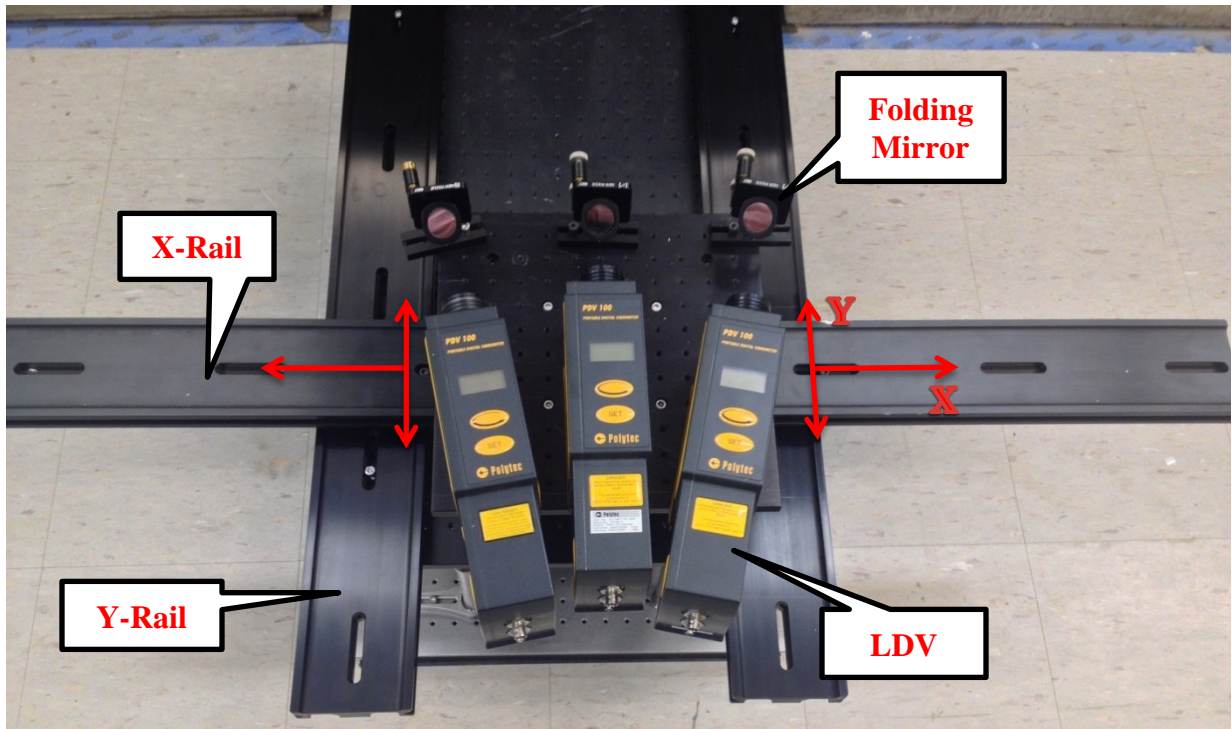
The top-down view of the apparatus shown in Figure 8 utilizes three optical rails and corresponding sliding carriers to allow three single-point LDVs, mounted to an optical breadboard, to freely slide in the X and Y directions. This large range of motion allows for quick and easy measurements: fifteen sets of three laser measurements were taken to span the entire slab. The optical rails sit atop a raised optical breadboard to elevate the rails, and subsequently the LDVs, above the base of the bridge so that they can be moved along the full depth of the top slab.

Figure 8. Experimental setup, top view.

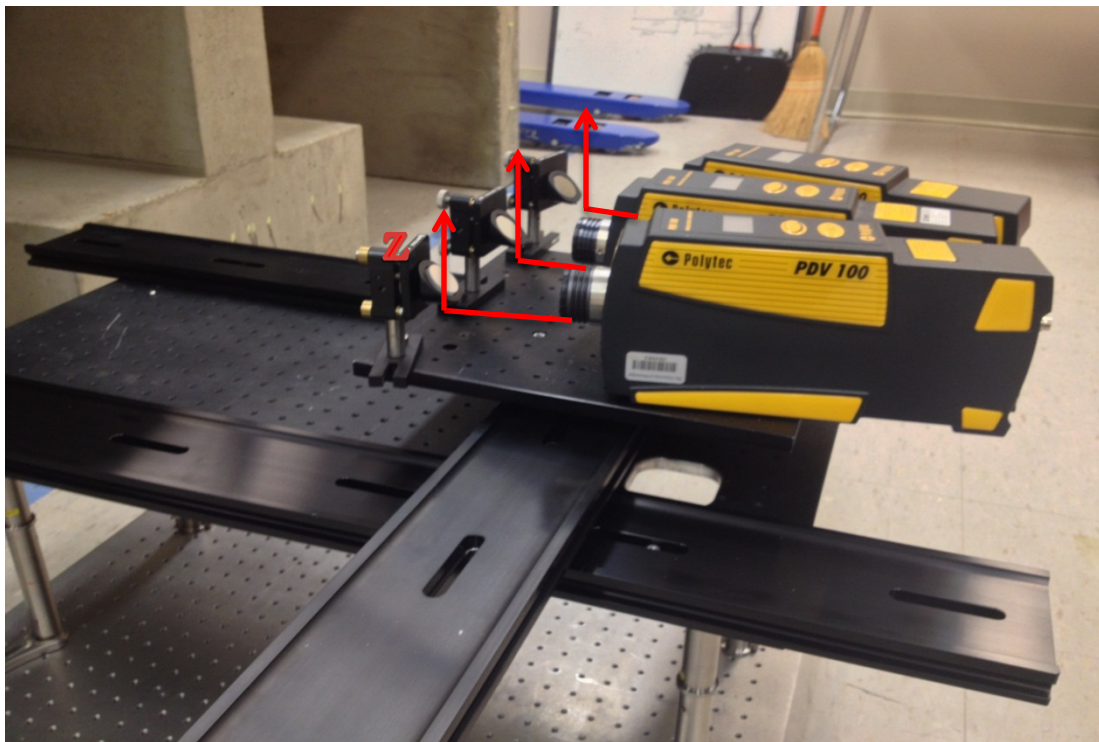
The side view of the apparatus in Figure 9 shows how the horizontal LDVs capture vertical measurements. The LDV beams are directed upwards by  $45^\circ$  mirrors in the Z direction, allowing for vertical beam targeting. Additionally, since the mirrors are mounted on the same breadboard as the LDVs, there is no realignment needed after each set of

Figure 9. Experimental setup, side view.

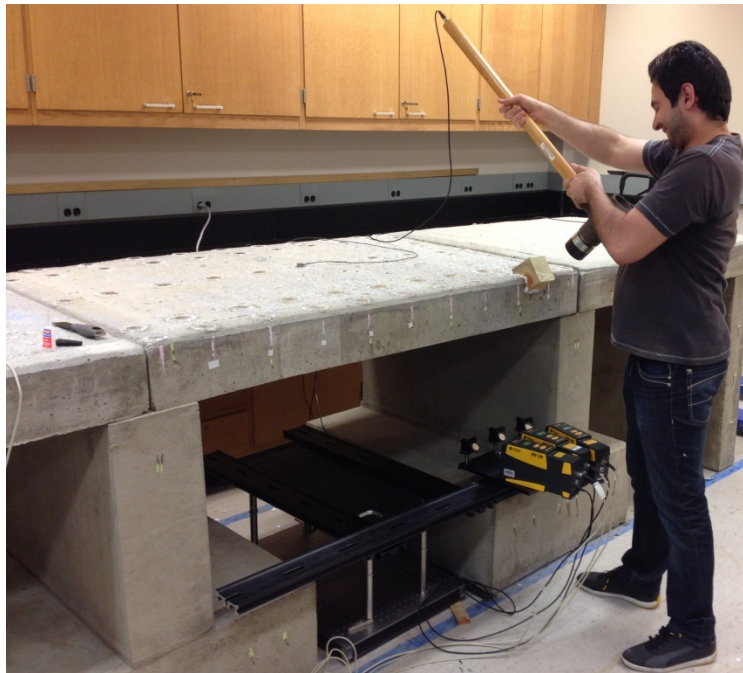
A test in progress is shown in Figure 10. Approximately fifty hammer hits were required to complete all necessary non-contact vertical slab measurements. If a traditional contact single-axis accelerometer method had been used, 150 hammer hits would have been required. Thus, in addition to the remote sensing advantage, effort has been reduced by one-third, a valuable time savings for inspectors. Note that the same number of hammer hits would be required to equate tri-axial accelerometer use.

**Figure 10. Impact test in progress.**

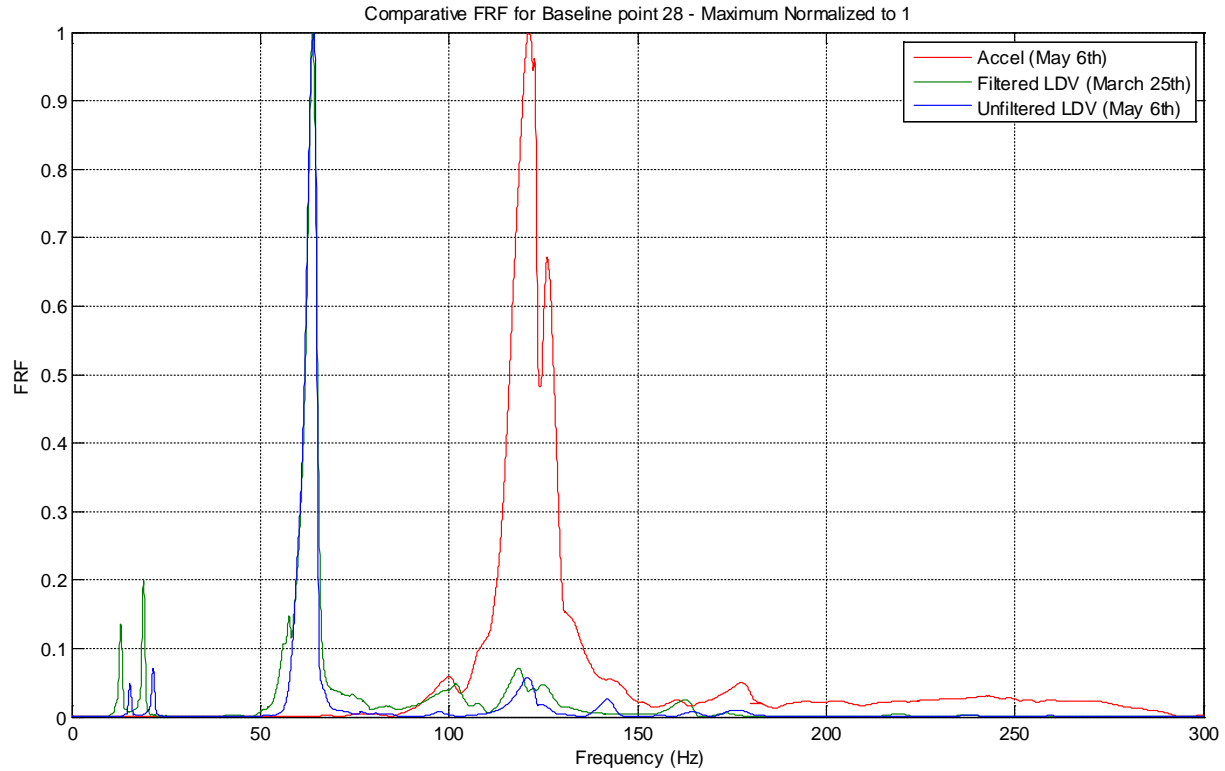
Recall that amplitudes are arbitrary due to normalization. The medium range response reveals similar resonances near 121 Hz, and other peaks are consistent. The peak around 60Hz appears only in the LDV responses and thus is most likely caused by line power. Harmonic interference could also be occurring near 120 Hz. The peak responses appear well correlated for the high frequency range, greater than 300 Hz. However, the low frequency range shows significant differences.

**Figure 12. Direct comparison of frequency response functions for Point 28.**

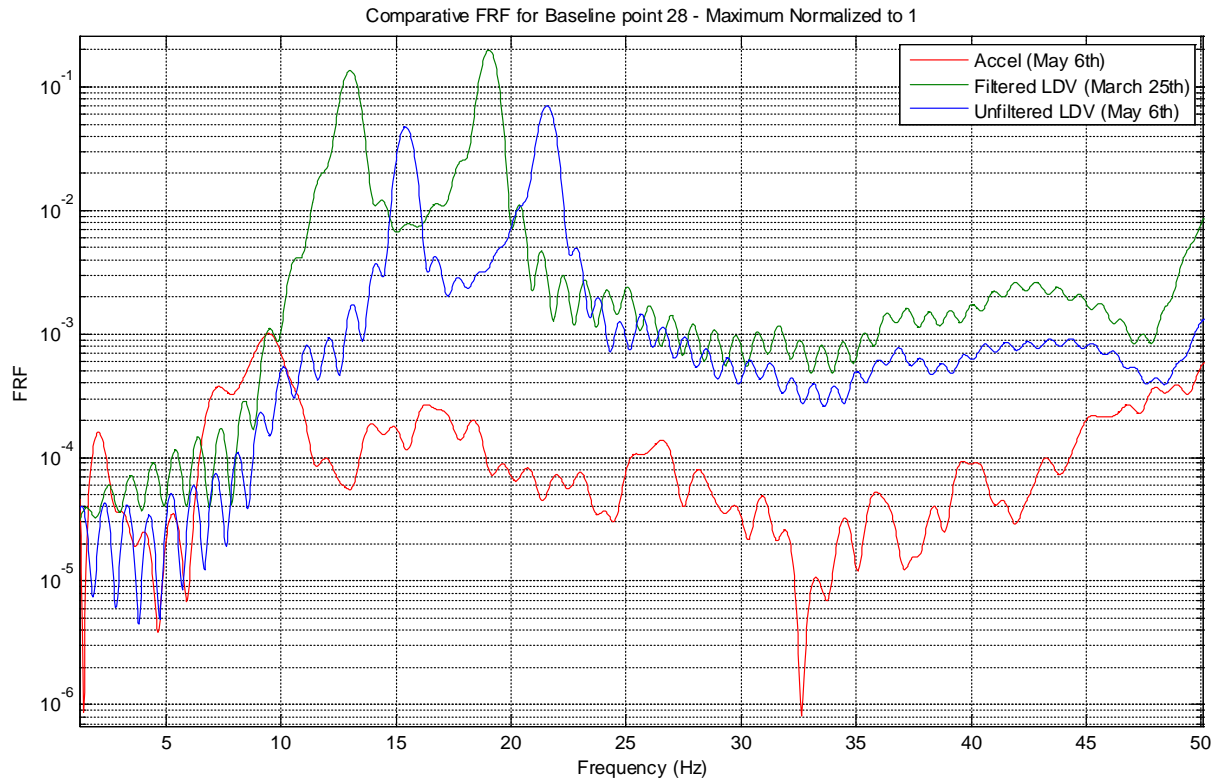
A major LDV setting, filtering has been examined for its effect on frequency content. A low-pass filter prevents frequencies above a certain threshold (here, 1 kHz) from causing measurement noise. However, filter use can induce artifacts in the data, such as shifting peaks, even at frequencies less than the selected threshold. Figure 13 shows that this is evident in the LDV responses (green vs. blue). Some peaks at LDV spectra, for example at 13 Hz and 19 Hz, could be caused by vibration response of LDV setup components, such as

**Figure 13. Direct comparison of frequency response functions for Point 28: 1 to 50 Hz, log scale.**

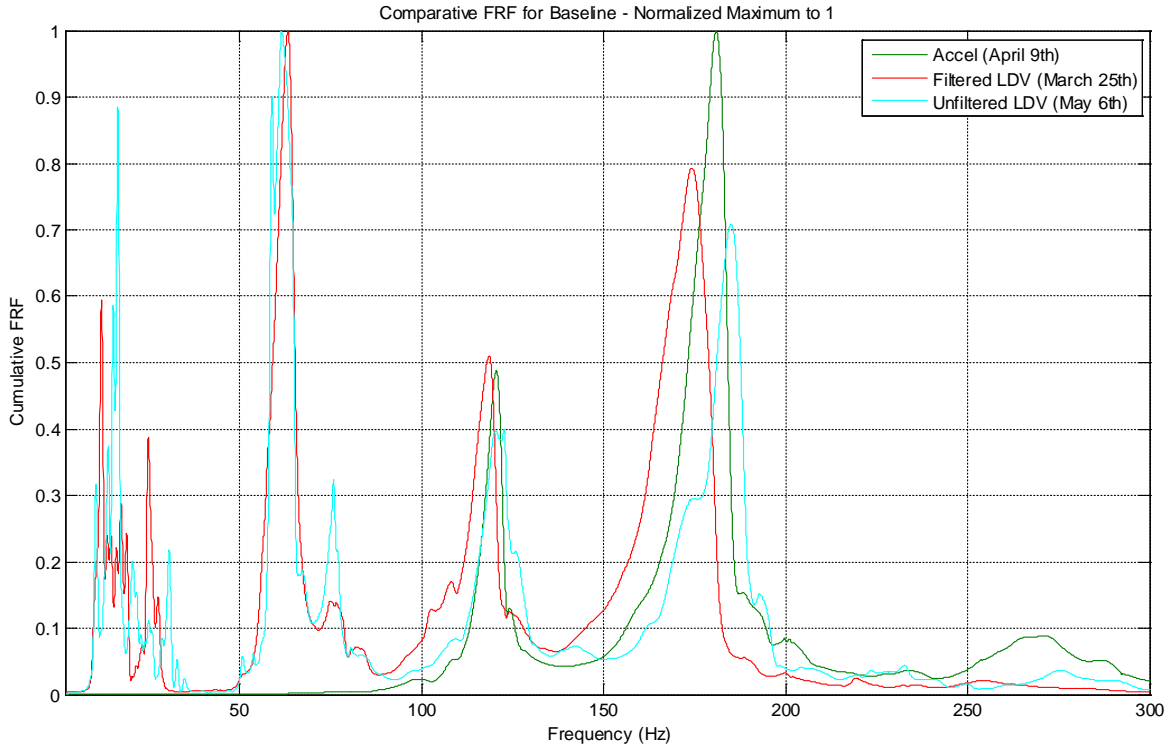
For the baseline case with concrete connections, Figure 14 presents the averaged frequency response functions using all 45 points. Following the non-contact tests, a tap test was performed by relocating the accelerometer for each hit, and only the Z-component signal was used herein.

The unfiltered LDV signal better matched the low frequency response: peaks were identified at 17, 25, 31, and 40 Hz. The filtered resonances are lower than others and thus will be disregarded in the future. That is, the LDV should be used without a filter. The difference may also be caused by LDV response to impulse loading, such as the hammer impact. These single point Polytec LDVs are normally used for continuous vibration signals, and their application for impact measurement may result in artifacts.

**Figure 14. Averaged frequency response functions for contact accelerometer vs. non-contact LDV data: baseline case.**

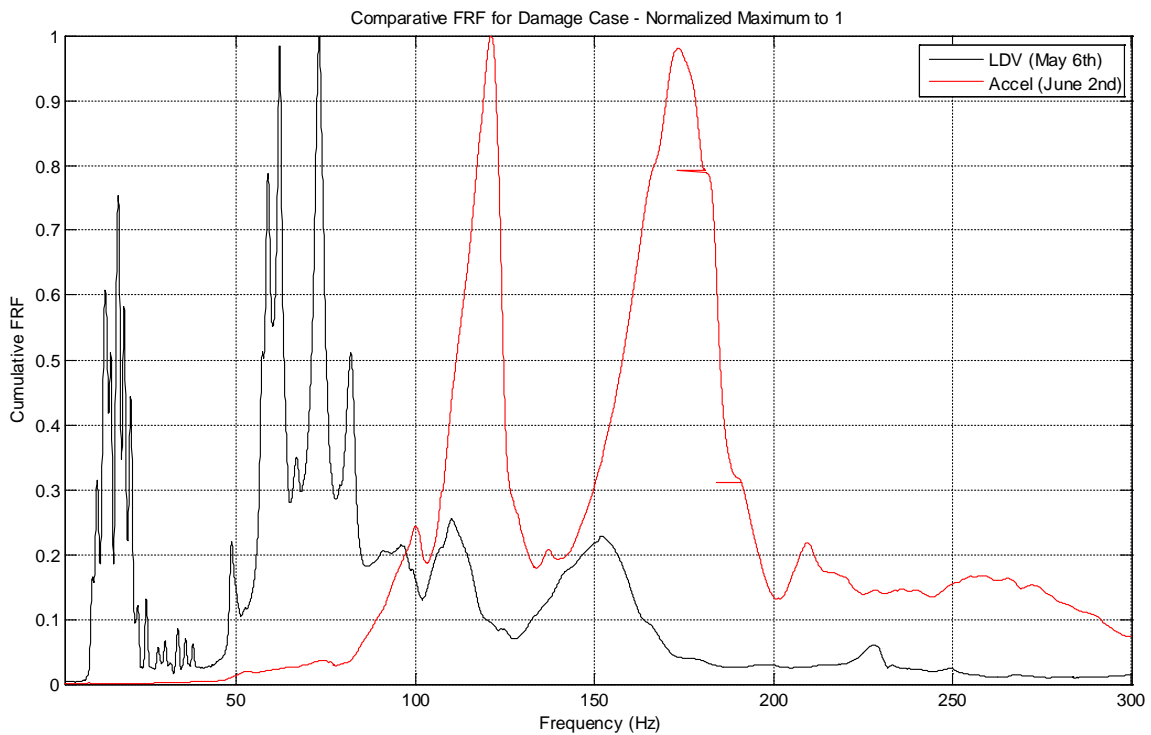
For the damaged case with one rubber bearing, Figure 15 presents the averaged frequency response functions using all 45 points. Following the non-contact tests, a tap test was performed by relocating the accelerometer for each hit, and only the Z-component signal was used herein.

The difference in sensor sensitivity is evident in Figure 15. The normalization focuses on the medium range for the LDV, but closer examination reveals reasonably close frequency content. The LDV measurements certainly have more noise, especially at low frequencies which changed significantly from the baseline. In fact, the LDV response is difficult to identify resonant peaks, so post-processing is underway. The LDV response does show interference at 60 Hz, the power line frequency, that the accelerometer does not indicate. Additionally, LDV peaks near 120 and 175 Hz appear to be shifted upward from accelerometer results. High frequency results greater than 200 Hz appear inconclusive.

**Figure 15. Averaged frequency response functions for contact accelerometer vs. non-contact LDV data: damaged case.**

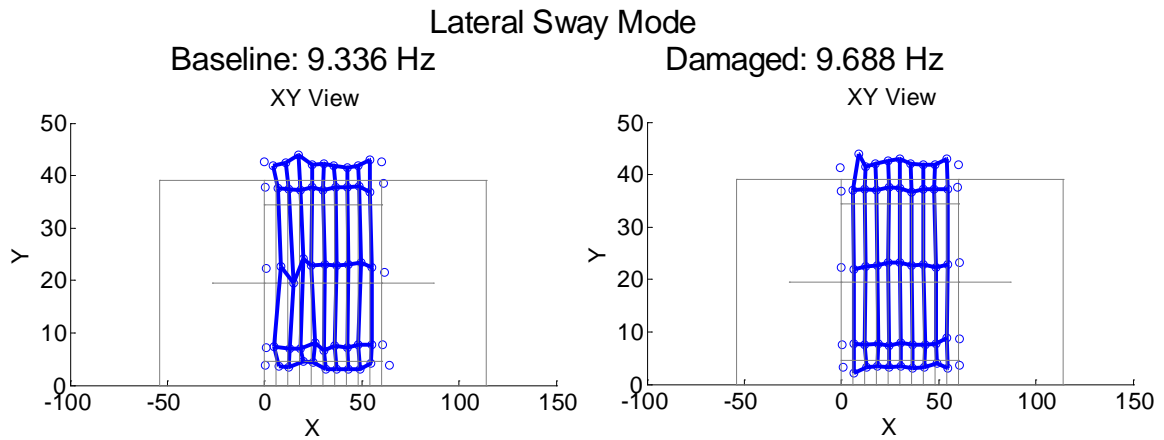
In fact, there existed few comparable modes between the LDV and the accelerometer. This was partially due to the lack of in-plane measurement: the laser can only measure along its beam. For example, the lateral translation mode is shown in Figures 16 and 17: the in-plane XY view is required to view the y-direction sway (Figure 16). Considering only z-direction is measured, this view is not available for LDV measurements from under the bridge, and normalization of each view further obscures any y-direction motion (Figure 17). The associated dominant peaks occur at 9.336 Hz for the cumulative acceleration signals and 10.464 Hz for the cumulative velocity signals. The 12.08% difference for this fundamental frequency was the greatest: all higher frequency peaks were within  $\pm 1.25\%$ . It is interesting to note that the frequency of the lateral sway mode actually increased 3.77% with damage for the accelerometer data; this is possible due to nature of concrete contact surfaces. Since damage softens structural stiffness, a decrease in natural frequency is expected, as in the LDV result of -5.97%.

**Figure 16. In-plane plot of the dominant sideways mode using tri-axial accelerometer data.**

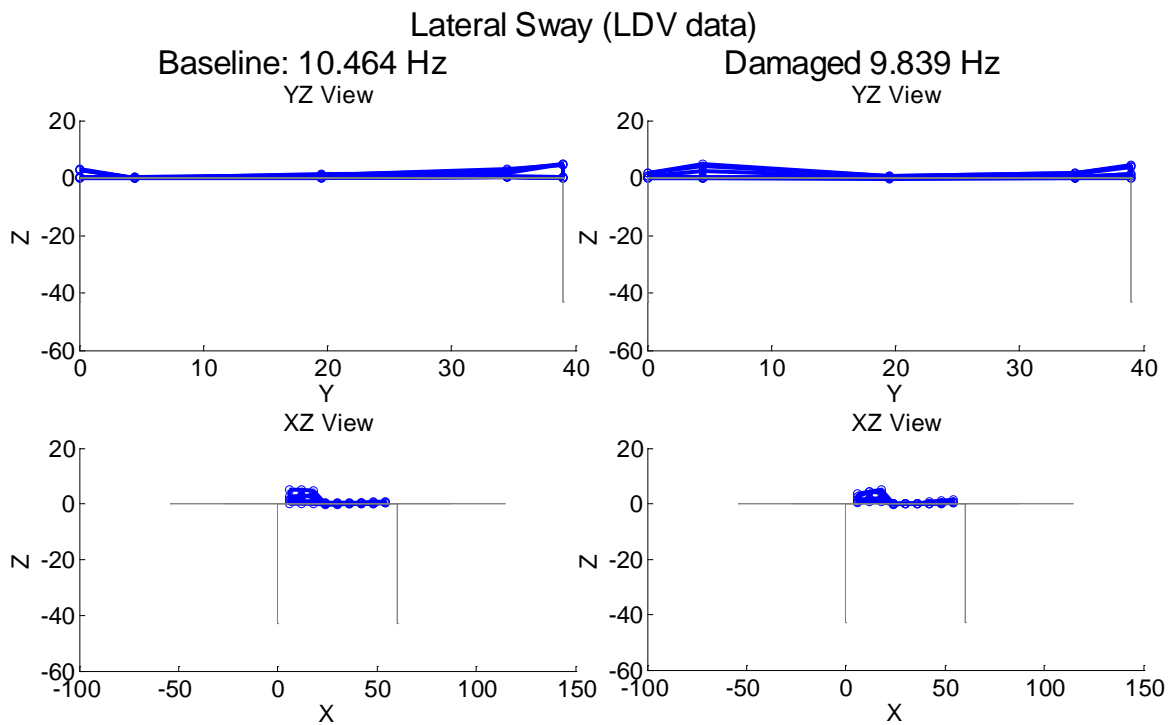
**Figure 17. Planar plots of the sideways mode using single axis LDV data.**

However, data comparison between the LDV baseline to LDV damaged case is valuable: as in Figure 17, coordinating baseline to damaged is possible. The same is true for data comparison between the acceleration baseline and the acceleration damaged case. Thus, the true success metric is the damage detection plots. These figures visibly identify damage level and location, and they can be directly contrasted for traditional accelerometer data versus the non-contact multi-beam LDV data. This is used to evaluate the sensitivity of the multi-beam method.

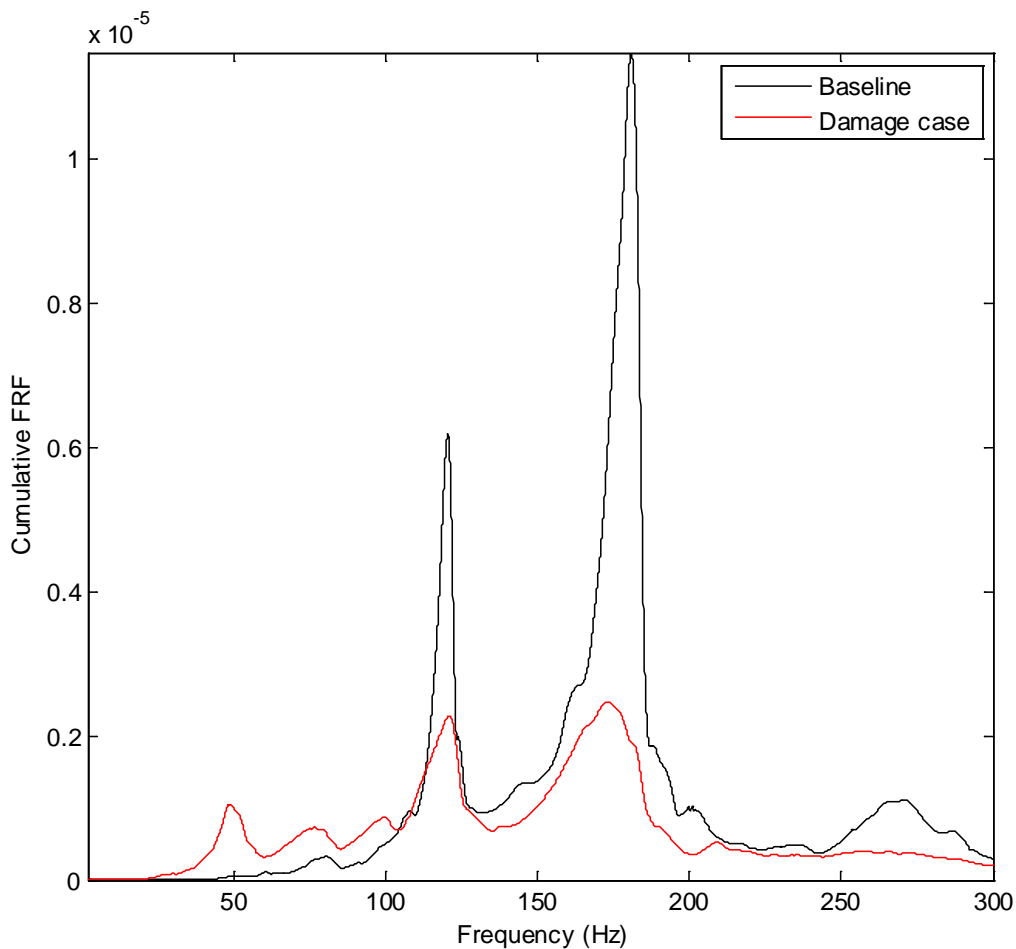
The cumulative frequency response functions (FRFs) are provided in Figure 18. These traces are the summation of all 55 data points in all three channels, or 165 time histories. The damaged trace's peaks have lesser magnitude and are "softer," demonstrating that more damping has been introduced into the system.

**Figure 18. Non-normalized cumulative FRFs using tri-axial accelerometer data.**

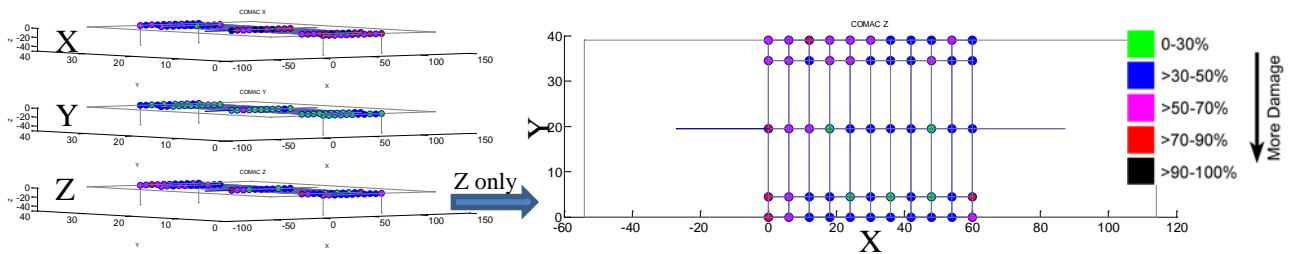
Coordinated Modal Assurance Criterion (COMAC) is a fairly common means of comparing two mode shapes. The tri-axial accelerometer data is mined to produce damage detection plots for each direction independently. The y-direction result often indicates the most damage as sideways is the fundamental mode. Yet, in order to compare with the LDV results, the z-direction results must be utilized as represented in Figure 19.

**Figure 19. Damage detection using COMAC on tri-axial (left) and z-direction (right) accelerometer data.**

The color scheme is normalized with respect to the maximum damage value in any direction and thus shows the percent of overall induced relative damage – not absolute damage as in a “safe” threshold. Even so, the damage is shown is a relatively diagonal pattern, indicating that torsion is quite dominant. Both boundaries indicate damage, but the greater effect exists at the left edge rather than the right pier. Five points of 70-90% damage are identified (with four of them along the left edge), so an inspector may be able to know something has changed in a boundary. False positives are at a minimum in this metric.

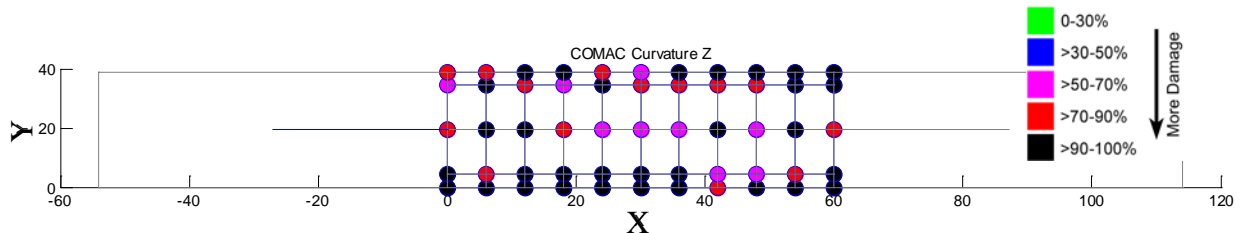
COMAC was also applied to mode shape curvature, or point-by-point numerical second derivative. The tri-axial accelerometer data is again mined to produce damage detection plots for each direction independently, and the z-direction results are shown in Figure 20. All points show at least 50% damage, but this is with respect to values in all three directions. Although there are no blue or green nodes, the black nodes are still at least 20% more damaged than the magenta nodes. No trend behavior is evident, except perhaps the slab’s center in spared some damage. An inspector would have no idea where to investigate and might even panic seeing so many false positives. This indicator appears too sensitive in this case.

**Figure 20. Damage detection using COMAC of mode shape curvature on z-direction accelerometer data.**

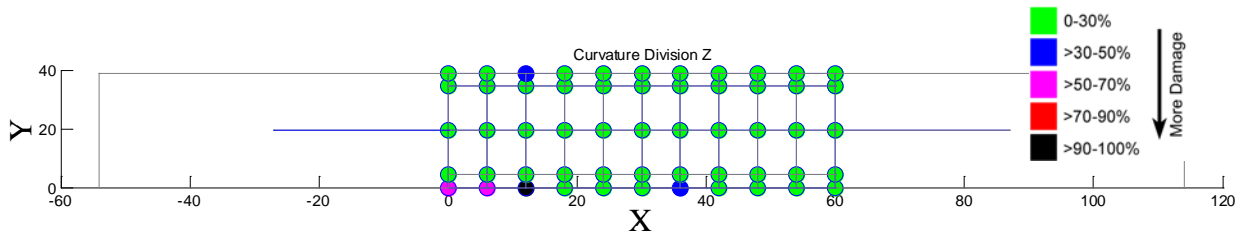
Mode shape curvature is also used as an indicator through proportional analysis, here direct division. A damaged mode shape's curvature is point-by-point divided by the associated baseline mode shape's curvature. Using this scheme, the tri-axial accelerometer data is mined to produce damage detection plots for each direction independently, and the z-direction results are shown in Figure 21. The variation in this indicator's magnitude is extreme, generating in a large disparity between maxima and minima. This results in a plot that shows little or no damage pattern, only singularities that could be false readings rather than trend behavior. An inspector might have false confidence, believing so many potentially false negatives.

**Figure 21. Damage detection using mode shape curvature division on z-direction accelerometer data.**

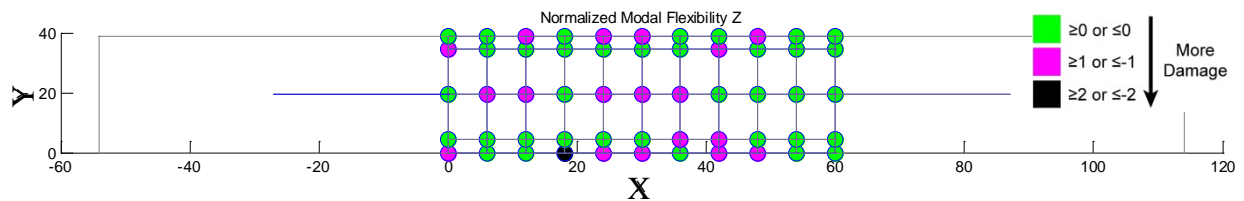
The flexibility of a structure can be proportionally estimated from two cross-correlated output signals. This is another means of comparing baseline to damaged mode shapes via standard deviation, creating the Normalized Flexibility Index. The tri-axial accelerometer data is mined to produce damage detection plots for each direction independently. To directly compare with the LDV data's plots, z-direction results are provided in Figure 22. The three-step color scheme is based upon the number of standard deviations away from the center of the bell curve. This plot shows no discernible damage pattern, and the least softened right edge is where the artificial damage was inflicted. An inspector would certainly not know where to investigate further.

**Figure 22. Damage detection using Normalized Modal Flexibility on z-direction accelerometer data.**

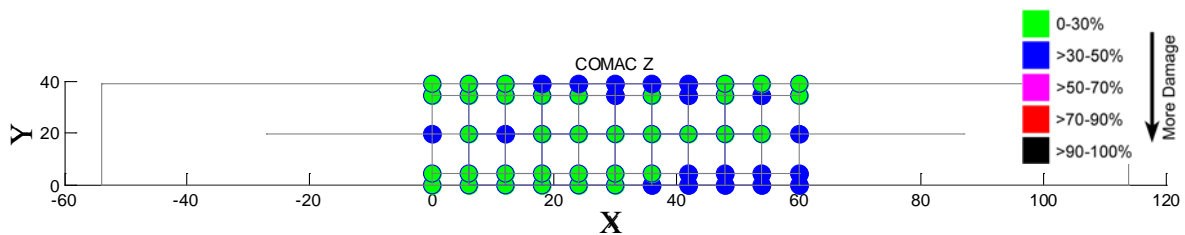
In short, the reduced number of coordinate modes provided no major improvement of these results. It is more likely that the dominance of the y-direction sideways has more effect.

**Figure 23. Damage detection using COMAC on reduced z-direction accelerometer data.**

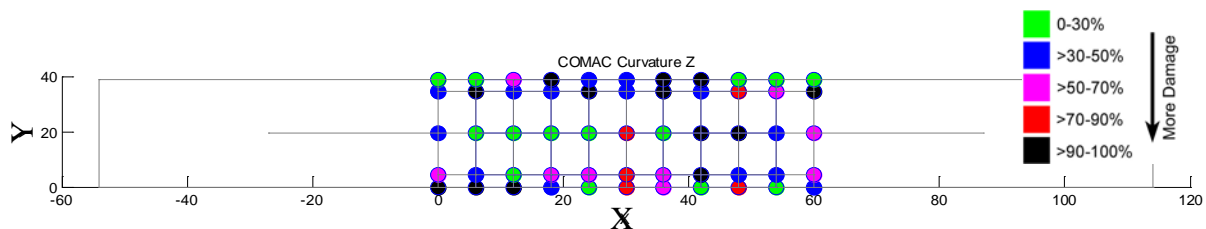
**Figure 24. Damage detection using COMAC of mode shape curvature on reduced z-direction accelerometer data.**

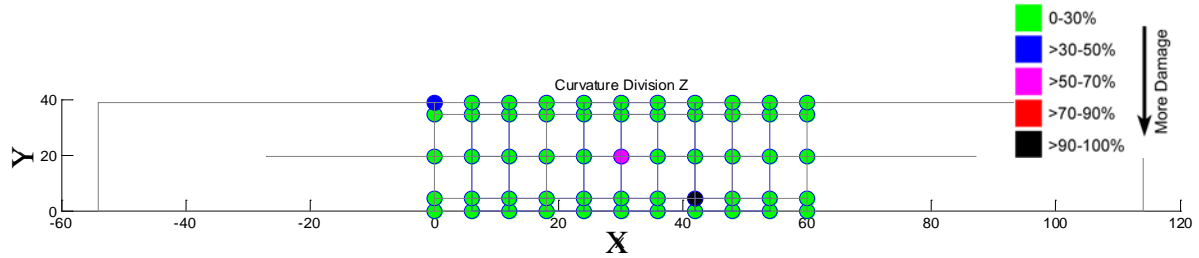
**Figure 25. Damage detection using mode shape curvature division on reduced z-direction accelerometer data.**

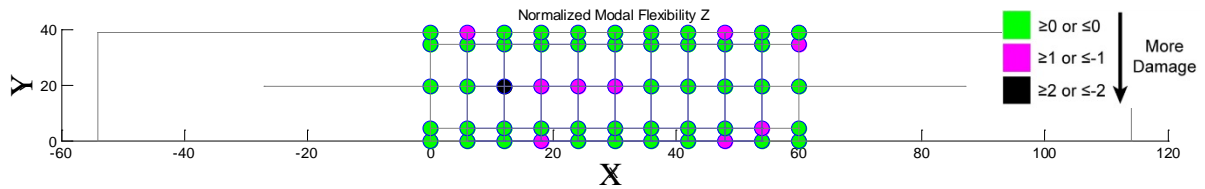
**Figure 26. Damage detection using Normalized Modal Flexibility on reduced z-direction accelerometer data.**

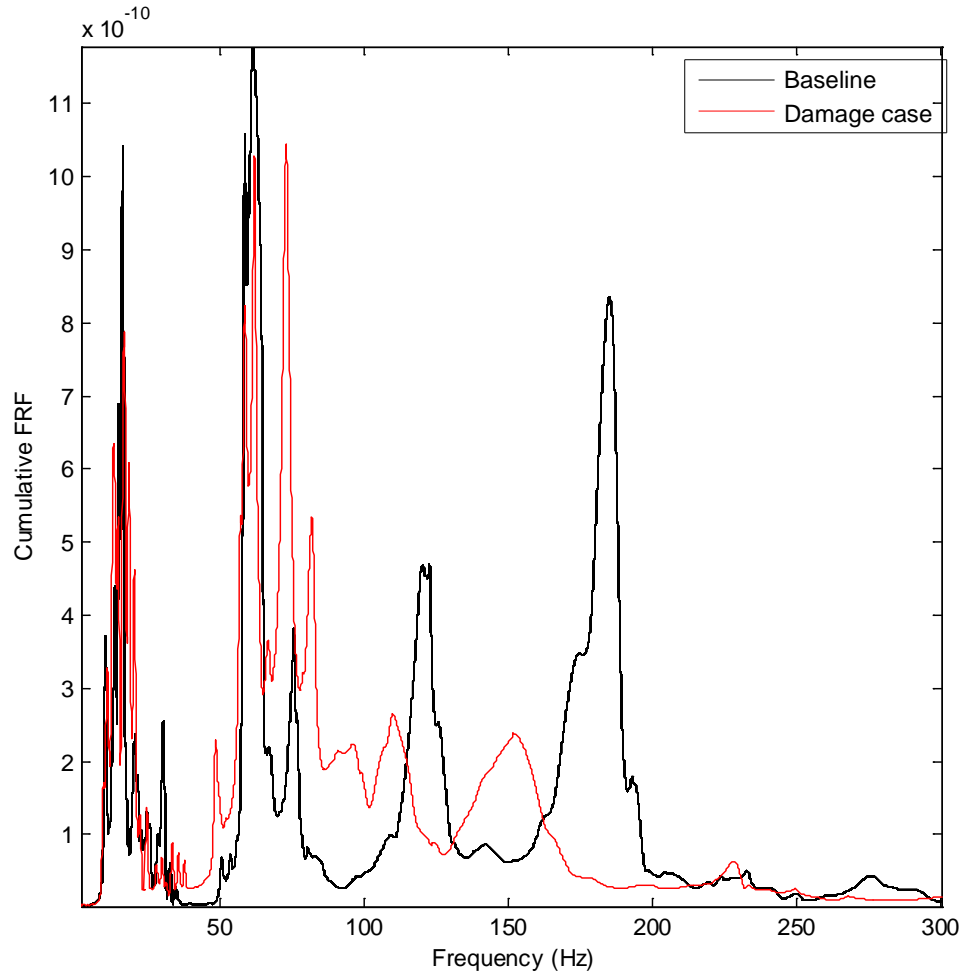
**Figure 27. Non-normalized cumulative FRFs using LDV data.**

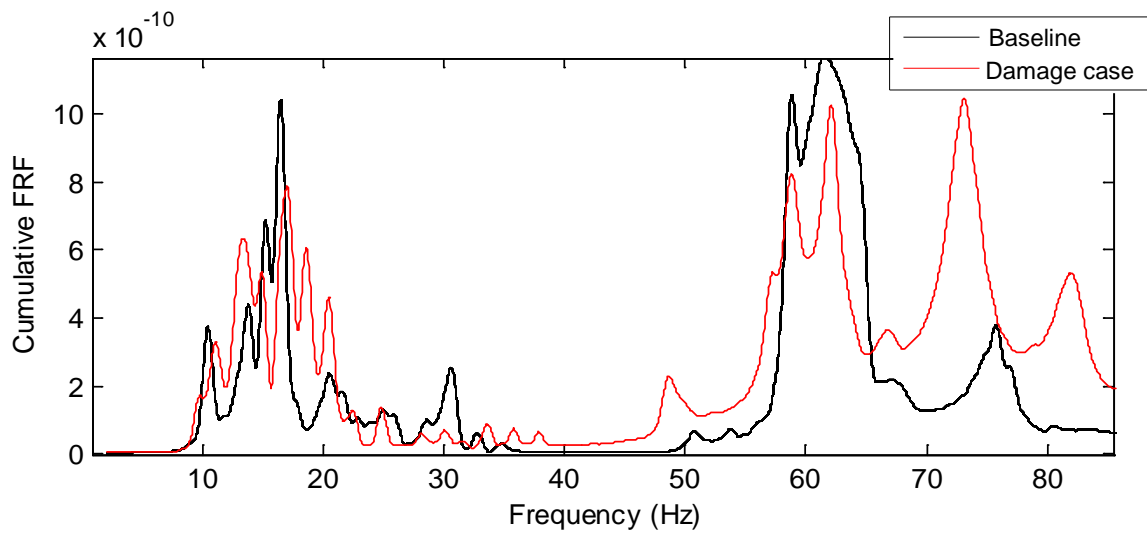
**Figure 28. Zoom of Figure 27: non-normalized cumulative FRFs using LDV data.**

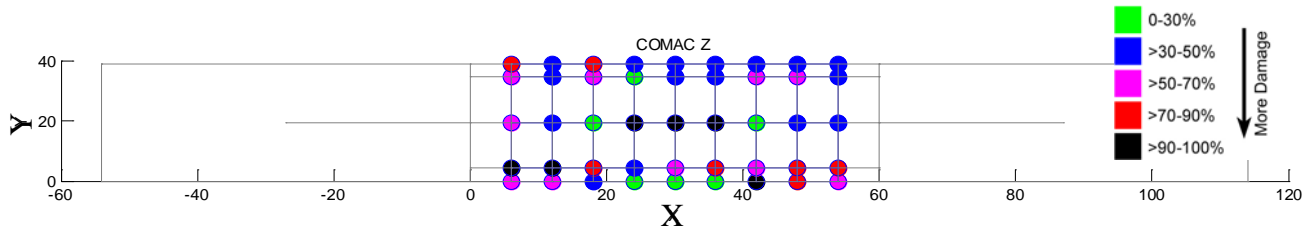
The vertical LDV data was mined to produce a damage detection plot using COMAC. Figure 29 illustrates a damage pattern that is more erratic than that obtained with the accelerometer data. The indication of most damaged three-node line at the slab's center is not possible. The left edge does show more damage than the right as prior studies, but not as induced.

**Figure 29. Damage detection using COMAC on LDV data.**

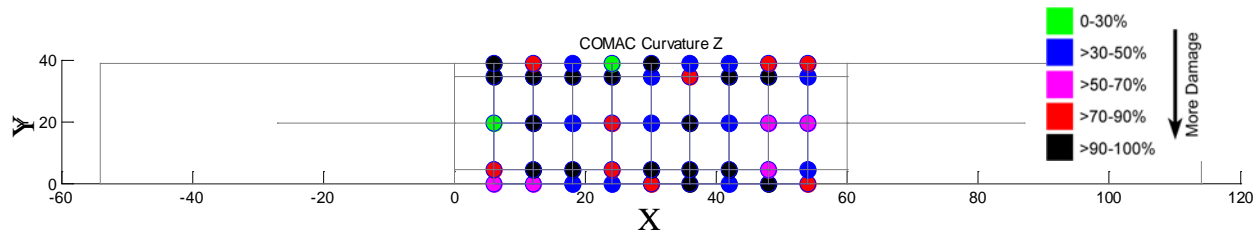
As plotted in Figure 30, COMAC on mode shape curvature employing the LDV data provides better range of damage index values. No trend behavior is evident, but the pattern is somewhat similar to that with the accelerometer data. This metric again shows too much damage, and an inspector would have no idea where to investigate due to such high sensitivity.

**Figure 30. Damage detection using COMAC of mode shape curvature on LDV data.**

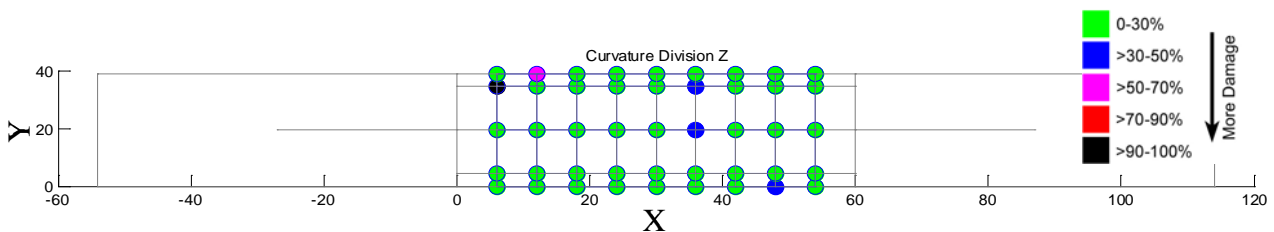
Direct division on mode shape curvature for the LDV data again provided extreme variations in magnitude. Figure 31 depicts a plot that shows no damage pattern, only singularities that could be false readings rather than trend behavior. These singularities are not the same nodes as those using the accelerometer data. An inspector might have false confidence or panicked inspection at an incorrect location.

**Figure 31. Damage detection using mode shape curvature division on LDV data.**

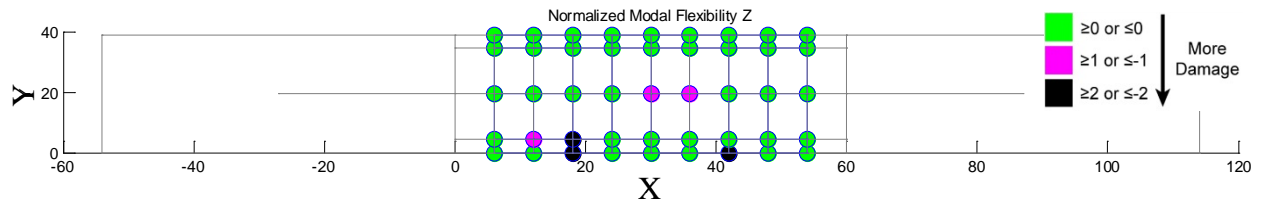
The Normalized Flexibility Index algorithm applied to the LDV data results in Figure 32. As that with the accelerometer data, this plot shows no discernible damage pattern. Perhaps an inspector's imagination would lead him to investigate the  $y=0$  line, but the result is certainly no better than that with contact sensor measurements.

**Figure 32. Damage detection using Normalized Modal Flexibility on LDV data.**
