EVALUATE METHODOLOGY TO DETERMINE LOCALIZED ROUGHNESS

Report 0-6610-2 Project 0-6610 Project Title: Impact of Changes in Profile Measurement Technology on QA Testing of Pavement Smoothness

> > Published: March 2018

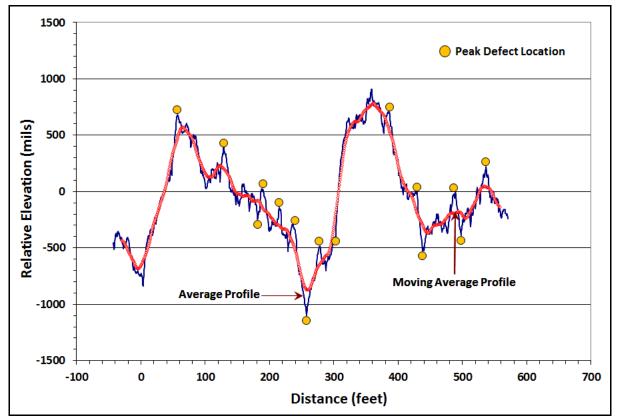
Figure 1. Illustration of Methodology for Identifying Defects on Item 585 Projects.

To identify defects, the methodology illustrated in Figure 1 uses the deviations between the average of the left and right wheel path profiles, and its moving average as determined using a 25-ft base length. This methodology is implemented in TxDOT's Ride quality program, which is used for QA testing of initial pavement smoothness under Item 585. In Figure 1, the blue line represents the average profile, while the red line represents its 25-ft moving average. Note that the moving average profile does not start and end at the same locations as the average profile since the calculation of the moving average requires a 12.5-ft lead-in and a 12.5-ft lead-out. In practice, this lead-in and lead-out will be included in the 100-ft leave-out segments at the project ends, which are tested using Surface Test Type A under Item 585. If one computes the IRI of the average profile illustrated in Figure 1, the resulting index would be 167 in/mile. In contrast, the IRI of the moving average profile is 44 in/mile. Thus, hypothetically, if one can correct the average profile to be like the moving average, a smoother pavement would result. This premise provides the rational for using the deviations between the average profile and its moving average to evaluate localized roughness. The specific procedure implemented in TxDOT's Ride Quality program to evaluate localized roughness is a modification of the methodology described in reference (2).

At each station, the Ride Quality program computes the difference between the average profile elevation and the elevation based on the moving average. Stations where the differences exceed 150 mils in magnitude are considered defect locations. In this analysis, a positive difference indicates a bump while a negative difference indicates a dip. In Figure 1, the yellow dots identify the stations where the defect magnitudes are at their maximum. To provide guidance for corrective work, the Ride Quality program reports the stations where the defects are at their peaks, as well as the widths of the defect intervals within which the deviations between the average profile and its moving average are above 150 mils.

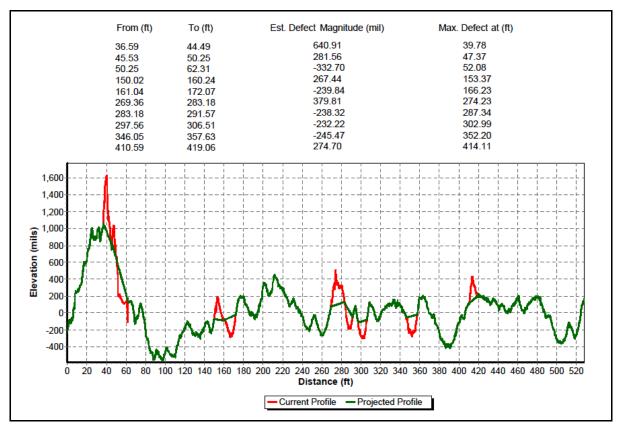
Figure 2. Sample Results from Analysis of Wheel Path Profiles to Identify Defects.

Figure 2 illustrates a sample of the results obtained from this analysis over a 528-ft section of continuously reinforced concrete pavement (CRCP) located along the inside lane of the southbound frontage road along SH6 south of College Station. Segments of the profile shown in red identify defects found from analyzing the left wheel path profile. The locations of the defects as well as their amplitudes are shown at the top of the chart given in Figure 2. The starting and ending locations of each defect are where the moving average profile intersects the measured wheel path profile on the lane tested. This definition of defect width provides the interval within which the measured profile deviates from its 25-ft moving average. Note that this interval is wider than the defect width reported by the Ride Quality program, which only includes stations where the deviations exceed the 150-mil threshold of the existing bump template defined in TxDOT Test Method Tex-1001-S (7). Defining the defect width as explained herein and using the measured wheel path profile in lieu of the average profile provide consistency with the original methodology proposed by Fernando and Bertrand (2) for determining localized roughness.

Researchers note that in tests conducted on TxDOT project 0-4863 (8), measured dynamic loads from an instrumented 18-wheeler were found to exhibit high variability at locations where defects are found along the pavement surface. This project showed that TxDOT's existing Ride Quality bump template, when used with the individual wheel path profiles, identified the locations of defects associated with high dynamic load variability. Project 0-4863 found that evaluating the defects based on the average profile tends to mask the defects that exist along the individual wheel paths, particularly on pavement sections where there are significant differences between the left and right wheel path IRIs. Given that the individual wheel path profiles are the measured data from the inertial profiler, using the current bump template with the individual wheel path profiles should give a better assessment of the localized roughness that exists on a given project, in terms of where the defects are, and the magnitudes of these defects. In Figure 2, the estimated magnitude of each defect is the maximum deviation of the measured wheel path profile from the moving average. This deviation is positive for bumps and negative for dips. The location where the maximum deviation occurs is also given in the figure.

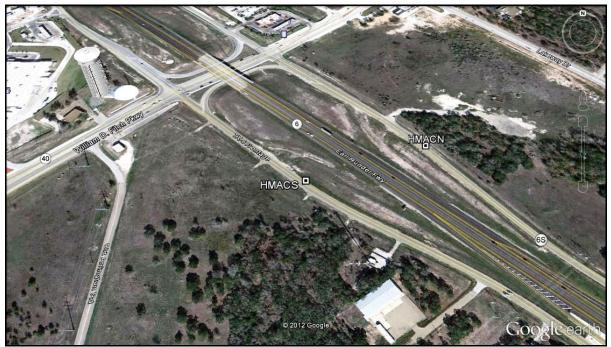
Figure 3. North End Points of HMAC Sections on SH6 Frontage Roads (Dotted Squares **Denote Section End Points).**

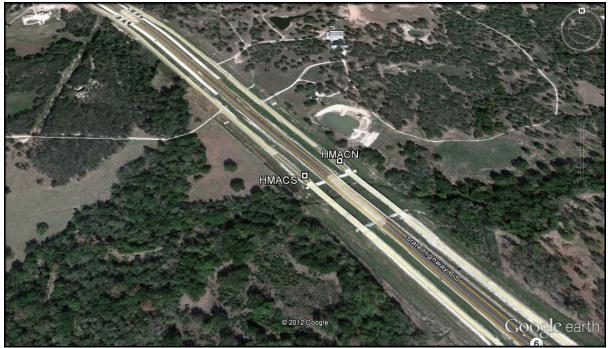
Figure 4. South End Points of HMAC Sections on SH6 Frontage Roads (Dotted Squares Denote Section End Points).

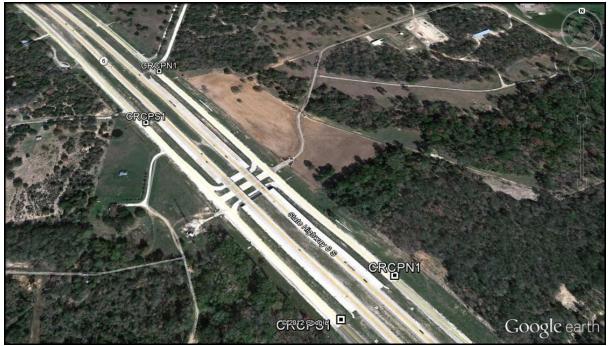
Figure 5. CRCPS1 and CRCPN1 Sections along SH6 Frontage Roads (Dotted Squares Denote Section End Points).

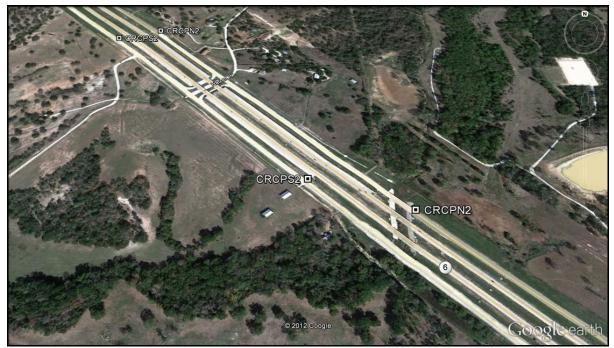
Figure 6. CRCPS2 and CRCPN2 Sections along SH6 Frontage Roads (Dotted Squares Denote Section End Points).

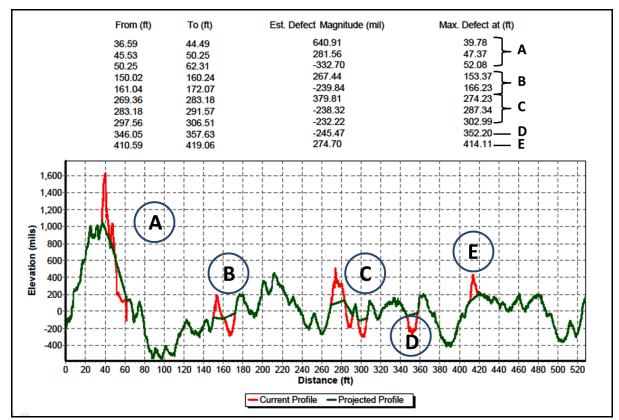
Figure 7. Illustration of Defect Groups Established in Each Survey Section.

The survey sections were presented earlier in this chapter. Within each section, researchers established groups of defect stations of varying defect amplitudes and widths. Figure 7 illustrates the defect groups along a 528-ft section of the CRC pavement located along the inside lane of the SH6 southbound frontage road south of College Station. The defect groups are identified as A, B, C, D, and E in the figure.

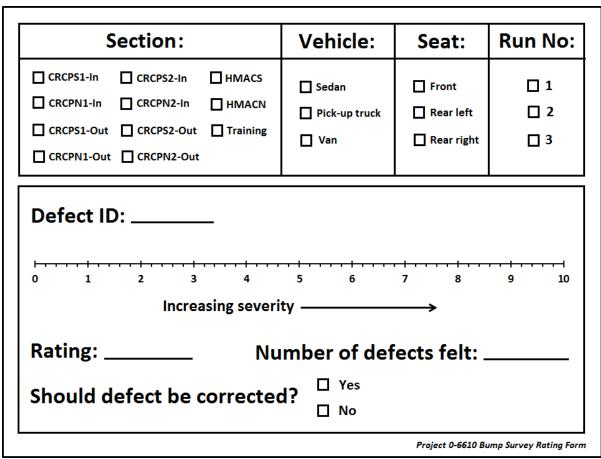
Figure 8. Bump Rating Panel Survey Form.

The bottom of the form is where the rater enters his or her rating for the given defect group. During the briefing, raters were instructed to rate each defect on a 0 to 10 scale, with 0 indicating that the rater felt no perceptible sensation while riding over the defect, and 10 indicating a defect that was harsh and notably uncomfortable to the rater. The raters were asked to write down their rating on the blank provided in the form. However, the rater was also given the option to mark his/her rating on the scale shown if this was easier for him/her to do. During the briefing, the researchers advised that if the rater marks the scale, that he/she write down the rating on the blank provided as soon as it was possible to do so, such as during the time between passes on a given section. The raters were also instructed to identify the defect on the form, whether the defect needed to be corrected or not, and how many defects he/she felt. The drivers provided the defect IDs for the raters to enter on the form.

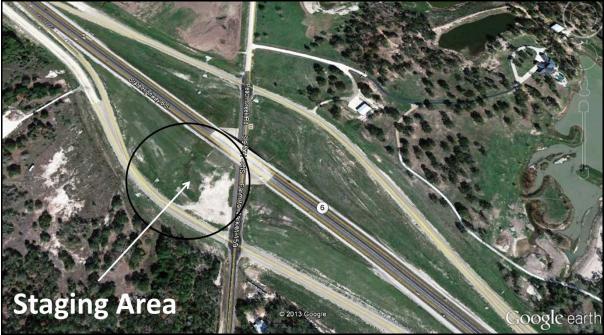
Figure 9. Staging Area Used during Bump Surveys.

runs on all test sections, drivers were instructed to proceed to the designated staging area, and wait for the other vehicles. This staging area (illustrated in Figure 9) is at the Millican exit along SH6. This area is where drivers and raters switched vehicles. During the briefing session, raters were instructed to switch positions as they move from one test vehicle to another. Thus, each rater got to occupy the front passenger seat, the left rear seat, and the right rear passenger seat. At any one time, each vehicle had four occupants, the driver and the three raters with him.

After the briefing session, everyone in the room proceeded to the designated staging area at the SH6 Millican exit. From there, the raters were driven on a section of the SH6 southbound frontage road to rate defects and go through training runs prior to the actual surveys. Researchers established the training section adjacent to the HMACS test section identified in Table 1. Researchers established 29 defect groups within this training section.

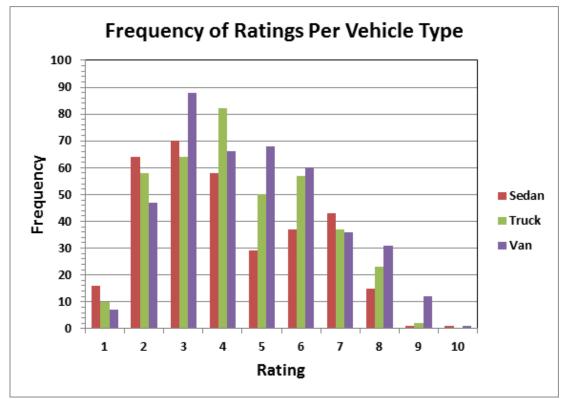
Figure 10. Variations in Ratings between Vehicles for all Raters Indicating Corrective Action Required.

On examining the data, researchers found significant variation between individual raters in both the ratings of bump severity, and the need for corrective action. Likewise, as expected, the ratings over the same section varied depending on the vehicle types. For example, Figure 10 illustrates the rating distribution between all raters within the different vehicle types for the cases where corrective action was required. It is noted that raters tended to give higher severity ratings (or defects were more noticeable) when traveling in the van than when the same defects were rated in the sedan. For comparison, Figure 11 provides an example of the ratings given by one of the pavement engineers who indicated corrective action was required within the vehicle types. For this rater, a total of 55 defect groups were classified as needing corrective action when in the van, 74 when in the truck, and 42 when in the sedan.

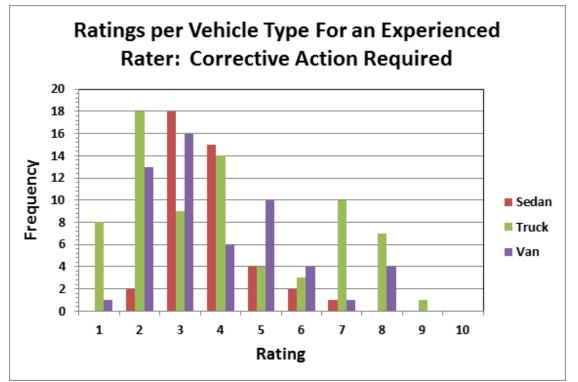
Figure 11. Variations in Ratings between Vehicles Indicating Corrective Action Required (Rater with Broad Pavement Engineering Experience).

A rater with relatively less experience in pavement condition assessment was driven in the same vehicle and over the same defects and gave very different ratings. This rater is consistent in that he always gave a rating of 3 when corrective action was selected. The only variation for this rater was in the number of defect groups classified as needing corrective action. When in the van, this rater found 13 defect groups requiring corrective action. When in the truck, the rater found 11, and when in the sedan, the rater only identified 2 defects requiring corrective work.

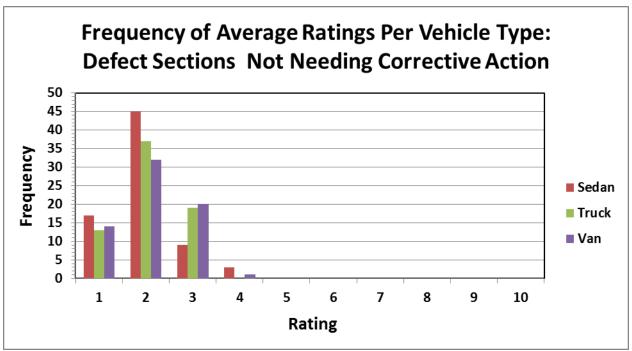
Figure 12. Variations in Average Ratings between Vehicles Where Raters Indicated No Corrective Action Needed.

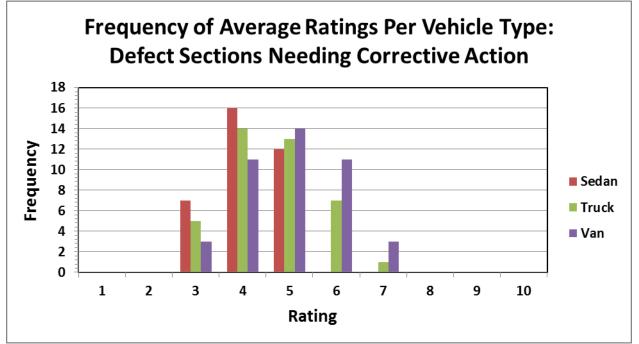
Figure 13. Variations in Average Ratings between Vehicles Where Raters Indicated Corrective Action Needed.

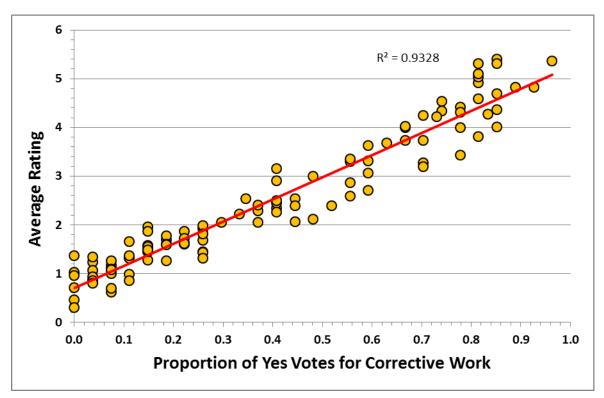
The model has an R^2 of 93.3 percent and a standard error of the estimate (SEE) of 0.3581. Figure 16 illustrates the goodness-of-fit of the model.

Figure 16. Relationship between Average Severity Rating and Proportion of Yes Votes to Correct a Given Defect.

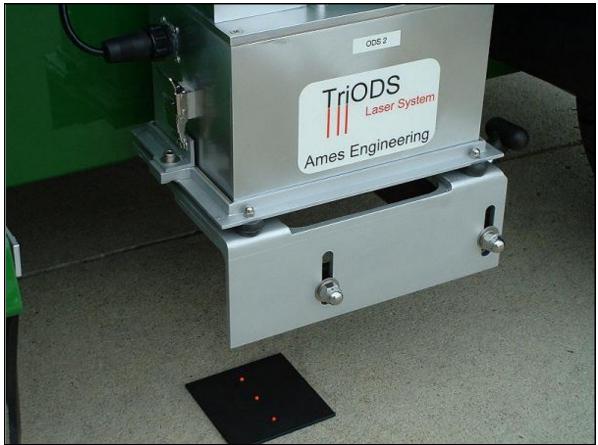
Figure 17. TriODS Three-Laser System from Ames Engineering.

Data were collected using the Ames Model 8200 profiler owned by Southern Crushed Concrete, which is affiliated with Webber, the company that placed the continuously reinforced concrete pavements along this new highway construction project. This particular profiler is equipped with the Ames TriODS shown in Figure 17, which uses three lasers for surface profile measurement per wheel path.
