Evaluation and Testing of a Lightweight Fine Aggregate Concrete Bridge Deck in Buchanan County, Iowa

Final Report
May 2016

Sponsored by
Iowa Highway Research Board
(IHRB Project TR-648)
Iowa Department of Transportation
(InTrans Project 12-434)
Federal Highway Administration

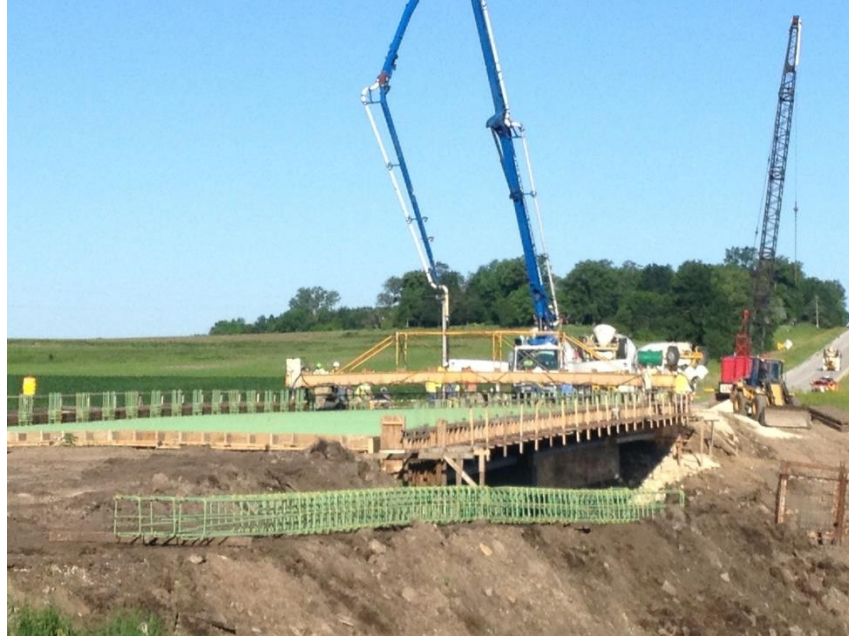
Figure 3. Three-span bridge at Pine Creek during concrete placement

- Owner: Buchanan County, Iowa
- Contractor: Jim Schroeder Construction, Inc.
- Location: 220th Street at Pine Creek
- Structure: Three-span bridge 176 ft long and 30 ft wide, one half (east end, both lanes) conventional mixture and the other half (west end) using internal curing concrete (Figure 3)
- The deck was 8 in. thick with a nominal 2.5-in. cover to the top layer of reinforcement and a nominal 1-in. cover to the bottom layer of reinforcement.
- The specified air content was 6.5% with a maximum of 8.5% and a minimum of 5.5%. The slump ranged from 1 in. to 3 in. with a maximum of 4 in.

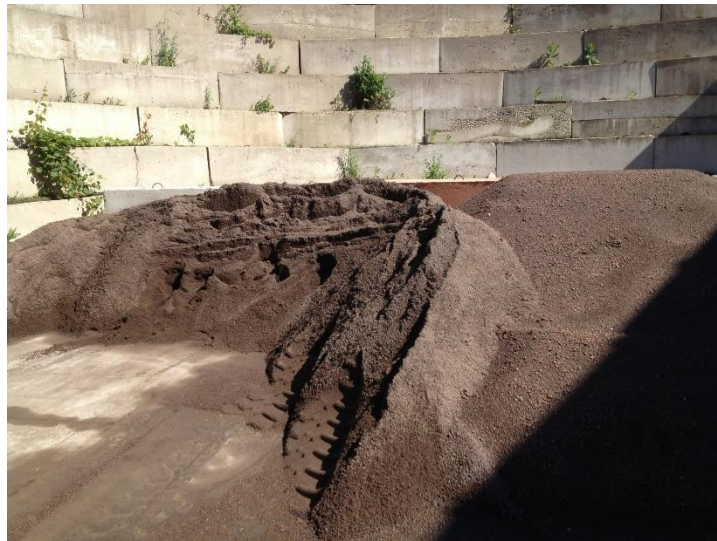
Figure 7. LWFA pile before mixing at central mix plant

- Concrete placement was by means of a form riding bridge deck paver.
- All concrete came from a fixed batch plant and was delivered to the job site in ready-mix trucks. Concrete was discharged from two ready-mix trucks simultaneously to a pump truck.
- The LWFAs were soaked for 48 hours and drained overnight before mixing. The LWFA pile at the central mix plant is shown in Figure 7.
- The mean temperature at the construction site was 71°F. The average humidity and wind speed were 57% and 12 mph (NW), respectively.
- Fresh concrete tests included slump, unit weight, and concrete temperature. Tests were conducted by Buchanan County Engineer/Secondary Roads staff, and the results are shown in Table 2.

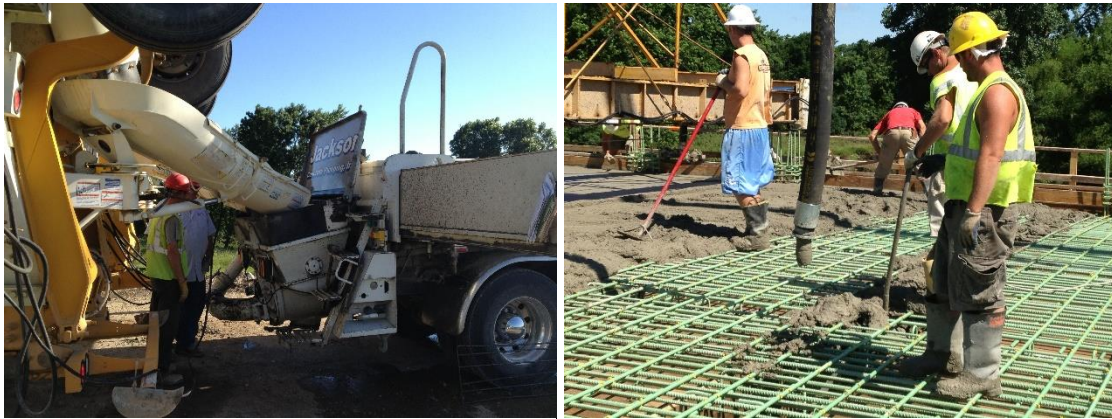
Figure 8. Concrete being discharged to a pump truck and then to the deck

Figures 8 through 11 illustrate some activities during the placing process.

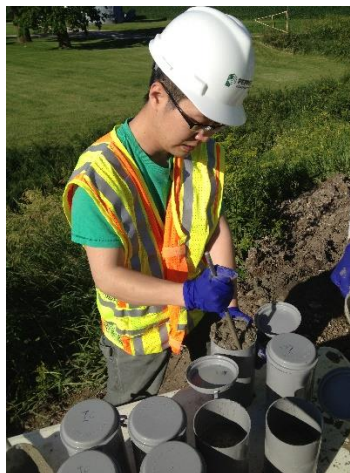
Figure 10. Concrete sample preparation

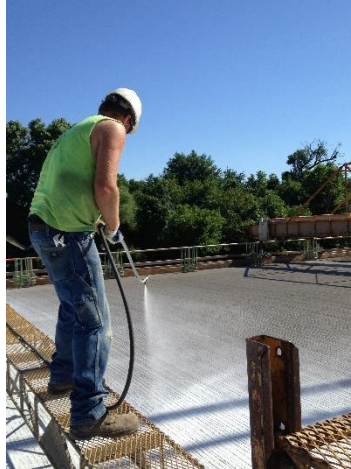
Figure 11. Curing compound being applied

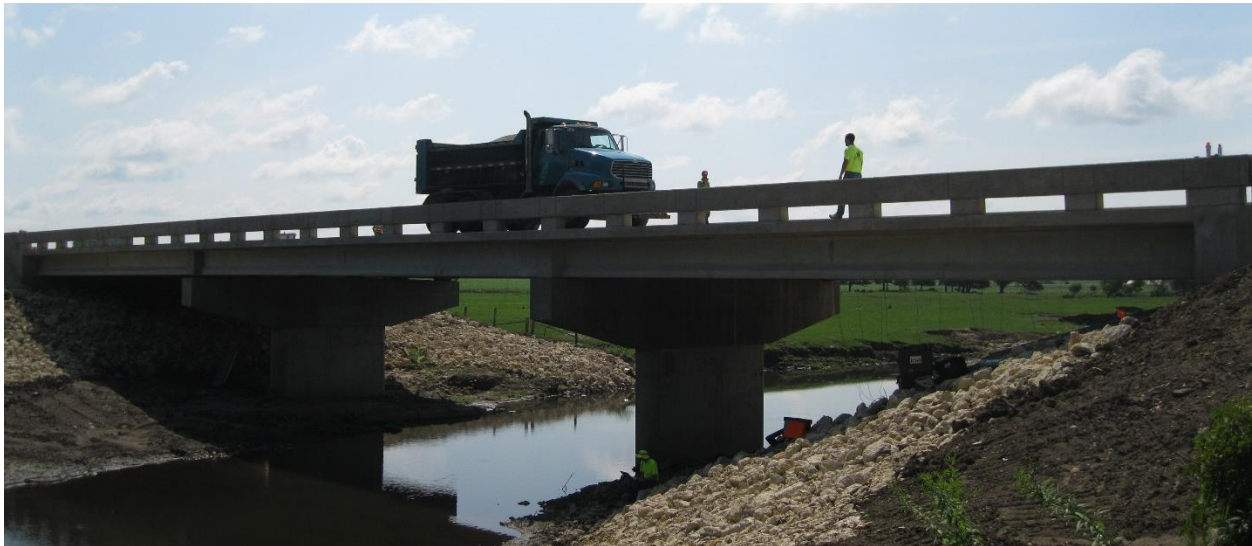
Figure 12. Live load testing of LWFA bridge, 2013

Following construction of the LWFA bridge, the Bridge Engineering Center (BEC) conducted live load tests of the bridge on three separate occasions: (1) immediately following construction just before the bridge was open to traffic (August 2013), (2) approximately one year after the initial load test (August 2014), and (3) approximately two years after the initial load test (November 2015). All three load tests involved instrumenting the bridge girders and deck with strain transducers and conducting static load tests using a fully loaded tandem-axle dump truck of known weight (see Figure 12).

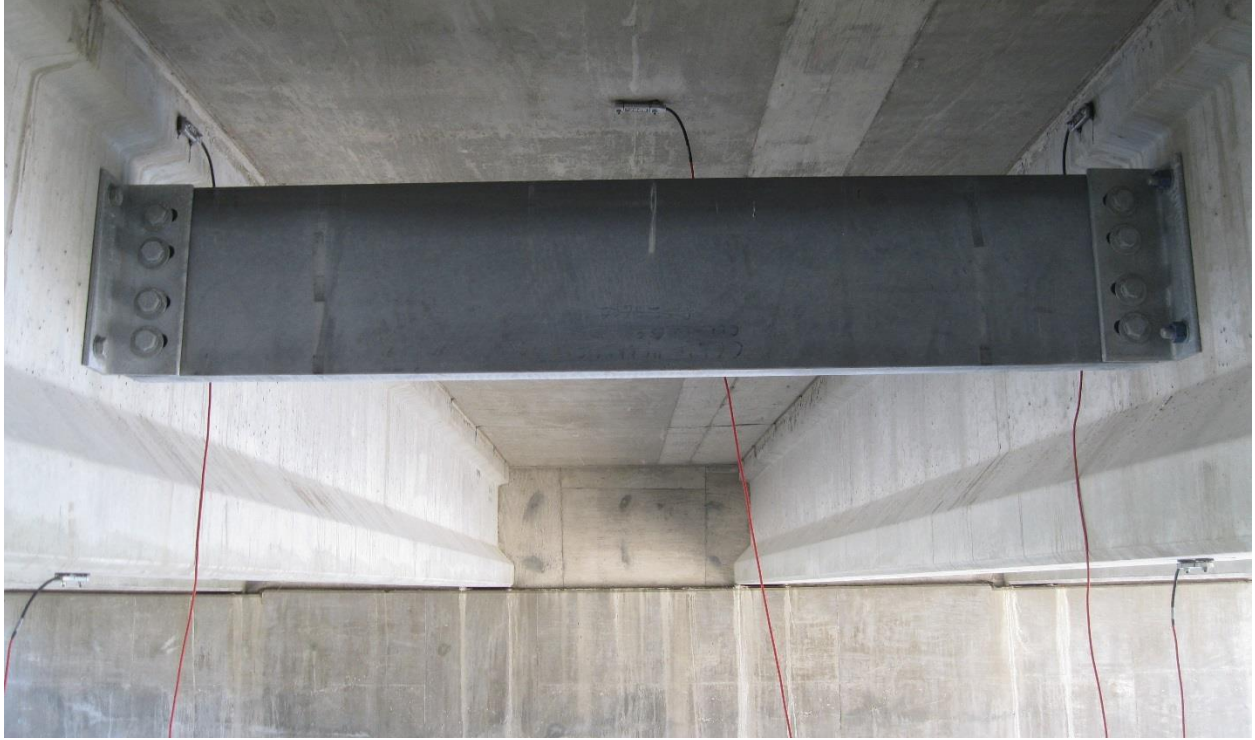
Figure 14. Typical instrumentation setup for testing of LWFA bridge

Figure 14 illustrates a typical strain gauge setup during testing, showing the placement of the top and bottom flange girder gauges and the deck gauge.

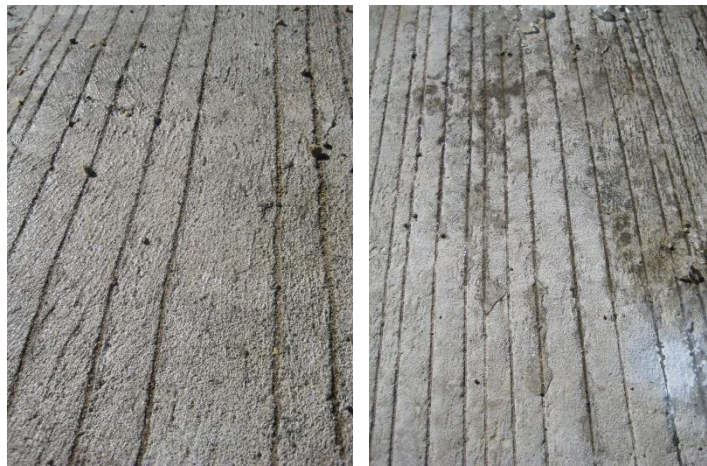
Figure 19. Control (left) and IC (right) section surfaces

- No cracks were found.
- The curing compound still appeared to be in place.
- Some traffic was using the bridge, although barriers were in place.
- Little observable difference was apparent between the IC and control sections.

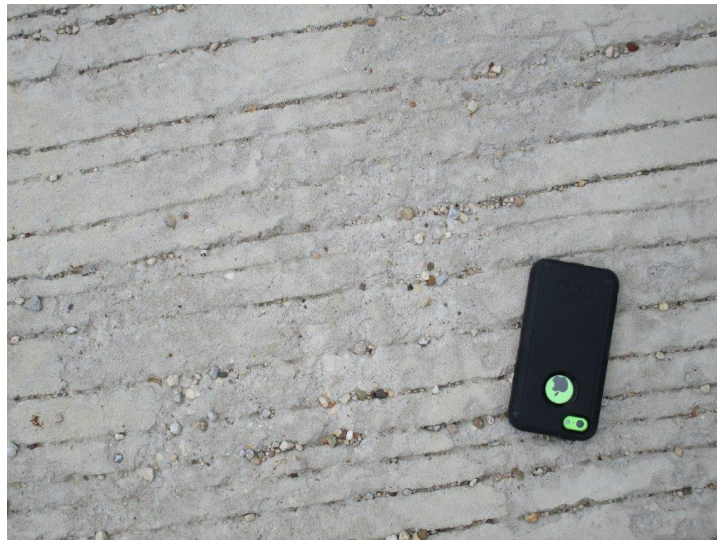
Figure 21. Limited scaling observed on the surface near drains

- No cracks were found.
- Slight scaling was observed on both control and IC sections near drains (Figure 21).
- Little observable difference was found between the IC and control sections.
