Long-Term Field Monitoring of Paving Fabric Interlayer Systems to Reduce Reflective Cracking

FINAL REPORT

Farshad Amini & Kejun Wen

Jackson State University

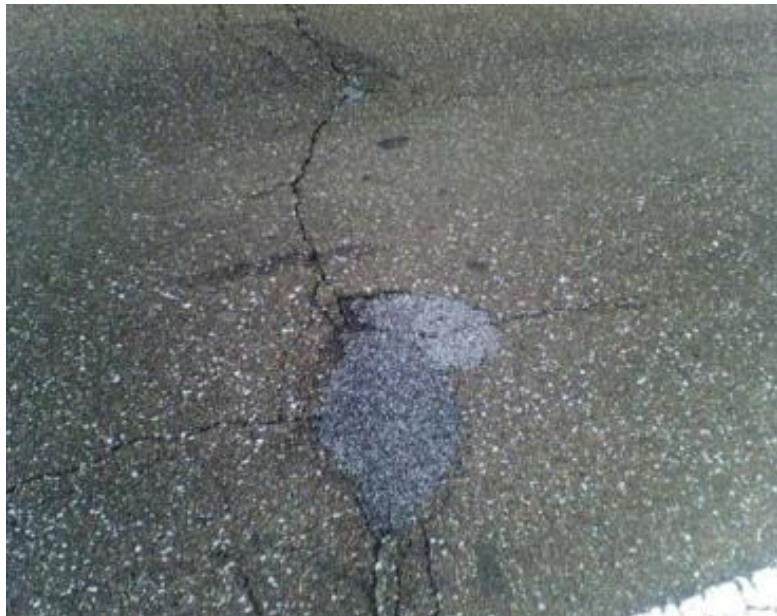
Figure 4.1 Typical Longitudinal Cracks in Pavement

Figures 4.1 and 4.2 show typical transverse and longitudinal cracks in the existing pavement. This portion of roadway indicates many distresses in asphalt pavements including raveling and transverse cracking with the need for milling, sealing, and overlay. There were cracks of considerable lengths and widths, small pot holes, and sections with uneven roadway. These characteristics made this part of roadway a suitable location for research purposes.

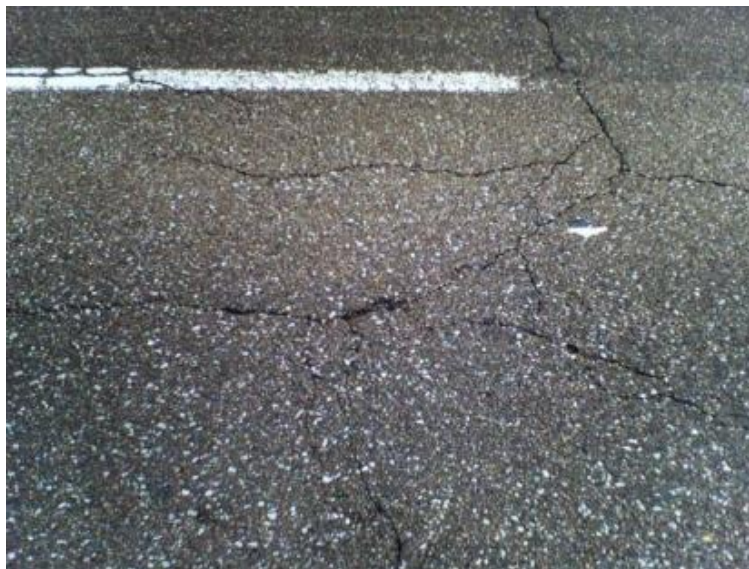
Figure 4.2 Typical Longitudinal Cracks in Pavement

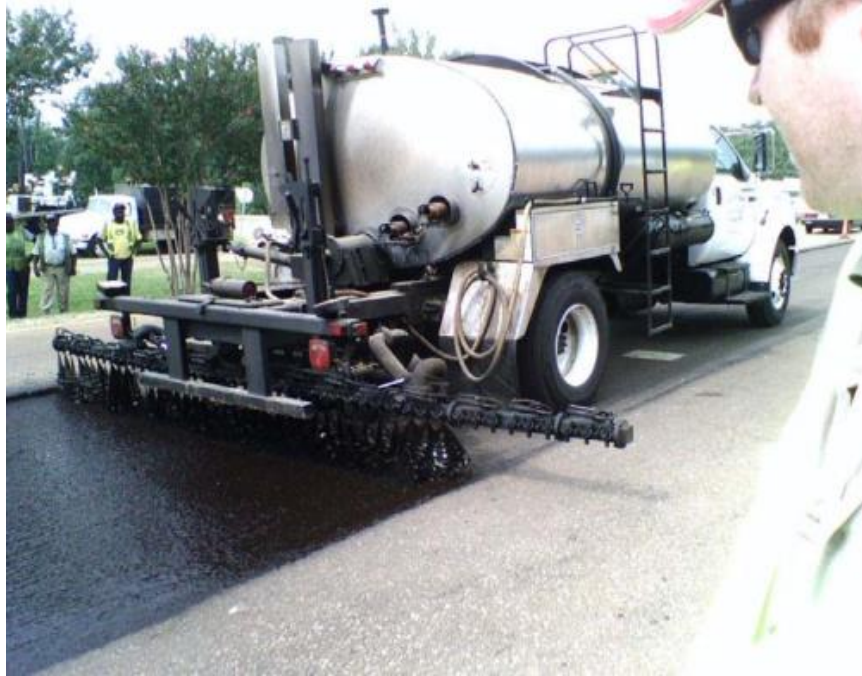
Figure 5.1 Applying Uniform Tack Coat on Test Section

The application of insufficient tack coat is one of the leading causes of problems with paving fabrics. The absence of adequate tack coat corresponds to the loss of paving system benefits and can lead to damage the overlay. Too much tack coat will also bleed through the new asphalt. Button and Epps (1983) developed the following equation to obtain pavement fabric tack coat.

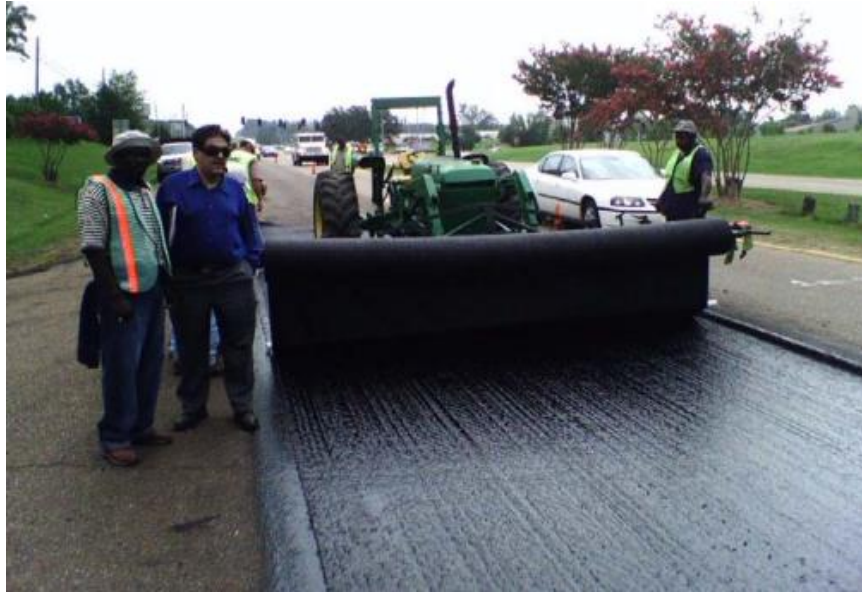
Figure 5.2 Placing Fabric on Test Section

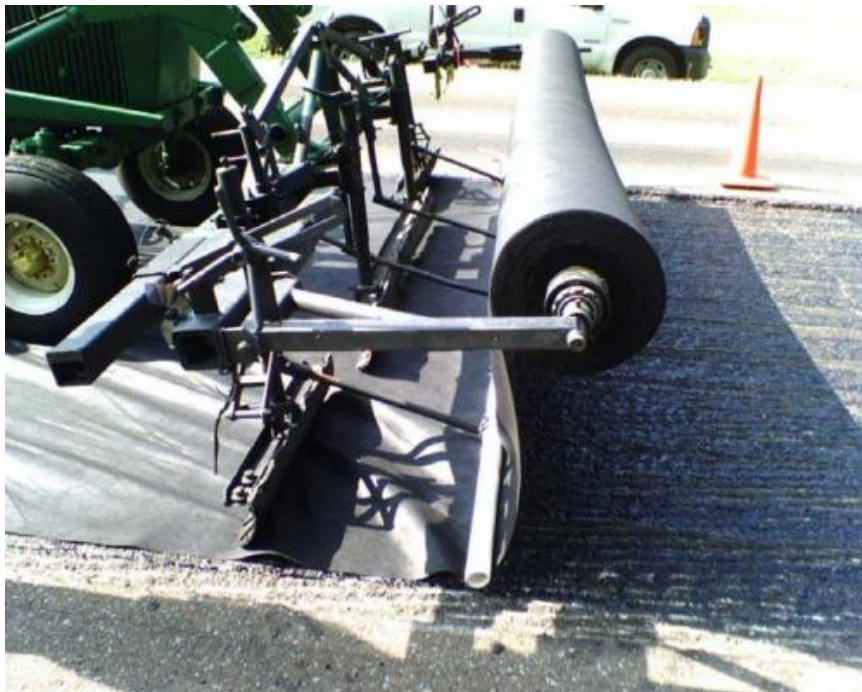
Figure 5.3 Placement of Paving Fabric

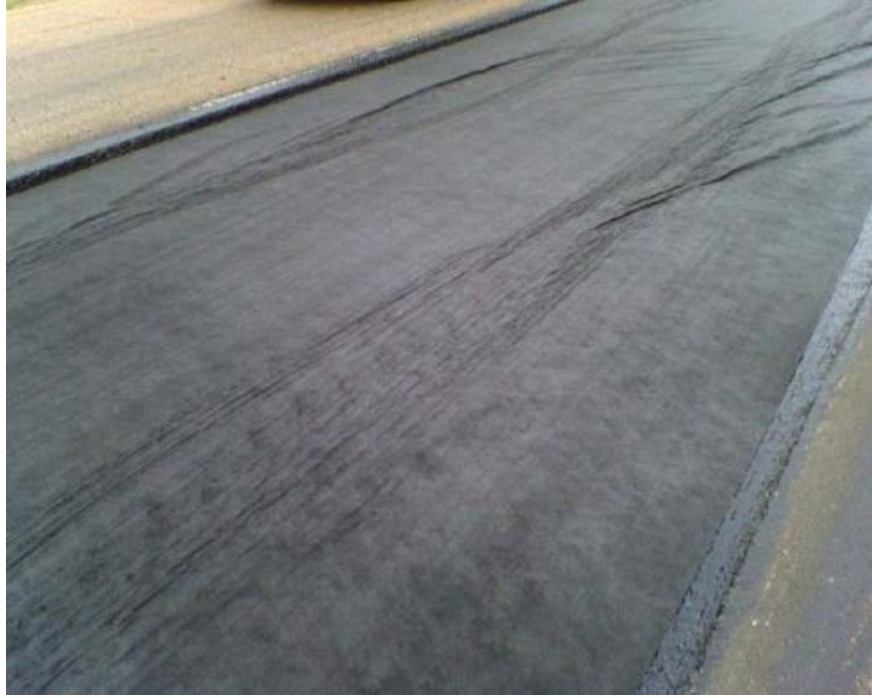
Figure 5.4 Wrinkles after Placement of Fabric

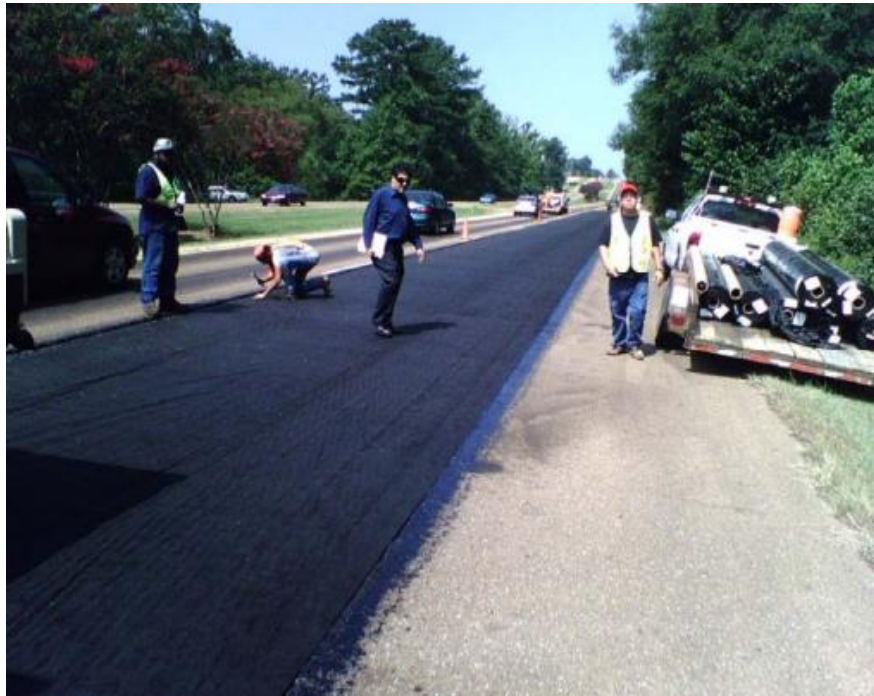
Figure 5.5 Engineer Inspecting of Fabric after Placement

In summary, proper installation procedures are critical for optimum performance. Installation of paving fabrics has become more sophisticated in recent years. In this project, when placing the paving fabric, special care was taken to ensure that the wheels from the tractor, equipped with an attachment that allowed the placement of a roll of fabric on the road surface up to 12 ½-ft (3.81 m), did not damage the fabric. In addition, the fabric was inspected to ensure that there was not excess bleeding through the fabric from the tack coat (see Figures 5.2 through 5.5). For this to be accomplished, the driver kept the turning of the equipment wheel to a minimum and made sure that the fabric was kept in full tension during placement, to reduce wrinkles. After placement, all excess wrinkles were pulled out by hand, rolled with a steel roller and allowed to adhere to the tack coating before paving overlay could begin. The details of paving fabrics installation are included in Amini and Turnquest (2008) and Amini et al. (2012).

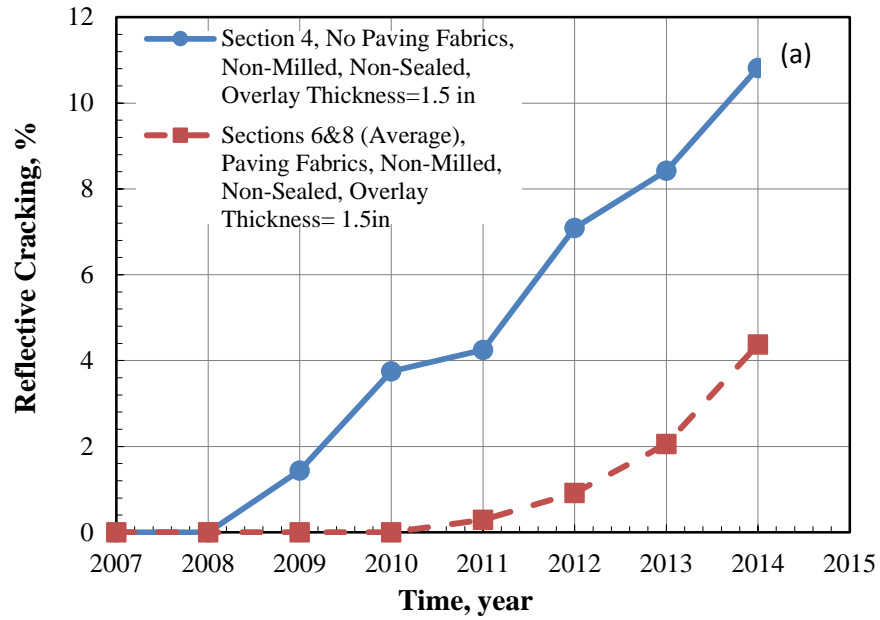
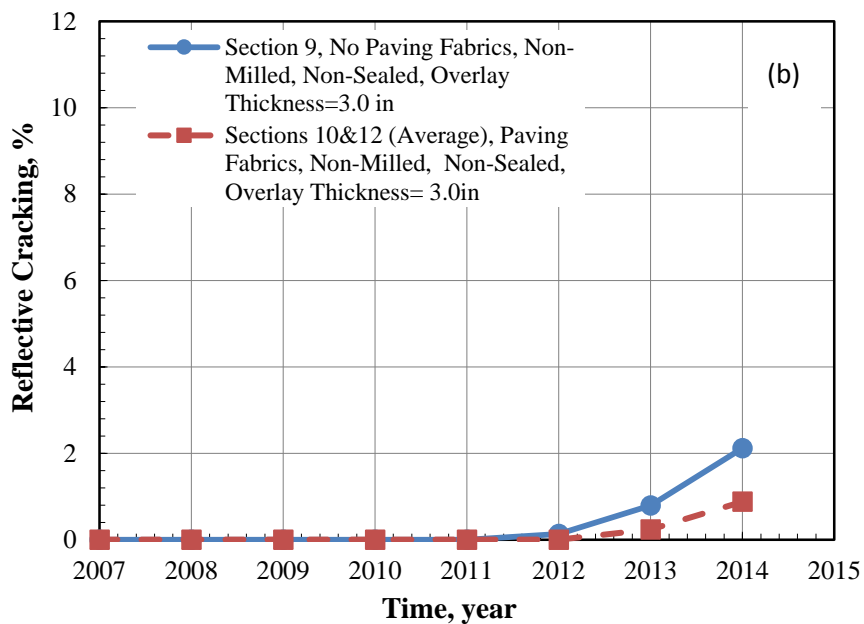
Figure 7.1.1 Performance of Pavement with and without Paving Fabrics, (a) 1.5 in (38.1 mm) Overlay Thickness; (b) 3.0 in (76.2 mm) Overlay Thickness

Figure 7.1.1 shows the effect of paving fabrics on the performance of the pavement section. Figure 7.1.1 (a) compares the reflective cracking of the Section 4 and the average of Sections 6 and 8 with 1.5 in. (38.1 mm) overlay thickness. As shown in this figure, Section 4 started cracking in 2008 and the reflective cracking increased to 11% by 2014. With the addition of paving fabrics, the cracking started in 2010. By 2014, the reflective cracking in Sections 6 and 8 increased to 4.3%, which was 40% of the cracking of Section 4. The pavement without paving fabrics started to crack in 2009, while for Sections 6 and 8, it started to crack in 2011. The improved performance of the paving fabrics section may be explained by the fact that the paving fabrics provided higher shear strength to prevent or delay cracking. In addition, the paving fabrics layer functioned as a waterproof barrier to prevent the water to go through the sub base that could cause more structure damage. In Figure 7.1.1 (b), when the overlay thickness was increased to 3.0 in (76.2 mm), the reflective cracking showed a similar trend in both the control section and the paving fabrics section (very limited early cracking). However, for the 3.0 in (76.2 mm) overlay thickness test section, it takes longer to crack due to the thicker overlay.

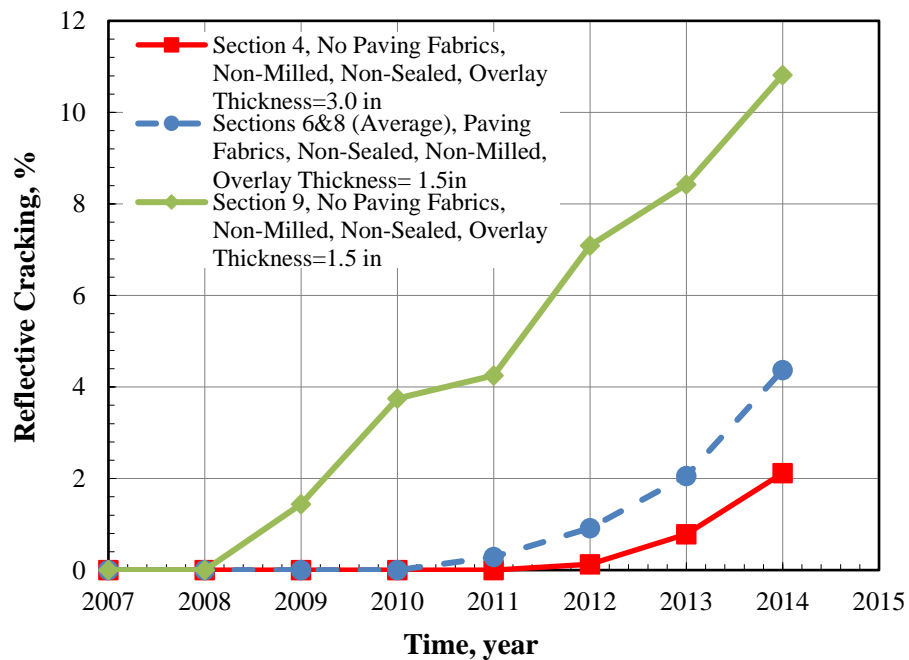
Figure 7.1.2 Equivalency between Performance of Pavement with Paving Fabrics and Thicker Overlay Control Section

The equivalency between paving fabrics section and a thicker overlay section is shown in Figure 7.1.2. For the paving fabrics section with 1.5 in (38.1 mm) overlay, the reflective cracking started in 2011, and the control section with 3.0 in overlay (section 4) started cracking in 2012. The cracking was approximately 2% (control section, 3.0 in overlay) to 4.2% (paving

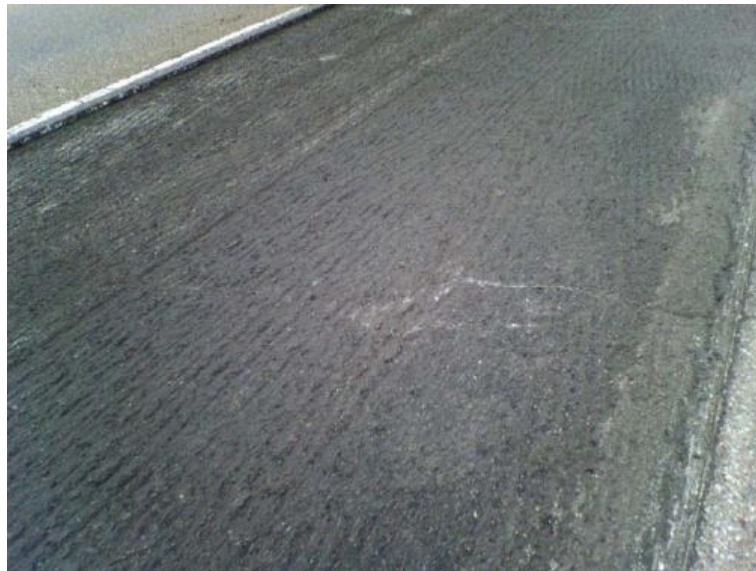
Figure 7.1.3 Milled Test Section

Milling and sealing are two traditional techniques to improve the pavement overlay performance. Milling usually can provide a better bond at the interface between the existing pavement surface and the new overlay (see Figure 7.1.3). Sealing the existing pavement cracks before placing the new overlay usually tends to prevent water from entering the base course layer (see Figure 7.1.4).

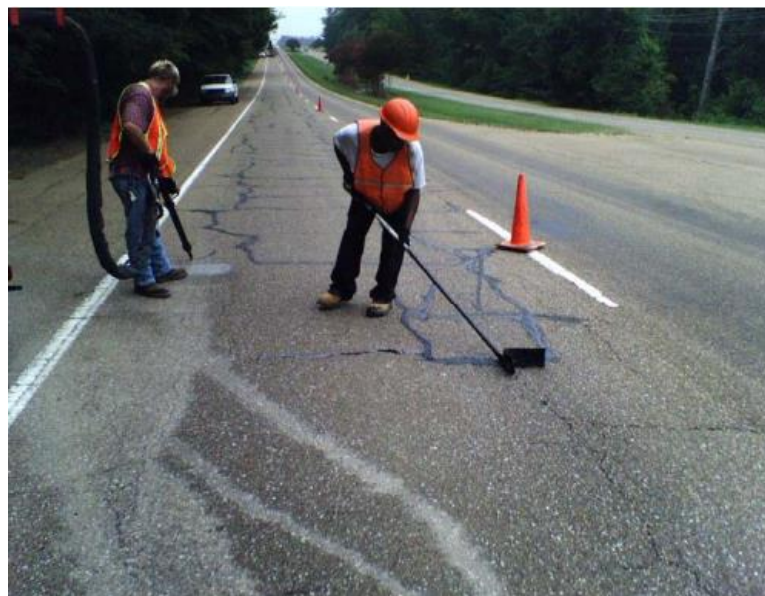
Figure 7.1.4 Sealing Cracks in Section 7

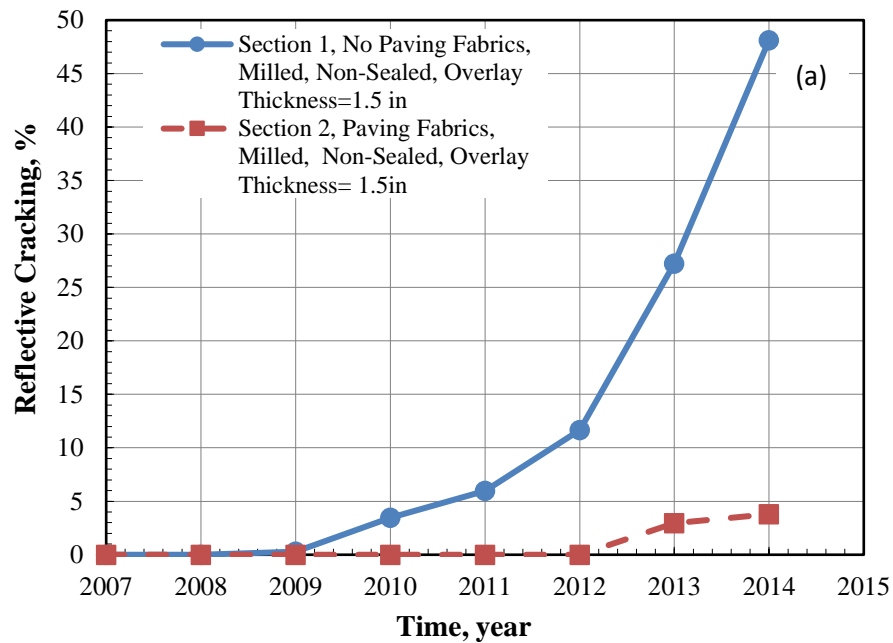
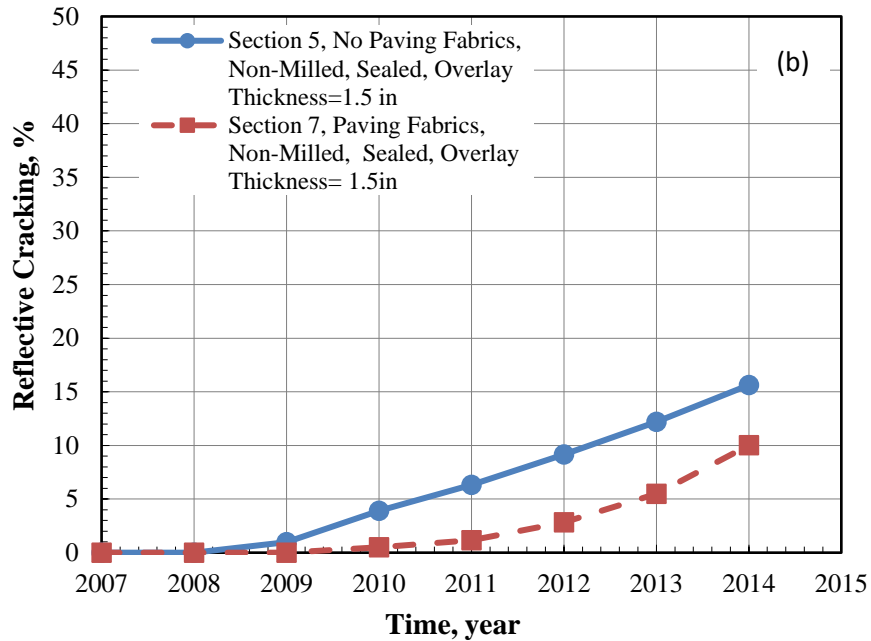
Figure 7.1.5 Performance of Pavement with and without Paving Fabrics under Milling and Sealing Conditions

In this project, milling and sealing methods were used in both the control section and the paving fabrics section to examine the performance of paving fabrics with milling and sealing methods. As shown in Figure 7.1.5(a), the paving fabric section over the milled section performed considerably better than the control section. The paving fabric section started cracking in 2012, three years later than the control section. By 2014, the paving fabric section had substantially less cracking than the control section (5% for the paving fabric section compared to 48% for the control section). Figure 7.1.5 (b) compares the performance of the pavement section with and without paving fabrics under sealing condition. As shown in this figure, the addition of paving fabrics delayed and reduced the reflective cracking. By 2014, the paving fabric section (10% cracking) had 5% less cracking than the control section (15% cracking). These results indicated that the paving fabrics sections still functioned well under milling and sealing conditions.

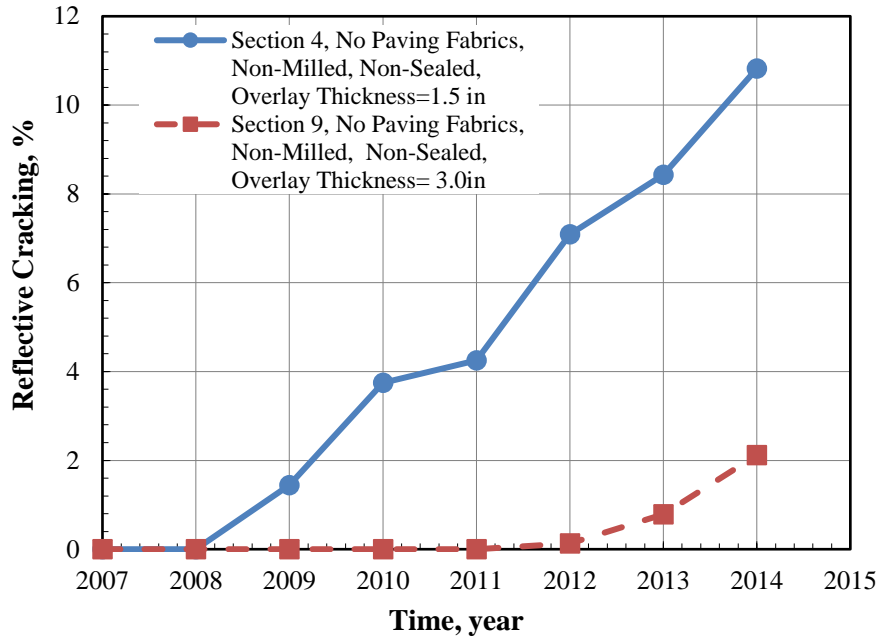
Figure 7.2.1 Performance of Pavement without Paving Fabrics for Various Overlay Thicknesses

Figure 7.2.1 presents the performance of the control section for different overlay thicknesses. From this figure, it can be seen that the 3.0 in (76.2 mm) overlay section had a much better performance than the 1.5 in (38.1 mm) overlay section. The thinner overlay section started to crack after 2 years, while for the thicker overlay section, it took 6 years to crack. As shown in this figure, an increase in overlay thickness from 1.5 in (38.1 mm) to 3.0 in (76.2 mm) would extend the time to 1% cracking from 2009 to 2013. Without paving fabrics, the presence of thicker overlays had a significant improvement on the pavement performance.

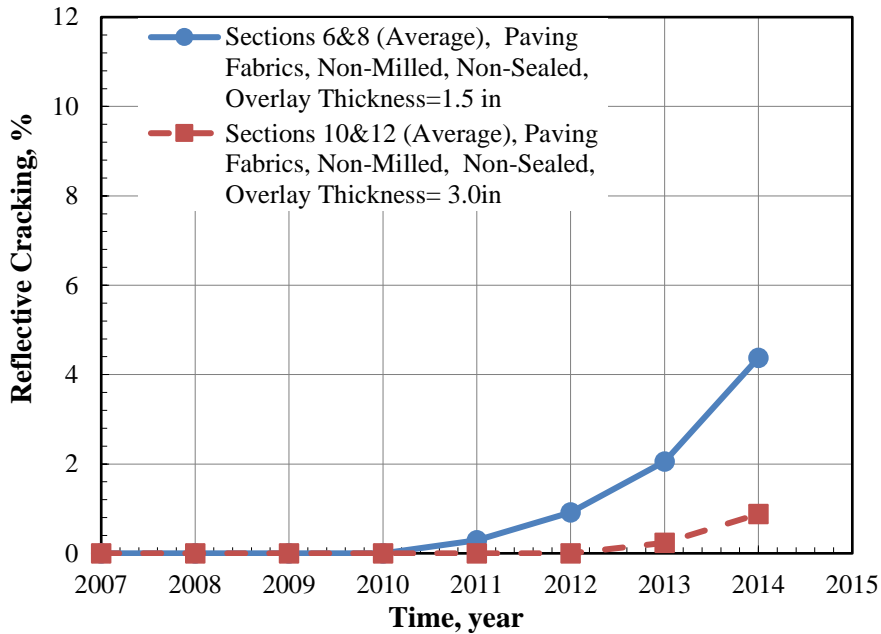
Figure 7.2.2 Performance of Pavement with Paving Fabrics for Various Overlay Thicknesses

Figure 7.2.2 presents the performance of the paving fabrics sections for different overlay thicknesses. The thicker overlay section performed better than the thinner overlay section in the long term. During the first three years, no reflective cracking was noted in all the test sections. The 3.0 in (76.2 mm) overlay section started to crack after 6 years, while the 1.5 in (38.1 mm) overlay section started to crack after 4 years.

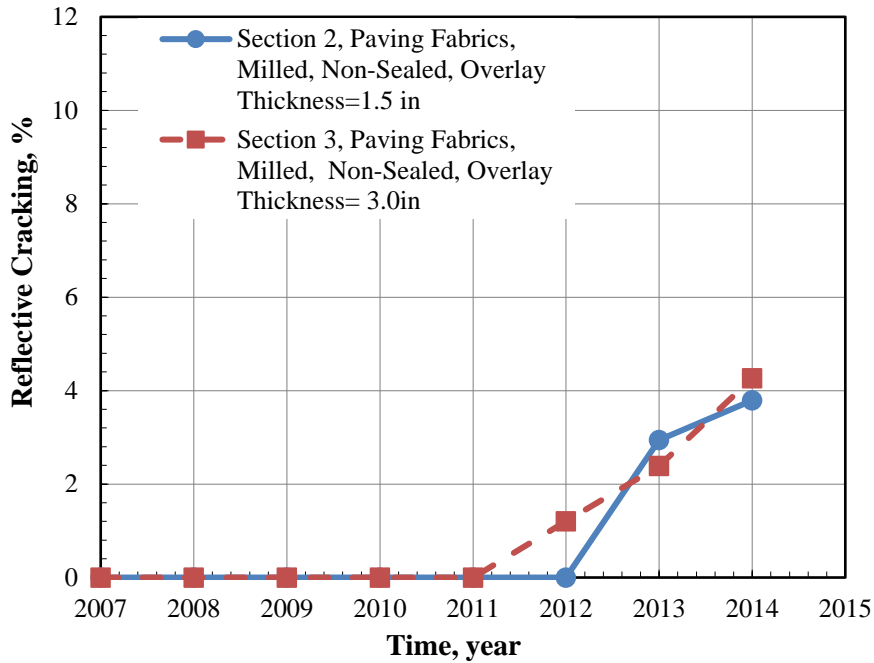
Figure 7.2.3 Performance of Pavement with Paving Fabrics and Milling Method for Various Overlay Thicknesses

Figure 7.2.3 shows the performance of pavements with paving fabrics for different overlay thicknesses under milling condition. As shown in this figure, the trends for both curves are essentially the same. Nevertheless, the 1.5 in (38.1 mm) overlay section started to crack one year later than the 3.0 in (76.2 mm) overlay section. However, there was no significant difference between the 1.5 in (38.1 mm) overlay (with paving fabrics) section and the 3.0 in (76.2 mm) overlay section during the first 8 years. The increase in overlay thickness on milled section did not influence the reflective cracking.

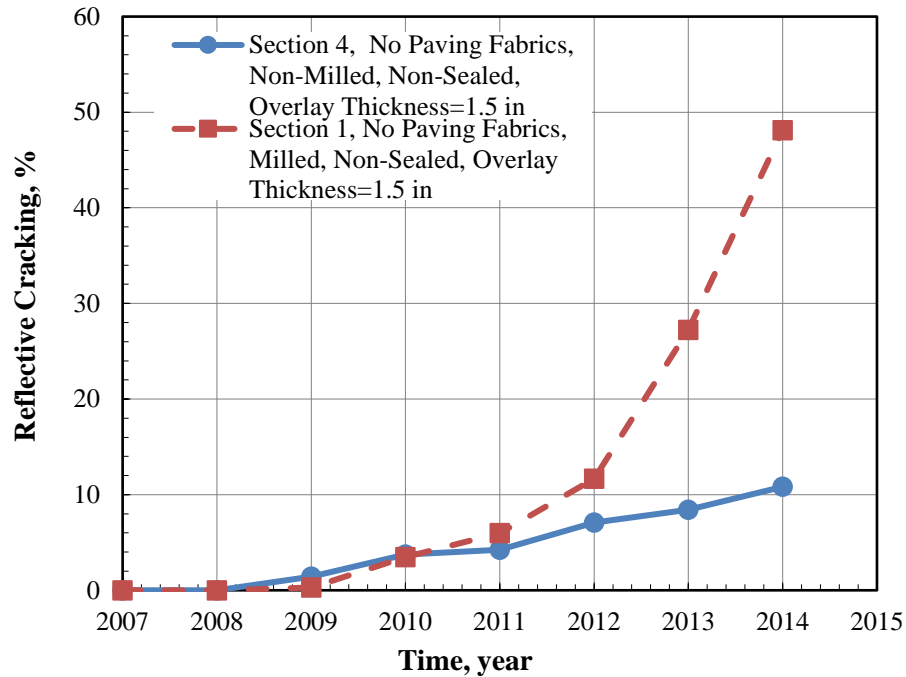
7.3.1 Performance of Pavement without Paving Fabrics under Milling Method

From Figure 7.3.1, it can be seen that the milled section without paving fabrics and the non-milled section without paving fabrics had similar cracks before 2011. After that, the reflective cracks in the milled section increased to 48% in 2014, which was almost 5 times that of the non-milled section (10.8%).

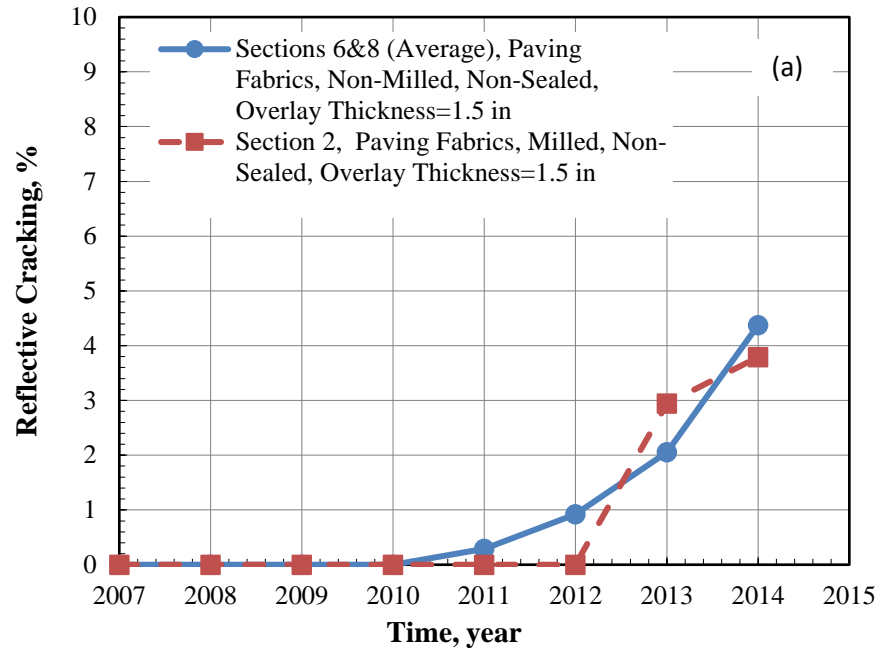
Figure 7.3.2 Performance of Pavement with Paving Fabrics under Milling Method, (a) 1.5 in (38.1 mm) Overlay Thickness; (b) 3.0 in (76.2 mm) Overlay Thickness

Figure 7.3.2 provides the effect of milling on the performance of pavements with paving fabrics for 1.5 in (38.1 mm) and 3.0 in (76.2 mm) overlay thickness. In Figure 7.3.2 (a), the milled section started to crack in 2013, while the non-milled section cracked in 2011. The performance of the milled section was better than the non-milled section between 2007 and 2012. After 2012, these two sections almost had the same reflective cracking in the new overlay surface. One year later in 2014, after seven years, the reflective cracking in the non-milled section increased to 4.4%, while for the milled section, the cracking increased to approximately 4%. As shown in Figure 7.3.2 (b), the milled section started cracking in 2012, while for the non-milled section, the cracking started in 2013. After 2011, the milled section started to crack and the reflective cracking increased to 4.3% by 2014. The non-milled section had less than 1% cracking by 2014.

In this case, the milling technique did not have a significant improvement on the performance of paving fabric sections, and for the thicker overlay section, the performance of the milled section was even worse than the non-milled section. This may be explained by the

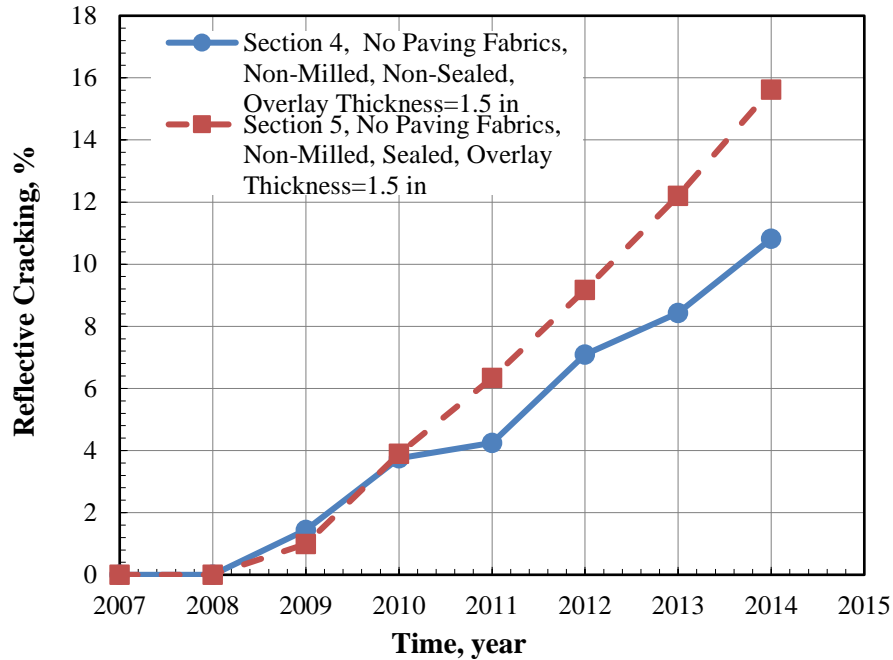
7.4.1 Performance of Pavement without Paving Fabrics under Sealing Method

Figure 7.4.1 shows the effect of sealing on the control section (No paving fabrics). From this figure, it can be seen that both two sections started cracking after 2008, and there was no significant difference between the sealed section (3.9% cracks) and the non-sealed section (3.8% cracks) before 2011. After eight years, the reflective cracks in the sealed section increased to 15.6%, which was 1.5 times that of the non-sealed section (10.8%)

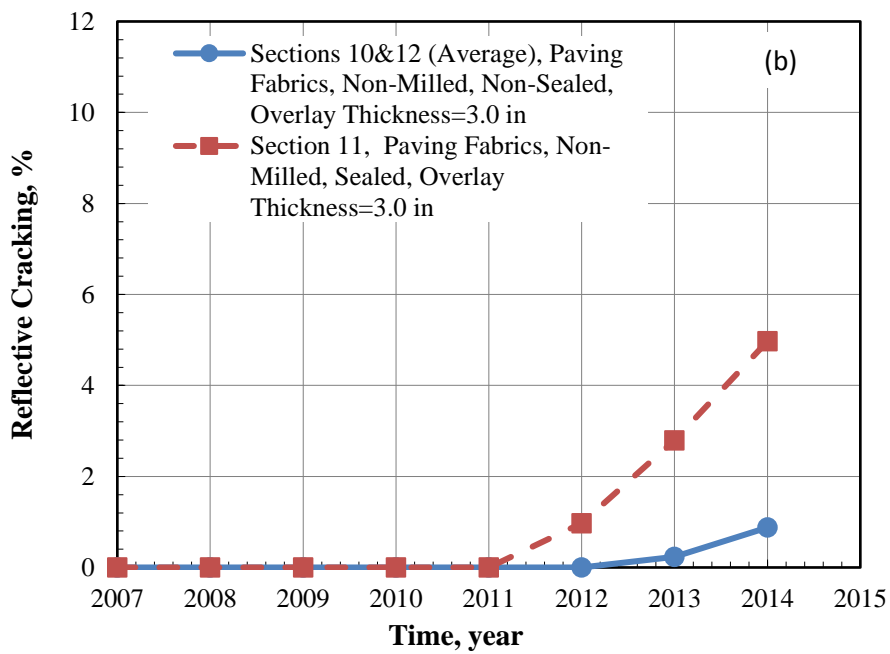
Figure 7.4.2 Performance of Pavement with Paving Fabrics under Sealing Method, (a) 1.5 in (38.1 mm) Overlay Thickness; (b) 3.0 in (76.2 mm) Overlay Thickness

Figure 7.4.2 provides the performance of pavement sections with paving fabrics under sealing condition for 1.5 in (38.1 mm) and 3.0 in (76.2 mm) overlay thickness. From this figure, it can be seen that the sealing did not significantly impact the performance of the pavement with paving fabrics, and the non-sealed section had less cracking than the sealed section. This was true for both the 1.5 in (38.1 mm) and the 3.0 in (76.2 mm) overlay sections. For the 1.5 in (38.1 mm) section, as shown in Figure 7.4.2 (a), the sealed section started to crack 2 years earlier than the non-sealed section, and by 2014, the reflective cracking for the sealed and the non-sealed sections was 10% and 3%, respectively. For the 3.0 in (76.2 mm) section, as shown in Figure 7.4.2 (b), the non-sealed section started to crack one year later than the sealed section. By 2014, the non-sealed section had only 1% reflective cracks, while the sealed section had approximately 5% reflective cracking. Instead of improving the performance of the pavement, sealing the existing cracks made it worse in this project.

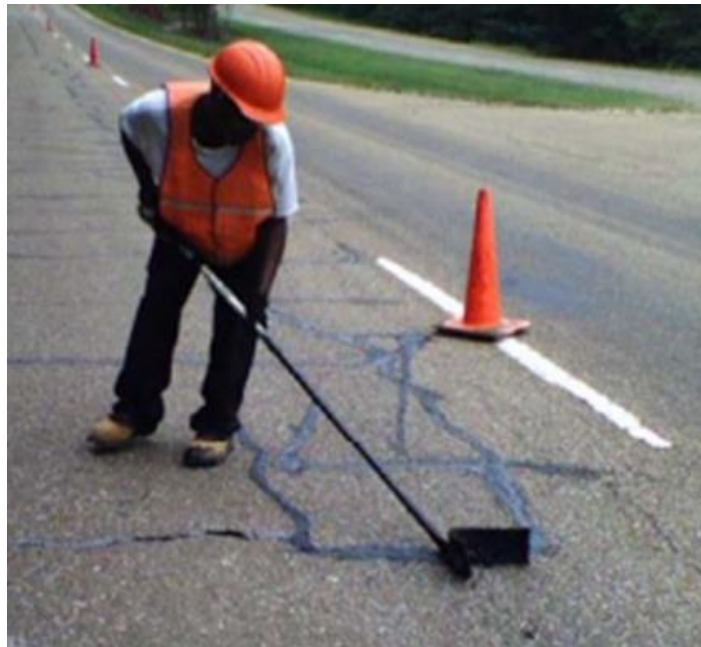
Figure 7.4.3 Cracks Over-Sealed in Sealed Section

This unusual result may be due to the situation that the cracks were over sealed in sealed sections (see Figure 7.4.3). Over sealing the existing cracking can cause more reflective

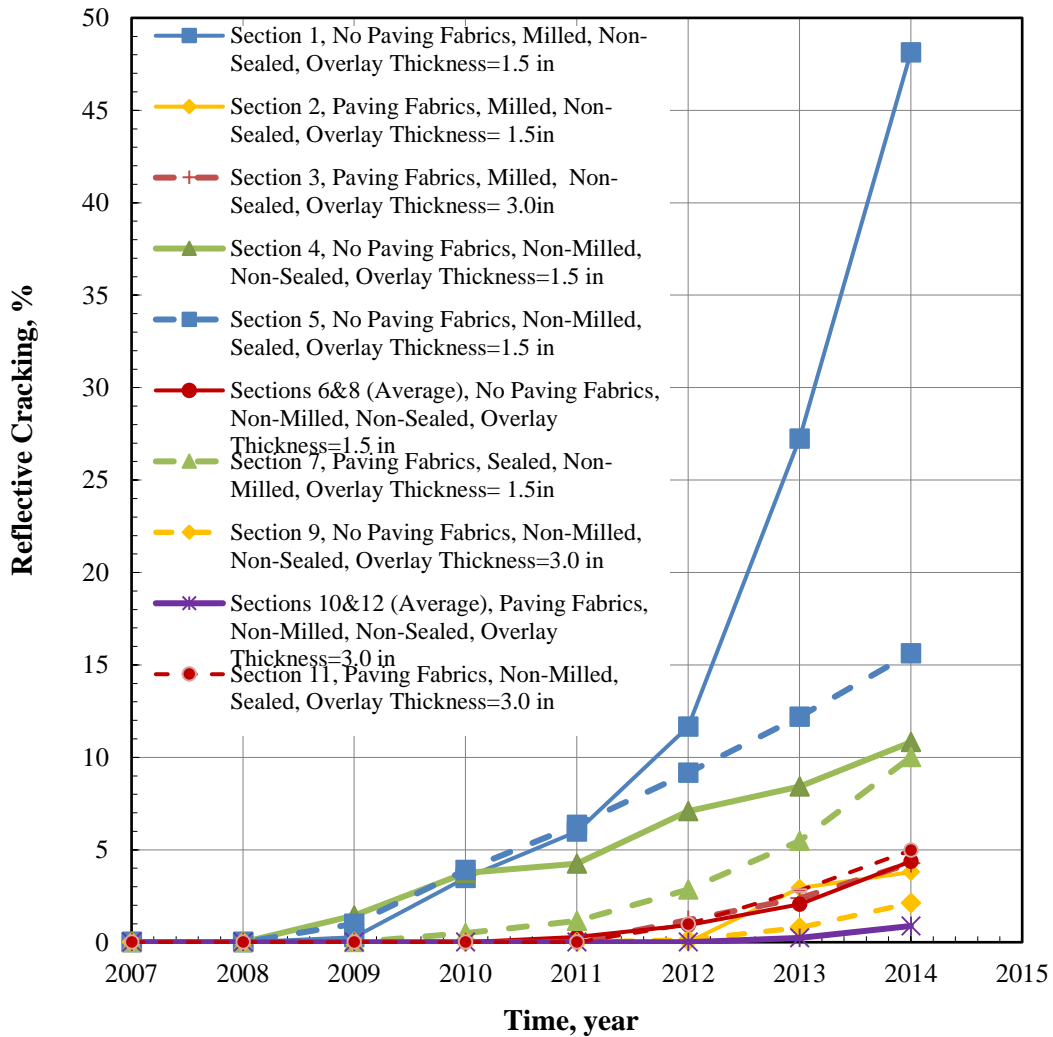
Figure 7.5.1 Summary of All Test Sections

The results for all sections are summarized in Figure 7.5.1. As shown in this figure, Sections 10 and 12 had the best performance on reducing the reflective cracking, and there was only about 1% cracking in 2014. Section 1 (no paving fabrics, milled) had the least effective performance, and the reflective cracking reached to 48% in 2014. The rankings for all sections are shown in Table 7.1.

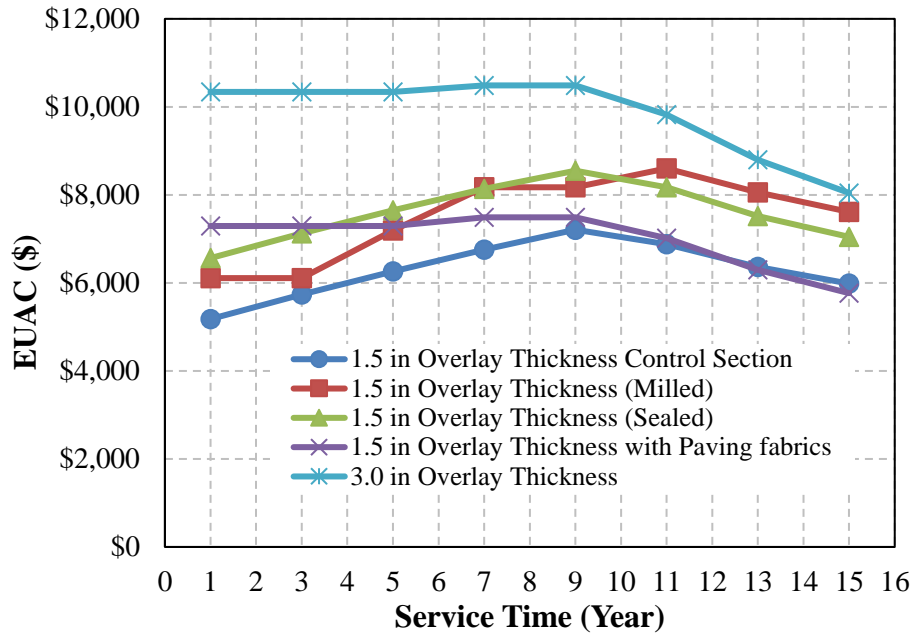
Figure 8.1 Cost Analysis of Five Different Type Test Sections.

Different stage analysis is shown in Fig. 8.1. From this figure, when the service time of the pavement is less than 13 years, the equivalent uniform annual cost (EUAC) of the control section (1.5 in overlay thickness without paving fabrics) is the least, and thus, indicates the most cost-efficient section. After 13 years, the 1.5 in (38.1 mm) overlay thickness with paving fabrics became the most cost-efficient section. On the other hand, it may be noted that the performance of paving fabrics section (3% reflective cracking) is much better than the control section (11% reflective cracking). Based on this analysis, the performance of the paving fabrics is more efficient in the long term (>10 years).

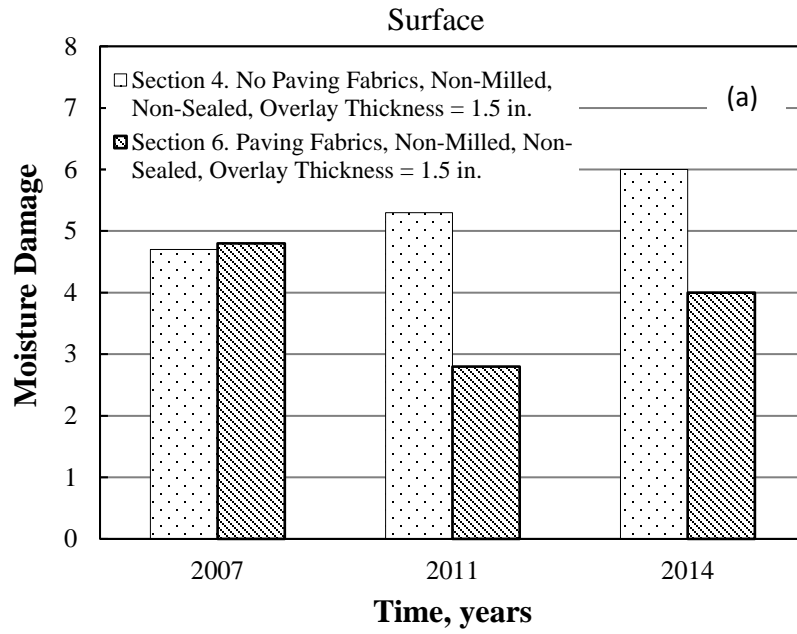
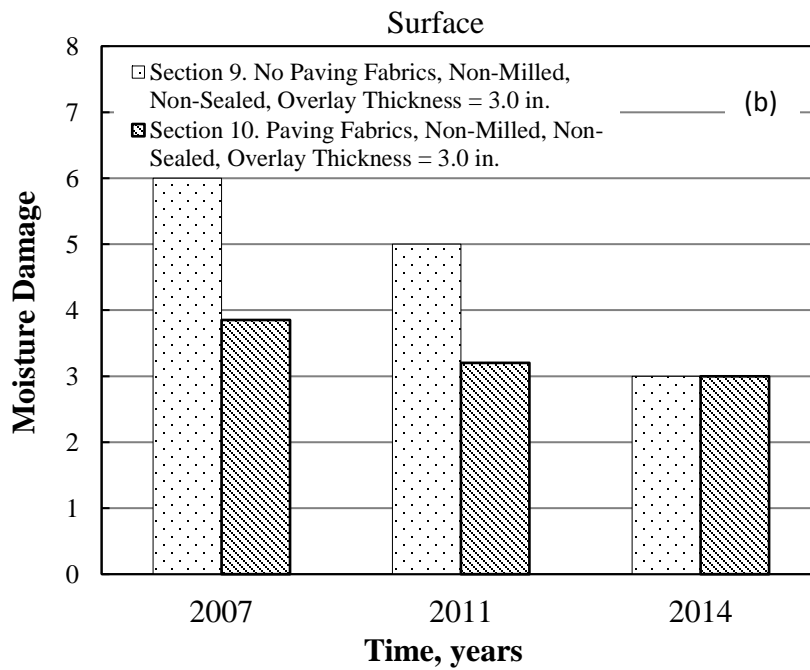
Figure 9.1 Effect of Paving Fabrics on Moisture Damage

Figure 9.1 compares the moisture damage between Section 4 and Section 6. Figure 9.1 (a) shows that with 1.5 in (38.1 mm) overlay thickness, Section 4 and Section 6 had similar moisture damage in 2007. After four years, the moisture damage of Section 6 was less than that of the Section 4, and the same trend was noted after seven years. Section 4 showed an increase in moisture damage level with time, whereas the presence of paving fabric reduced moisture damage for the 1.5 in. (38.1 mm) overlay section. Figure 9.1 (b) shows the same comparison for the 3.0 in (76.2 mm) sections. The results from both Section 9 and Section 10 indicated that the moisture damage decreased after seven years. In thicker overlay section, the presence of paving fabric did not show a significant improvement in moisture damage. From these results, it may be concluded that there is no increase in moisture damage level in the presence of paving fabric.

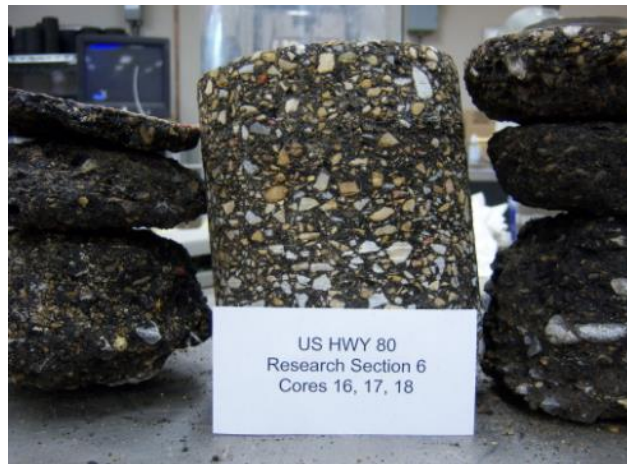
Figure 9.2 Coring Sample at Section 6 in 2007

Figure 9.2 shows the moisture damage condition of Section 6 (No. 16; No.17; No. 18) before the rehabilitation (2007). In addition, the observation of the moisture damage after four

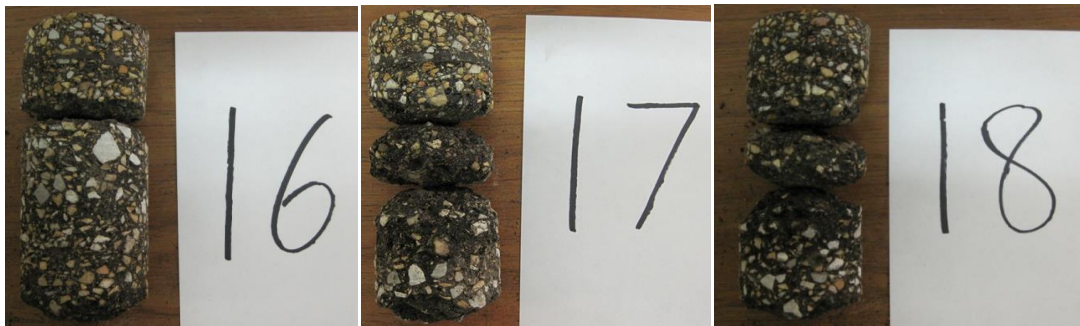
Figure 9.3 Coring Sample at Section 6 in 2011

years and seven years is shown in Figures 9.3 and 9.4, respectively. Additional pictures about other sections are included in Appendix II.

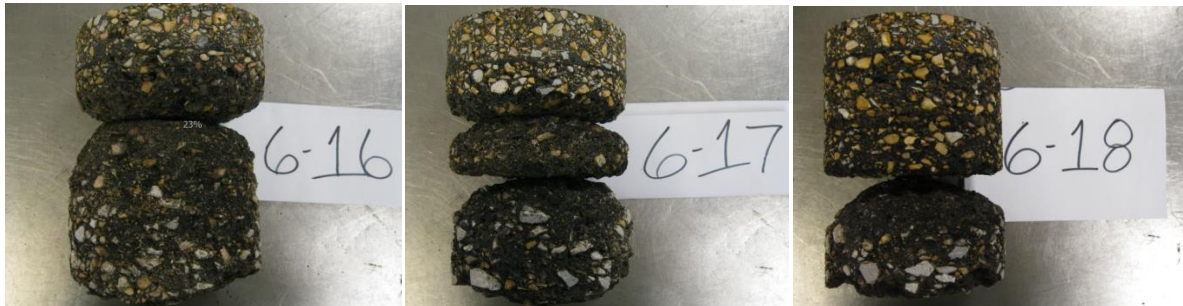
Figure 9.4 Coring Sample at Section 6 in 2014

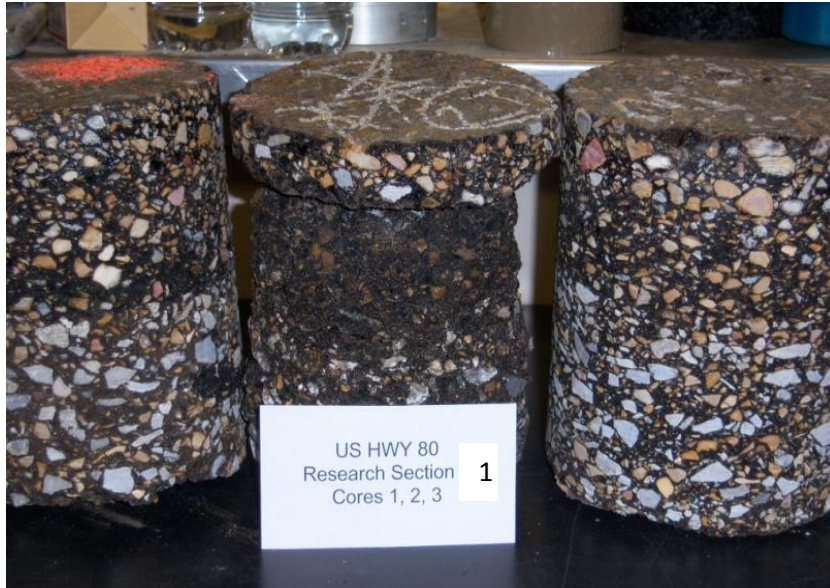
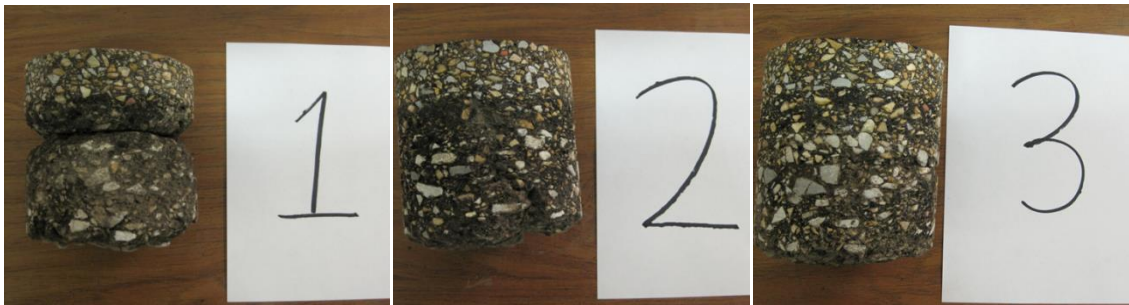
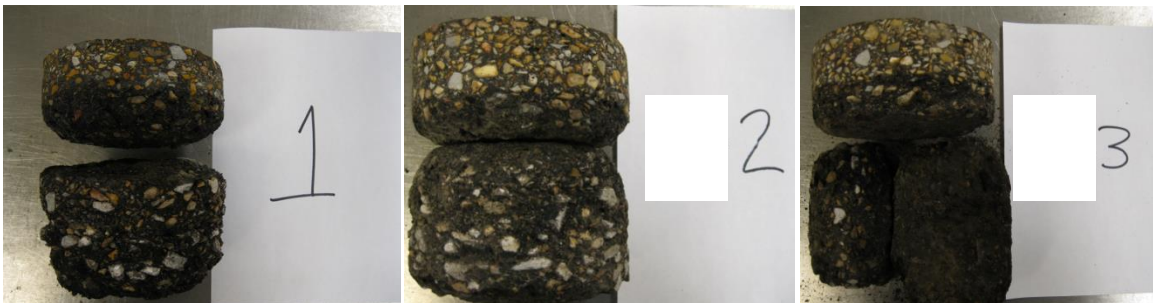
Figure II.1 Coring Sample at Section 1 in 2007, 2011, 2014

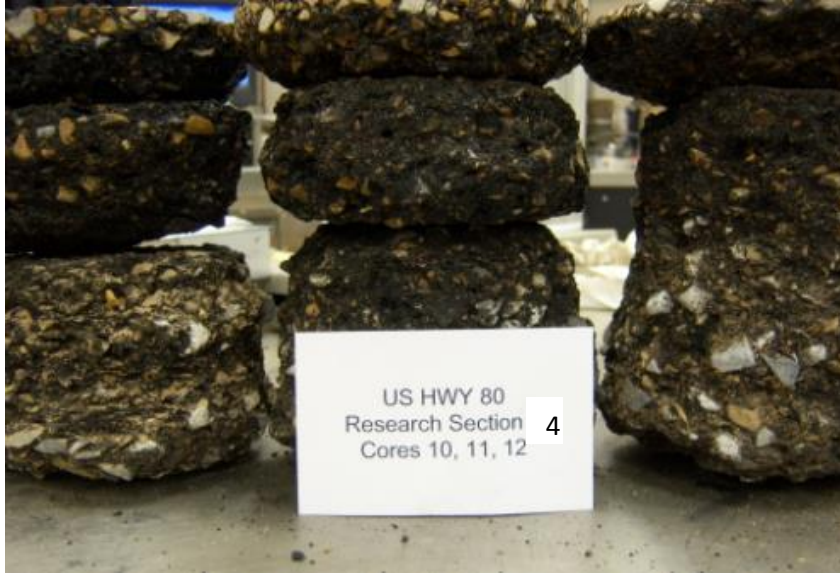
Figure II.2 Coring Sample at Section 4 in 2007, 2011, 2014

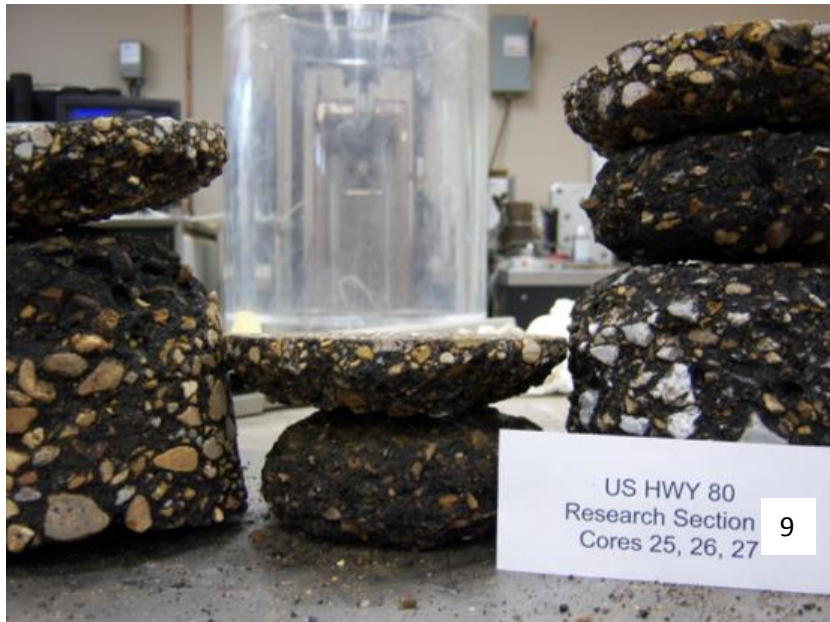
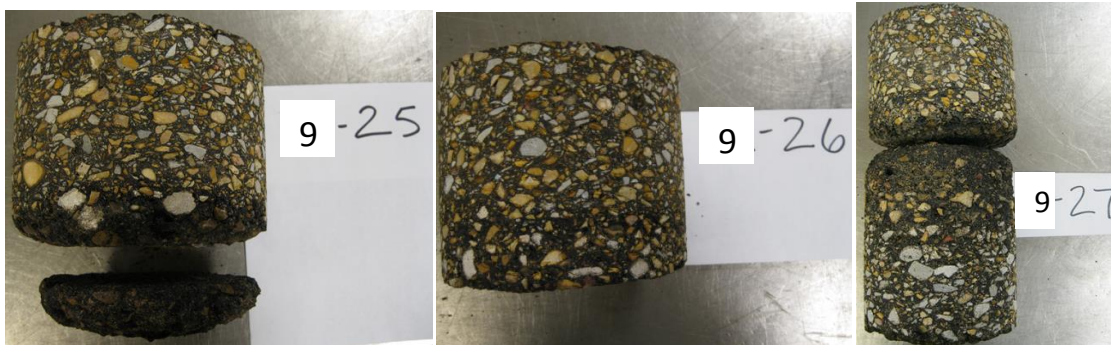
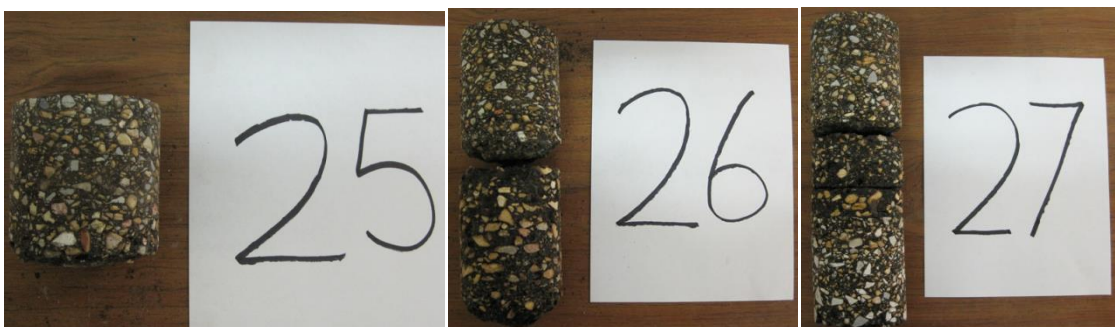
Figure II.3 Coring Sample at Section 9 in 2007, 2011, 2014
