Long-Term Field Monitoring of Paving Fabric Interlayer Systems to Reduce Reflective Cracking

FINAL REPORT

Farshad Amini & Kejun Wen

Jackson State University

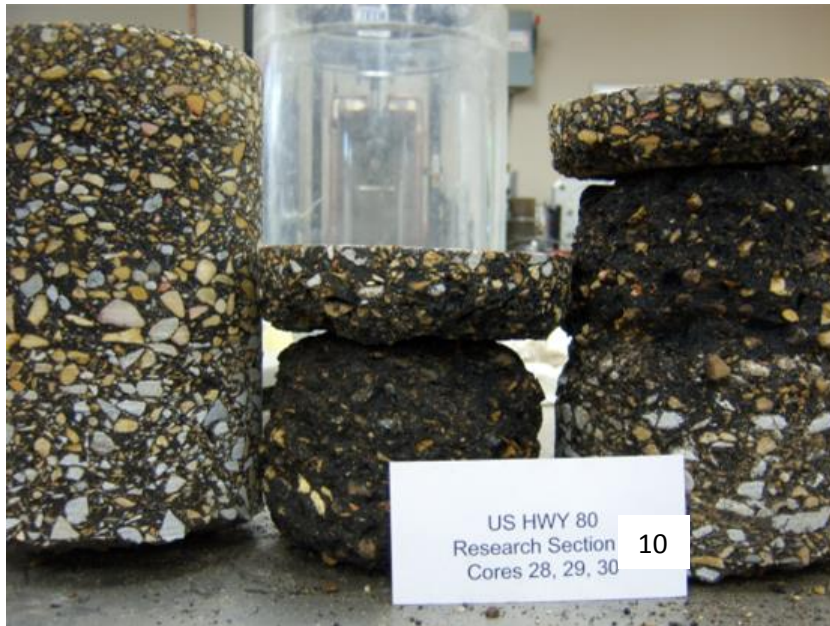
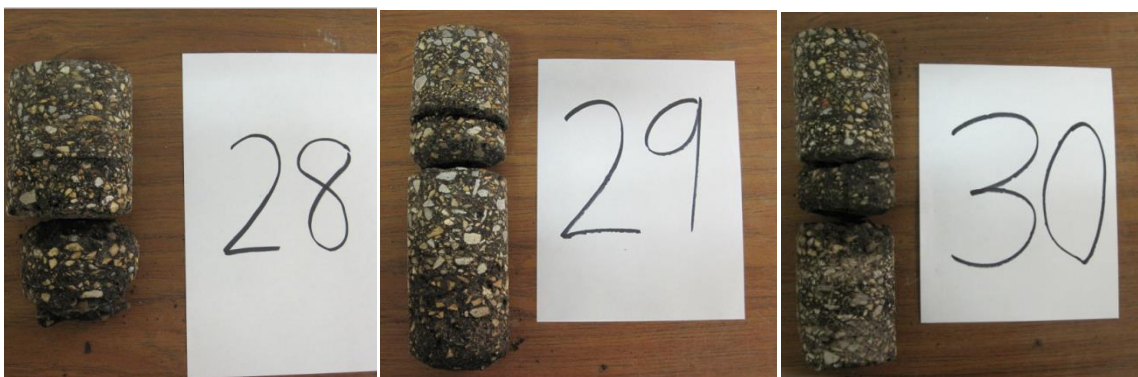
Figure II.4 Coring Sample at Section 10 in 2007, 2011, 2014
