Laboratory Performance of Wicking Fabric H2Ri in Silty Gravel, Sand and Organic Silt

Billy Connor, P.E.
Xiong Zhang, P.E., Ph.D.
University of Alaska Fairbanks

May 2016

INE/AUTC 16.04

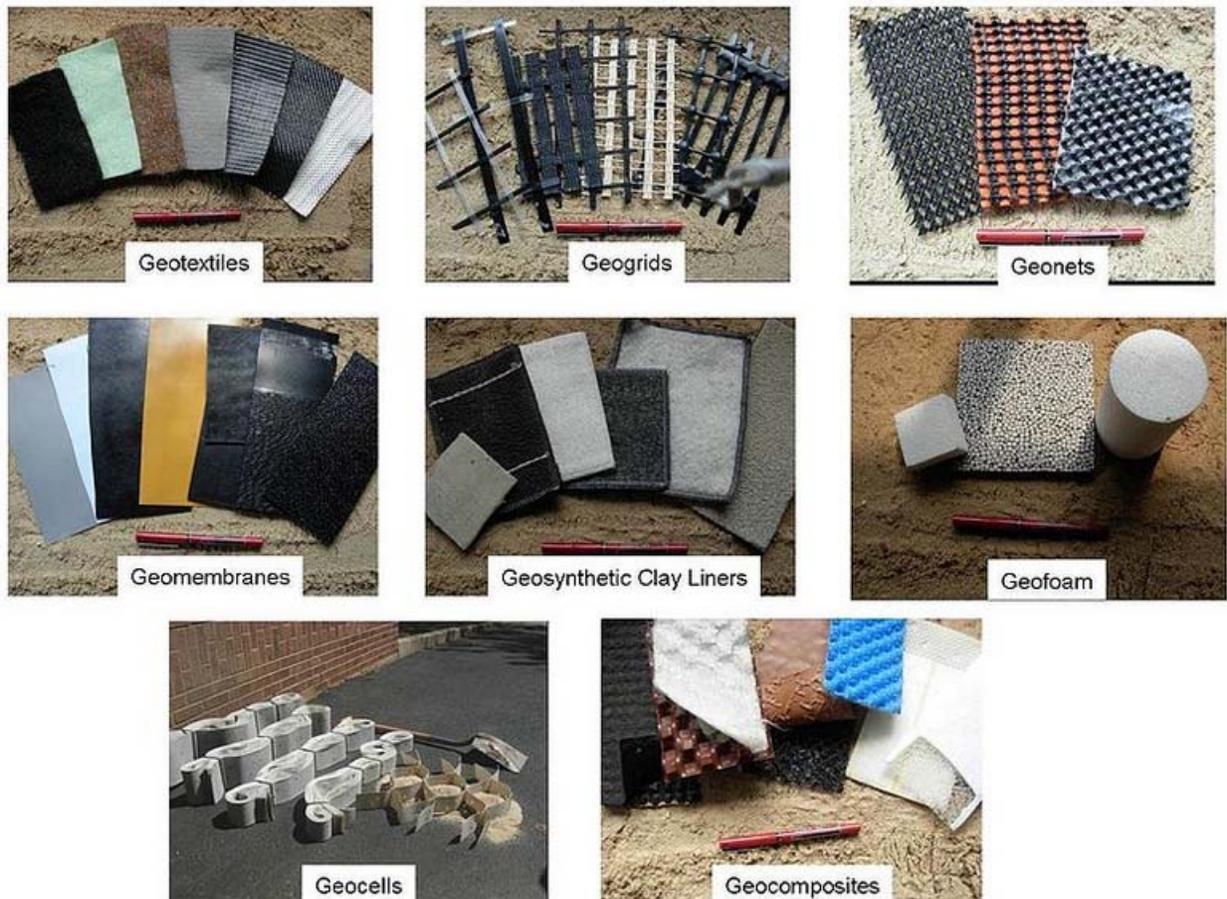
Figure 2.8 Geosynthetic categories

Geosynthetics are synthetic and polymeric materials used in civil engineering. There are eight major product categories: geotextile, geogrid, geocell, geomembrane, geofiber, geofilm, geosynthetic clay liner, and geocomposite (see Figure 2.8). Geosynthetics have a wide range of

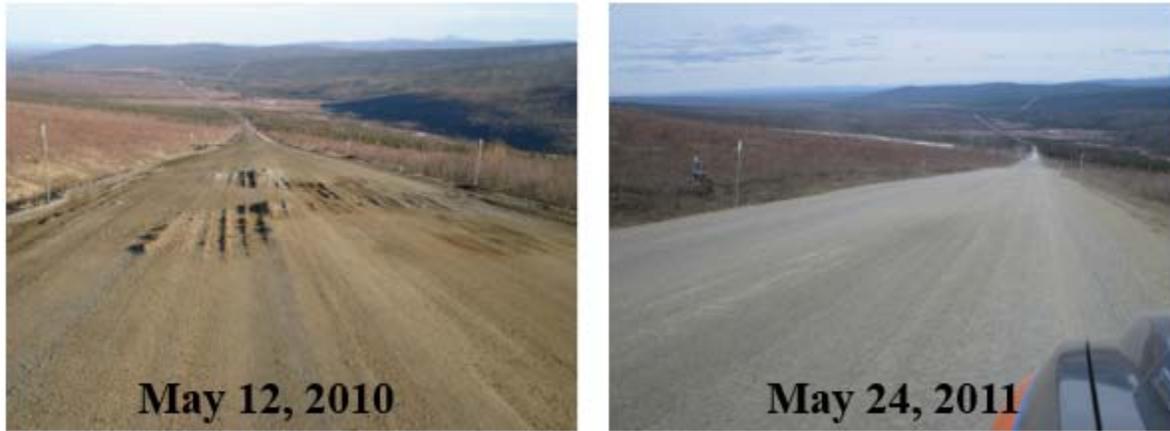
Figure 2.15 Test section comparison

In summary, over 2 years of monitoring shows good overall performance of the testing section. Field observation clearly showed a road surface difference between sections with and without geotextile, as shown in Figure 2.15. No soft spots have been observed during early springs, and soil at the shoulders is damp, which indicates that water flows along the direction of the geotextile wicking fabric. The geotextile successfully eliminated weakening of the structural section due to excess water during the spring. Even though soil 4.5 feet beneath the surface and lower showed the existence of excess water, the soil at that point is beyond the depth of frost heave and thaw

weakening and had limited effect on roadway performance. It is clear that the H2Ri significantly reduced the flow of water to the surface during the fall months eliminating excess water in the structural layer during the freezing process. This is particularly impressive since the fall is the wettest season in this area.

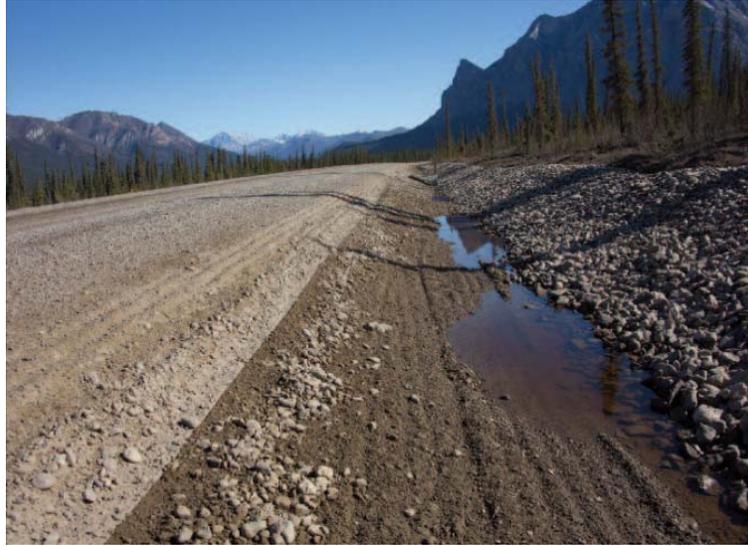
Figure 2.16 Preliminary field observation at Coldfoot, Alaska

Frost heave problems similar to Beaver Slide occurred in a harsh environment about 30 miles north of Coldfoot, Alaska. The road is located in an area of extremely cold winter temperatures. A 12-mile test section (6 miles with geotextile material and 6 miles without) was constructed in 2012 in an effort to mitigate the frost heaving and prevent ice lens formation. Twelve inches of aggregate over the geotextile was completed on one lane first. Then the other lane was constructed using the same structure with a minimum of 1.5 feet of geotextile overlap. The goal was to reduce the weakening of the upper 1.5 feet of material which carries 80% of the load. Test results showed successful application of the geotextile to stop water from rising to the subgrade via capillary action. Since this project is new, close monitoring is required to evaluate overall long-term roadway performance. However, as shown in Figure 2.16, preliminary observations indicate that the geotextile material has effectively served as a capillary break, wicking water out of the structural section.

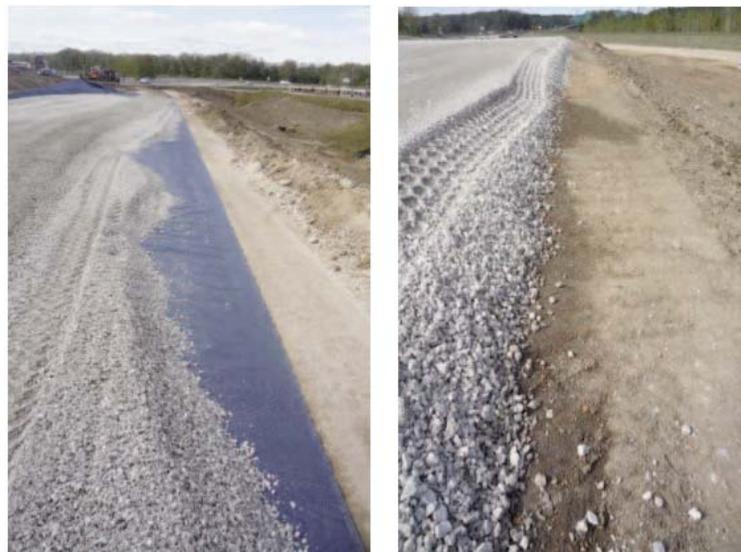
Figure 2.17 Field observation at St. Louis County, Missouri

In this case, a new bridge was being constructed over the Missouri River. The objective in using the geotextile material was to remove water from underneath the pavement section. The original design was to construct a pavement section with 4 inches of base aggregate, 4 inches of drainable aggregate, and a prepared subgrade. It was expected that the geotextile could reduce the aggregate base material by 2 inches, and wick water from under the pavement. Observation is shown in Figure 2.17. The results proved that the geotextile successfully wicked water out of the aggregate.

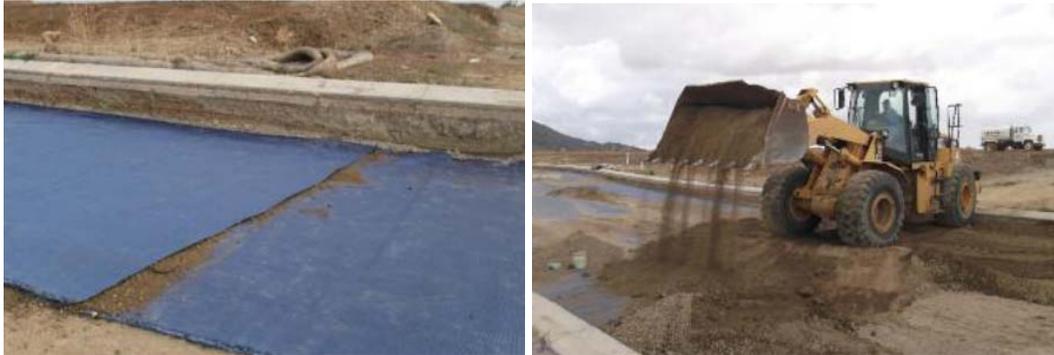
Figure 2.19 Field construction at Corona, California

In Corona, California, a large section of roadway had become saturated by an excessive amount of natural water run-off, causing the roadway section to fail. The geotextile with wicking fabric was used to help drain away the excess water while providing enhanced stabilization (Figure 2.19). A 6-inch layer of base material was placed on top of the geotextile. A layer of geogrid was placed on top of that, followed by another 6-inch layer of base material. A 4-inch layer of AC was the final element of design to complete the road section. Observation indicated that the geotextile provided superior tensile strength at low strain for subgrade support, separated the natural subgrade

soils from the aggregate base, wicked excess water, and provided lateral confinement for the base section.

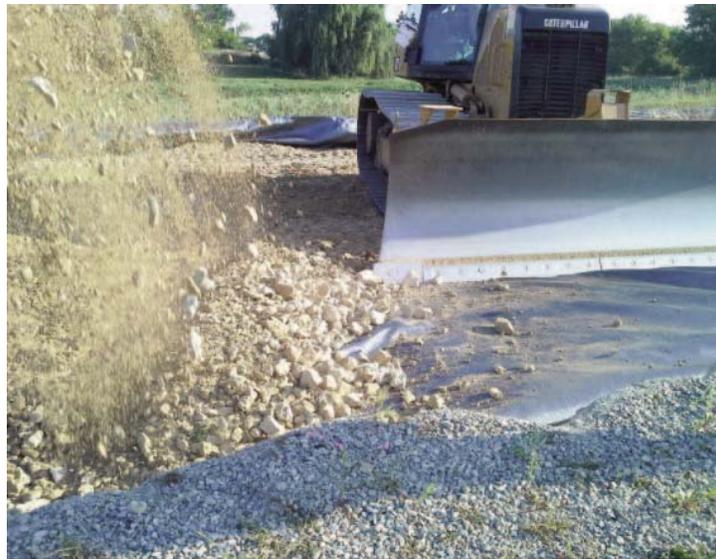
Figure 2.20 Field construction at Jefferson County, Wisconsin

Another application of geotextiles occurred at Jefferson County, Wisconsin, where the material was used to solve a differential settlement problem. The primary challenge was the presence of wet and saturated silt and peat deposits to depths exceeding 30 feet below the existing pavement. Simply removing the deposits was not an economically feasible solution. The geotextile was directly placed on the exposed subgrade, followed by a 15-inch lift of crushed stone, a single layer of geogrid, and a 15-inch lift of crushed stone, as shown in Figure 2.20. The Jefferson County Highway Department reported that subgrade undercutting was minimized to 30 inches, compared with a potential 5–8 feet undercut (or more) for the soil conditions present. In addition to the cost savings, a substantial time savings was realized in the project construction schedule.

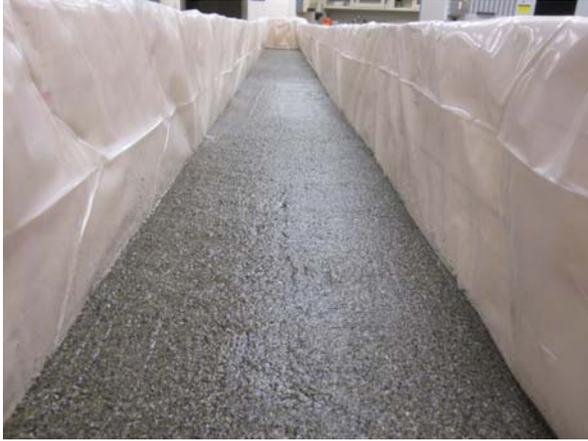
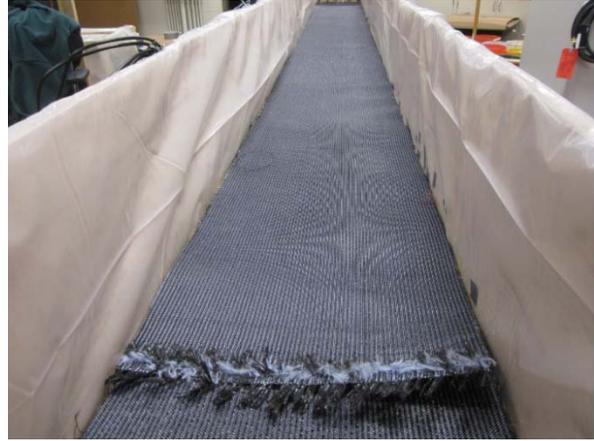
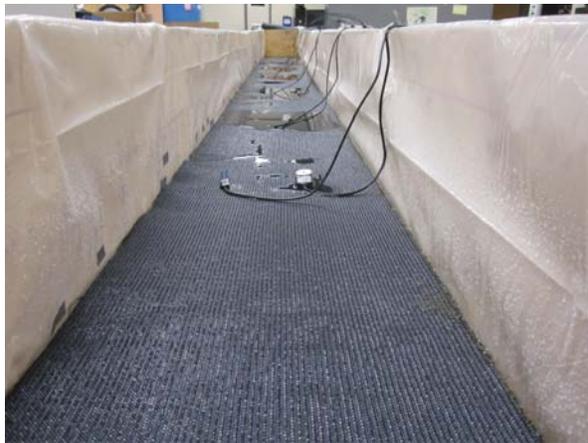
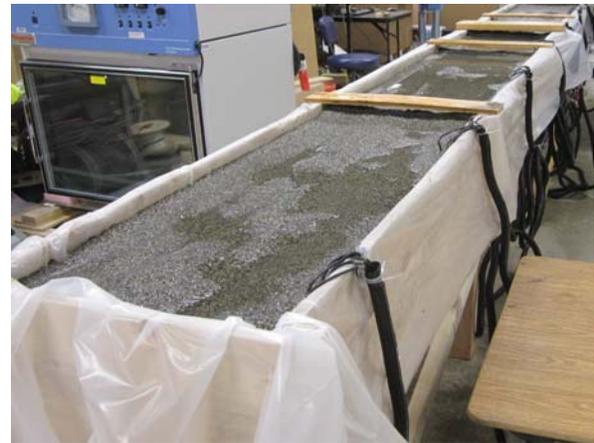
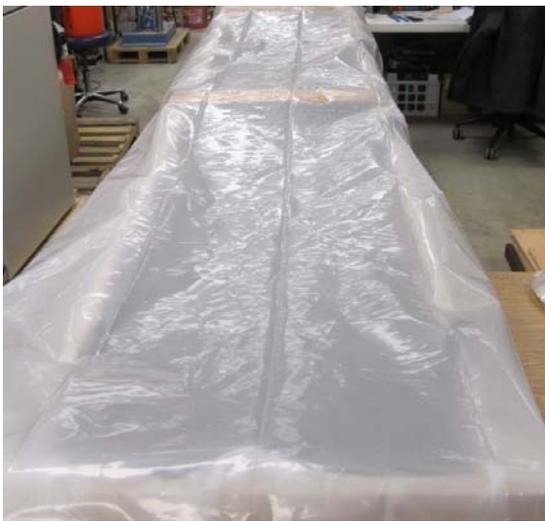
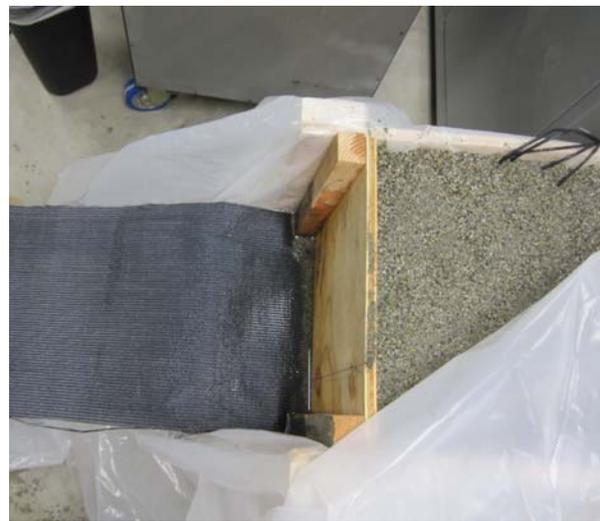
Figure 4.2 Testing flume construction

The construction process started by filling the flume with 1 in. of saturated sand, as shown in Figure 4.2(a). The testing flume was first covered with a layer of plastic wrap to prevent water from flowing outside the system. Both sides of the flume walls were marked at the anticipated heights, and the sand was then flattened with a trowel to the marker. Next, the wicking fabric was put into the testing flume as shown in Figure 4.2(b). Since the fabric roll was not long enough, a 3 ft. overlap was placed at a distance of 5 ft. from the left side of the testing flume. In the case of the 73 ft flume, splices were centered at 64 in., 210 in., 354 in., 498 in., 642 in., and 786 in. The first layer of sensor was placed on top of the fabric, as shown in Figure 4.2(c). One set of sensors was put at each location, and 8 sets of sensors were put in one layer. The fabric was then saturated with water before another layer of soil was put into the testing flume. Figure 4.2(d) shows the testing flume filled with 12 in. of saturated sand. The walls of the testing flume were fastened with wood plates to prevent the walls from expanding. After all the sensors were put into the testing flume, the testing system was covered with plastic wrap (see Figure 4.2[e]). Furthermore, at the left side of the testing flume, the wicking fabric was exposed to the open air so that the water inside the testing system could be wicked out.

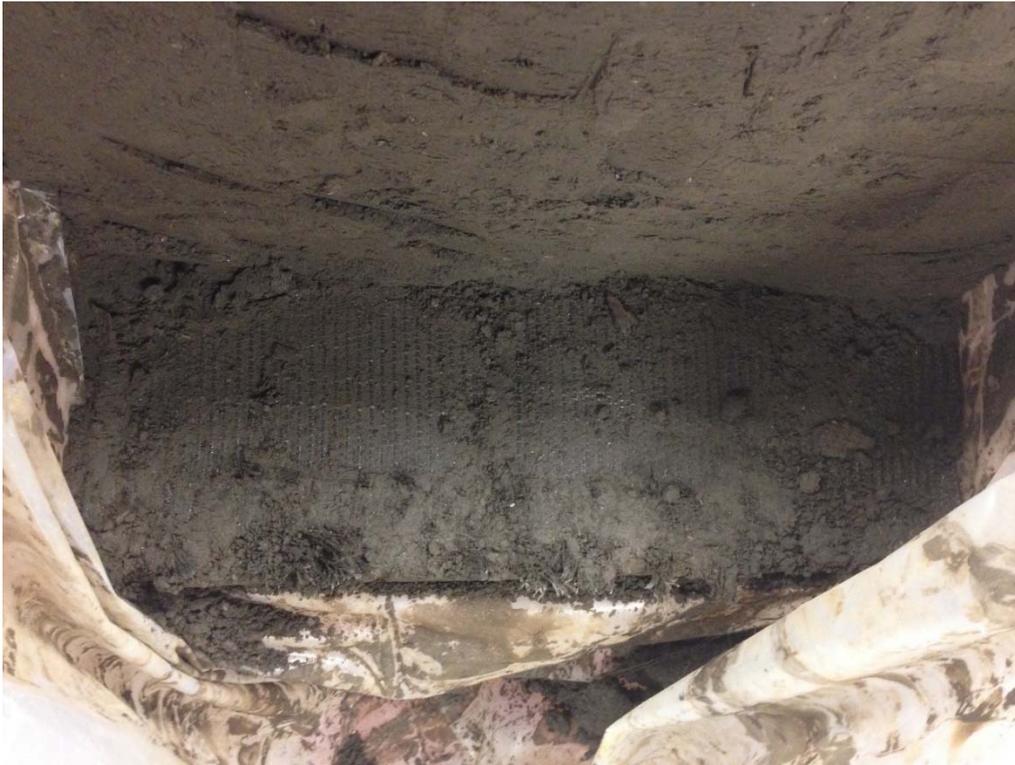
Figure 5.6 Photo of organic silt and blinding of the fabric at the bottom

It is clear that organic silt has low permeability. Water added at the inlet end of the flume stabilized at about 8 inches and remained essentially at that height, clearly indicating that silt is impermeable and that the wicking fabric failed to transfer water. Photomicrographs were taken of a bundle of fibers at a magnification of 1500x. **Error! Reference source not found.** shows that the fibers were blinded by the small clay particles contained in the silt, which rendered the fabric ineffective.

Based on the literature we anticipated that H2Ri performs well in gravels, sands and silts. However, when tested in organic silt with an organic content of 5% the wicking fabric was immediately blinded and ceased to perform. This result was confirmed by two methods first by supplying clear water at the upstream end of the fabric. The fabric failed to remove any of the water. The fabric at the outlet of the flume remained completely dry throughout the test. The photomicrographs of the wicking bundles showed the fibers were coated with the organic clay contained in the silt (Figure 7.1).

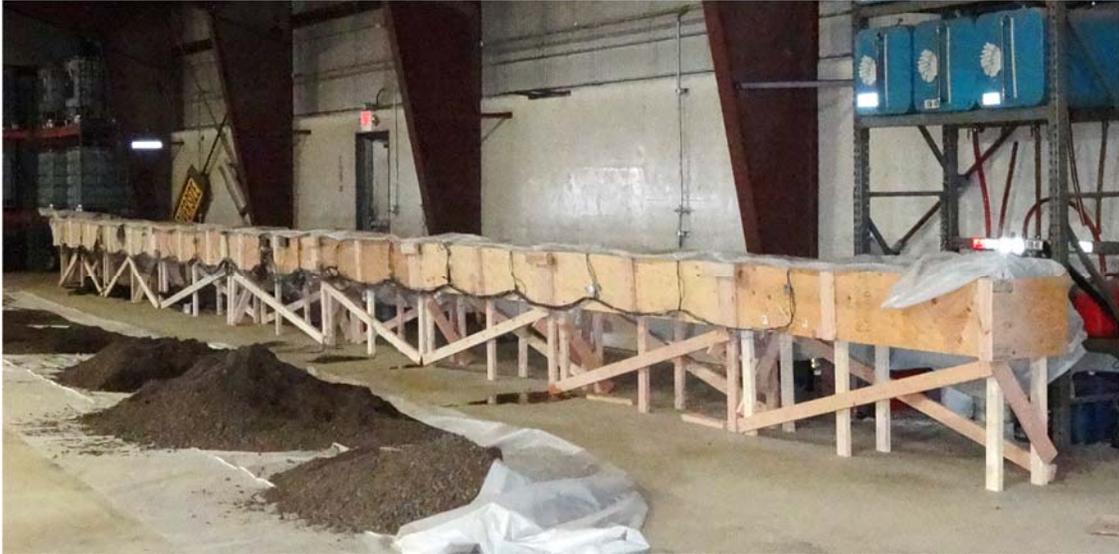
Figure 5.7 73-foot test flume

The application of H2Ri on airport runways requires the ability to transport water at least 75 feet for a 150-foot-wide embankment. To test the ability of the wicking fabric to meet that requirement a 73-foot flume was constructed (Figure 5.7). As in the previous tests, the flume was lined with 8 mil polyethylene sheeting that fully encapsulated the soil including the top.
