Evaluation of Cost Effective Protective Coatings for ODOT Snow & Ice Equipment

State Job Number 134935

April 2016

Final Report

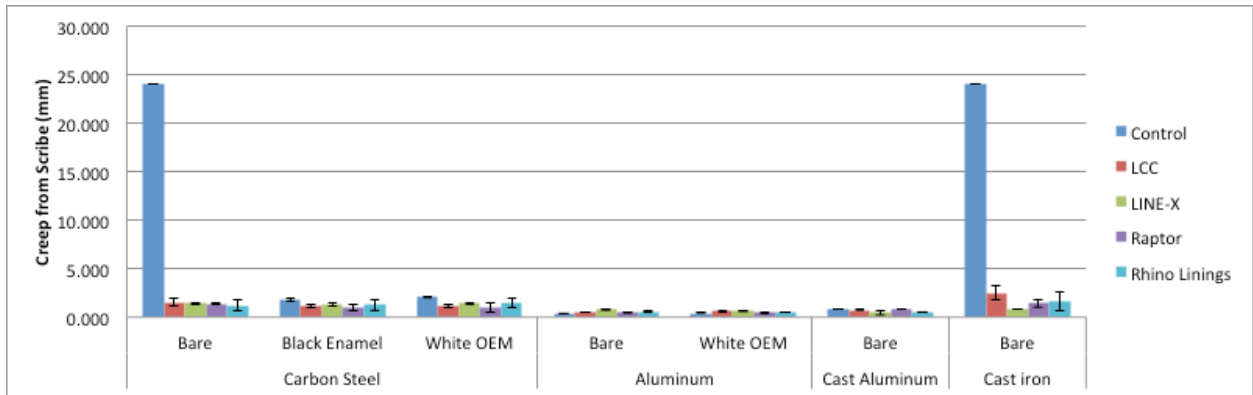
Figure 3.1-2: Average creep from scribe for all coated and uncoated (control) samples after 336 hours of salt spray exposure.

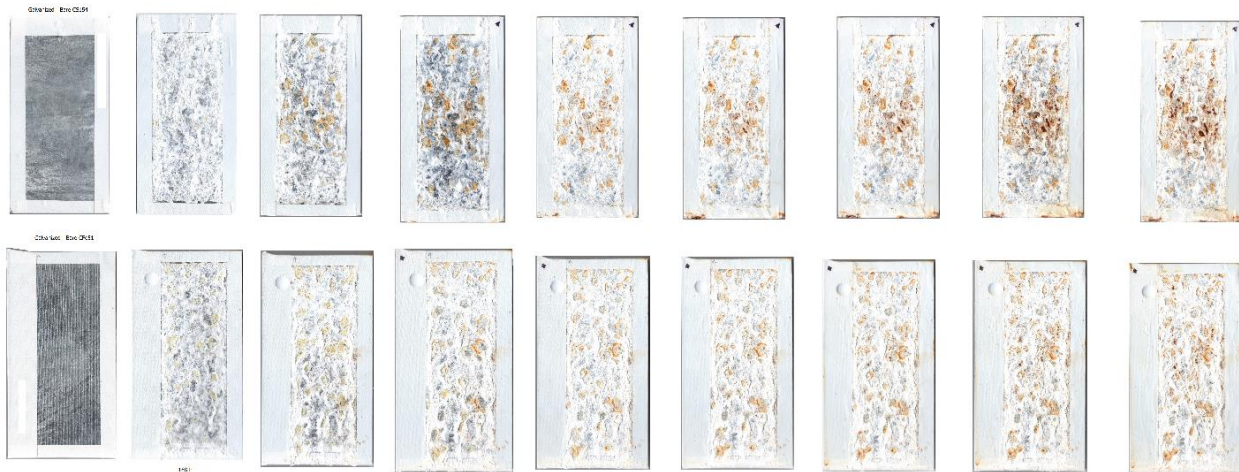
Figure 3.1-11: Example of unscribed coated panels (galvanized) after salt spray exposure. From left to right, scans of the panels were taken each week for eight weeks.

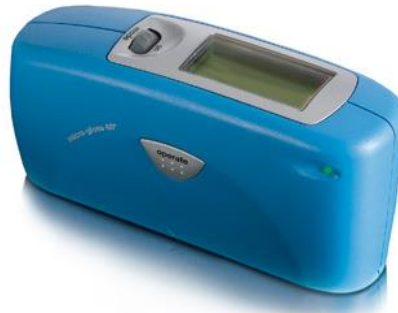
Figure B 3. BYK Gardner Micro-Tri-Gloss 20/60/85° gloss meter.

The specular gloss of the coatings studied in this work was evaluated by ASTM standard D523(ref) (Standard Test Method for Specular Gloss) using a BYK Gardner Micro-Tri-Gloss 20/60/85° gloss meter (see Figure B3). Gloss is associated with the visual observation of surface shininess and it is reported based on reflection of light from the specimen to a black glass standard. Table B22 shows gloss measurements of coatings studied in this work reporting 20, 60 and 85°.

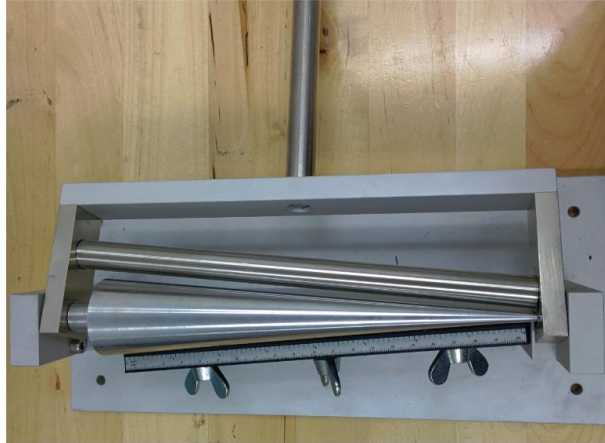
Figure B 4. Conical mandrel test apparatus.

Flexibility of the coatings studied in this work was evaluated by ASTM standard D522(ref) (Standard Test Methods for Mandrel Bend Test of Attached Organic Coatings) using a conical mandrel (see Figure B4). Metal panels were placed with two sheets of brown kraft wrapping paper on each side between the mandrel and the drawbar. The lever is moved 180° to bend the panel to approximately 135°. Any cracks are measured by using the chart in Figure B5. Results are displayed in Table B25 and show the elongation percentage of coatings employed in this study indicating its respective

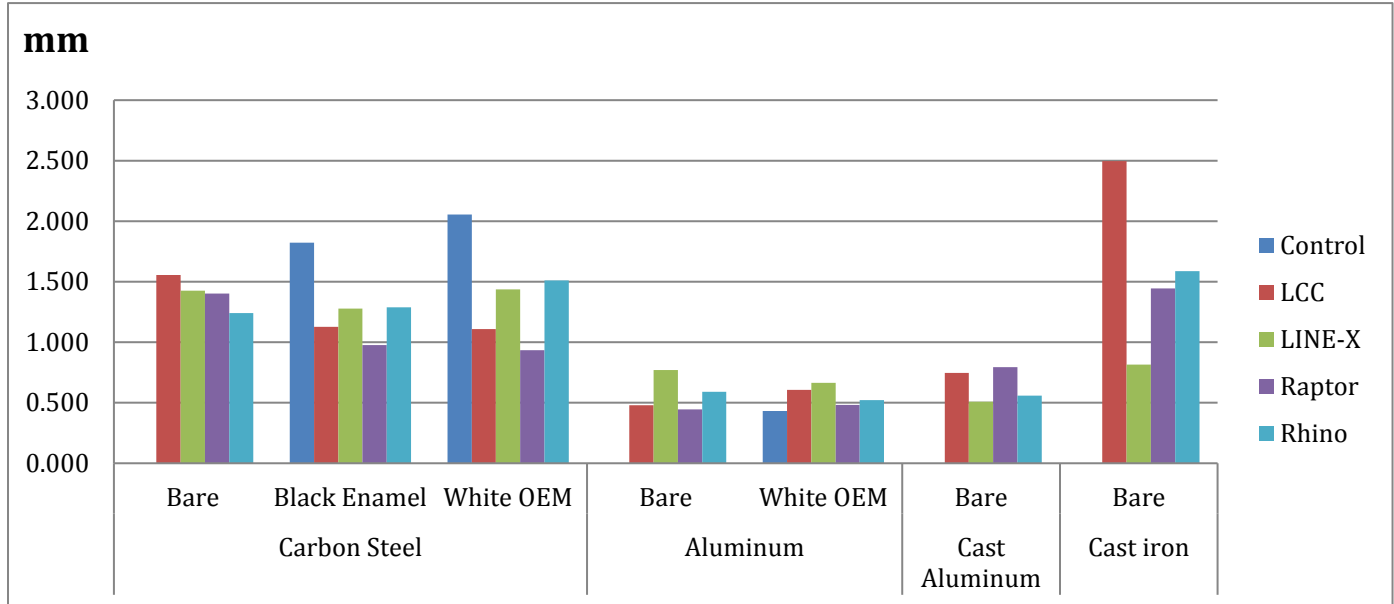
Figure C 1. Representative Creep rate measurements in mm of exposed metal panels to salt spray chamber for 336 hours.

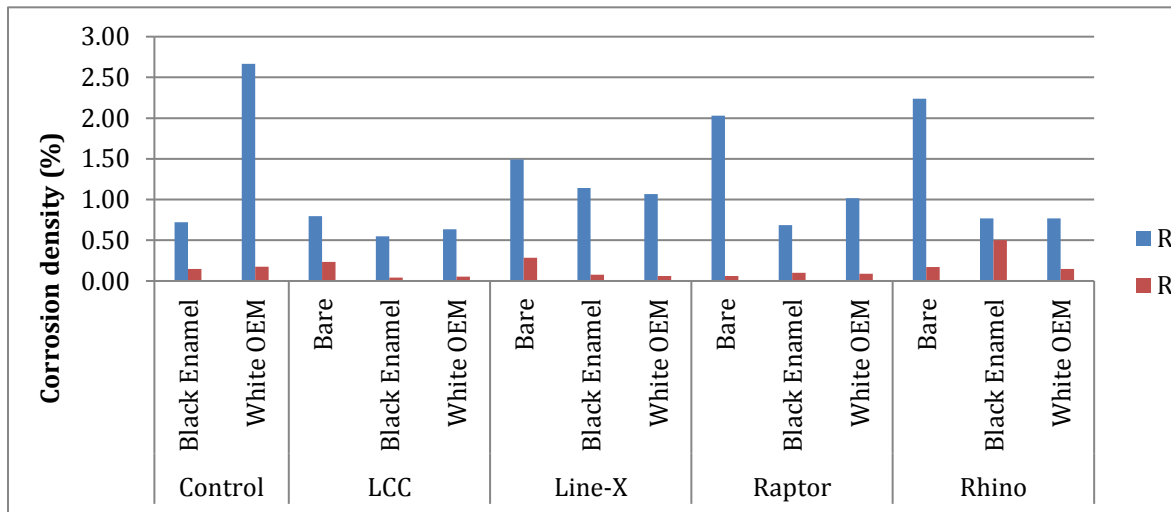
Figure E 7. Average of corrosion density on carbon steel samples exposed to accelerated corrosion testing (B117) for each of the coating systems studied in this work.

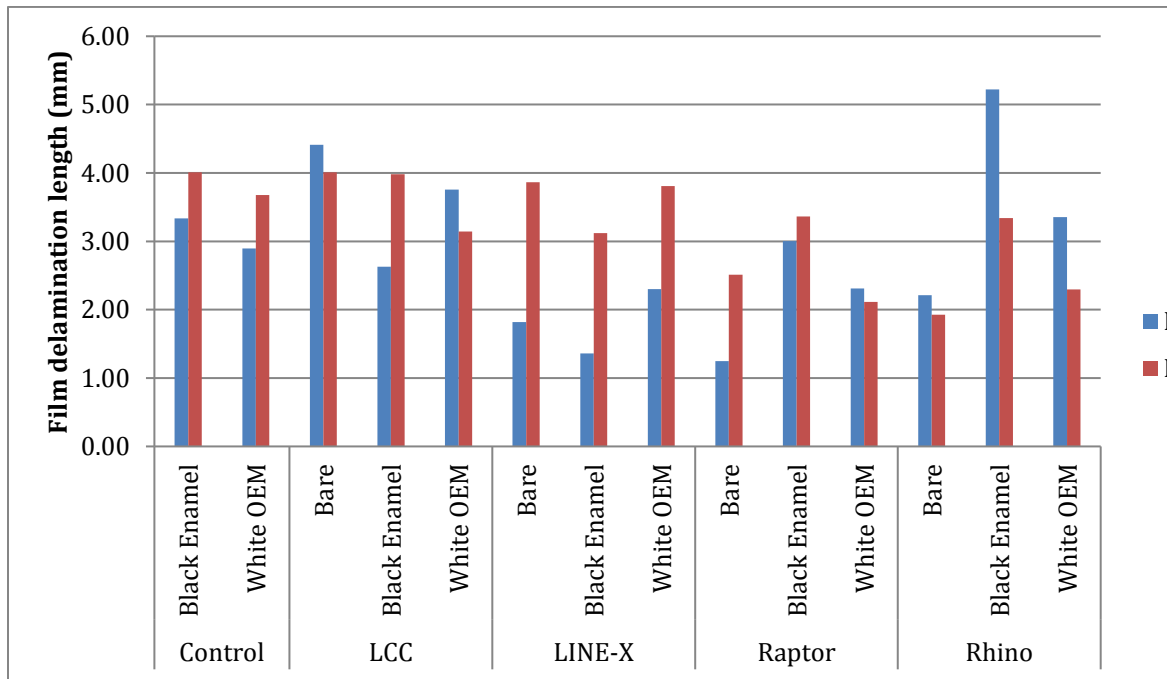
Figure E 9. Average of film delamination length of carbon steel panels exposed to accelerated corrosion testing (B117) for each of the coating systems studied in this work.

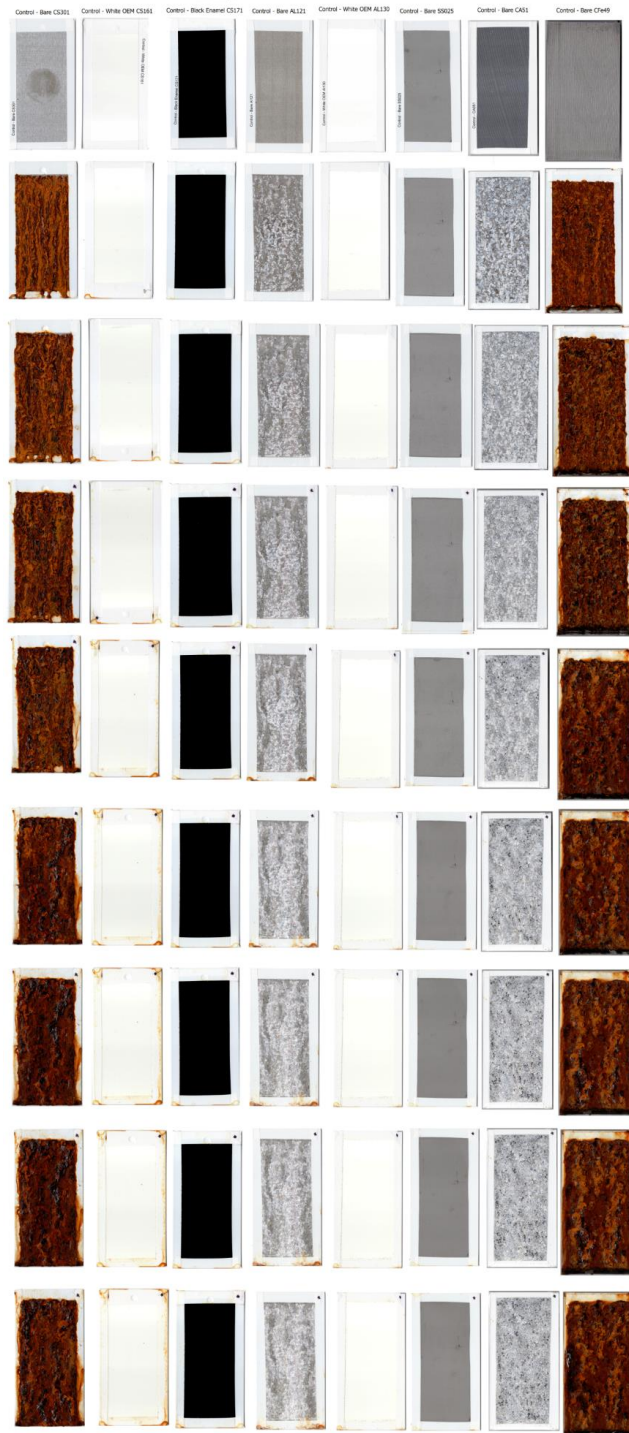
Figure F 1. Control unscrubbed metal panels exposed to the salt spray chamber

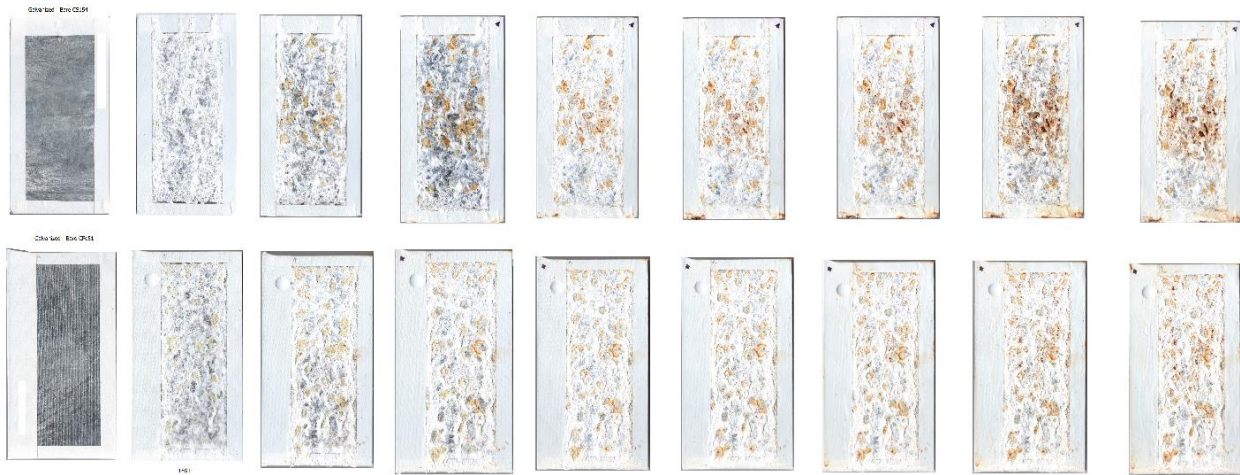
Figure F 2. Galvanized unscribed metal panels exposed to the salt spray chamber.

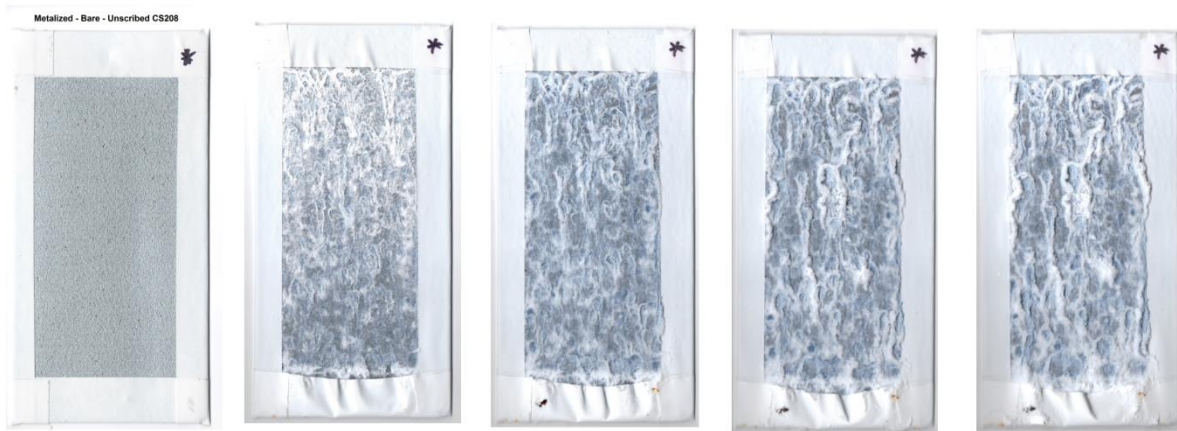
Figure F 5. Metalized unscribed metal panels exposed to the salt spray chamber.

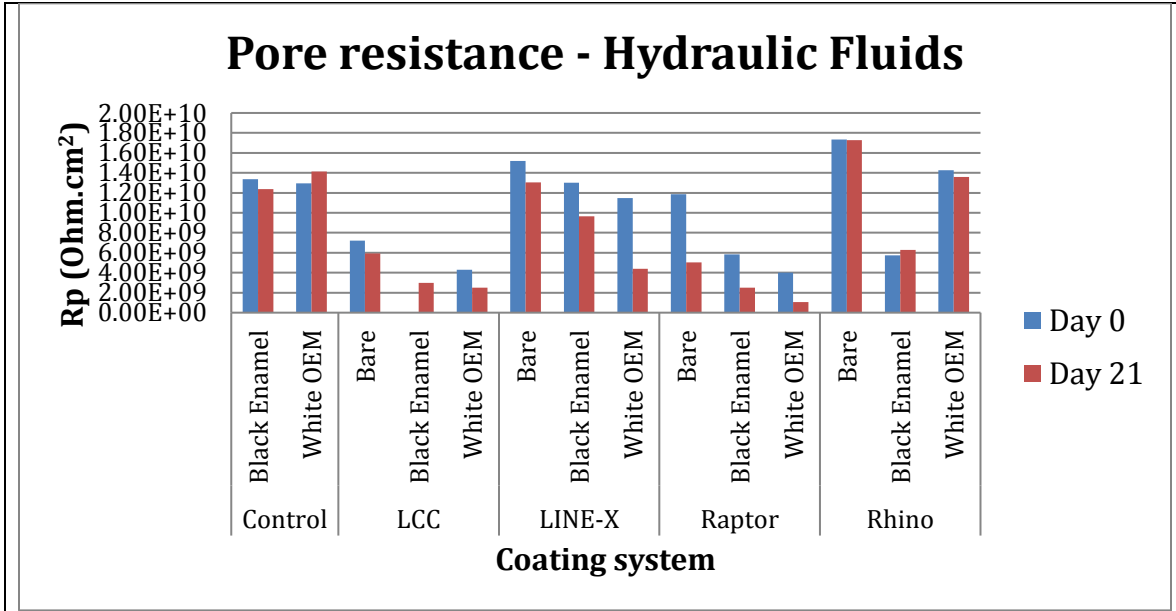
Figure G 19. Pore resistance of coating systems exposed to hydraulic fluids (AW32) over 21 days. Notice that LINE-X and Raptor have a large decrease in pore resistance, indicating a large uptake of motor oil into the coating. This may lead to a breakdown in the coating over time. Pore resistance of LCCCOAT on black enamel at day 0 was too large to be determined.

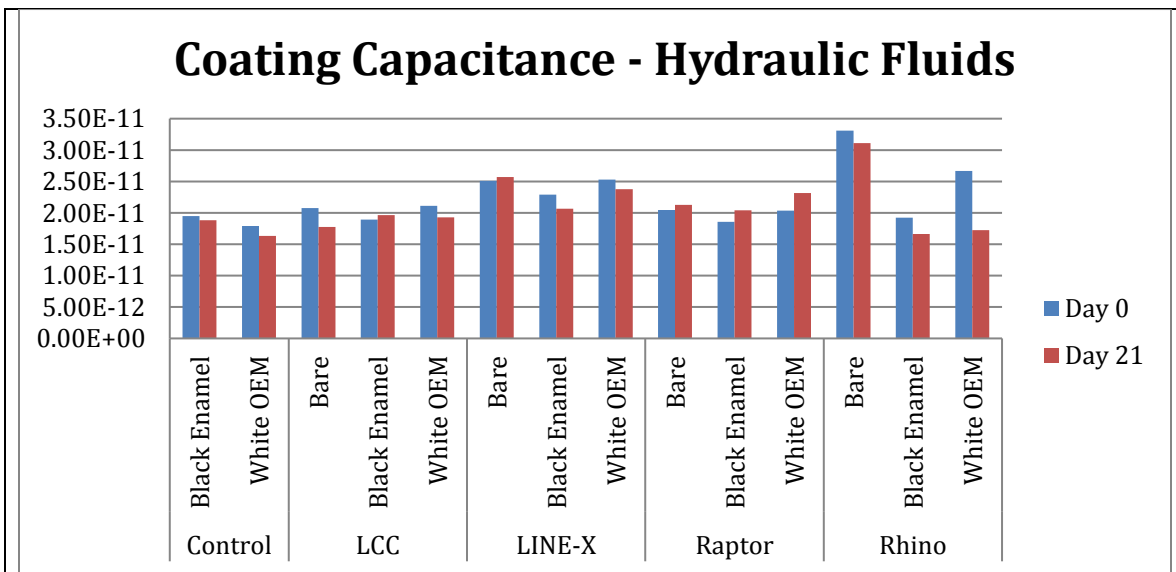
Figure G 20. Coating capacitance of coating systems exposed to hydraulic fluids (motor oil) over 21 days. Notice that most coatings have a small decrease in coating capacitance, indicating an uptake of motor oil into the coating. On the other hand, Raptor shows an increase in coating capacitance. As AW32 is less corrosive than sodium

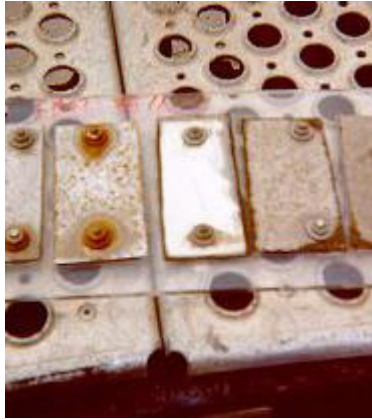
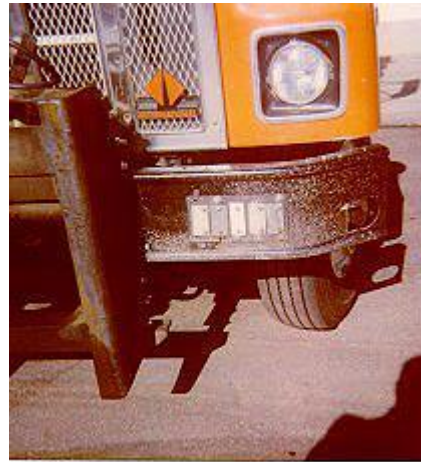
Figure L 3: Metal coupons used to measure corrosion on winter maintenance vehicles. Corrosion rate was measured as weight lost over time due to exposure of the coupons to two different salt solutions (Xi and Xie 2002).
